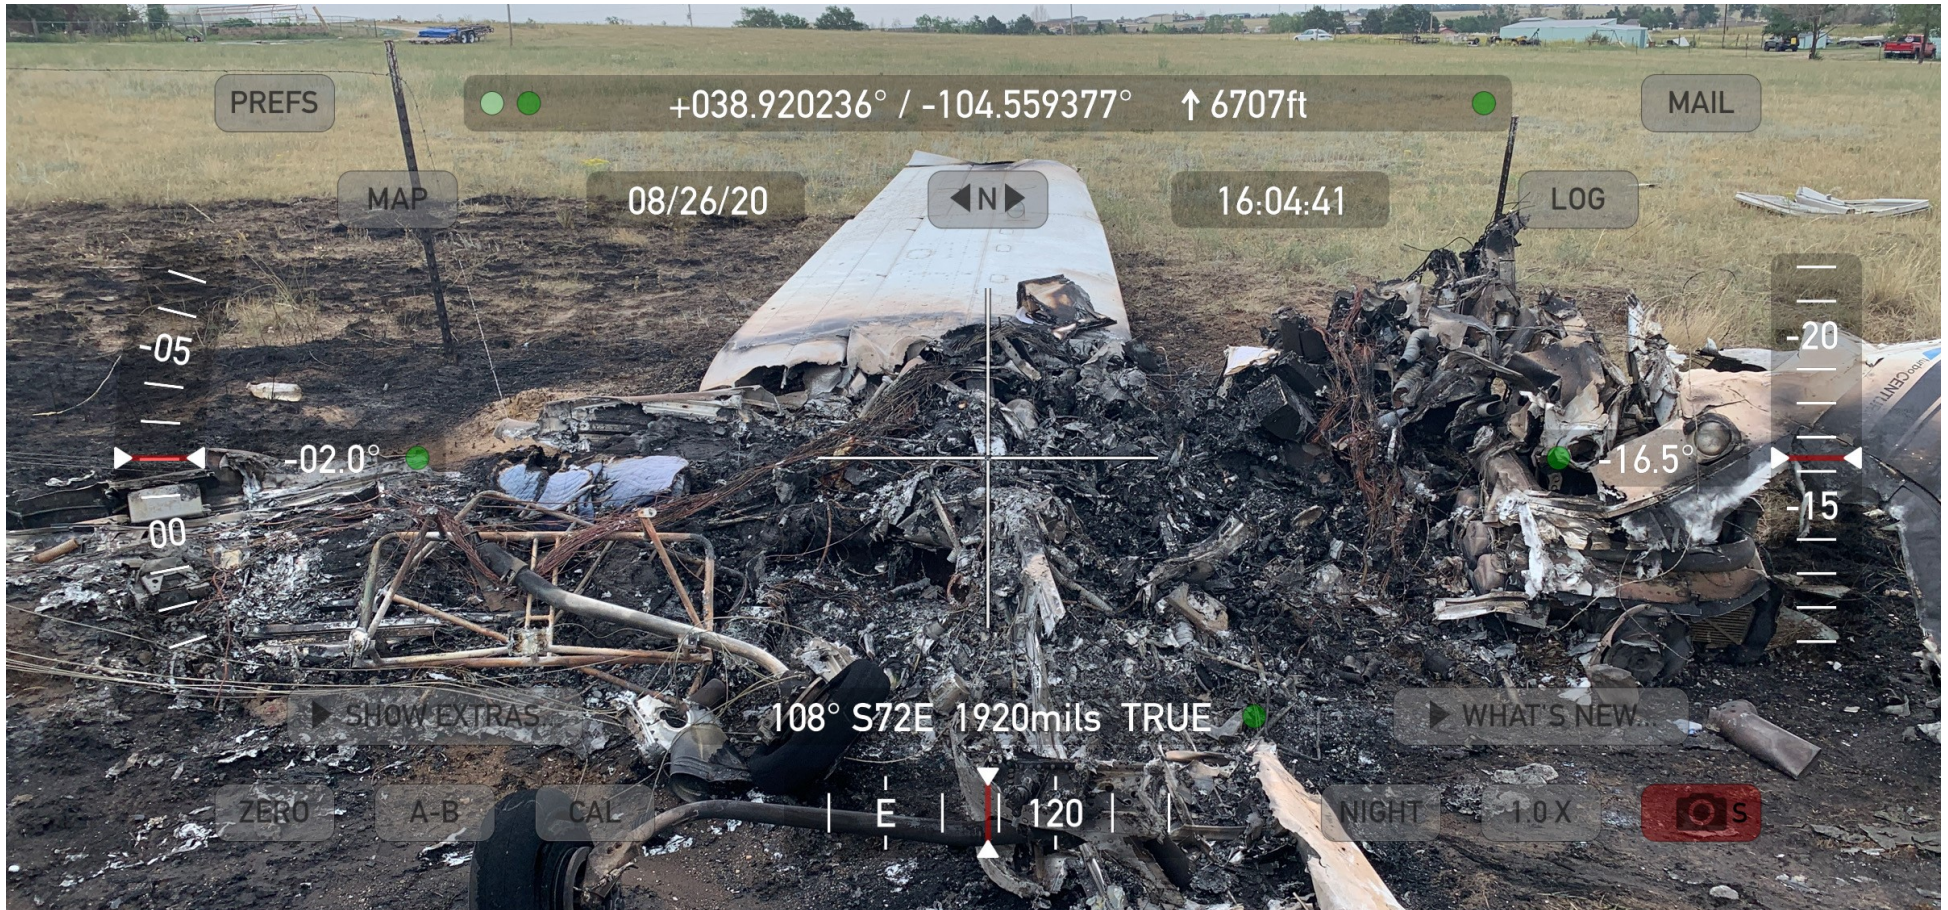
Photo 1 – Supplied photo of the inverted fuselage and right wing.

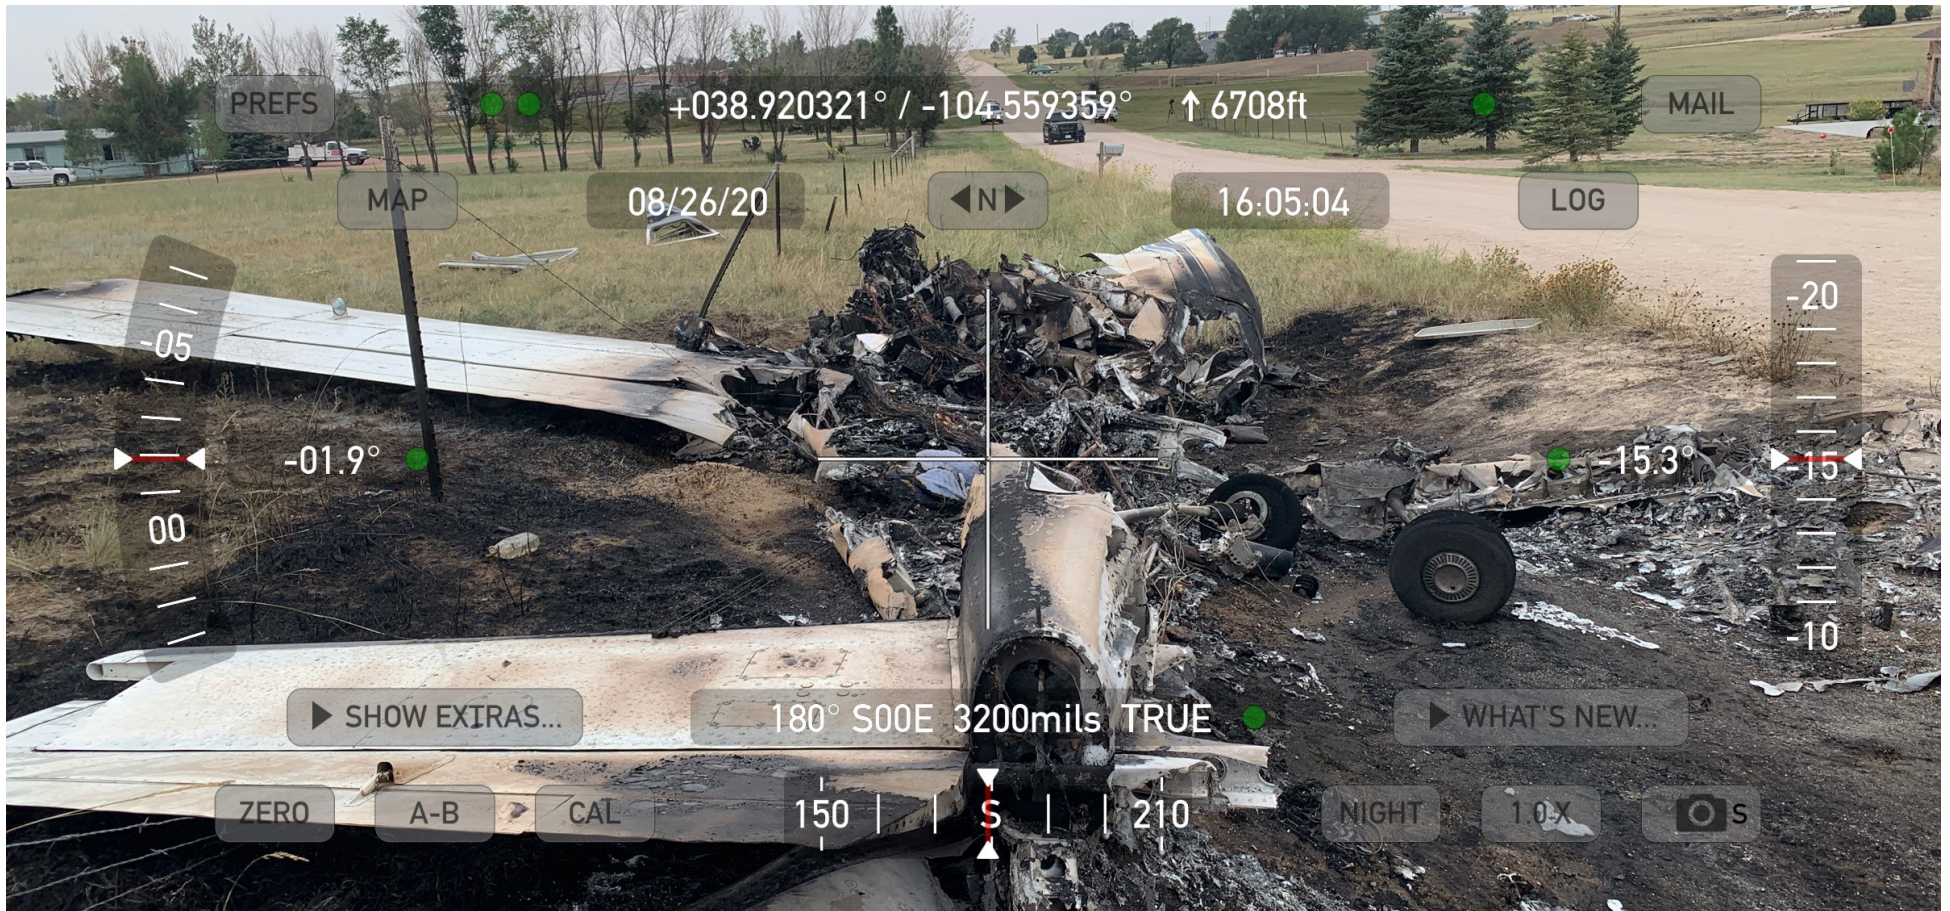
Photo 2 - Supplied photo of the inverted fuselage, empennage, and right wing.

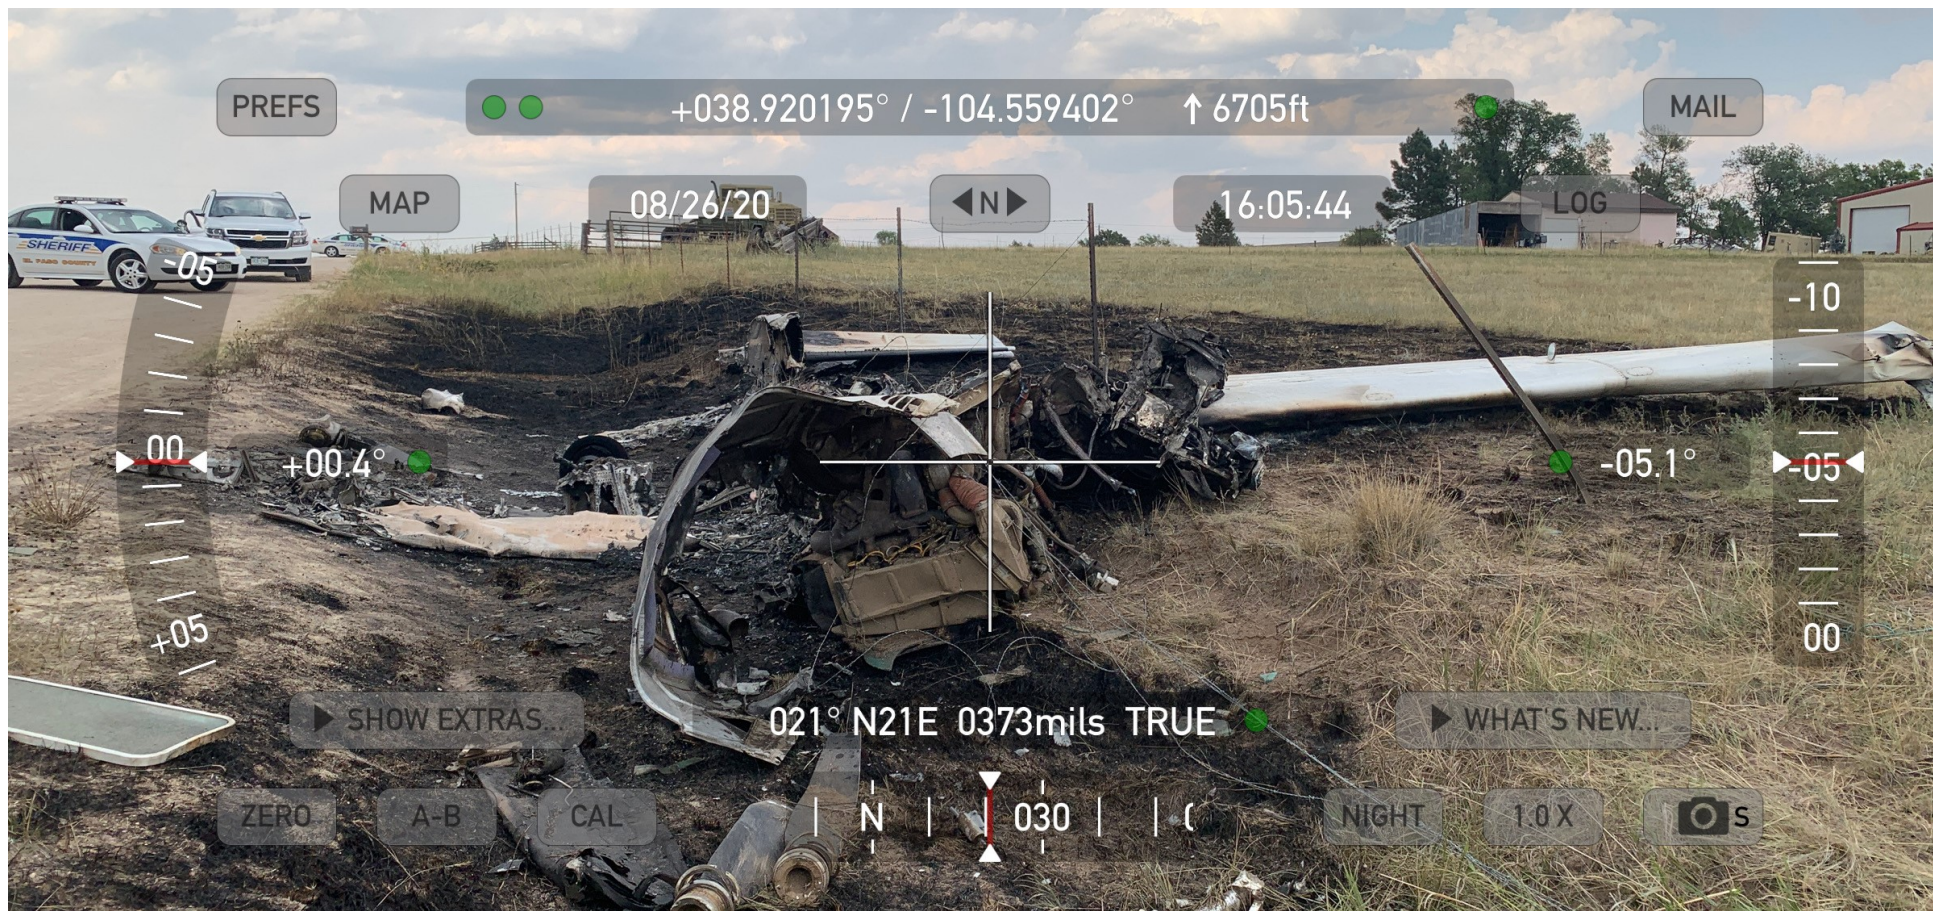
Photo 3 - Supplied photo of the front of the inverted fuselage, empennage, and right wing.

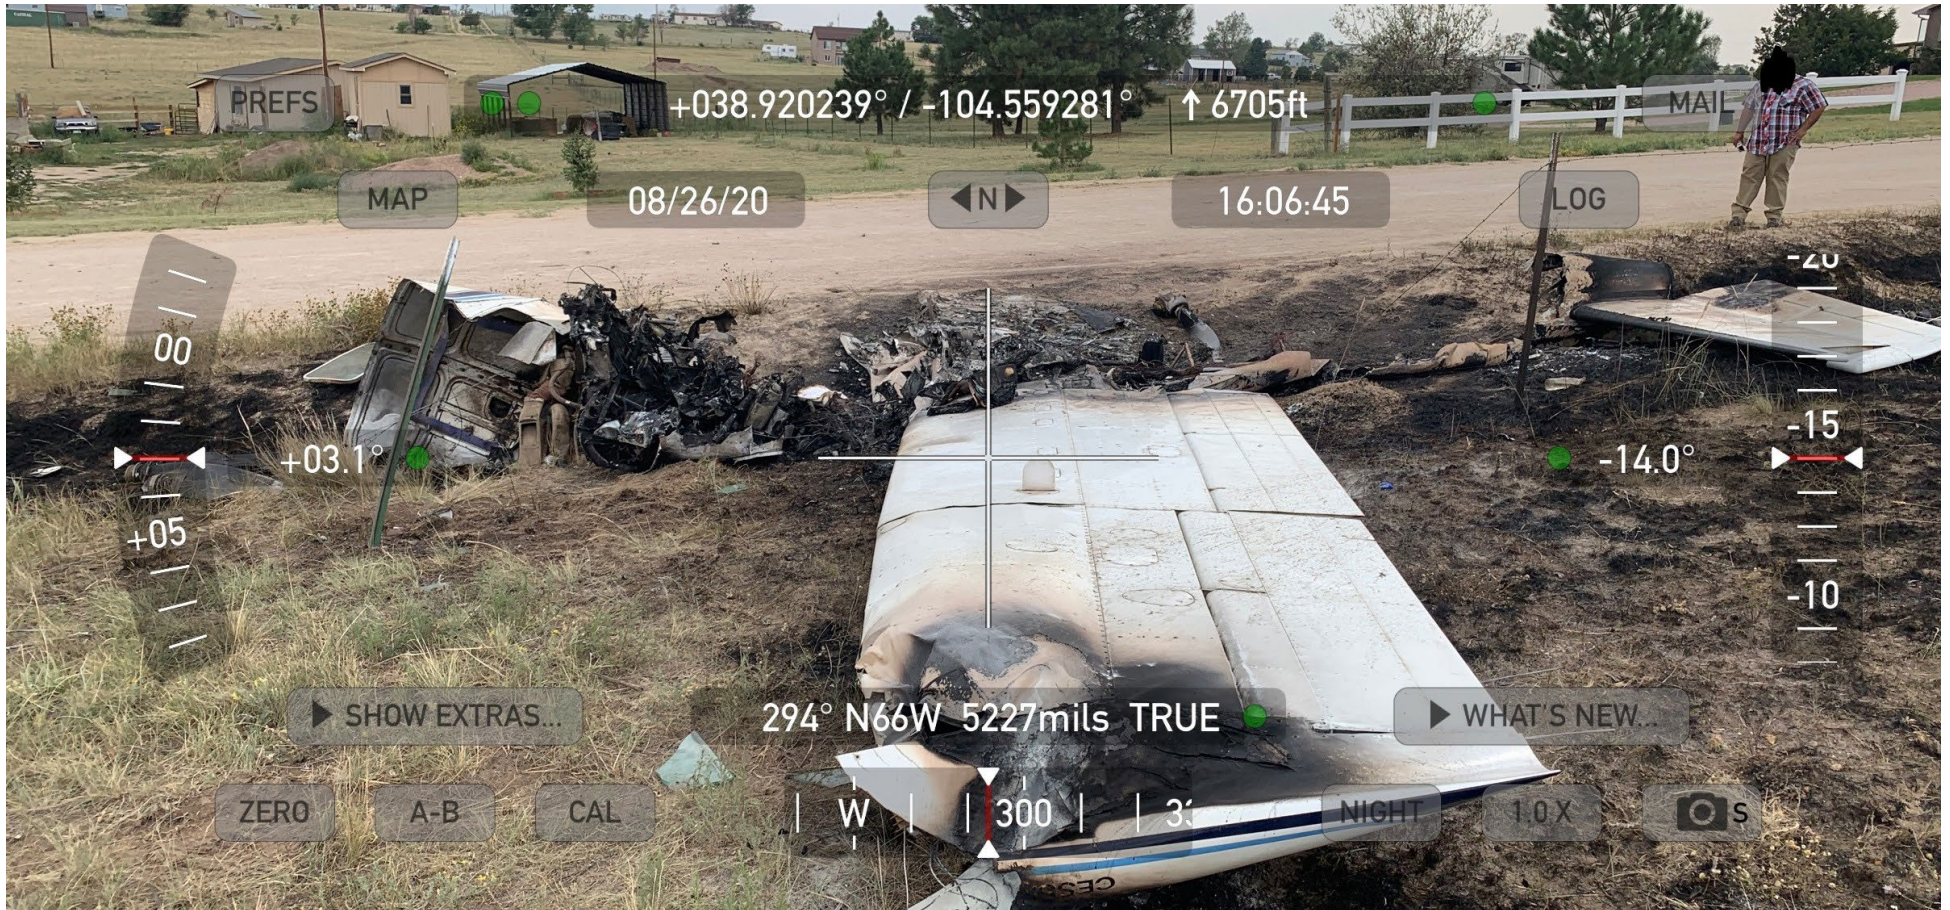
Photo 4 - Supplied photo of the inverted right wing.

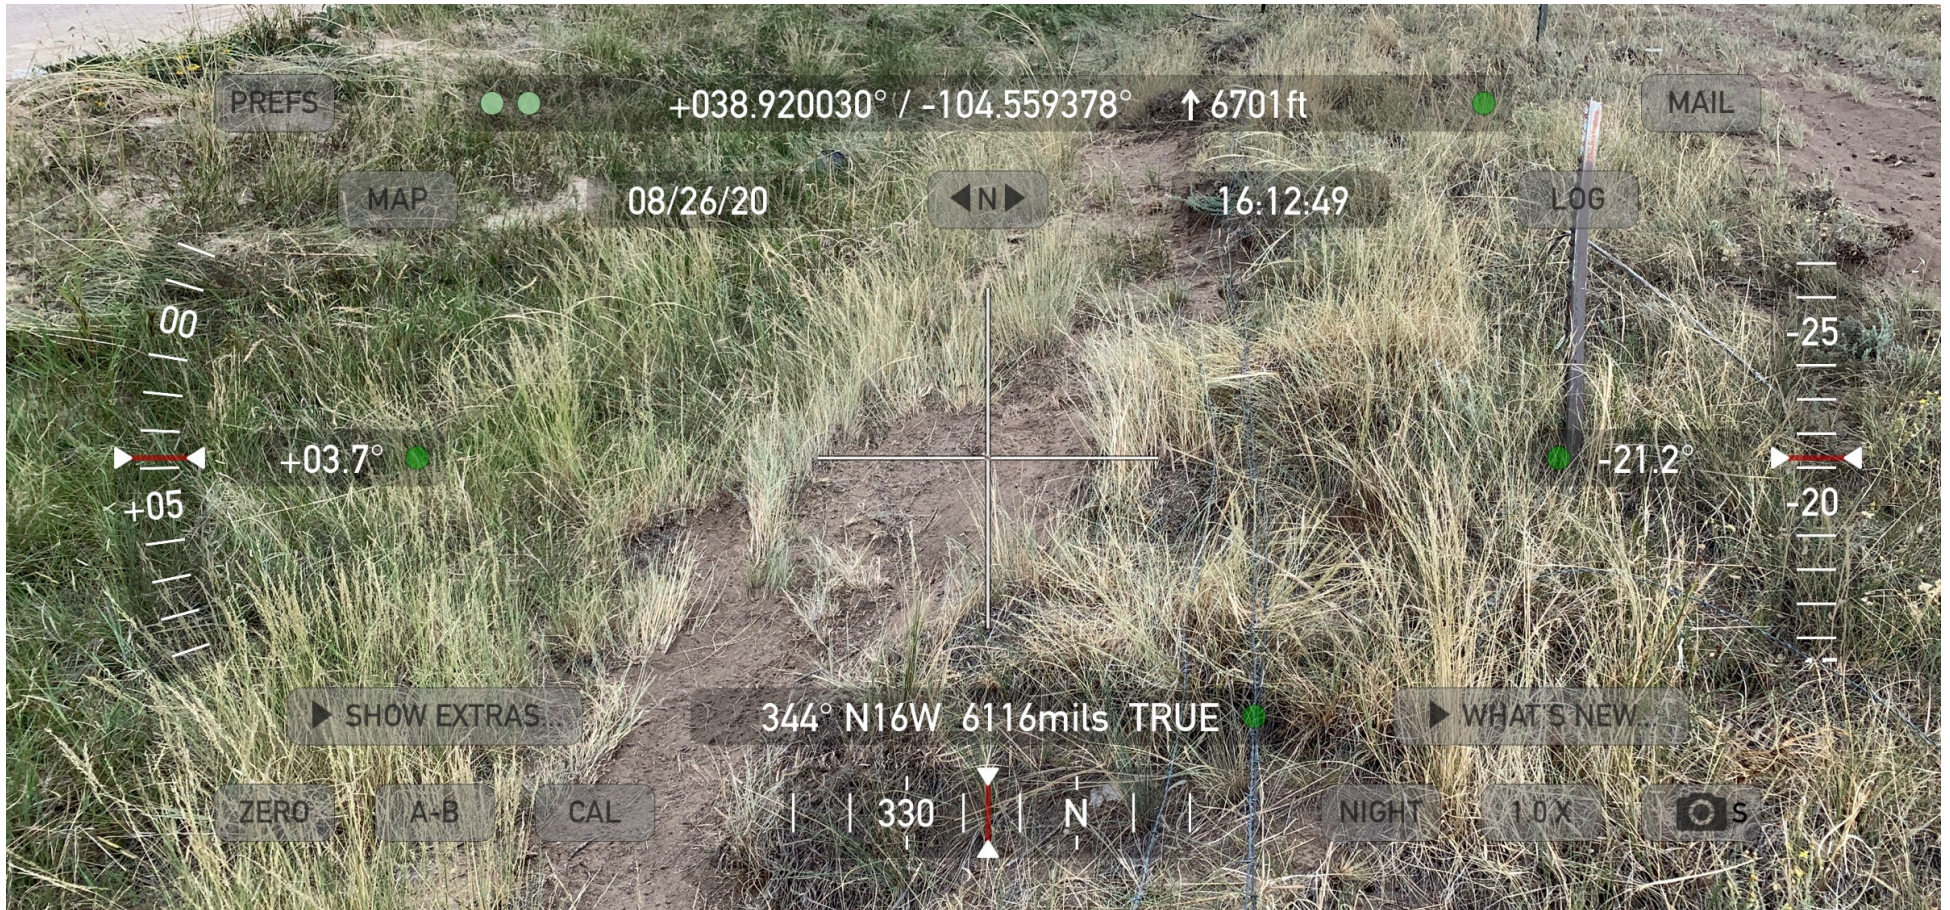
Photo 5 - Supplied photo of a ground scar.

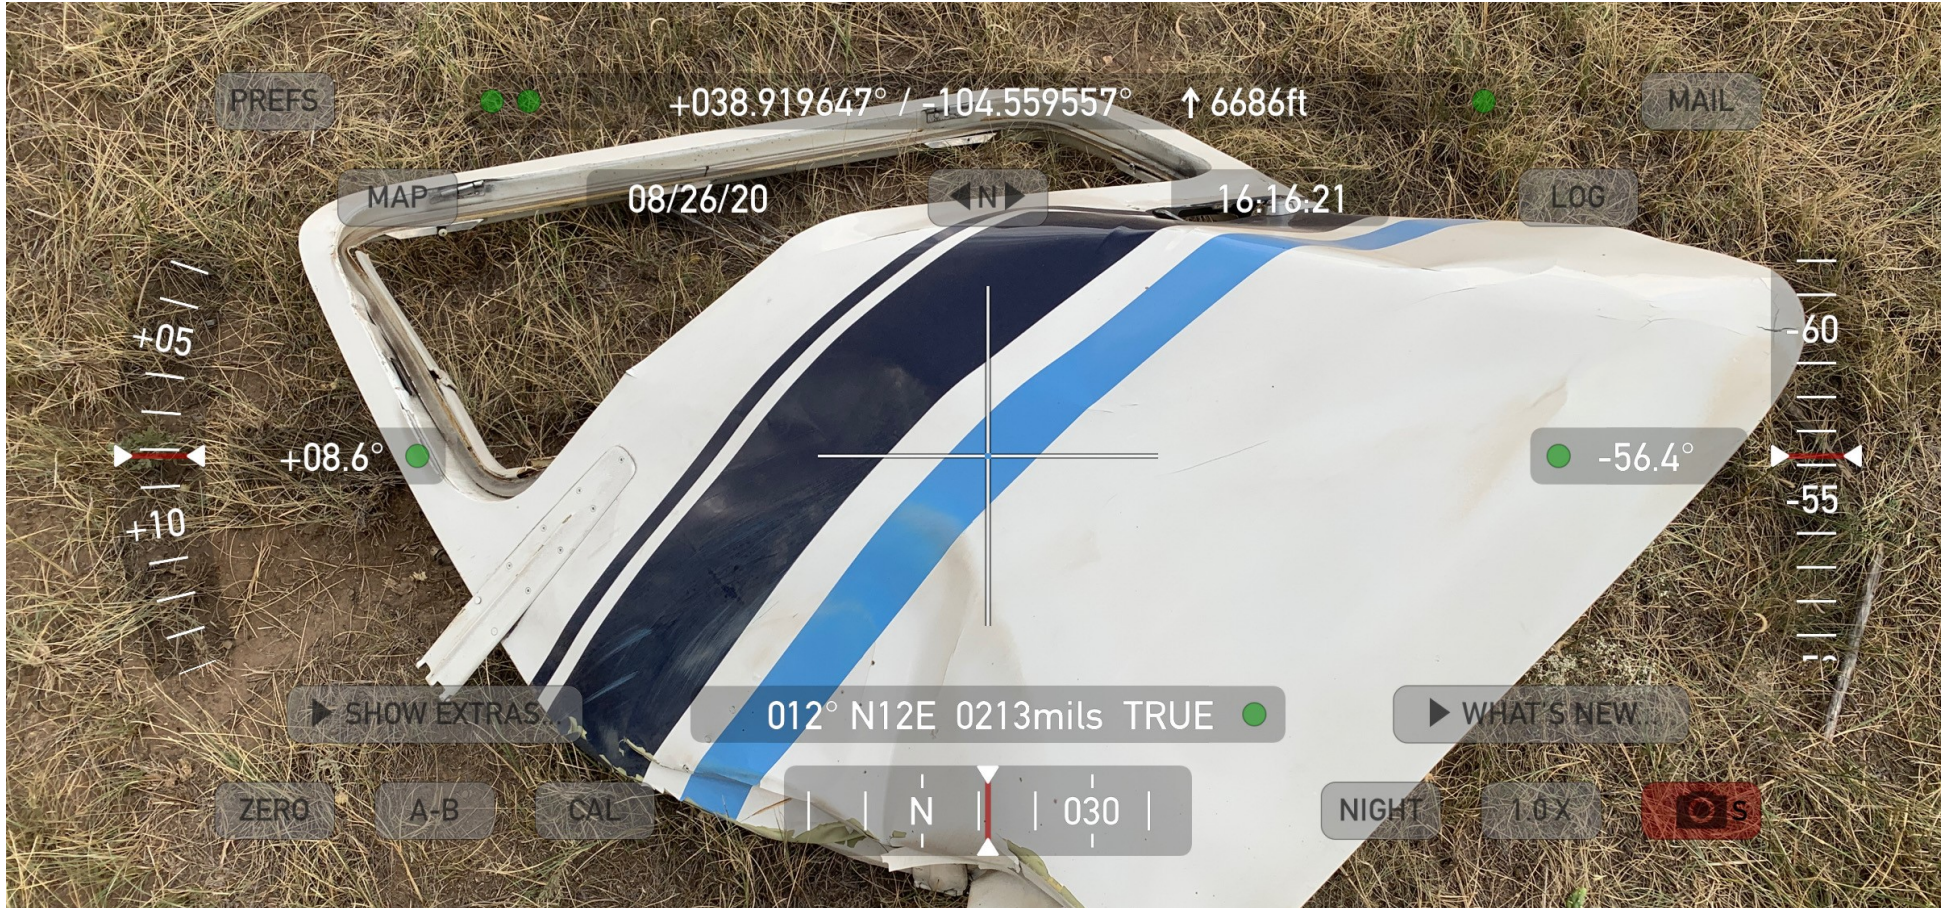
Photo 6 - Supplied photo of a cabin door.

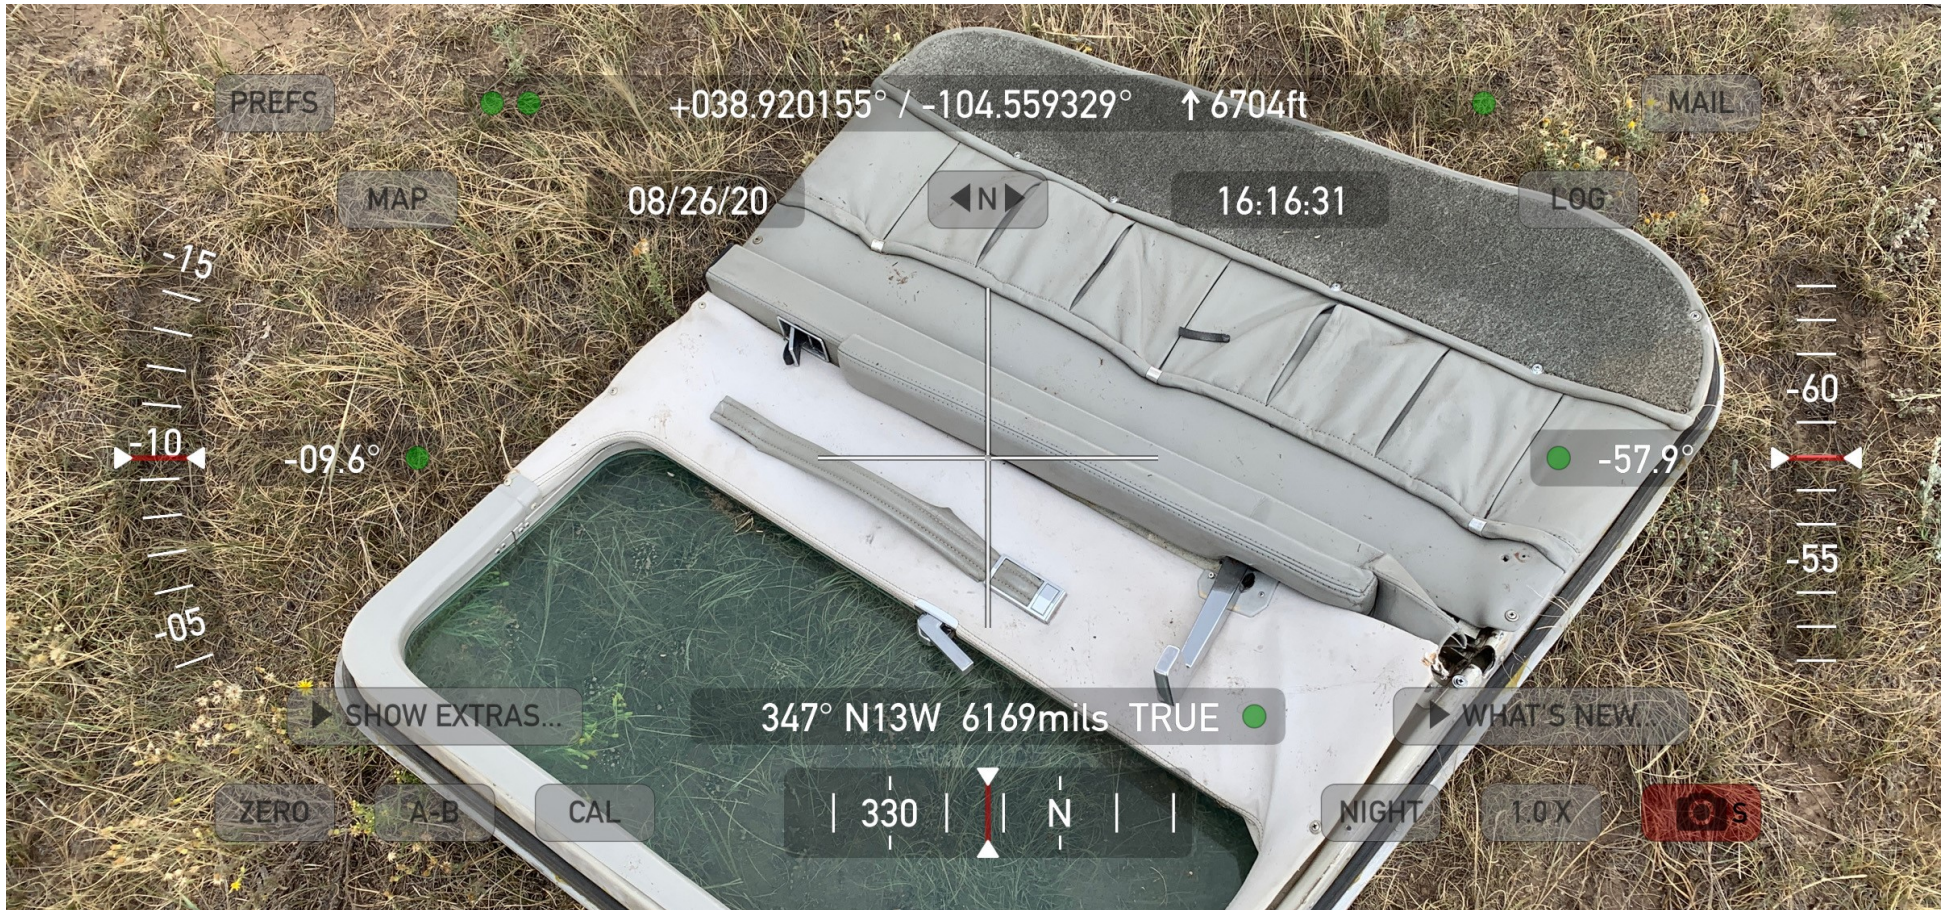
Photo 7 - Supplied photo of a cabin door.

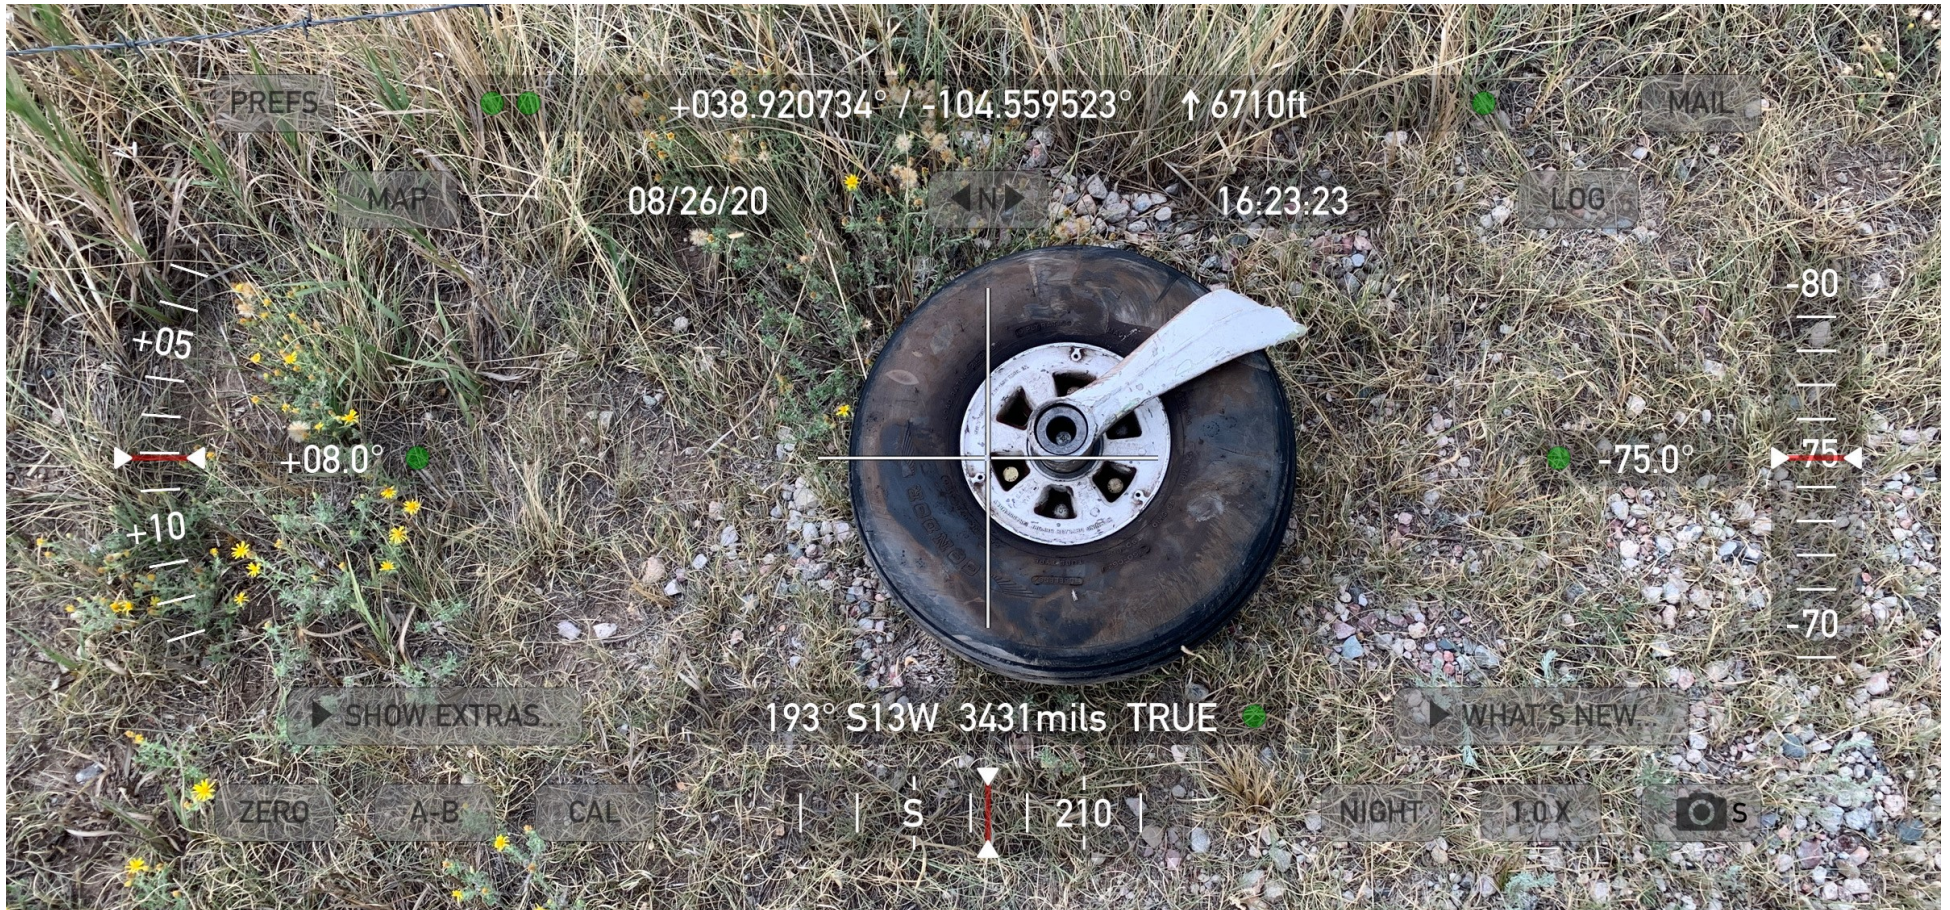
Photo 8 - Supplied photo of the nose landing gear wheel.

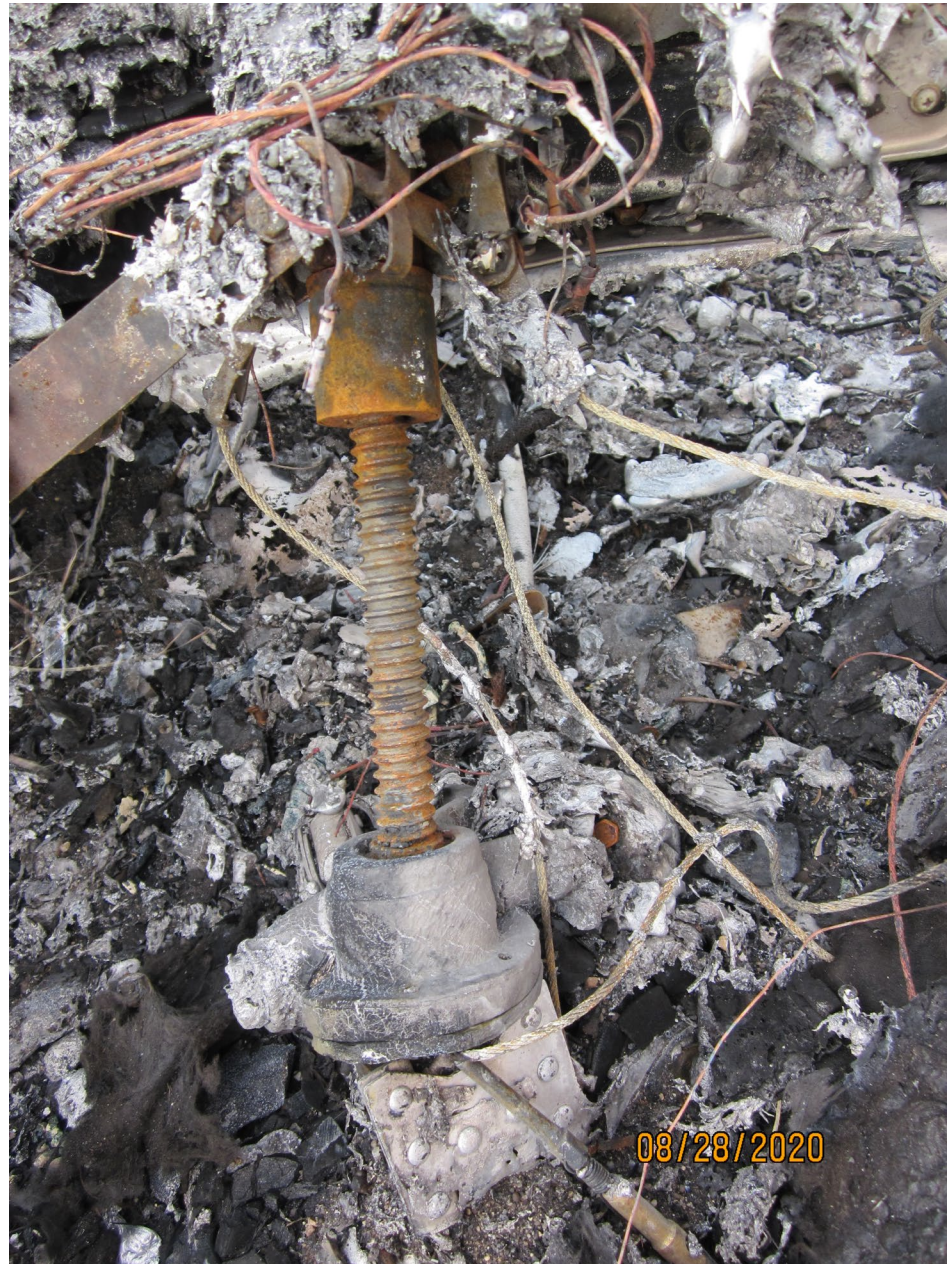
Photo 9 - Supplied photo of the flap jackscrew.

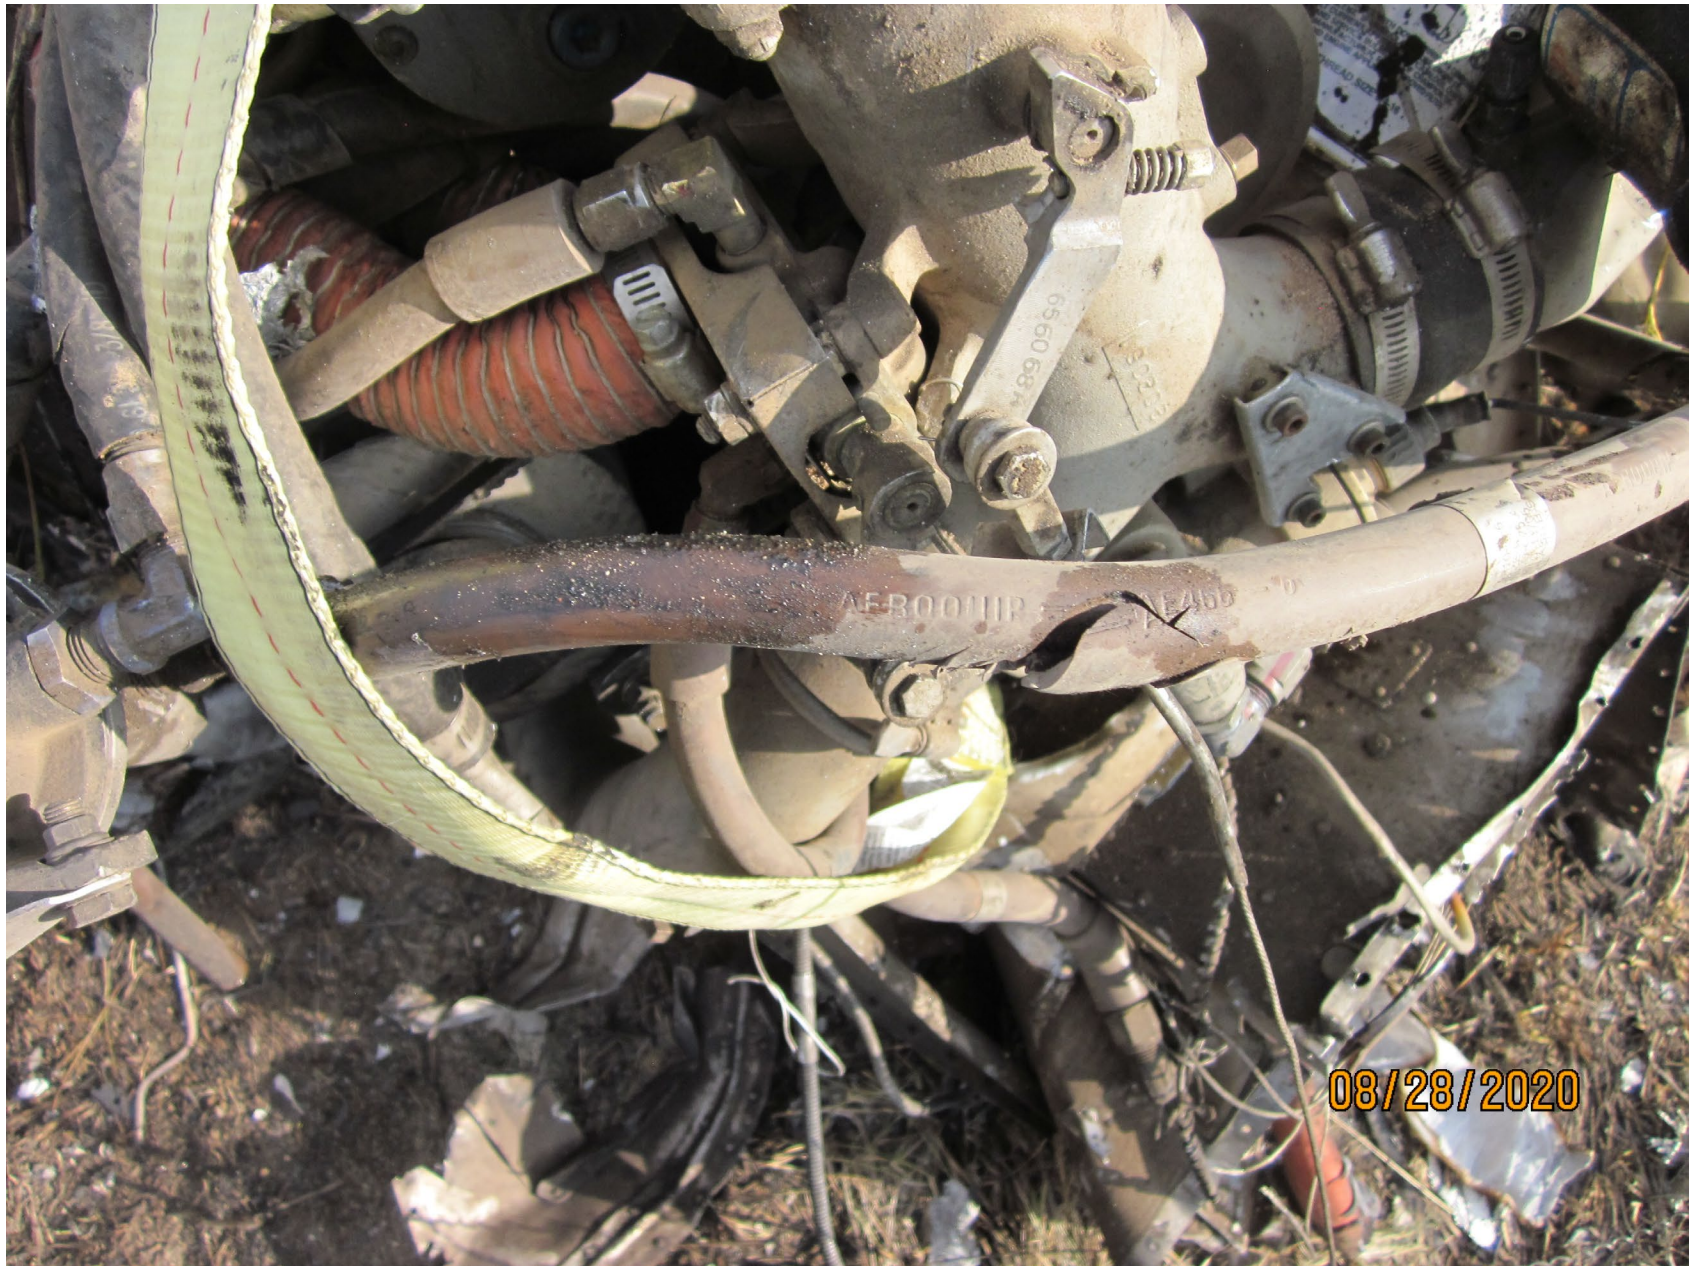
Photo 10 - Supplied photo of the throttle and mixture linkages.

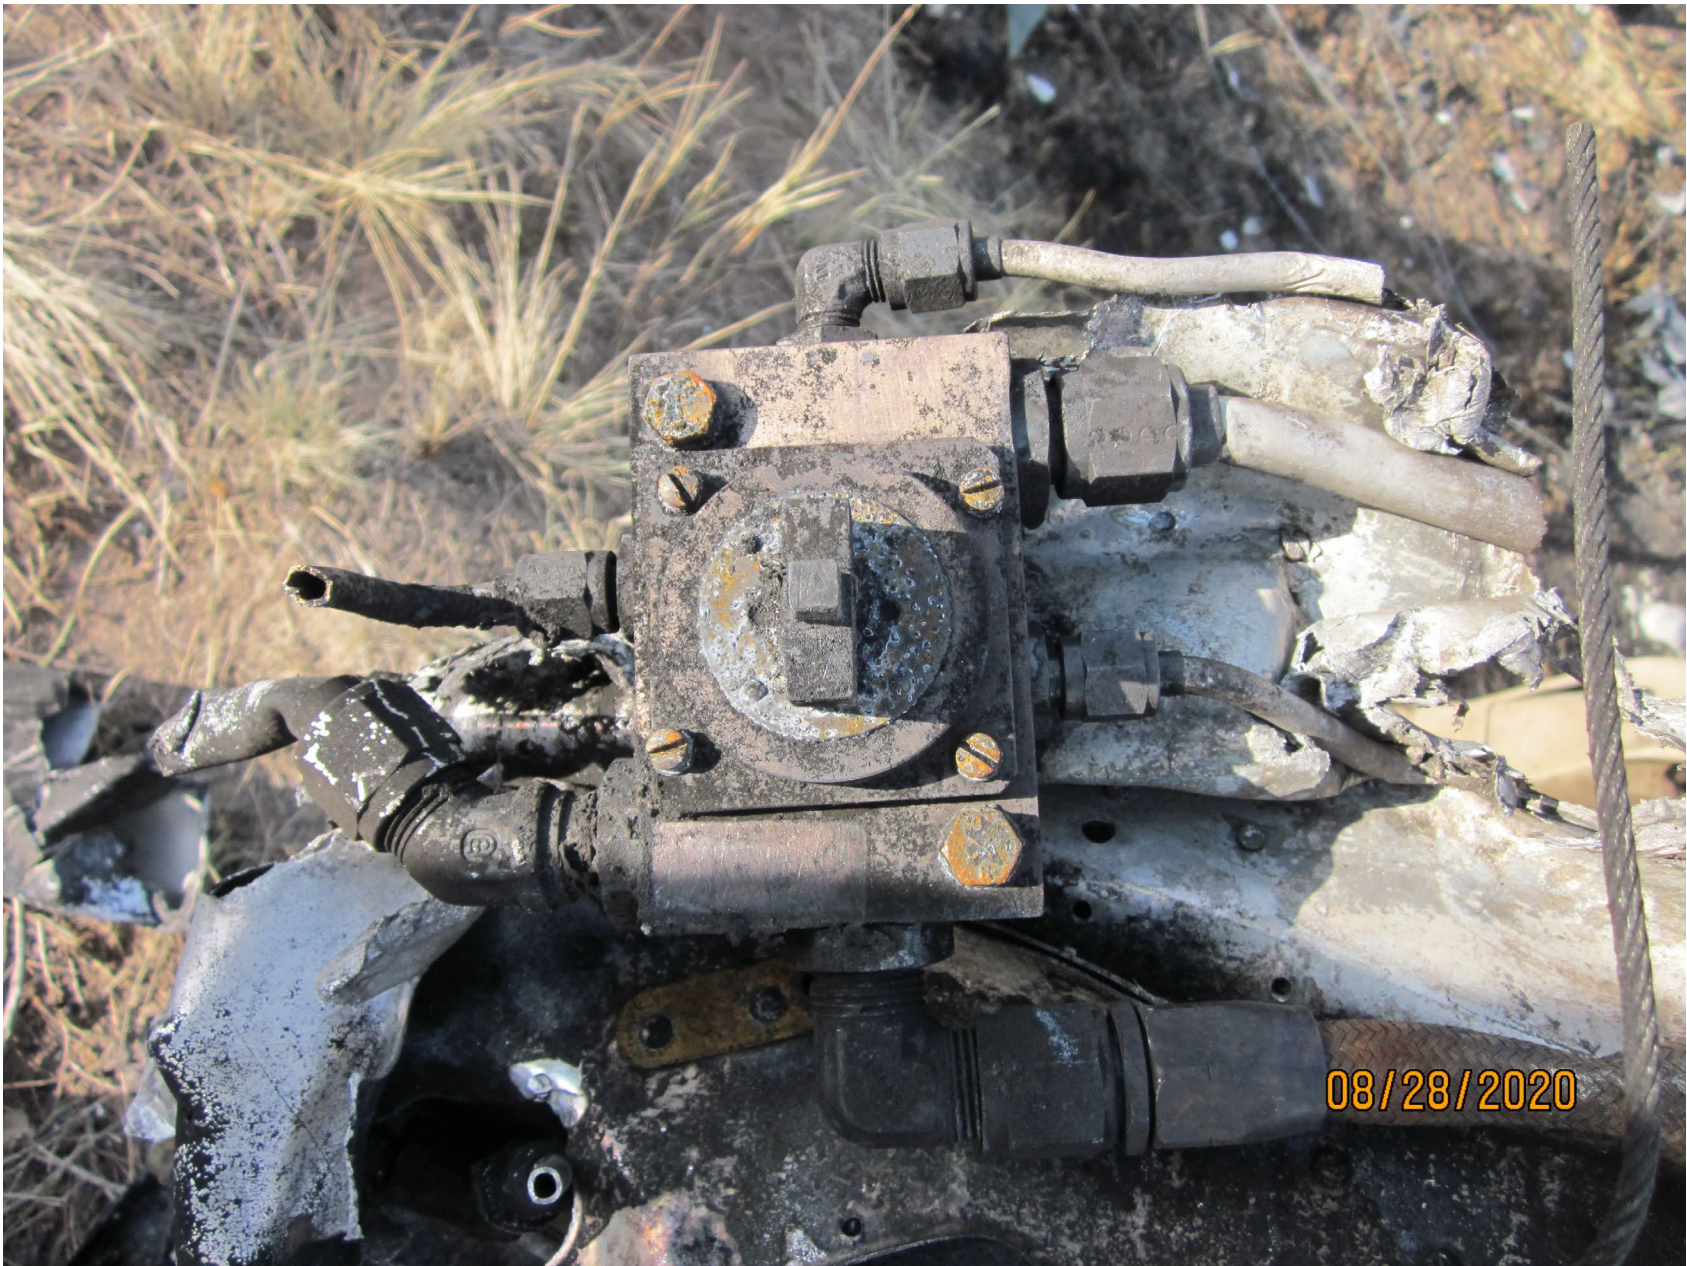
Photo 11 - Supplied photo of the fuel tank selector valve.

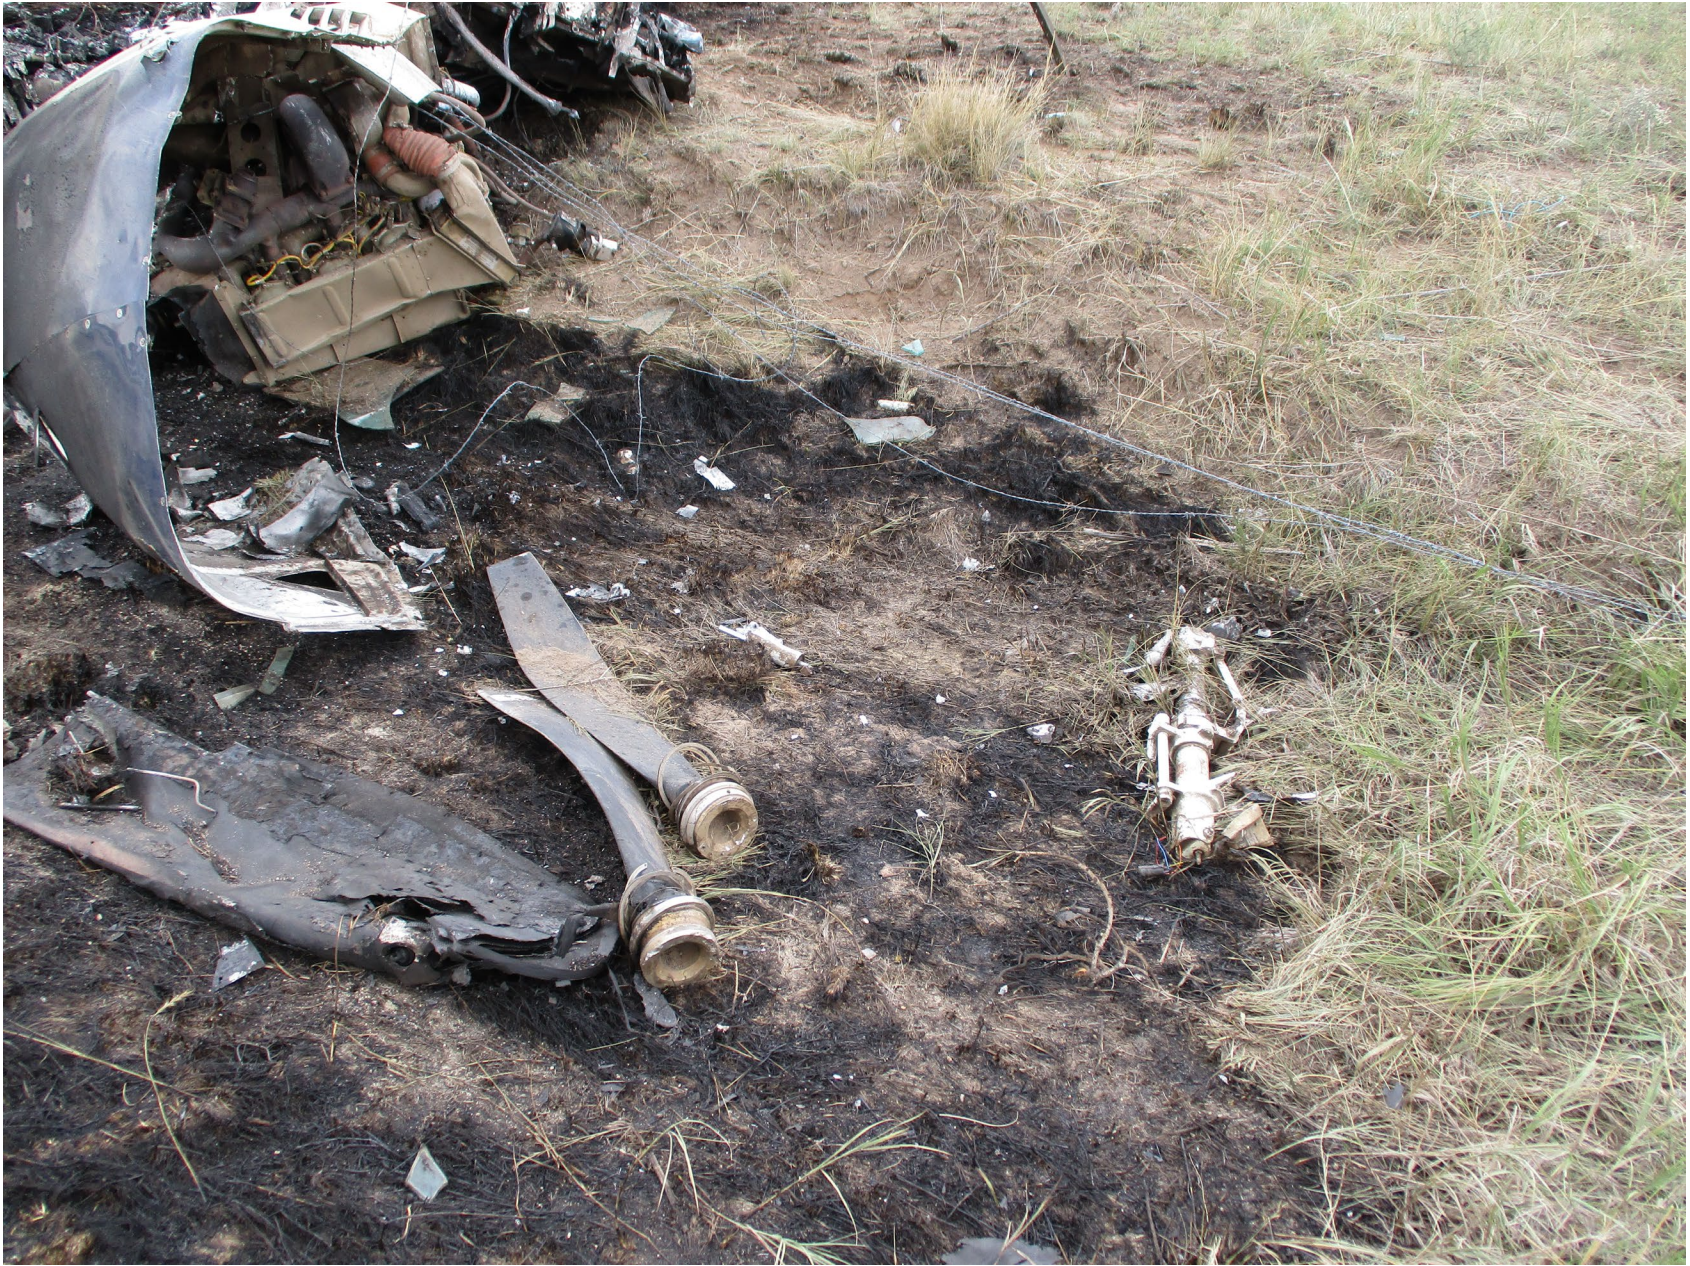
Photo 12 - Supplied photo of propeller blades.
