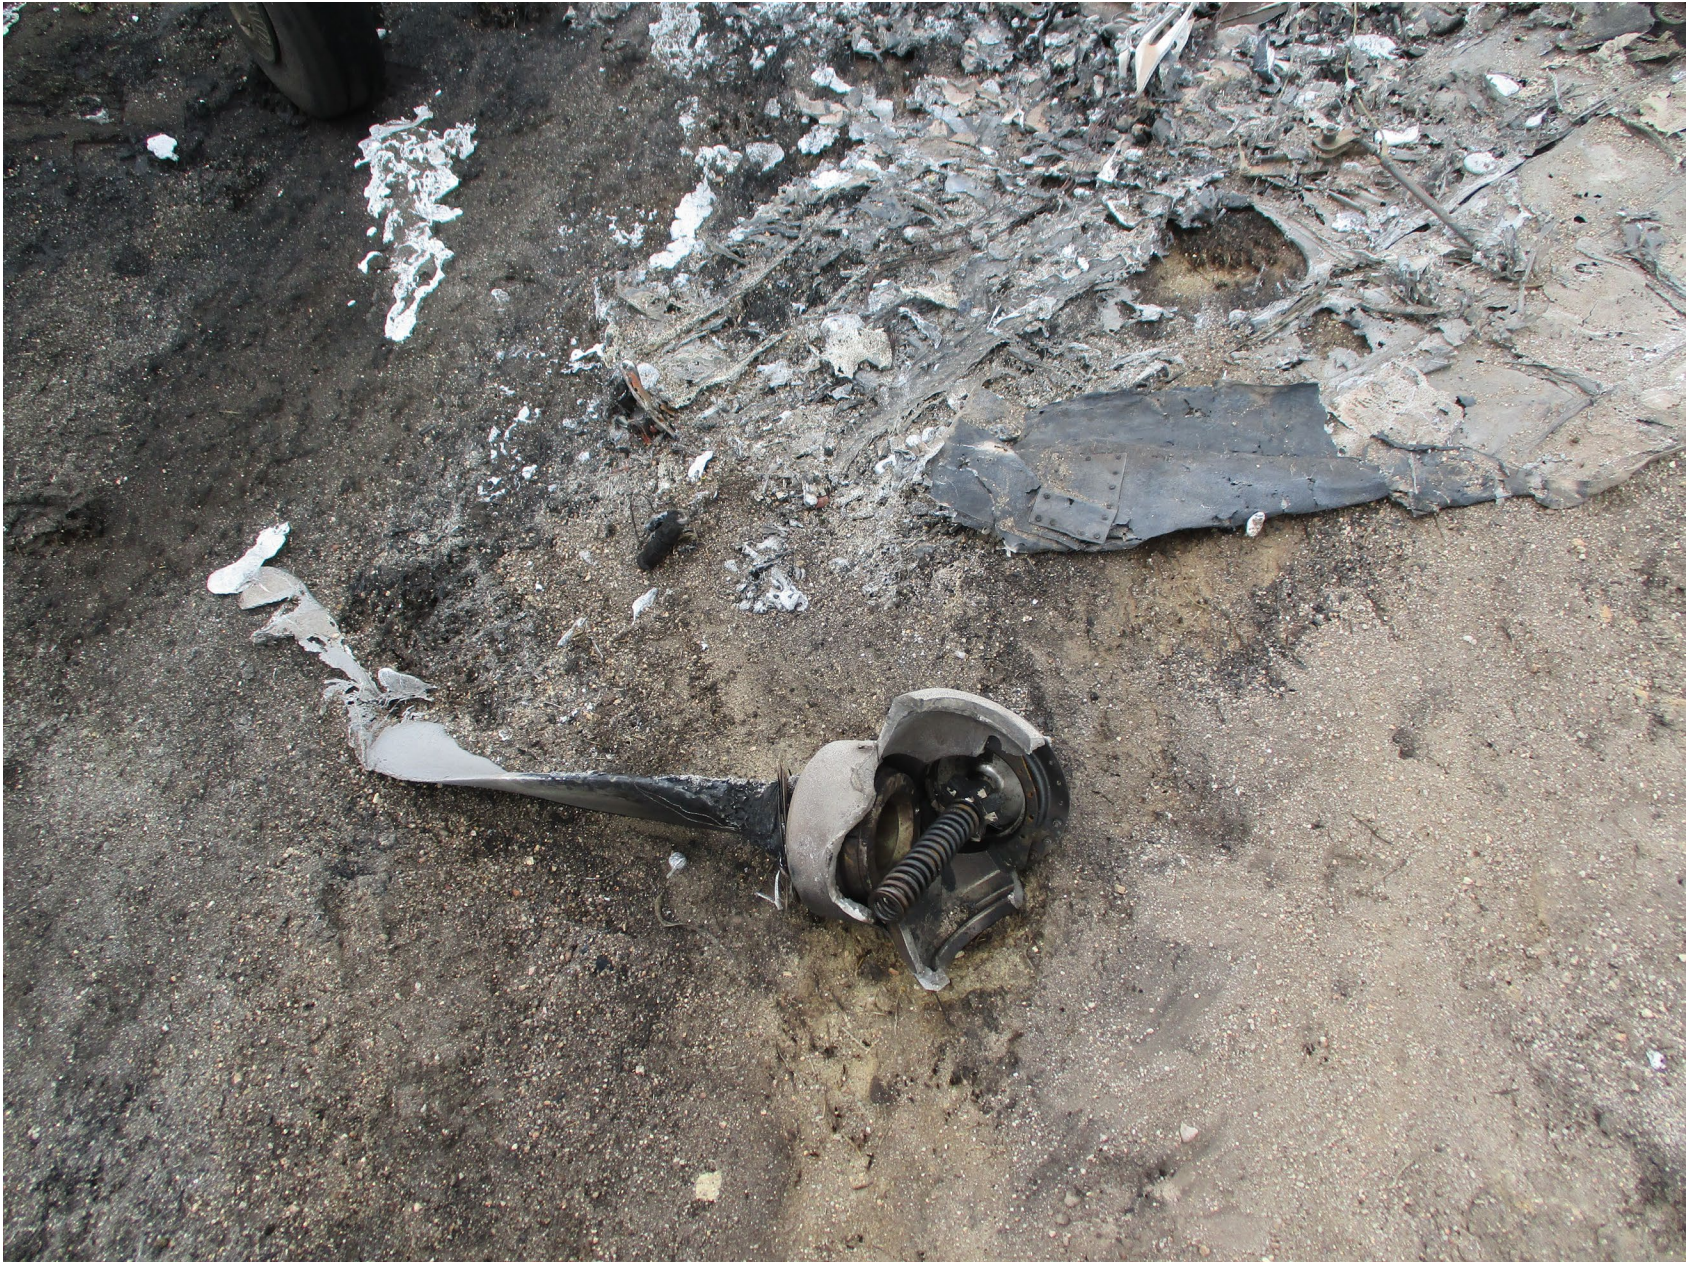
Photo 13 - Supplied photo of a propeller blade and hub.

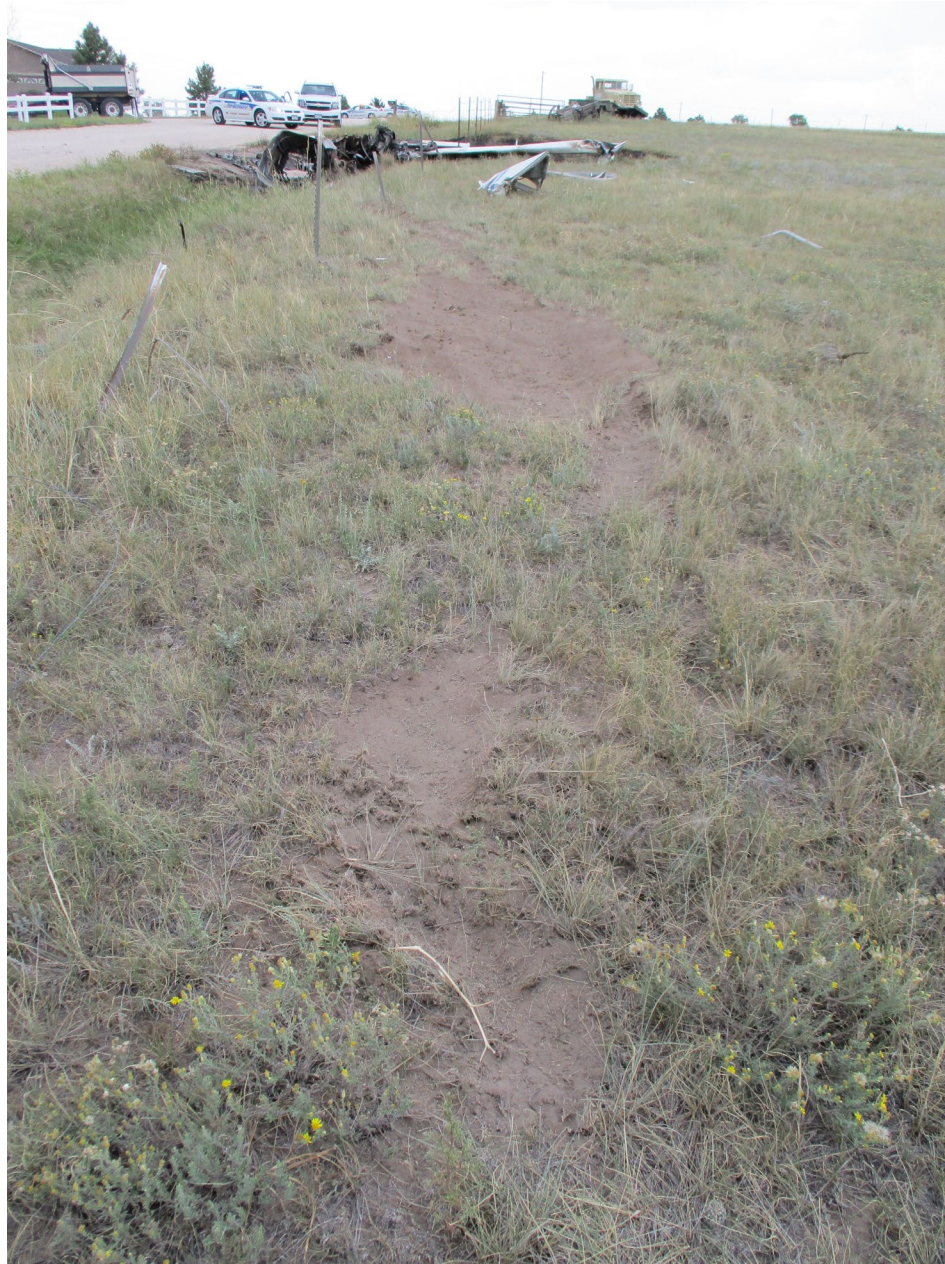
Photo 14 - Supplied photo of the ground scar and airplane in the background.

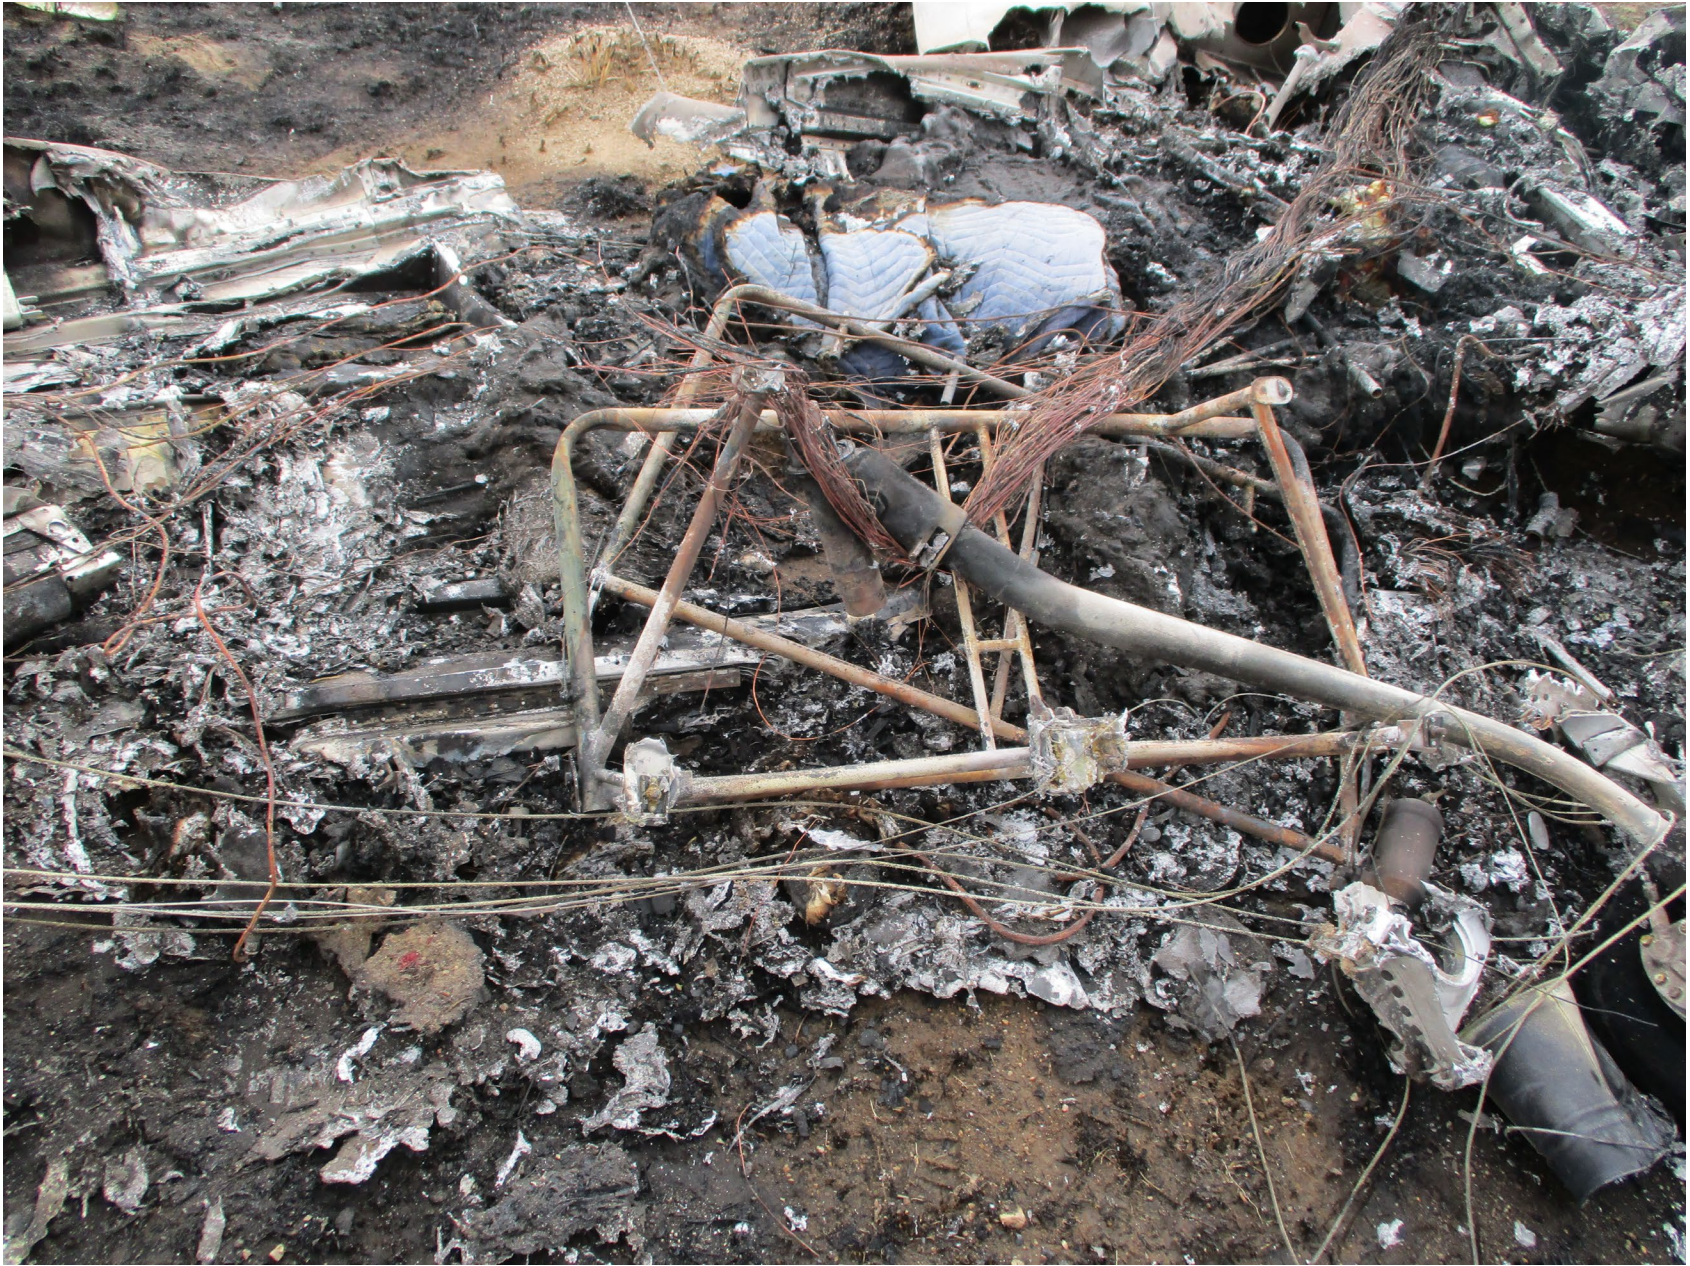
Photo 15 - Supplied photo of flight control cables.

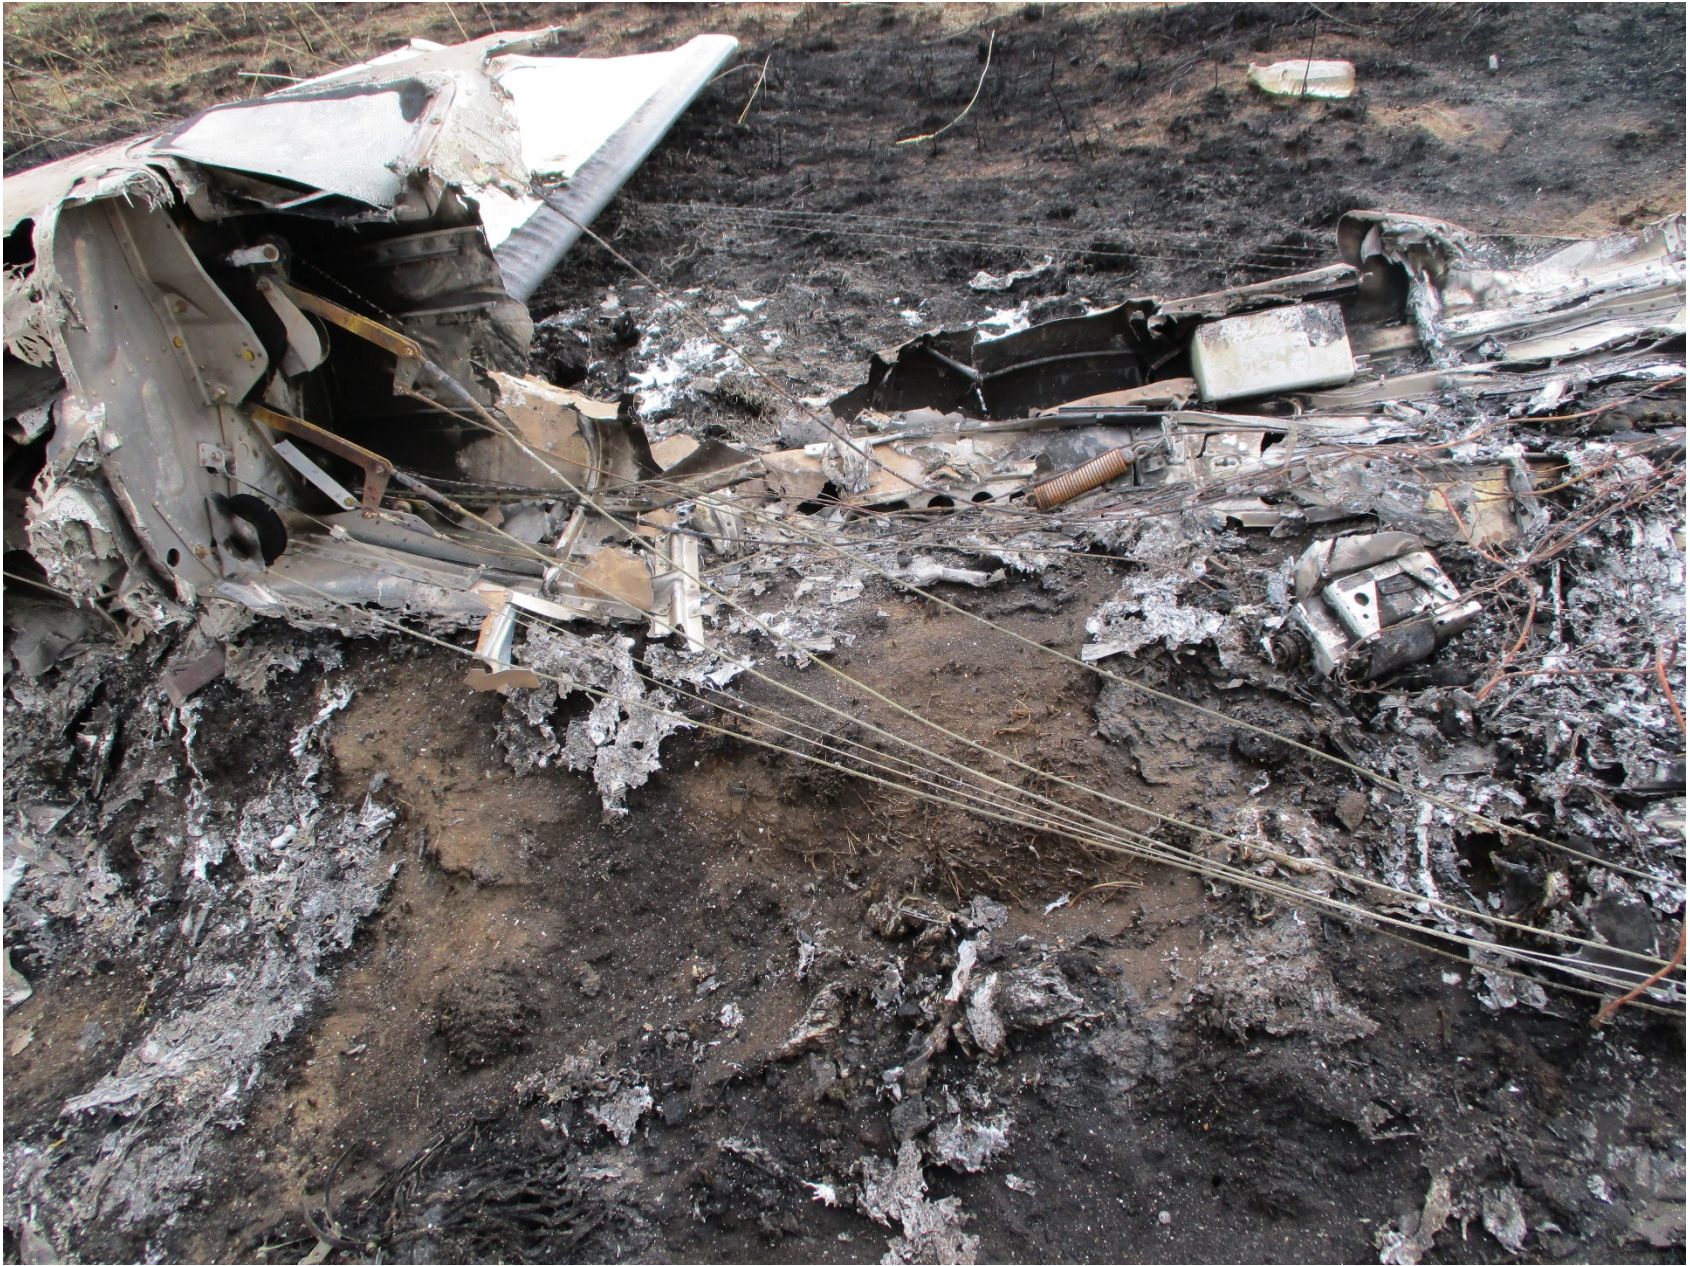
Photo 16 - Supplied photo of flight control cables near the empennage.

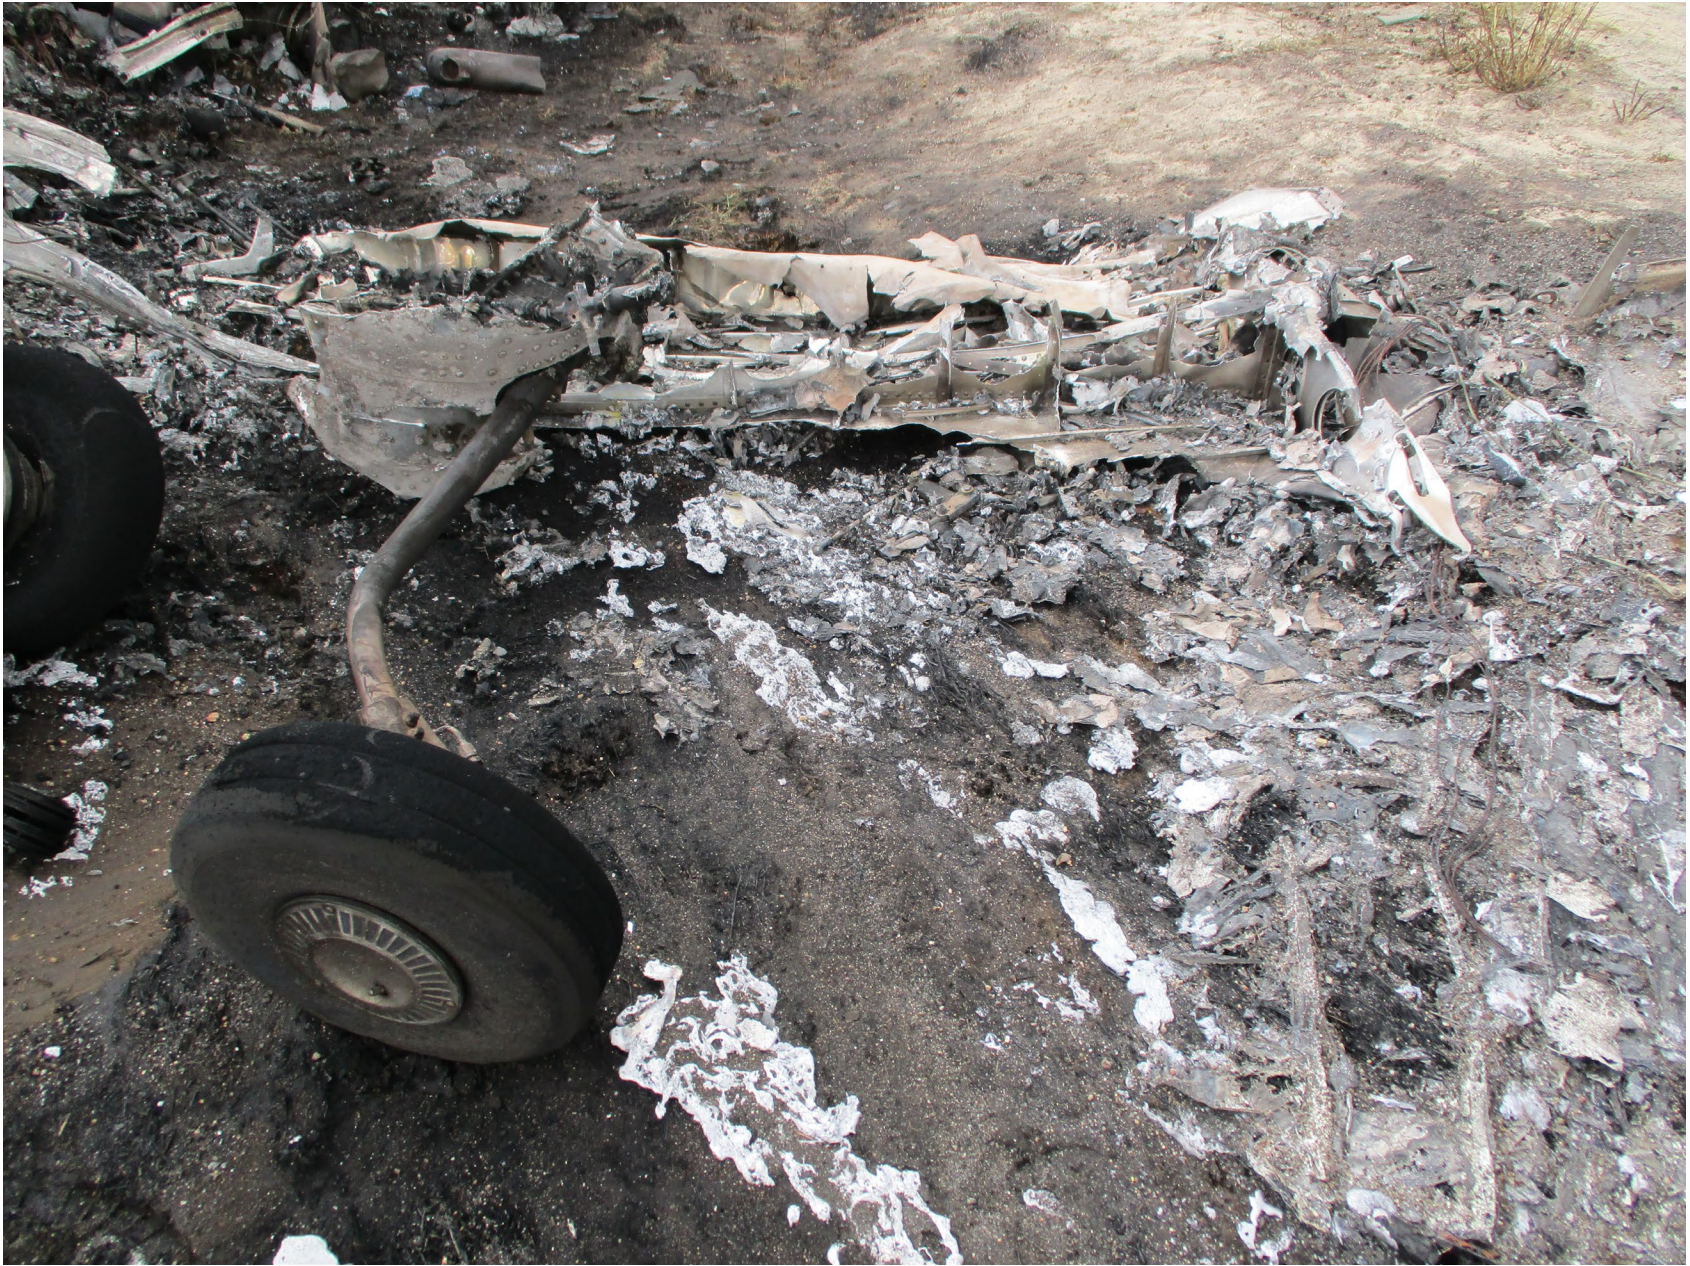
Photo 17 - Supplied photo of a main landing gear and wheel.

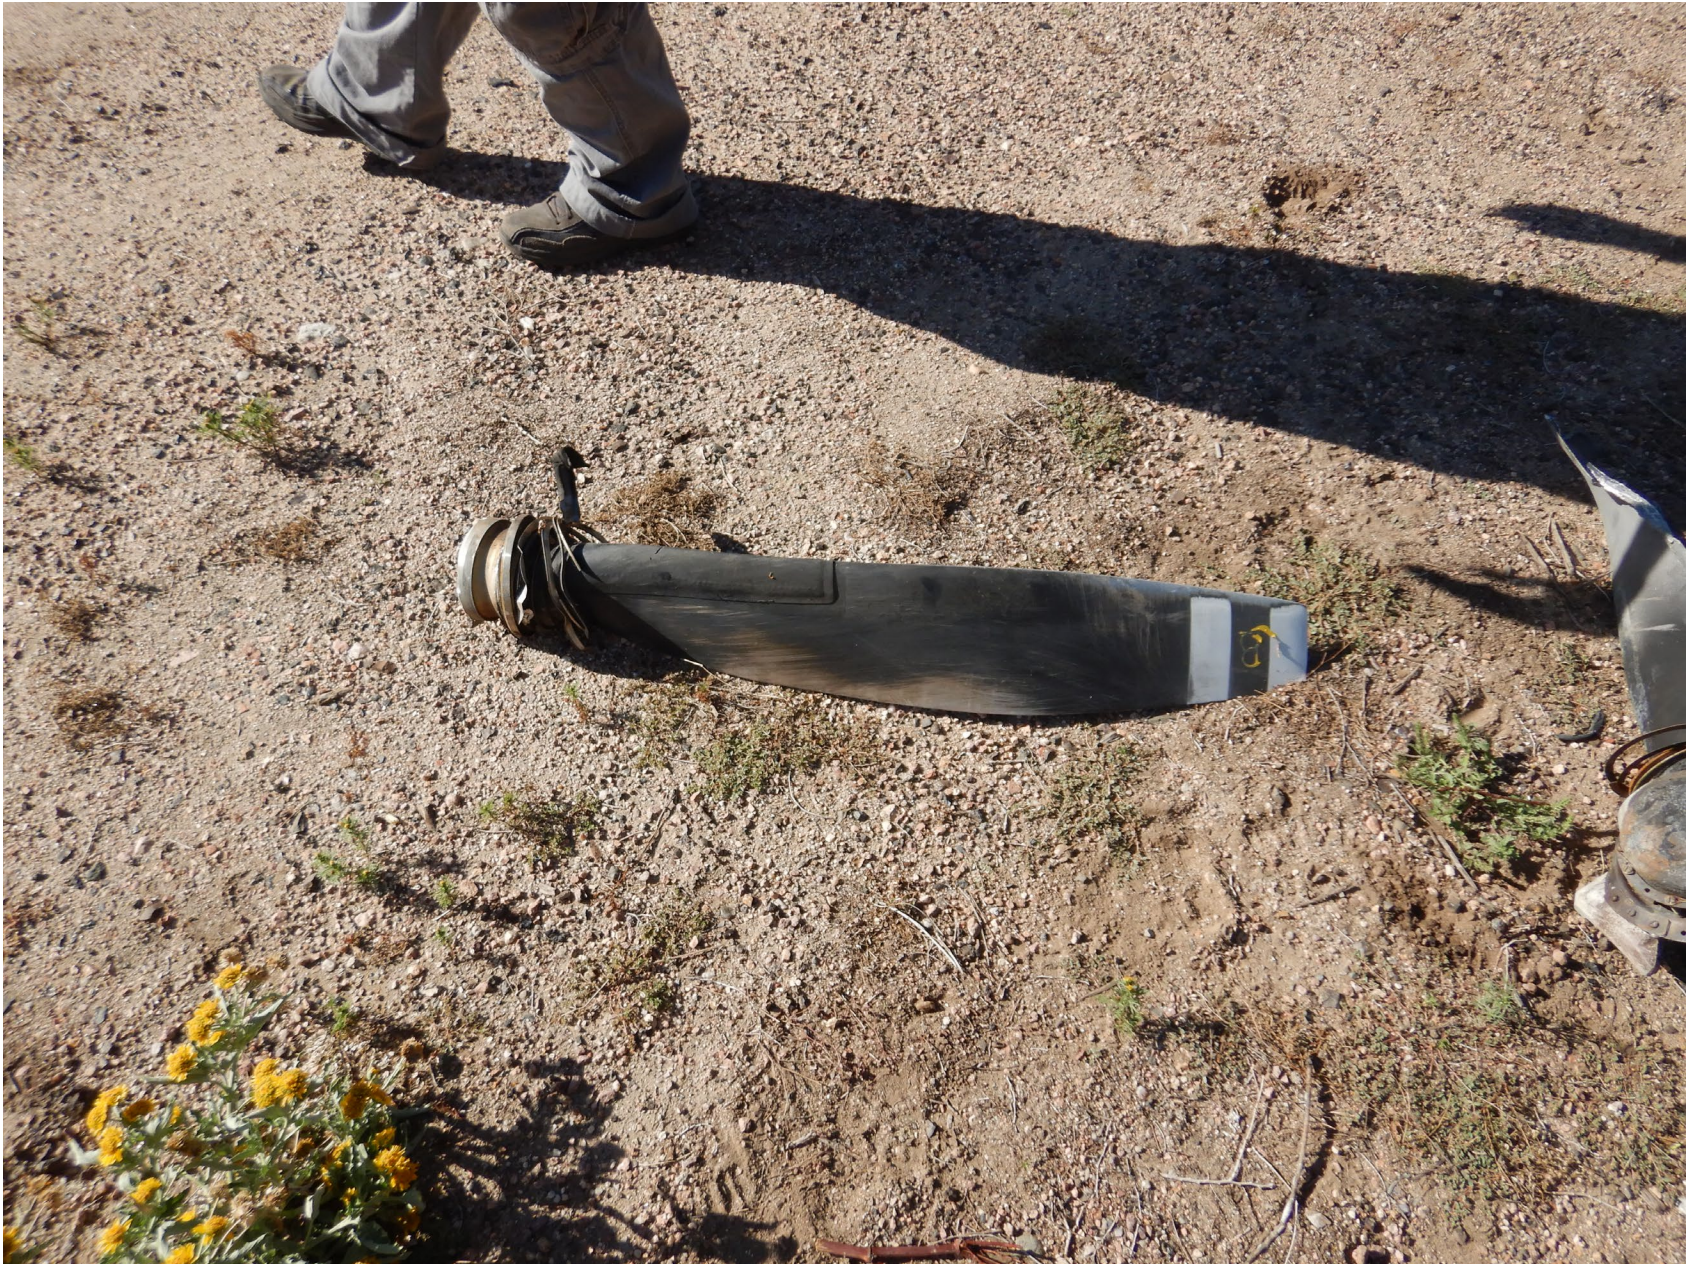
Photo 18 - Supplied photo of a propeller blade. The blade exhibits leading edge abrasion.

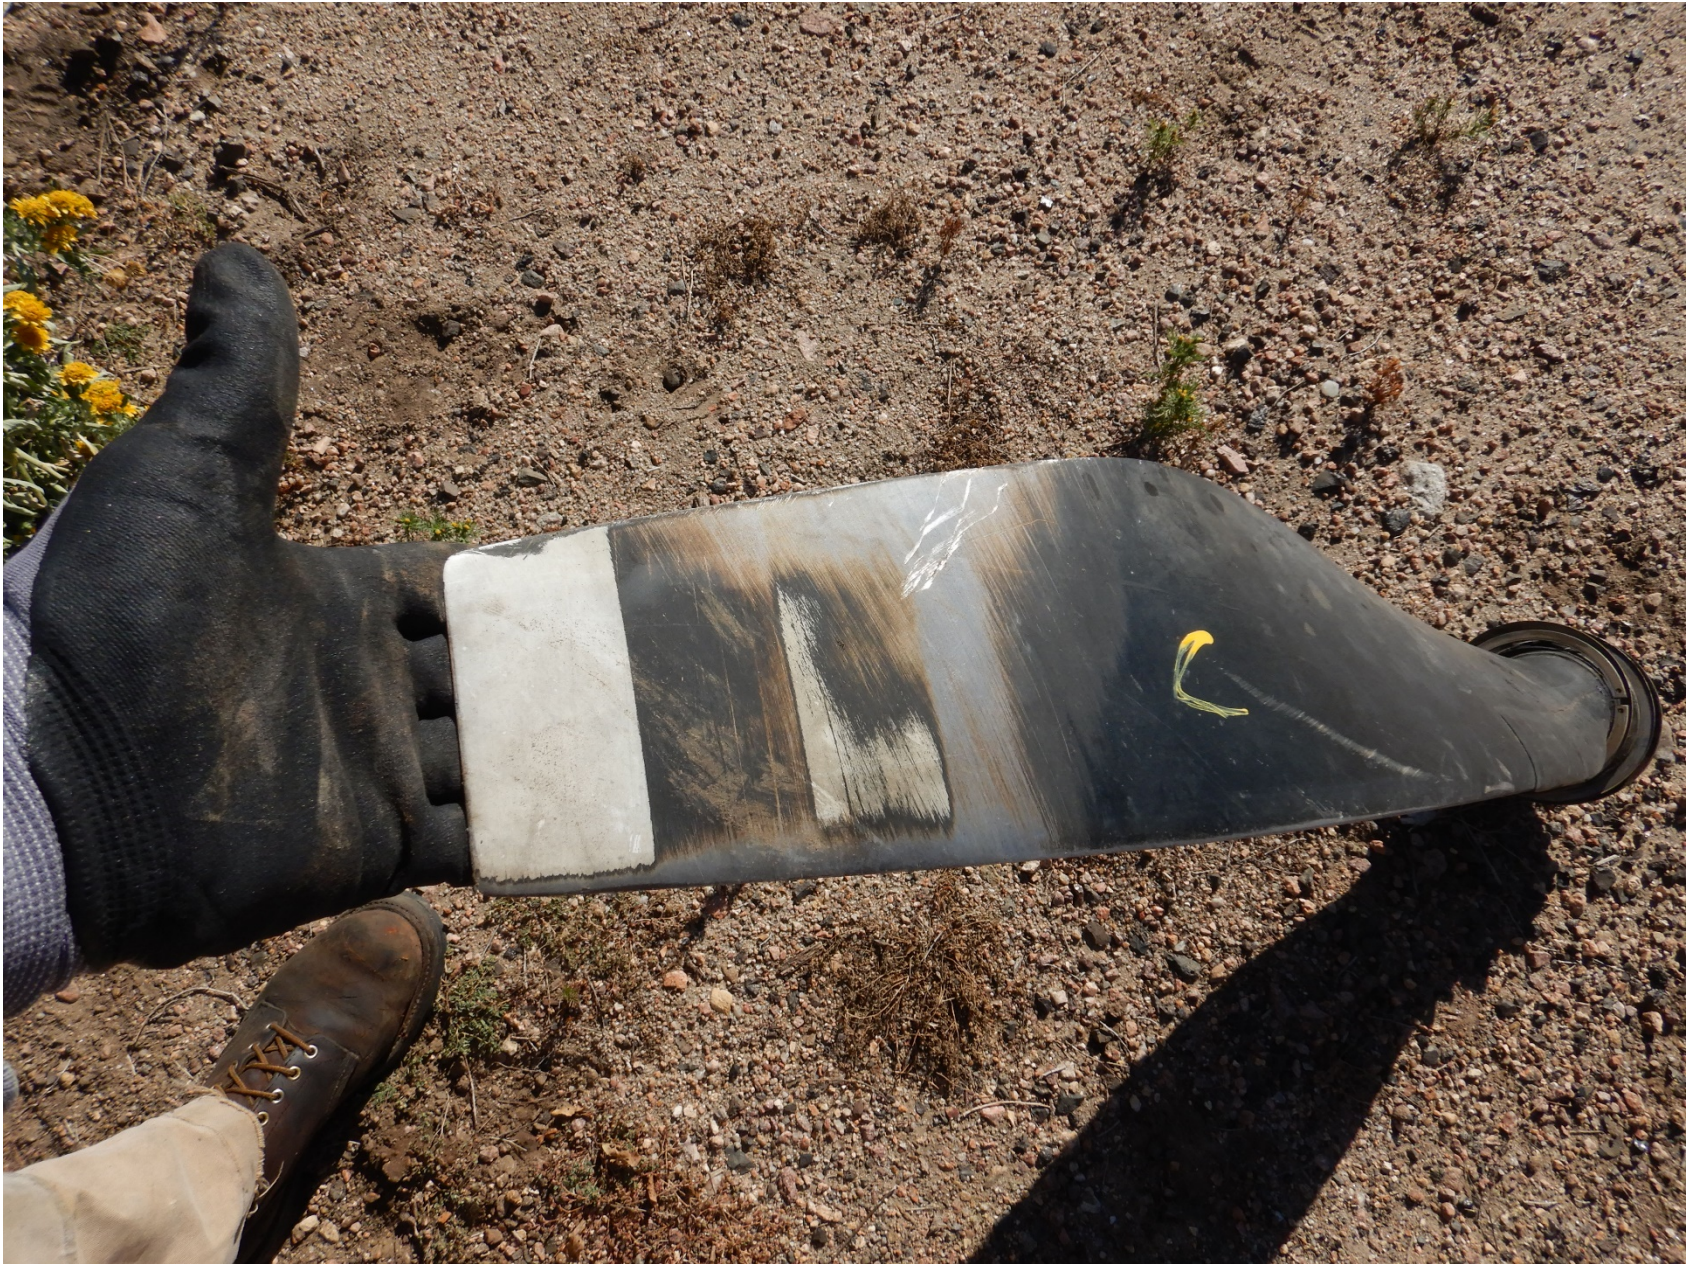
Photo 19 - Supplied close-up photo of a propeller blade. The blade exhibits chordwise abrasion.

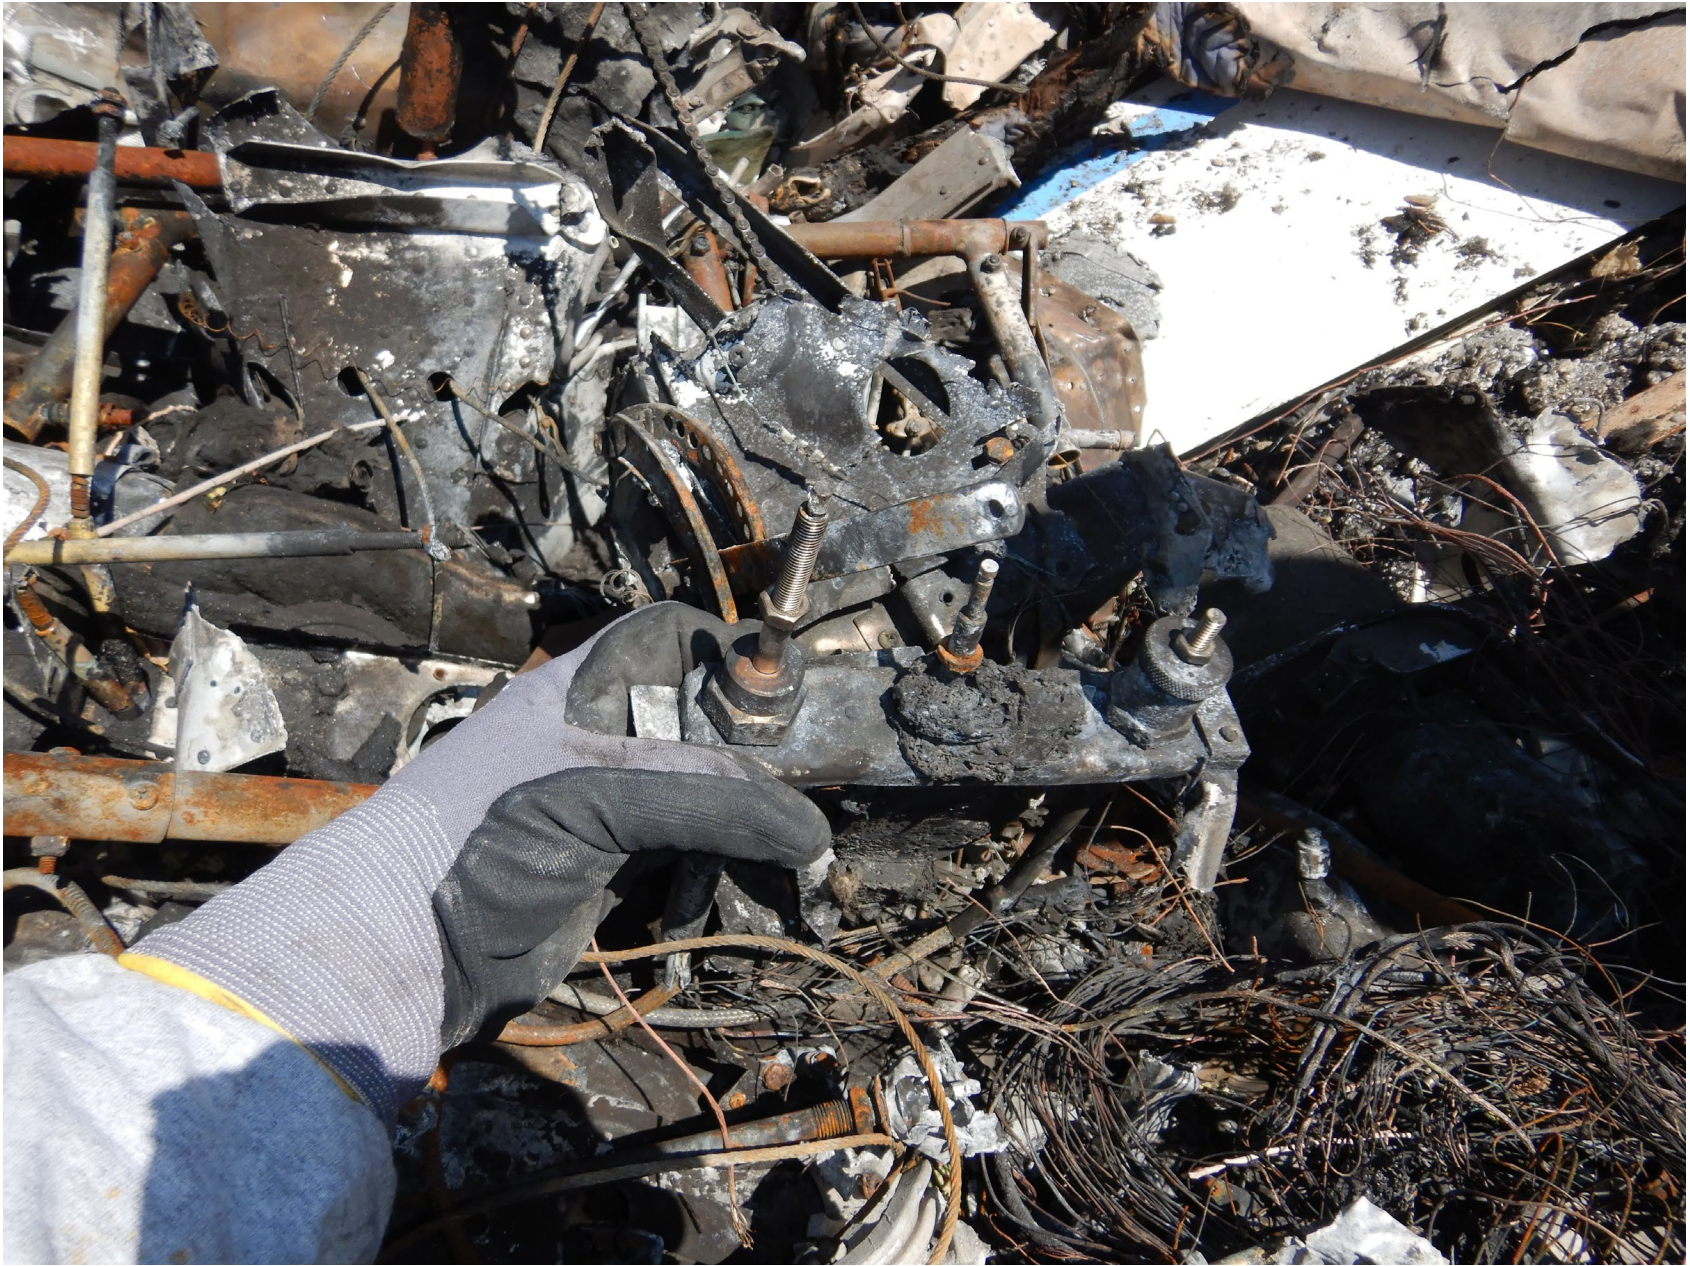
Photo 20 - FAA supplied close-up photo of the engine control quadrant.

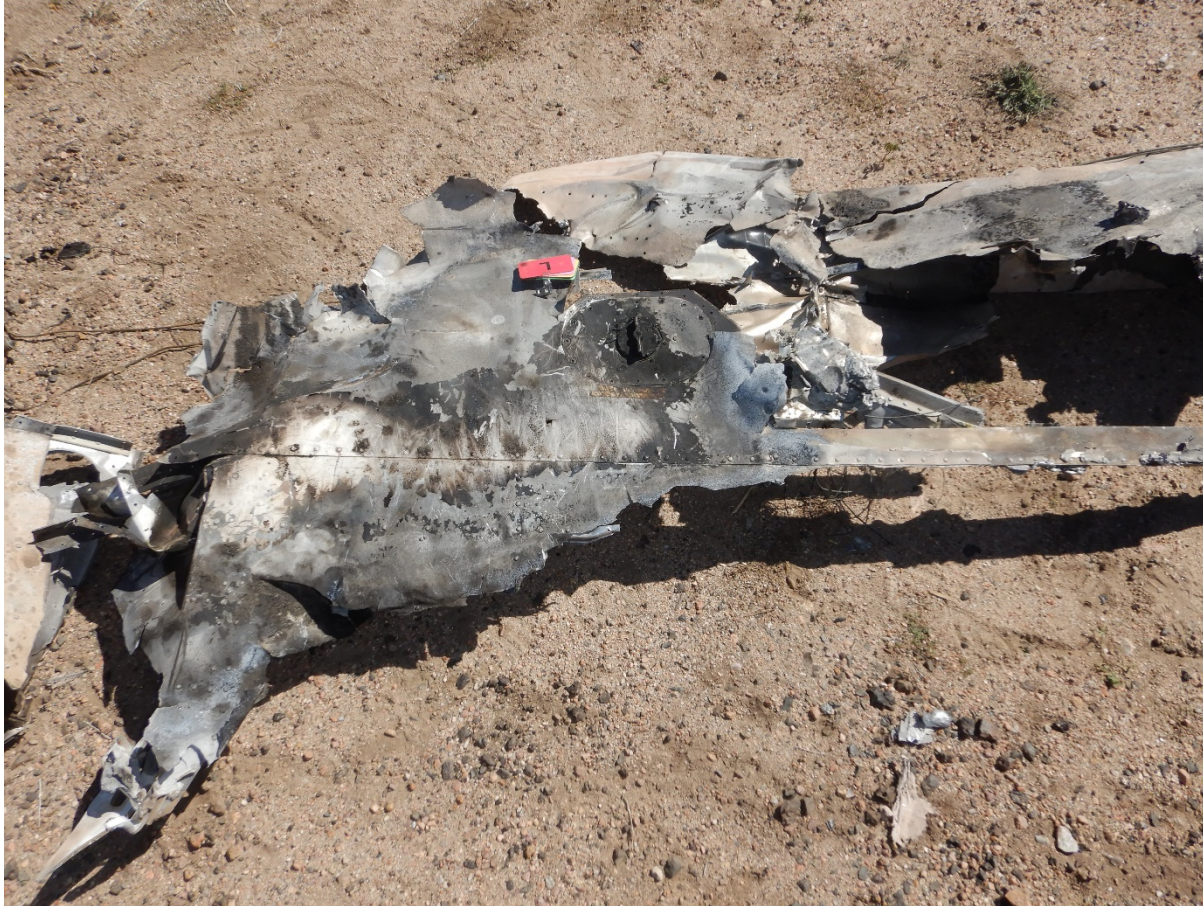
Photo 21 – Supplied photo of the left wing.

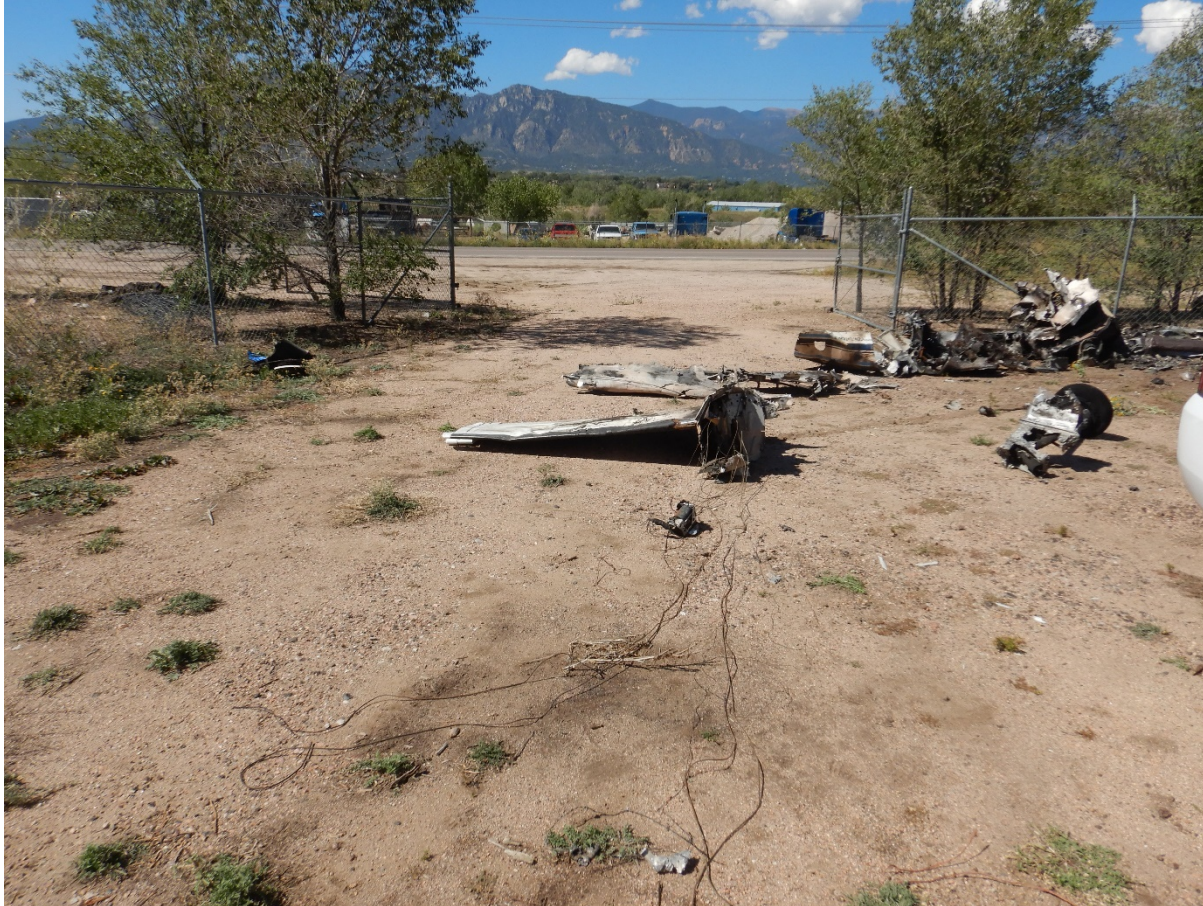
Photo 22 - Supplied photo of the empennage in the background and flight control cables going to the empennage.

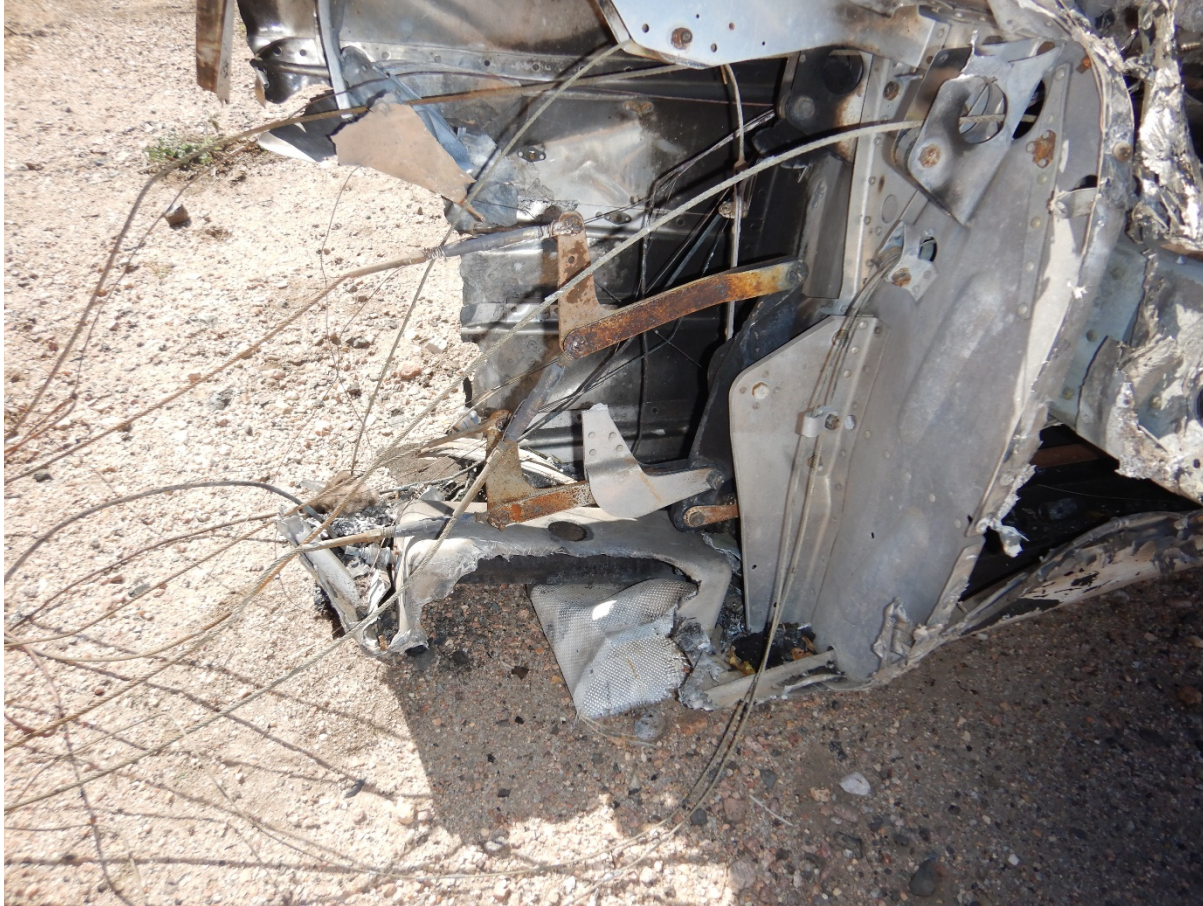
Photo 23 - Supplied close-up photo of the flight control cables near the empennage.

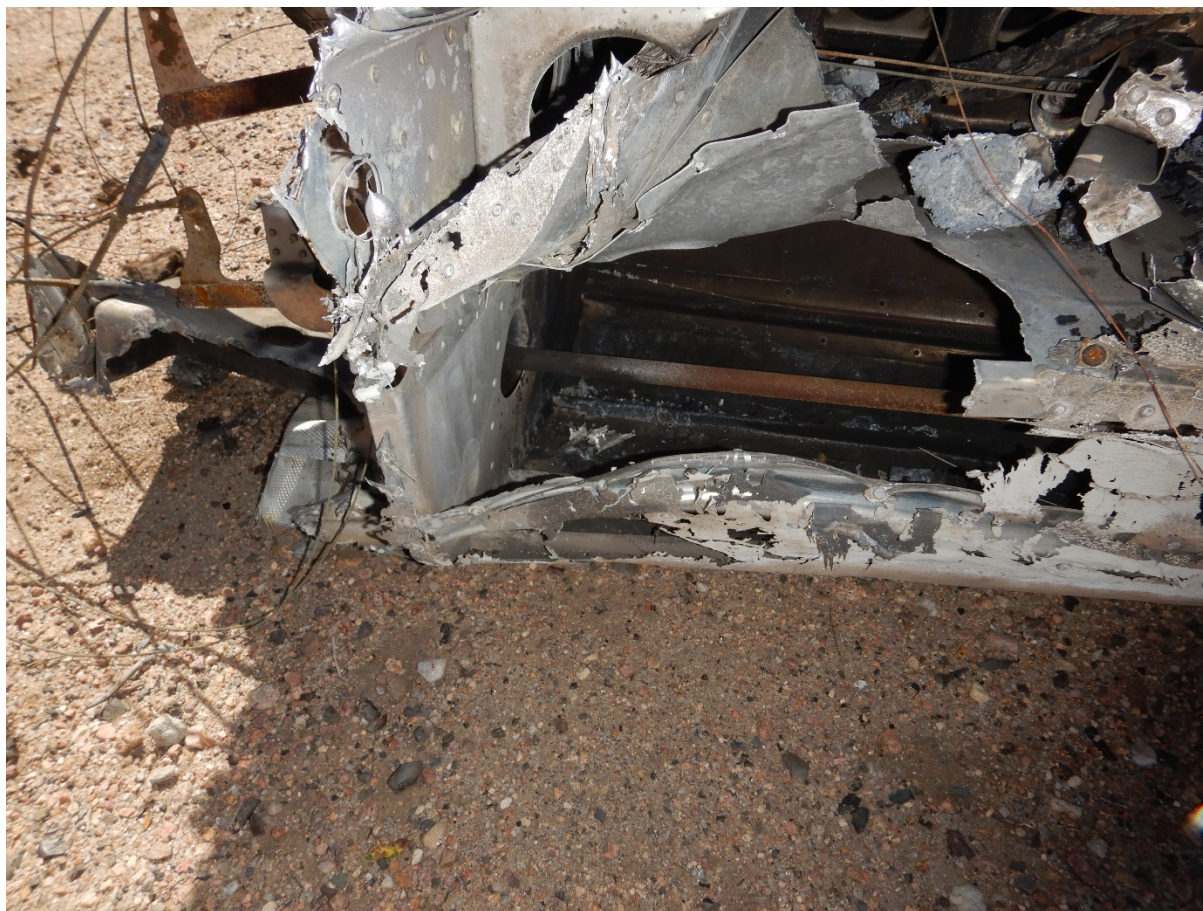
Photo 24 - Supplied close-up photo of the lower empennage.

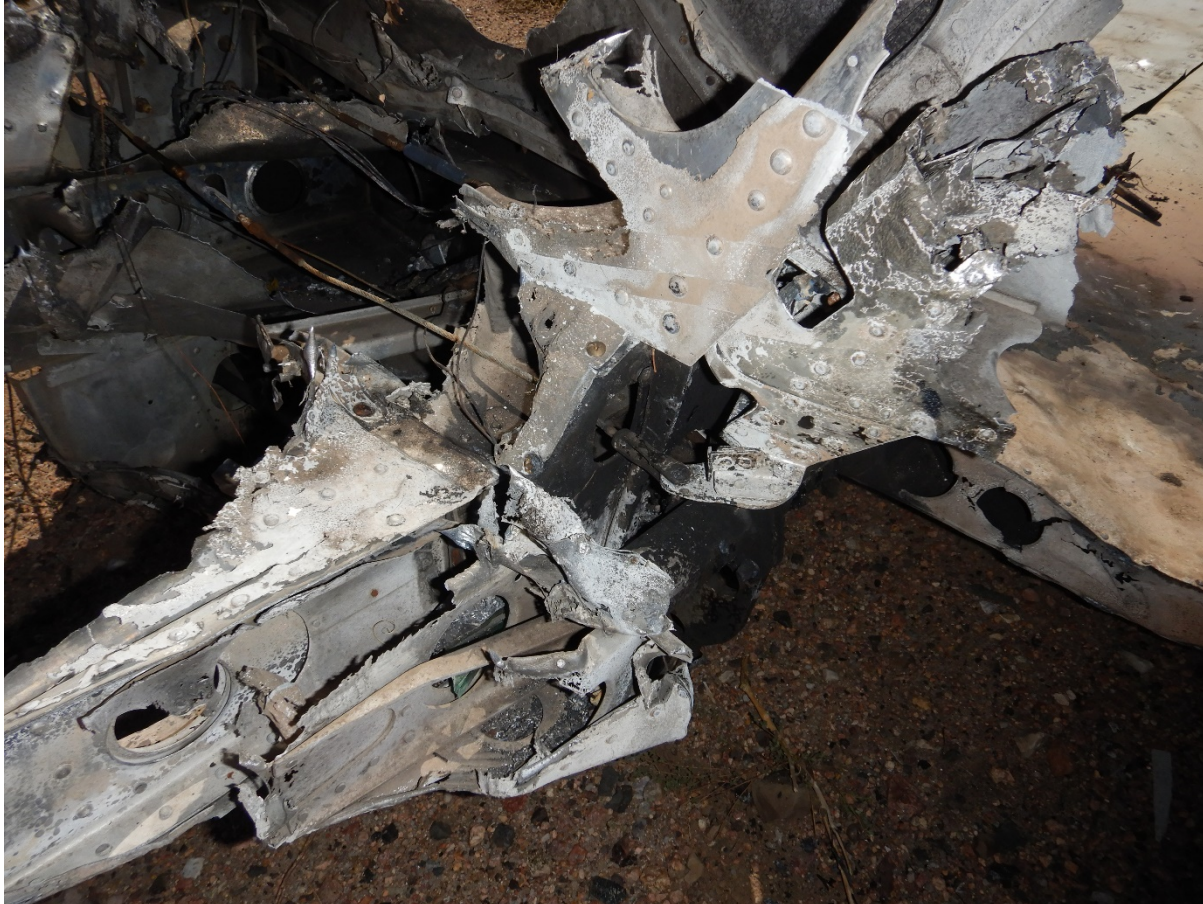
Photo 25 - Supplied close-up photo of the empennage.

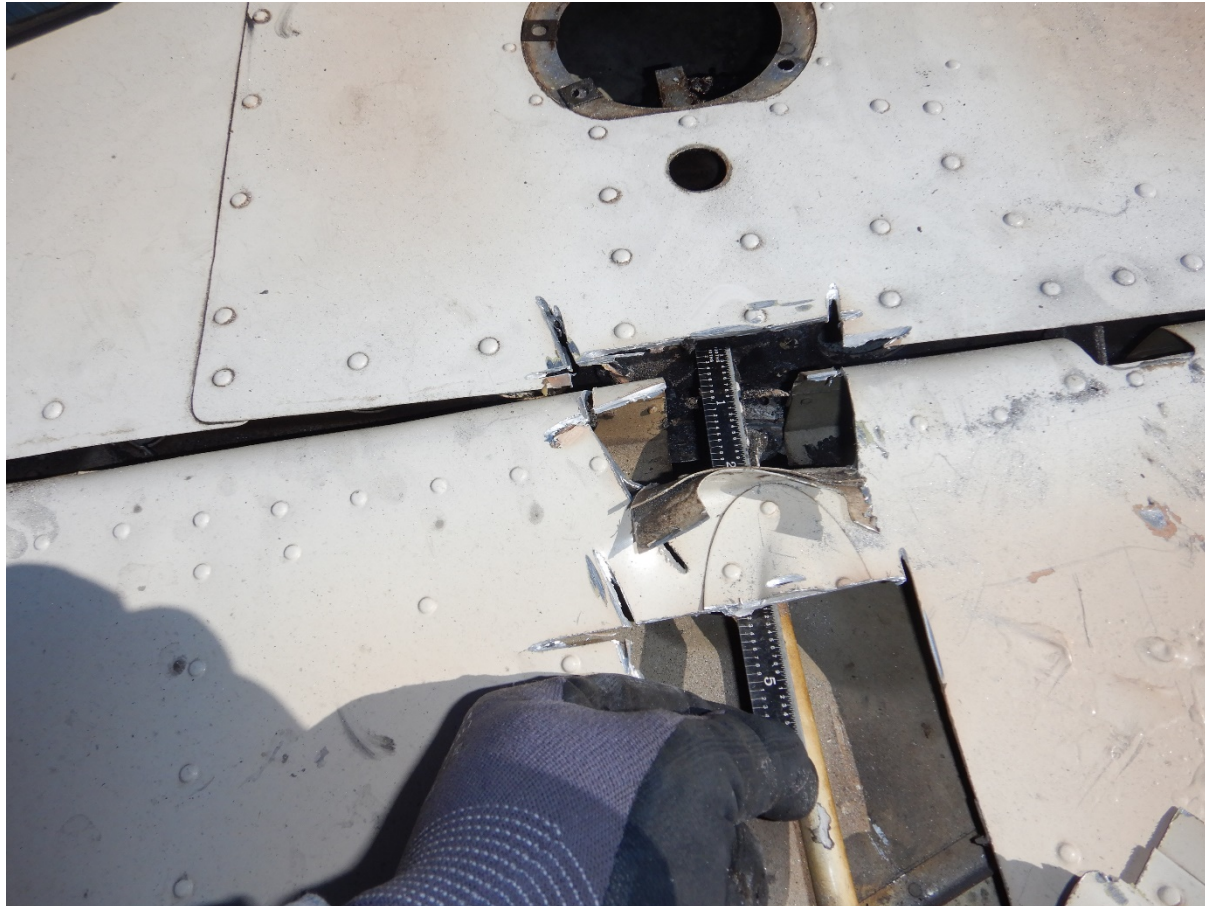
Photo 26 - Supplied close-up photo of the elevator trim measurement.
