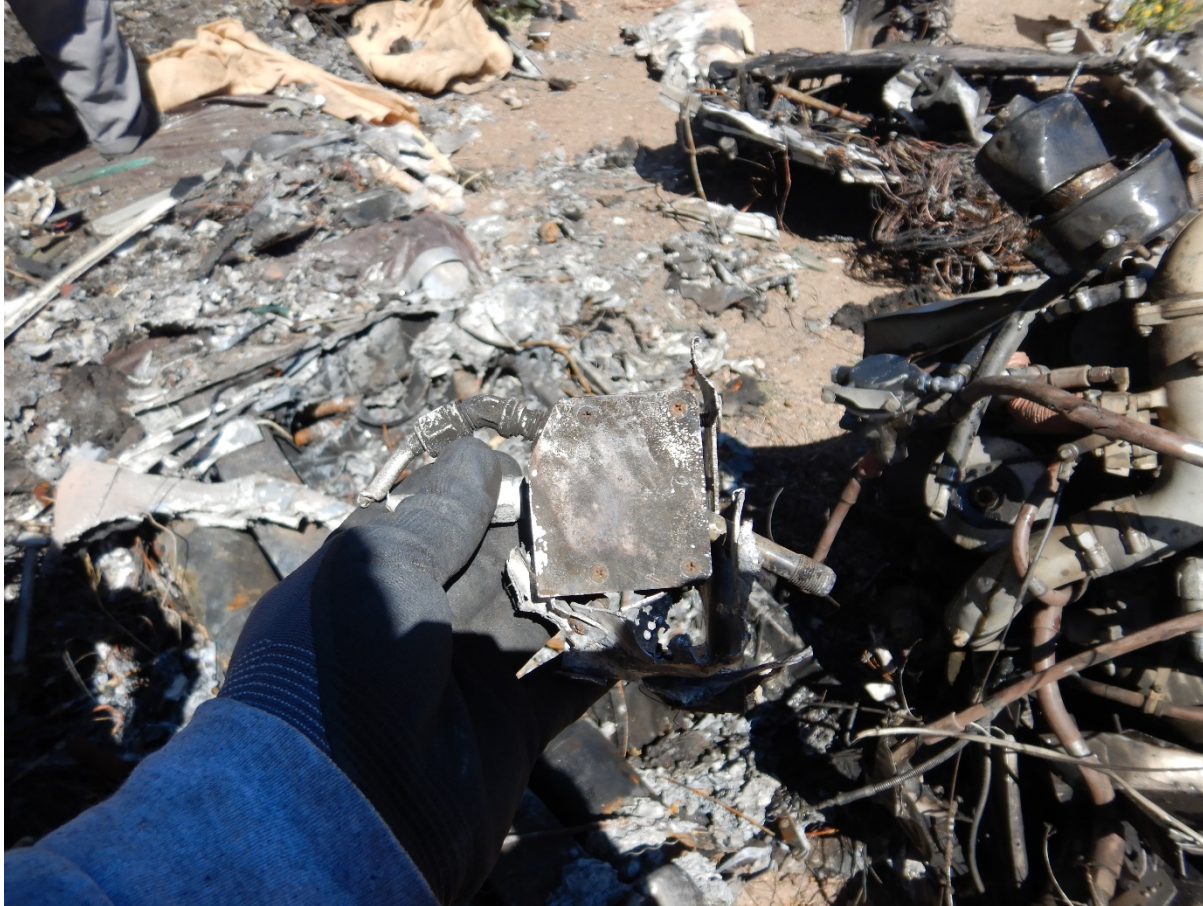
Photo 27 - Supplied close-up photo of the landing gear selector.

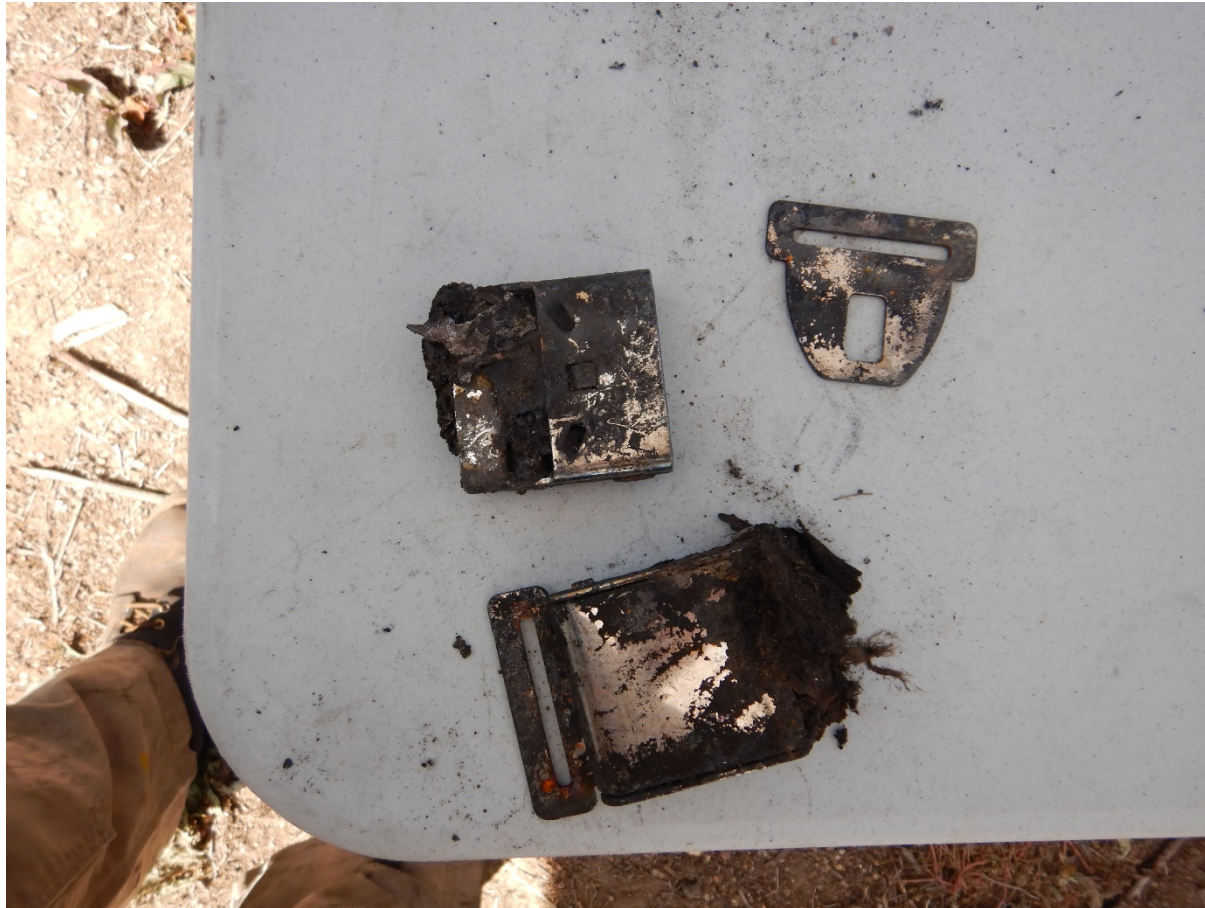
Photo 28 - Supplied close-up photo of seatbelt buckle hardware.

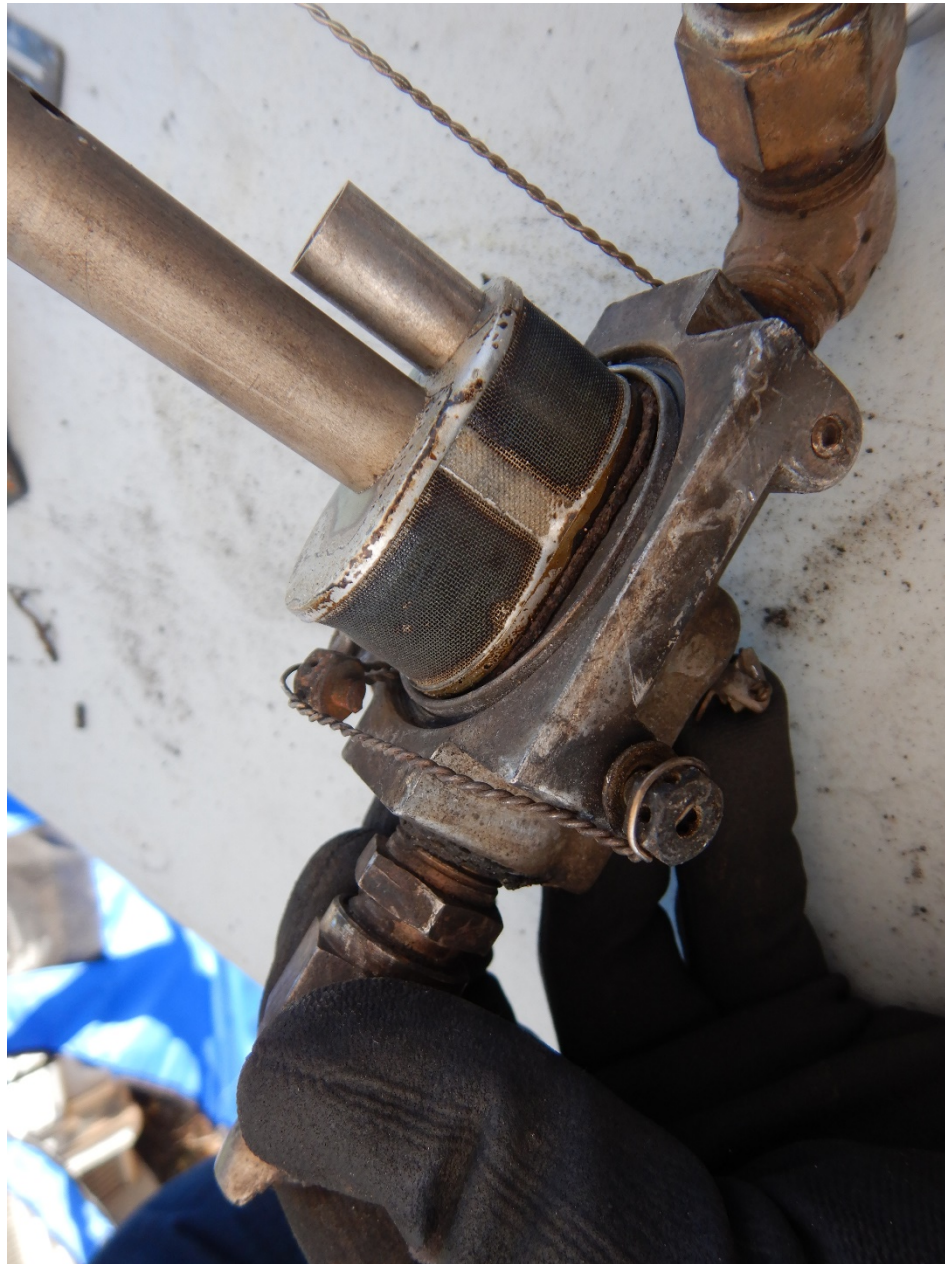
Photo 29 - Supplied close-up photo of gascolator fuel filter strainer screen.

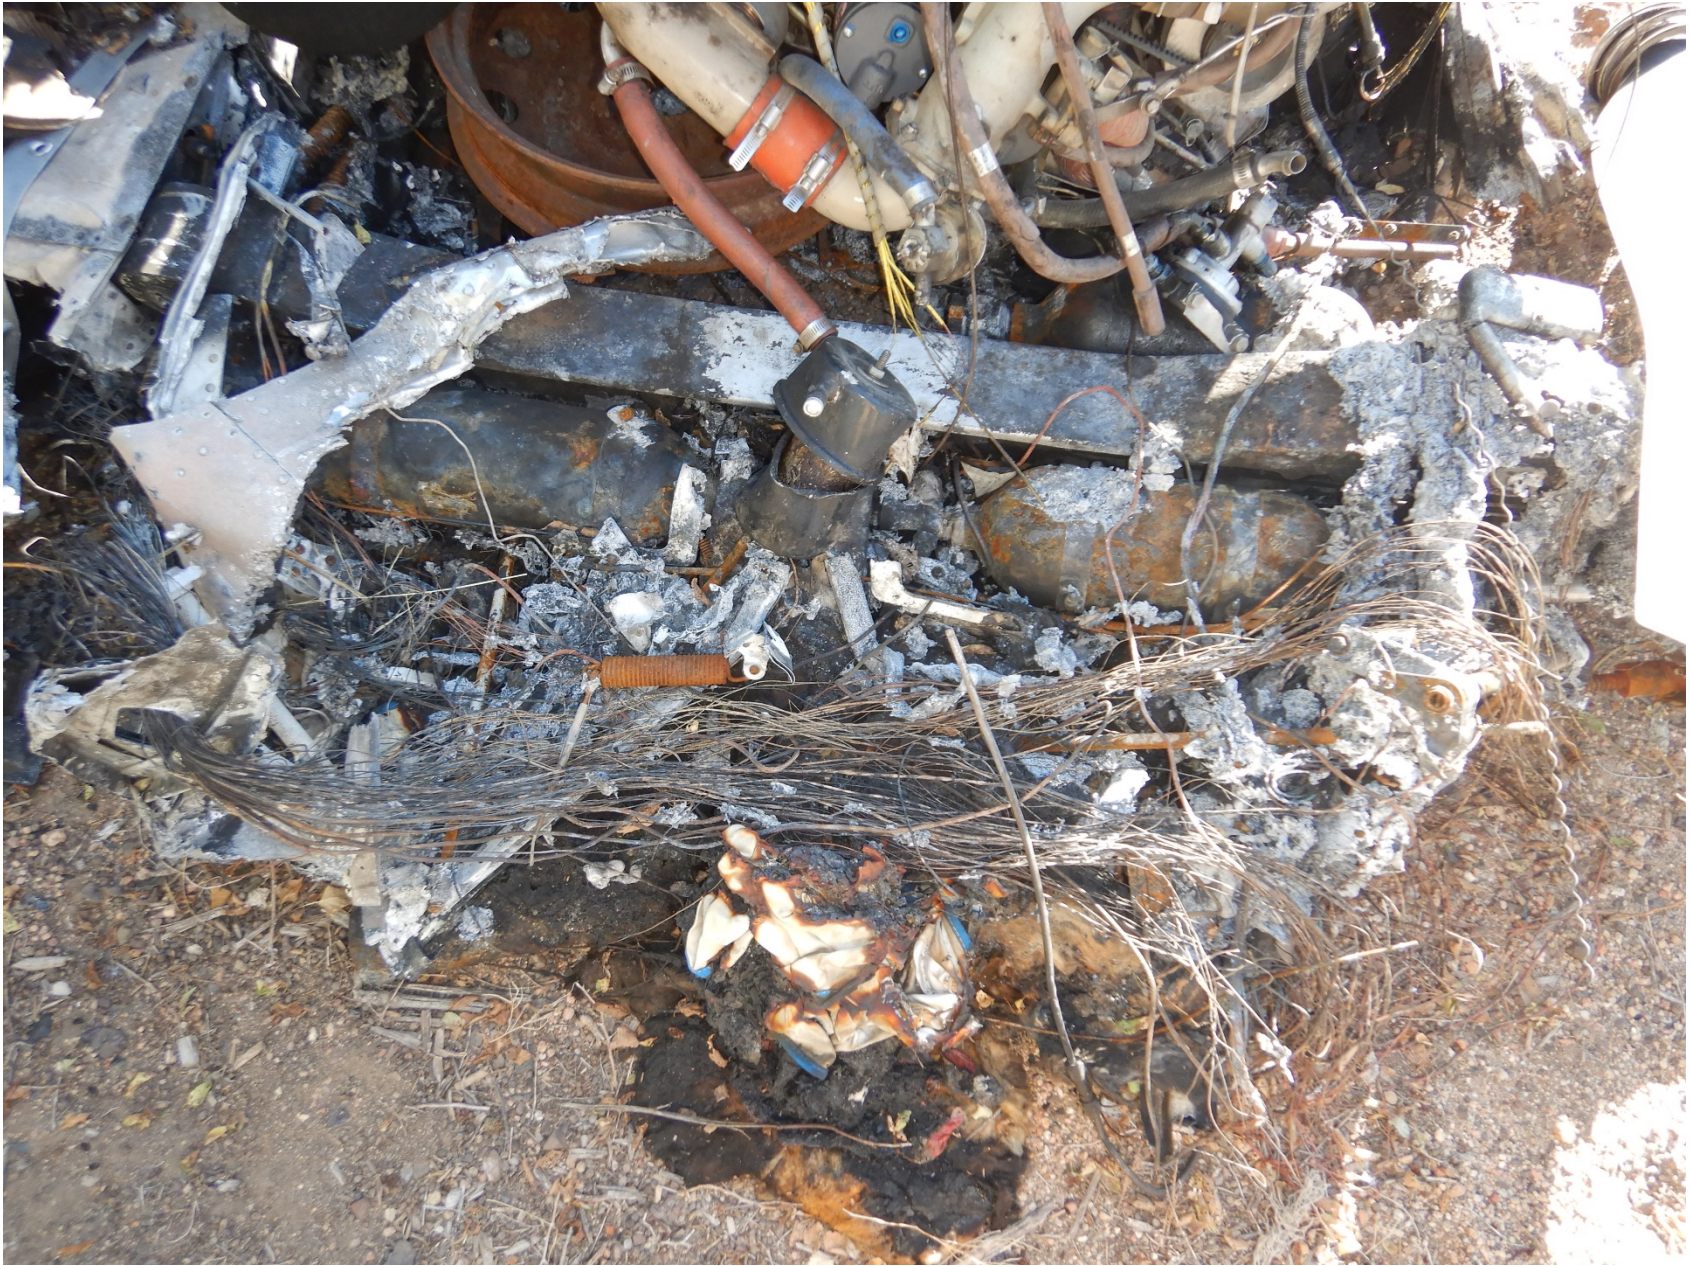
Photo 30 - Supplied view of the carry thru spar and oxygen bottles.

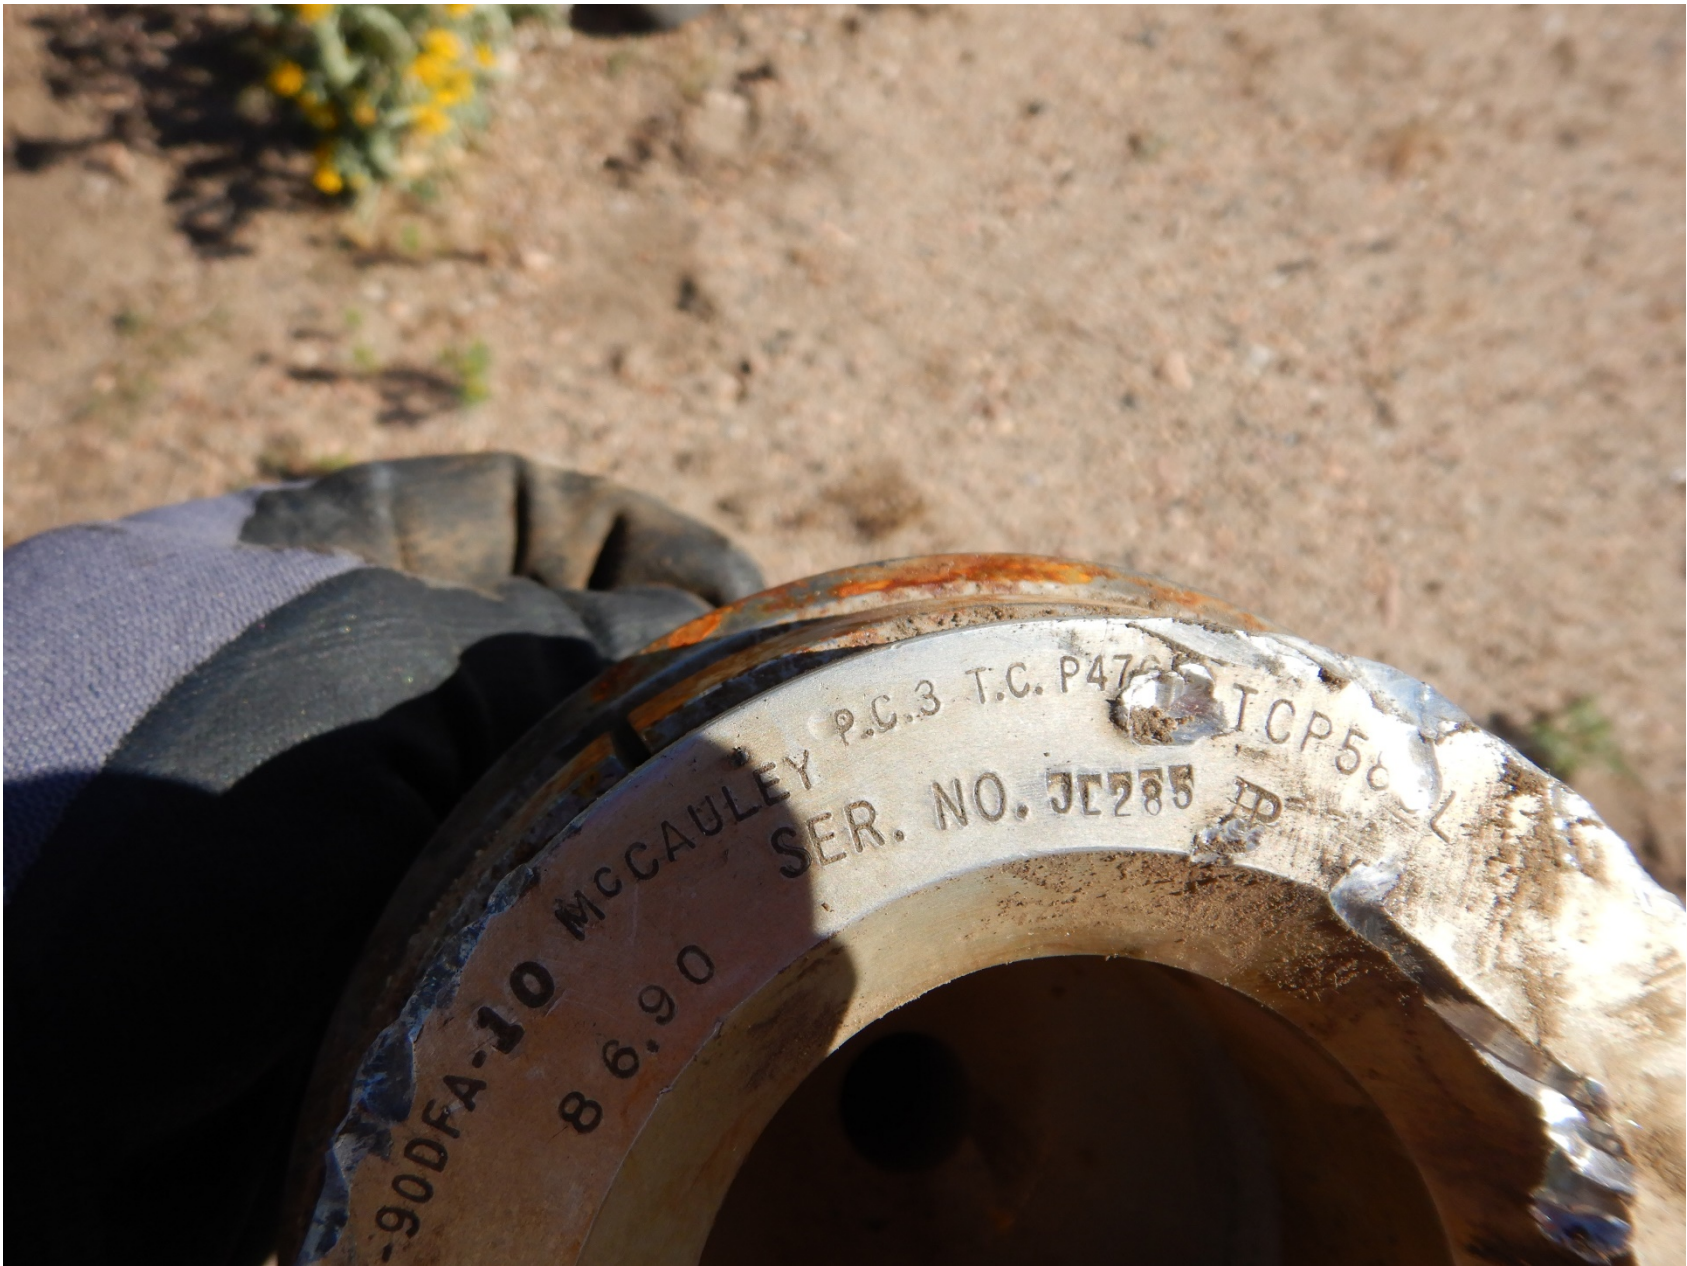
Photo 31 - Supplied close-up view of the "C" propeller blade butt.

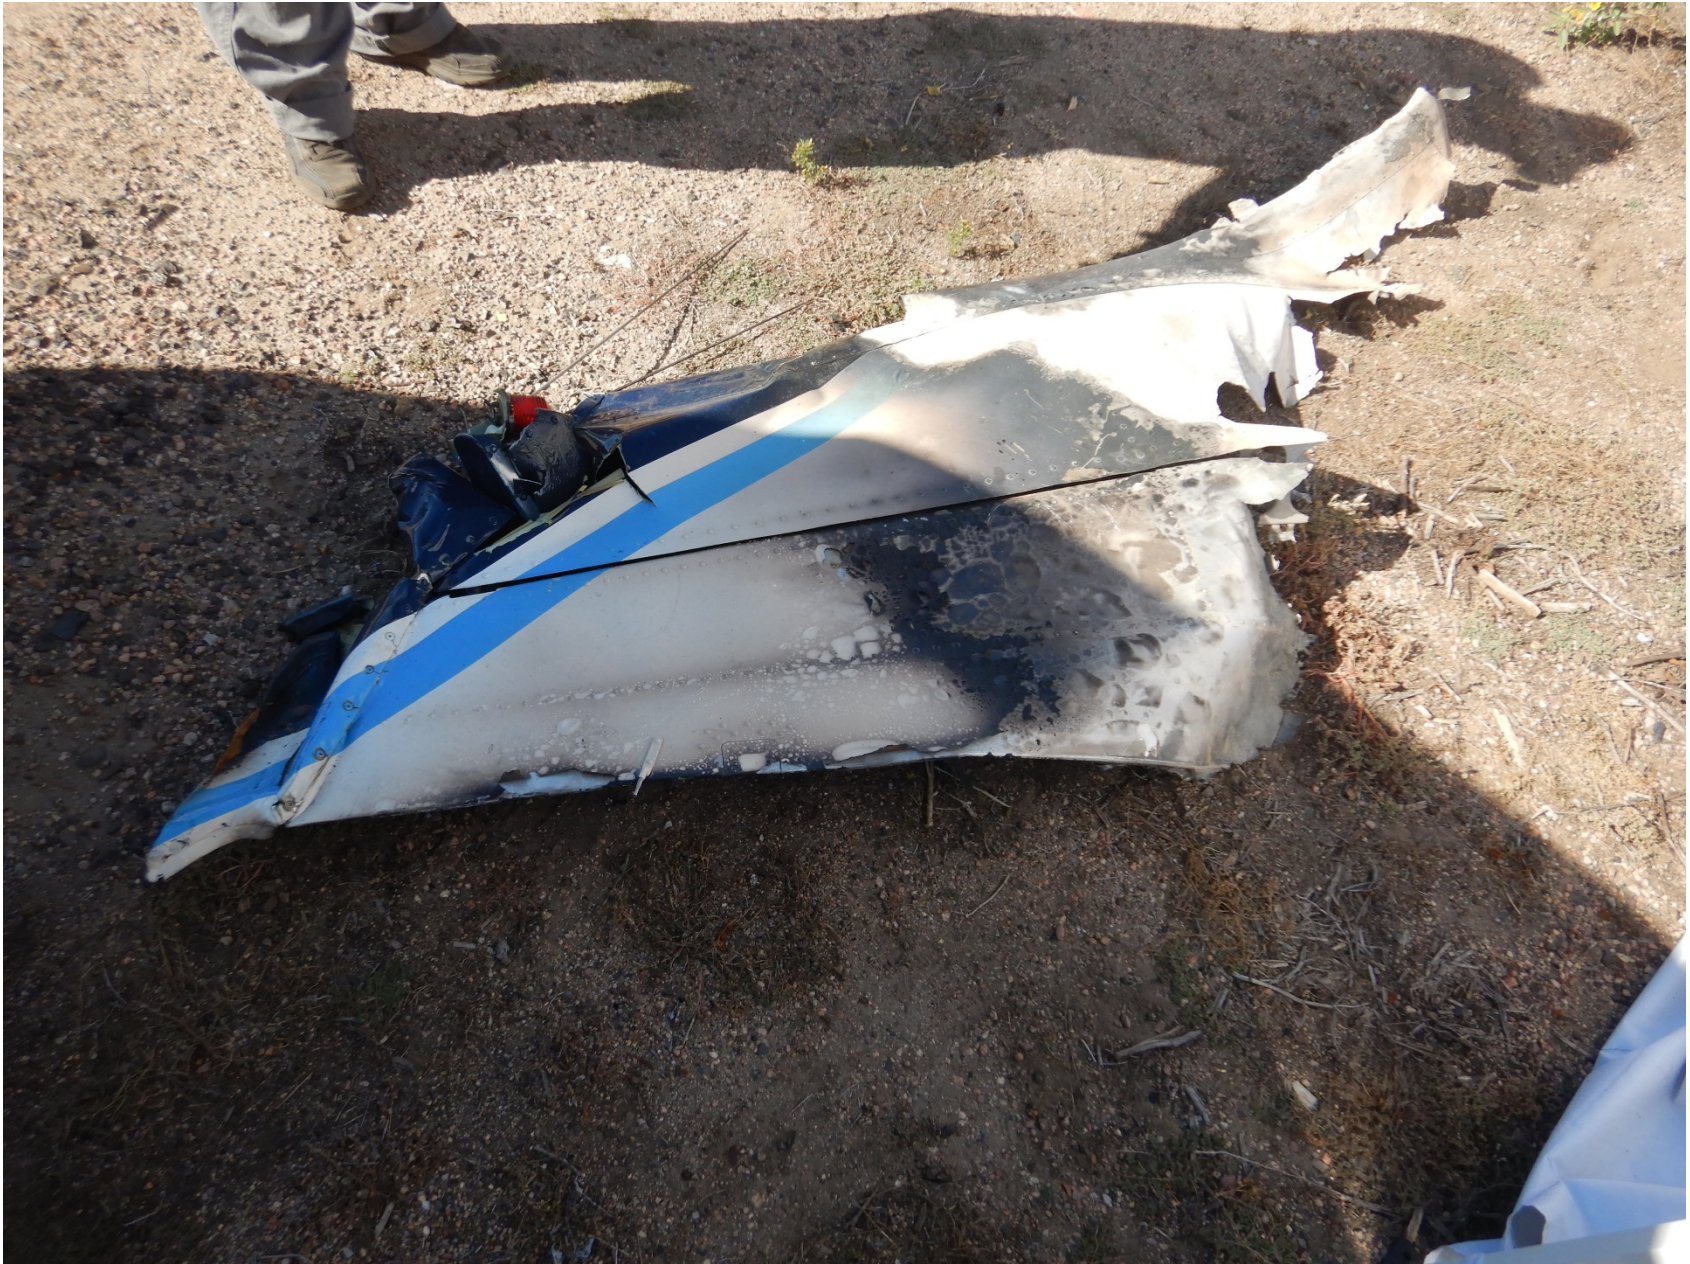
Photo 32 - Supplied view of the vertical stabilizer and rudder.

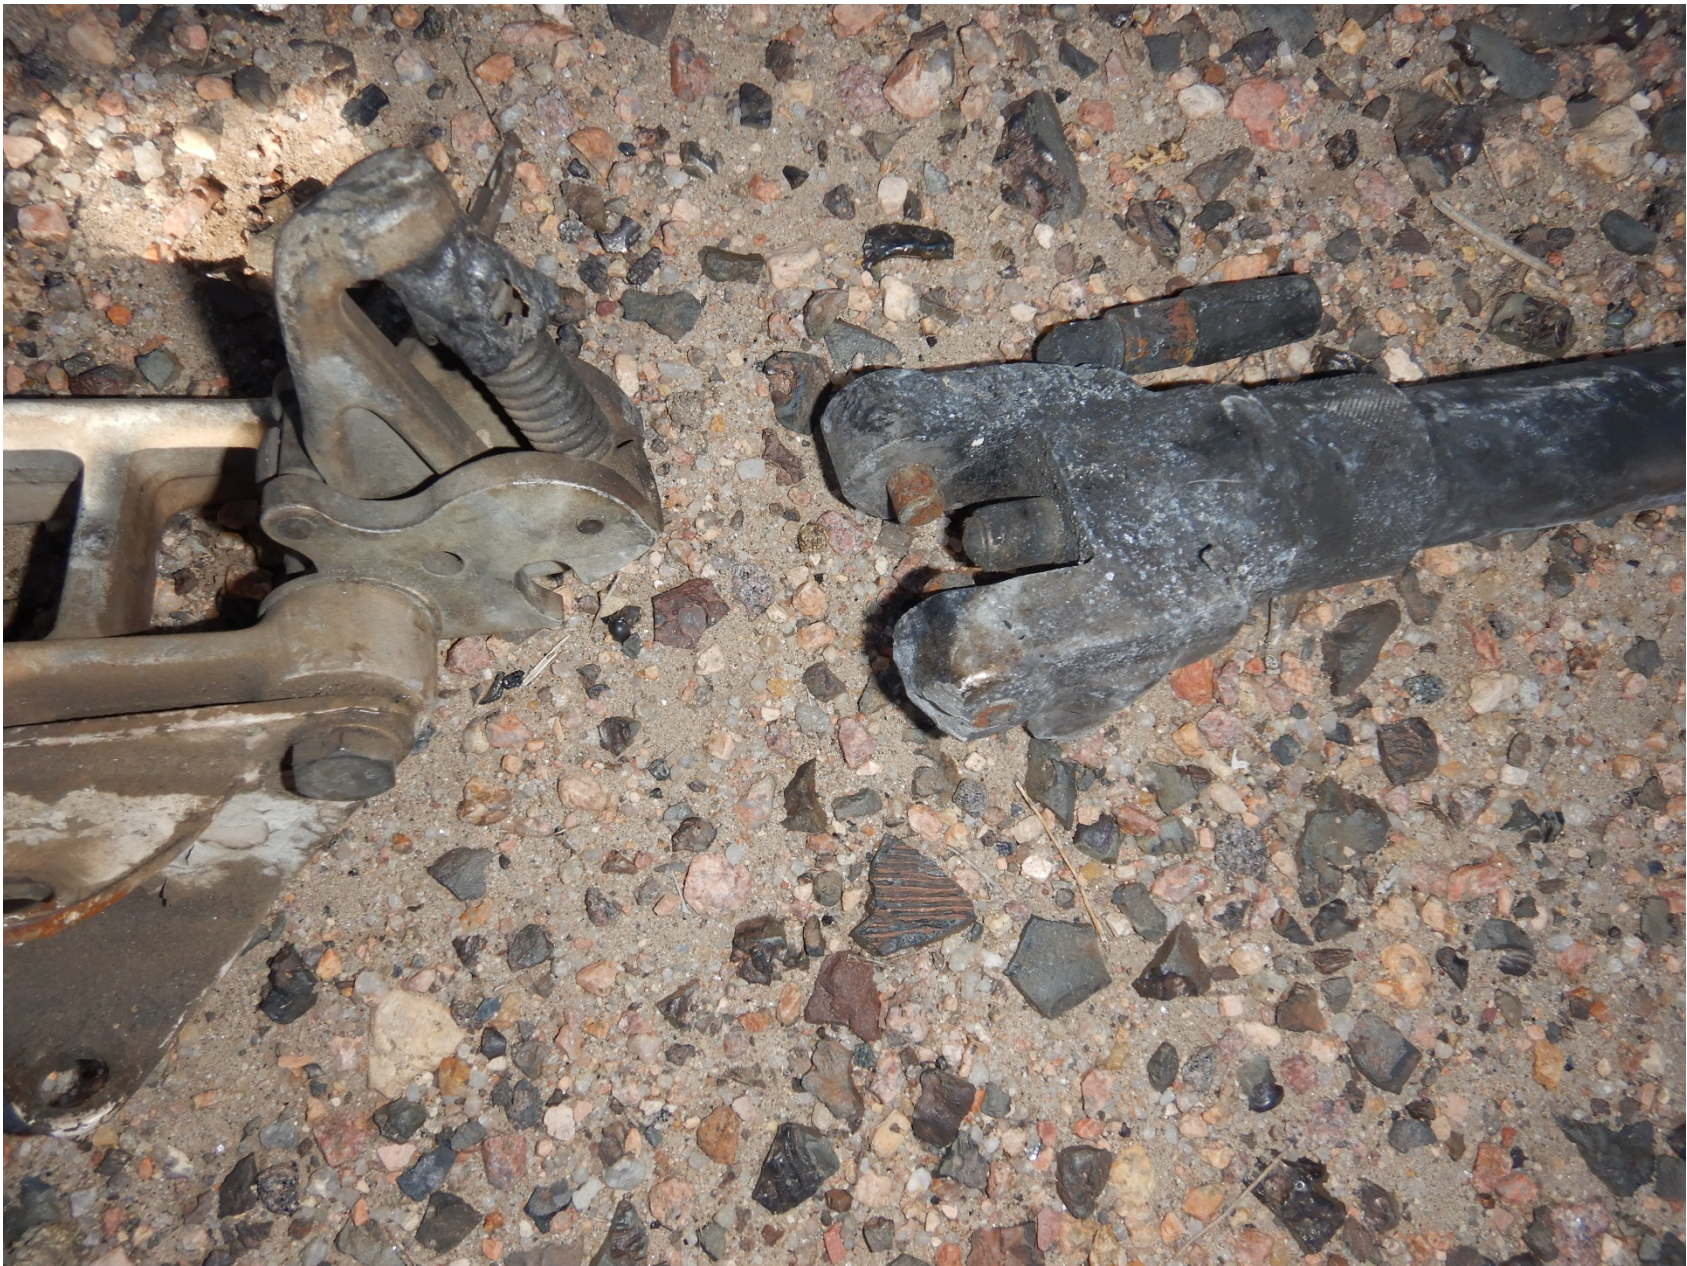
Photo 33 - Supplied view of the nose landing gear actuator and trunnion.

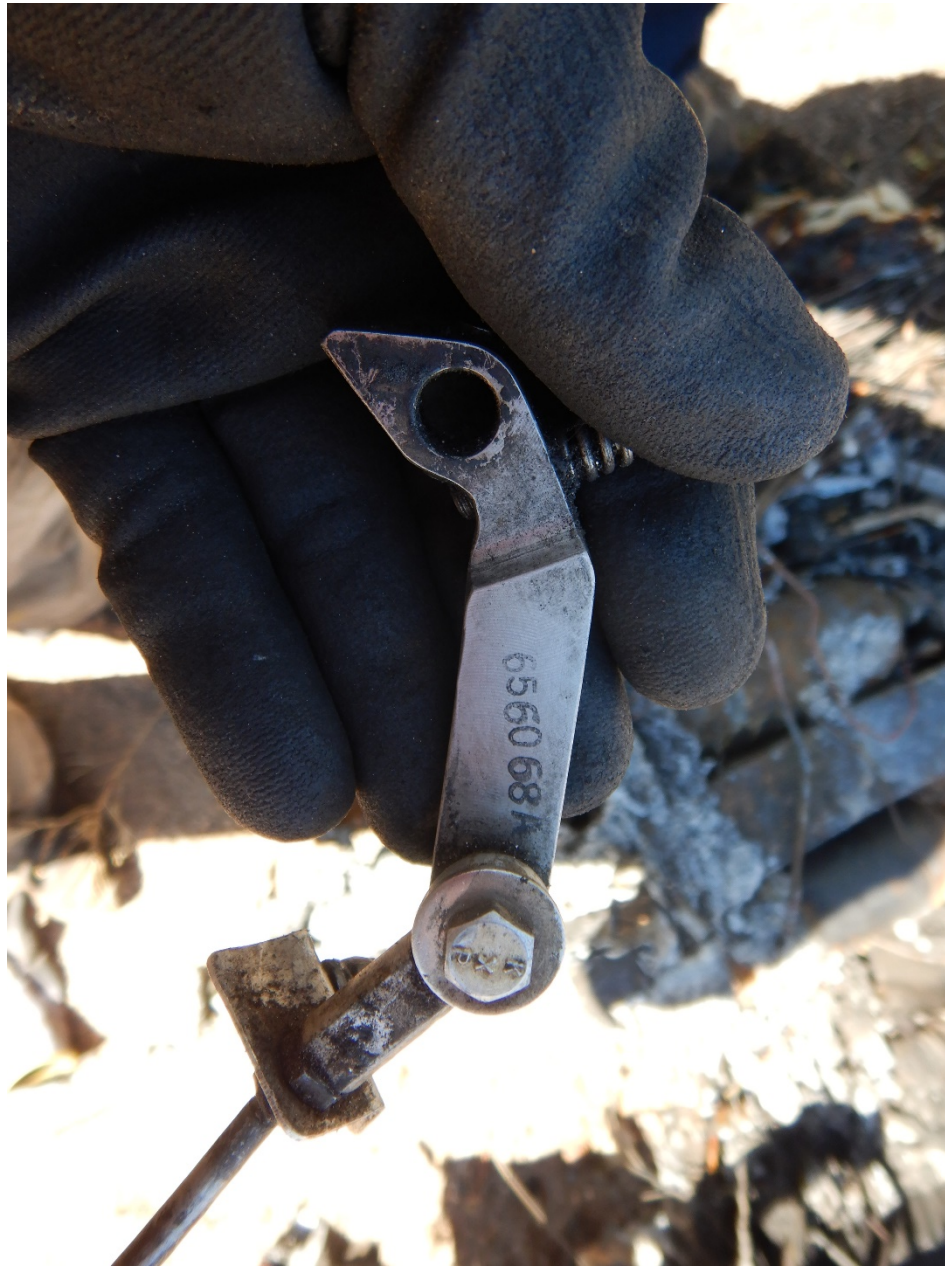
Photo 34 - Supplied close-up view of the throttle linkage.

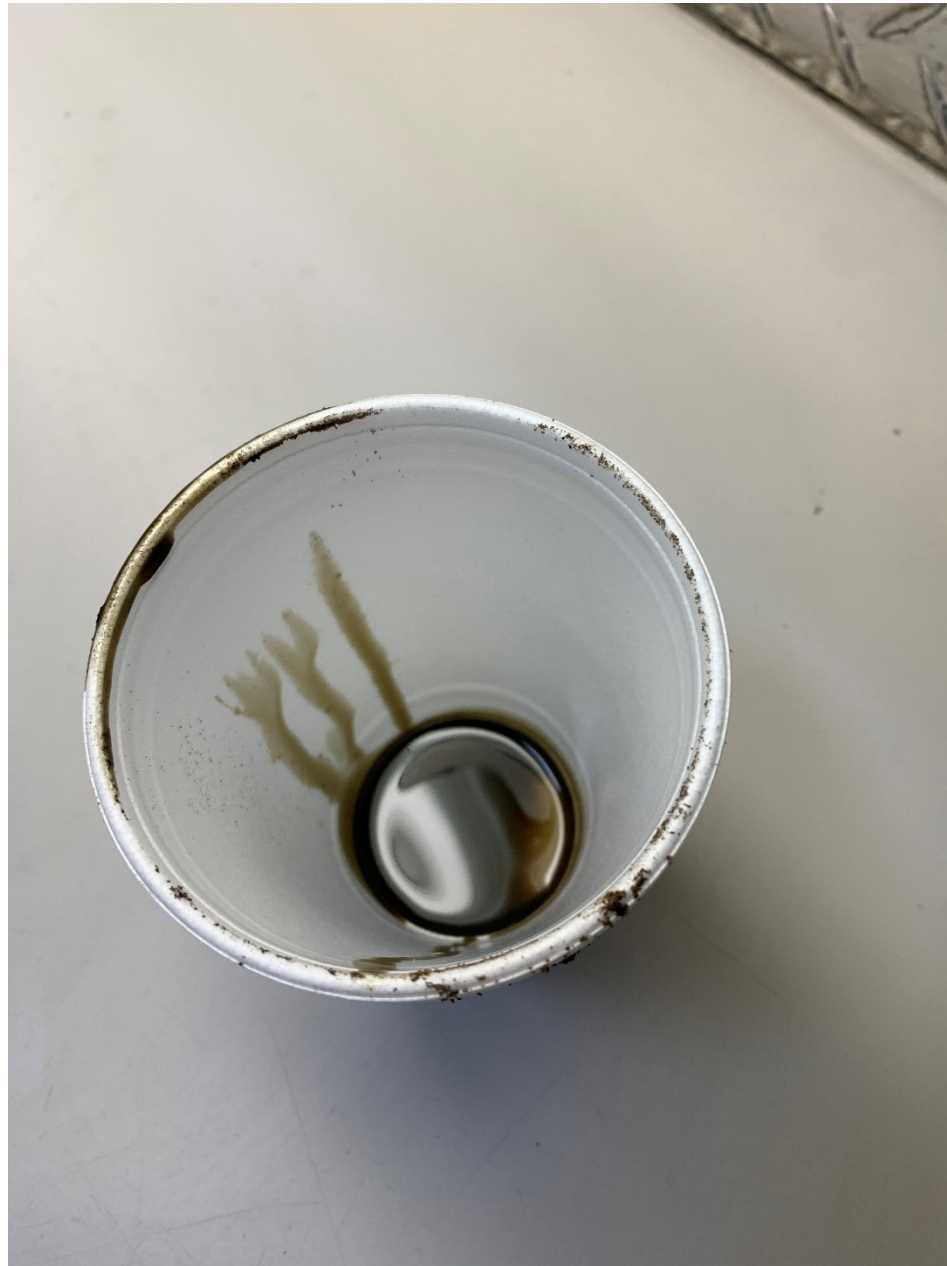
Photo 35 - View of oil collected during the engine examination.

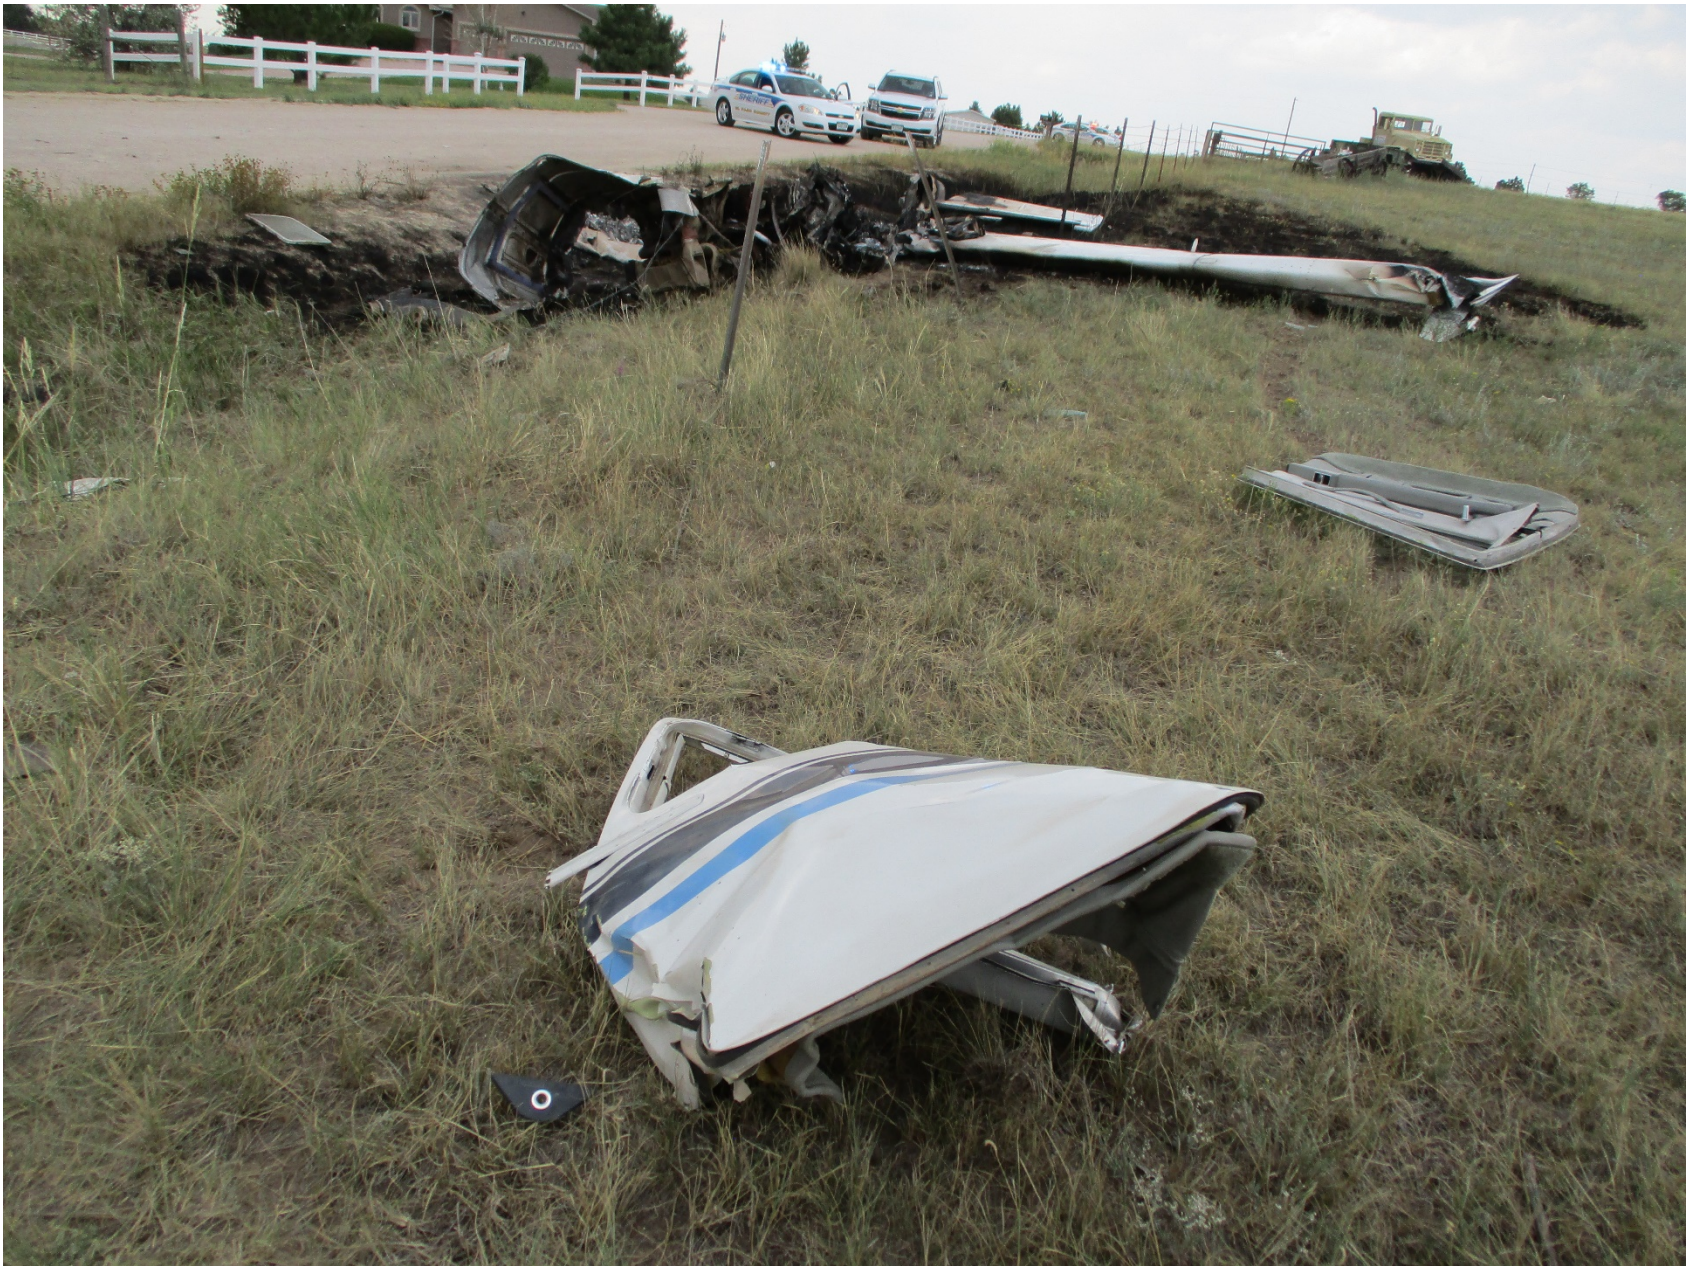
Photo 36 - Supplied view of the cabin doors.

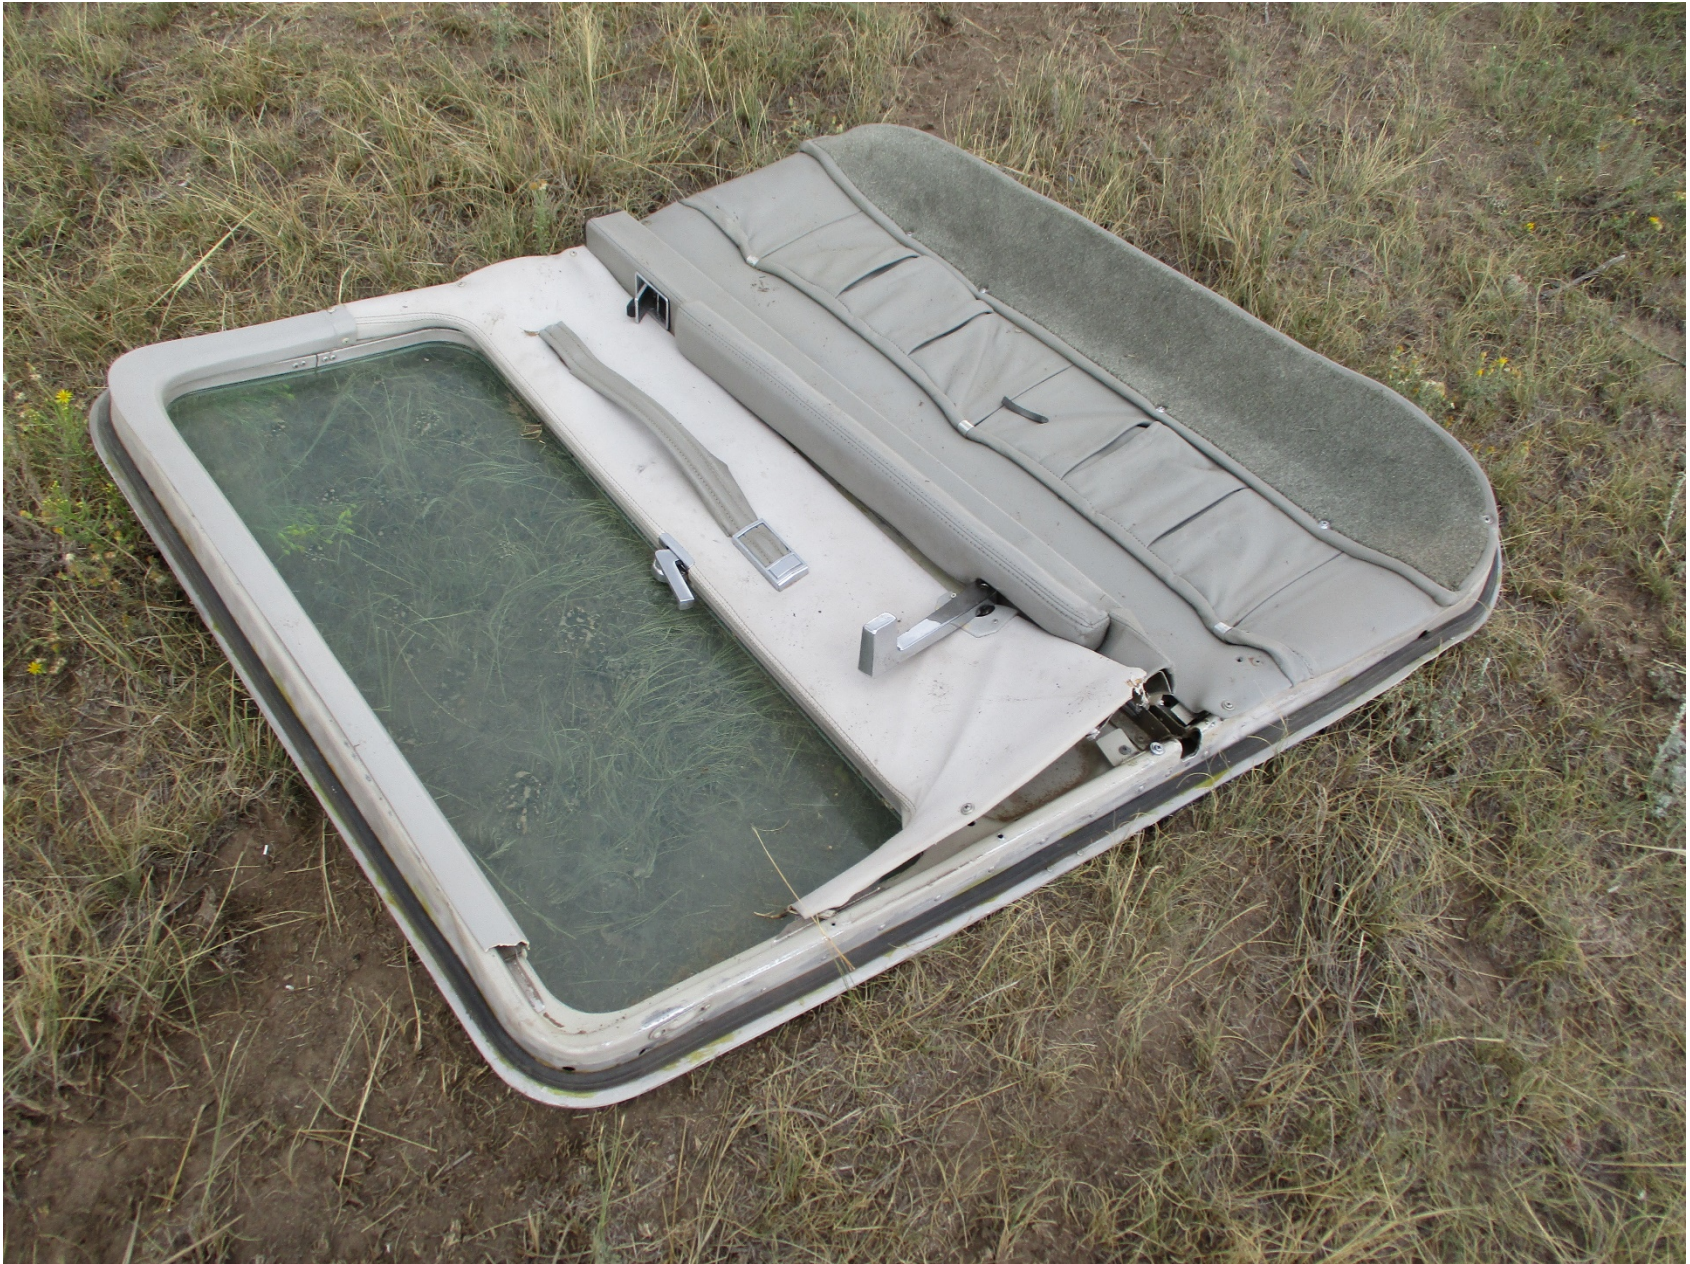
Photo 37 - Supplied view of a cabin door.

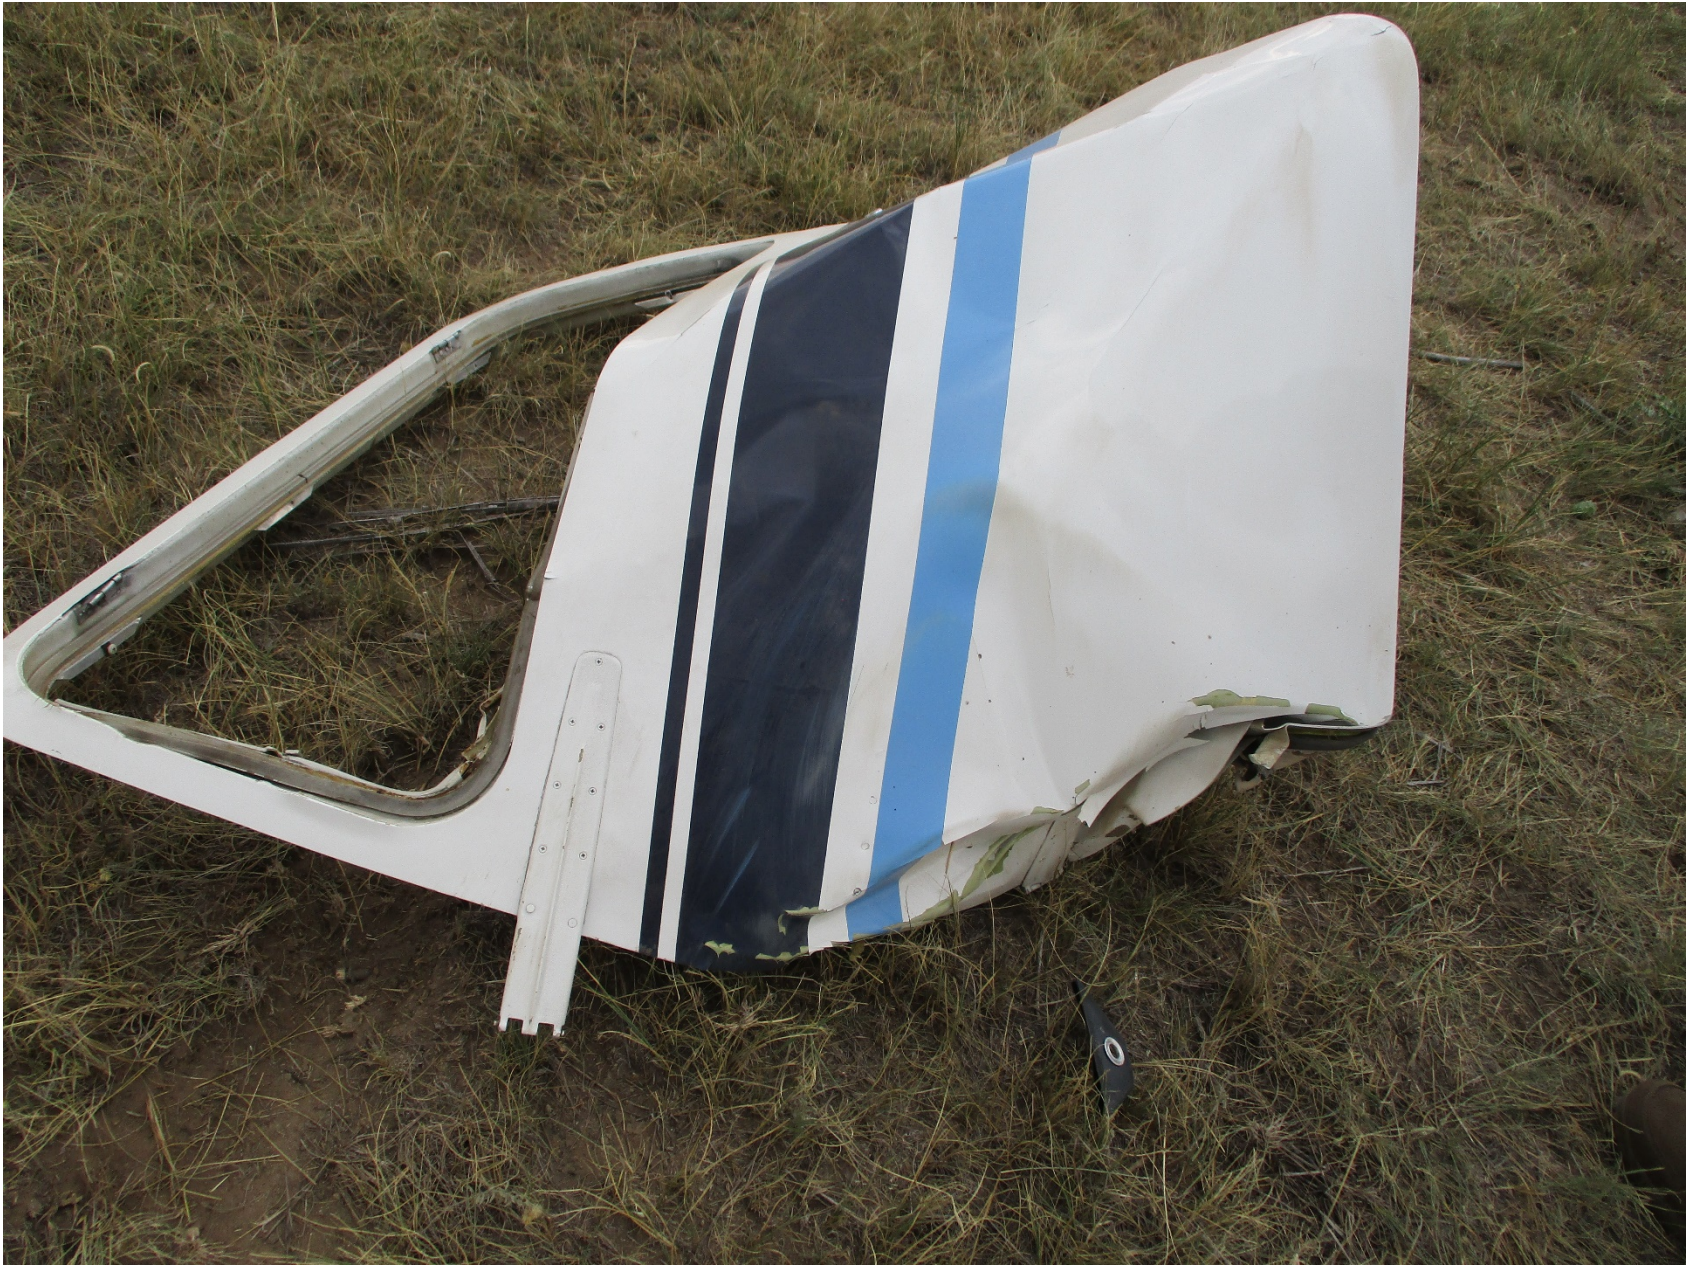
Photo 38 - Supplied view of a cabin door.

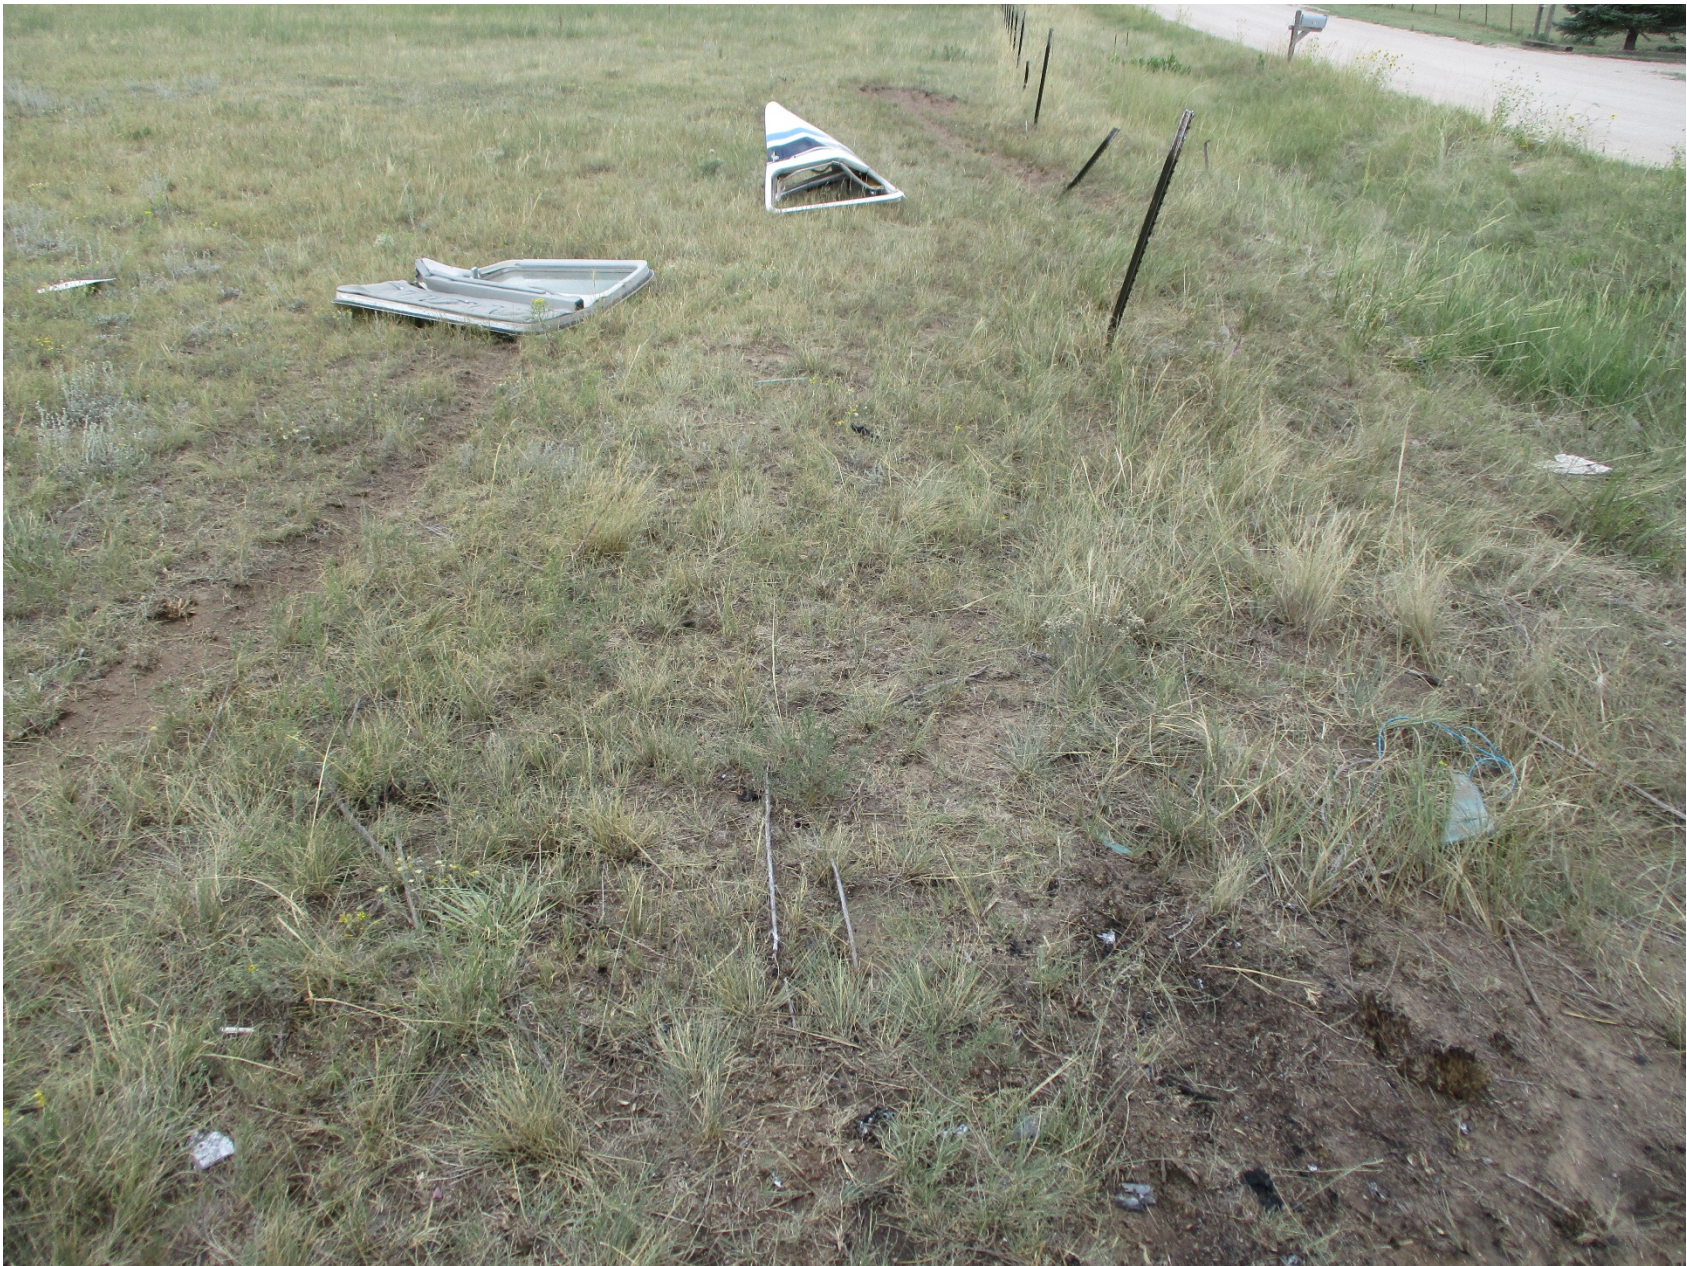
Photo 39 - Supplied view of a ground scar in the foreground and the cabin doors in the backgeroud.
