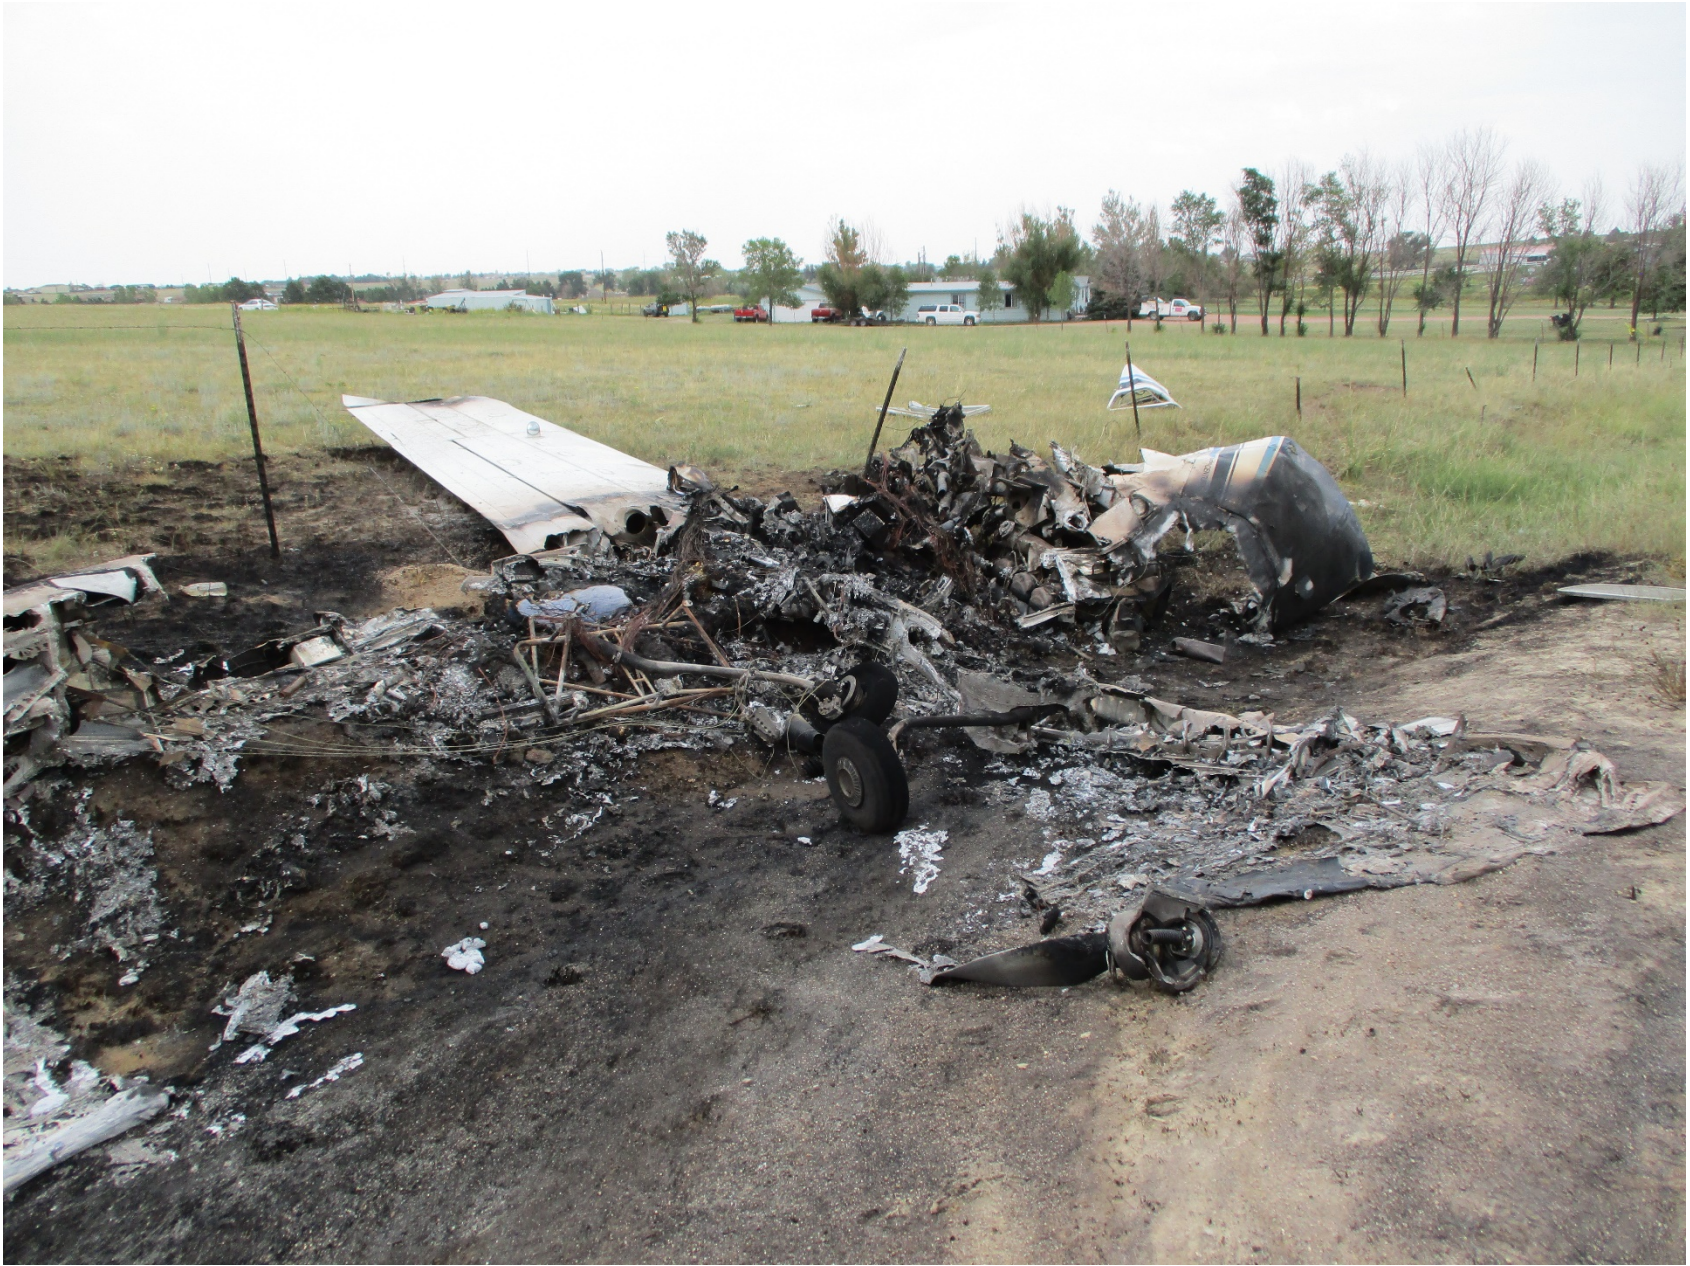
Photo 40 - Supplied view of overall accident site.
