Accident / Incident Report

Report No.: 21-128

**Antonio L. Elias
Piper PA 46-500TP, N31062
Manteo, North Carolina, USA
July 6, 2021
PT6A-42A, RM0227**

**NTSB: ERA21LA287
TSB Identification: A21F0093
P&WC File No.: 21-128
RFA No.: 21SIE00236**

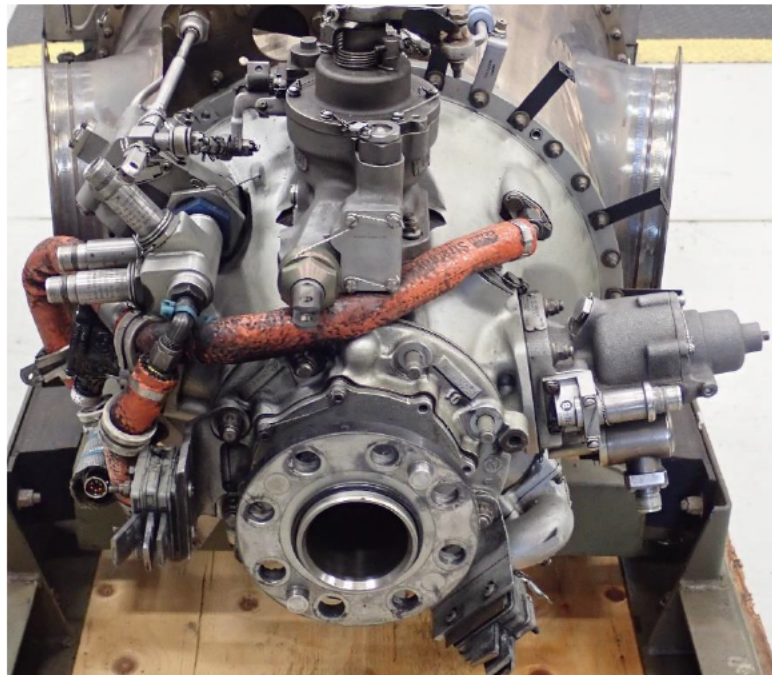
Photo No. 1, view of the front of the engine

The engine was received in a sealed shipping container and was opened in the presence of the NTSB. The reduction gearbox and the exhaust duct were unremarkable (Ref. Photo No. 1 to 4, overall views of the engine). The gas generator case exhibited some buckling at 6 o'clock region forward of the inlet case mating flange. The inlet screen and areas at the bottom of the center and rear fireseals were contaminated with oil, soil, and organic material. All six of the inlet case struts were fractured (Ref. Photo No. 9). The accessory gearbox was unremarkable. One end of the fuel to oil heat exchanger mounting flange was fractured, adjacent to a bolt hole.

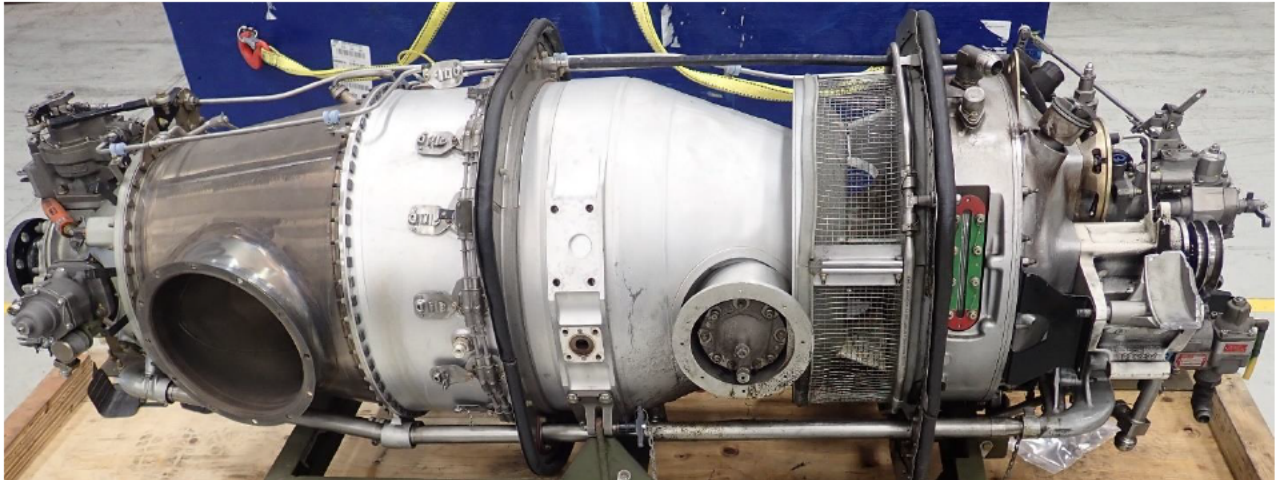
Photo No. 2, view of the left-hand side of the engine

Exhaust Duct: The exhaust duct was unremarkable (Ref. Photos No. 2 & 3).

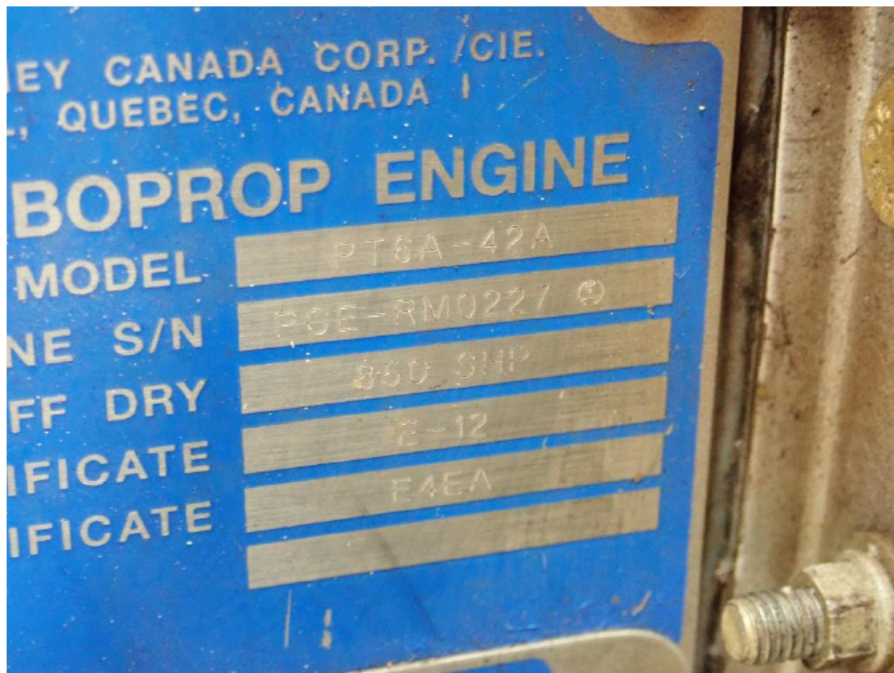
Photo No. 5

The engine data plate showed the engine serial number was PCE-RM0227 (Ref. Photo No. 5).

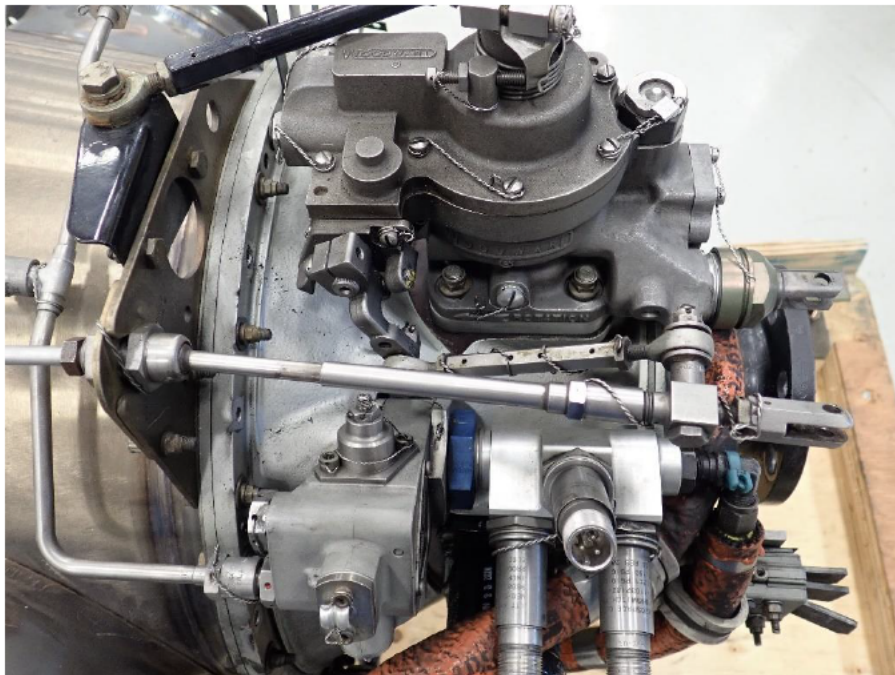
Photo No. 6

Reduction Gearbox (RGB): The reduction gearbox was unremarkable (Ref. Photo No. 6).

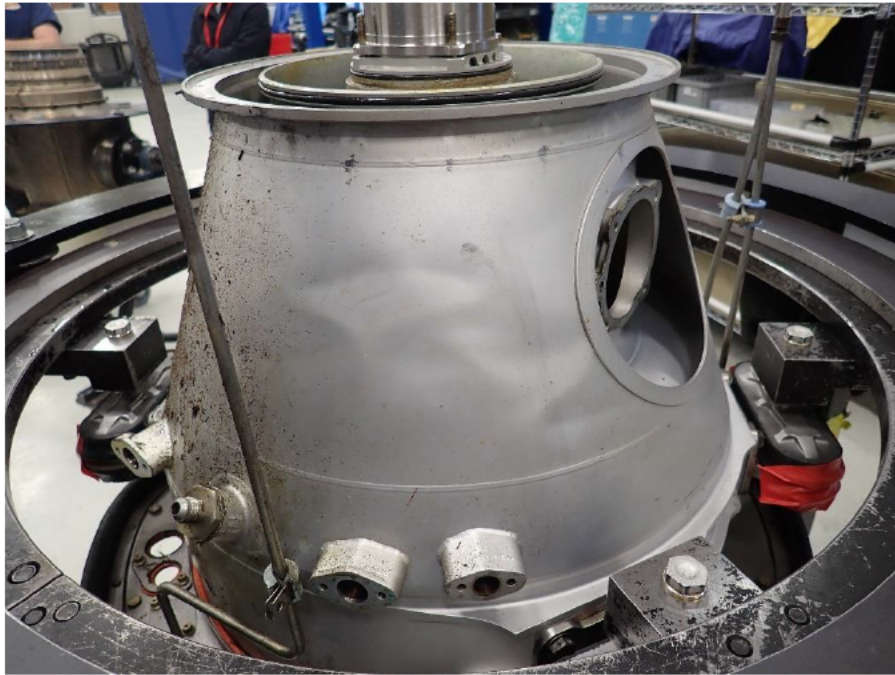
Photo No. 7

Gas Generator Case (GGC): The gas generator case exhibited localized bending on the bottom section between the bleed valve bosses (Ref. Photo No. 7).

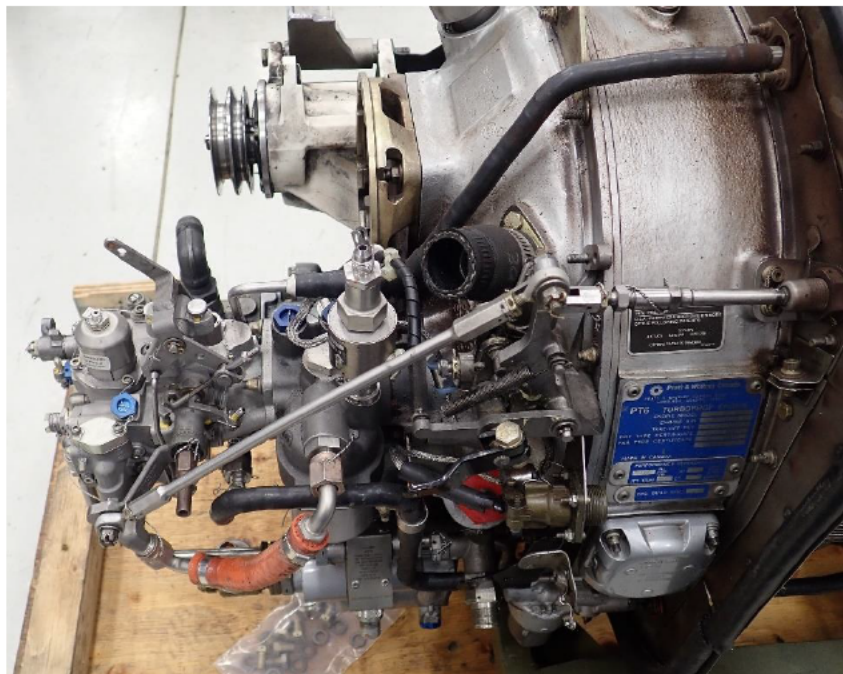
Photo No. 8

Accessory Gearbox (AGB) and Inlet Case: The gearbox was unremarkable (Ref. Photo No. 8). The inlet case struts were fractured (Ref. Photo No. 9).

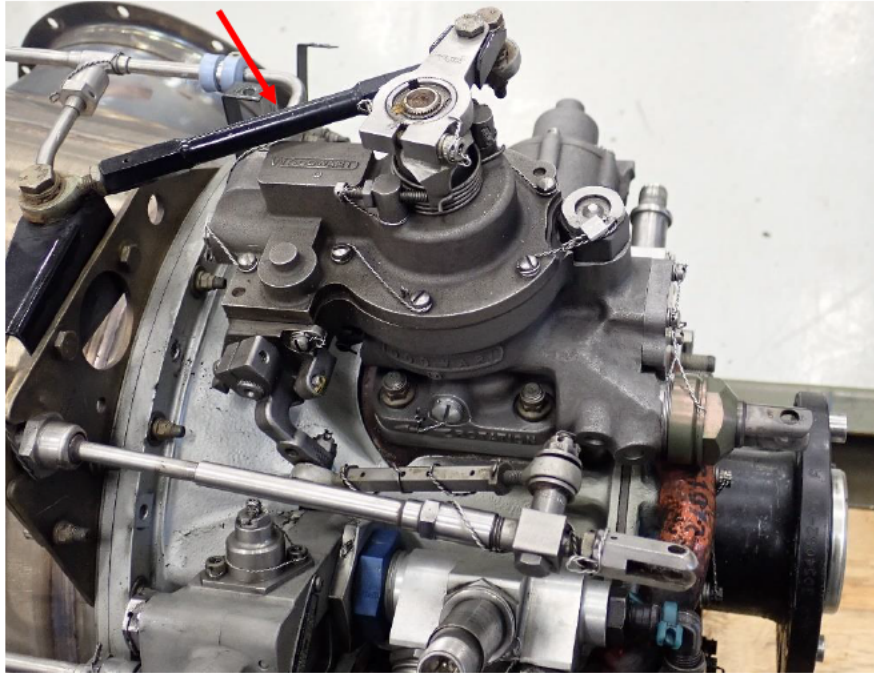
Photo No. 10

The reversing (beta) lever was not received with the engine. The front linkage was in place and secured (Ref. Photo No. 10). The propeller governor lever was secured in a fixed position with an airframe bracket/rod (Ref. Photo No. 10, red arrow).

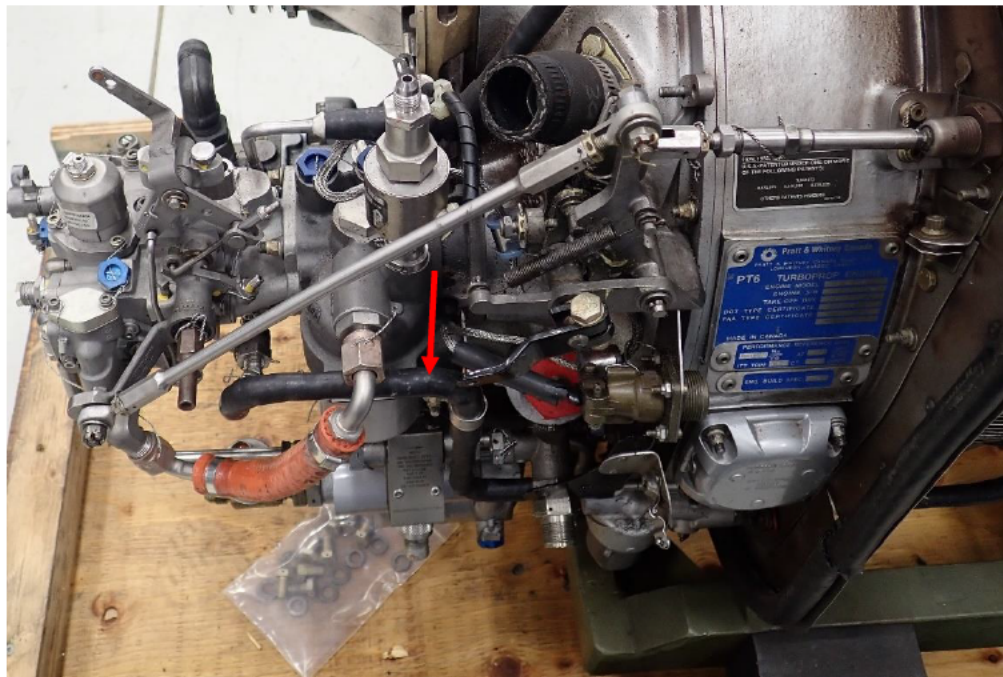
Photo No. 11

The rear linkage was in place and secured (Ref. Photo No. 11).

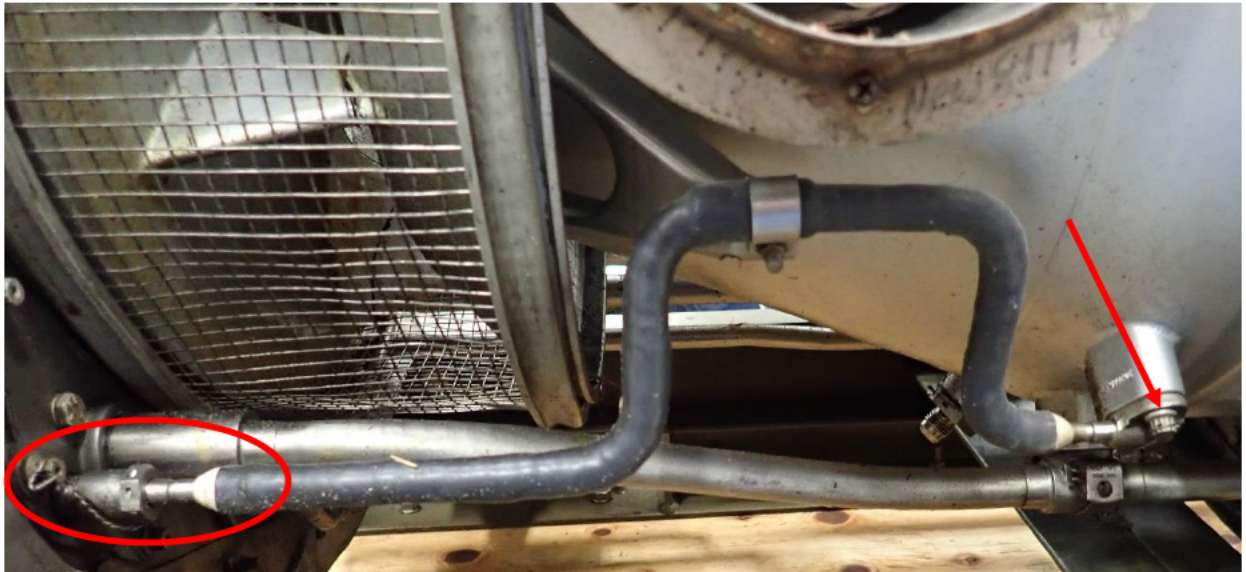
Photo No. 12

Compressor Discharge Air (P3) and P3 Filter: The front of the P3 line was secured to the gas generator case (Ref. Photo No. 12, red arrow). The rear coupling nut was lockwired to the adjacent bolt (Ref. Photo No. 12, red oval). The lockwire was removed and the coupling nut was loosely fitted (not torqued) with its respective mating tube to boss nipple. The exterior surface of the nut exhibited fretting wear from contact with the twists of the lockwire (Ref. Photo No. 13, red arrow). The nipple exhibited some polishing/fretting from contact with the mating surface of the tube (Ref. Photo No. 14, red arrow). The fittings on the rear section of the line between the compressor air filter housing and the fuel control were lockwired and secured/torqued to their respective tube to boss nipple/elbow (Ref. Photo No. 11, red arrow & 15). Both tube to boss nipples were tight in the filter housing. The P3 filter was removed from the compressor air filter housing. No visible contamination was observed in the filter (Ref. Photo No. 16).

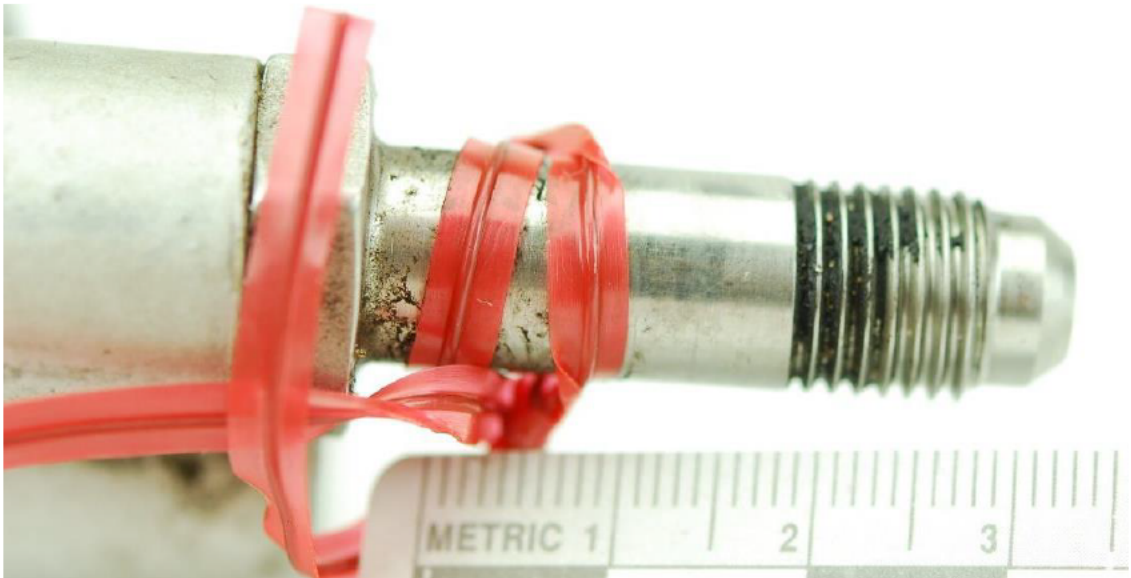
A view of the threads on nipple (3024606) shows a clean area indicating contact with the mating B nut (Ref. Photo No. 17). The remaining threads were filled with a blackish residue indicating these threads were not in the B nut (Ref. Photo No. 17).

Photo No. 17, nipple 3024606

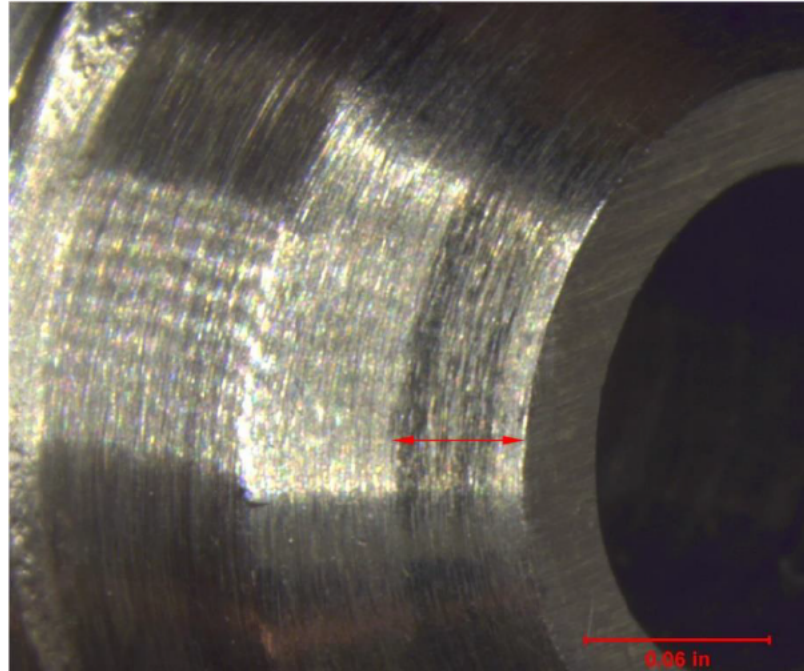
Evidence of a slight change in the surface texture of the conical sealing surface at the tip of nipple 3024606 was consistent with rubbing, this is indicative of contact with the mating part (Ref. Photo No. 18a, double headed red arrow). The conical surface is 0.093" and the contact area is estimated to be approximately 0.048" (Ref. Photo No. 18a). The contact area on the conical surface for nipple MS9193-04 appears slightly more pronounced and the length of the contact is approximately 0.044" (Ref. Photo No. 18b, double ended red arrow).

Photo No. 18b, nipple MS9193-04

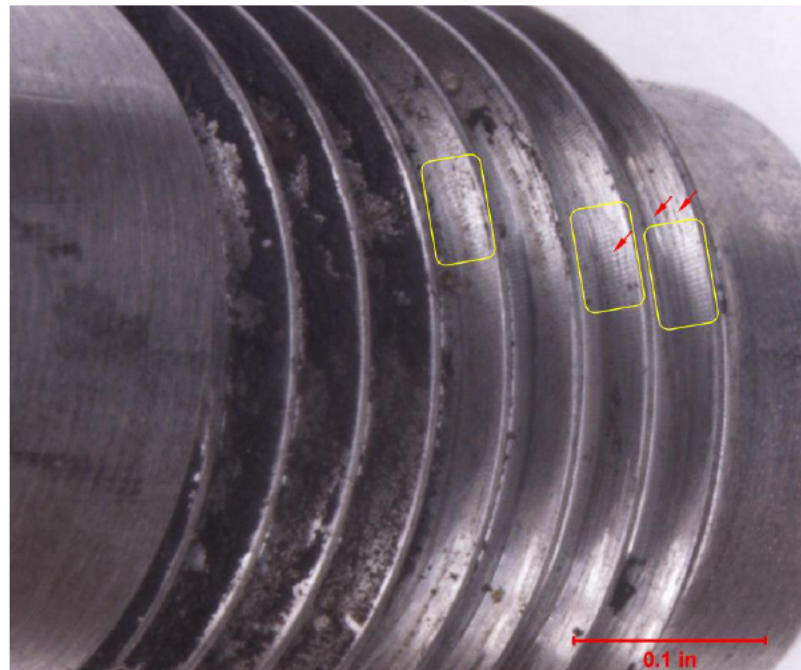
The loaded flank of the threads of the nipple 3024606 shows radial chatter marks from the threads machining process (Ref. Photo No. 19a, yellow rectangles). Light superimposed circumferential marks/scratches from contacting with the mating threads (Ref. Photo No. 19a, red arrows) were observed. The loaded flank of the threads of nipple MS9193-04 did not display any evidence of chatter marks from the machining process but faint circumferential lines from the assembly with the mating (Ref. Photo No. 19b).

Photo No.19a, nipple 3024606

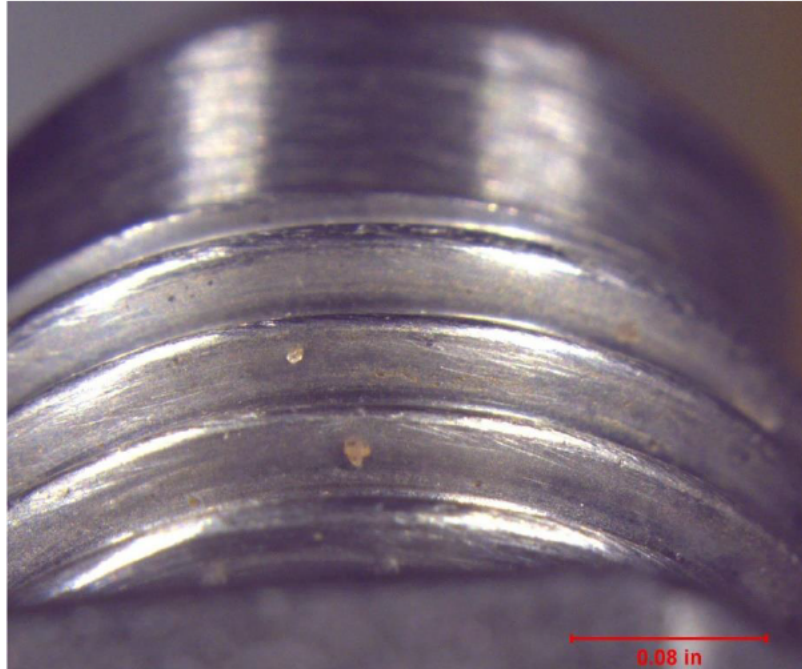
Photo No. 19b, nipple MS9193-04

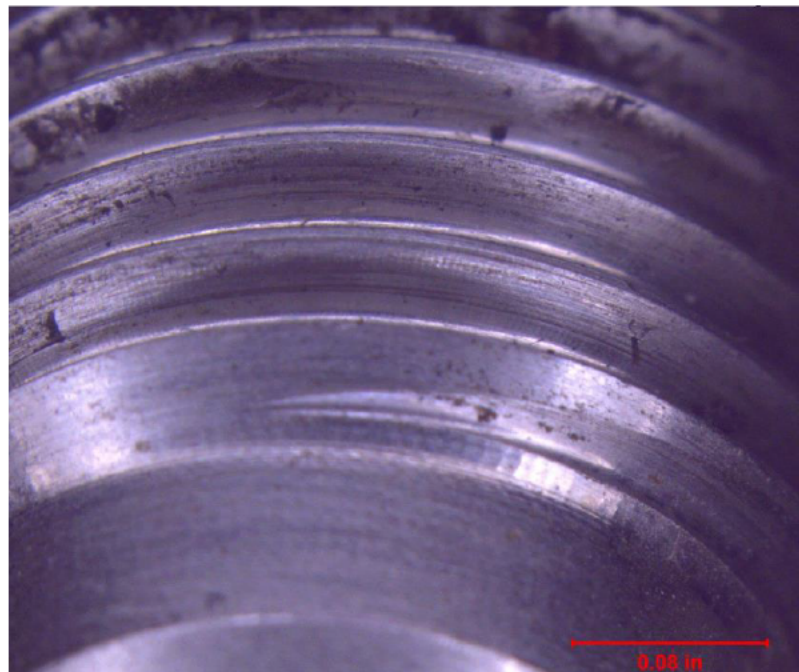
The threads on the non-loaded flank of nipple 3024606 show very little evidence of rubbing damage and no along the crest of the threads (Ref. Photo No. 20a). Radial orientated chatter marks from the machining process are visible (Ref. Photo No. 20a). The threads on the non-loaded flank of nipple MS9193-04 show no evidence of chatter marks from the machining process (Ref. Photo No. 20b). Faint circumferential lines from assembly with the mating nut as well as some damage to the last threads are visible (Ref. Photo No. 20b, red arrows). This type of damage was not observed on the other examined nipple and may have occurred as a result of torquing when the threads are fully engaged.

Photo No. 20a, nipple 3024606

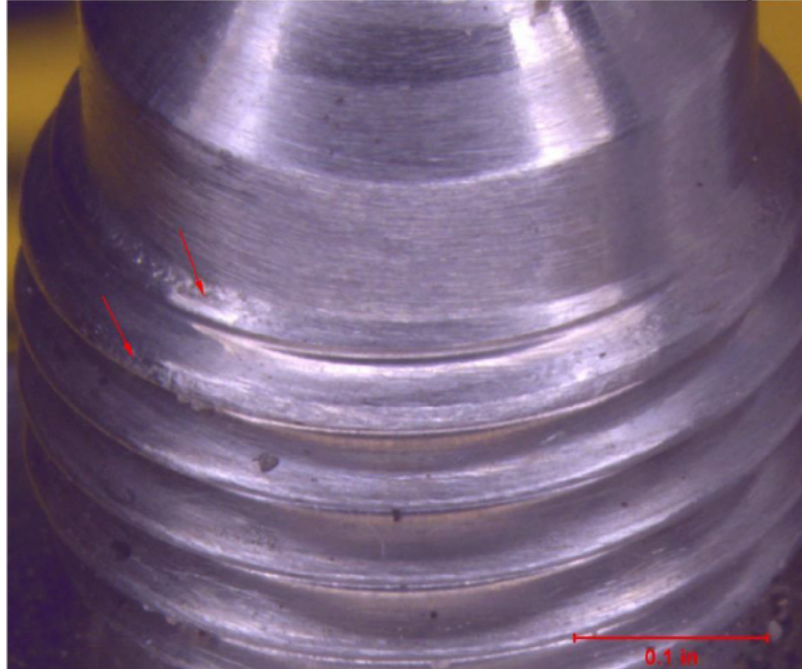
Photo No. 20b, nipple MS9193-04

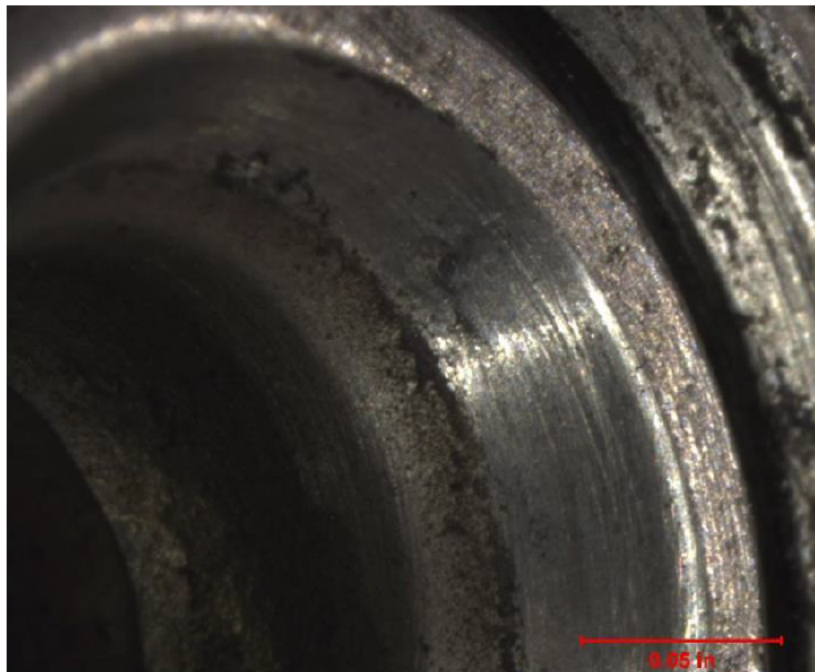
A tilted view of the conical sealing surface of the flared tube coupling of tube 3019295 mating with nipple 3024606 of the air filter housing exhibits very little evidence of contact along the surface (Ref. Photo No. 21a). A tilted view of the conical sealing surface of the flared tube coupling of tube 3027791 mating with nipple MS9193-04 shows a change of coloration and residues (Ref. Photo No. 21b, black arrows) suggesting the contact area between the two mating components (Ref. Photo No. 21b, double headed red arrow).

Photo No. 21a, tube 3019295

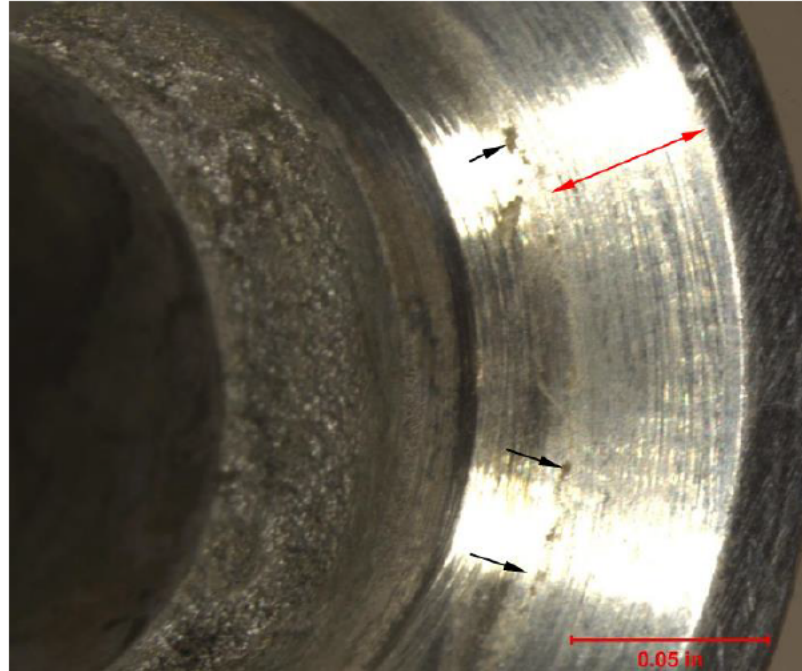
Photo No. 21b, tube 3027791

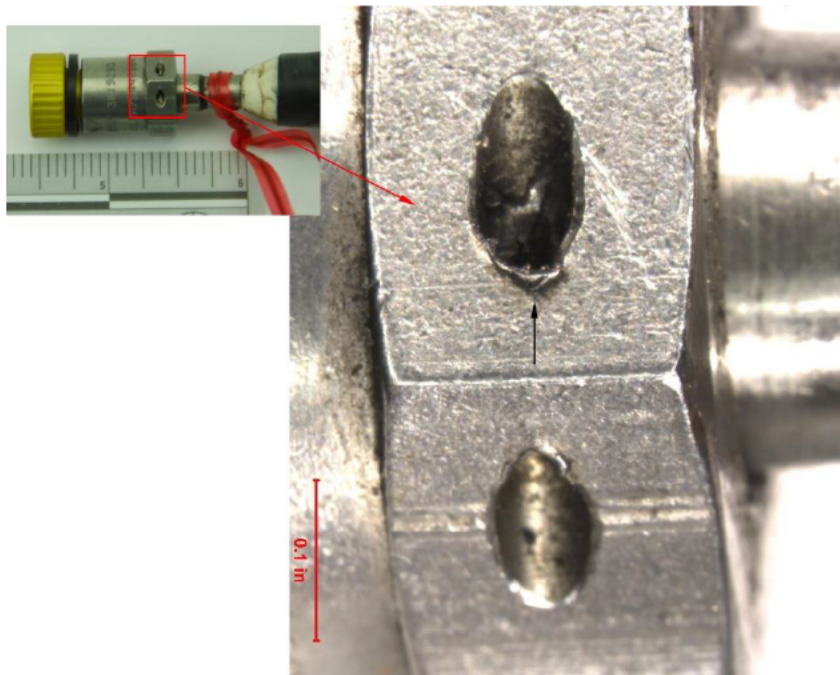
Photo No. 22

2.2 The displaced material on the lockwire channels of the B nuts suggests that the P-3 tubes had been installed on their respective mating nipples on more than one occasion. In P&WC's experience, wear has been witnessed on other "B" nuts from fretting with the lockwire. The dirt buildup in the nipple threads occurs during engine operation as the "B" nut does not fully cover all the nipple threads at this location. The "B" was not properly torqued, it most likely started leaking enough P3 air during the event flight to contribute to a loss of engine power/performance. The pilot reported a loss of engine power and some recovery on several occasions indicating the P3 leak may have been intermittent initially but was most likely degrading over time.

A view of one of the lockwire channels shows evidence of material displacement on one side of the wrenching flat (Ref. Photo No. 22, black arrow). Material displacement was evident on the lockwire channel/wrenching flat on the opposite side of the nut as well. The other two nuts on tube 3027791 exhibited damage to both lockwire channels also suggesting these B nuts had been installed on more than once as well.

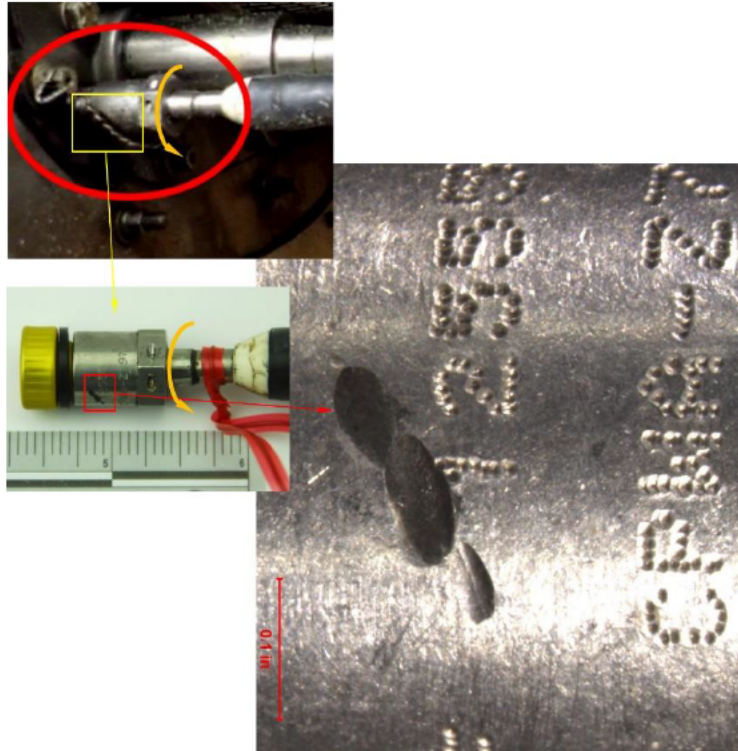
Photo No. 23

3.2 The loose P3 tube "B" nut to the mating nipple most likely resulted in a loss of P3 air pressure to the fuel control unit. Inadequate P3 air pressure to the fuel control would result in a partial loss of engine power as reported by the pilot. The root cause for the loss of torque on the P3 tube "B" nut could not be determined.

A view of the indentation as a result of fretting wear on the lateral surface of the nut corresponds to the location of the lockwire in operation (Ref. Photo No. 23, red oval). Fretting occurs under small amplitude displacements between contacting surfaces. The location of the fretting wear indentations suggests a movement of the coupling (B nut) in the counter-clockwise direction (Ref. Photo No. 23, curved orange arrow). This indicates the nut may have not been properly torqued became loose during operation.

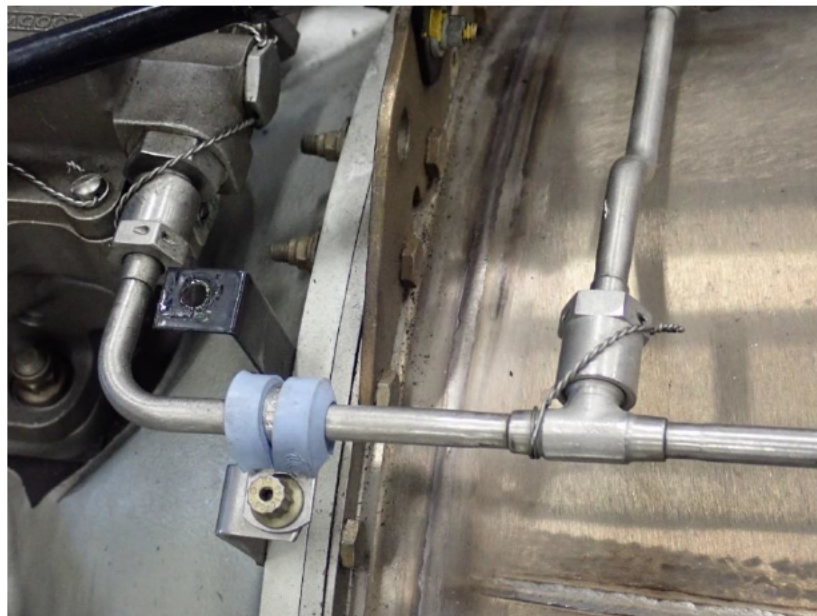
Photo No. 24

Power Turbine Control (Py): The PY line was lockwired at all the connections and all the fittings were torqued (Ref. Photos No. 24 & 25).

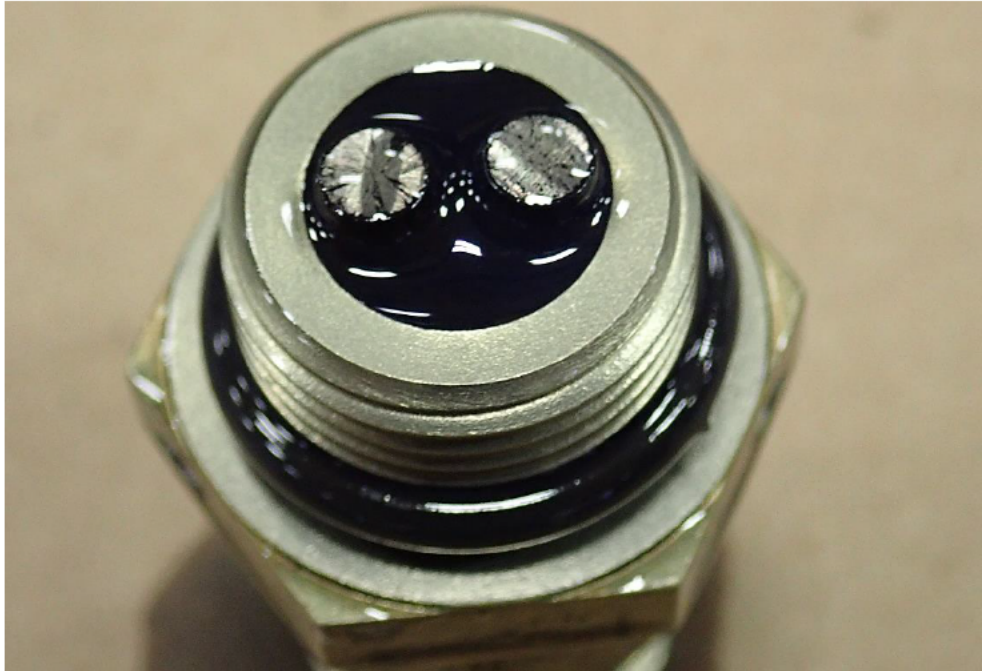
Chip Detectors: Some dark colored particulates build up was evident on the magnetic poles of the accessory gearbox and reduction gearbox chip detectors (Ref. Photo No. 26). The particulates was consistent with carbon.

Photo No. 26, view of the accessory gearbox chip detector

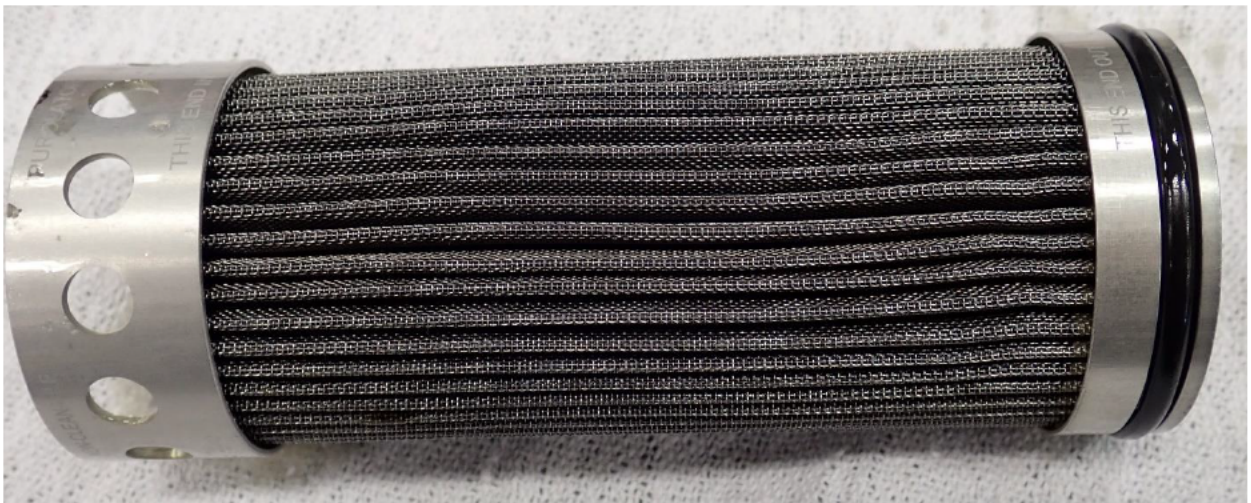
Photo No. 27

Oil Filter: No visible contamination was observed in the filter (Ref. Photo No. 27).

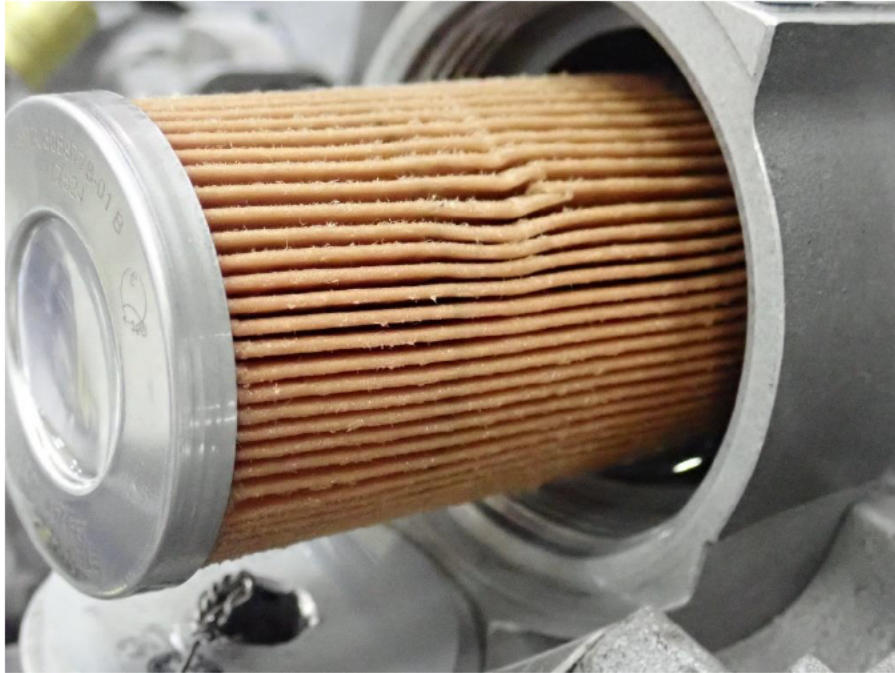
Photo No. 28

Fuel Filter: No visible contamination was observed in the filter (Ref. Photo No. 28).

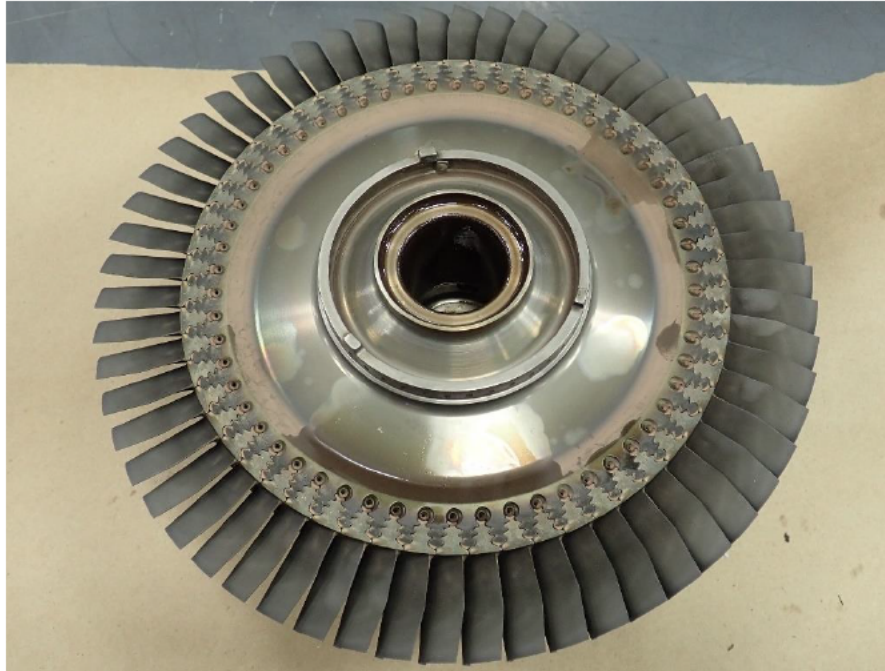
The downstream side of the compressor turbine was unremarkable (Ref. Photo No. 29). The upstream side exhibited circumferential wear on the blades and rivets from contact with the bleed valve baffle (Ref. Photos No. 30 & 31). The blade tips exhibited some operational type of wear (Ref. Photo No. 32).

Photo No. 29, view of the downstream side

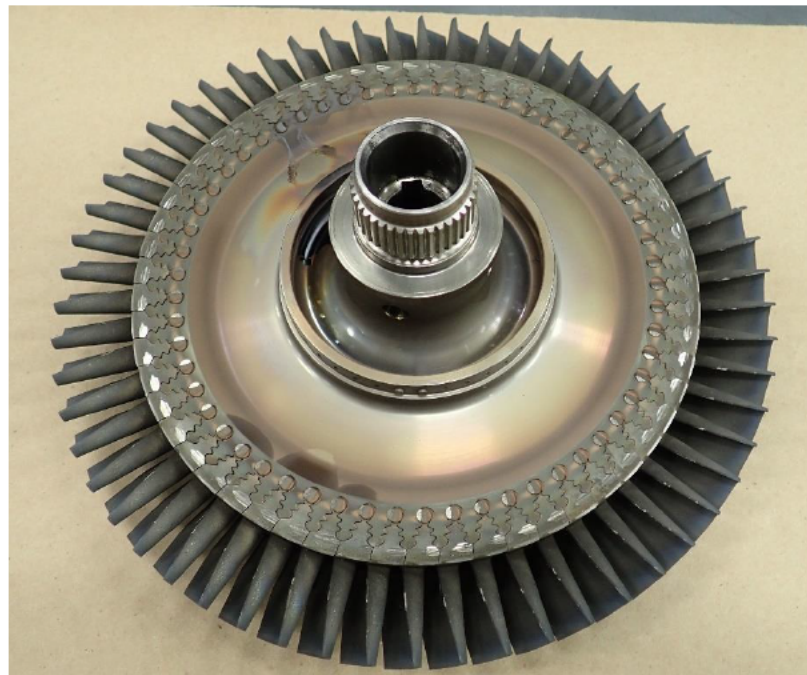
2.1 The scoring on the upstream side of the compressor turbine disc, the rolled over material on the 1st stage compressor rotor and centrifugal impeller indicate that the engine was producing some power during the landing/impact sequence.

Photo No. 30, view of the upstream side

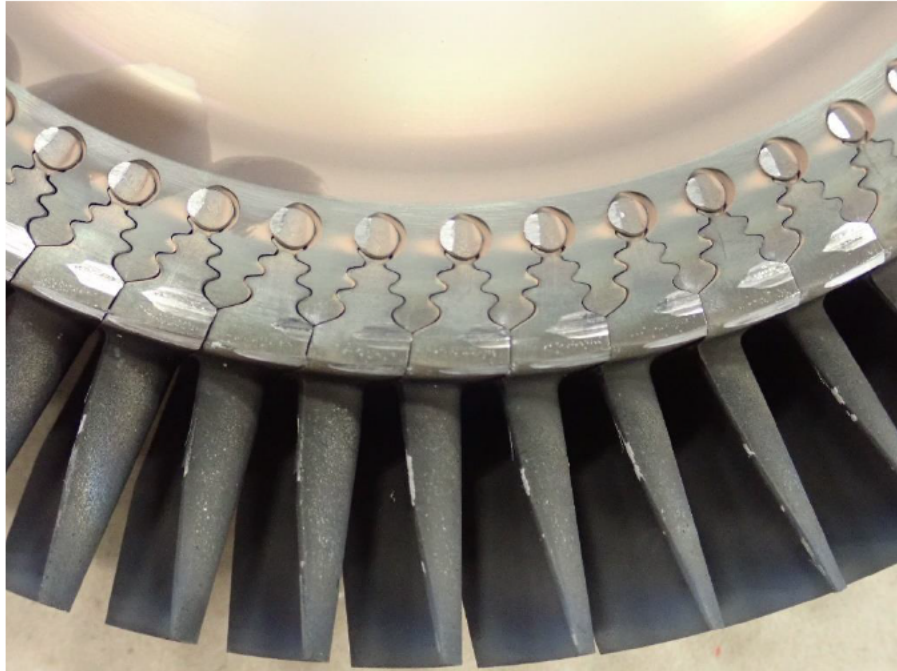
Photo No. 31, view of the upstream side

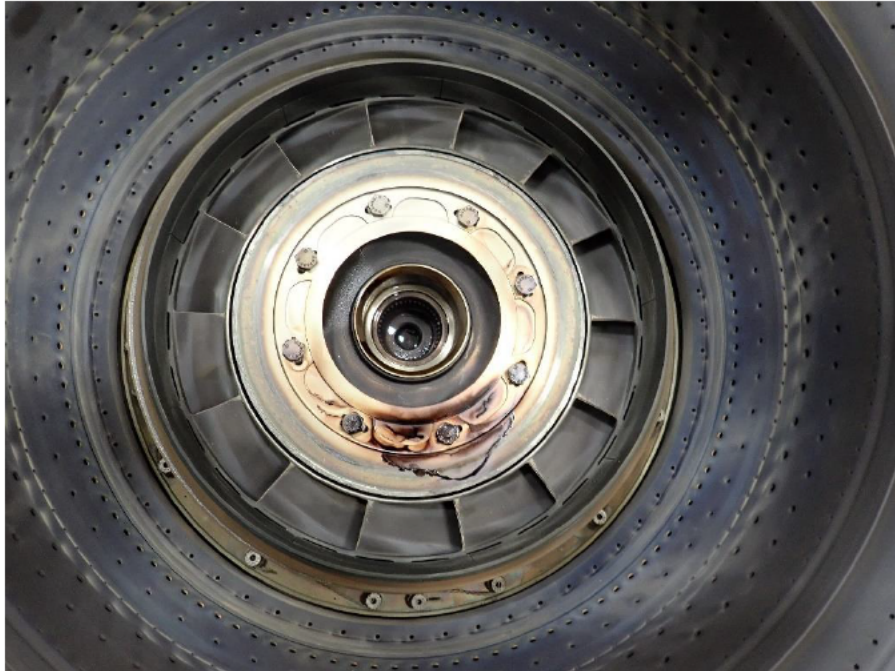
The bleed valve baffle was worn from contact with the compressor turbine (Ref. Photo No. 33 & 34, red arrows). The downstream side of the compressor turbine vane exhibited some soot/carbon on the surface (Ref. Photo No. 33). The shroud segments exhibited operational type wear (Ref. Photo No. 35).

Photo No. 33, view of the downstream side

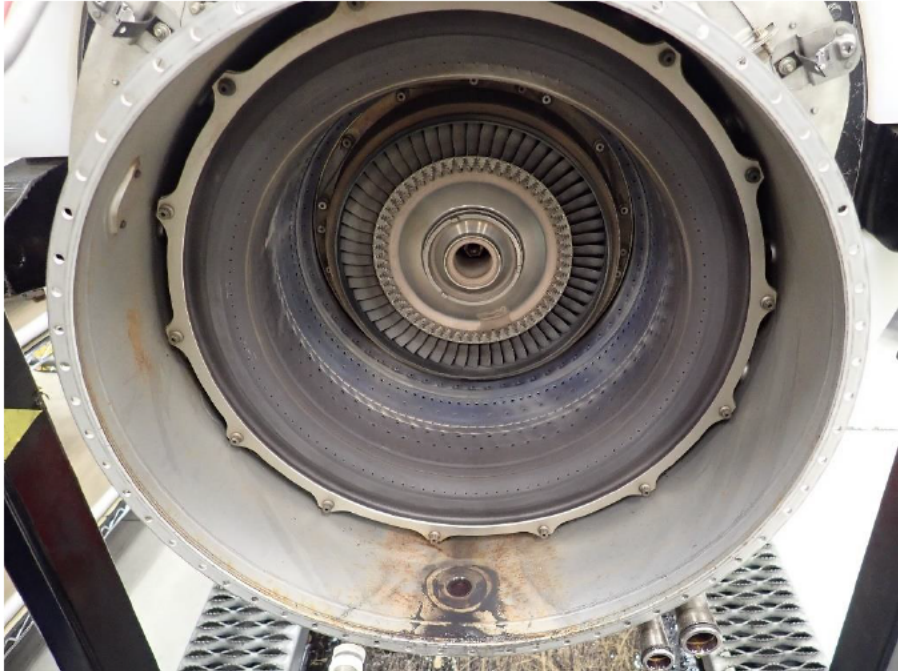
Photo No. 36

The visible area of the inner combustion chamber liner was unremarkable (Ref. Photo No. 36). The combustion chamber liners and the small exit duct were not removed for the purpose of this investigation.

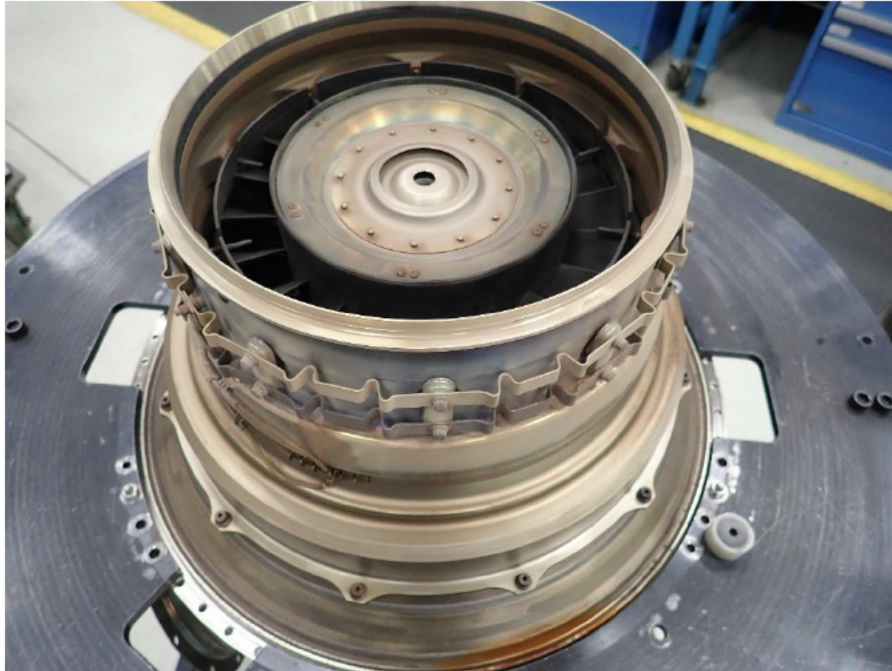
Photo No. 37

The inter turbine temperature (ITT) probes, busbar, and harness, were in place and secured, no damage was evident (Ref. Photo No. 37).

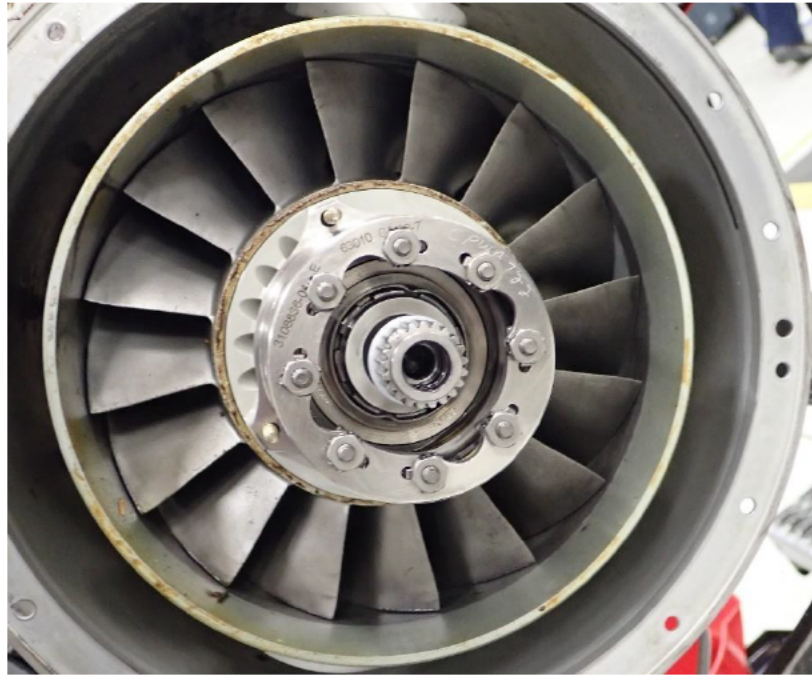
The No. 1 & 2 bearings were in place and rotated freely (Ref. Photos No. 38 & 40). The No. 1 bearing rotor airseal and compressor rotor air seal were rubbed from contact with their respective stator airseals (Ref. Photos No. 39 & 40).

Photo No. 38, view of the No. 1 bearing

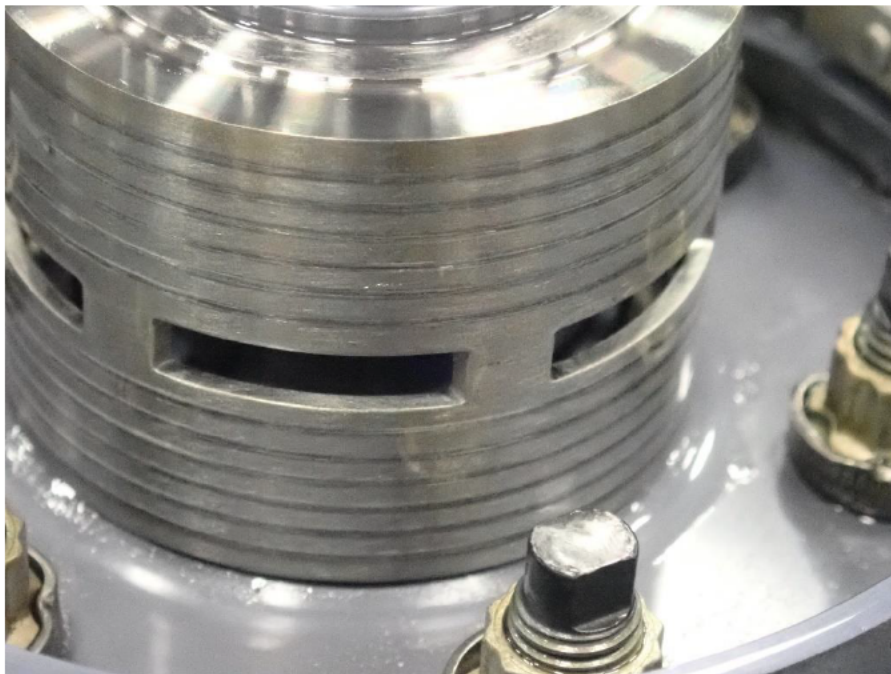
Photo No. 39, view of the No. 1 bearing rotor airseal

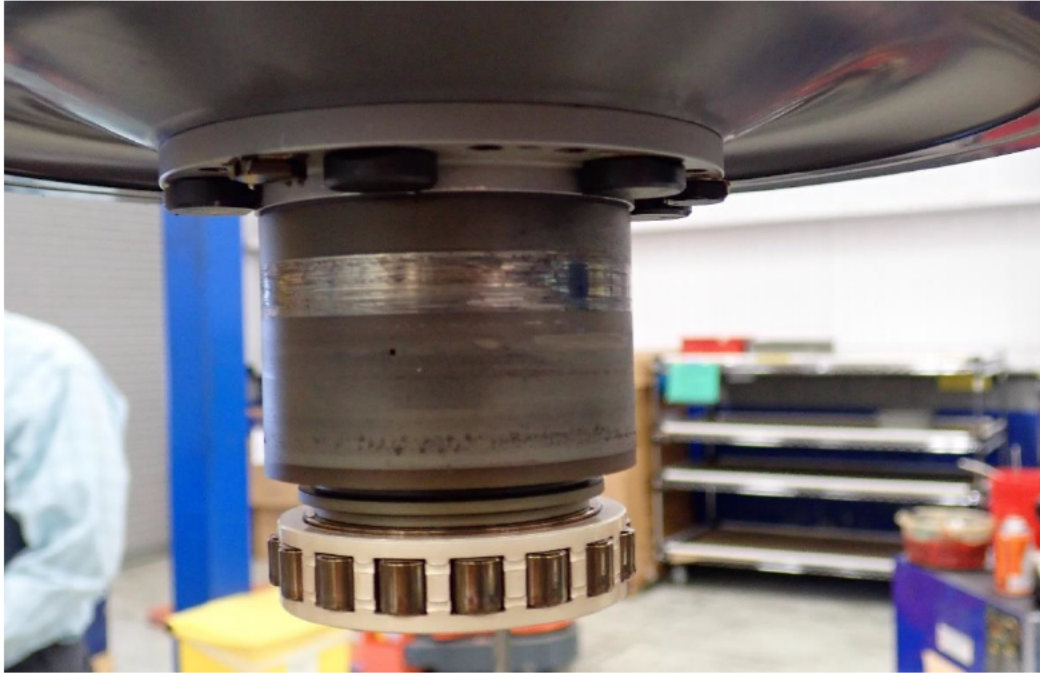
Photo No. 40, view of the compressor rotor airseal and No. 2 bearing

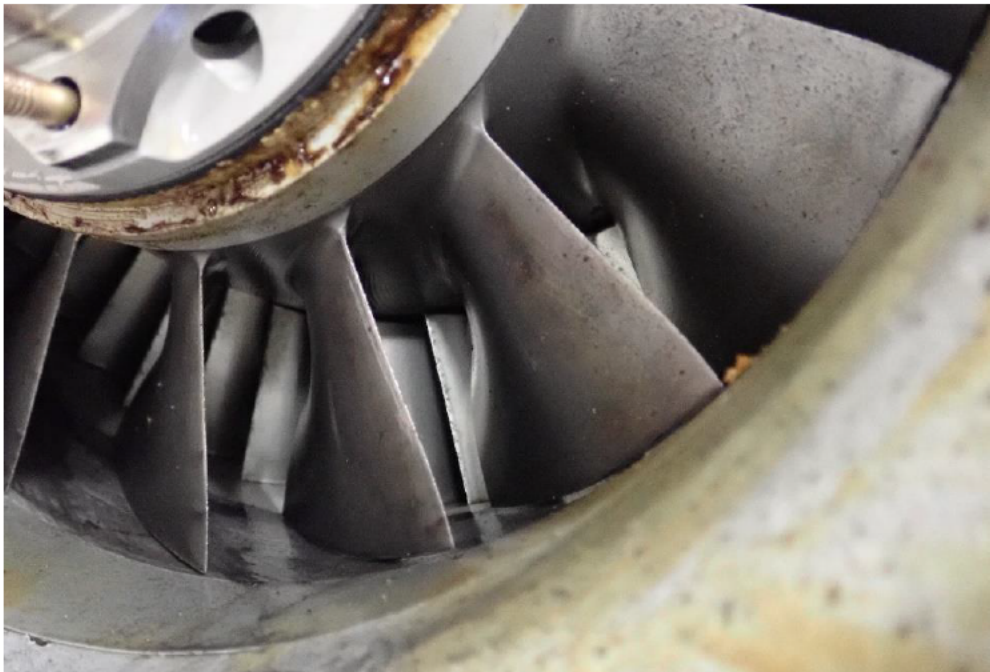
Photo No. 41

The 1st stage compressor blades had rubbed with their respective shroud (Ref. Photo No. 41). The blade tips exhibited rolled over material (Ref. Photo No. 42). The 1st stage compressor vane airfoils exhibit rolled over material on the tips from contact with the adjacent spacer. The centrifugal impeller airfoils were rubbed with rolled over material from contact with the impeller shroud (Ref. Photo No. 43). The compressor was not disassembled for the purpose of this investigation.
