Accident / Incident Report

Report No.: 21-128

**Antonio L. Elias
Piper PA 46-500TP, N31062
Manteo, North Carolina, USA
July 6, 2021
PT6A-42A, RM0227**

**NTSB: ERA21LA287
TSB Identification: A21F0093
P&WC File No.: 21-128
RFA No.: 21SIE00236**

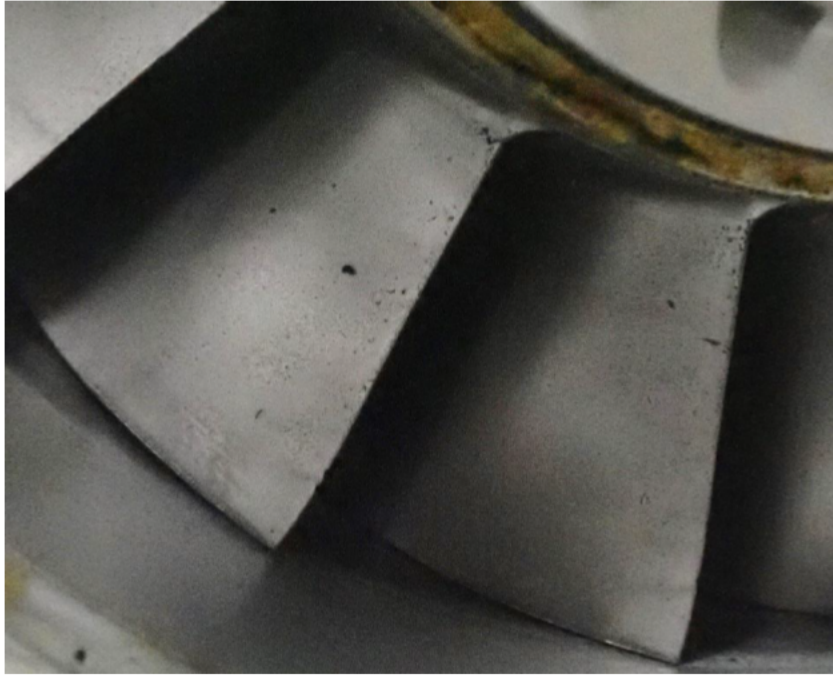
Photo No. 42

The 1st stage compressor blades had rubbed with their respective shroud (Ref. Photo No. 41). The blade tips exhibited rolled over material (Ref. Photo No. 42). The 1st stage compressor vane airfoils exhibit rolled over material on the tips from contact with the adjacent spacer. The centrifugal impeller airfoils were rubbed with rolled over material from contact with the impeller shroud (Ref. Photo No. 43). The compressor was not disassembled for the purpose of this investigation.

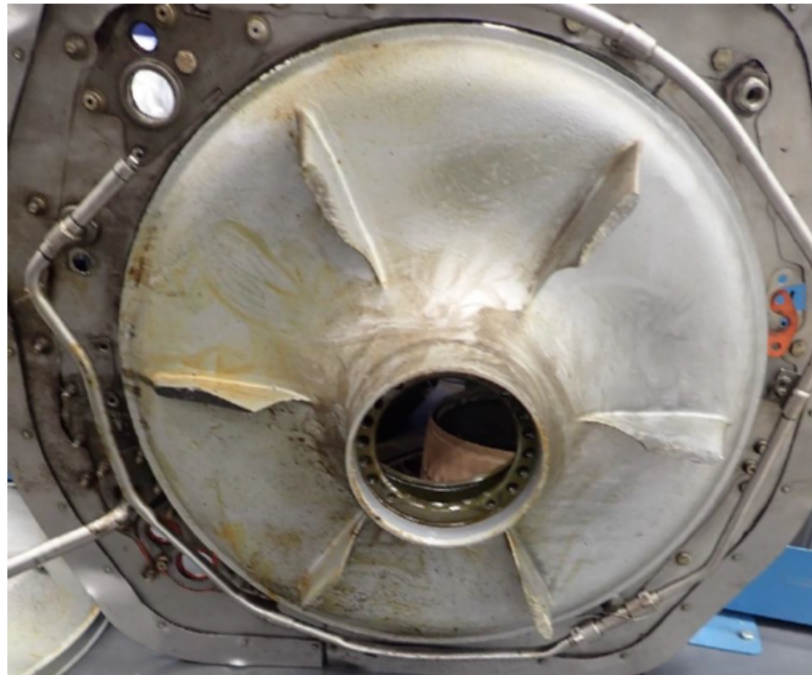
Photo No. 44

The AGB was not disassembled for the purpose of this investigation. The inlet case struts were fractured which separated the case into two sections (Ref. Photos No. 44 & 45).

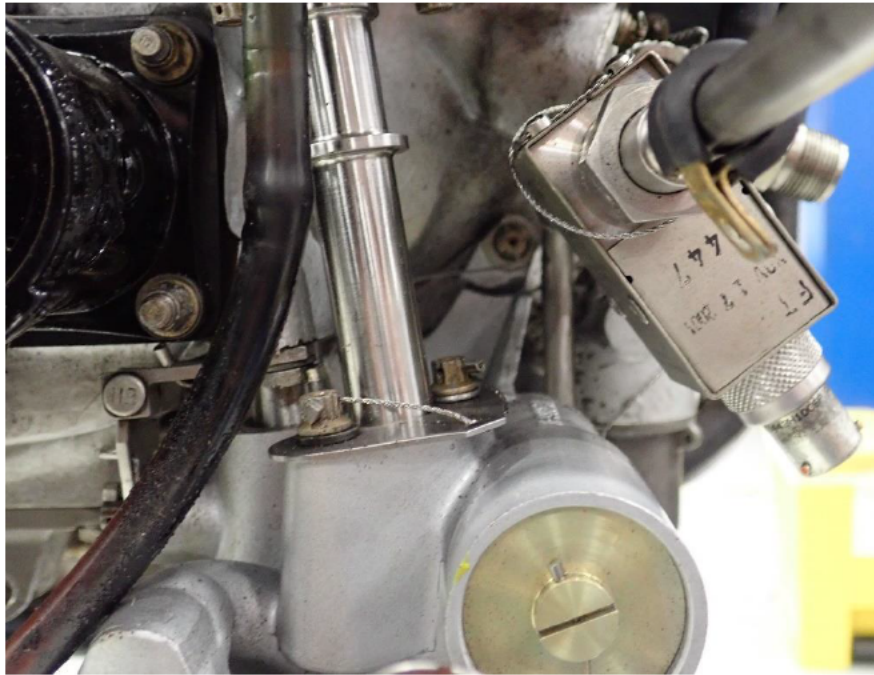
Photo No. 46

Fuel Oil Heat Exchanger (FOHE): One of the mounting flange bolt holes of the fuel to oil heat exchanger was fractured (Ref. Photos No. 46 & 47). The exchanger was forwarded to P&WC's Accessories Investigations for functional testing and investigation. All the bores, except for the fuel inlet were scored (Ref. Photos No. 48a to 48e). Slivers were present in the oil outlet, oil inlet, and the fuel outlet ports (Ref. Photos No. 48b, 48c, & 48e). The thermal element was functional tested in accordance with the manufacture's component maintenance manual (CMM) preassembly check method. The thermal element travel met the manual requirements.

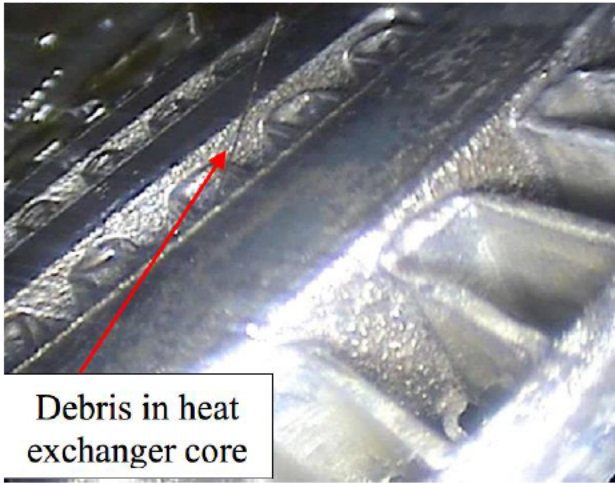
Photo No. 51

The FOHE was forwarded to the manufacturer for additional functional testing and investigation. The unit passed the oil bypass valve function tests. The slivers of debris that were collected were forwarded to the manufacturer for analysis. The thermal element was removed, and slivers were present on the bypass valve sleeve (Ref. Photo No. 49). The outside diameter of the oil bypass valve exhibited scuff marks (Ref. Photo No. 50). A Borescope inspection revealed that slivers of debris were present further down in the oil out port and in the FOHE core, when viewed from the drain port (Ref. Photos No. 51 & 52).

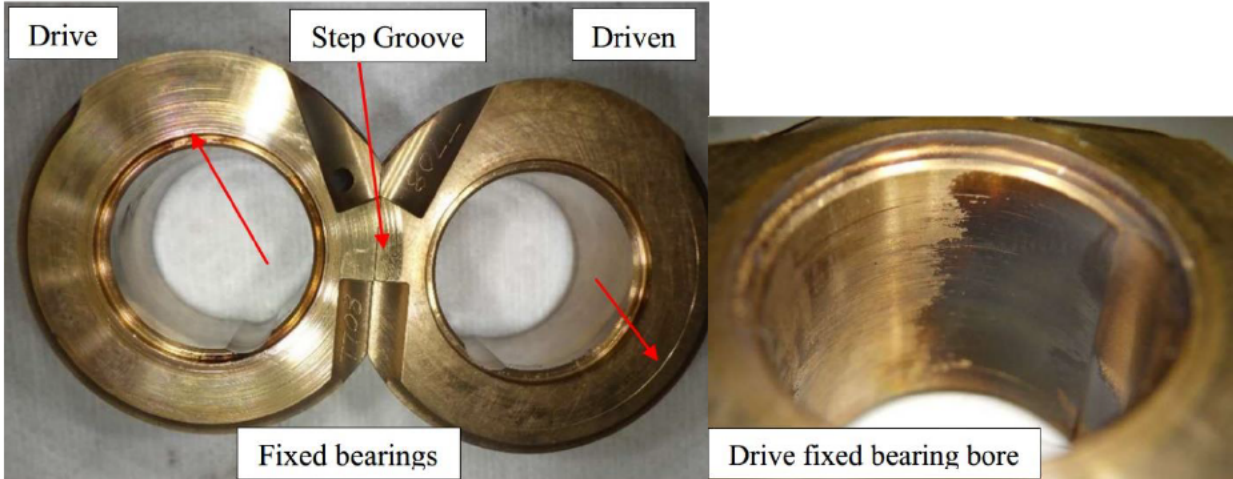
Photo No. 54

The pump was disassembled. The two drive side bearings and the driven side fixed bearing exhibited scoring marks on the face mating with the gears (Ref. Photos No. 54 & 55). The two drive side bearings showed some localized darkened area with the presence of scoring (Ref. Photos No. 54 & 55). A step groove was present in the fixed driven bearing from contact with the drive gear, as well as a step groove in the drive floating bearing from contact with the drive gear (Ref. Photos No. 54 & 55). The outside diameters of the two pressurized bearings displayed discoloration (Ref. Photo No. 56). The drive gear faces mating with the bearings were scored (Ref. Photos No. 57 & 58). Localized brown-blueish coloration was observed on the drive gear, as well as a circumferential scoring mark on the pressurized bearing side of the gear journal (Ref. Photos No. 58, red arrows & 59).

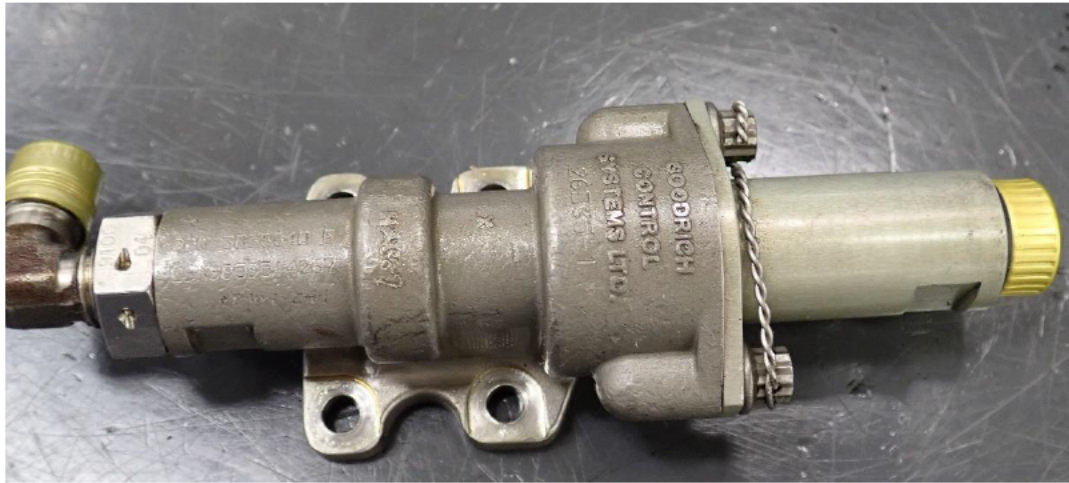
Phot No. 60

Flow Divider Valve (FDV): The flow divider was in place and secured on its respective mounting pad on the fuel nozzle (Ref. Photo No. 60). The flow divider was forwarded to P&WC's Accessories Investigation for functional testing. The valve was satisfactorily tested in accordance with the manufacture's CMM.

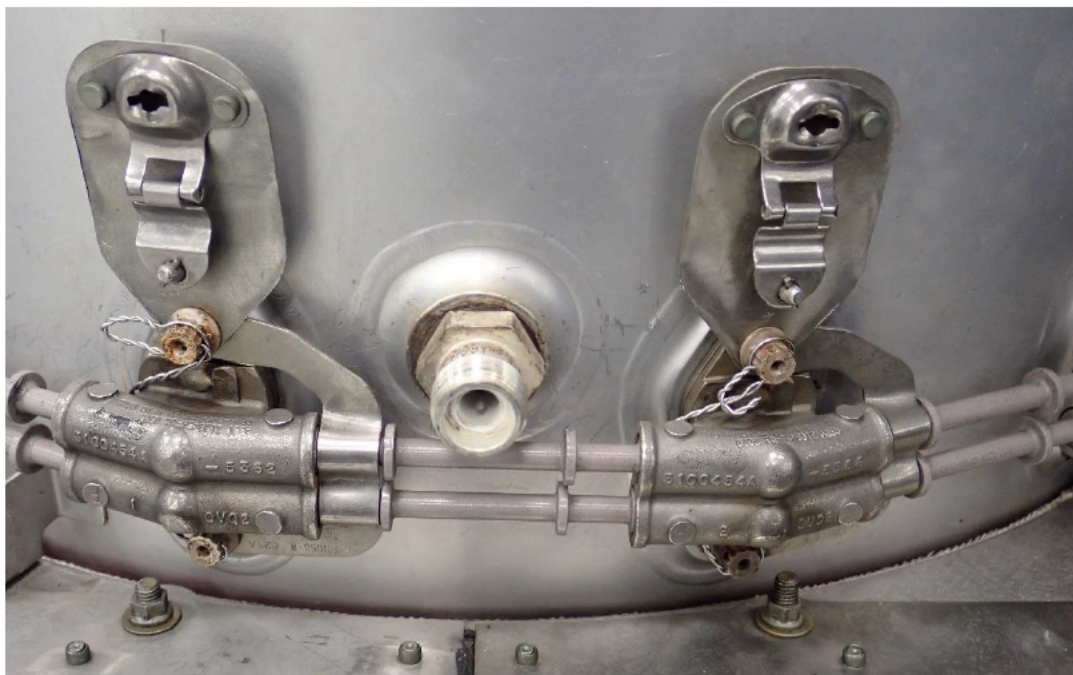
Photo No. 61

Fuel Nozzles: The fuel nozzles were in place and secure on their respective pads on the gas generator case (Ref. Photo No. 61).

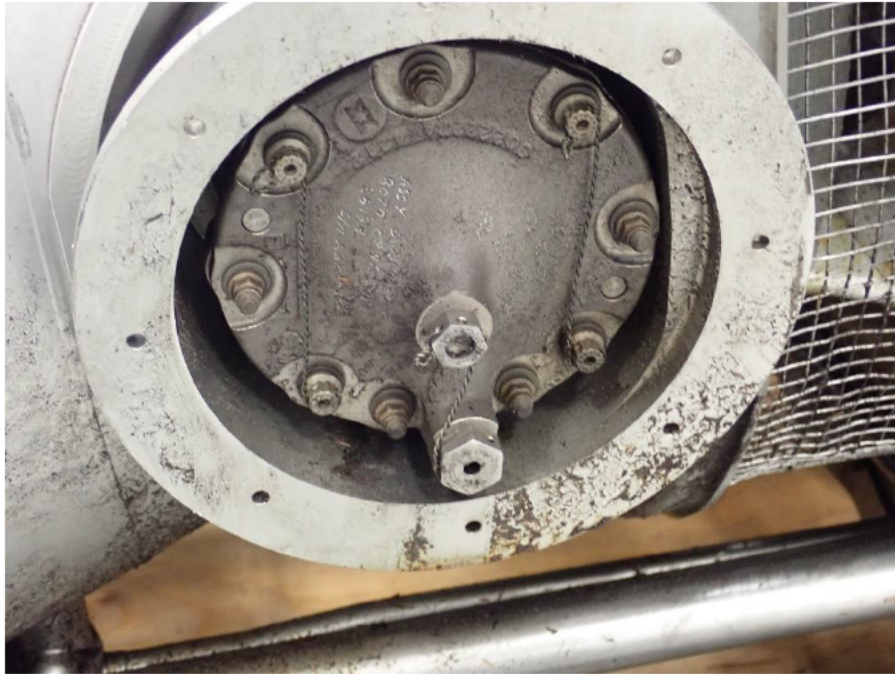
Compressor Bleed Valve (BOV): Both (low-pressure and high-pressure) bleed valves were in place and secured to their respective mounting pads on the gas generator case (Ref. Photos No. 62 & 63). No visible damage was evident. The bleed valves were forwarded to P&WC's Accessories Investigation for functional testing. The calibration pressure check on the low-pressure bleed valve revealed the minimum flow was below the P&WC overhaul manual tolerance. The calibration check on the high-pressure bleed valve revealed that the leakage rate was over the manual tolerance. The leak was determined to be originating from the damper set screws. The bleed valve deviations did not contribute to the event.

Photo No. 62, view of the low-pressure bleed valve

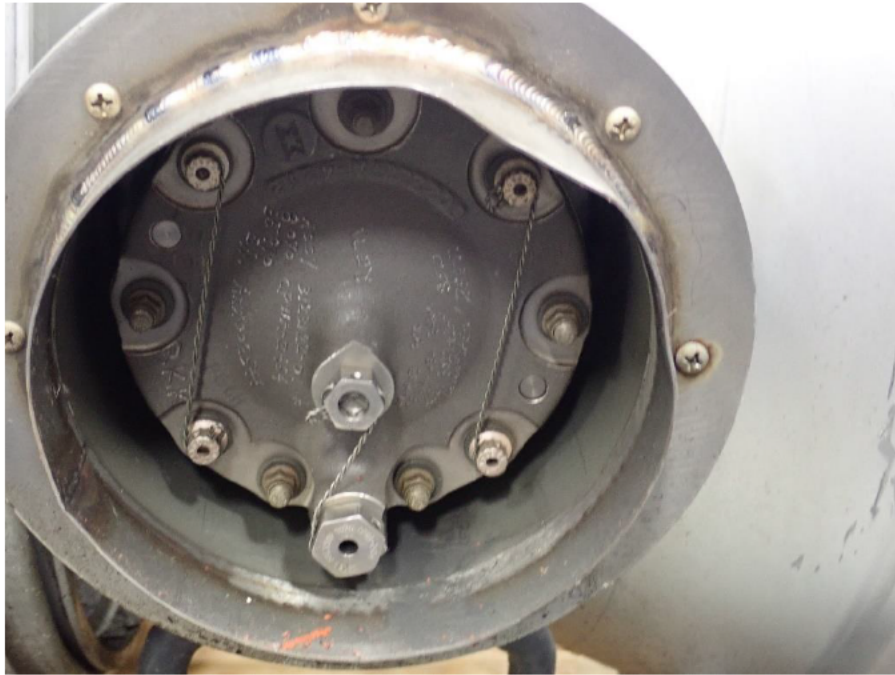
Photo No. 63, view of the high-pressure bleed valve

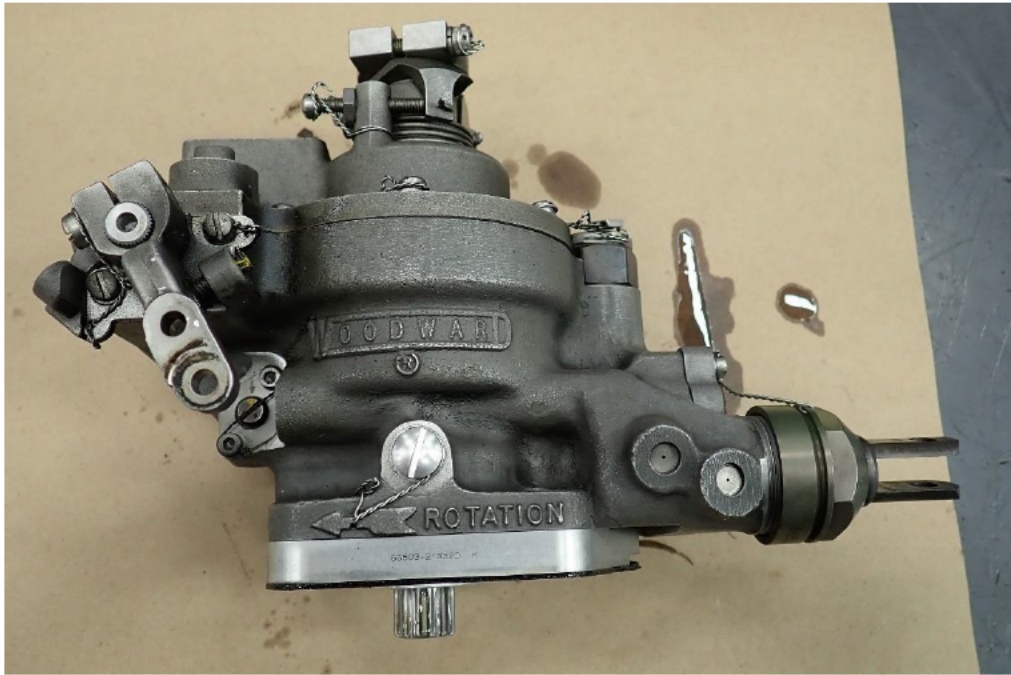
Photo No. 64

Propeller Governor (CSU): The propeller governor was in place and secured to its respective mounting pad on the reduction gearbox. No visible damage was evident (Ref. Photo No. 64). The propeller governor was forwarded to P&WC's Accessories Investigation and the manufacturer for functional testing and investigation. The manufacture testing showed some deviations that were related to field adjustments. The unit was re-calibrated within the manufacture's CMM requirements.
