NATIONAL TRANSPORTATION SAFETY BOARD

MATERIALS LABORATORY FACTUAL REPORT

Report No. 21-017

Place : Mesa, Arizona
Date : April 24, 2020
Vehicle : Bell UH-1H, N3276T
NTSB No. : WPR20LA130
Investigator : Samantha Link, AS-WPR, and Chihoon Shin, AS-40

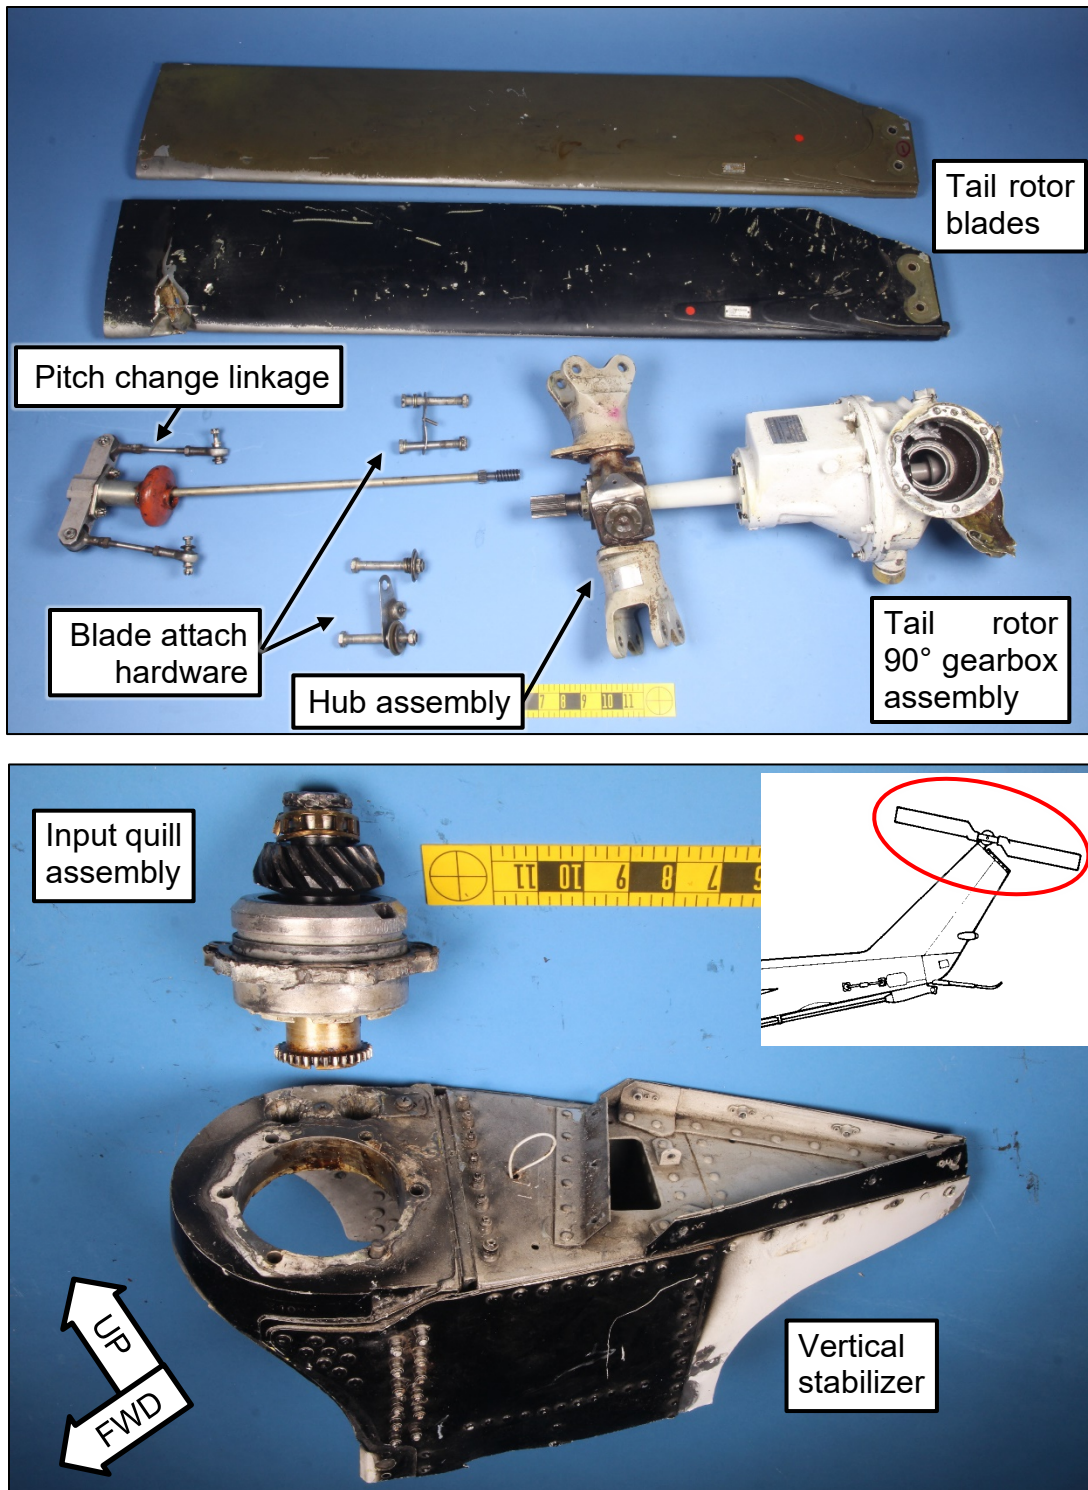
Overall views of the submitted components as received are shown in figure 1. The tail rotor blades and pitch change linkage had been disassembled, and the upper end of the vertical stabilizer had been cut to facilitate shipment to the NTSB Materials Laboratory. The tail rotor 90° gearbox assembly and tail rotor assembly had reportedly separated in flight. The attachment studs on the 90° gearbox case for attaching the gearbox assembly and input quill assembly to the upper aft end of the vertical stabilizer were fractured. The tail rotor blades were damaged at the leading edges near the blade tips and had multiple dents along the span of the blades. The pitch change control rod also was bent.

Figure 1. Overall views of the submitted components as received. The inset diagram shows the helicopter tail section with the location of the submitted components shown circled.

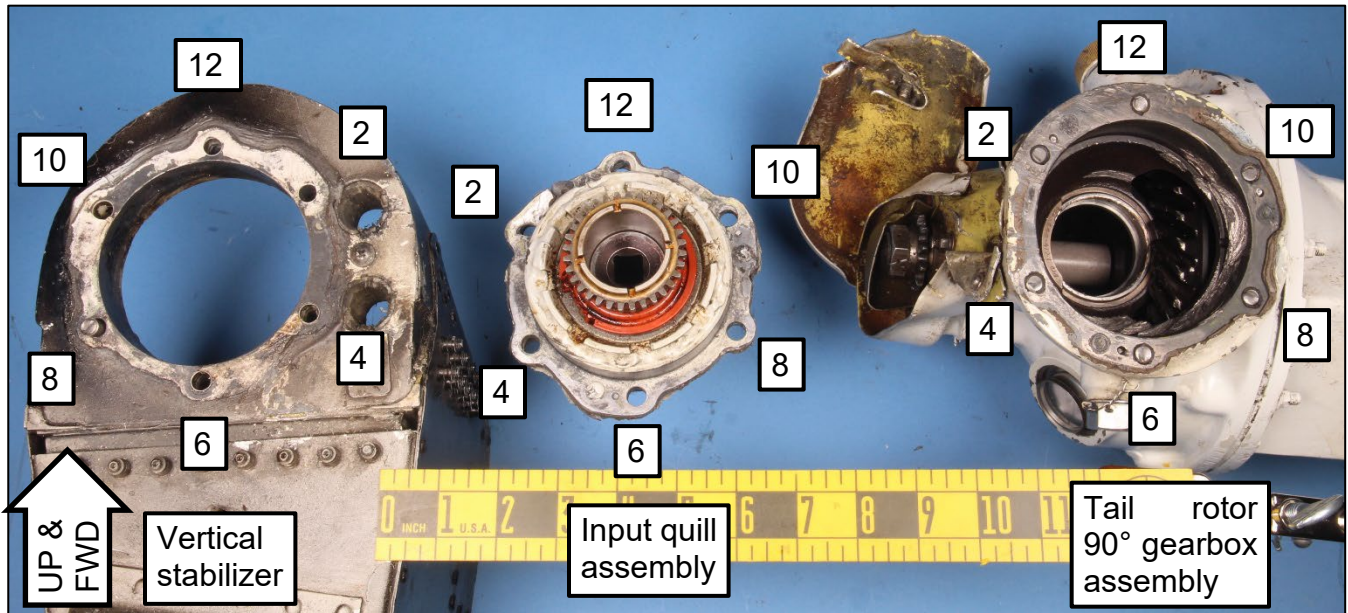
Views of the attachment surfaces for the tail rotor input quill assembly and 90° gearbox assembly and the corresponding mounting face on the upper aft end of the vertical stabilizer are shown in figure 2. The clock positions for the attachment studs and corresponding attachment holes are labeled on each piece, where the clock positions are as viewed looking forward and down on the vertical stabilizer. As assembled on the helicopter, 6 studs on the 90° gearbox case are inserted through corresponding holes in the shim plate (see figure 3), input quill sleeve flange (also shown labeled in figure 3), and the upper casting on the vertical stabilizer. The attachment is then secured with washers and nuts attached to the studs.

Figure 2. Upper aft side of the vertical stabilizer, mating surface of the input quill assembly, and mounting surface from the tail rotor 90° gearbox assembly. Mounting studs and corresponding attachment holes are numbered by clock position for reference.

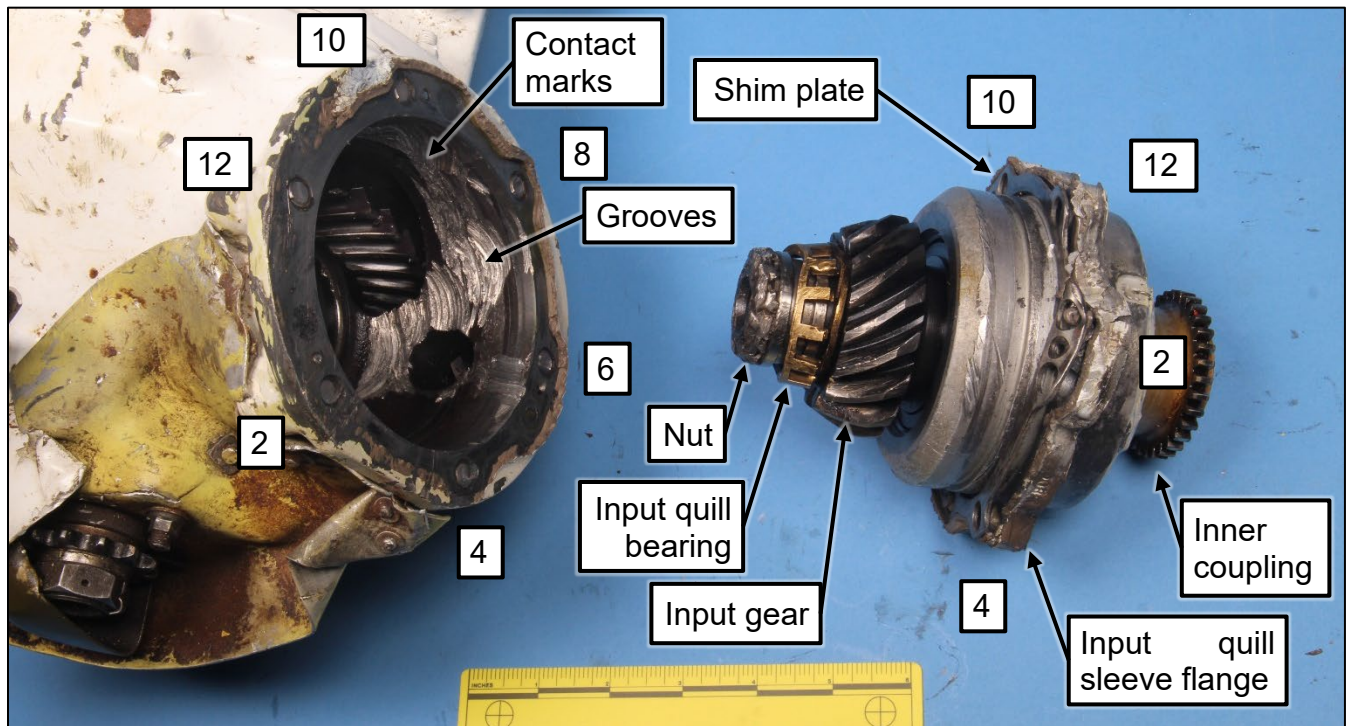
Another view of the input quill assembly and the corresponding mounting surface on the tail rotor 90° gearbox assembly is shown in figure 3. The input quill sleeve flange and shim plate were bent at the 2 o'clock position. Contact marks were observed around the sleeve corresponding to relative movement and off-axis contact between the sleeve and the 90° gearbox case opening. The input quill bearing inner race and cage were

separated from the outer race, and the rolling elements were missing. The bearing cage was bent, and several of the element separators were fractured. The nut adjacent to the input quill bearing was deformed and rubbed, and rubbing damage was present on the outer diameter of the input gear.

Curving contact marks and grooves were observed on the interior of the 90° gearbox as indicated in figures 3 and 4. The grooves and contact marks had sliding contact features consistent with off-axis contact with the rotating nut and input gear on the input quill assembly as the tail rotor 90° gearbox assembly separated from the input quill assembly.

Figure 3. Input quill assembly and tail rotor 90° gearbox assemblies showing grooves on the interior surface of the gearbox housing and damage to the input quill bearing and adjacent nut.

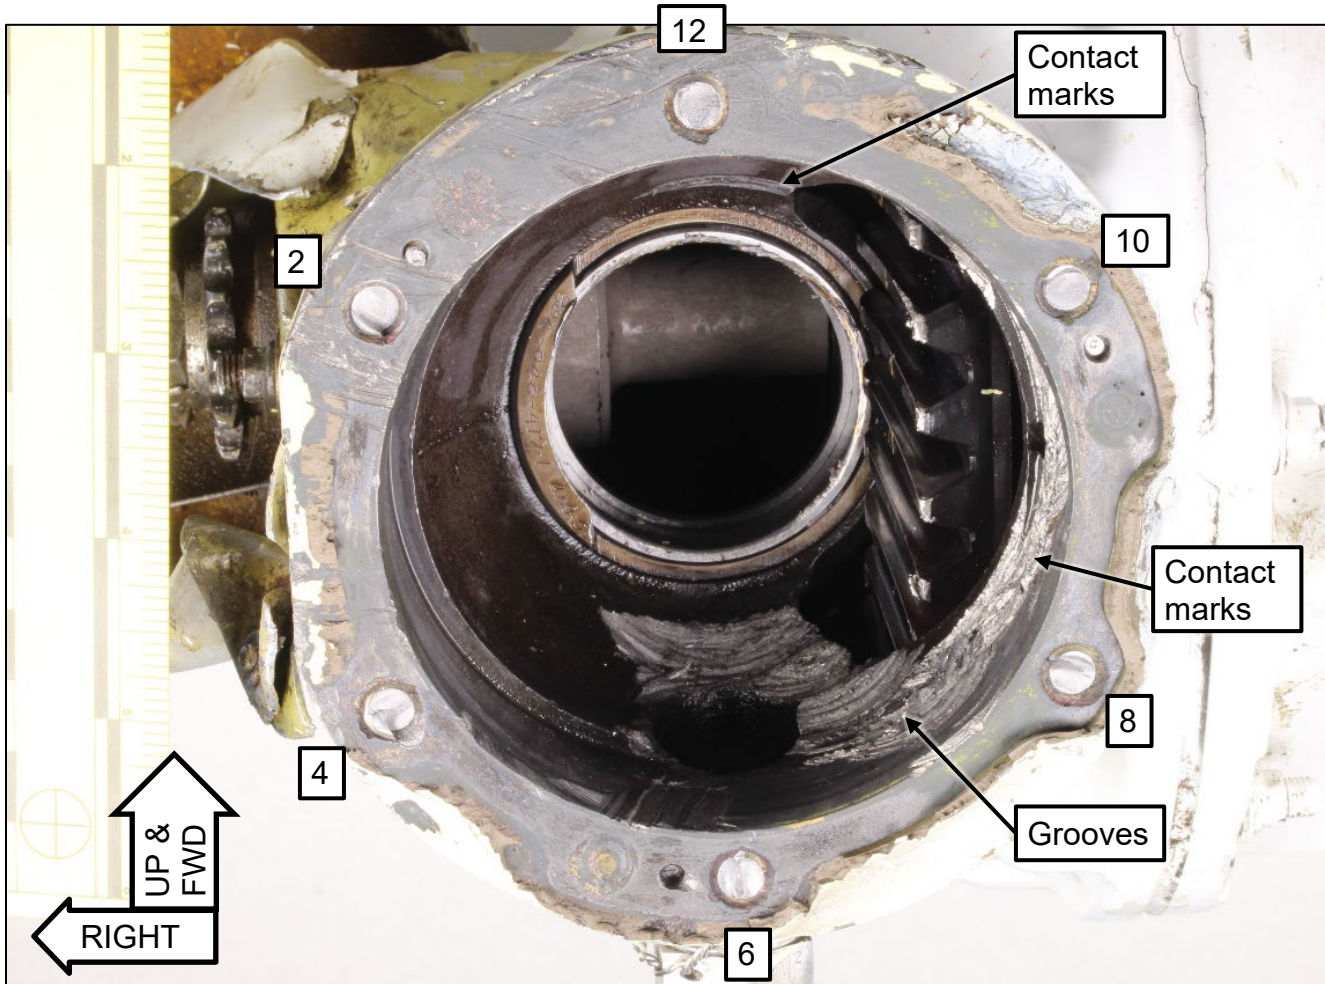
The fractured 90° gearbox attachment studs and corresponding mounting surfaces on the 90° gearbox, input quill sleeve flange, and vertical stabilizer were partly covered with greasy deposits. The deposits were cleaned from the surfaces by gentle cleaning using a soft-bristle brush dipped in a solution of Alconox detergent and warm water. After cleaning, the surfaces were rinsed with water then ethanol followed by drying with pressurized air. Images in figures 4 through 11 were taken after all components had been cleaned. The 90° gearbox is shown in the cleaned condition also in figures 2 and 3.

Figure 4. Mounting surface of the 90° gearbox assembly after cleaning. Fractured attachment studs are numbered by clock position as shown in figure 2.

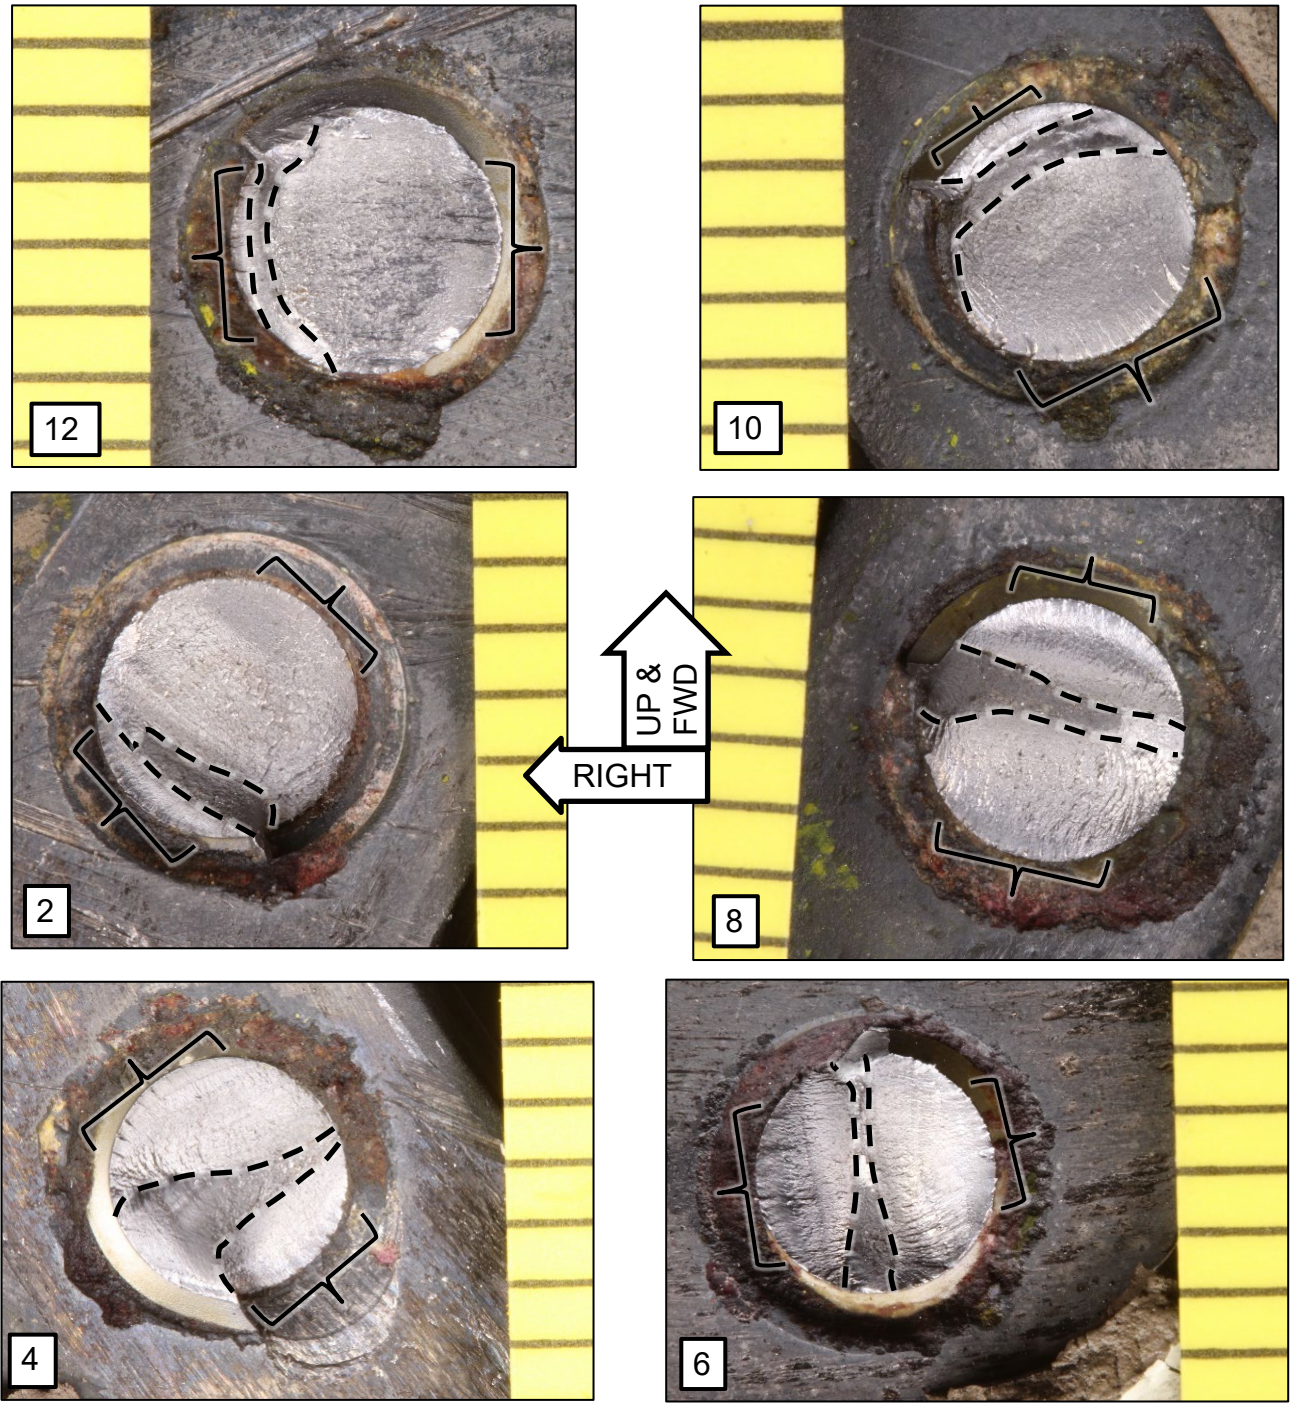
Fracture surfaces for each of the 90° gearbox attachment studs are shown in figure 5. The studs were fractured mostly in the plane of the 90° gearbox case mounting surface. Steps in the fracture surface plane (ratchet marks) were observed emanating from the edges of the fracture origins in the areas indicated with unlabeled brackets, features consistent with cracks with multiple origins. The origin areas were located on opposite sides of the studs, consistent with crack growth under reverse bending. Curving crack arrest lines were observed on the stud fracture surfaces consistent with progressive crack growth, and dashed lines in figure 5 indicate the extent of progressive crack growth from each origin area. The surfaces associated with progressive crack growth were relatively rough, consistent with low-cycle fatigue or cyclic overstress crack growth under relatively high cyclic stresses.

The origin areas were approximately centered on each side of the stud on the clockwise and counterclockwise side, consistent with torque loading about the input quill opening axis in both the clockwise and counterclockwise loading directions. For studs at the 10, 12, and 2 o'clock positions, cracks that propagated in the clockwise direction (as viewed from above) extended much further than those that propagated in the counterclockwise direction. In the remaining three studs on the lower half of the gearbox case, the crack propagation in each direction was more equal.

Figure 5. Close views of the 90° gearbox attachment stud fracture surfaces. Dashed lines indicate progressive crack growth boundaries, and brackets indicate crack origins.

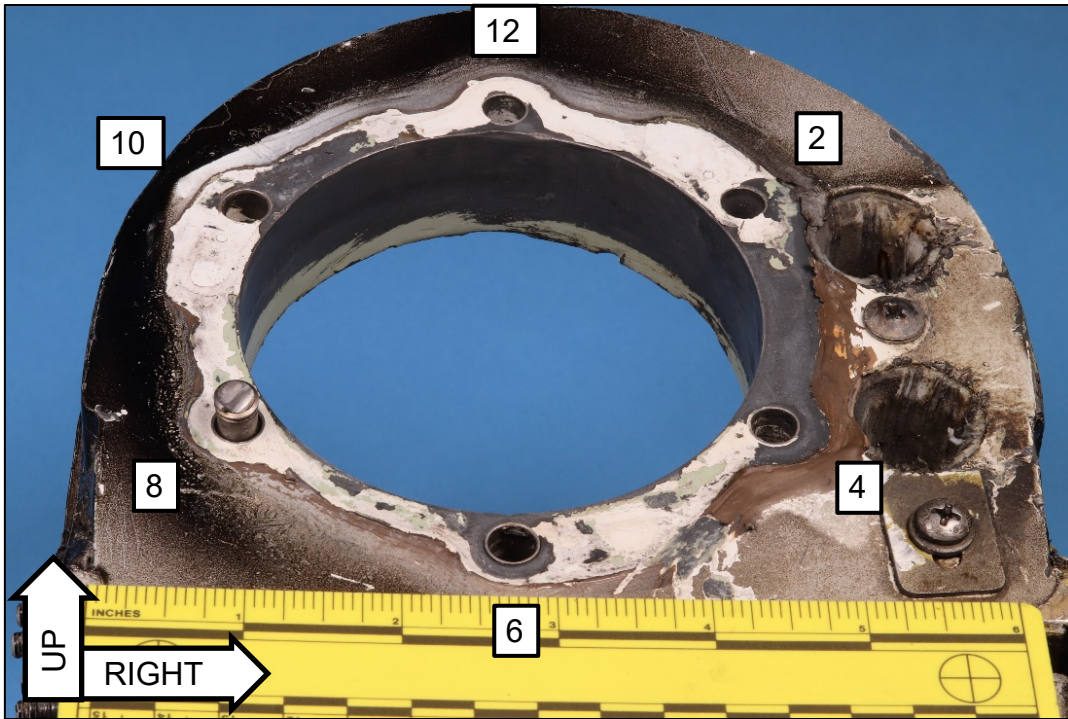
The upper aft surface of the vertical stabilizer is shown in figure 6. The mating piece of the stud at the 8 o'clock position remained trapped in the corresponding attachment hole, and the nuts and washers remained attached to the stud as shown in figure 7. Brown sealant had been applied around the outer edge of the joint between the input quill sleeve and the vertical stabilizer, and the mounting face was outlined with fractured sealant material on the vertical stabilizer surface. Sealant on the outer side of the fracture was painted with black paint over bright white paint consistent with paint observed on the exterior surfaces of the vertical stabilizer (see figure 1). A different

Figure 6. Upper aft surface of the vertical stabilizer after cleaning showing the mounting face for the 90° gearbox assembly.

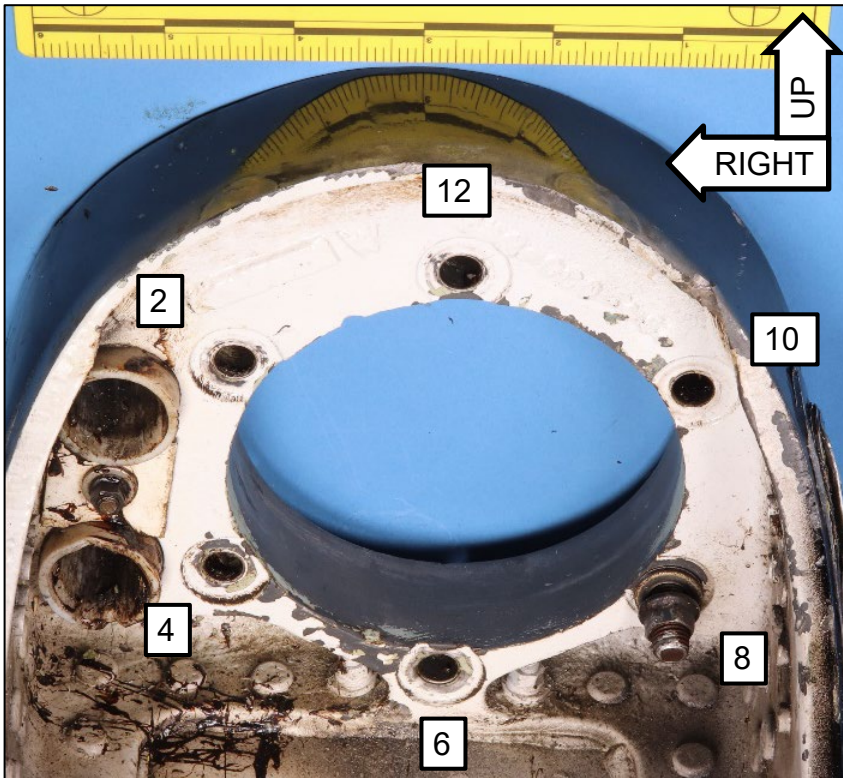
colored white paint with a more beige-colored tint over a green-colored primer was observed under the layers of black and bright white paint. The beige-tinted white paint and green primer were observed as the outermost paint layer on the mounting surface for the input quill sleeve within the sealant outline shown in figure 6. Additionally, the beige-tinted white paint layer was the outermost paint layer on the interior surface of the vertical stabilizer shown in figure 7 and was observed on the washer seating faces for the 90° gearbox attachment hardware.

Figure 7. Lower forward surface of the support casting at the upper aft end of the vertical stabilizer after cleaning showing numbered mounting holes for the 90° gearbox assembly.

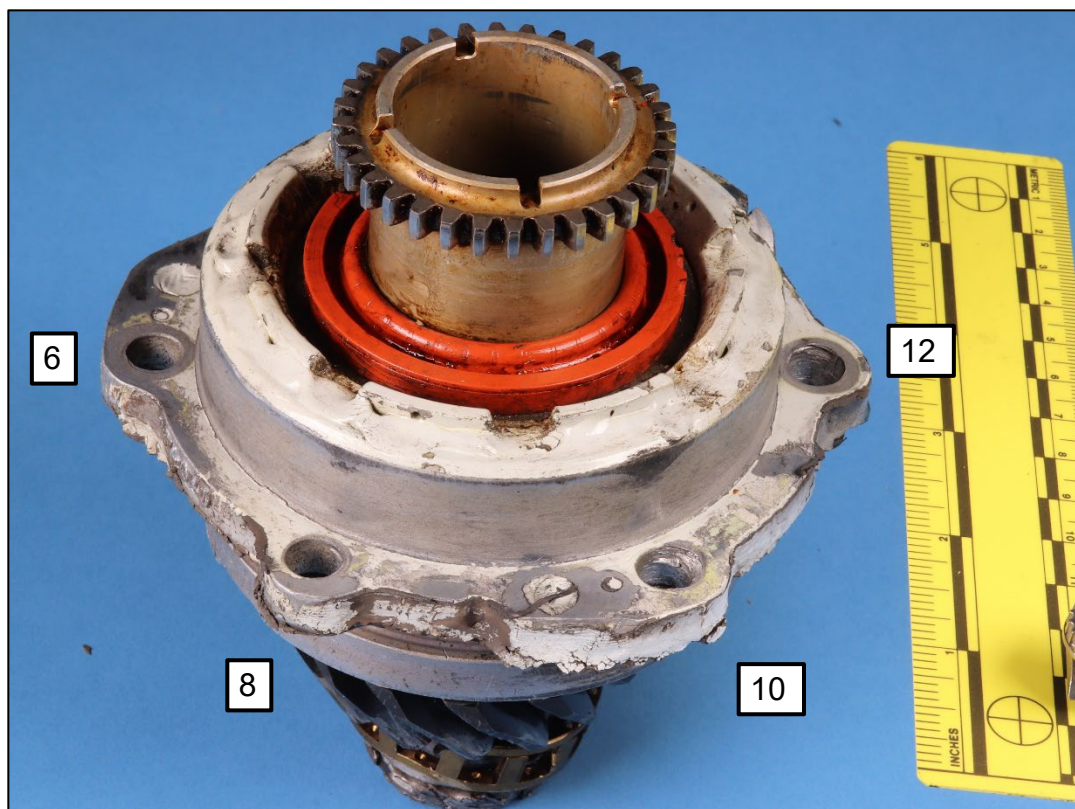
Multiple layers of primer, paint, and sealant were also observed on the input quill assembly as shown in figures 8 through 10. At the lower forward end of the input quill sleeve and castellated nut, a layer of brown sealant was covered by yellow primer and beige-tinted white paint. The mounting surface on the sleeve flange that had mated to the vertical stabilizer was also coated with yellow primer and beige-tinted white paint except for areas that appeared rubbed by contact with the mating surface and two well-defined circular areas around attachment holes at the 6 o'clock and 12 o'clock positions.

Figure 8. Lower forward side of the input quill assembly showing painted sleeve surfaces.

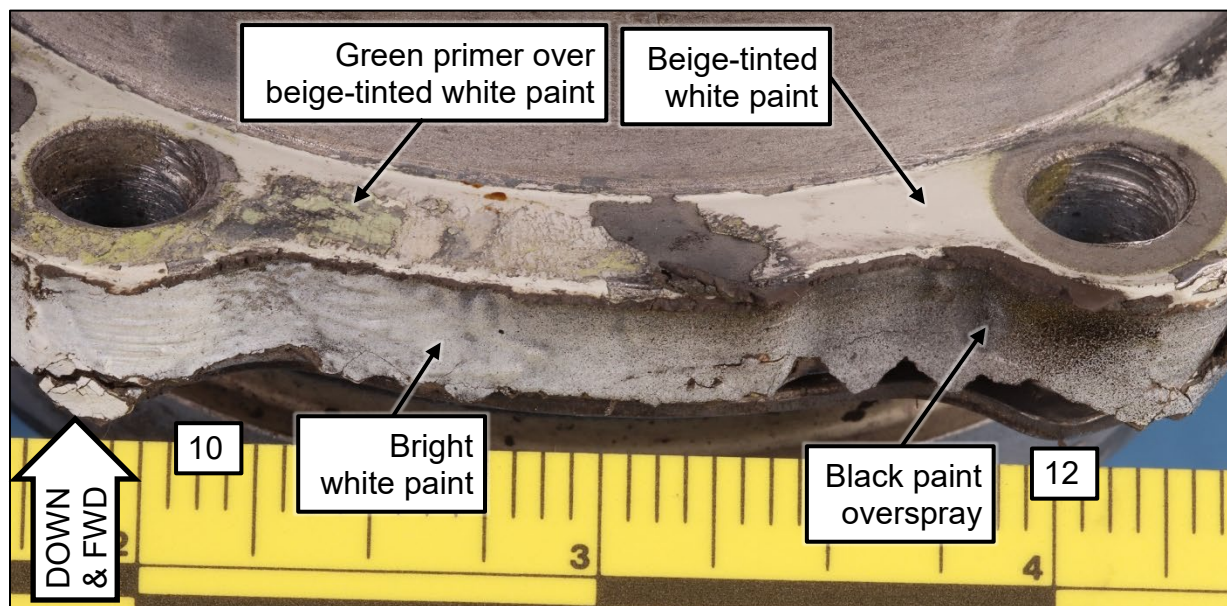
A closer view of the input quill sleeve between the 10 o'clock and 12 o'clock positions is shown in figure 9. Bright white paint and black overspray was observed around the outside of the flange as indicated. The mounting surface was covered with yellow primer and beige-tinted white paint. Near the 10 o'clock position, additional layers of green primer and beige-tinted white paint were observed on the painted flange surface consistent with paint transfer from the corresponding surface on the vertical stabilizer.

Figure 9. Input quill sleeve flange between the 10 o'clock and 12 o'clock mounting holes showing the mounting surface (vertical stabilizer side) and adjacent exterior surface.

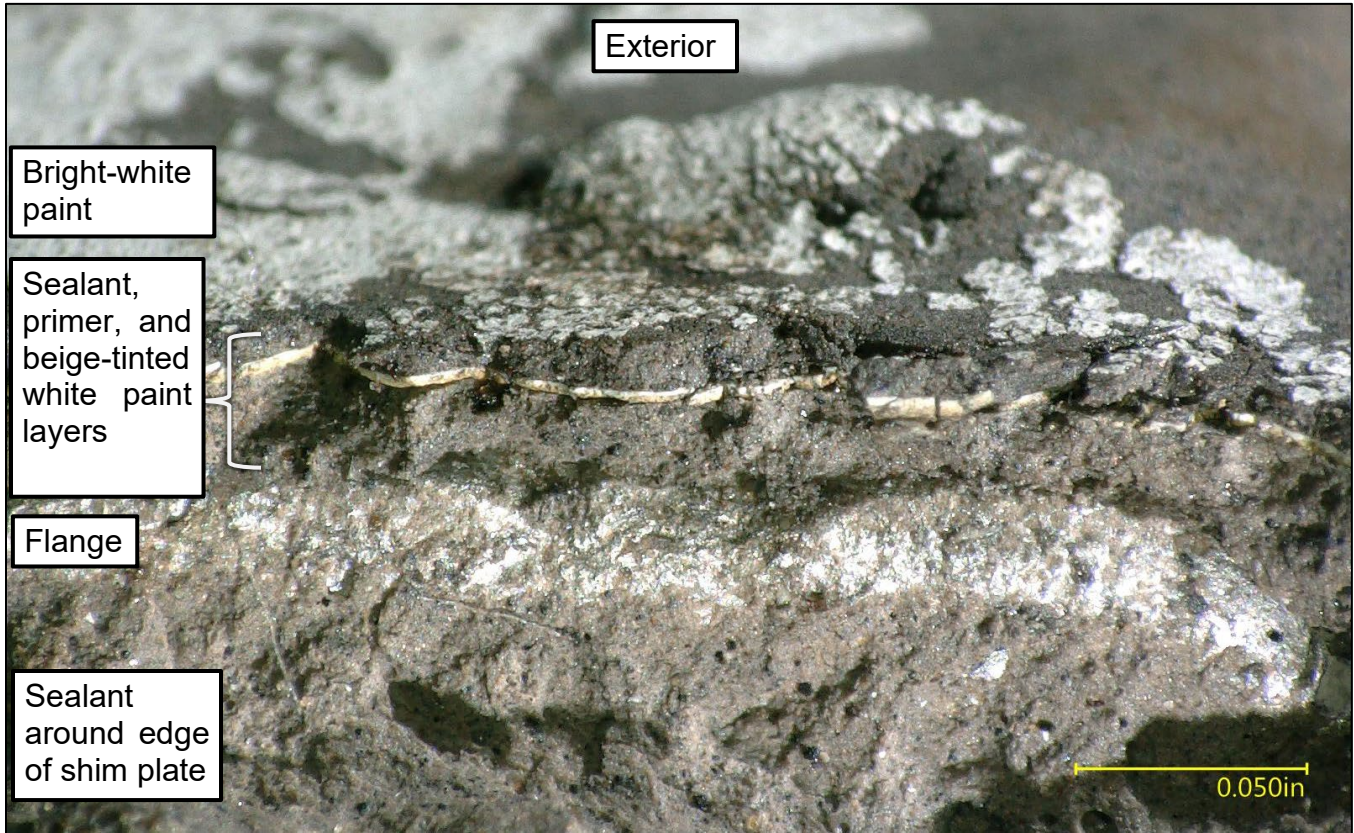
A cross-section of the paint and sealant layers at the edge of the quill sleeve mounting flange is shown in figure 10. Fractured sealant in figure 10 is from sealant around the joints between the input quill sleeve, shim plate, and 90° gearbox case. As shown in figure 10, the input quill sleeve flange at the joint was covered with a layer of brown sealant, followed by yellow primer, beige-tinted white paint, another layer of brown sealant, and then bright white paint.

Figure 10. Edge of the input quill sleeve mounting flange showing sealant, primer, and paint layers on the side of the flange that mated to the tail rotor 90° gearbox.

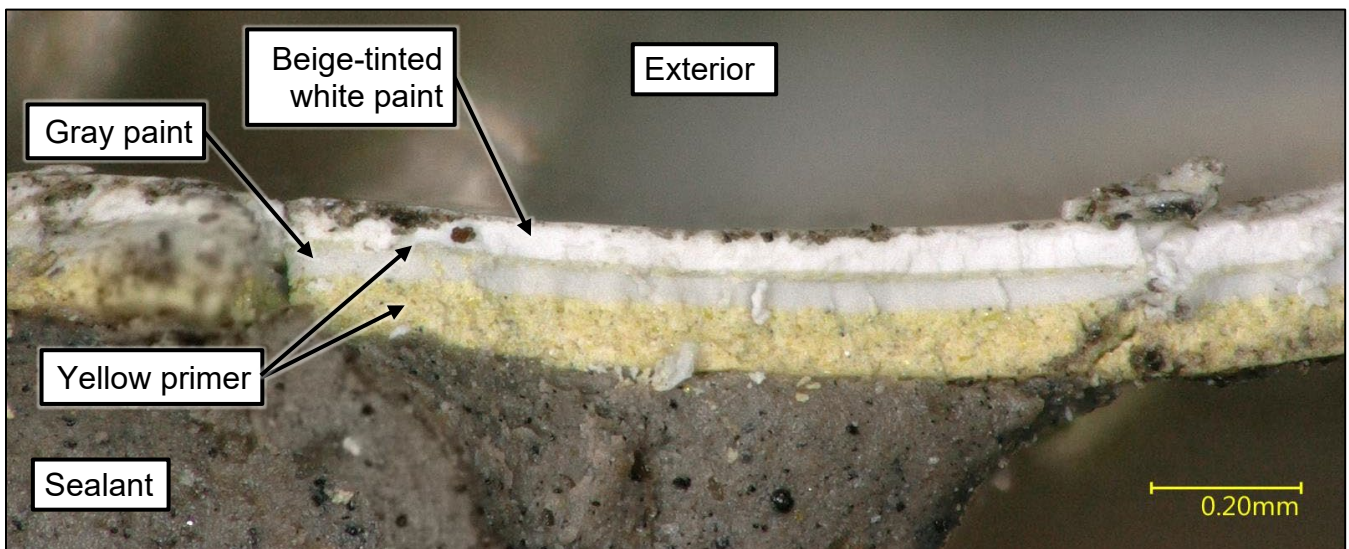
A sample of paint and sealant material was cut from the joint between the output quill sleeve and the 90° gearbox housing using a scalpel, and a cross-section of the collected sample is shown in figure 11. The collected coating layers consisted of a brown sealant at the surface followed by yellow primer, gray paint, another layer of yellow primer, and finally beige-tinted white paint on the exterior surface.

Figure 11. Sealant, primer, and paint layers on a sample cut from the joint between the output quill sleeve and the gearbox case on the 90° gearbox assembly.
