NATIONAL TRANSPORTATION SAFETY BOARD

MATERIALS LABORATORY FACTUAL REPORT

Report No. 21-022

Place : Corpus Christi
Date : August 21, 2020
Vehicle : 16-inch propane pipeline
NTSB No. : DCA20FM026
Investigator : Paul Stancil

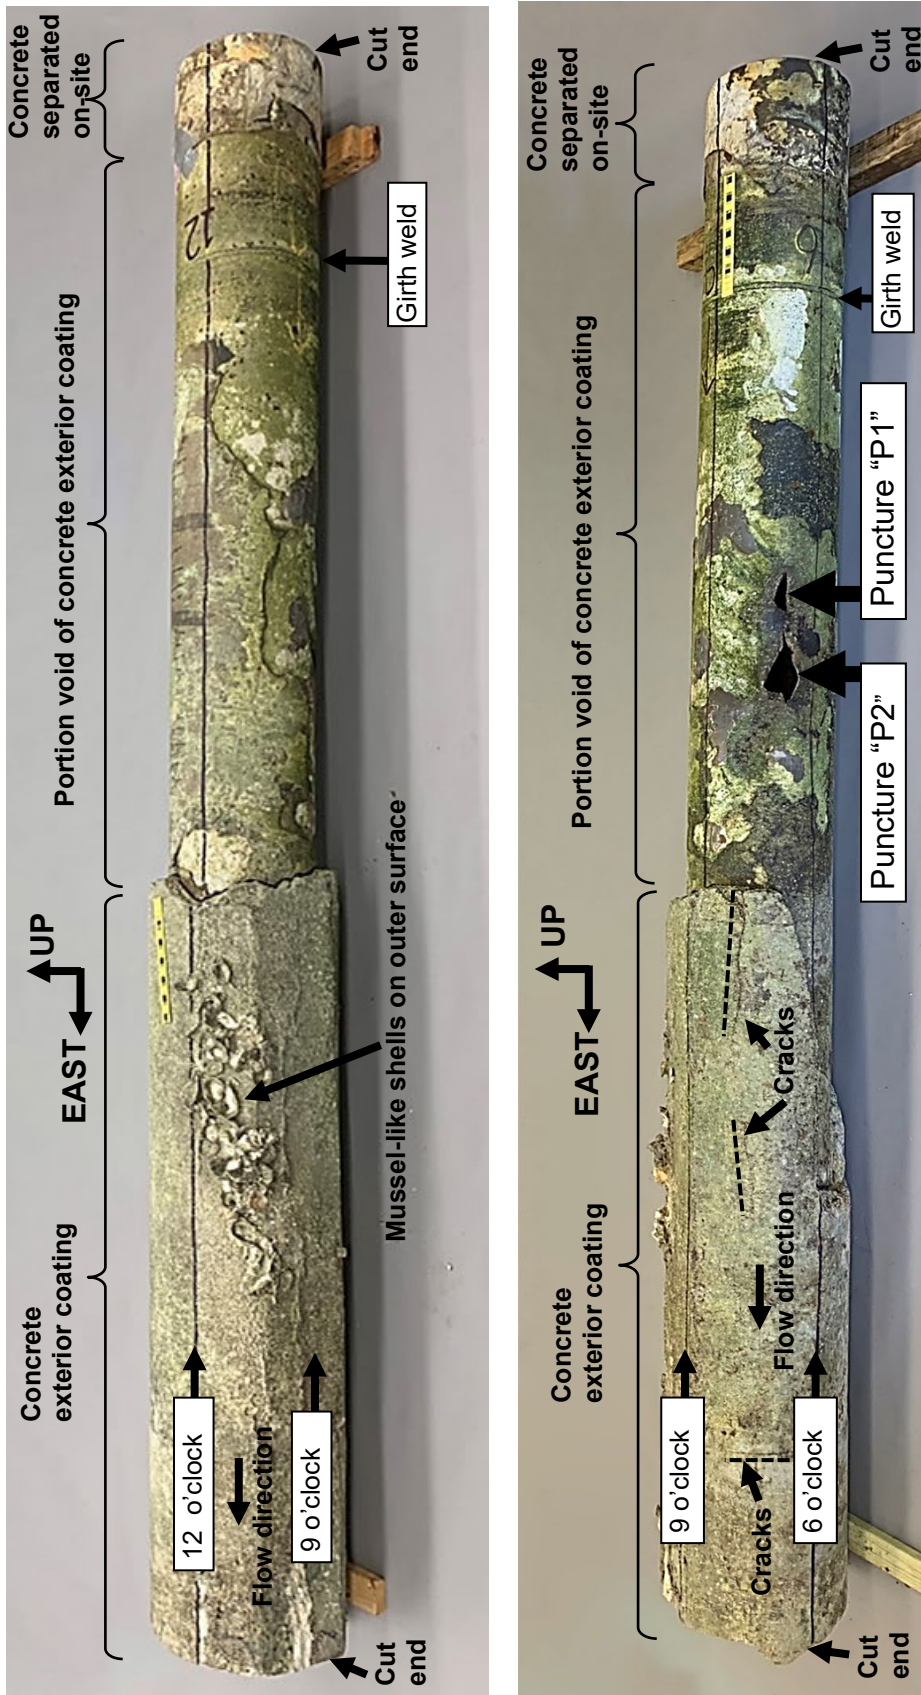
Figure 1. As-received damaged pipe segment showing the top side (12 o'clock) and the bottom side (6 o'clock). The pipe contained two punctures in the areas indicated by arrows "P1" and "P2". The punctures were located at approximately at 7 o'clock. Clock positions are when looking east. Cracks on the concrete external coating are indicated by dashed lines. Two halves of a 1-foot in length concrete exterior coating separated on-site (during recovery operation) from the west end of the pipe segment.

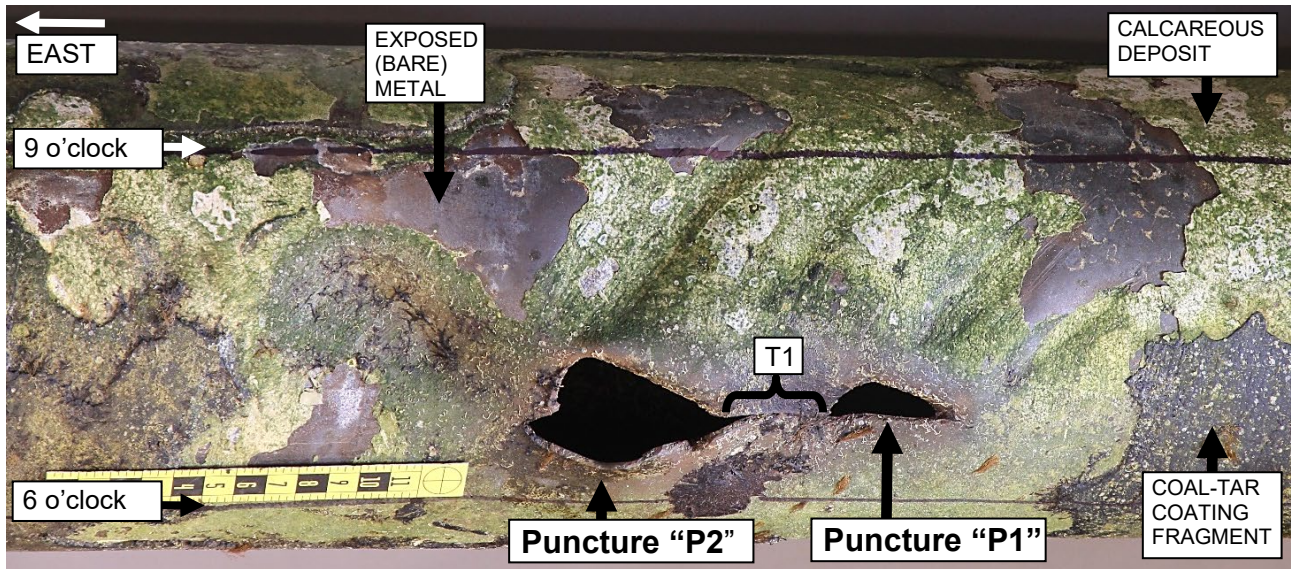
The fracture faces of the punctures “P1” and “P2” and fracture “T1” exhibited no evidence of a pre-existing crack, such as a fatigue crack, or a corrosion cavity along the fracture. The fracture faces showed evidence of a coarse texture features typical of overstress separation.

Figure 6. Close-up view of the as-received pipe in the areas of punctures "P1" and "P2" and a fracture, indicated by bracket "T1" that intersected both punctures. During handling, calcareous deposit separated from isolated areas of the pipe exposing (bare) metal.

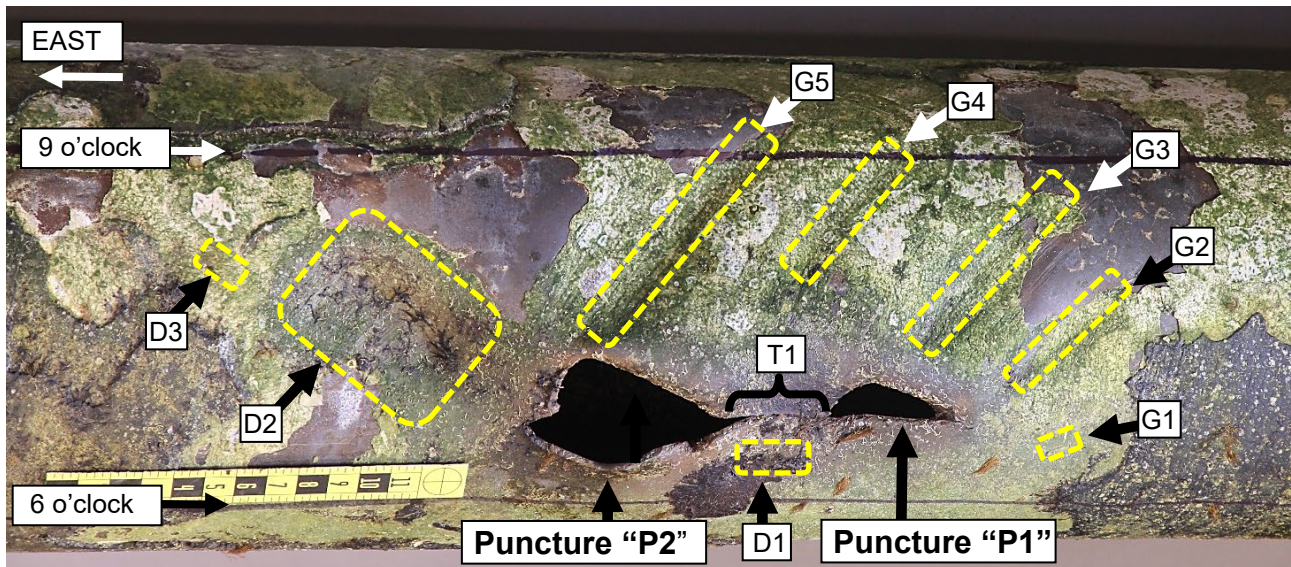
The two punctures were connected by a fracture "T1", as shown in figures 7 through 9. The pipe also contained five elongated dent features arbitrarily labelled "G1" through "G5", and three dents arbitrarily labelled "D1" through "D3", as shown in figures 7 and 9. Elongated dent "G1" contained one major gouge within the dent. Elongated dents "G2" through "G5" were nearly parallel to each other and diagonally oriented with respect to the axial length of the pipe. The upper end of the elongated dents did not intersect (connect with) the two punctures.

Figure 7. Same view as in figure 6 but also showing the location of elongated dents "G1" through "G5"; and dents "D1" through "D3", which have been highlighted by yellow dashed lines.

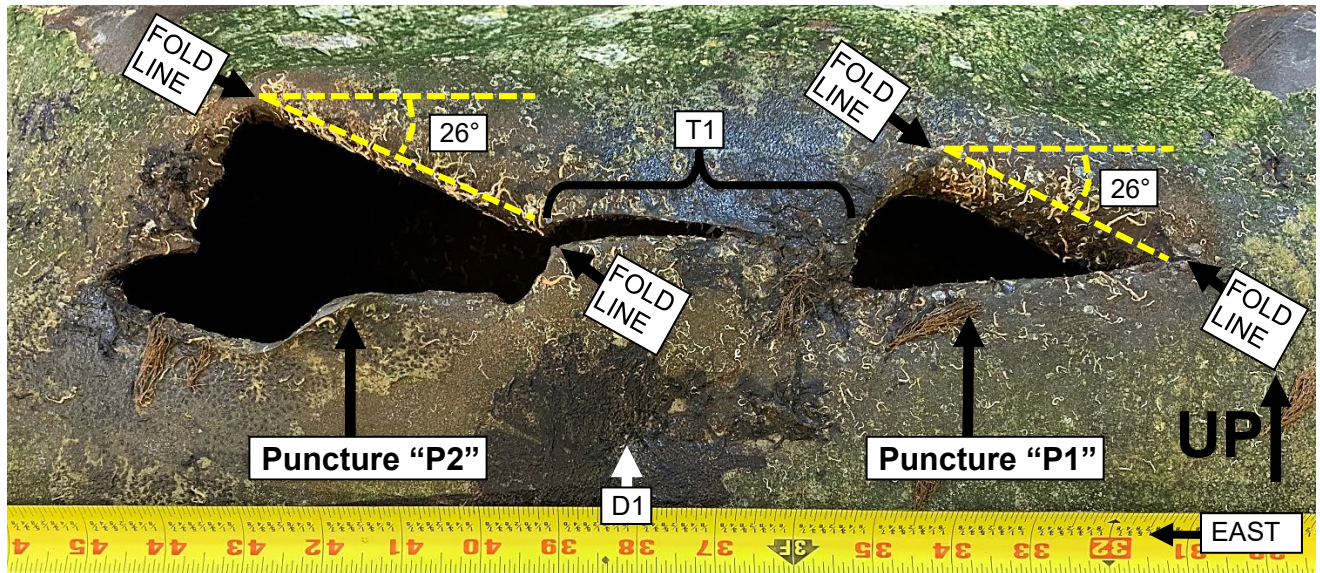
Figure 8. Close-up view of the pipe in the area of punctures “P1” and “P2”, fracture “T1”, and dent “D1”. Each puncture contained a lip (wall) portion that exhibited inward bending deformation. Only a small portion of each lip is visible in this view. The base of the lip (containing a fold line) for each puncture was located at the upper end of the puncture. The outer surface was covered with biological fouling (biofouling). Oblique view of the imaginary fold line at the base portion of the lip for puncture “P1” is shown in figure 21. The fold lines were oriented approximately 26 degrees down relative to the axial length of the pipe.

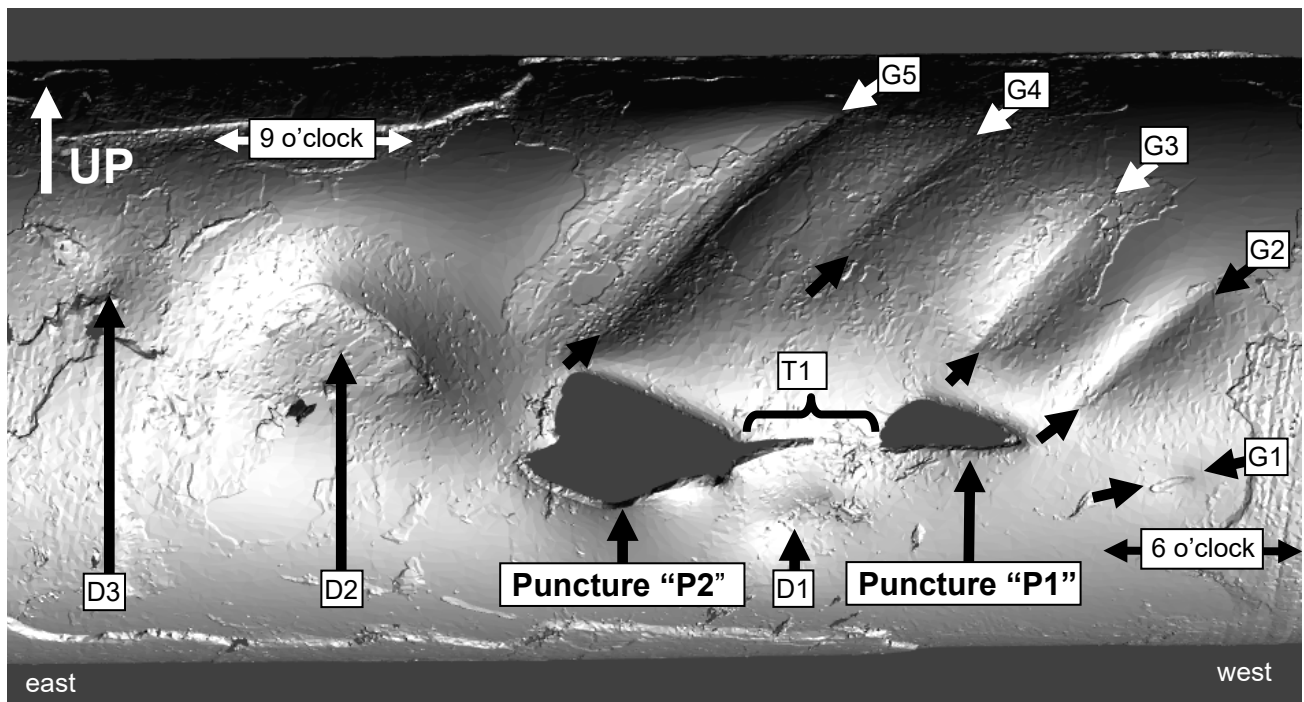
Figure 9. 3D laser scanned image of the pipe in the area of punctures “P1” and “P2”, fracture “T1”, elongated dents “G1” through “G5”, and dents “D1” through “D3”. Scanned onsite by contractor for Enterprise. Courtesy of Enterprise.

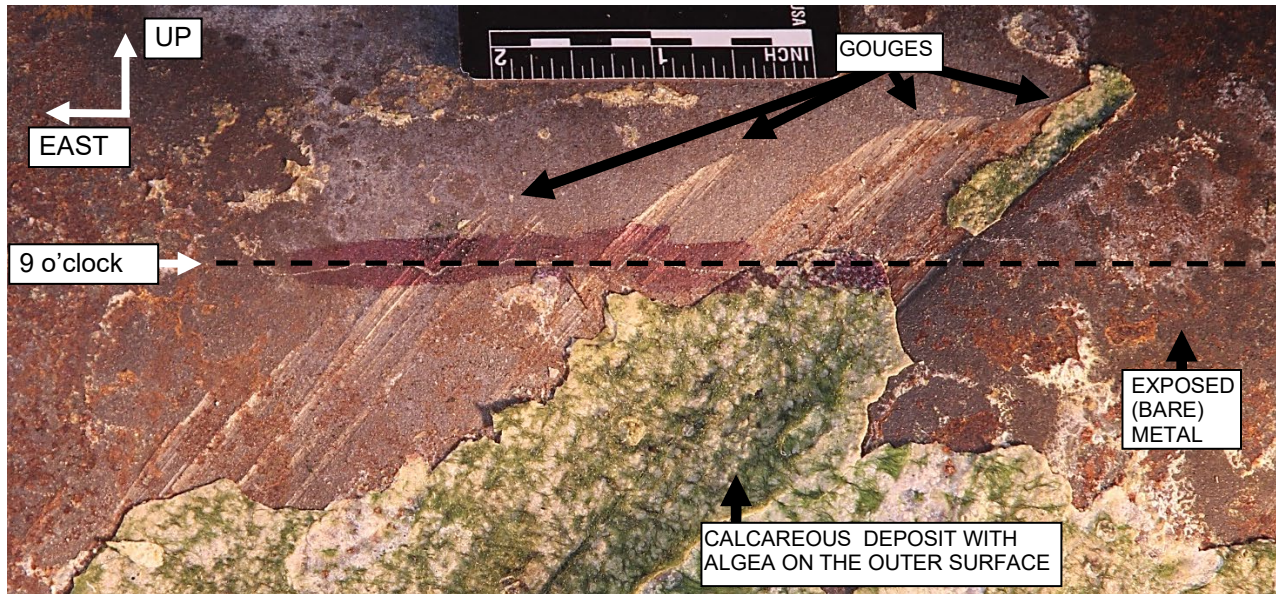
During laboratory handling, pieces of the calcareous deposits fractured from the outer surface of the pipe, exposing cluster of gouges on the metal surface of the pipe, as shown in figure 10. Figure 11 shows the outer surface of the pipe after a large amount of calcareous deposit was removed from a cluster of gouges associated with elongated dent “G5” and “G4”. The thickness of the calcareous deposit layer measured between 0.026 inch and 0.04 inch.

Figure 10. Close-up photograph of a cluster gouges on the metal surface of the pipe in the general area at the upper end and within elongated dent “G5”. Cluster of gouges extended under the adhering and intact calcareous deposit.

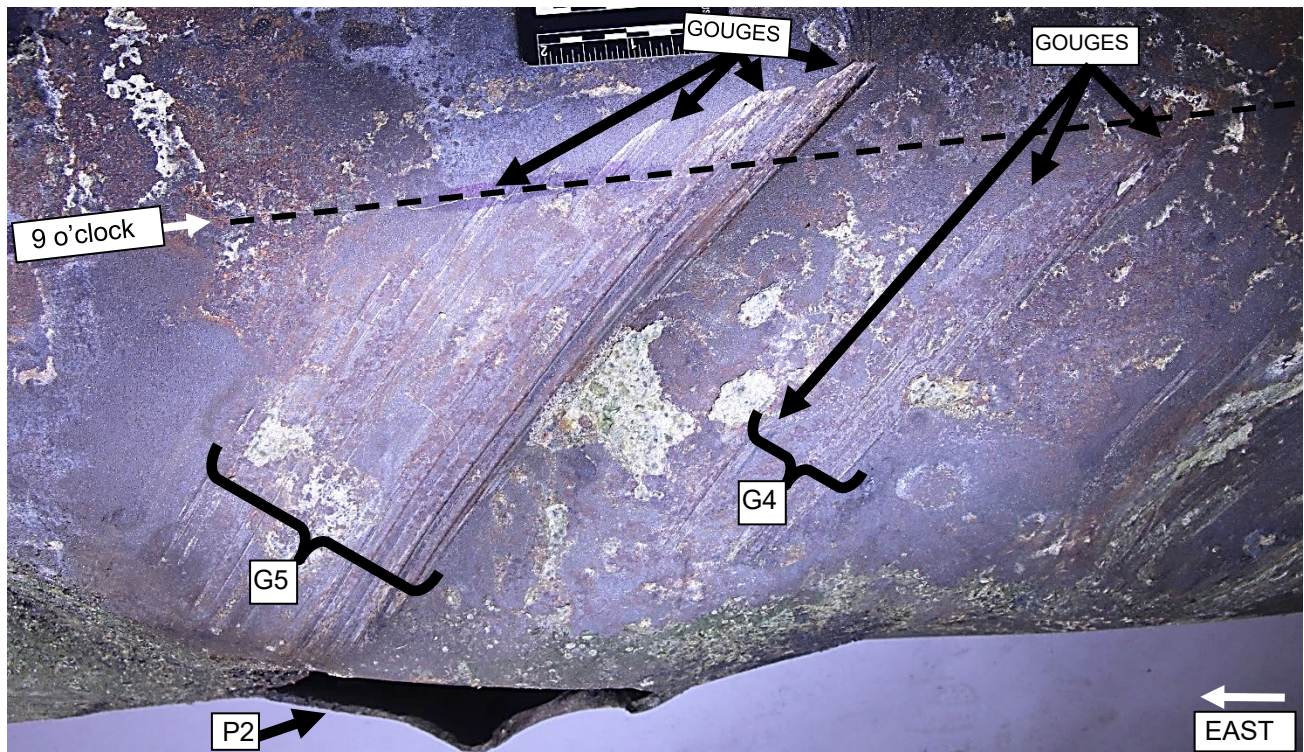
The cleaning procedure exposed all the gouges that were associated with elongated dents “G1” through “G5”. To reiterate, only one major gouge was found within dent “G1”, whereas a cluster of gouges was found with each respective elongated dent. Figure 11 shows an example of a cluster of gouges associated with elongated dent “G5”. The width of the cluster of gouges associated with elongated dent “G5” is indicated by a bracket in figure 11.

Figure 11. Exterior view of the pipe in the area of puncture “P2” after a large amount of calcareous deposit was removed from elongated dents “G4” and “G5” showing exposed cluster of gouges. The width portion of each cluster gouges is indicated by a bracket. A cluster of gouges was associated with each elongated dent. The width associated with each elongated dent was measured and recorded in table 5.

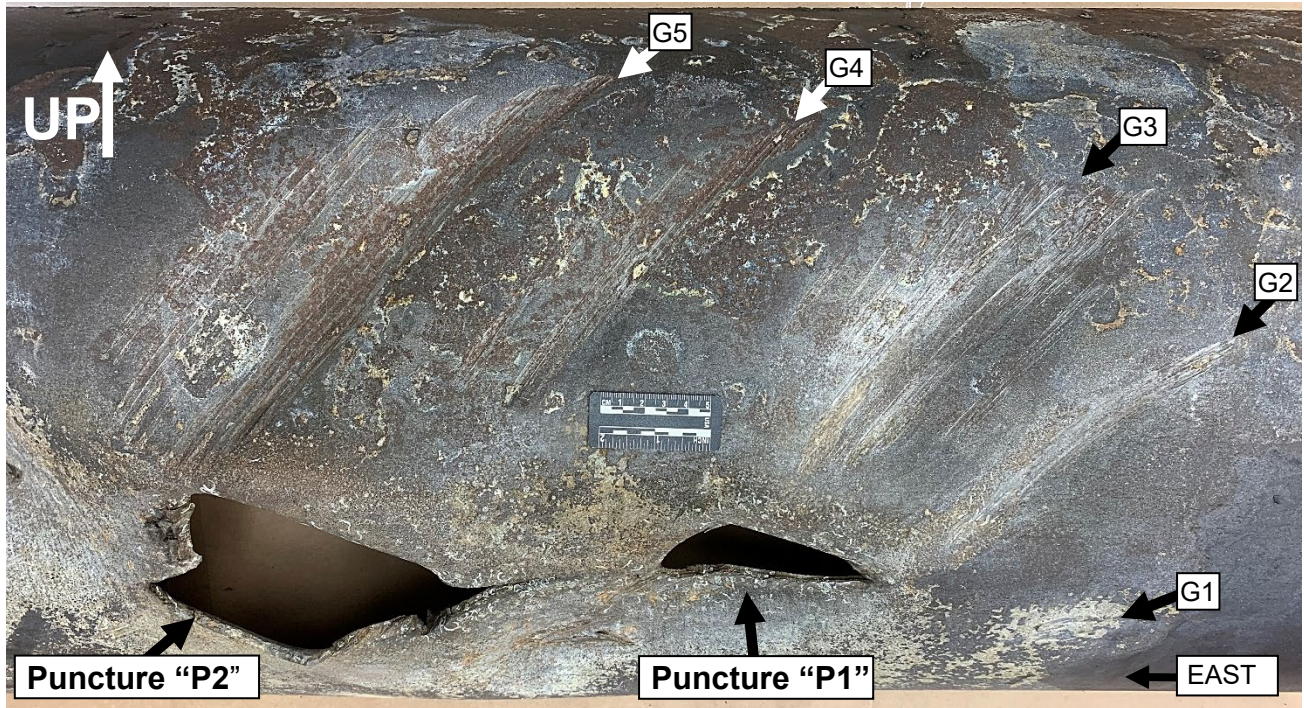
Figure 14. Outer surface of the pipe showing exposed cluster of gouges within elongated dents “G2” through “G5”, after cleaning.

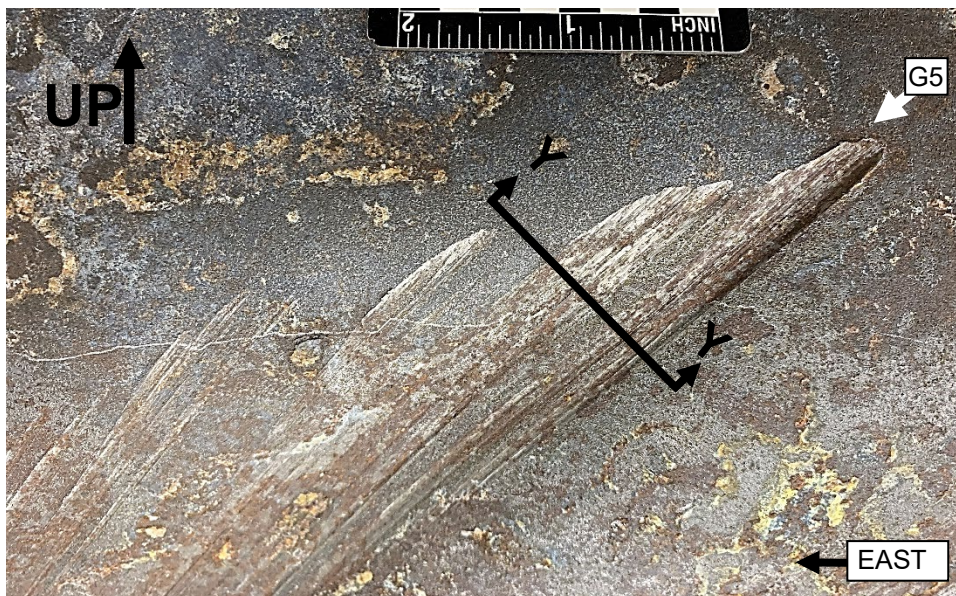
Figure 15. Close-up photograph of the outer surface of the pipe in the area of elongated dent “G5” showing several gouges at the upper end of the elongated dent, after cleaning.

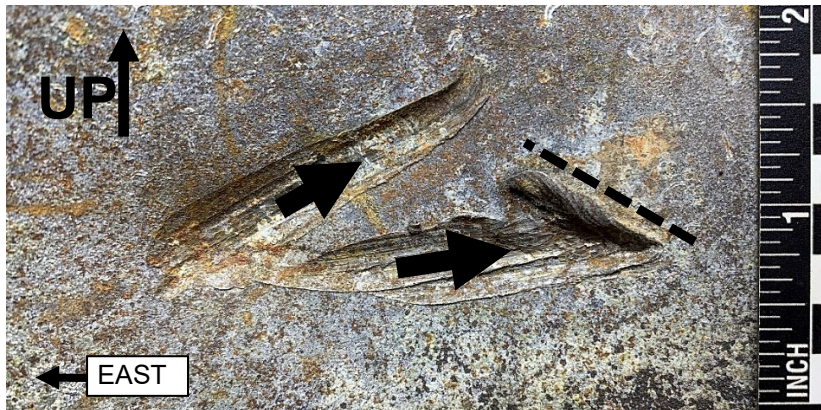
Figure 16. Close-up photograph of the outer surface of the pipe in the area of dent “D1” showing two major gouges located within dent, after cleaning. Arrows indicate general direction of metal flow. Metal flow terminated in the general area indicated by a dashed line.

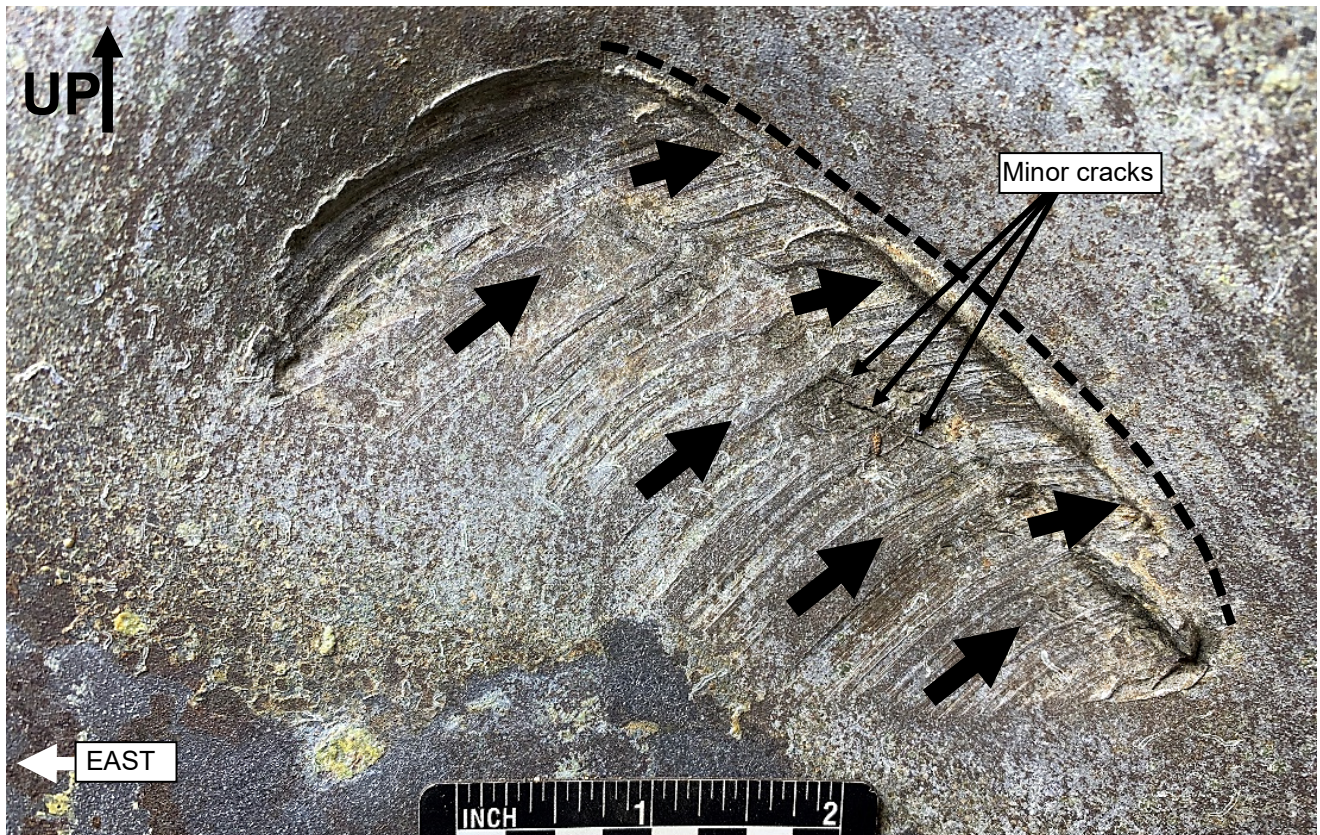
Figure 17. Close-up photograph of the outer surface of the pipe in the area of dent “D2” showing gouges within dent “D2”, after cleaning. The gouges exhibited evidence of metal flow deformation that was in the general direction indicated by the arrows. Metal flow deformation terminated in the general area indicated by a dashed line (area containing metal build-up). Evidence of minor cracks were found within the dent. The cracks did not penetrate the wall.

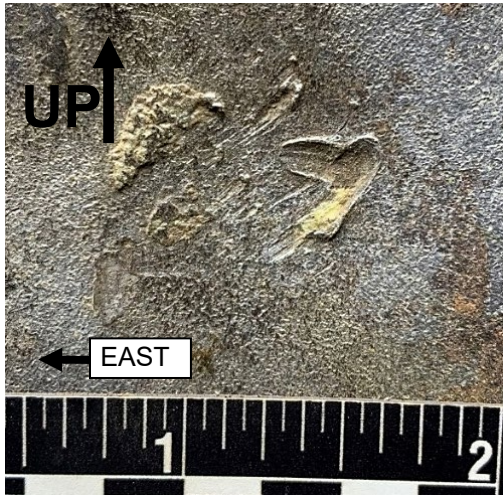
Figure 18. Close-up photograph of the outer surface of the pipe in the area of dent “D3” showing evidence of several minor gouges within the dent, after cleaning.

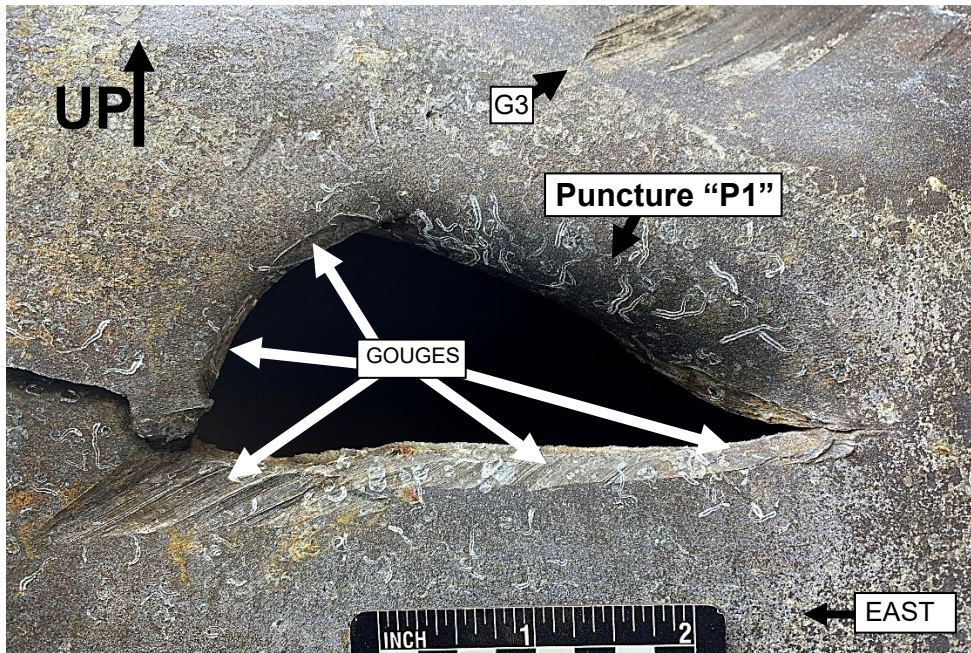
Figure 19. Close-up photograph of the outer surface of the pipe in the area of puncture “P1”, after cleaning, showing gouges along the edges of the fracture faces.

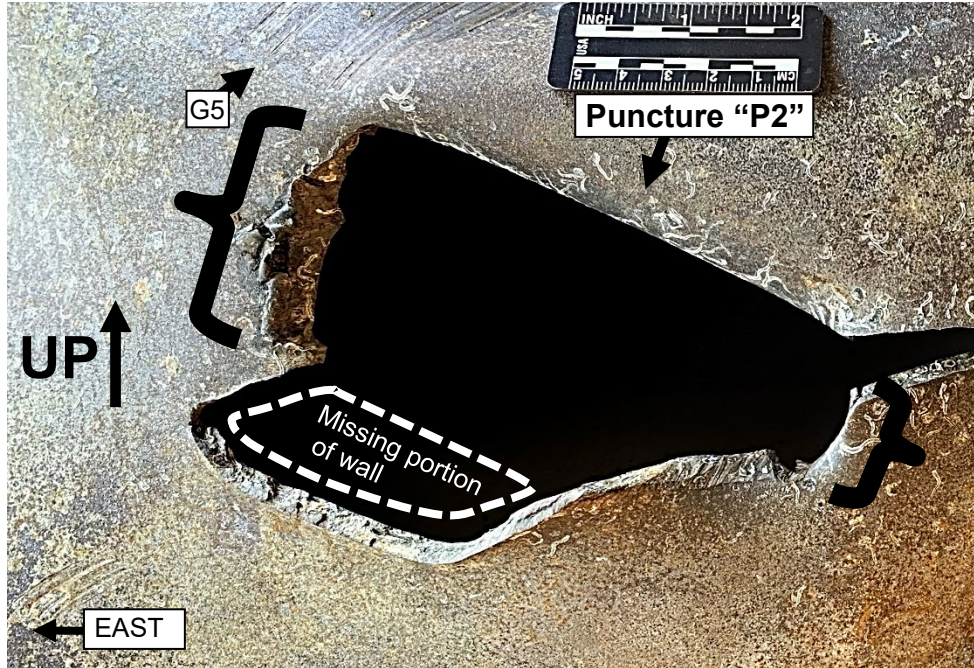
Figure 20. Close-up photograph of the outer surface of the pipe in the area of puncture "P2", after cleaning. A portion of the wall is missing from the area enclosed by a dashed line (the length of the lip portion does not extend into the missing portion of the wall). The west end of the puncture shows inward metal deformation, in the area indicated by a bracket. The east end of the puncture shows severe metal deformation, in the area indicated by a bracket.

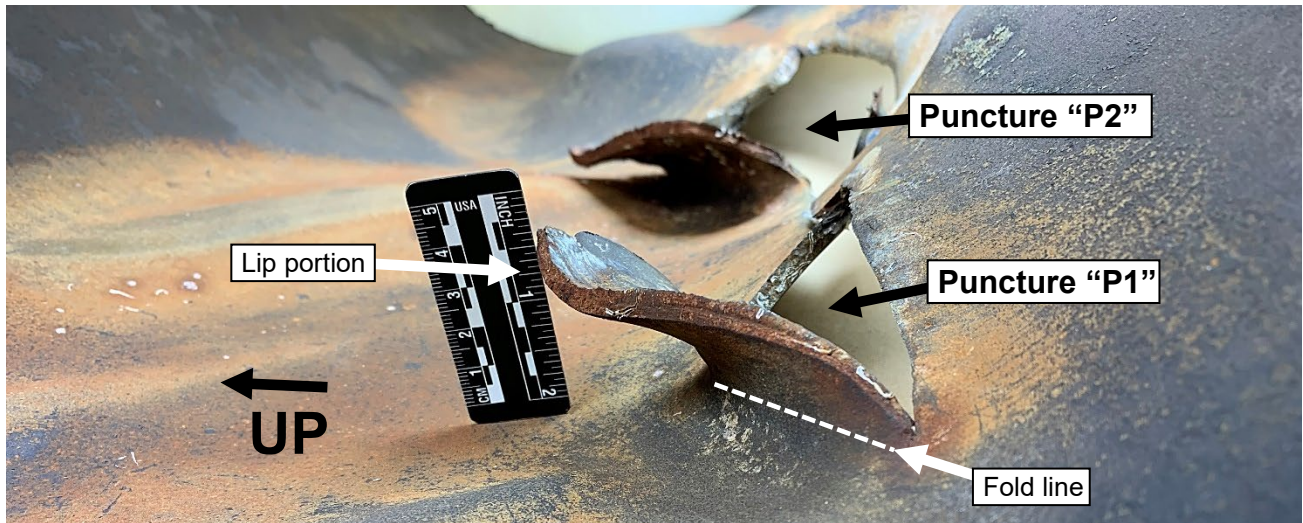
Figure 21. View looking east at the Inner surface of the pipe showing puncture "P1" in the foreground and puncture "P2" in the background, after cleaning. Dashed line indicates a fold line at the base of the lip.

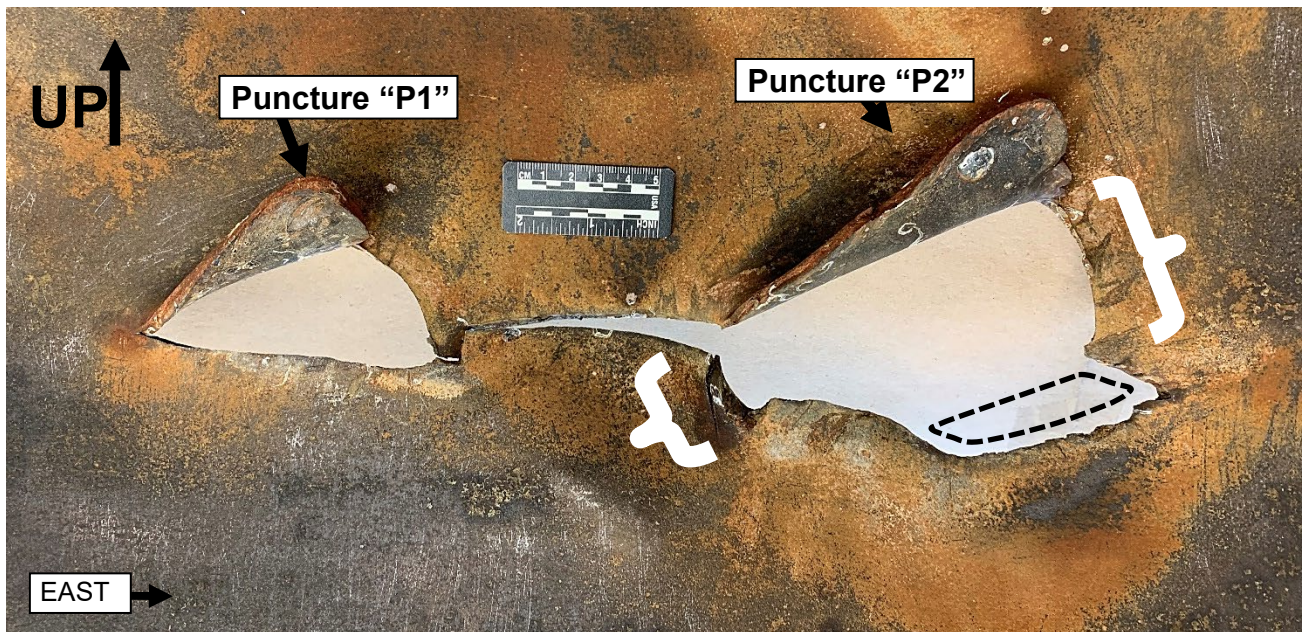
Figure 22. Inner surface of the pipe showing punctures "P1" and "P2", after cleaning. A portion of the wall is missing from the area enclosed by a dashed line. The west end of the puncture shows inward metal deformation in the area indicated by a bracket. The east end of the puncture shows severe metal deformation in the area indicated by a bracket.

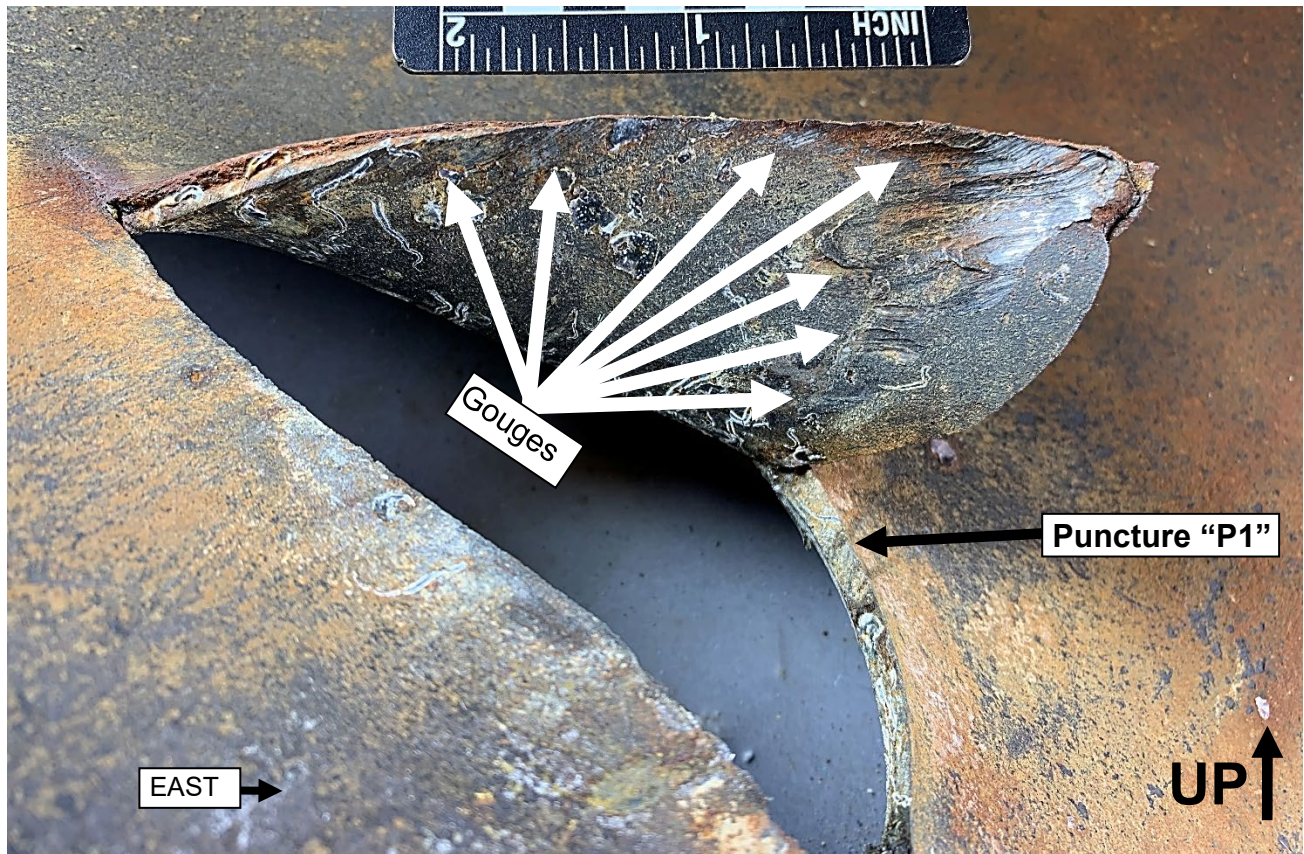
Examination of the lip portion for puncture “P1” revealed the outer surface exhibited evidence of impact marks (deformed surface that contained gouges). The impact marks were prevalent in the areas along the edges of the fracture faces, as shown in figure 23.

Figure 23. Close-up photograph of the inner surface of the pipe in the area of puncture "P1", after cleaning. The outer face of the lip portion at the edges of the fracture showed evidence of impact marks (deformed surface containing gouges).

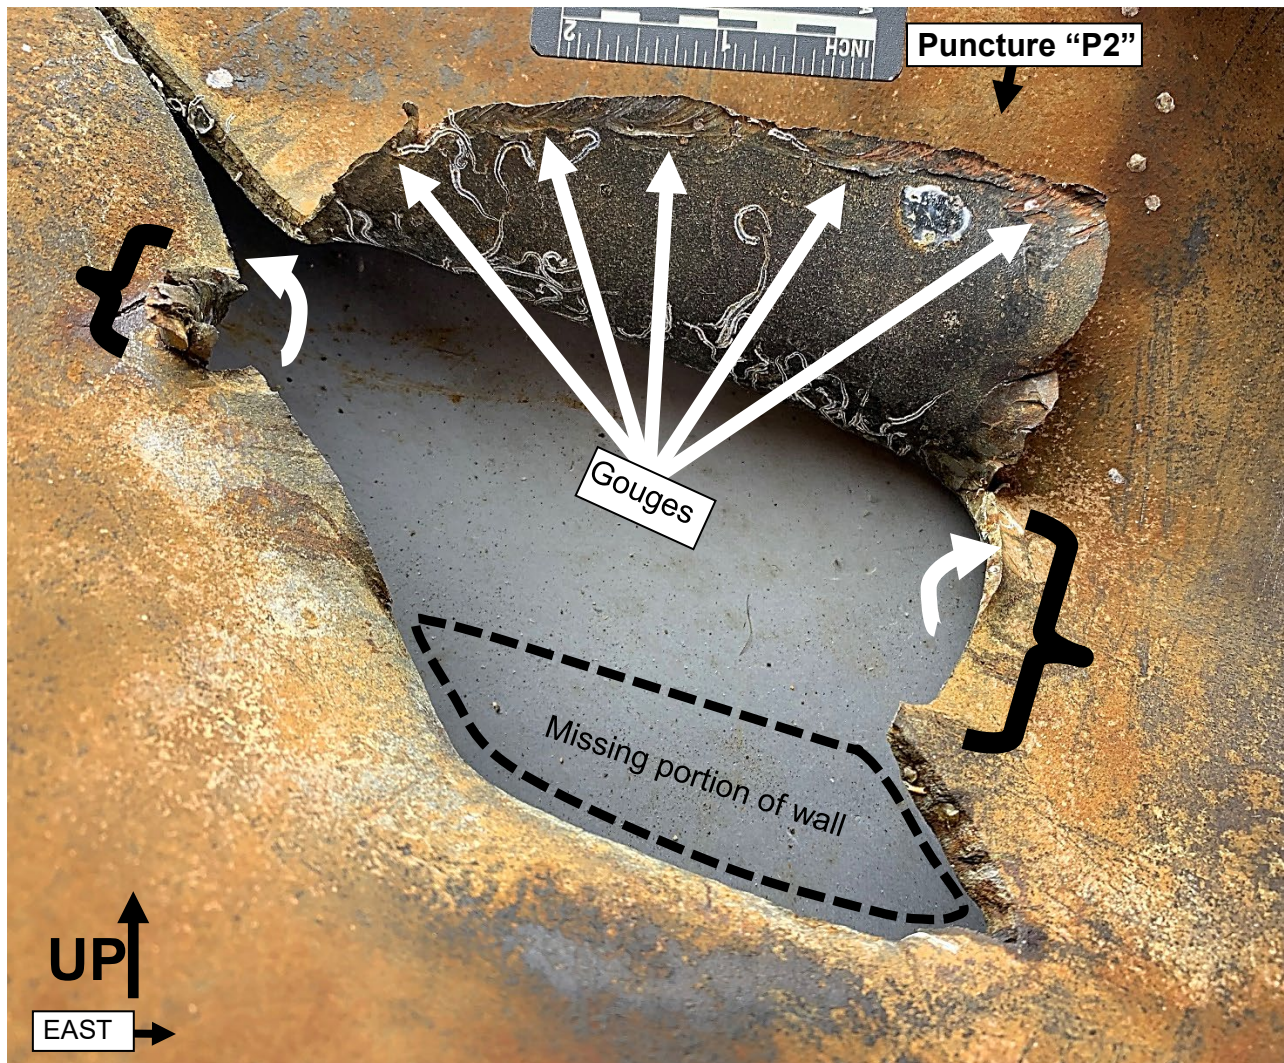
Examination of the lip portion for puncture “P2” also revealed the outer surface exhibited evidence of impact marks (deformed surface that contained gouges). The impact marks were prevalent in the areas along the edges of the fracture faces, as shown in figure 24. The east and west ends of the puncture exhibited evidence of severe metal deformation, in areas indicated by brackets in figures 20, 22 and 24. When looking at the inner face of the pipe, the east and west ends of the puncture “P2” showed inward bending deformation, in the general direction indicated by arrows in figure 24. A portion of the wall had fractured and was missing from puncture P2” in the area enclosed by a dashed line in figures 20, 22, 24, and 26 (the lip portion did not extend into the missing portion of the wall).

Figure 24. Close-up photograph of the inner surface of the pipe in the area of puncture "P2" after cleaning. The outer face of the lip portion at the edges of the fracture showed evidence of impact marks (deformed surface containing gouges). The wall of the pipe at the east and west ends of the puncture, in the areas indicated by brackets, showed inward bending deformation (in the general direction indicated by arrows). A portion of the wall is missing from the area enclosed by a dashed line.

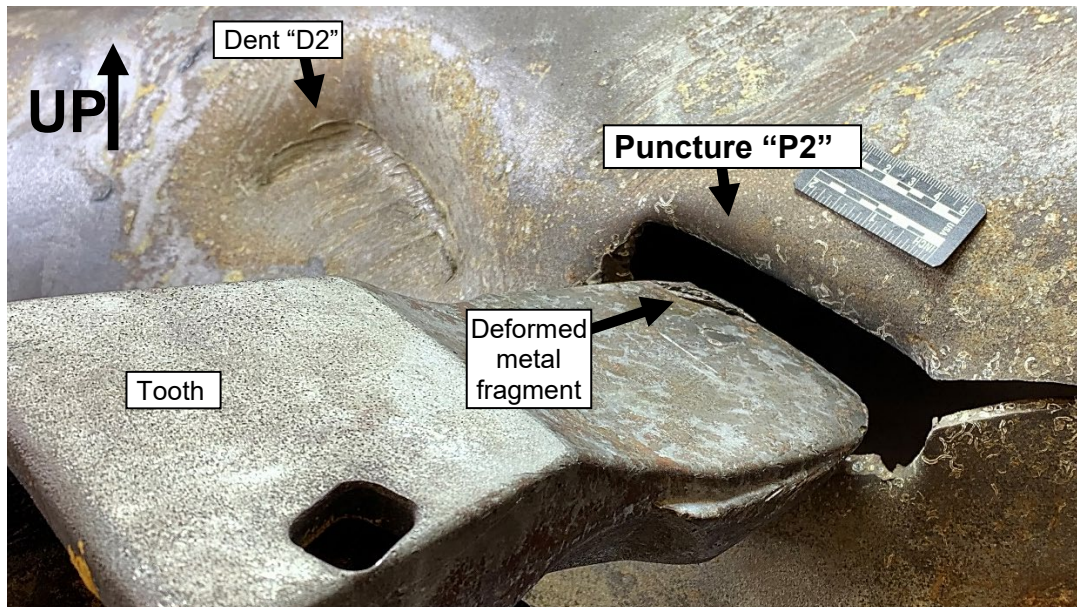
Figure 25. Oblique view of puncture "P2" with the tip portion of tooth "C1" facing the puncture and dent "D3" containing gouges in the background, after cleaning. The tip of tooth "C1" contained evidence of a deformed metal fragment.

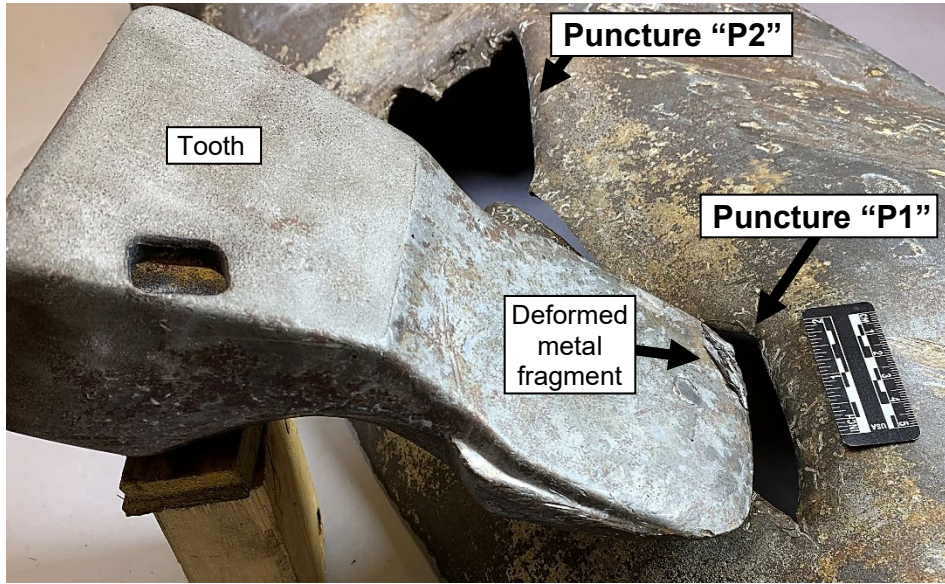
Figure 27. Oblique view of puncture "P1" with the tip portion of tooth "C1" facing the puncture, after cleaning. The tip of tooth "C1" contained evidence of a deformed metal fragment.

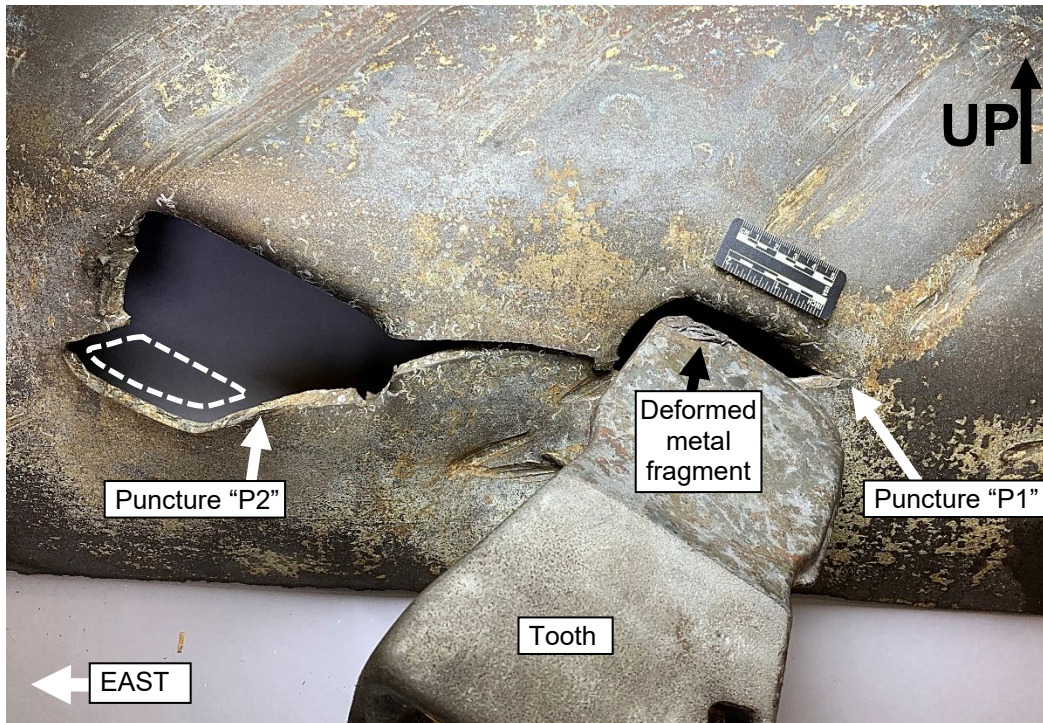
Figure 28. Oblique view of puncture "P1" with the tip portion of tooth "C1" facing the puncture, after cleaning. The tip of tooth "C1" contained evidence of a deformed metal fragment. A portion of the wall is missing from the area enclosed by a dashed line.

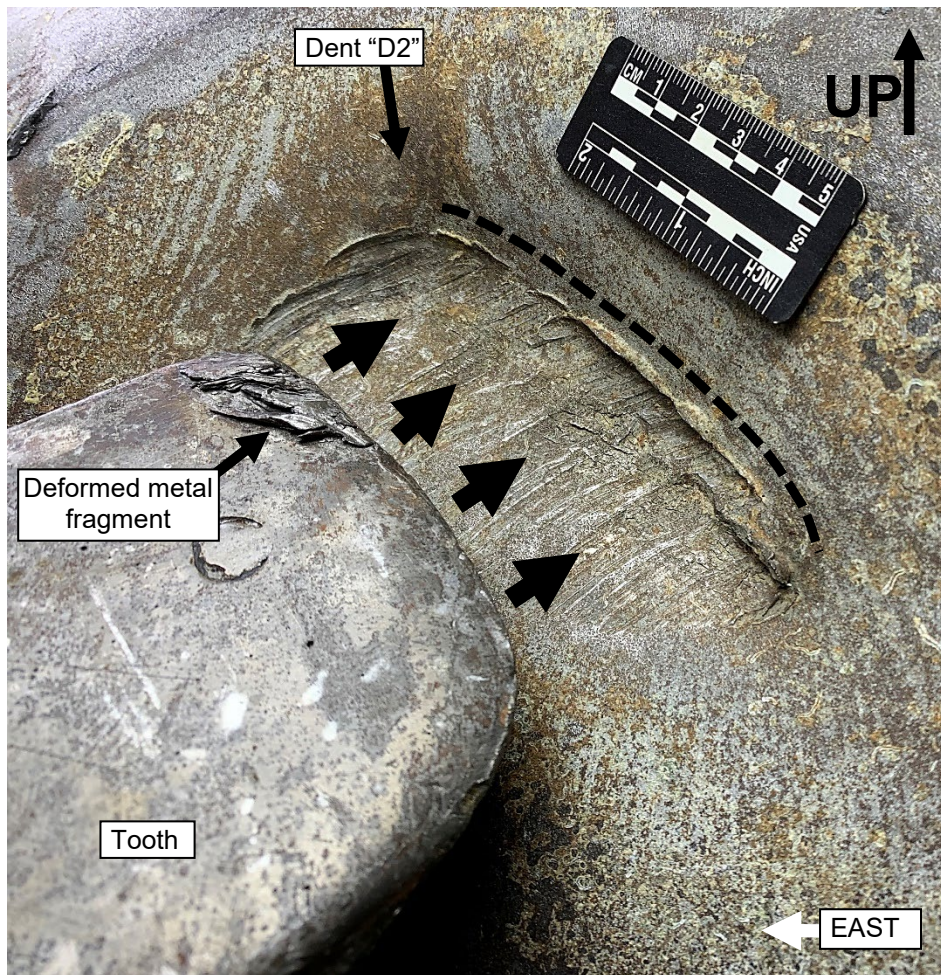
Figure 29. Outer surface of the pipe in the area of dent "D2" with tooth "C1" positioned next to the dent, after cleaning. The dent contained gouges consistent with metal flow in the general direction indicated by black arrows. Metal flow deformation terminated in the general area indicated by a dashed line. The tip of tooth "C1" contained evidence of a deformed metal fragment.

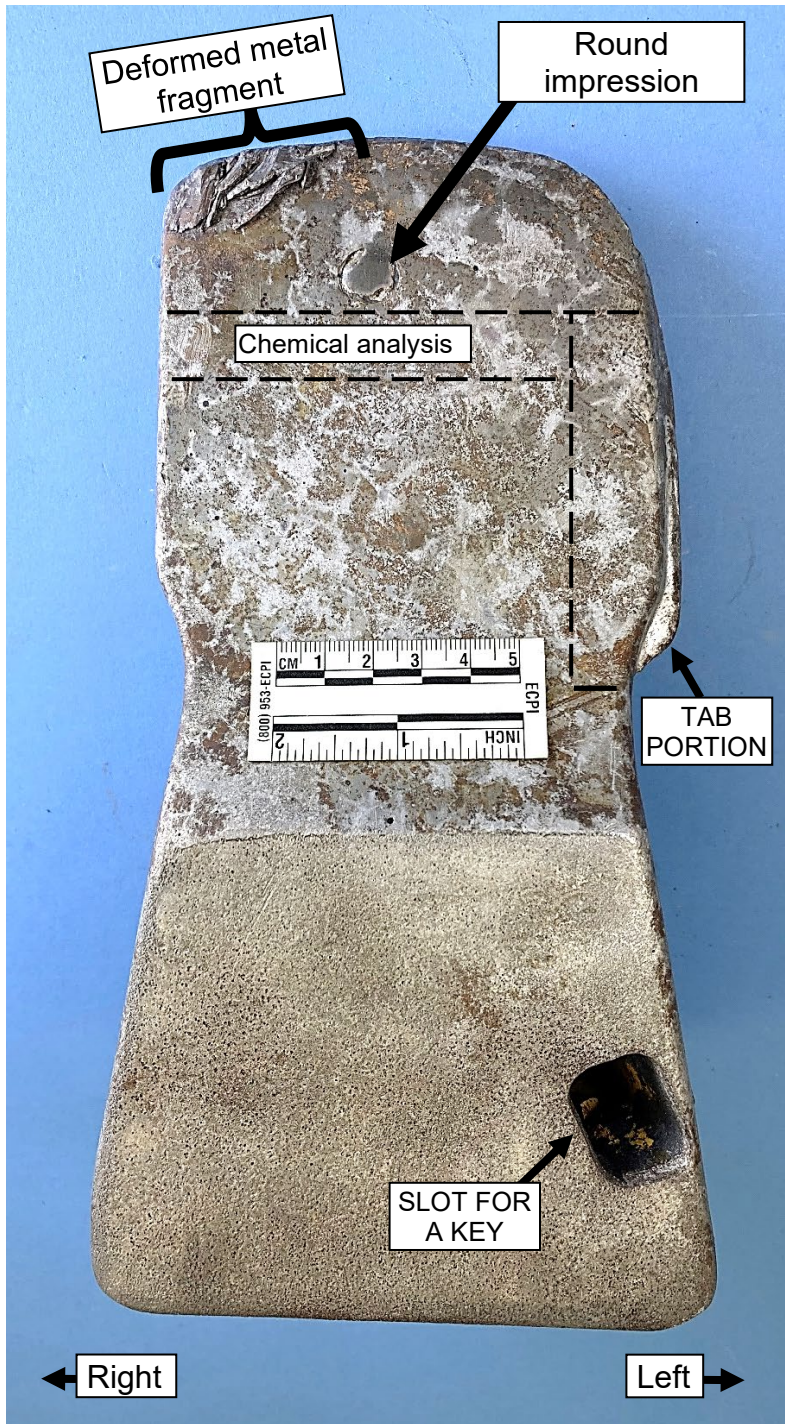
Figure 32. Back face of tooth “C1” after cleaning, showing a deformed metal fragment that was imbedded at the tip portion. Dashed lines indicate cuts made to facilitate examination of the gouges at the tip of the tooth and for chemical analysis.

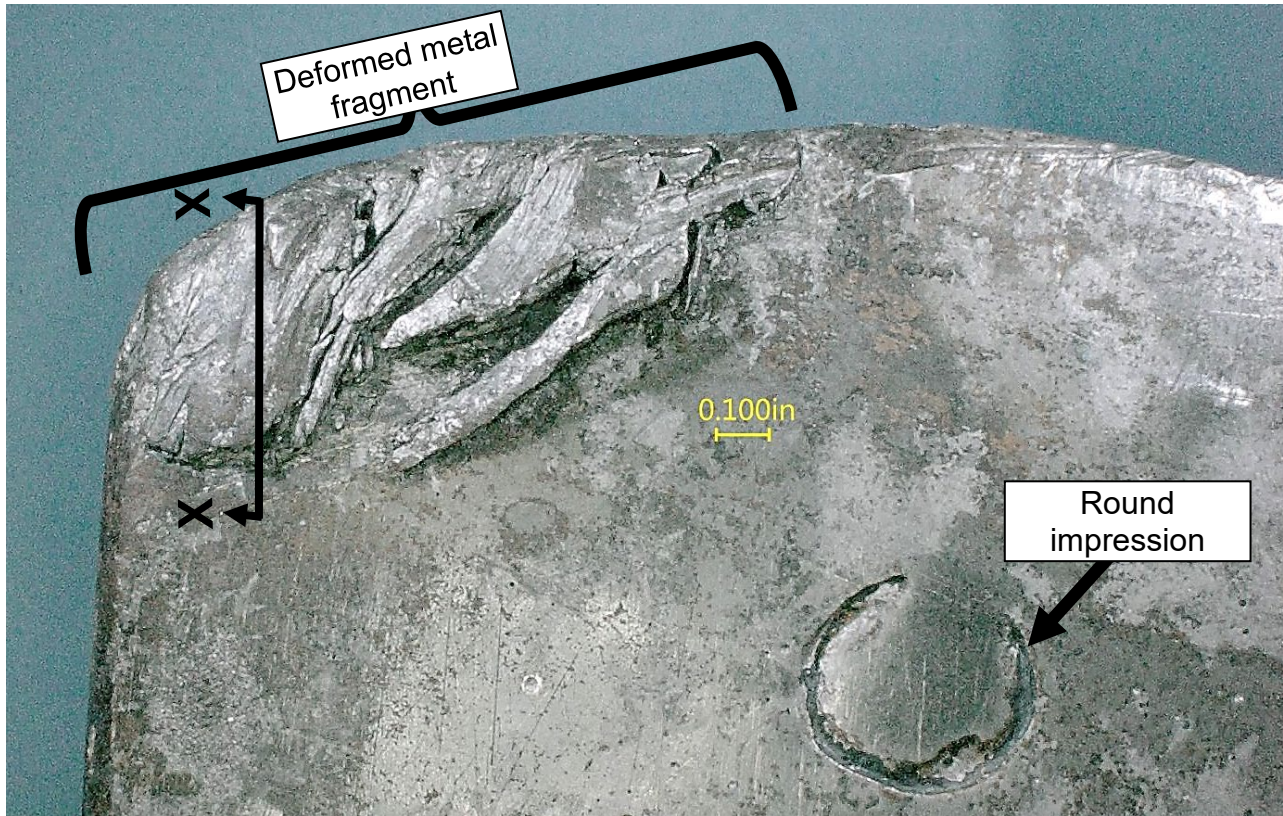
Figure 33. Back face of tooth "C1" after cleaning showing deformed metal fragment that was imbedded at the tip portion.
