NATIONAL TRANSPORTATION SAFETY BOARD

MATERIALS LABORATORY FACTUAL REPORT

Report No. 21-022

Place : Corpus Christi
Date : August 21, 2020
Vehicle : 16-inch propane pipeline
NTSB No. : DCA20FM026
Investigator : Paul Stancil

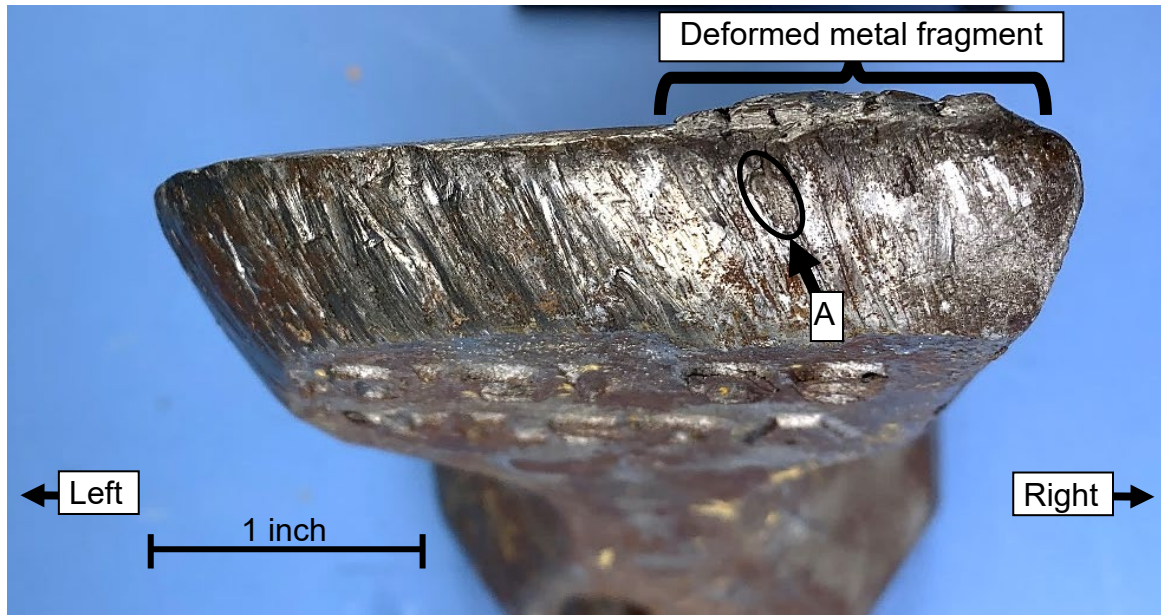
Figure 34. View of the tip portion of tooth "C1" showing deformed metal fragment at the back face, after cleaning. The abraded surface at the tip of the tooth also showed evidence of metal build-up in the area indicated by arrow "A".

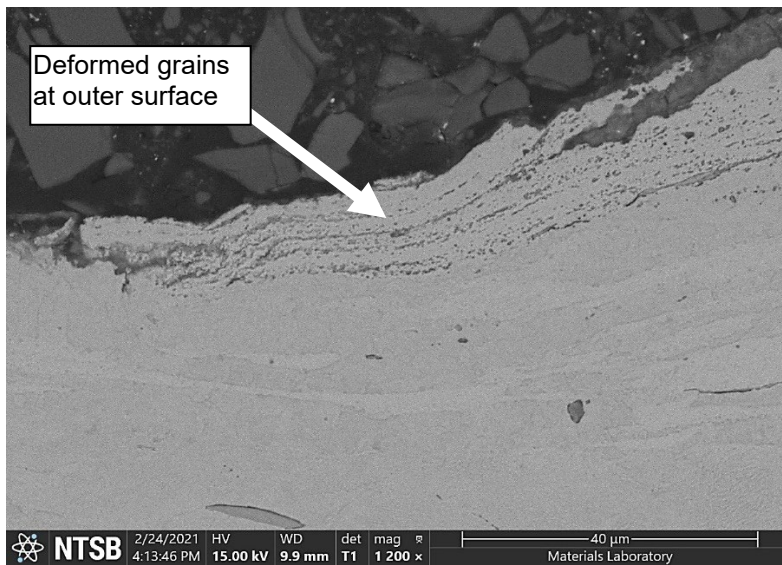
Figure 39. SEM image of the pipe wall cross section showing severely deformed grains at the outer surface. Etched with 2% Nital reagent. 1,200X

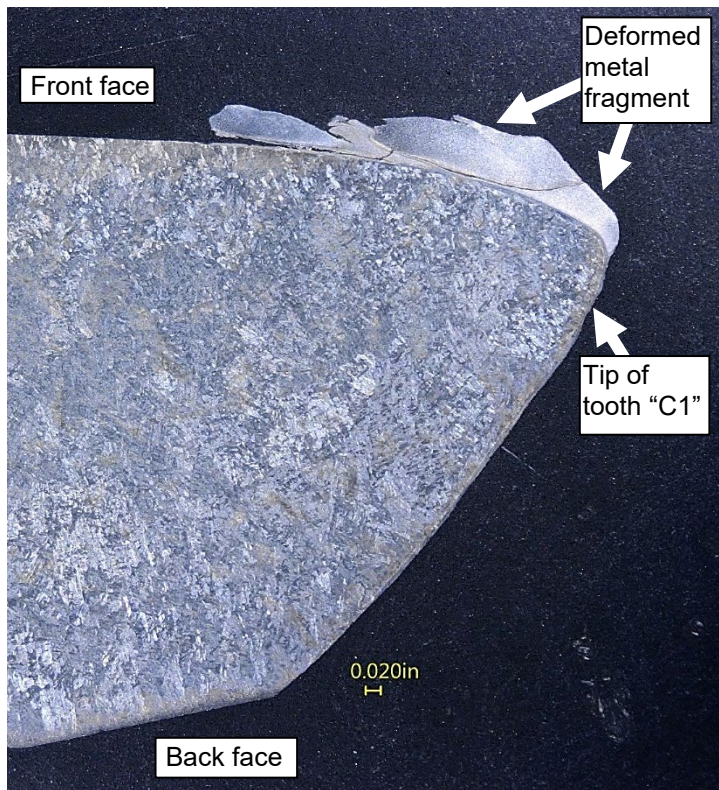
A metallurgical section was made through the tip of the tooth and deformed metal fragment, in the orientation indicated by section line “X-X” in figure 33. Figure 43 shows an overall view of section “X-X”. The section was prepared and etched with 2% Nital reagent. Examination of the prepared section revealed the deformed metal fragment showed evidence of severely deformed microstructure of ferrite and pearlite grains (see figure 44), whereas the tooth showed evidence of a cast microstructure (see figure 45).

Figure 43. Metallurgical section "X-X" in figure 33 showing the tip of tooth "C1" and deformed metal fragment. Etched with 2% Nital reagent.

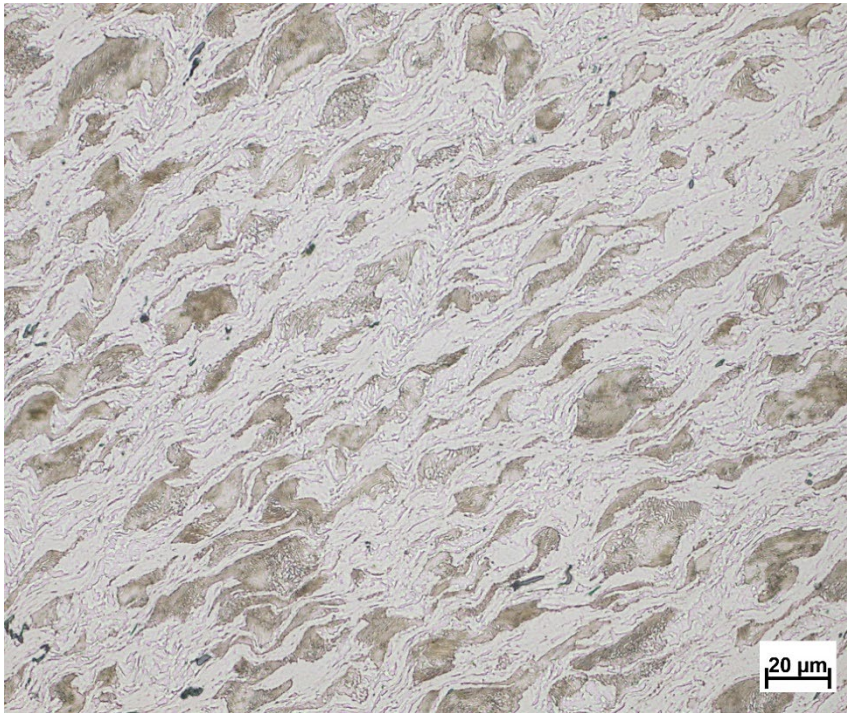
Figure 44. Microstructure of the deformed metal fragment at the tip of tooth "C1" showing pearlite and ferrite grains that exhibited evidence of deformation. Etched with 2% Nital reagent. 500X
