NATIONAL TRANSPORTATION SAFETY BOARD

MATERIALS LABORATORY FACTUAL REPORT

Report No. 21-023

Place : Corpus Christi
Date : August 21, 2020
Vehicle : 16-inch propane pipeline
NTSB No. : DCA20FM026
Investigator : Andrew Ehlers

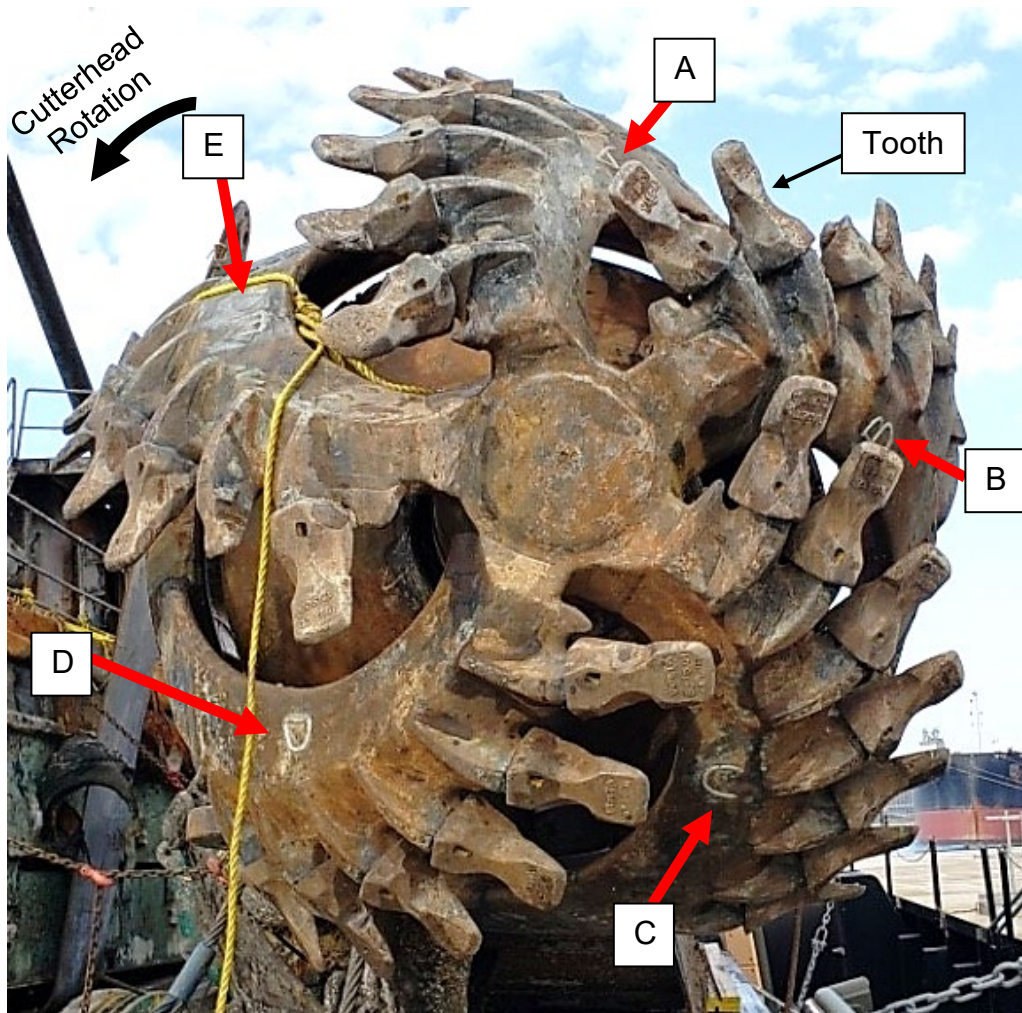
feet, representing the overall diameter of the cutter assembly. The axial length of the cutterhead assembly was approximately 4 feet. Table 1 indicates which teeth were intact, partially fractured, or entirely missing. Tooth "B3" fractured at the tip portion (major portion of the tip was missing).

Preliminary onsite examination by investigators revealed tooth "C1" appeared to have heavy contact and possible transfer of material at the tip portion (material appeared different compared to the tooth). The tip of tooth "E3" showed wear that was similar to the other blades and possible metal build-up. Blades "B3", "C1", and "E3" were submitted to the NTSB Materials Laboratory for detailed examination.

Figure 2. Front view of cutterhead assembly after underwater recovery (looking aft). The cutterhead assembly contained 5 blades, labelled by the manufacturer as “A”, “B”, “C”, “D”, and “E”.

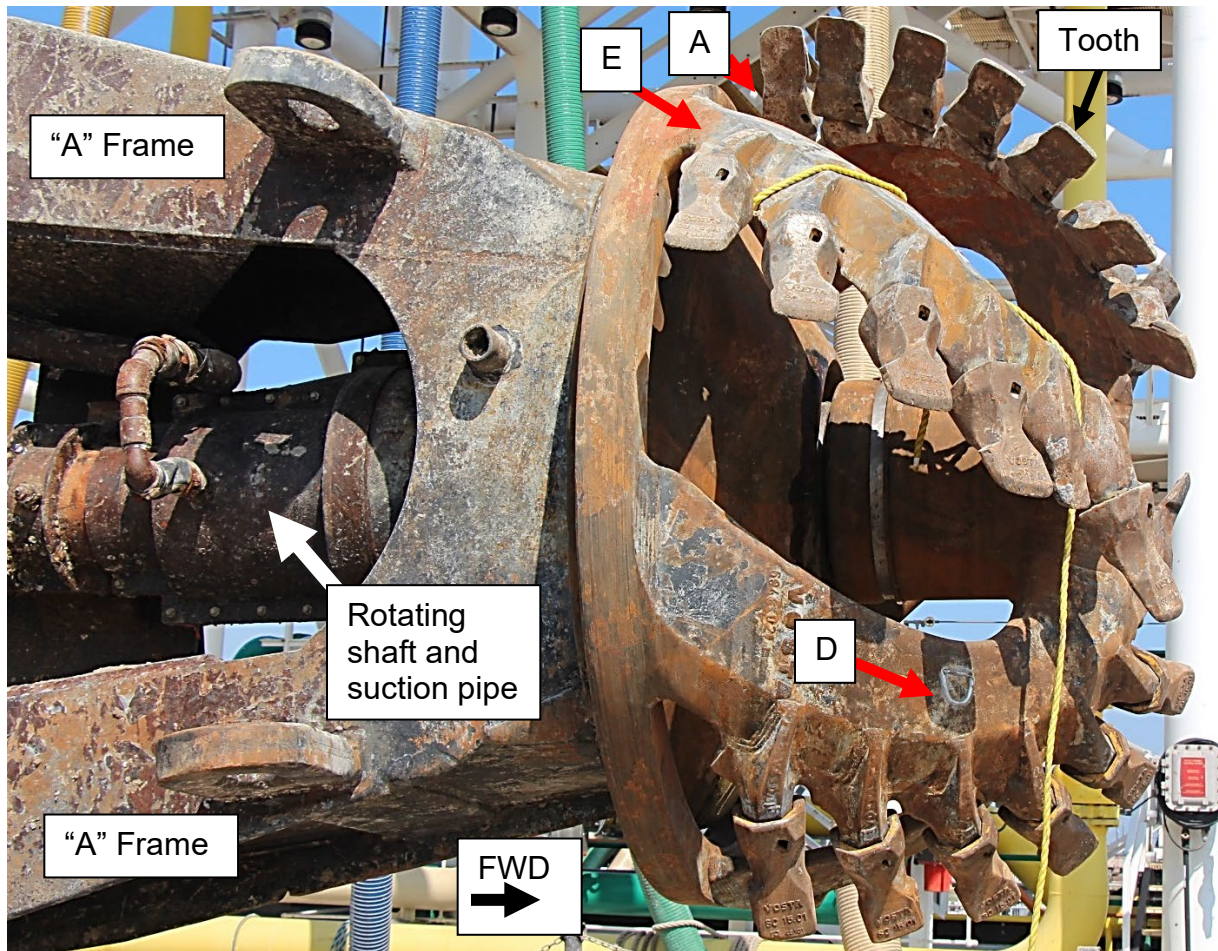
Figure 3. Top view of the “A” frame showing the side profile of the cutterhead assembly after underwater recovery. The side profile of the cutterhead assembly follows a conical-elliptical-like contour. Blades “A”, “D”, and “E” are shown in this view.

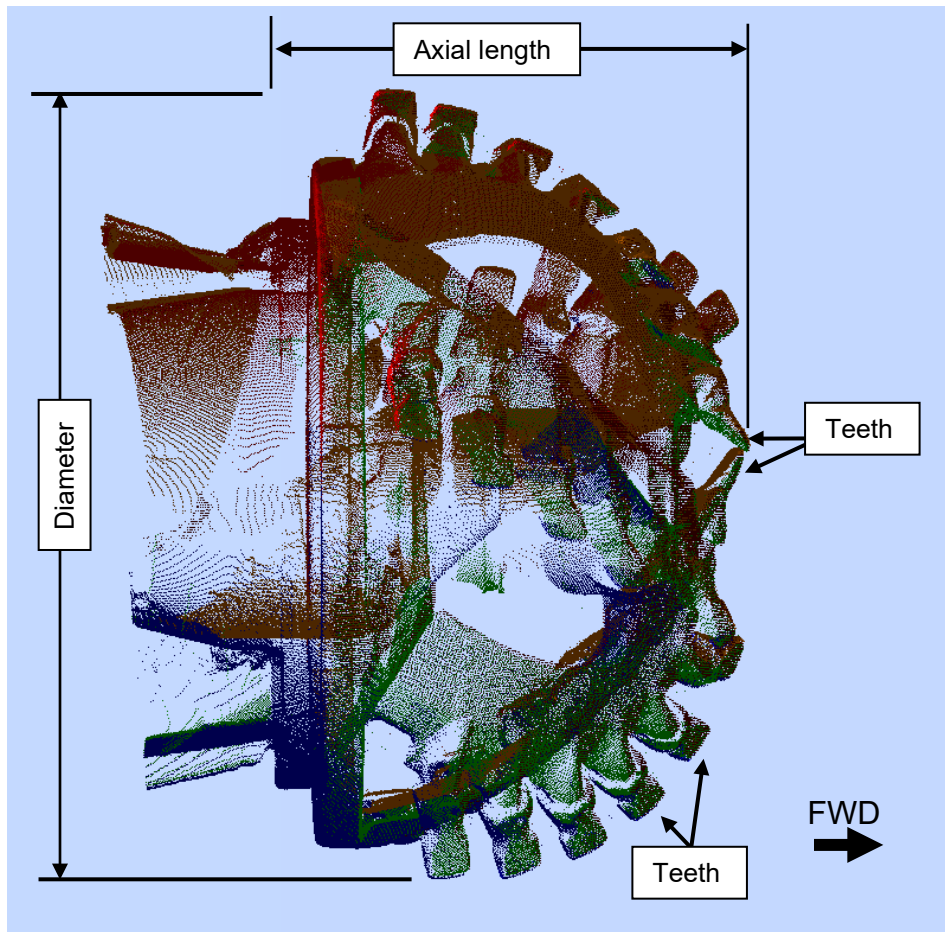
Figure 4. Reconstructed 3D image of the cutterhead assembly showing the side profile. Scanned onsite by Texas Rangers Public Safety Department using a Leica P40 laser scanner. This side view image was reconstructed by NTSB Vehicle Performance Division using SCENE software.
