# NATIONAL TRANSPORTATION SAFETY BOARD

MATERIALS LABORATORY FACTUAL REPORT

Report No. 21-034

Place : Anchorage, Alaska  
Date : June 8, 2020  
Vehicle : Piper PA-12  
NTSB No. : ANC20LA059  
Investigator : Brice Banning, AS-ANC

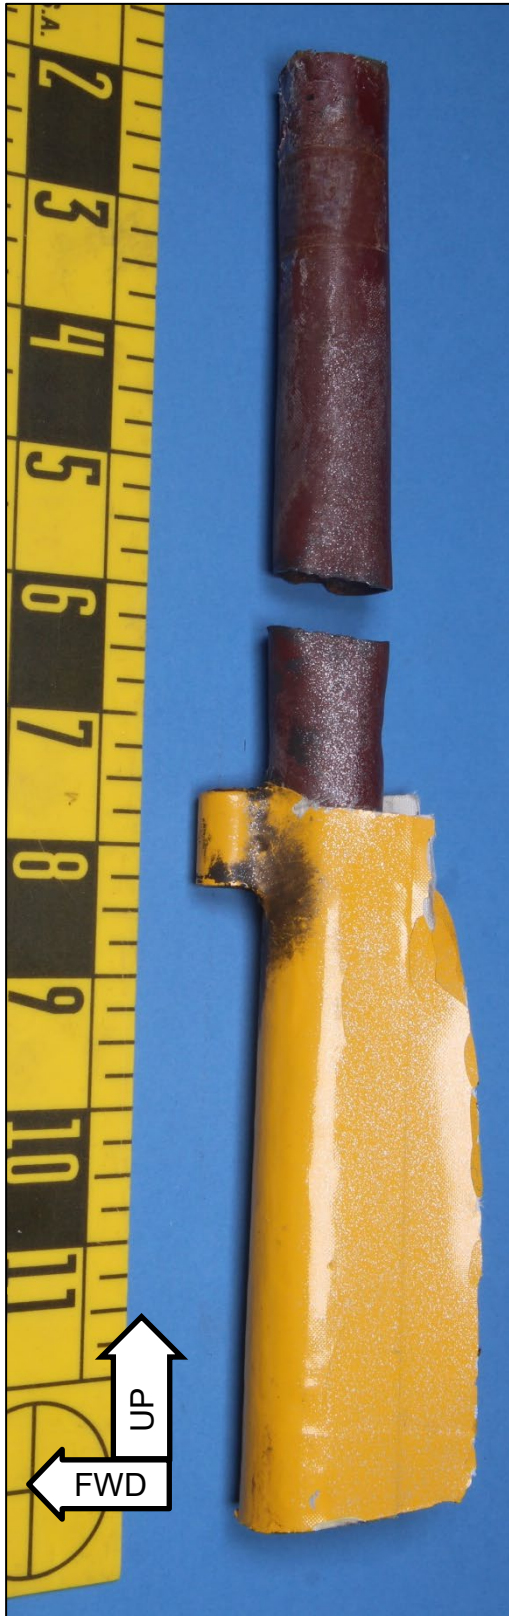
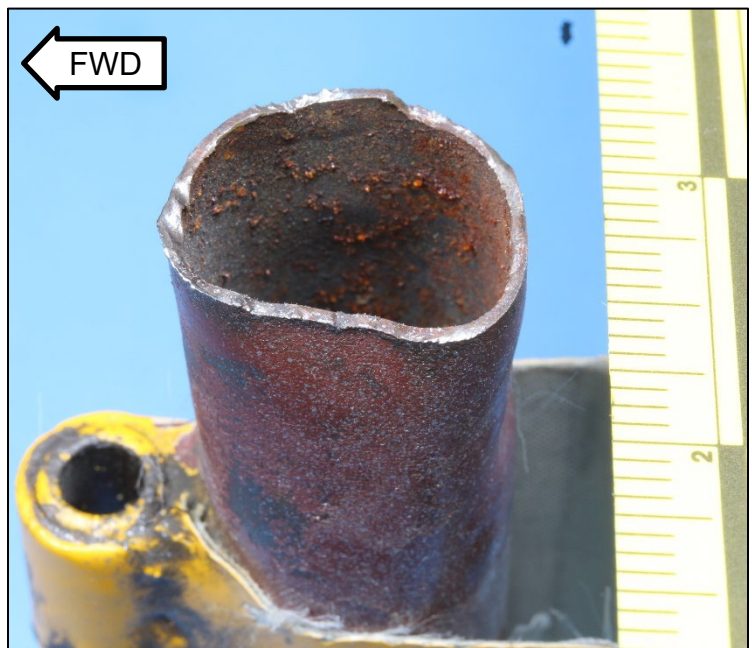
An overall view of the submitted rudder post pieces is shown in figure 1. The rudder was from a Piper PA-18 airplane and was submitted as an exemplar fractured rudder post in support of the accident investigation described in Section A above. The rudder post was fractured approximately 1.31 inches above the upper hinge barrel, and the submitted pieces had been cut from the remainder of the rudder to facilitate shipment and examination at the NTSB Materials Laboratory.

A photograph of the fracture surface on the lower piece is shown at the lower right in figure 1. The fracture surfaces on both sides of the fracture were substantially battered and rubbed with post-fracture contact between the mating fracture surfaces. The tubular cross-section of the post was deformed into an oblong shape at the fracture location with flattening on both the left and right sides, but the left side was flattened more, resulting in a cross-section that resembled a "D" shape.

Figure 1. Overall view of the submitted rudder post pieces (left) with a closer look at the fracture surface on the lower piece (below).

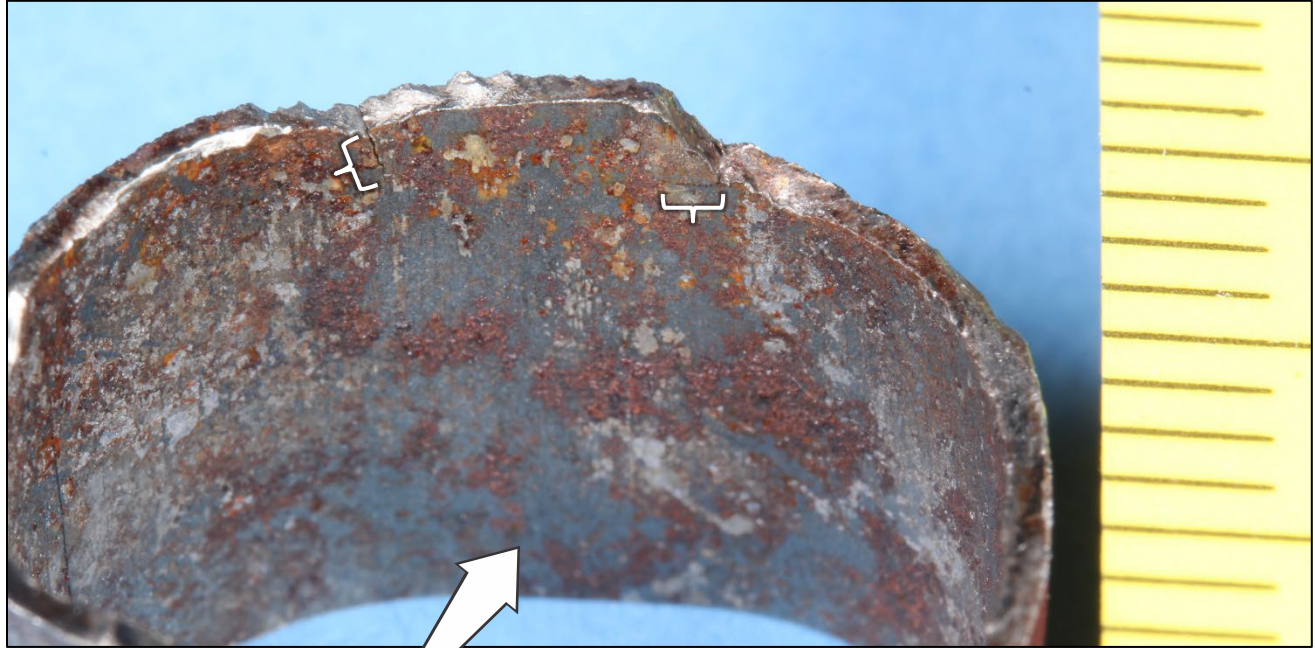
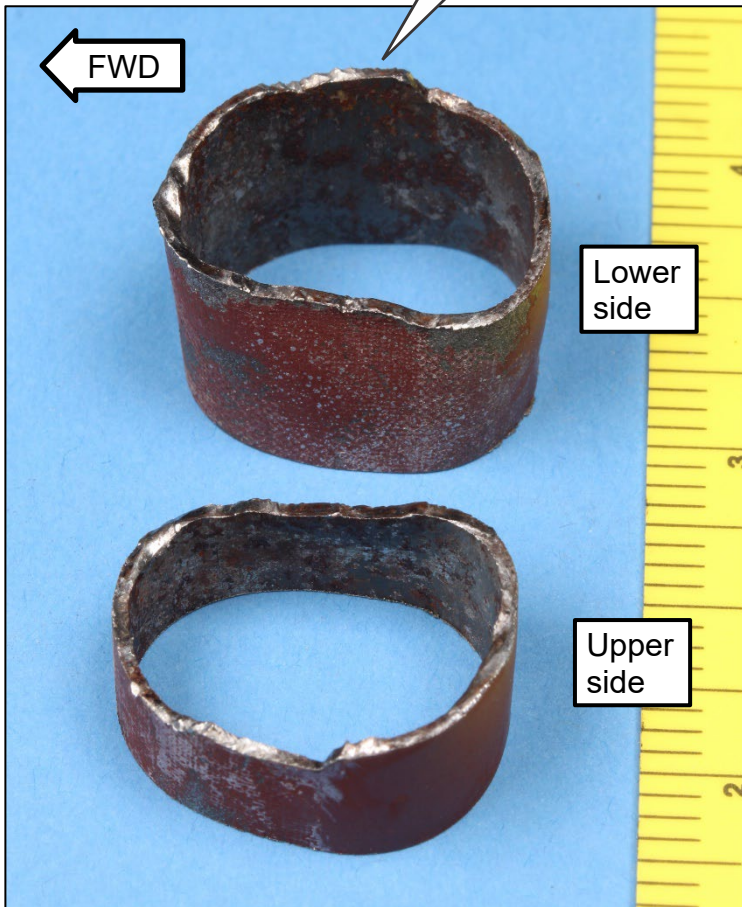
Transverse cuts were made through the post near the fracture surfaces, and the pieces with fracture surfaces were submerged in a solution of Alconox detergent and water and cleaned using an ultrasonic cleaner. The sectioned and cleaned pieces with the upper and lower sides of the fracture are shown in figure 2. Most of the fracture occurred in a nearly circumferential plane with a relatively large step on the right side. A circumferential branching crack was observed at the location of the step, and another nearly longitudinal branching crack was observed nearby as indicated with brackets in the upper image in figure 2. Rubbing deformation on the fracture surface and relative displacement of the branching crack faces were consistent with final fracture at the right side between the branching cracks with the upper side of the fracture rotating clockwise relative to the lower side (clock references as viewed from above).

Figure 2. Upper and lower sides of the fracture after sectioning and cleaning (left) with a closer view of the right side of the lower fracture surface (above). Brackets in the upper image indicate branching cracks.

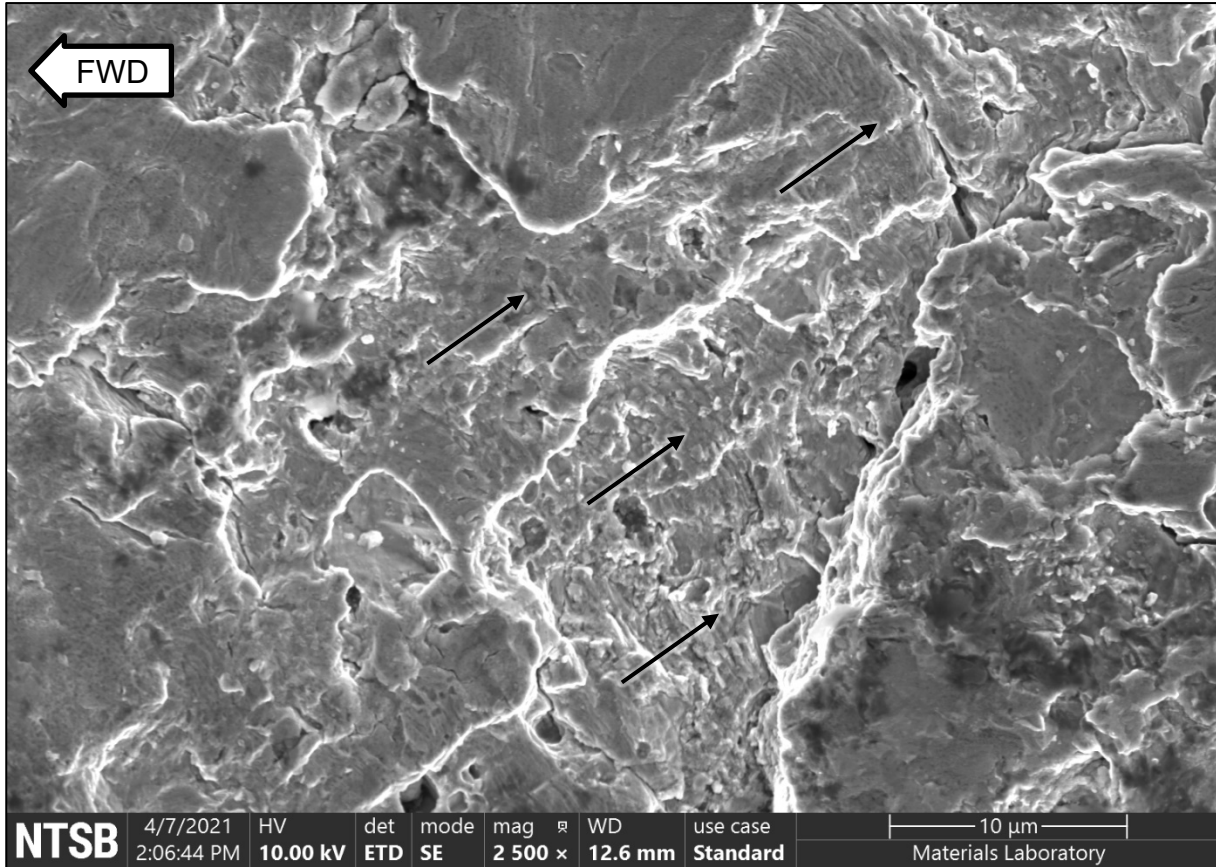
The piece with the lower fracture surface was examined using a scanning electron microscope (SEM). Most of the fracture surface was rubbed, obliterating the original fracture features. However, isolated areas with fracture features were observed in the left aft quadrant of the fracture surface including the area shown in figure 3. Flat fracture features with curving striations were observed consistent with a fatigue fracture mechanism. Unlabeled arrows in figure 3 indicate the direction of fatigue crack propagation at this location, consistent with circumferential fatigue crack growth in a counterclockwise direction.

Figure 3. SEM image of fatigue fracture features on the lower piece. The area shown was in the aft left quadrant, and unlabeled arrows indicate the direction of circumferential fatigue crack propagation.
