NATIONAL TRANSPORTATION SAFETY BOARD

MATERIALS LABORATORY FACTUAL REPORT

Report No. 21-049

Place : Bethel, Alaska
Date : April 11, 2019
Vehicle : Piper PA-32-300, N4466T
NTSB No. : ANC19LA016
Investigator : Eric Swenson, AS-ANC

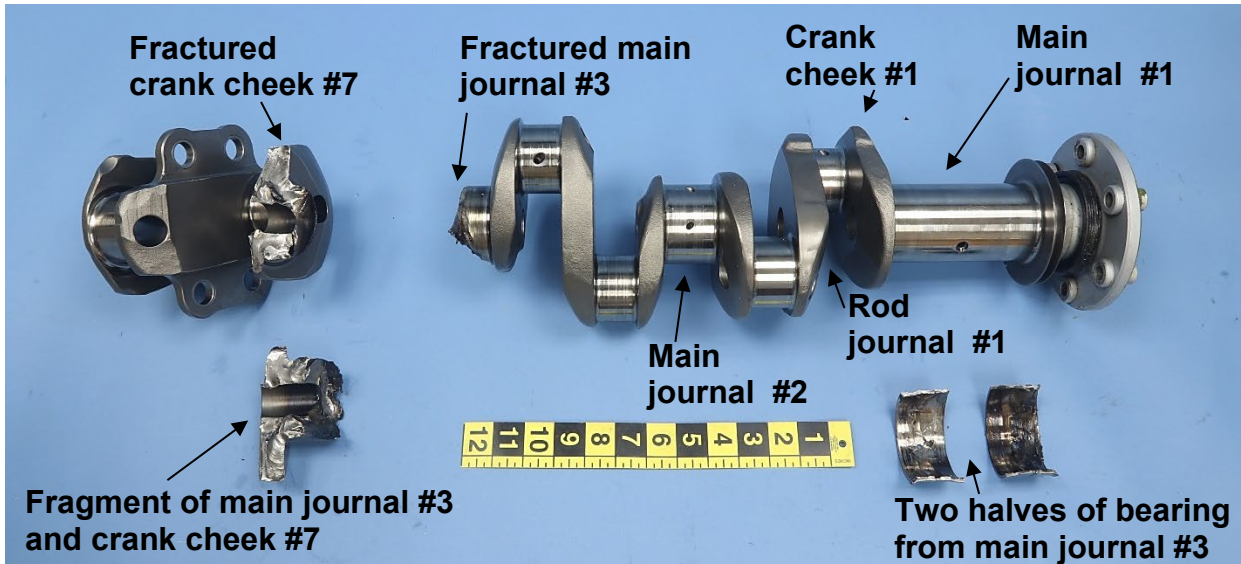
Figure 1 shows a photograph of the as-received crankshaft and two halves of a bearing from main journal #3. The main journals, rod journals, and crank cheeks are numbered from the forward end to the aft end, starting with main journal #1 that is located adjacent to the propeller flange. The crankshaft fractured into three pieces. The fracture intersected main journal #3.

Figure 1. As-received crankshaft and two halves of bearing from main journal #3.

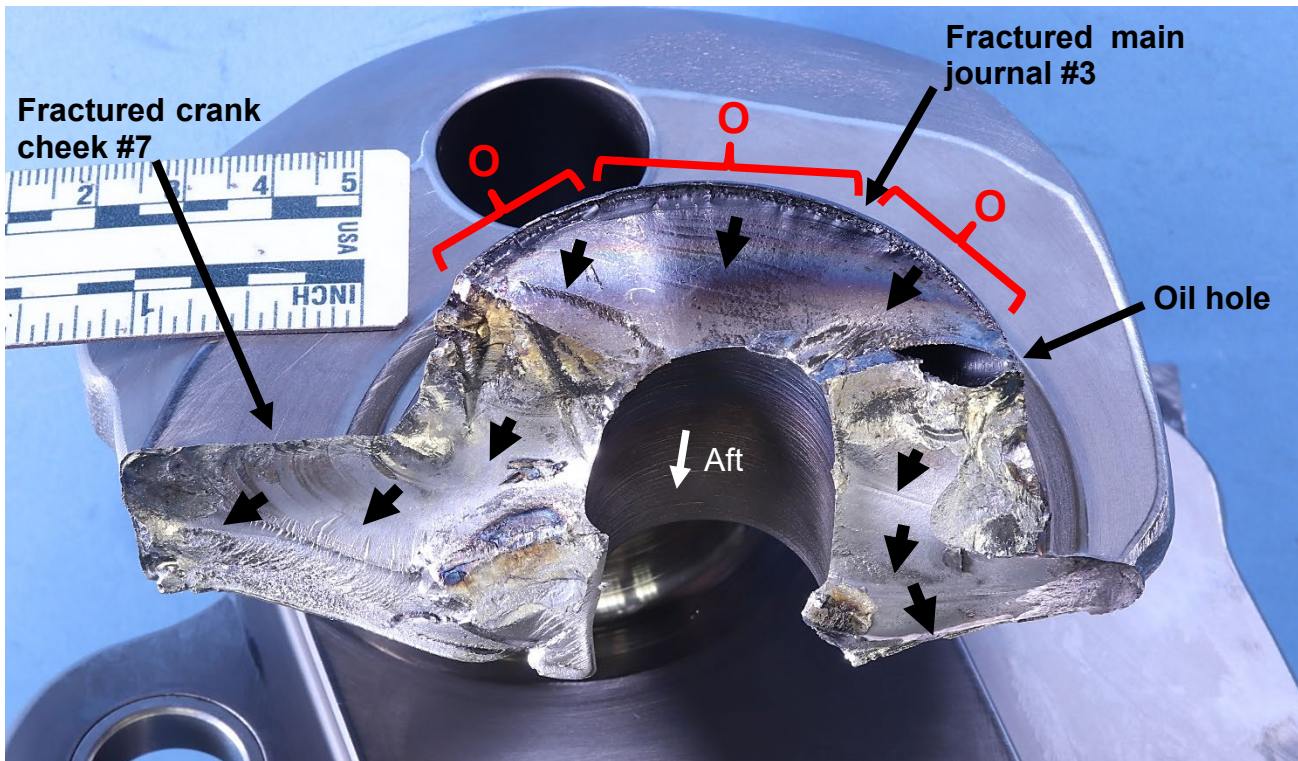
Bench binocular microscope examination of the crankshaft revealed crack arrest marks typical of fatigue cracking emanated from multiple origins at the surface of main journal #3 in the areas indicated by brackets "O" in figures 2 through 4. The fatigue origin area was located near the center of the main journal. The fracture face at the fatigue origin area exhibited evidence of blue, grey, and red tinting consistent with exposure to heat. The fracture features at the origin of the fatigue crack and other portions of the fracture were obliterated by post fracture relative movement between mating fracture faces. The fatigue crack propagated toward the core of the main journal where it split into two fatigue cracks. One fatigue crack propagated through the main journal to the diametrically opposite side of the main journal, see figure 1. The other fatigue crack propagated aft and through crank cheek #7, in the general direction indicated by arrows in figure 2.

Figure 2. Aft fracture face of main journal #3 showing fatigue crack origin area indicated by brackets "O" and general direction of fatigue crack propagation.

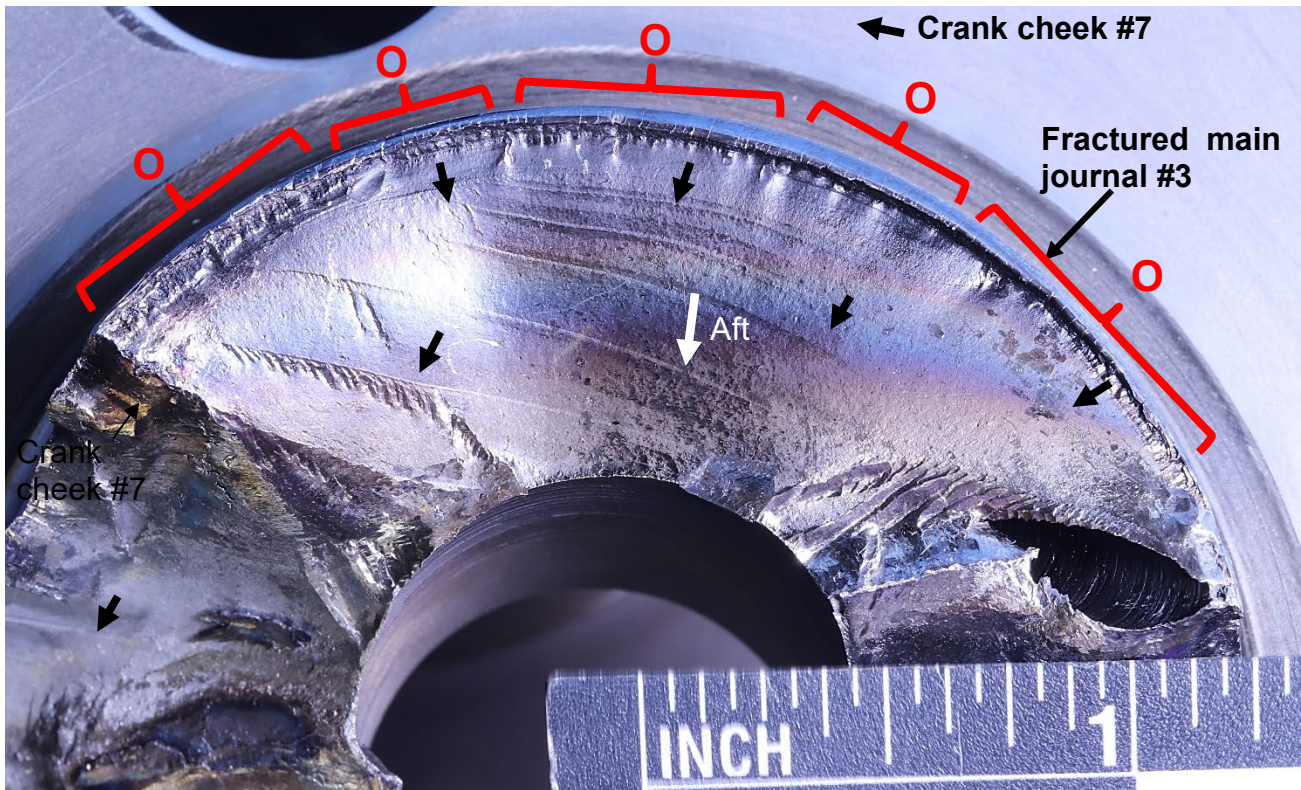
Figure 3. Close-up photograph of the aft fracture face of main journal #3 showing fatigue crack origin area indicated by brackets "O" and general direction of fatigue crack propagation.

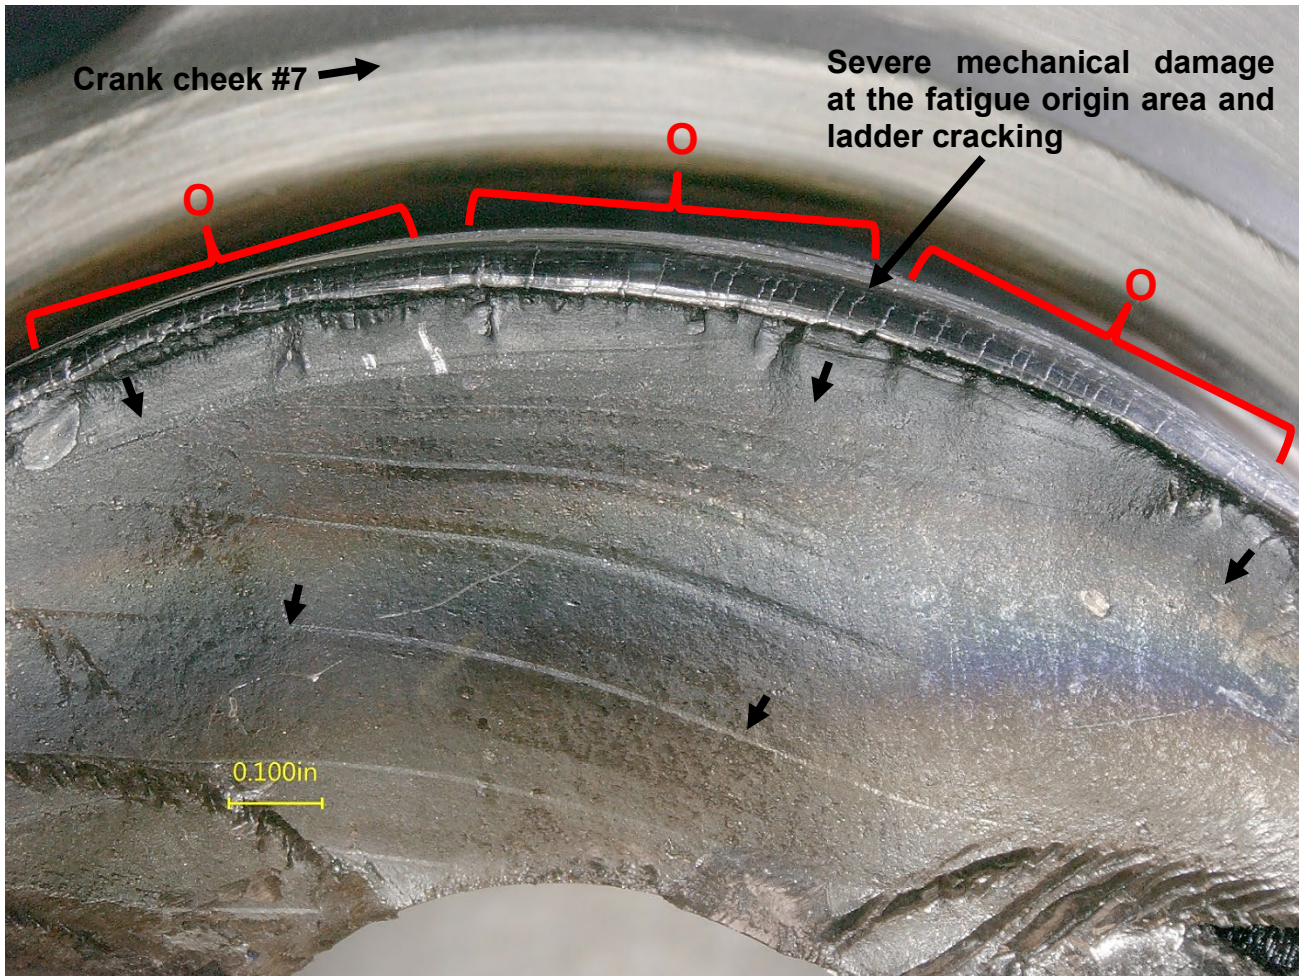
Figure 4. Close-up photograph of the aft fracture face of main journal #3 showing fatigue crack origin area indicated by brackets "O" and general direction of fatigue crack propagation. The origin of the fatigue crack exhibited evidence of severe mechanical damage and multiple ladder cracks.

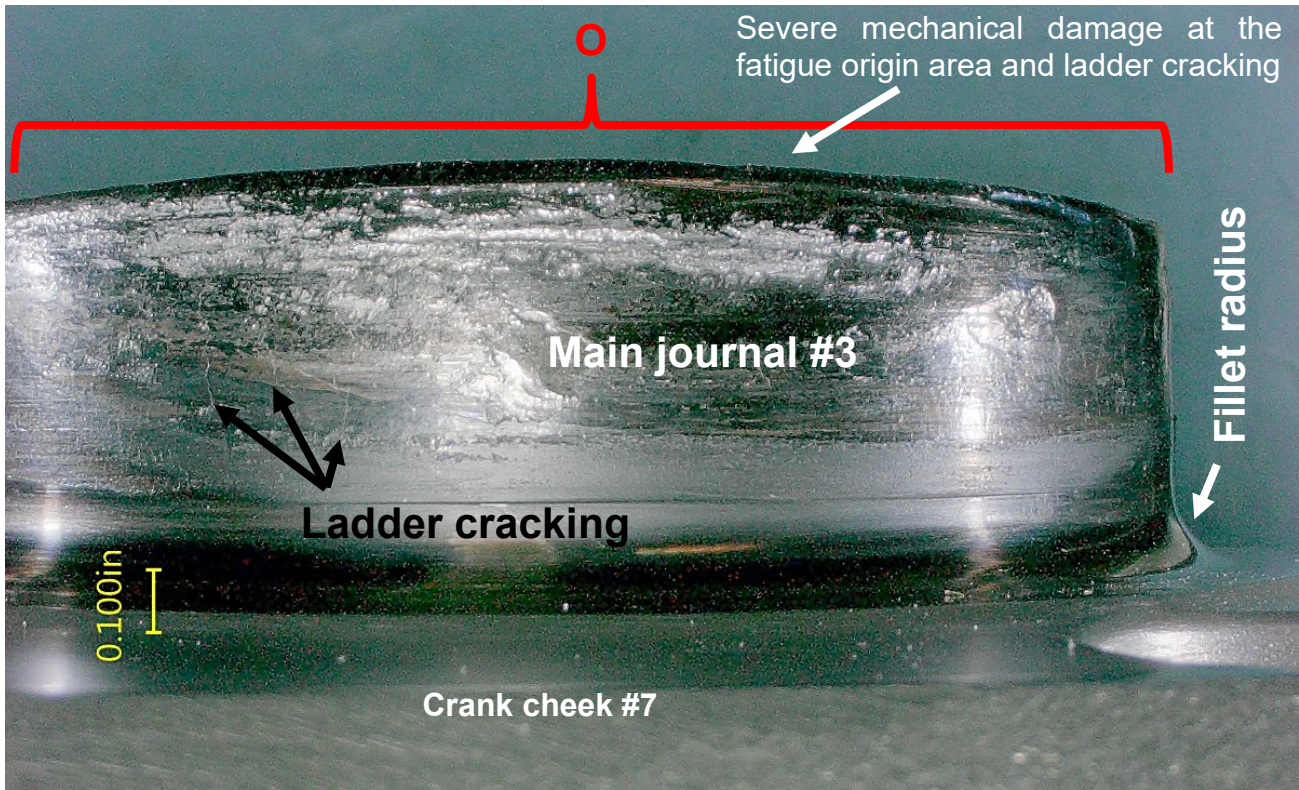
The surface of main journal #3 exhibited evidence of severe mechanical damage such as circumferential abrasion, wear, galling and heat tinting (see figure 5). The surface also contained evidence of ladder cracking (multiple longitudinally oriented parallel cracks). The remaining rod and main journals showed no evidence of mechanical damage and heat

Figure 5. Side view of main journal #3 showing the outer face and severe mechanical damage such as gouges and blue tint.
