NATIONAL TRANSPORTATION SAFETY BOARD

MATERIALS LABORATORY FACTUAL REPORT

Report No. 21-059

Place : Camp Dwyer, Afghanistan
Date : April 20, 2020
Vehicle : Sikorsky S-61N, N908CH
NTSB No. : DCA20LA100
Investigator : Dan Bower, AS-10

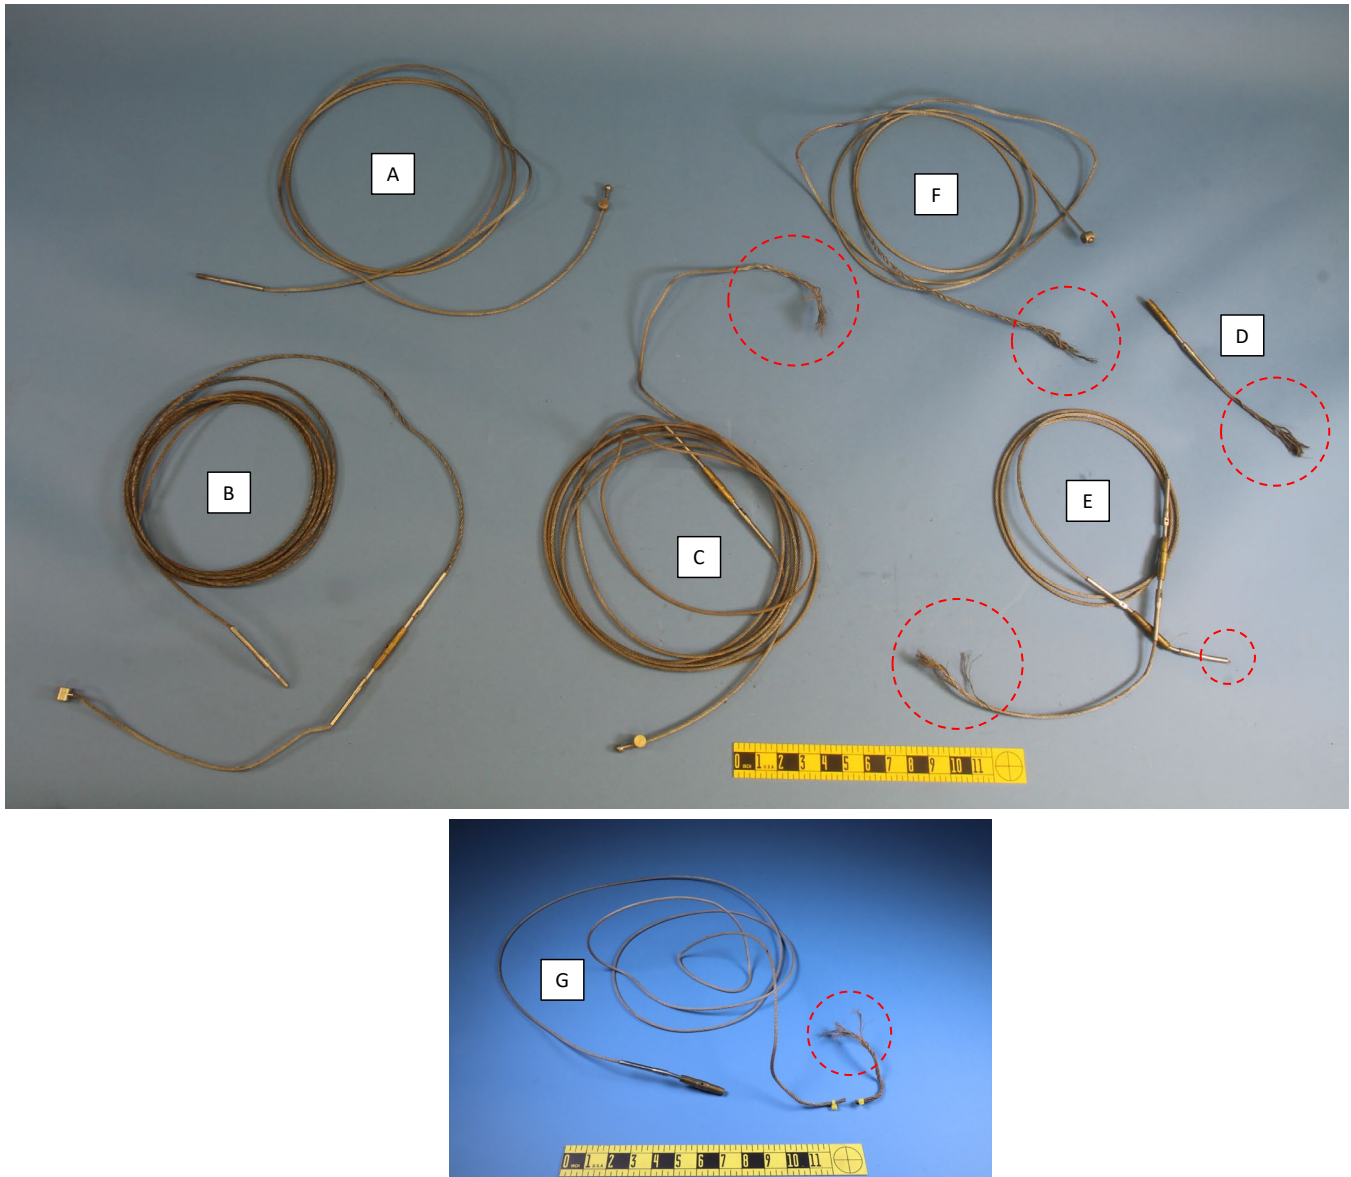
A total of seven portions of wire rope (cable) assemblies, some connected via turnbuckles, were received for examination as shown in figure 1. Portions of cables were initially labeled A through G in the order examined. Two lengths of cable assemblies were received with no apparent fractures. The other five lengths of cable assemblies were fractured on at least one end of the cable run. After all portions received were measured and compared to specified cable lengths and index numbers in Table 201 and Figure 202, respectively, in the Sikorsky S-61N Maintenance Manual for the Rotary Rudder Flight Control System¹, it was possible to correlate the cables and fracture locations to the index numbers assigned to each cable in the system. All wire ropes examined were consistent with a right regular lay construction consisting of 7 strands of 19 wires (7x19) and had an average diameter of approximately 0.16 inch. All threaded terminals were stamped "MS21260." All intact cable sections did not show any apparent signs of excessive wear or corrosion, and a greasy black-brown substance was observed on the cable exterior and interspersed between

Figure 1: Photographs of the portions of cable as received. Locations where cables were fractured are circled in red. Identification labels A through G were assigned based on order of observation.

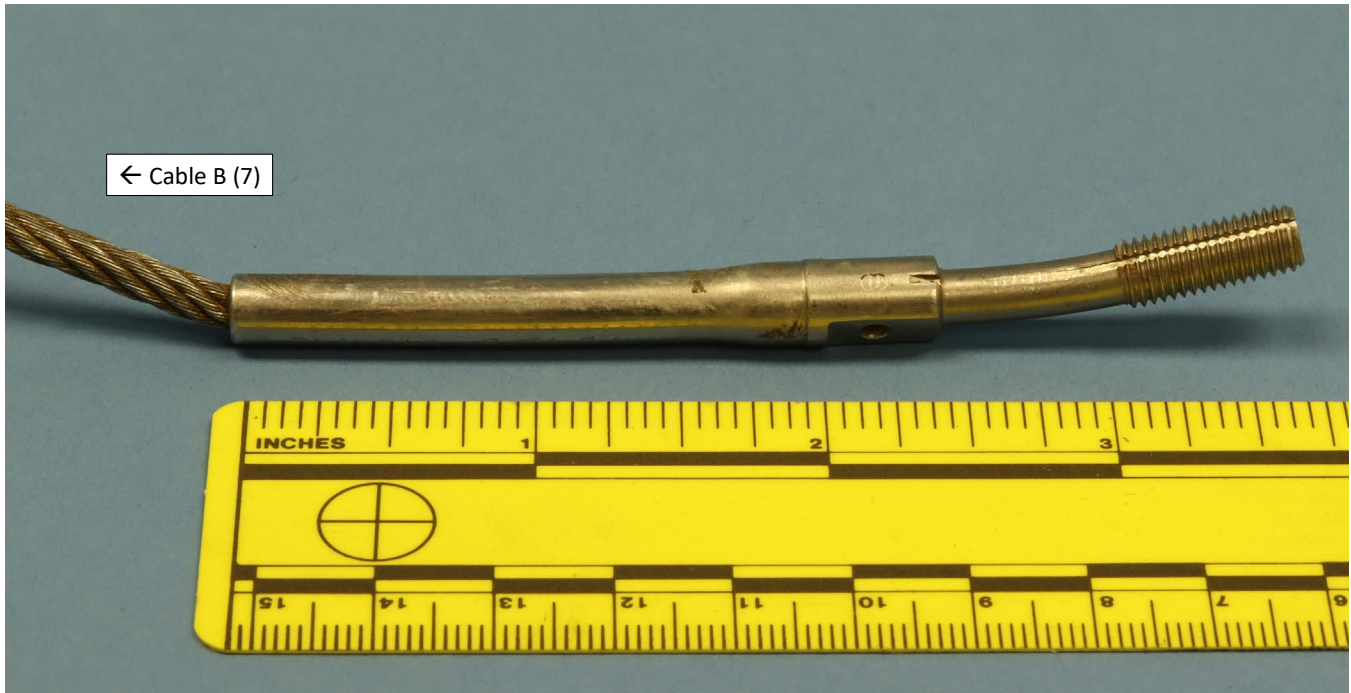
Figure 2: A photograph of the threaded end terminal of cable B (7) as received, which exhibited bending deformation.

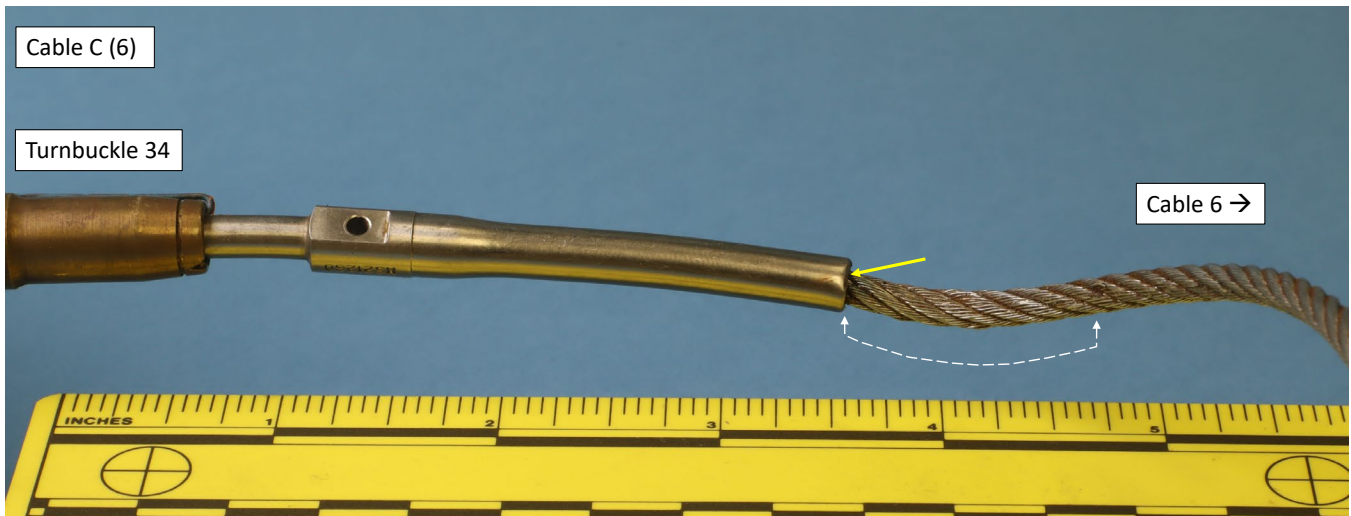
The third length of assembled cables examined, labeled C in figure 1, consisted of a fractured cable connected via a turnbuckle to another shorter length of cable between a threaded terminal and a ball and socket terminal. The total length of the assembly was approximately 288 inches which was consistent with cable 6 (fractured) connected to cable 33 via turnbuckle 34 as identified in the maintenance manual. The turnbuckle was connected to the threaded terminals with both locking clips present. The threaded terminal on the fractured portion of cable was bent and exhibited deformation at the base of the shank as detailed in figure 3. The adjacent wire strands were flattened and permanently set in a curved profile consistent with localized contact and loading above the yield strength of the cable. There were no apparent fractured wires in this area.

Figure 3: A photograph of the threaded end terminal of cable 6 which exhibited bending deformation. The base of the terminal was locally deformed as indicated by the yellow arrow and adjacent strands were flattened and permanently set in a curved profile as indicated by the white bracket, consistent with local contact and loading above the yield strength of the cable.

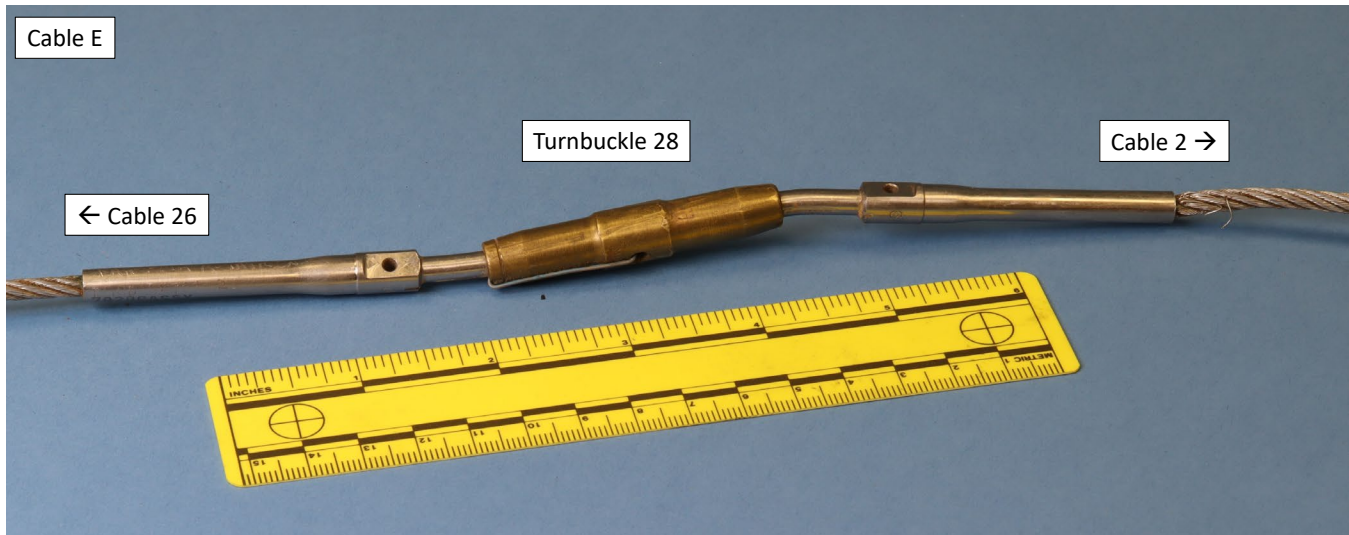
The fifth length of cable assemblies examined, labeled E in figure 1, consisted of a fractured cable approximately 17-1/4 inches long connected via a turnbuckle to another length of cable between two threaded terminals which was connected via another turnbuckle to a threaded terminal with fractured wires protruding from the base of the shank. The total length of the assembly was approximately 105-1/2 inches which was consistent with cable 2 (intact) connected to fractured ends of cables 6 (shorter end) and 26 (longer end) via turnbuckles 5 and 28, respectively, as identified in the maintenance manual. The longer section of fractured cable was retained in the turnbuckle with a locking clip and no locking clip was present at the connection to the intact cable. The threaded terminals were bent about the reduced diameter threaded section as shown in figure 4. Two broken wires were

observed near the base of the threaded terminal shank of the intact cable. At the other turnbuckle connection, no locking clip was present at the intact cable connection and a portion of a locking clip was retained between the groove in the threaded terminal of the shorter fractured cable and the turnbuckle. The portion of locking clip was separated and bent away from the turnbuckle hole. Both threaded terminals were bent about the reduced threaded section. The end of the turnbuckle with the partially separated locking clip was deformed and partially torn and a gray-silver scrape mark extended across the length of the turnbuckle and threaded terminal as shown in figure 5. Small areas of yellow material transfer were observed along the scrape mark and a piece of foreign metallic material rich in aluminum as determined by x-ray fluorescence (XRF) spectroscopy, was observed wedged between the torn end of the turnbuckle and the bent threaded terminal. This turnbuckle was ultimately removed from the intact cable to facilitate closer examination of the fractured wires protruding from the base of the threaded terminal shank.

Figure 4: A photograph of the connection of cables 26 and 2 at turnbuckle 28. The threaded terminals on both cables exhibited bending deformation. Two broken wires were observed at the base of the cable 2 threaded terminal.

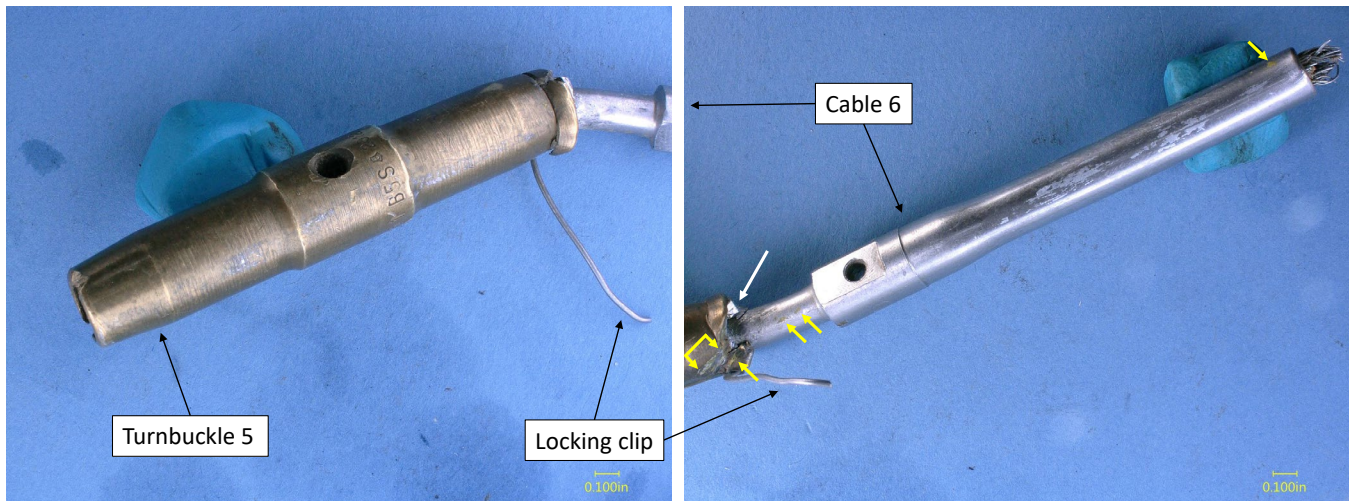
Figure 5: Digital microscope images of turnbuckle 5 (left) connected to the shorter fractured portion of cable 6 (right). A gray-silver scrape mark was observed along the span of the turnbuckle and threaded terminal. The turnbuckle was deformed and torn at the connection to cable 6 as observed in the top right area of the left image and the lower left area of the right image. A piece of aluminum rich metallic material was wedged between the damaged turnbuckle and threaded terminal as indicated by the white arrow. Yellow arrows indicate areas of yellow material transfer along the scrape mark.

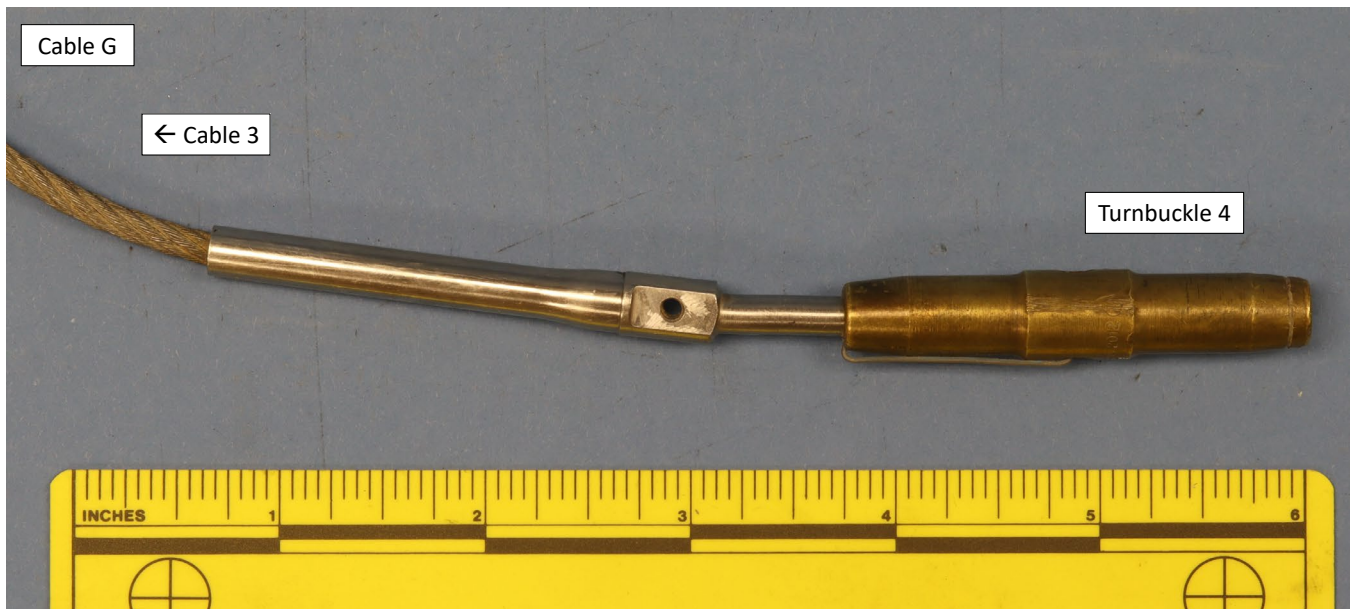
The seventh length of cable examined, labeled G in figure 1, was received later and was less greasy and more reddish brown in color especially in the vicinity of the fracture, consistent with the presence of oxidation and residual dried lubricant and soil. It consisted of a fractured cable with a threaded terminal connected to a turnbuckle. The total length of the assembly was approximately 140 inches which was consistent with cable 3 (fractured) connected to turnbuckle 4 as identified in the maintenance manual. The threaded terminal was bent about the reduced diameter threaded section as shown in figure 6 and a locking clip was present at the turnbuckle-to-threaded terminal connection.

Figure 6: A photograph of the threaded end terminal of cable 3 as received, which exhibited bending deformation.

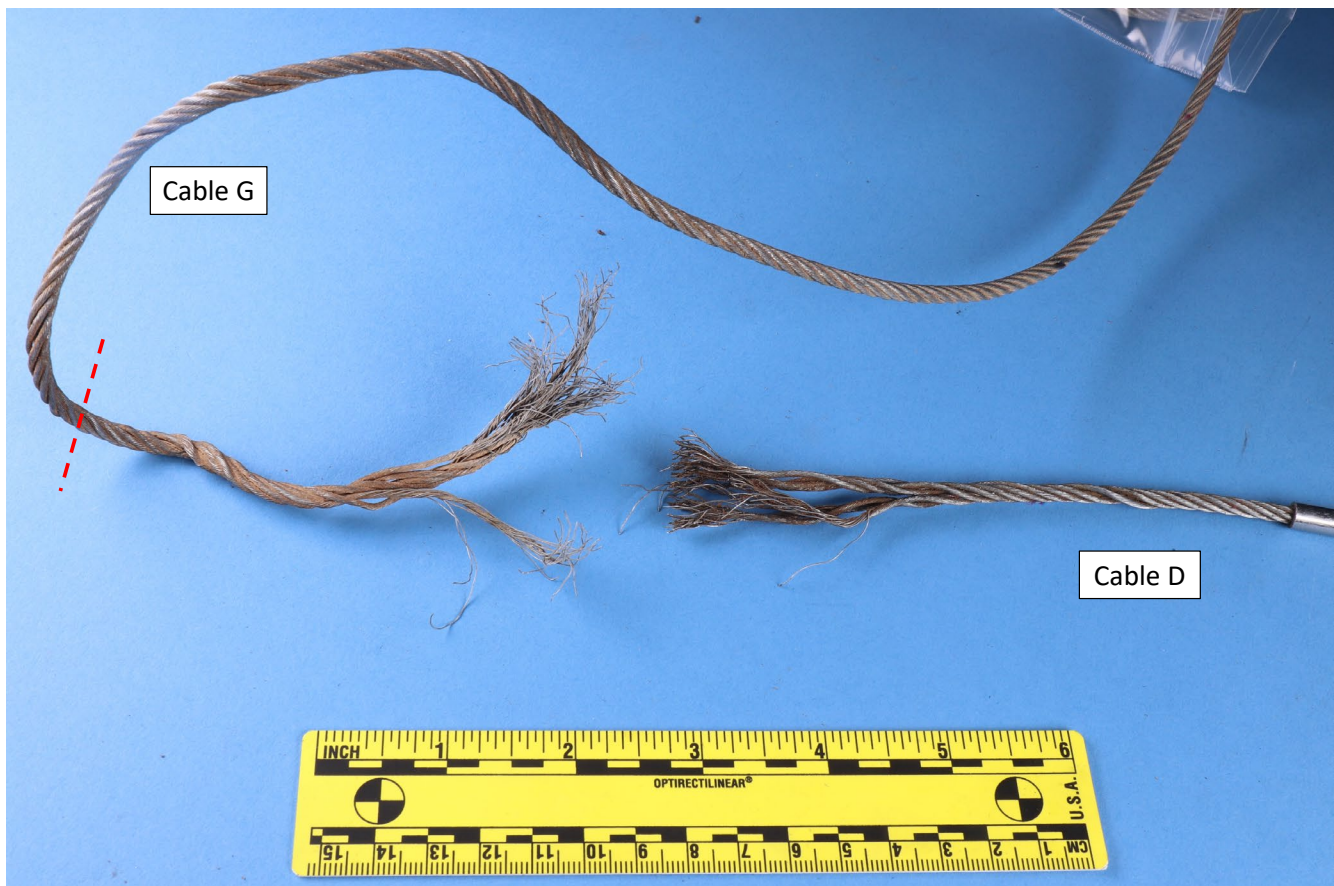
Figure 7 shows a photograph of both sides of fractured cable 3. The fracture location was approximately 9 inches from the threaded terminal connection to cable 25 at turnbuckle 27 or approximately 140 inches from the threaded terminal connection to cable 7 at turnbuckle 4 as indexed in the maintenance manual. Strands and wires were raveled and splayed open approximately 2 to 4 inches from the fracture surface, consistent with a high energy fracture event. A section was extracted from cable segment G as indicated by the red dashed line in figure 7 which was subsequently cleaned ultrasonically using acetone for closer examination. Figure 8 shows a SEM image of typical fractured wires observed on the specimen. Necking deformation, evidenced by reduced wire cross-sections, was observed preceding the fracture surfaces which were of the cup-and-cone and slant type, consistent with tensile overstress separation. Residual lubricant and general surface corrosion areas were observed as irregular rough deposits near fractured wire ends.

Figure 7: A photograph of both sides of fractured cable 3. Strands and wires were raveled and splayed open approximately 2 to 4 inches from the fracture surface. The red dashed line indicates the approximate location of a section cut made in cable G to facilitate closer exam of fractured wires using SEM.

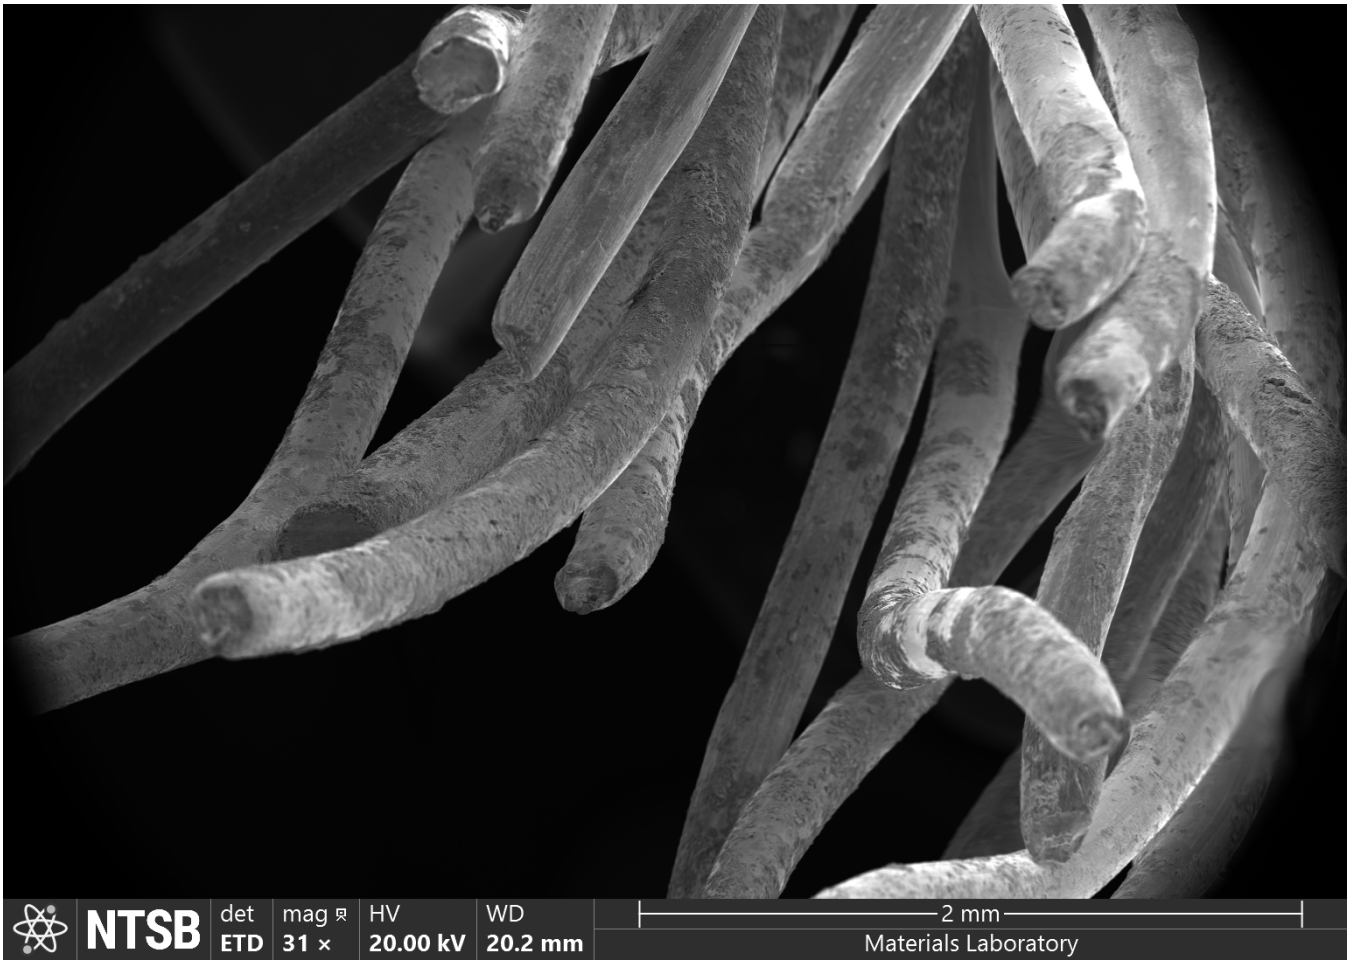
Figure 8: A secondary electron image of typical wire fracture surfaces observed in cable 3.

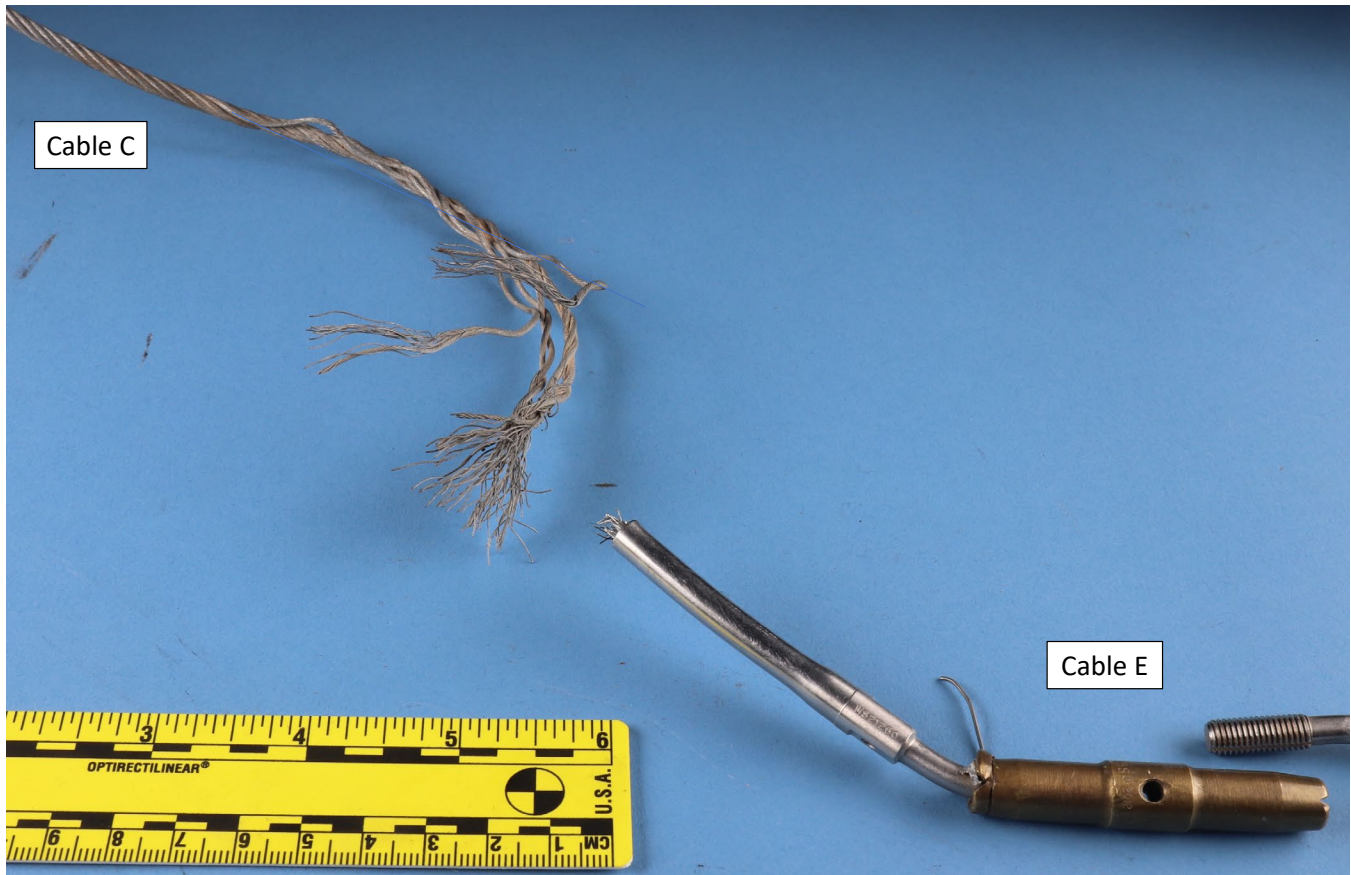
Figure 9 shows a photograph of both sides of fractured cable 6. The fracture location was approximately 270 inches from the connection to cable 33 at turnbuckle 34 which was at the base of the threaded terminal connection to cable 2 at turnbuckle 5 as indexed in the

maintenance manual. Strands and wires were raveled and splayed open approximately 7 inches from the fracture surface along the cable segment C side, consistent with a high energy fracture event. Wires were observed protruding in multiple directions from the base of the threaded terminal on the mating side of the fracture from cable segment E. The portion of cable segment E was subsequently cleaned ultrasonically using acetone for closer examination. Figure 10 shows a SEM image of typical fractured wires observed on the specimen. Necking deformation, evidenced by reduced wire cross-sections, was observed preceding the fracture surfaces which were of the cup-and-cone and slant type, consistent with tensile overstress separation.

Figure 9: A photograph of both sides of fractured cable 6. Strands and wires were raveled and splayed open approximately 7 inches from the fracture surface along cable segment C. Wires were observed protruding in multiple directions from the base of the threaded terminal from cable segment E.

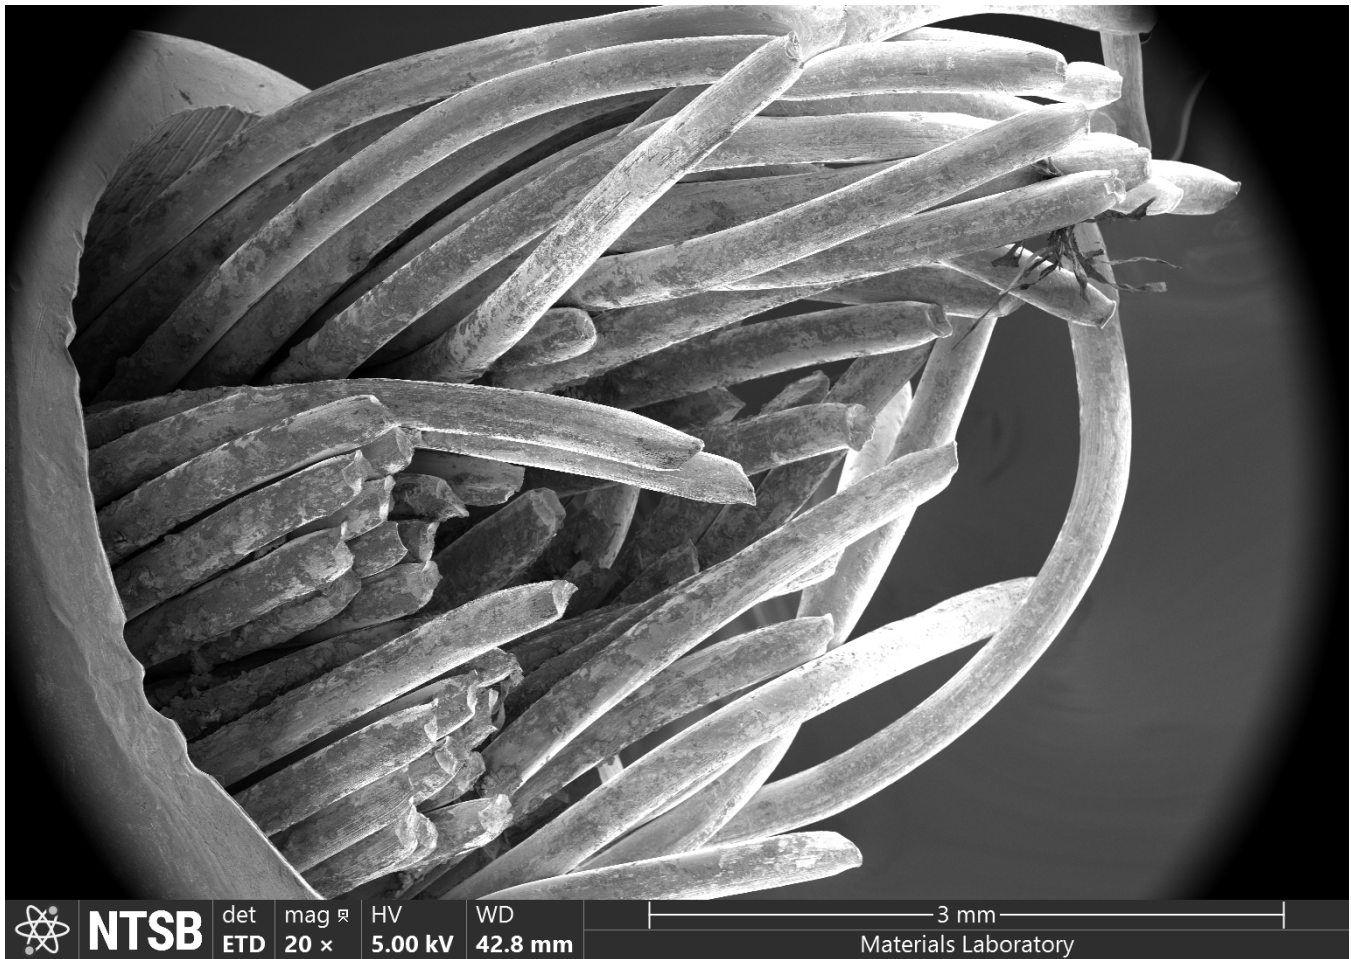
Figure 10: A secondary electron image of typical wire fracture surfaces observed in cable 6.

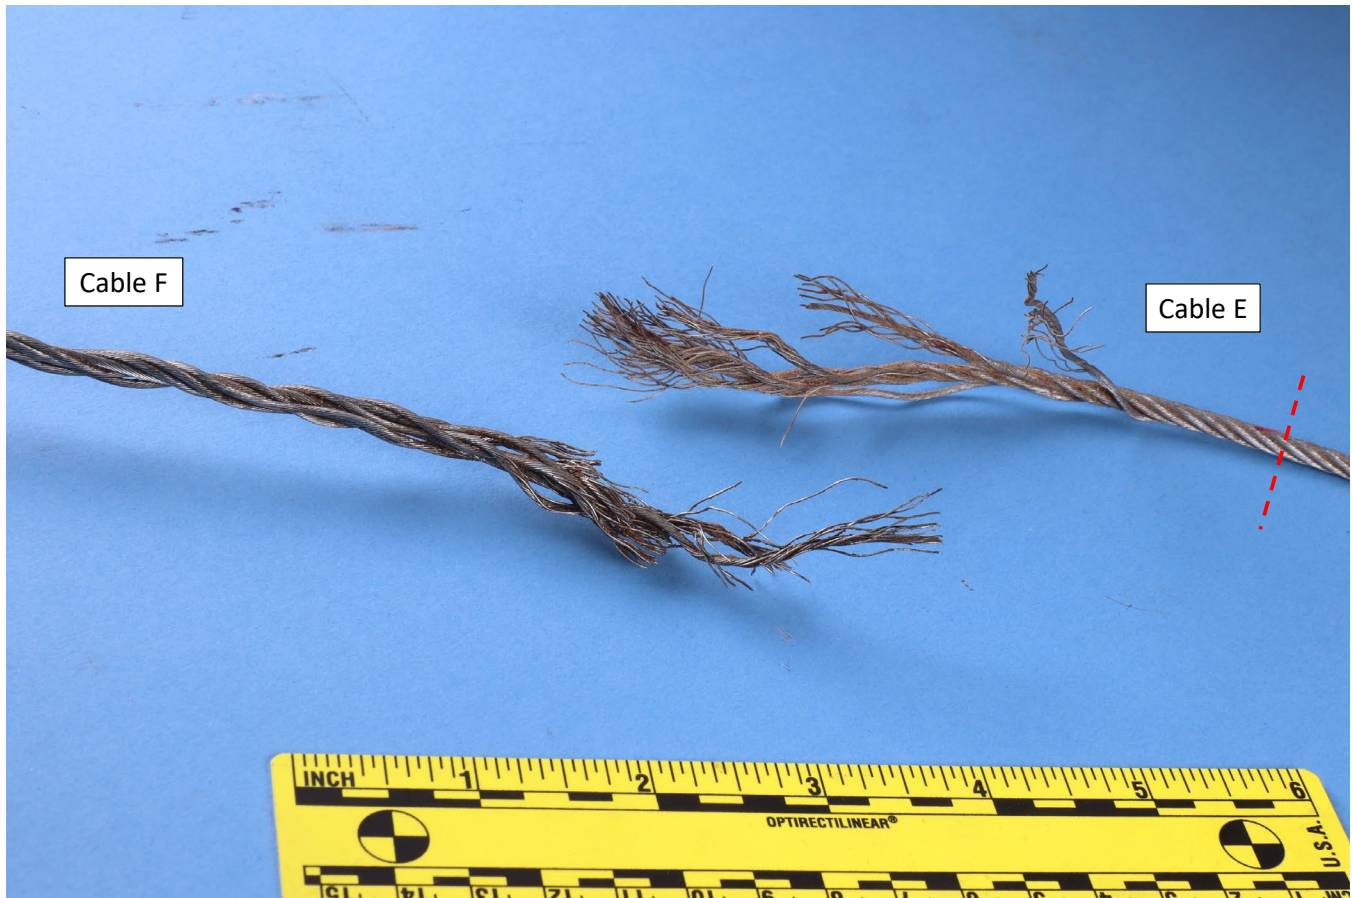
Figure 11 shows a photograph of both sides of fractured cable 26. The fracture location was approximately 140 inches from the ball end terminal (approximately 18 inches from the connection to cable 2 at turnbuckle 28) as indexed in the maintenance manual. Strands and wires were raveled and splayed open approximately 4 to 6 inches from the fracture surface, consistent with a high energy fracture event. A section was extracted from cable segment E as indicated by the red dashed line in figure 11 which was subsequently cleaned ultrasonically using acetone for closer examination. Figure 12 shows a backscattered electron (BSE) image from SEM examination of typical fractured wires observed on the specimen. Necking deformation, evidenced by reduced wire cross-sections, was observed preceding the fracture surfaces which were of the cup-and-cone and slant type, consistent with tensile overstress separation. Residual lubricant and general surface corrosion areas were observed as irregular rough deposits near fractured wire ends.

Figure 11: A photograph of both sides of fractured cable 26. Strands and wires were raveled and splayed open approximately 4 to 6 inches from the fracture surface. The red dashed line indicates the approximate location of a section cut made in cable E to facilitate closer exam of fractured wires using SEM.

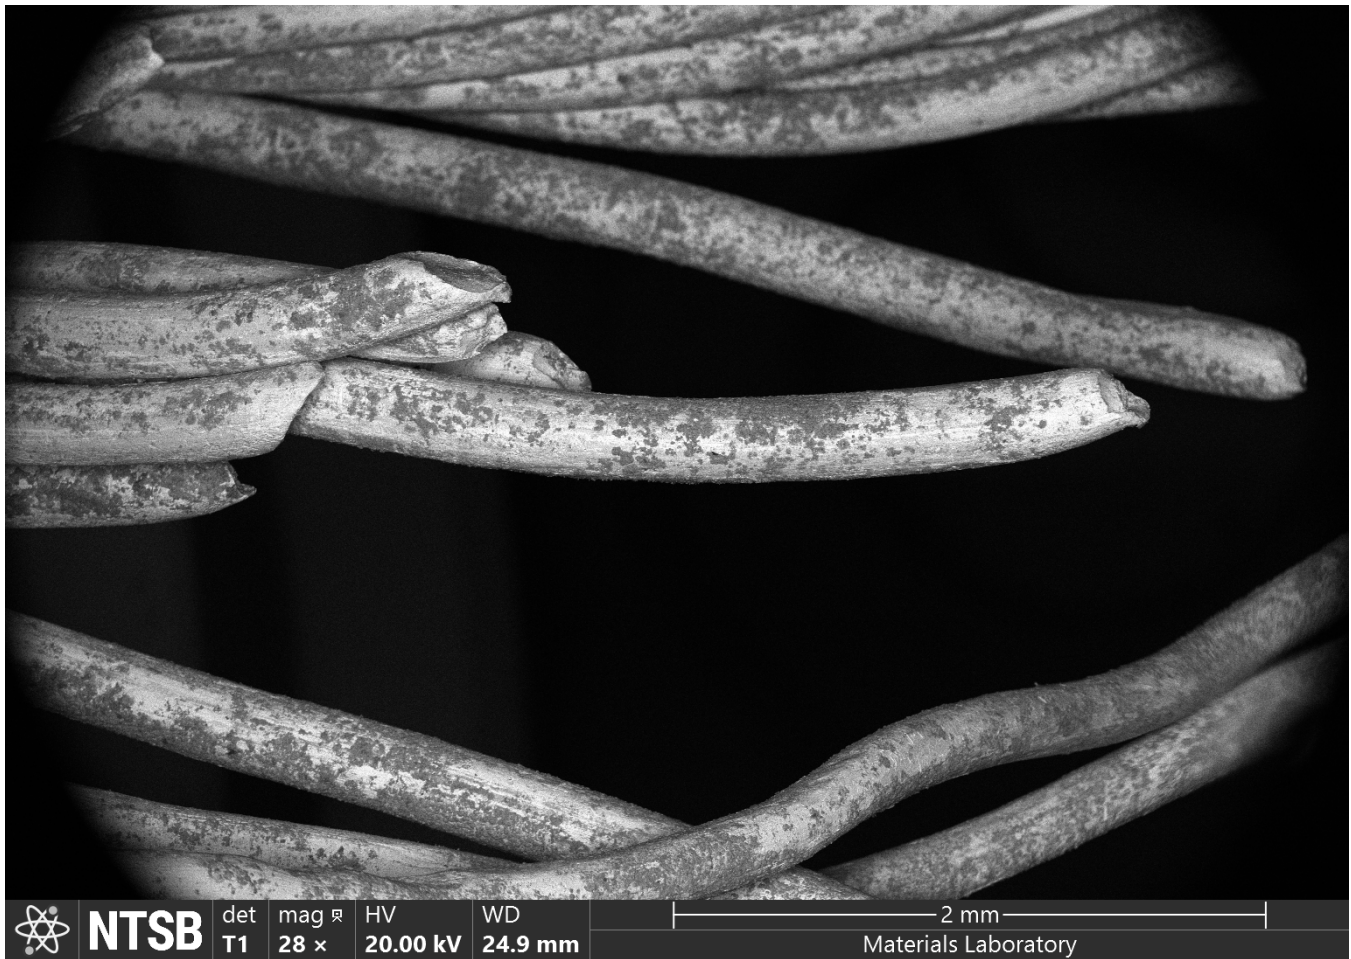
Figure 12: A backscattered electron image of typical wire fracture surfaces observed in cable 26.

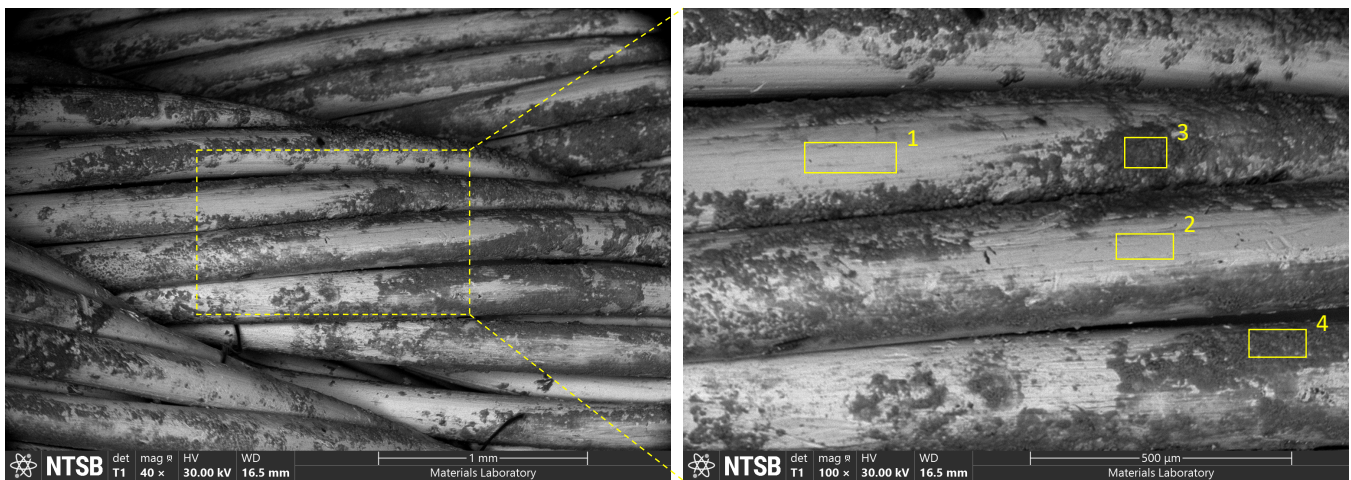
A section from cable G preceding the fracture and raveled strands was extracted for closer examination. The resulting specimen was cleaned using soapy water, a soft bristled brush, and ultrasonic agitation followed by acetone with ultrasonic agitation. A SEM supplemented with EDS was used to examine the composition of the cleaned specimen. Figure 13 shows BSE images of the specimen. The bright gray areas as viewed using a BSE detector correspond to elemental compositions with higher atomic weight such as iron and zinc where darker gray areas indicate the presence of lighter elements. Light gray areas of wire appeared smoother and more uniform where darker areas appeared as rough irregular shaped deposits on the surface of the wires. EDS spectra were acquired at the locations identified by solid yellow boxes in the right image of figure 13. Figure 14 shows the spectra acquired at locations 2 and 3 as identified in figure 13. Locations 1 and 2 (smooth light gray areas) were similar in composition to each other and showed major peaks of iron with minor peaks of zinc and other common alloying elements in steel and was consistent with galvanized steel. Locations 3 and 4 (rough dark gray deposits) were similar in composition, and relative to locations 1 and 2, showed a significantly lower concentration of iron and significantly higher concentrations of oxygen, zinc, phosphorus, and silicon consistent with galvanic corrosion product and residual lubricant and soil. No appreciable reduction in cross section was observed in the strands of wire.

Figure 13: A backscattered electron image of a specimen extracted from cable G which preceded the fracture location. The image on the right is a closer view of the area highlighted by a dashed yellow box. The numbered solid yellow boxes on the right image indicate locations where EDS spectra were acquired.

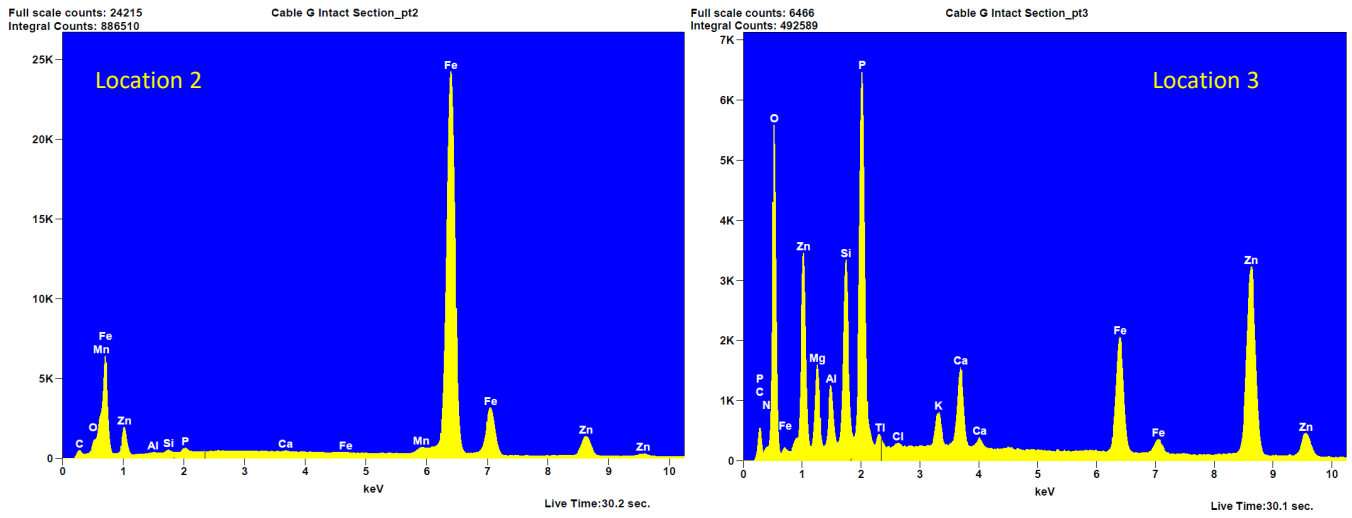
Figure 14: EDS spectra acquired from locations 2 (left) and 3 (right) as identified in the previous figure.
