# NATIONAL TRANSPORTATION SAFETY BOARD

## MATERIALS LABORATORY FACTUAL REPORT

Report No. 21-066

Place : York, Pennsylvania  
Date : December 30, 2020  
Vehicle : Piper PA-46R-350T, N463ST  
NTSB No. : ERA21LA238  
Investigator : Ralph Hicks, AS-ERA

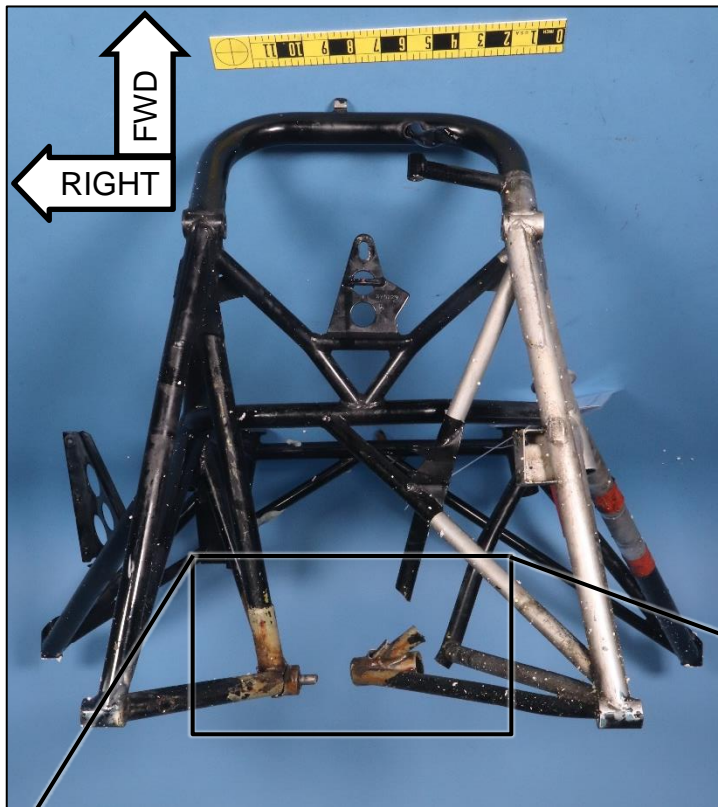
An overall view of the lower side of the submitted engine mount as received is shown in figure 1, and closer views of the nose landing gear (NLG) actuator attachment feet are shown in figures 1 (lower image) and 2. On the left side, several tubes near the NLG actuator attachment foot were bent and had been cut, and one tube was fractured near its weld to the attachment foot. On the right side, the NLG attachment foot was fractured at the toe of the support tube welds on the upper and forward sides of the foot and through the lower support tube on the underside of the foot. Portions of the fracture around the right attachment foot were covered with resolidified metal deposits.

Figure 1. Overall view of the lower side of the engine mount (left) with a closer view of the NLG actuator attachment feet (below).

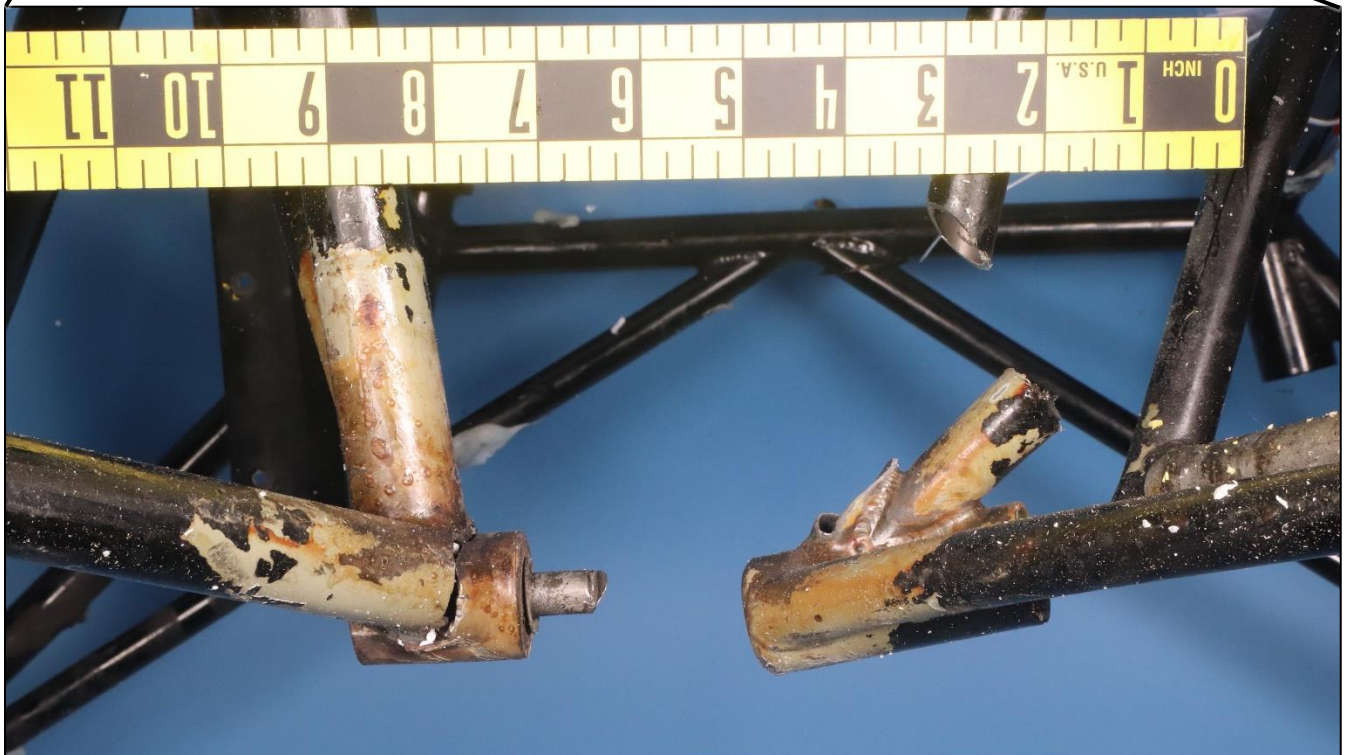
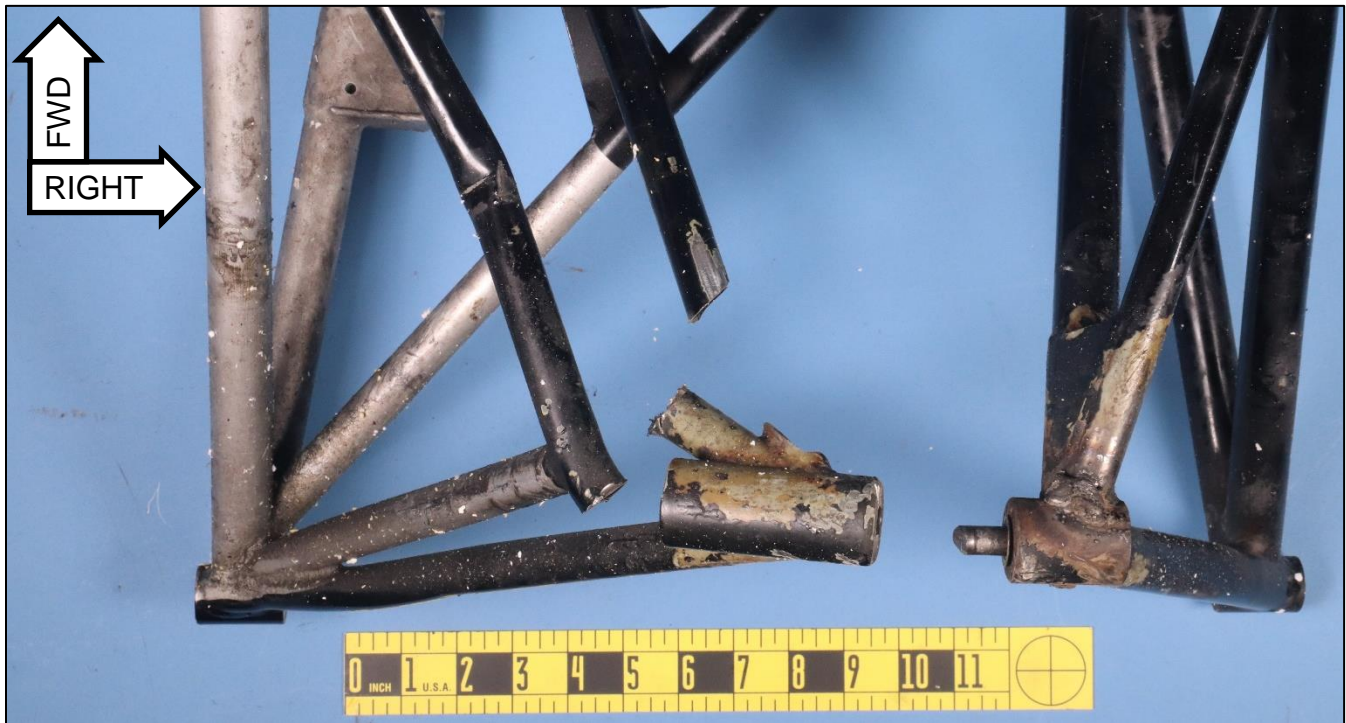
Paint and primer had been removed from areas around the NLG actuator attachment feet, exposing the underlying metal surface mostly on the forward and lower sides around the welds. A translucent brown coating was observed covering the exposed metal, primer, and paint around the NLG actuator attachment feet. Engine mount inspections described in Piper Service Bulletin (SB) 1103F<sup>1</sup> require removal of coatings on the NLG actuator attachment feet and 1 to 3 inches of the adjacent tubes to conduct fluorescent penetrant inspections for cracks. If no crack indications are found, SB 1103F states the area where paint was removed is to be cleaned and coated with Dinitrol/Ardrox AV8 followed by Dinitrol/Ardrox AV30 corrosion prevention compound.

Figure 2. NLG actuator attachment feet as viewed from above.

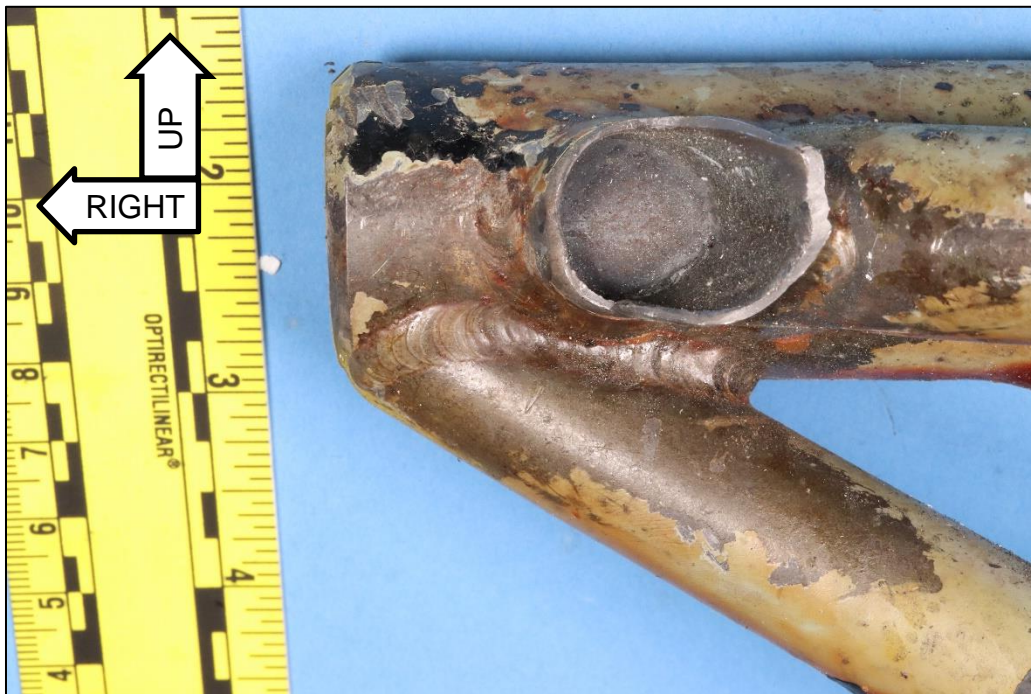
A close view of the forward face of the left NLG actuator attachment foot is shown in figure 3. The tube welded to the forward face was fractured adjacent to the weld. The fracture surface appeared light gray and was on slant angles, features consistent with ductile overstress fracture.

Figure 3. Left NLG actuator attachment foot as viewed looking aft.

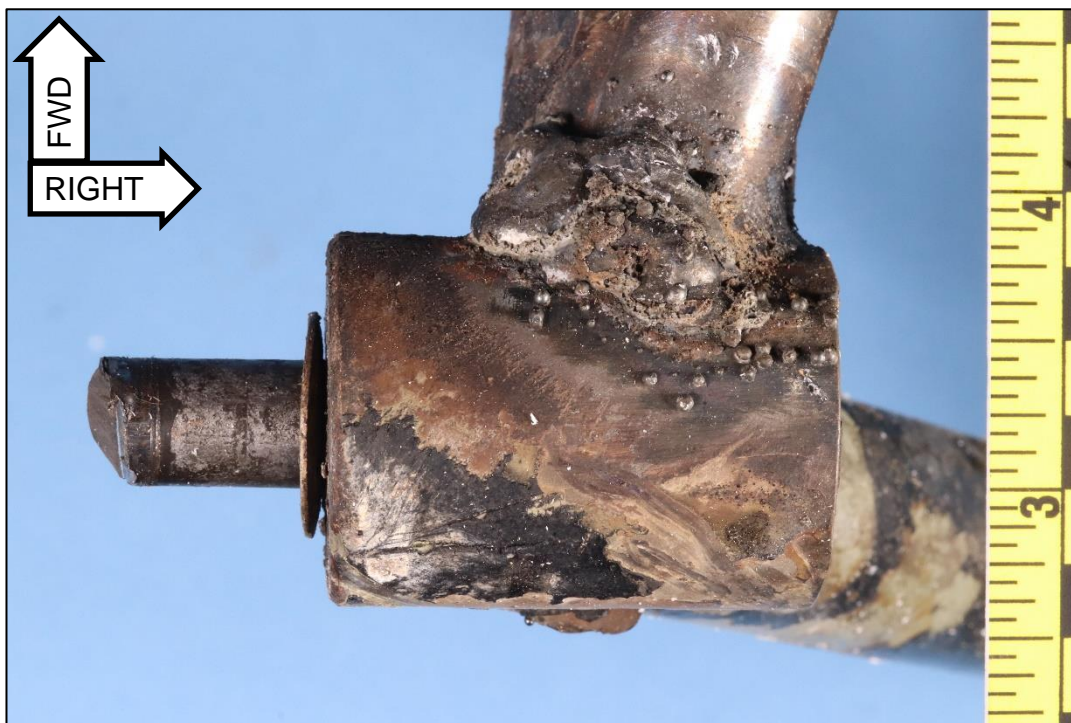
Close views of the right NLG actuator attachment foot are shown in figures 4 and 5. Deposits of resolidified pools of molten metal were observed on the upper side shown in figure 4 and on the interior surface shown in figure 5. The areas around the deposits were tinted brown and black consistent with local heating produced by a welding process. The crack in the foot was gaped open, and weld metal deposits spanned and filled the space between the crack faces. Smaller beads of resolidified metal consistent with weld spatter were observed fused to adjacent surfaces, including exposed crack faces.

Figure 4. Upper side of the right NLG actuator attachment foot.

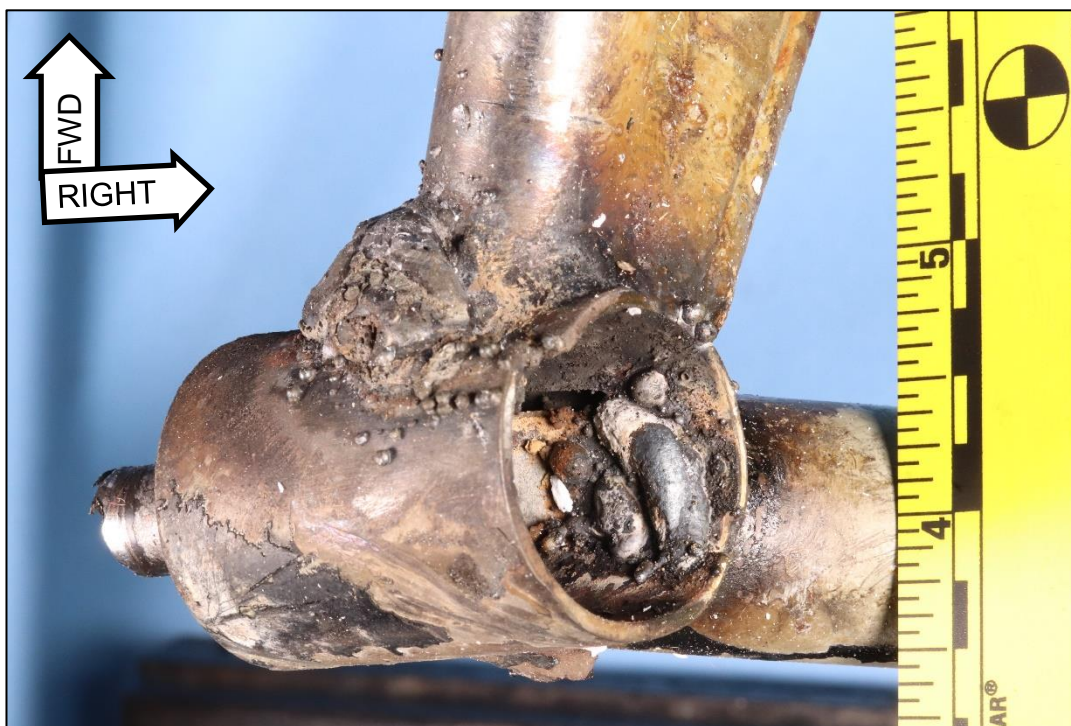
Figure 5. Oblique view showing the upper and interior surfaces of the right NLG actuator attachment foot.

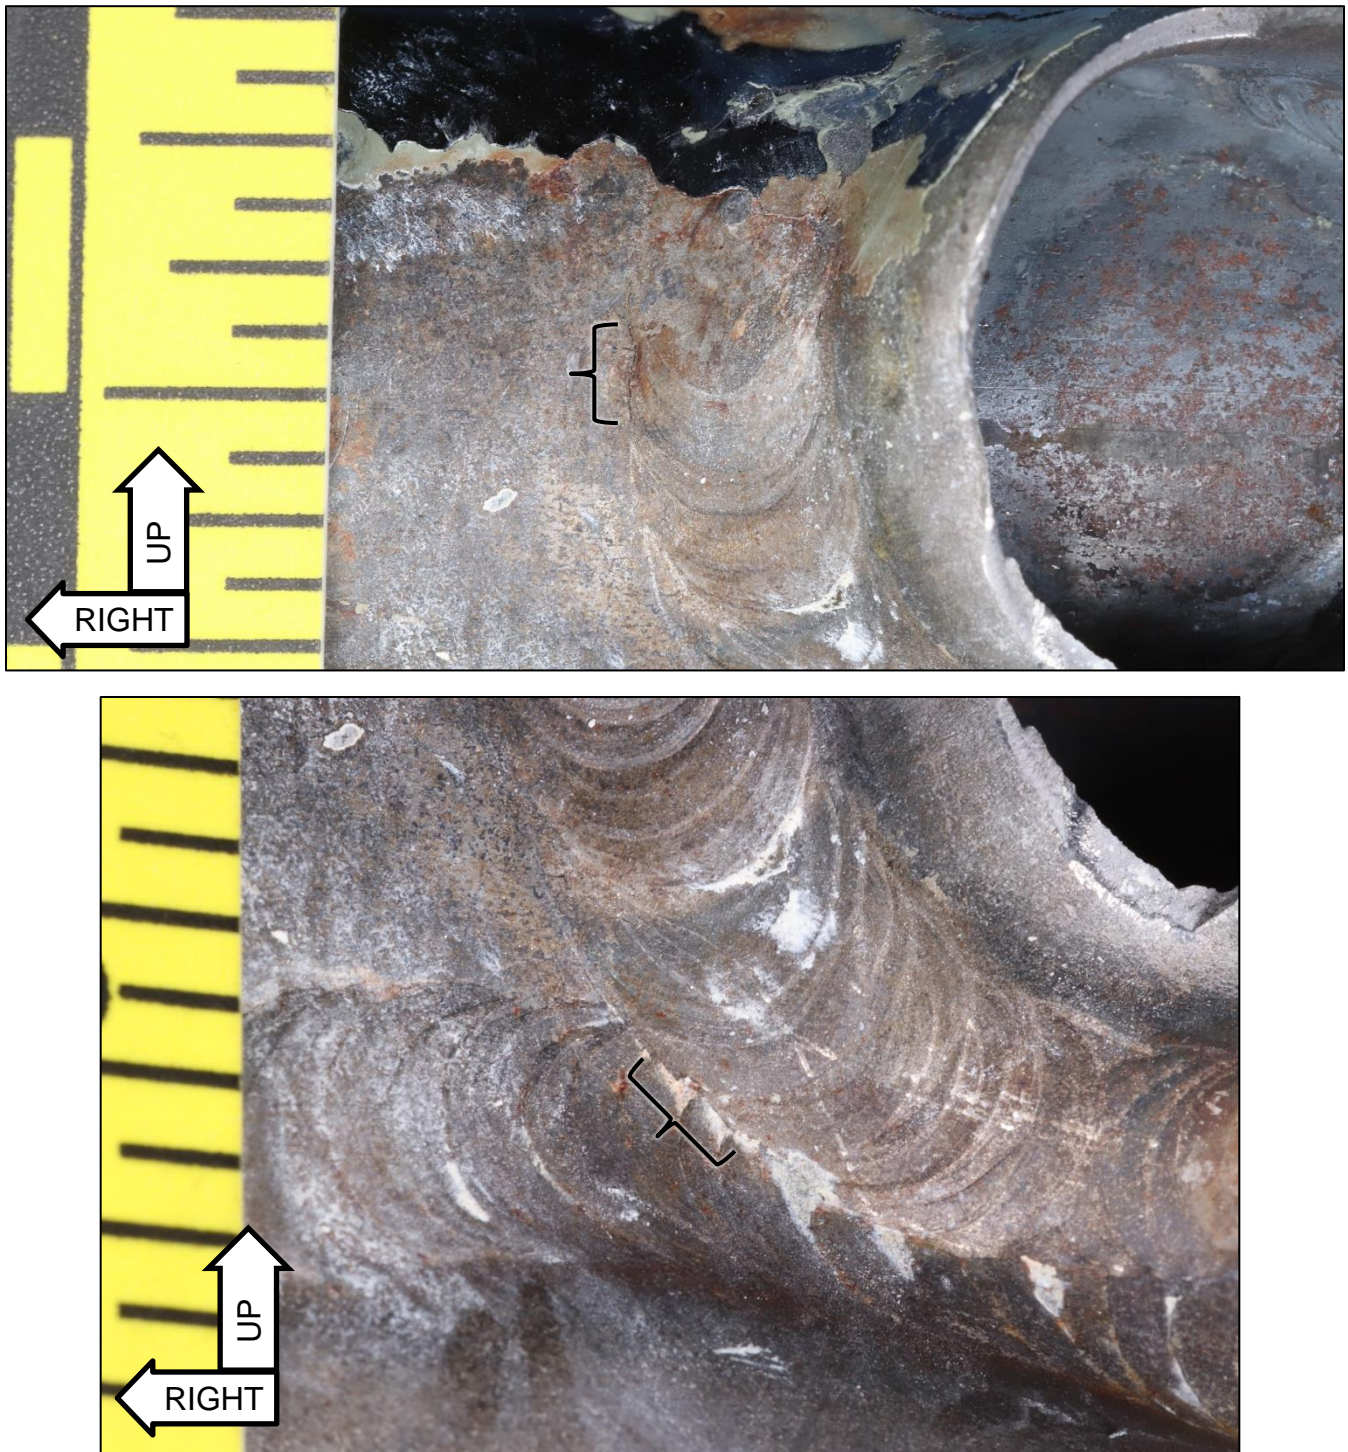
To facilitate a closer examination of the NLG actuator attachment feet, the engine mount tubes were cut several inches away from the feet to separate the feet from the remainder engine mount. The feet were soaked in mineral spirits, and surfaces were lightly brushed with a soft-bristle brush to remove the corrosion prevention compound. Views of the attachment feet after cleaning with mineral spirits are shown in figures 6 and 7. The cleaned surfaces were examined using an optical stereomicroscope, and crack indications were observed at the toe of the weld on the left foot as indicated with brackets in figure 6.

Figure 6. Forward face of the left NLG actuator attachment foot after cleaning with mineral spirits showing crack indications at the weld toe (locations marked with unlabeled brackets) as detected using an optical stereomicroscope.

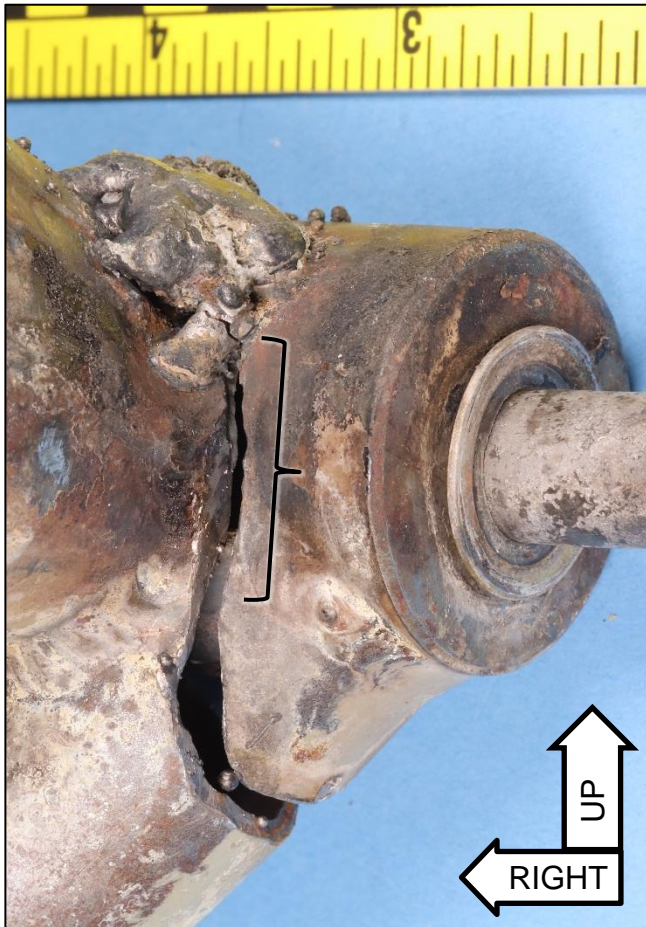
Figure 7. Right NLG actuator attachment foot after cleaning with mineral spirits as viewed looking aft. An unlabeled bracket indicates the fracture surface shown in figure 8.

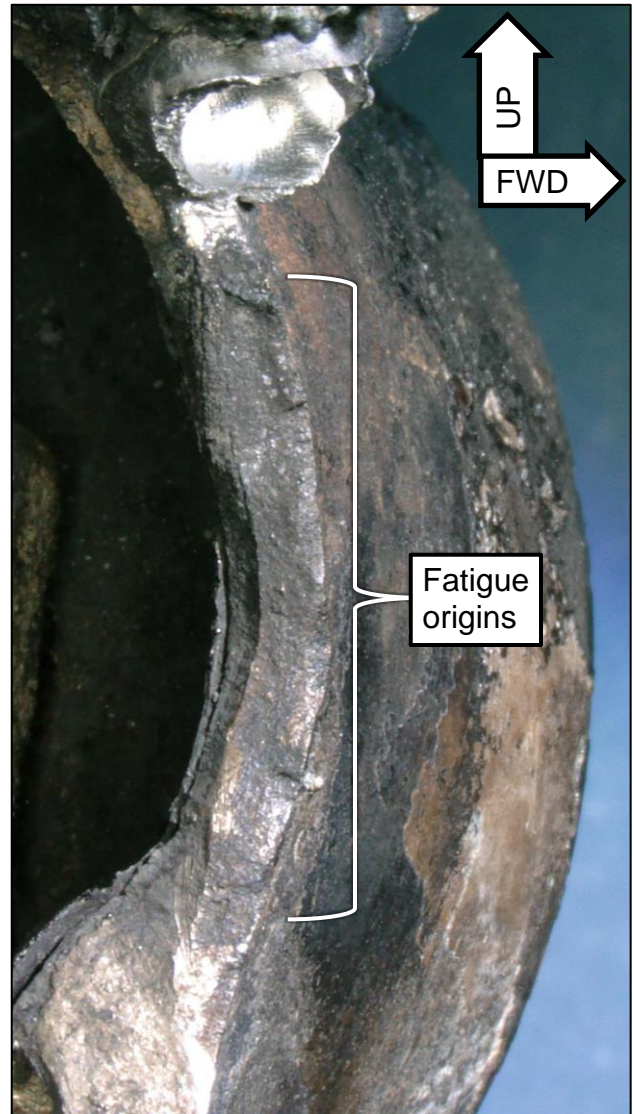
The attachment bolt shank extending from the right NLG actuator attachment foot was placed in a vice, and the weld deposits were fractured by hand forces applied to the attached structural tube segments. Most of the fracture surfaces were obscured or obliterated by the post-fracture weld process or heavy recontact damage. However, an area of relatively flat fracture features in planes perpendicular to the forward surface and separated by ratchet marks<sup>2</sup> were observed on the forward side of the right NLG actuator attachment foot, features consistent with fatigue fracture. The fracture surface was covered with oxidation. To further examine the fracture surface, the foot piece was immersed in Evapo-Rust<sup>3</sup> for approximately 20 minutes followed by lightly brushing the surface with a soft-bristle brush. The resulting fracture surface on the forward side of the right NLG actuator attachment foot is shown in figure 8. Curving crack arrest lines consistent with a fatigue fracture were observed. The fatigue initiated from multiple origins at the forward side of the foot as indicated with a bracket in figure 8.

Figure 8. Fracture surface on the forward side of the right NLG actuator attachment foot after cleaning and oxide removal.
