# NATIONAL TRANSPORTATION SAFETY BOARD

MATERIALS LABORATORY FACTUAL REPORT

Report No. 21-068

Place : ANC21LA064  
Date : July 23, 2021  
Vehicle : Piper PA-14, N4206H  
NTSB No. : ANC21LA064  
Investigator : Shaun Williams, AS-WPR

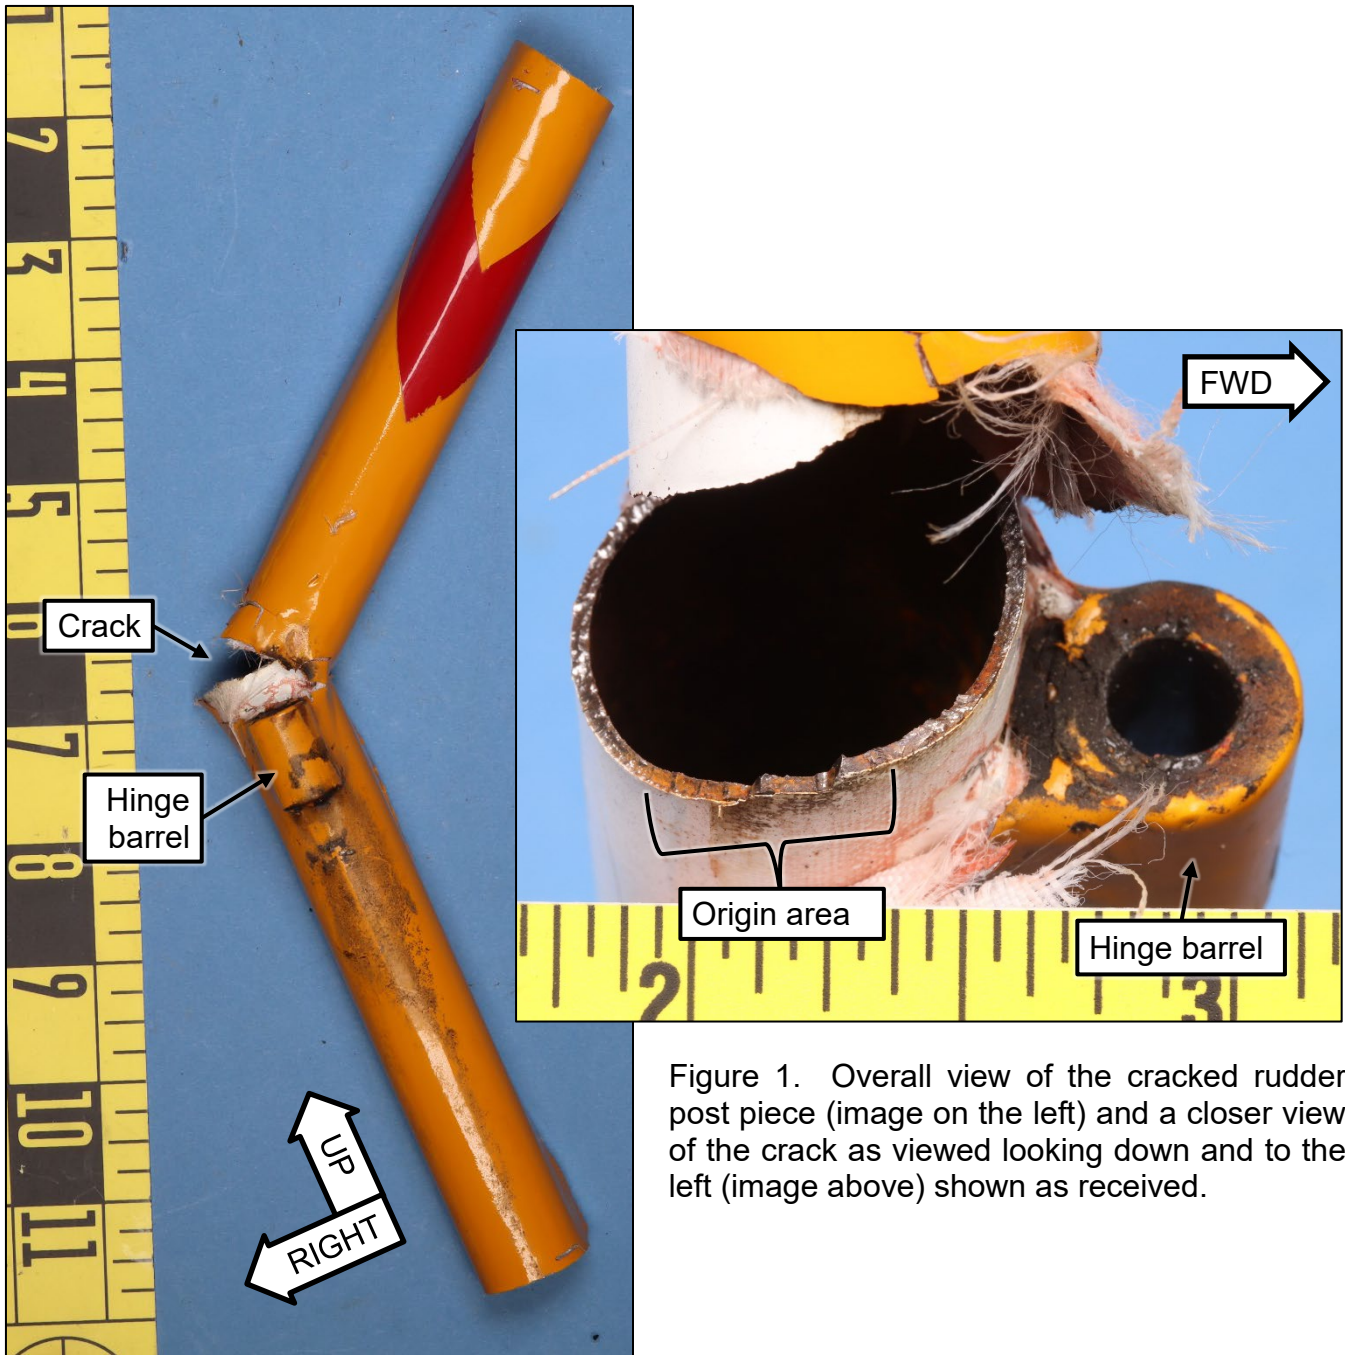
An overall view of the submitted rudder post piece is shown in figure 1. The rudder post was cracked approximately  $\frac{1}{4}$  inch above the upper hinge barrel. The crack extended around most of the circumference, and the upper portion of the post was bent to the left relative to the lower portion, thereby separating the crack faces at the right side. The cracked post section had been cut from the remainder of the rudder to facilitate shipment to the NTSB Materials Laboratory.

On the right side of the post, the fracture surfaces were on flat planes perpendicular to the longitudinal axis, features consistent with fatigue. Step-like features (ratchet marks) were observed between offset planes consistent with multiple origins at the outer diameter along the right side in the bracketed area shown in figure 1.

Figure 1. Overall view of the cracked rudder post piece (image on the left) and a closer view of the crack as viewed looking down and to the left (image above) shown as received.

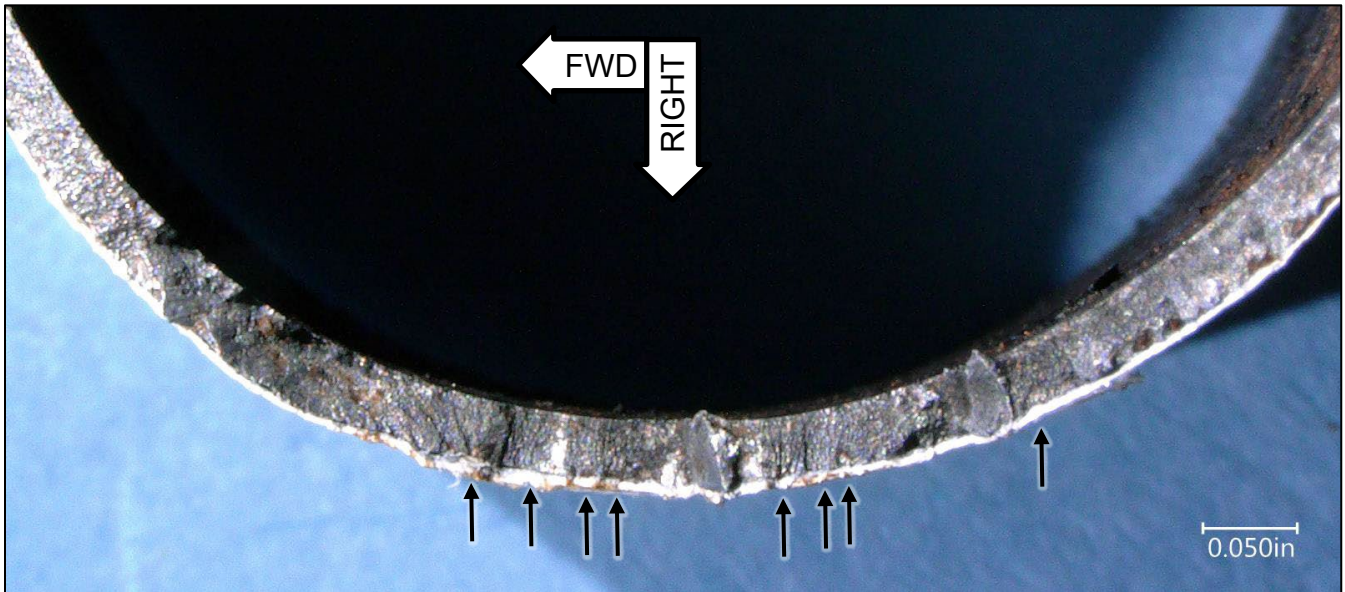
To further examine the fracture surfaces, the remaining ligament of bent tube wall on the left side of the post was fractured in the lab by overstress bending to complete the separation of the two sides of the crack. The rudder skin on the upper piece was then peeled away from the post. Next, a transverse cut was made through the upper piece approximately 1 inch away from the fracture surface. The piece with the upper side of the fracture was then submerged in Evapo-Rust<sup>1</sup> for approximately 15 minutes followed by light brushing of the surface using a soft-bristle brush dipped in Evapo-Rust. The resulting fracture surface is shown in figure 2. Radial features with crack arrest lines were observed consistent with fatigue from multiple origins at the outer diameter as indicated by unlabeled arrows in figure 2.

Figure 2. Upper side of the crack surface after the fracture surfaces were deoxidized. Unlabeled arrows point to multiple origins at the outer diameter on the right side.

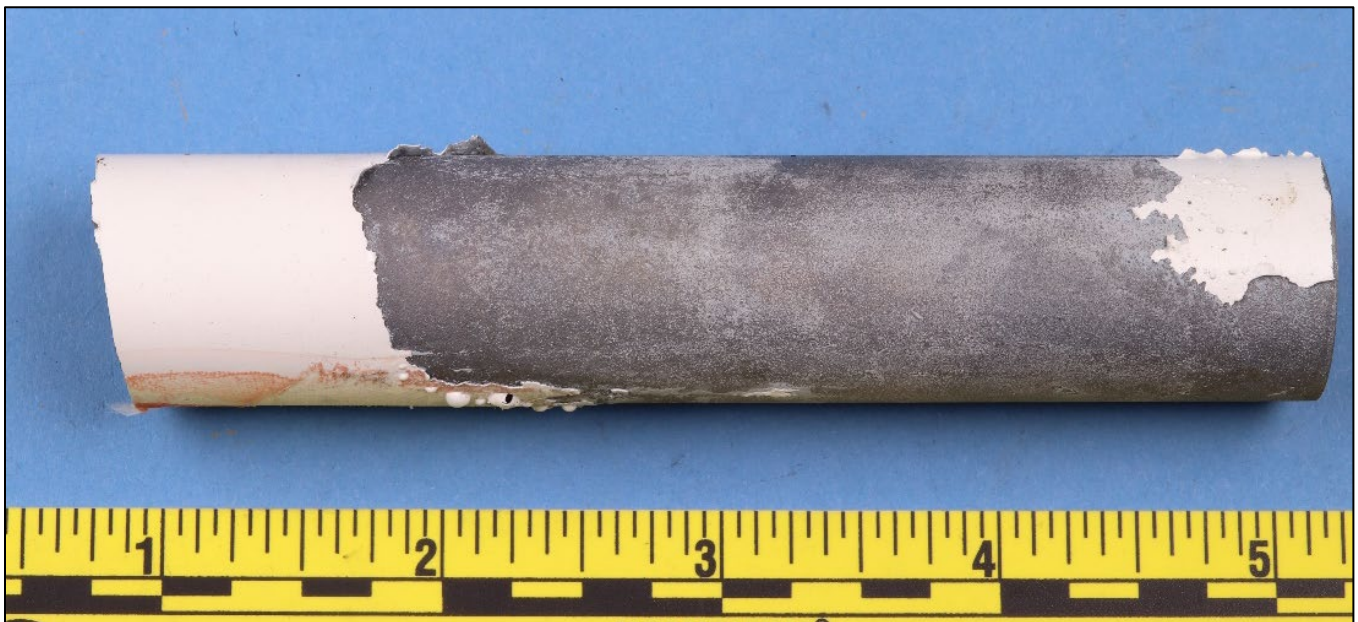
Next, the two pieces of the cut upper portion of the post segment were soaked in Cee Bee A-202 epoxy and polyurethane stripper,<sup>2</sup> and the coatings were scraped away using wood and plastic scrapers. The resulting exposed metal surface on the upper cut piece is shown in figure 3. The surface had a uniform gray appearance with a surface finish consistent with a grit-blasted surface.

In the stripped area on the upper piece shown in figure 3, the thickness of the tube wall measured 0.0350 inch, and the outer diameter measured 0.871 inch. According to engineering drawings for the part number 40622-3 rudder post, the tube for the rudder post was specified as a 7/8-inch tube with a wall thickness of 0.035 inch.

One side of the upper rudder post piece shown in figure 3 was sanded with 240-grit abrasive paper to expose material below the grit-blasted surface, and the sanded area was then ground to a 600-grit finish. The sanded area was then tested using a Rockwell hardness indenter. Initial tests using the HRB scale were invalid due to the thickness of the wall and resulted in visible deformation around the indentation. Next, a nearby area was tested using the HR30T scale. The resulting measured hardness was

Figure 3. Upper post section after paint and primer were stripped from the surface.

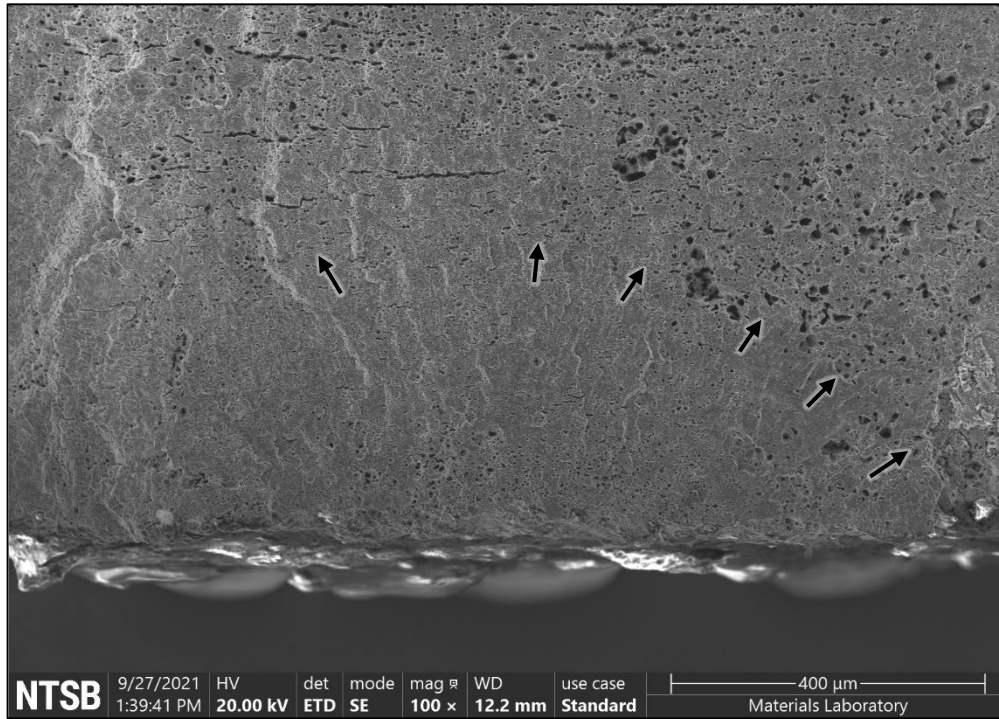
The piece with the upper side of the fracture was further examined using a scanning electron microscope (SEM). Multiple fatigue origins were identified on the right side including the area shown in figure 4. The fatigue originated from corrosion pits on the exterior surface such as the pit shown in figure 5. Sizes of corrosion pits were measured at two of the fatigue origins. The pit shown in figure 5 measured 0.0119 inch (302 micrometers) wide and 0.0014 inch (35 micrometers) deep. At a nearby origin area, a pit at that fatigue origin measured 0.0131 inch (332 micrometers) wide and 0.0018 inch (45 micrometers) deep.

Figure 4. SEM image of one of the fatigue origin areas. Unlabeled arrows indicate a crack arrest line partially visible on the surface.

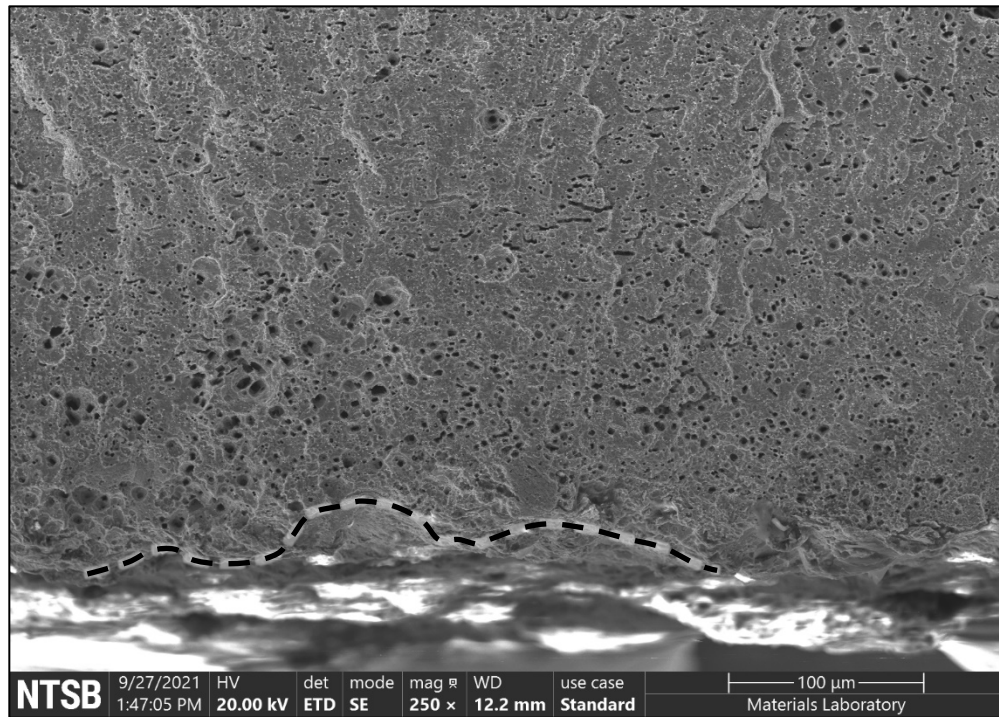
Figure 5. SEM image of the origin area at higher magnification showing a corrosion pit at the origin. A dashed line indicates the pit boundary.

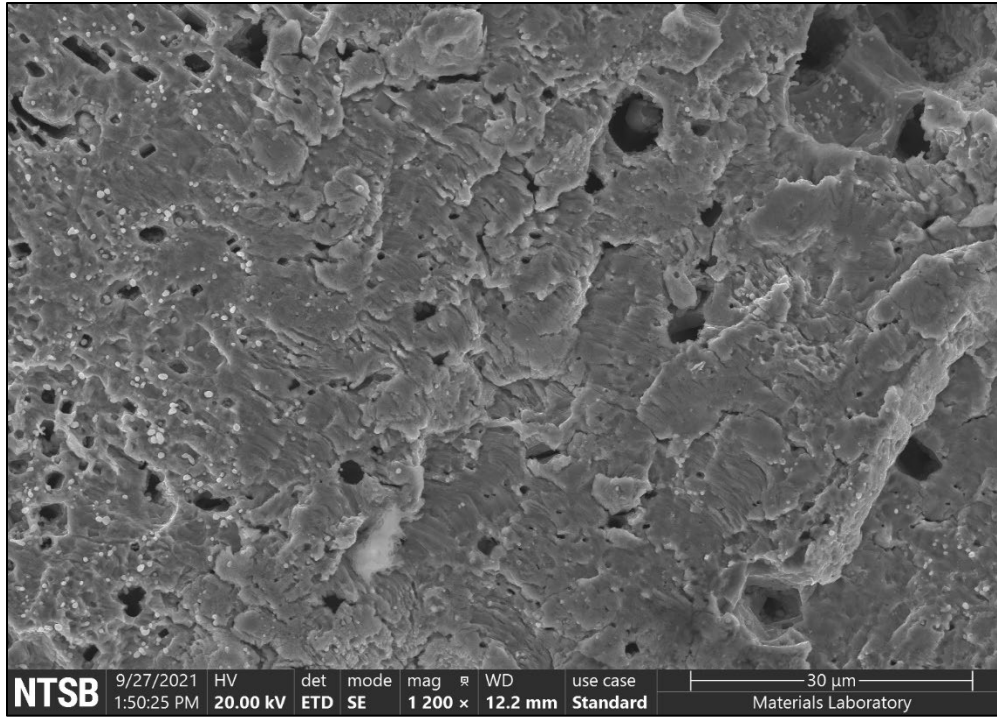
The fracture surface showed damage including rubbing and pitting damage in the fatigue regions. However, fatigue striations were observed in undamaged areas such as the area shown in figure 6, which was imaged near the crack arrest line shown in figure 4. Fatigue fracture features were identified around approximately  $\frac{1}{4}$  of the circumference on the right side, but the total extent of fatigue cracking could not be determined conclusively due to post-fracture contact damage on the surfaces.

Figure 6. SEM image of fatigue features near the crack arrest line shown in figure 4.

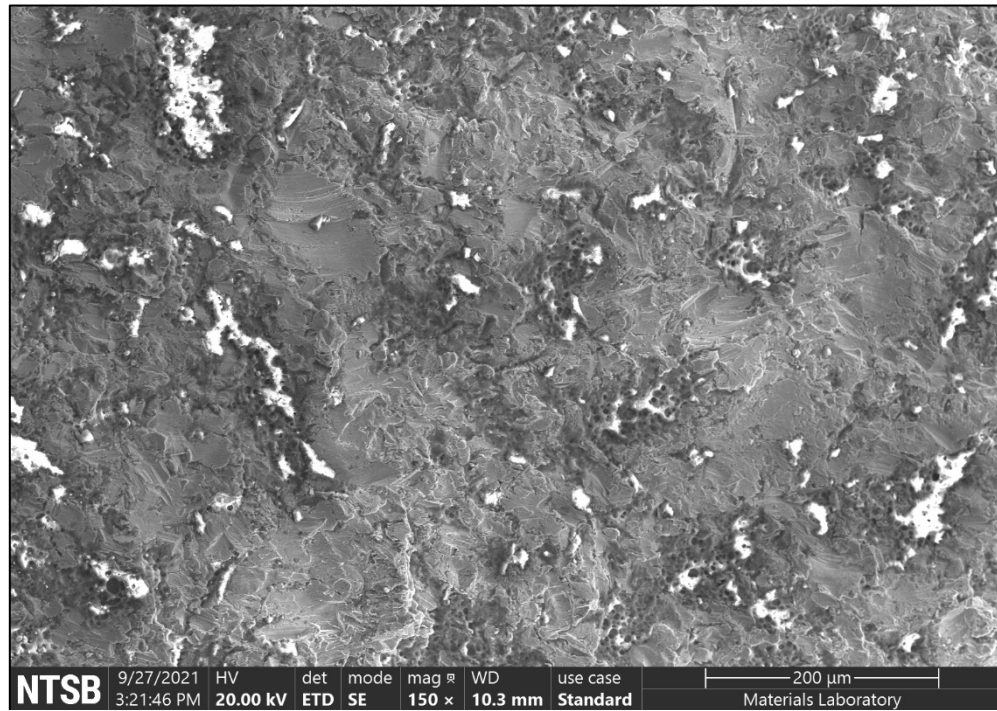
The exterior surface adjacent to the fracture was also examined using the SEM, and a typical view of the exterior surface is shown in figure 7. Pockets of primer material remained on the surface, appearing both darker gray and bright white in figure 7.<sup>3</sup> Upon closer examination, faceted particles such as the one shown in figure 8 were observed embedded in the surface. The particles were analyzed using energy dispersive x-ray spectroscopy (EDS), and the resulting spectra showed high peaks of magnesium, silicon, and oxygen with smaller peaks of carbon, aluminum, calcium, and iron, consistent with olivine abrasive blasting media.

Figure 7. SEM image of the external surface on the post showing pockets of primer on the grit-blasted surface.

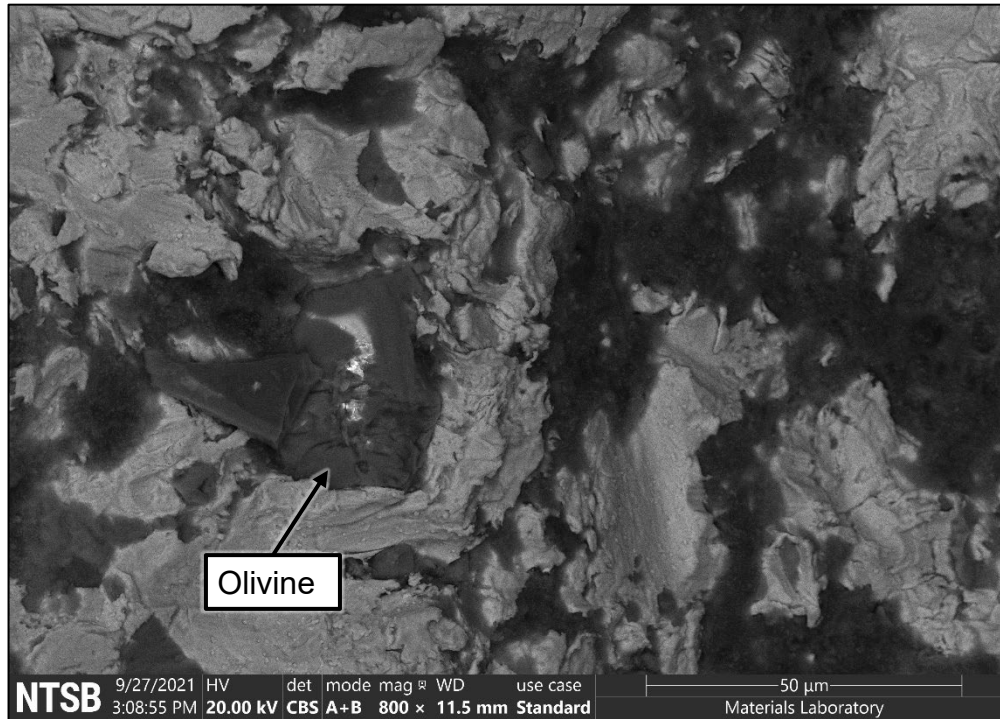
Figure 8. SEM image using a backscattered electron detector showing a particle having a composition consistent with olivine embedded in the surface.
