NATIONAL TRANSPORTATION SAFETY BOARD

MATERIALS LABORATORY FACTUAL REPORT

Report No. 21-073

Place : Thonotosassa, Florida
Date : February 9, 2021
Vehicle : Vans RV7, N611E
NTSB No. : ERA21LA127
Investigator : Brian Rayner, AS-ERA

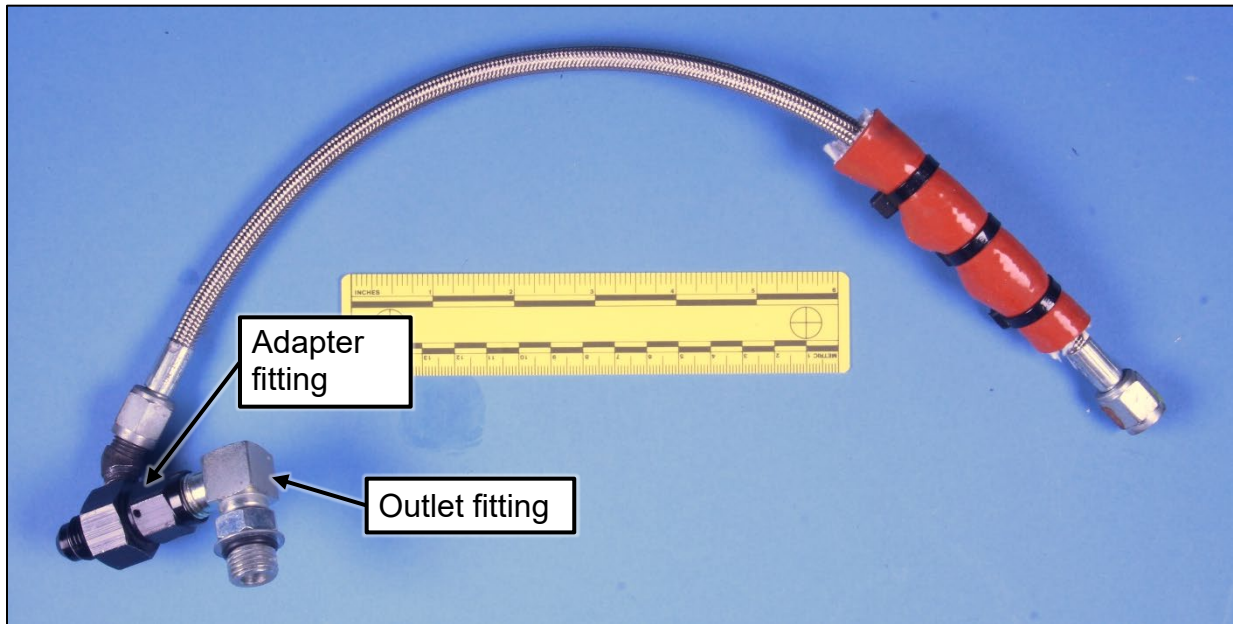
An overall view of the submitted hose and fitting assembly is shown in figure 1. The 90-degree outlet fitting had been attached to the fuel pump outlet, and the fuel pressure adapter fitting is shown attached to the outlet fitting. A 45-degree fitting and hose are shown attached to the fuel pressure outlet on the side of the adapter fitting. The adapter fitting and outlet fitting were found separated after the accident and were subsequently reassembled and tested before submission to the NTSB Materials Laboratory. During testing, the adapter fitting was reportedly torqued to 150 pound-inches.

Figure 1. Overall view of the submitted fuel line fittings and hose.

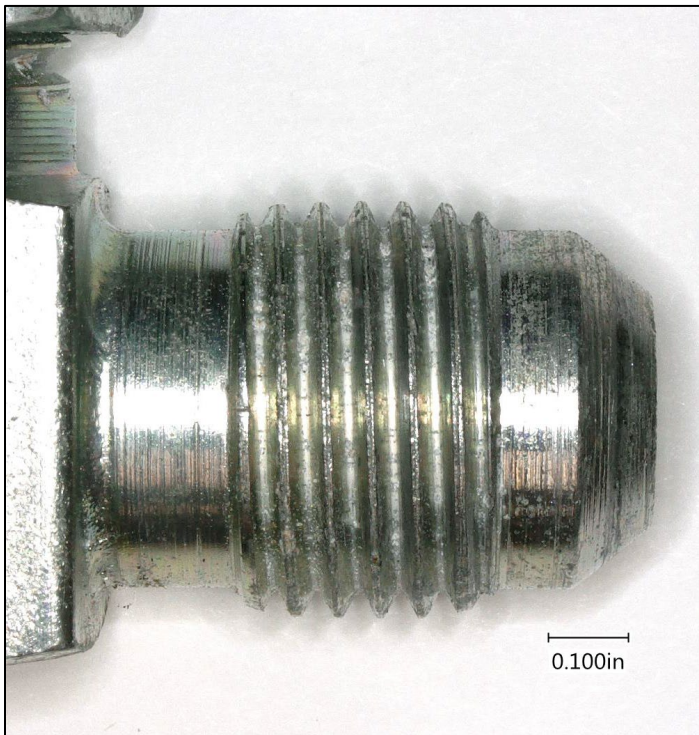
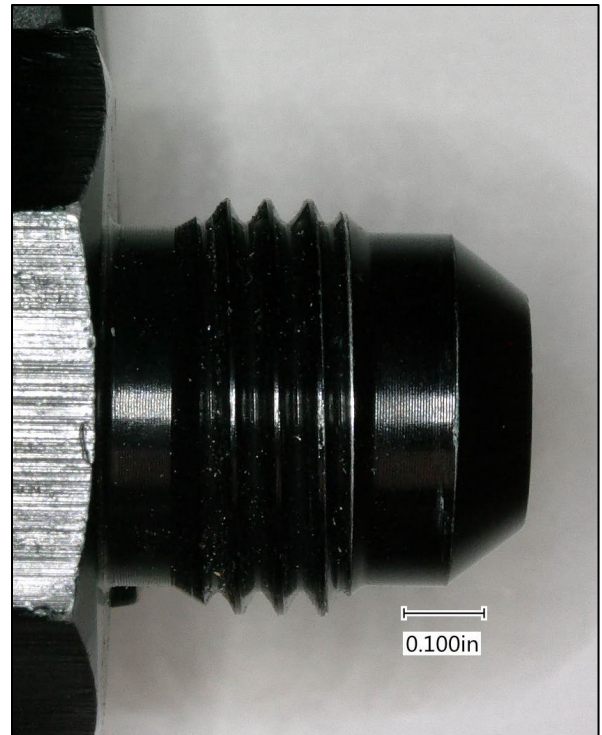
The hose and fitting were removed from the side of the adapter fitting, and the outlet and adapter fittings were separated to facilitate further examination of the joint. The silver-colored 90-degree outlet fitting was made of zinc-coated steel, and the black-colored fuel pressure adapter fitting was made of an aluminum alloy. The outlet end of the outlet fitting and the male and female ends of the adapter fitting were reportedly -6AN fittings. The outlet ends on each of the two fittings are shown for comparison in figure 2, showing similar thread profiles and sealing surface angles.

Figure 2. Threaded male end of the 90-degree outlet fitting (left) and the fuel pressure adapter fitting (right).

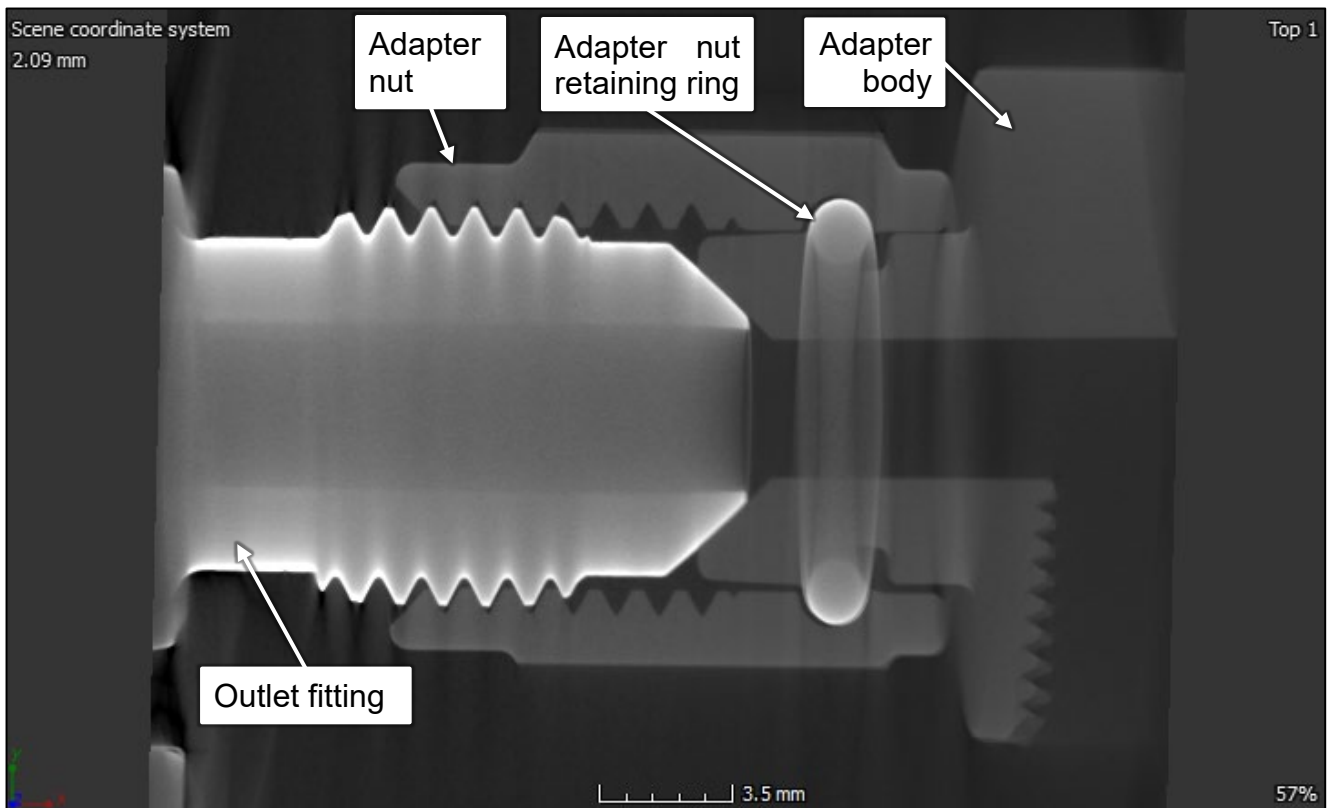
The adapter fitting was reassembled on the outlet fitting and tightened to a snug condition. The joint was then CT scanned using a General Electric Nanomex 180 X-ray inspection system, and a cross-sectional x-ray image of the joint is shown in figure 3. The images showed the nut on the adapter fitting had a recess that housed a higher-density (higher relative to the aluminum alloy) curved rod (or retaining ring) that nearly circled the nut. The retaining ring rested against a shoulder on the body of the adapter which acted to retain the nut with the adapter body when the joint was disassembled and to transfer clamping force between the nut and the adapter body in the assembled condition shown.

Figure 3. Cross-sectional image of the connection between the outlet fitting and the fuel pressure adapter fitting from an x-ray CT scan of the assembled fittings.

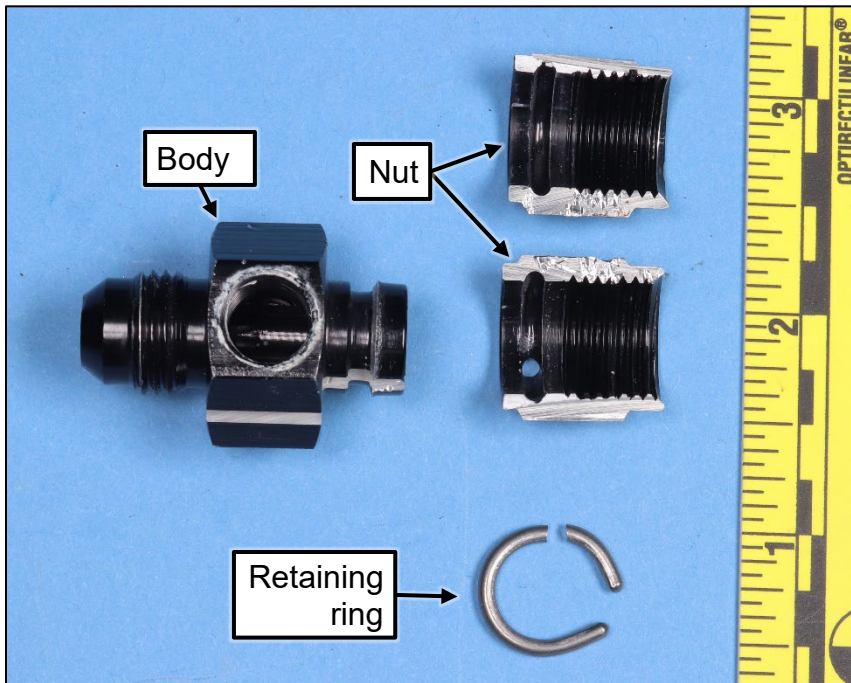
After testing, the nut was sectioned longitudinally on opposite sides using a water-cooled abrasive saw. The first cut extended through the nut cross-section into the body of the adapter, and the second cut extended through most of the nut cross-section. Following the cuts, the nut was pried open to fracture the remaining ligament on the partially cut side. The resulting sectioned and disassembled components of the adapter fitting are shown in figure 4. The retaining rod that had been housed in the nut recess was apparently made of steel and had been cut during the first saw cut as shown in figure 4.

Figure 4. Overall view of the fuel pressure adapter fitting after removing the 45 degree fitting attached to the side of the adapter fitting, torque testing, and sectioning to remove the nut from the adapter body.

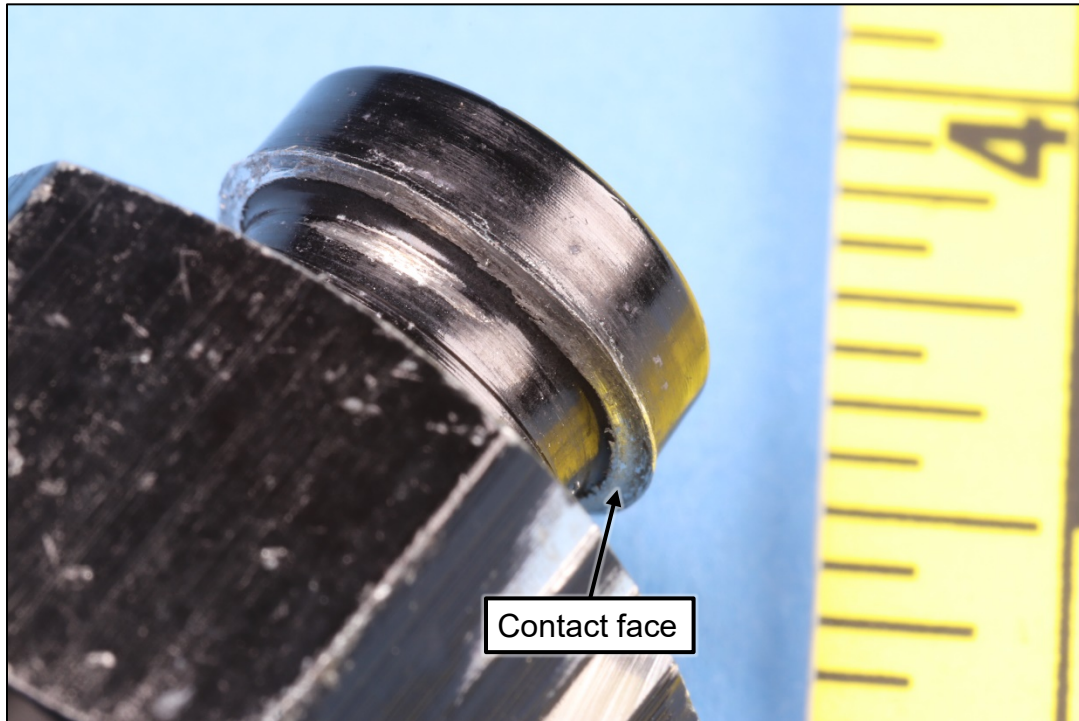
Following separation, the nut threads were examined and appeared to be free of deformation or damage. The contact face in the recess in the nut for the retaining rod had a rubbed appearance, and the black surface finish was disturbed. The contact face on the adapter body shoulder showed heavy rub damage around the circumference as shown in figure 5, and the edge of the shoulder was deformed radially outward to form a lip. Corresponding rub damage and material transfer was observed on the retaining rod, particularly near the end closer to the cut location.

Figure 5. Retaining ring contact face on the shoulder of the adapter body after the nut was sectioned and removed.
