NATIONAL TRANSPORTATION SAFETY BOARD

MATERIALS LABORATORY FACTUAL REPORT

Report No. 21-077

Place : Camp Dwyer, Afghanistan
Date : April 20, 2020
Vehicle : Sikorsky S-61N, N908CH
NTSB No. : DCA20LA100
Investigator : Dan Bower, AS-10

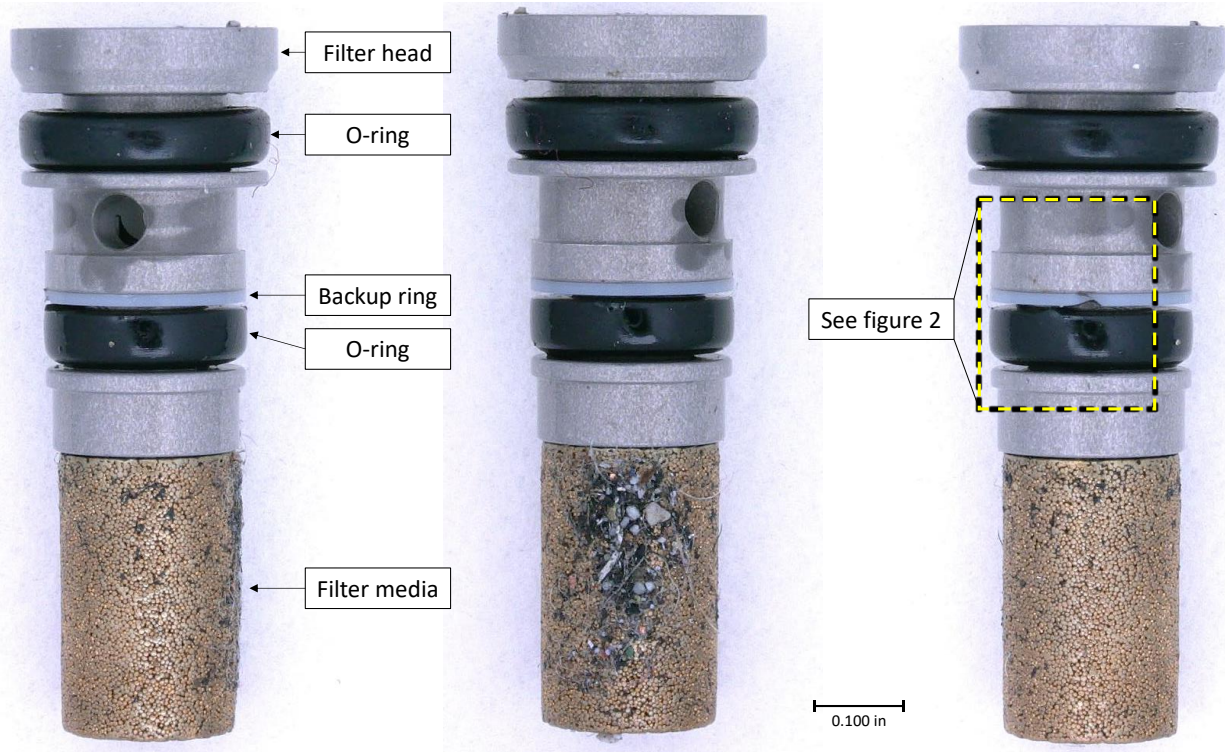
filter element was affixed to the smaller base of the filter head. A debris cluster was observed locally on the filter element as shown in figure 1.

Figure 1: Digital microscope images of the as-received filter component. Each view shows a different segment around the filter component. The middle view shows the debris cluster on the filter media, a closer view is shown in a subsequent figure. A closer view of the area in the right image within the dashed yellow box is shown in a subsequent figure.

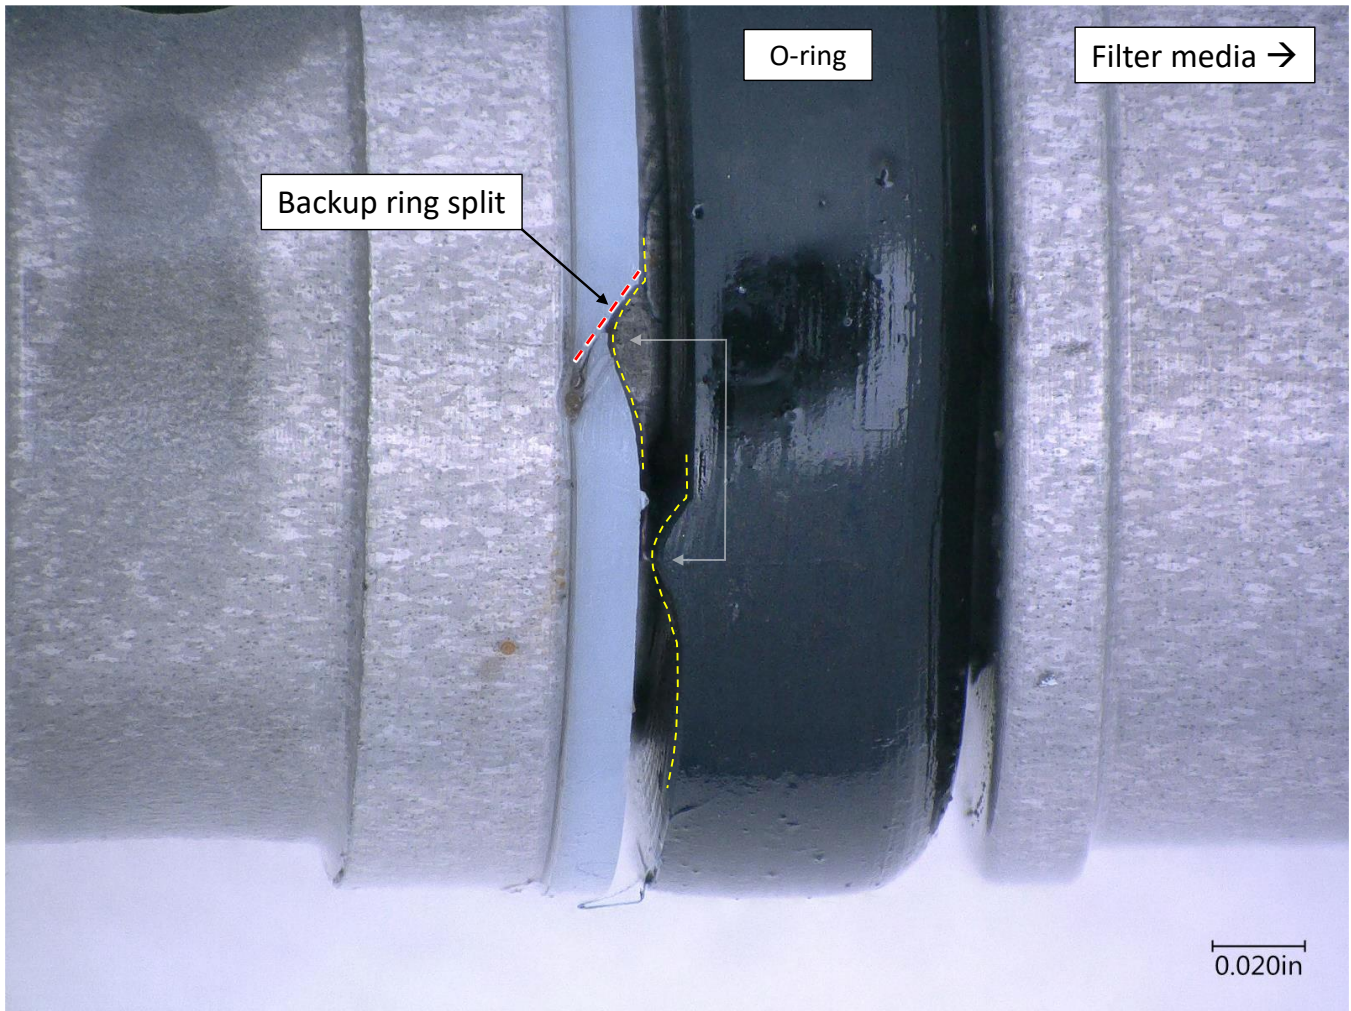
Figure 2 shows a closer view of the interface between the smaller O-ring and the backup ring. The red dashed line indicates a diagonally oriented split location consistent with the backup ring design. The lower side of the split, as oriented in this view, exhibited plastic flow deformation consistent with compression loading. The mating surface of the O-ring was deformed and exhibited a profile which correlated with the backup ring deformation, as highlighted by yellow dashed lines connected by light gray arrows. The comparable deformation profiles were consistent with the O-ring material extruding into the backup ring split location under pressure loading.

Figure 2: A higher magnification digital microscope image of the area highlighted by the yellow box in figure 1, rotated 90 degrees to the left. The backup ring split location is highlighted by the red dashed line. The lower side of this split location, as oriented in the image, exhibited plastic flow deformation which correlated with O-ring deformation as highlighted by yellow dashed lines.

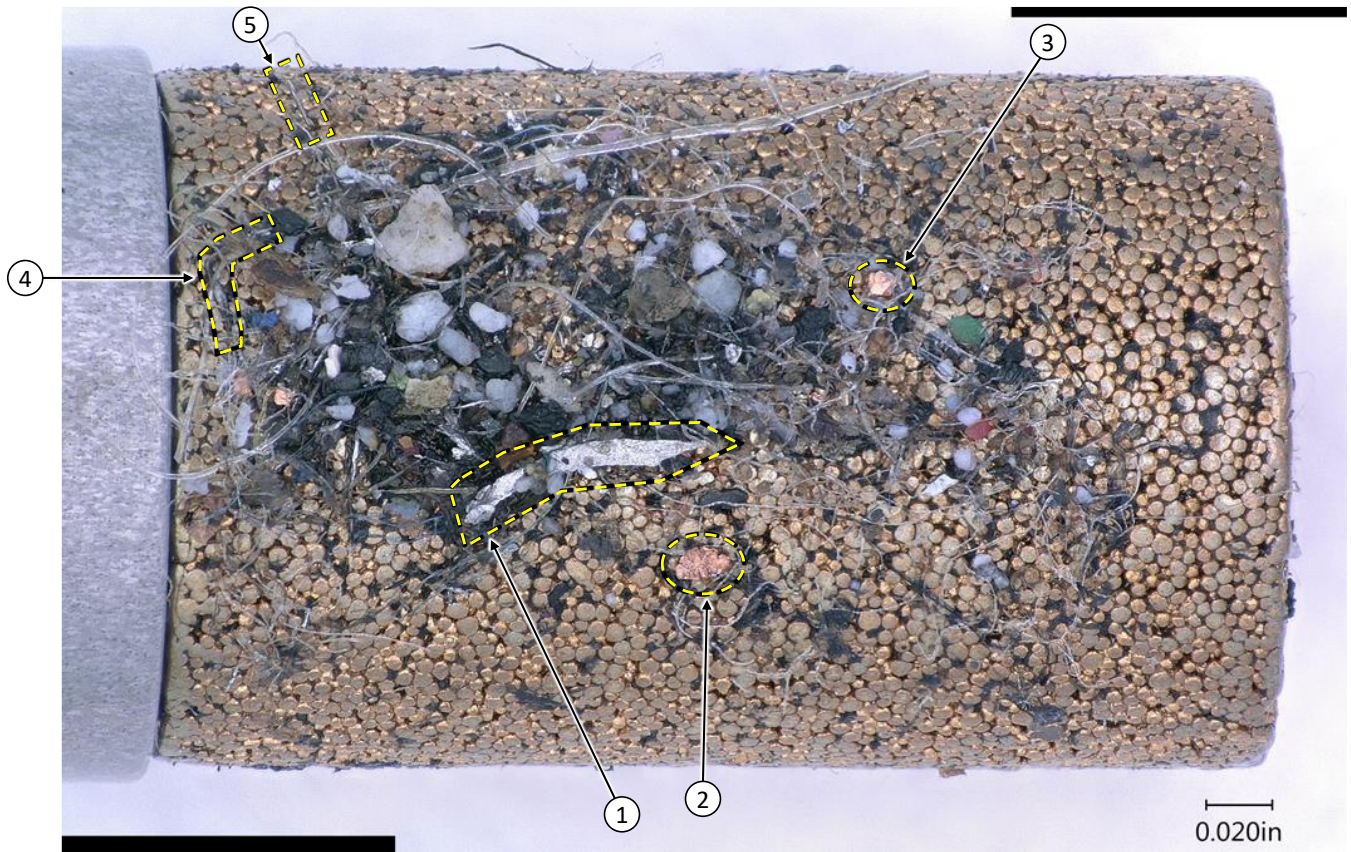
The debris cluster was examined with the aid of a 4X – 80X zoom stereomicroscope and was comprised of multi-colored particles of various shapes and sizes, tangled strands of translucent fibers of various lengths and diameters, black-colored deposits, and shiny, metallic looking particles. A digital microscope image of the debris cluster is shown in figure 3 with the visible metallic-looking particles arbitrarily identified 1 through 5 and outlined by yellow dashed shapes. These particles and the debris cluster were further examined using a scanning electron microscope (SEM) equipped with an energy dispersive x-ray spectrometer (EDS), results of which are discussed later in this report.

Figure 3: A digital microscope stitched image showing a closer view of the debris cluster on the filter media. The numbered areas highlighted by yellow dashed boxes correspond to particles that were visually observed to exhibit a shiny metallic appearance. These locations were examined further using a scanning electron microscope equipped with an energy dispersive x-ray spectrometer.

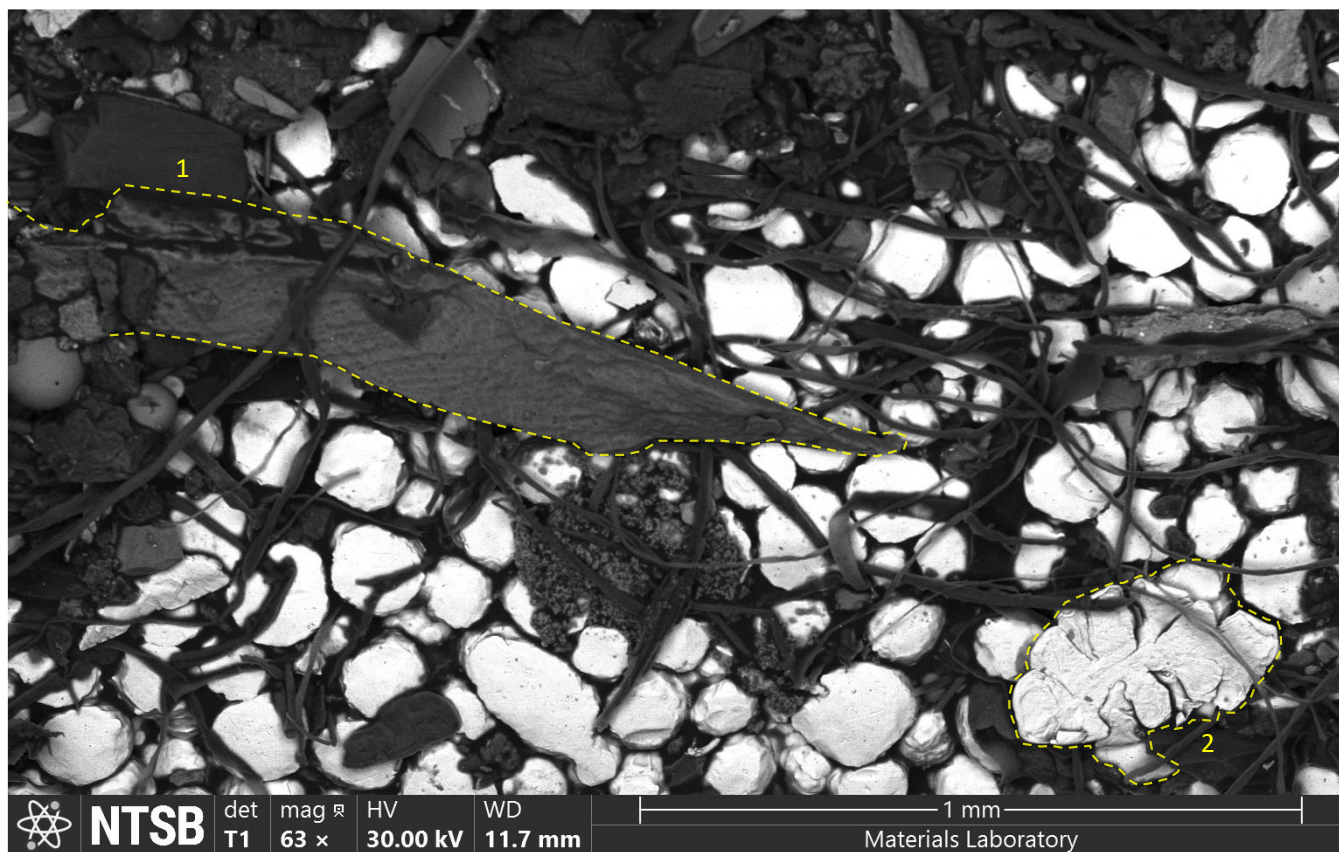
Figure 4 shows a backscattered electron² (BSE) image containing a portion of particle 1 and particle 2 labeled and outlined by yellow dashed lines. The smooth, white, approximately-equiaxed circular areas in the background correspond to the filter media. Particle 1 exhibited a darker gray appearance and a shape consistent with a metal flake with some apparent smearing and deformation. The major visible surface exhibited a faint dimpled appearance. Particle 2 appeared whiter in color with a faint dimpled appearance on the visible surface. Radially oriented cracks emanated from the central region of particle 2.

Figure 4: A backscattered electron micrograph showing a closer view near particles 1 and 2 as identified in figure 3. The particles of interest are labeled and outlined by a yellow dashed line.

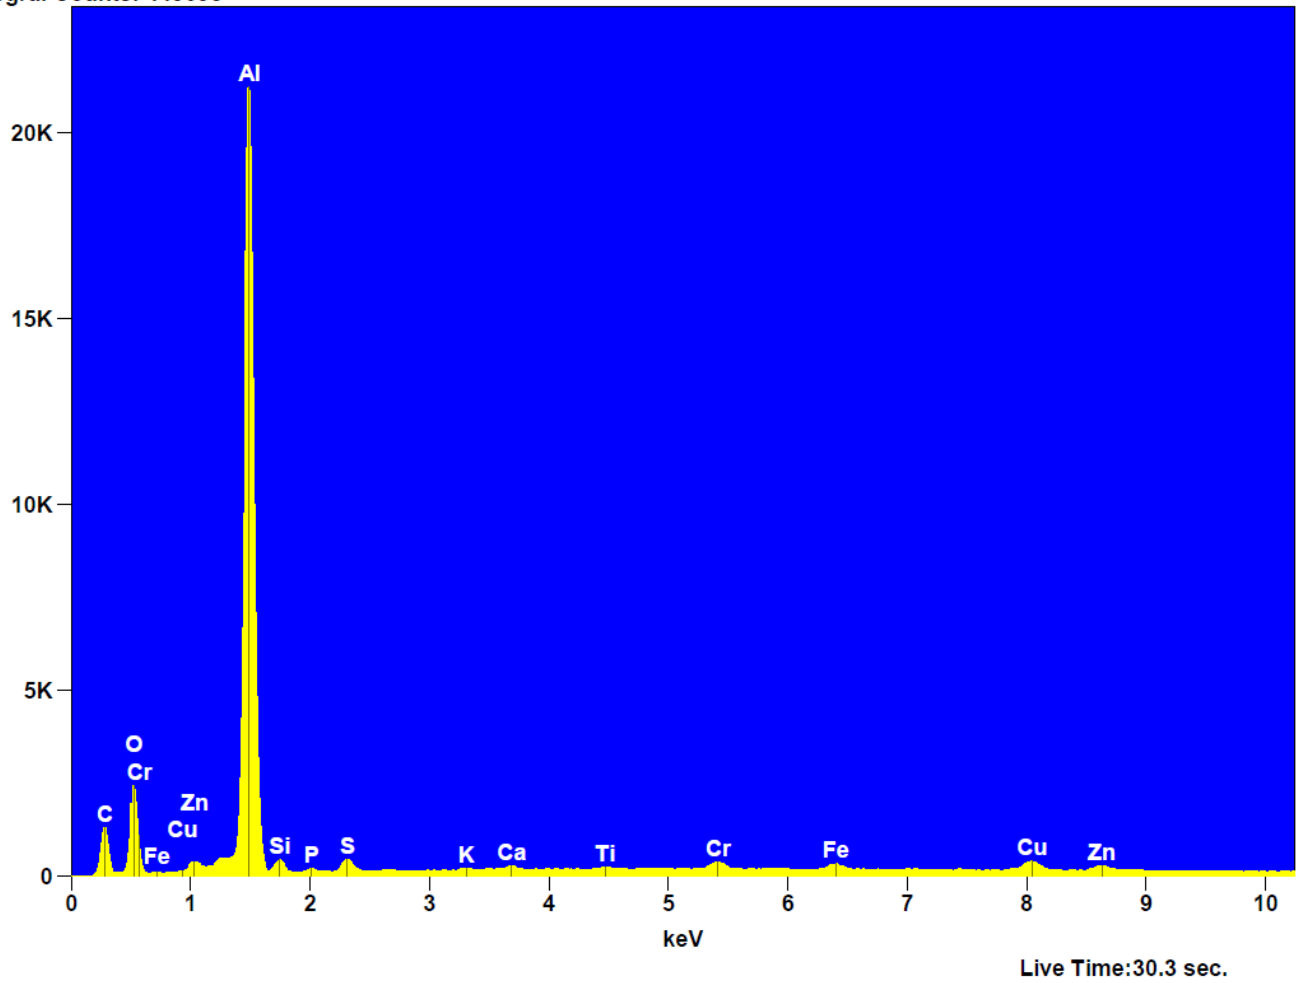
Location 1

Figure 5 shows the EDS spectrum acquired on particle 1 which showed a strong aluminum peak and minor peaks of copper, zinc, and silicon which were consistent with

common alloying elements found in aluminum alloys. Other elements detected in lesser amounts were consistent with common elements found in sand/soil and other aircraft alloys.

Figure 5: EDS spectrum acquired from the particle identified as location 1.

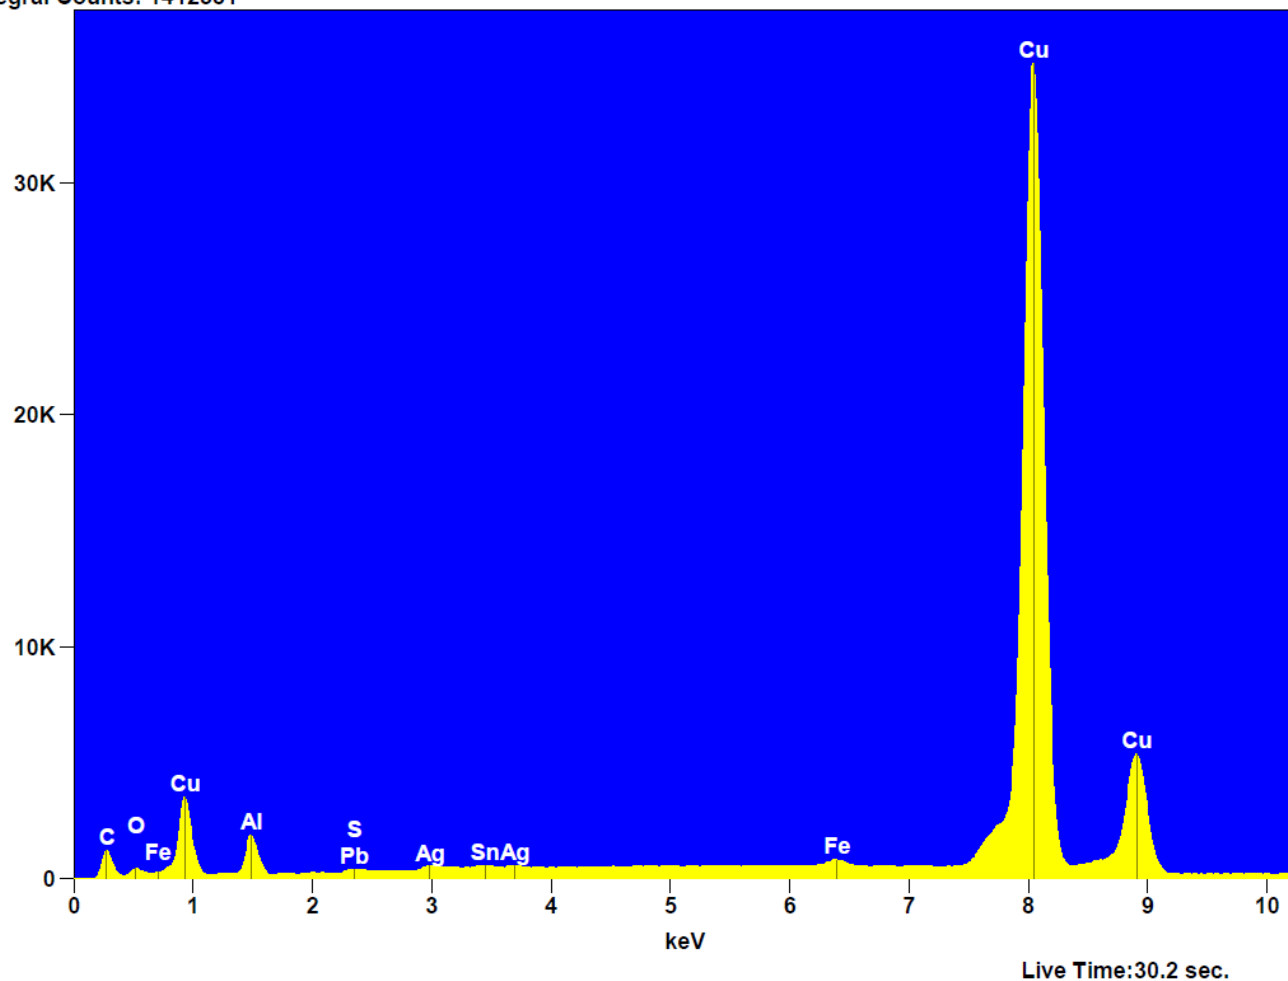
Location 2

Figure 6 shows the EDS spectrum acquired on particle 2 which showed strong copper peaks and a minor aluminum peak with lesser amounts of lead, iron, tin, silver, and sulfur identified which were consistent with common elements found in copper, copper alloys, aluminum alloys, and steels.

Figure 6: EDS spectrum acquired from the particle identified as location 2.

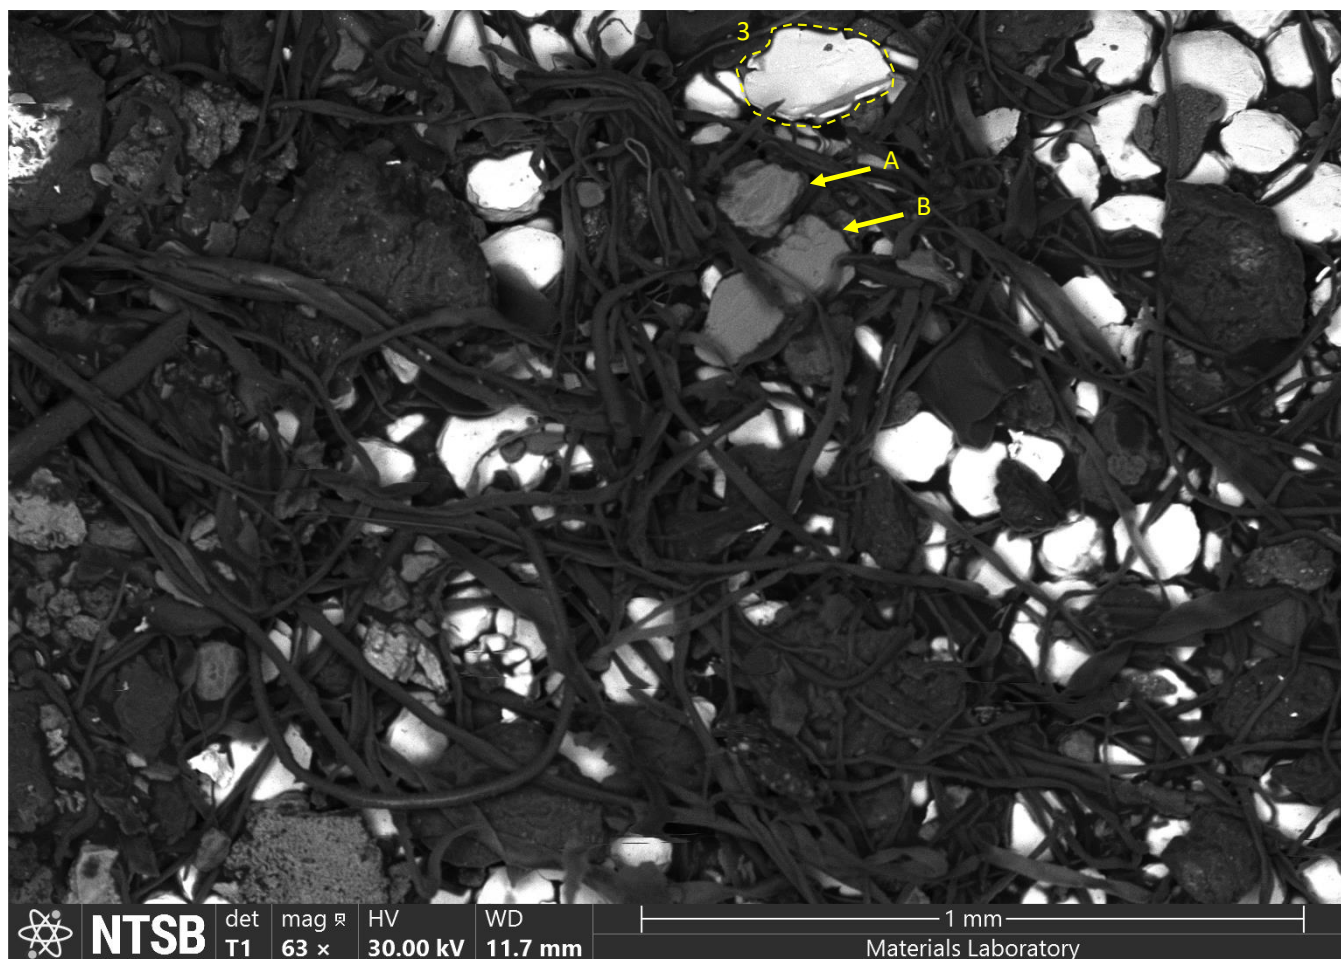
Figure 7 shows a BSE image with particle 3 outlined by a yellow dashed line. Particle 3 appeared white in this image and had a red-orange metallic luster in visible light, as viewed in figure 3, which was distinct from the baseline filter media. Two dark gray particles, labeled "A" and "B" with yellow arrows, were observed in the BSE image. EDS spectra were acquired on these particles and are shown in subsequent figures. Black fibers, which exhibited strong carbon peaks from EDS were observed tangled throughout this view. These fibers appeared translucent in visible light as viewed in figure 3.

Figure 7: A backscattered electron micrograph showing a closer view near particle 3 as identified in figure 3. Particle 3 is labeled and outlined by a yellow dashed line. Two additional particles of interest were identified and labeled with yellow arrows. EDS spectra of the particles of interest are shown in subsequent figures.

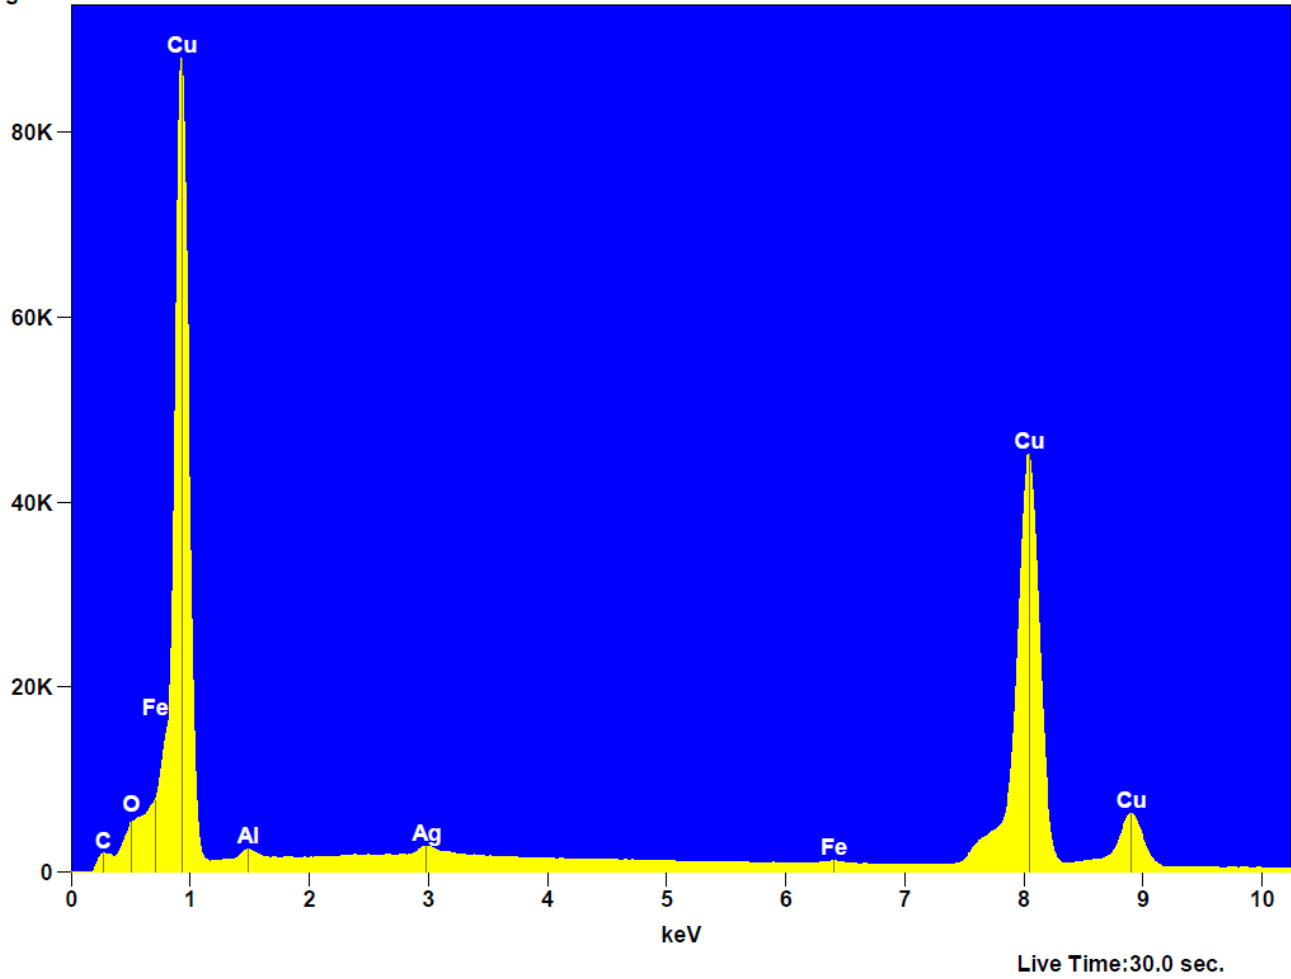
Location 3

Figure 8 shows the EDS spectrum acquired on particle 3 which shows strong copper peaks with minor peaks of silver, aluminum, and iron. Figure 9 shows the EDS spectrum acquired for particle "A" identified in figure 7 and shows major peaks of carbon, oxygen, copper, and tin that were detected with smaller amounts of other elements detected which are common in aircraft alloys and sand/soil. Figure 10 shows the EDS spectrum acquired for particle "B" identified in figure 7 and shows major peaks of carbon, oxygen, silicon, potassium, and aluminum, and small amounts of other elements common in minerals of sand/soil.

Figure 8: EDS spectrum acquired from the particle identified as location 3.

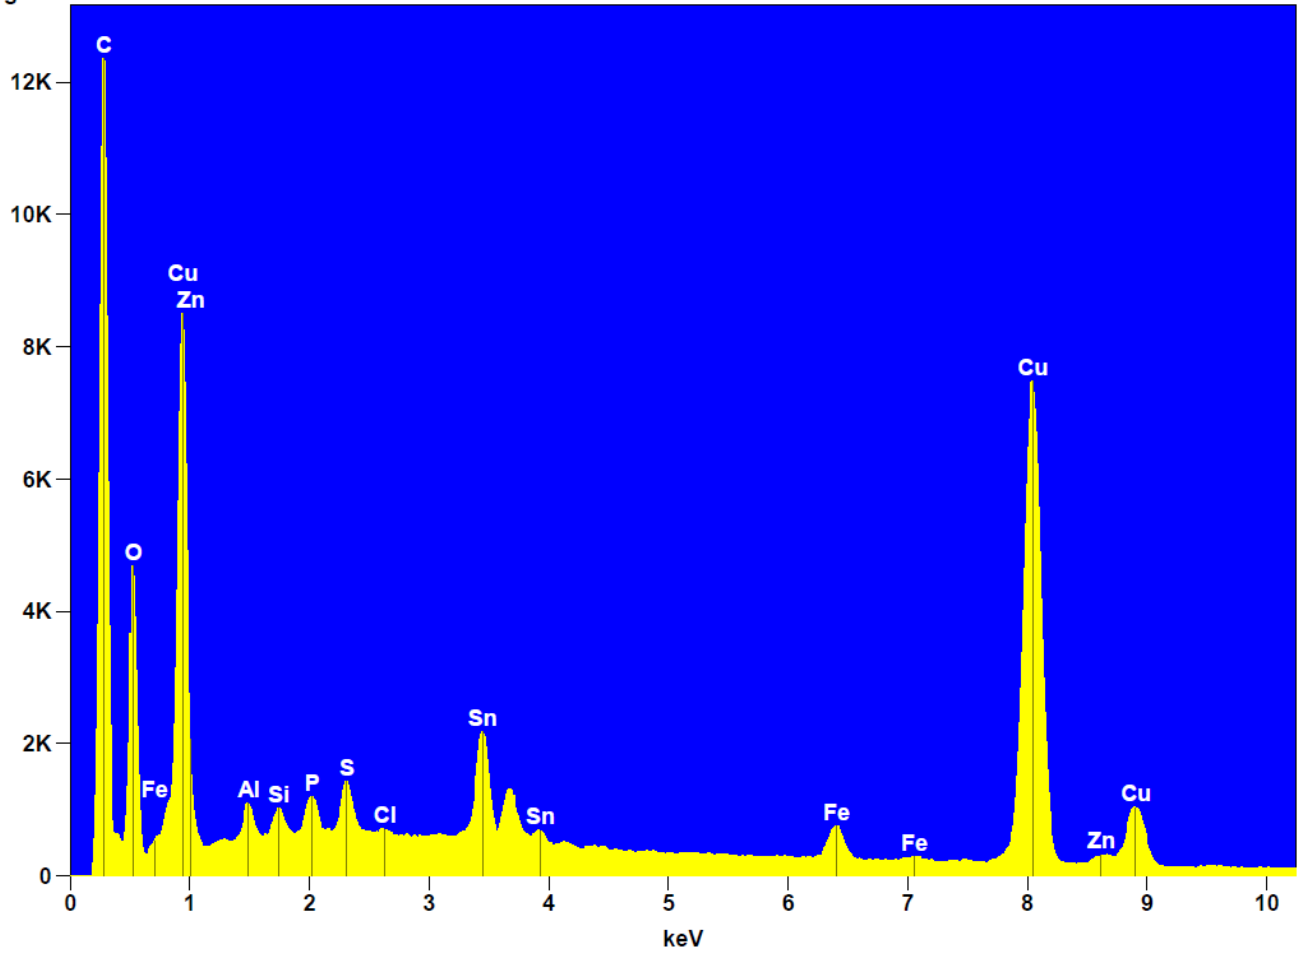
Yellow Arrow "A"

Figure 9: EDS spectrum acquired from the particle identified by yellow arrow labeled "A" in figure 7.

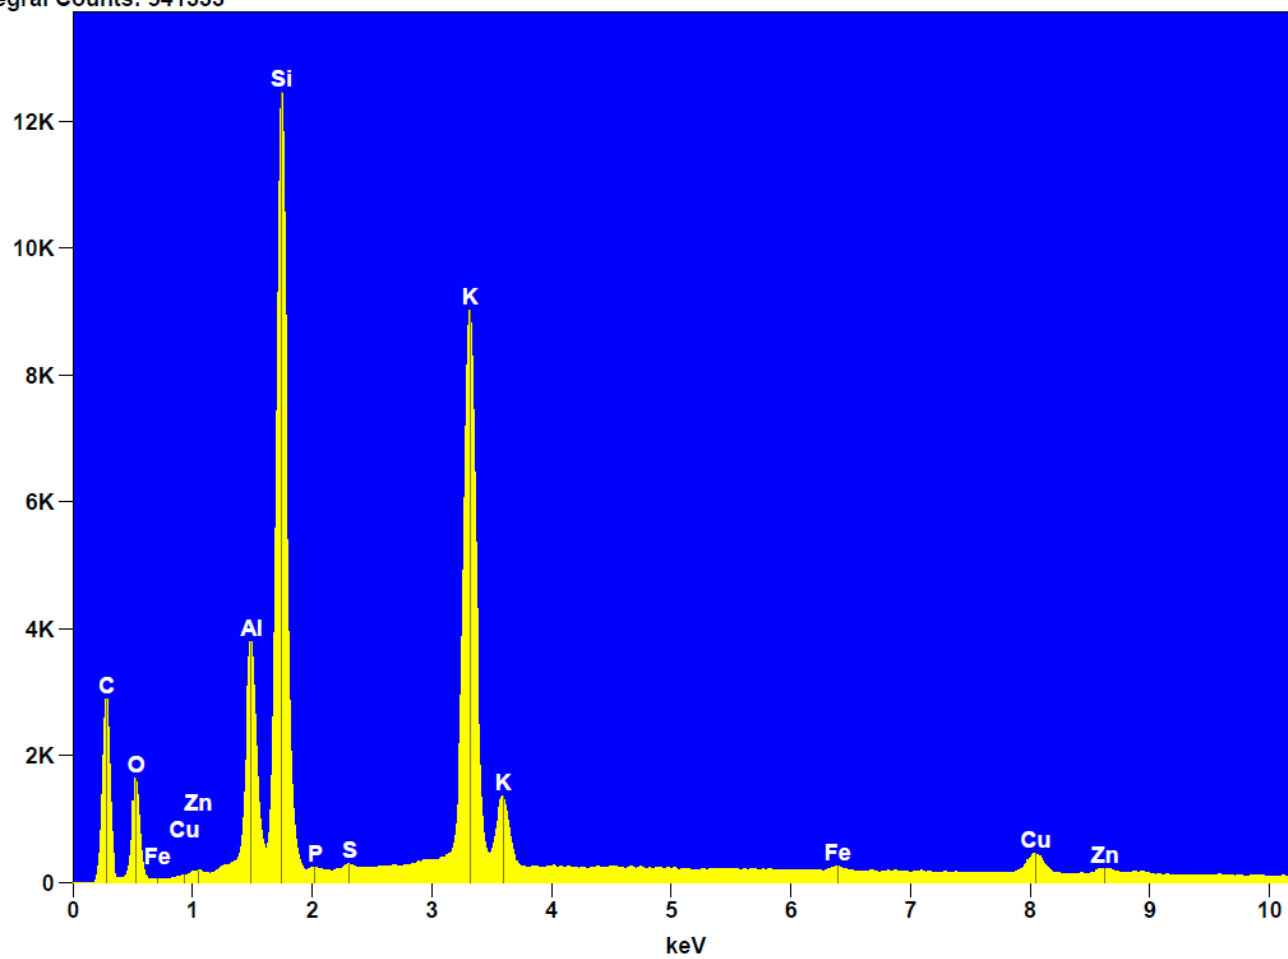
Yellow Arrow "B"

Figure 10: EDS spectrum acquired from the particle identified by yellow arrow labeled "B" in figure 7.

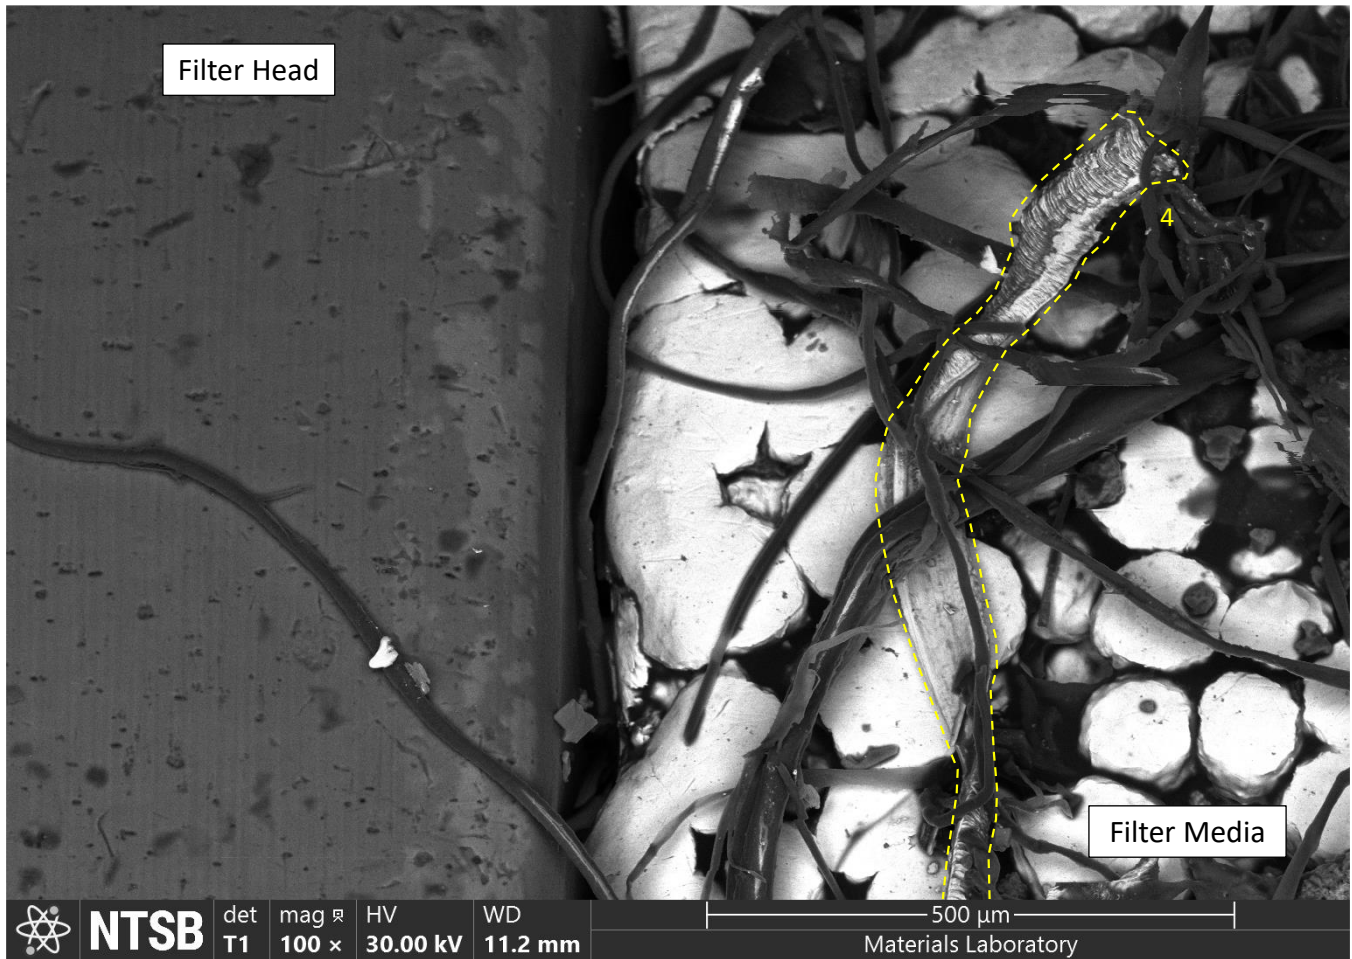
Figure 11 shows a BSE image containing a portion of particle 4 labeled and highlighted within yellow dashed lines. Particle 4 exhibited a light gray appearance and a shape consistent with a twisted and deformed metal shaving.

Figure 11: A backscattered electron micrograph showing a closer view near particle 4 as identified in figure 3. The gray filter head is visible on the left side of the image.

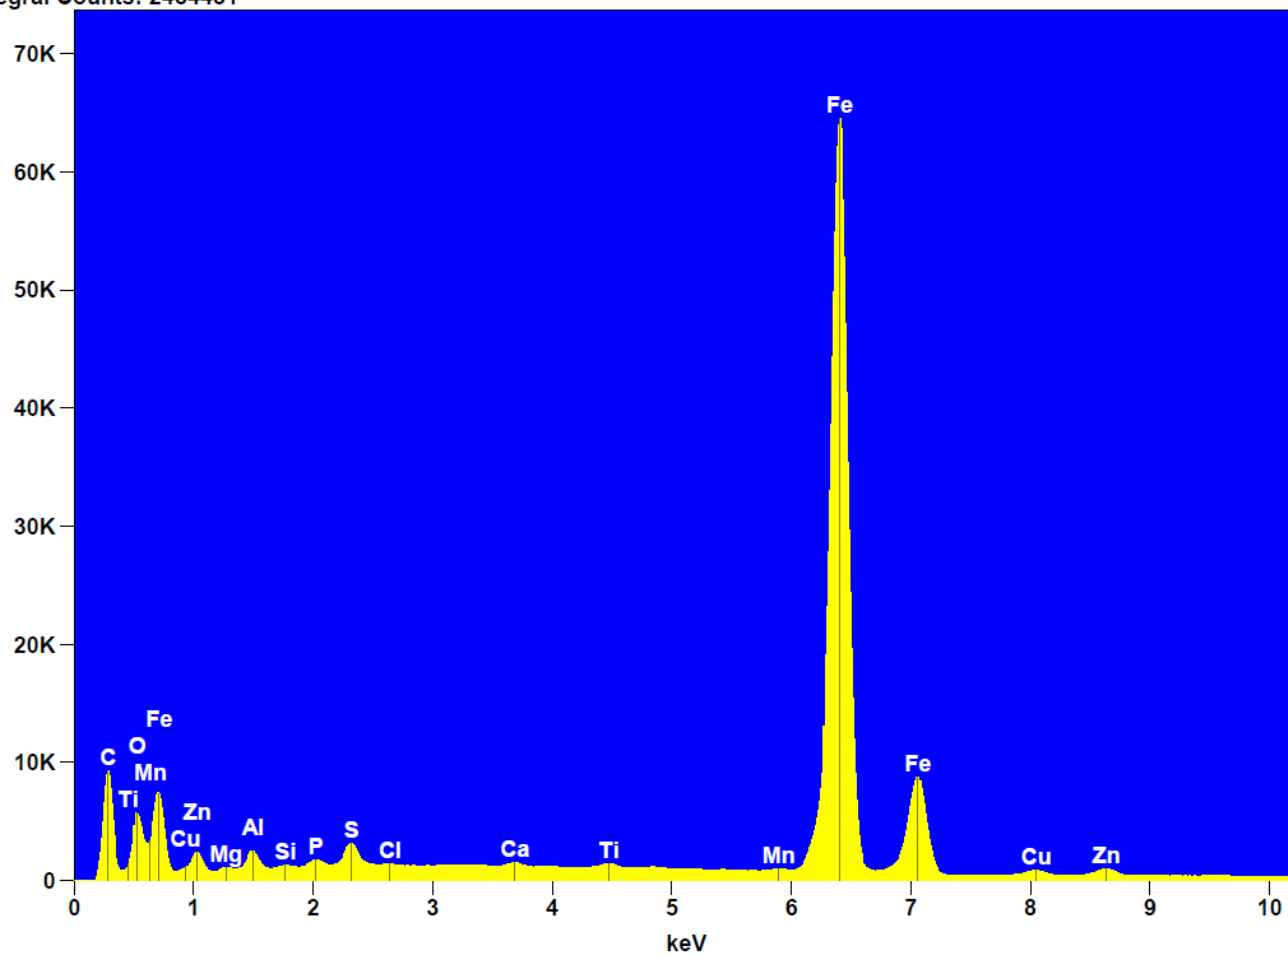
Location 4

Figure 12 shows the EDS spectrum acquired on particle 4 which shows major iron peaks with smaller peaks of elements consistent with typical alloying elements found in steel as well as constituents found in sand/soil minerals.

Figure 12: EDS spectrum acquired from the particle identified as location 4.

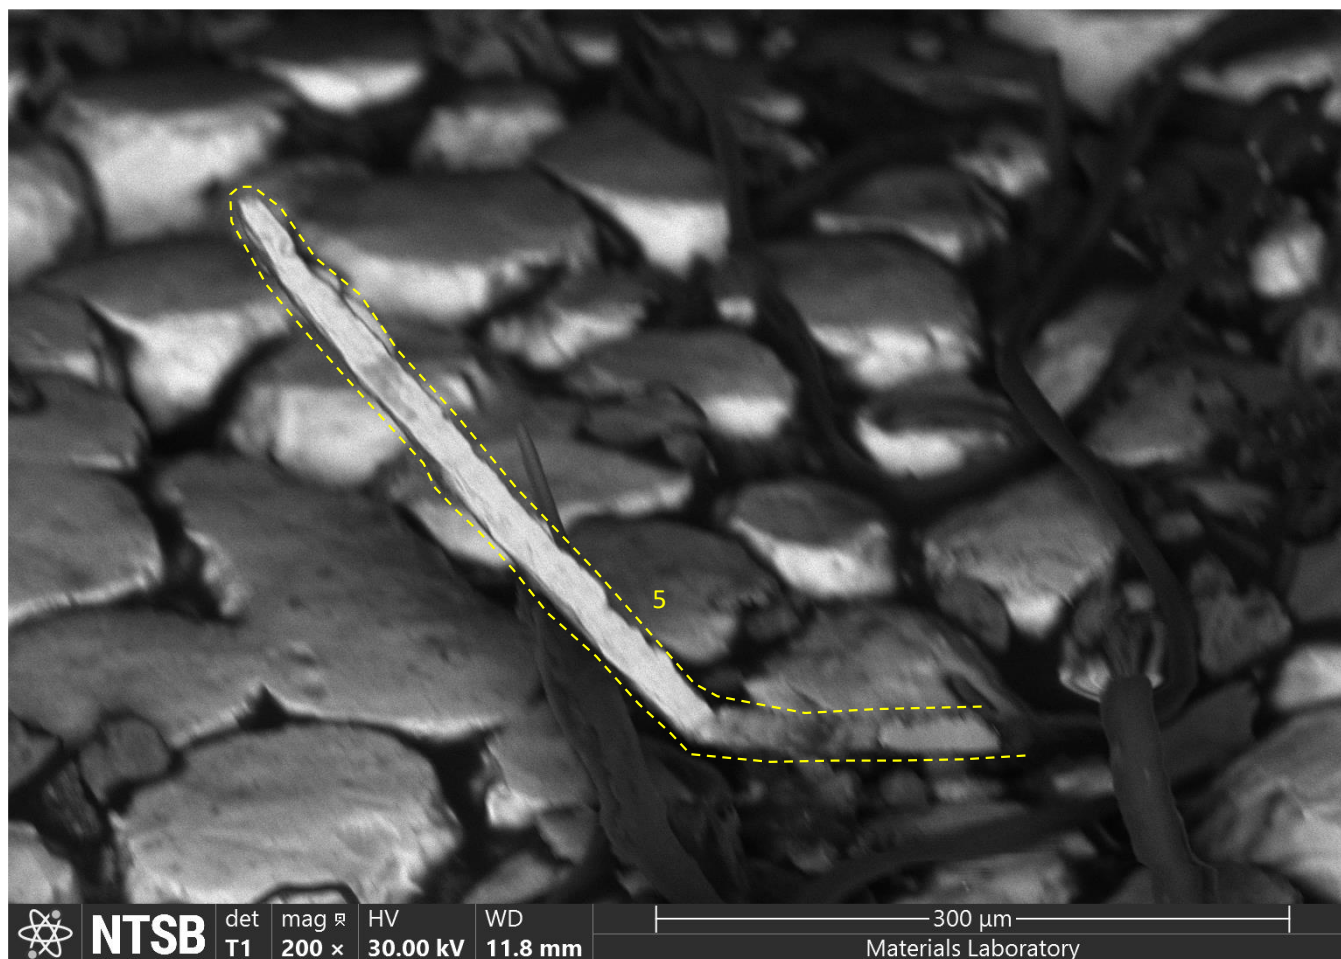
Figure 13 shows a BSE image containing particle 5 labeled and highlighted within yellow dashed lines.

Figure 13: A backscattered electron micrograph showing a closer view near particle 5 as identified in figure 3.

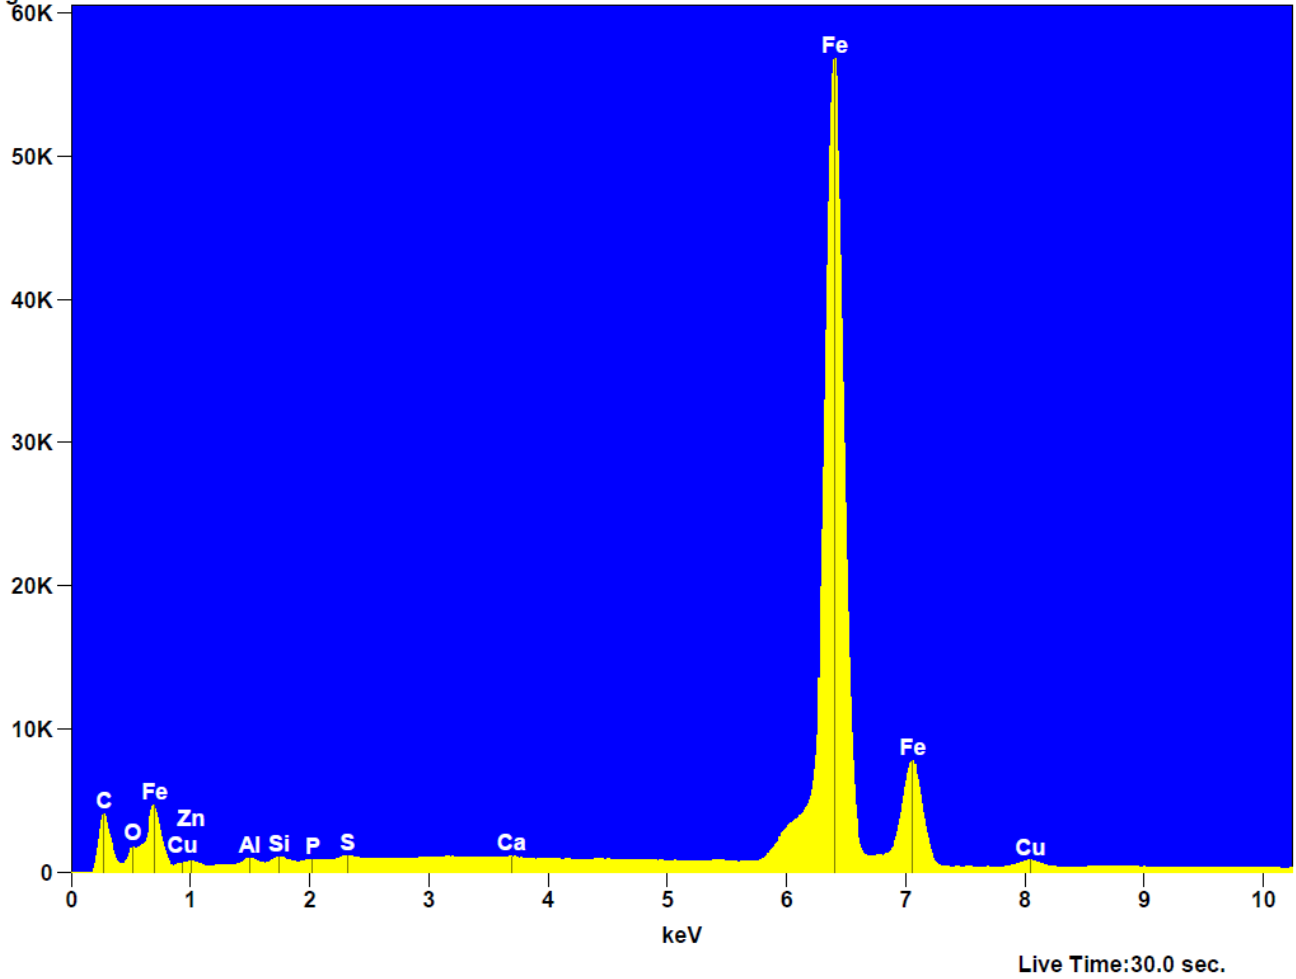
Location 5

Figure 14 shows the EDS spectrum acquired on particle 5 which shows major iron peaks with smaller peaks of elements consistent with typical alloying elements found in steel as well as constituents found in sand/soil minerals.

Figure 14: EDS spectrum acquired from the particle identified by location 5.

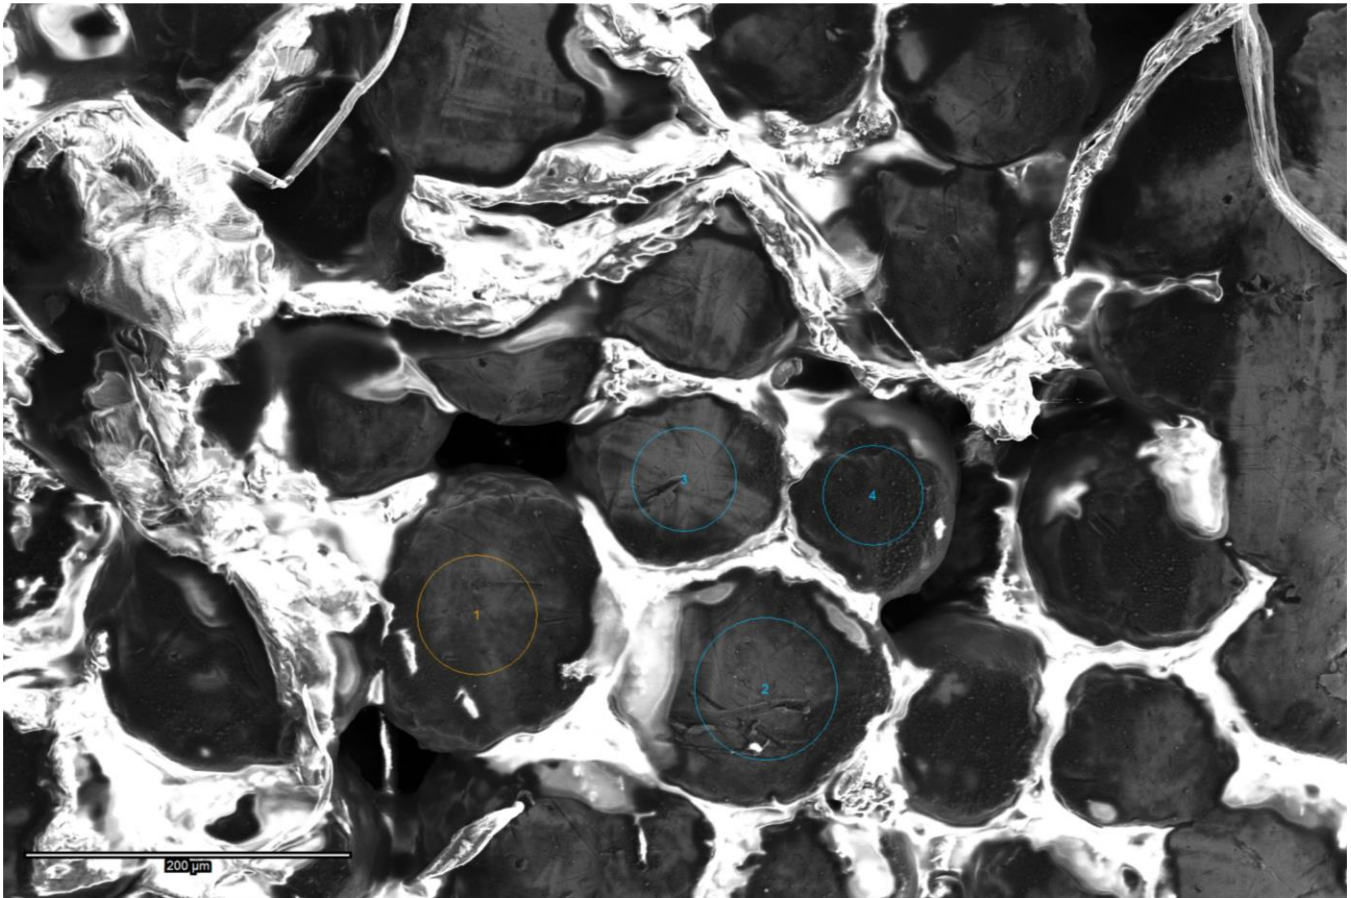
Figure 15 shows a secondary electron image of an area of the filter media used to acquire EDS spectra for baseline compositional analysis of the filter media. The orange and blue circular areas correspond to locations where spectra were obtained. The white areas observed between the dark circular filter media regions correspond to non-conductive filtered material charging when exposed to the electron beam.

Figure 15: Secondary electron micrograph of the filter media acquired for EDS analysis. The orange and blue circular annotations numbered 1 through 4 indicate where spectra were acquired.

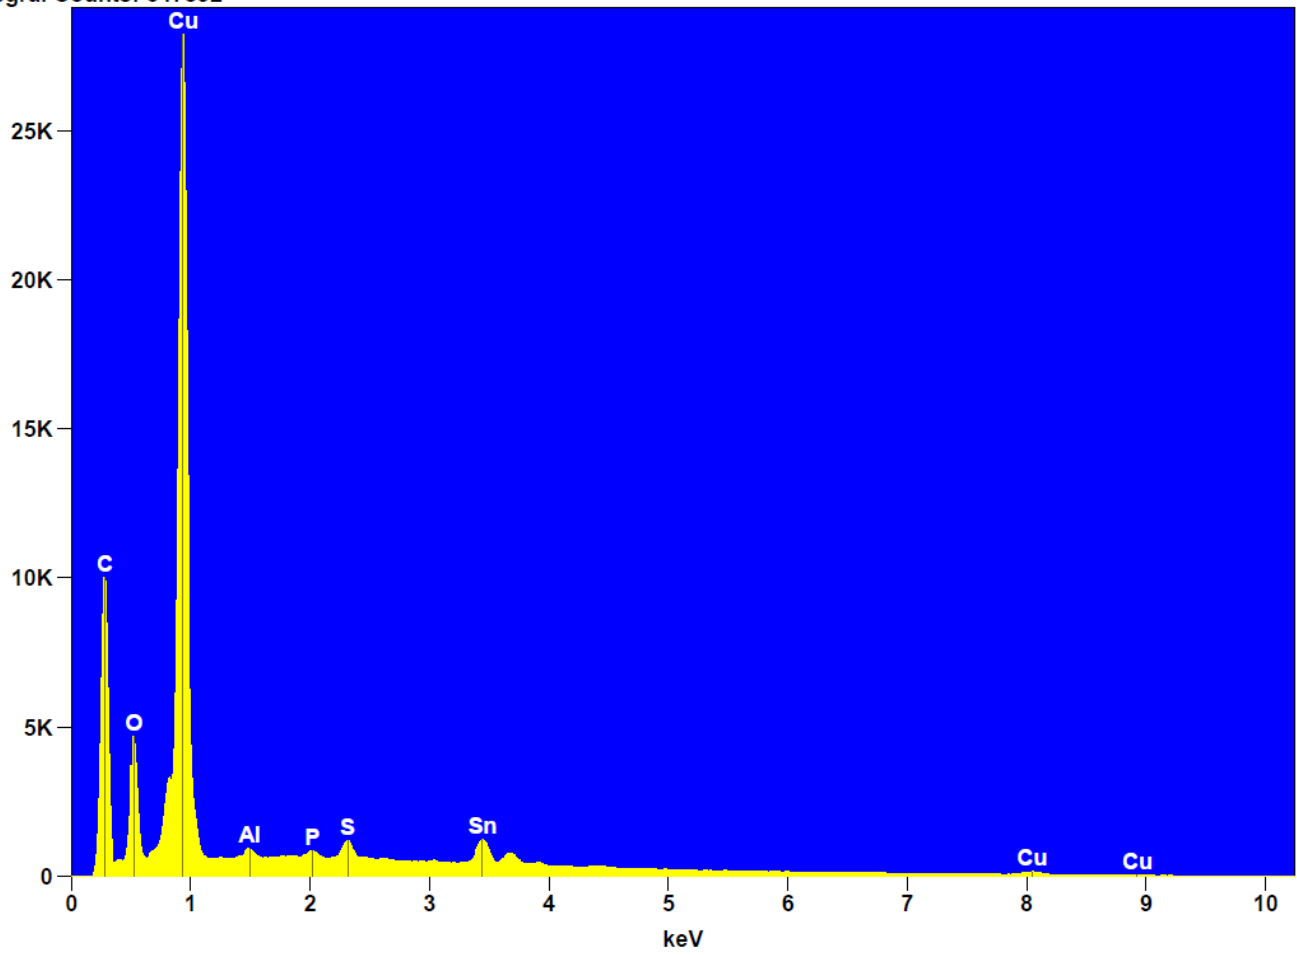
Filter Baseline_pt3

Figure 16 shows a representative spectrum of the baseline filter media which contains primarily copper with small amounts of tin, consistent with a sintered bronze porous filter element which are common in fuel, pneumatic, and hydraulic applications.

Figure 16: Typical EDS spectra acquired from the filter media locations identified in figure 15.
