NATIONAL TRANSPORTATION SAFETY BOARD

MATERIALS LABORATORY FACTUAL REPORT

Report No. 21-091

Place : Daytona Beach, Florida
Date : April 4, 2018
Vehicle : Piper PA-28R-201, N106ER
NTSB No. : ERA18FA120
Investigator : Aaron McCarter, AS-ERA / Clinton R. Crookshanks, AS-40

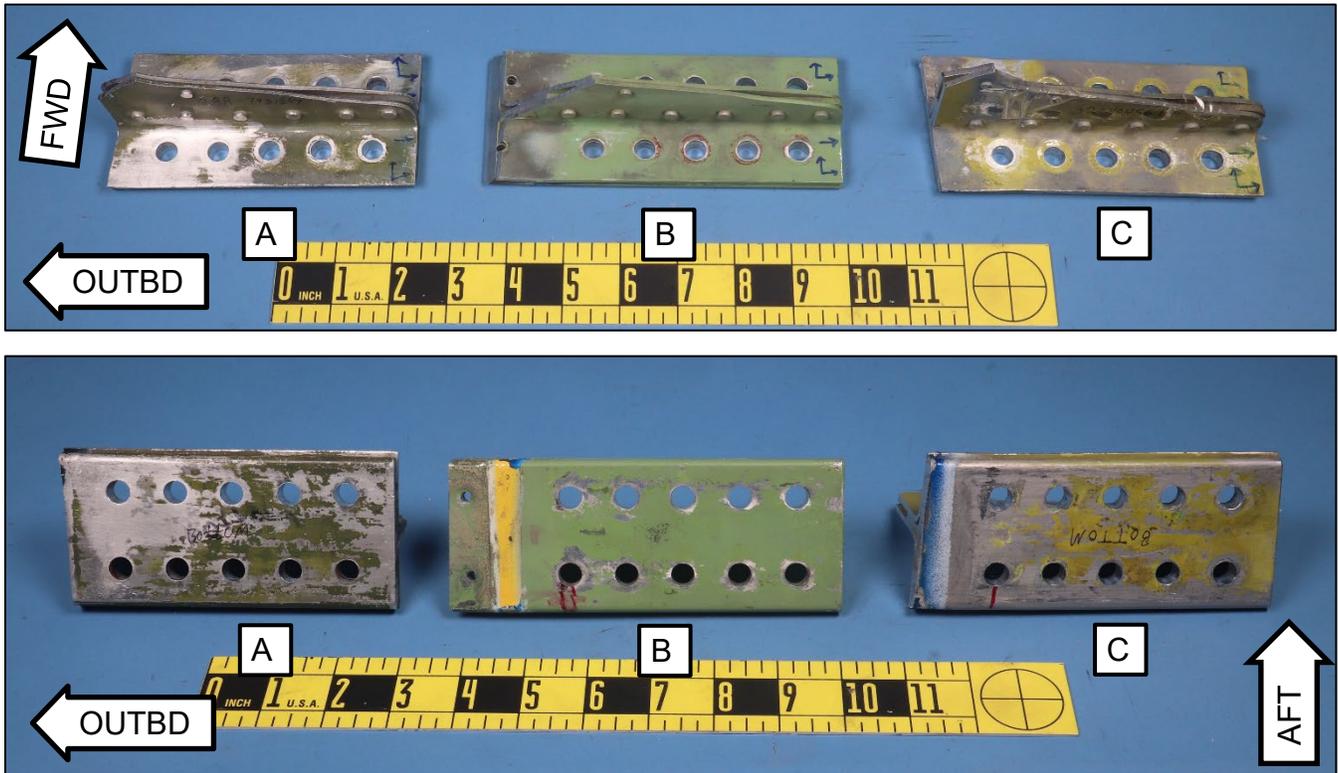
The inboard ends of 3 main spar lower spar caps with attached doubler pieces were received for examination as shown in figure 1. For reference in this report, the spars were labeled A through C as noted above. The spars were part of the left wing structure on three airplanes having model numbers and serial numbers affected by Federal Aviation Administration Airworthiness Directive (AD) 2020-26-16, which requires an eddy current bolt hole inspection of main wing spar attachment bolt holes of certain airplanes. Each of the three spars had a crack indication that was detected through eddy current inspection followed by visual inspections and/or fluorescent penetrant inspections.

Figure 1. Overall views of the submitted main spar lower spar cap pieces.

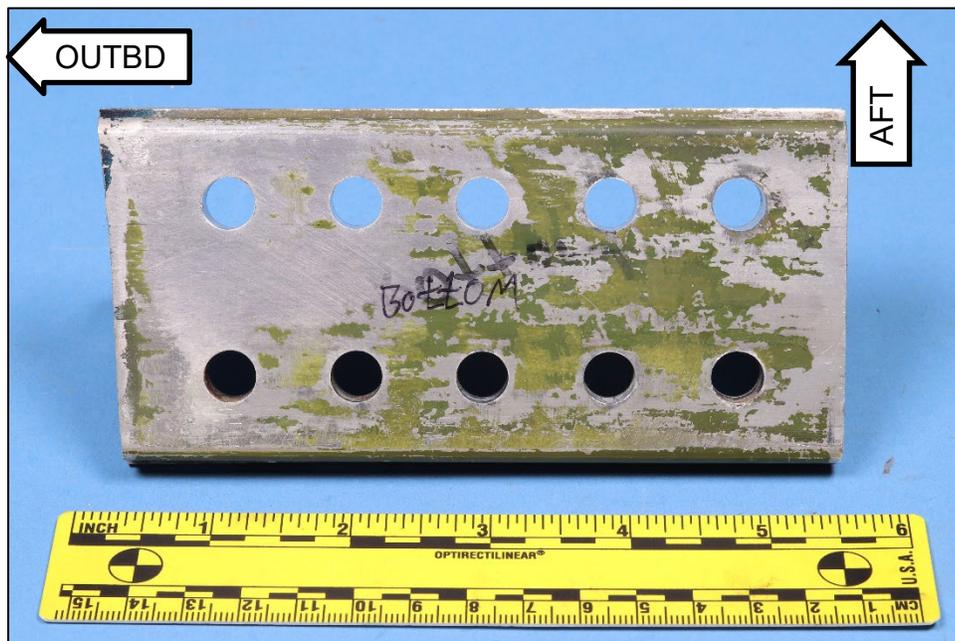
An overall view of the lower surface of the spar A lower spar cap is shown in figure A1, and closer views of the outboard attachment holes are shown in figures A2 to A4. Deposits of reddish orange oxides, likely from the attachment bolt, were present on the interior of hole LC-1, particularly on the outboard half. A relatively large vertical scratch was also observed on the inboard forward quadrant of hole LC-1 as shown in figure A3.

Figure A1. Spar A lower surface.

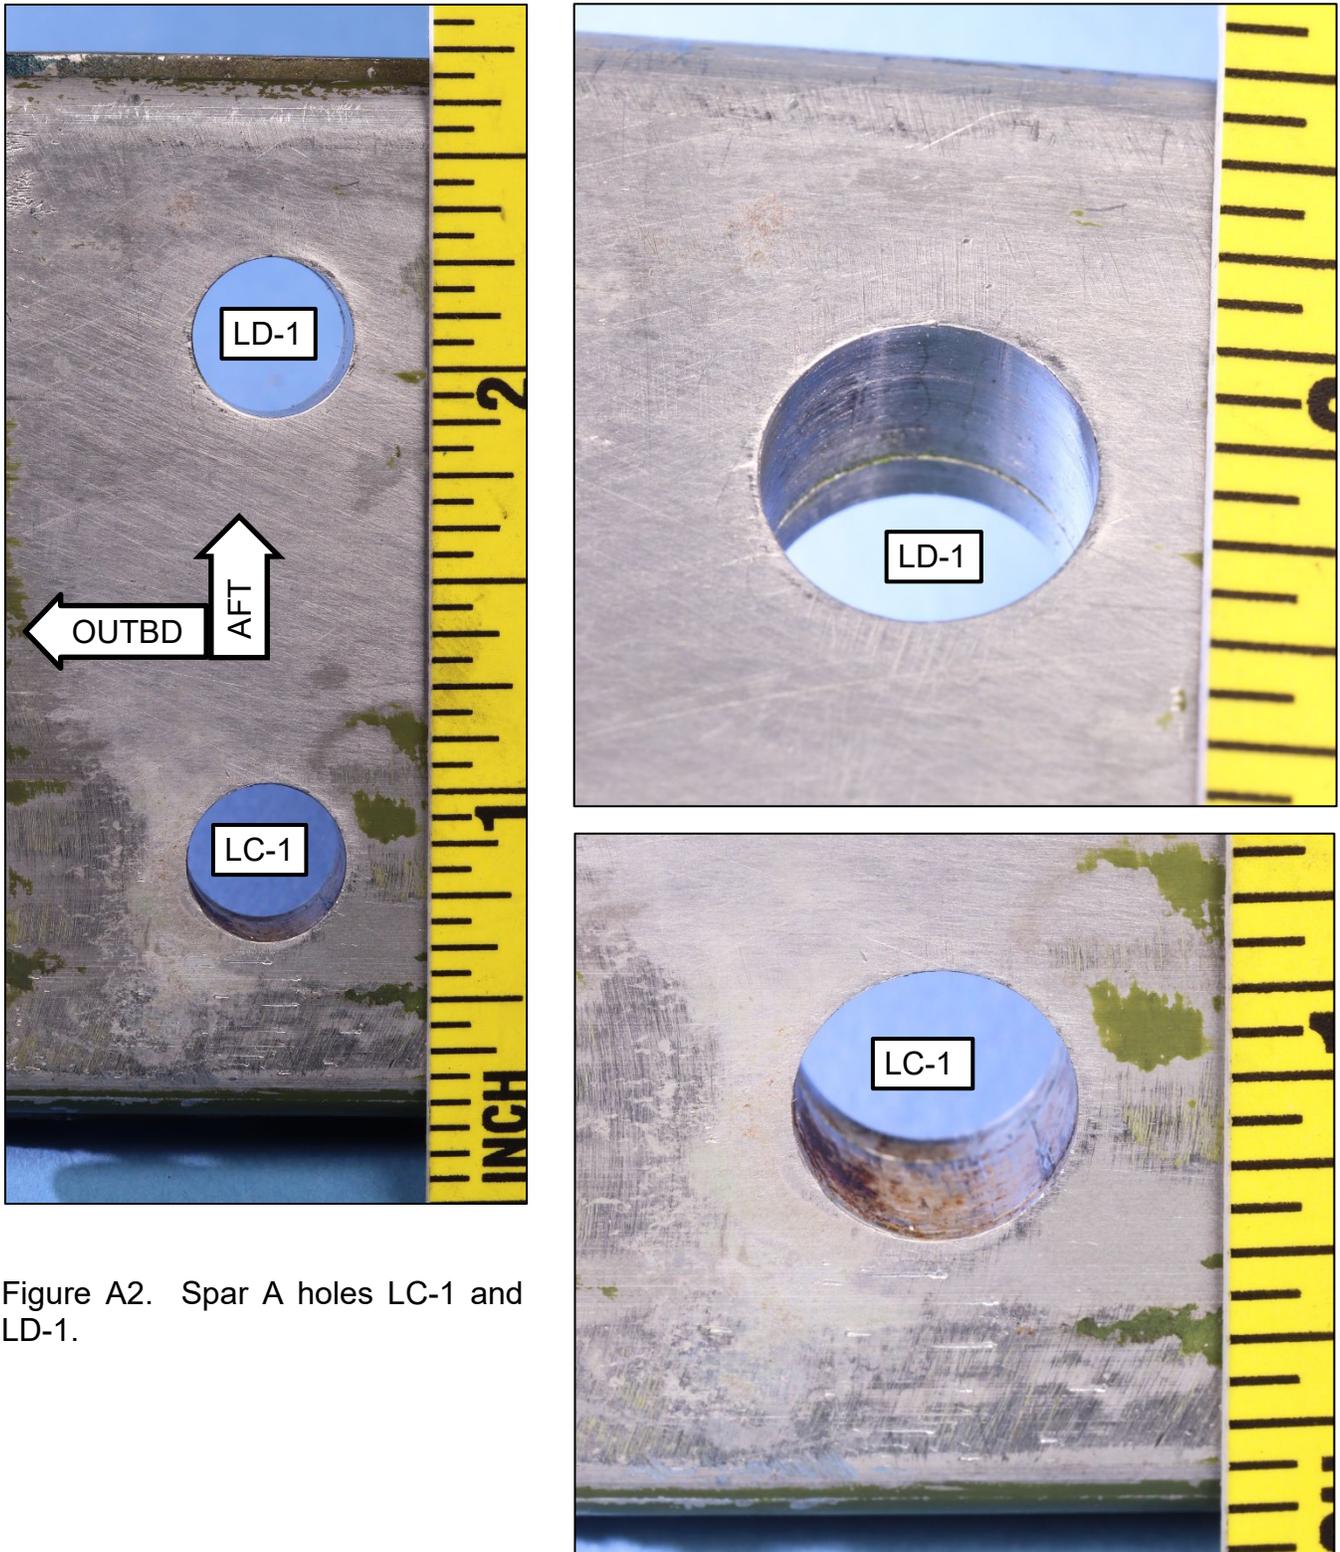
Figure A2. Spar A holes LC-1 and LD-1.

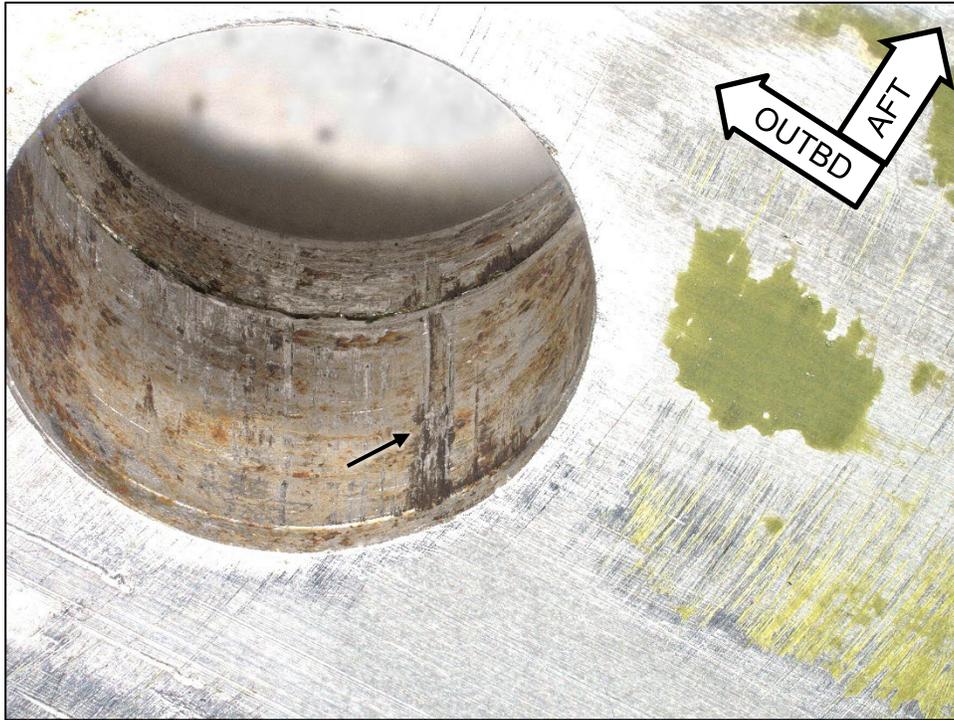
Figure A3. Scratch on the inboard forward quadrant of hole LC-1.

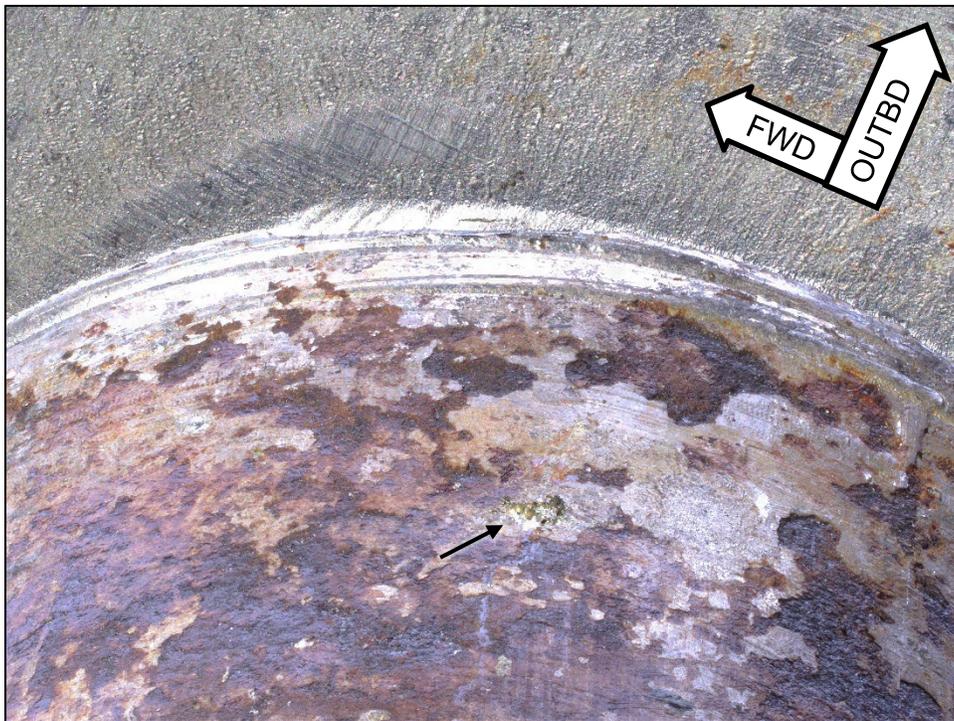
A pit was observed on the outboard side of hole LC-1 as shown in figure A4. The spar piece was placed in a scanning electron microscope (SEM), and SEM images of the hole LC-1 surface at the pit are shown in figures A5. The pit had dimpled features with some mud cracking on the surface and oxide-filled areas, features consistent with a corrosion pit. The area around the pit was mostly covered by thicker iron oxides.

Figure A4. Pit on the outboard side of hole LC-1.

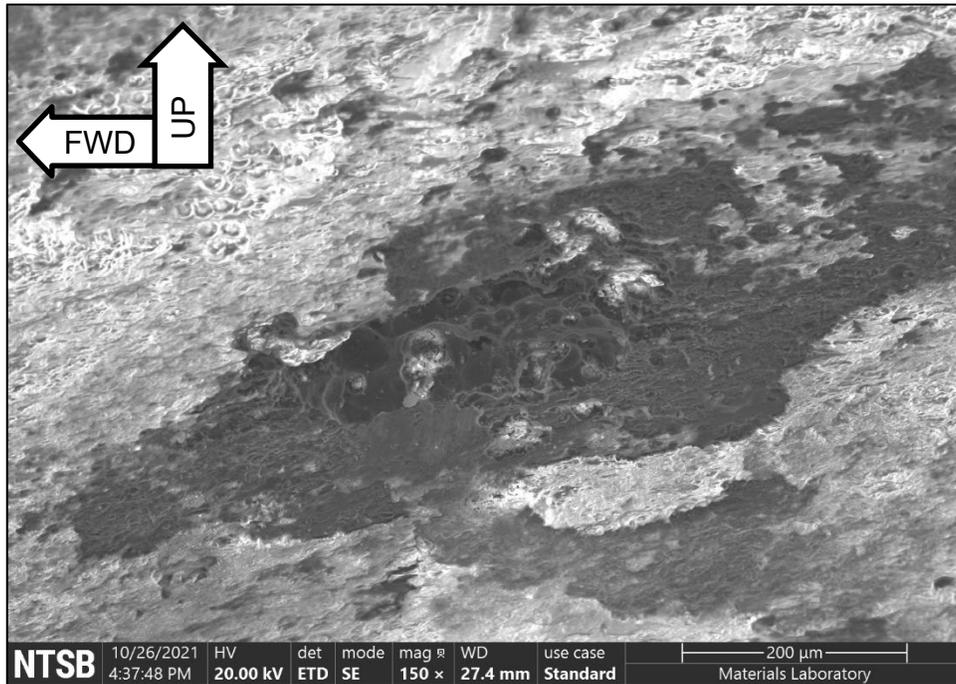
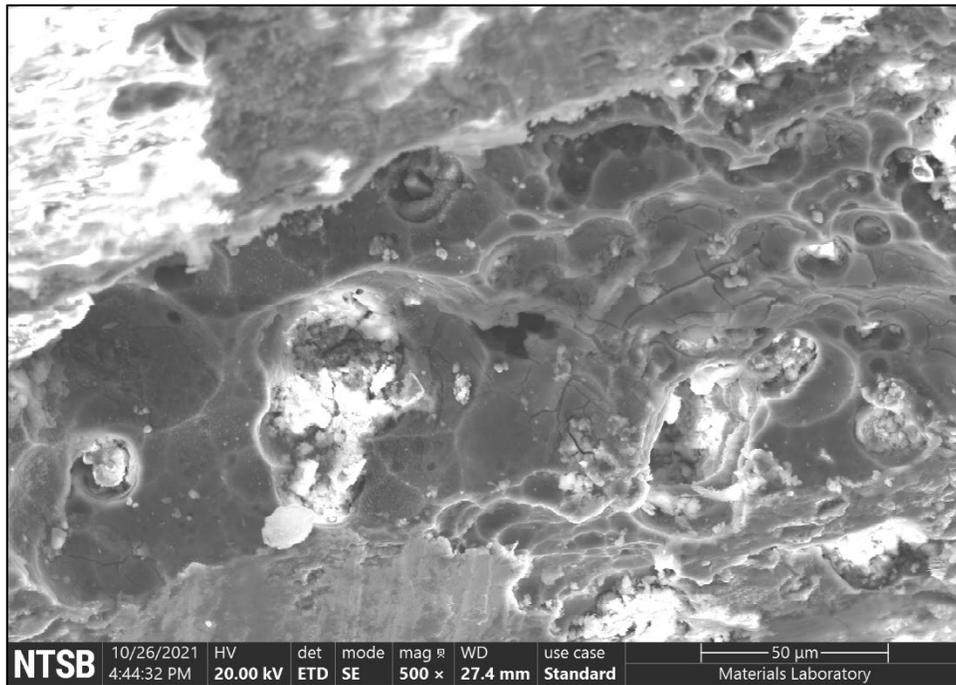
Figure A5. SEM images of the pit in the outboard side of hole LC-1.

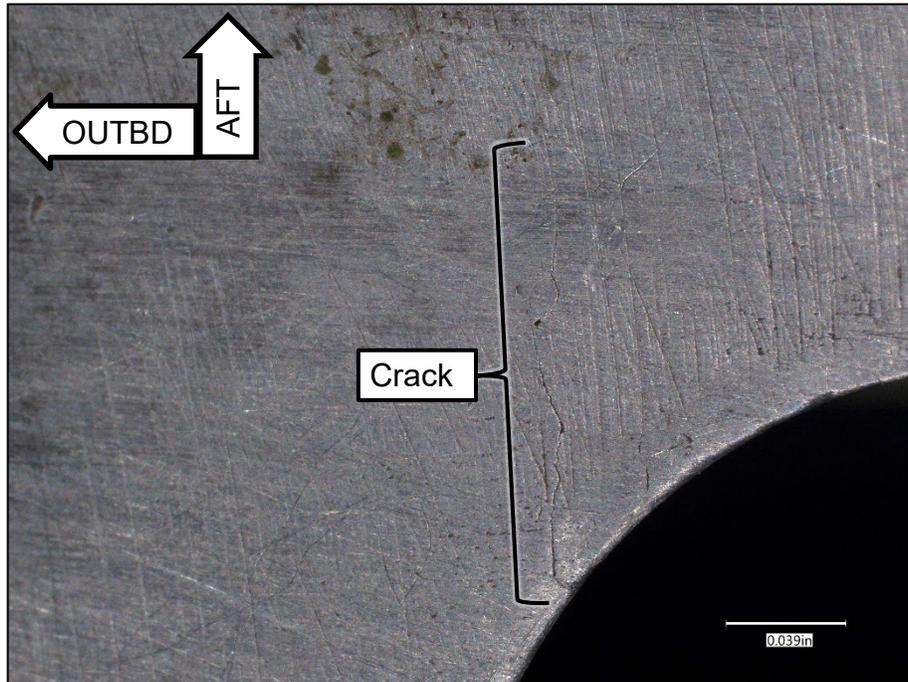
A crack was observed at the outboard aft quadrant of hole LD-1 as shown in figure A6. The crack intersected the lower surface to the extent indicated with a bracket in figure A6 and was observed intersecting part of the hole LD-1 bore. An SEM image of the area where the crack intersected hole LD-1 is shown in figure A7. Corrosion pits were observed on the hole LD-1 bore near the crack as indicated in figure A7.

Figure A6. Optical image of the lower surface showing a crack at the outboard aft quadrant of hole LD-1.

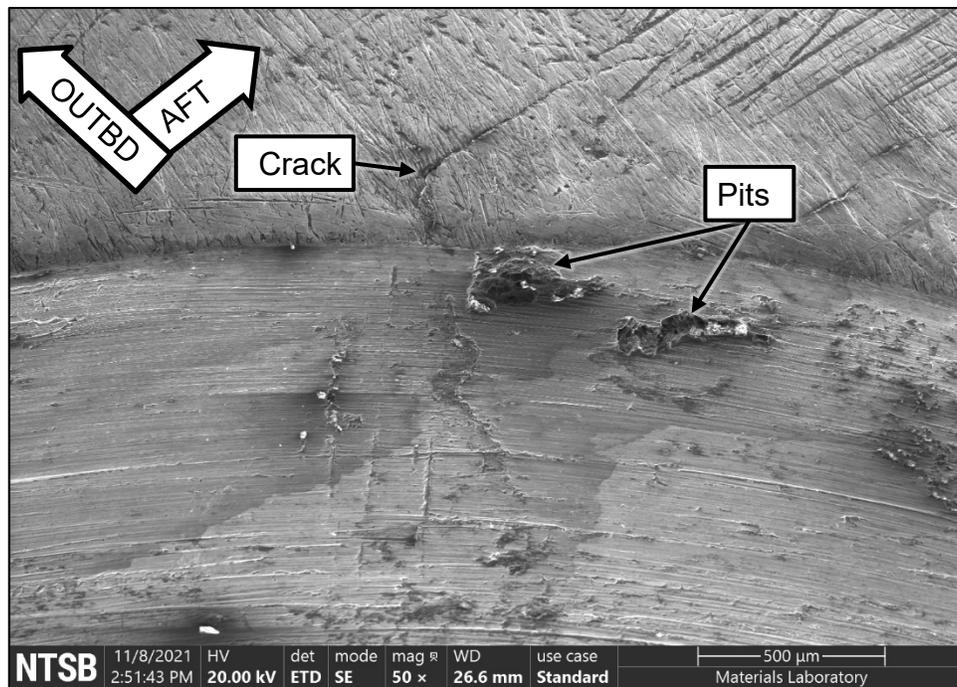
Figure A7. SEM image of the lower corner of hole LD-1 showing a crack and corrosion pits at the outboard aft quadrant.

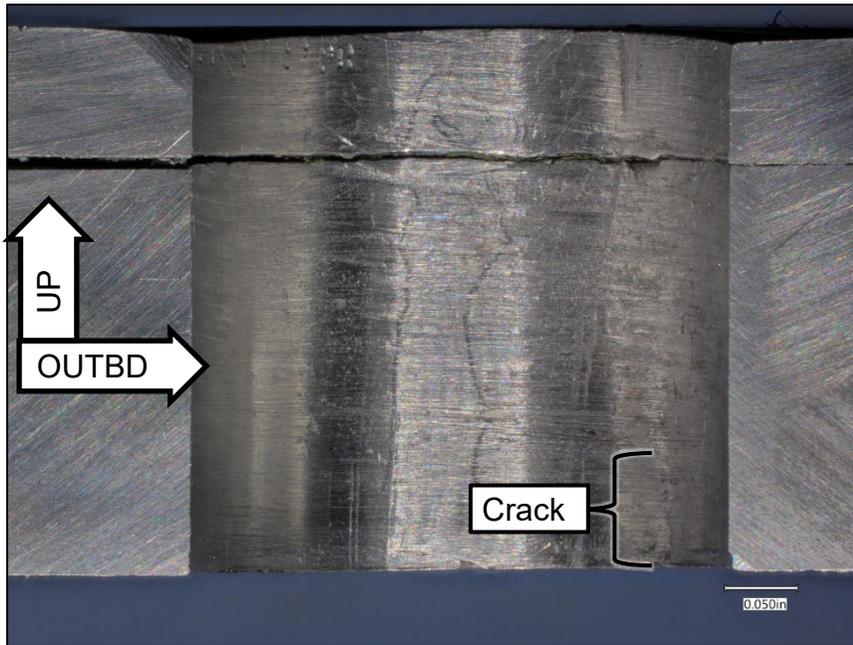
Next, a line of cyanoacrylate gel adhesive was applied to the trailing edge at the joint between the doubler and the spar piece and was allowed to dry. Then the spar was sectioned longitudinally through the hole LD-1 through 5 axes to facilitate a direct view of the hole bores. A view of the LD-1 bore after sectioning is shown in figure A8. The crack was visible at the lower end of the hole bore as indicated in figure A8. No crack was detected in the upper portion of the hole bore through the spar cap or in the doubler on the upper side of the spar cap.

Figure A8. Optical image of the aft side of the hole LD-1 bore showing a crack at the outboard aft quadrant of hole LD-1.

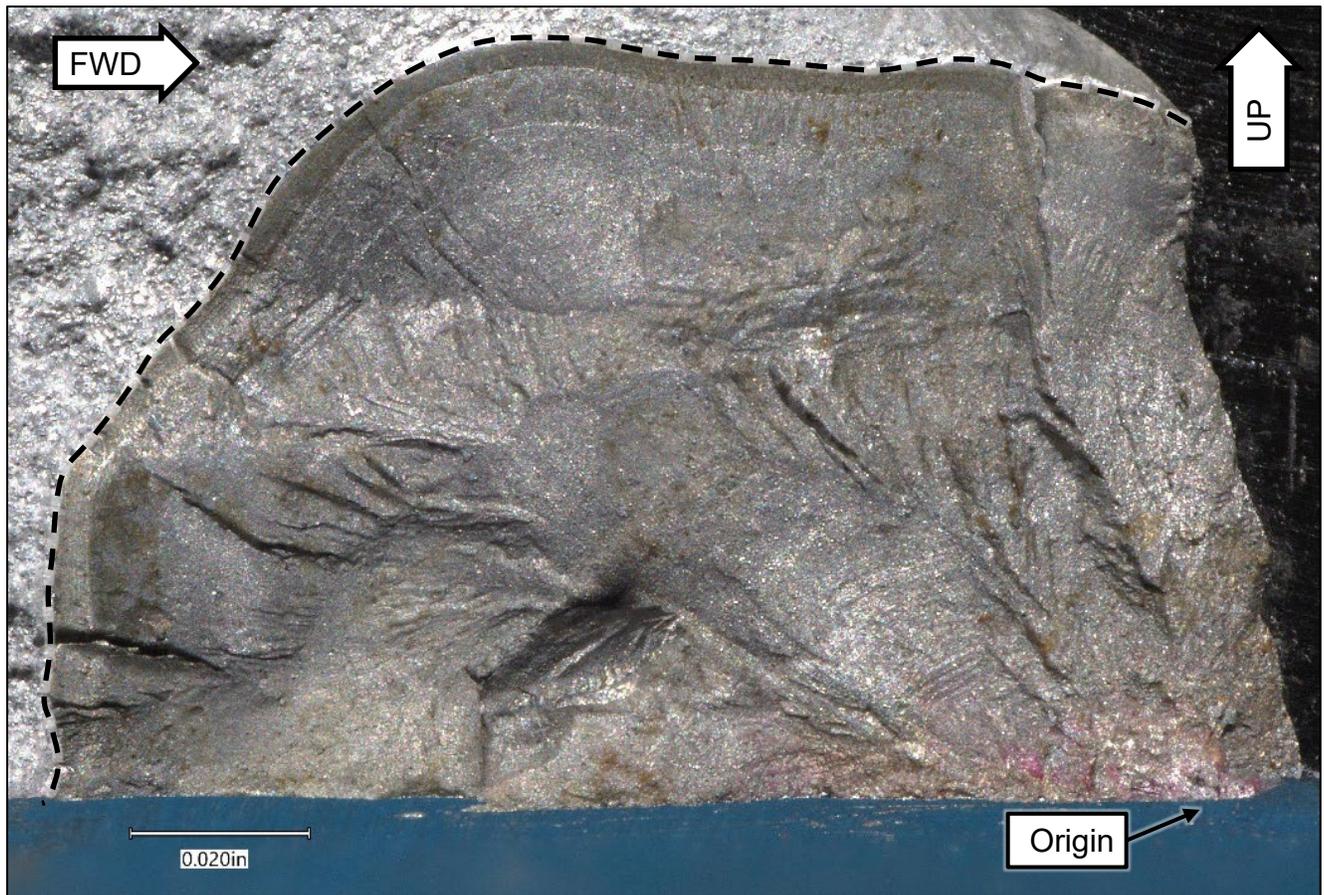
dissolve the adhesive that had been applied to the trailing edge. Then to expose the crack fracture surfaces, a V-shaped section was cut from the trailing edge of the spar toward the visible crack tip on the lower surface, and the crack was opened by lab fracture. The inboard side of the crack was then cleaned by applying acetate tape to remove loose oxides and deposits followed by ultrasonic cleaning while submerged in acetone. An optical image of the crack surface after the initial cleaning is shown in figure A9. The image was acquired with a Keyence VHX-7000 microscope using a depth-up focus function.¹ Radial features and curving crack arrest lines consistent with fatigue emanated from an origin area at the lower edge of the fracture surface aft of hole LD-1 as indicated in figure A9. A dashed line in figure A9 indicates the fatigue crack boundary, which extended 0.140 inch aft of the hole at the lower surface and 0.076 inch upward from the lower surface at the hole LD-1 bore.

Figure A9. Inboard side of the crack after opening and acetate-tape cleaning.

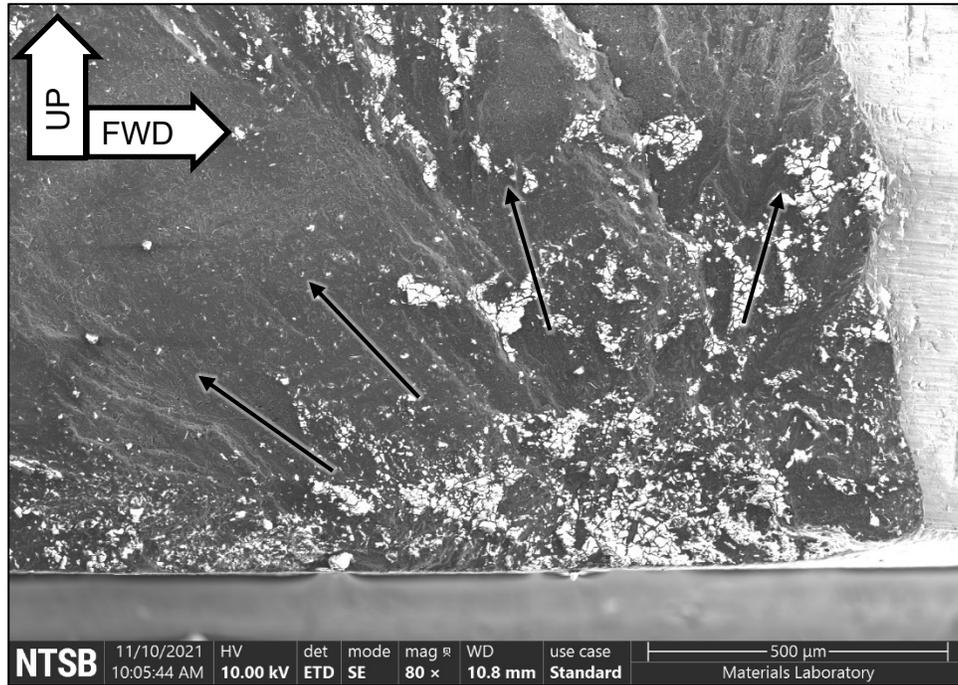
The fracture surface was then examined using the SEM, and an SEM image of the fatigue origin area is shown in figure A10. Unlabeled arrows in figure A10 indicate general directions of crack propagation away from the origin area that was mostly obscured by oxides and deposits. The oxides at the origin area were analyzed using energy dispersive x-ray spectroscopy (EDS), and a typical spectrum is shown in figure A11. The EDS spectrum of the oxides and deposits at the origin area included a small peak of chlorine.

Figure A10. SEM image of the crack origin area after acetate-tape cleaning.

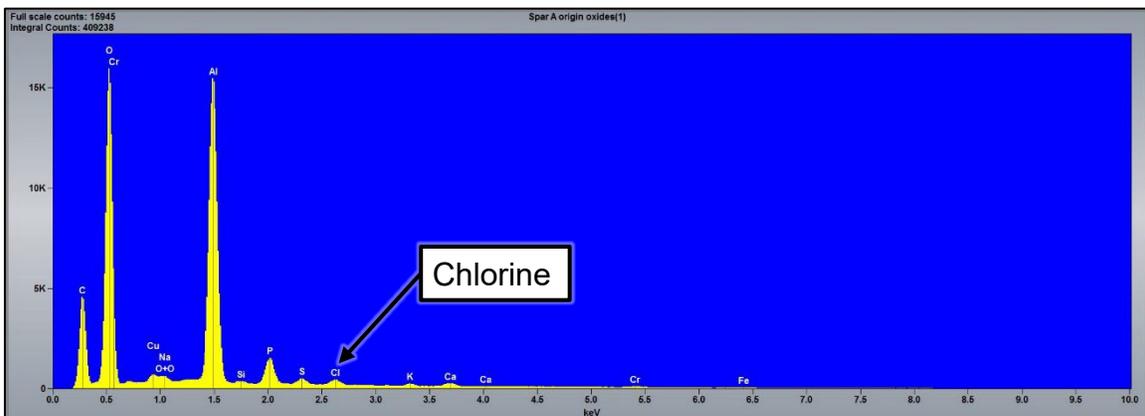
Figure A11. EDS spectrum of oxides and deposits near the origin on the acetate-tape cleaned surface (accelerating voltage = 10 kV).

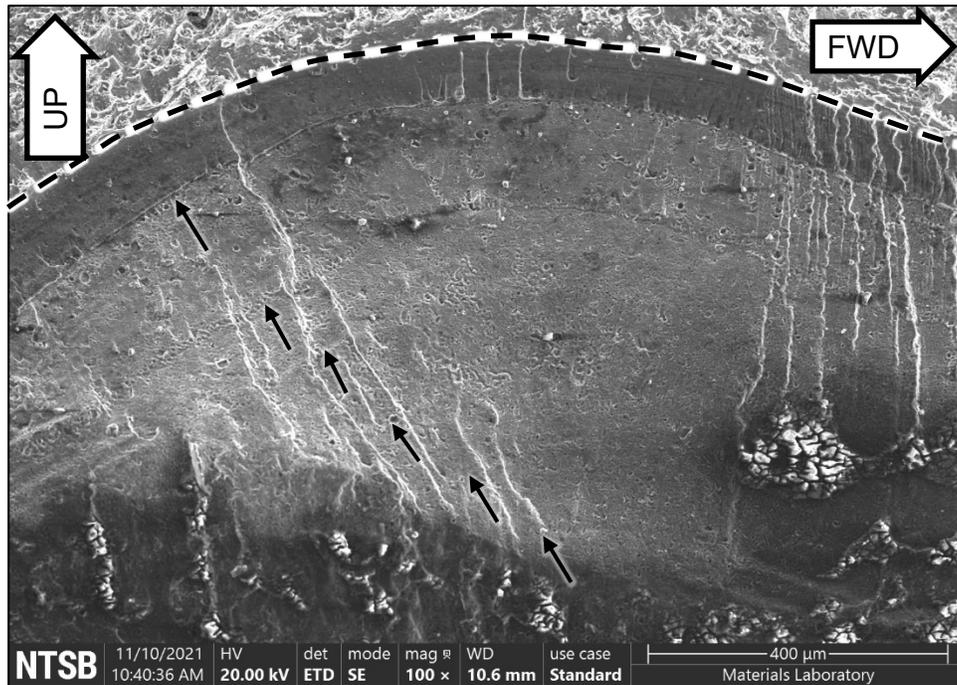
An SEM image of fracture features at the fatigue boundary is shown in figure A12. Unlabeled arrows in figure A12 indicate multiple relatively prominent crack arrest lines that were observed at relatively low magnification. A distinct change in fracture features was observed between the last prominent arrest line and the boundary, which could indicate a change in airplane usage or storage environment.

Figure A12. SEM image of the crack boundary after acetate-tape cleaning. Unlabeled arrows indicate relatively prominent crack arrest lines.

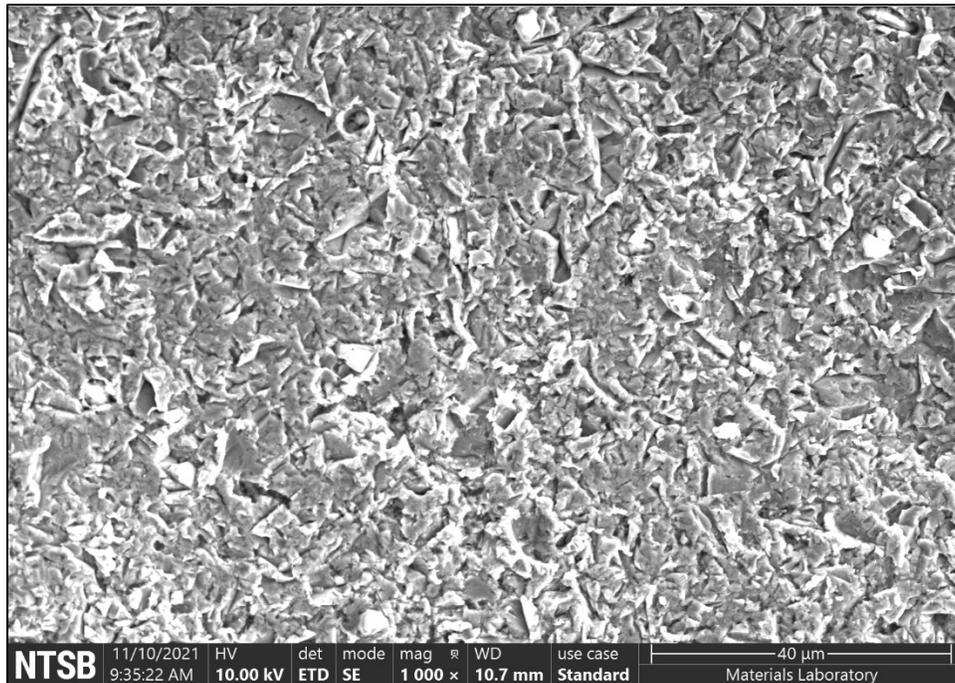
Fracture features across most of the fatigue region were substantially damaged with faceted impressions and rubbed features. An SEM image of the fracture surface in the damaged area is shown in figure A13. Multiple faceted nonconductive particles were found embedded in the damaged surface, and EDS analyses of the particles had spectra such as those shown in figure A14. High peaks of aluminum and oxygen consistent with aluminum oxide (corundum) were observed on some faceted particles, and others had high peaks of silicon and oxygen consistent with silica (quartz).

Figure A13. SEM image of fracture surface damage as observed across most of the fatigue region.

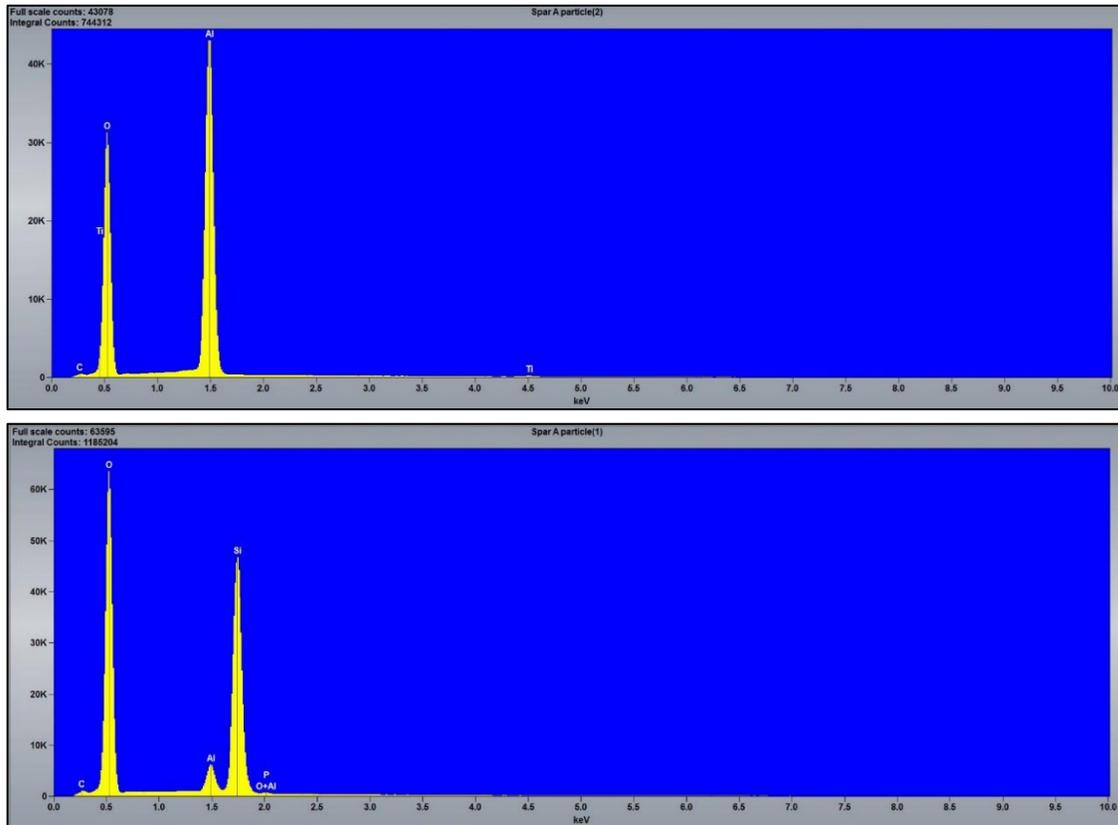
Figure A14. EDS spectra of nonconductive faceted particles observed embedded in the fracture surface (accelerating voltage = 10 kV).

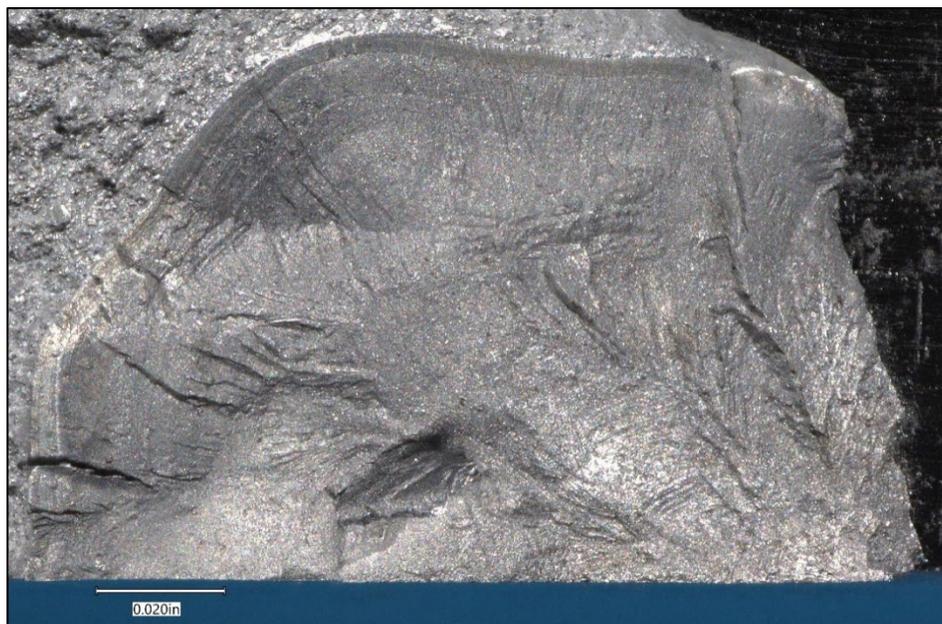
The inboard side of the lab fracture was cleaned using a heated aqueous solution of chromic acid and phosphoric acid for removing oxides on aluminum. An optical image of the fatigue region after oxide removal is shown in figure A15, and a montage of SEM images of the same area is shown in figure A16. A fatigue origin was observed on the lower surface approximately 0.012 inch away from the hole bore as indicated in figures A17 and A18. The origin area was damaged by corrosion pitting. However the surface showed hints of fine radial features emanating from a semi-circular pitted area that measured up to 0.0006 inch deep.

Figure A15. Optical image of the fracture surface after oxide removal.

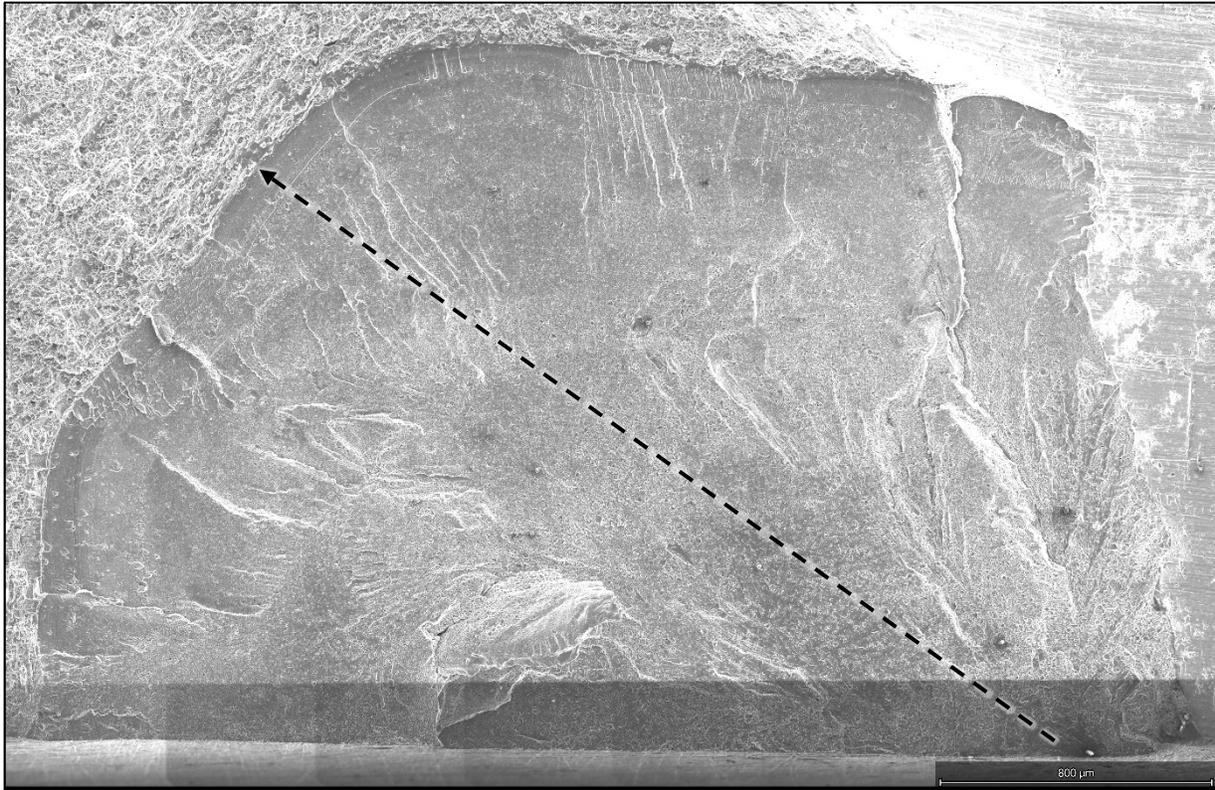
Figure A16. Montage of SEM images showing the fracture surface after oxide removal.

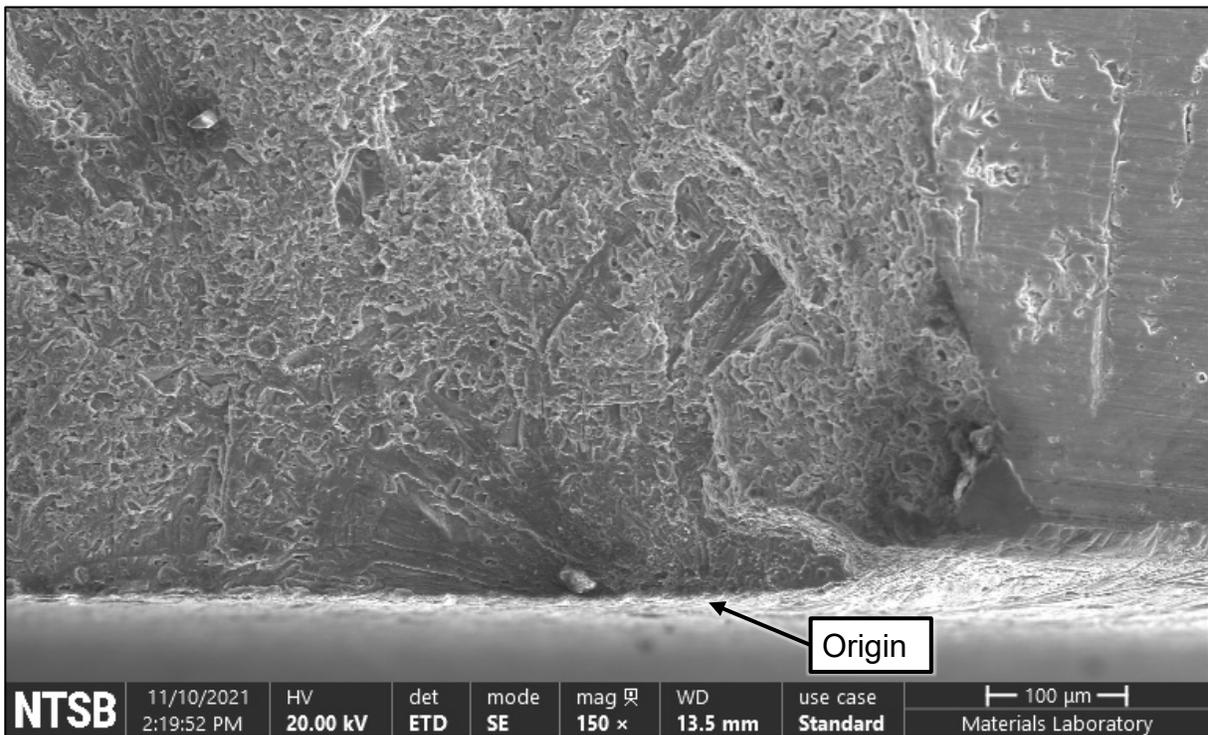
Figure A17. SEM image of the fatigue origin area after oxide removal.

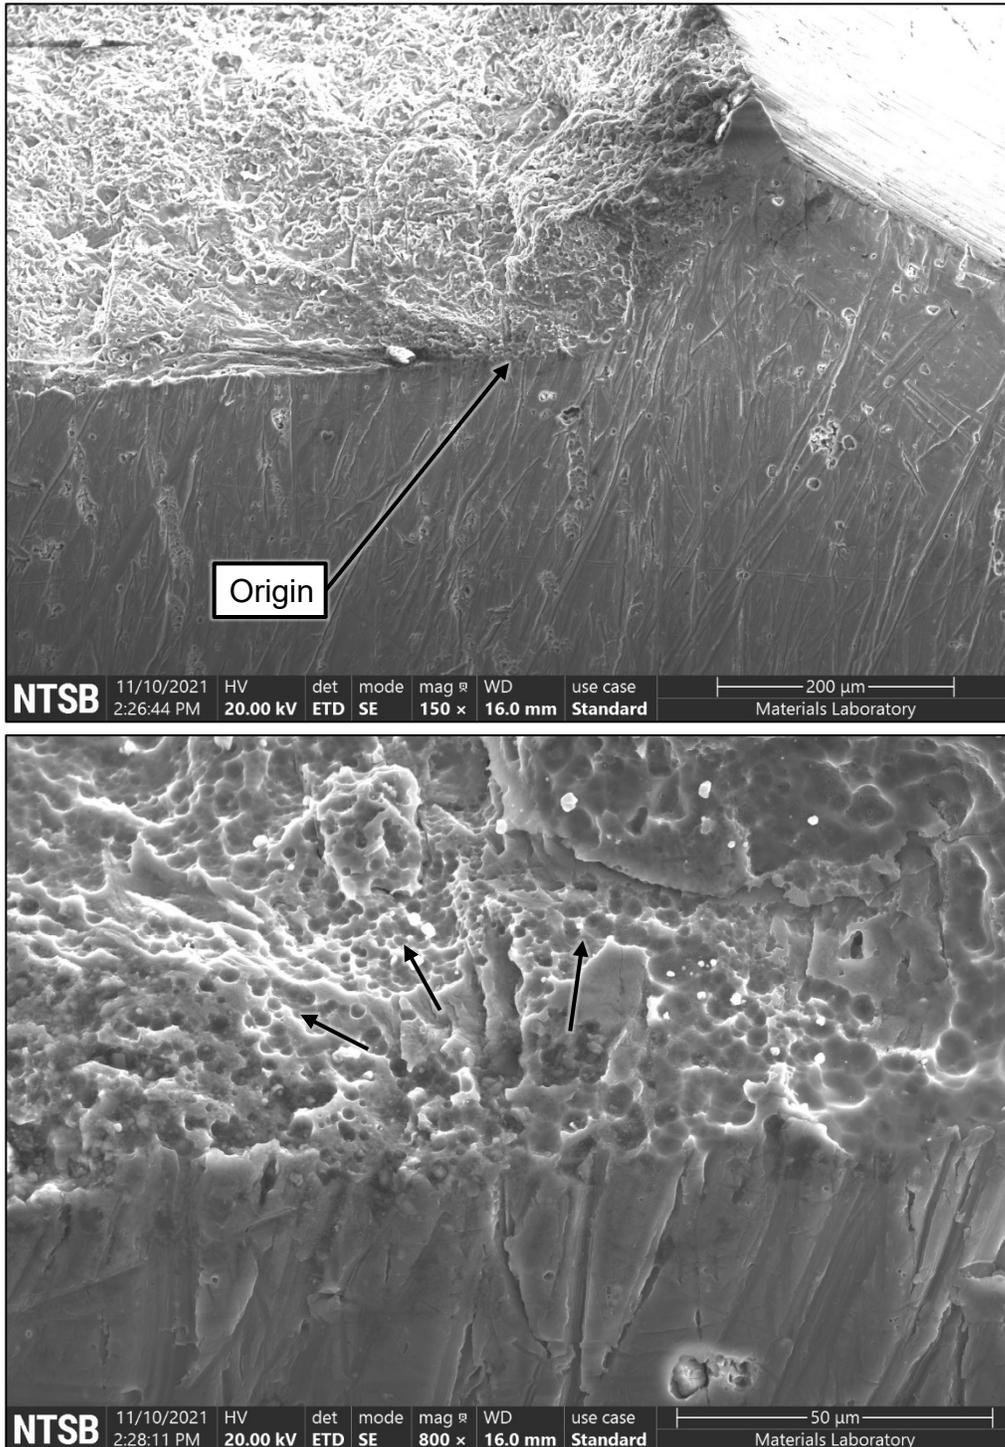
Figure A18. Oblique views of the fatigue origin after oxides removal. Unlabeled arrows in the lower image indicate fracture propagation based on apparent radial features emanating from the origin.

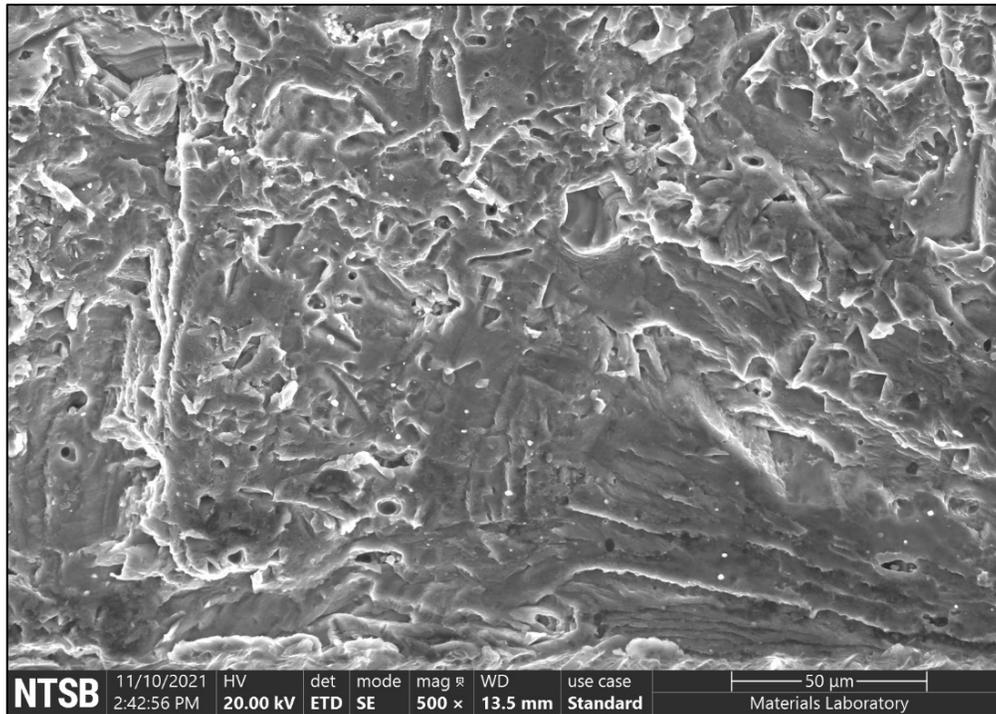
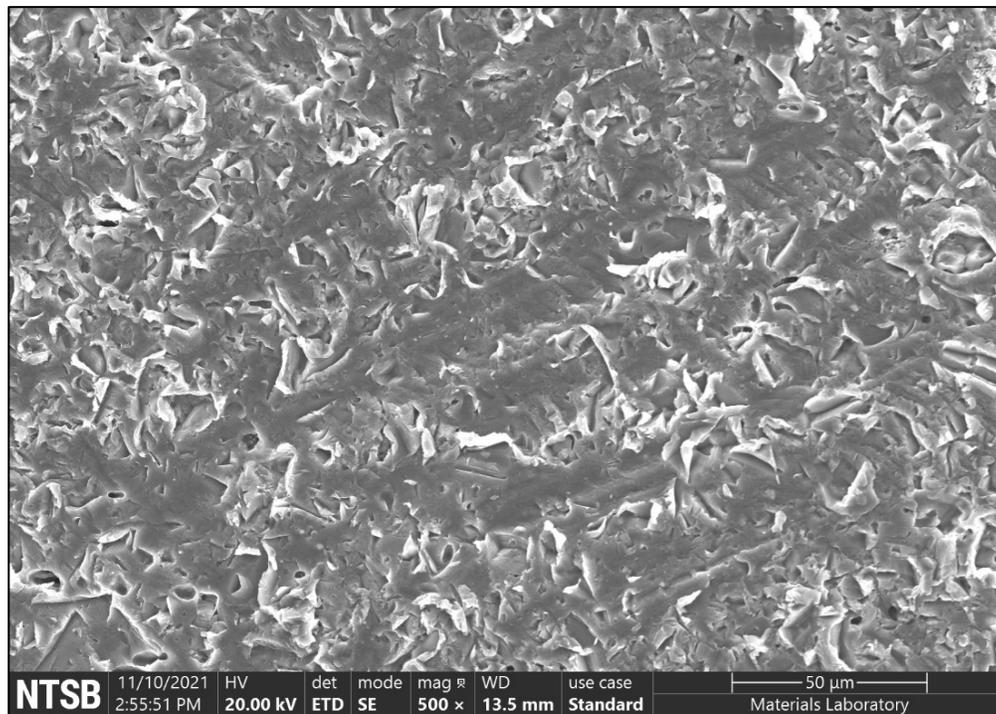
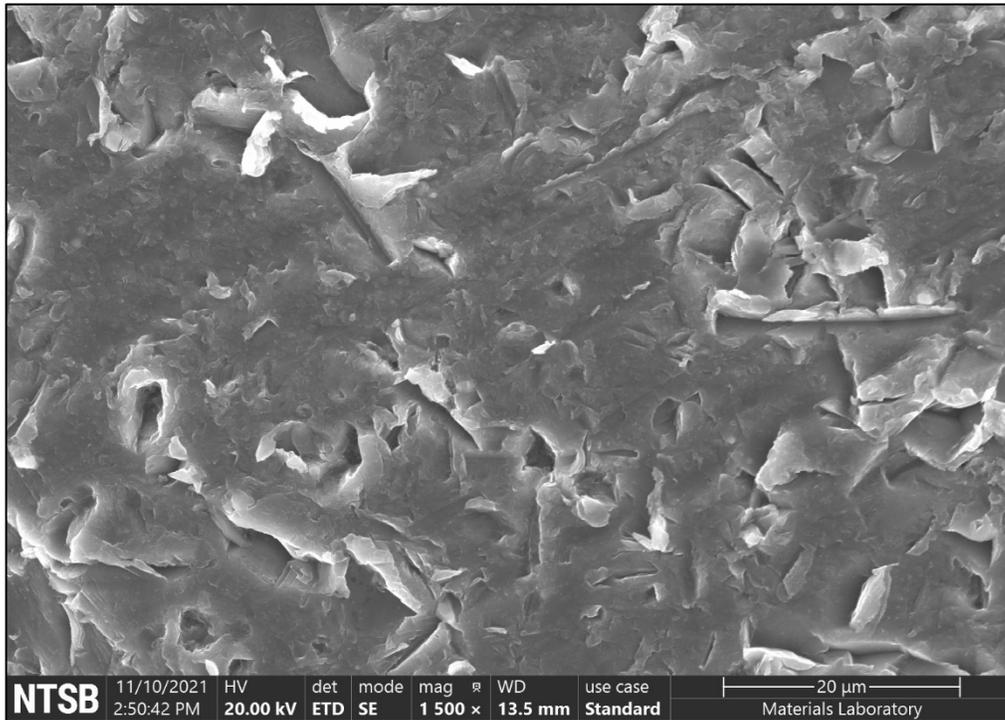
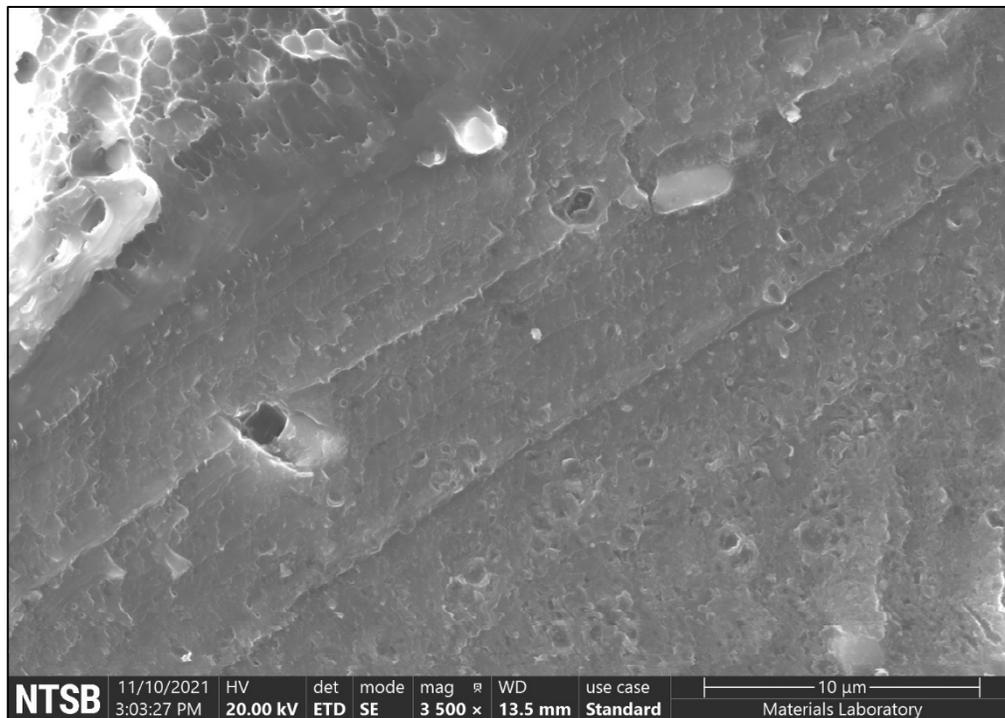
Striations and crack arrest lines consistent with fatigue crack growth under spectrum loading conditions were observed on the fracture surface as shown in figures A19 to A22. The images were generally taken along a path indicated with a dashed line in figure A16. Many of the finer fracture features were obscured or destroyed by post-fracture damage from hard particles or oxidation, particularly near the origin area.

Figure A19. SEM image of fatigue features 0.0106 inch from the origin (oxides removed).

Figure A20. SEM image of fatigue features 0.0328 inch from the origin (oxides removed).

Figure A21. SEM image of fatigue features 0.0492 inch from the origin (oxides removed).

Figure A22. SEM image of fatigue features at the fatigue boundary located 0.116 inch from the origin (oxides removed).
