NATIONAL TRANSPORTATION SAFETY BOARD

MATERIALS LABORATORY FACTUAL REPORT

Report No. 21-091

Place : Daytona Beach, Florida
Date : April 4, 2018
Vehicle : Piper PA-28R-201, N106ER
NTSB No. : ERA18FA120
Investigator : Aaron McCarter, AS-ERA / Clinton R. Crookshanks, AS-40

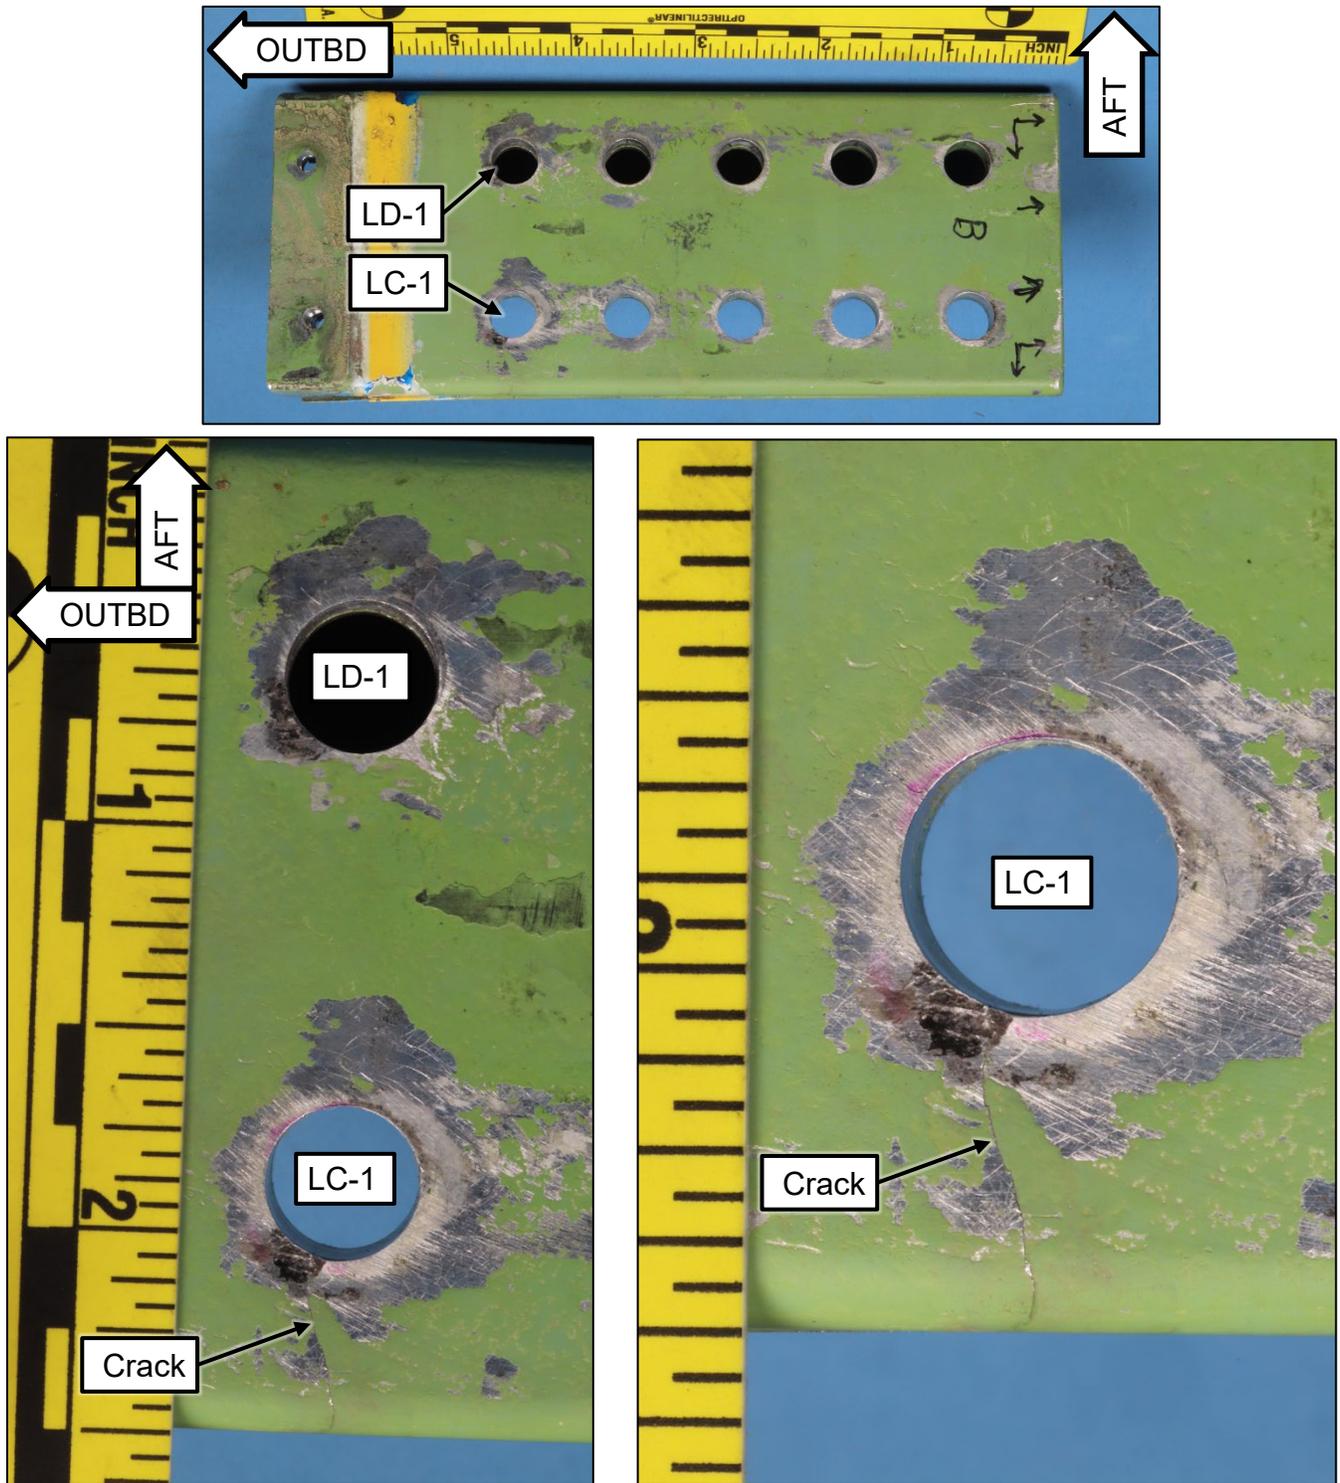
Views of the lower surface of the spar B piece are shown in figure B1. A crack was observed at the forward side hole LC-1 and was visible on the lower surface forward to the spar leading edge as shown in figure B2.

Figure B1. Spar B lower surface after wiping surfaces with acetone.

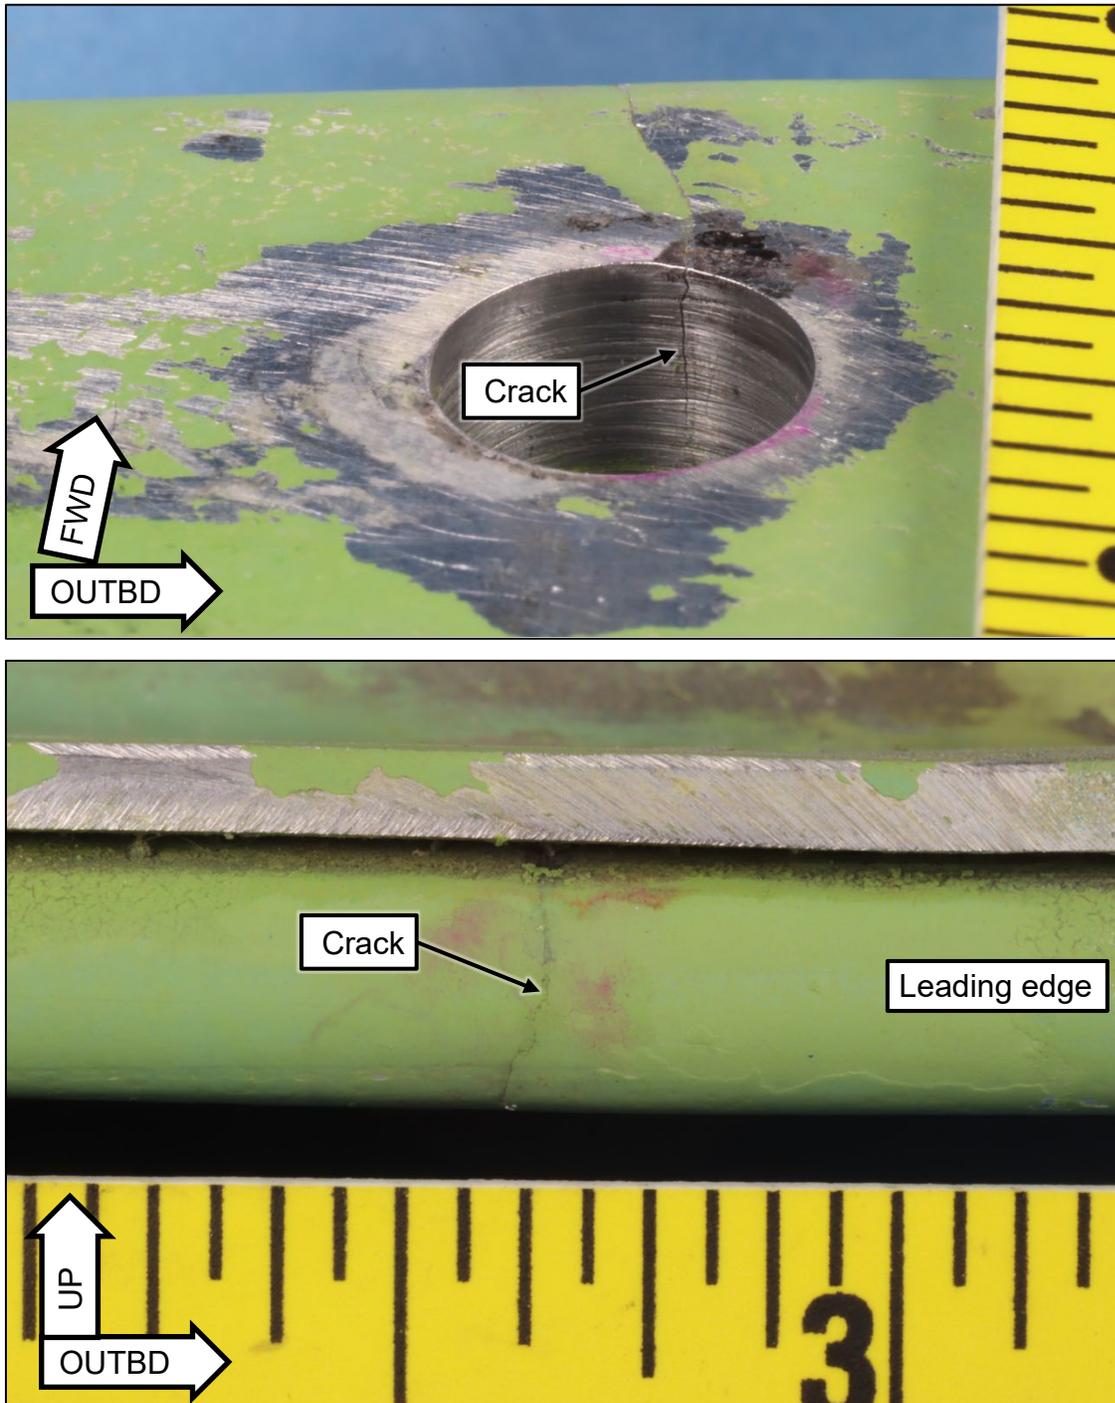
Figure B2. Crack intersecting hole LC-1 and leading edge.

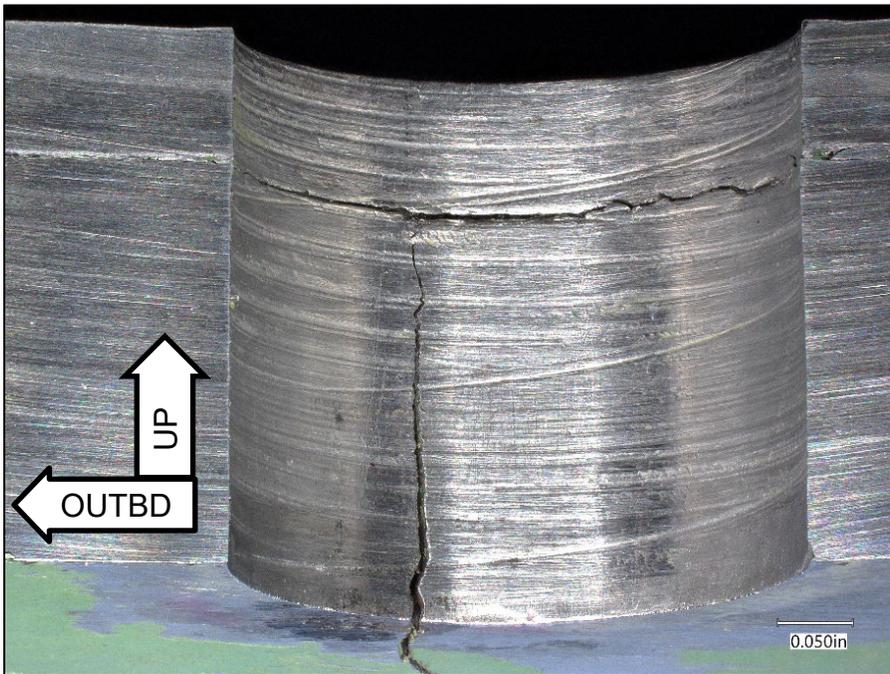
Next, a line of cyanoacrylate gel adhesive was applied to the leading edge between the doubler and the spar piece and was allowed to dry. Then the spar was sectioned longitudinally through the hole LC-1 through 5 axes to facilitate a direct view of the hole bores. A view of the crack in the forward side of the hole LC-1 bore after sectioning is shown in figure B3. The crack was visible intersecting the hole surface along the entire length of the hole in the spar. No crack was detected in the doubler on the upper side of the spar cap.

Figure B3. Forward side of hole LC-1 after sectioning.

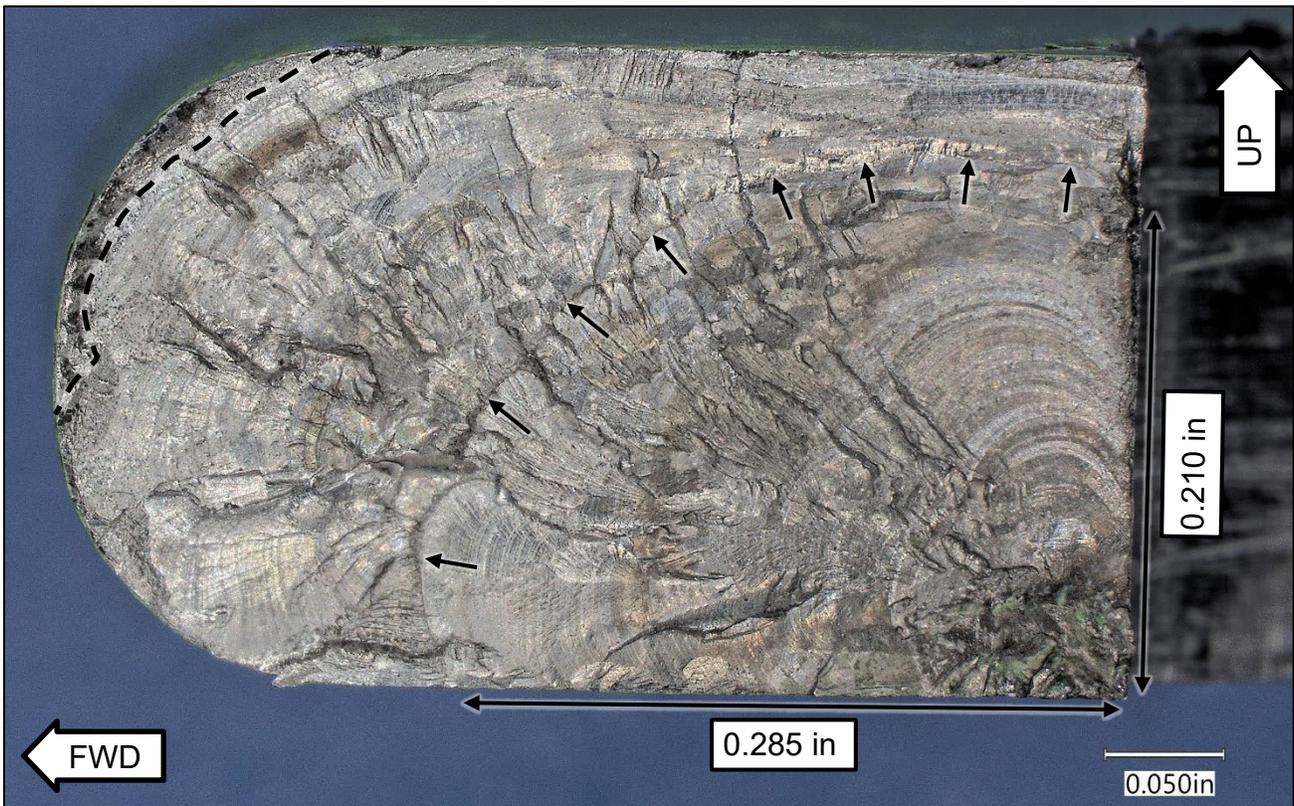
Next, the sectioned piece with the leading edge was soaked in acetone to remove the doubler by dissolving the adhesive. The crack faces then separated from each other once the doubler was removed. The inboard side of the crack was then cleaned by applying acetate tape to remove loose oxides and deposits followed by ultrasonic cleaning while submerged in acetone. A view of the fracture surface after initial cleaning is shown in figure B4. Fracture features consistent with fatigue were observed across most of the fracture surface to the dashed line in Figure B4. A relatively prominent crack arrest line was observed near the middle of the fracture as indicated with unlabeled arrows in Figure B4. The crack lengths associated with the relatively prominent arrest line were 0.285 inch along the lower surface and 0.210 inch upward at the hole bore as indicated in figure B4.

Figure B4. Inboard side of the fracture surface after cleaning with acetate tape and acetone. A dashed line indicates the fatigue boundary, and unlabeled arrows indicate a relatively strong crack arrest mark.

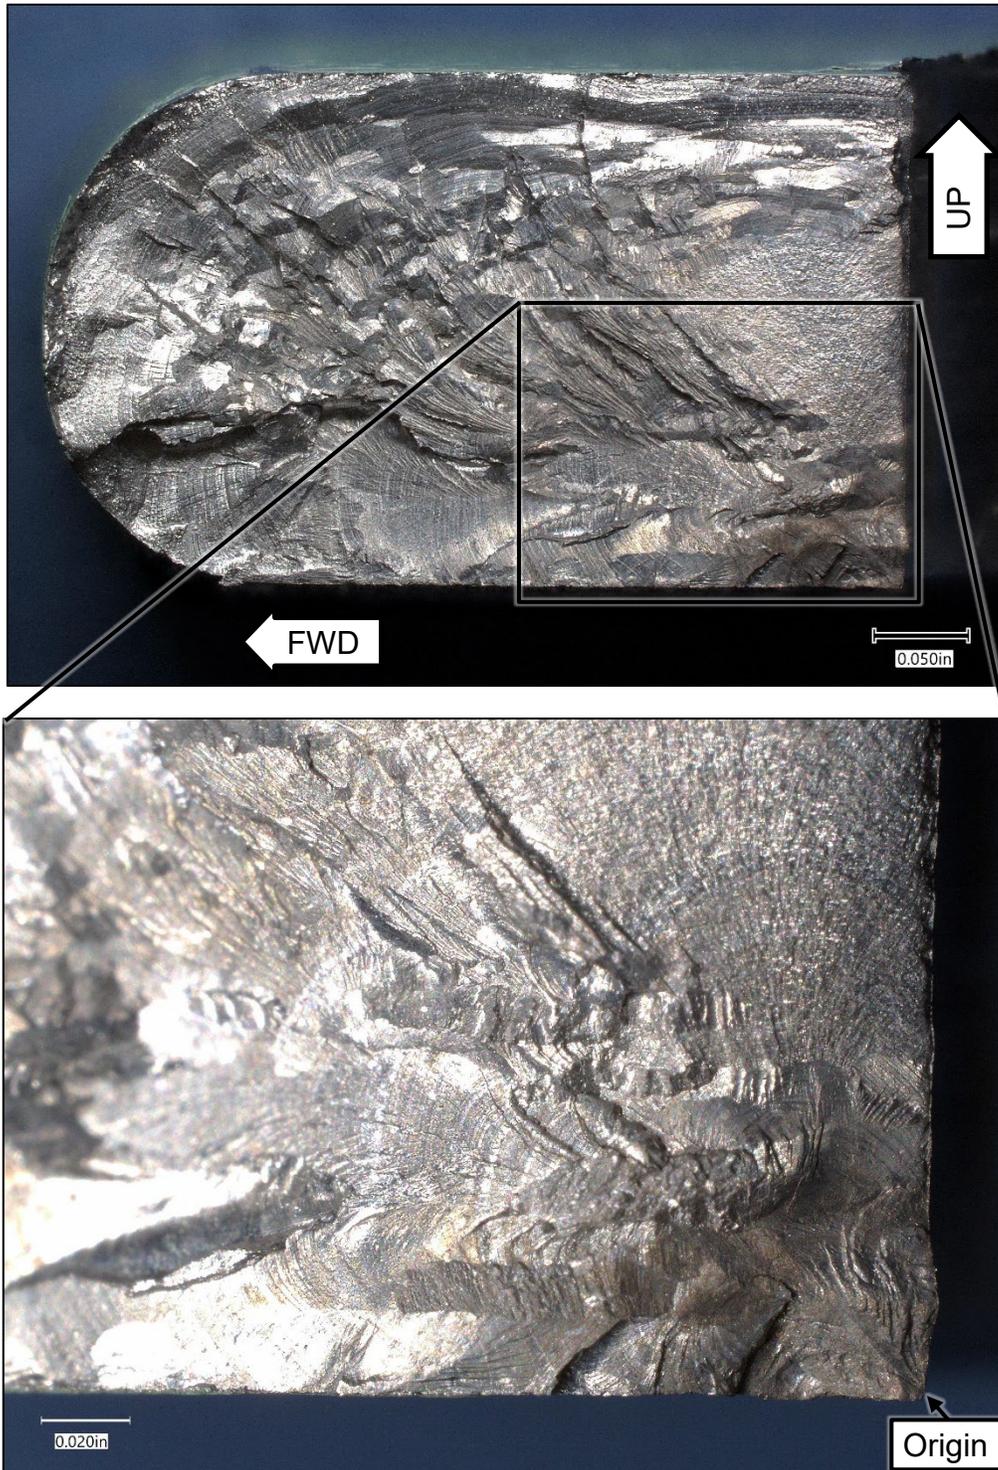
A view of the fracture surface after oxide removal is shown in figure B5. Fatigue fracture features emanated from an origin area near the lower forward corner of hole LC-1. The fracture surface with oxides removed was then further examined using an SEM. A montage of SEM images to depict the entire fatigue region and a view of the origin area at higher magnification are shown in figure B6. Fine fracture features near the origin were mostly obliterated by oxidation damage on the fracture surface. However, radial features on the fracture surface and fatigue features in isolated intact fracture surface areas (dark gray areas in figure B6) near the origin emanated from an origin area at the hole LC-1 bore near the lower surface. The origin area appeared to be located at the lower end of a corrosion pit in the hole bore measuring up to 0.00035 inch deep.

Figure B5. Inboard side of the fracture surface after oxide removal.

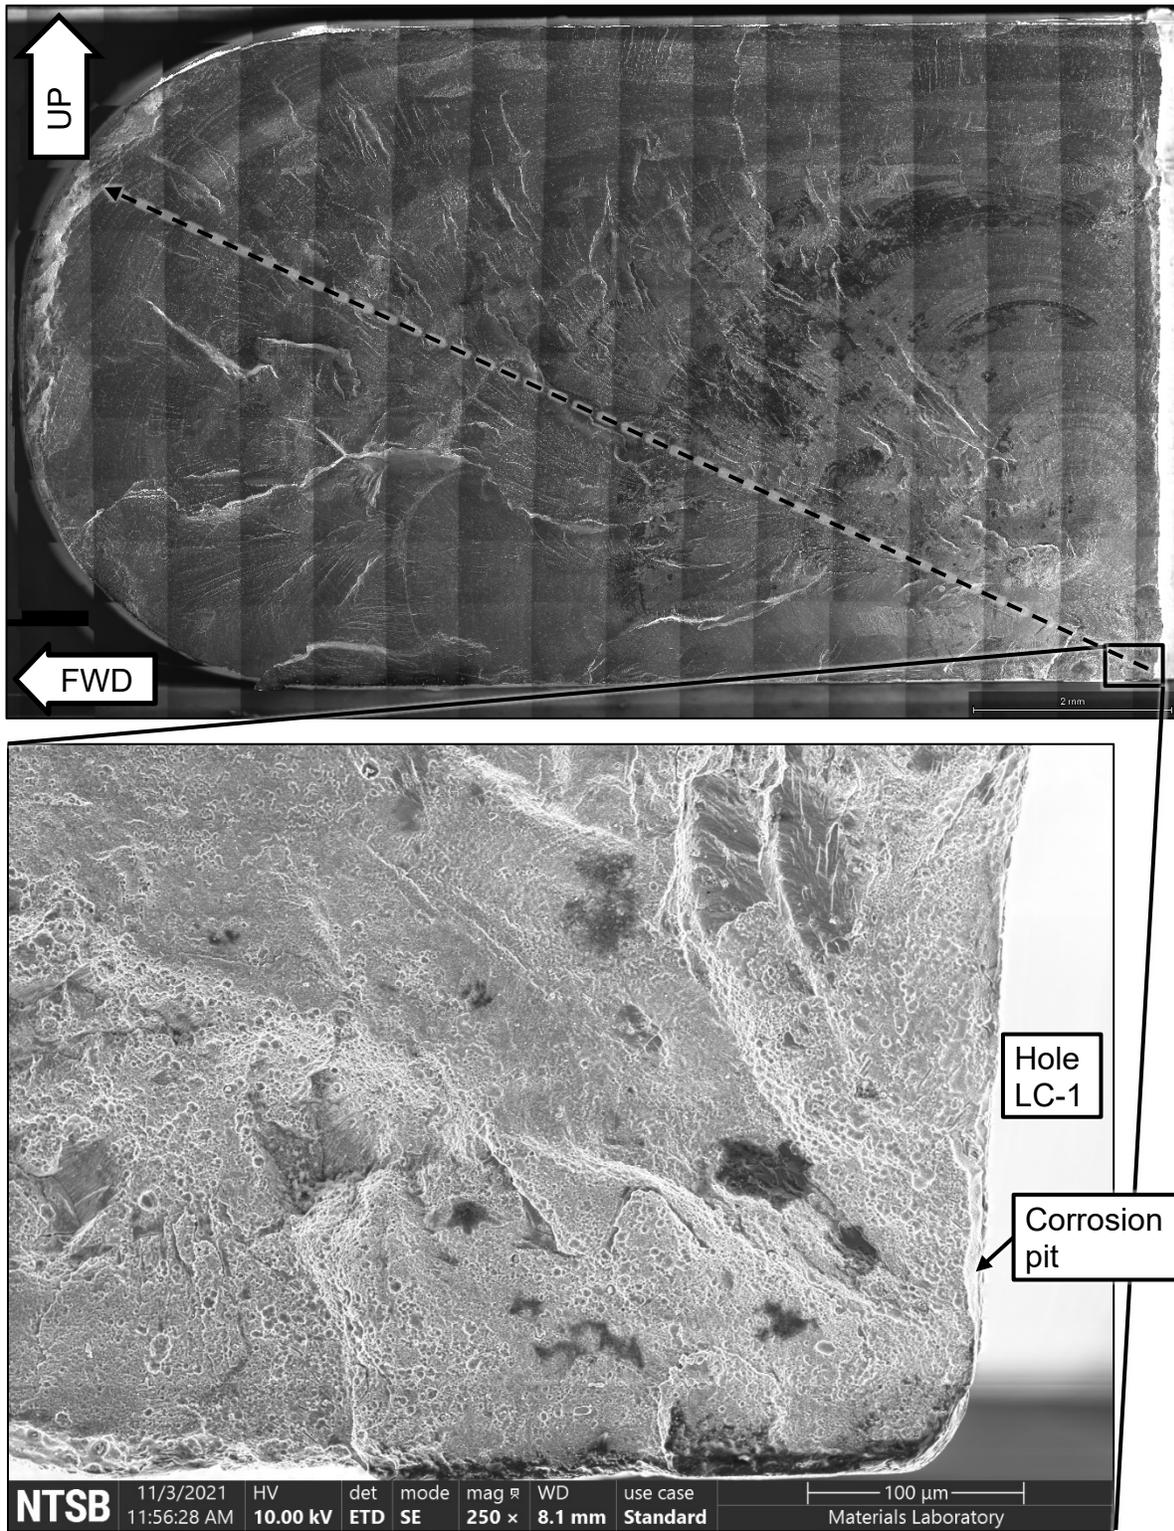
Figure B6. SEM images of the fracture surface after oxide removal.

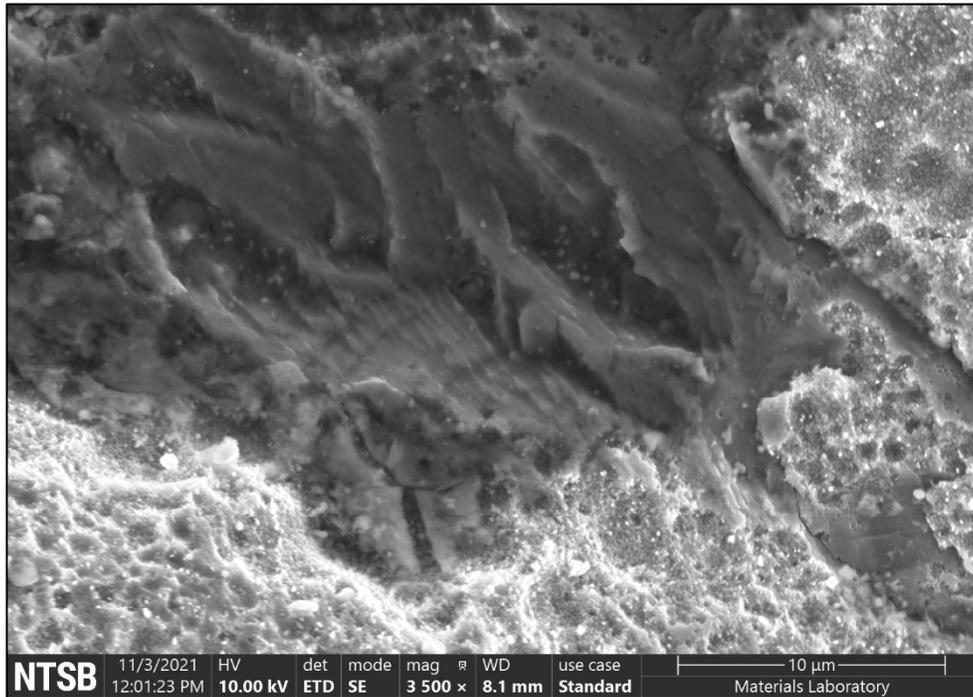
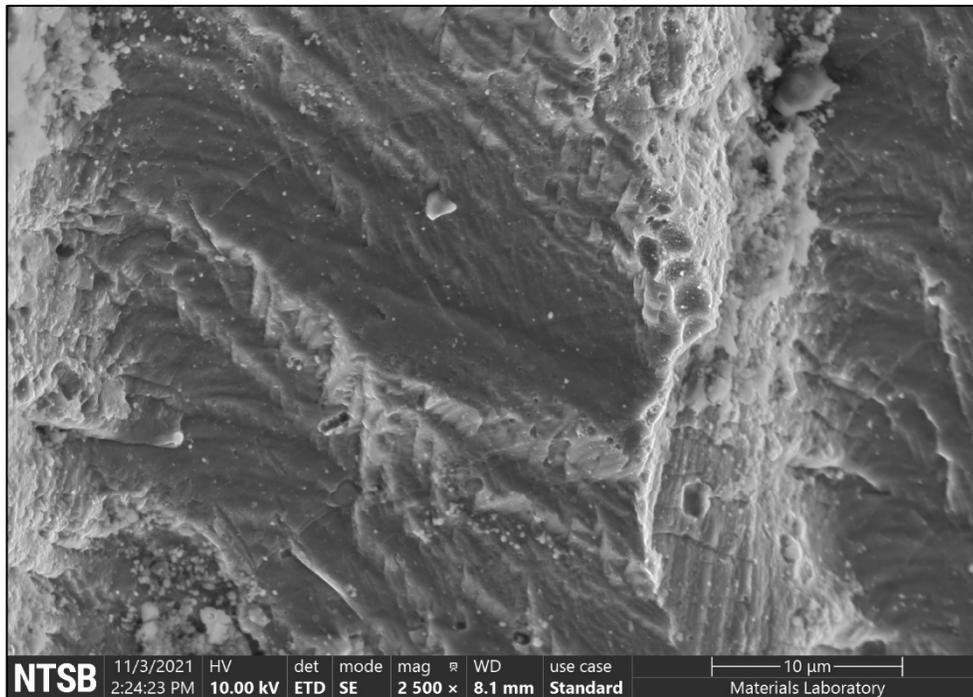
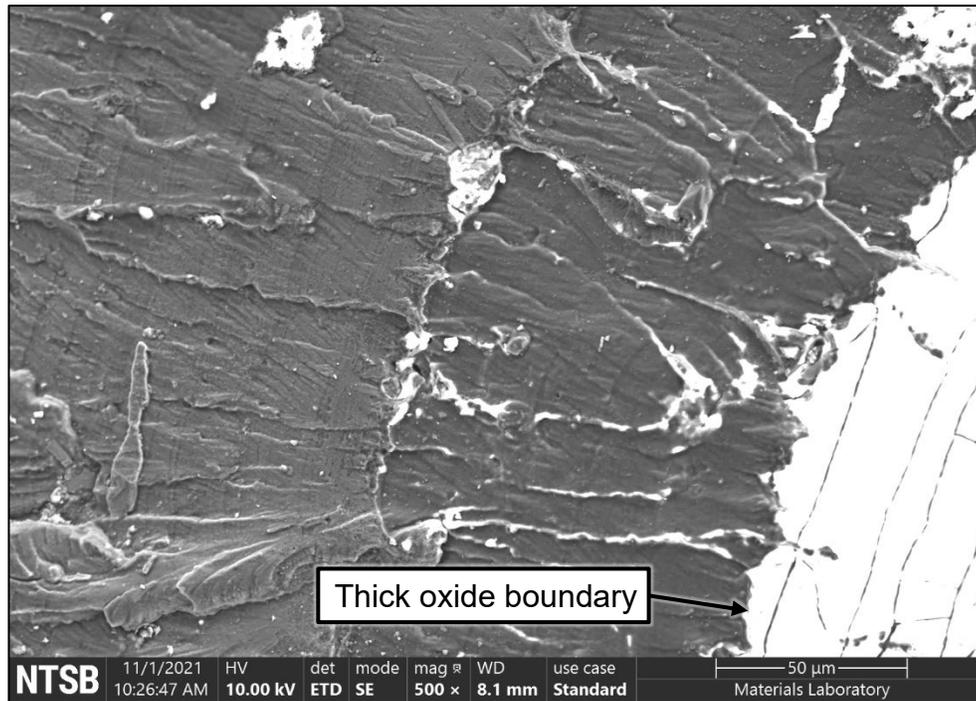
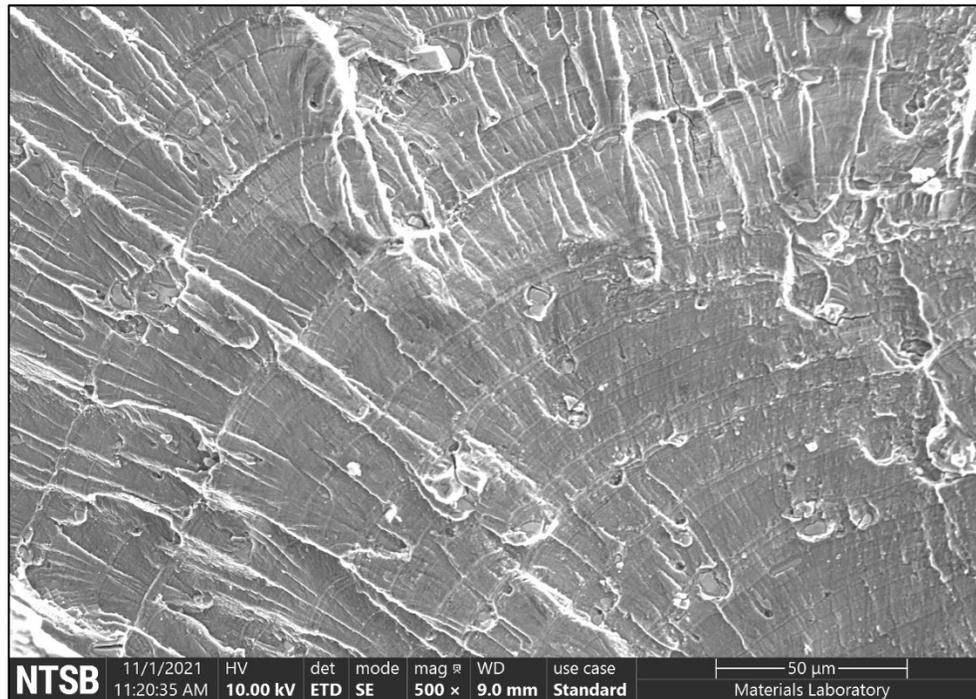
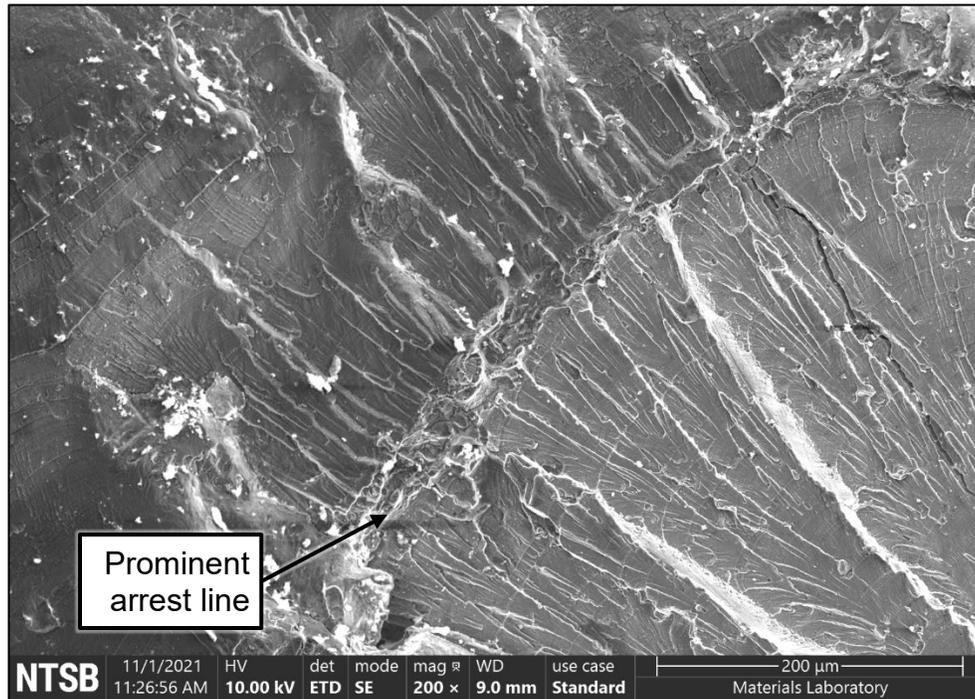
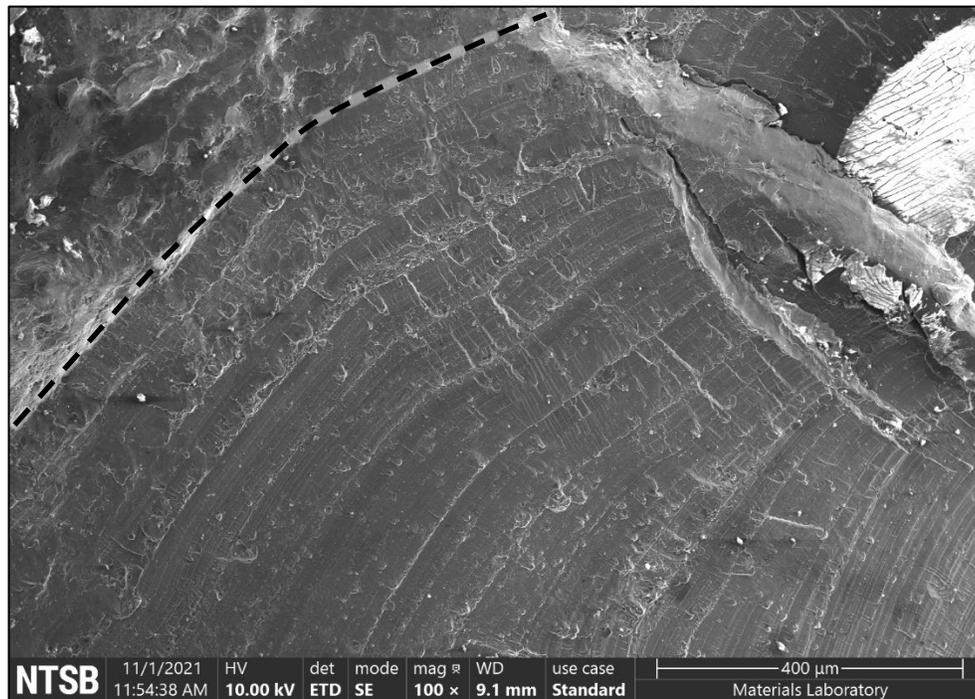
Striations and crack arrest lines consistent with spectrum loading were observed on the fracture surface as shown in figures B7 through B12. The SEM images in figures B7 through B12 show snapshots of the fracture surface along a path indicated with a dashed line in figure B6 extending forward and upward from the origin. As noted in the figure captions, SEM images close to the origin were taken after oxides had been removed, and the remaining images were taken before the oxide removal. A relatively thick and continuous oxide had been observed on much of the area near the origin up to the crack arrest line associated with the oxide boundary indicated in figure B9. The relatively prominent crack arrest line indicated with arrows in figure B4 is shown in figure B11.

Figure B7. Fatigue features 0.0024 inch from the origin (oxides removed).

Figure B8. Fatigue features 0.0089 inch from the origin (oxides removed).

Figure B9. Fatigue features 0.114 inch from the origin (before oxide removal).

Figure B10. Fatigue features 0.274 inch from the origin (before oxide removal).

Figure B11. Fatigue features 0.295 inch from the origin showing the prominent crack arrest line (before oxide removal).

Figure B12. Fatigue features at the fatigue boundary (before oxide removal).

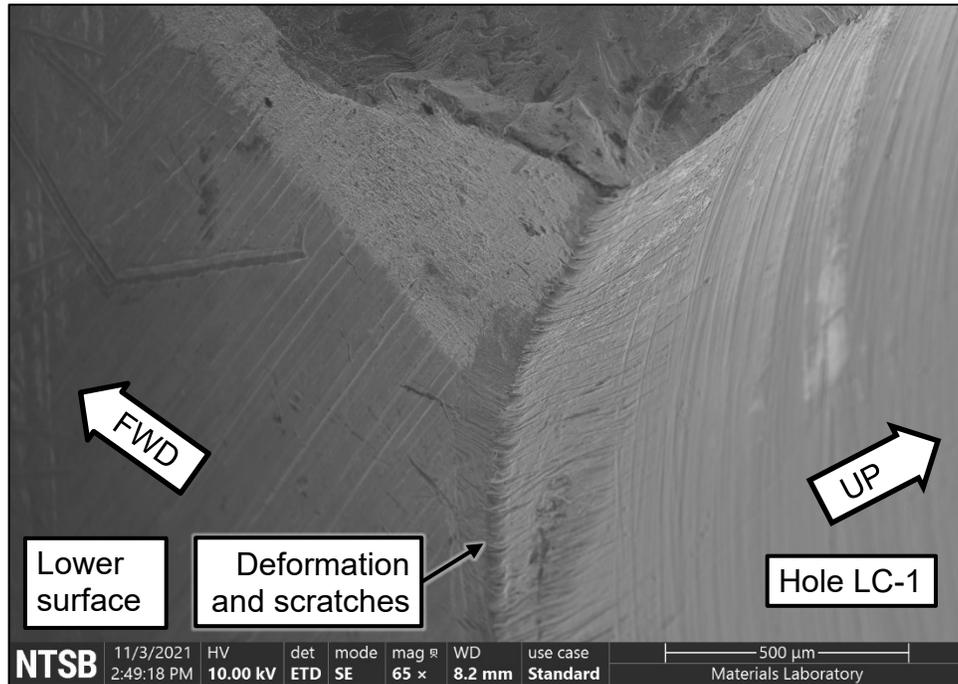
The lower forward corner of hole LC-1 was deformed slightly out of round and had vertical scratches as indicated in figures B13 and B14. Additionally, corrosion pits were observed on the hole LC-1 bore near the lower end as shown in figures B14 through B16. Secondary cracks were observed at the forward lower corner (see figure B15) and in corrosion pits in the hole LC-1 bore (see figure B16).

Figure B13. Deformed and scratched forward lower corner of hole LC-1 (after oxide removal).

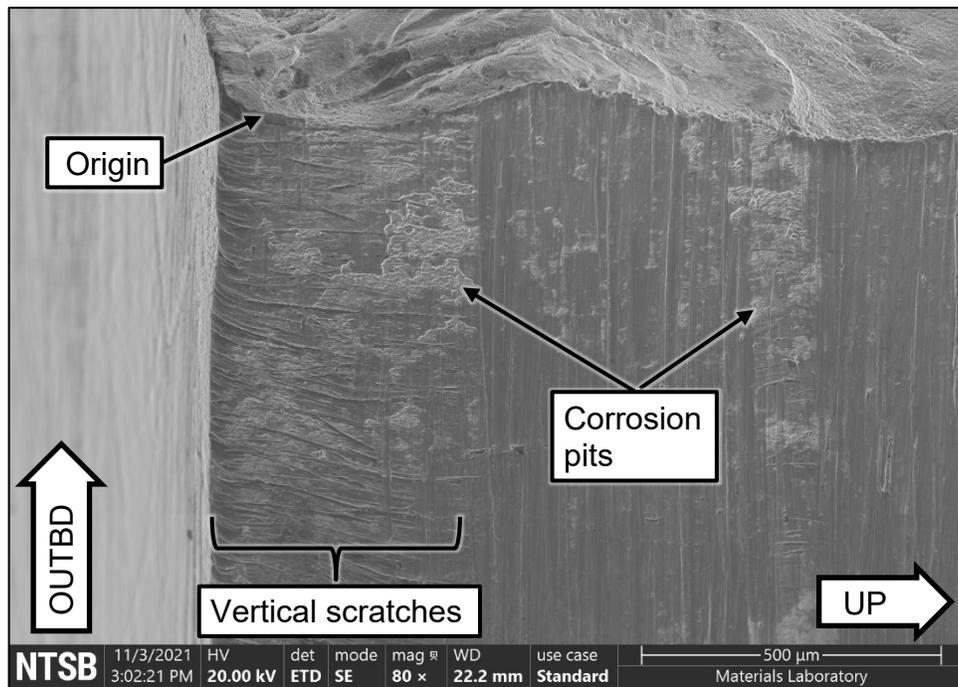
Figure B14. Hole LC-1 surface adjacent to the fatigue origin showing corrosion pits and vertical scratches (after oxide removal).

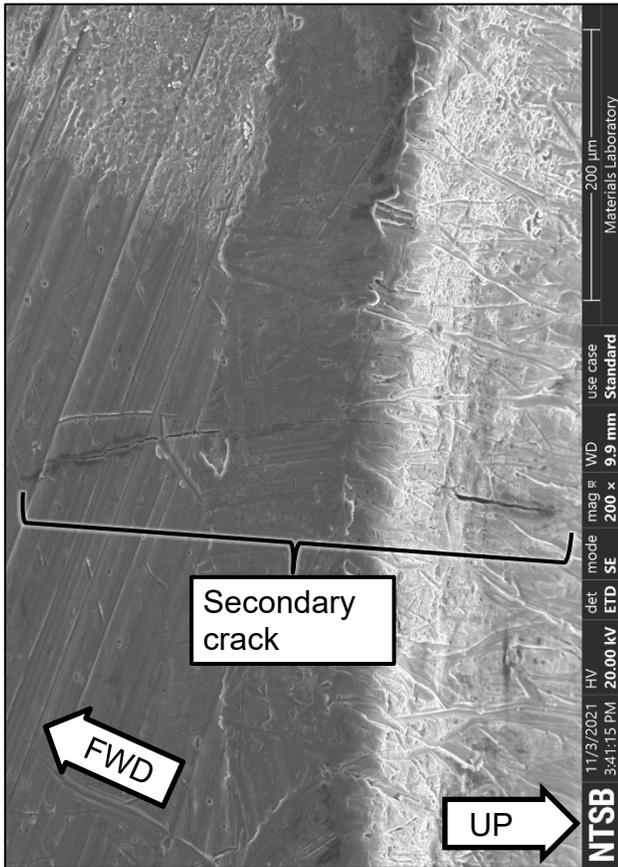
Figure B15. Secondary crack at the hole LC-1 lower forward corner (after oxide removal).

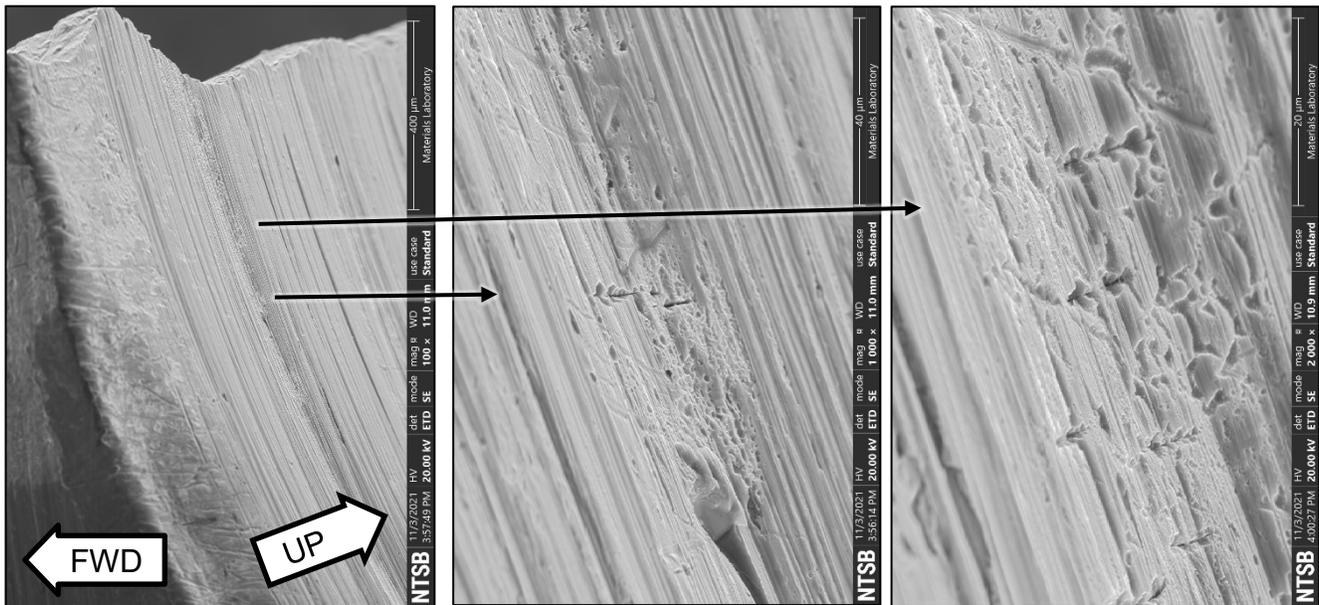
Figure B16. Secondary cracks at corrosion pits in the hole LC-1 bore (after oxide removal).

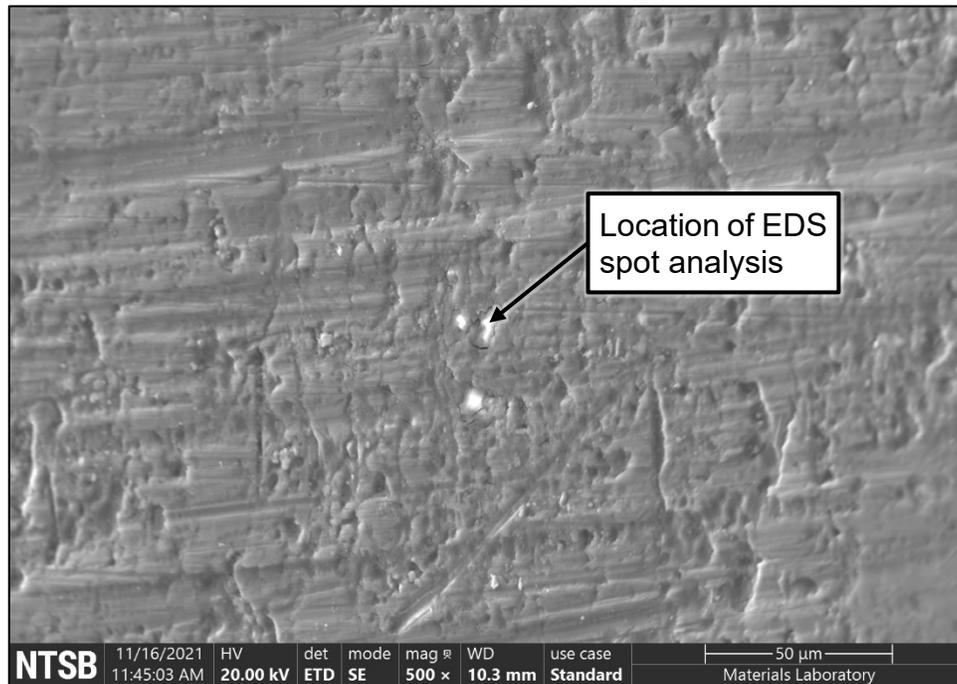
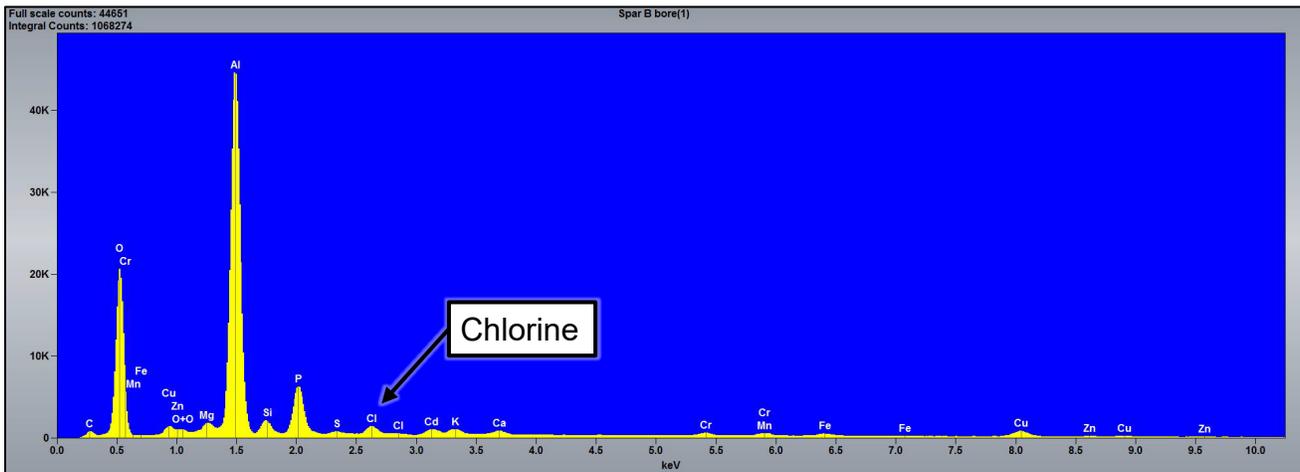
Oxides and corrosion pits on spar piece with the mating (outboard) side of the crack were examined using an SEM. The piece had been cleaned with acetone using an ultrasonic cleaner but had not been exposed to the oxide-removing solution. Corrosion pits and oxides were observed on the hole bore adjacent to the crack as shown in figure B17. One of the oxidized areas was randomly selected for analysis using EDS, and the resulting spectrum showed a peak of chlorine as indicated in figure B17.

Figure B17. SEM image of the hole LC-1 bore as cleaned with acetone (upper image). The oxide at the location indicated was analyzed using EDS, resulting in the spectrum shown.

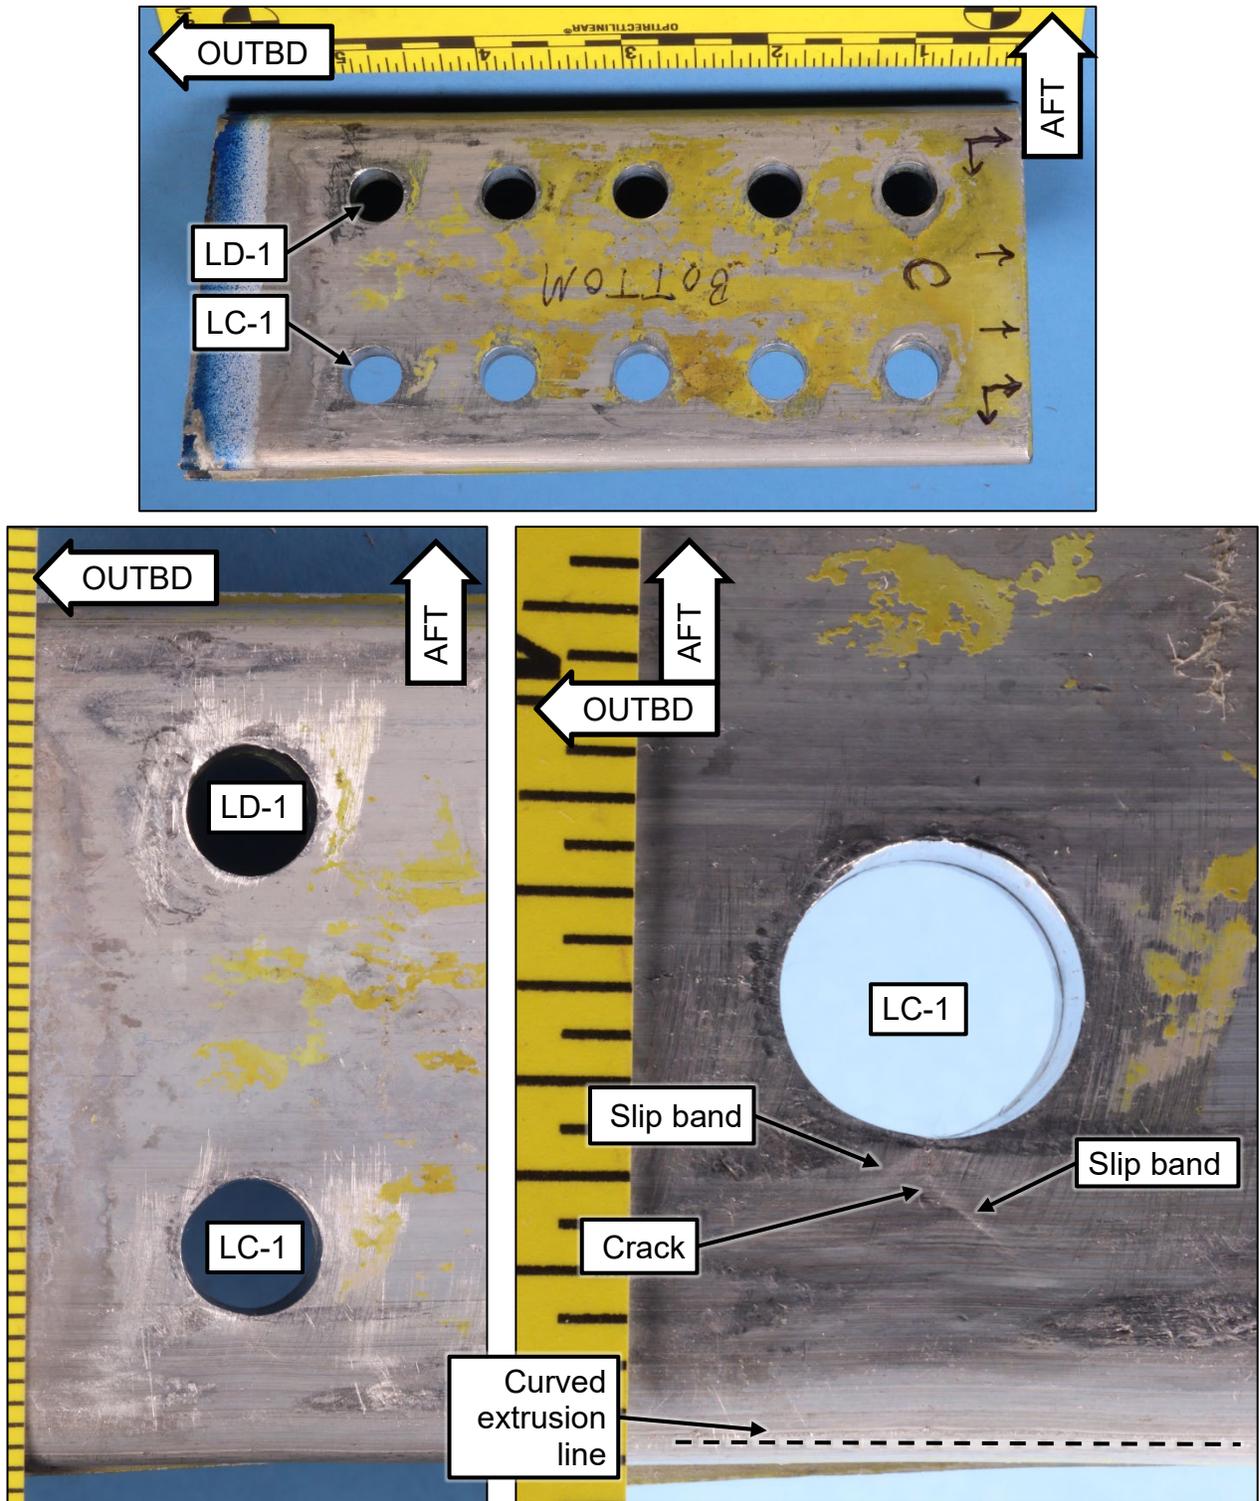
Views of the lower surface of the submitted spar C piece are shown in figure C1. A crack was observed at the forward side of hole LC-1 intersecting the lower surface and the entire length of the hole LC-1 bore on the forward side of the hole as shown in figures C1 and C2. No crack was detected in the doubler.

Figure C1. Spar C lower surface after wiping surfaces with acetone.

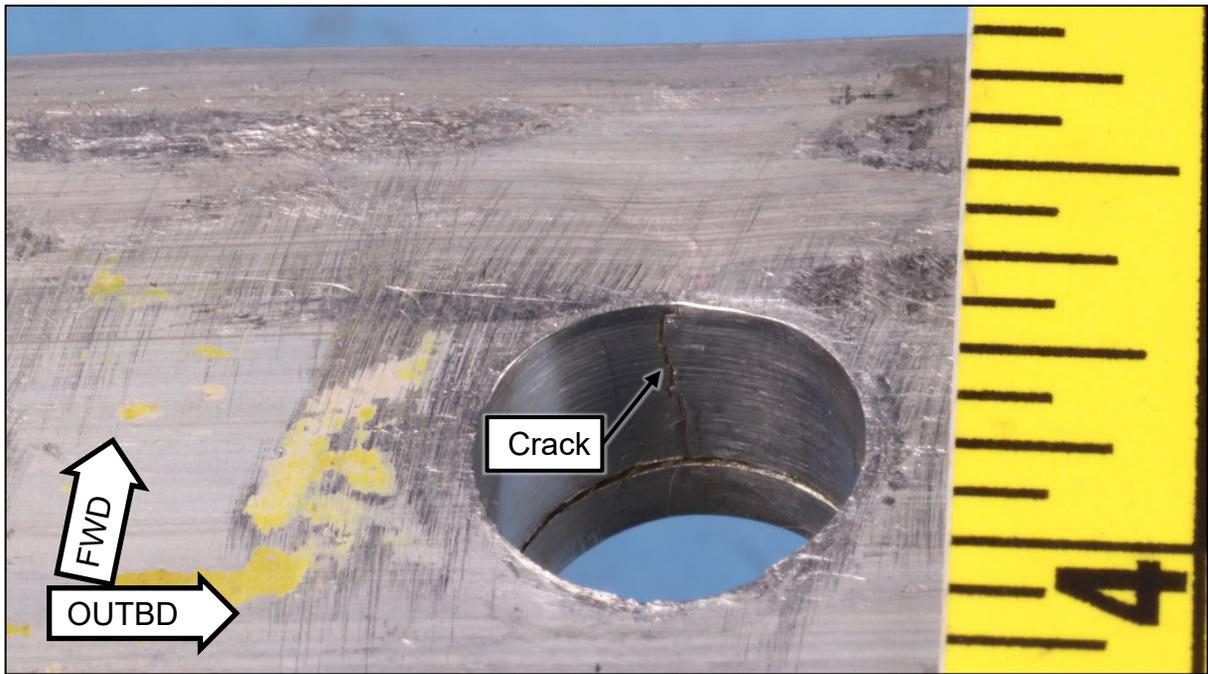
Figure C2. Crack on forward side of hole LC-1.

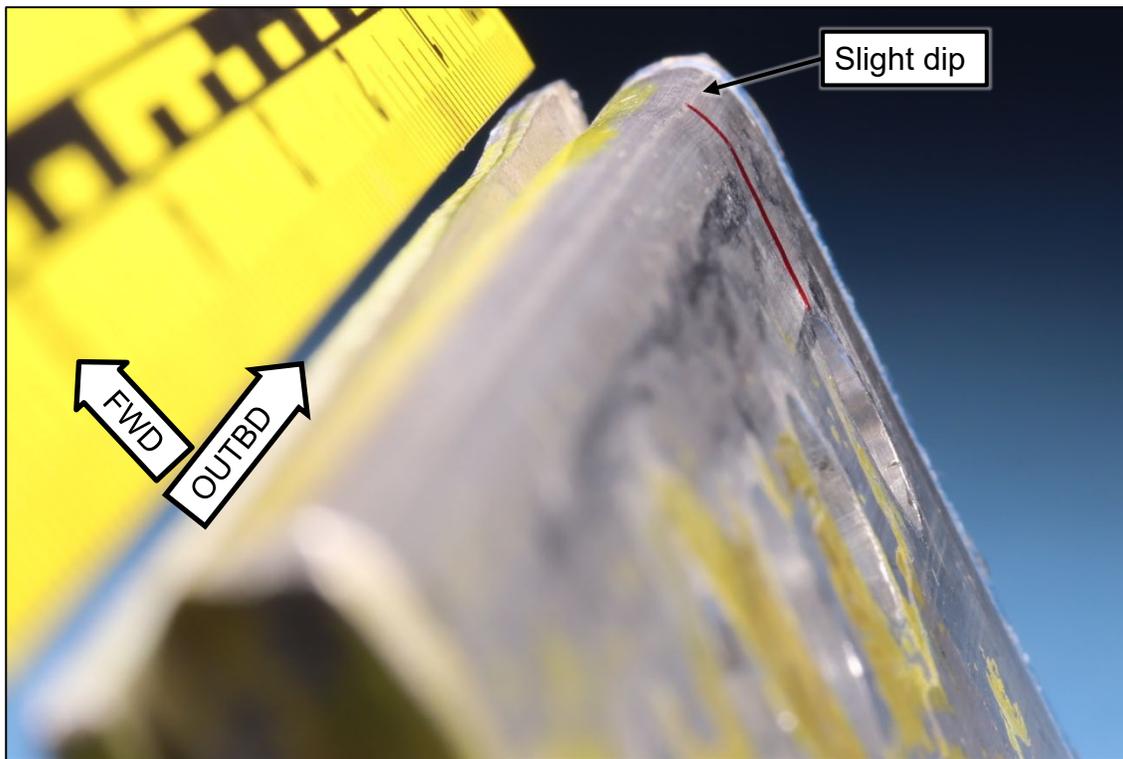
Multiple indications of plastic deformation were observed near the outboard holes on the spar C piece. The lower surface of the spar forward of hole LC-1 had a textured appearance consistent with plastic deformation associated with varying surface grain orientations. Additionally, linear surface texture features emanated from the crack at 45-degree angles consistent with deformation associated with plastic slip (slip bands). A slight dip in the leading edge was noted forward of hole LC-1 as indicated in figure C3, and longitudinal extrusion lines were curved at that location as indicated in figure C1. On the aft side of the spar shown in figure C4, the doubler had a slight S-shaped bend near hole D1 consistent with a compression buckle.

Figure C3. Deformation of the spar leading edge forward of hole LC-1.

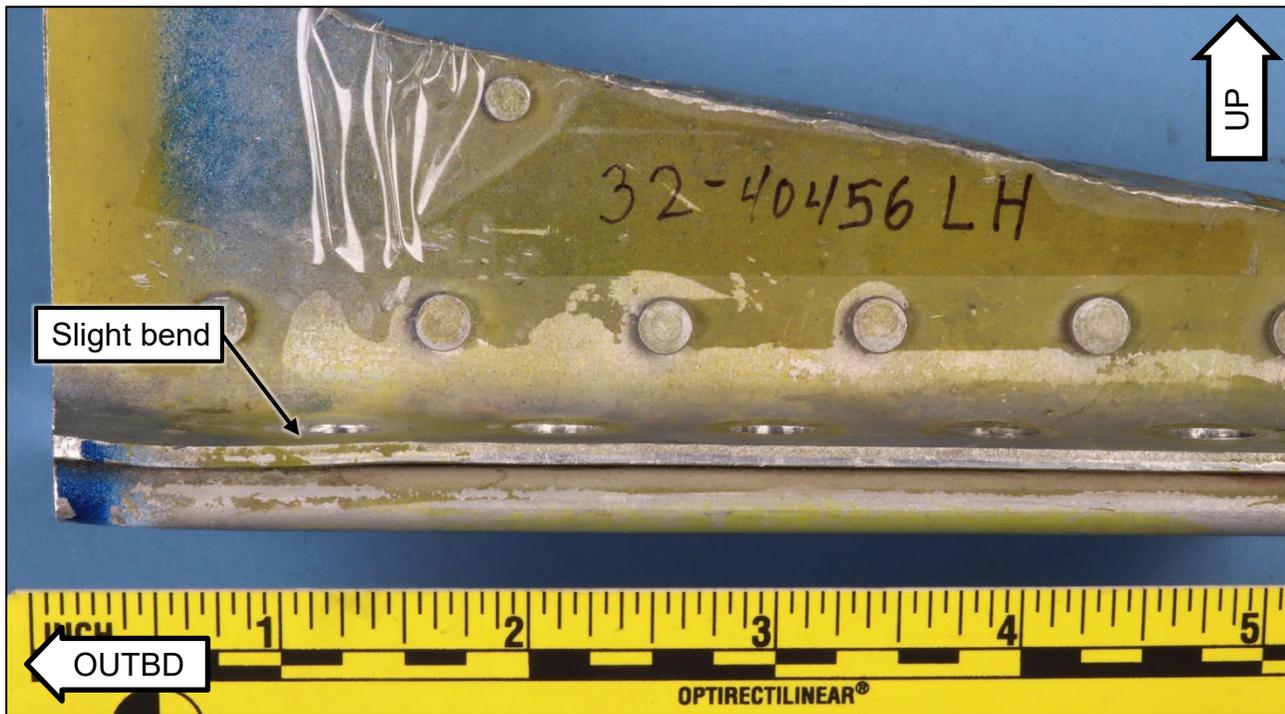
Figure C4. The lower flange of the aft doubler was slightly bent aft of hole LD-1.
