NATIONAL TRANSPORTATION SAFETY BOARD

MATERIALS LABORATORY FACTUAL REPORT

Report No. 21-091

Place : Daytona Beach, Florida
Date : April 4, 2018
Vehicle : Piper PA-28R-201, N106ER
NTSB No. : ERA18FA120
Investigator : Aaron McCarter, AS-ERA / Clinton R. Crookshanks, AS-40

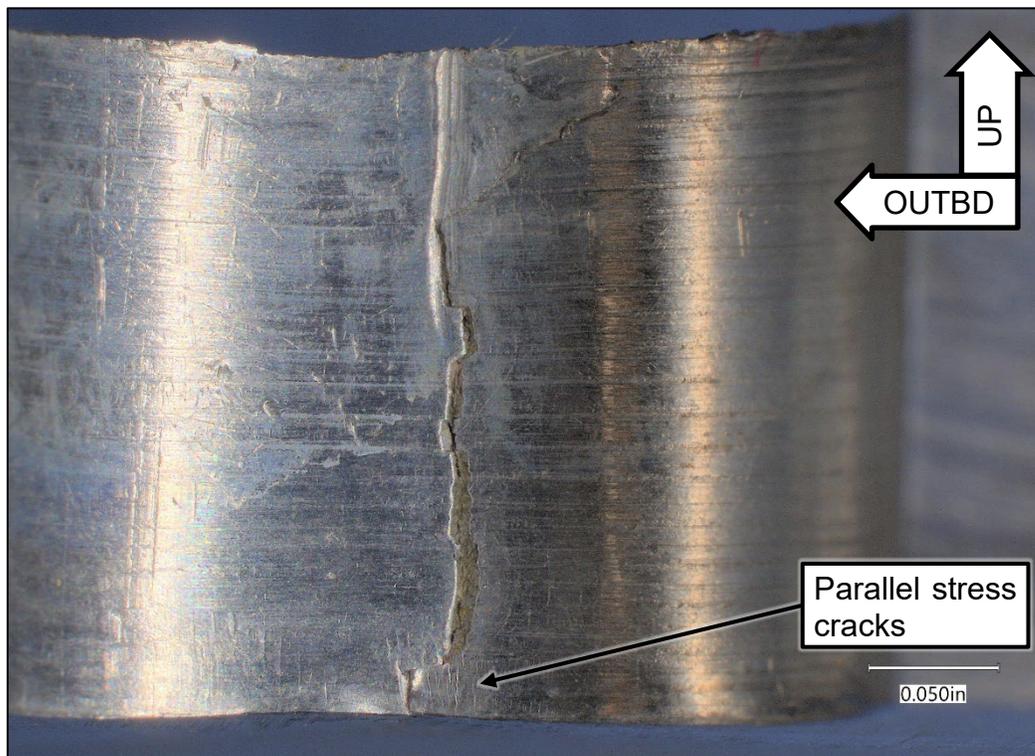
Next, a line of cyanoacrylate gel adhesive was applied to the leading edge between the doubler and the spar piece and was allowed to dry. Then the spar was sectioned longitudinally through the hole LC-1 through 5 axes to facilitate a direct view of the hole bores. After an initial look at the hole bores, the doubler was removed from the forward piece by soaking in acetone to dissolve the adhesive. A view of the crack in the forward side of the hole LC-1 bore is shown in figure C5 after sectioning and removing the doubler. The crack was visible intersecting the hole surface along the entire length of the hole in the spar as shown in figure C5 and extended forward from the hole on the lower and upper surfaces as shown in figures C6 and C7. At the lower end of hole LC-1, a series of parallel shallow cracks consistent with stress cracks were observed on the hole bore adjacent to the crack as indicated in figure C5. At the upper end of hole LC-1, the crack deviated inboard relative to the hole centerline. Deformed longitudinal extrusion lines consistent with plastic deformation were noted on both the lower and upper surfaces at the forward side of hole LC-1 as indicated in figures C6 and C7.

Figure C5. Forward side of hole LC-1 after sectioning showing parallel cracks consistent with stress cracks.

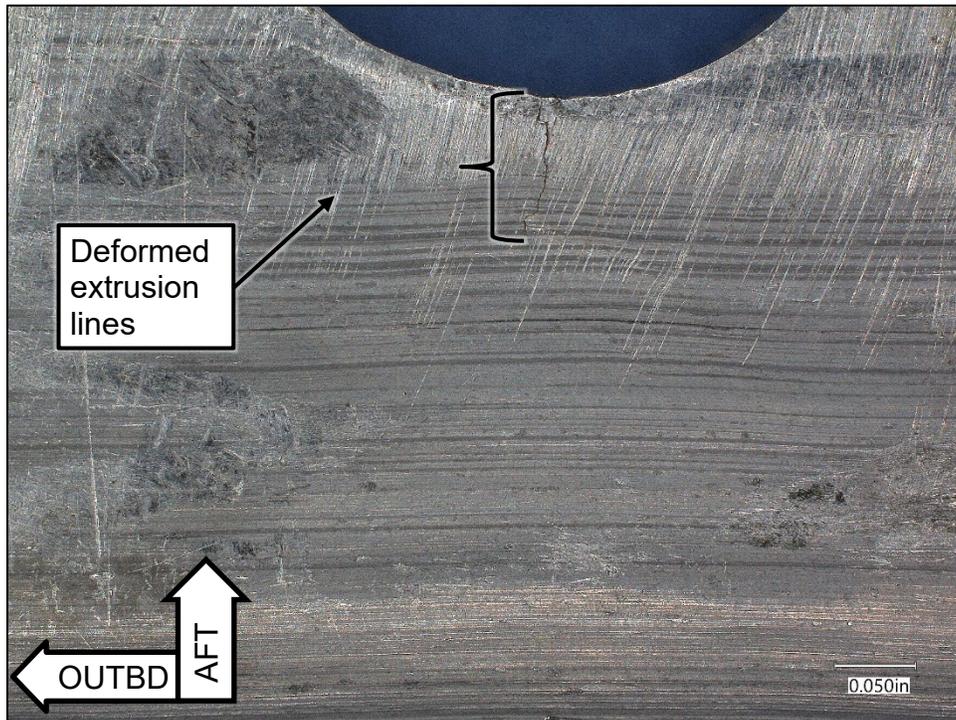
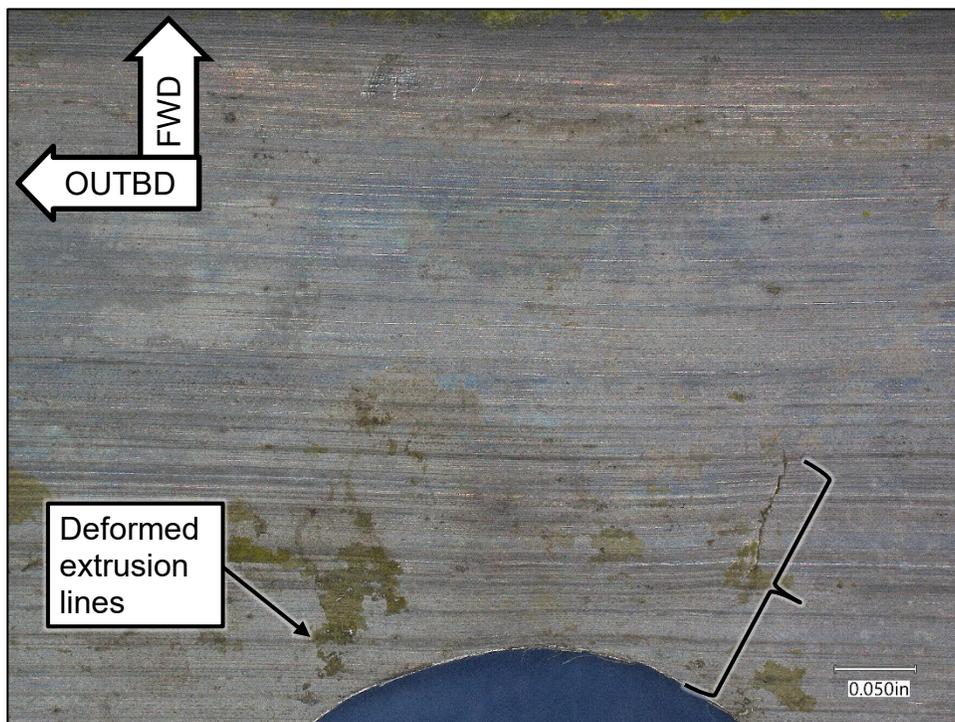
Figure C6. Lower surface forward of hole LC-1 showing the crack and deformed extrusion lines.

Figure C7. Upper surface forward of hole LC-1 showing the crack and deformed extrusion lines.

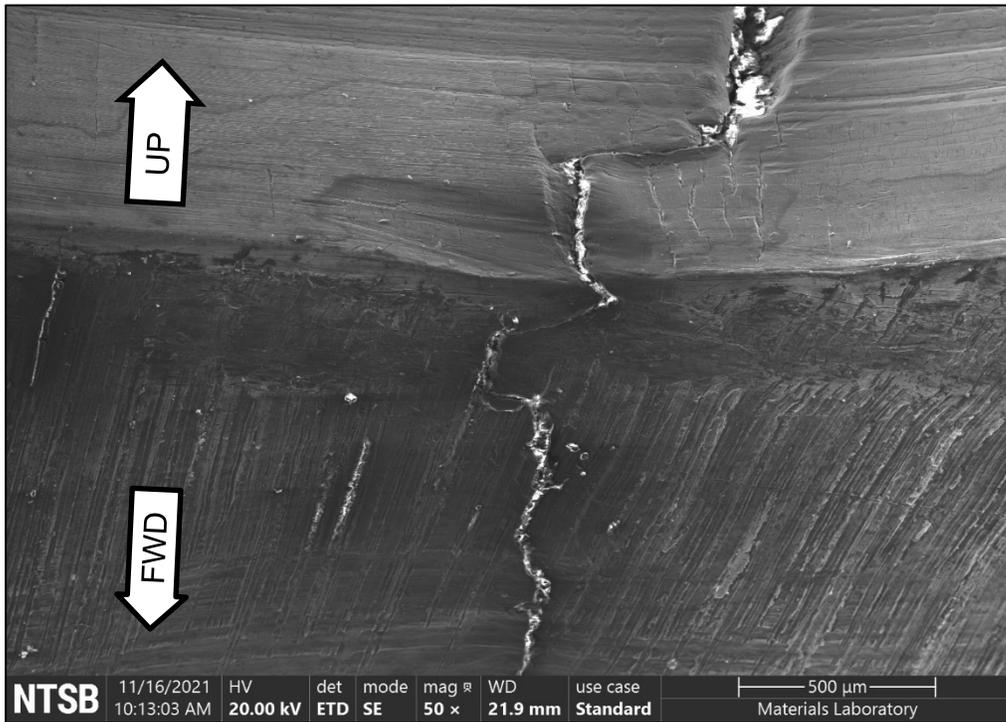
The forward side of the hole LC-1 bore and adjacent lower surface forward of the hole were examined using an SEM, and an oblique view of the lower forward corner of the hole is shown in figure C8. Nonconductive material (appearing white in figure C8) was observed in the crack at the lower forward corner of hole LC-1. The EDS spectrum of the nonconductive material in the crack opening included a small chlorine peak as shown in figure C9.

Figure C8. SEM image of the crack in an oblique view of the lower forward corner of hole LC-1.

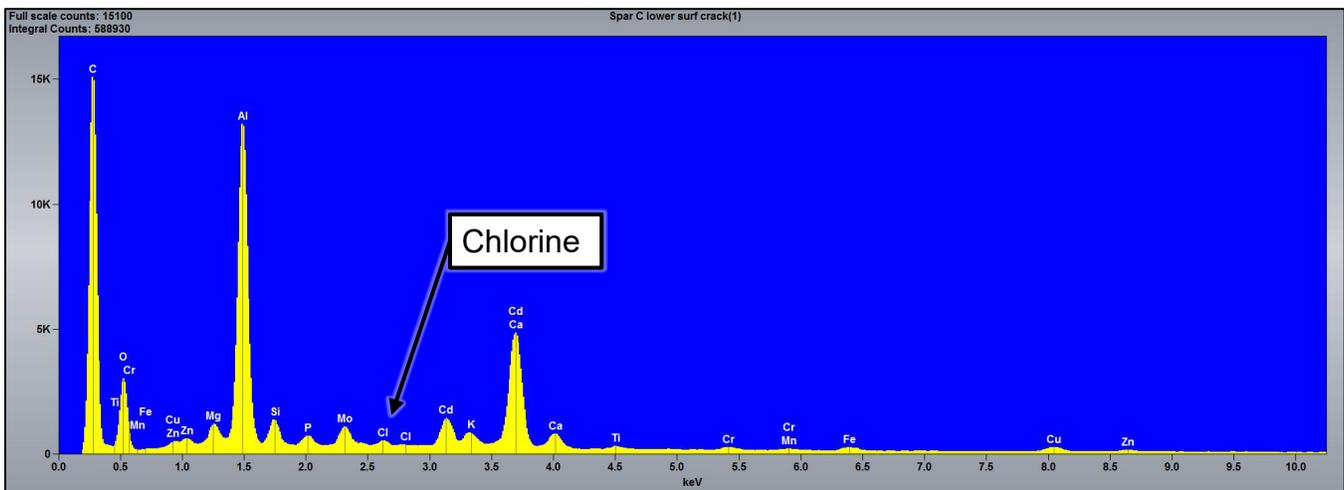
Figure C9. EDS spectrum of nonconductive material in the crack opening as analyzed at the hole LC-1 corner.

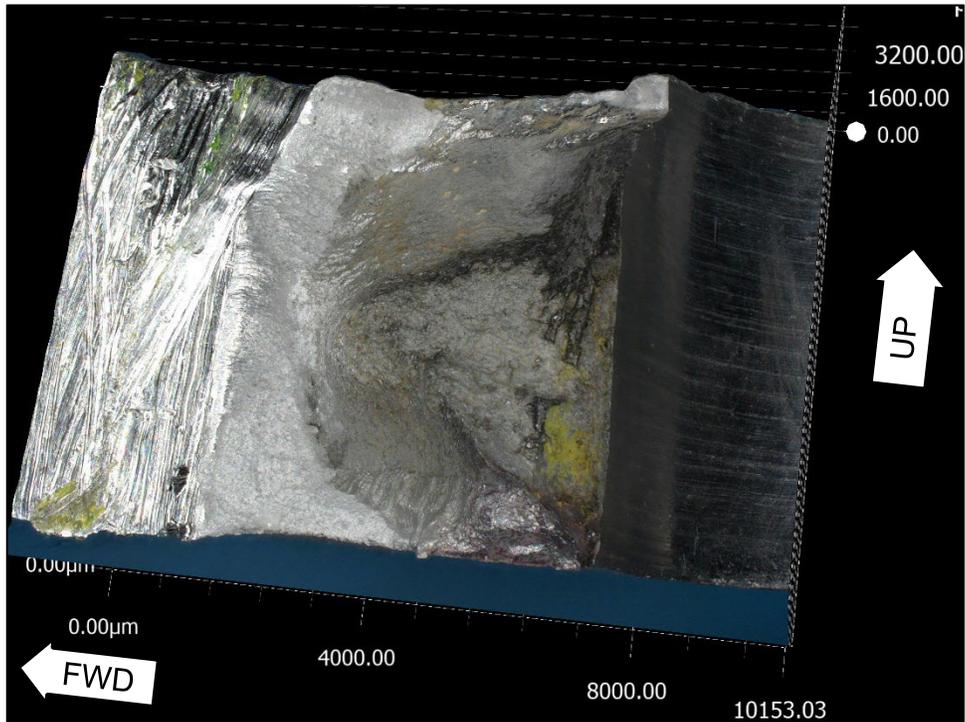
ultrasonic cleaning while submerged in acetone. A 3-dimensional representation of the fracture surface as obtained using the depth-up feature on the Keyence VHX-7000 optical microscope is shown in figure C10. The fracture surface had relatively rough features that intersected surfaces at slant angles, features consistent with overstress fracture. Dark oxides and reflective areas were consistent with post-fracture rubbing and sliding contact between the faces.

Figure C10. Three-dimensional representation of the opened crack after cleaning using acetone.

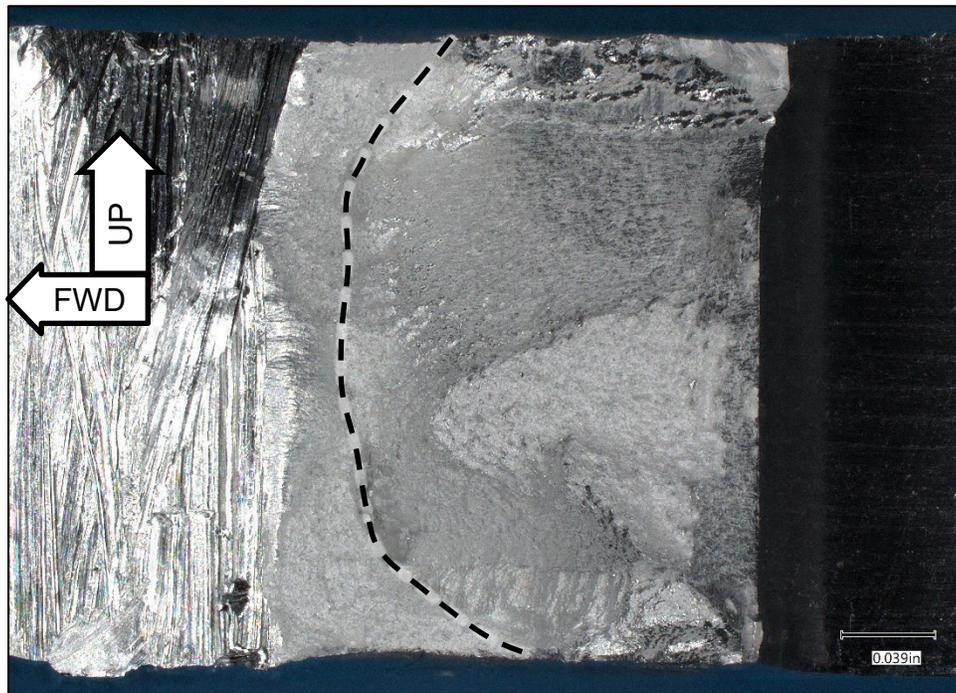
The inboard side of the fracture was cleaned using a heated aqueous solution of chromic acid and phosphoric acid for removing oxides on aluminum, and the resulting fracture surface as obtained using the depth-up feature on the Keyence microscope is shown in figure C11. The overall fracture had a matte gray appearance consistent with ductile overstress fracture. A dashed line in figure C11 indicates the extent of the crack before lab fracture.

Figure C11. Optical image of the opened crack after oxide removal. A dashed line indicates the approximate crack boundary before lab fracture.

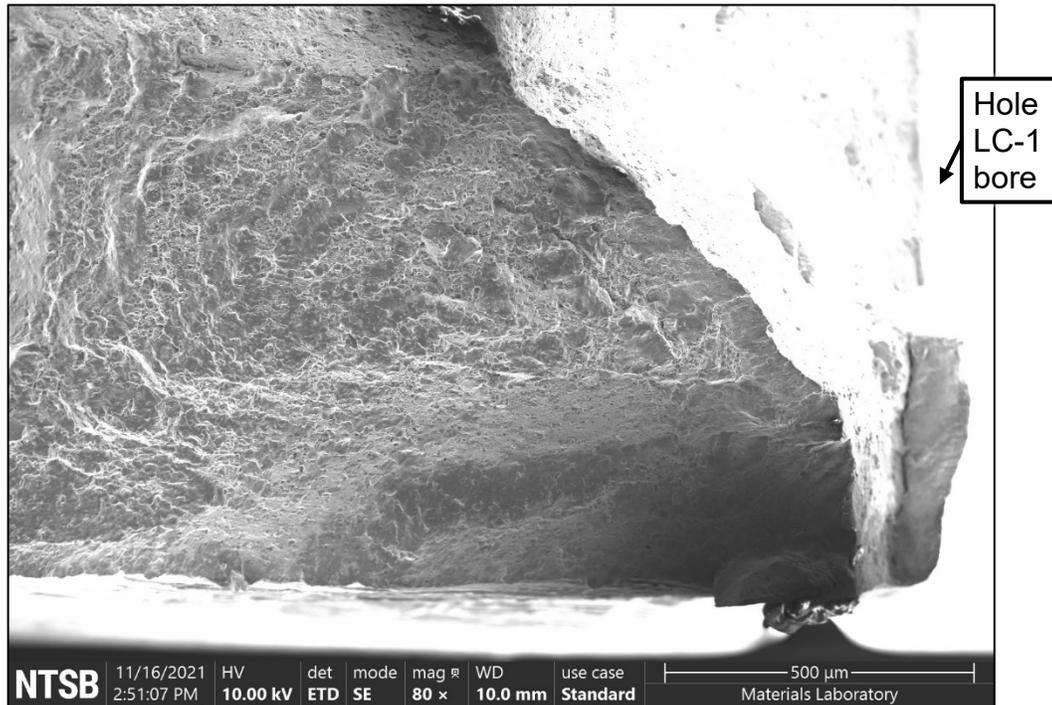
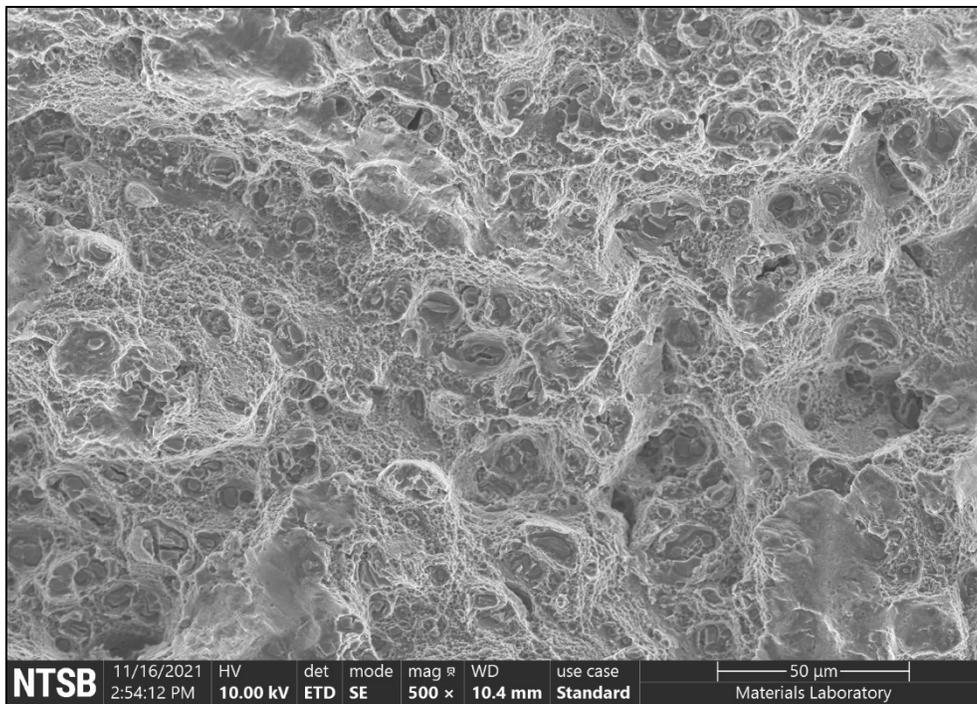
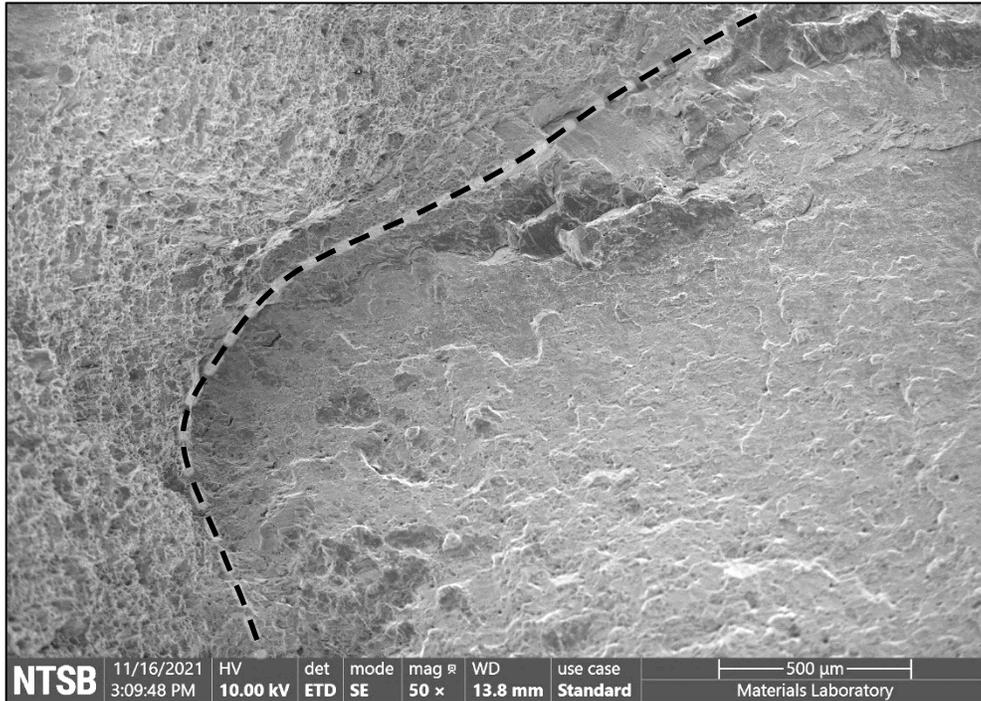
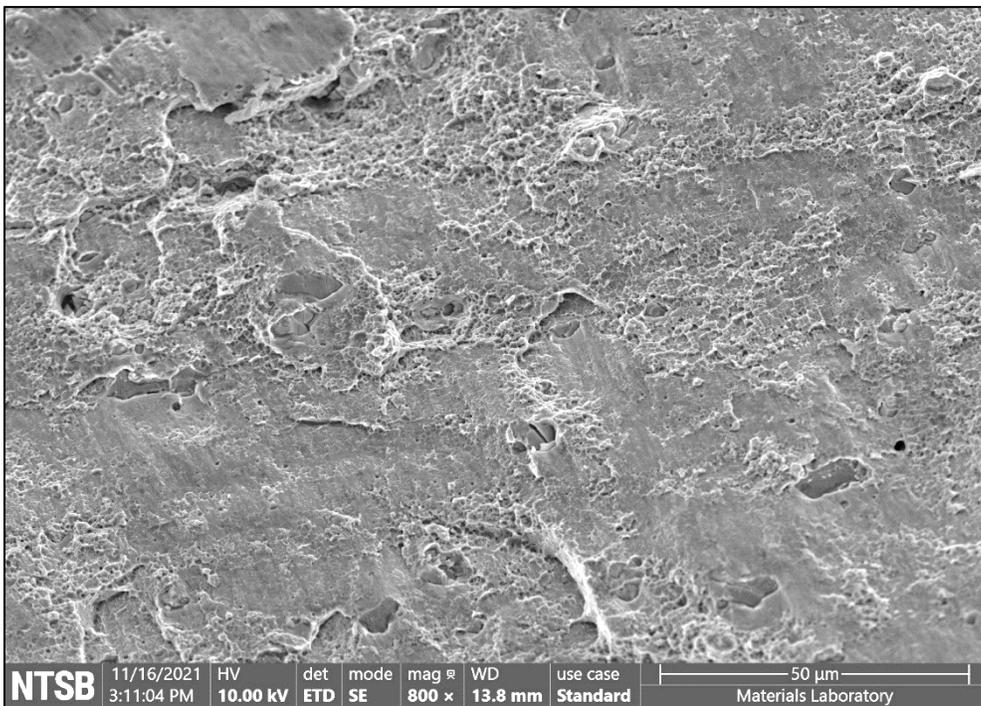
The inboard side of the crack fracture surface was examined using the SEM, and images showing typical fracture features are shown in figures C12 through C15. SEM images of the inboard side of the crack fracture surface showed dimples and sliding contact features consistent with ductile overstress fracture. No evidence of fatigue or any other progressive fracture mechanism was observed.

Figure C12. Fracture surface at the lower end of the crack after oxide removal.

Figure C13. Ductile dimples observed on the crack fracture surface after oxide removal.

Figure C14. Fracture features at the crack boundary (dashed line) after oxide removal.

Figure C15. Dimples and sliding contact features near the crack boundary after oxide removal.
