# NATIONAL TRANSPORTATION SAFETY BOARD

MATERIALS LABORATORY STUDY

Report No. 21-092

Place : Daytona Beach, Florida  
Date : April 4, 2018  
Vehicle : Piper PA-28R-201, N106ER  
NTSB No. : ERA18FA120  
Investigator : Aaron McCarter, AS-ERA / Clinton R. Crookshanks, AS-40

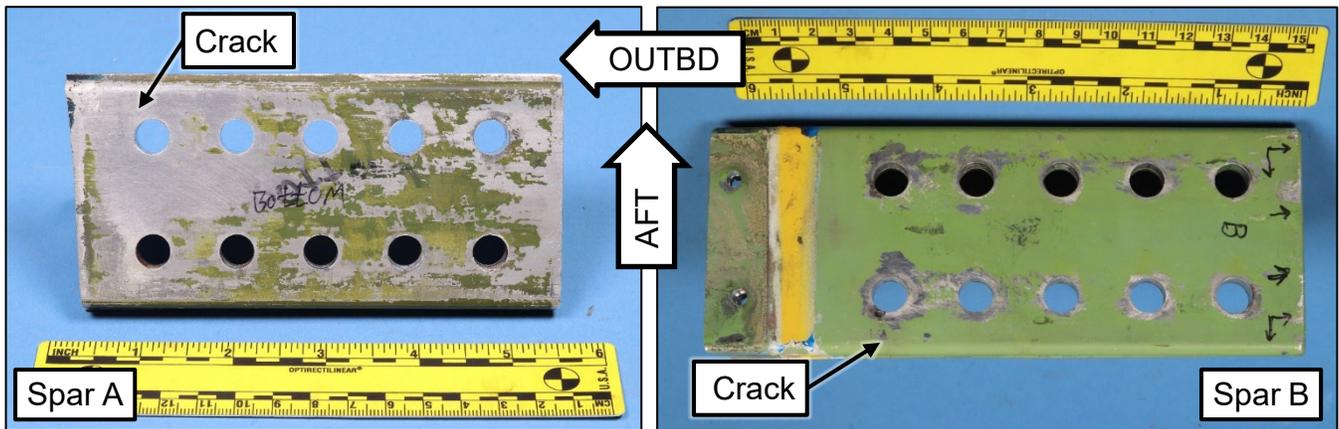
Figure 1. Spars A and B lower surfaces showing crack locations.

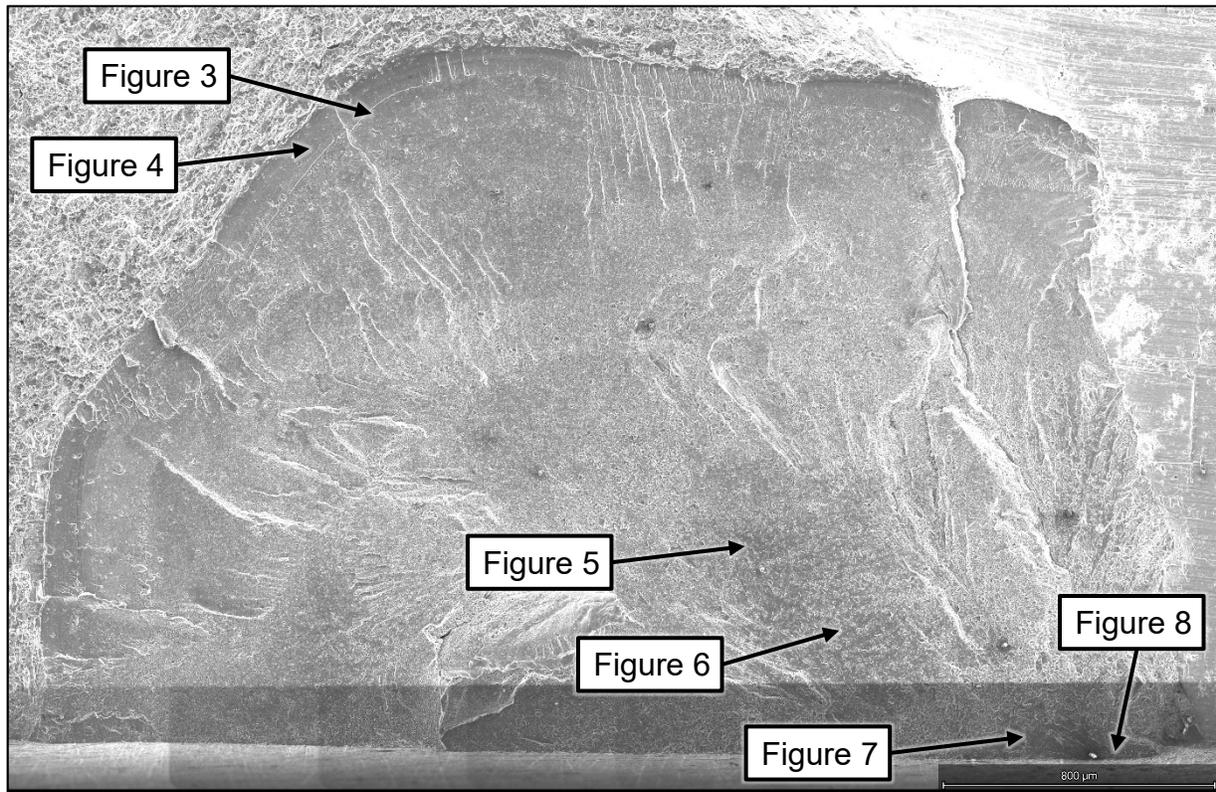
An overall view of fracture features associated with the crack in spar A is shown in figure 2. SEM images of typical fatigue features at multiple locations from the crack boundary to the origin are shown in figures 3 through 8. Many of the fracture features were damaged by oxidation and contact from hard particles that had migrated into the crack. However, relatively prominent arrest lines, intermediate arrest lines, and striations were noted on the crack surfaces as identified in figures 3 through 7. At the crack origin, radial features emanated from a pitted origin area shown bounded by a dashed line in figure 8.

Figure 2. Montage of SEM images showing the spar A crack fracture surface. Locations of higher magnification images shown in subsequent figures are indicated.

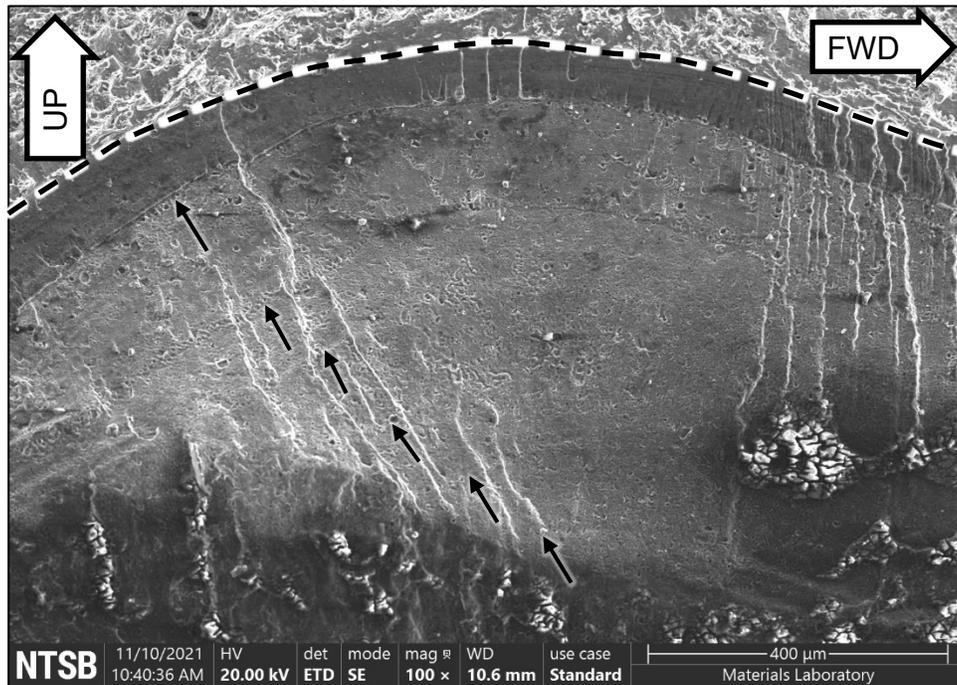
Figure 3. SEM image of the crack boundary on spar A. Unlabeled arrows indicate relatively prominent crack arrest lines, and the dashed line indicates the fatigue boundary.

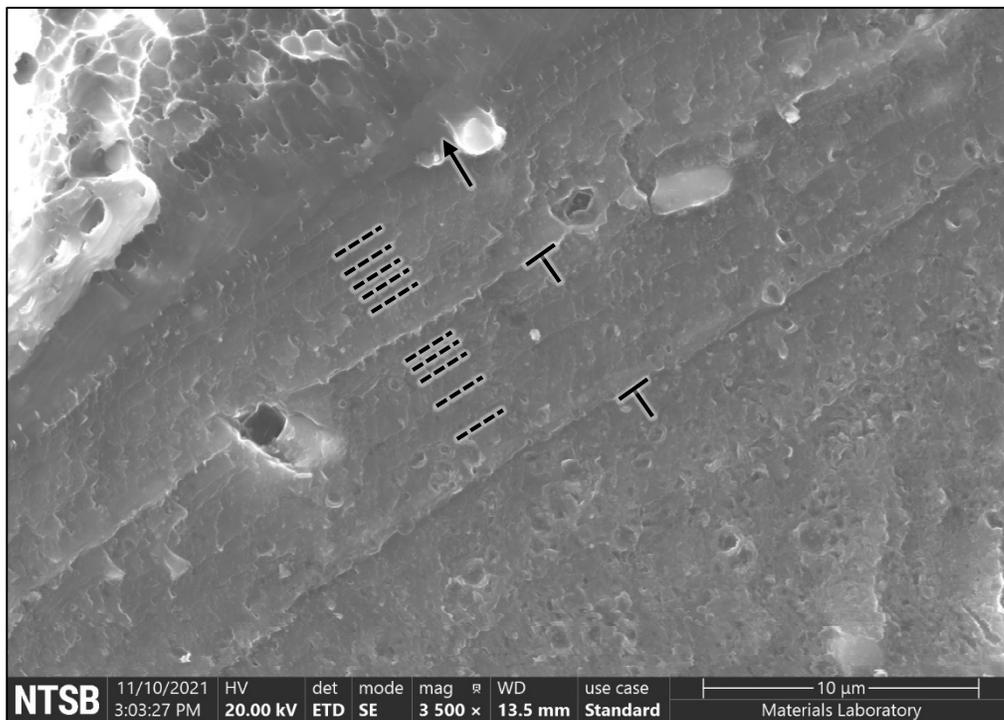
Figure 4. SEM image of the fatigue boundary located 0.116 inch (2.95 mm) from the origin on spar A. An arrow indicates the fatigue boundary, T-shaped markers indicate intermediate crack arrest lines, and dashed lines indicate striations.

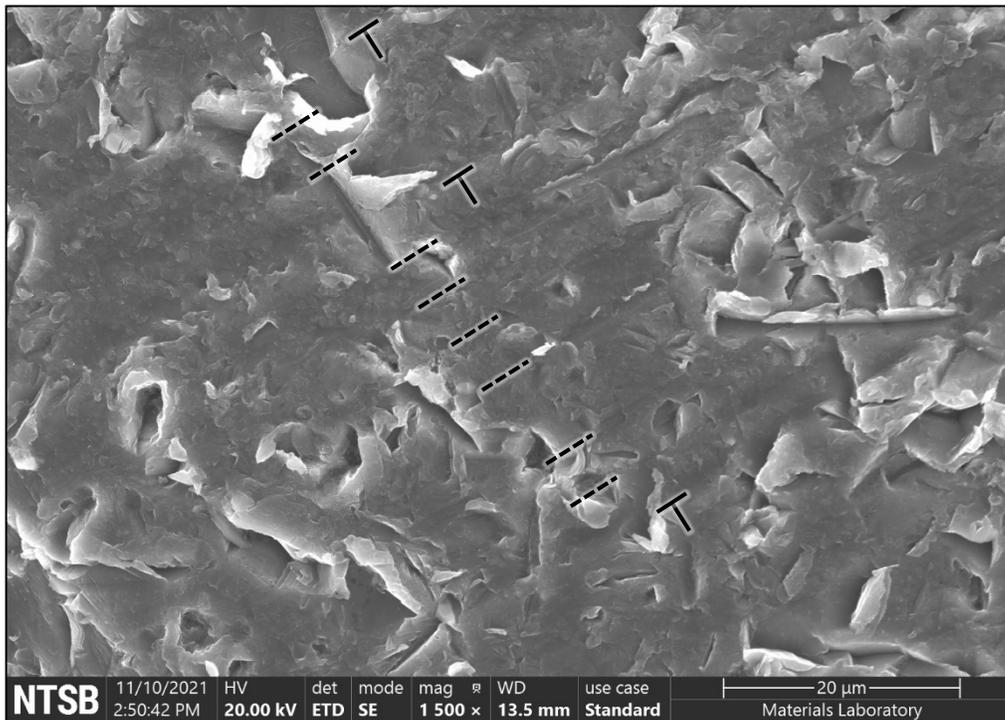
Figure 5. SEM image of fatigue features 0.0492 inch (1.25 mm) from the origin on spar A where T-shaped markers indicate intermediate crack arrest lines, and dashed lines indicate striations.

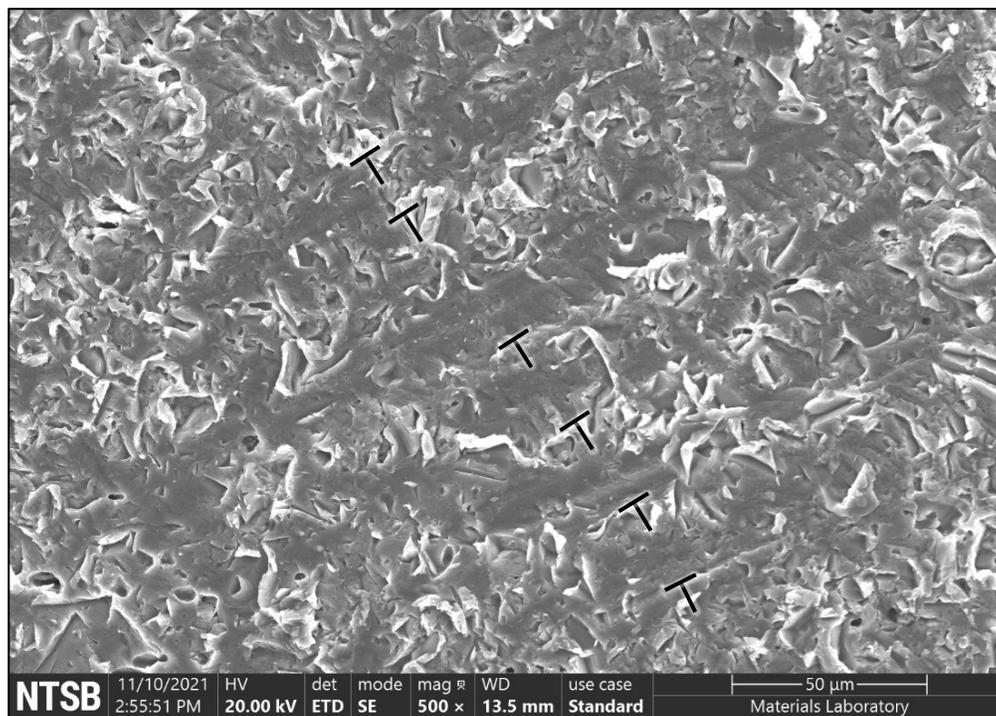
Figure 6. SEM image of fatigue features 0.0328 inch (0.833 mm) from the origin on spar A showing intermediate crack arrest lines (T-shaped markers).

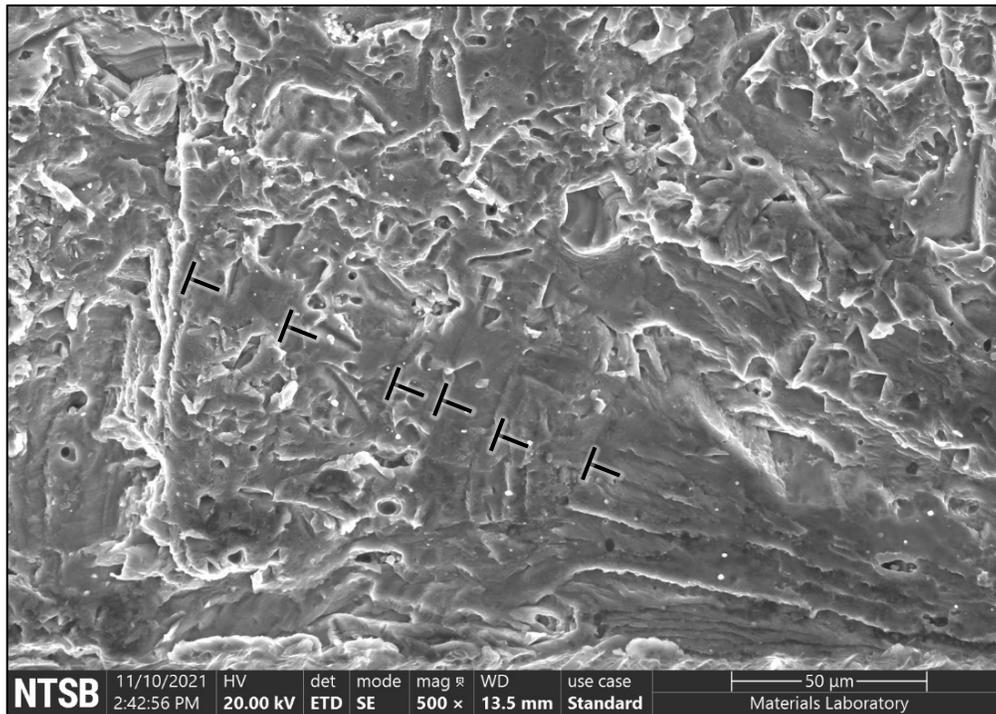
Figure 7. SEM image of fatigue features 0.0106 inch (0.269 mm) from the origin on spar A showing intermediate crack arrest lines (T-shaped markers).

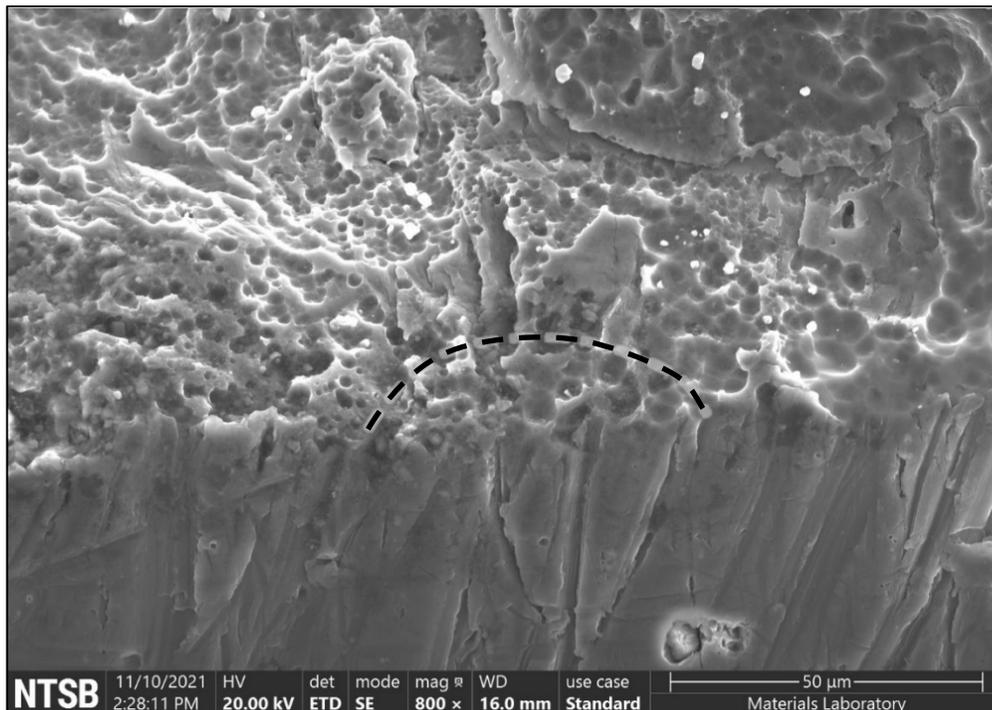
Figure 8. Spar A origin area indicated with a dashed line.

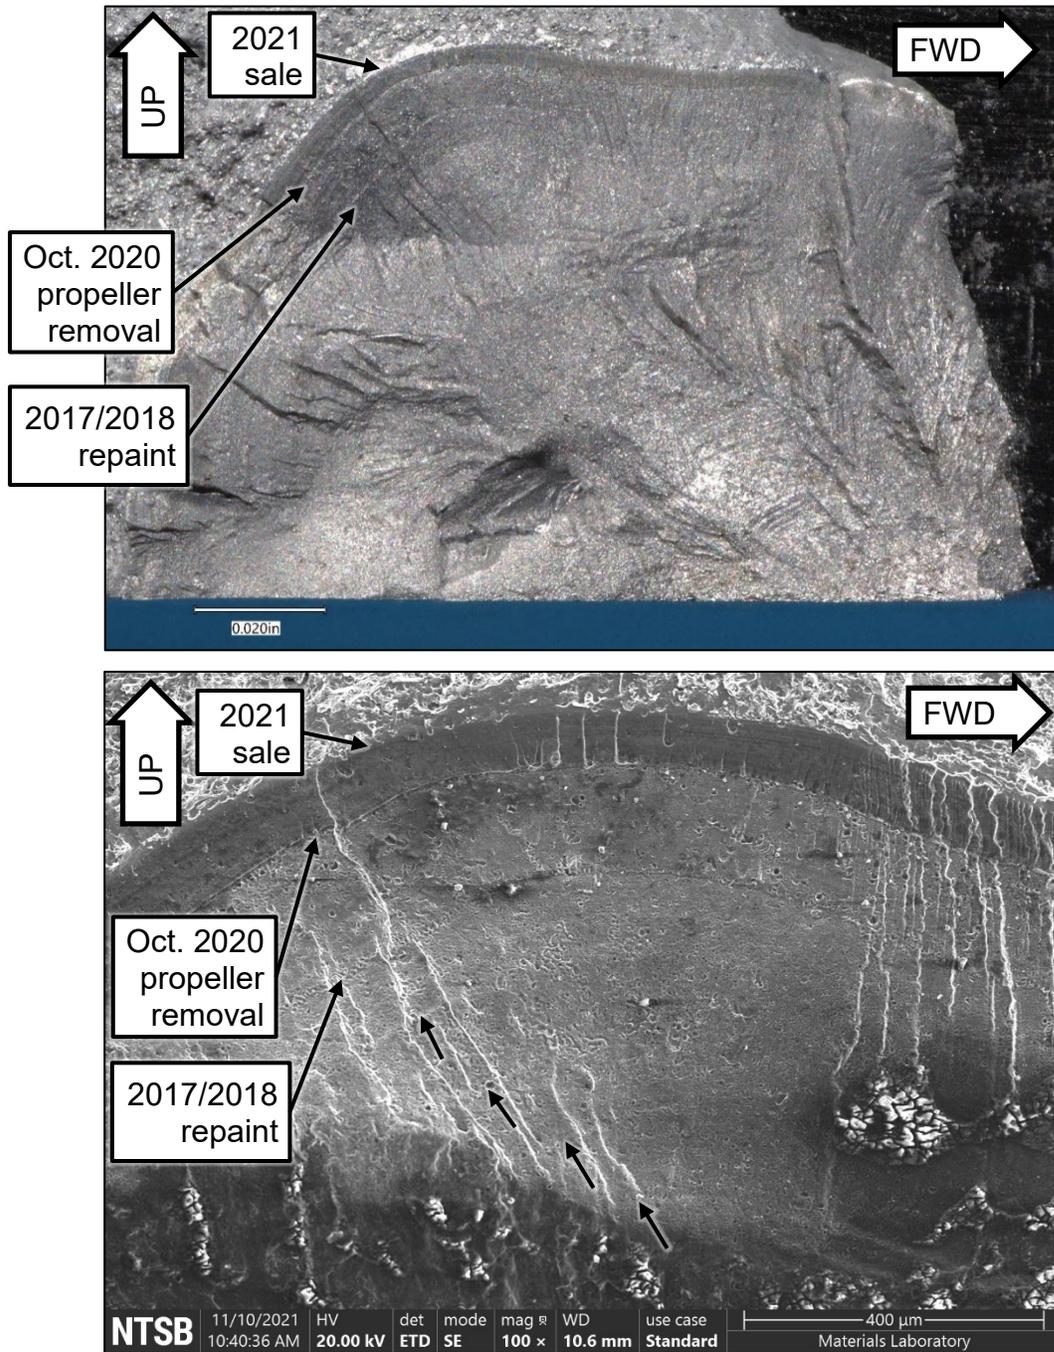
The reported flight hours at the time of the crack find in spar A matched the time listed in the 2021 listing advertising the sale of the airplane. Additional recent events inferred from online photographs that could have been associated with changes in operation type or frequency included the photo of the airplane with its propeller removed in 2020 and a repaint that occurred sometime in 2017 and 2018. These recent events could be associated with relatively prominent crack arrest lines as indicated in figure 9. Several additional prominent crack arrest lines noted with unlabeled arrows in the SEM image in figure 9 could be associated with annual usage patterns assuming infrequent usage in recent years.

Figure 9. Optical (upper image) and SEM (lower image) images of relatively prominent arrest lines at the Spar A crack boundary with notations of possible changes in airplane usage patterns inferred from online data.

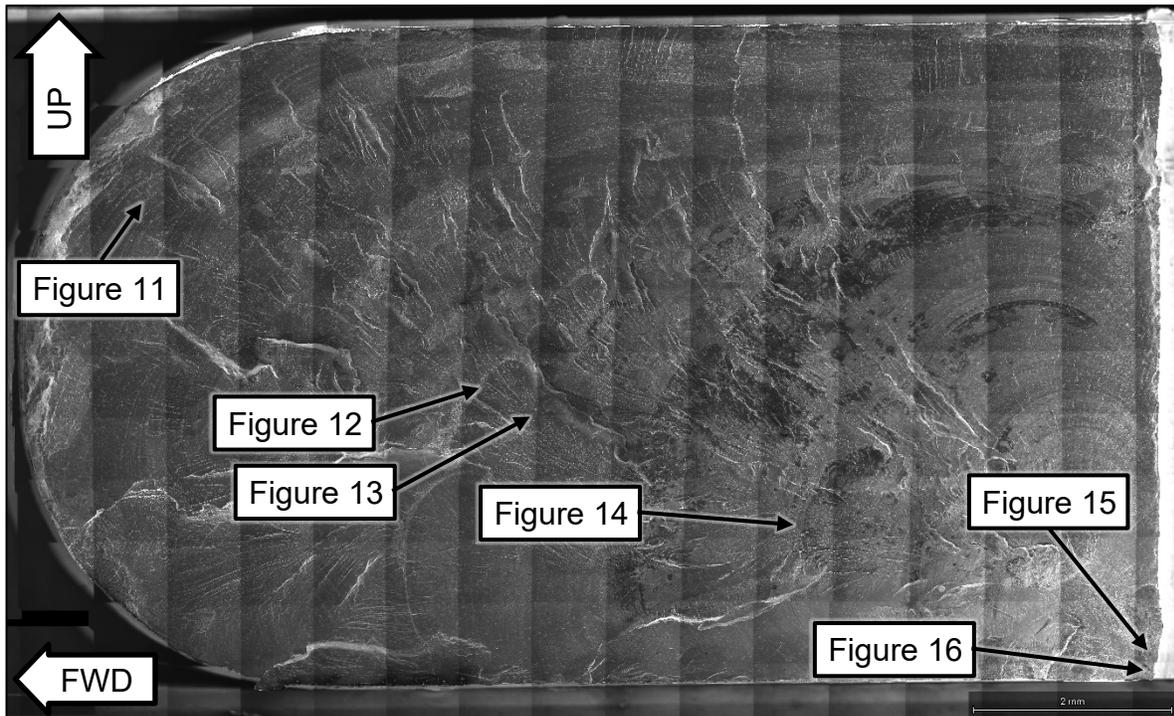
An overall view of fracture features associated with the crack in spar B is shown in figure 10. SEM images of typical fatigue features at multiple locations from the crack

Figure 10. Montage of SEM images showing the spar B crack fracture surface. Locations of higher magnification images shown in subsequent figures are indicated.

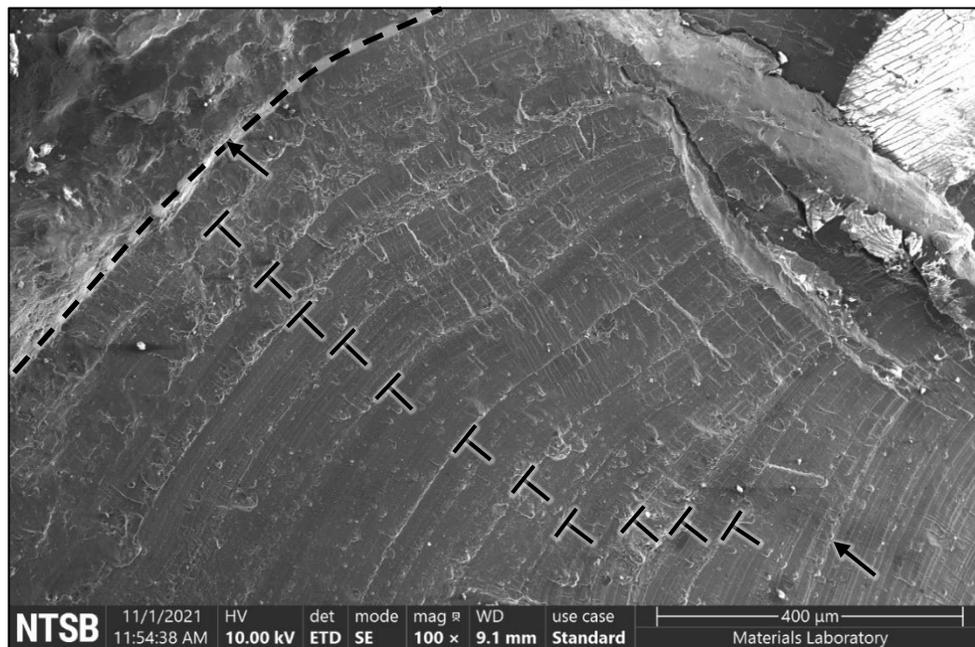
Figure 11. SEM image of the crack boundary on spar B. Unlabeled arrows indicate relatively prominent crack arrest lines including the fatigue boundary (dashed line), and T-shaped markers indicate intermediate crack arrest lines.

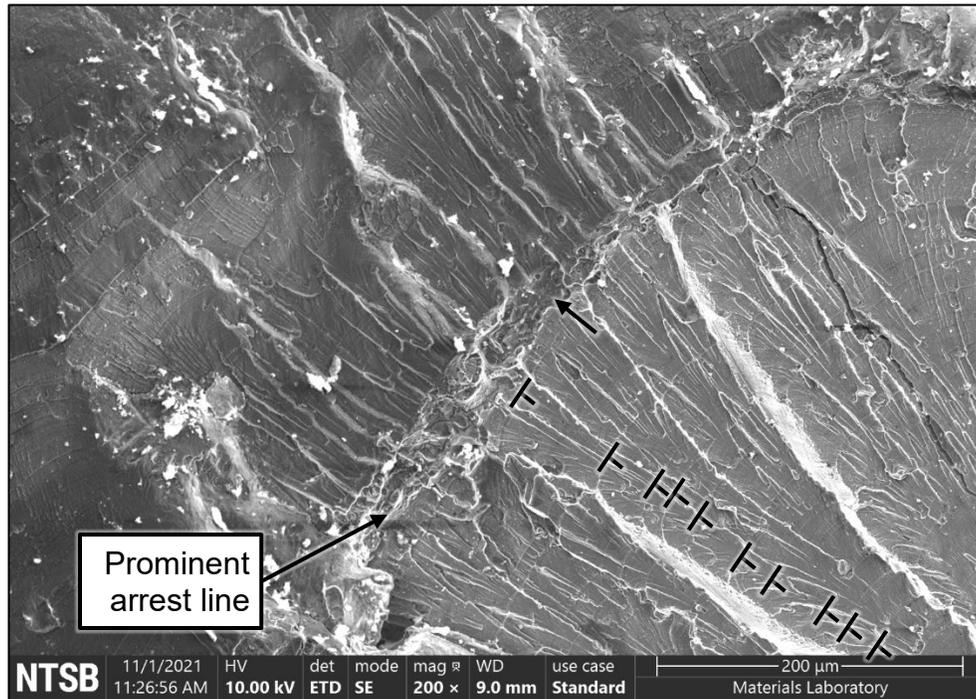
Figure 12. Prominent arrest line 0.295 inch (7.5 mm) from the origin on spar B with intermediate arrest lines indicated by T-shaped markers.

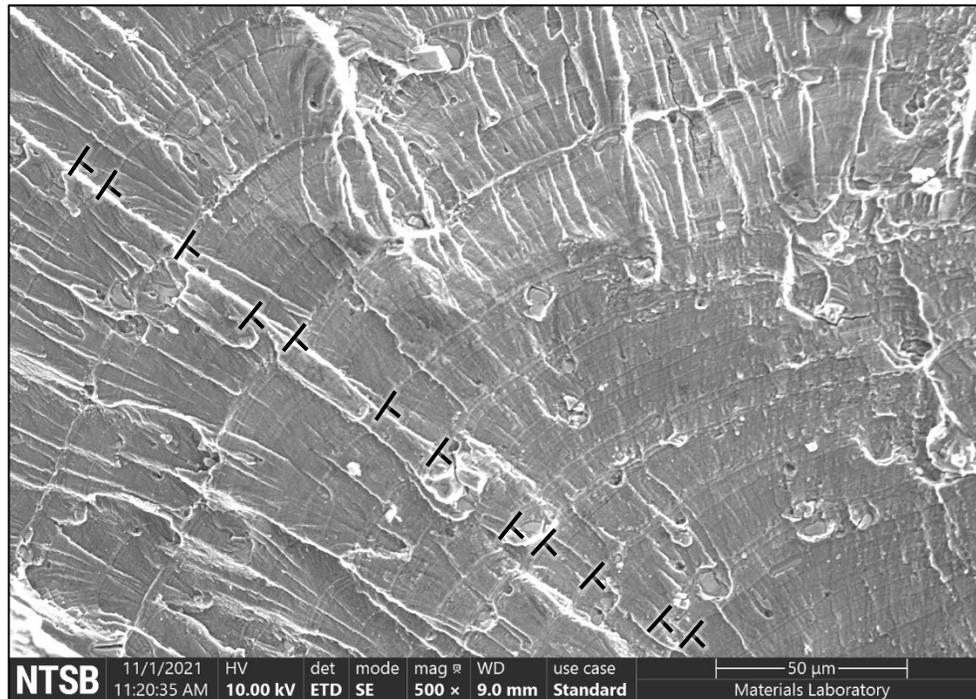
Figure 13. Fatigue features 0.274 inch (6.97 mm) from the origin on spar B showing intermediate crack arrest lines (T-shaped markers).

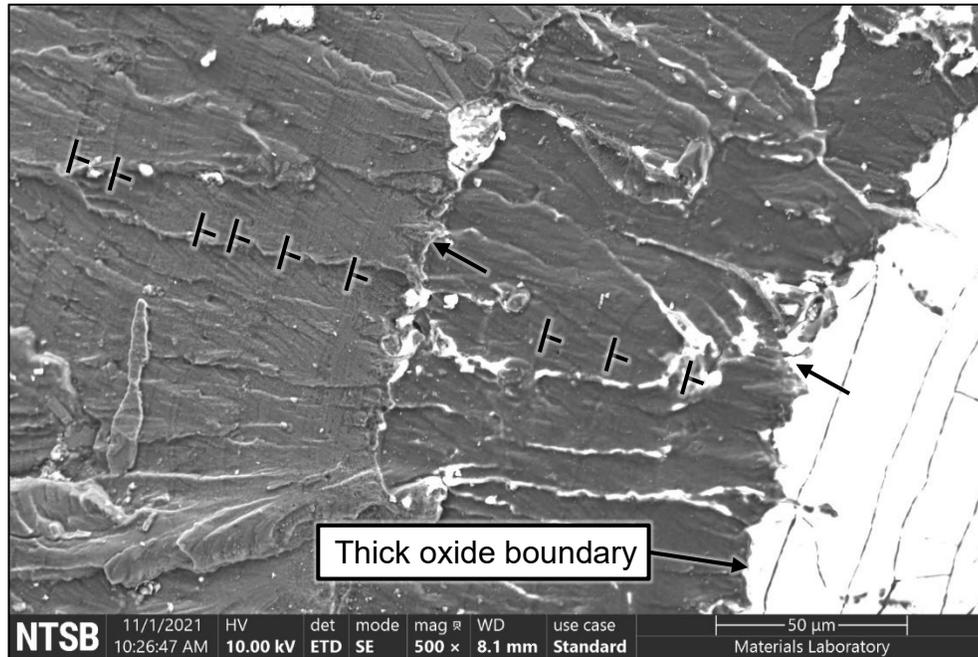
Figure 14. Fatigue features 0.114 inch (2.89 mm) from the origin on spar B showing relatively prominent crack arrest lines (unlabeled arrows) and intermediate crack arrest lines (T-shaped markers).

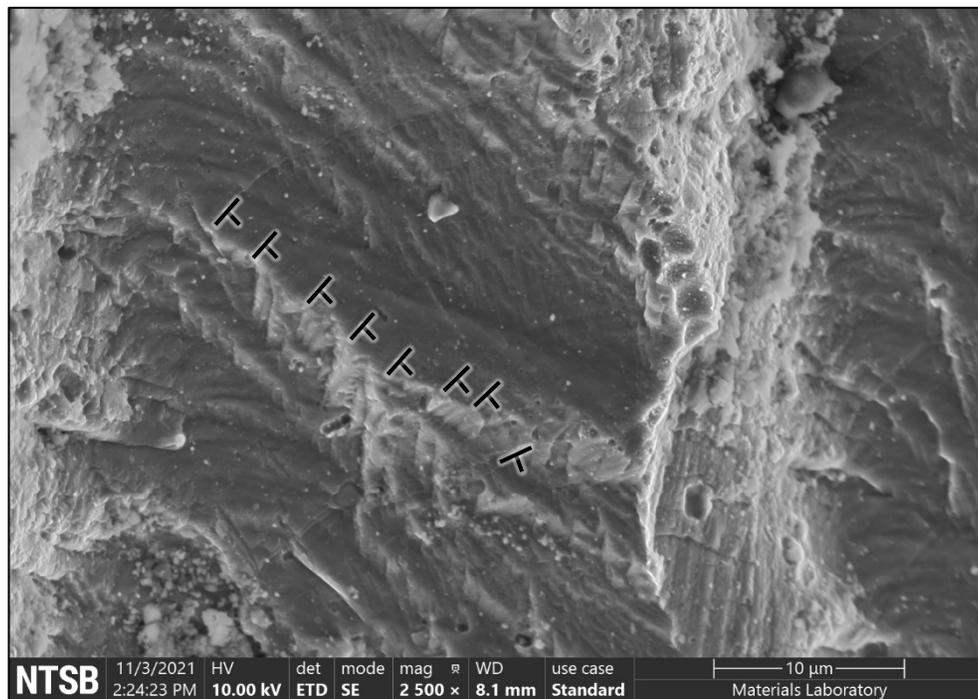
Figure 15. Fatigue features 0.0089 inch (0.226 mm) from the origin on spar B showing intermediate crack arrest lines (T-shaped markers).

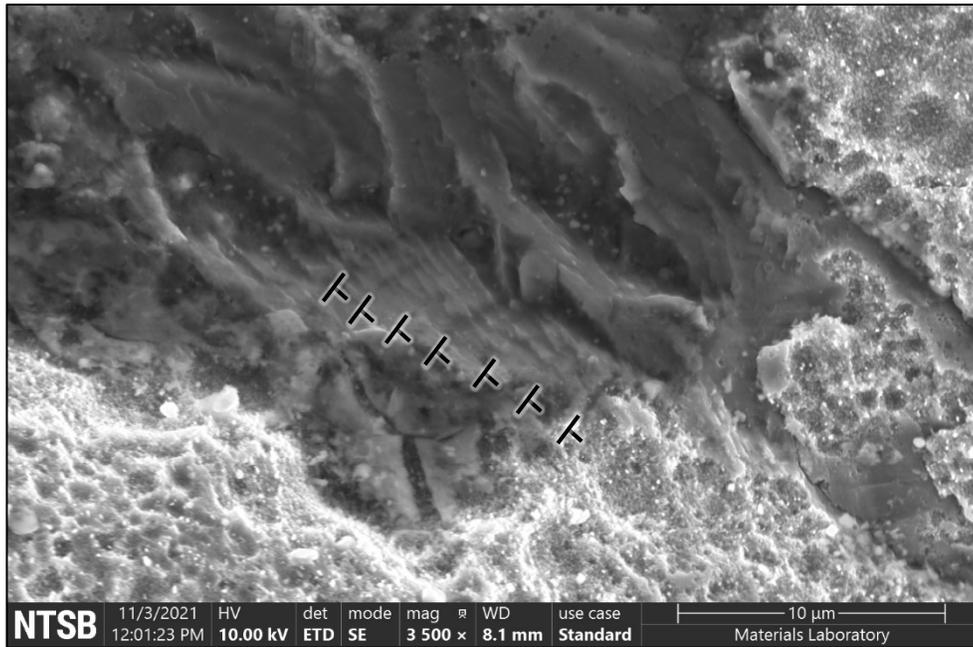
Figure 16. Fatigue features 0.0024 inch (0.062 mm) from the origin on spar B showing intermediate crack arrest lines (T-shaped markers).

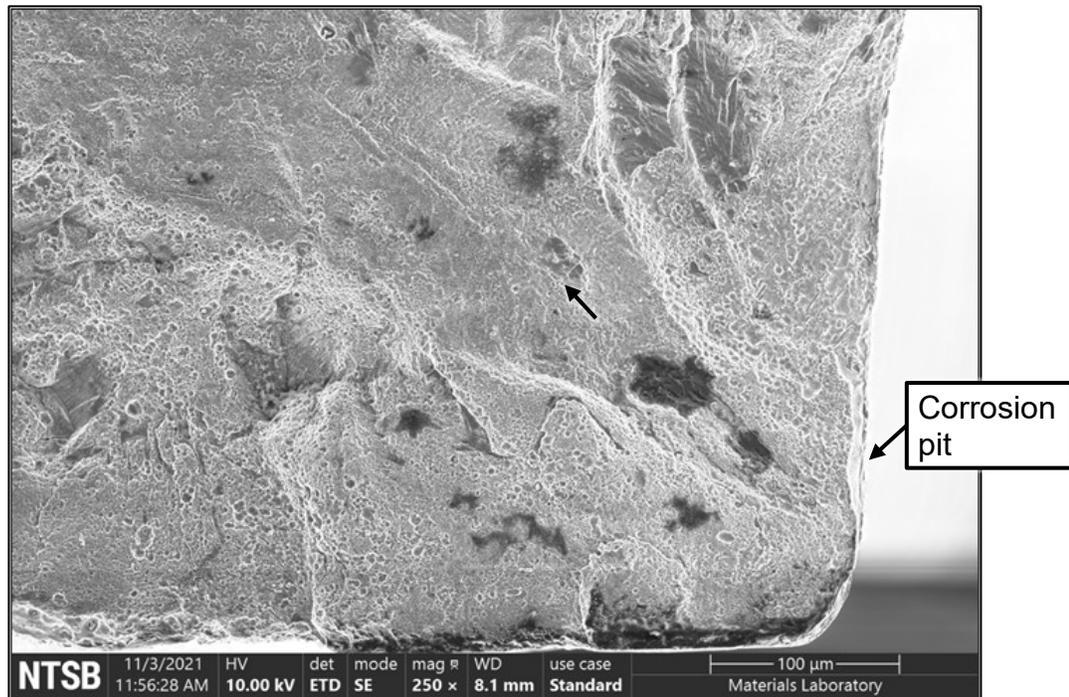
boundary to the origin are shown in figures 11 through 17. Many of the fracture features near the origin were damaged by oxidation. However, relatively prominent arrest lines, intermediate arrest lines, and striations were noted on the crack surfaces as identified in figures 11 through 17. Fine fracture features near the origin were mostly obliterated by oxidation, but radial features and isolated areas of arrest lines emanated from an origin at the lower end of a 0.00035-inch (0.009-mm) deep corrosion pit as indicated in figure 17.

Figure 17. Origin area on spar B showing a prominent arrest line near the origin (unlabeled arrow).

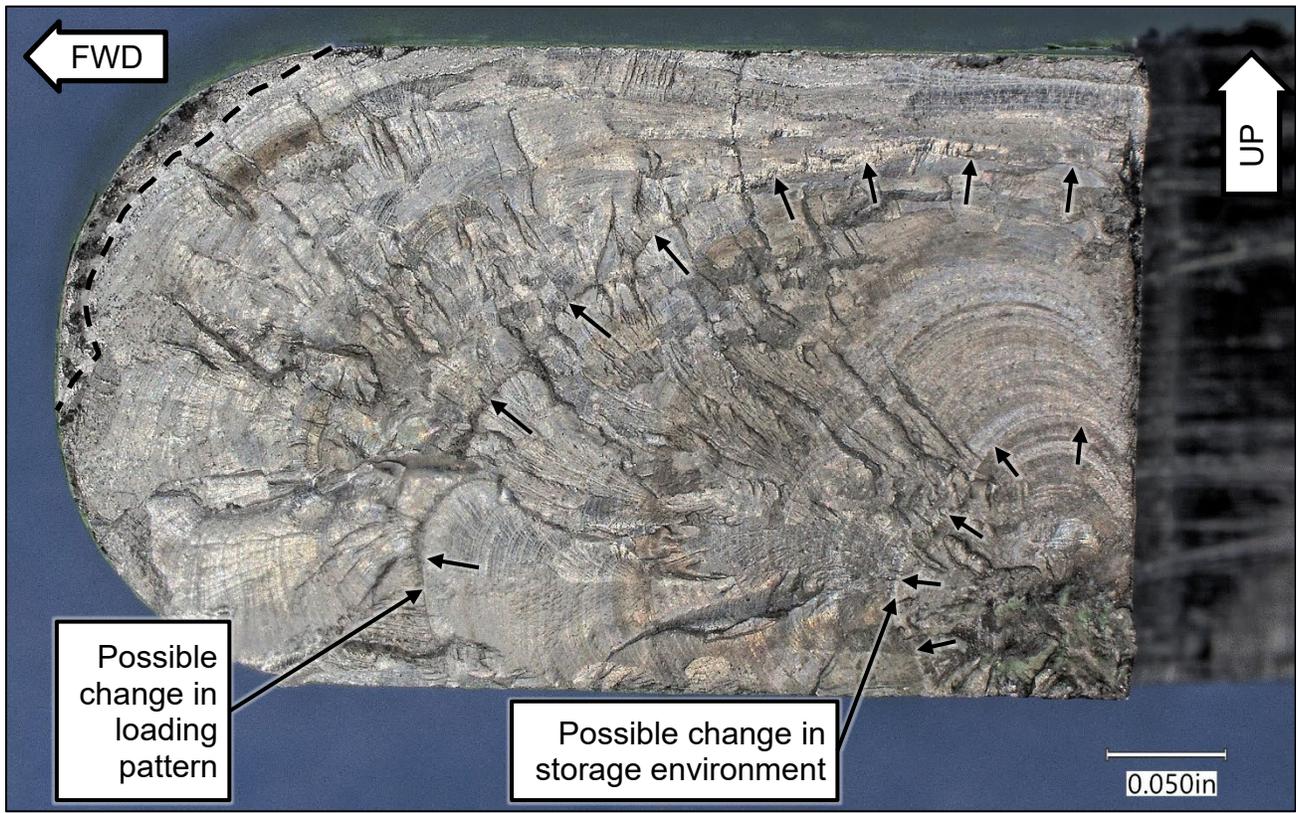
Many prominent arrest lines were observed across the fracture surface, but three were particularly distinct as shown with a dashed line and unlabeled arrows in figure 18. A distinct change in fracture plane occurred at the fatigue boundary, and the remainder of the fracture to the upper leading edge was on a slant plane consistent with overstress fracture of the final ligament between the crack tip and the surface. Another prominent arrest line near the middle of the fracture surface had a distinct step along the entire crack front with substantial radial features on the convex side indicative of substantial crack reinitiation. This crack arrest line could indicate a significant change in aircraft usage or could represent a high load event such as a hard landing. Closer to the origin, a distinct change in the oxidation pattern was associated with a prominent arrest line on the fracture surface. The distinct change in oxidation patterns suggests the prominent arrest line at that location could be associated with a change in storage environment. Based on the registration history, a change in storage environment likely occurred when the airplane was sold by ERAU or the subsequent owner from Daytona Beach, Florida.

Figure 18. Inboard side of the fracture surface after cleaning with acetate tape and acetone. A dashed line indicates the fatigue boundary, and unlabeled arrows indicate two prominent arrest lines representing possible changes in loading pattern or environmental conditions.

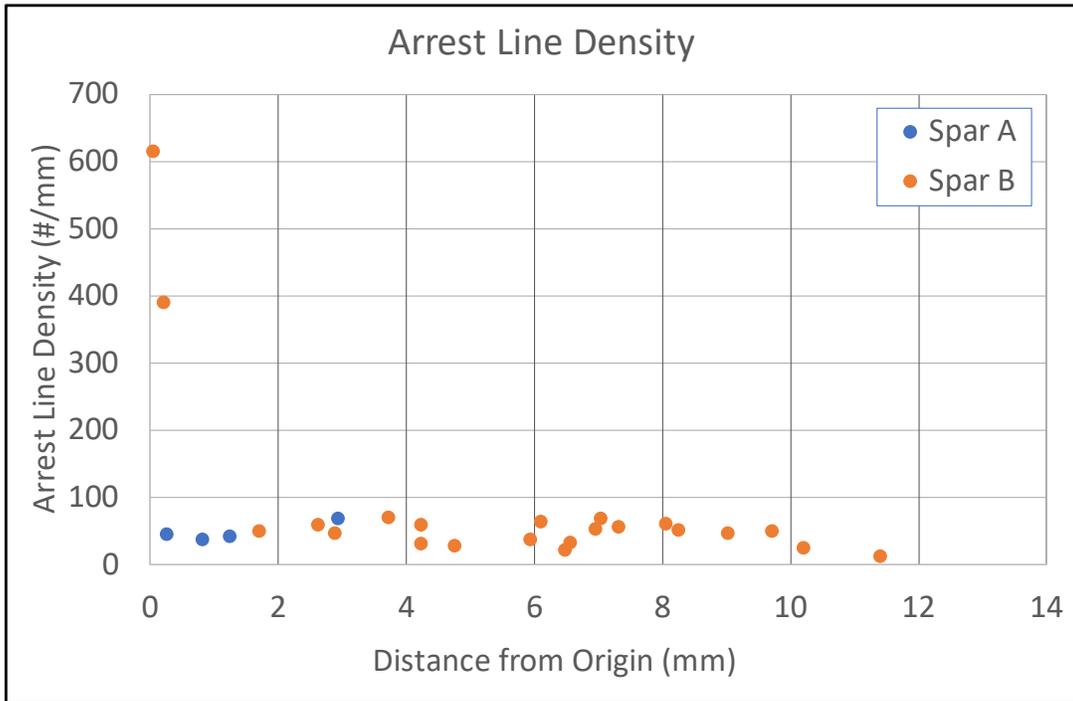
The intermediate arrest line density data for spar B showed a general decreasing trend with distance from the origin consistent with changes in stress intensity under uniform cyclic loading conditions. However, the arrest line density for spar A was relatively unchanged. At the crack boundary for spar A, the arrest line density of 68 arrest lines per millimeter of crack growth was similar to that of spar B at the same distance, but contrary to expectation based on stress intensity, the arrest line density closer to the origin on Spar A was less dense with an average of 40 arrest lines per millimeter of crack growth. The observed differences in arrest line density measurements between spars A and B during early crack growth stages could be related to differences in flight profiles but

Figure 19. Arrest line density plot.

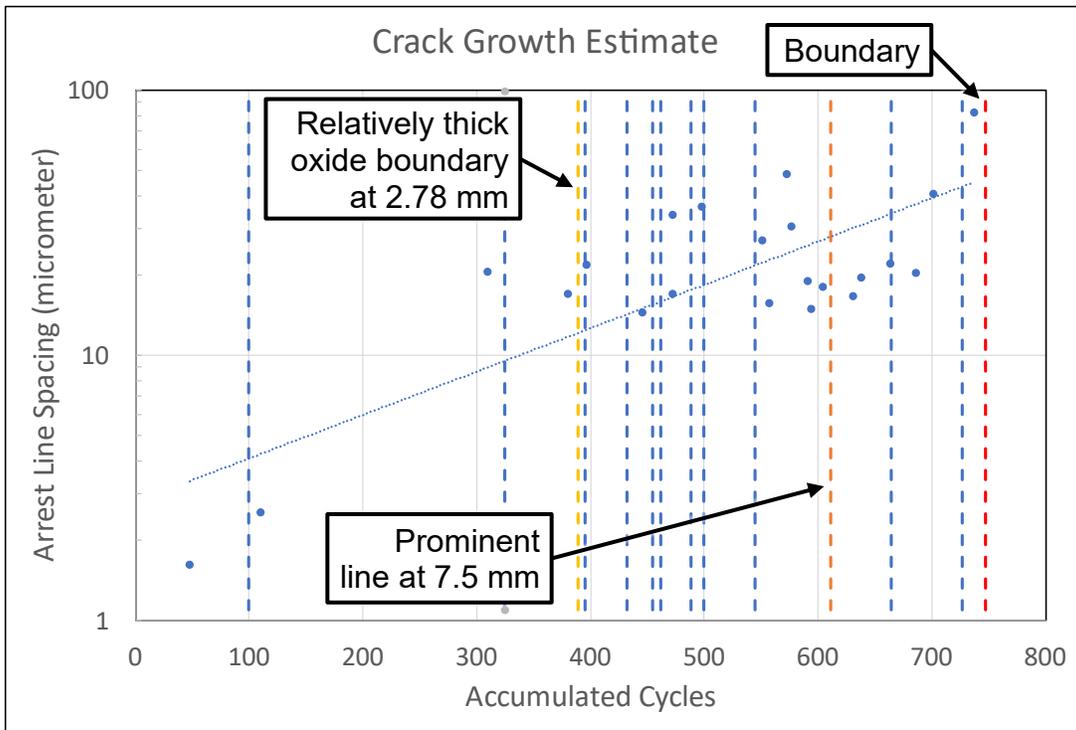
By changing the upper limit of integration in equation 3 to the distance from the origin associated with an individual density measurement, the total number of accumulated flight cycles could be estimated for each measurement location. The average spacing between the intermediate arrest lines at each location was then calculated by taking the inverse of the density value. The resulting crack growth data for spar B as plotted in a log-linear chart is shown in figure 20.

Vertical dashed lines in figure 20 indicate locations of relatively prominent arrest lines including the three relatively distinct arrest lines noted in figure 18. Based on the crack growth estimate shown in figure 20, the crack had extended to the distinct oxide boundary line approximately 360 flight cycles before the crack reached the fatigue boundary, and the prominent arrest line with the distinct step had formed 220 flight cycles later (approximately 140 flight cycles before the crack reached the fatigue boundary).

Figure 20. Crack growth estimate for spar B. Vertical dashed lines indicate relatively prominent crack arrest lines.
