Texas DPS Post Crash Vehicle Inspection Report

Monaville, Texas December 17, 2021

HWY22FH002

VEHICLE INSPECTION REPORT FOR MAJOR CRASH

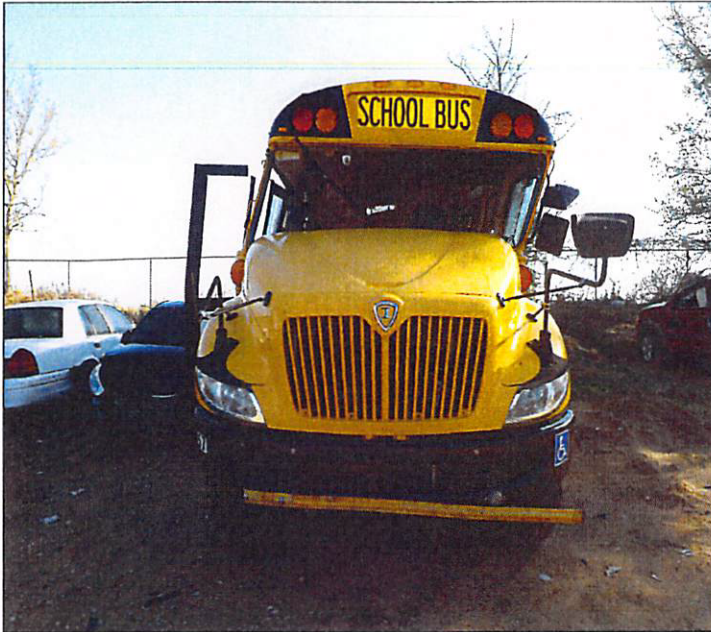
Image of Front of Vehicle

LEFT HEADLAMP BROKEN: <u> NO </u>	RIGHT HEADLAMP BROKEN: <u> NO </u>
AMOUNT OF DIRT ON HEADLAMP: <u> LIGHT </u>	AMOUNT OF DIRT ON HEADLAMP: <u> LIGHT </u>
DESCRIBE FILAMENT: <u> INTACT/NORMAL </u>	DESCRIBE FILAMENT: <u> INTACT/NORMAL </u>
LEFT TURN INDICATOR BROKEN: <u> NO </u>	RIGHT TURN INDICATOR BROKEN: <u> NO </u>
DESCRIBE FILAMENT: <u> INTACT/NORMAL </u>	DESCRIBE FILAMENT: <u> INTACT/NORMAL </u>

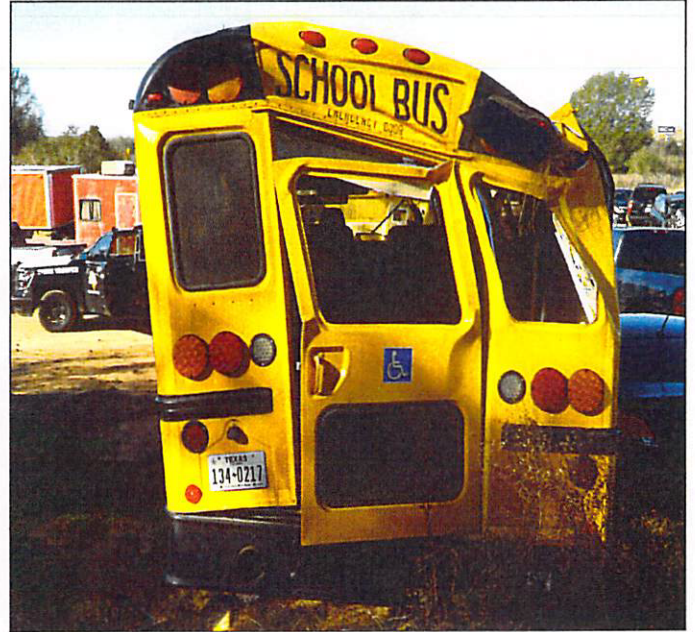
Image of Rear of Vehicle

REAR WINDSHIELD

DESTROYED

LEFT TAIL LAMP BROKEN: NO
AMOUNT OF DIRT ON LENS: LIGHT
DESCRIBE FILAMENT: LED-Non-Functional
LEFT TURN INDICATOR BROKEN: NO
DESCRIBE FILAMENT: LED-Non-Functional
BACK UP LIGHTS CONDITION: NORMAL
REAR EXHAUST CONDITION: GOOD

RIGHT TAIL LAMP BROKEN: NO
AMOUNT OF DIRT ON LENS: LIGHT
DESCRIBE FILAMENT: LED-Non-Functional
RIGHT TURN INDICATOR BROKEN: NO
DESCRIBE FILAMENT: LED-Non-Functional
REAR LENSES REFLECTIVE: YES
OTHER: SIGNIFICANT DAMAGE FROM ROLLOVER

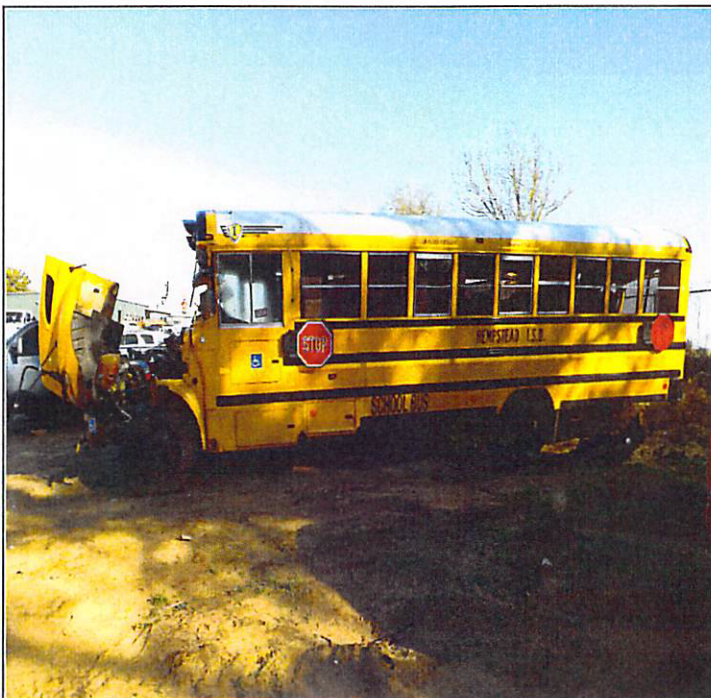
Image of Left Side of Vehicle

LEFT SIDE PASSENGER WINDOWS (SEVEN ROWS) ROW 3 AND 4 ARE BROKEN DUE TO IMPACT FROM UNRESTRAINED 15 YOF PASSENGER. LEFT SIDE EXTERIOR OF BUS HAS SCRAPES FROM CRASH EFFECTS.

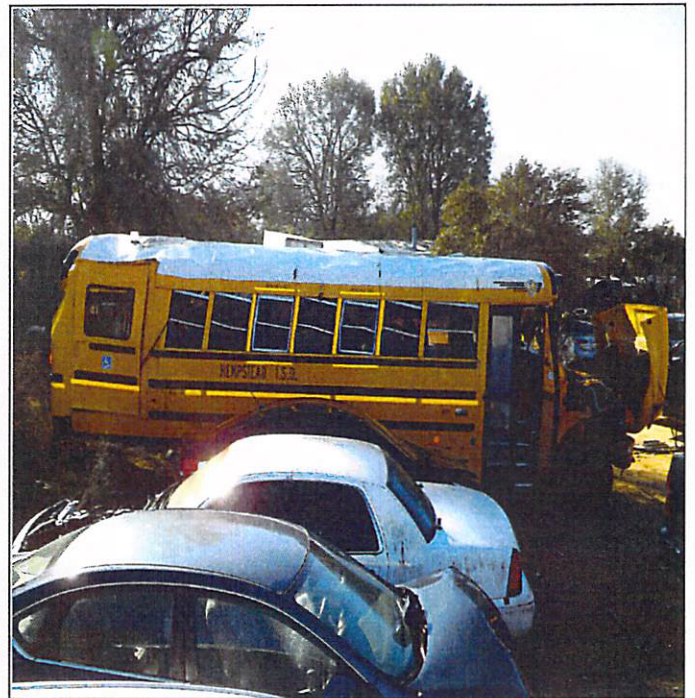
Image of Right Side of Vehicle

DOOR: _____
FORCED OPEN BY COLLISION: YES
LOCKED INSIDE: NO
JAMMED SHUT: NO
OPERATE NORMALLY: NO
WAS THE WINDOW UP? YES
WINDOW BROKEN: YES
BROKEN GLASS: INSIDE & OUTSIDE

BROKEN BEFORE ACCIDENT NO
BROKEN DURING ACCIDENT YES

IS THERE A REAR DOOR ? YES
FORCED OPEN BY COLLISION: NO
LOCKED INSIDE: NO
JAMMED SHUT: YES
OPERATE NORMALLY: NO
IS THERE A REAR WINDOW? YES
WAS THE WINDOW UP? YES
WINDOW BROKEN: YES
BROKEN GLASS: INSIDE & OUTSIDE

RIGHT SIDE PASSENGER WINDOWS (SEVEN ROWS) ROW 1 THROUGH 7 ARE BROKEN DUE TO IMPACT FROM ROLLOVER EFFECTS.
