NATIONAL TRANSPORTATION SAFETY BOARD

MATERIALS LABORATORY FACTUAL REPORT

Report No. 21-003

Place : Coolidge, Arizona
Date : August 15, 2021
Vehicle : 30-inch natural gas transmission pipe operated by Kinder Morgan
NTSB No. : PLD21FR003
Investigator : Kim West (RPH)¹

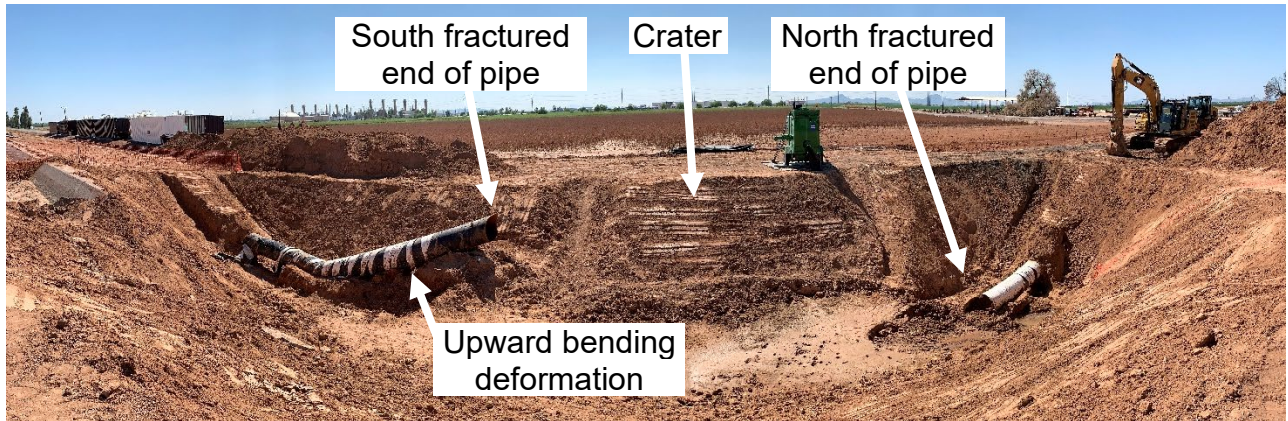
Figure 1. Photograph of the two fractured ends of the ruptured gas pipe located within the crater, after excavation crew exposed portions of the underground pipe.

Two fractured ends of the pipeline were exposed in the crater. The south end fracture had an exposed length of approximately 3-feet. Reportedly, on the day of the accident, the North end fracture had an exposed length of approximately 1-foot. On the following day soil and water had accumulated at the bottom of the crater and covered the north end fracture. No pipe fragments were found in the crater.

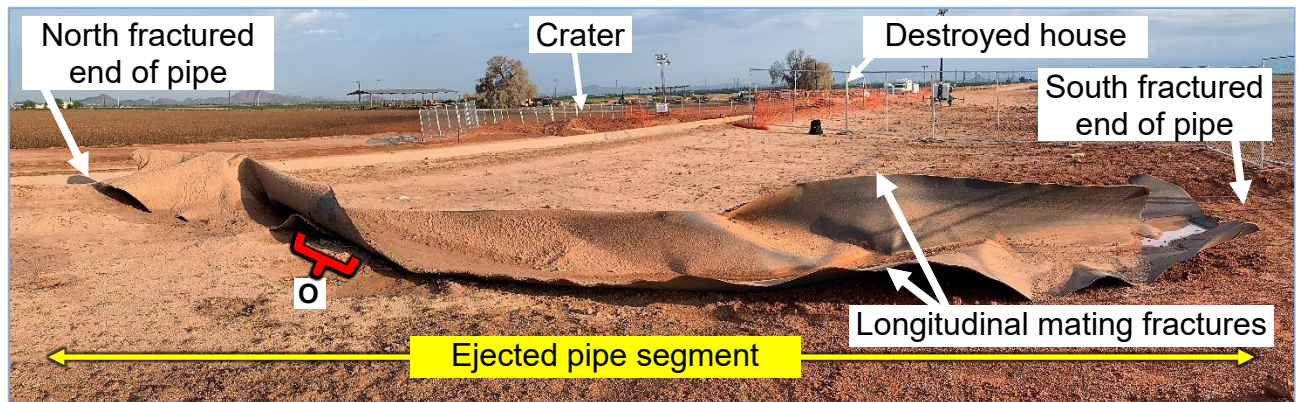
On-site examination revealed an approximately 47-foot-long segment fractured from the pipeline (see figures 1 through 3). The fracture was predominately through the toe portions of the DSAW longitudinal seam. Details of the on-site examination are documented in Appendix 1. Pieces of interest were submitted to the NTSB Materials Laboratory for examination.

Figure 2. Photograph of the approximately 47-foot ejected segment of pipe. The origin of the fracture was ultimately determined to be located in the general area indicated by bracket "O".

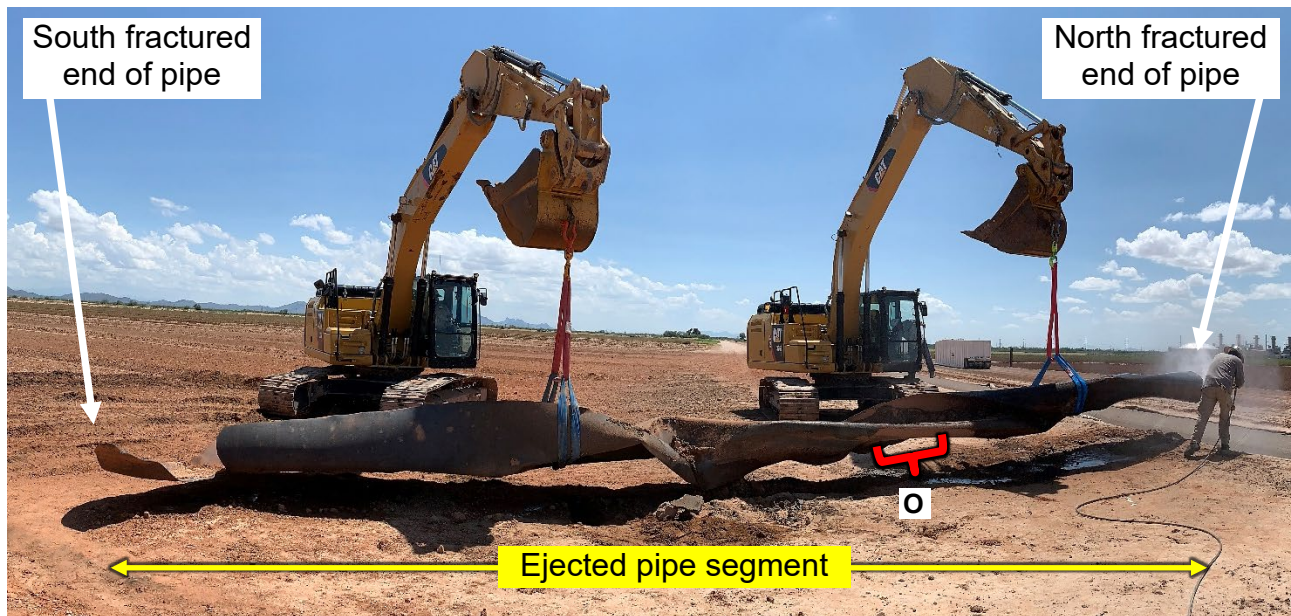
Figure 3. Two track hoes lifting approximately 47-feet of the ejected pipe segment for power-wash cleaning with water prior to inspection by NTSB. The origin of the fracture was ultimately determined to be located in the general area indicated by bracket "O".

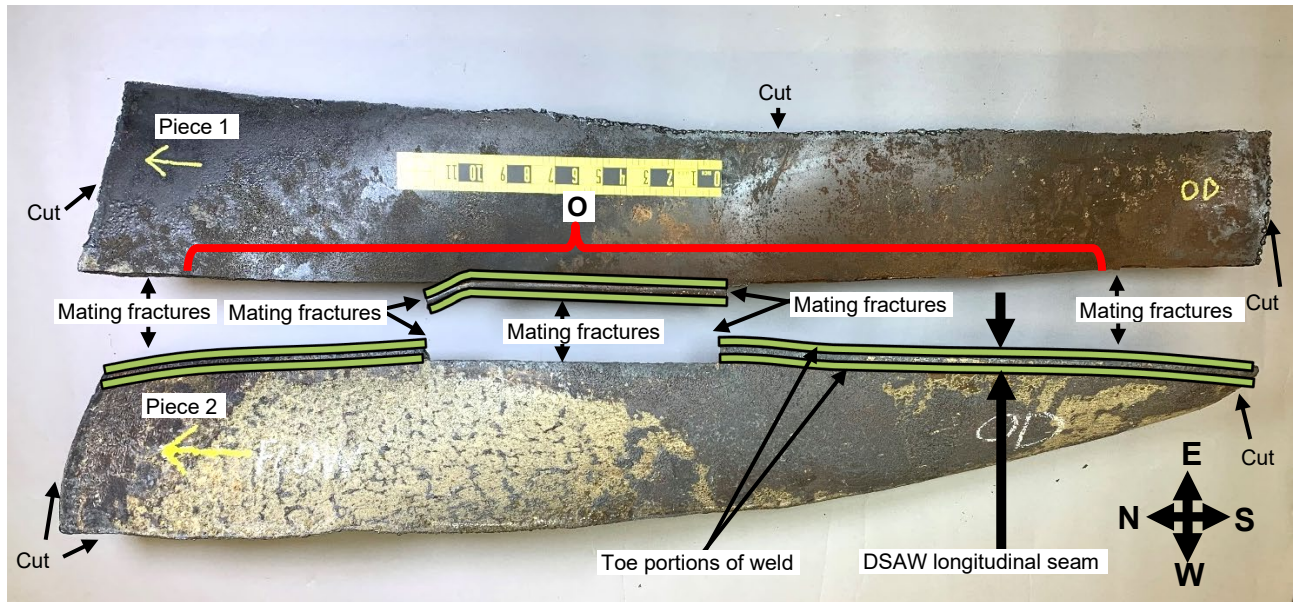
Figure 4. As-received pieces arbitrarily labelled “1” and “2” that were torch cut from the pipe showing the outer face with the mating fractures facing each other. The fracture intersected the toe portions of the DSAW longitudinal seam. The fracture faces contained evidence of ratchet fracture features, indication of multiple origins, that emanated from the outer surface, in the general area indicated by bracket “O” in this figure and by bracket “O” in figures 2 and 3. The location of the toe portions of the weld are indicated by green lines. At the time of the accident, gas was flowing north in the direction indicated by a yellow arrow.

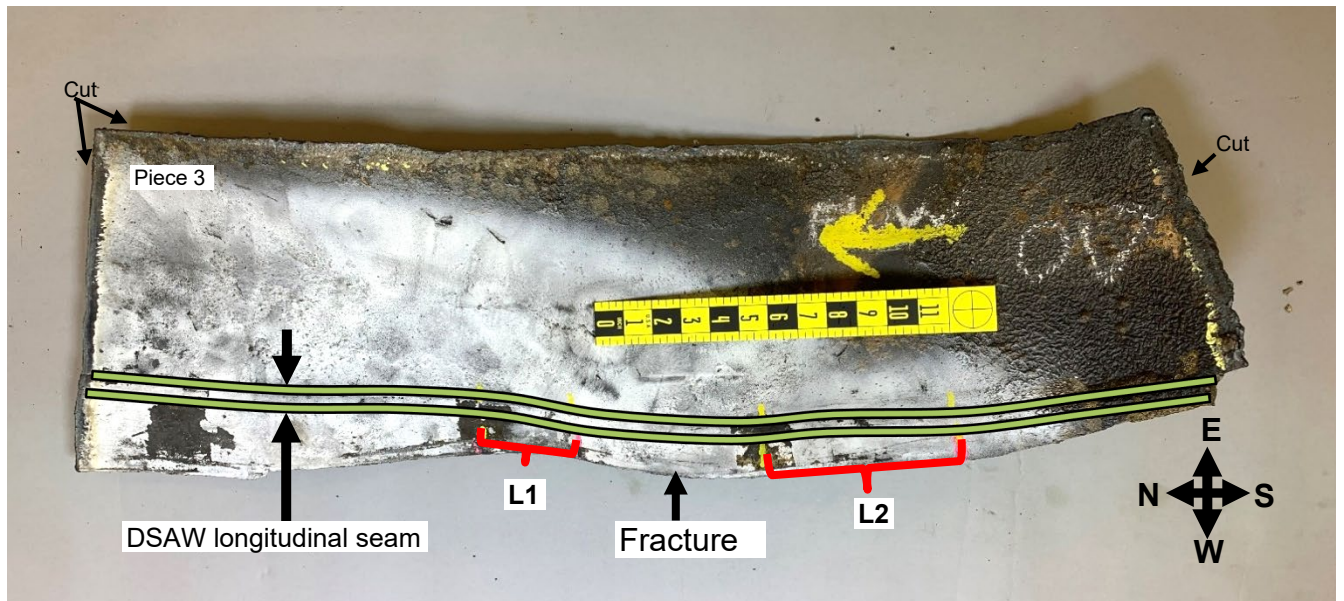
Figure 5. As-received piece “3” that was torch cut from the pipe showing the outer face. The toe portions of the DSAW longitudinal seam are located in areas marked by green lines. Portion of the outer surface was painted white to enhance magnetic particle inspection (MPI). On-site MPI found linear indications at the toe of the longitudinal weld seam (the toe portion closest to the fracture face) in the areas indicated by bracket “L1” and “2”.

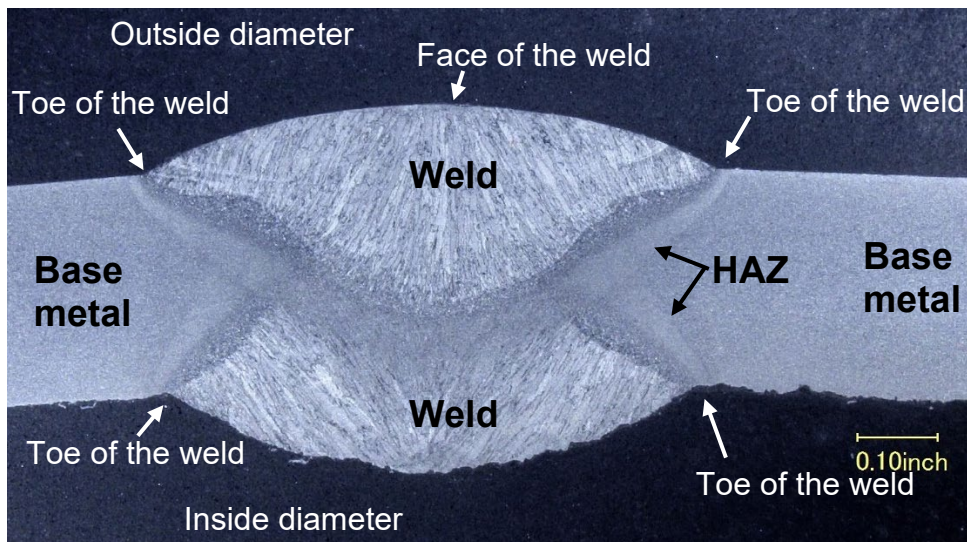
The joint for the DSAW longitudinal seam was specified as double V-groove butt-joint (see Figure 7). The process for making the pipe joint starts with a flat steel plate that is formed into a cylinder shape. The edges of the rolled plate are formed with double V-shaped grooves on the interior and exterior surfaces at the location of the longitudinal seam. An automated arc welder makes a single pass on the inner V-groove forming the inner longitudinal weld bead. This process is repeated on the outer V-groove forming the outer longitudinal weld bead. The outer face of the longitudinal weld seam contains a toe² portion at both edges of the weld. Similarly, the inner face of the longitudinal weld seam contains a toe portion at both edges of the weld.

Figure 7. Cross section of the DSAW longitudinal seam from the ring portion looking south (upstream), in the orientation indicated by section line “R-R” in figure 6, showing various parts of the weld, such as location of the toe portions of the welds, base metal, and heat affected zones (HAZ). Etched with 2% Nital reagent.

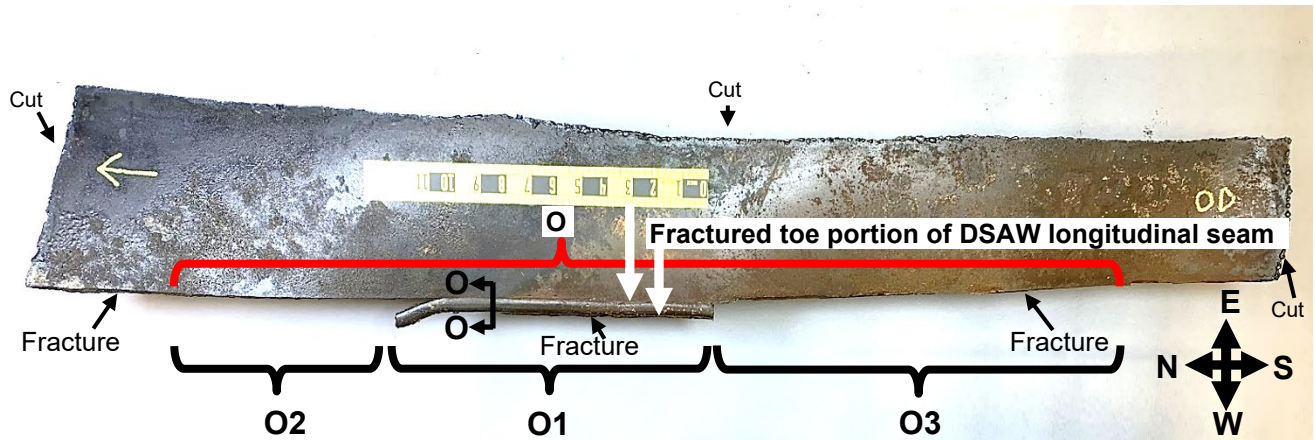
Detailed visual examination of piece “1” revealed the outer face (that included the longitudinal weld, toe portions of the longitudinal weld, and base metal) showed evidence of pitting corrosion. The fracture face showed evidence of ratchet fracture features, indication of multiple origins, that emanated from the outer surface of the pipe at the toe portions of the DSAW longitudinal seam, in the area indicated by bracket “O” in figures 2, 3, 4 and 8. The origin of the fracture incorporated three separate fracture regions, indicated by brackets “O1”, “O2”, and “O3” in figure 8. Fracture region “O1” extended between 12.3 feet and 13.4 feet upstream of GW256360, measuring a length of 1.1 feet. Fracture region “O2” extended between 11.5 feet and 12.3 feet upstream of GW256360, measuring a length of 0.6 feet. Fracture region “O3” extended between 13.4 feet and 14 feet upstream of GW256360, measuring a length of 1.4 feet. The downstream (north) end of the 1.1-foot-long fracture region was connected to the upstream (south) end of fracture region “O2” by a transverse fracture that crossed over the DSAW longitudinal seam. The upstream (south) end of the 1.1-foot-long fracture region was connected to the downstream end of fracture region “O3” by another transverse fracture that crossed over the DSAW longitudinal seam.

Bench binocular microscope examination of the fracture face in the area corresponding to fracture regions “O1” and “O2” in figure 8 revealed evidence of multiple and continuous ratchet fracture features, indication of multiple origins, that emanated at the outer surface of the toe portion of the weld (see figure 9). The ratchet fracture regions were oriented perpendicular to the outer face of the pipe (on a radial-longitudinal plane). The fracture face in the area that corresponded to fracture region “O3” in figure 8 showed evidence of intermittent (non-continuous) regions of ratchet fracture features, that emanated at the outer surface of the toe portion of the weld. Intermittent in this report

Figure 8. As-received pipe piece "1" showing the outer face and fracture that intersected the toe portions of the DSAW longitudinal seam. The origin of the fracture indicated by bracket "O" incorporated three separate fracture segments indicated by brackets "O1", "O2", and "O3".

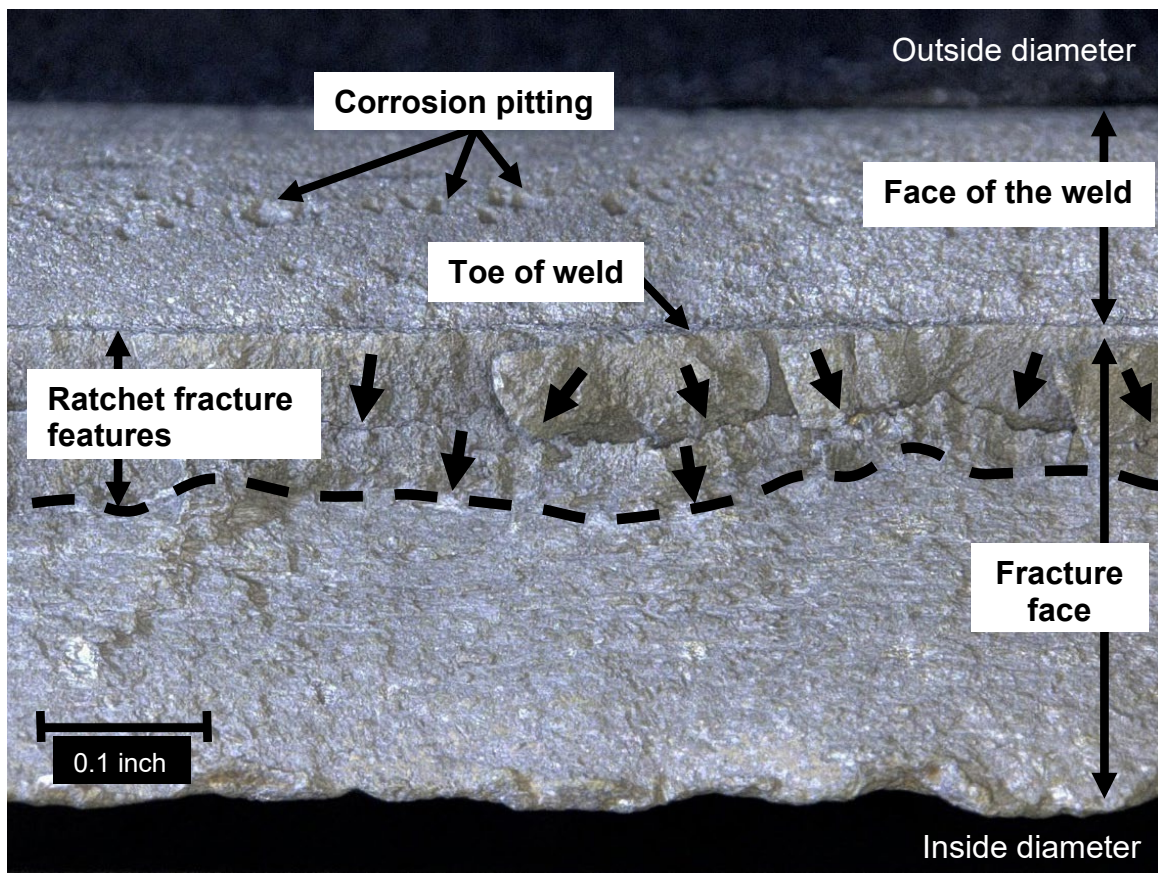
Figure 9. Optical photograph of a portion a fracture face showing typical ratchet fracture features that emanated from the toe of the weld at the origin of the fracture in the area indicated by bracket "O" in figures 2, 3, 4, and 8. General direction of fracture propagation is indicated by arrows. The ratchet features extended approximately 0.1 inch below the toe of the DSAW longitudinal seam to the areas indicated by a dashed line.

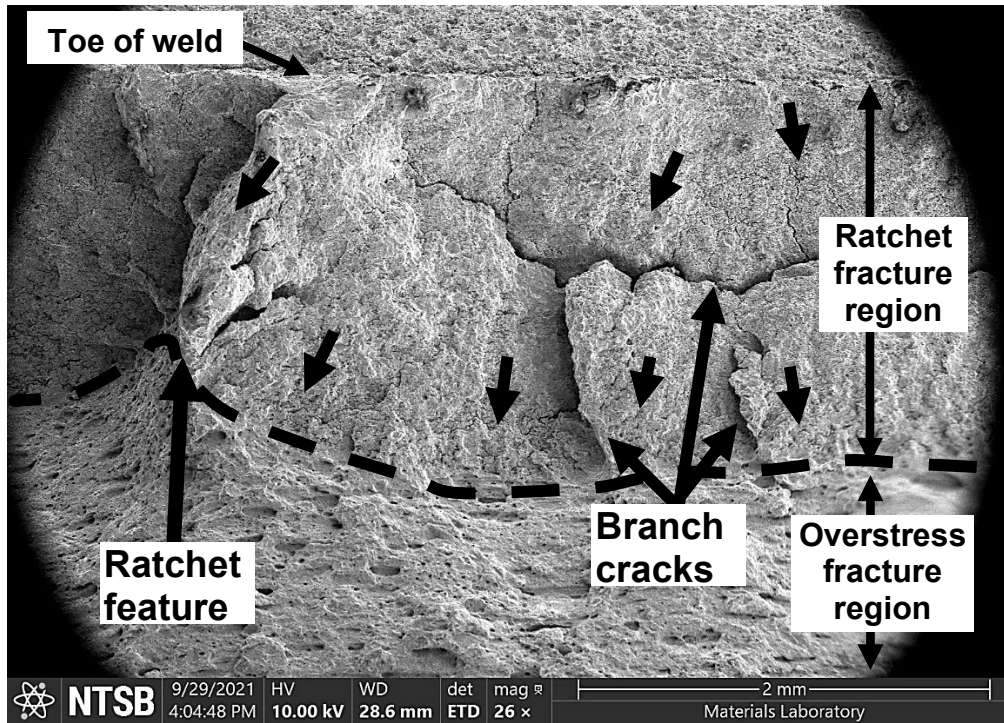
A 4.5-inch-long portion of the fracture face was cut from fracture region “O1” in figure 8 and ultrasonic cleaned with Alconox, a commercial detergent, followed by immersing the piece in “Evapo-Rust”, a commercial rust (corrosion) cleaner. The cleaning procedure removed oxide scale from the exposed surfaces. Scanning electron microscope (SEM) examination of the fracture face after the cleaning procedure revealed ratchet marks emanated from the outer surface of the pipe. Branch cracks were found within the ratchet feature regions and at the terminus of the ratchet fracture feature regions (see figures 10 and 11). The depth of the ratchet fracture features was similar to those observations made by bench binocular microscope. The areas located outside of the ratchet regions exhibited micro-void coalescent features typical of overstress separation, see figures 10 and 11.

Figure 10. SEM photograph of the fracture face located within the origin of the fracture indicated by bracket "O" in figures 2, 3, 4, and 8. Arrows indicate the general direction of fracture propagation within the ratchet fracture region.

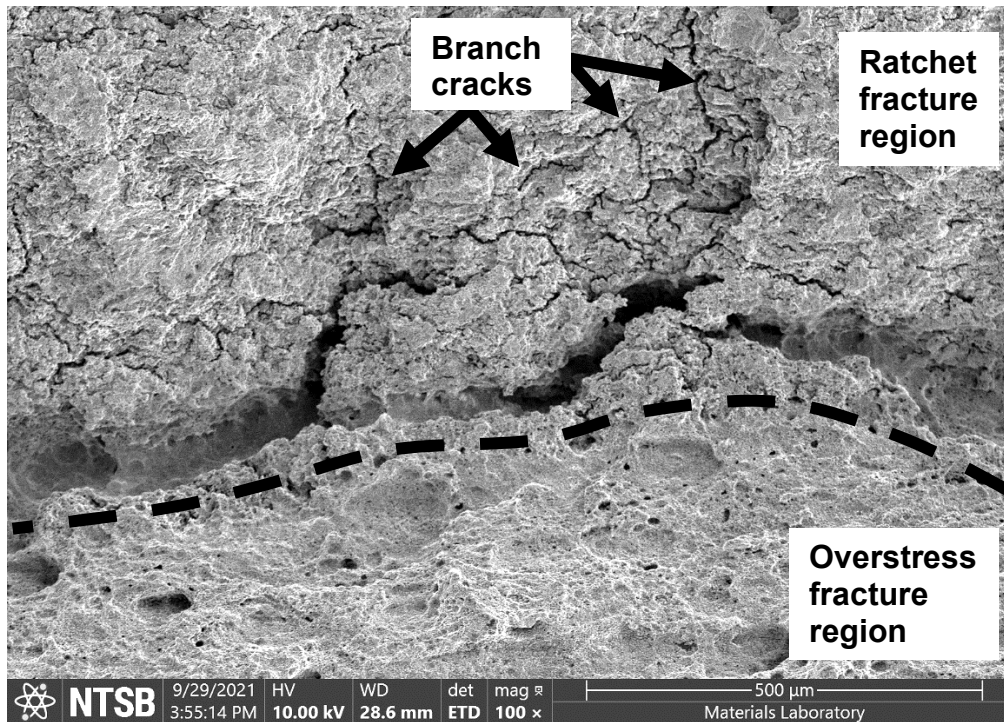
Figure 11. SEM photograph of the fracture face showing a typical transition region between the ratchet region and the overstress region (micro-void coalescence features). The ratchet fracture region contained several branching cracks.

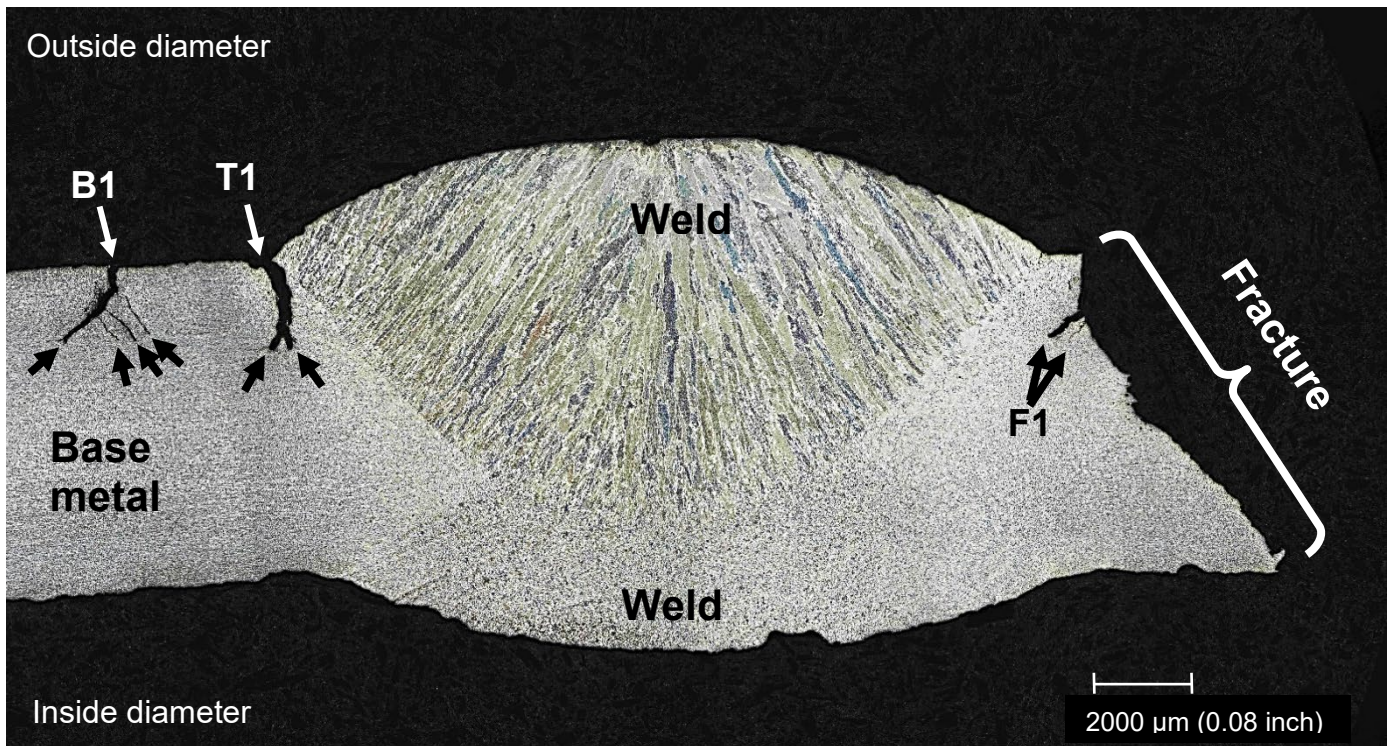
A transverse section (longitudinal-radial section) was made through fracture region “O1”, in the orientation indicated by section line “O-O” in figure 8. The section was polished and etched with 2% Nital reagent. Examination of the etched section revealed the fracture face in the area near the outer surface exhibited a branch crack, indicated by arrow “F1” in figure 12. The other toe portion of the weld contained a branch crack, indicated by arrow “T1” in figure 12, that extended approximately 0.07 inch below the surface. The outer surface of the pipe in the base metal portion also contained a branch crack, indicated by arrow “B1” in figure 12, that extended as deep as 0.06 inch below the surface.

Figure 12. Metallurgical cross section O-O showing the fracture face; a branch crack extending from the fracture face in the area indicated by arrows "F1"; a branch crack indicated by arrow "T1" (approximately 0.07 inches deep) that intersected the toe of the weld; and a branch crack indicated by arrow "B1" (approximately 0.06 inches deep) that extended into the base metal. Crack "B1" was located approximately 0.12 inch laterally away from crack "T1". The ends of the branch cracks are indicated by arrows. Etched with 2% Nital reagent.

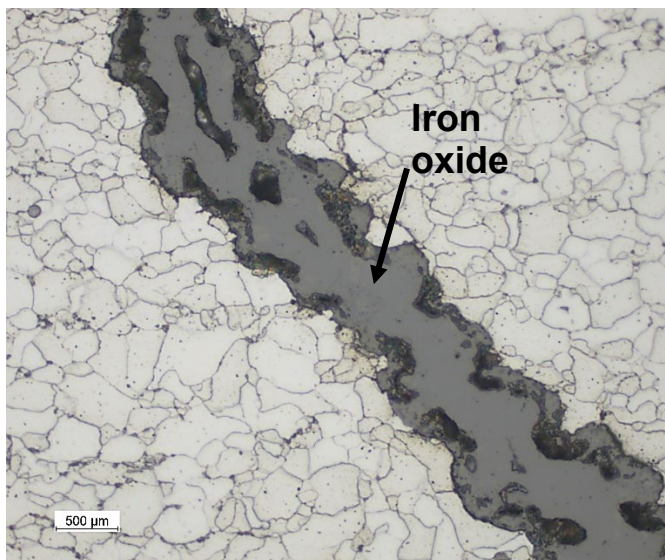
Figure 13. Iron oxide deposit (light grey area) within a branching crack "B1" in figure 12. Etched with 2% Nital reagent.

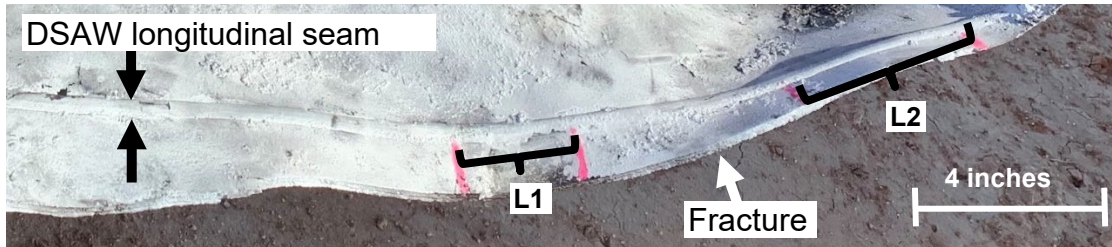
Follow-up fluorescent MPI of the outer surface of piece “3” disclosed evidence of linear crack indications at the toe portion of the longitudinal weld in the same two areas identified on-site by MPI as having linear indications (indicated by brackets “L1” and “L2”

Appendix 1A. On-site photograph of the outer face of the pipe showing MPI linear indications that were found at the toe portions of the longitudinal weld, in the areas indicated by brackets "L1" and "L2".

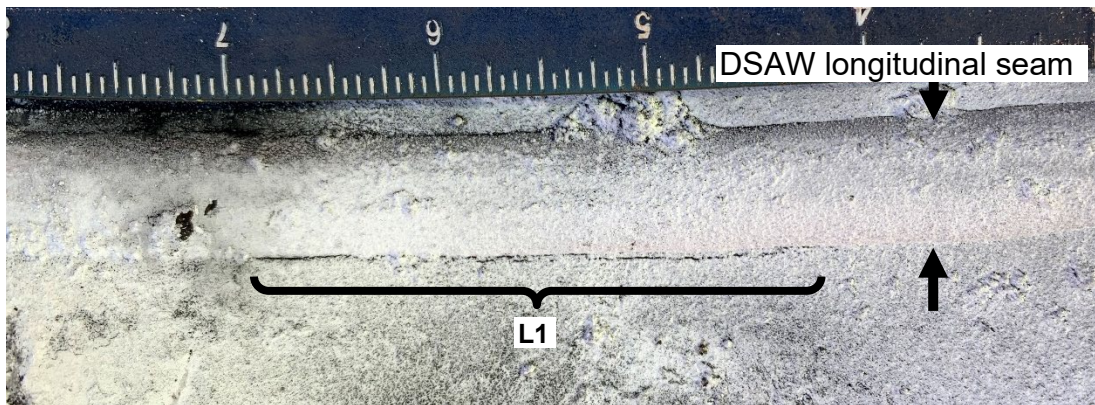
Appendix 1B. Close-up photograph of MPI linear indication "L1" in Appendix 1A.

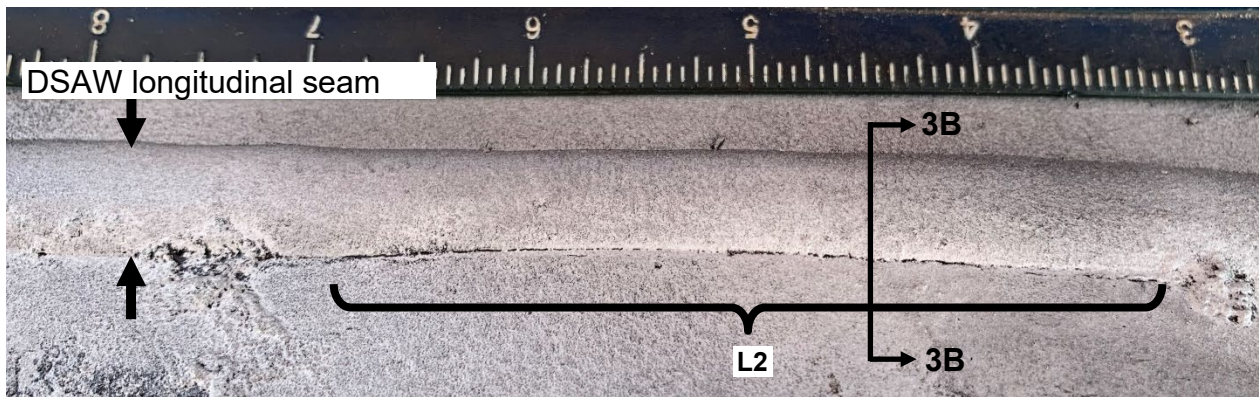
Appendix 1C. Close-up photograph of MPI linear indication "L2" in Appendix 1A.

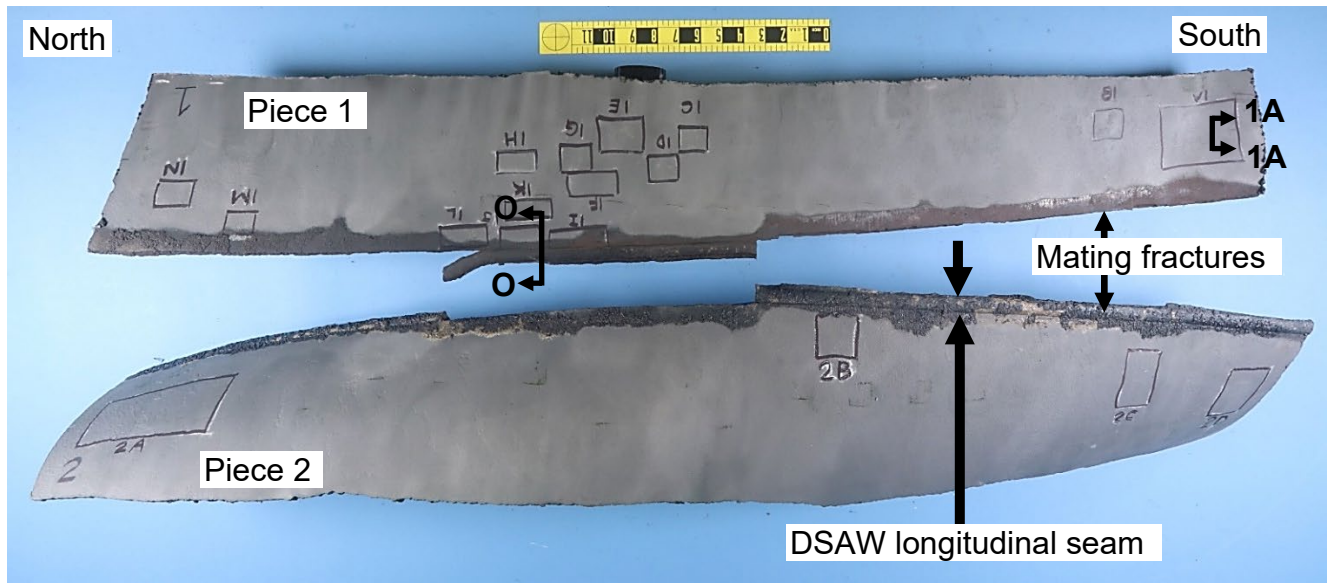
Appendix 2A. Outer face of the pieces “1” and “2” after grit blast cleaning. On piece “1”, areas showing cluster of MPI linear indications were arbitrarily identified by regions “1A” through “1N”. On piece “2”, areas showing cluster of MPI linear indications were arbitrarily identified by regions “2A” through “2D”. A one-inch-wide portion along the fracture face of each piece was masked to protect the fracture face from the grit blasting procedure). Pieces are shown after removing masking material. Section “O-O” was made approximately 1.5 feet from the north cut end. Section “1A-1A” was made approximately 0.2 feet from the south cut end.

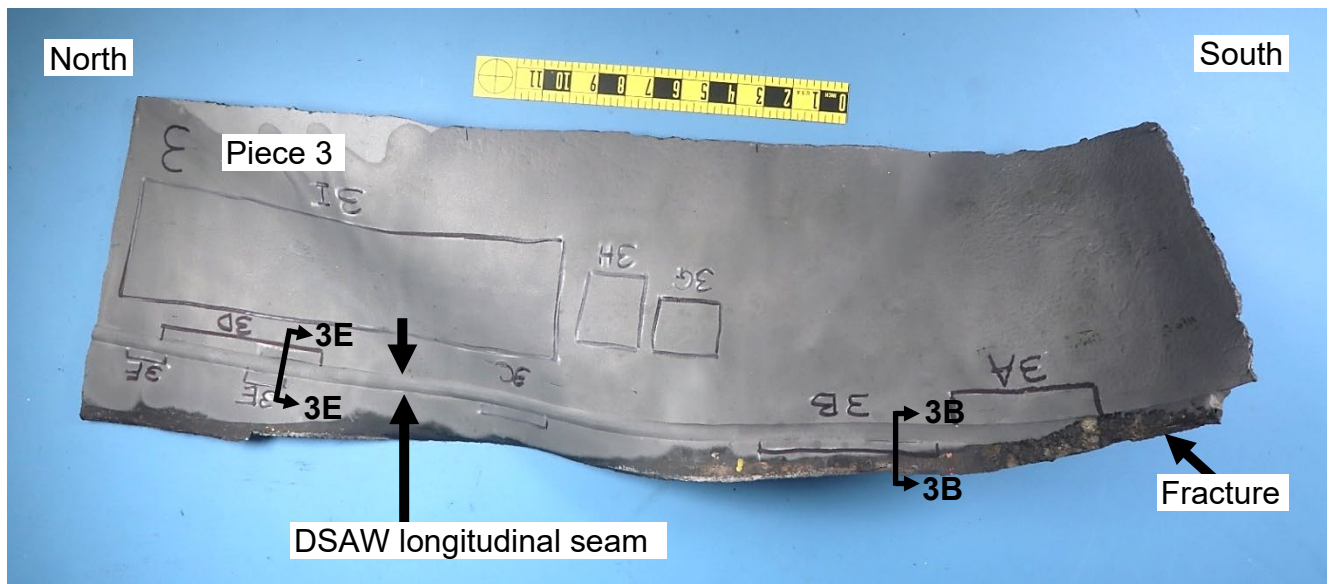
Appendix 2B. Outer face of the piece “3” after grit blast cleaning. Areas showing MPI linear indications are indicated by regions “3A” through “3F”. A one-inch-wide portion along the fracture face of each piece was masked to protect the fracture face from the grit blasting procedure). Piece is shown after removing masking material. Section “3E-3E” was made approximately 0.7 feet from the north cut end. Section “3B-3B” was made approximately 3 feet from the north cut end.

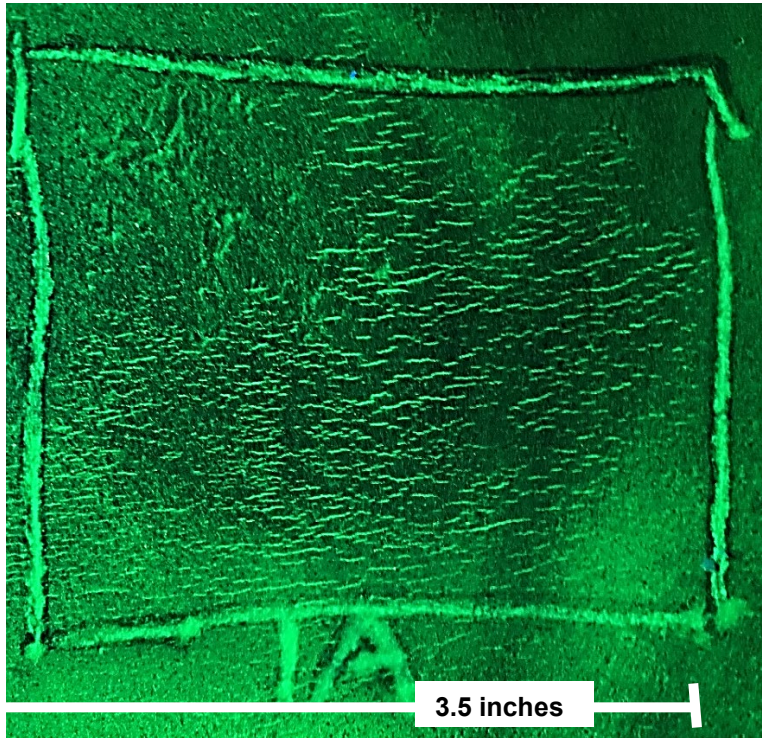
The fluorescent MPI method revealed the outer surface of the three submitted pieces contained evidence of multiple colonies of longitudinal linear indications that were parallel to each other, consistent with stress corrosion cracking (SCC). The outer boundaries of each region of SCC colony were marked by a rectangle pattern (see Appendices 2A through 2B) to indicate the extent of a SCC colony. The size of each rectangle pattern (general size of a SCC colony) was measured. Piece “1” contained a total of 14 separate regions of SCC colonies; piece “2” contained a total of 4 separate regions of SCC colonies; and piece “3” contained a total of 9 separate regions of SCC colonies. Piece 3 contained the largest region of a SCC colony and it measured approximately 16.3 inches in length by 4 inches in circumference. The general size of each colony of longitudinal linear indication is tabulated in Appendix 2. Examples of a typical colony of longitudinal linear indications are shown in Appendices 2C through 2F.

Appendix 2C. Outer surface of piece 1 showing region 1A when viewed with black (ultraviolet) light during fluorescent MPI. This area contained colonies of longitudinal crack indications consistent with SCC. Surface was grit blasted prior to MPI.

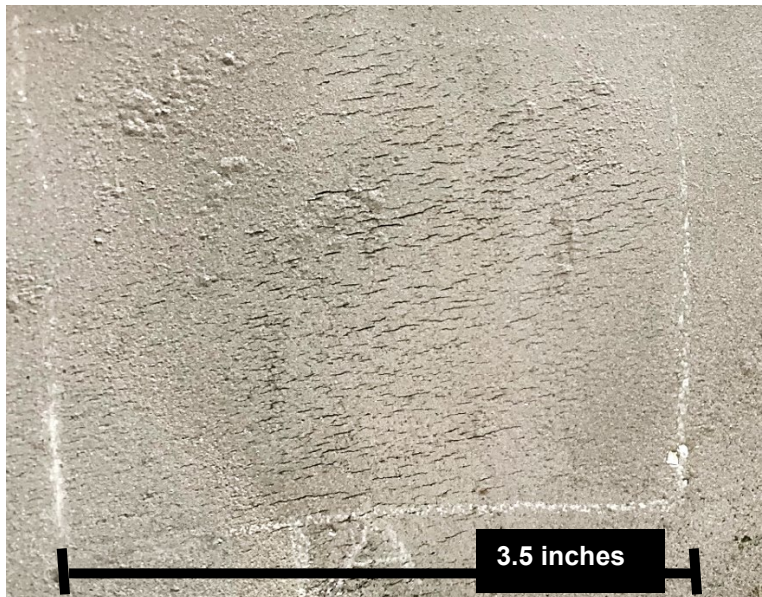
Appendix 2D. Outer surface of region 1A when viewed with incandescent light showing surface breaking cracks that coincided with colonies of longitudinal crack indications. Photograph taken after grit blast cleaning and MPI. Pitting corrosion is present in the general area.

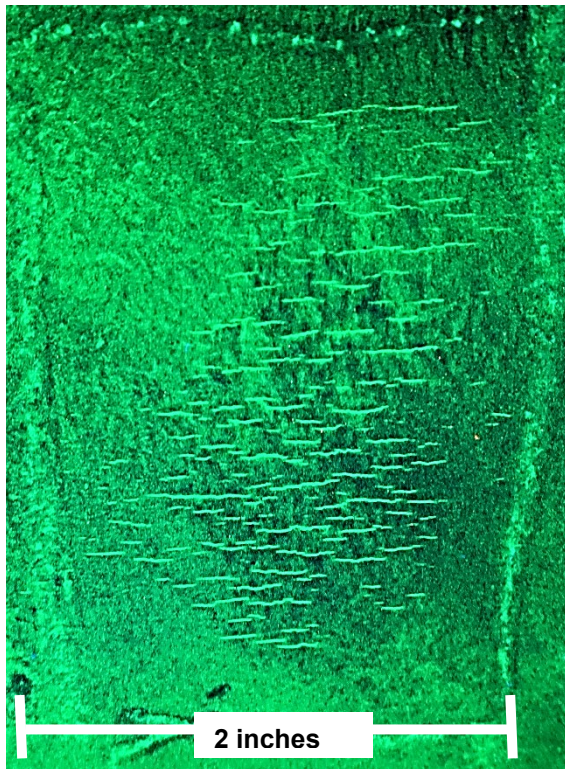
Appendix 2E. Outer surface of piece 2 showing region 2D when viewed with black (ultraviolet) light during fluorescent MPI. The area contains longitudinal colonies of crack indications consistent with SCC. Surface was grit blasted prior to MPI.

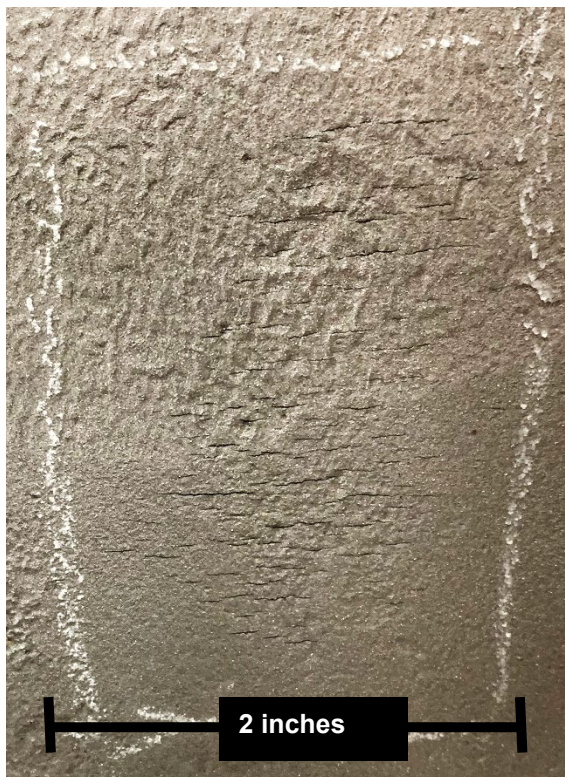
Appendix 2F. Outer surface of piece 2 showing region 2D showing when viewed with incandescent light showing surface breaking cracks that coincided with colonies of longitudinal crack indications. Photograph taken after grit blast cleaning and MPI. Pitting and general corrosion is present in the general area.

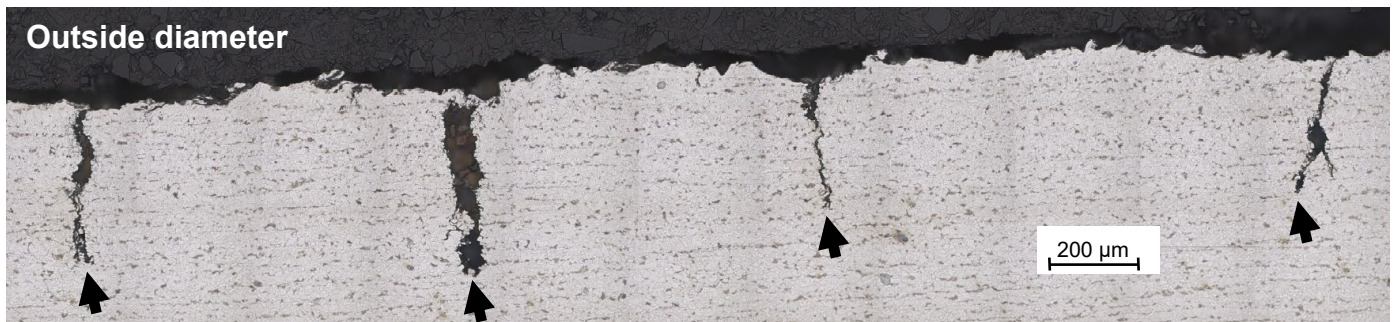
The three pipe pieces were returned to the NTSB Materials Laboratory to determine whether the colony of longitudinal linear indications were surface breaking cracks. A transverse metallurgical section was made through the wall (base metal) of piece “1”, in the orientation indicated by section line “1A-1A” in Appendix 2A, a region that MPI exposed colonies of longitudinal linear indications. The photograph in Appendix 2G shows four of the many surface-breaking cracks that were found in section “1A-1A”. The location of the surface breaking cracks corresponded to colonies of linear indications. The shallow portion of the cracks propagated through the wall by intergranular crack path (see Appendices 2H through 2J). The deeper cracks were filled with iron oxide (verified by X-ray energy dispersive spectroscopy [EDS] analysis). The cracks in the base metal as observed in section “1A-1A” extended as deep as 0.016 inch below the surface.

Appendix 2G. Portion of cross section 1A-1A showing four separate surface breaking cracks in the base metal, in the areas indicated by arrows. These cracks are part of the colonies of cracks that were detected by fluorescent MPI. In this view, the maximum depth of the surface cracks measured approximately 0.014 inch.

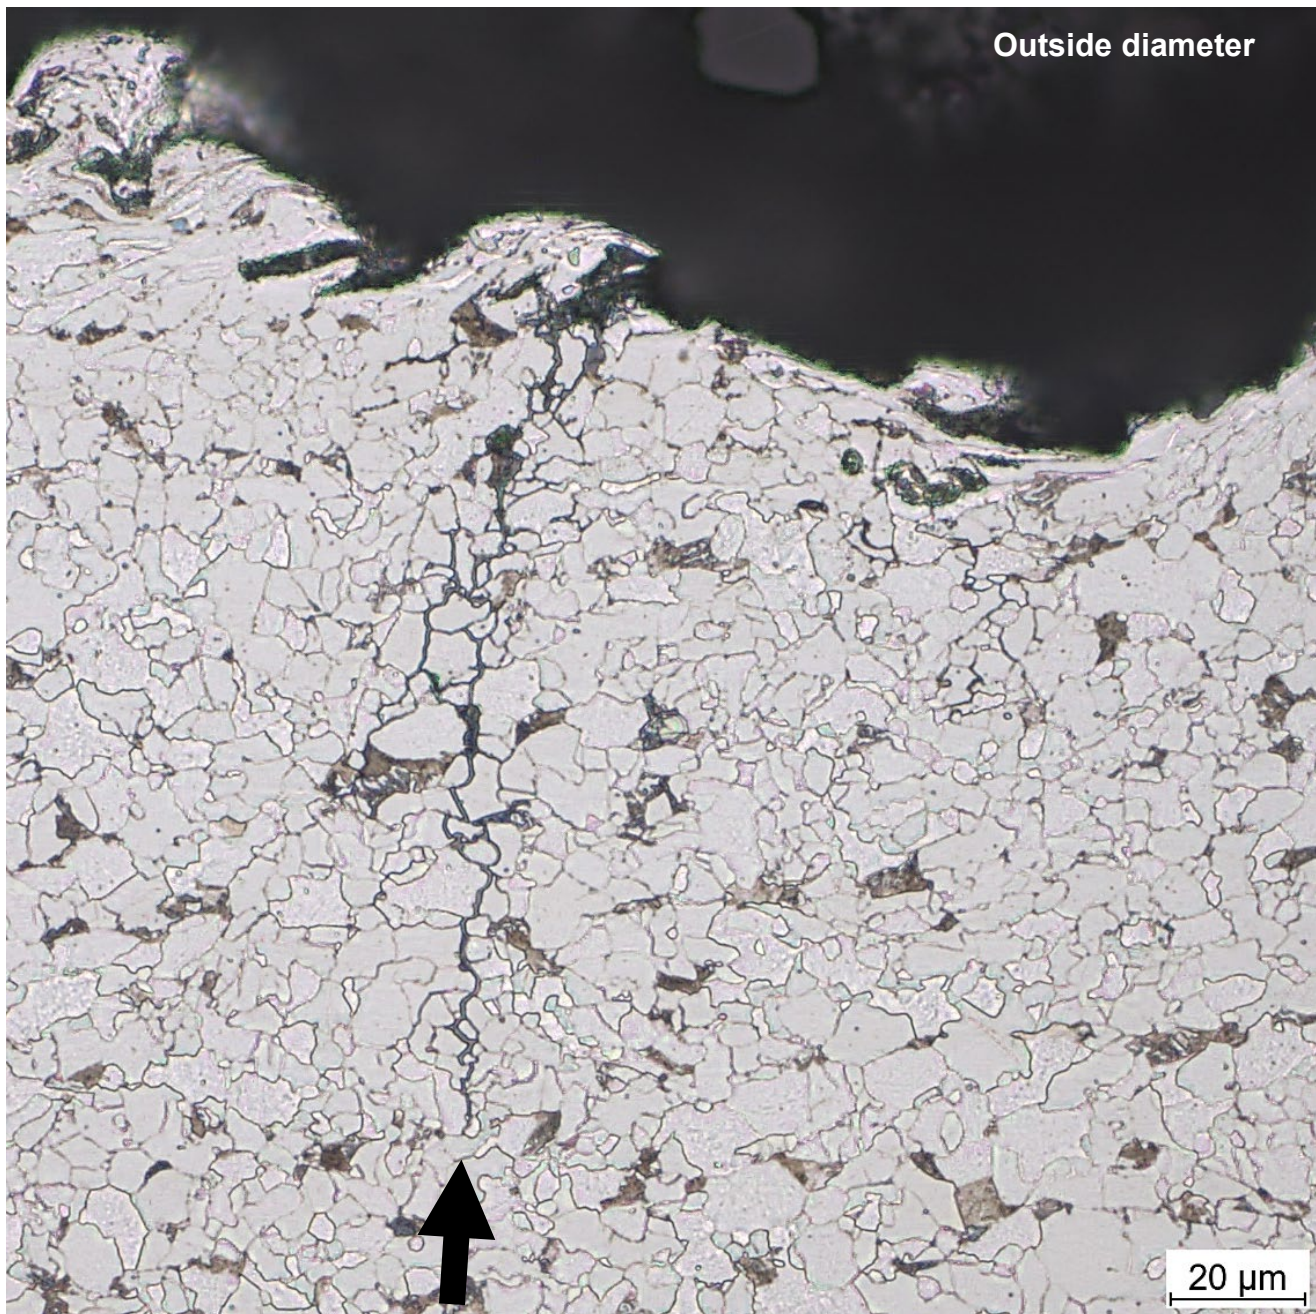
Appendix 2H. . Portion of cross section 1A-1A showing a surface breaking crack, indicated by an arrow, at the outer face of the pipe. These are part of the colonies of cracks that were detected by fluorescent MPI. In this micrograph, the maximum depth of the crack measured approximately 0.005 inch. The crack appears to be propagating by intergranular mode.

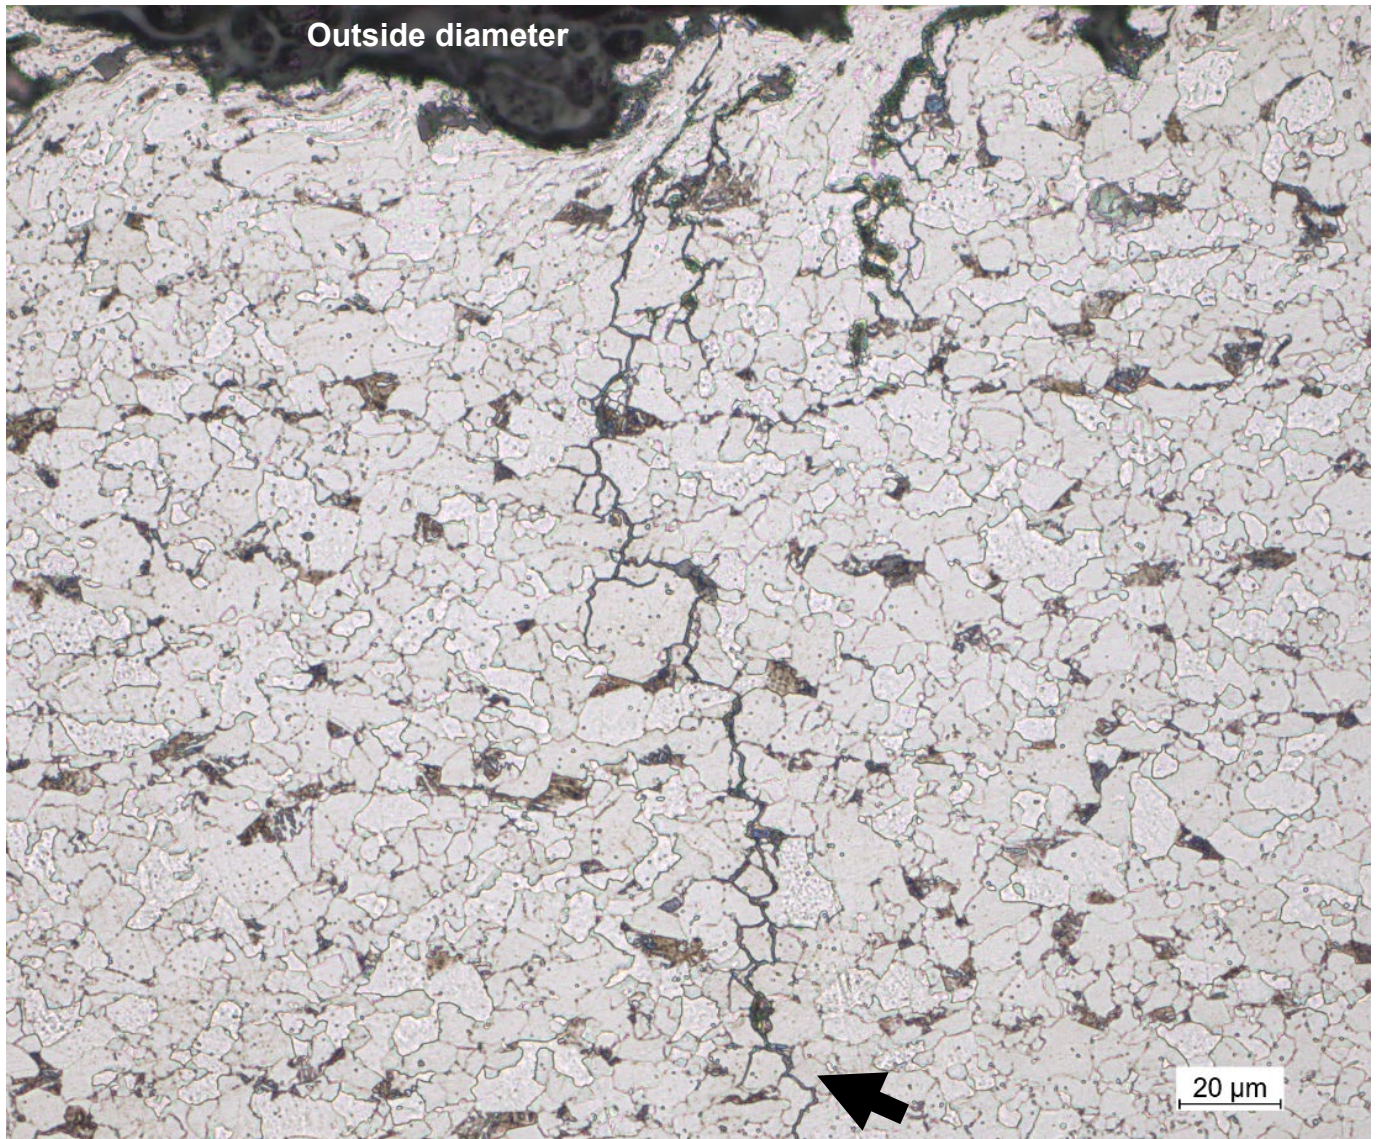
Appendix 2I. Portion of cross section 1A-1A showing a surface breaking crack, indicated by an arrow, at the outer face of the pipe. These are part of the colonies of cracks that were detected by fluorescent MPI. In this micrograph, the maximum depth of the crack measured approximately 0.009 inch. The crack appears to be propagating by intergranular mode.

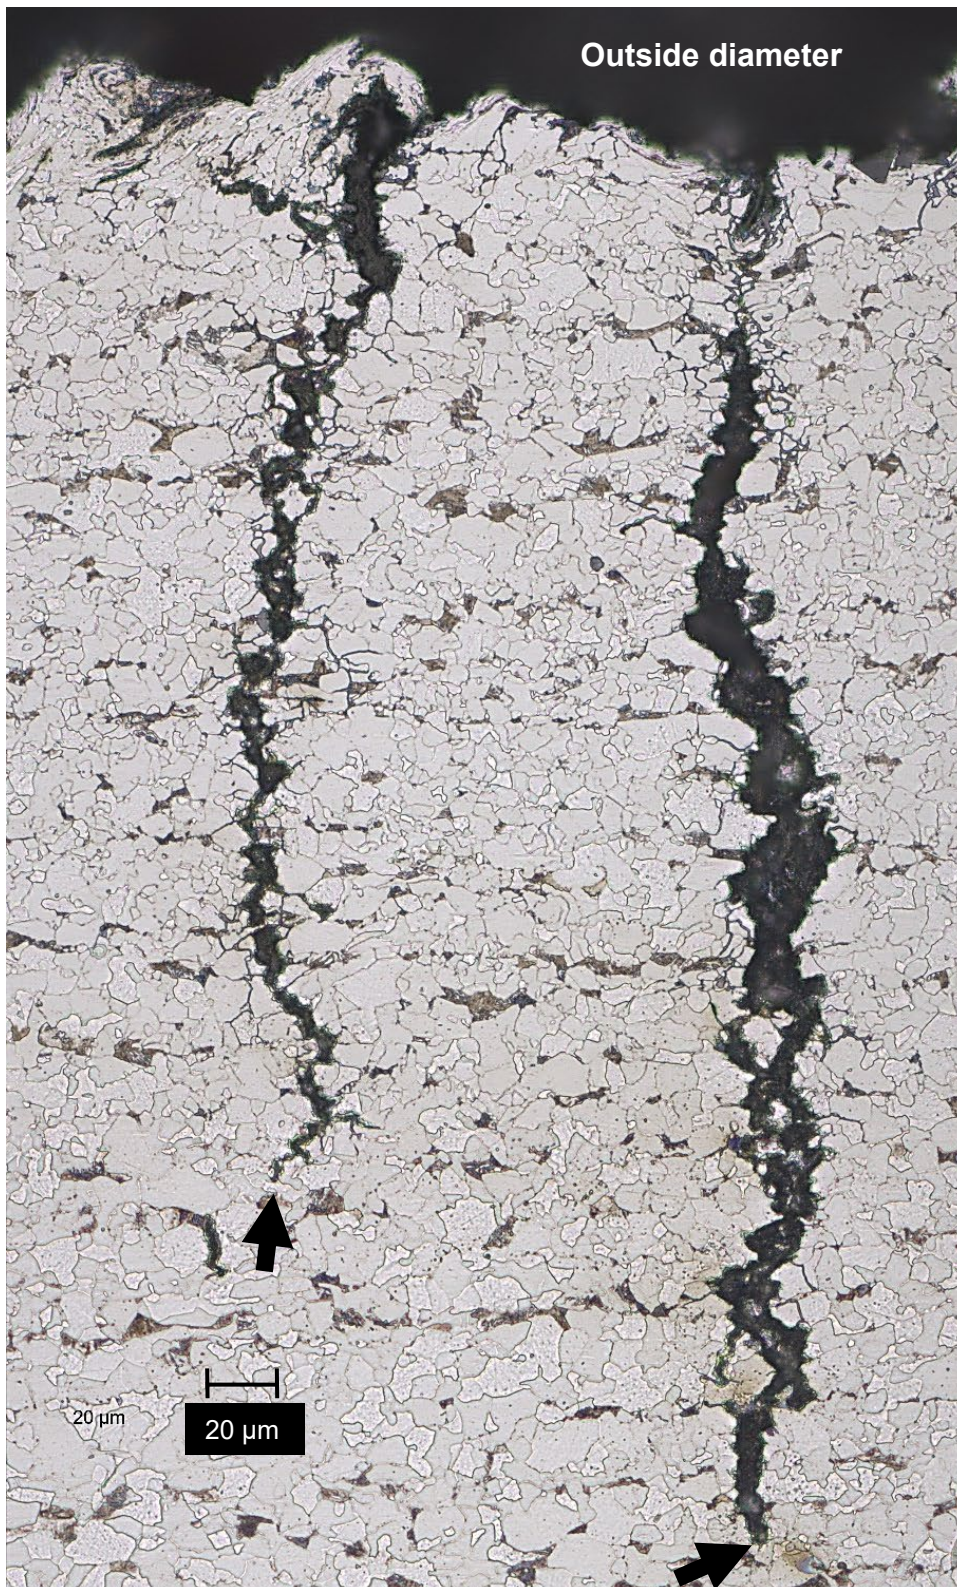
Appendix 2J. Portion of cross section 1A-1A showing two separate surface breaking cracks, indicated by arrows, at the outer face of the pipe. These are part of the colonies of cracks that were detected by fluorescent MPI. In this micrograph, the maximum depth of the cracks measured approximately 0.07 inch. The crack appears to be propagating by intergranular mode.
