NATIONAL TRANSPORTATION SAFETY BOARD

MATERIALS LABORATORY FACTUAL REPORT

Report No. 21-003

Place : Coolidge, Arizona
Date : August 15, 2021
Vehicle : 30-inch natural gas transmission pipe operated by Kinder Morgan
NTSB No. : PLD21FR003
Investigator : Kim West (RPH)¹

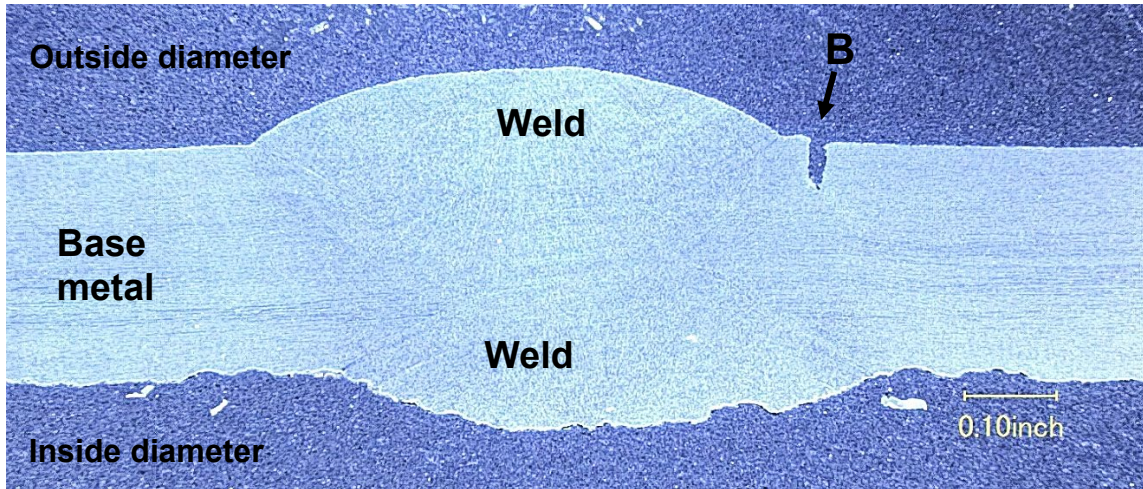
in Appendices 1A through 1C). A cross section was made through linear indication “L2” in the orientation indicated by section line “3B-3B in Appendix 1C and 2B. The section was prepared and etched with 2% Nital reagent (see Appendix 2K). Examination of section “3B-3B” revealed the crack at the toe portion of the weld, indicated by arrow “B” in Appendices 2K through 2M, extended 0.06 inch below the surface.

Appendix 2K. Metallurgical cross section 3B-3B showing a crack indicated by arrow "B" (approximately 0.06 inch deep) that intersected an area adjacent to the toe portion of the weld. Etched with 2% Nital reagent.

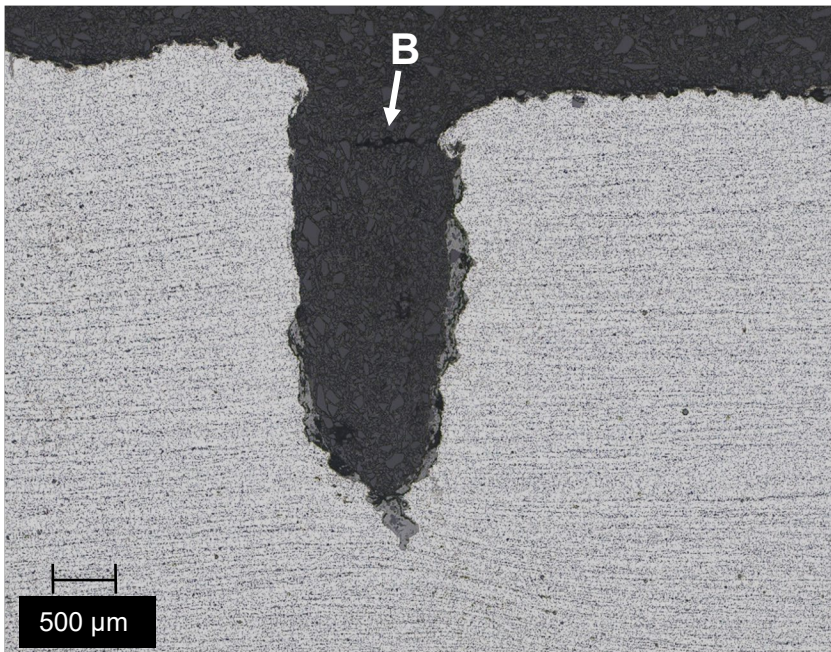
Appendix 2L. Close-up micrograph of the crack arrowed "B" in section 3B-3B showing that the edges of the crack cavity contained iron oxide scale. Etched with 2% Nital reagent.

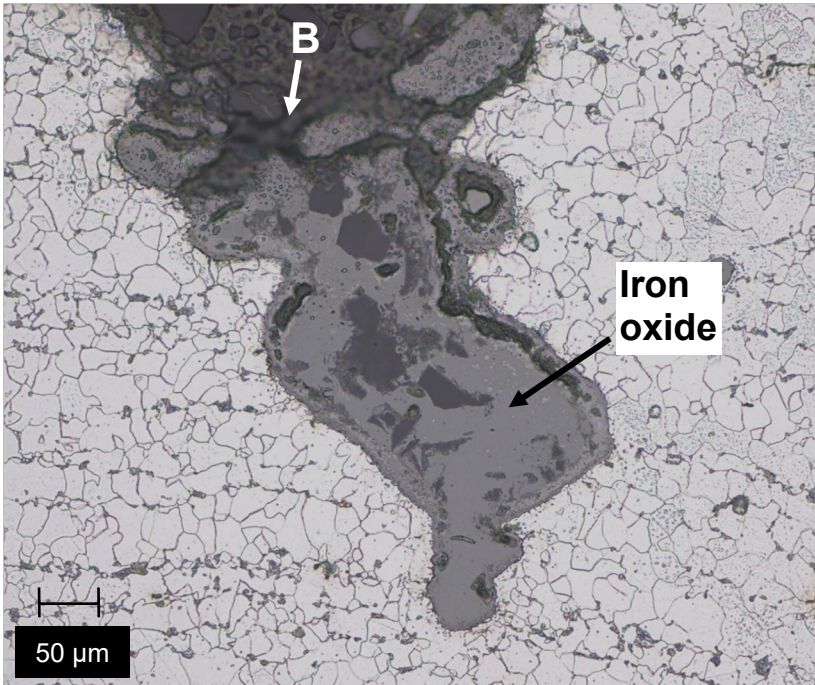
Appendix 2M. Bottom of crack "B" in section "3B-3B" showing deposit of iron oxide (light grey color).

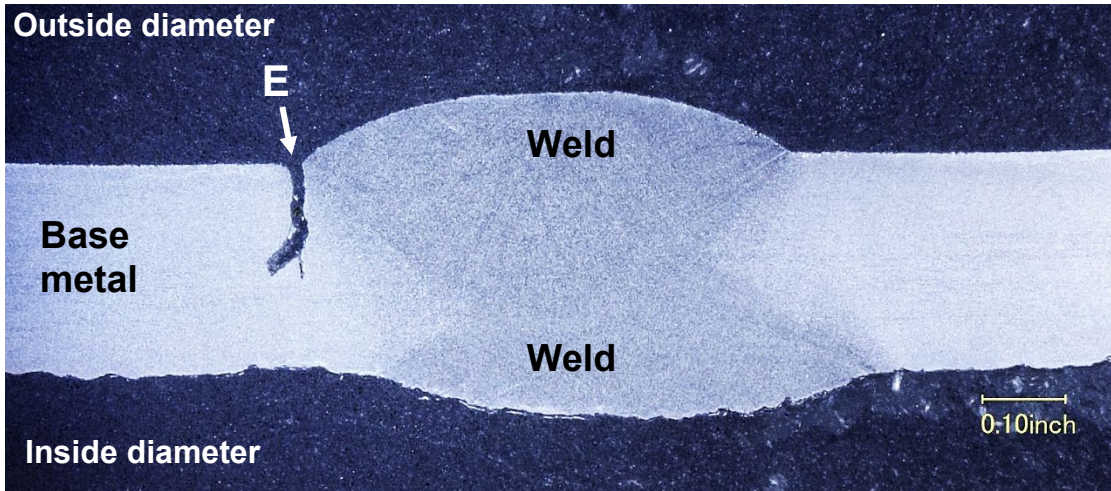
Another section was made through a linear indication at the toe portion of the weld in the orientation indicated by section line “3E-3E” in Appendix 2B (discovered by fluorescent MPI and unrelated to crack indications “L1” and “L2”). Appendix 2N shows a photograph of section “3E-3E”. The crack at the toe portion of the weld, indicated by arrow “E” in Appendices 2N through 2P, extended 0.14 inches below the surface.

Appendix 2N. Metallurgical cross section 3E-3E showing a branch crack indicted by arrow “E” (approximately 0.14 inch deep) that intersected the toe portion of the weld. Etched with 2% Nital reagent.

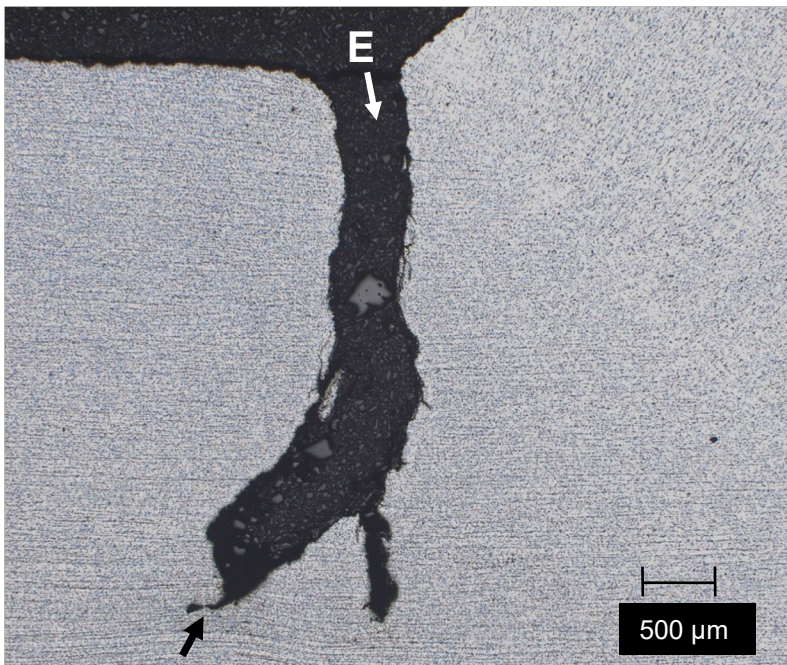
Appendix 2O. Close-up micrograph of the crack arrowed “E” in section 3E-3E showing that the cavity within the crack contained iron oxide scale in the area indicated by a black arrow. Etched with 2% Nital reagent.

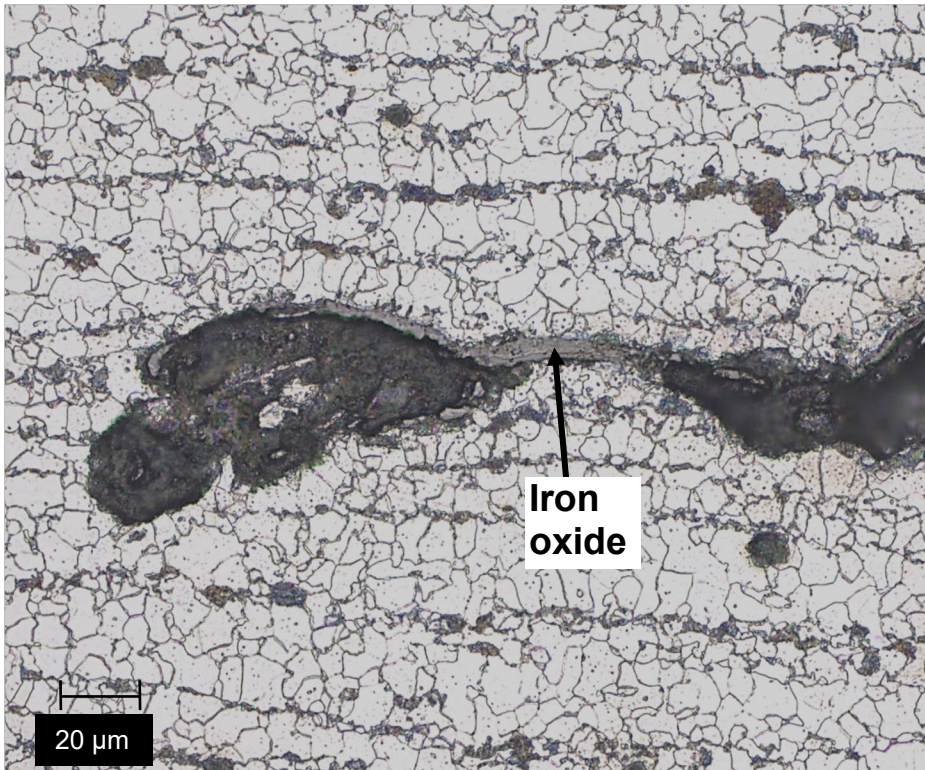
Appendix 2P. Bottom of crack "E" in section "3E-3E" showing a deposit of iron oxide (light grey color).
