NATIONAL TRANSPORTATION SAFETY BOARD

MATERIALS LABORATORY FACTUAL REPORT

Report No. 22-028

Place : Brookshire, Texas
Date : October 19, 2021
Vehicle : McDonnell Douglas DC-9-87
NTSB No. : DCA22MA009
Investigator : Tom Jacky, AS-40

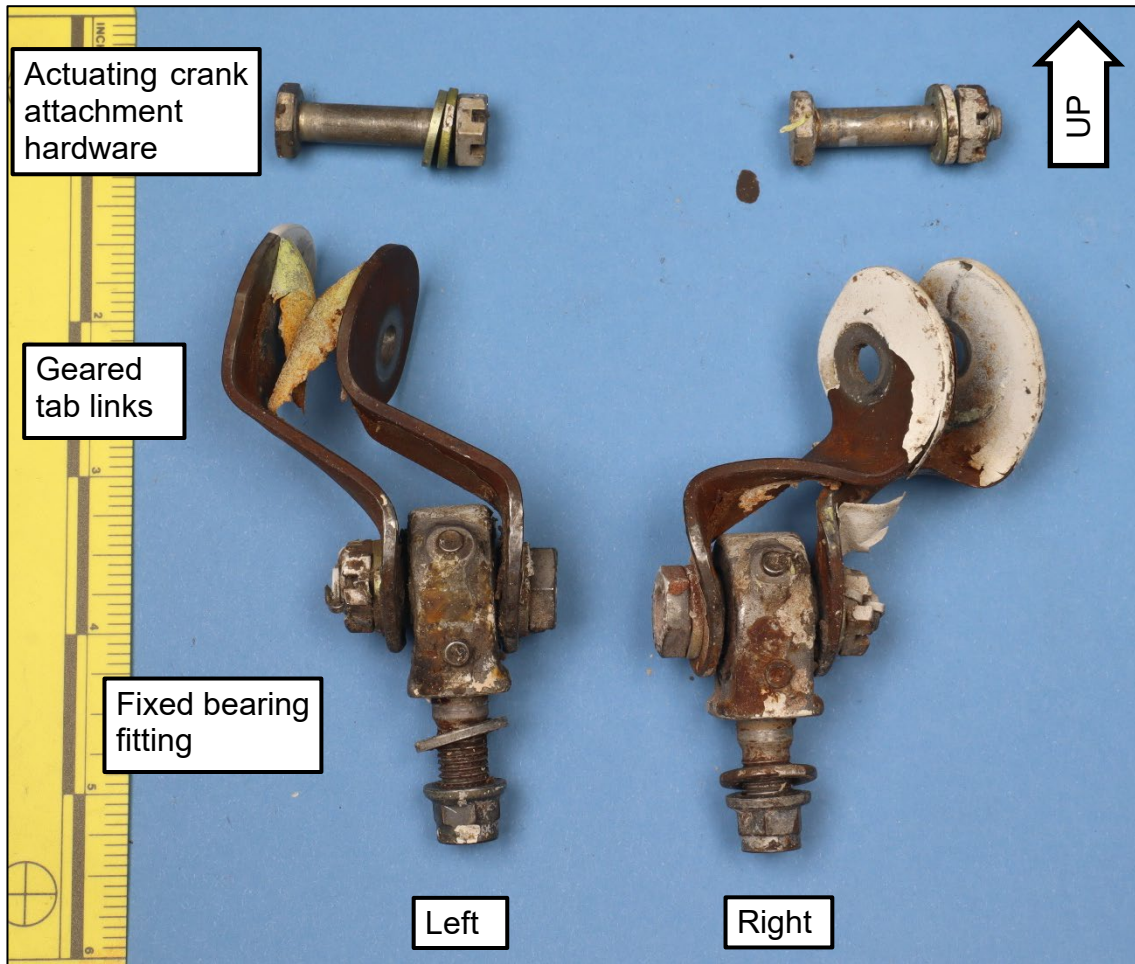
Each of the submitted geared tab links were bent laterally outboard. The pair of links for the right geared tab assembly were also twisted counterclockwise as viewed from above. Peeling white paint was observed, and the underlying surfaces were covered with dark reddish-orange oxides. The paint had peeled from most of the deformed area in the middle of the links and was also peeling from areas of the tabs that showed little or no deformation. The actuating cranks were also bent outboard in the beam portion of the crank near the clevis at the aft end as shown in figure 3.

Figure 1. Overall view of the aft side of the submitted links, fixed bearing fittings, and associated hardware.

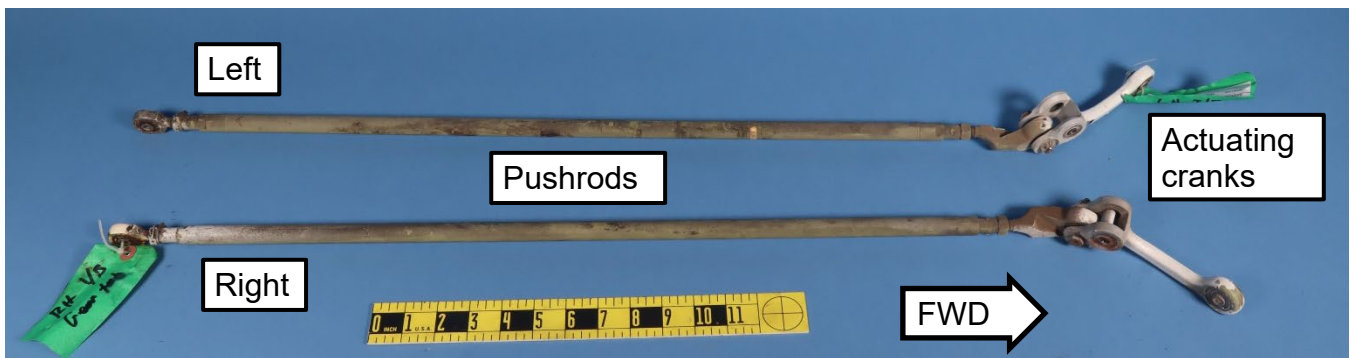
Figure 2. Overall view of the upper side of the submitted actuating cranks and attached pushrods.

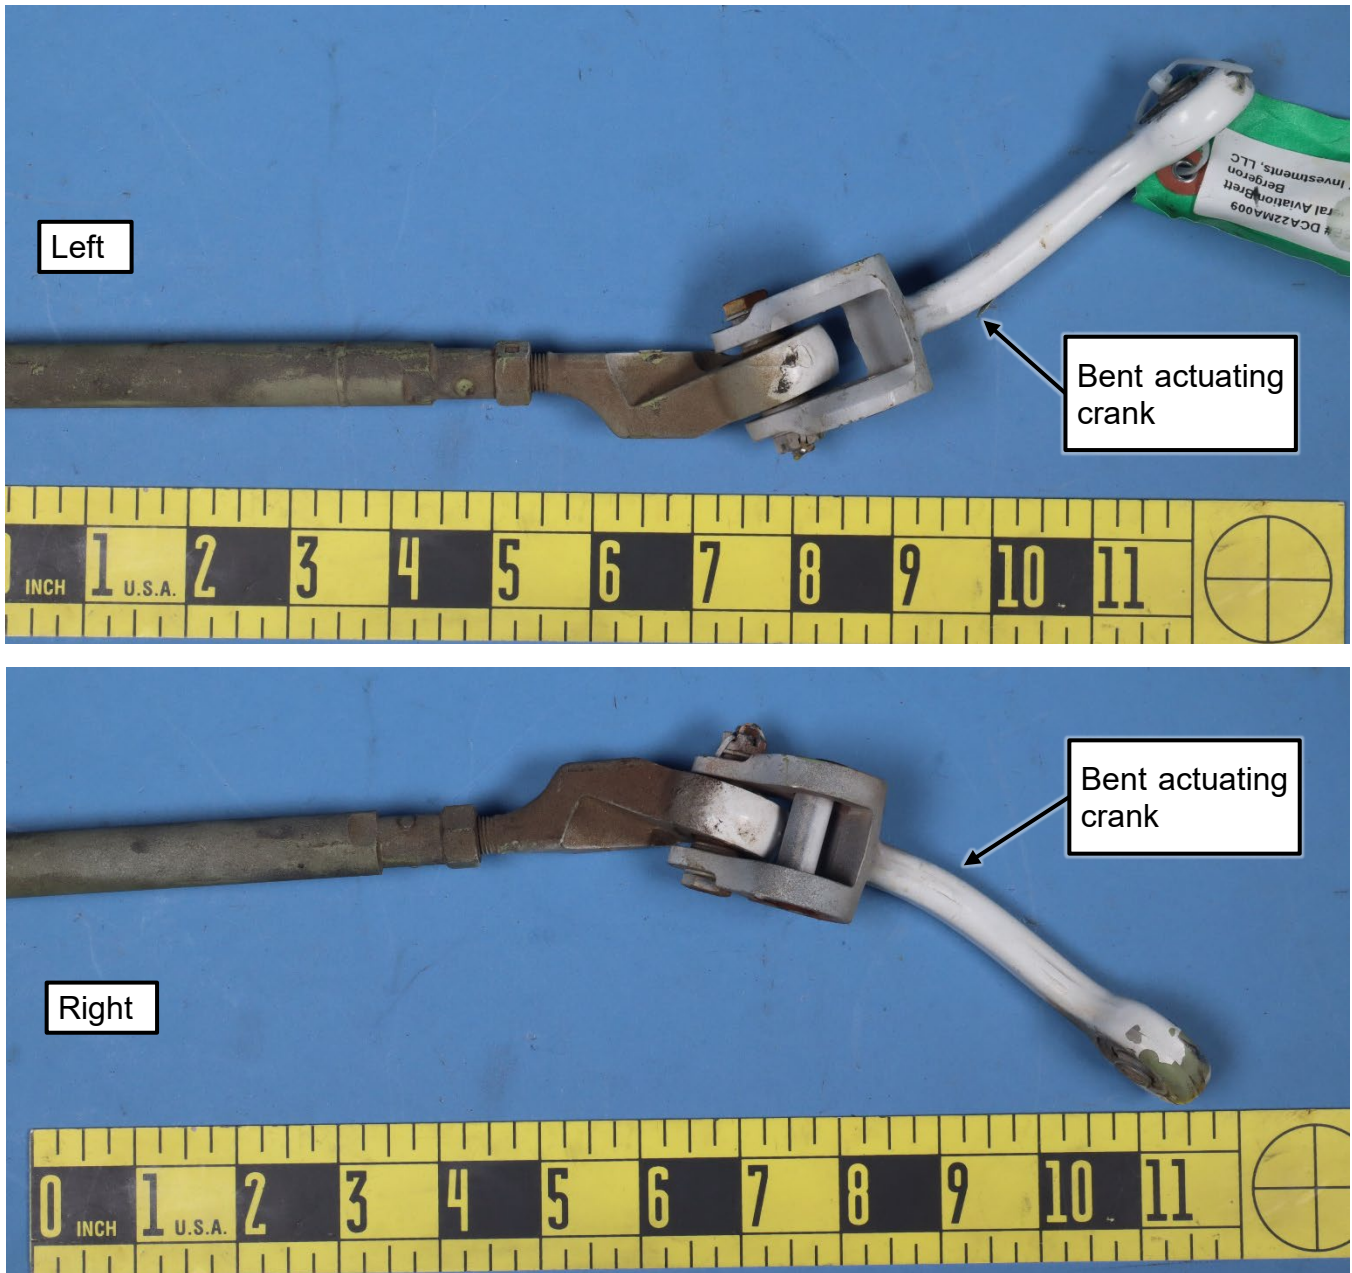
Figure 3. Forward ends of the left and right pushrods showing closer views of the bent actuating cranks.
