National Transportation Safety Board

Office of Research and Engineering

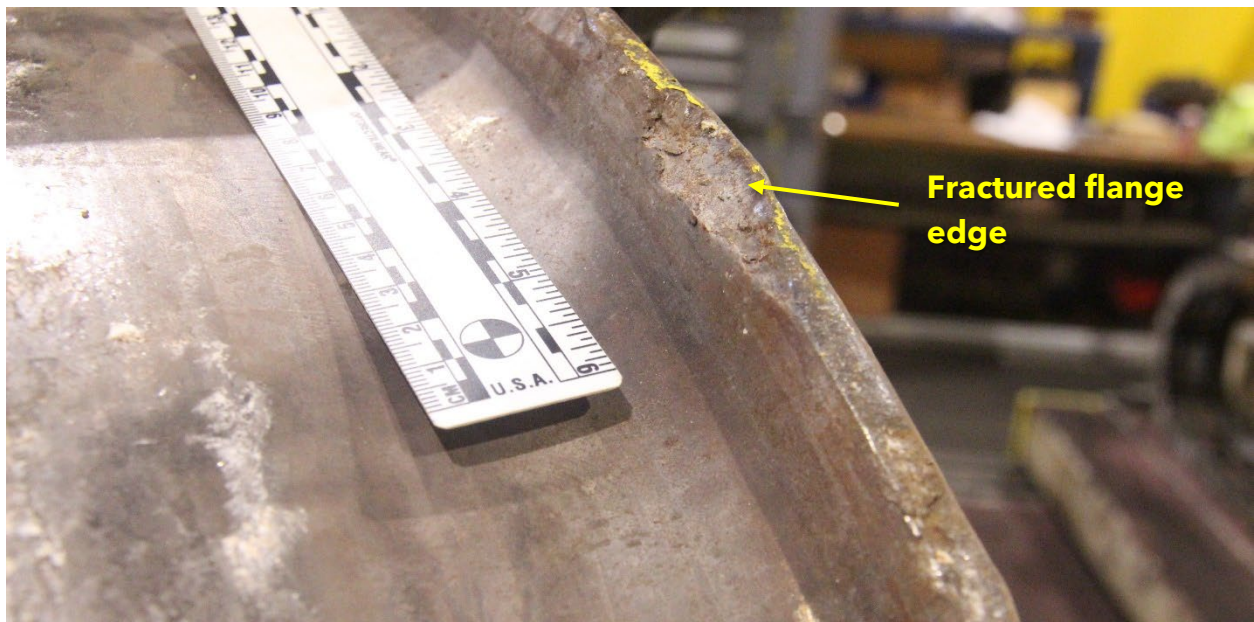
Figure 7. View of a fractured flange segment of the LS wheel rim.

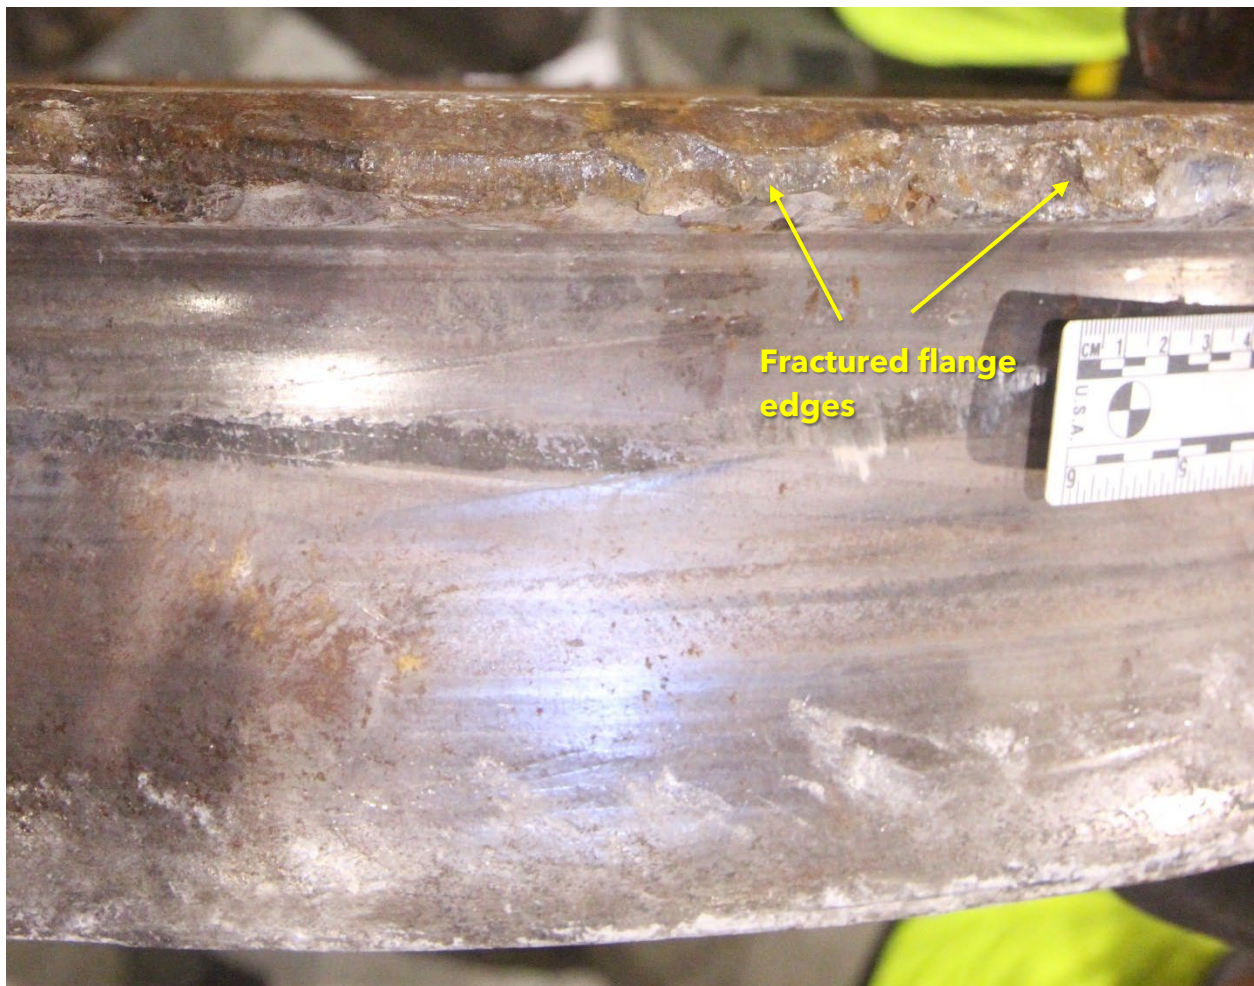
Figure 8. Additional views of damage to the rim of the LS wheel.

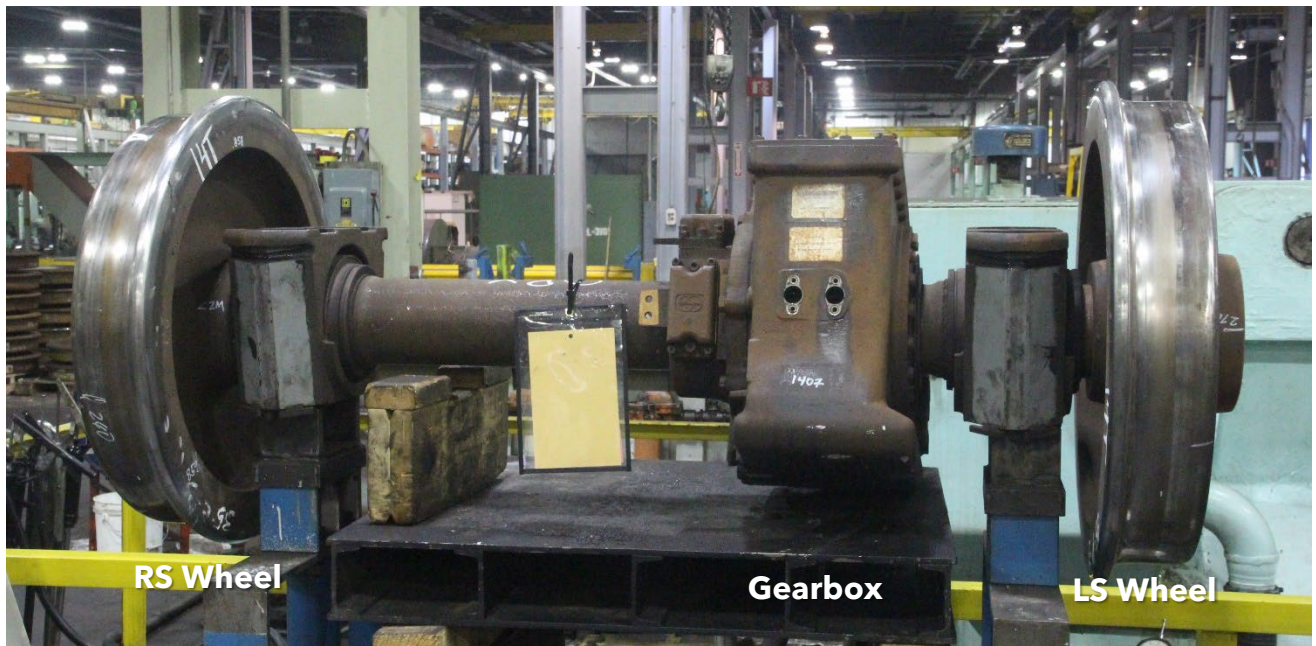
Figure 9. Wheelset from Car 7344, prior to disassembly at ORX.

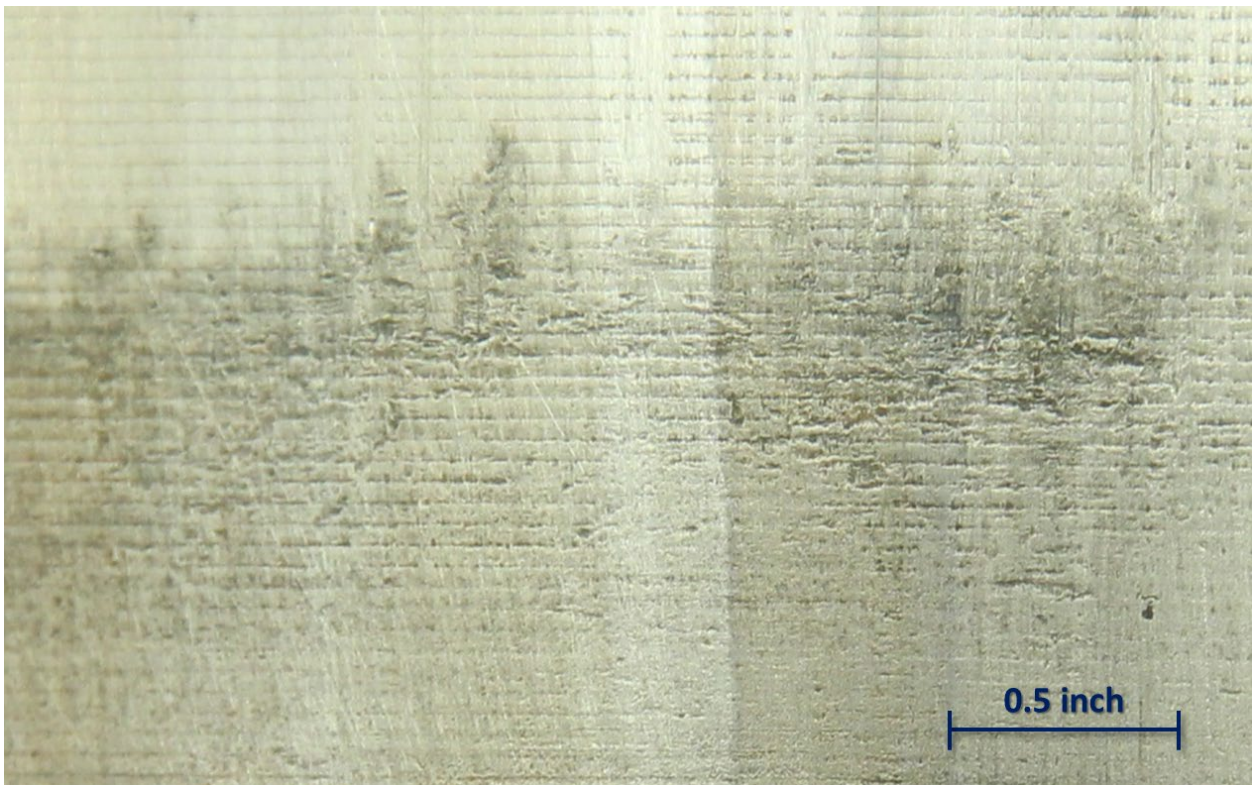
Figure 23. Closer view of fretting damage on the inboard area of the LS wheel seat.

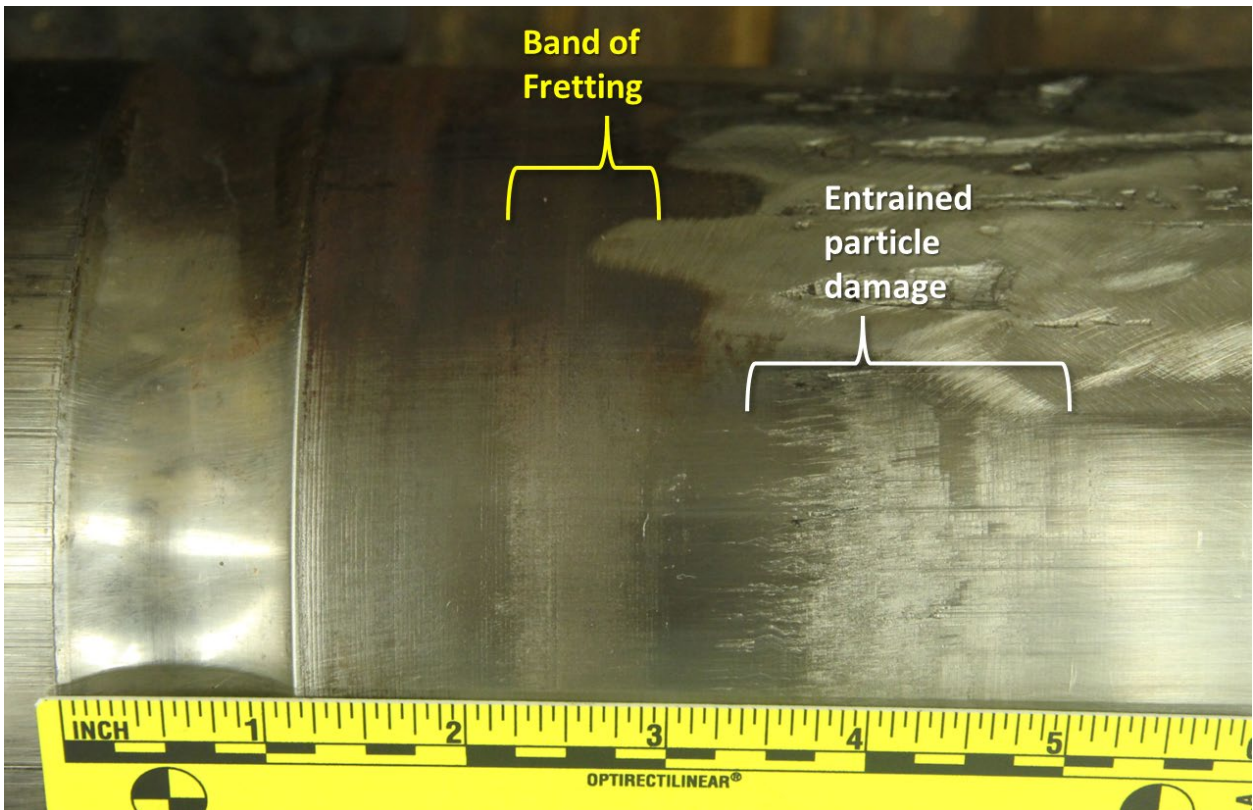
Figure 24. View of the inboard portion of the RS wheel seat after partial cleaning, showing a band of fretting, and areas of entrained particle damage outboard.

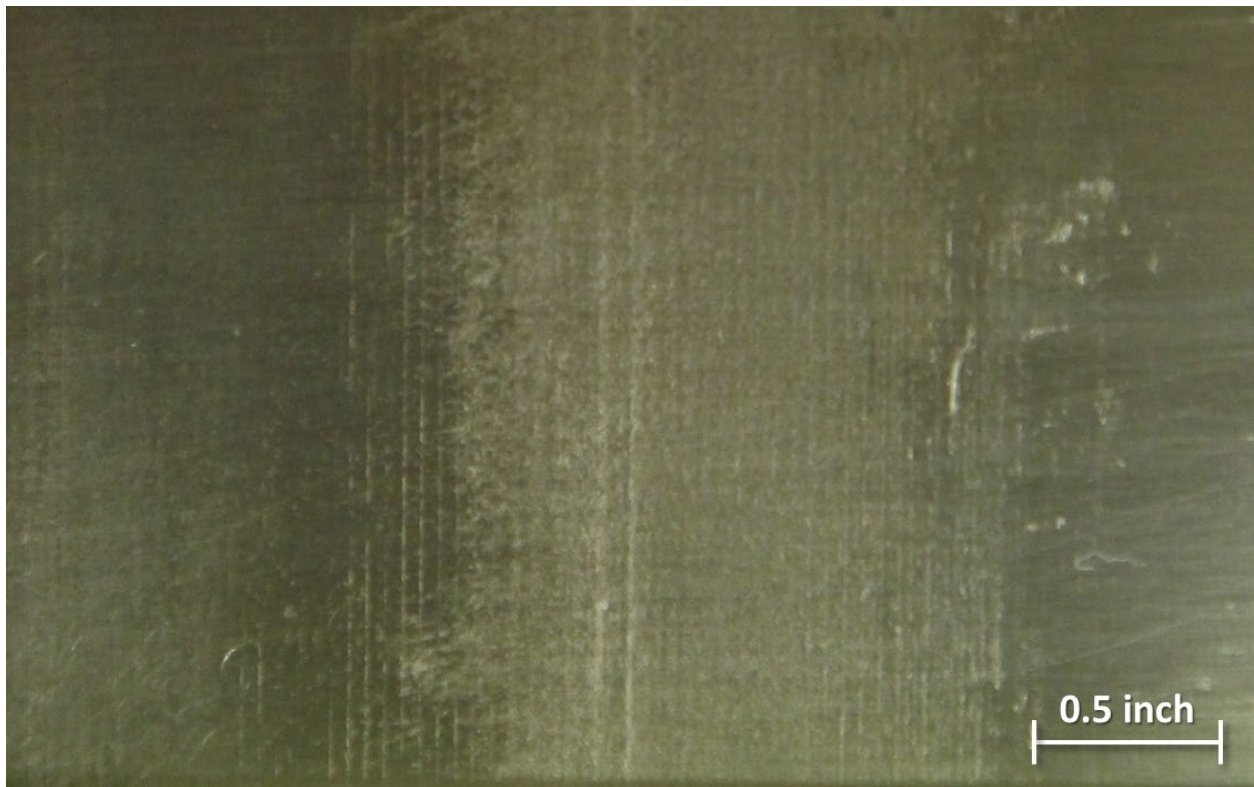
Figure 25. Closer view of the fretting damage on the RS wheel seat.

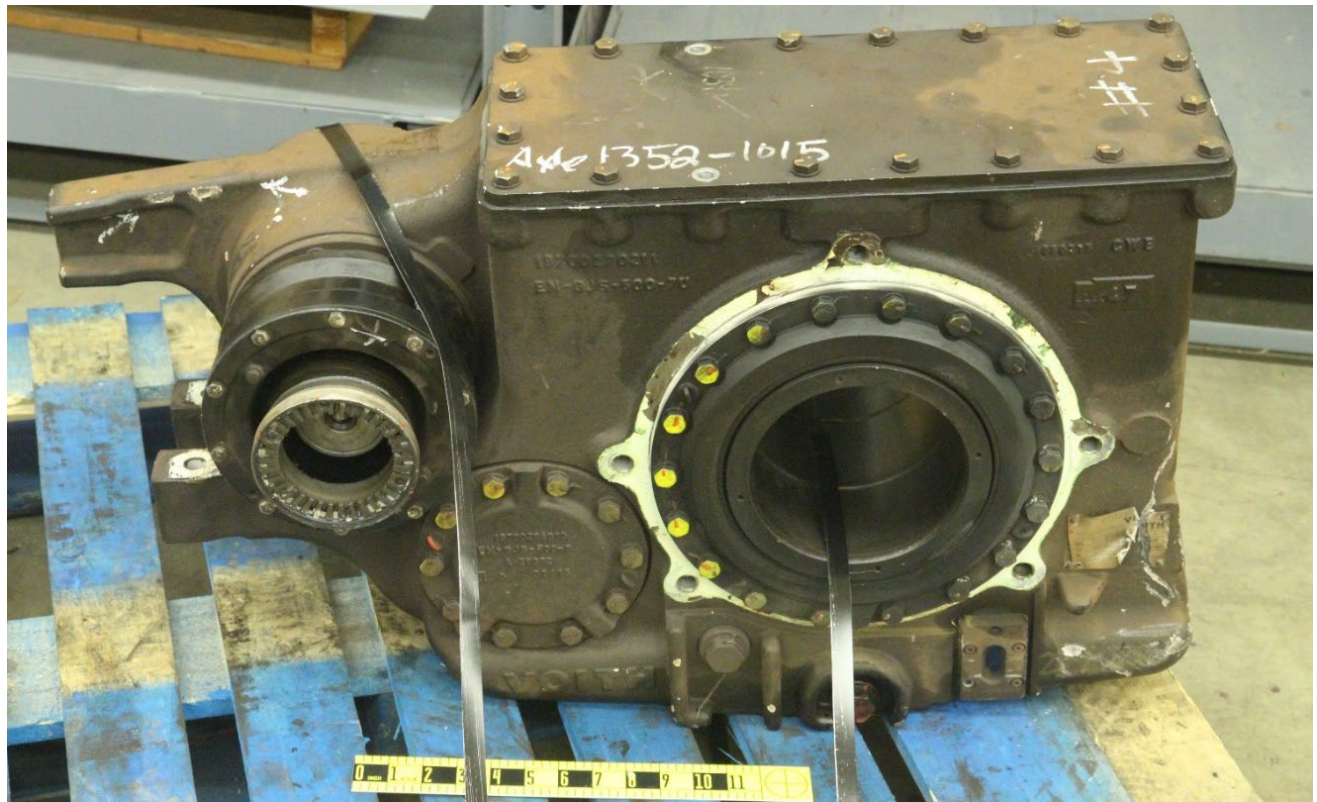
Figure 26. View of the gearbox assembly from the accident wheelset.

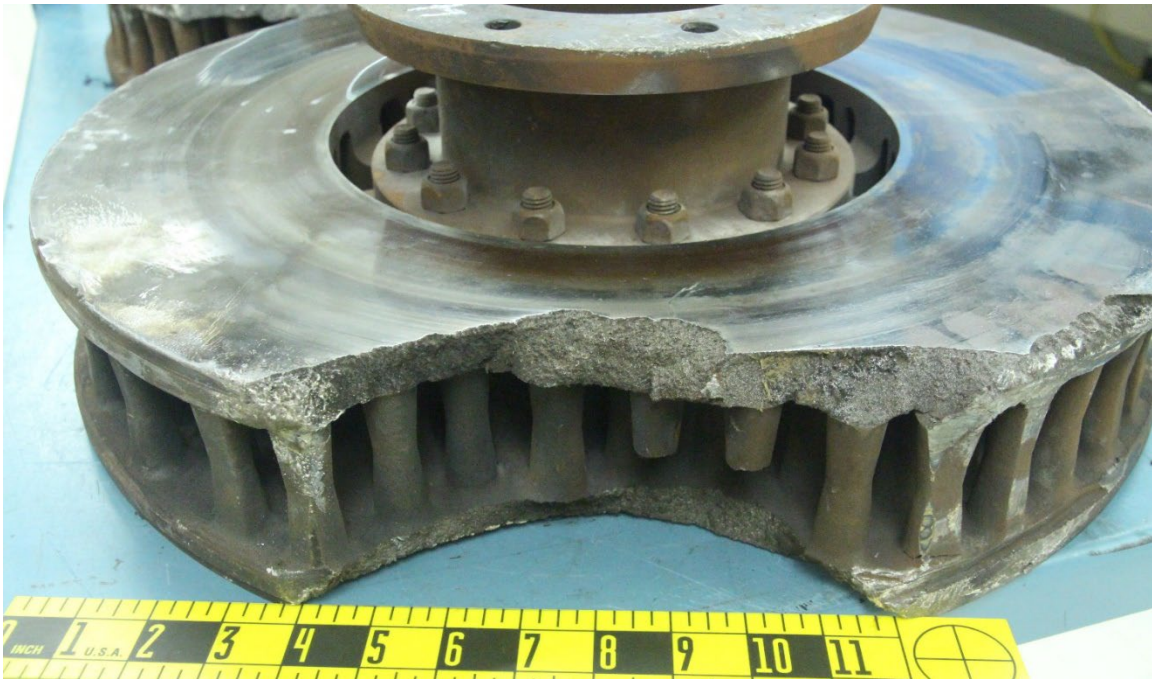
Figure 28. View of the fracture surface from the left side brake disc, as received.

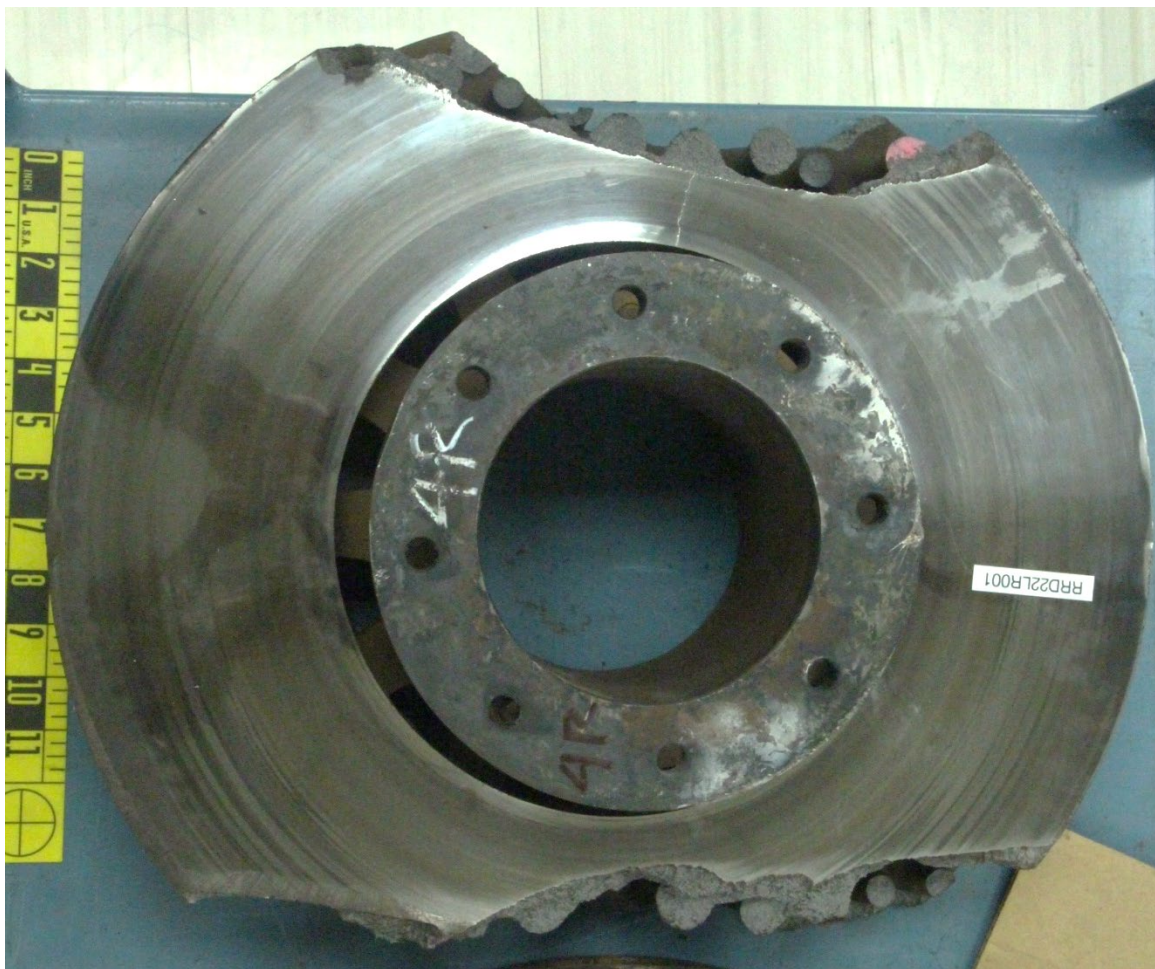
Figure 29. View of the opposite or right side brake disc, as received.

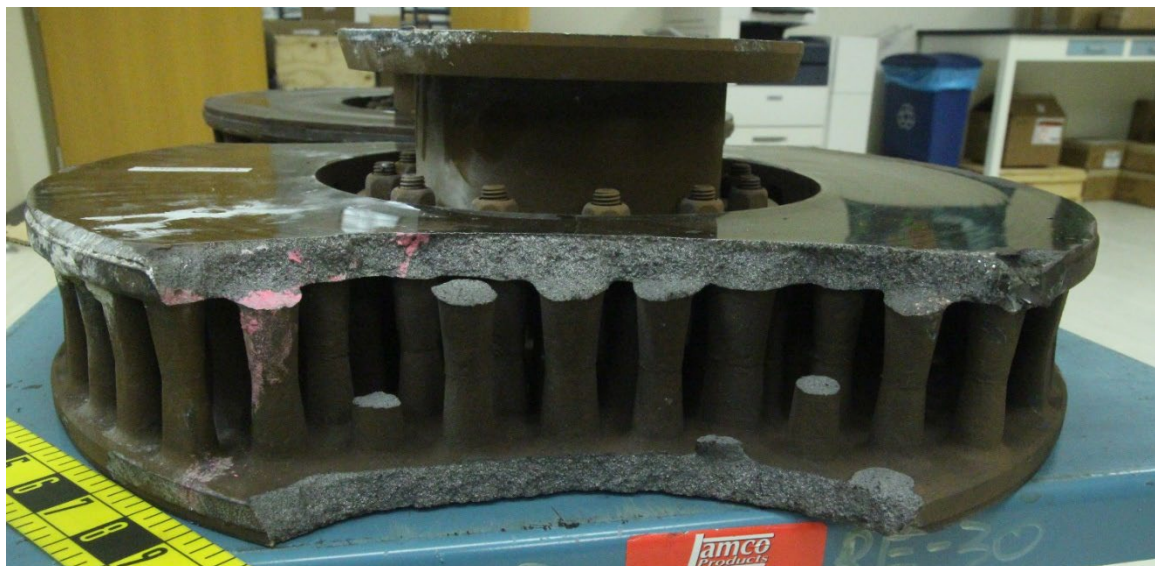
Figure 30. View of the fracture surface of the right side disc surface in Figure 29.

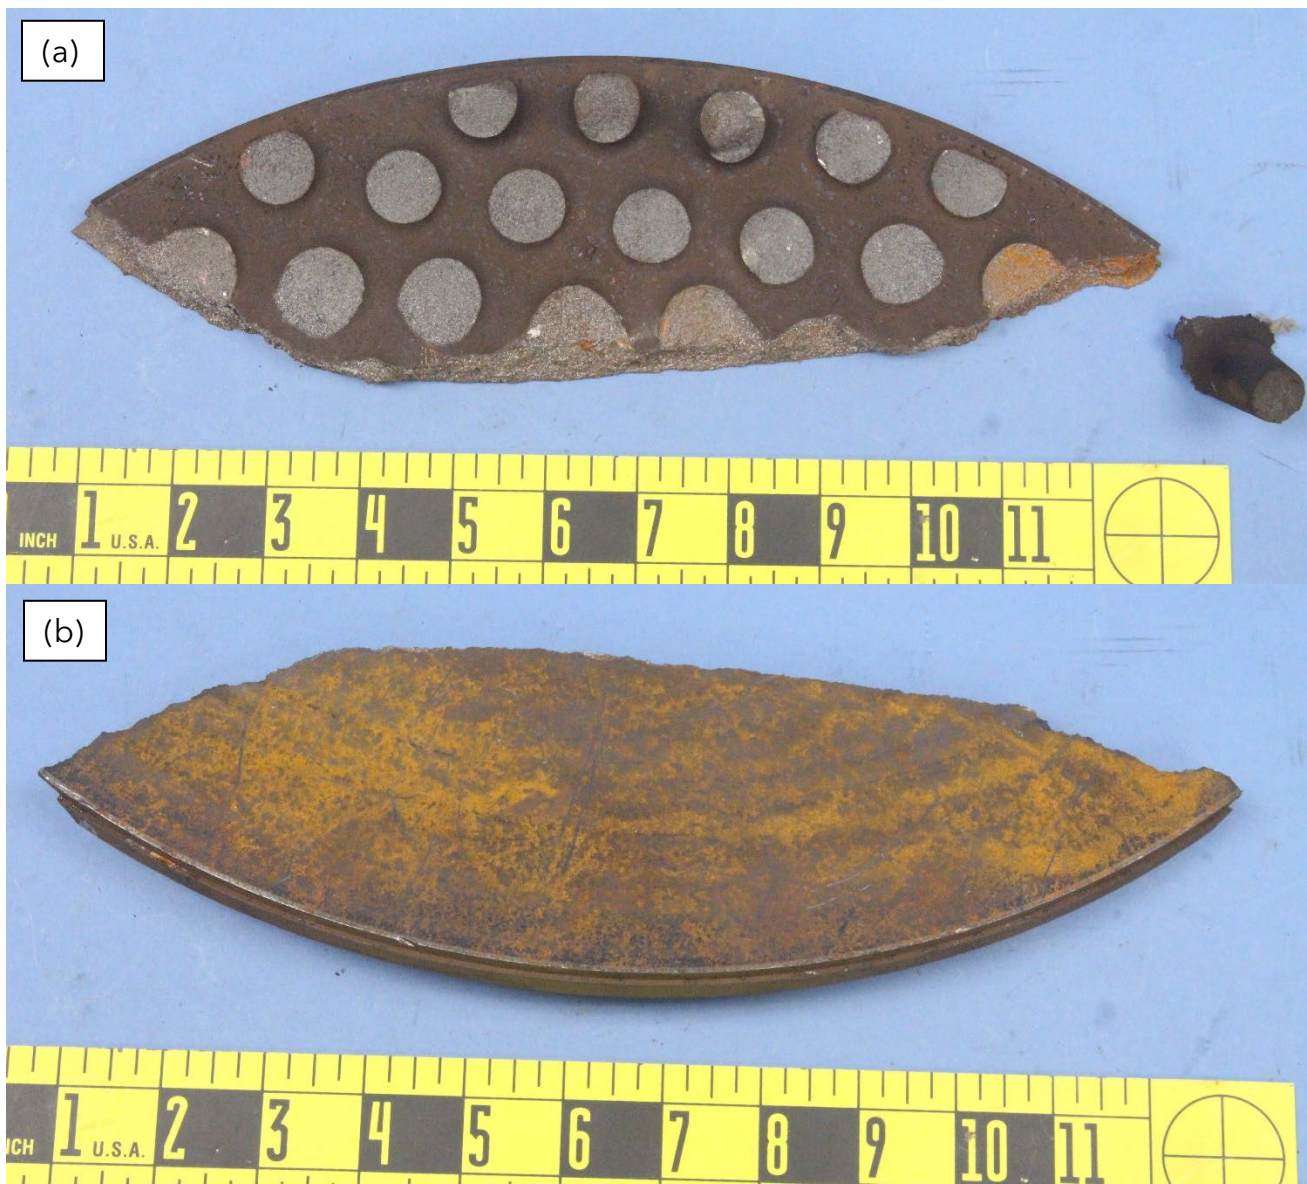
Figure 31. Opposite views of the brake disc remnants that mates with the right side fracture surface in Figure 30.

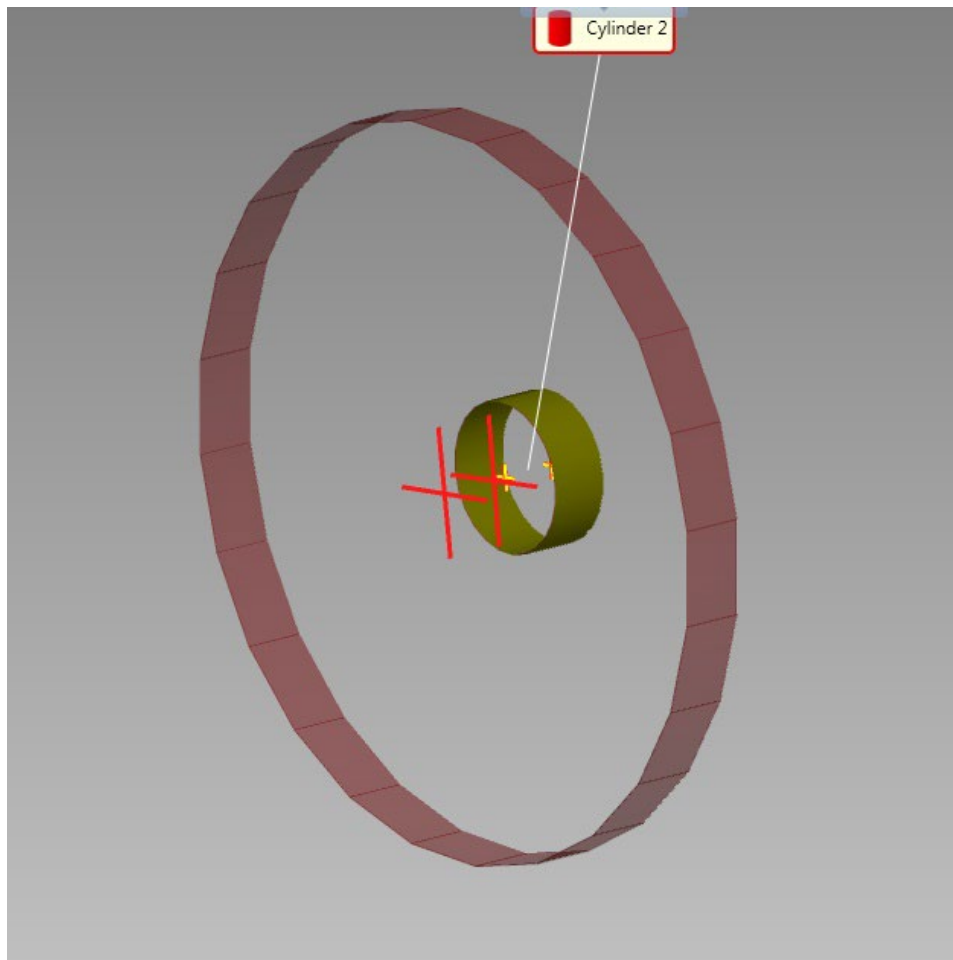
Figure 32. Wireframe representation of the cylindricity and concentricity of the accident wheel measurements.

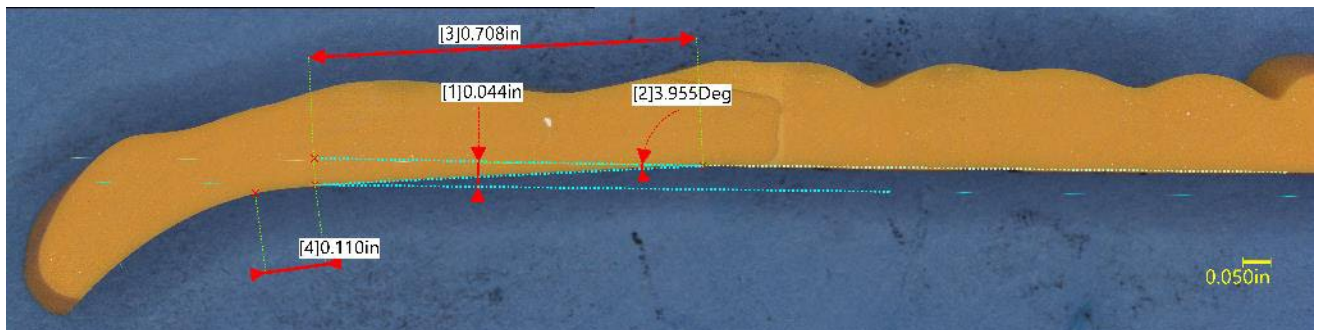
Figure 33. Cross section of a reproduction rubber negative an area of the right side wheel, showing various measurements describing the inboard circumferential wear near the flange.

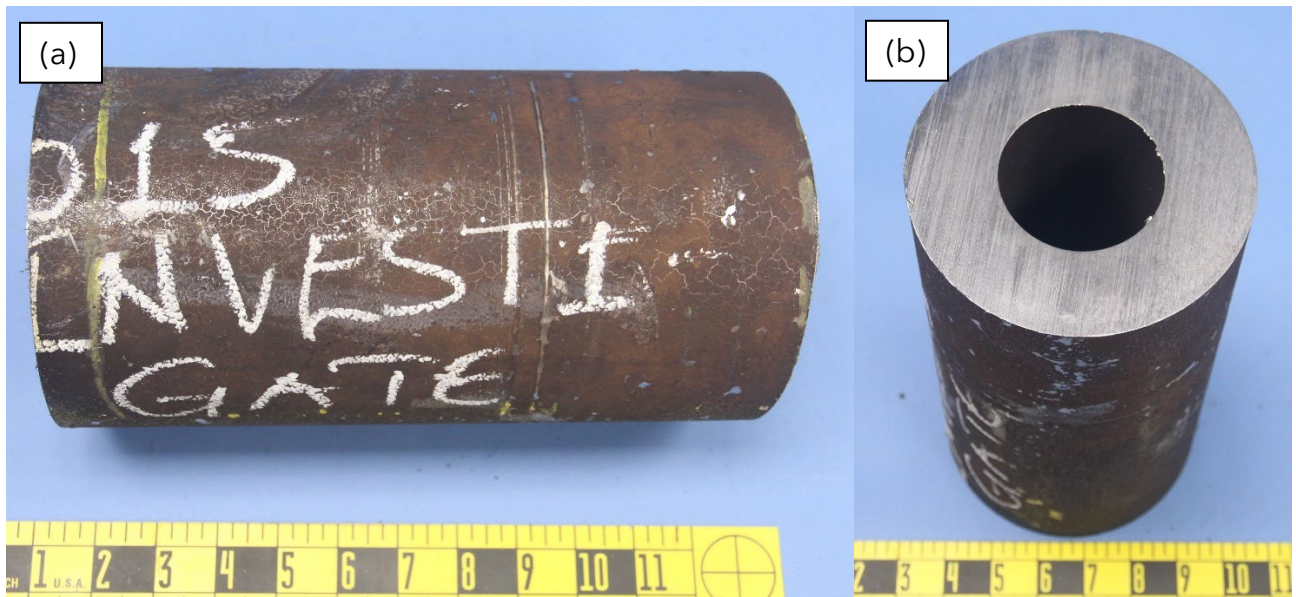
Figure 34. Sections of the accident axle, view from the longitudinal and transverse faces.

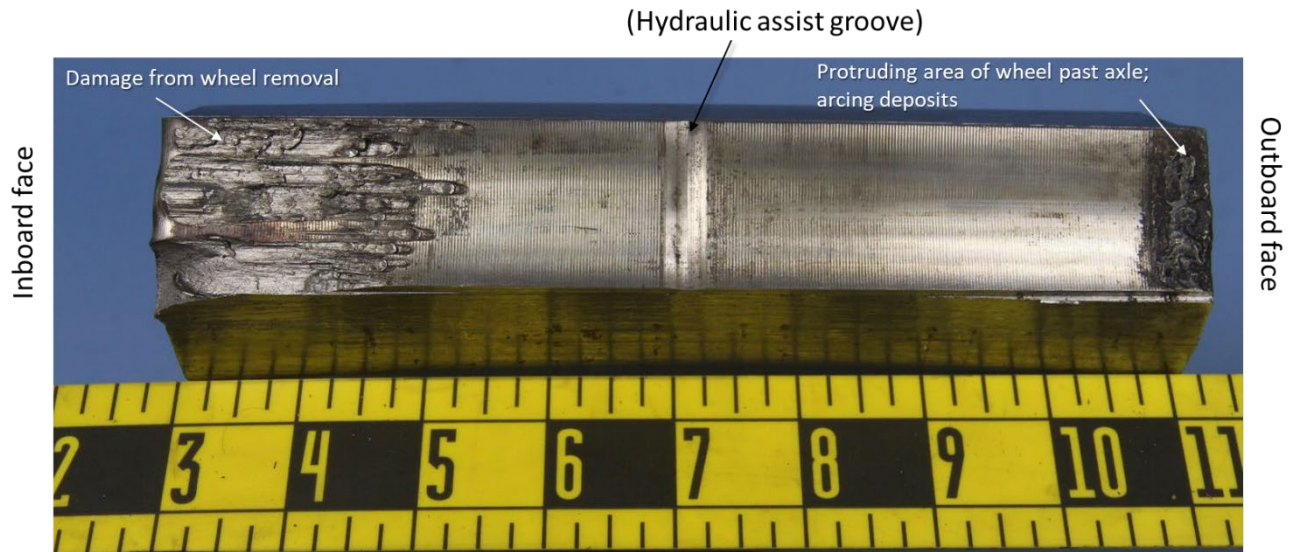
Figure 37. Views of the sectioned left wheel bore, showing damage on the inboard and outboard edges.

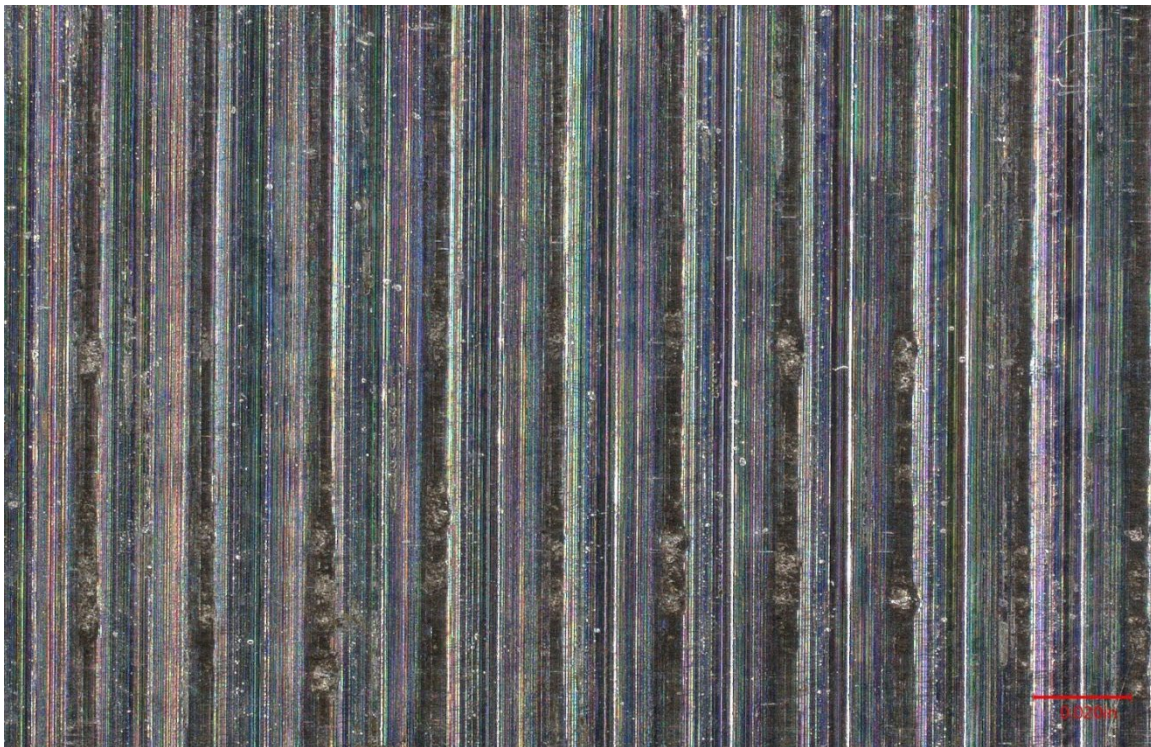
Figure 38. View of the machine marks on the wheel bore surface, taken in a relatively undamaged area.

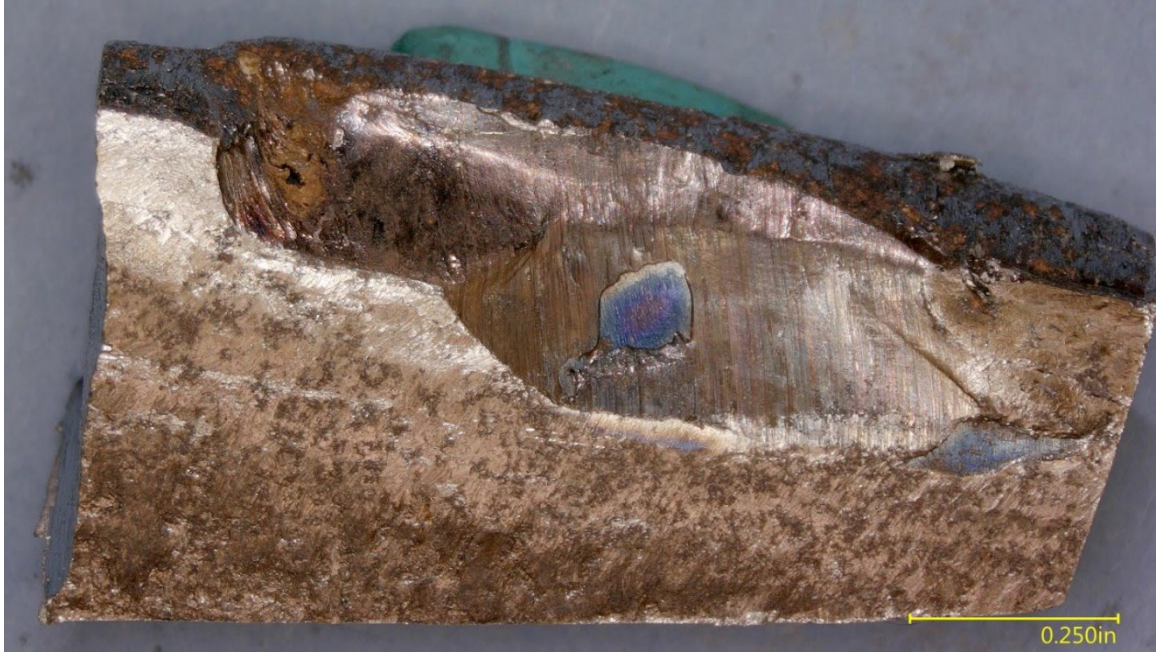
Figure 42. View of the sectioned fractured piece of the flange.

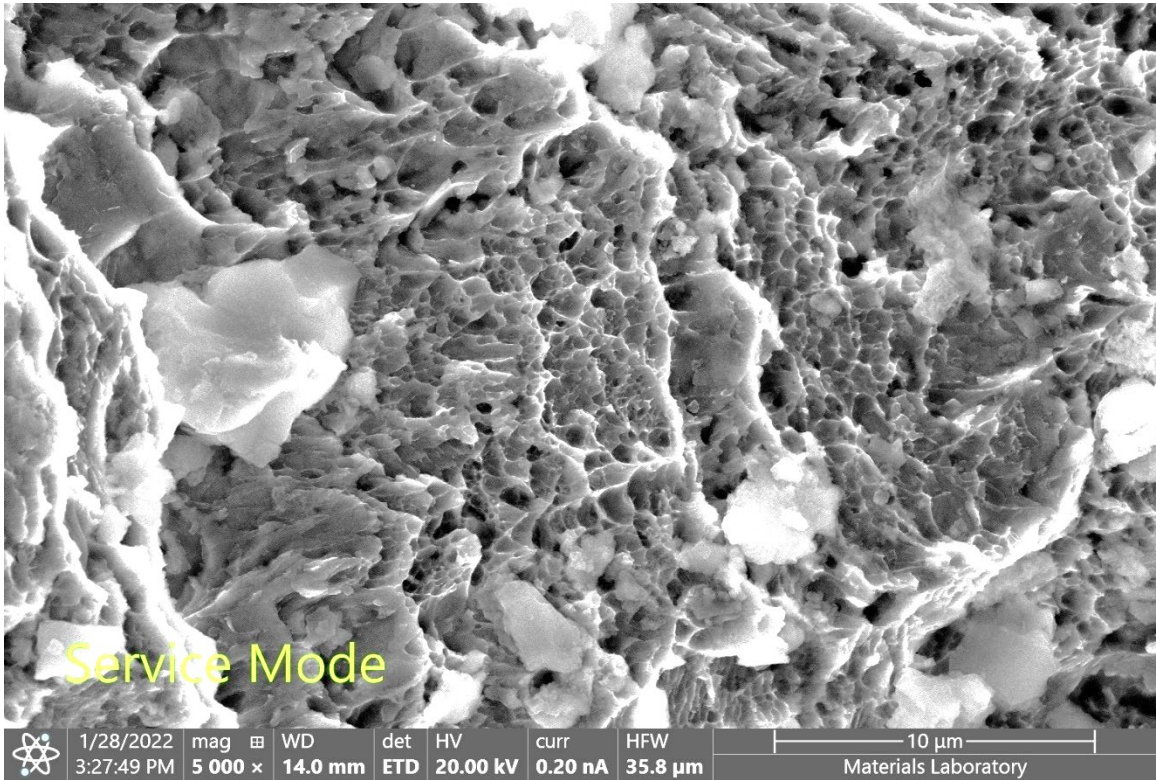
Figure 43. Secondary electron (SE) micrograph of a typical area of the flange fracture surface.

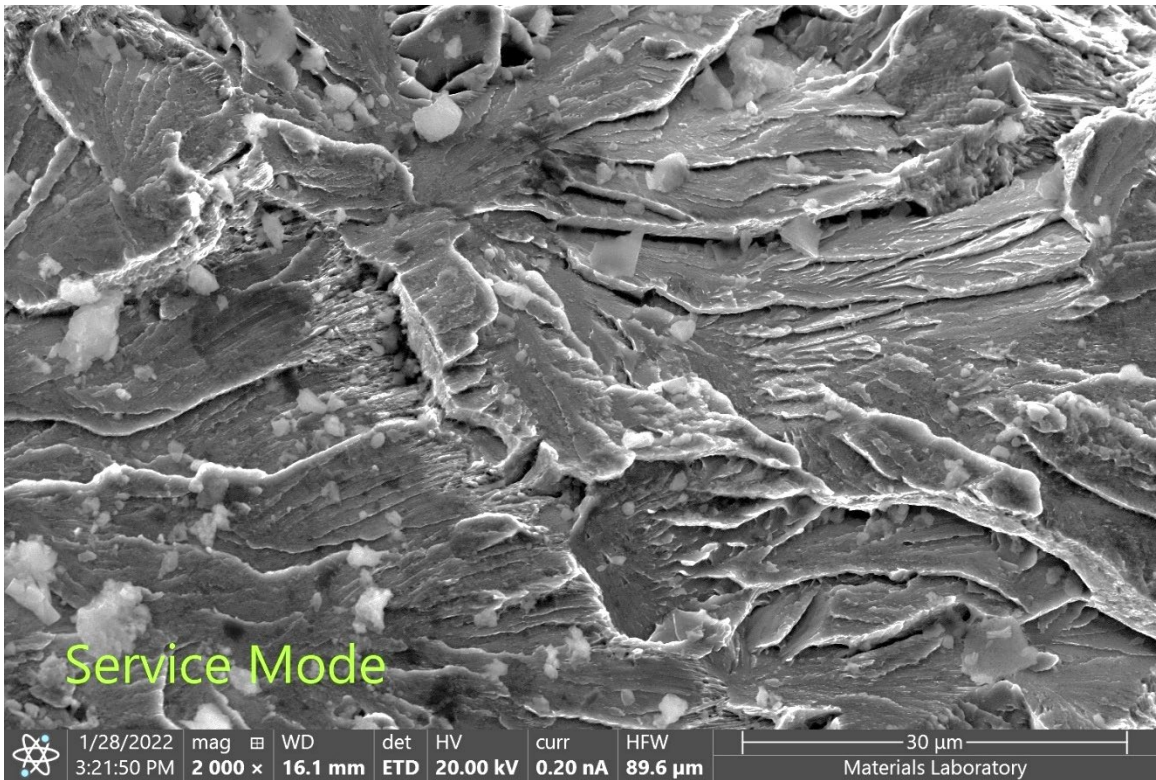
Figure 44. SE micrograph of cleavage facets on the flange fracture.

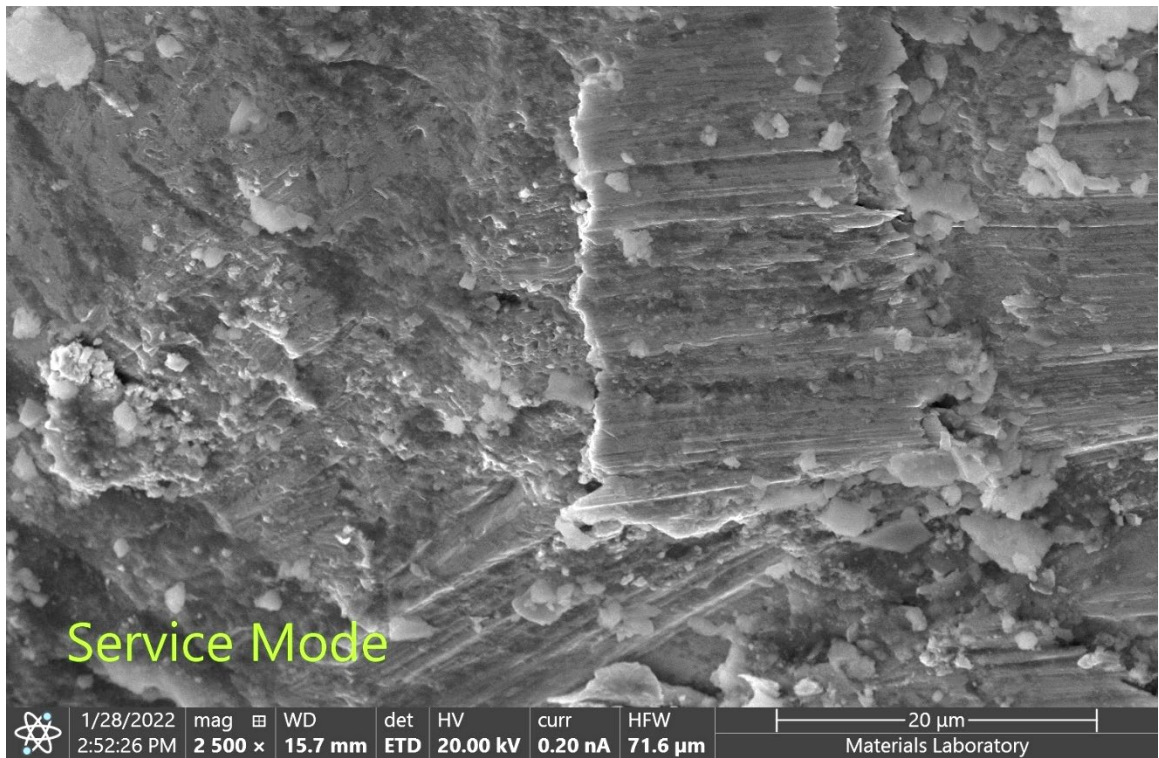
Figure 45. SE micrograph of dimpled rupture and smearing on the flange fracture.

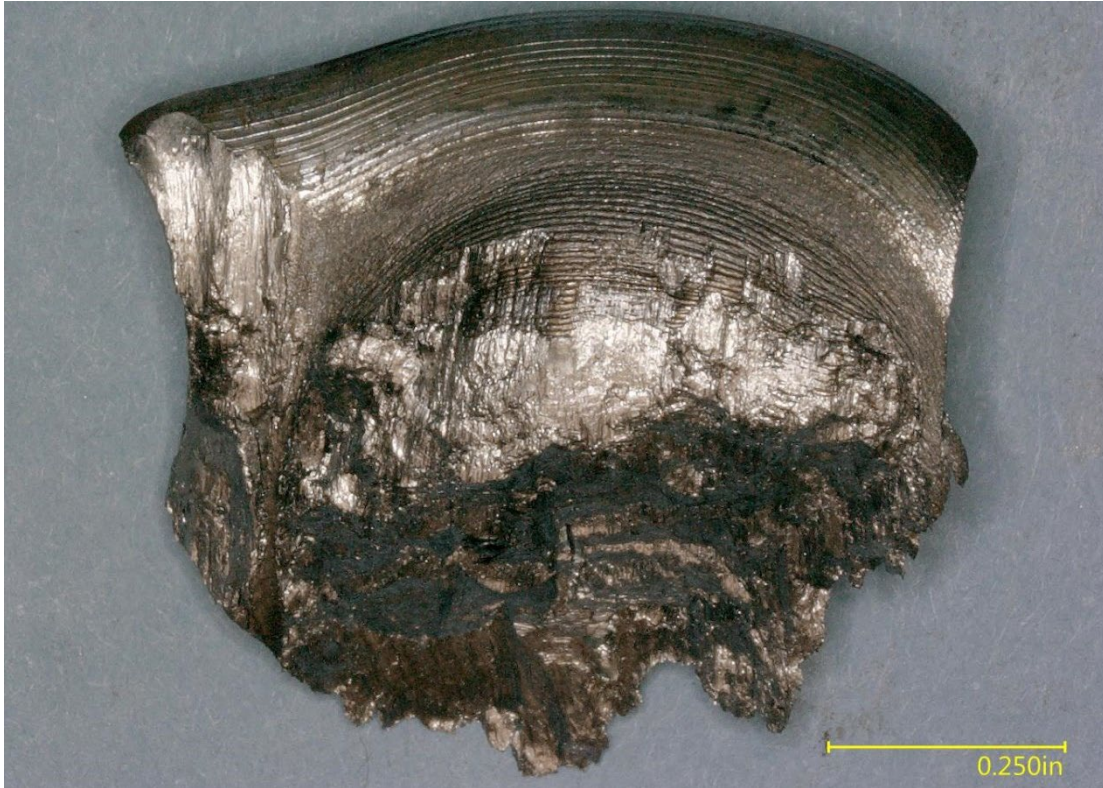
Figure 46. View of the remnant that separated from the RS wheel bore.

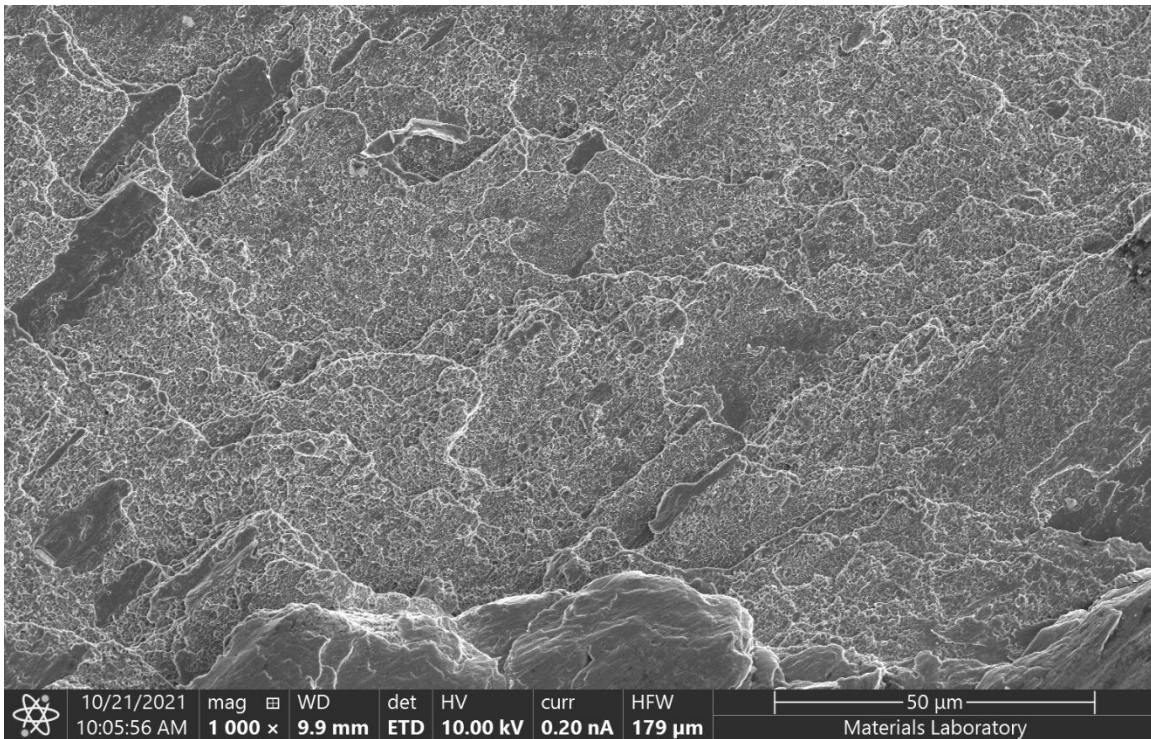
Figure 47. Secondary electron (SE) micrograph of a typical area of the remnant fracture in Figure 46.

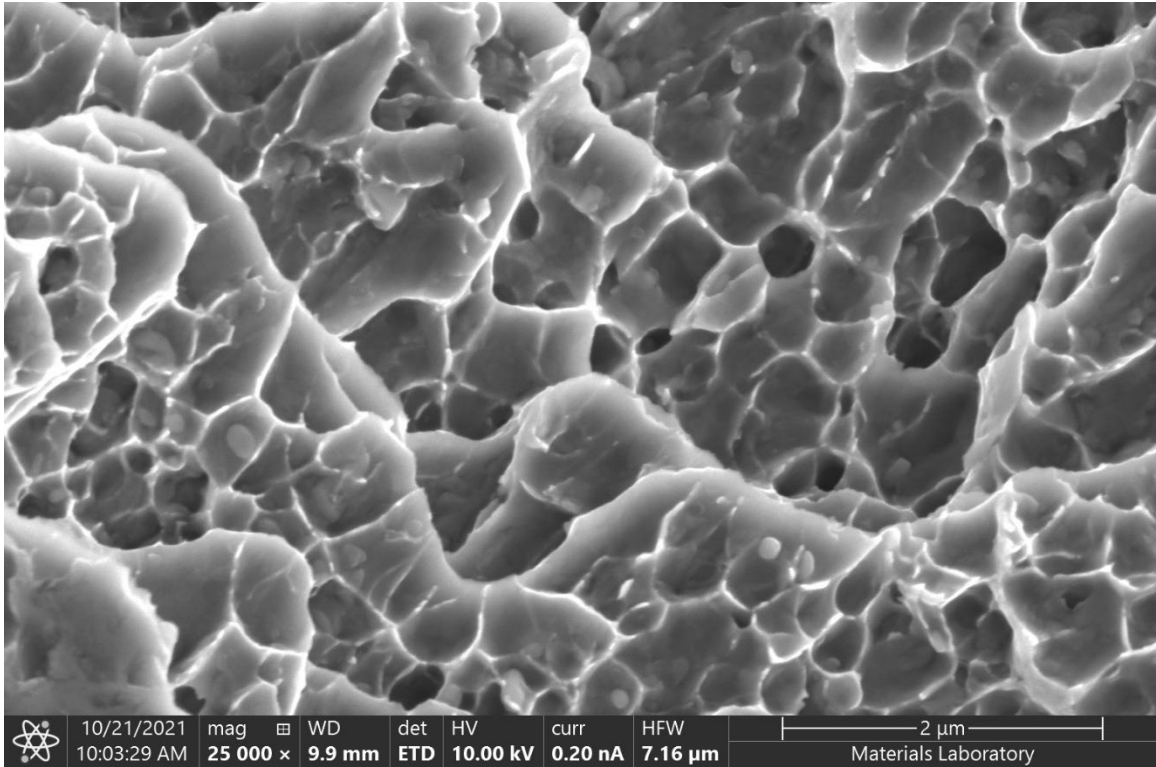
Figure 48. SE micrograph of dimpled rupture on the wheel remnant.

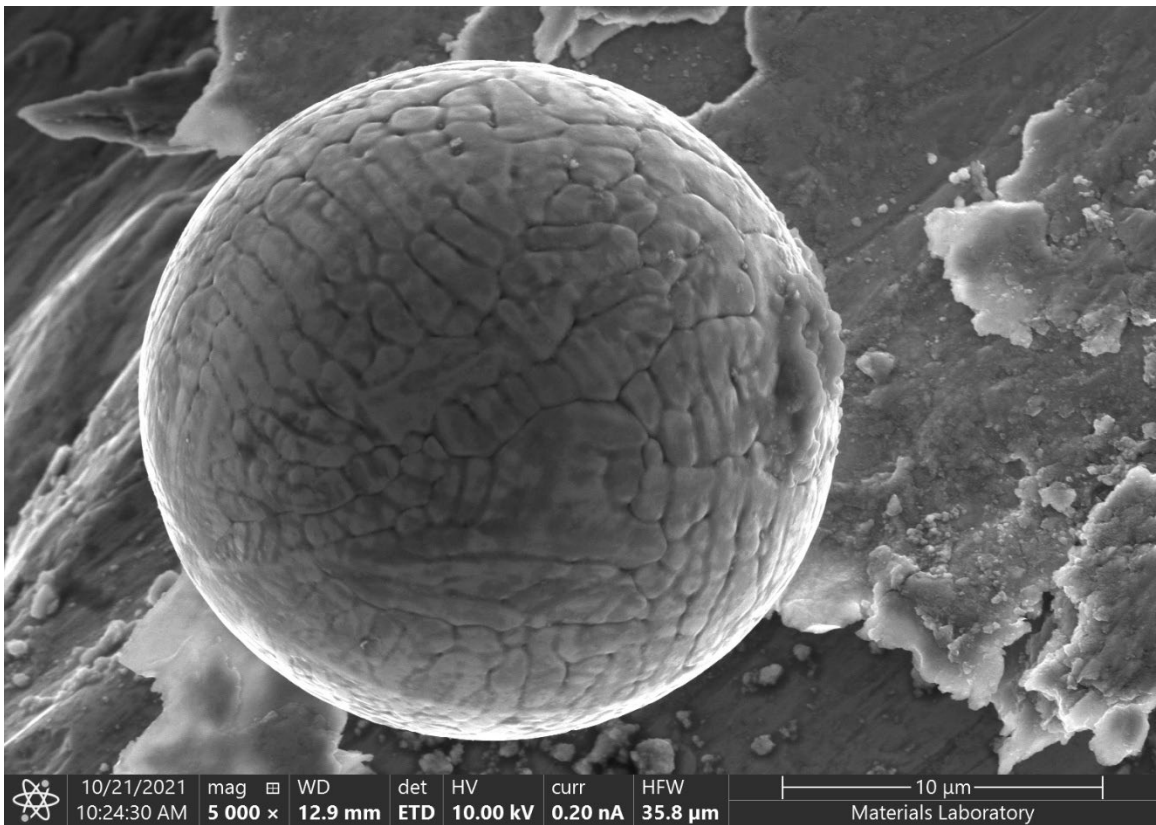
Figure 49. SE micrograph of a spherical solidified arc ball on the remnant.
