National Transportation Safety Board

Office of Research and Engineering

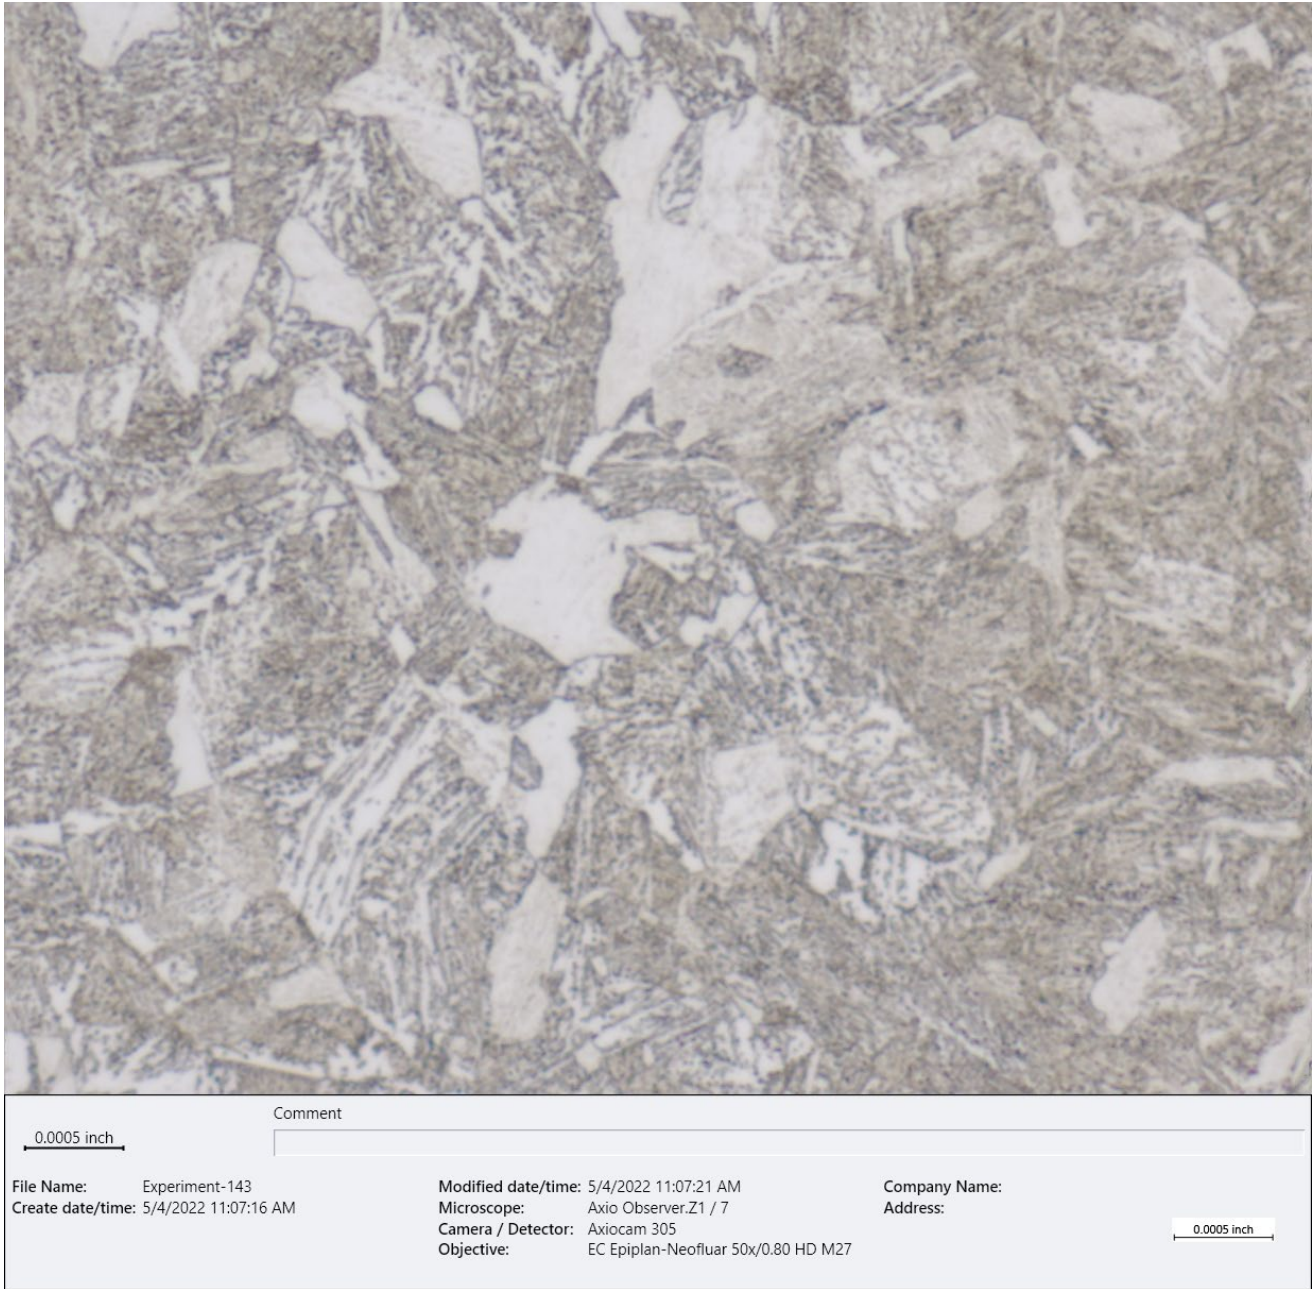
Figure 50. Bright field (BF) optical micrograph of a typical view of the accident axle microstructure (etched 2% Nital, ~1000X).

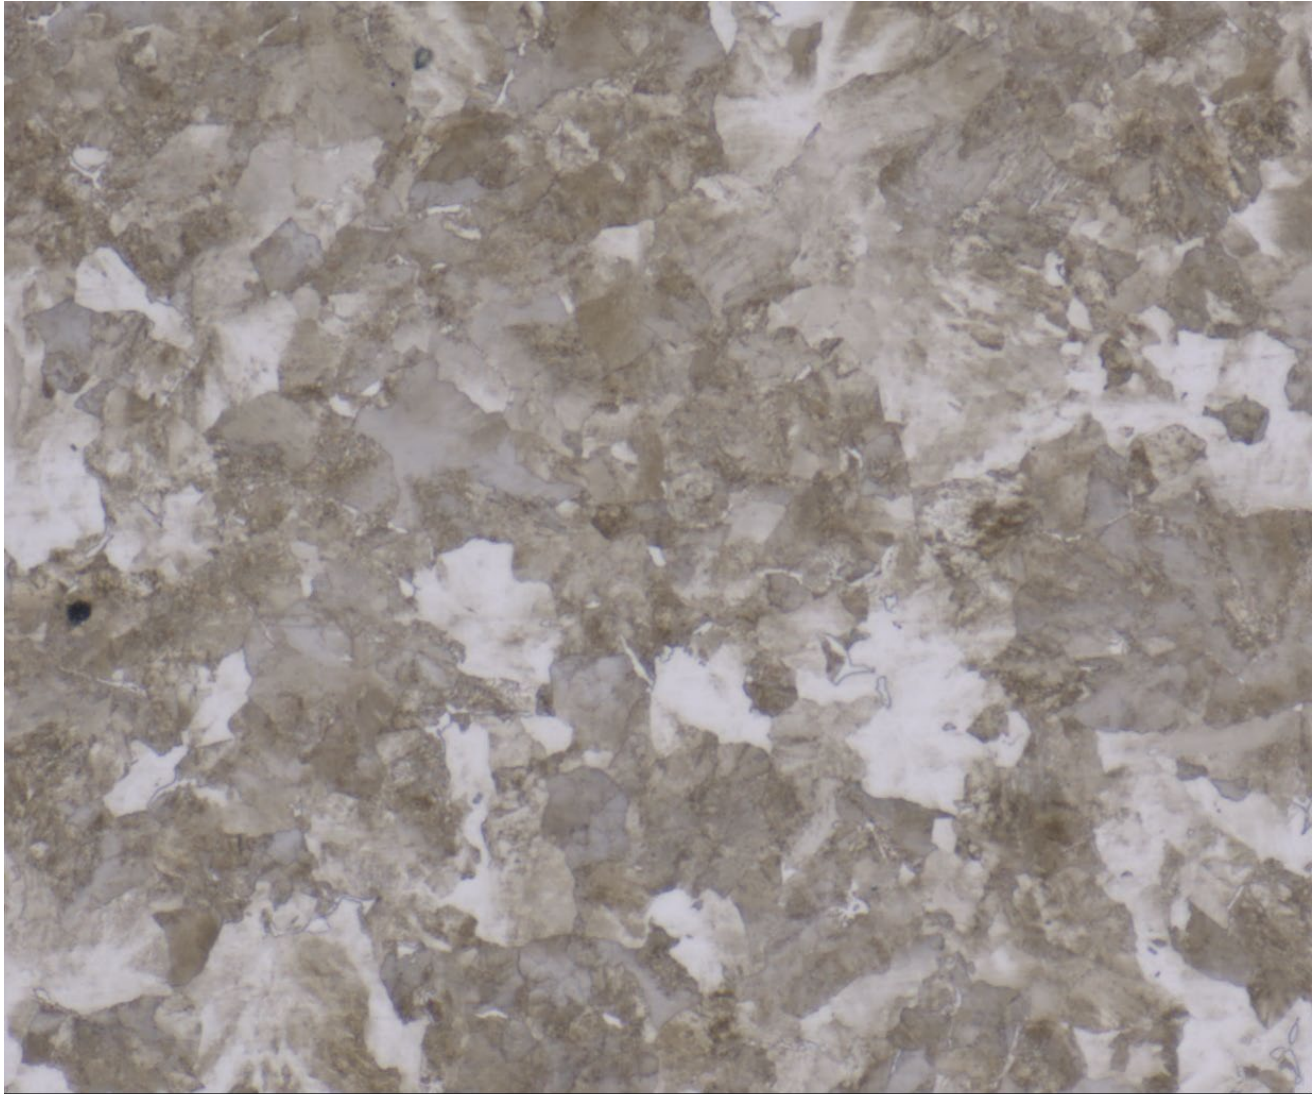
<u>0.001 inch</u>		Comment	
File Name: Experiment-73	Modified date/time: 2/24/2022 11:45:32 AM	Company Name:	
Create date/time: 2/24/2022 11:45:28 AM	Microscope: Axio Observer.Z1 / 7	Address:	
	Camera / Detector: Axiocam 305		<u>0.002 inch</u>
	Objective: EC Epiplan-Neofluar 20x/0,50 HD M27

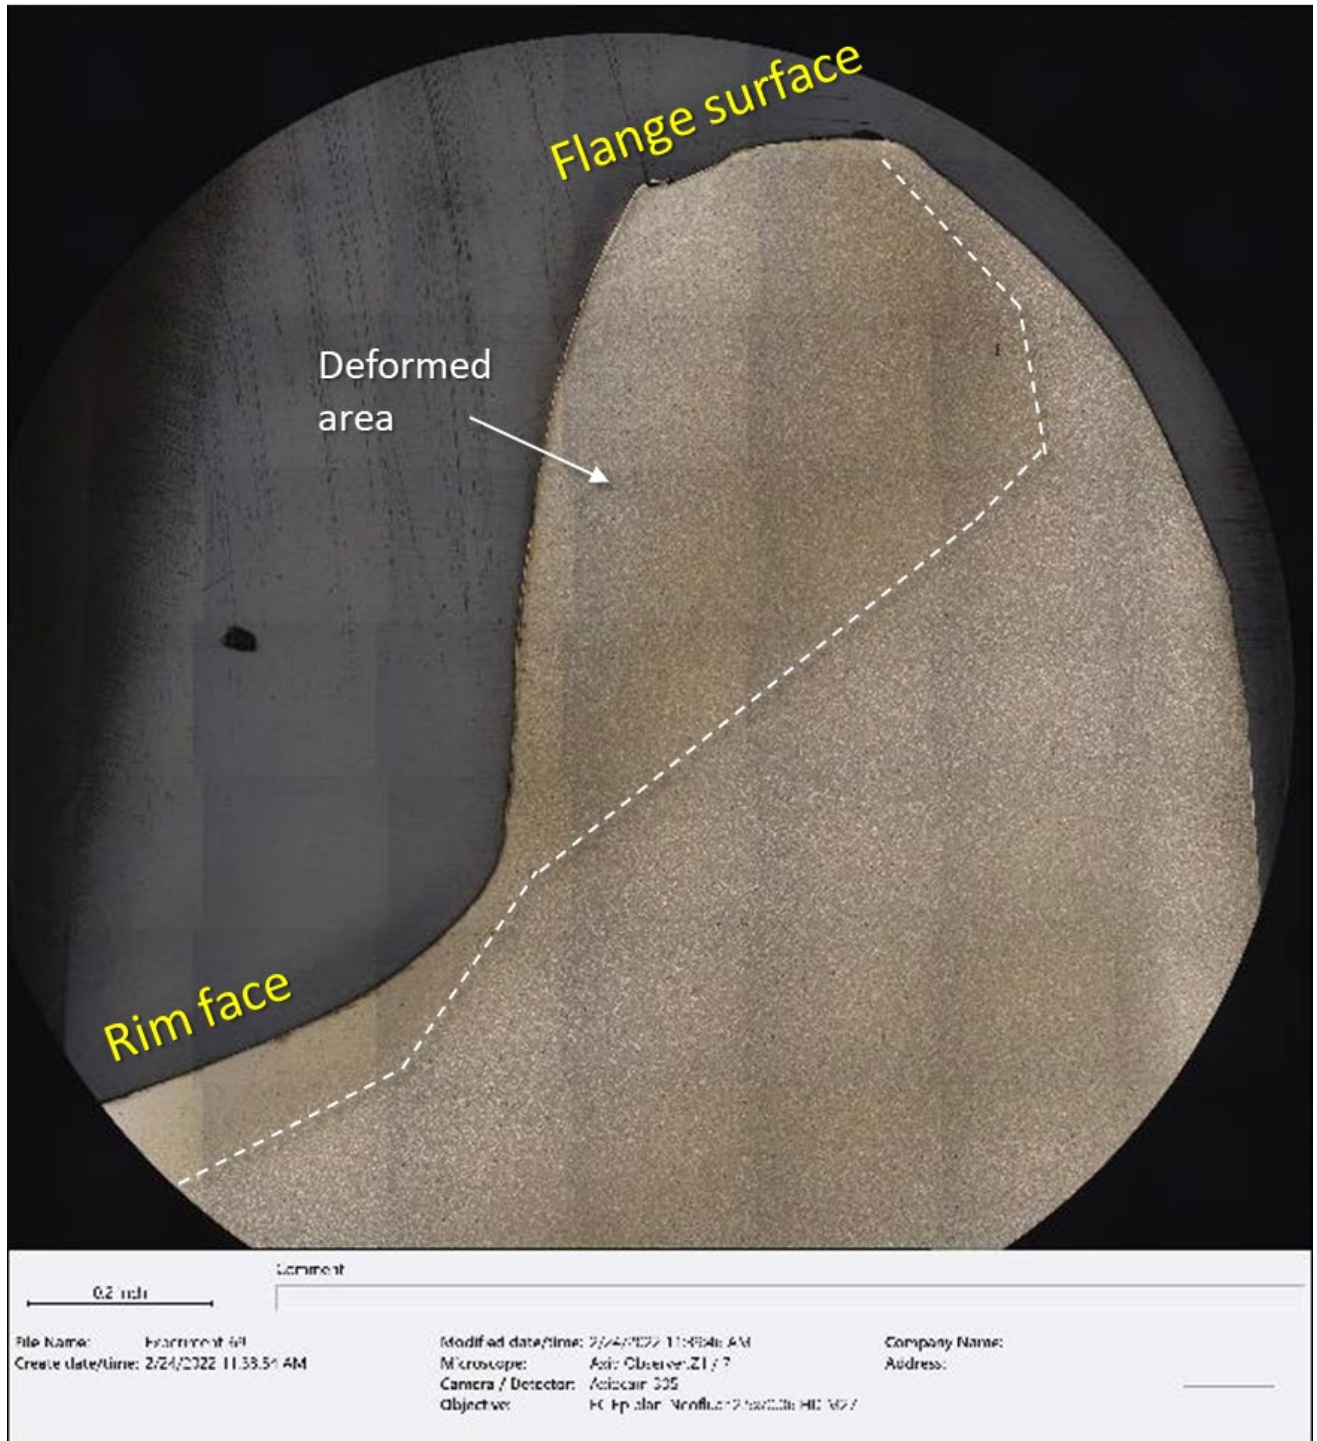
Figure 52. Montage of BF optical micrographs of the accident LS wheel cross section, annotated to show the deformed area of the microstructure on the flange and rim face (etched 2% Nital, ~25X).

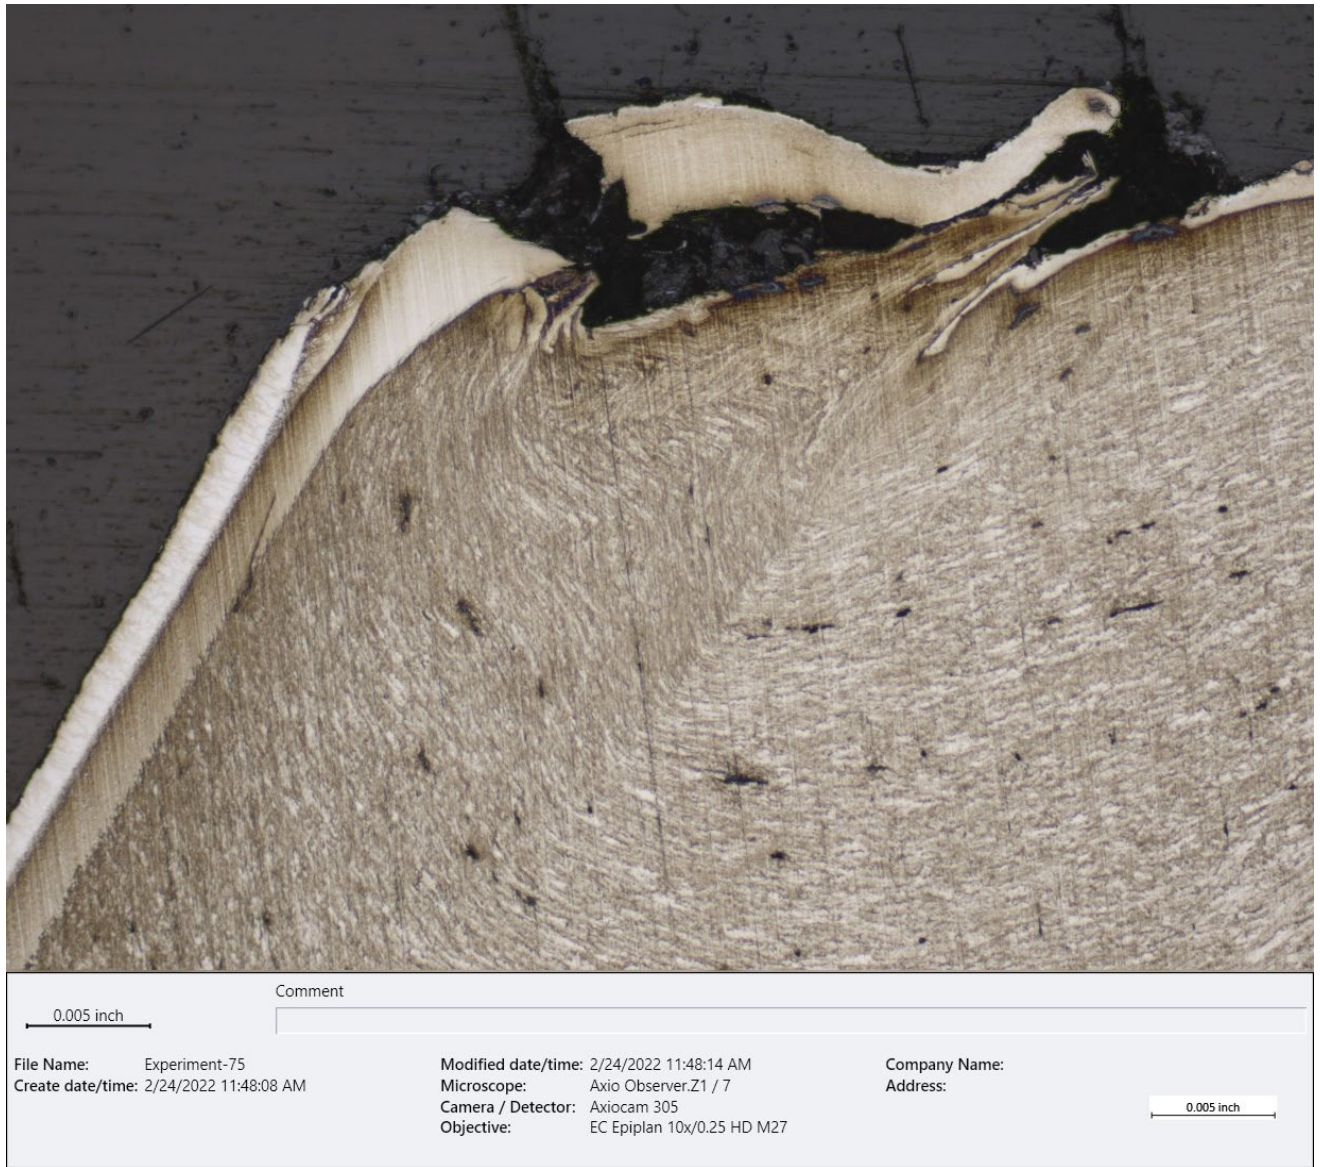
Figure 53. BF optical micrograph of the outboard edge of the LS wheel flange, showing deformation and surface martensite (~100X, etched 2% Nital).

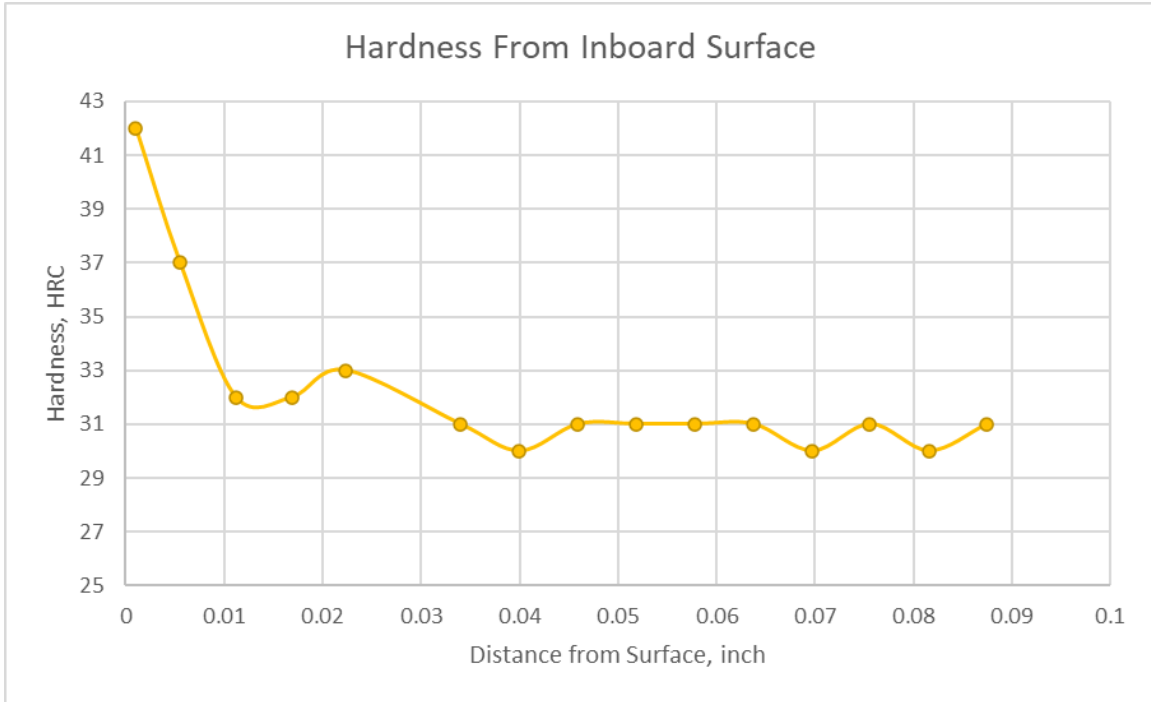
Figure 56. Chart of the hardness on the from the inboard worn surface, in HRC converted from HV₅₀₀.

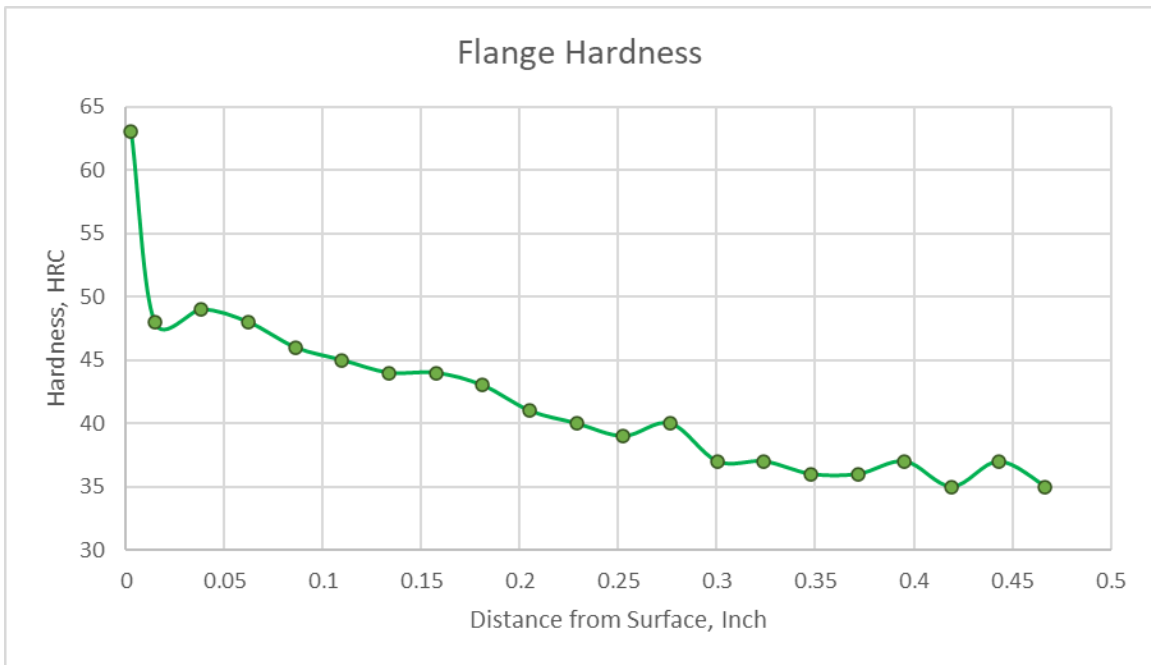
Figure 57. Chart of the hardness on the from the flange surface, in HRC converted from HV₅₀₀.

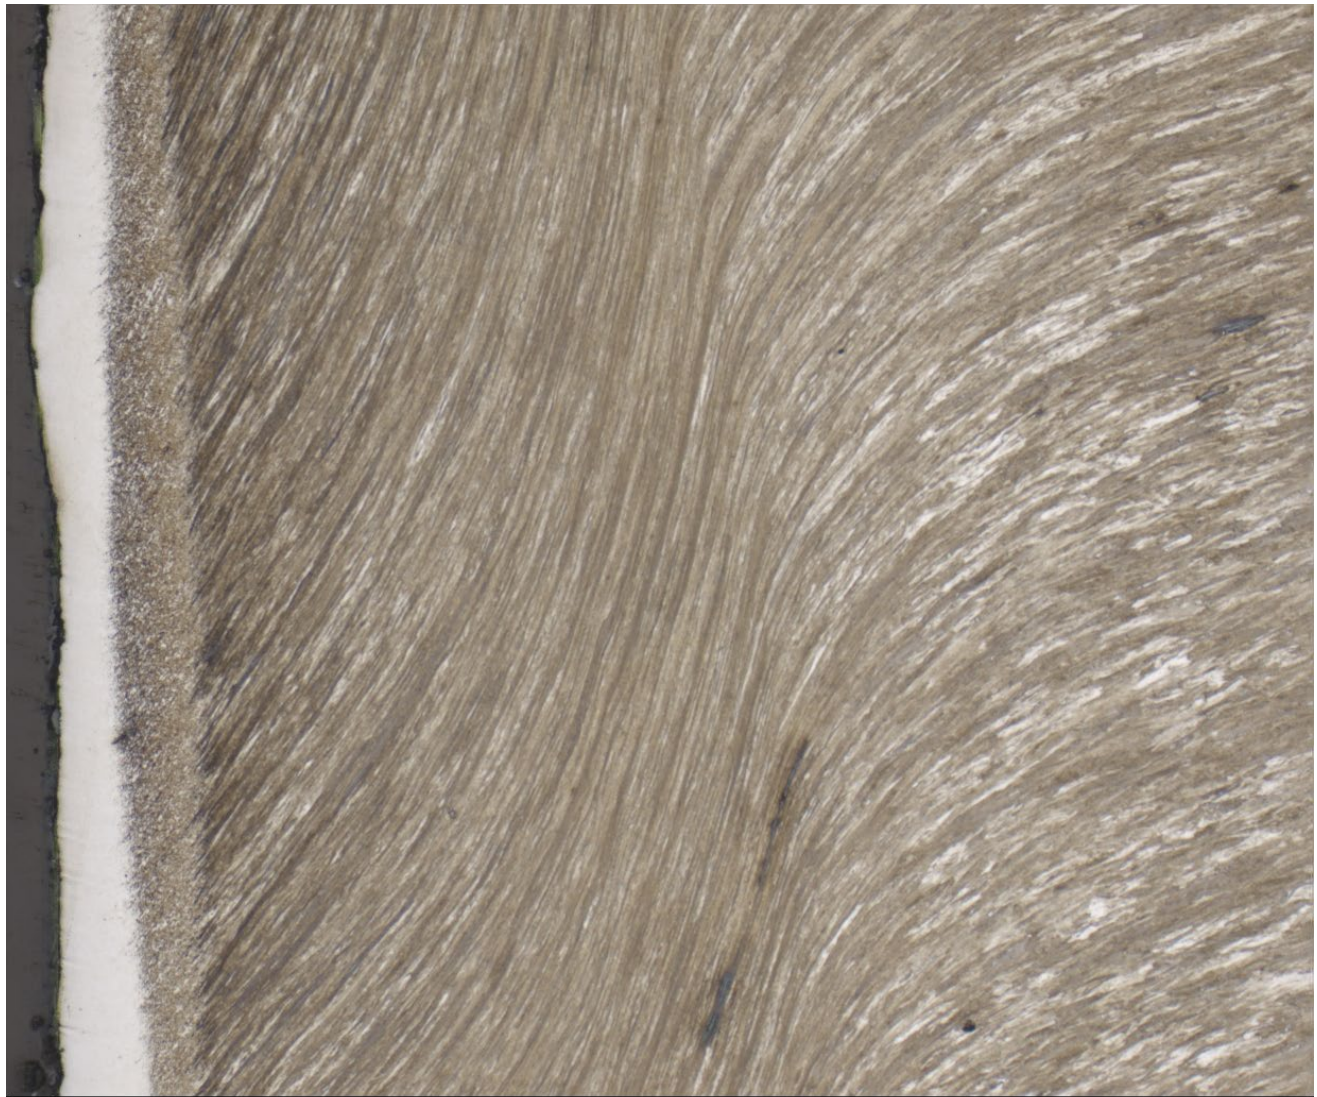
Figure 61. Closer view of the outboard face of the LS wheel microstructure, showing a jump, lumpy layer (~200X, etched 2% Nital).

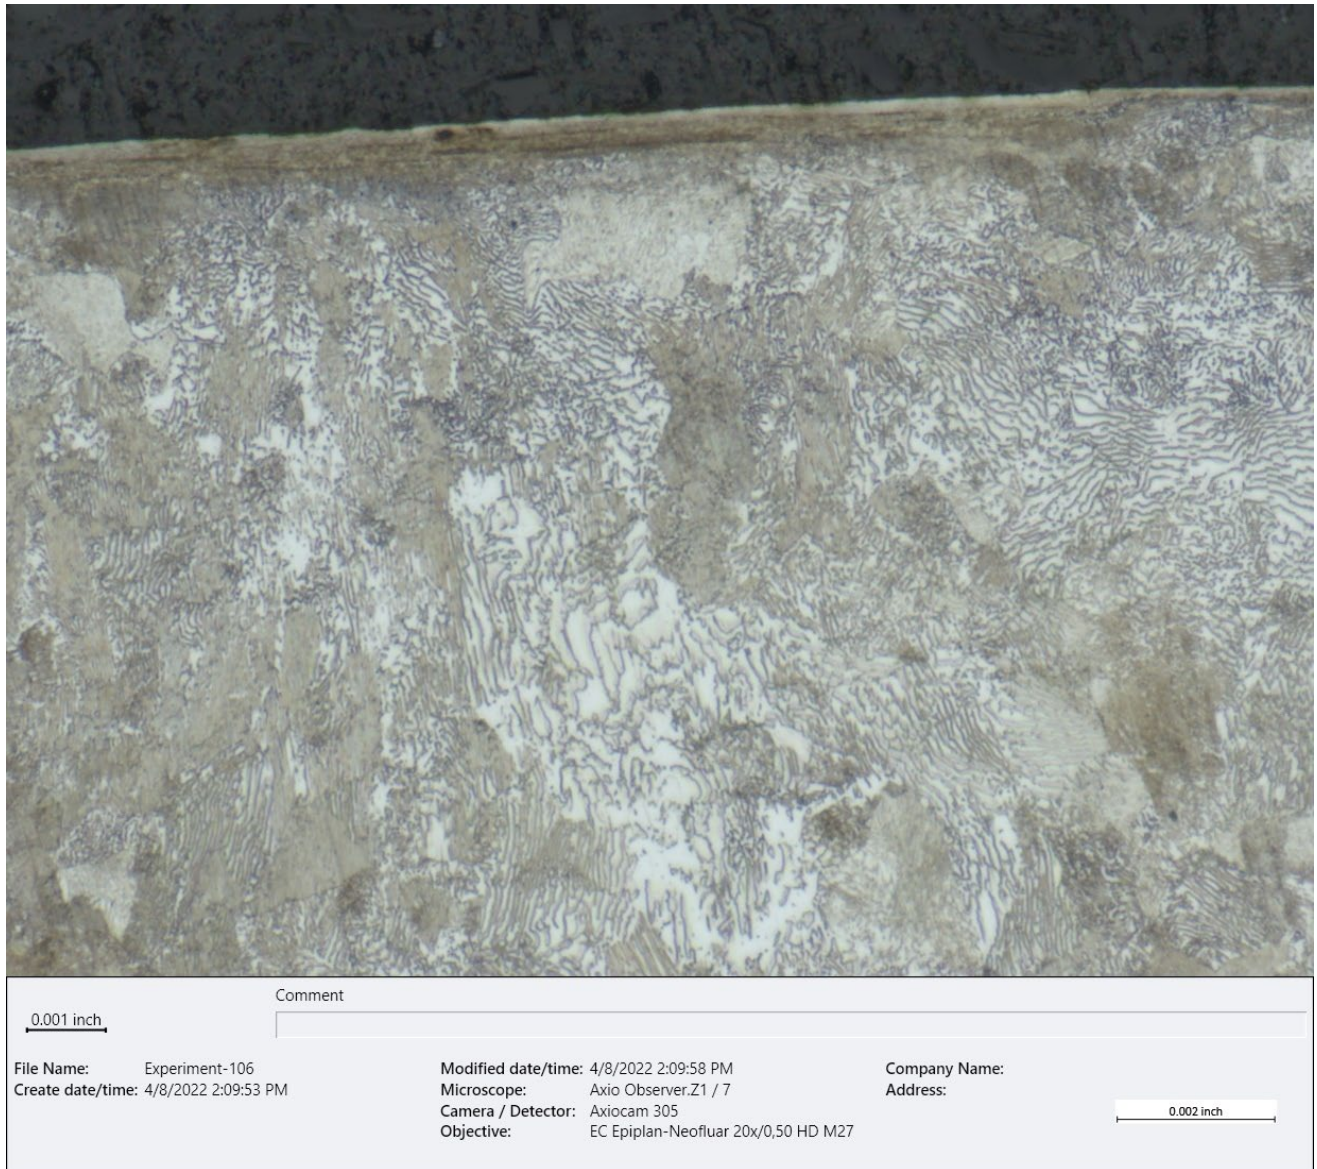
Figure 66. BF optical micrograph of the wheel bore surface, inboard from the edge, showing less surface damage and microstructural change (~500X, etched 2% nital).

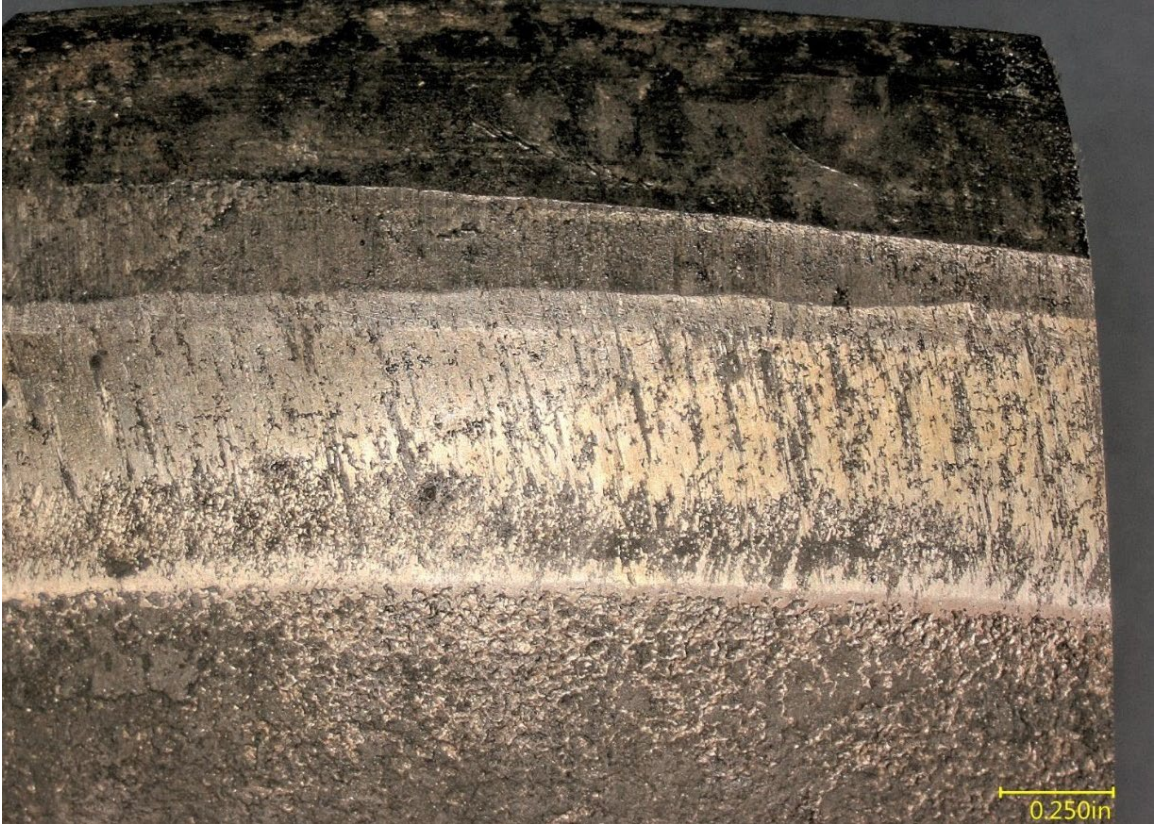
Figure 67. View of the circumferential wear pattern on inboard face of the LS wheel, near the flange.

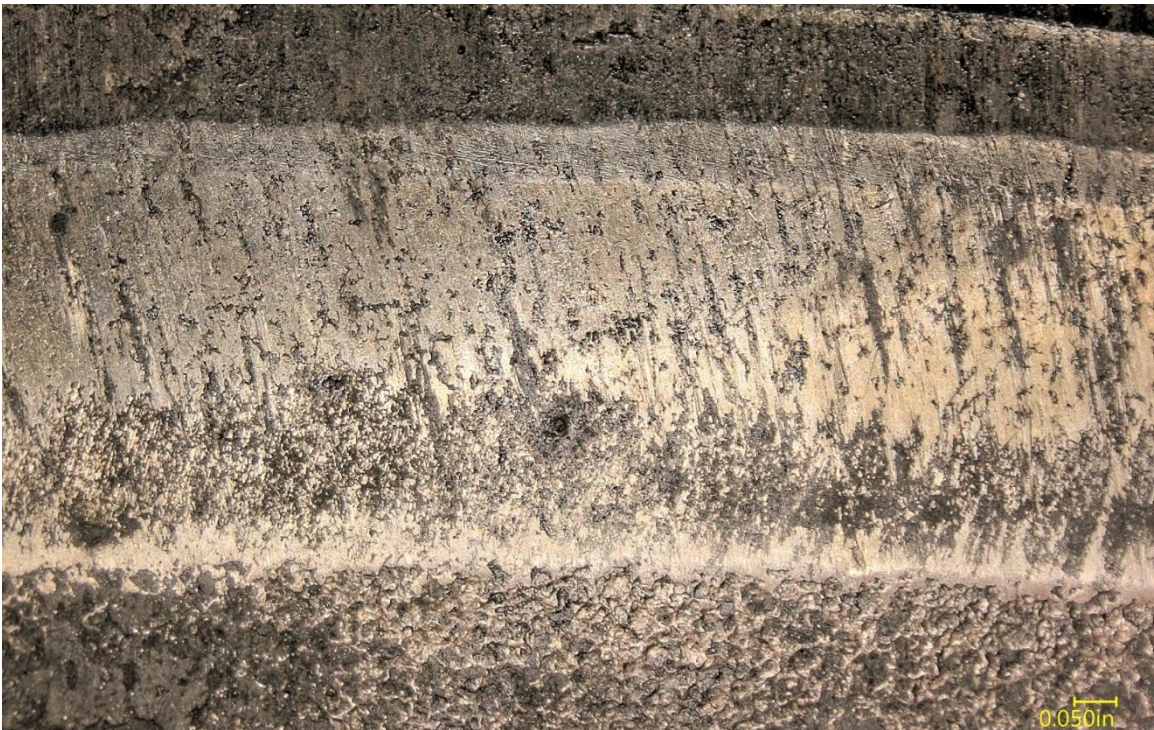
Figure 68. Closer view of the wear on the inboard face in Figure 67.

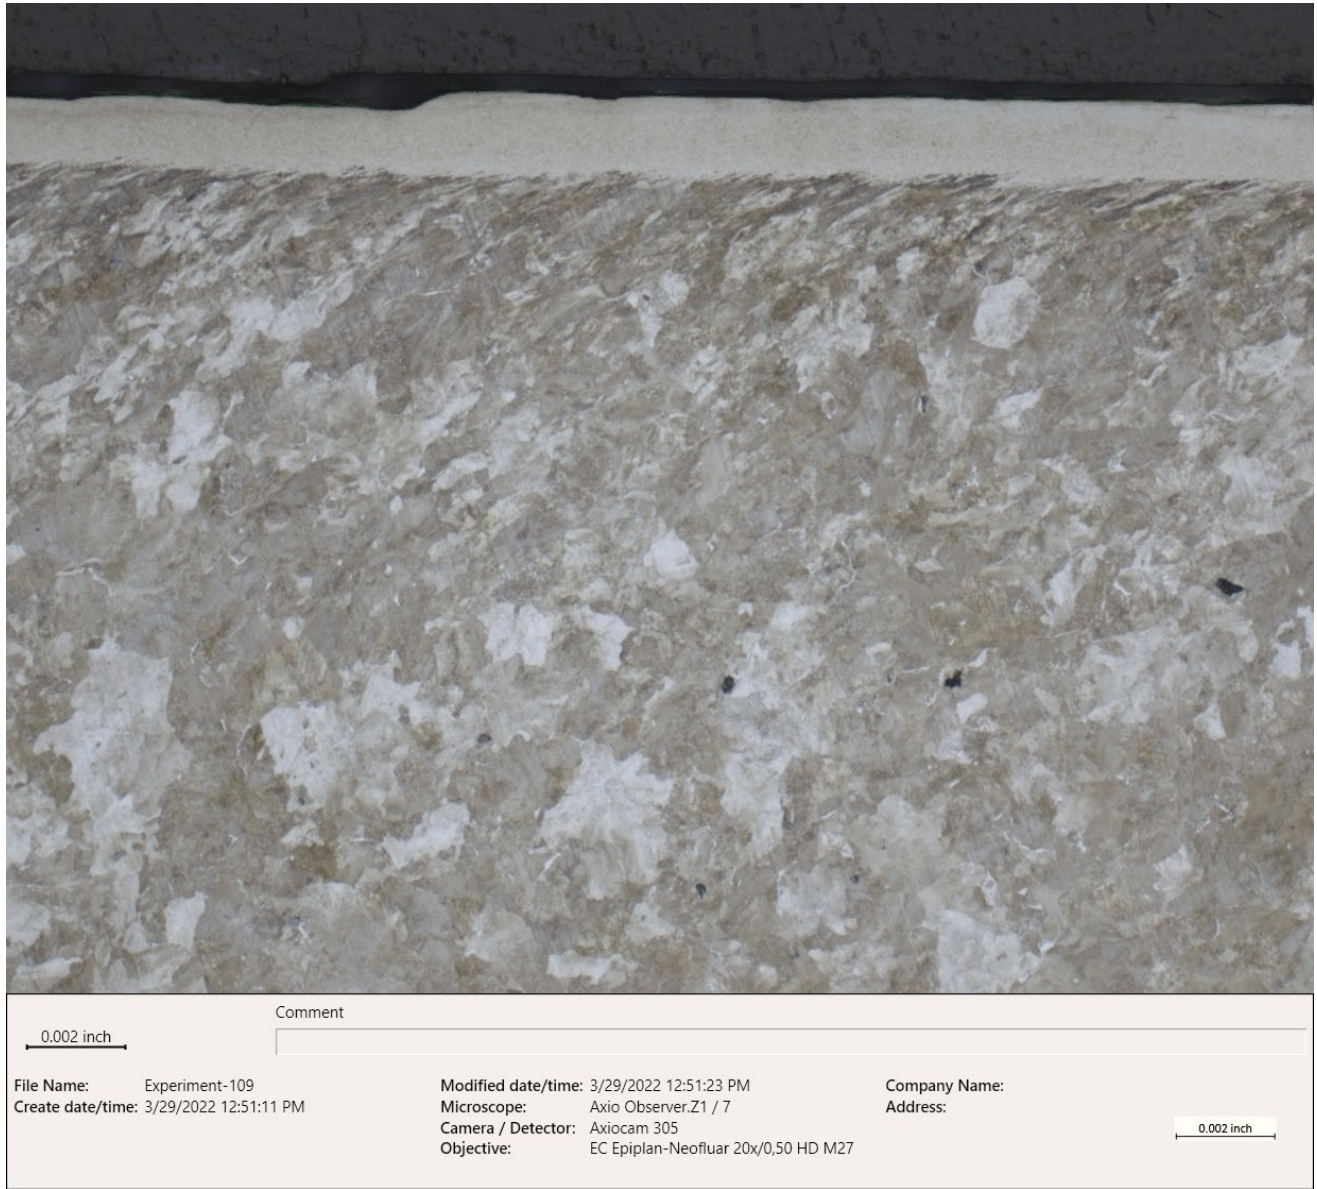
Figure 69. BF optical micrograph of surface deformation and martensite on the inboard wheel surface near the flange (~200X, etched 2% Nital).
