National Transportation Safety Board

RRD22LR001

Specialist's Factual Report - Supplemental 22-032C

Location: Arlington, Virginia
Date: October 12, 2021
Time: 4:50pm eastern daylight time
Vehicle: WMATA Metro Blue Line
Investigator: Joe Gordon, RPH-10

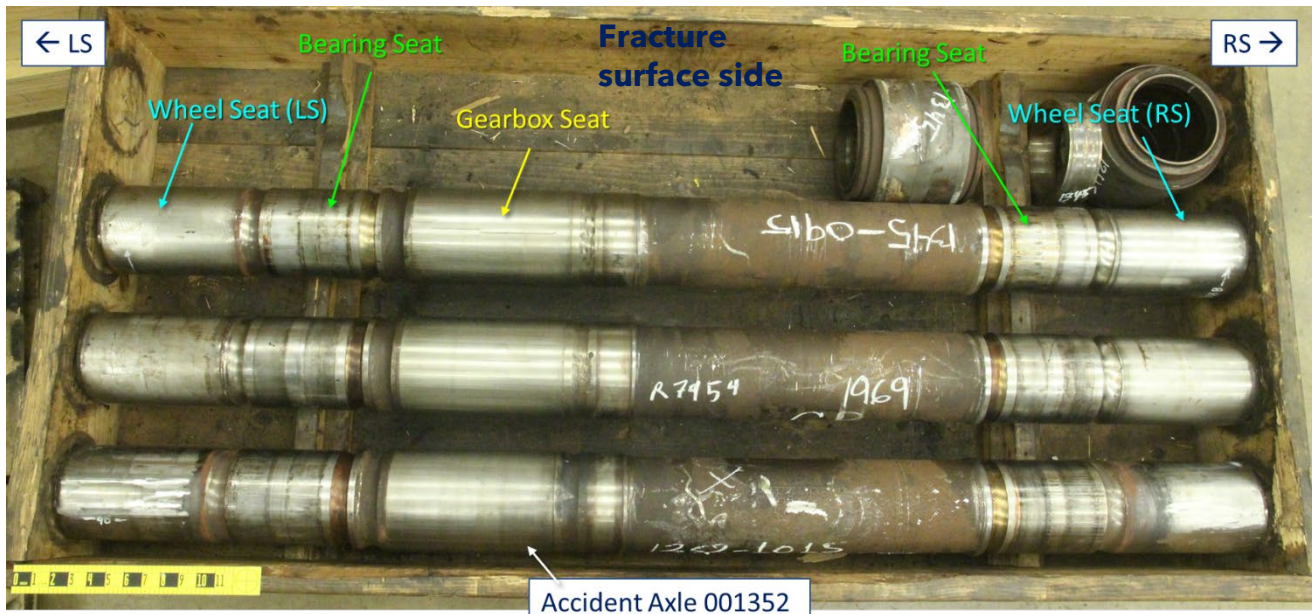
Figure 1 shows the three axles as received. The axle depicted on the bottom, axle 001352, was the axle of the derailed wheelset from the accident. The wheel seats of the accident axle had been partially ground to facilitate dimensional measurements by the Washington Metropolitan Area Transit Authority (WMATA) before receipt by the NTSB.

Figure 1. View of the three axles as received. The axle on the bottom was examined in this report.

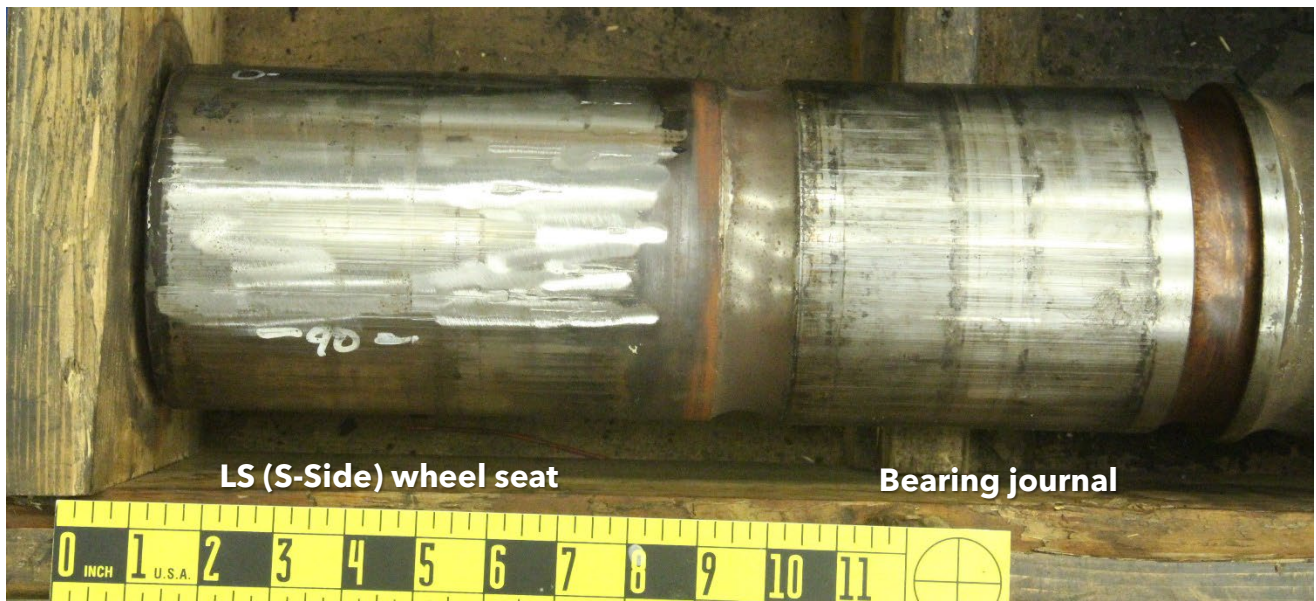
Figure 2 shows the wheel seat and the bearing journal of the left, or gearbox, side of the accident axle. The right-side wheel seat and bearing surfaces are shown in Figure 3 and Figure 4. The wheel seats of the accident axle were examined to inspect for indications of erosion and possible movement. After cleaning with a scouring pad and soapy water, followed by isopropyl alcohol, underlying features were observed consistent with bands of fretting wear and entrained particle damage. Localized plastic deformation and microscopic pit-like features were observed on the wheel seat surfaces. Prior to cleaning, the inboard portions of the wheel seat surfaces exhibited enough oxidation to obscure the underlying surface features—these characteristics were consistent with fretting wear.

Figure 2. The left side wheel seat and bearing journal from the accident axle, 1352, as received.

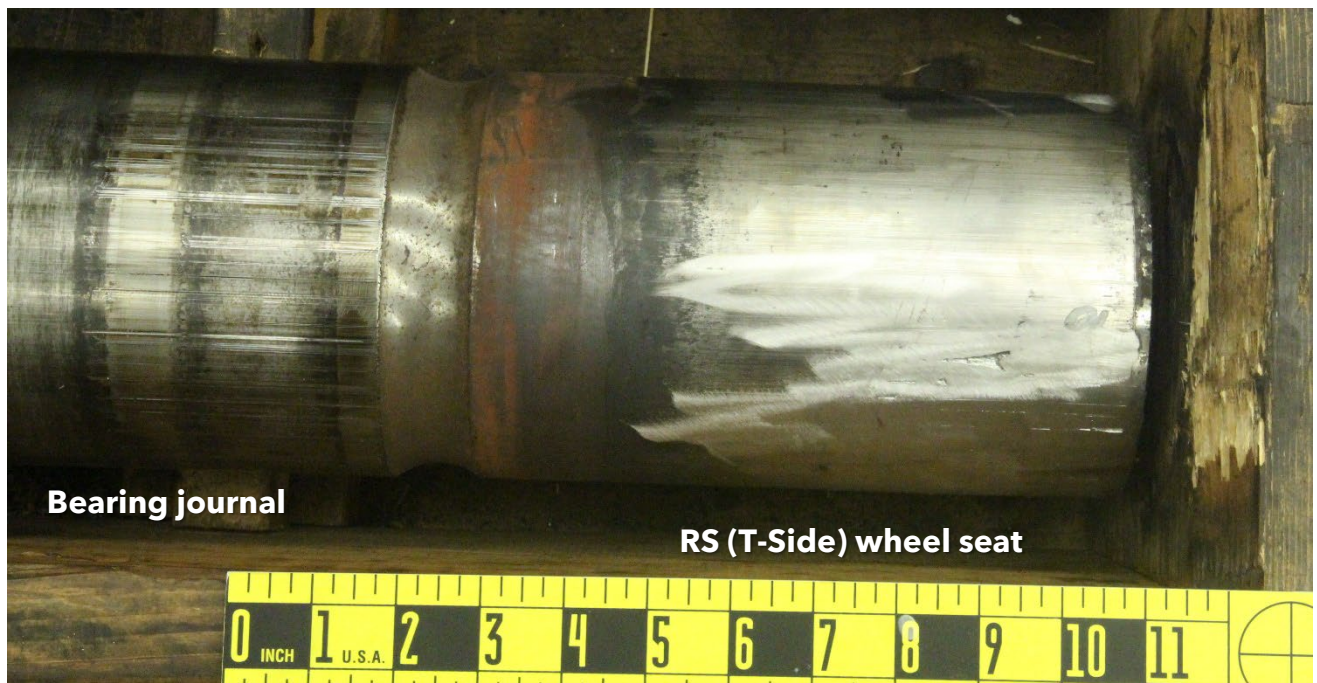
Figure 3. The right side wheel seat on the accident axle, as received.

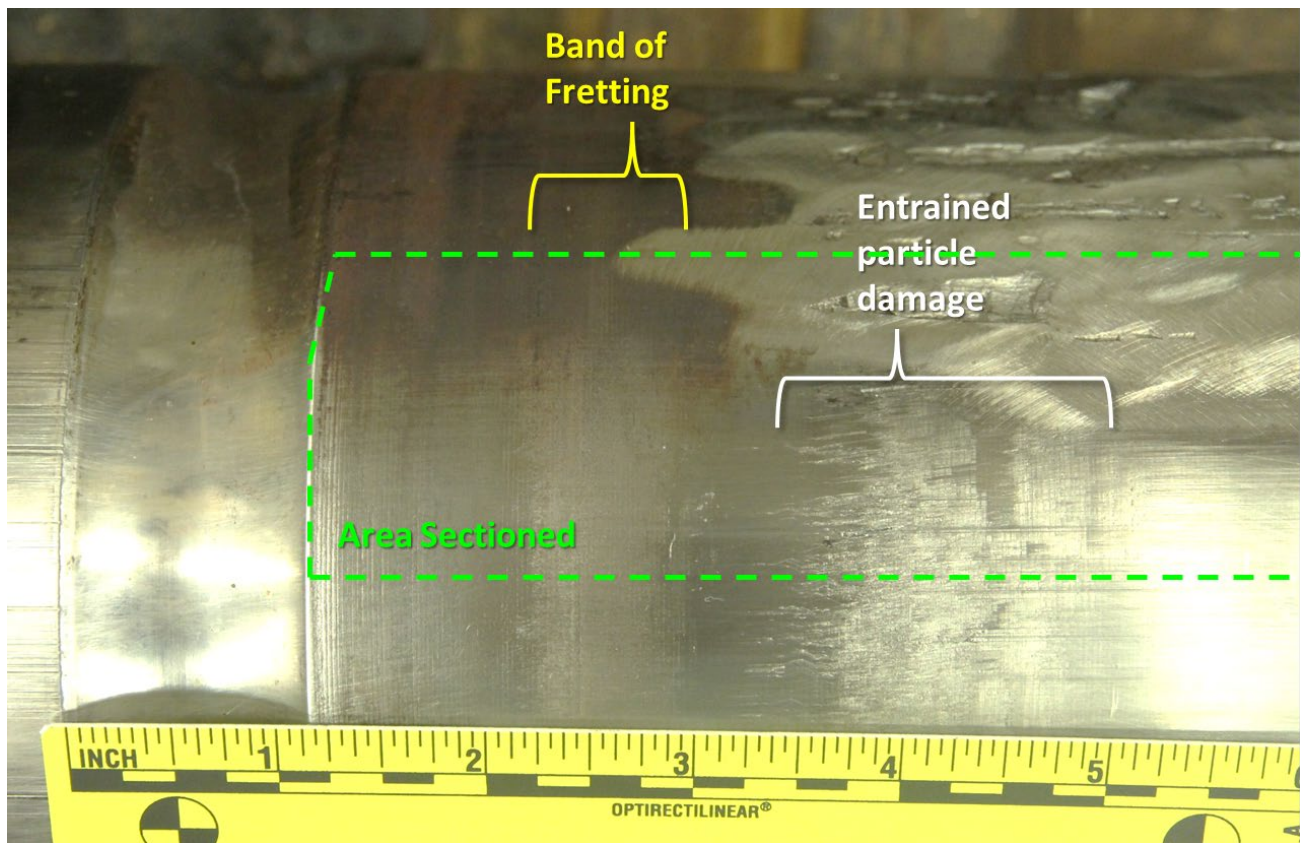
This band of fretting wear was visible to the naked eye, located on the right-side wheel seat of the axle approximately 0.75 inches in width, as shown in Figure 4. Outboard of the visual fretting wear band was an area of thin erratic gouges, oriented

parallel to the axle direction. A closer examination of this region found this was consistent with entrained particles that had been ground into the axle during the removal (press-off) of the right-side wheel.

The right axle wheel seat area was sectioned parallel to the longitudinal direction, as highlighted in Figure 4. Figure 5 shows a montage of the surface of the excised portion of the axle. The section had been cleaned in an ultrasonic bath using acetone.

Figure 4. Annotated views of the area of fretting wear, areas of entrained particle damage, and the boundaries of the sectioned axle area.

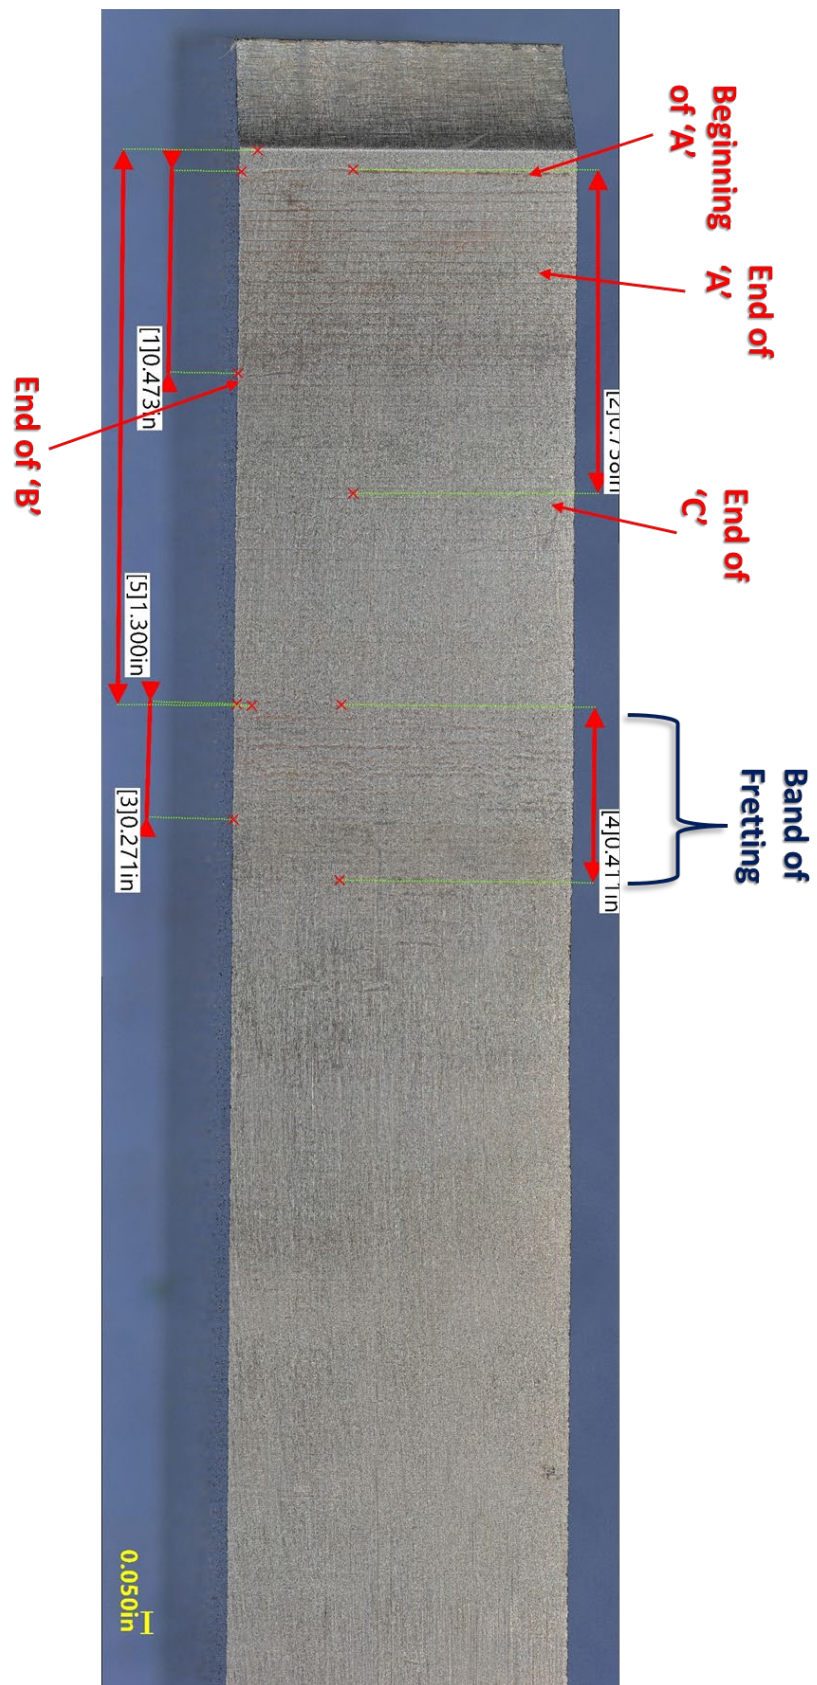
WMATA had categorized certain circumferential areas of the inboard wheel seat surface as Areas 'A,' 'B,' and 'C,' based on the apparent thickness of the surface oxidation (rust). The distances of each of these areas were annotated in Figure 5. Area A was approximately 0.29 inches in width from the inboard groove, B was a further 0.18 inches, and the width of C was 0.28 inches outboard of Area B. The width of the outboard band of fretting wear was measured as 0.41 inches, with the most severe damage being the inboard-most 0.27 inches. This band of fretting wear was located 1.30 inches from the inboard groove of the wheel seat.

Figure 5. Montage of the surface of the right-side axle section, annotated to show the various regions and their distances from the inboard groove (top of figure).

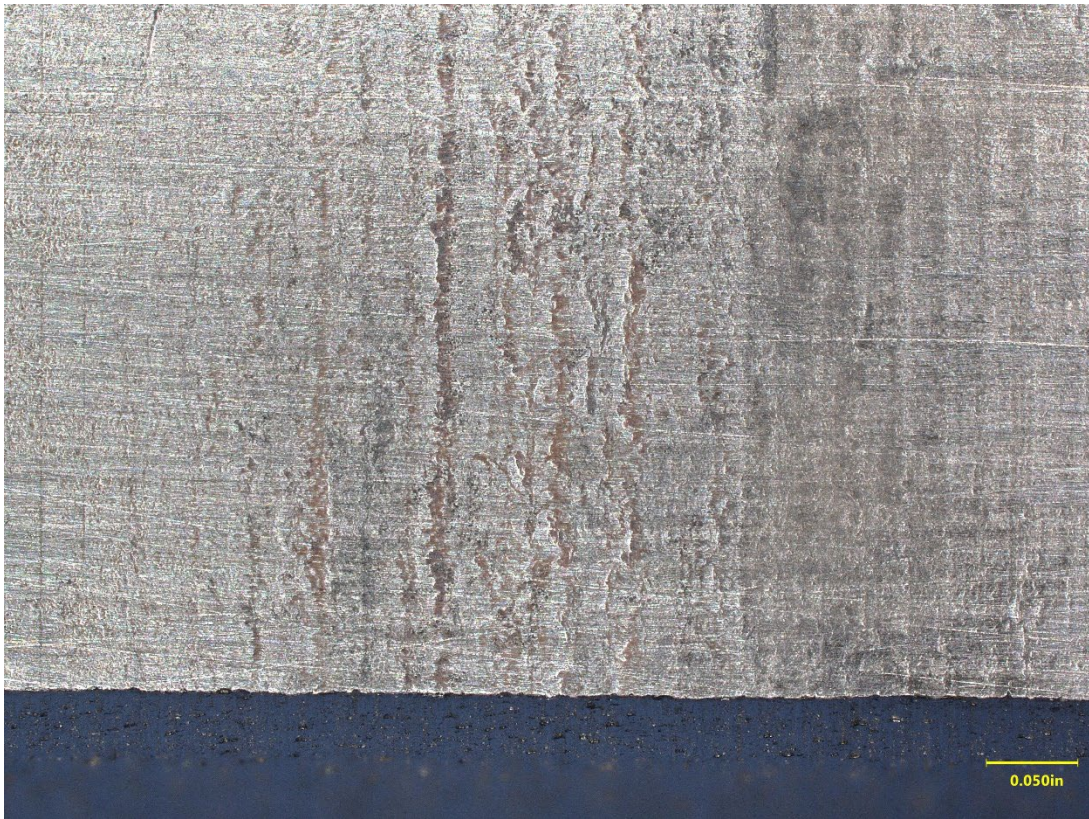
Figure 6 shows a closer view of the most severe area of fretting wear damage. This region exhibited parallel wavy/linear features, oriented perpendicular to the longitudinal direction of the axle. The bands exhibited a brownish-maroon color, consistent with localized oxidation (rust) on the surface. Figure 7 shows a closer view of this region, demonstrating the folds and localized deformation on the surface.

Figure 6. View of the most severe band of fretting wear on the axle wheel seat surface.

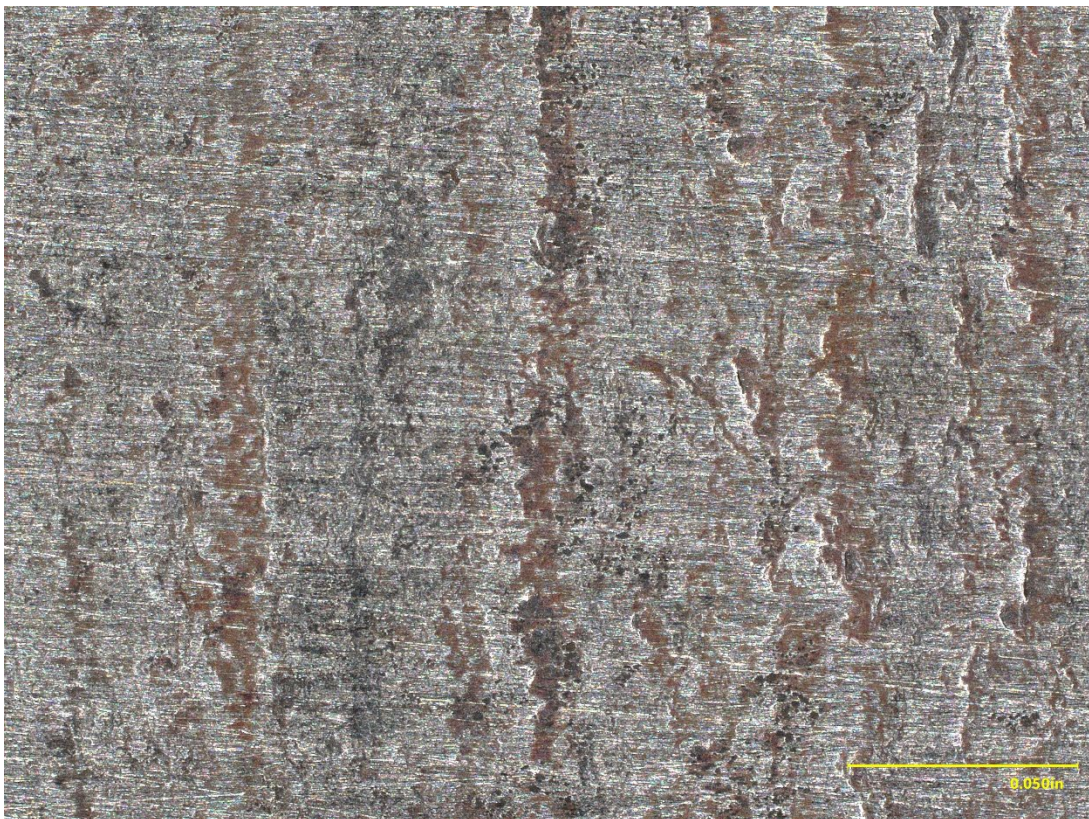
Figure 7. Closer view of the fretting wear features in **Figure 6**.

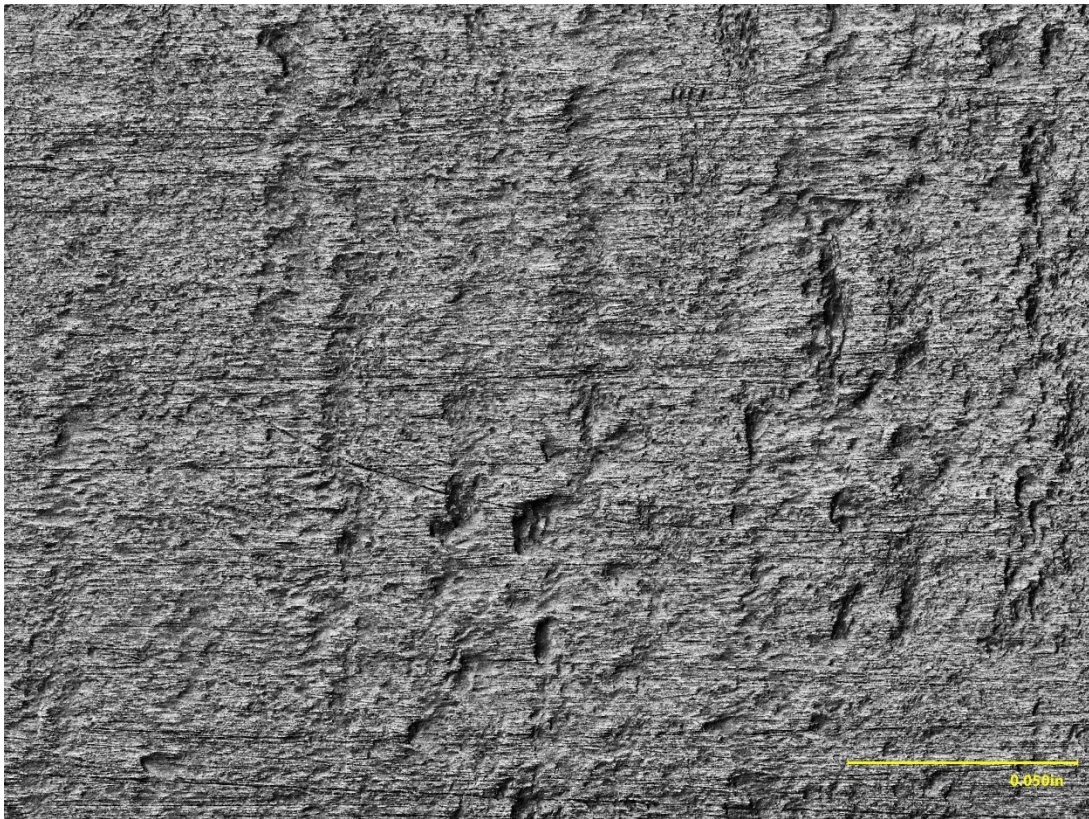
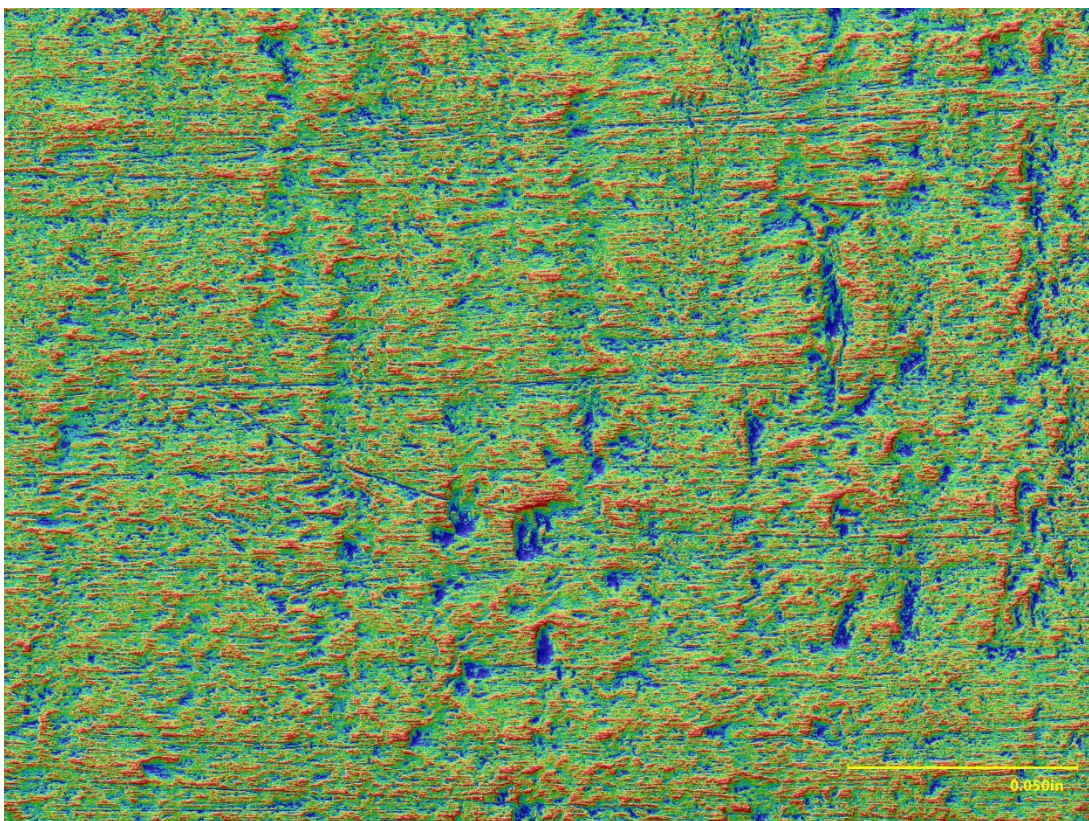
Figures 8 and 9 show differential optical shadowing and false color overlaying of the image geometry, respectively, to illustrate and amplify the morphology of the surface. In the optical shadowing figures, darker colors indicated valleys. In the false-color image, green represents a neutral plane, with blues being valleys/depressions, and yellow, orange, and red as peaks. These figures illustrate pits along the linear features, surrounded by corresponding parallel raised areas.

Figure 8. Differential optical shadowing image of the area in **Figure 7**.

Figure 9. False color image of peaks (red) and valleys (blue) in the surface topography of **Figure 8**.

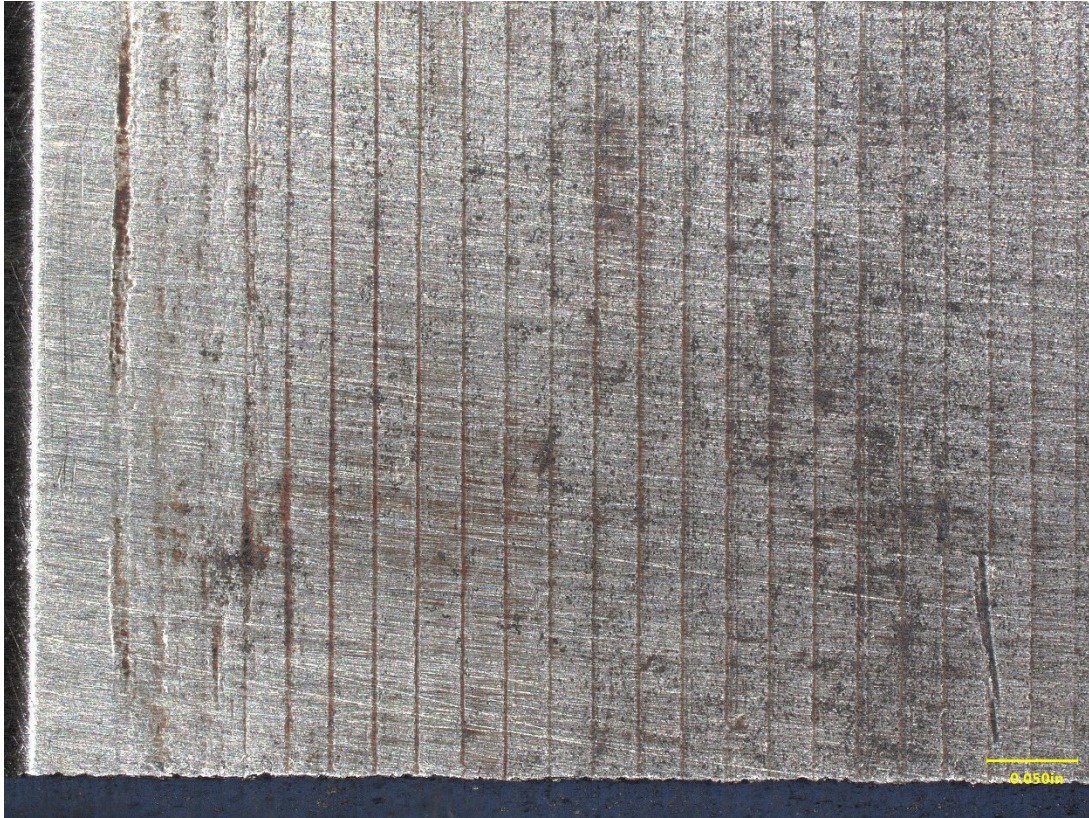
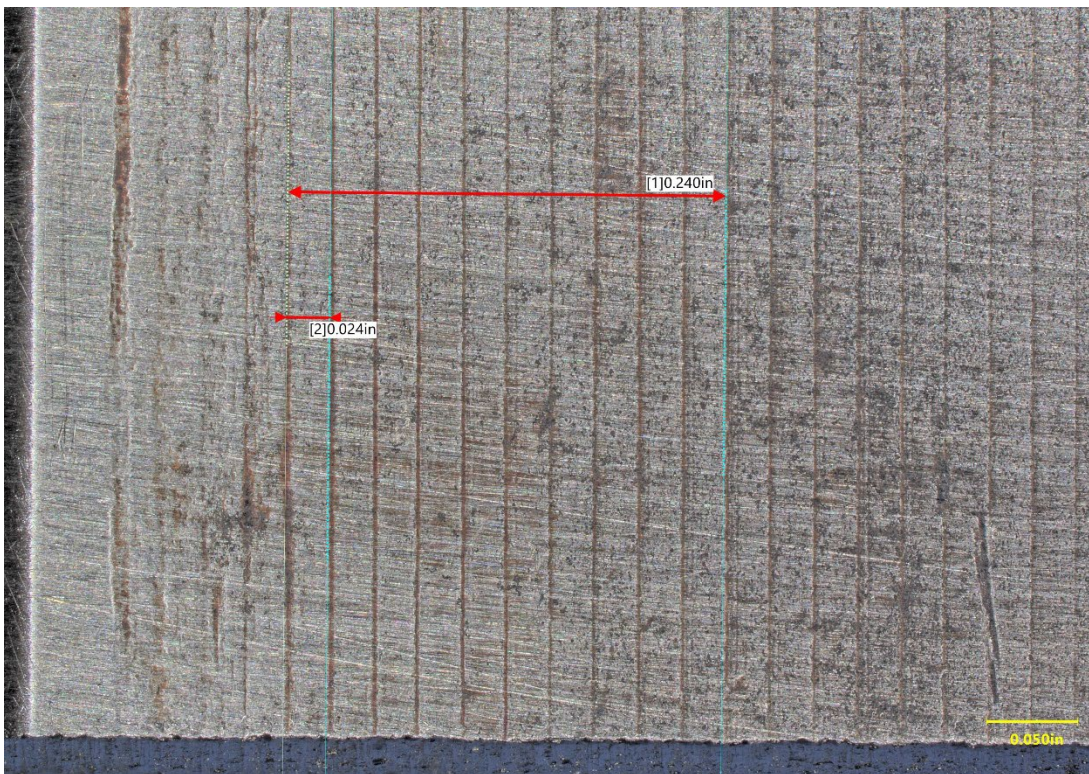
Figure 10 and Figure 11 highlight Area 'A', which exhibited repeating, evenly spaced linear features that were oriented perpendicular to the axle longitudinal direction. These features were spaced 0.024 inches apart, consistent with the machine marks of the mating wheel bore (described in *Factual Report 22-032*). These marks were consistent with brinelling from the wheel bore surface.

Figure 10. View on the inboard corner of Area A, showing brinelling of the surface from the wheel bore.

Figure 11. **Figure 10** annotated to show several measurements between marks.

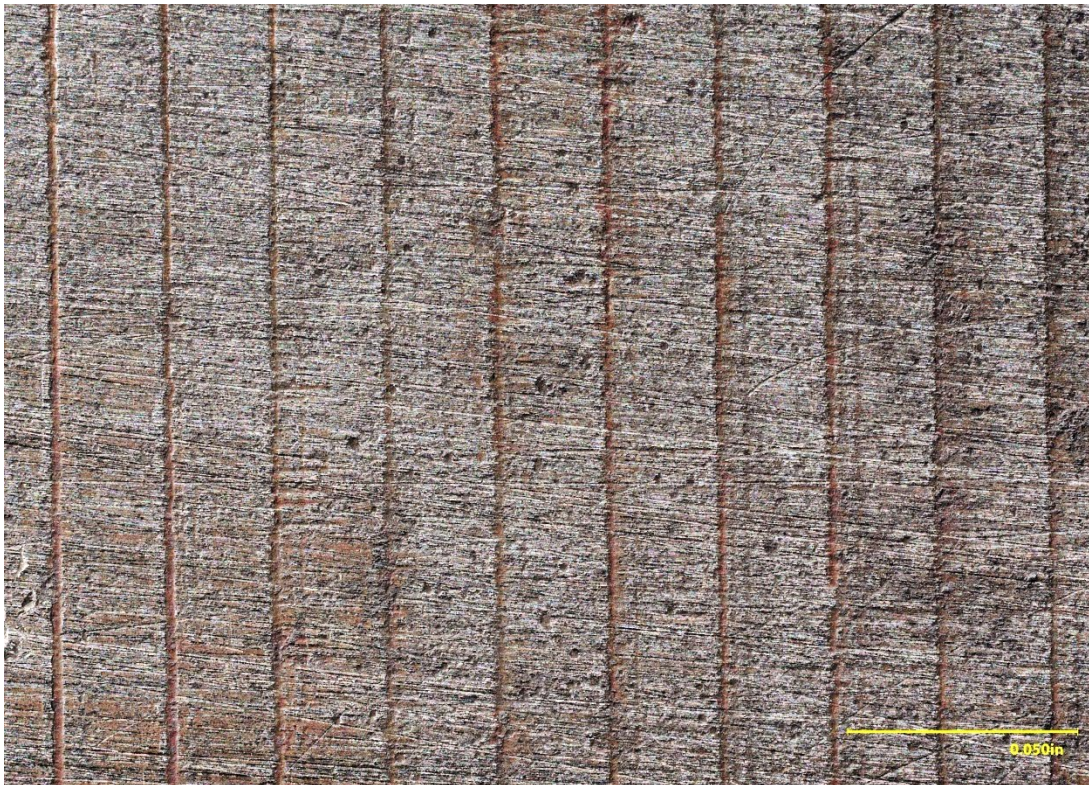
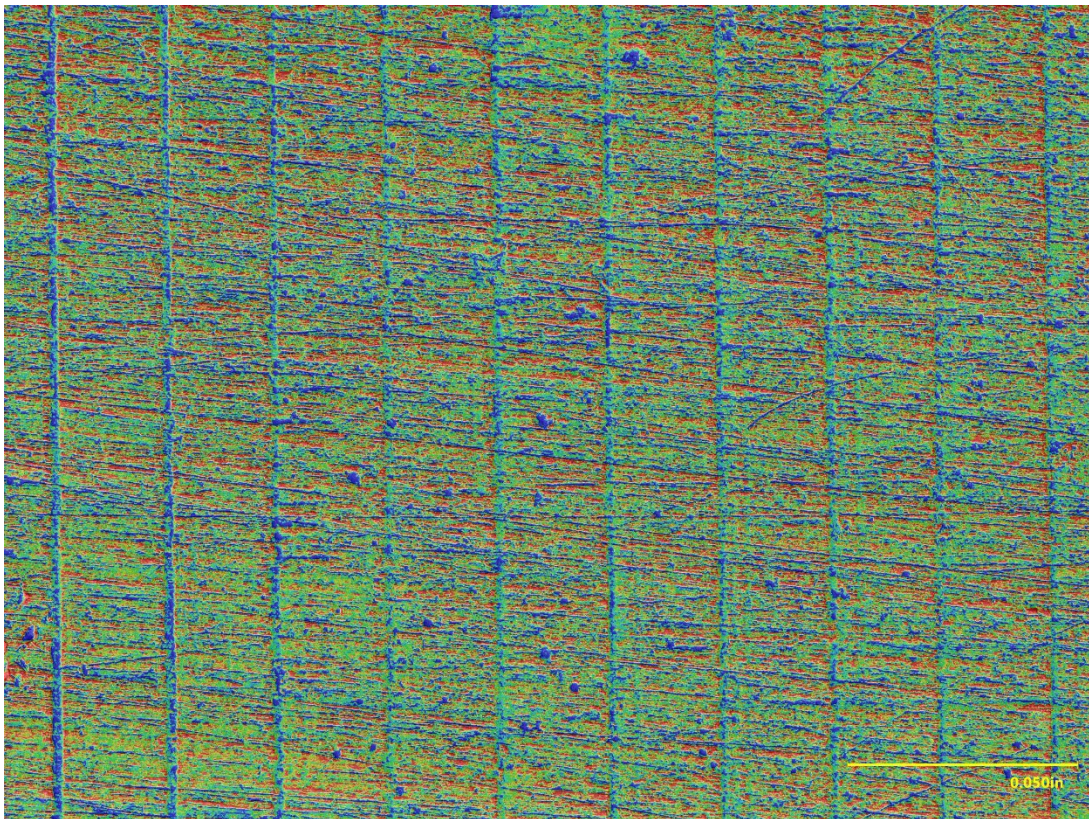
Figures 12 and 13 depict differential optical shadowing and false color overlaying of the image geometry, illustrating and amplifying the morphology of the surface. The images demonstrate depressions present along the brinelling line locations. However, they were generally absent corresponding adjacent parallel peaks, which would manifest as red lines next to blue rather than the depicted green next to blue.

Figure 12. Closer view of the brinelling marks in **Figure 11**.

Figure 13. False color image of peaks (red) and valleys (blue) in the surface topography of **Figure 12**.

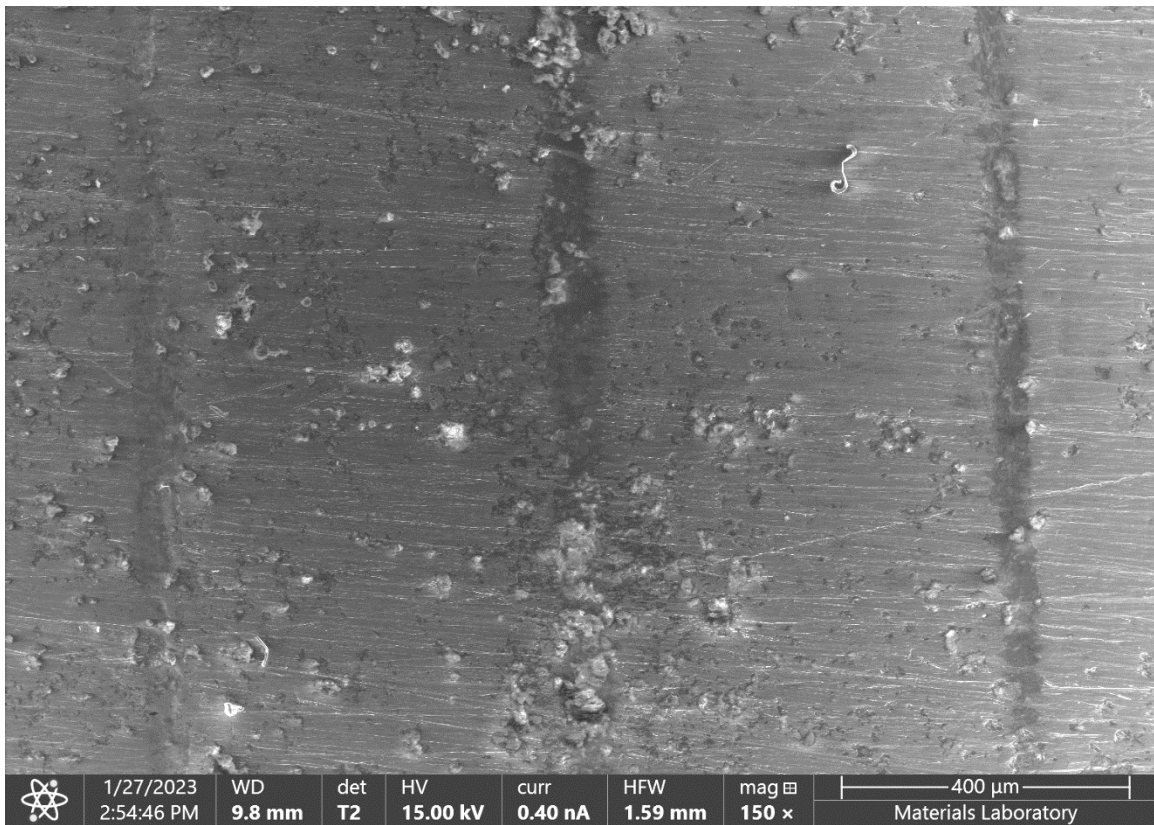
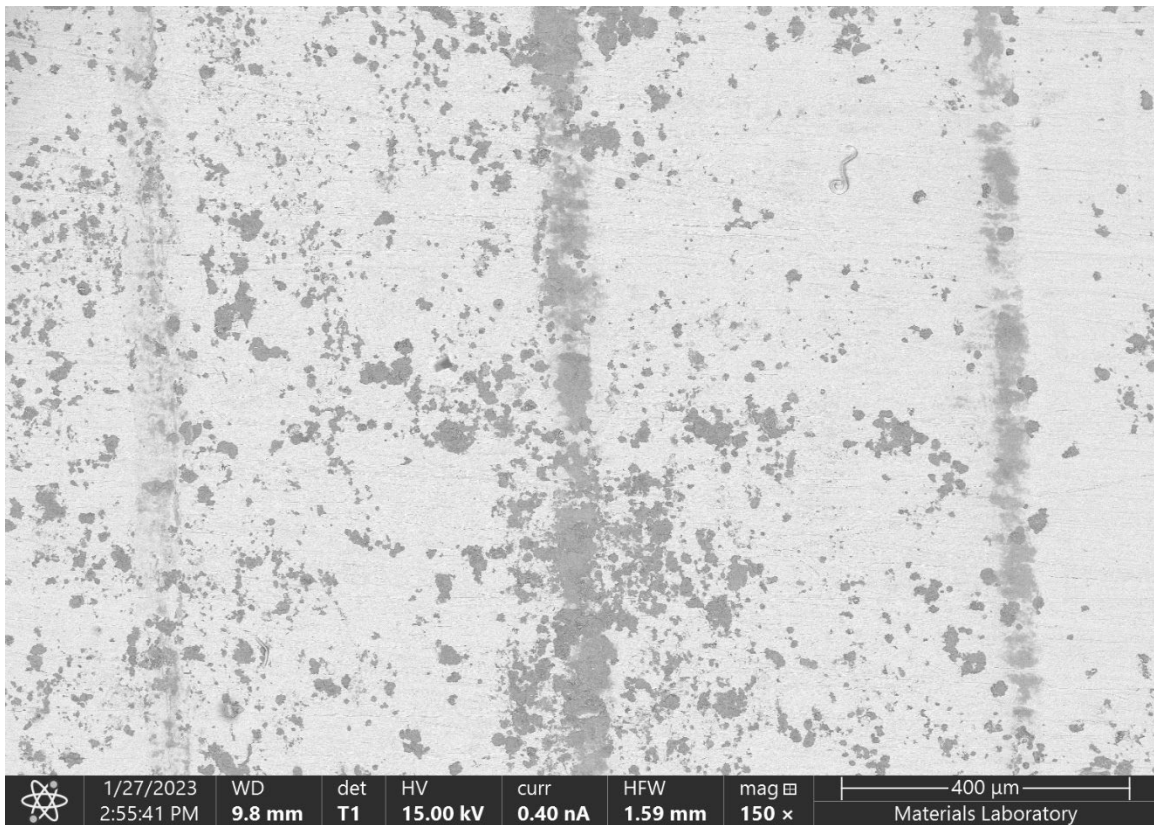
illustrated in Figures 14 and 15, in secondary and backscattered mode, respectively.¹ These figures show that the areas with the valleys (brinelling) also exhibited areas of with lower atomic number material.

Figure 14. Secondary electron (SE) micrograph of brinelling in Area A.

Figure 15. Backscattered electron (BE) micrograph of brinelling in Area A.

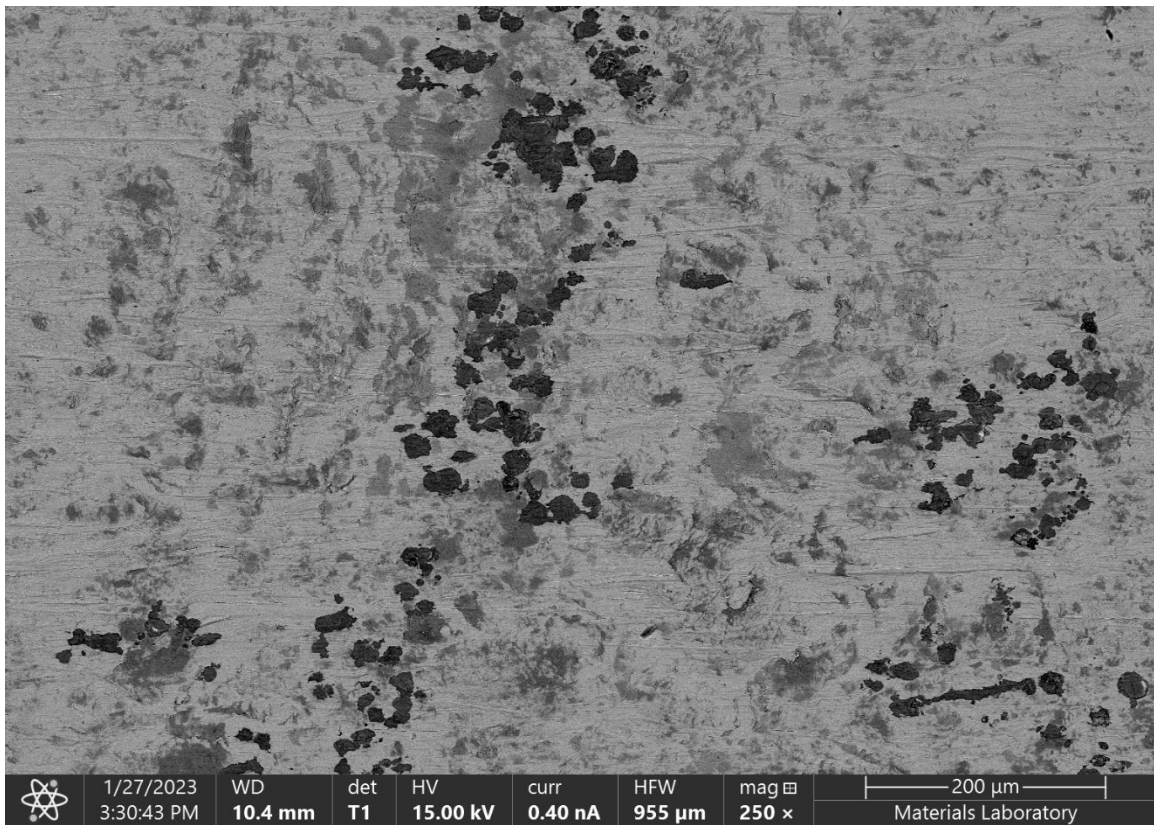
Figure 16 shows a closer view of these lower atomic mass materials, illustrated as dark black and darker gray areas. The dark gray areas exhibited concentric crescent shapes, with alternating areas of light gray. Examination of these areas using energy dispersive x-ray spectroscopy (EDS) found the dark gray material to be consistent with iron oxides. The black areas were also consistent with iron oxides which also contained higher levels of silicon, sulfur, and carbon. The light gray areas were consistent with the axle steel material.

Figure 16. BE micrograph of showing a closer view of the different surface phases in Figure 15.

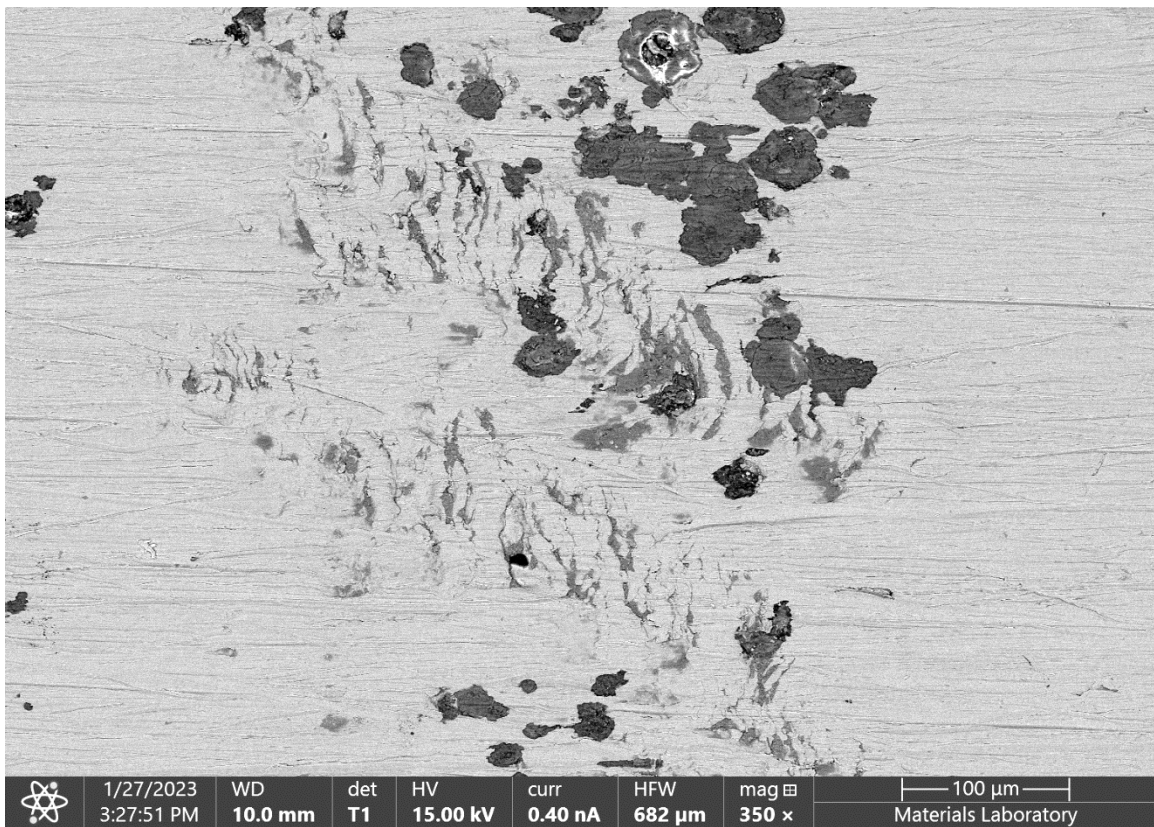
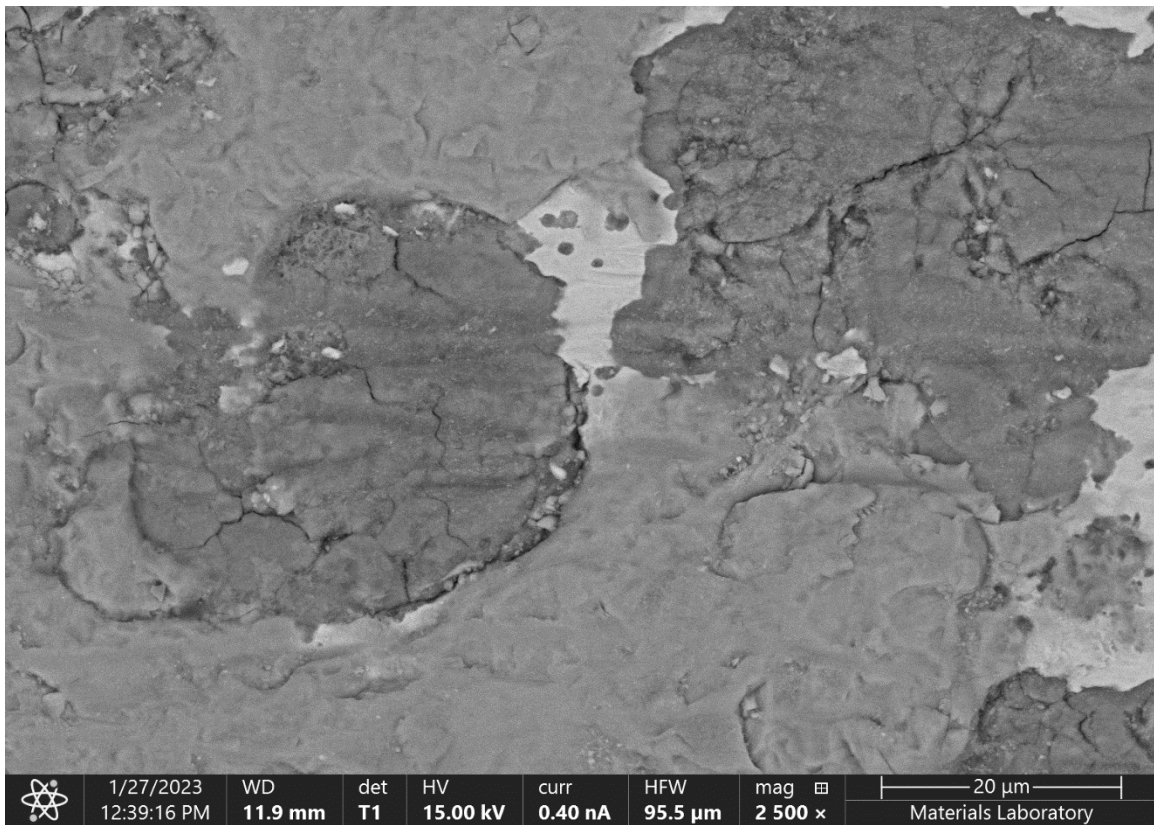
Similar features were observed in Area 'C,' which exhibited less damage and was absent much of the brinelling features apparent in areas 'A' and 'B.' The area highlighted in Figure 17 shows the concentric crescent-shaped areas with dark gray material, found by EDS examination to be consistent with iron oxide. A closer view of an area with darker material is shown in Figure 18. This figure shows that the darker (containing less Fe) oxide was layered on top of the underlying iron oxide (dark gray).

Figure 17. BE micrograph of fretting wear and surface deformation in Area C.

Figure 18. BE micrograph of layers of oxide from **Figure 17**.

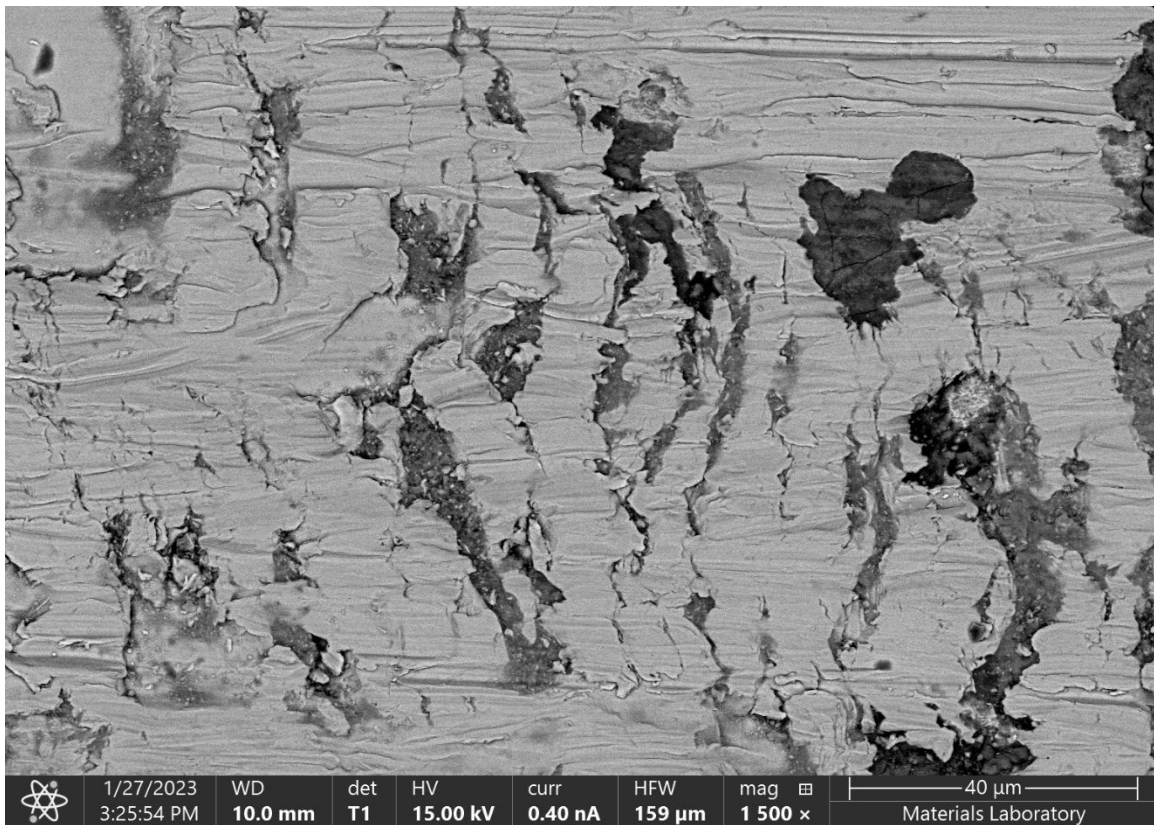
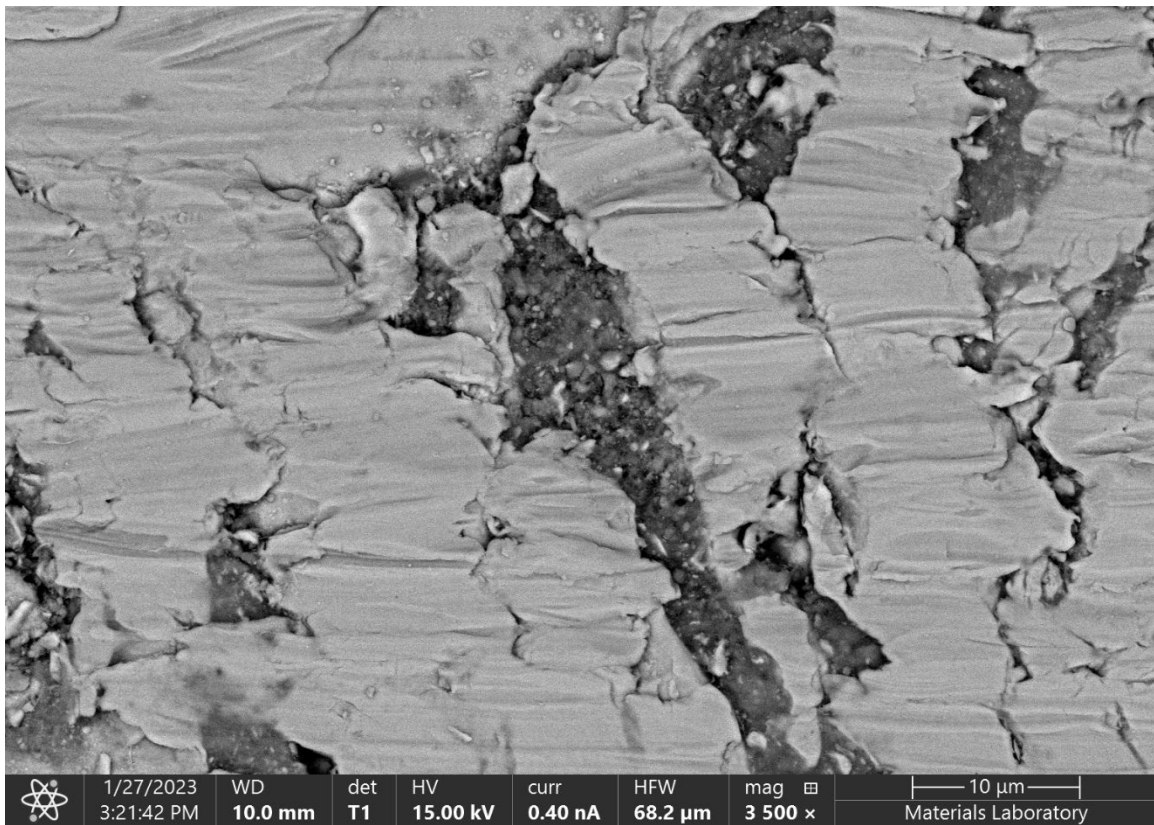
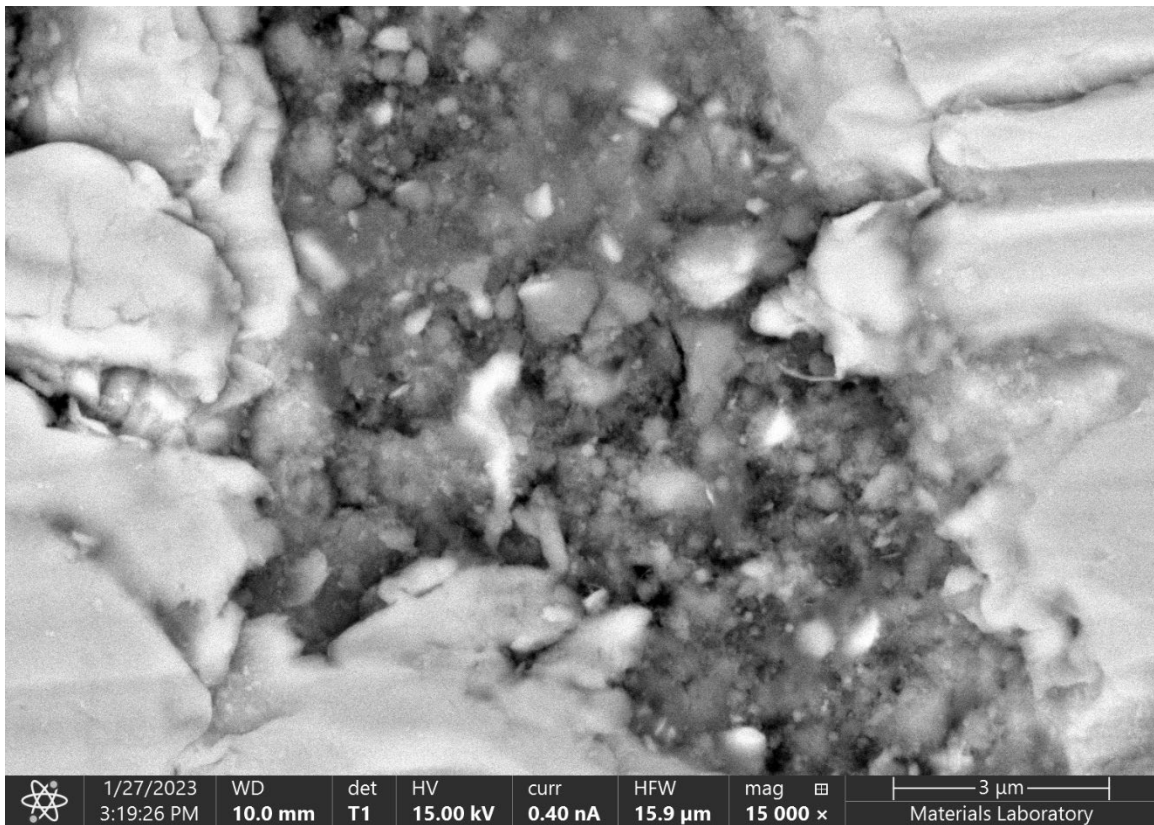
Figure 19 shows another region in Area 'C' that exhibited similar prominent concentric crescent marks features. Figures 20 and 21 show closer views of one of the darker contrasting crescent features. The material within these features had been pressed into the axle surface, with metallic material folded over them. EDS examination of the embedded material in Figure 21 was consistent with iron oxide and ferrous alloy particles. These features were consistent with oxidized wear debris typical of fretting wear between two faying surfaces.

Figure 19. BE micrograph of folds, deformation, and entrained oxidation in Area C.

Figure 20. BE micrograph of a closer view of the features in **Figure 19**.

Figure 21. BE micrograph of the entrained oxide in **Figure 20**.
