National Transportation Safety Board

RRD22LR001

Specialist's Factual Report - Supplemental 22-032C

Location: Arlington, Virginia
Date: October 12, 2021
Time: 4:50pm eastern daylight time
Vehicle: WMATA Metro Blue Line
Investigator: Joe Gordon, RPH-10

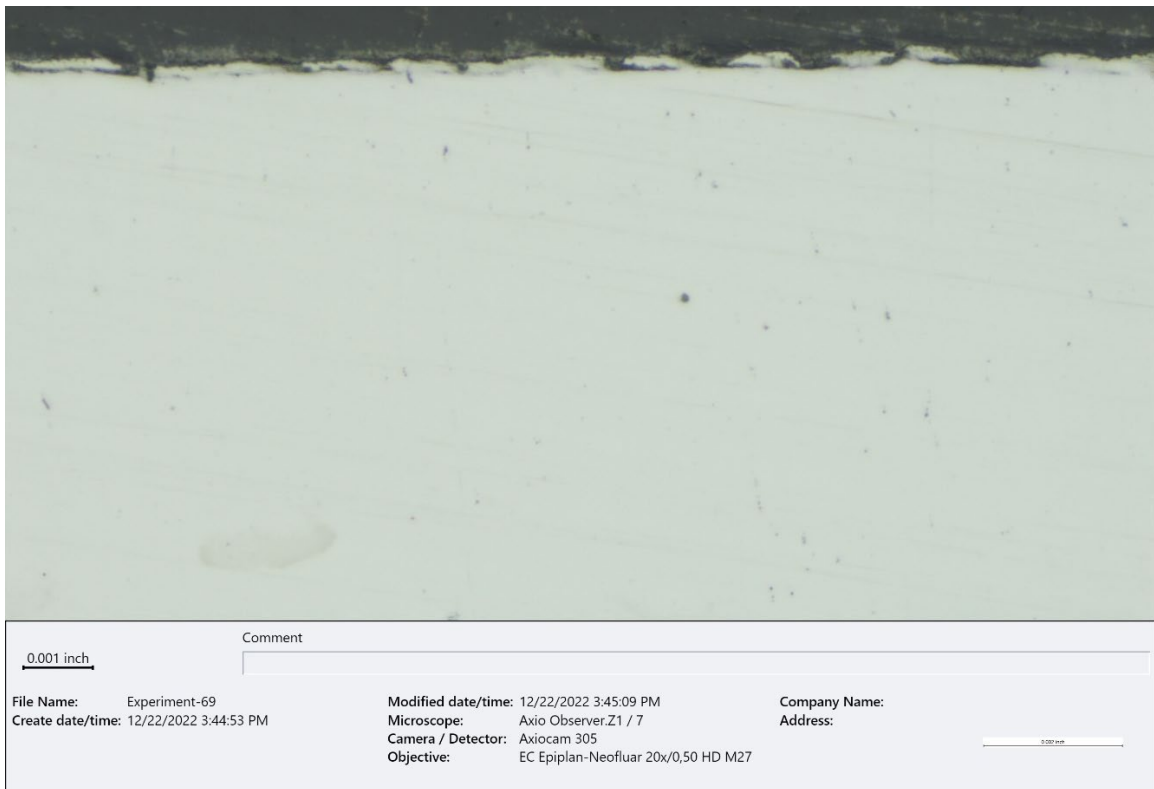
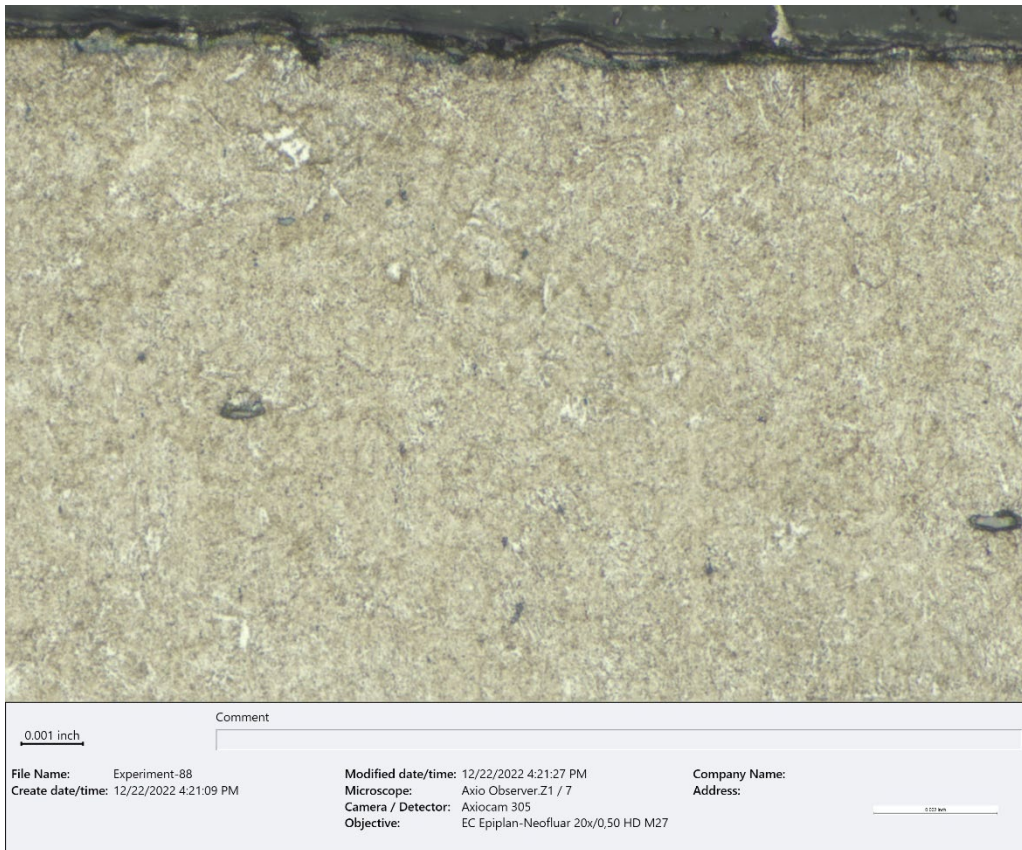
Figures 22 and 23 show a cross-section through the inboard part of Area 'A.' While these figures do not show pits or inward-propagating cracks, a layer of nonuniform material was present on the surface, consistent with the axle material, indicating localized plastic deformation of the surface.

Figure 22. Bright-field (BF) optical micrograph of the beginning of A (~500X, as polished).

Figure 23. Bright-field (BF) optical micrograph of the beginning of A (~500X, etched 2% Nital).

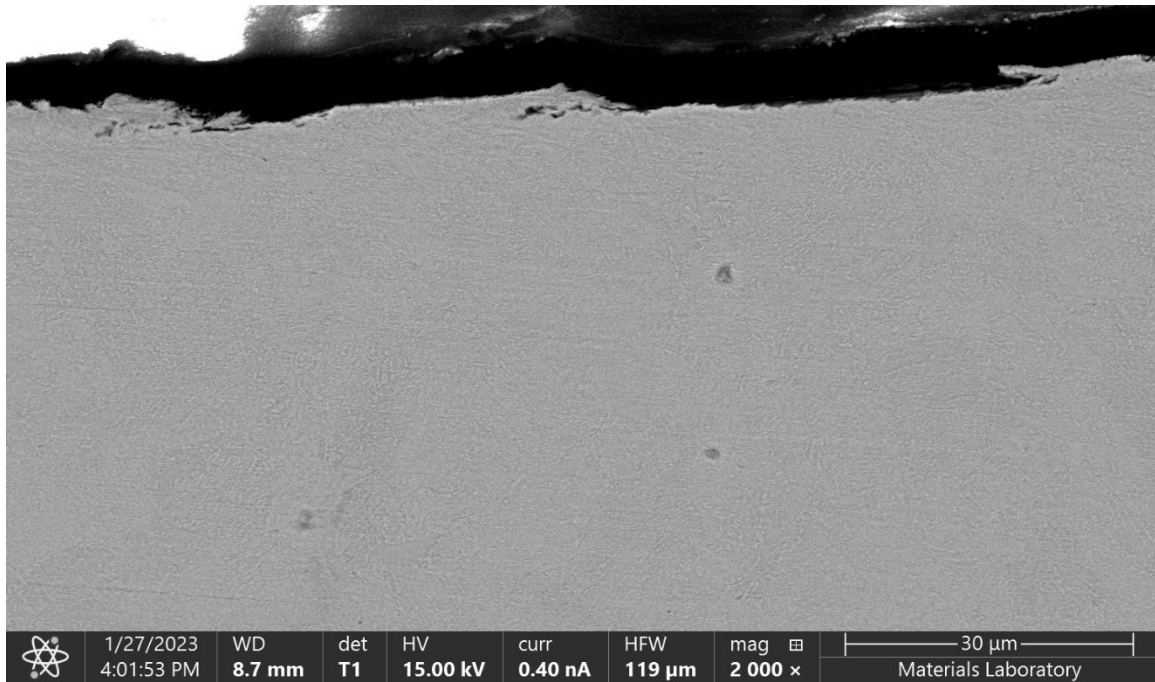
Figure 24 shows a closer view of one of the brinelling marks. This figure shows a generally flat depression in the surface, with no corresponding peaks on the feature

edges. However, the edges did exhibit localized folds, oriented parallel to the surface. This fold consisted of areas with small cracks, approximately 5 - 10 μm ($2 - 4 \times 10^{-4}$ inches) in length. A brinelling mark in Area 'C' exhibited a similar shape, with a flat depression and two opposite-oriented longitudinal cracks underneath folds on the edges. This brinelling feature also contained dark gray material, consistent with iron oxide.

Figure 24. Backscattered electron (BE) micrograph of a cross section of brinelling marks in Area A.

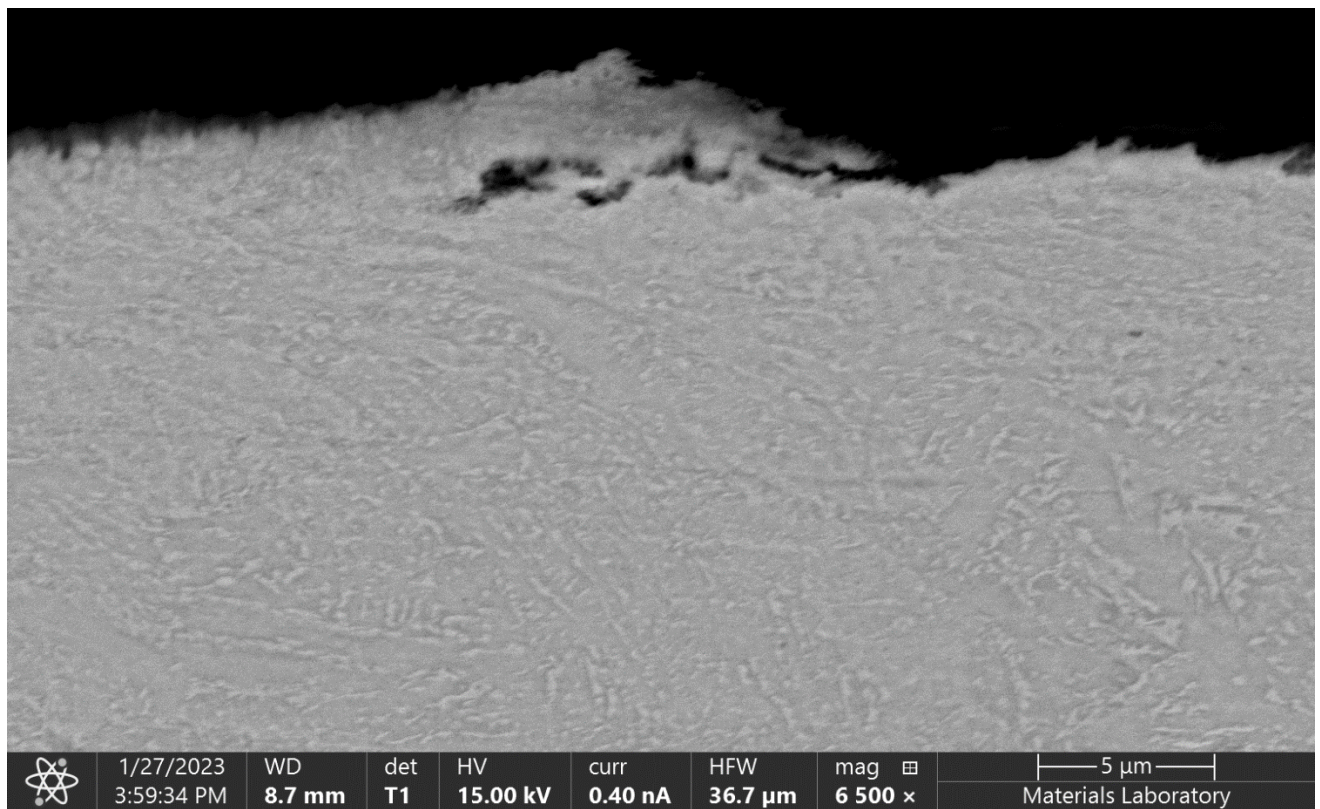
Figure 25. BE micrograph of a closer view of the left side of Figure 16.

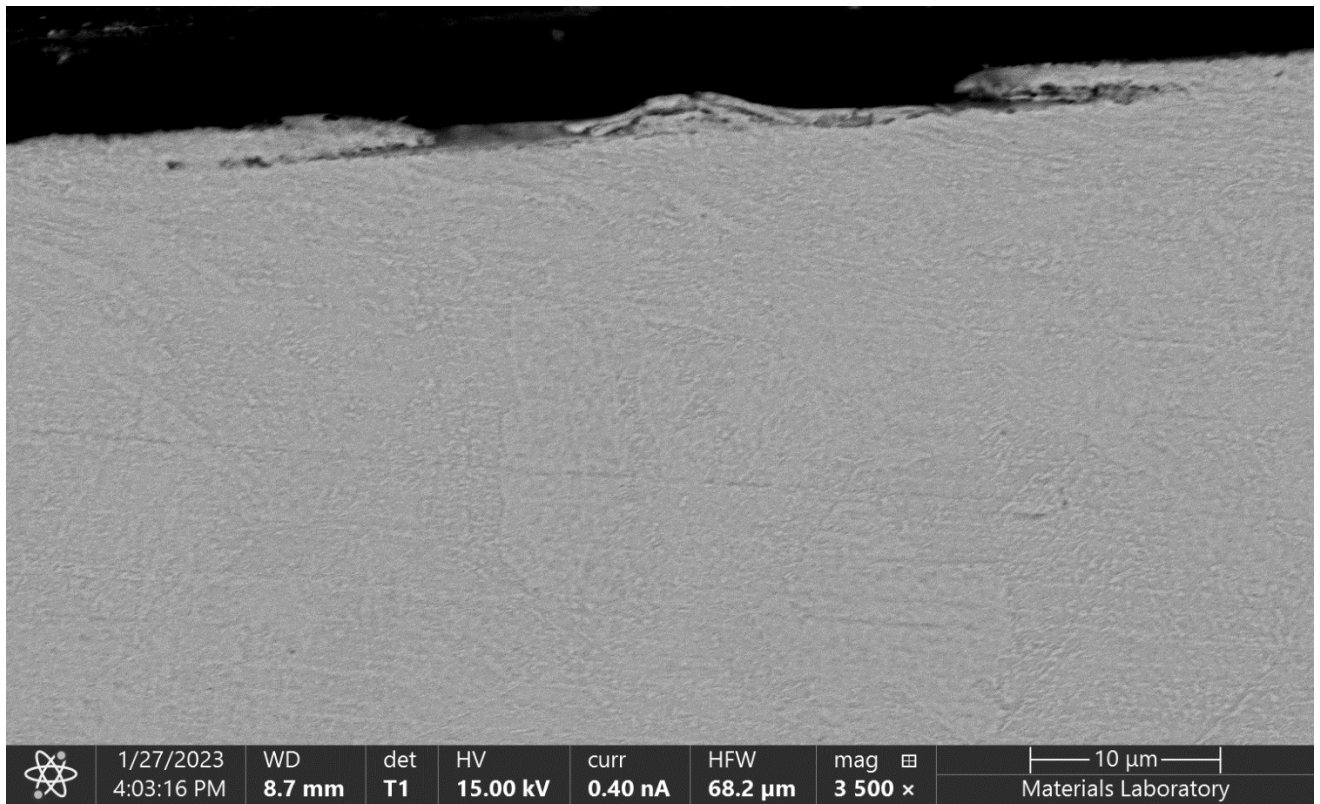
Figure 26. BE micrograph of a cross section of brinelling in Area C.

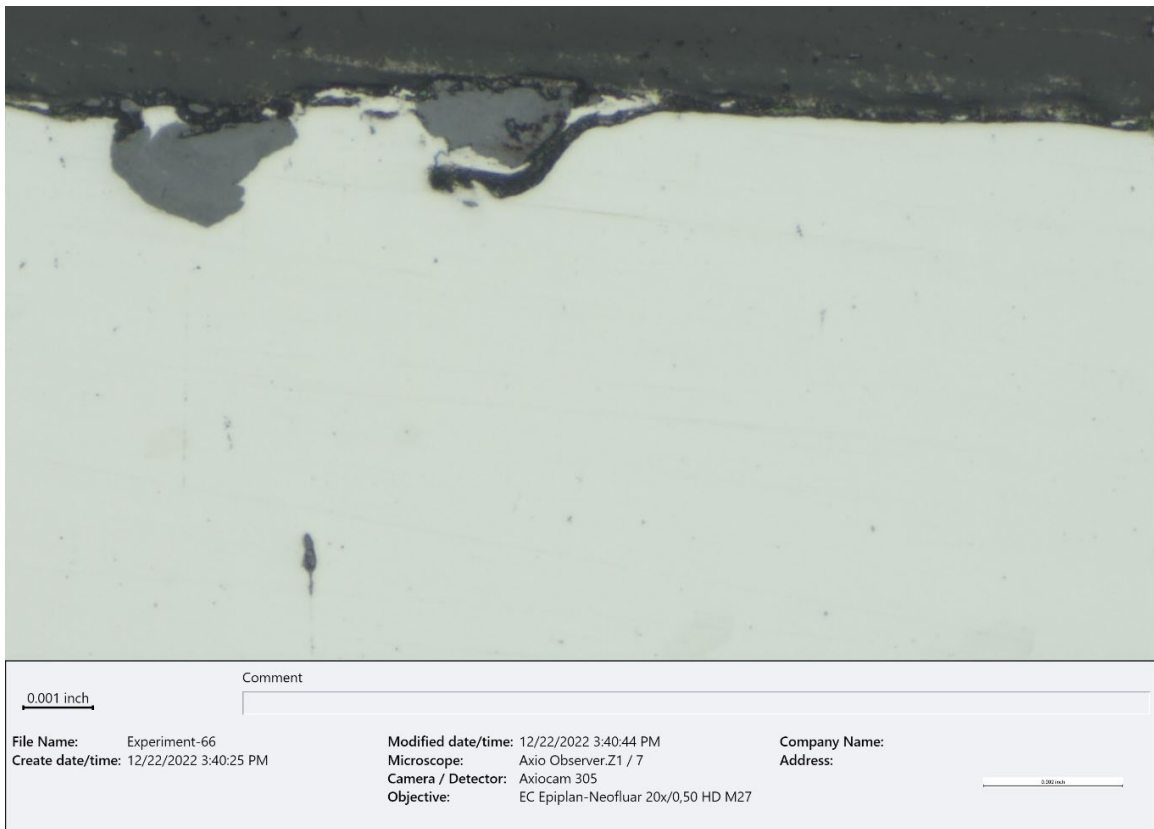
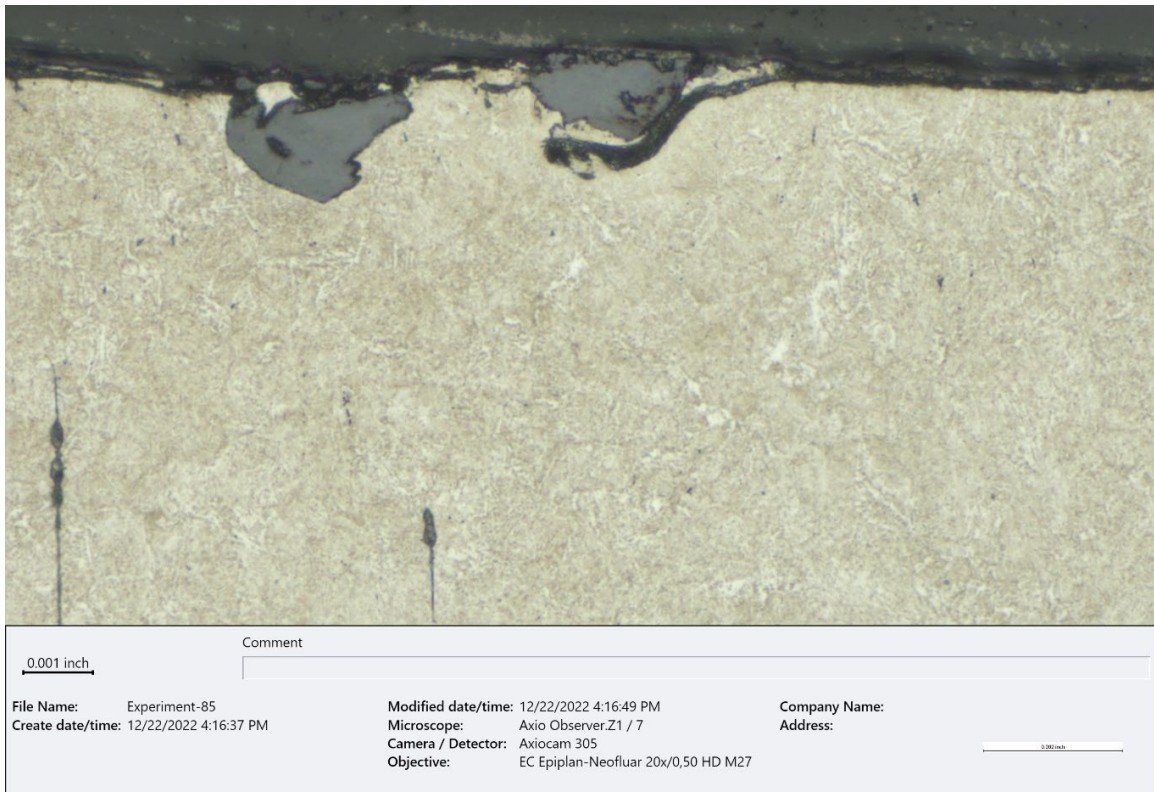
The surface also exhibited entrained particles, which contrasted darker in optical micrographs. Figures 27 and 28 show some of these particles observed on Area 'A' surface. The particle to the right was associated with an underlying discontinuity consistent with a deformation fold. This feature exhibited tiny secondary cracks emanating from the particle. Similar particles were observed on the surface in Area 'B.' EDS examination of these particles found them to be consistent with iron oxide, with higher levels of silicon, carbon, and chromium.

Figure 27. BF optical micrograph of the embedded particles in the end of A (~500X, as polished).

Figure 28. BF optical micrograph of embedded particles in A (~500X, etched 2% Nital).

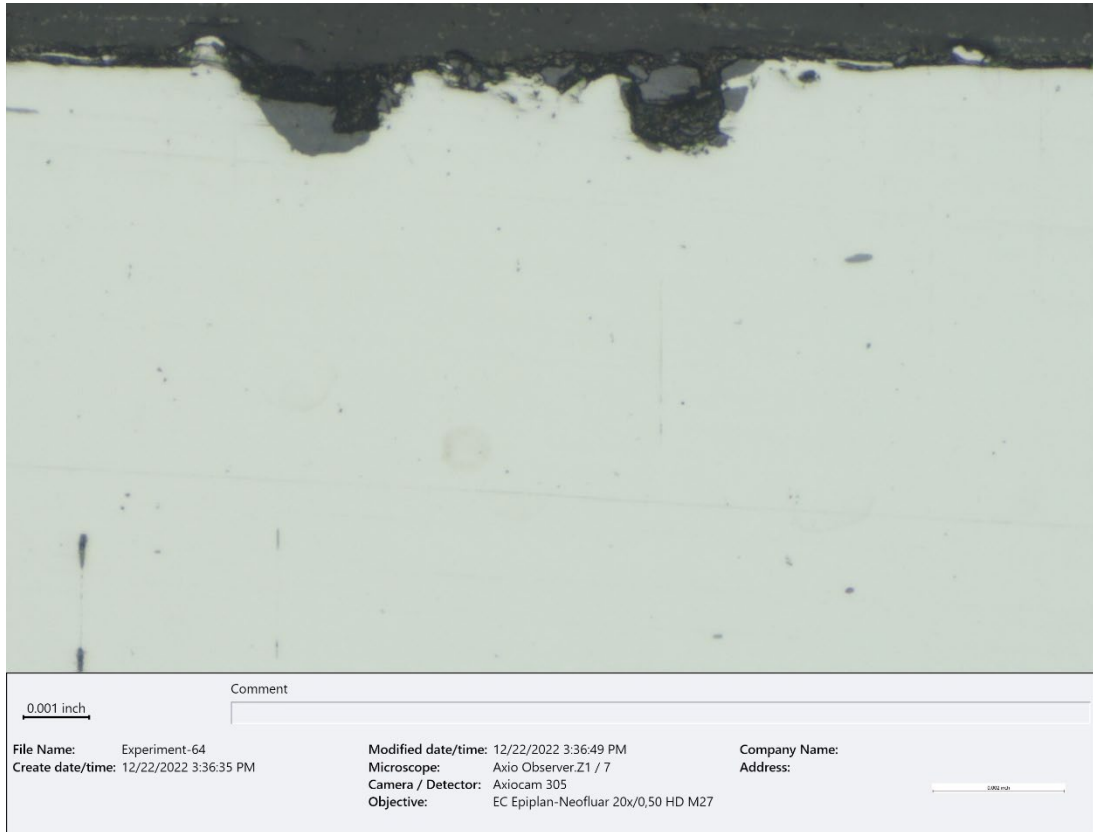
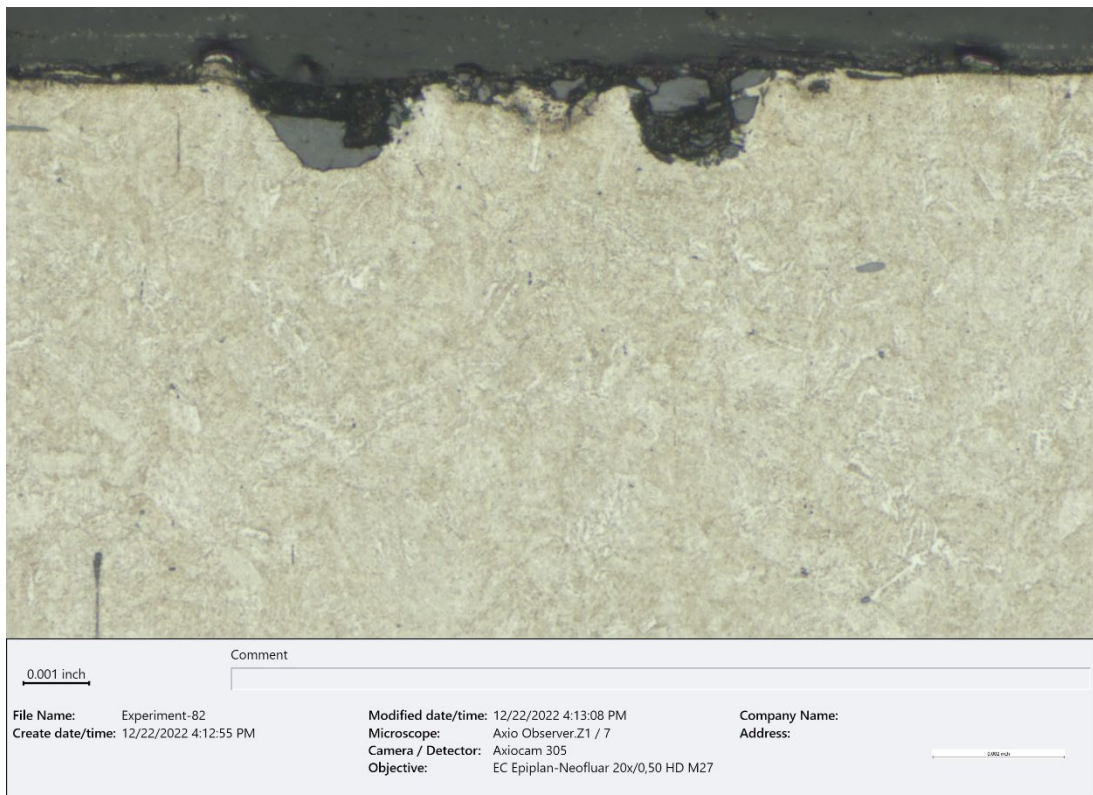
Figure 29. BF optical micrograph of embedded particles in B (~500X, as polished).

Figure 30. BF optical micrograph of embedded particles in B (~500X, etched 2% Nital).

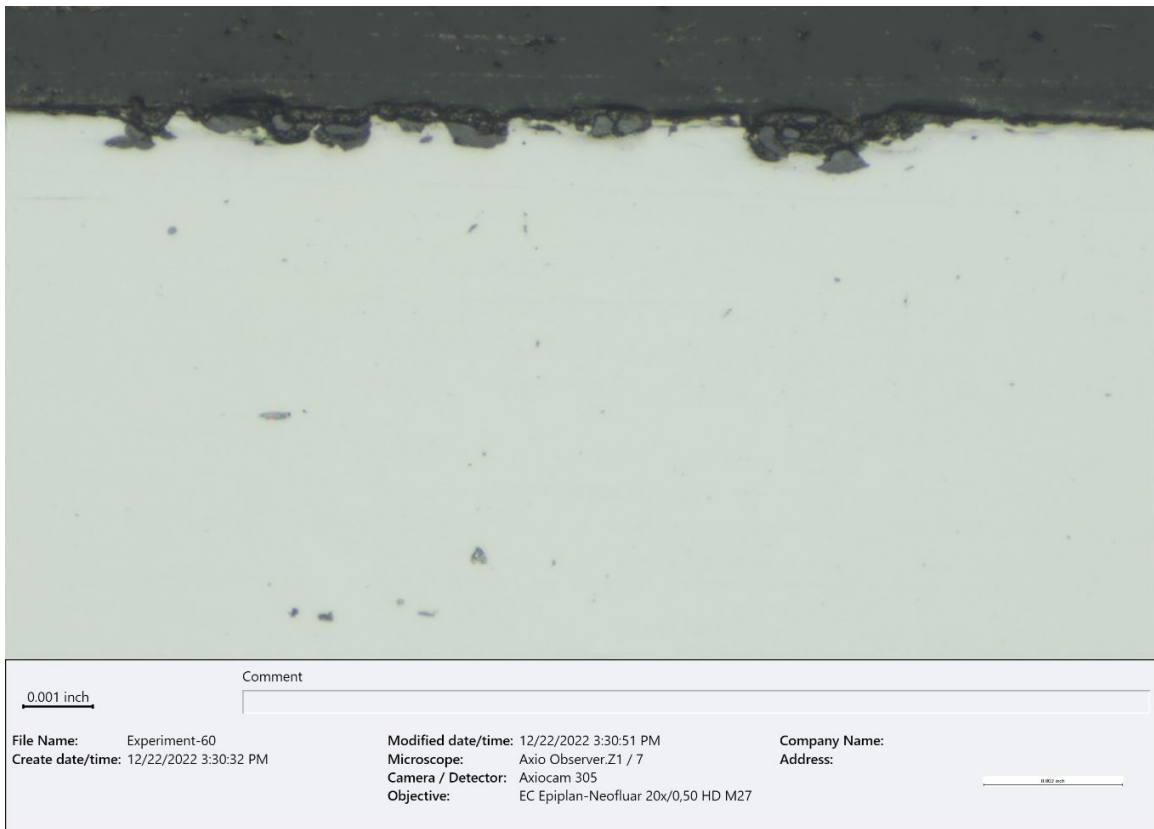
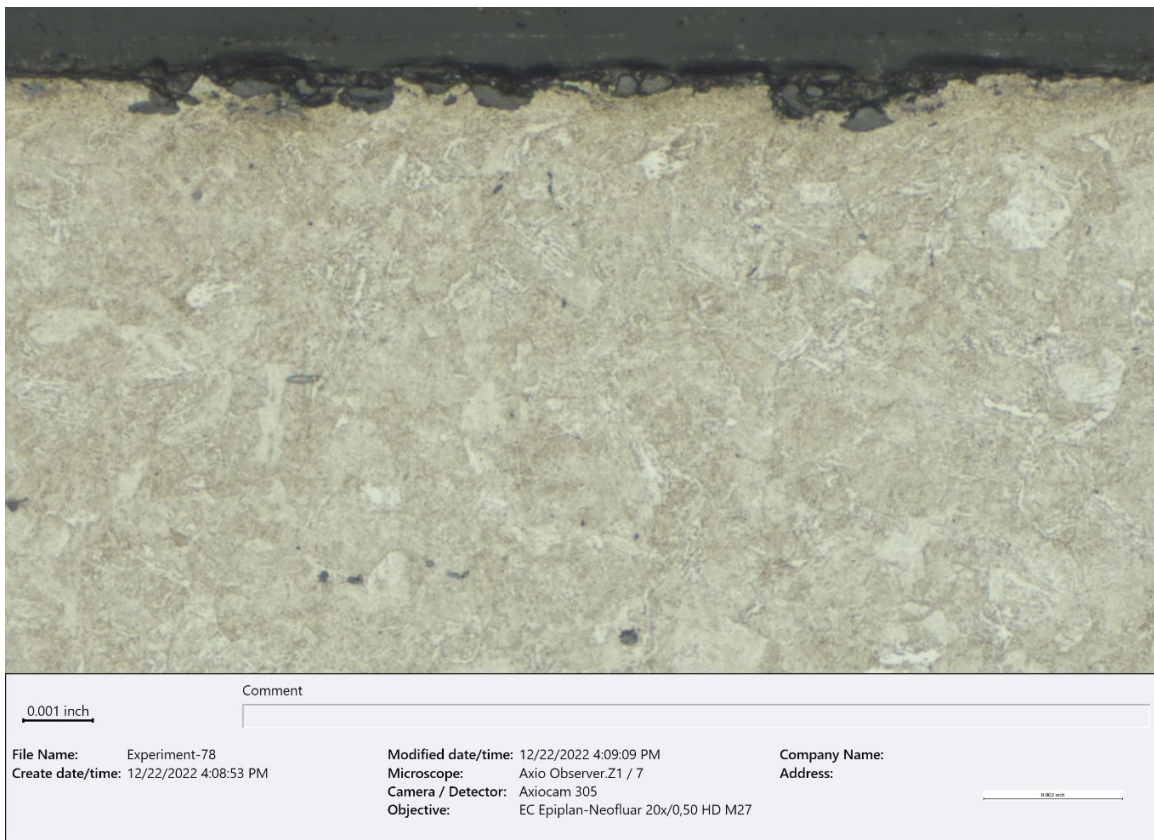
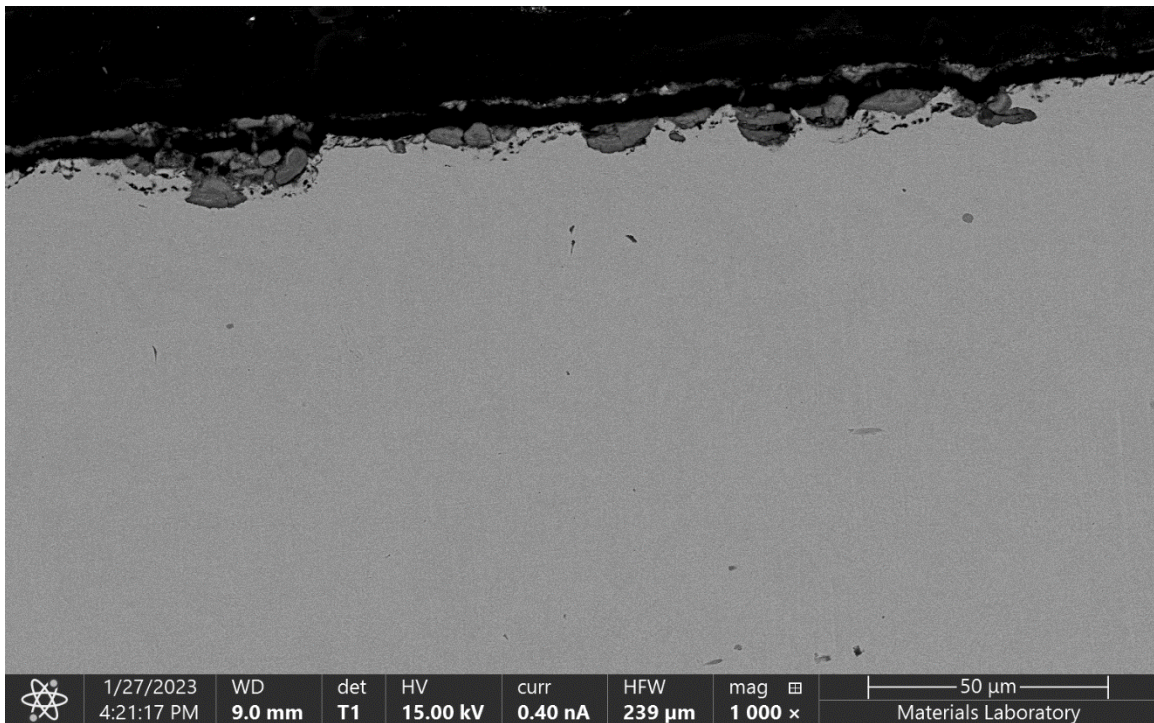
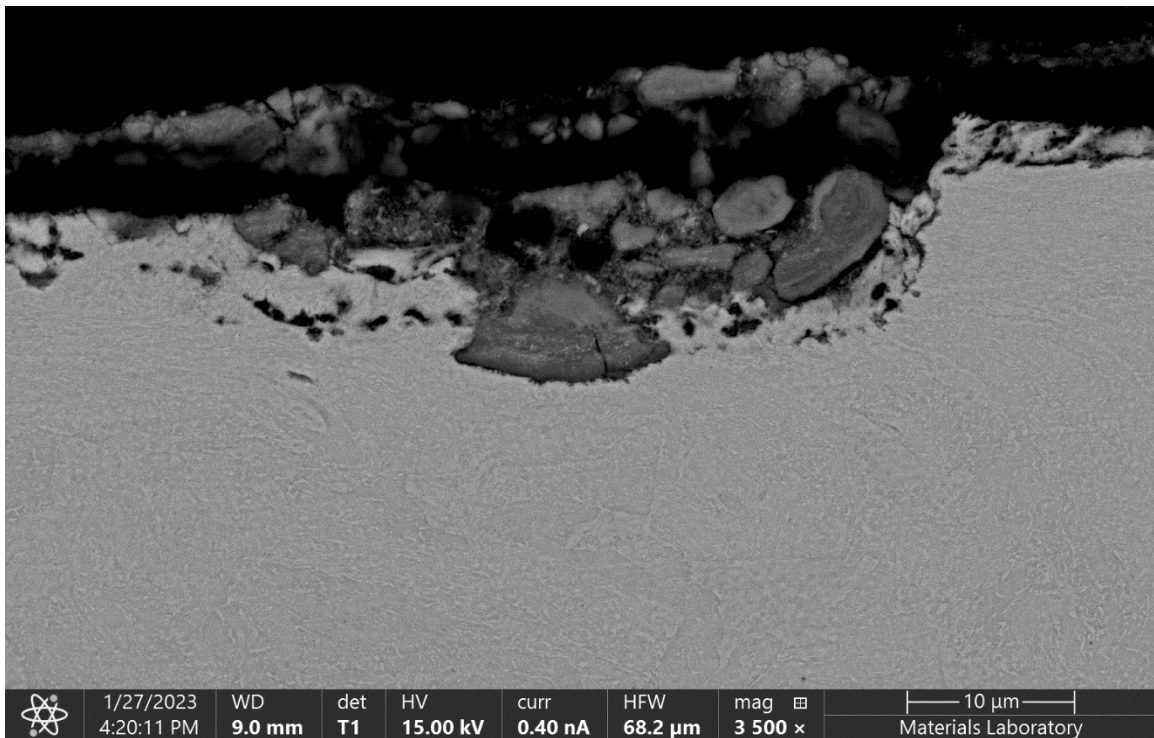
Area 'C' also exhibited surface oxide particles, as illustrated in Figures 31 through 34. This area was not consistent with individual large particles but rather a series of smaller debris fragments clustered along the surface. Figure 34 shows a closer view of one of the large debris areas, exhibiting interior fracturing and adjacent microstructure deformation consistent with compression into the axle surface. Determined to be consistent with iron oxide, this debris was consistent with that which typically had accumulated in bands of fretting wear.

Figure 31. BF optical micrograph fretting wear damage in Area C (~500X, as polished).

Figure 32. BF optical micrograph of fretting wear in Area C (~500X, etched 2% Nital).

Figure 33. BE micrograph of fretting wear damage in Area C.

Figure 34. BE micrograph of a closer view of a surface particle in Figure 33.

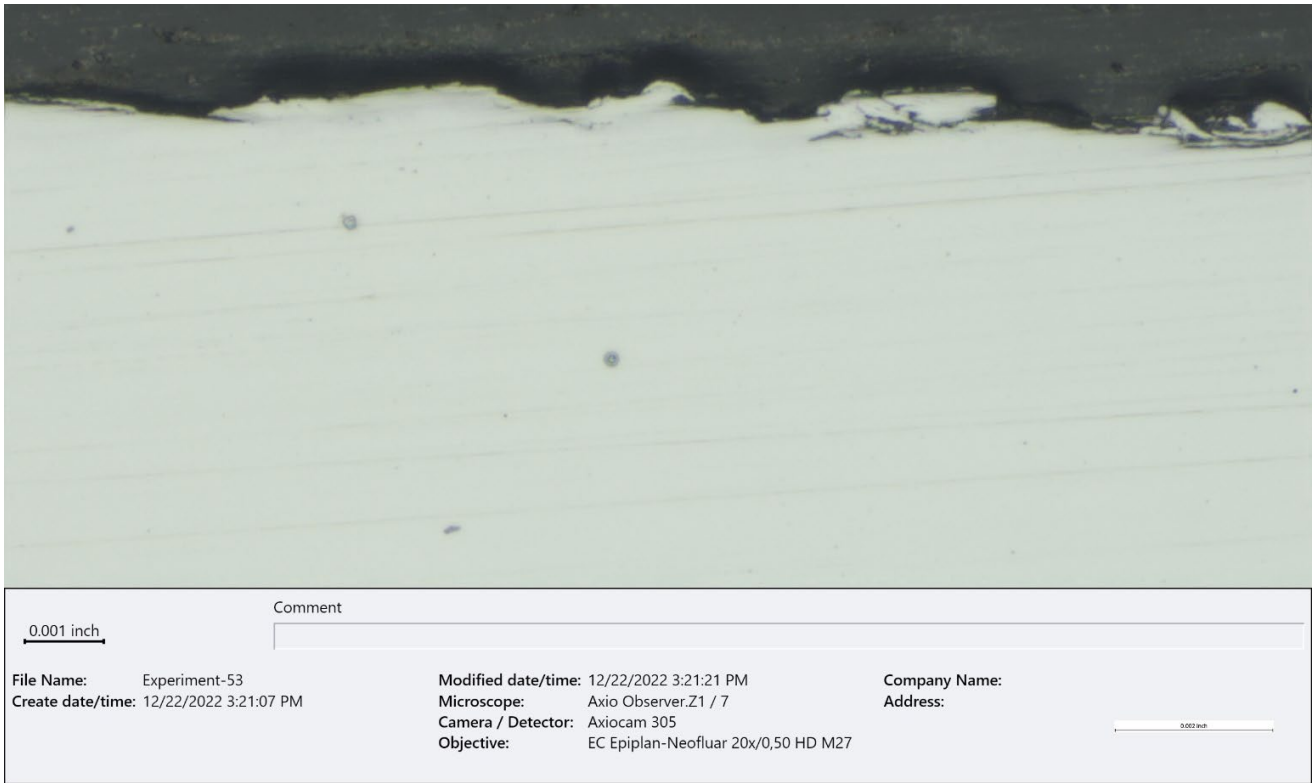
The area described as the 'band of fretting' in Figure 5 exhibited more surface distortion than in inboard Areas A through C. Figure 35 shows a typical area displaying an undulating surface profile with underlying microcracking. These cracks were oriented parallel to the surface of the axle wheel seat. The largest crack exhibited a depth of 0.0005 inches and a length of 0.0015 inches (0.013 mm depth and 0.038 mm long).

Figure 35. BF optical micrograph of fretting wear in the outboard axle areas (~500X, as polished).

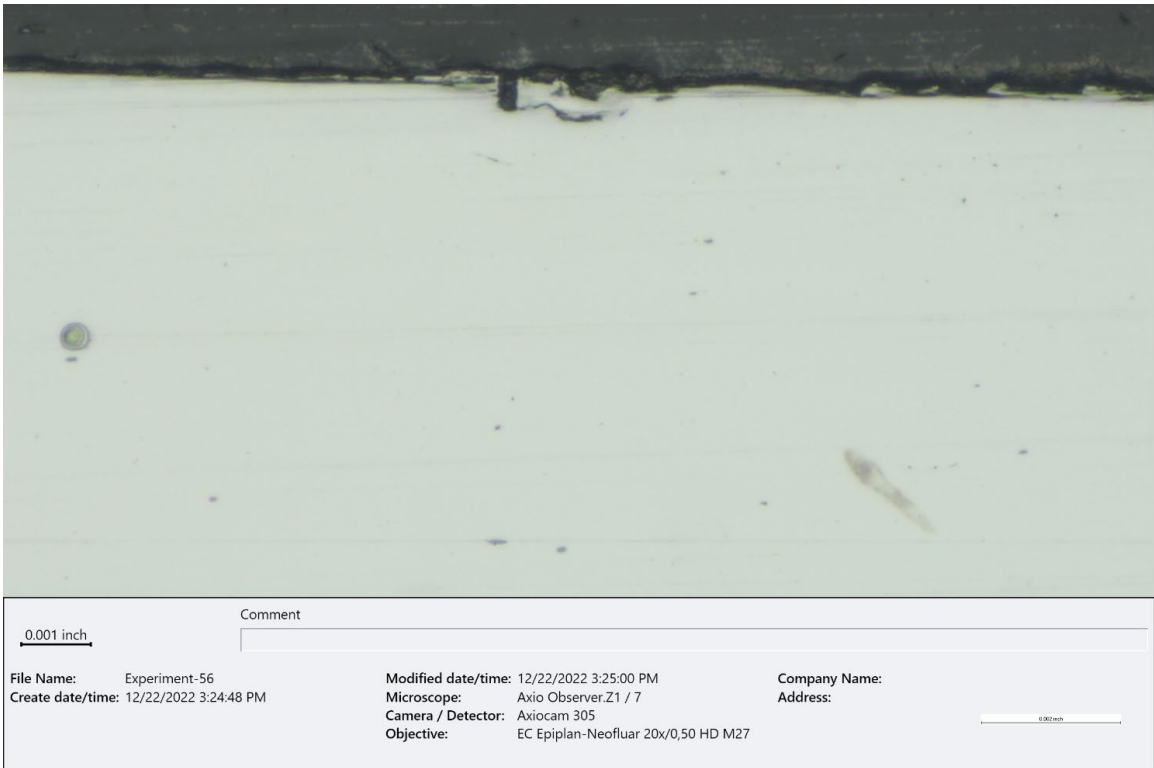
Small pits were also observed in the band of fretting wear. Figure 36 shows an area with a small pit. A microcrack had begun to propagate towards the right in the Figure. A closer examination of a similar site in an SEM is illustrated in Figure 37. This Y-shaped pit was adjacent to a circular pit, with an area of folded surface material between them. Cracks were observed emanating from both pits, oriented parallel to the axle surface. Figure 38 shows a closer view of the Y-shaped pit, with oxide in the valley. This material was found to be consistent with iron oxide, containing minor amounts of chlorine and phosphorus.

Figure 36. BF optical micrograph of a subsurface crack in a fretting wear area (~500X, as polished)

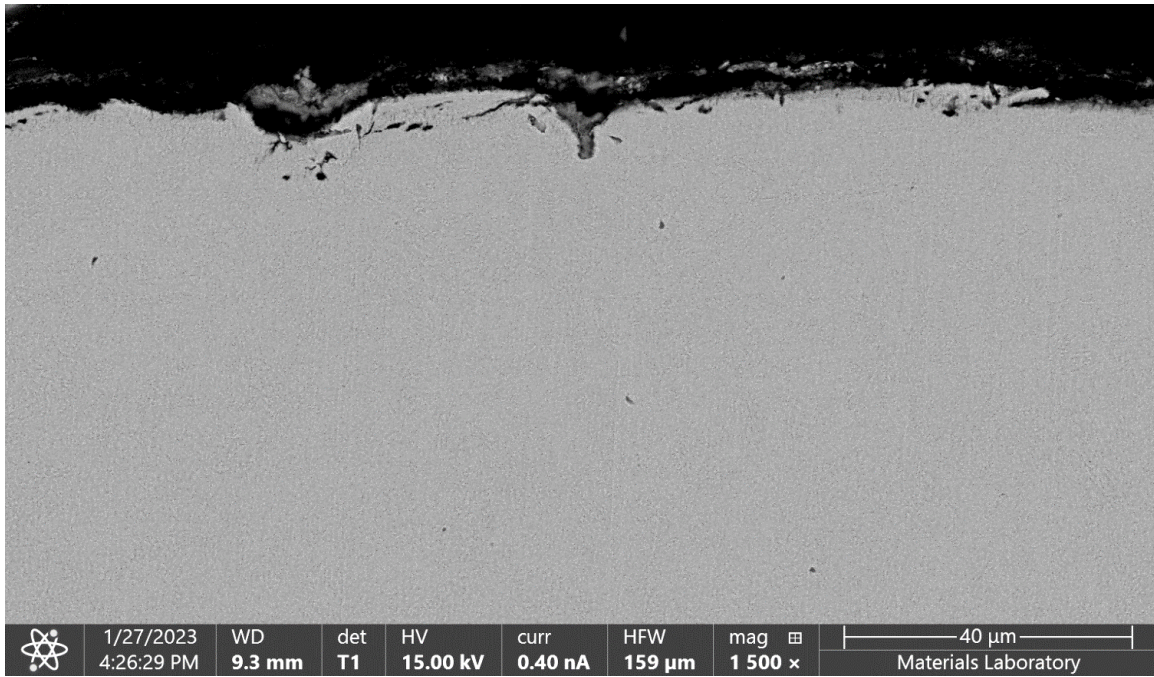
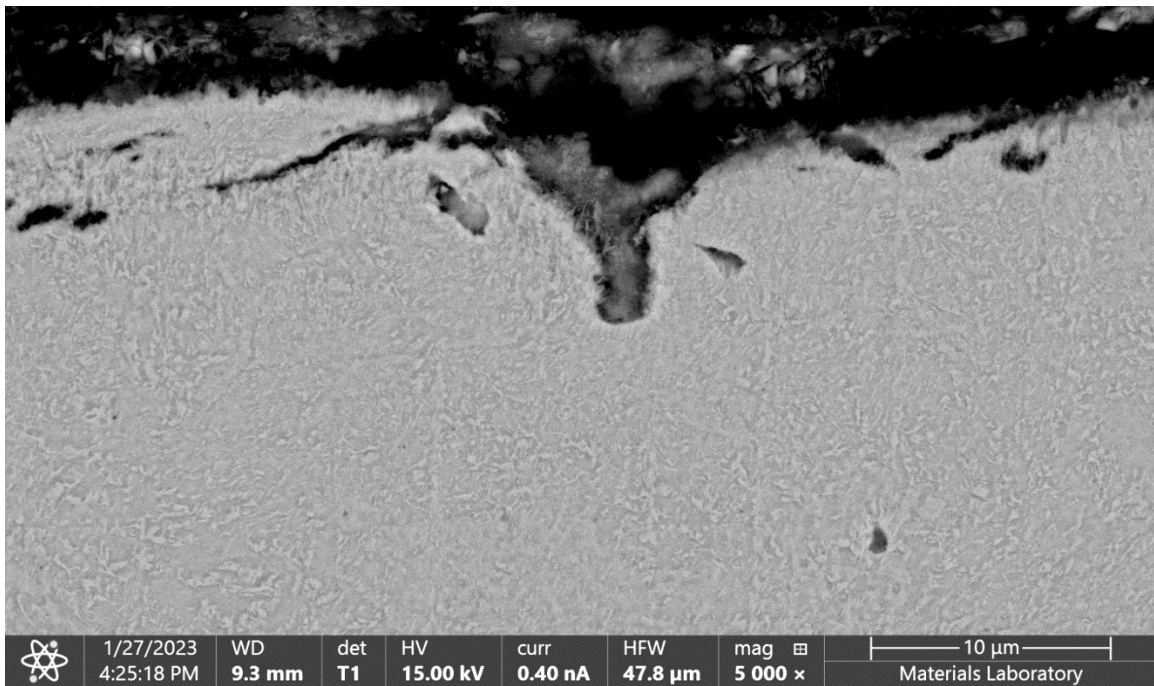
Figure 37. BE micrograph of surface damage, oxidation, and subsurface cracking under areas of surface fretting wear.

Figure 38. BE micrograph of the depression feature in **Figure 37**.

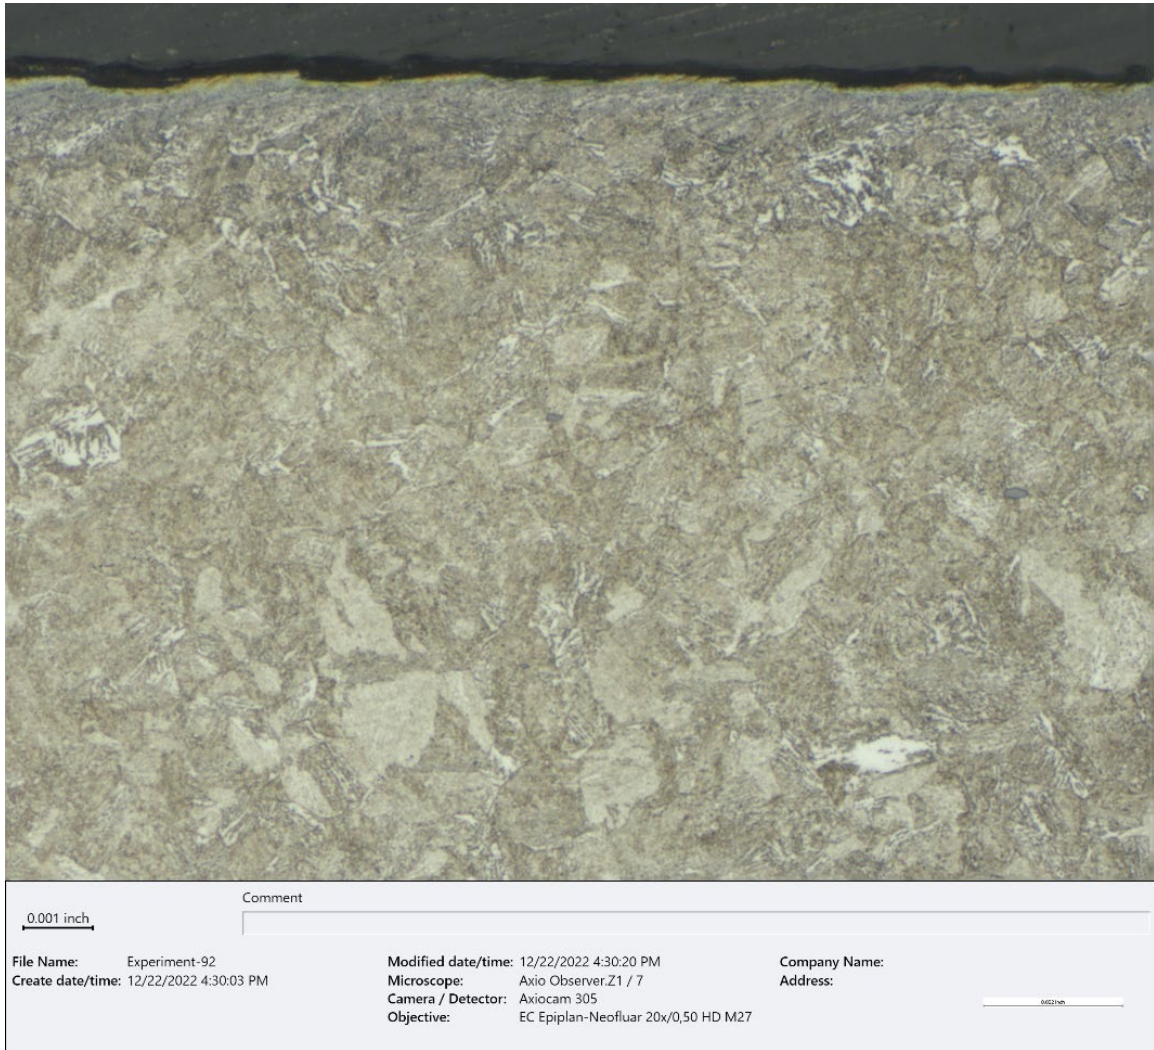
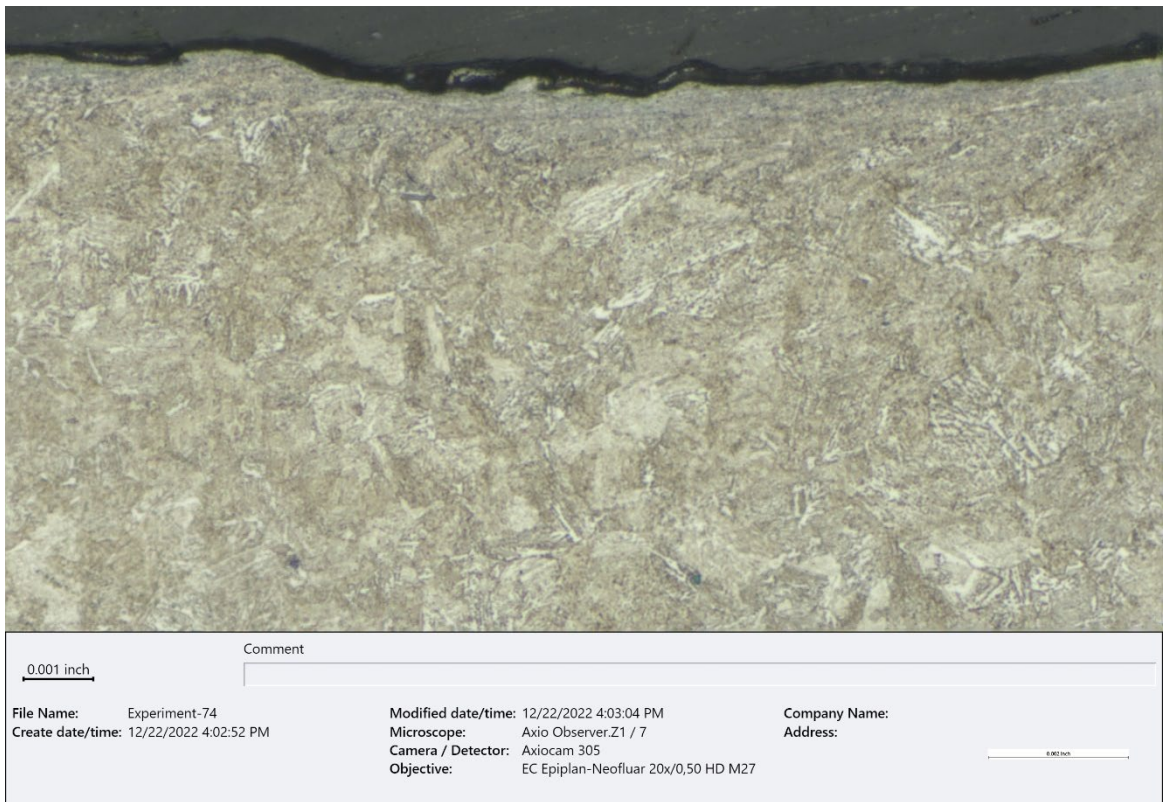
Besides pits, folds, and cracks observed on the surface, the adjacent microstructure of the axle had been altered adjacent to the surface. Figures 39 and 40 provide closer views of the surface in the etched condition. While the interior (bottom of the figures) exhibited a more equiaxed appearance, consistent with prior austenite grain boundaries, the material near the surface revealed a curved and flattened

morphology. These microstructural features were bent towards the outboard direction of the axle. There were no indications of a white surface layer, which could indicate localized overheating.

Figure 39. BF optical micrograph, etched to show grain deformation near the surface (~500X, etched 2% Nital).

Figure 40. BF optical micrograph, etched to show grain deformation near the surface (~500X, etched 2% Nital).

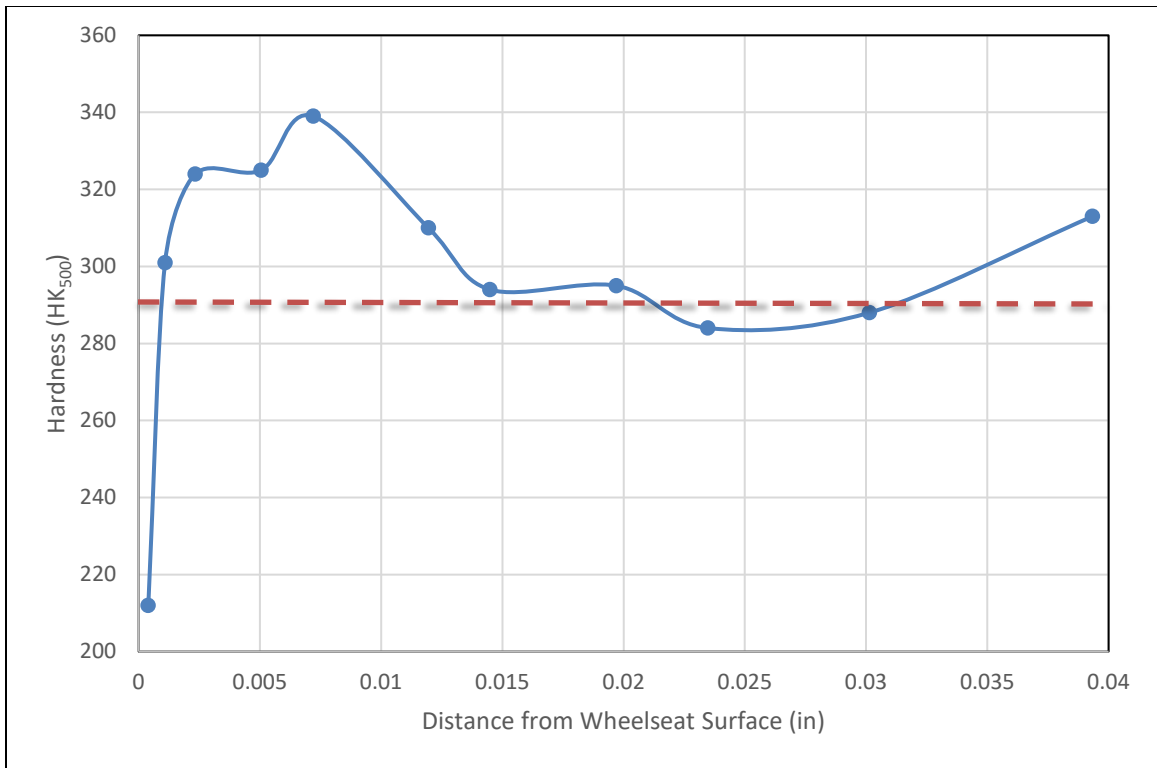
The cross-section of the band of fretting wear was examined using an automatic microhardness indenter per ASTM E384.³ Figure 41 shows the hardness data plotted against distance from the surface. From previous testing of the axle, the average hardness of the material was 27 HRC (equivalent to 290 HK₅₀₀ per ASTM E140).⁴ The data indicate that the surface exhibited a lower hardness, followed by a slightly higher hardness subsurface, before averaging towards 290 HK₅₀₀ at a depth of 0.012 inches. These data indicate that the surface deformation and fretting wear altered the local mechanical properties of the axle.

Figure 41. Chart of changes in microindentation hardness values from an area of the wheel seat surface of the axle shown in **Figure 39**. The orange dashed line represents the average microhardness of the axle, equivalent to 27 HRC.
