# National Transportation Safety Board

## **MATERIALS LABORATORY**

Factual Report 22-038

On March 11, 2022, the Woodpat pipeline, a 22-inch-diameter hazardous liquids pipeline operated by Marathon Pipe Line, LLC (Marathon), ruptured in Edwardsville, IL. About 3500 barrels of crude oil were released, some of which entered Cahokia Creek, a tributary of the Mississippi River. No injuries occurred, and the crude oil did not ignite.

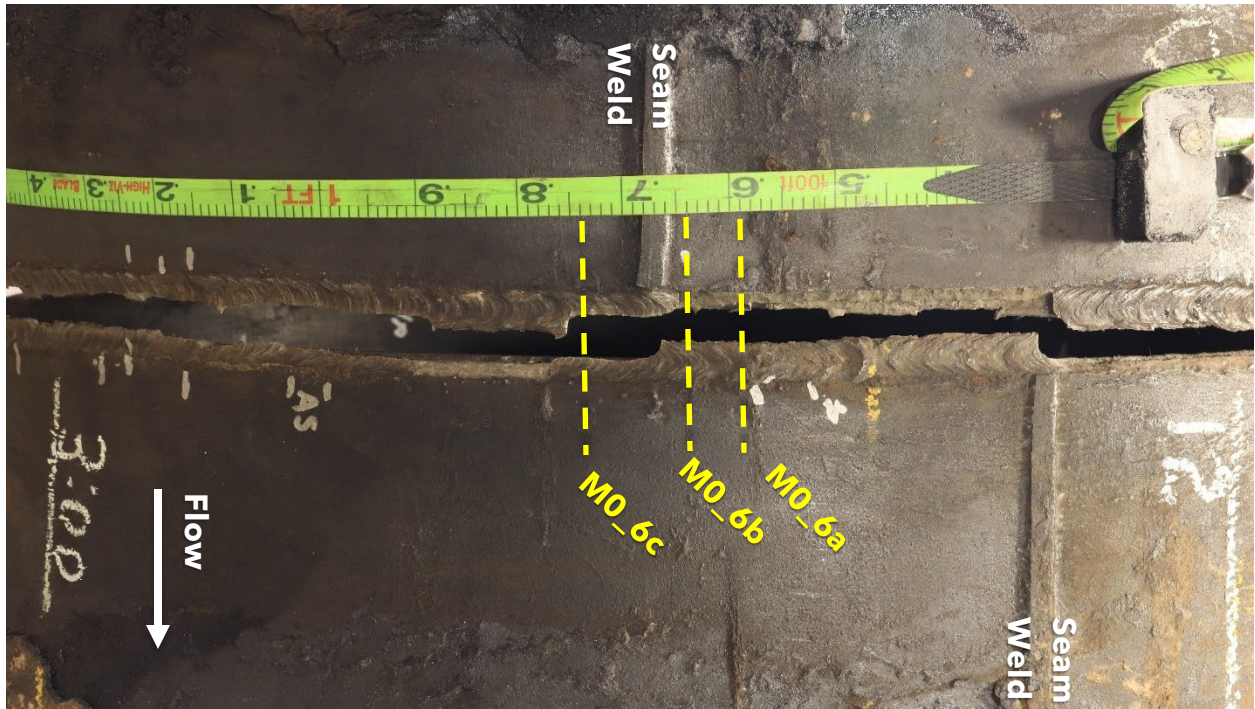
Figure 3 through Figure 6 show the mating sides of the girth weld that fractured between Pipe 1 and Pipe 2. The fracture, viewed from the outer diameter surface, shows the fracture occurred along the girth weld without extending into the pipe plate material. In most of the circumference, the fracture was present along the midline of the weld, as exemplified in Figure 4. The fracture exhibited sharp, jagged edges, with the most prominent areas being in Figure 3 and Figure 5, where the fracture was located toward the side of the heat affected zone. Figure 7 shows an angled view of this fractured region, with the fracture located toward either the side with Pipe 1 or the side with Pipe 2.

Figure 3. View of the mating fractured of Pipe 1 and 2 between the 3 and 12 o'clock position, showing a seam weld and the location of metallographic mount locations M0\_6a, b, and c.

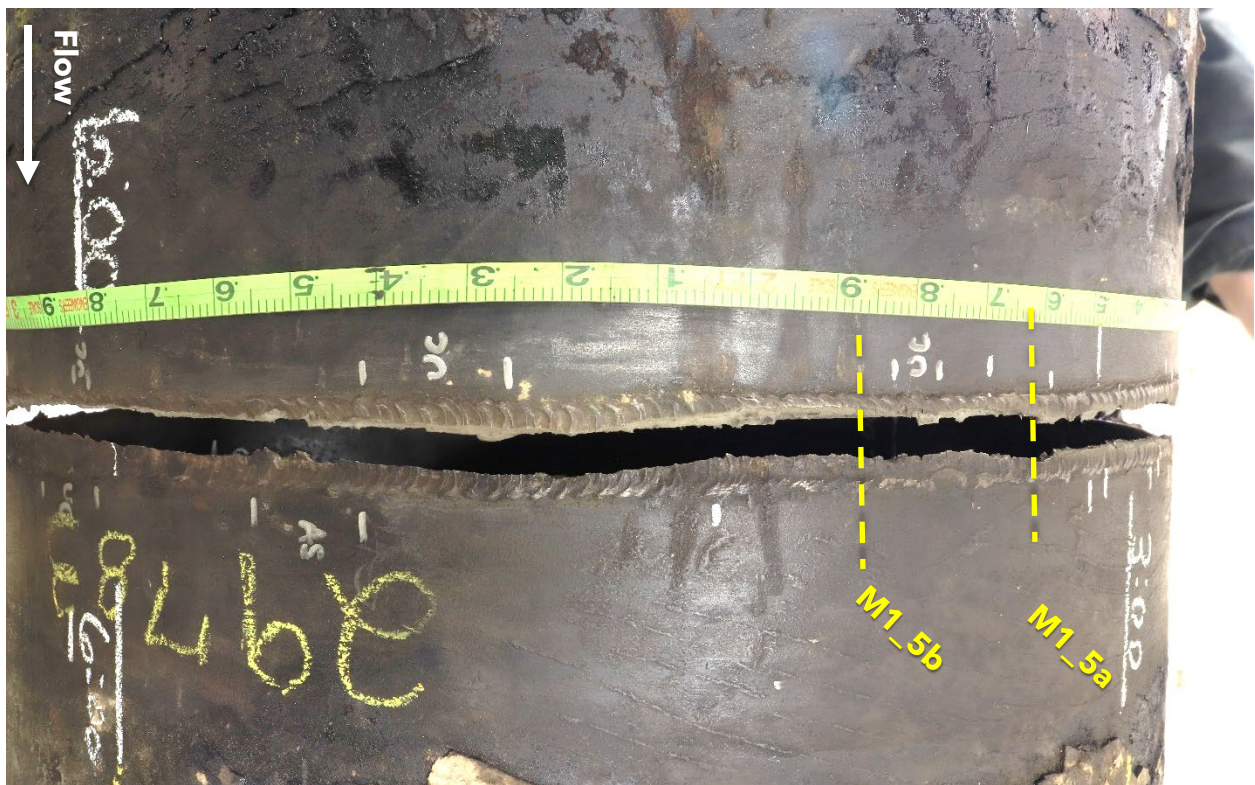
Figure 4. View of the mating fractured of Pipe 1 and 2 between the 6 and 3 o'clock positions, annotated to show metallographic mount locations and girth weld flaws: arc strike (AS) and undercut (UC).

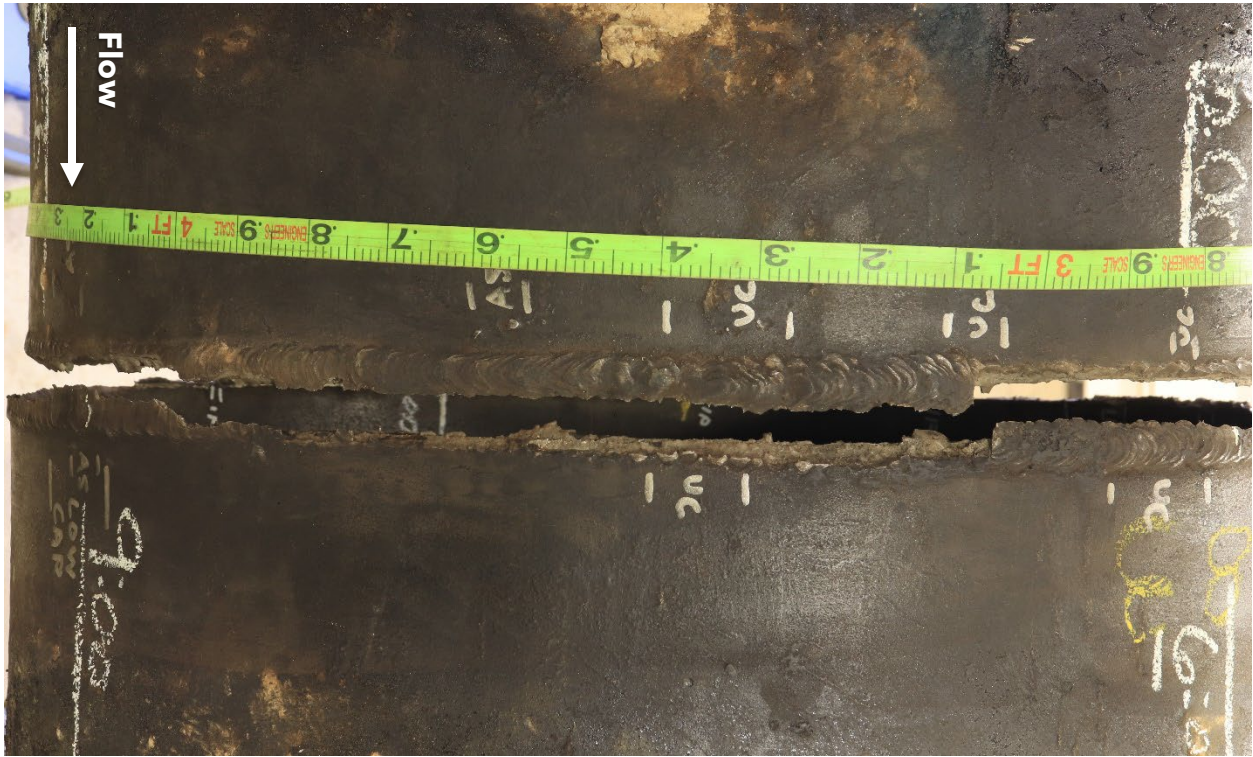
Figure 5. View of the mating fractured of Pipe 1 and 2 between the 9 and 6 o'clock position, annotated to show girth weld features, like arc strikes (AS) and undercut (UC).

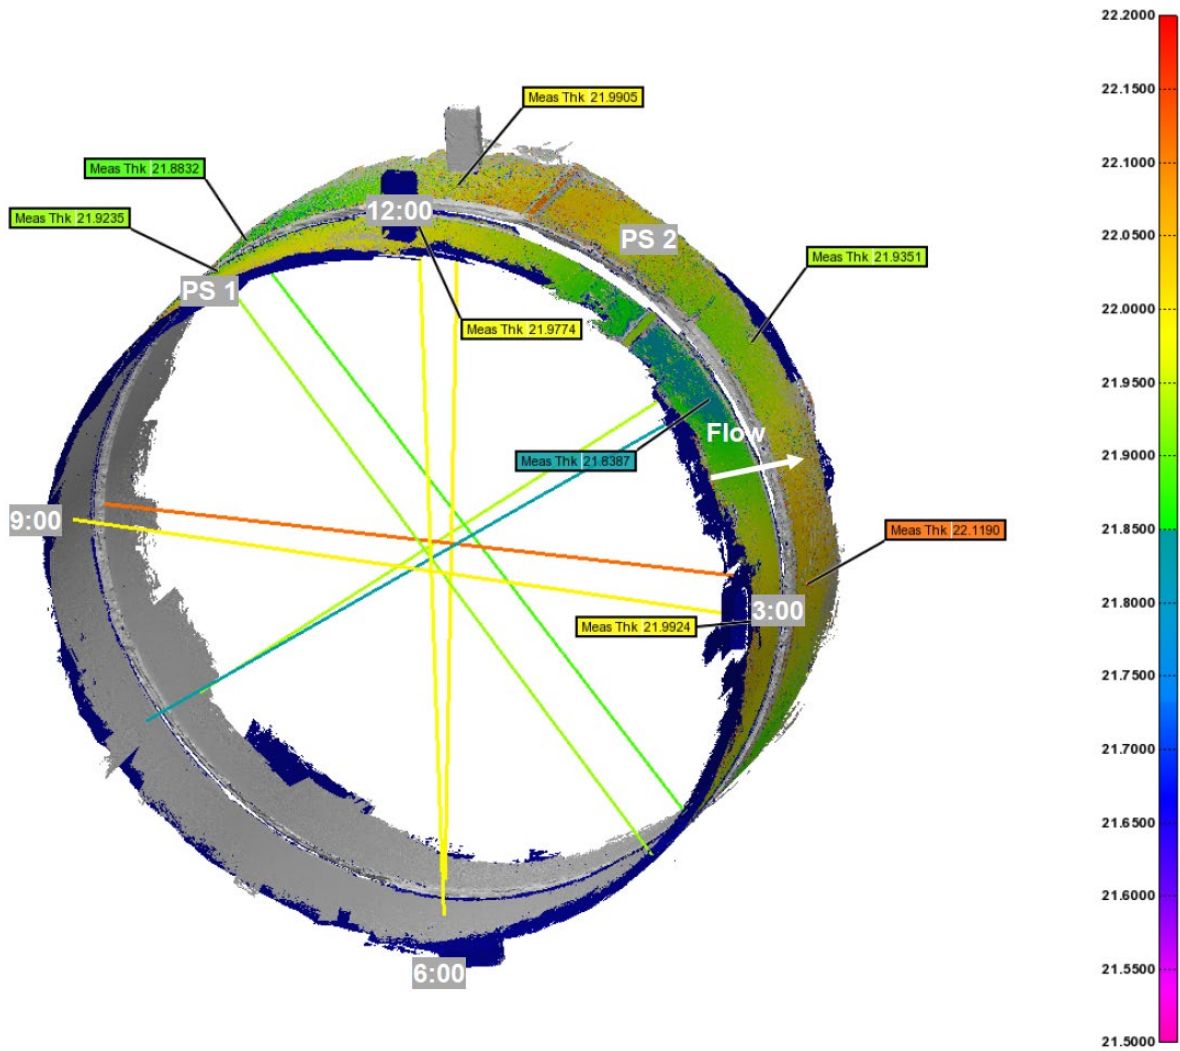
Figure 18 shows the laser scanned outside diameter measurements of the pipe ends near the fracture surface. This scan found diameter measurements from 21.839 inches to 22.119 inches. The diameter measurements in the vertical and horizontal directions (12 to 6 o'clock and 9 to 3 o'clock, respectively) were slightly longer than those in the 45° degree diagonals, being about 0.12 inches longer (22.02 average inches versus 21.90 average inches). These data were consistent with that collected from manual measurements in Table IV.

Figure 18. Outside diameter measurements in inches near the fracture surfaces between Pipe 1 and 2, based off laser scanning data. The color coding represents the diameter size from 21.5 to 22.2 inches, as denoted by the scale on the right.

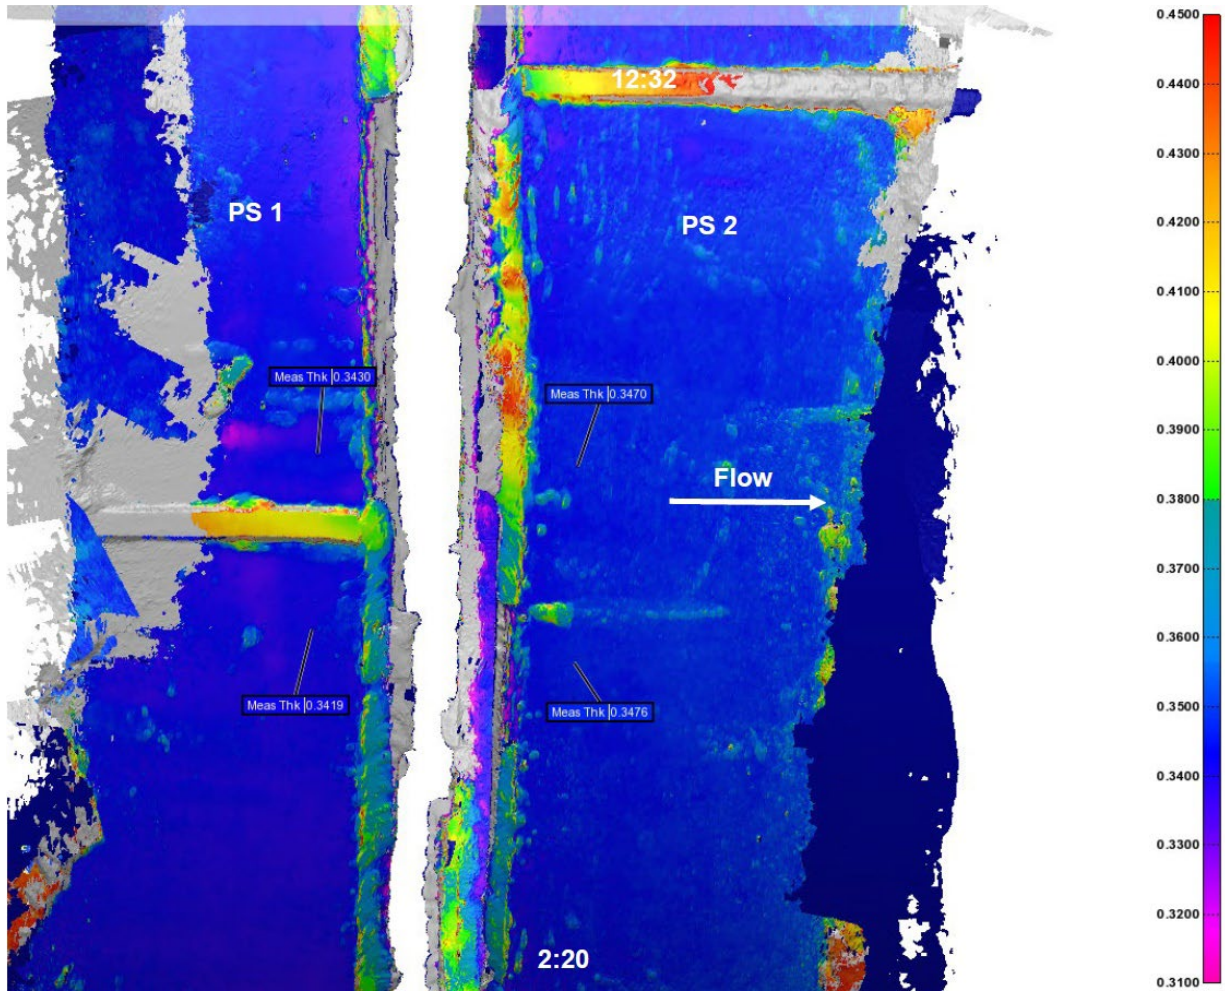
Figure 19 illustrates a topographical thickness map of the side of Pipe segments 1 and 2 about the fractured girth weld. The thicknesses ranged between 0.31 inches and 0.45 inches, with the thickest areas being along the fractured girth weld and intact seam welds (represented by yellow, orange, and red colors). The thinnest areas, represented by pink/purple, were at the fracture surface and pipe ends. The mean thickness on much of the pipe ranged between 0.341 and 0.347 inches. These data were within the range of the manual measurements of the pipeline thickness (after coating removal), detailed in Table V.

Figure 19. Thickness map representing Pipe 1 and Pipe 2 following laser scanning of the OD and ID surfaces, along with the fracture surfaces from the area shown in Figure 3. The color represents the thickness, in inches, as denoted by the scale on the right.

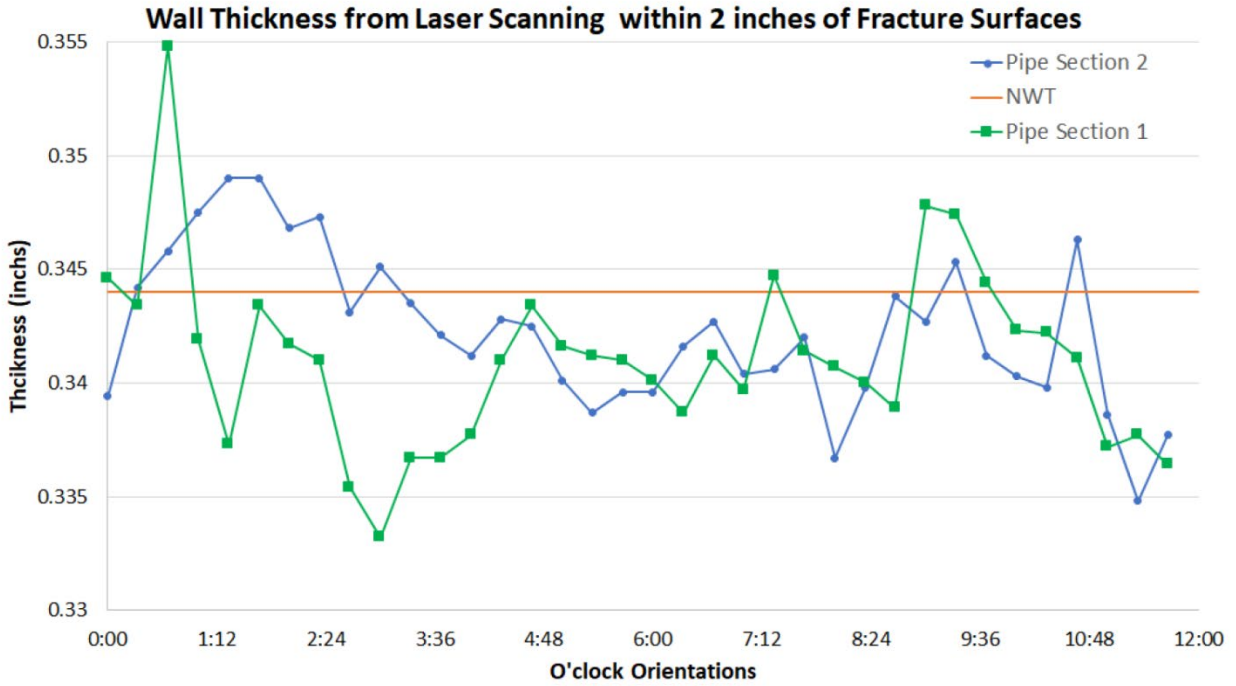
Figure 20 shows the circumferential wall thickness within 2 inches of the fracture surface, based on the pipe clock positions, from the Pipe 1 (upstream) and Pipe 2 (downstream) sides. Pipe 1 exhibited the greatest deviations from the nominal wall thickness (NWT) of 0.344 inches. The data showed lower thicknesses than NWT around the 6 o'clock and 12 o'clock positions, with higher thicknesses near the 9 o'clock and 2 o'clock locations.

Figure 20. Laser scanning wall thicknesses measured within 2 inches of the fracture surface every 10 to 20°. The horizontal orange line represents the nominal wall thickness.

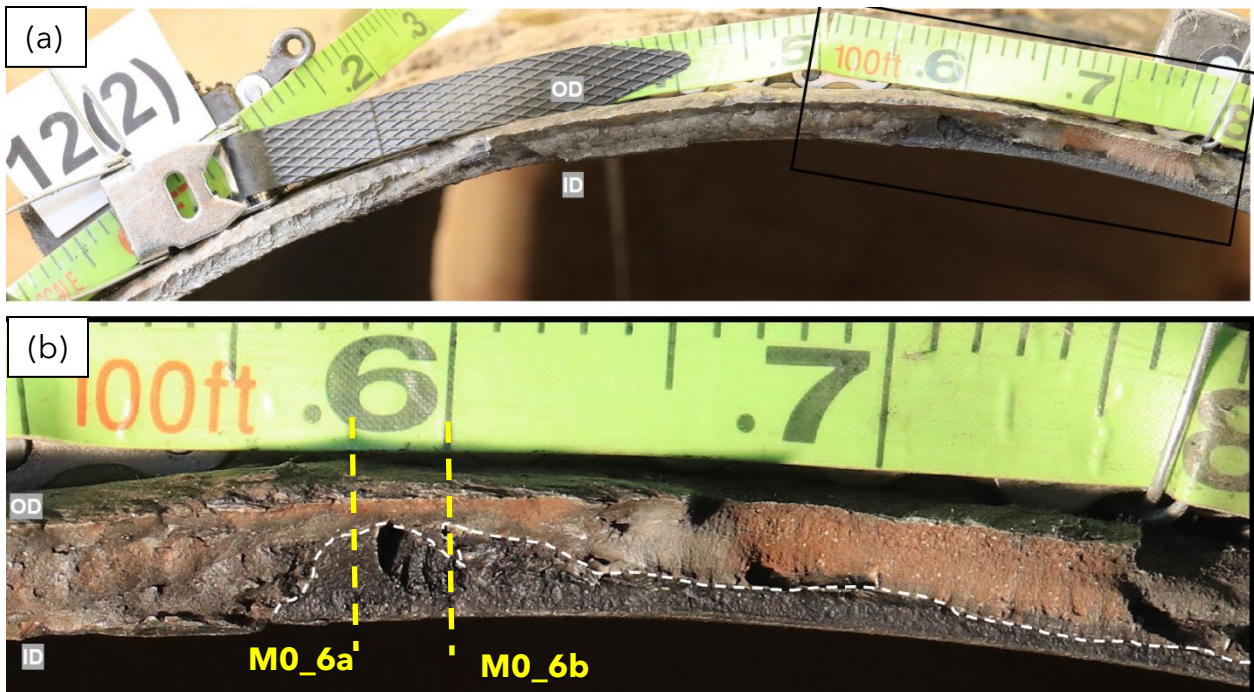
Figure 26 exhibited a pronounced fracture surface breaking feature located at the top dead center or 12 o'clock position. This feature appeared visually dark against the surrounding, maroon-colored fracture surface. This area was examined further in higher magnification scanning electron microscopy and cross-sectional metallography, locations denoted on the Figure 26.

Figure 26. View of the Pipe 2 fracture surface (a) clockwise of the 12 o'clock position, post cleaning with (b) showing an inner diameter surface breaking feature, outlined by white dashed lines. Between 0.5 and 1.2 feet clockwise of TDC.

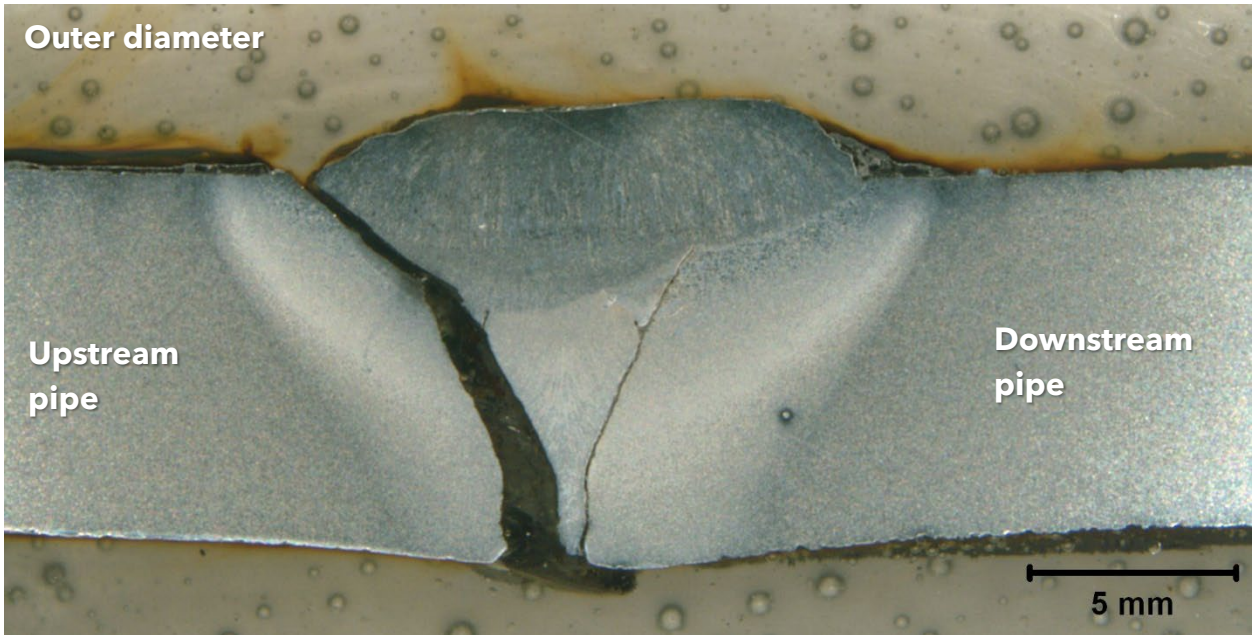
Several cross-sections were taken through areas of the mating fracture surfaces, as identified in Figure 3 through Figure 6. One such site, identified as M0\_6a, is illustrated in Figure 34. This area shows a pipeline fracture to the left of the girth weld, with a second crack terminating under the top weld pass. This crack and the fracture exhibited features consistent with originating at the inner diameter surface (bottom of Figure 34). This crack to the right of the fracture in Figure 34 was located between the weld metal and the base metal, which exhibited a heat-affected zone typical of weld processes.

Figure 34. Bright-field (BF) optical micrograph of the M0\_6a location of the fractured girth weld, sectioned 7 inches clockwise of 12 o'clock near the deepest portion of the ID surface braking flaw in Figure 26b (~5X, etched 2% Nital).

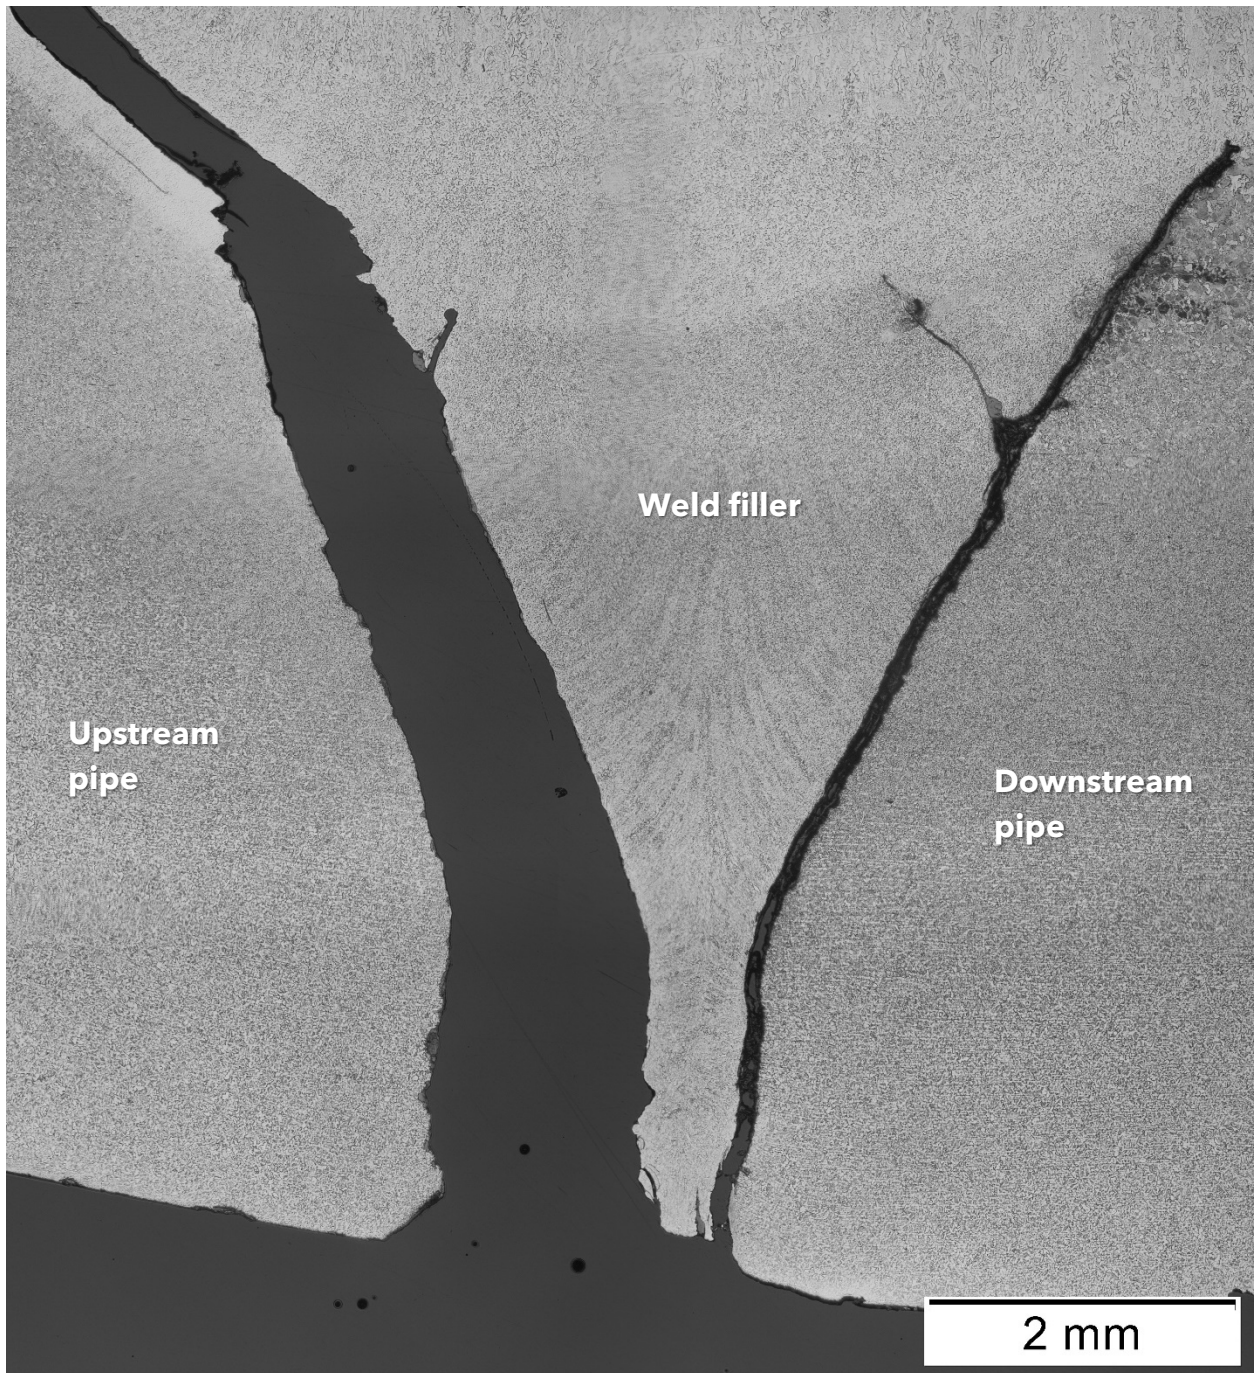
Figure 35 shows a closer view of the inner surface at M0\_6a, showing smaller branched cracks emanating from the primary and second fractures. This location was around the 1 o'clock position of the fractured girth weld. Both these branching cracks had terminated at the lower surface of the outer weld pass. These features were consistent with a location lack of fusion at this location.

Figure 35. BF optical micrograph of the inner diameter portion of the fracture at M0\_6A (~25X, etched 2% nital)

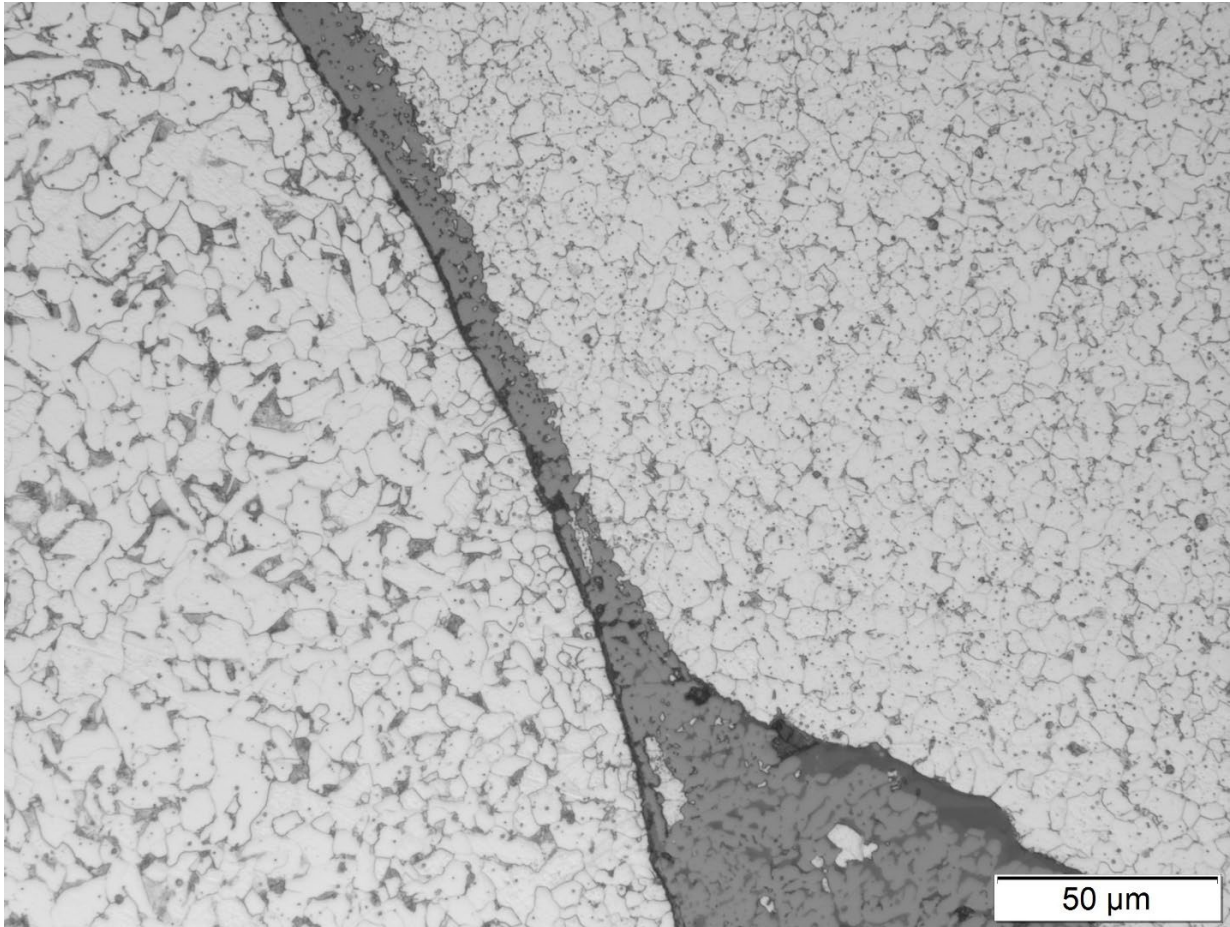
A closer view of the branch crack on the right showed it contained non-reflective material, consistent with nonmetallic compounds (Figure 36). These compounds exhibited a dendritic morphology, indicating they had solidified from a molten state. This morphology would be consistent with forming during welding, typical of slag formation.

Figure 36. BF optical micrograph of the inward crack branch below the weld in M0\_6a (~400X, etched 2% Nital).

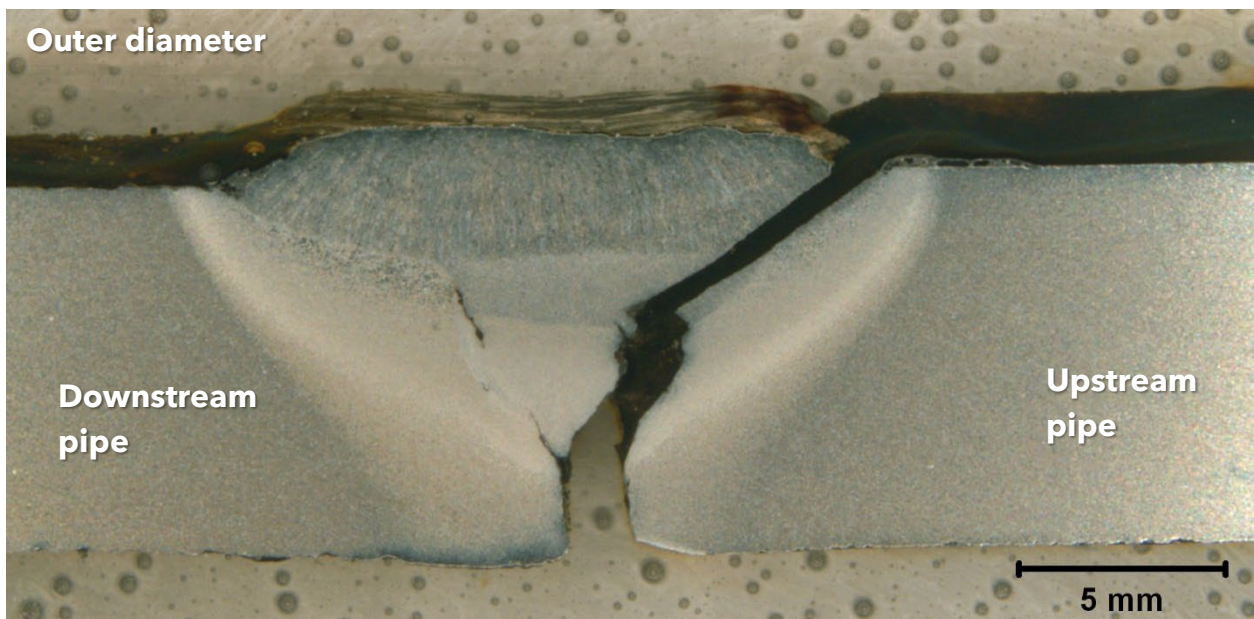
Figure 37 shows the fracture cross-section at the girth weld location M0\_6b, located just counterclockwise of the long seam weld that intersected the fractured girth weld (see Figure 3). This area also exhibited a fracture toward the side of the outer weld pass, with a secondary crack that terminated below the weld, located within the weld bead about 0.5 mm from the boundary between the weld and the heat affected zone. In this case, though, the second crack branched off the main fracture. Figure 38 shows a closer view of the fracture and the branching crack from the inner surface edge.

Figure 37. BF optical micrograph of the fracture at the girth weld at location M0\_6b (~5X, etched 2% Nital).

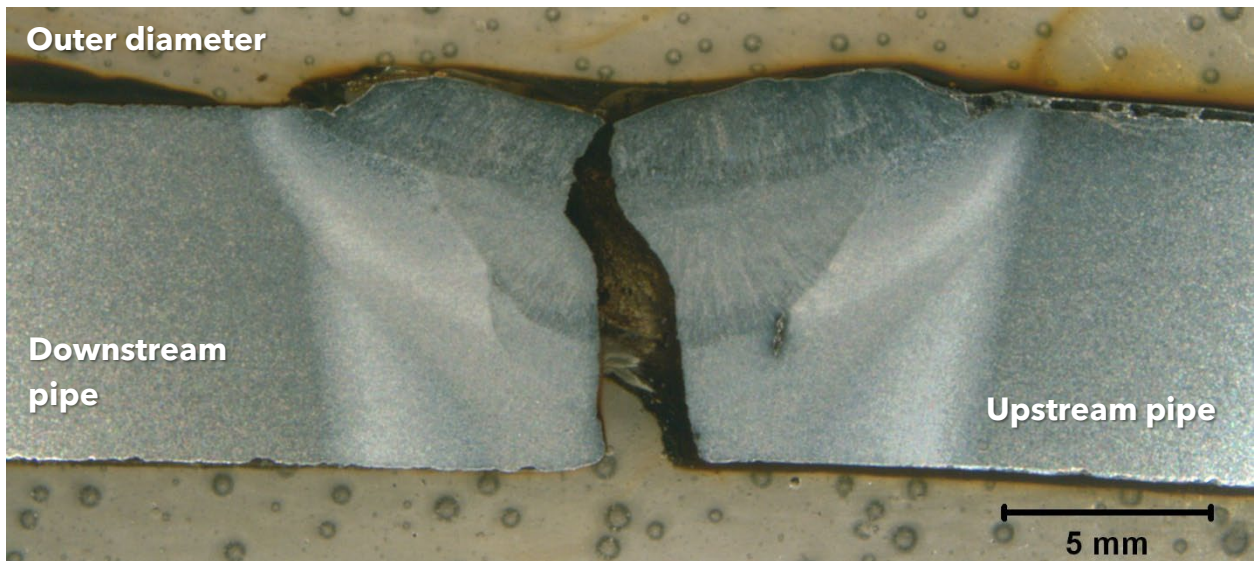
Figure 42 shows a cross-section of the fractured weld at M0\_6c, located just clockwise of the seam weld shown in Figure 3. This fracture completely bisected the weld filler, with a perpendicular orientation near the inner surface (figure bottom) and a curved, angled direction along the outer weld bead. Figure 43 shows the fracture on the inner side of the pipeline. This side of the fracture exhibited nonmetallic material along part of the surface closest toward the inner surface. This oxide was not layered but rather blocky and located at discontinuities in the metal surface.

Figure 42. BF optical micrograph of the fracture at the girth weld at location M0\_6c (~5X, etched 2% Nital).

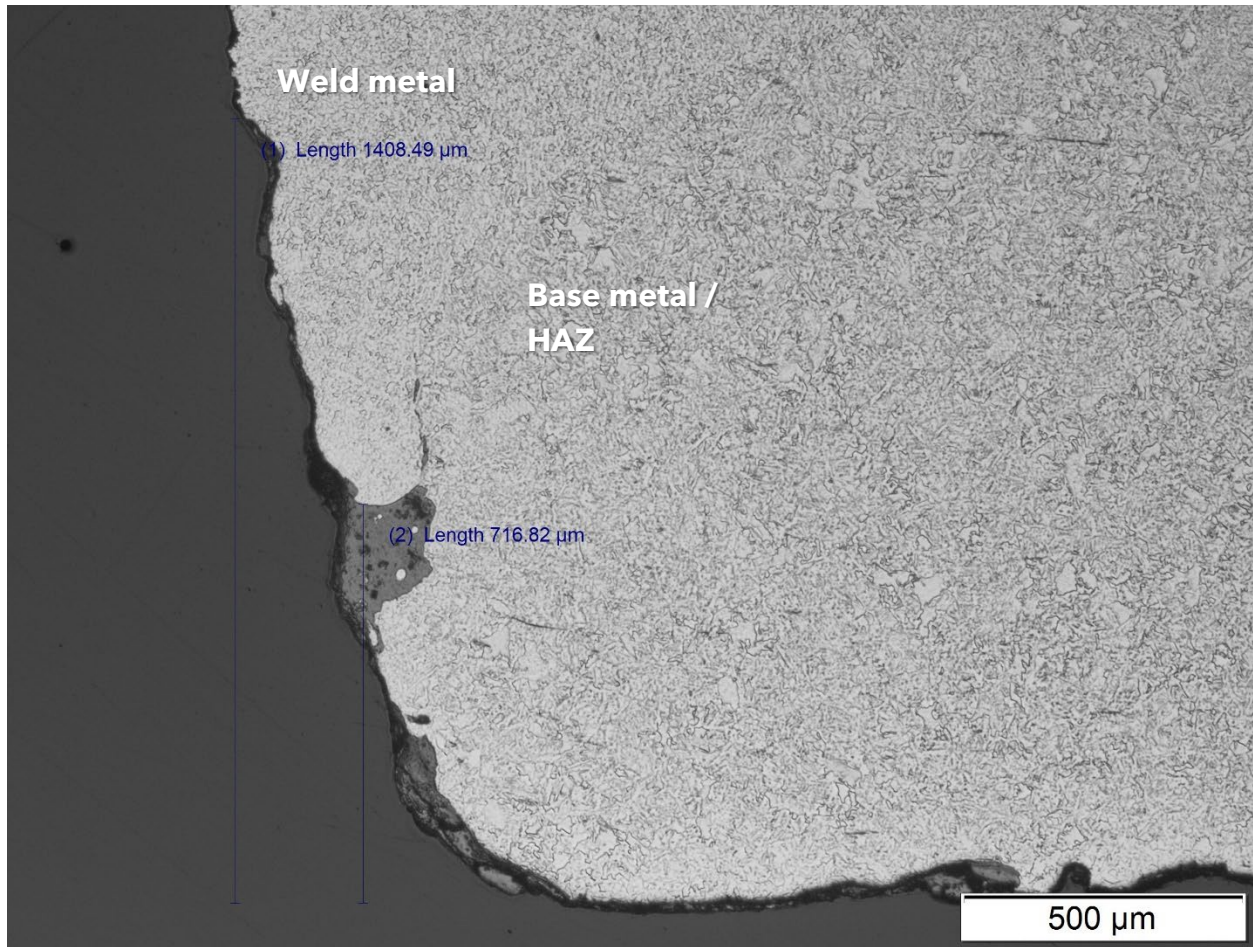
Figure 44 shows a closer view of these nonmetallic materials, annotated to show their depth from the inner surface. The larger blocky oxide in the figure was 717  $\mu\text{m}$  (0.028 in) from the surface, whereas the outermost oxide was found at 1.41 mm (0.056 in). Figure 45 shows a closer view of the oxide, exhibiting an alternating contrast consistent with a dendritic structure indicative of slag solidifying from the molten weld deposits. The slag manifest between the innermost weld bead and the base metal. These features were consistent with incomplete fusion at this location.

Figure 44. BF optical micrograph of surface oxides in the lower right of Figure 43, annotated with measurements from the inner diameter. (~100X, etched 2% Nital).

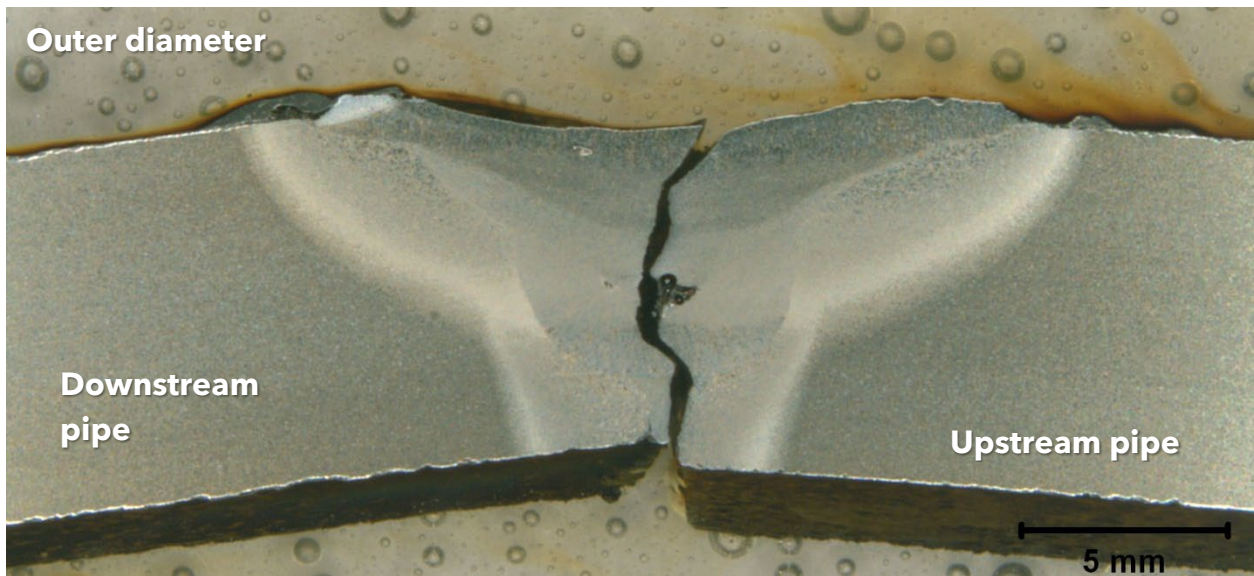
Figure 46 shows the fracture through weld location M1\_5a, denoted in Figure 4 near some detected undercut around the 4 o'clock position. This fracture morphology was more angled, perpendicular to the pipe circumferential direction toward the inner surface. Figure 47 shows this inner surface corner of the fracture, along with an internal triangular-shaped feature. Figure 48 shows a closer view of the interior corner of the fracture, exhibiting rounded laps from the welding process and vertical discontinuities consistent with cracking. The crack was present between weld passes and had emanated from a pit-like feature on the interior, which exhibited nonmetallic material. The fracture surface also revealed nonmetallic material on the surfaces near the inner pipe surface, most notably on the right mating side in Figure 48.

Figure 46. BF optical micrograph of the fracture at the girth weld at location M1\_5a, 1.61 feet clockwise from 12 o'clock (~5X, etched 2% Nital).

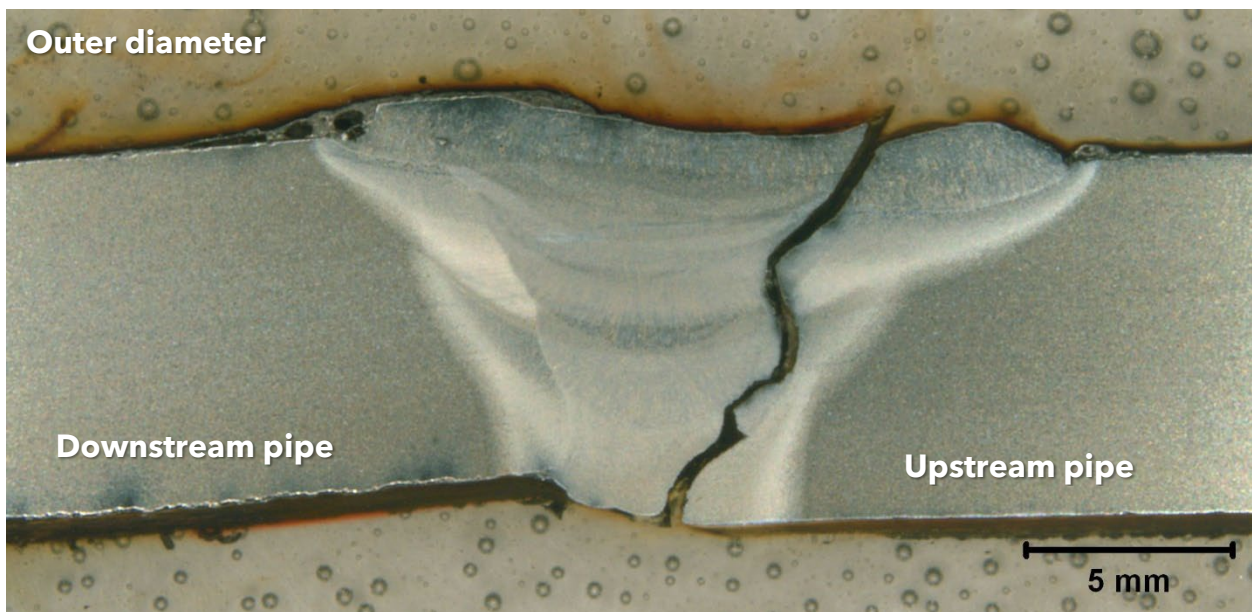
Figure 52 shows the fractured weld at location M1\_5b, several inches clockwise of M1\_5a. The location of this fracture was biased toward one side of the weld, located on the right in the figure. Figure 53 shows a montage of the inner part of the crack, which was located along one of the weld pass boundaries, except for a small area in the lower right. The figure also demonstrates the changing microstructure from the welding process. As indicated in Figure 54, the fracture surfaces exhibited a thin nonmetallic oxide layer, with blocky material area near the weld's inner surface. Figure 55 shows a closer view of this oxide, exhibiting a dendritic morphology. Figure 55 also shows the difference in microstructure between the weld and the HAZ, with the former exhibiting more ferrite and an acicular morphology of the carbon-rich phase and the latter having more cementite present.

Figure 52. BF optical micrograph of the fracture at the girth weld at location M1\_5b (5X, etched 2% Nital).

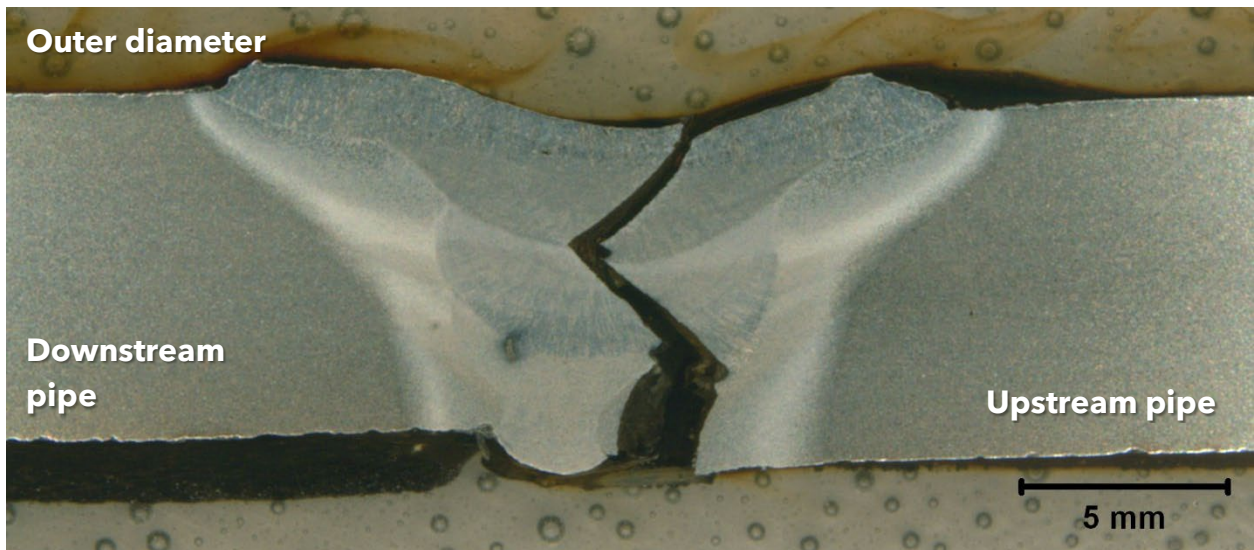
Figure 56 shows the fracture of the weld at location M4\_3, near the 9 o'clock position illustrated in Figure 6. This fracture exhibited a zig-zag morphology, consistent with much of the girth weld fracture exhibiting shear lips and a recessed center (see Figure 31 and Figure 32). As shown in Figure 56, this weld exhibited a lack of cap fill on the exterior, contoured consistent with the individual weld passes in that area. Figure 57 shows an elongated inclusion just outside one of the weld passes. Unlike the other slag deposits, this feature exhibited a more metallic, optically reflective quality.

Figure 56. BF optical micrograph of the fracture at the girth weld at location M4\_3, removed 4.31 feet clockwise of 12 o'clock top dead center (~5X, etched 2% Nital)

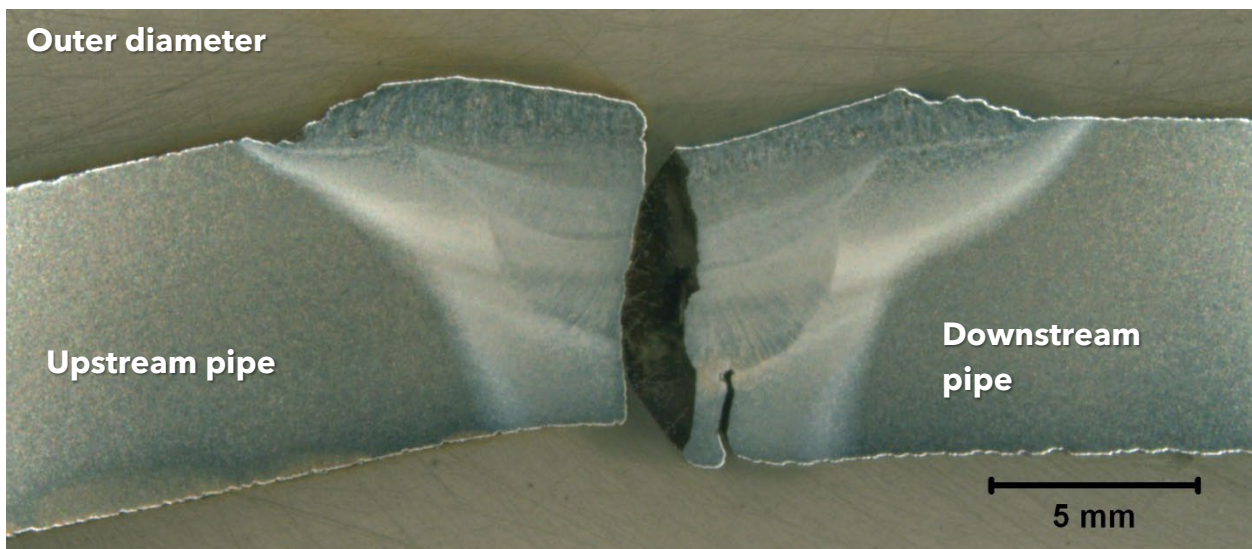
Figure 60 illustrates the fracture of the weld at location M5\_2, located near the 11 o'clock position shown in Figure 6. The fracture location was nearly perpendicular to the pipe along the weld centerline but also exhibited a discernible crack that was present through the innermost third of the pipe thickness. Figure 61 shows a closer view of this crack alongside the inner surface corner of the fracture. The crack and fracture exhibited thin layers of nonmetallic material along the surface, consistent with oxidation after opening to the environment. The crack extended towards the lower area of the primary weld pass, measured as 2.08 mm (0.082 in).

Figure 60. BF optical micrograph of the fracture at the weld at location M5\_2, approximately 5.29 feet counterclockwise of top dead center (5X, etched 2% Nital).

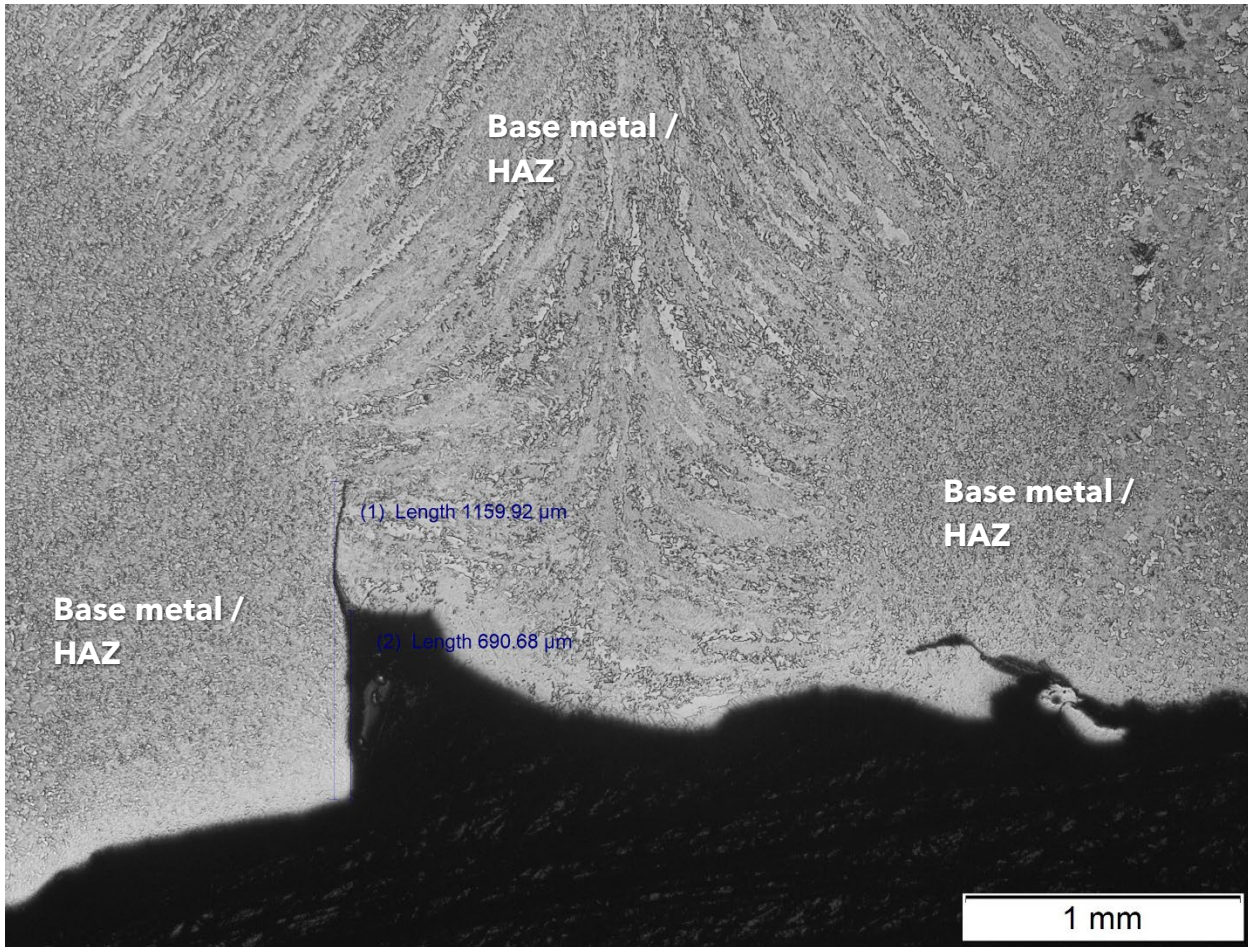
Figure 92. BF optical micrograph of the discontinuity and cracking in M3-2, annotated showing distances from the inner diameter surface (~25X, etched 2% Nital).

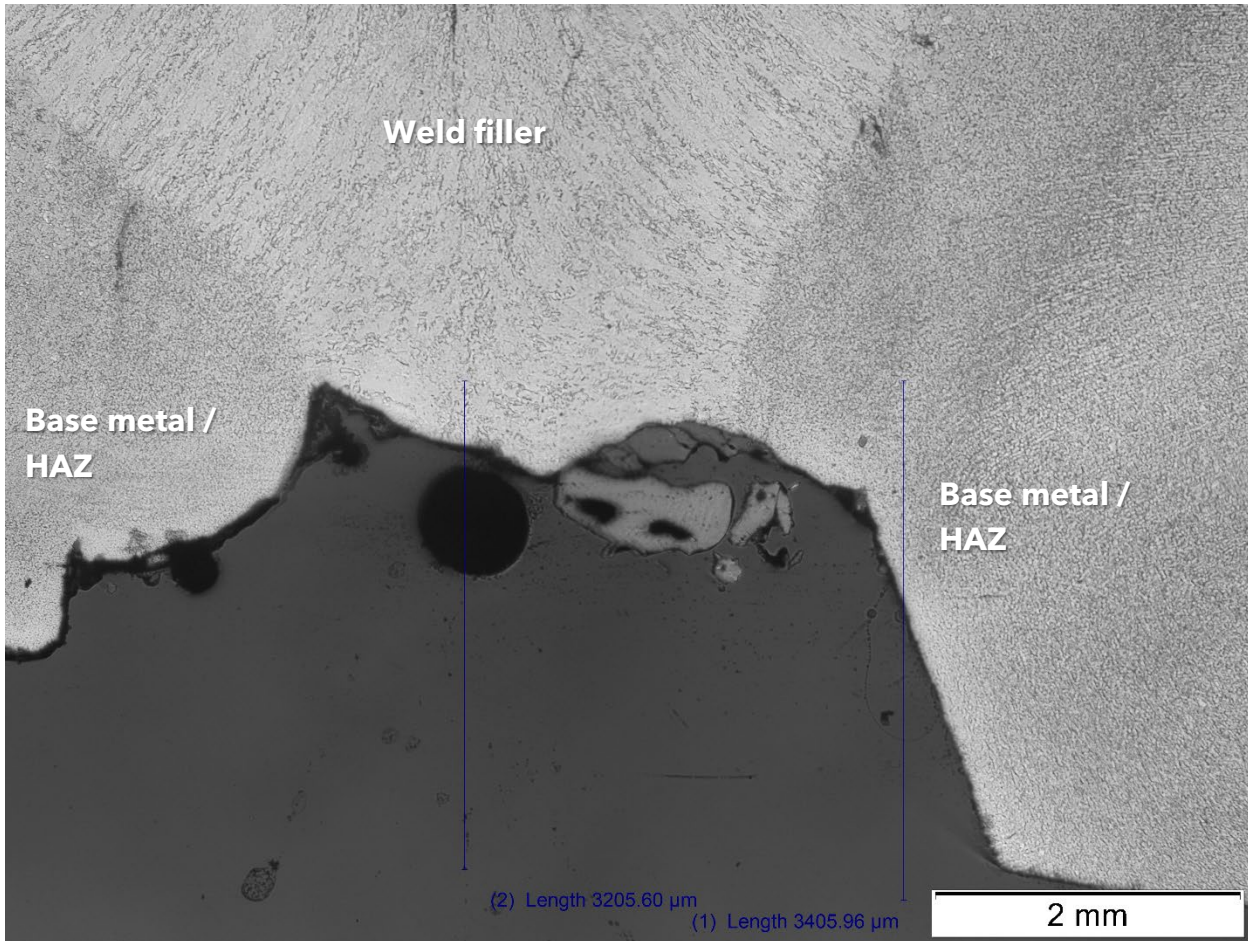
Figure 95. BF optical micrograph of the area of burn through in M3-5, annotated showing distances from the inner diameter surface (~25X, etched 2% Nital).
