# National Transportation Safety Board

## **MATERIALS LABORATORY**

Factual Report 22-038

On March 11, 2022, the Woodpat pipeline, a 22-inch-diameter hazardous liquids pipeline operated by Marathon Pipe Line, LLC (Marathon), ruptured in Edwardsville, IL. About 3500 barrels of crude oil were released, some of which entered Cahokia Creek, a tributary of the Mississippi River. No injuries occurred, and the crude oil did not ignite.

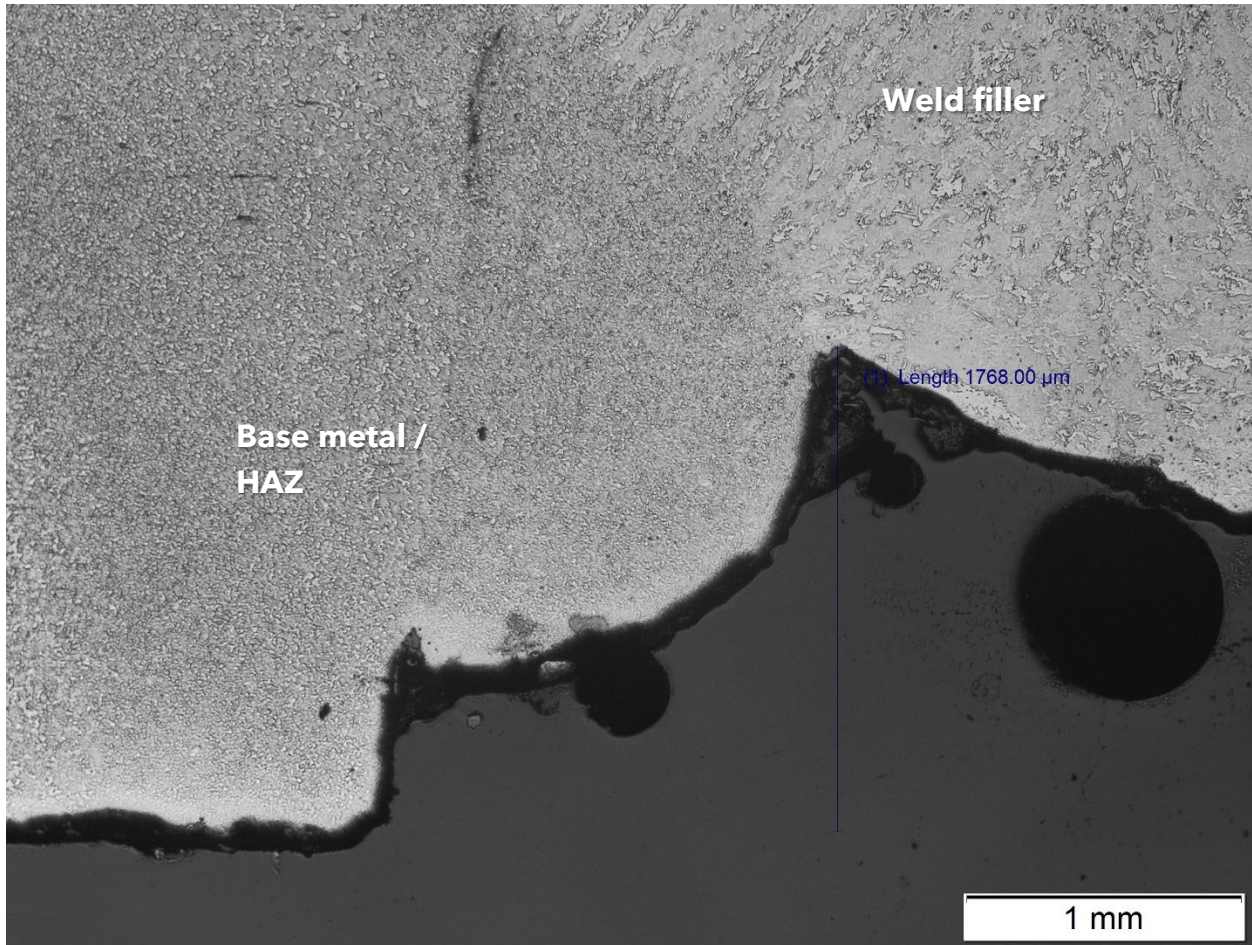
Figure 96. BF optical micrograph of the area of burn through in M3-5, annotated showing distances from the inner diameter surface (~25X, etched 2% Nital).
