# NATIONAL TRANSPORTATION SAFETY BOARD

MATERIALS LABORATORY FACTUAL REPORT

Report No. 22-045

Place : Oklaunion, Texas  
Date : January 8, 2022  
Vehicle : DOT 117J tank cars  
NTSB No. : HMD22LR001  
Investigator : Paul Stancil, RPH-20

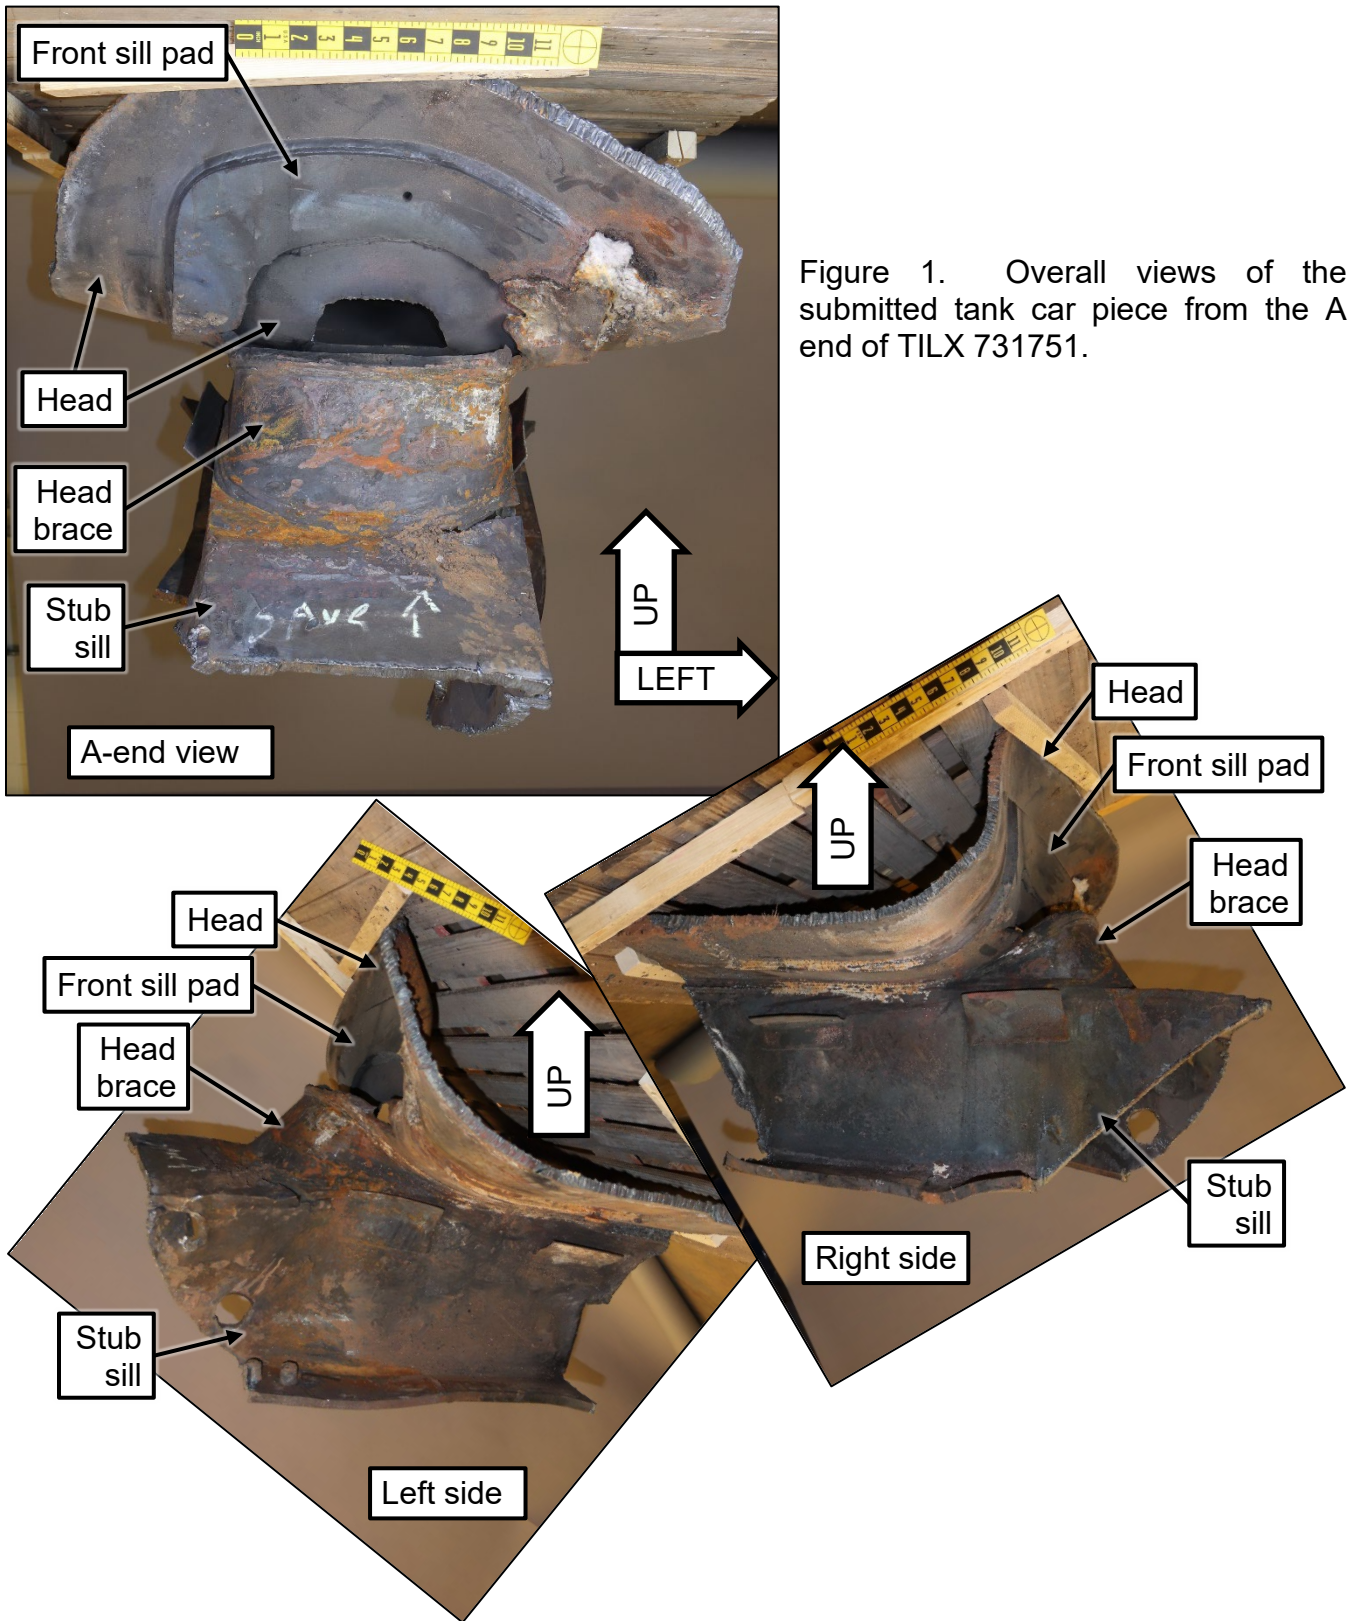
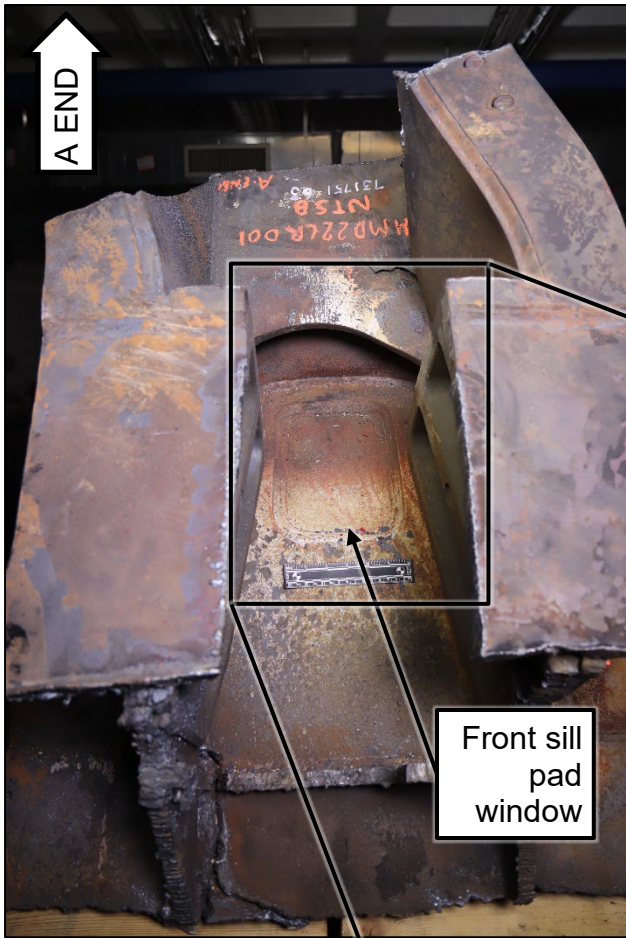
Overall views of the submitted piece of tank car TILX 731751 are shown in figures 1 and 2. The piece included the head brace and portions of the stub sill, front sill pad, head, and shell that had been cut by plasma torch from the A end of the tank car. The various components of the assembly are shown labeled in figure 1, and a view of the front sill pad window as viewed from the underside of the tank car piece is shown in figure 2. A computer-generated 3D model of components at the A end of the tank car is shown in figure 3. The model is shown sliced longitudinally through the middle, and individual components are shown labeled.

The submitted piece shown in figures 1 and 2 was generally oxidized and sooty consistent with exposure to heat from a fire. The head and front sill pad were deformed upward and inboard relative to the stub sill, and a contact mark was observed on the front sill pad surface as shown in figure 4. The contact mark had a shape consistent with an opening in the jacket for the stub sill and head brace. The right side of the contact mark aligned with the right side of the head brace, consistent with the jacket being pushed to the left relative to the stub sill before contacting the front sill pad.<sup>1</sup>

Figure 2. Lower side of the submitted tank car piece including a closer view of head brace-to-pad welds and pad-to-head welds at the front sill pad window (area where head is visible).

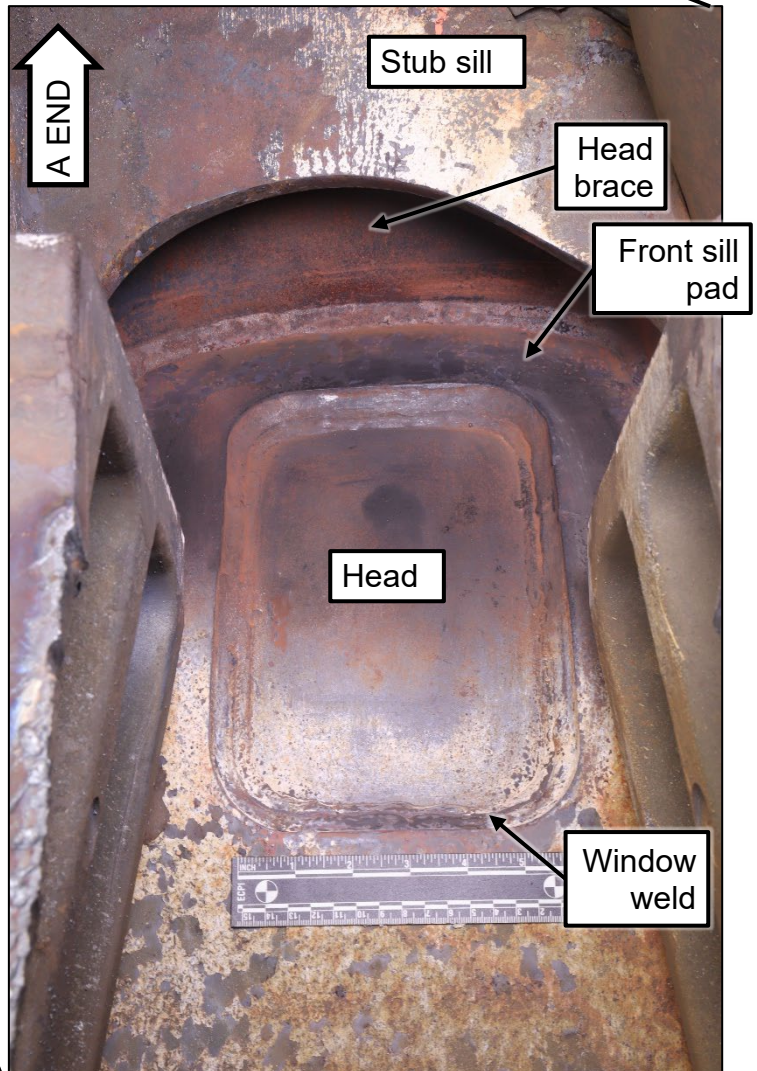
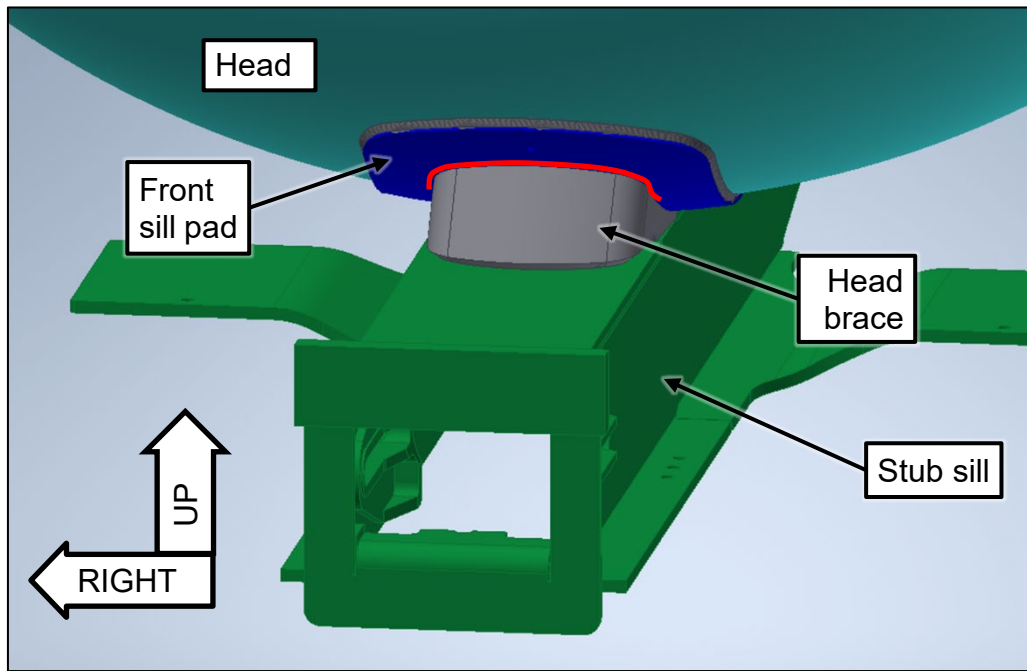
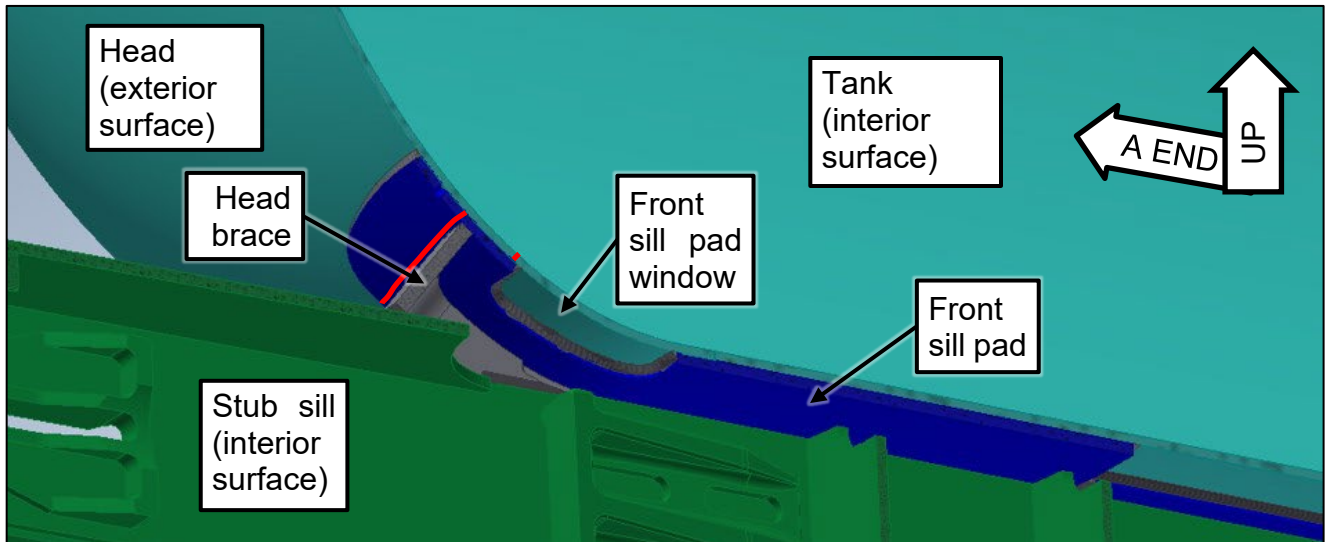
The front sill pad and head were fractured at locations shown with red lines in figure 3. A closer view of the fractures in the front sill pad and the head are shown in figure 5. The front sill pad was fractured at the toe of the weld between the head brace and the pad, and the head was fractured near the rectangular window in the front sill pad

Figure 3. A-end view (upper image) and longitudinal cross-section (lower image) from a 3D computer model showing various components of the tank car construction. Fracture locations are indicated in red. (Adapted from images provided courtesy of TrinityRail).

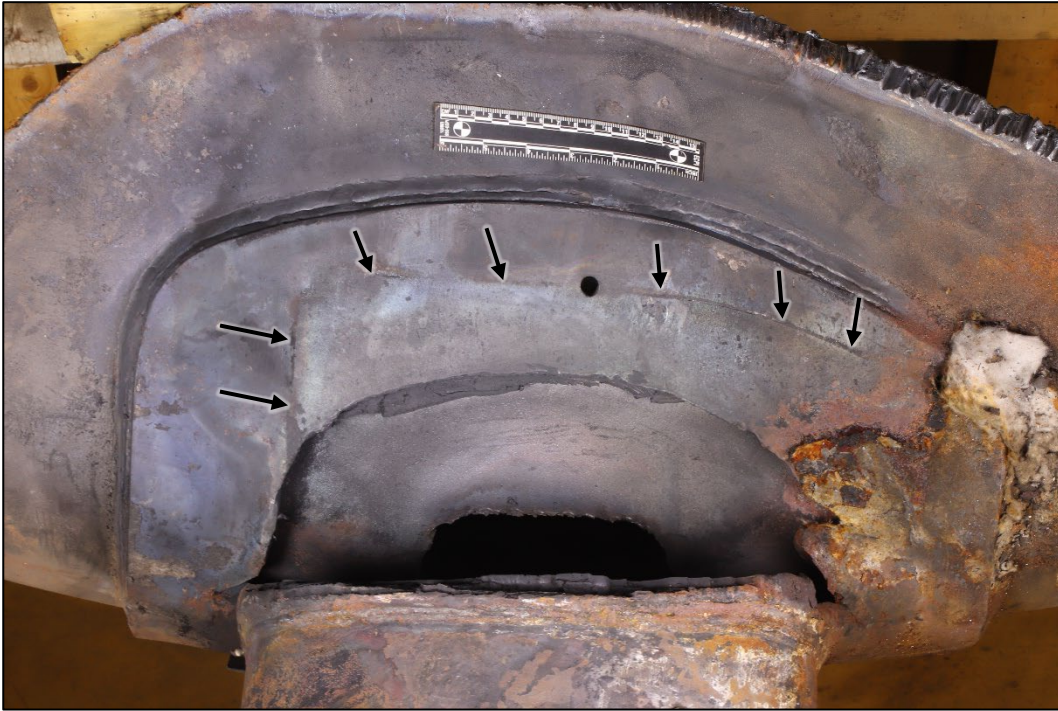
Figure 4. Contact mark on the front sill pad (unlabeled arrows) corresponding to contact with the jacket opening for the stub sill.

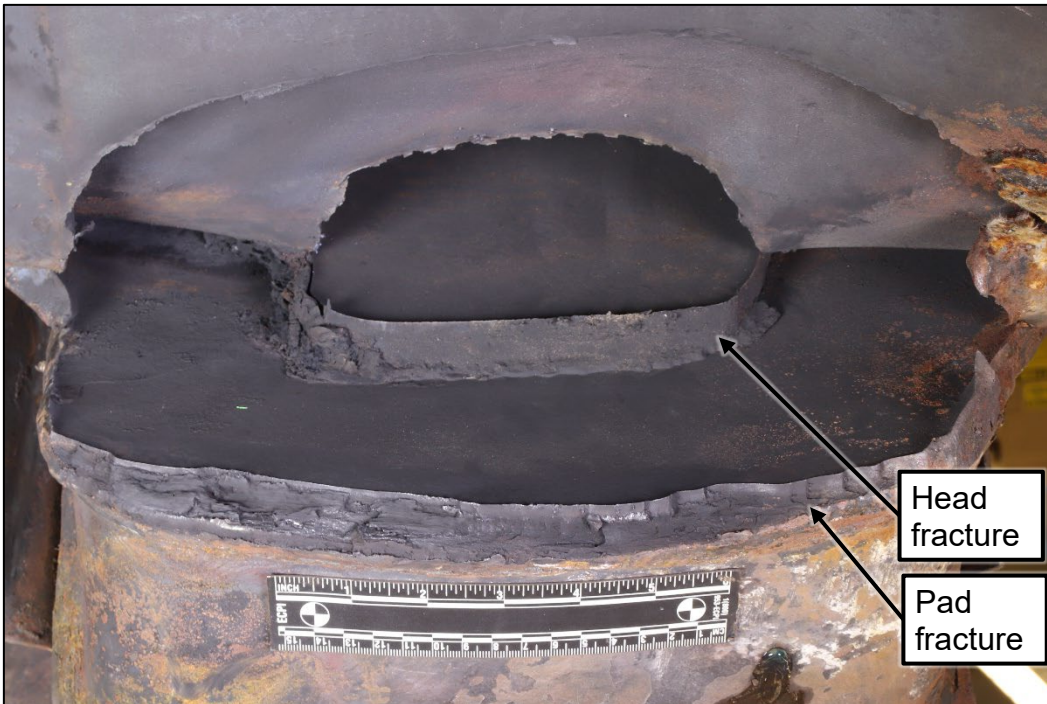
where the pad was welded to the head. The head fracture was approximately 10.25 inches long, and the maximum opening displacement was approximately 2.5 inches.

Figure 5. Closer view of fractures through the front sill pad and the head.

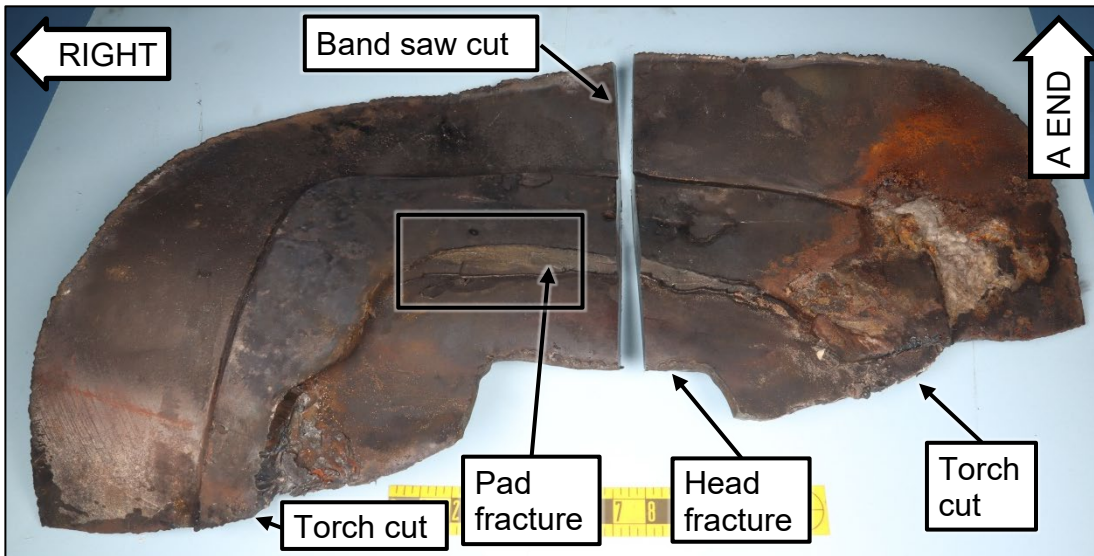
A view of the upper portion of the head and front sill pad after the plasma torch cuts and bandsaw cut is shown in figure 7. Closer views of fracture features on the front sill pad fracture are shown in figures 8 and 9. A vertical lip was observed along the front edge (at the toe of the weld), and the fracture extended at a slight angle through the thickness of the front sill pad toward the weld root. The vertical lip had smeared fracture features consistent with shear, and the angled portion had feathery features consistent with limited ductility overstress propagation under tensile stress. The feathery features emanated from an origin area near the right side at the location within the rectangle in figure 7 and shown at higher magnification in figure 8. No evidence of any preexisting cracks or anomalies were observed. At the corners on either side of the fracture, smeared fracture features were observed consistent with direct shear fracture consistent with the outboard portion of the front sill pad moving upward relative to the head brace.

Figure 7. Head and front sill pad pieces with fracture surfaces after transverse plasma torch cuts and a longitudinal band saw cut were made to separate the pieces for closer views of the fracture surfaces and for the preparation of metallographic samples. The area in the rectangle is shown in figure 8.

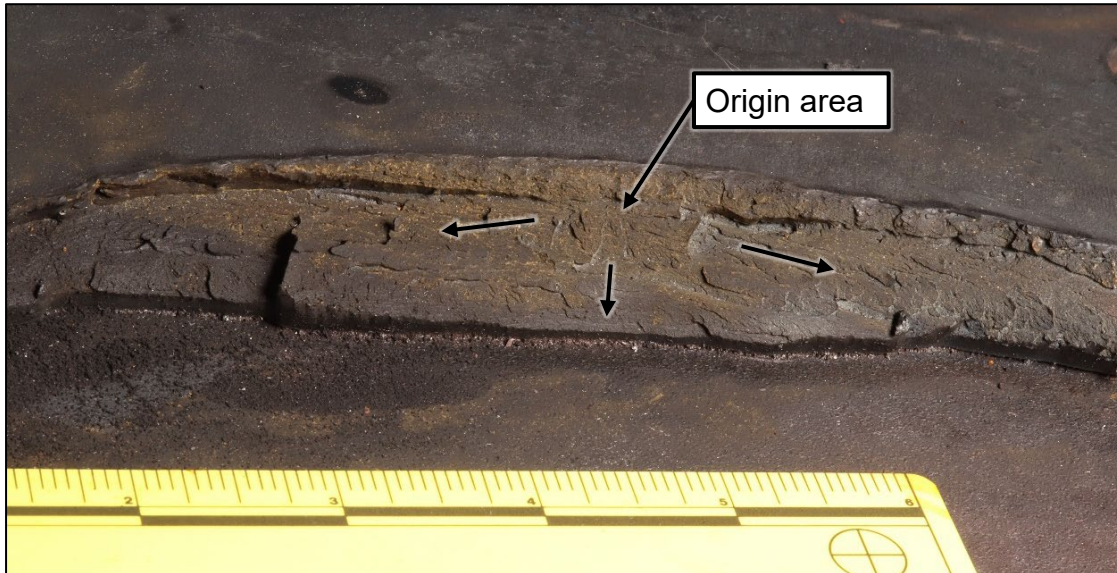
Figure 8. Close view of the pad fracture in the area highlighted with a rectangle in figure 7. Fracture features generally emanated from an origin area at the toe of the weld between the head brace and the front sill pad at the location indicated.

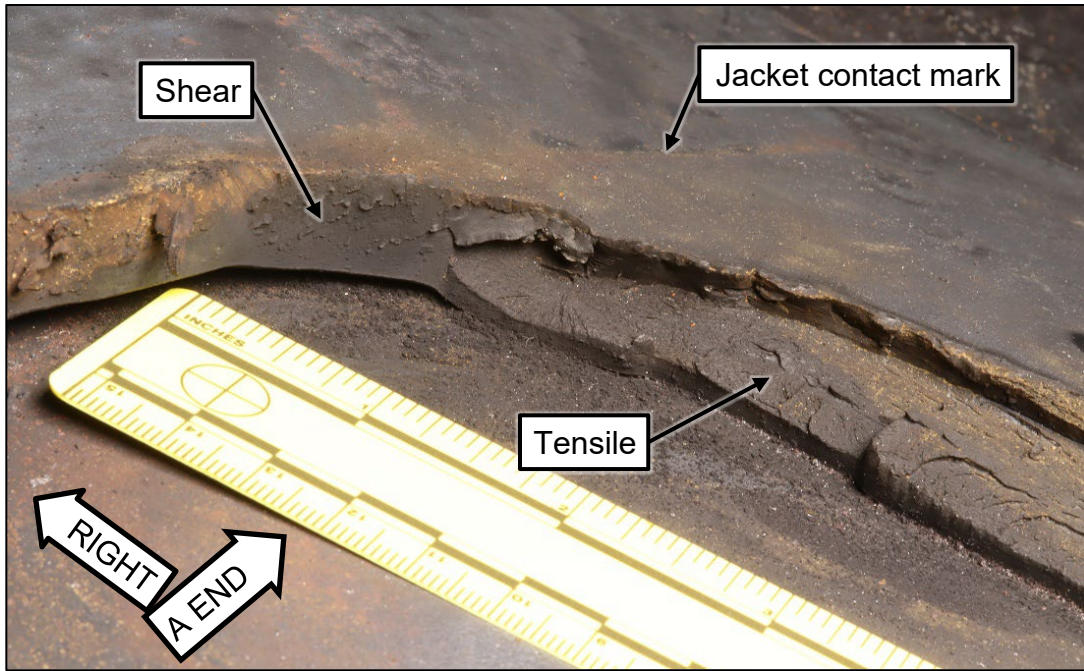
Figure 9. Right side of the front sill pad fracture showing transition from tensile fracture features to direct shear features consistent with the head brace moving downward relative to the front sill pad.

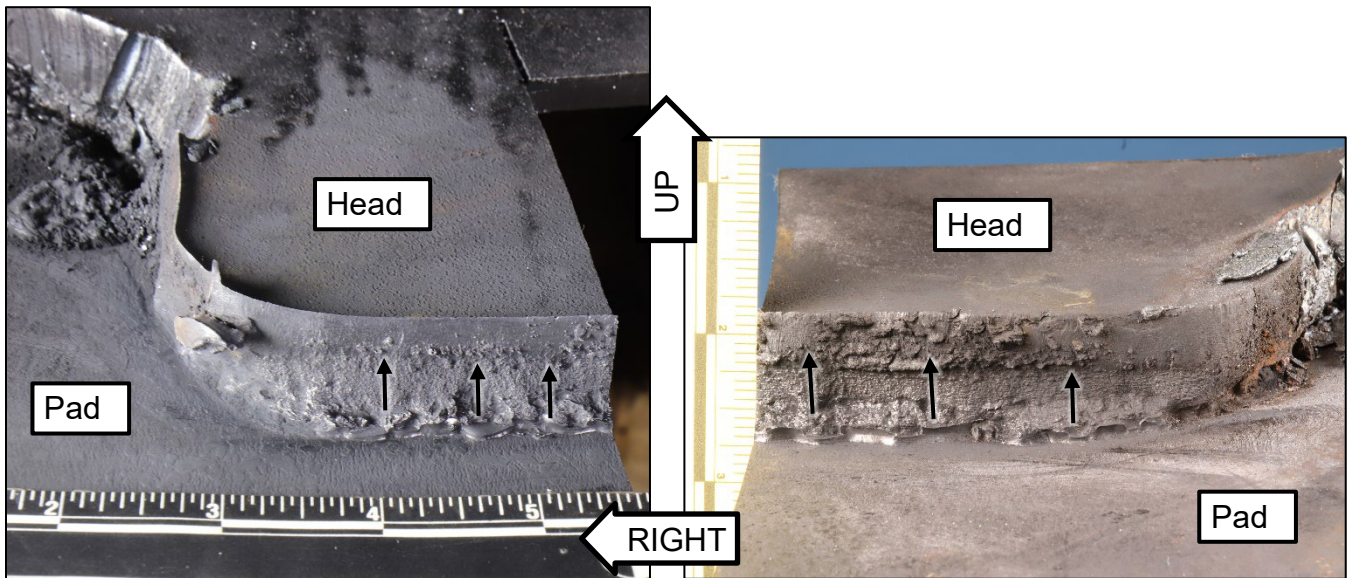
Fracture features for the head are shown in figure 10. The fracture plane was nearly vertical through the thickness of the head. Adjacent to the pad, smooth features were observed consistent with the weld root between the front sill pad window and the head. Just above the weld root, rough matte gray fracture features were observed consistent with ductile overstress fracture propagating upward from the weld toe as indicated with unlabeled arrows in figure 10. At the upper edge of the fracture, smooth features consistent with compression and shear were observed, consistent with an overall upward bending load associated with the fracture. Smeared fracture features were observed on the left and right sides consistent with direct shear fracture as the outboard side of the head moved upward relative to the inboard side at the fracture location. No evidence of preexisting cracks or anomalies were observed.

Figure 10. Close view of the head fracture after longitudinal and transverse cuts were made using a bandsaw. Fracture initiated at the weld root between the pad window and the head then propagated upward as indicated by unlabeled arrows. The upper side of the fracture was smeared consistent with a bending load at the fracture location.

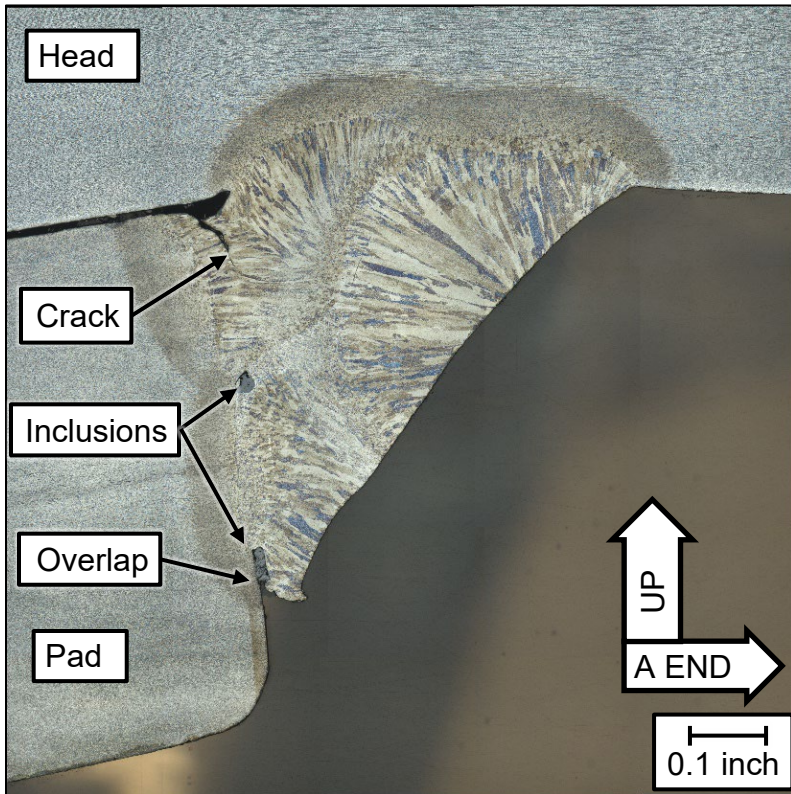
Anomalies in the welds were noted as indicated in figures 16 through 25. Cracks were observed at the weld root in welds HPL1o, PBL1i, SBL2, and HPT1i. Inclusions

were noted in welds HPL1o and PBL1i. An overlap was observed at the weld toe in weld HPL1o, and incomplete penetration was observed in groove welds attaching the head brace to the front sill pad and the stub sill to the head brace (welds PBT1i, PBT1o, SBT1i, and SBT1o).

Figure 16. Fillet weld between the head and the front sill pad outboard edge in the centerline longitudinal cut plane (weld HPL1o). Image is a stitched montage using a 2.5x objective lens and is etched with 2% nital.

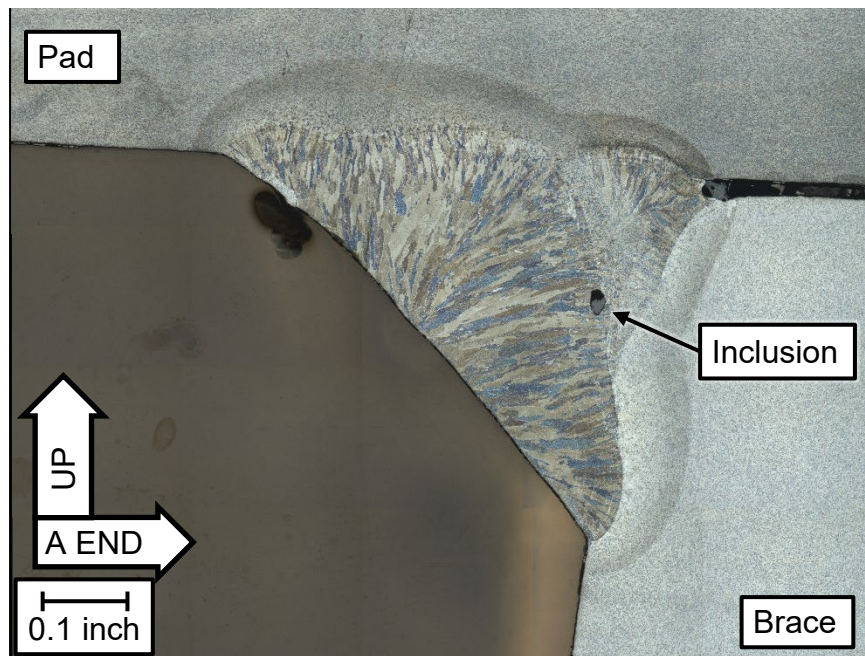
Figure 18. Fillet weld between the head brace and the front sill pad on the inboard side of the brace in the centerline longitudinal cut plane (weld PBL1i). Image is a stitched montage using a 2.5x objective lens and is etched with 2% nital.

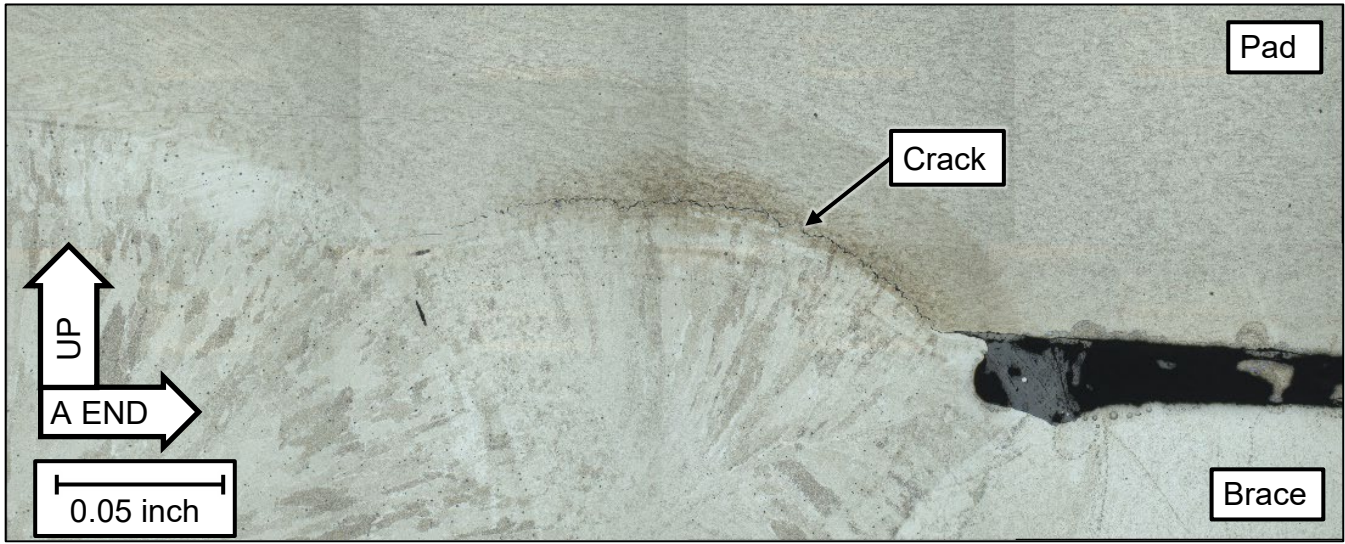
Figure 19. Closer view of a crack emanating from the weld root in the heat affected zone in weld PBL1i. Image is a stitched montage using a 2.5x objective lens and is etched with 2% nital.

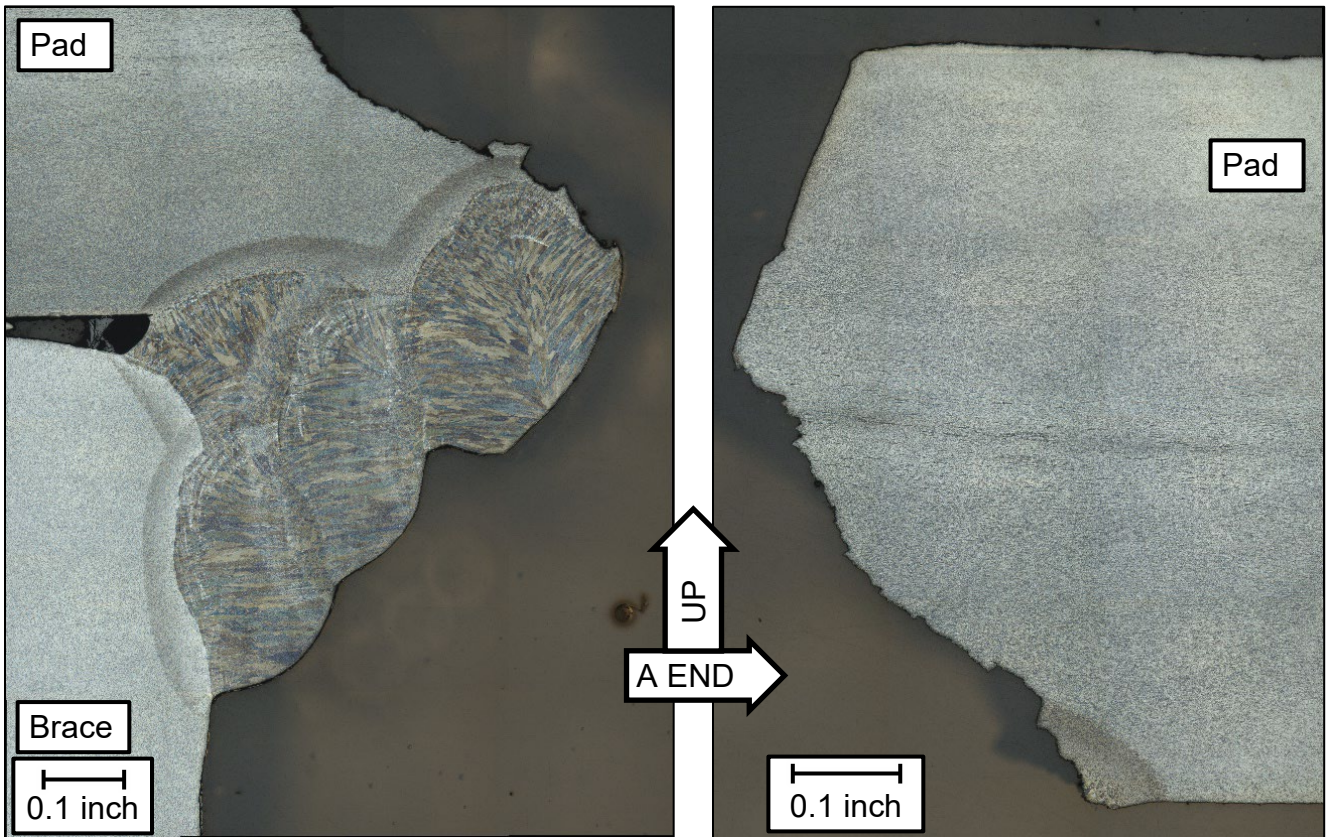
The profile of the fracture through the front sill pad is shown in figure 20. The lower end of the fracture intersected the toe of the fillet weld and extended initially through the heat-affected zone of the weld. At the head fracture location shown in figure 17, the fracture initially propagated through resolidified material at the weld root before propagating upward through the head.

Figure 20. Outboard fillet weld between the front sill pad and the head brace in the centerline longitudinal cut plane (weld PBL1o). Images are stitched montages using a 2.5x objective lens and are etched with 2% nital.

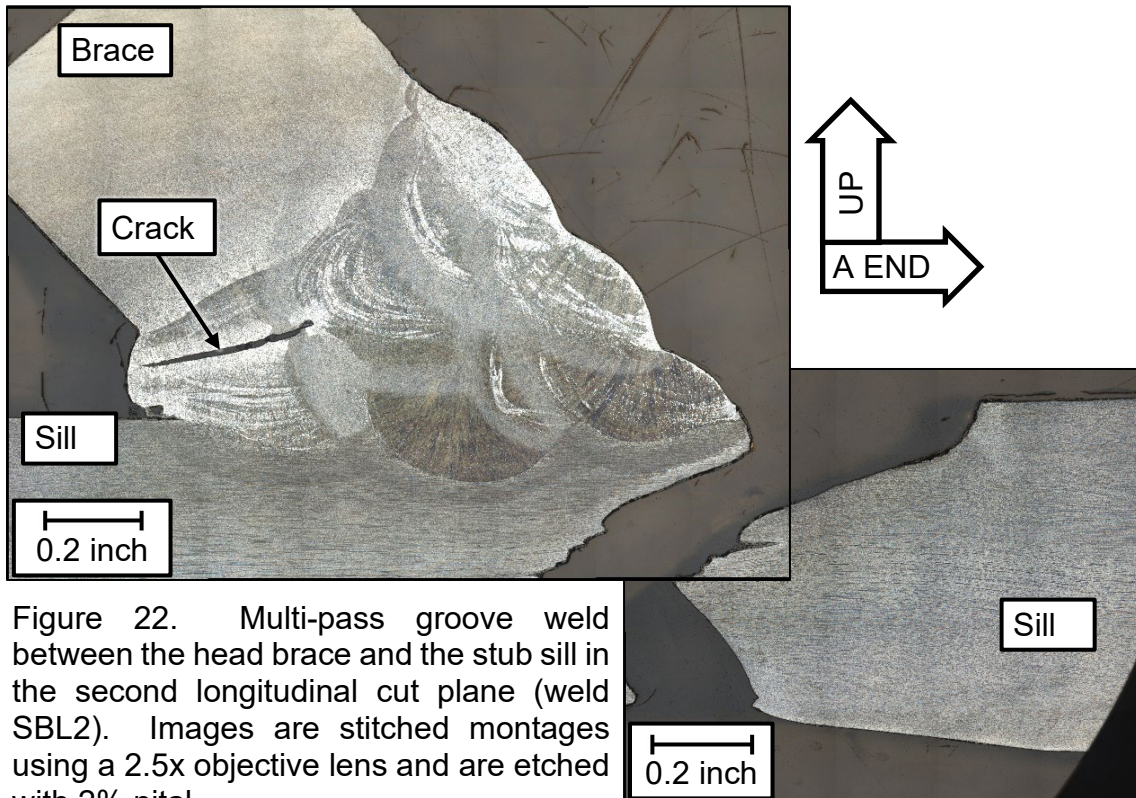
Figure 22. Multi-pass groove weld between the head brace and the stub sill in the second longitudinal cut plane (weld SBL2). Images are stitched montages using a 2.5x objective lens and are etched with 2% nital.

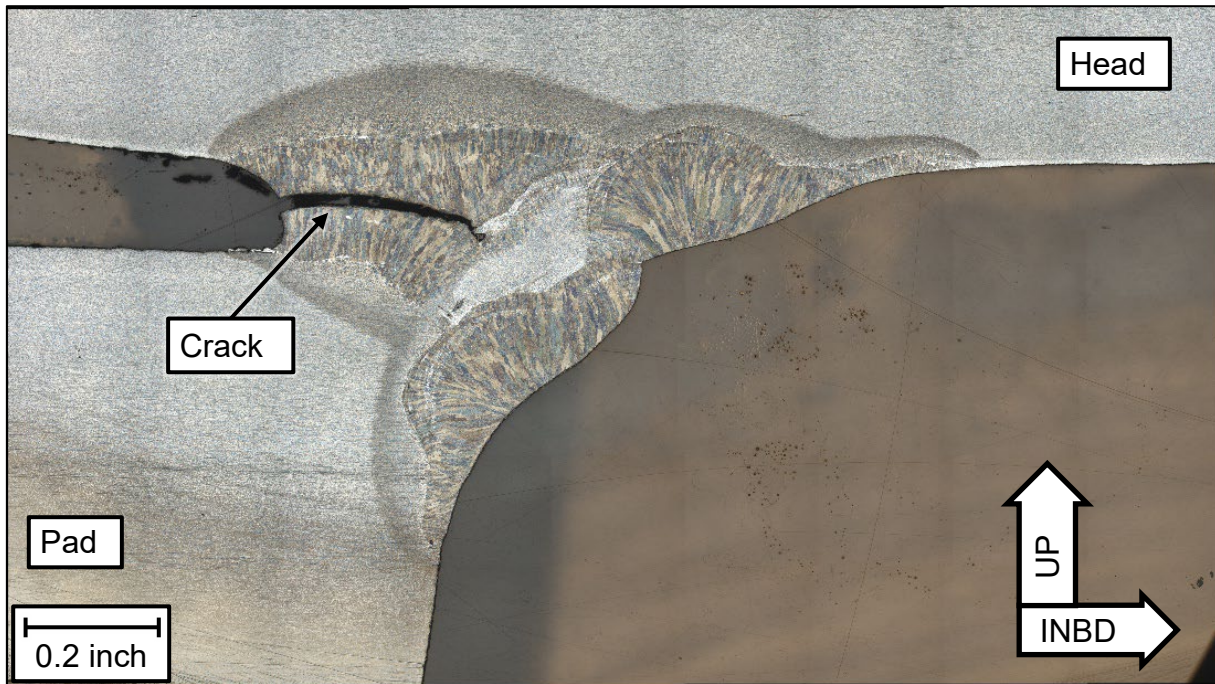
Figure 23. Fillet weld between the head and the front sill pad window in the transverse cut plane (weld HPT1i). Image is a stitched montage using a 2.5x objective lens and is etched with 2% nital.

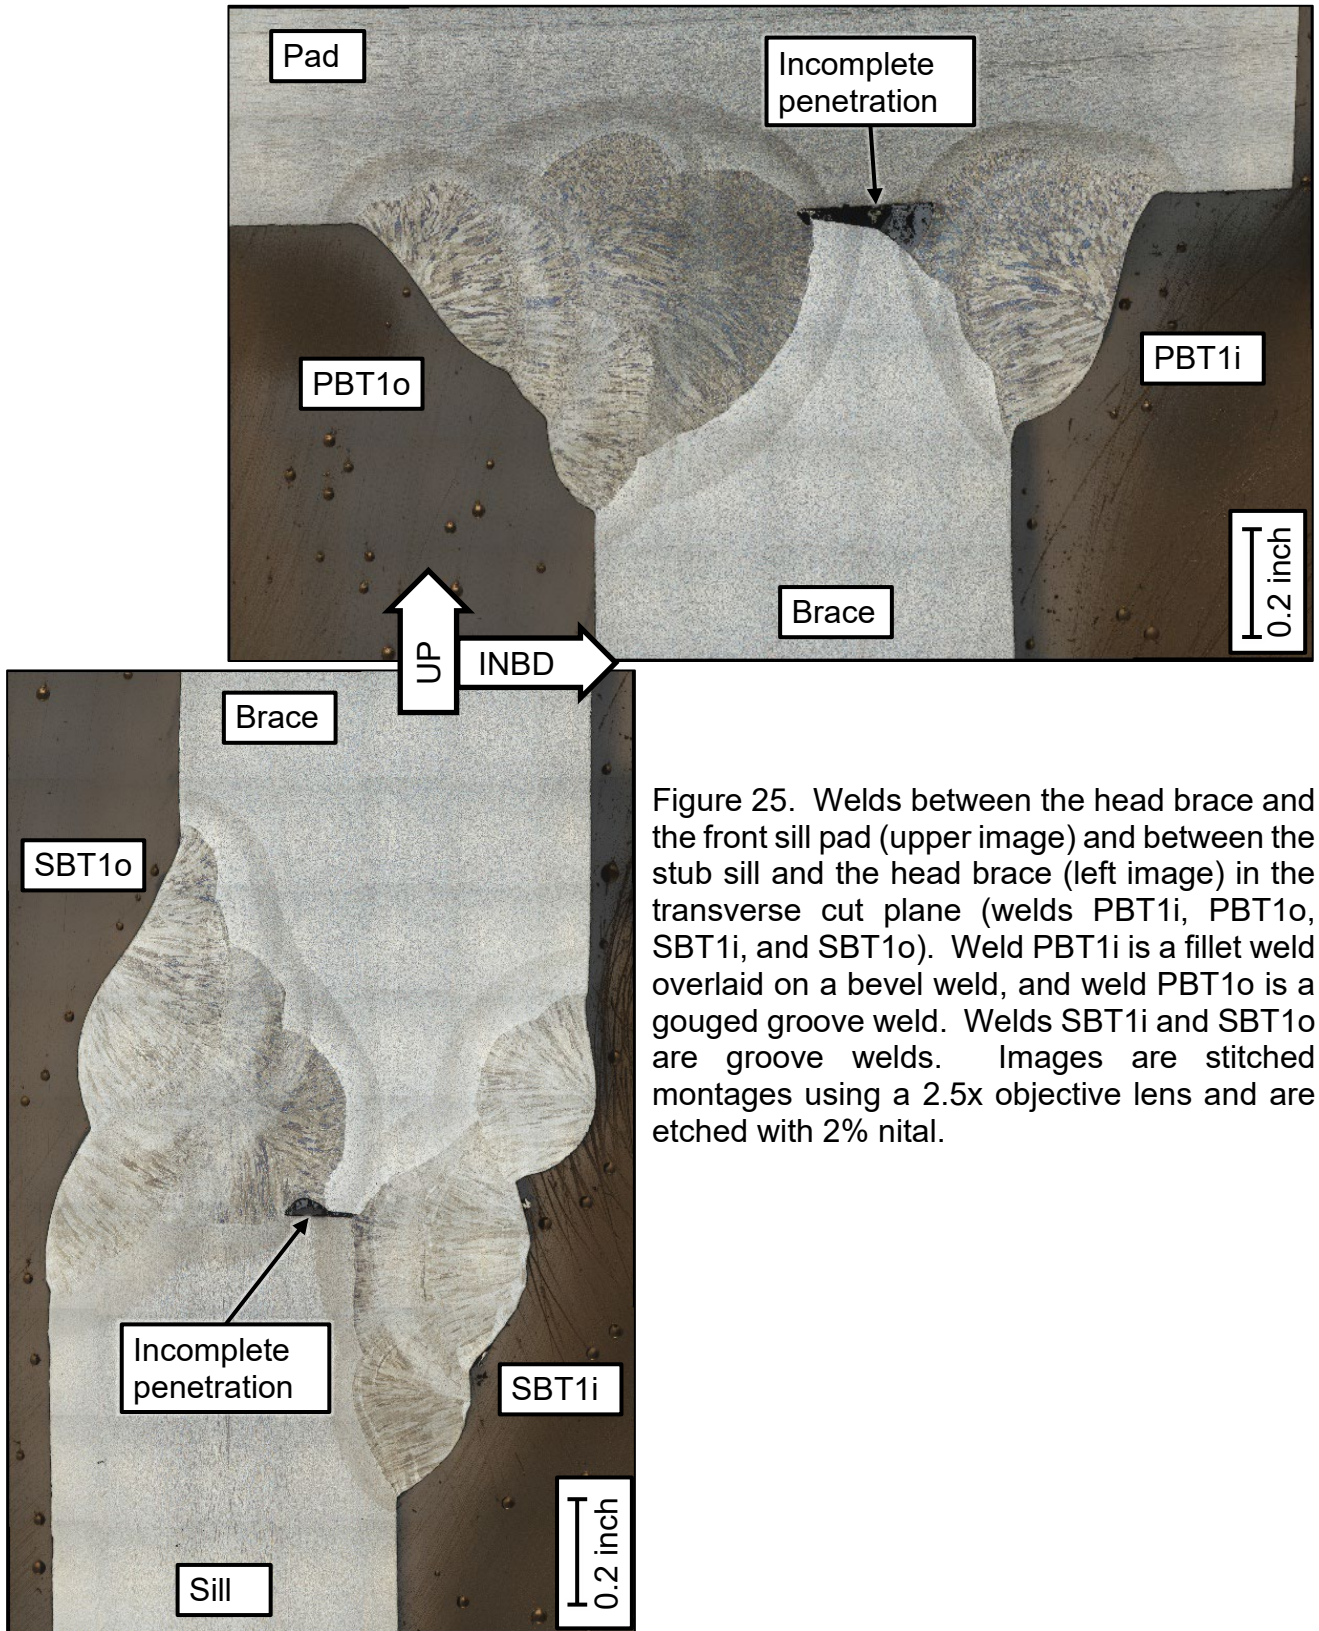
Figure 25. Welds between the head brace and the front sill pad (upper image) and between the stub sill and the head brace (left image) in the transverse cut plane (welds PBT1i, PBT1o, SBT1i, and SBT1o). Weld PBT1i is a fillet weld overlaid on a bevel weld, and weld PBT1o is a gouged groove weld. Welds SBT1i and SBT1o are groove welds. Images are stitched montages using a 2.5x objective lens and are etched with 2% nital.

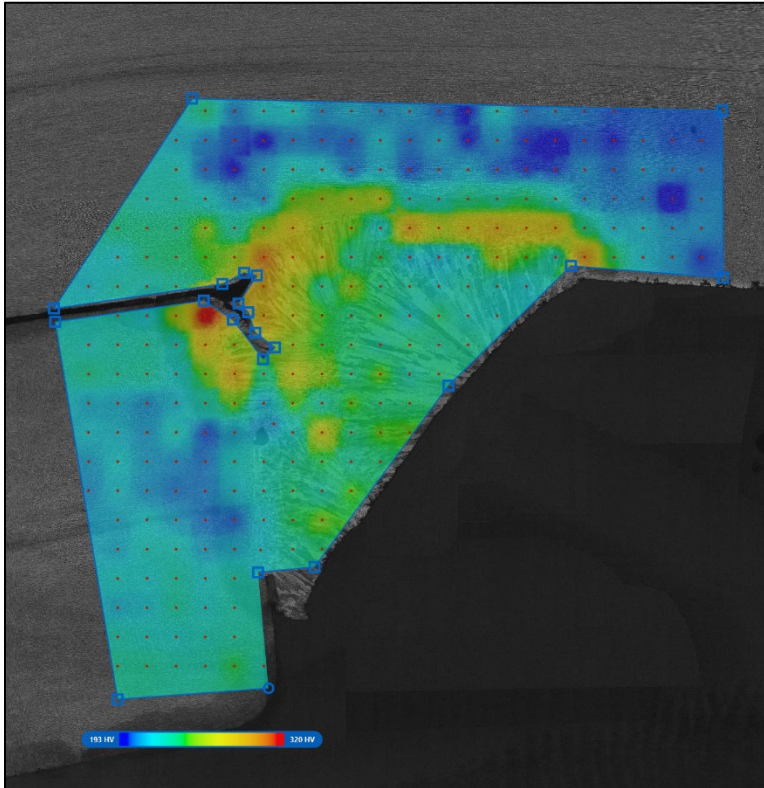
In addition to the Rockwell hardness tests, the metallographic specimens for welds in the centerline plane were tested using a Leco LM248AT microhardness tester. Each weld was mapped with a grid of Vicker's indents using a 500-gram load to produce maps of hardness variations across the welds. Resulting hardness maps are shown in figures 29 through 33. In each case, the weld metal and/or the heat-affected zone was harder relative to the adjacent welded components. While isolated areas of relatively high hardness were observed in several welds, areas of relatively higher hardness were also associated with crack locations at the weld root in welds HPL1o and PBL1i. Overall, the highest hardness values were measured in the heat affected zones in welds HPL1o and HPL1i.

Figure 29. Hardness map for the fillet weld between the head and the front sill pad at the outboard edge of the pad in the centerline longitudinal cut plane (weld HPL1o). Hardness ranged from 193 HV (blue) to 320 HV (red). On the Rockwell scale, hardness ranged from 91.5 HRB to 32.3 HRC.

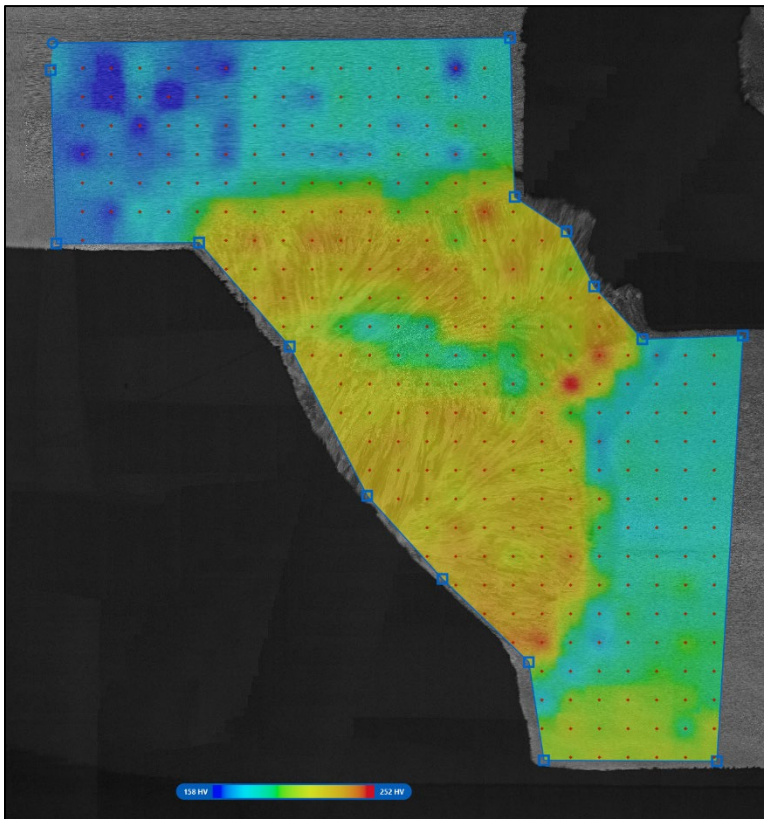
Figure 30. Hardness map for the fillet weld between the head and the front sill pad at the pad window in the centerline longitudinal cut plane (weld HPL1i). Hardness ranged from 158 HV (blue) to 252 HV (red). On the Rockwell scale, hardness ranged from 82.6 HRB to 22.6 HRC.
