# NATIONAL TRANSPORTATION SAFETY BOARD

MATERIALS LABORATORY FACTUAL REPORT

Report No. 22-049

Place : Azusa, California  
Date : March 19, 2022  
Vehicle : Eurocopter AS3321L1, N950SG  
NTSB No. : WPR22LA125  
Investigator : Fabian Salazar, AS-WPR

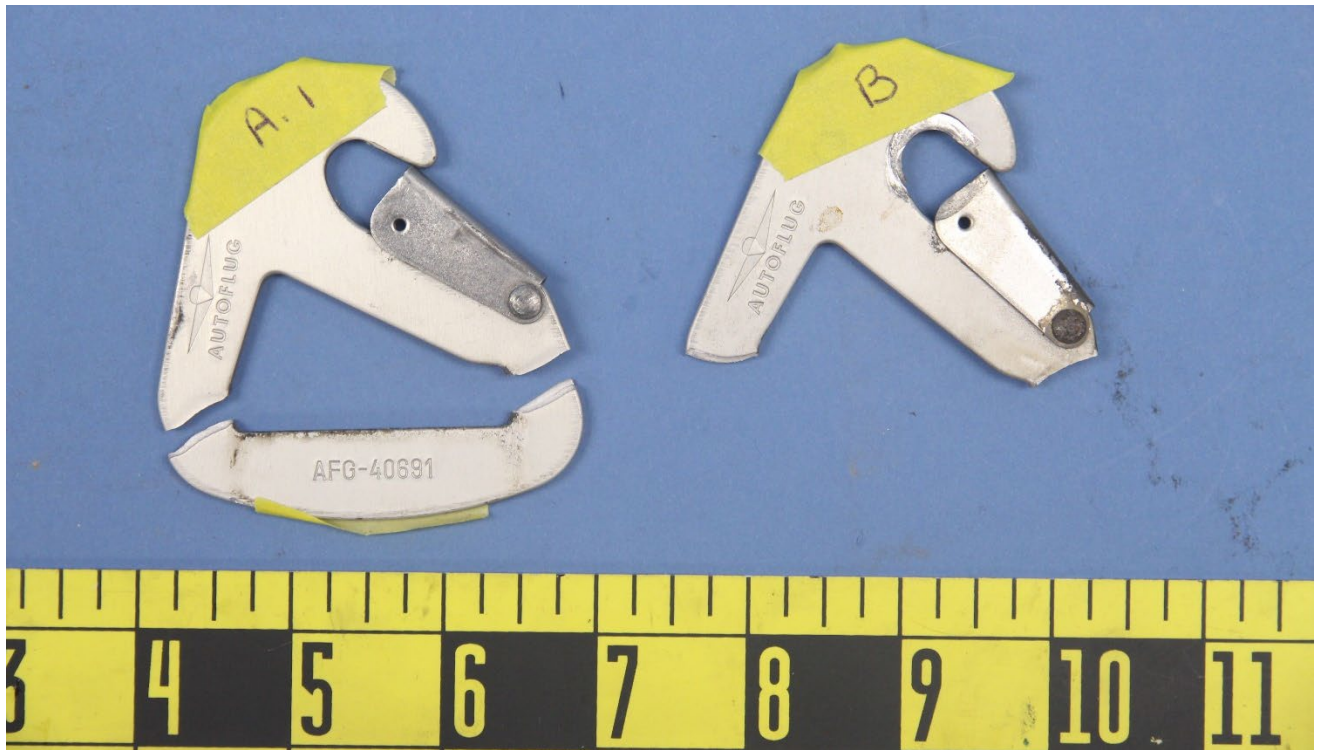
Figure 1 and Figure 2 show the fractured seat belt clips, as received. The clips were labeled A and B prior to receipt, with the two fragments of the A clip labeled A1 and A2. There was only one fragment from the B clip received.

The clasps on each clip were able to be actuated. There were circumferential wear patterns around the inside surfaces where the clasps enclosed. These worn areas were approximately 1/8 inch in thickness, as can be seen in Figure 1 for the B clip and Figure 2 for the A clip. There were no indications of gouges or cracks emanating from these areas.

Both arms with the riveted clasp connection fractured approximately 0.20 inches from the rivet. In each of these locations, the arm exhibited localized necking adjacent to the fracture surface (see Figures 1 and 2). As shown on the left and right in Figures 4a and 6a, the short side edges had bowed inward. There were small shear lips located along the long edges. In both Figure 4b and 6b, the fractures exhibited an angled orientation with a two-level morphology. These angled faces are towards the reader in both figures. The fractures in Figures 4a and 4b exhibited a dull, gray luster with a rough surface texture.

Figure 1 – Views of the seat belt clip remnants, as received, with the A clip on the left and the B clip on the left.

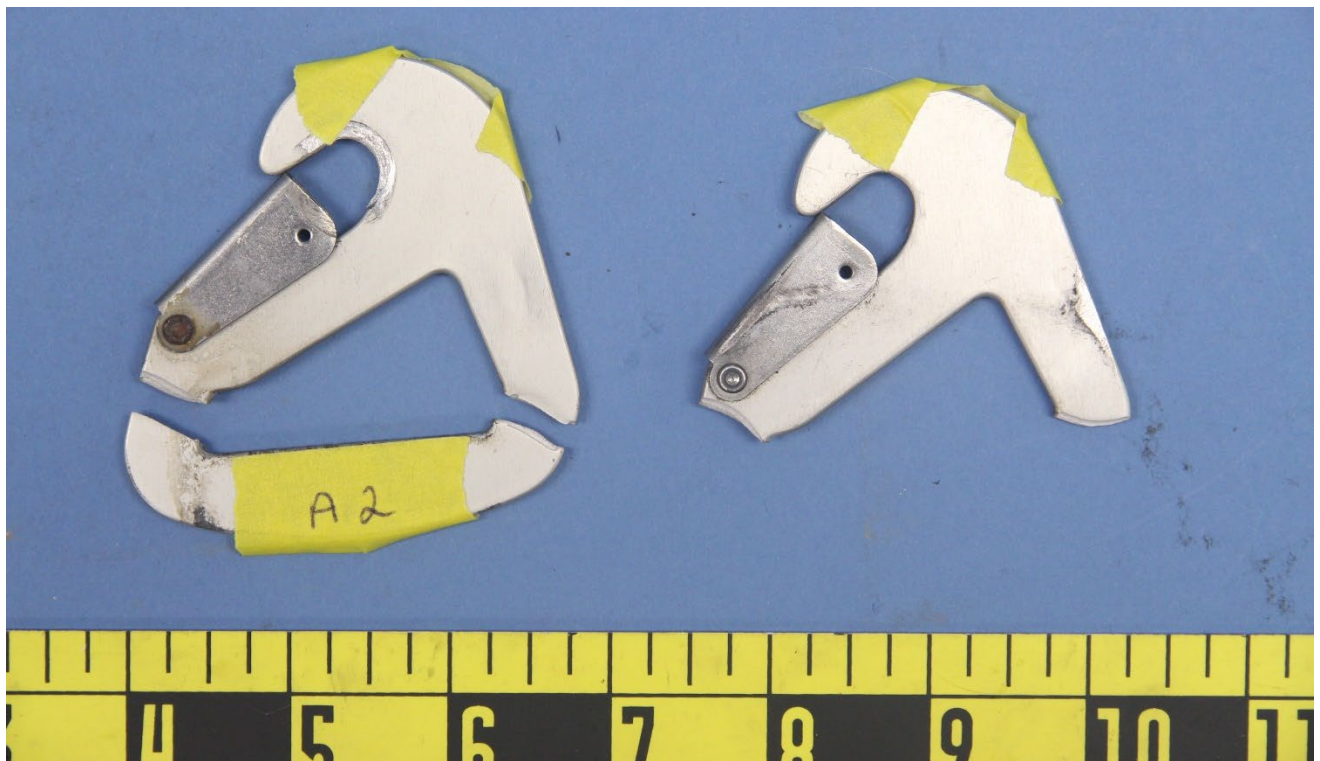
Figure 2 – Reverse views of the seat belt clips from Figure 1.

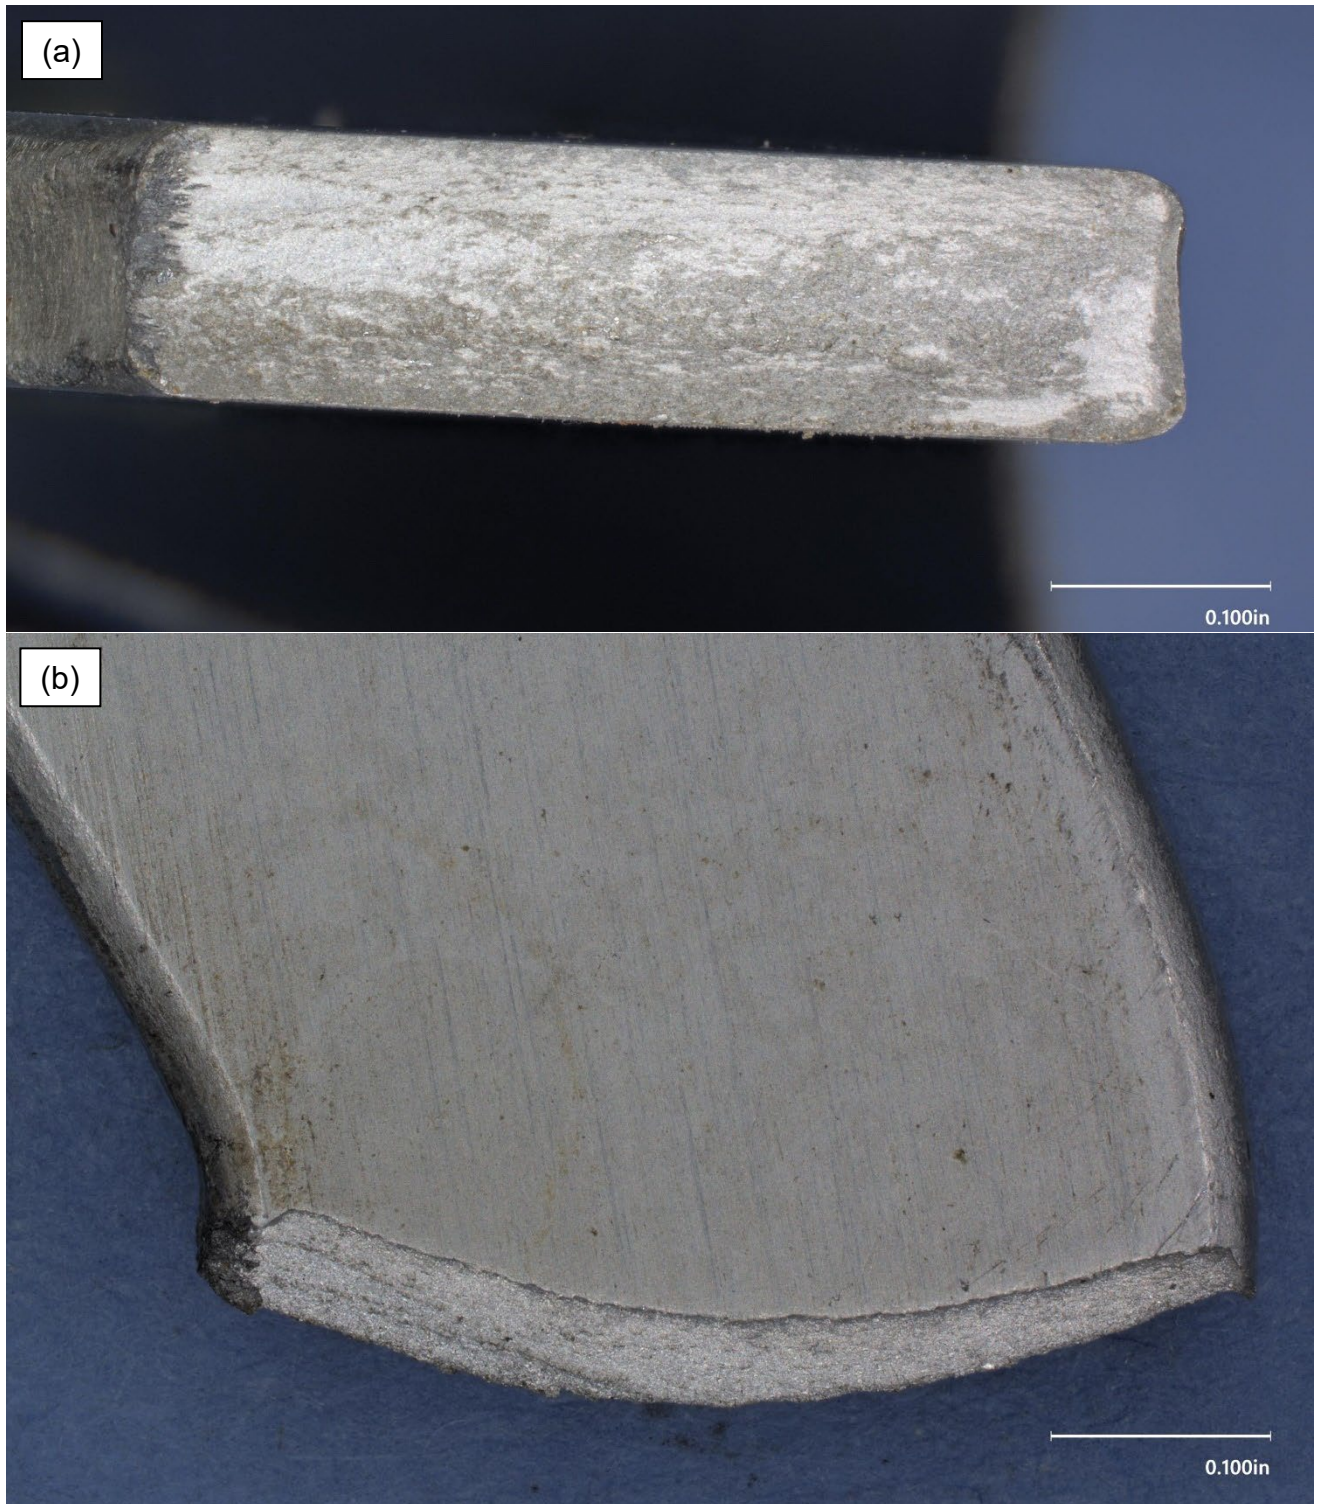
Similarly, the fracture surfaces along unriveted arms of the clips also exhibited surface features with a dull, gray luster and rough surface texture. Each of these fractures, located near the corner of the bridge, exhibited a concave orientation (see Figures 3b and 5b), though in opposite directions.

Figure 3 – View of the B clip fracture surface on the non-riveted arm from (a) the surface and (b) the side, as received.

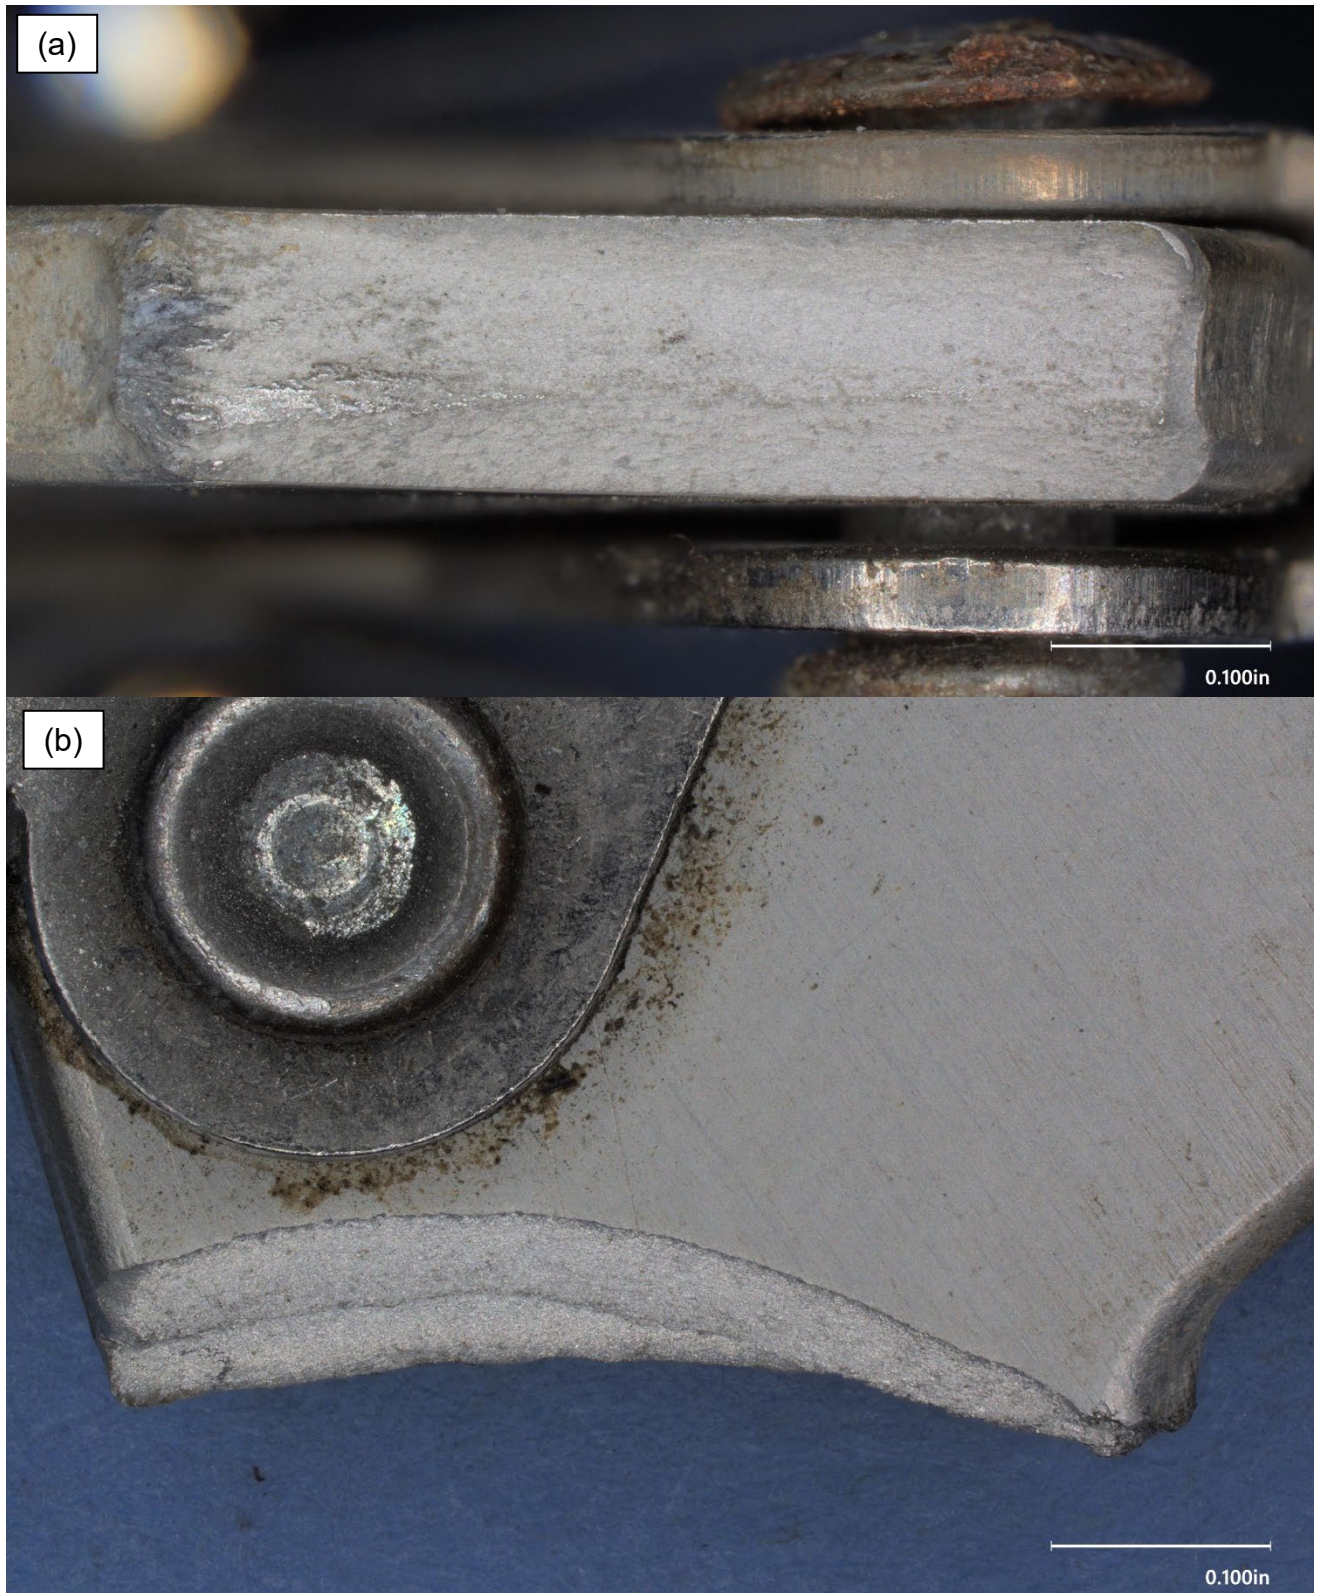
Figure 4 – View of the B clip fracture surface on the riveted arm from (a) the surface and (b) the side, as received.

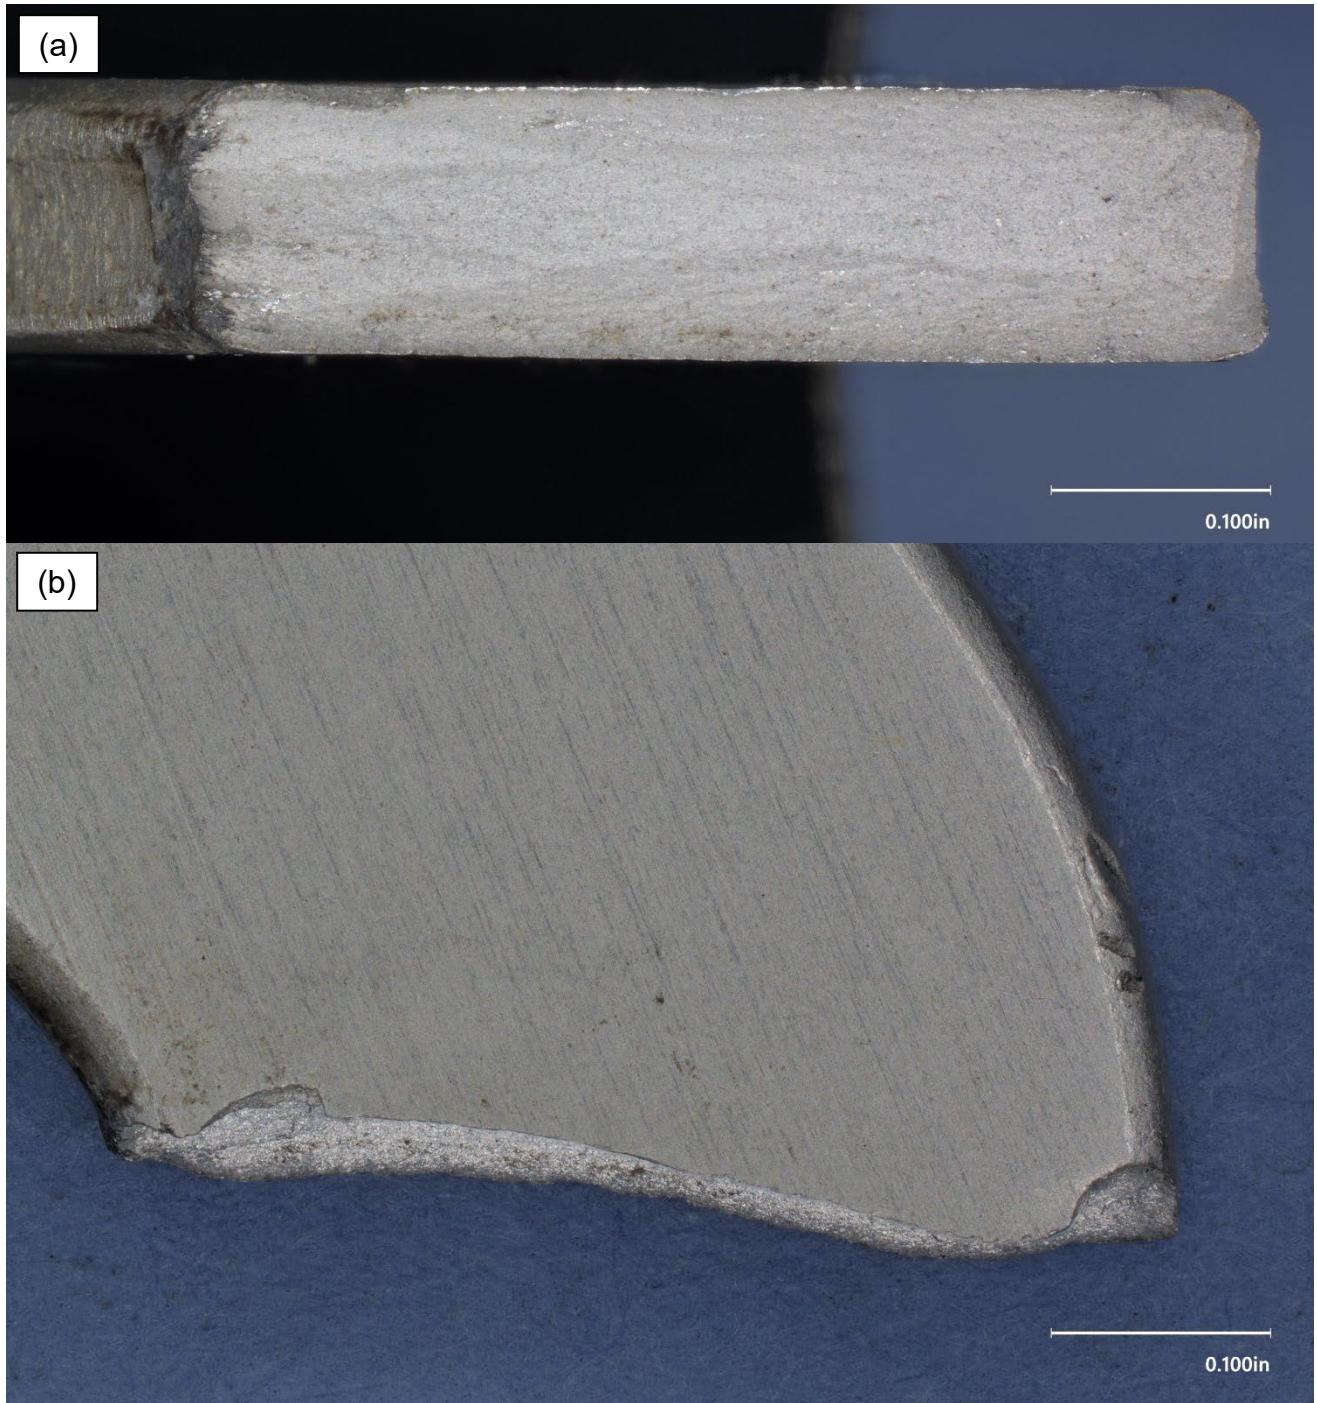
Figure 5 – View of the A clip fracture surface on the non-riveted arm from (a) the surface and (b) the side, as received.

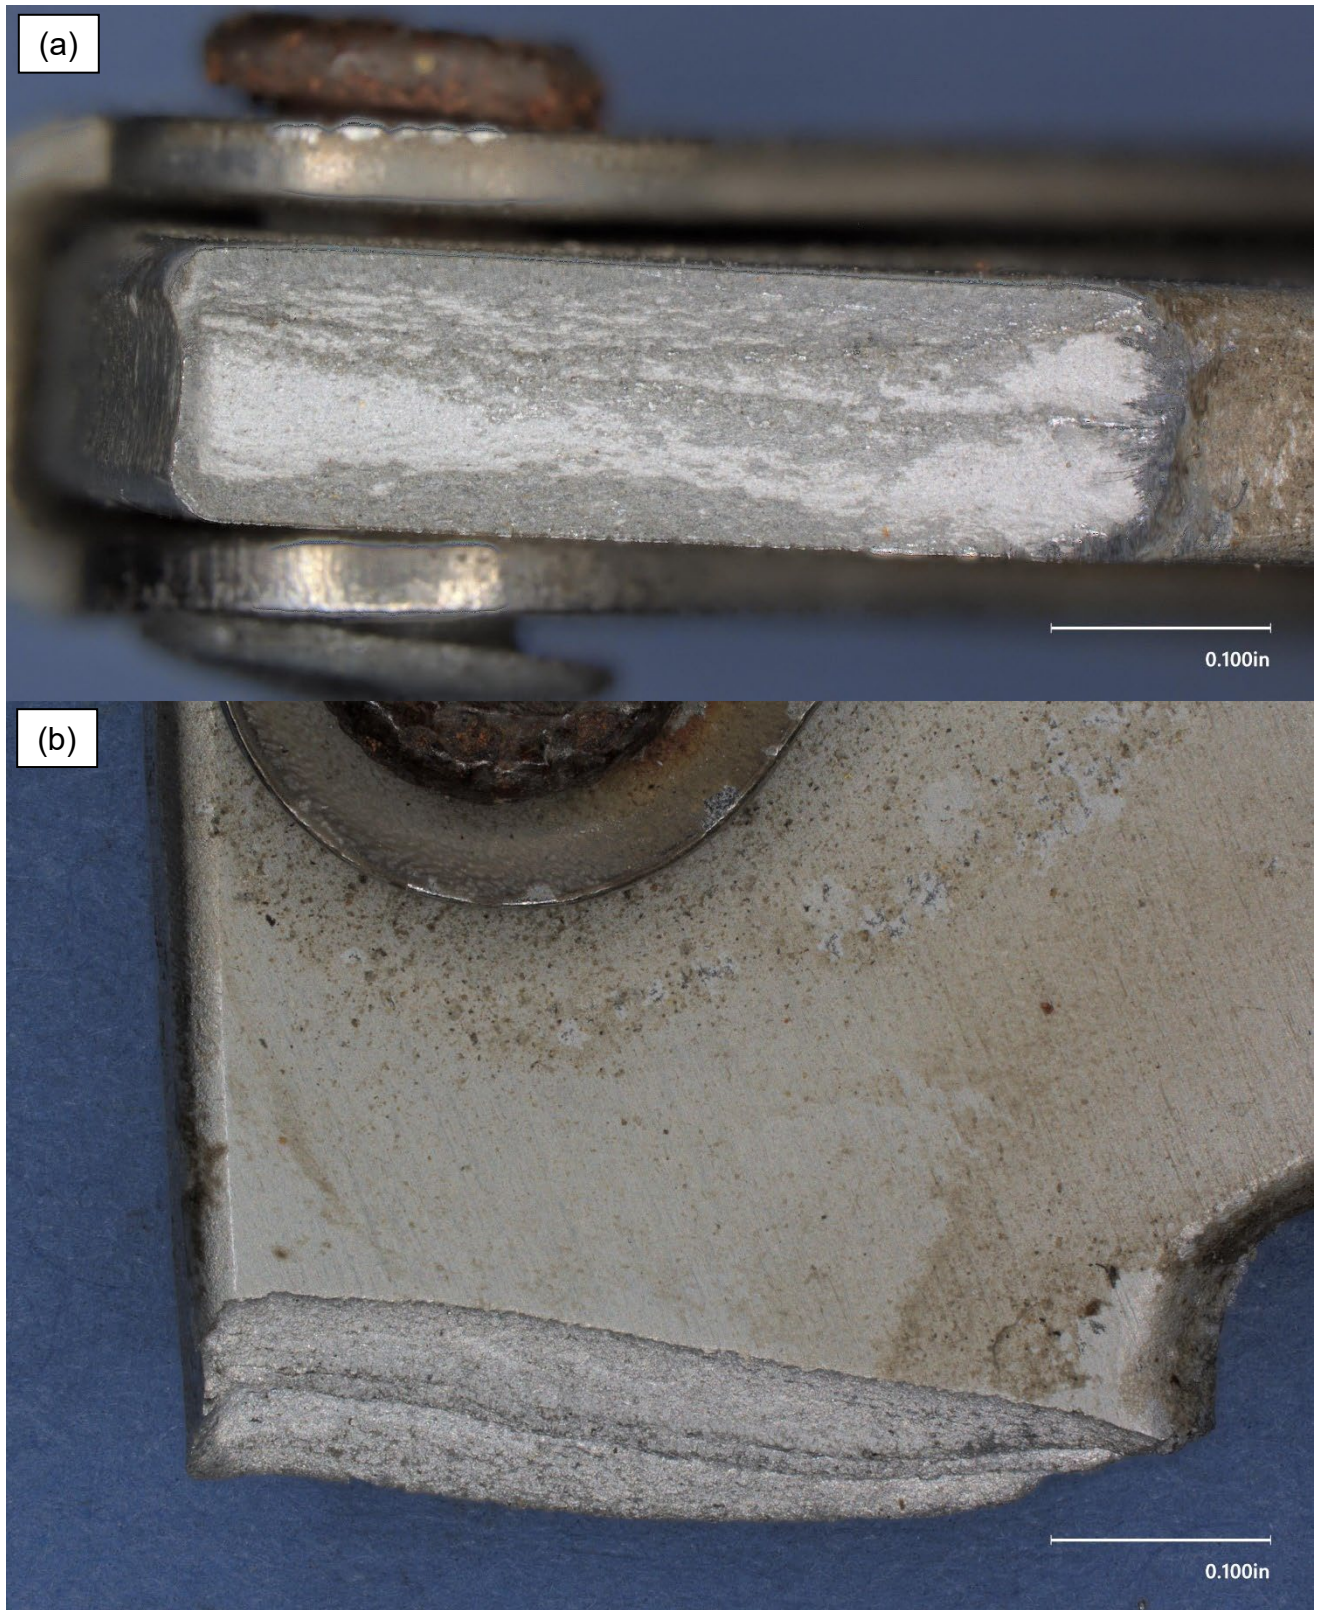
Figure 6 – View of the A clip fracture surface on the riveted arm from (a) the surface and (b) the side, as received.

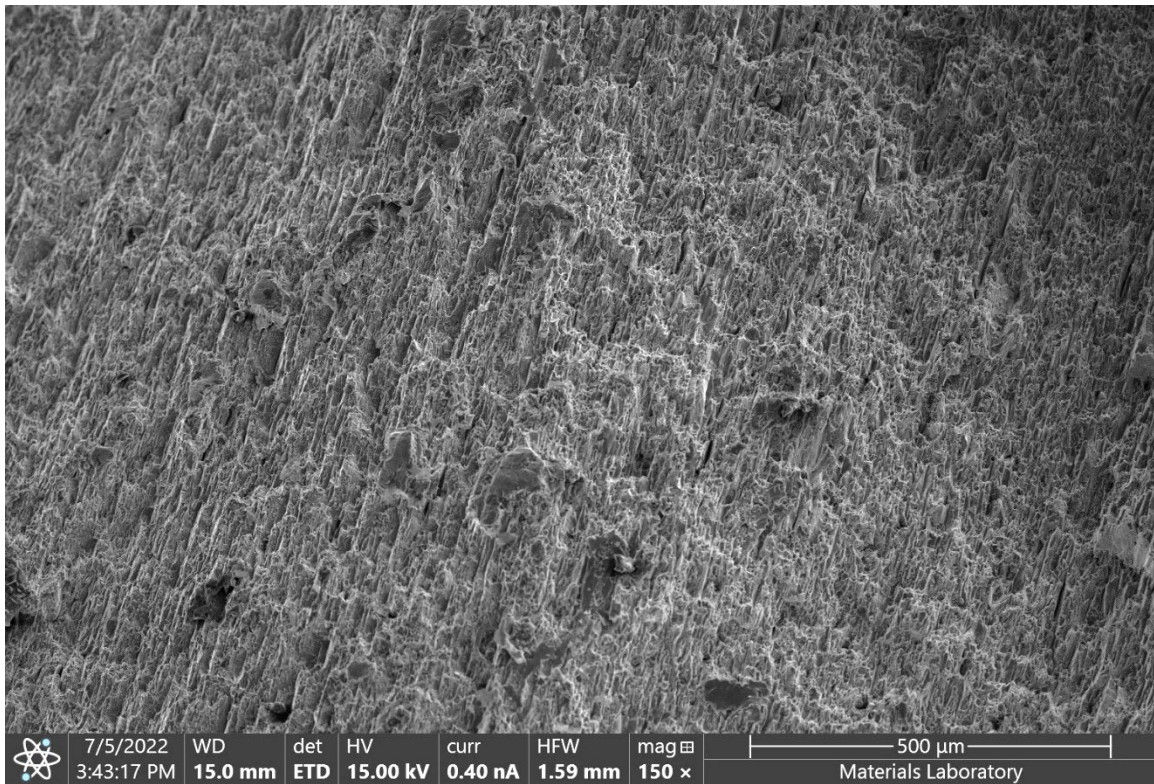
The fracture surfaces were examined as received using a scanning electron microscope (SEM). Figures 7 through 11 highlight selected areas on the A clip fracture surfaces, as the B clip fracture surfaces exhibited comparable features and patterns. Figure 7 shows a typical area of one of the clip fracture surfaces, exhibiting elongated features, consistent with the grain direction from the working of the metal in the clip shape. The tortuous surface morphology is exemplified in Figure 8, with the elongated grain structure angled in the figure from lower left to upper right. A closer view of these features revealed dimpled rupture, consistent with overstress fracture (Figure 9).

Figure 7 – Secondary electron (SE) micrograph of the fracture surface of the non-riveted arm of the A clip fracture surface.

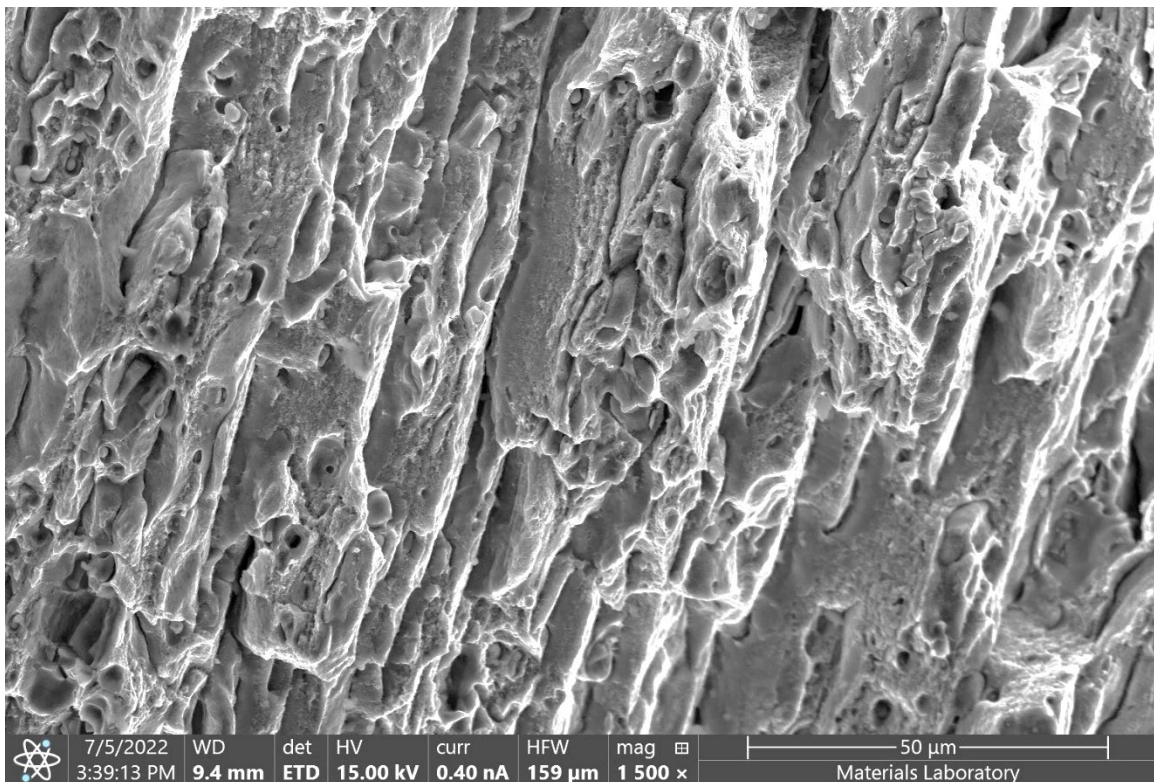
Figure 8 – SE micrograph of a closer view of fracture features in Figure 7.

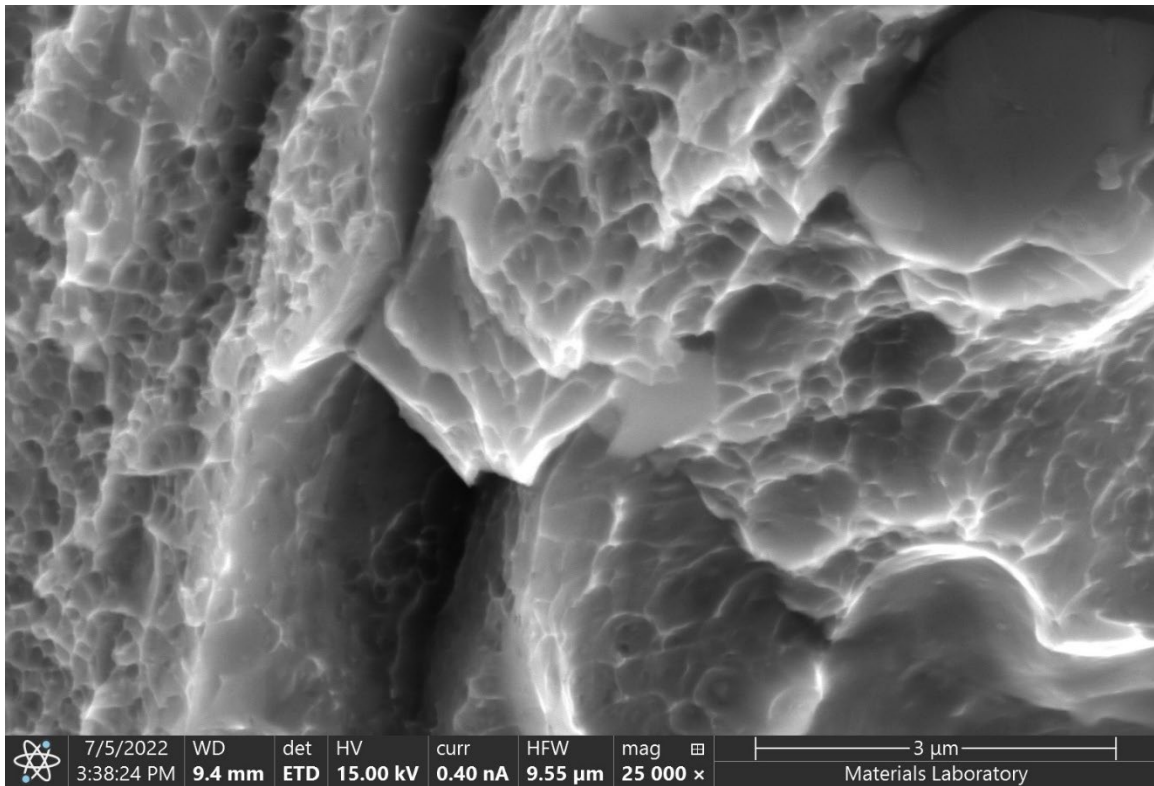
Figure 9 – SE micrograph of fine dimpled rupture in Figure 8.

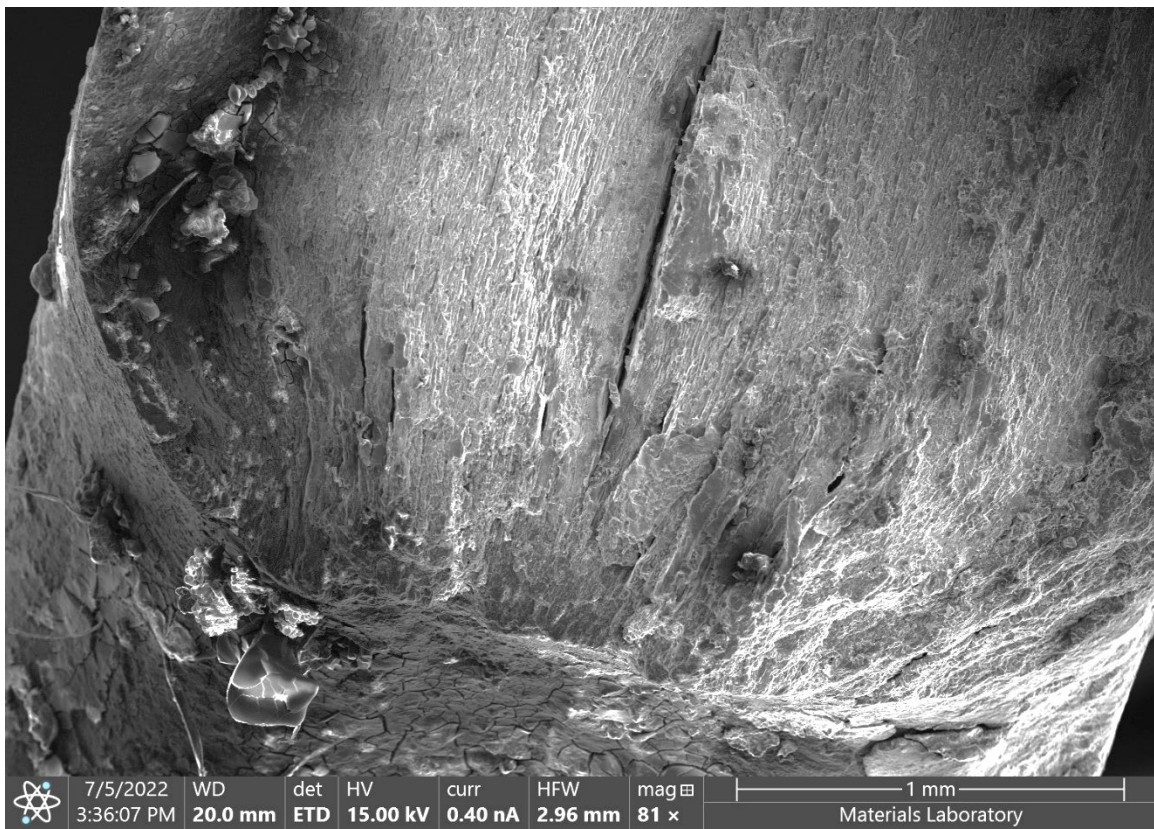
Figure 10 shows the initiation of the overstress fracture of the clasp-less arm of the A clip. At a lower magnification, the fracture surface exhibited flow lines and river patterns, consistent with the overstress fracture beginning at the inside corner and advancing outward. At the corner shown in Figure 11, there were no features consistent with pre-existing cracks or other features leading to local stress concentrations. Likewise, the opposite riveted arm of the same clip exhibited flow lines consistent with overstress fracture starting at the inside corner surface (Figure 12). Concurrent with these fracture patterns were parallel tears along the inner surface near the fracture surface.

Figure 10 – SE micrograph of the inside edge of the non-riveted arm of the A clip.

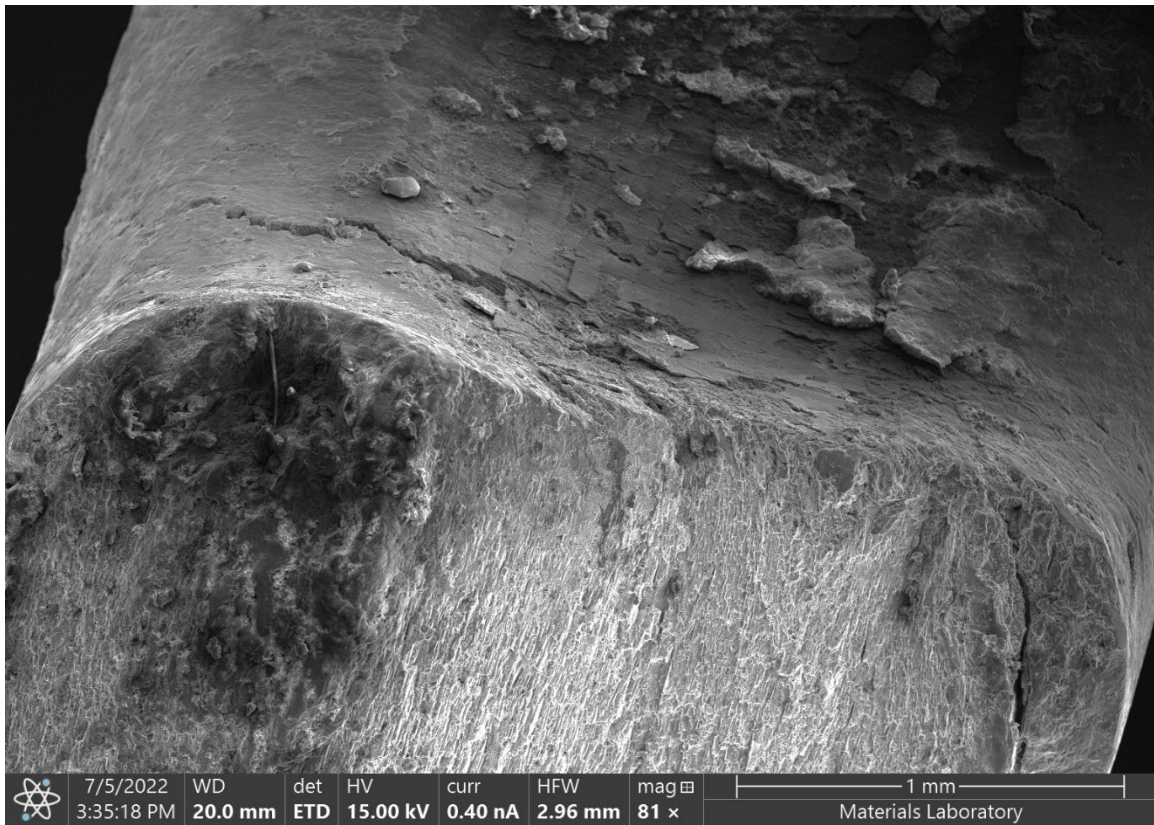
Figure 11 – SE micrograph of the inside corner of the fracture surface of the opposite riveted A-clip arm, showing tearing near and along the fracture.
