# NATIONAL TRANSPORTATION SAFETY BOARD

MATERIALS LABORATORY REVIEW REPORT

Place : Oklaunion, Texas  
Date : January 8, 2022  
Vehicle : BNSF Railway freight train/Ethanol tank car  
NTSB No. : HMD22LR001  
Investigator : Paul Stancil  
RPH-20

# Thermal Testing of Polymeric Railcar Gasket

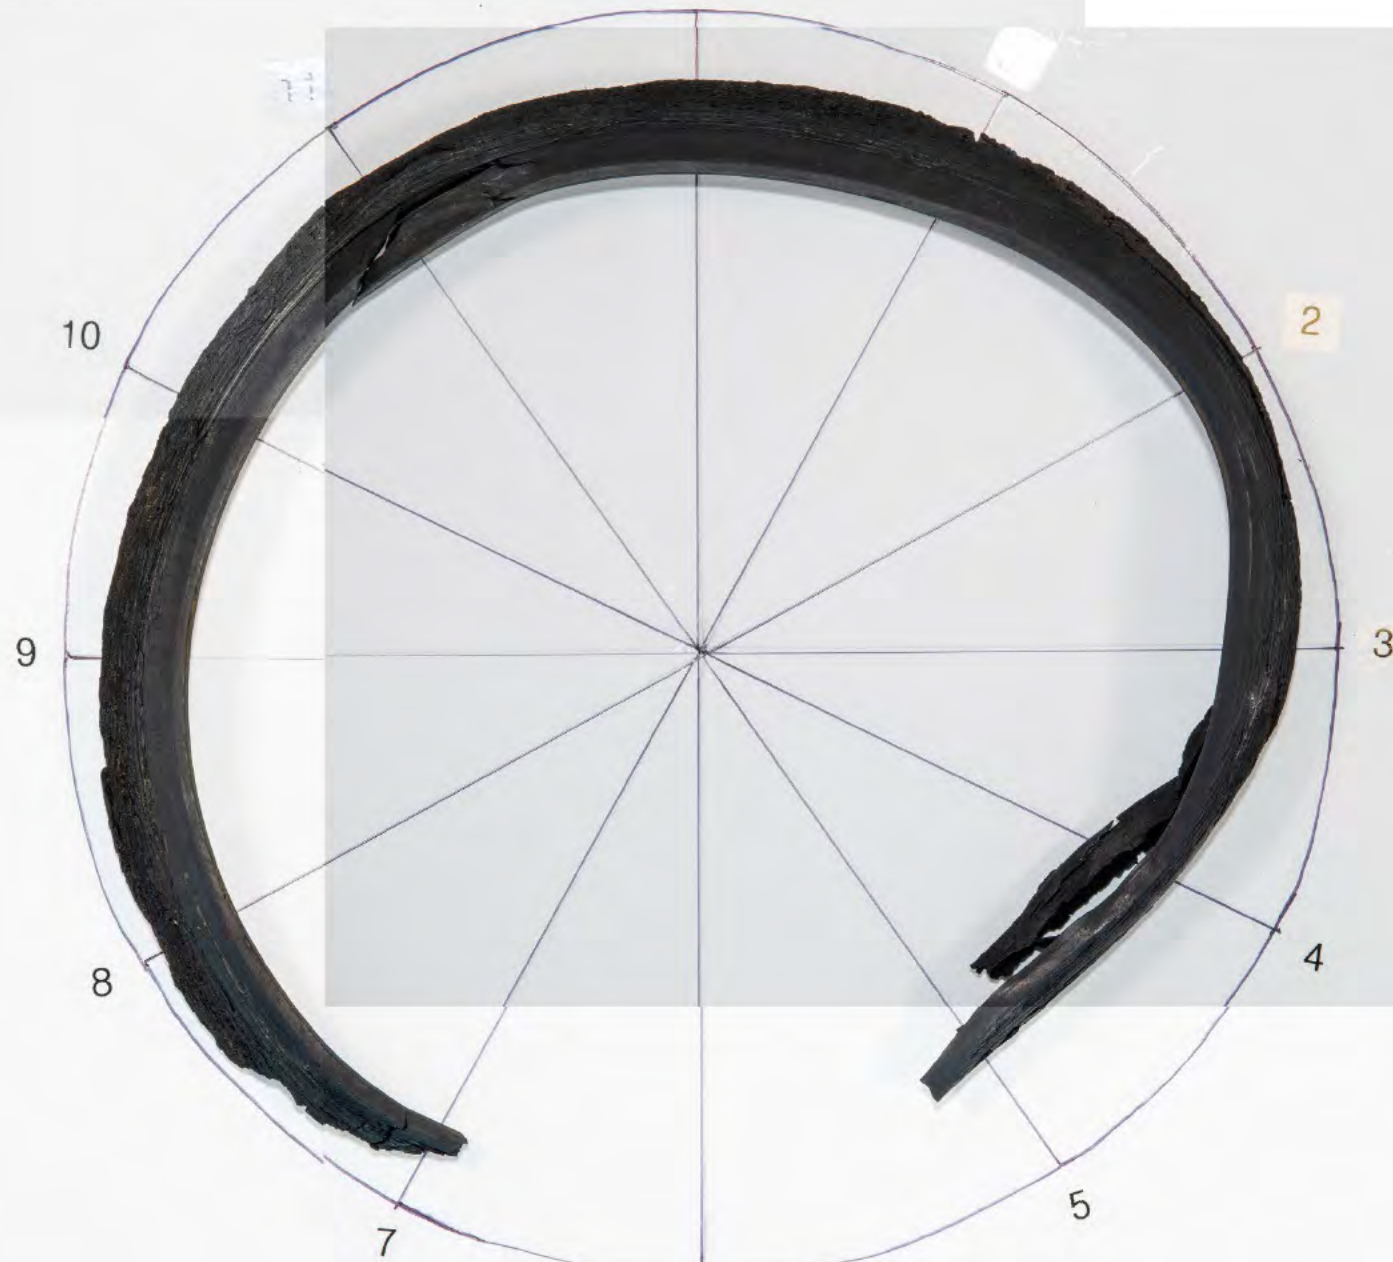
Gasket Collage Front

The subject gasket is circular in shape, approximately 12 inches in diameter, comprised of a black rubber material. The width of the gasket is 1.000 inch, and the thickness of the gasket is approximately 0.250 inches. The overall appearance of the two sides of the gasket is shown in Figures 1 and 2 of Appendix A.

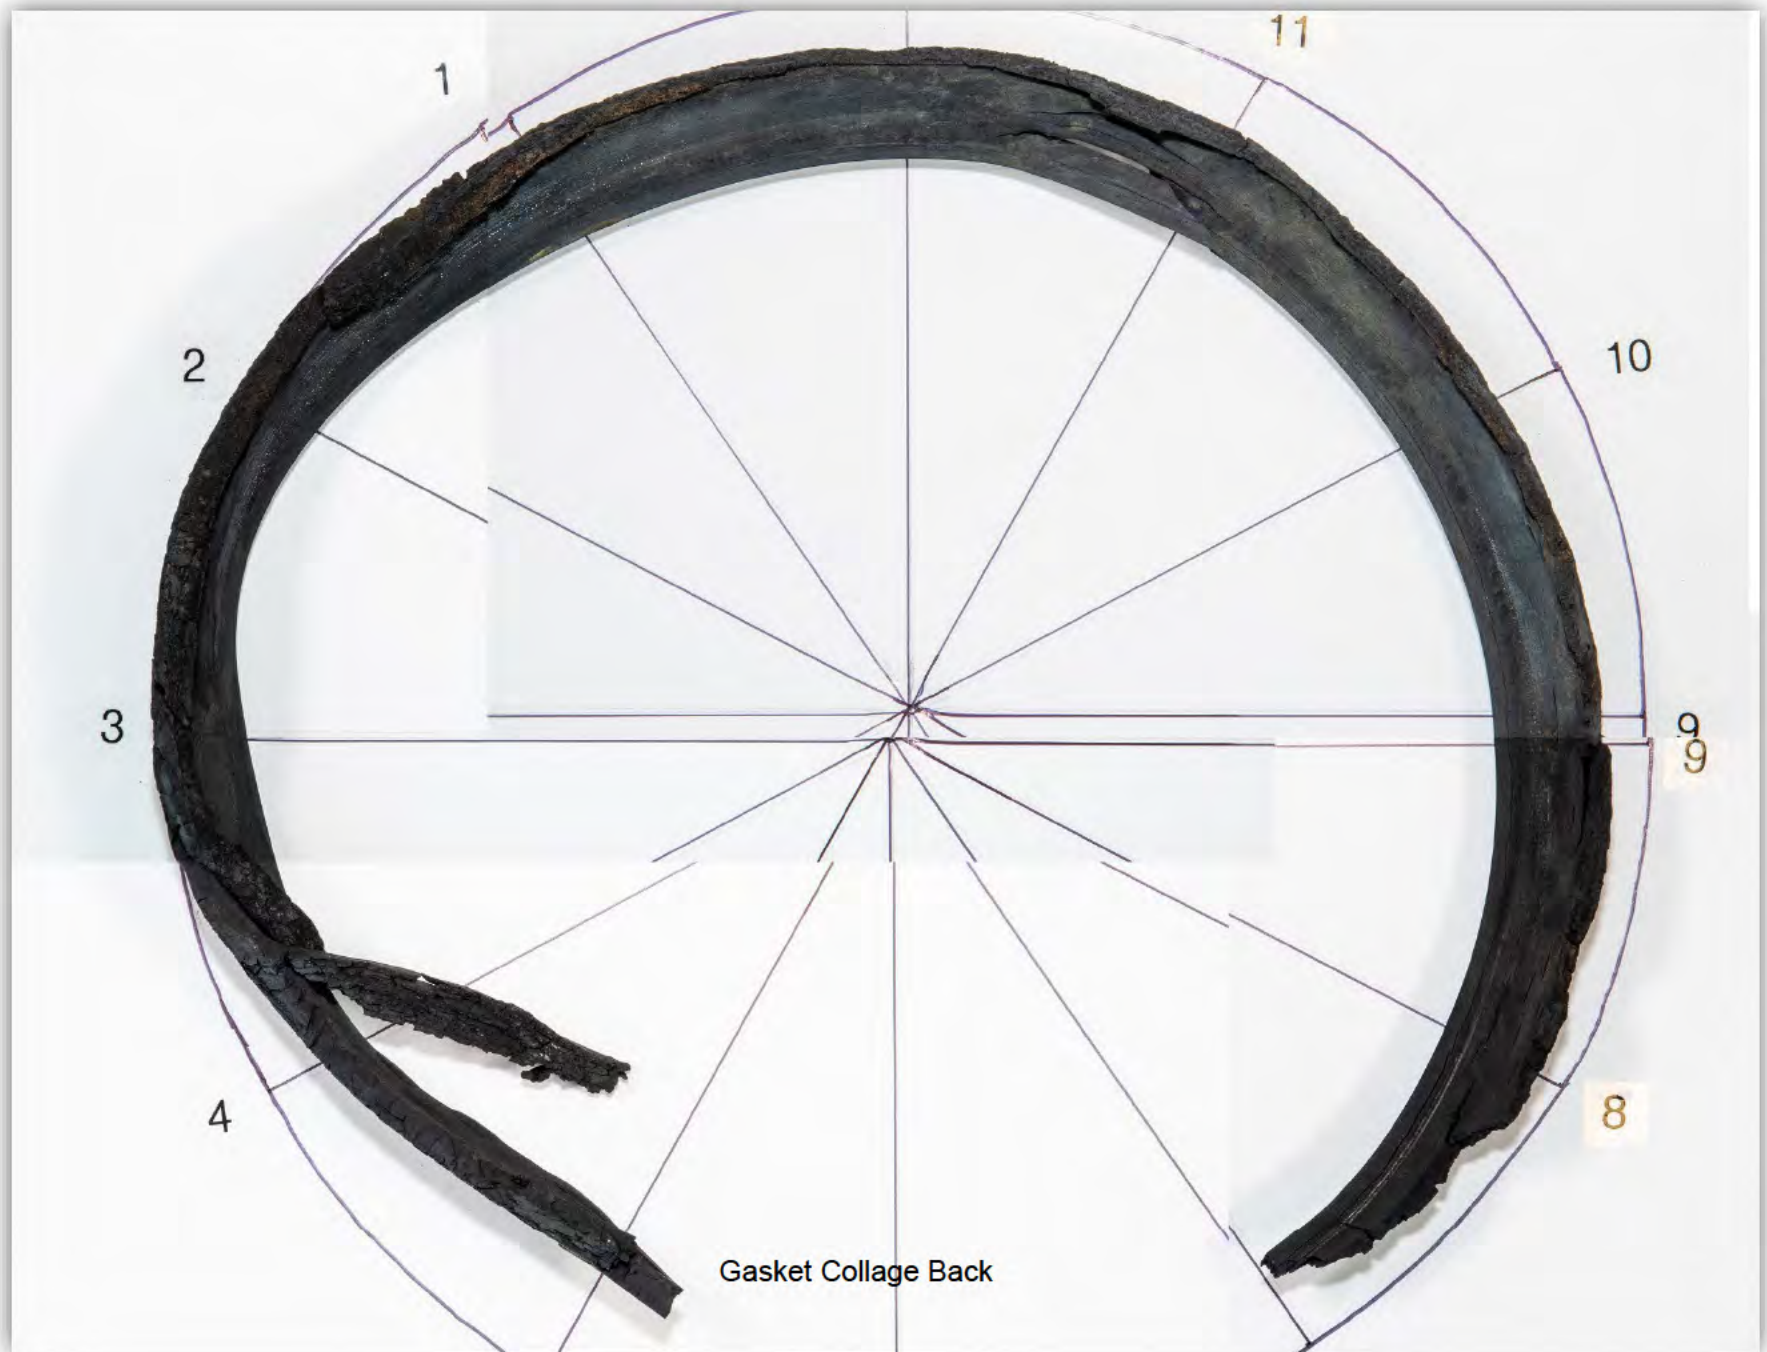
Figure 1

The gasket material near the section where there is gasket material missing appears to have the most affected surface. The rubber gasket at this location (4 o'clock, Figure 1) is significantly cracked and exhibits alligator skin type of morphology. Figures 3-10 in Appendix A show the appearance of the surface condition of the subject gasket around the four quadrants of the gasket.

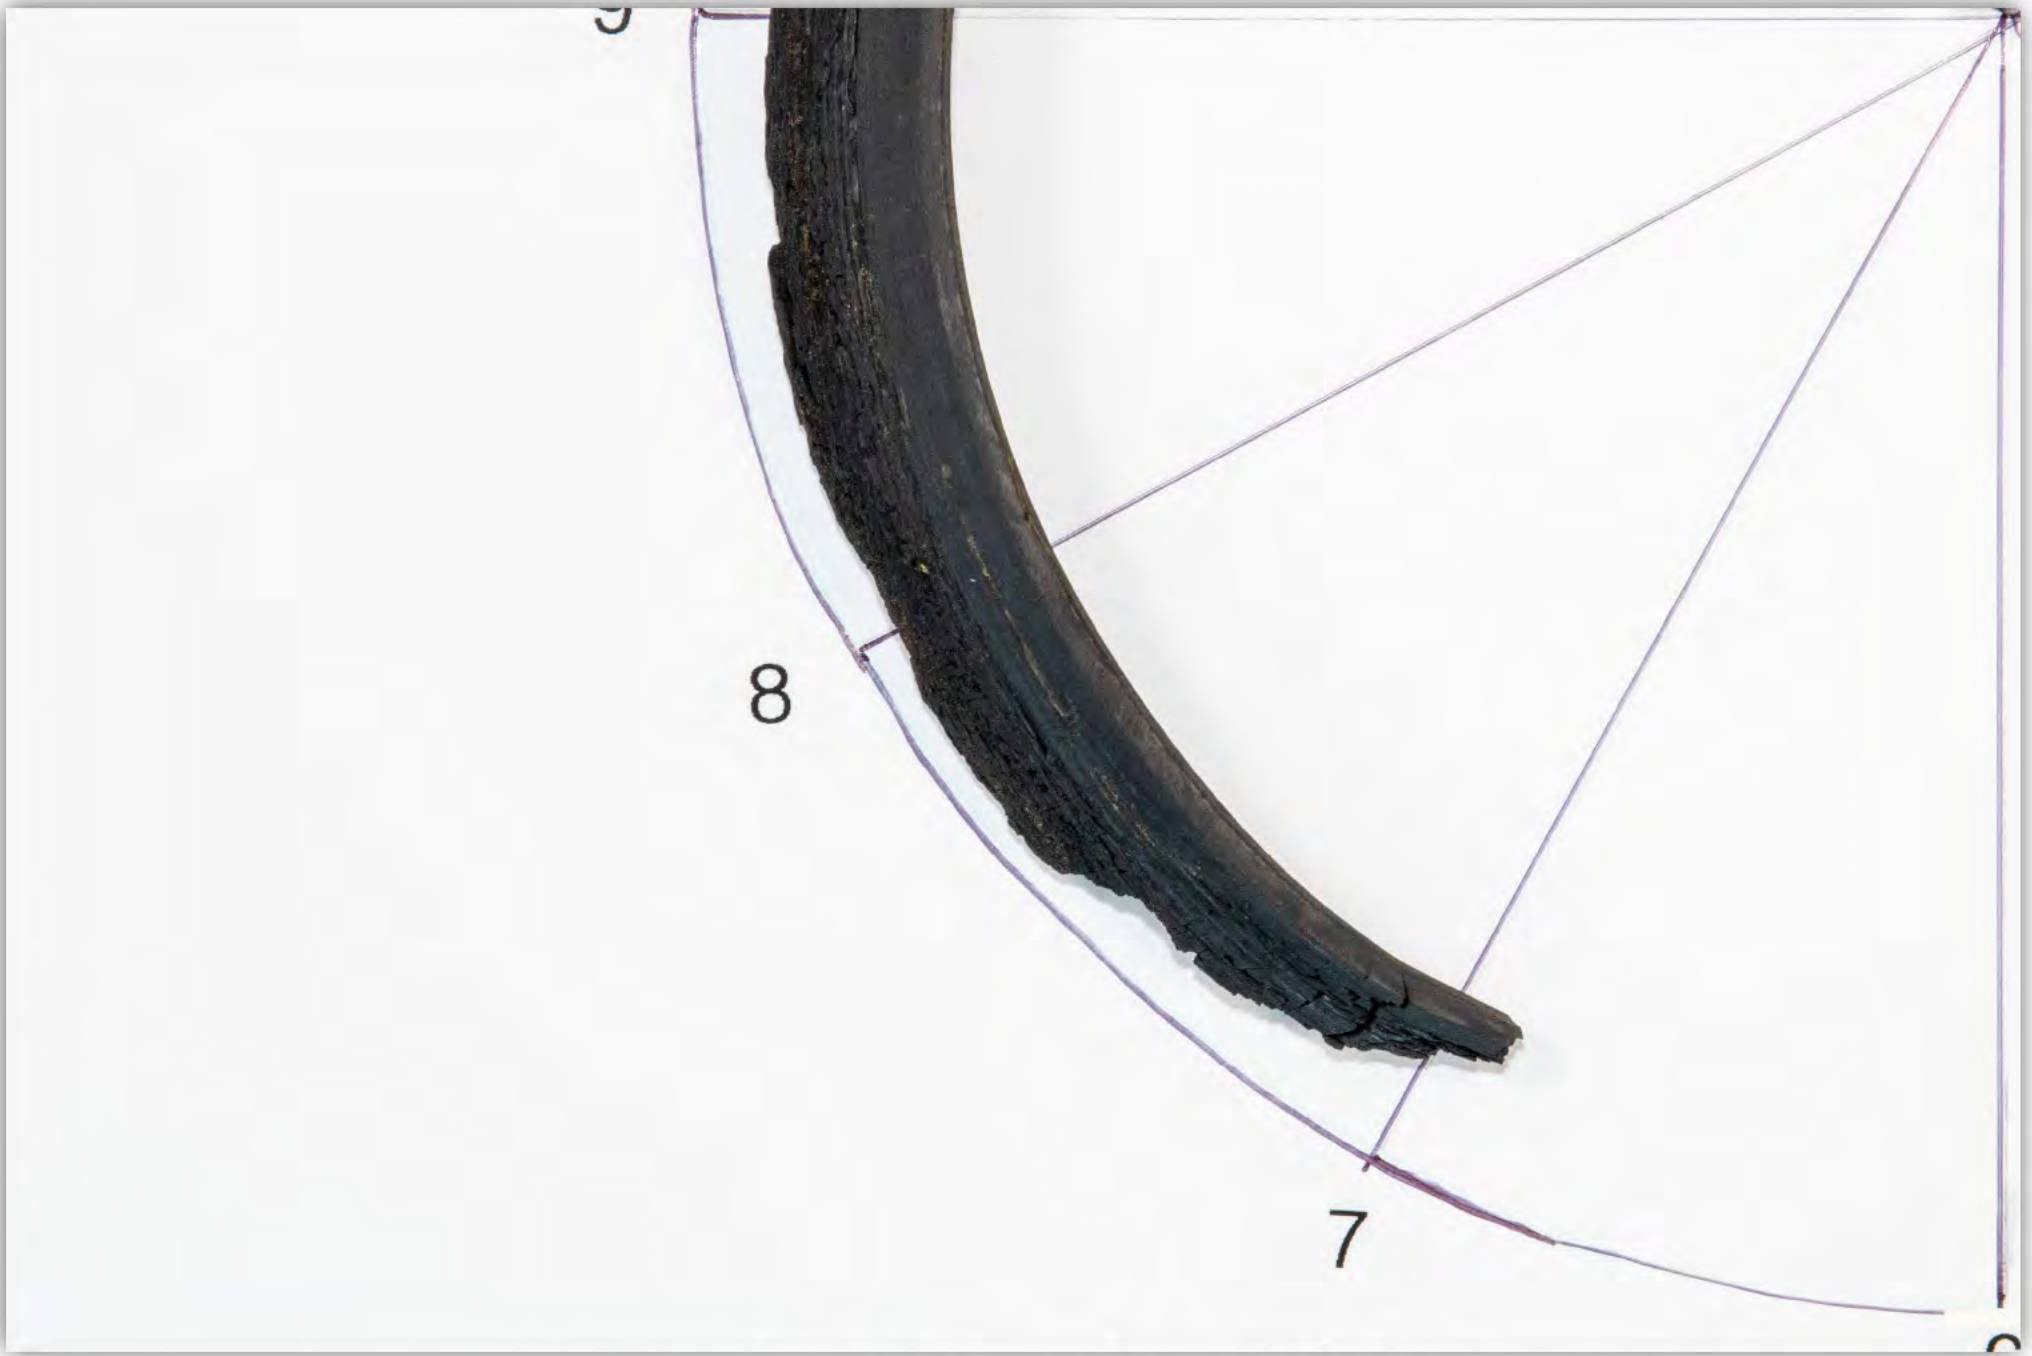
ESi did not find any product identification printed or any embossed lettering on the subject gasket surface. There is a portion of the gasket material between the 5 o'clock and 7 o'clock position that is missing and was not provided. There is evidence of greater thermal exposure of the gasket around the outer edges of the gasket. There is material fracture at various locations on the gasket with the most noticeable fracture at the 4 o'clock to 5 o'clock location as well as directly opposite at the 11 o'clock location.

Figure 4. Front quadrant between 3 & 6 o'clock

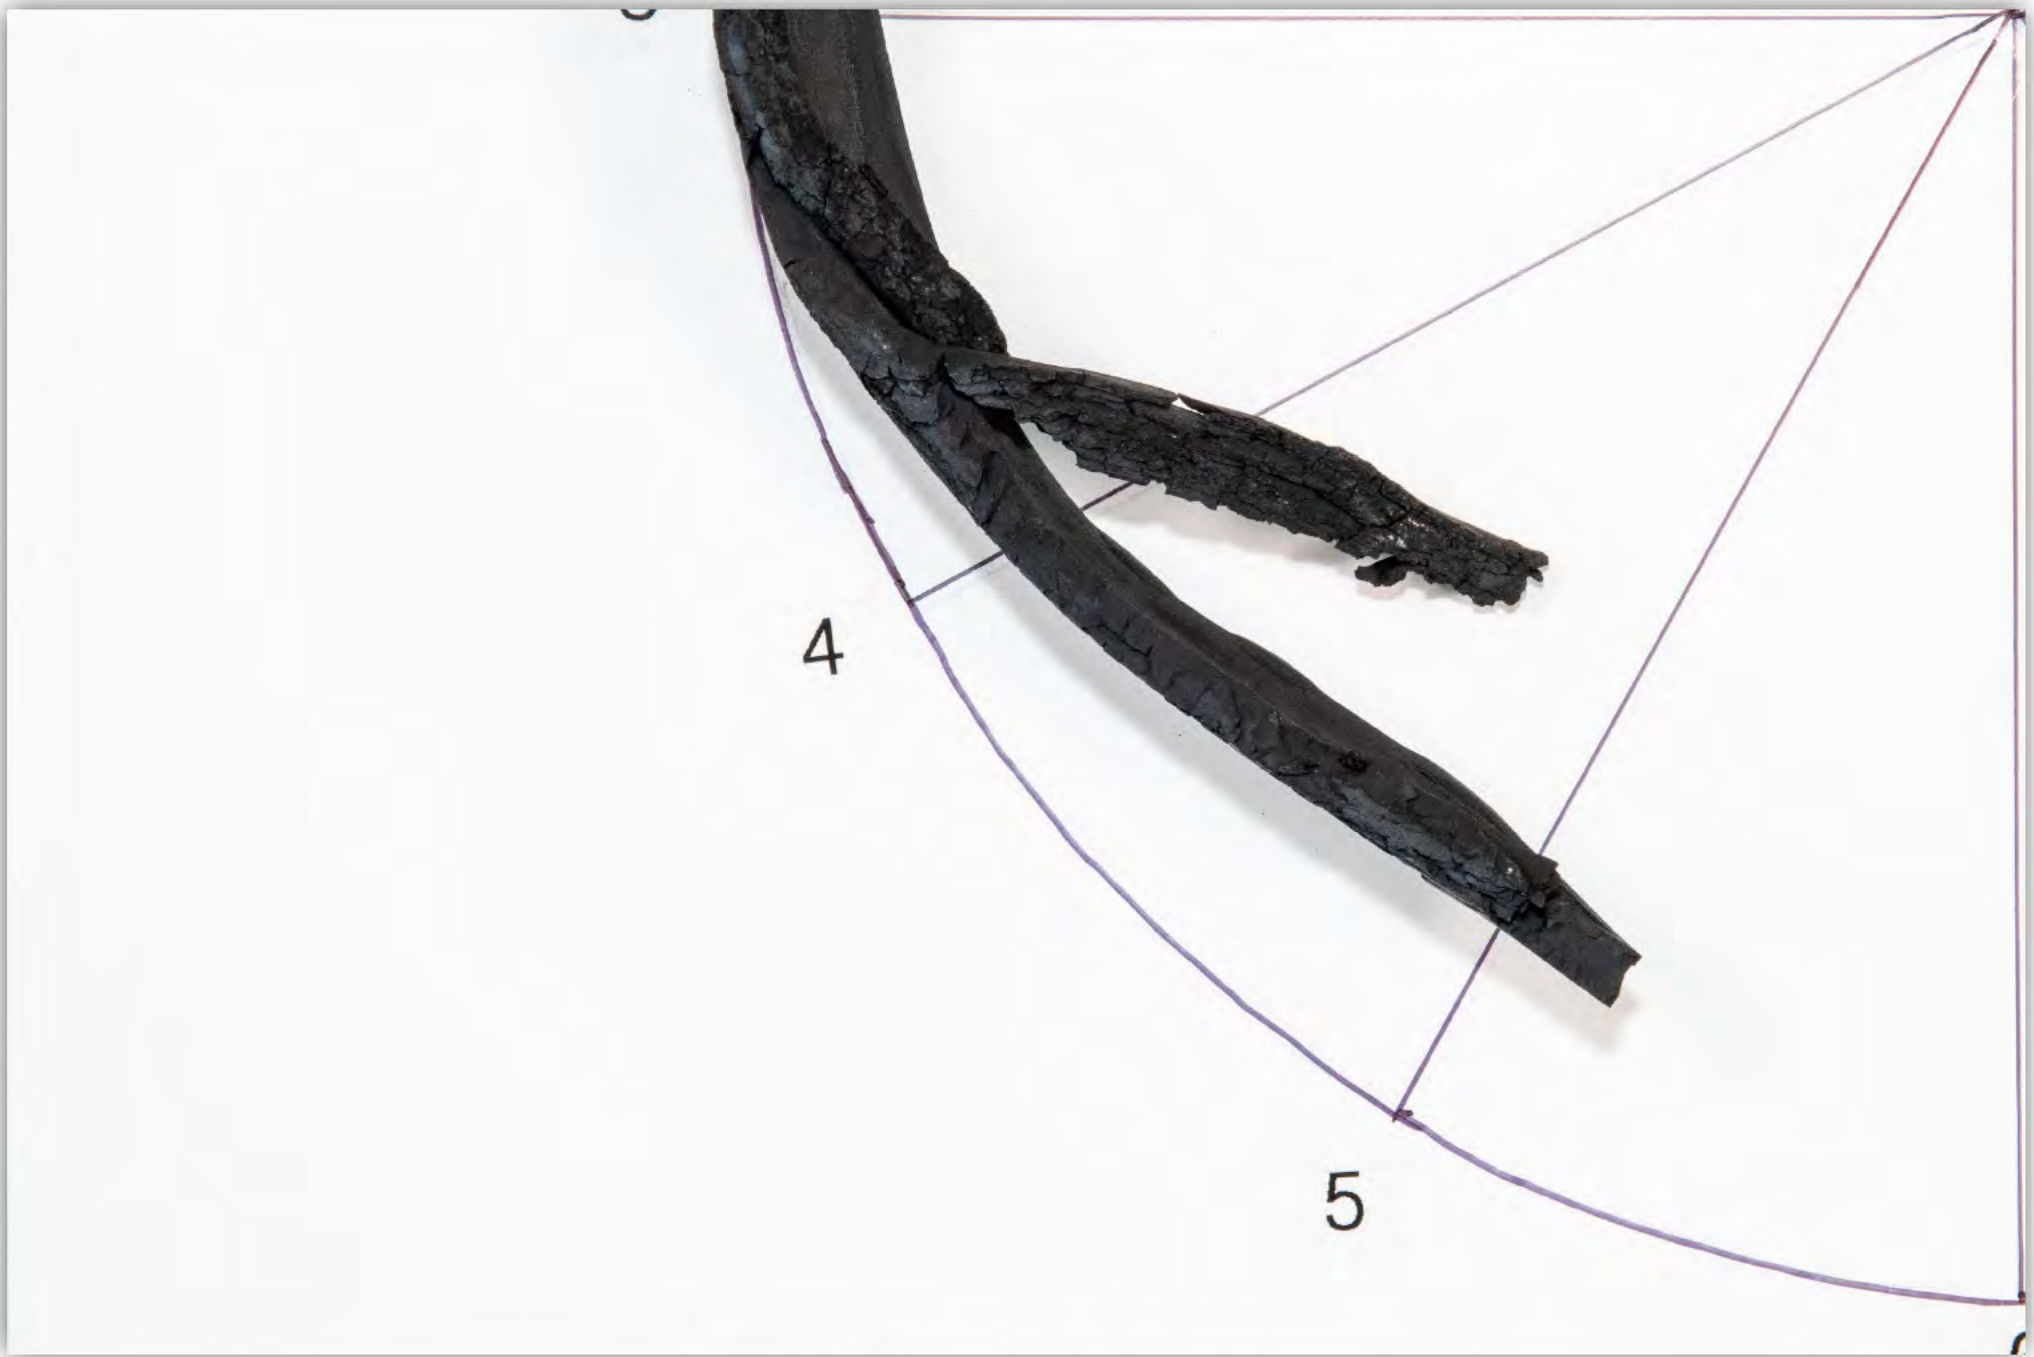
Figure 8. Backside quadrant between 12& 3 o'clock

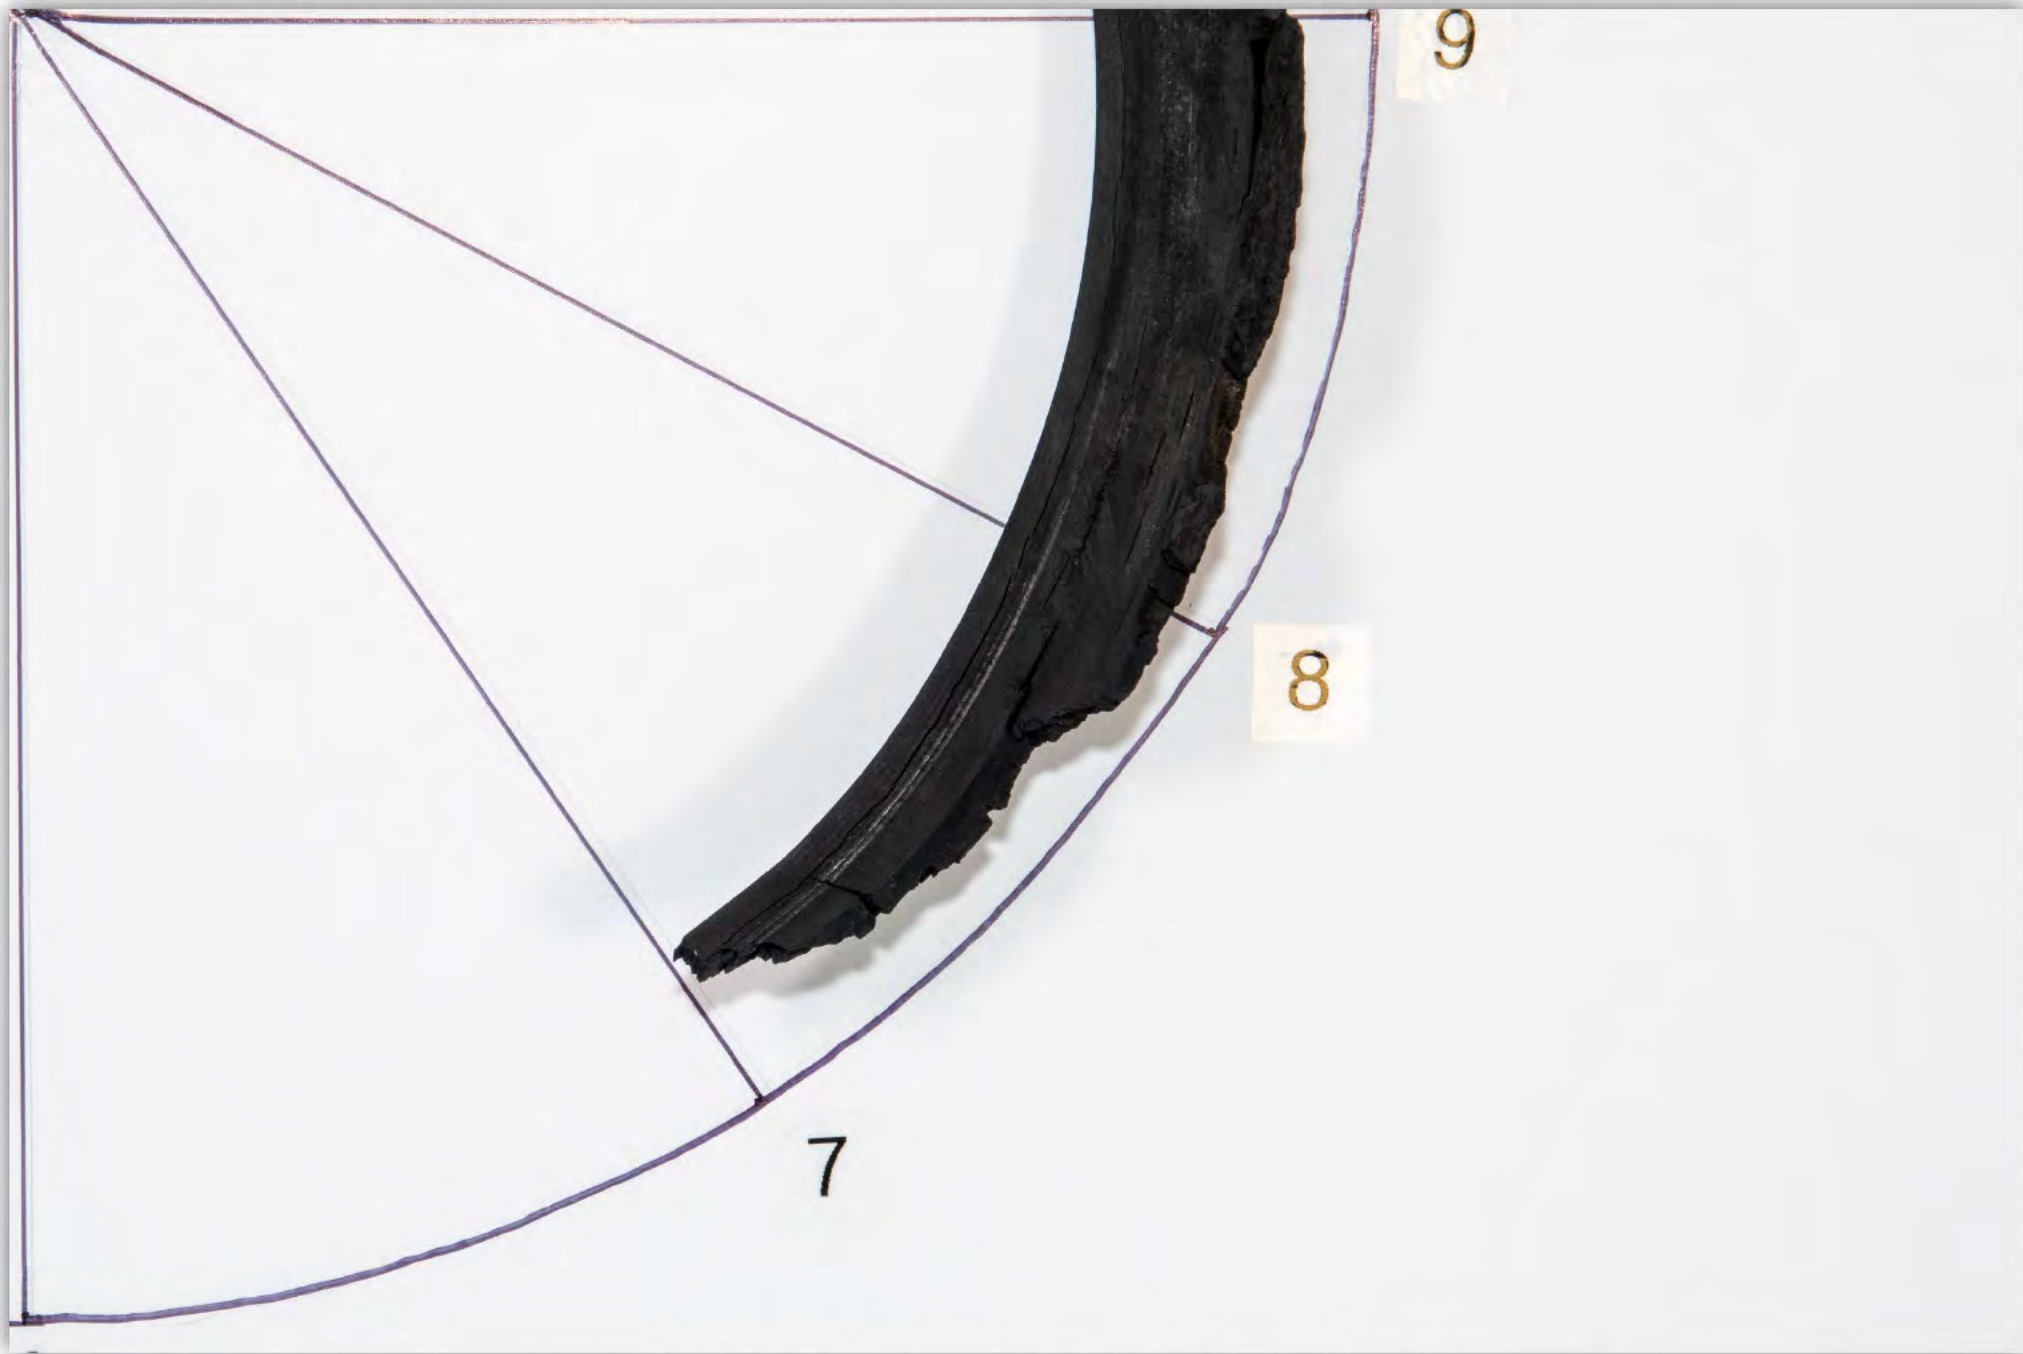
Figure 9. Backside quadrant between 3 & 6 o'clock

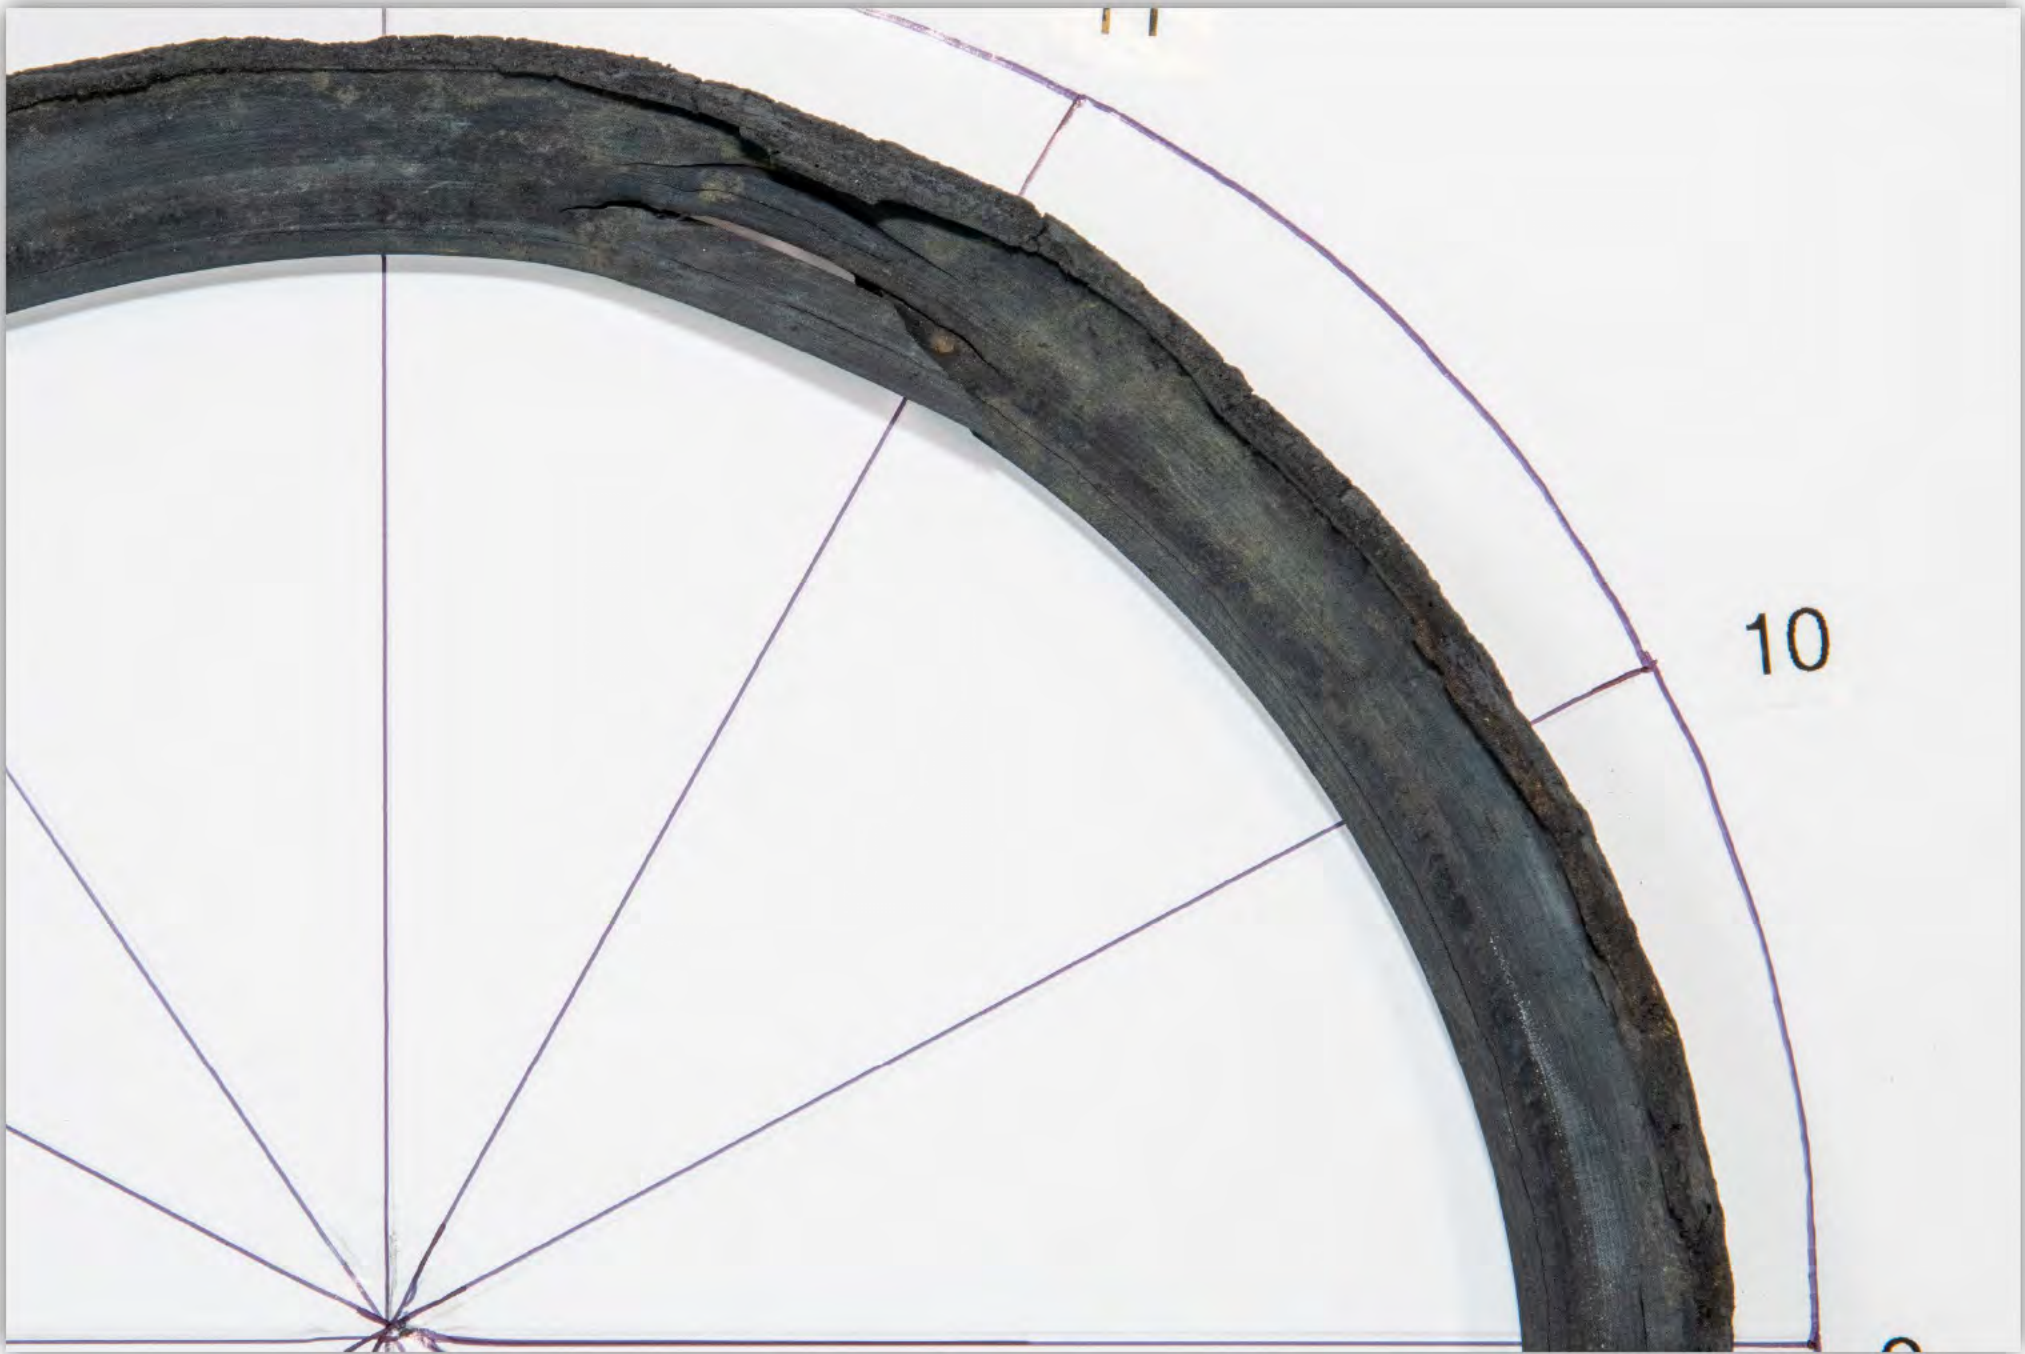
Figure 10. Backside quadrant between 6 & 9 o'clock

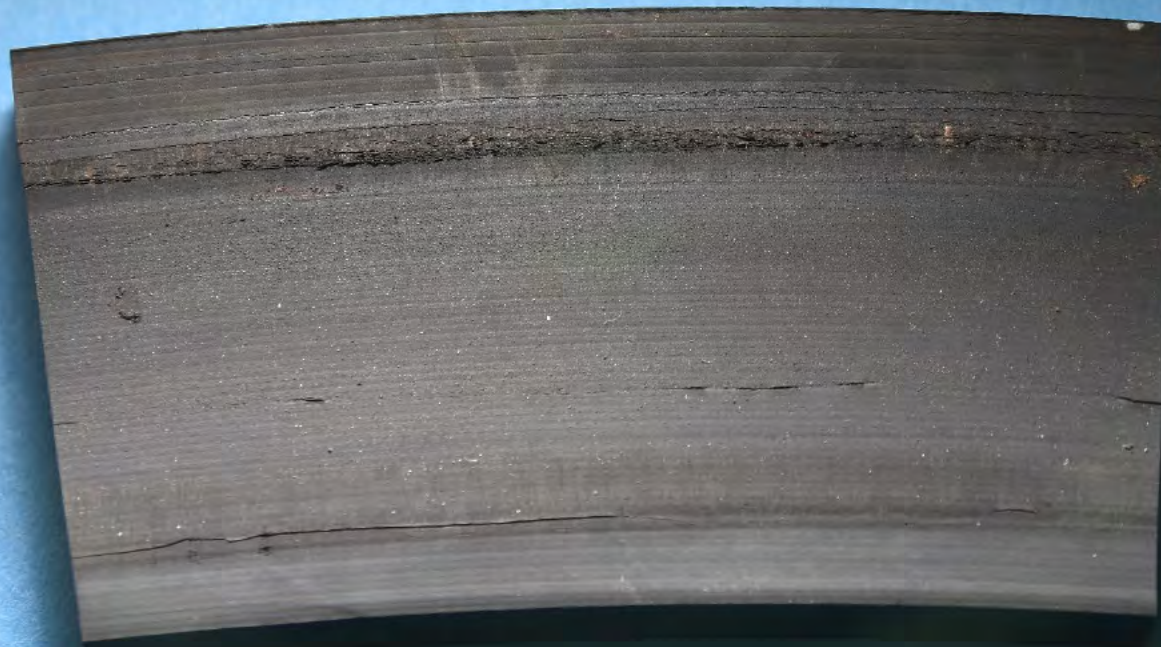
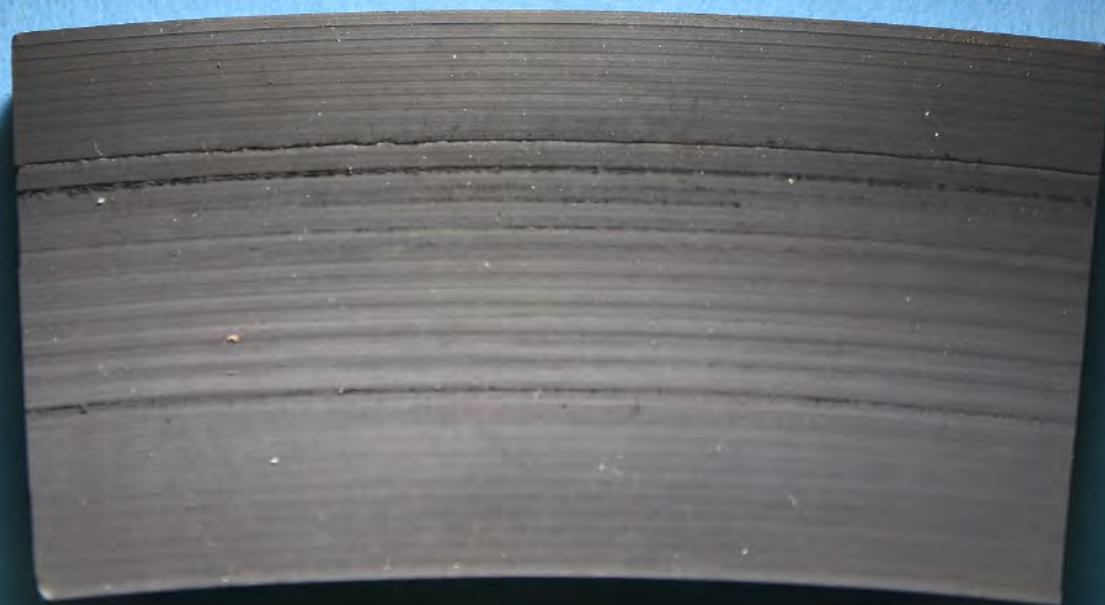
(3) 250 Deg. C.

The photos after the thermal exposure testing showing the surface appearance of the lab samples tested in the range of 250 to 350 degrees Celsius show a surface that is comparatively similar to the different locations of the subject gasket material. The thermal exposure in the range of 250–300-degrees Celsius leads to formation of micro-cracks on the surface, and as temperature increases to 350, there is evidence of tearing, separation of material between the network of cracks, and hardening of the rubber material. Above 350 degrees Celsius, the rubber material ignited and formed very fragile char that broke easily.

Testing at 250 degrees Celsius front side burn tested

Testing at 250 degrees Celsius back side burn tested
