# NATIONAL TRANSPORTATION SAFETY BOARD

MATERIALS LABORATORY REVIEW REPORT

Place : Oklaunion, Texas  
Date : January 8, 2022  
Vehicle : BNSF Railway freight train/Ethanol tank car  
NTSB No. : HMD22LR001  
Investigator : Paul Stancil  
RPH-20

# Thermal Testing of Polymeric Railcar Gasket

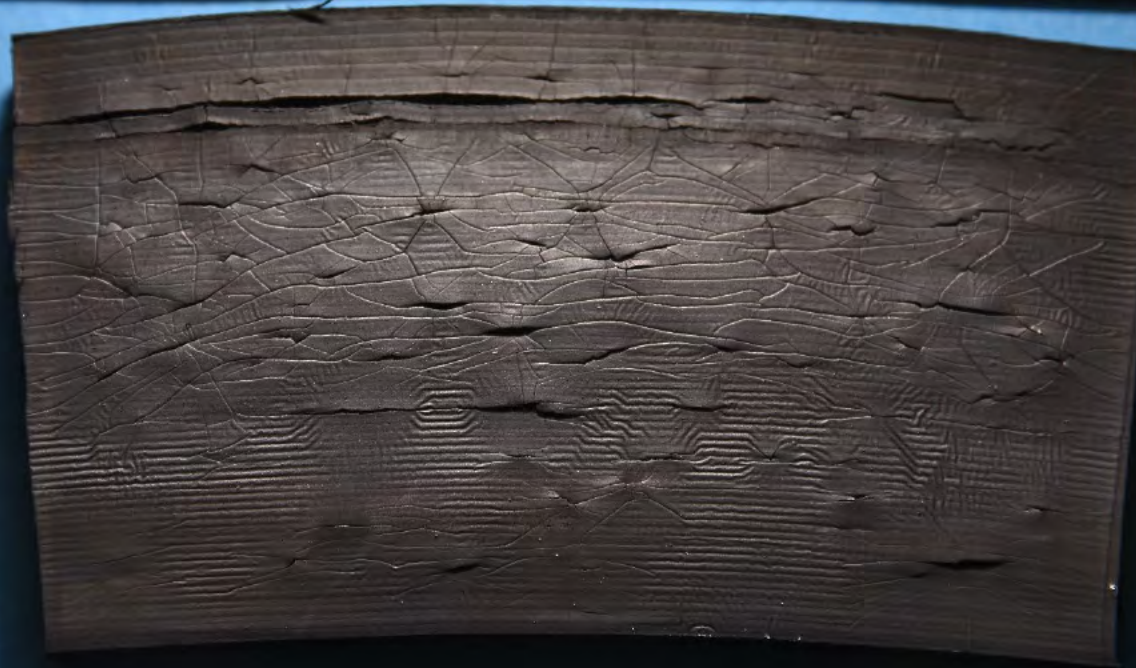
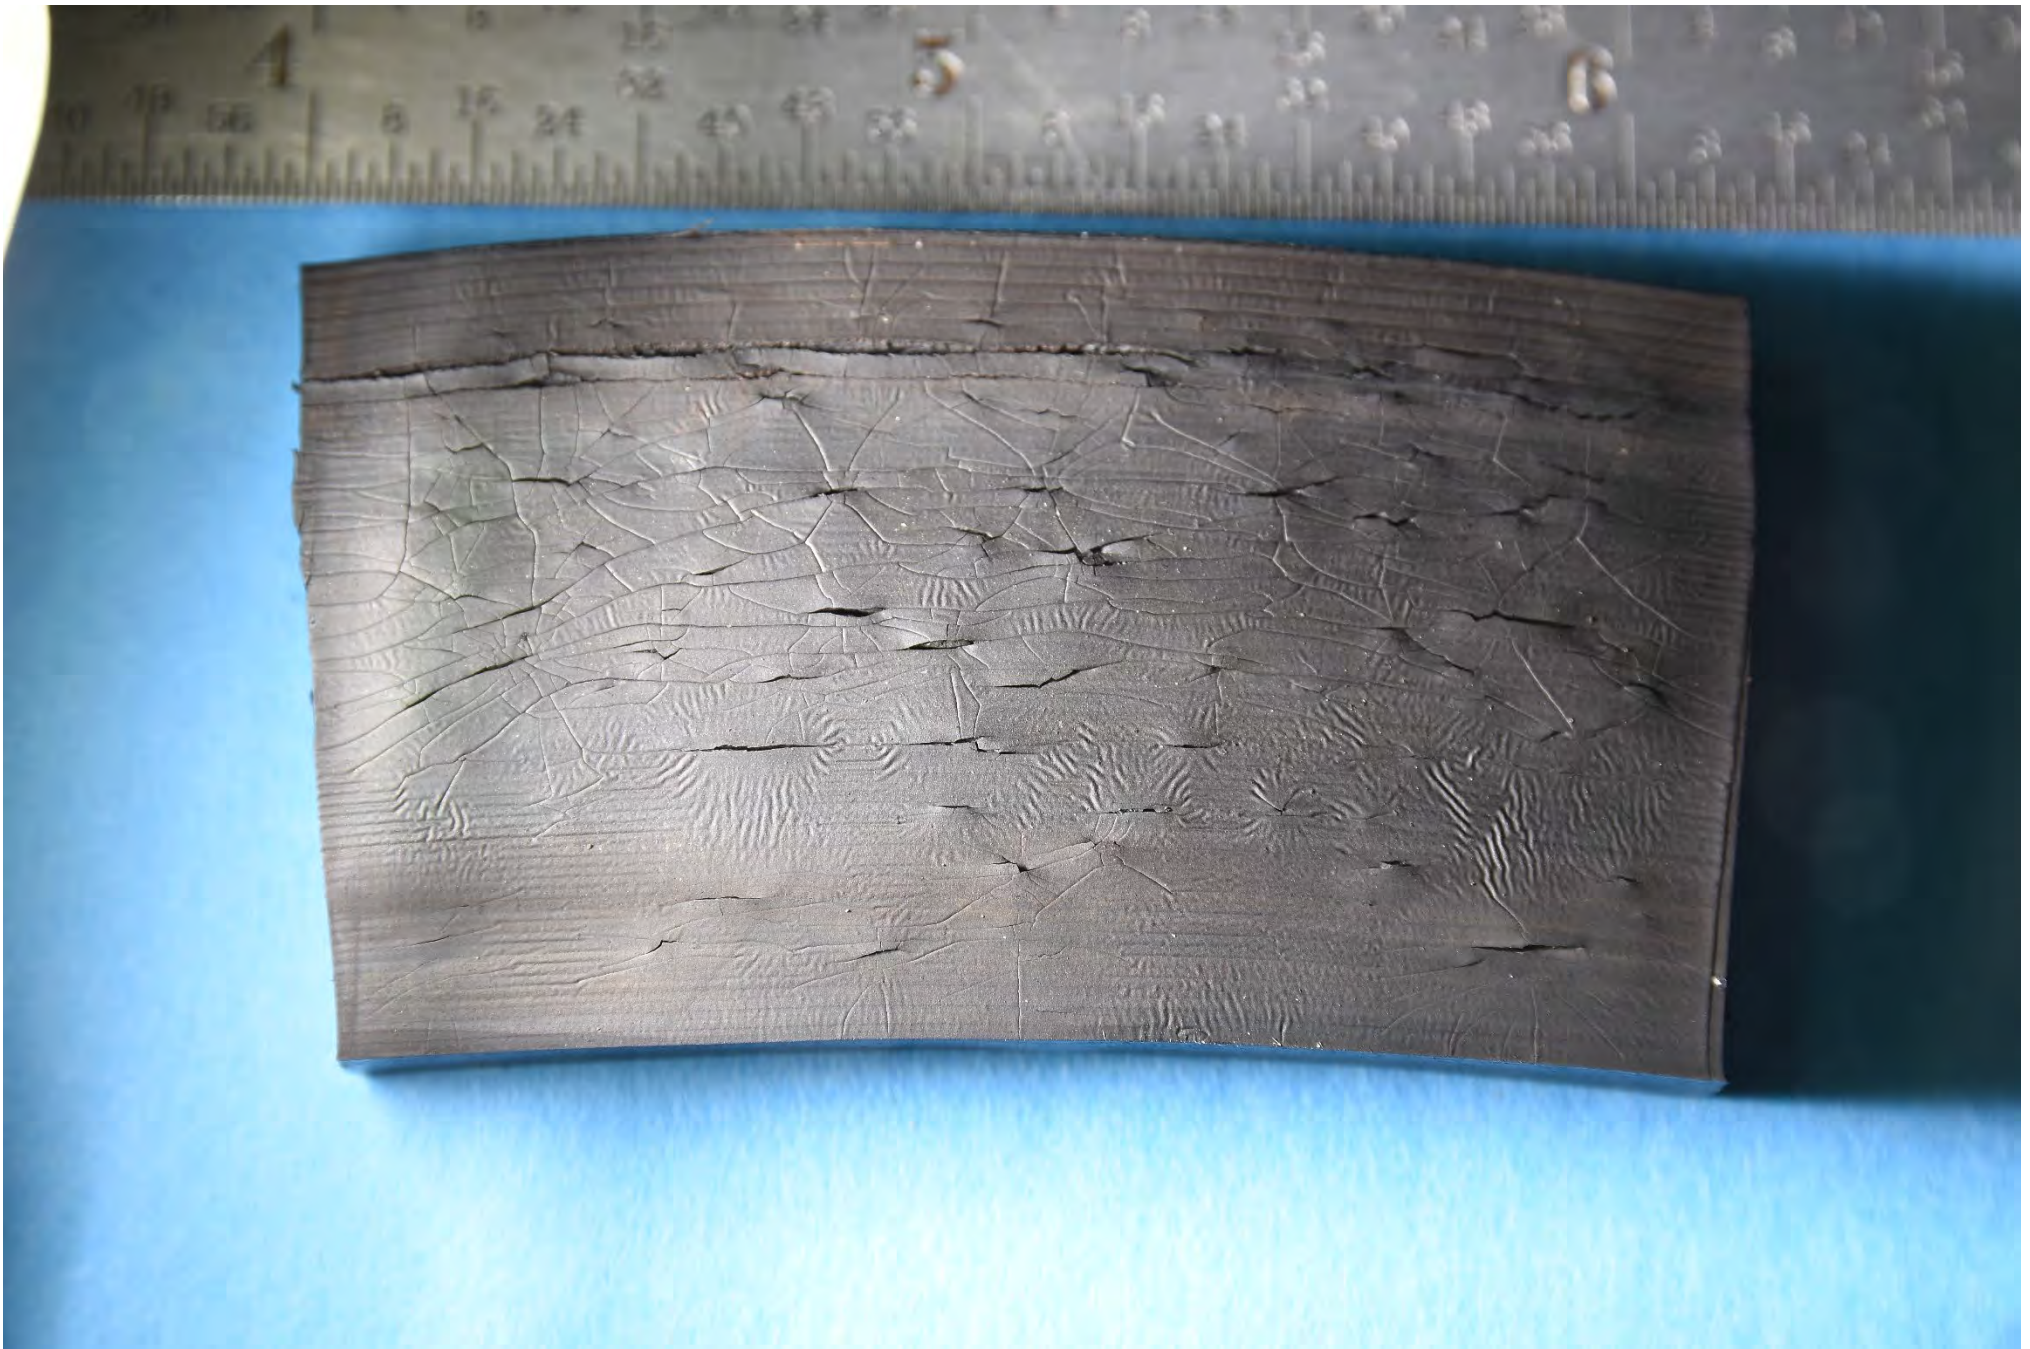
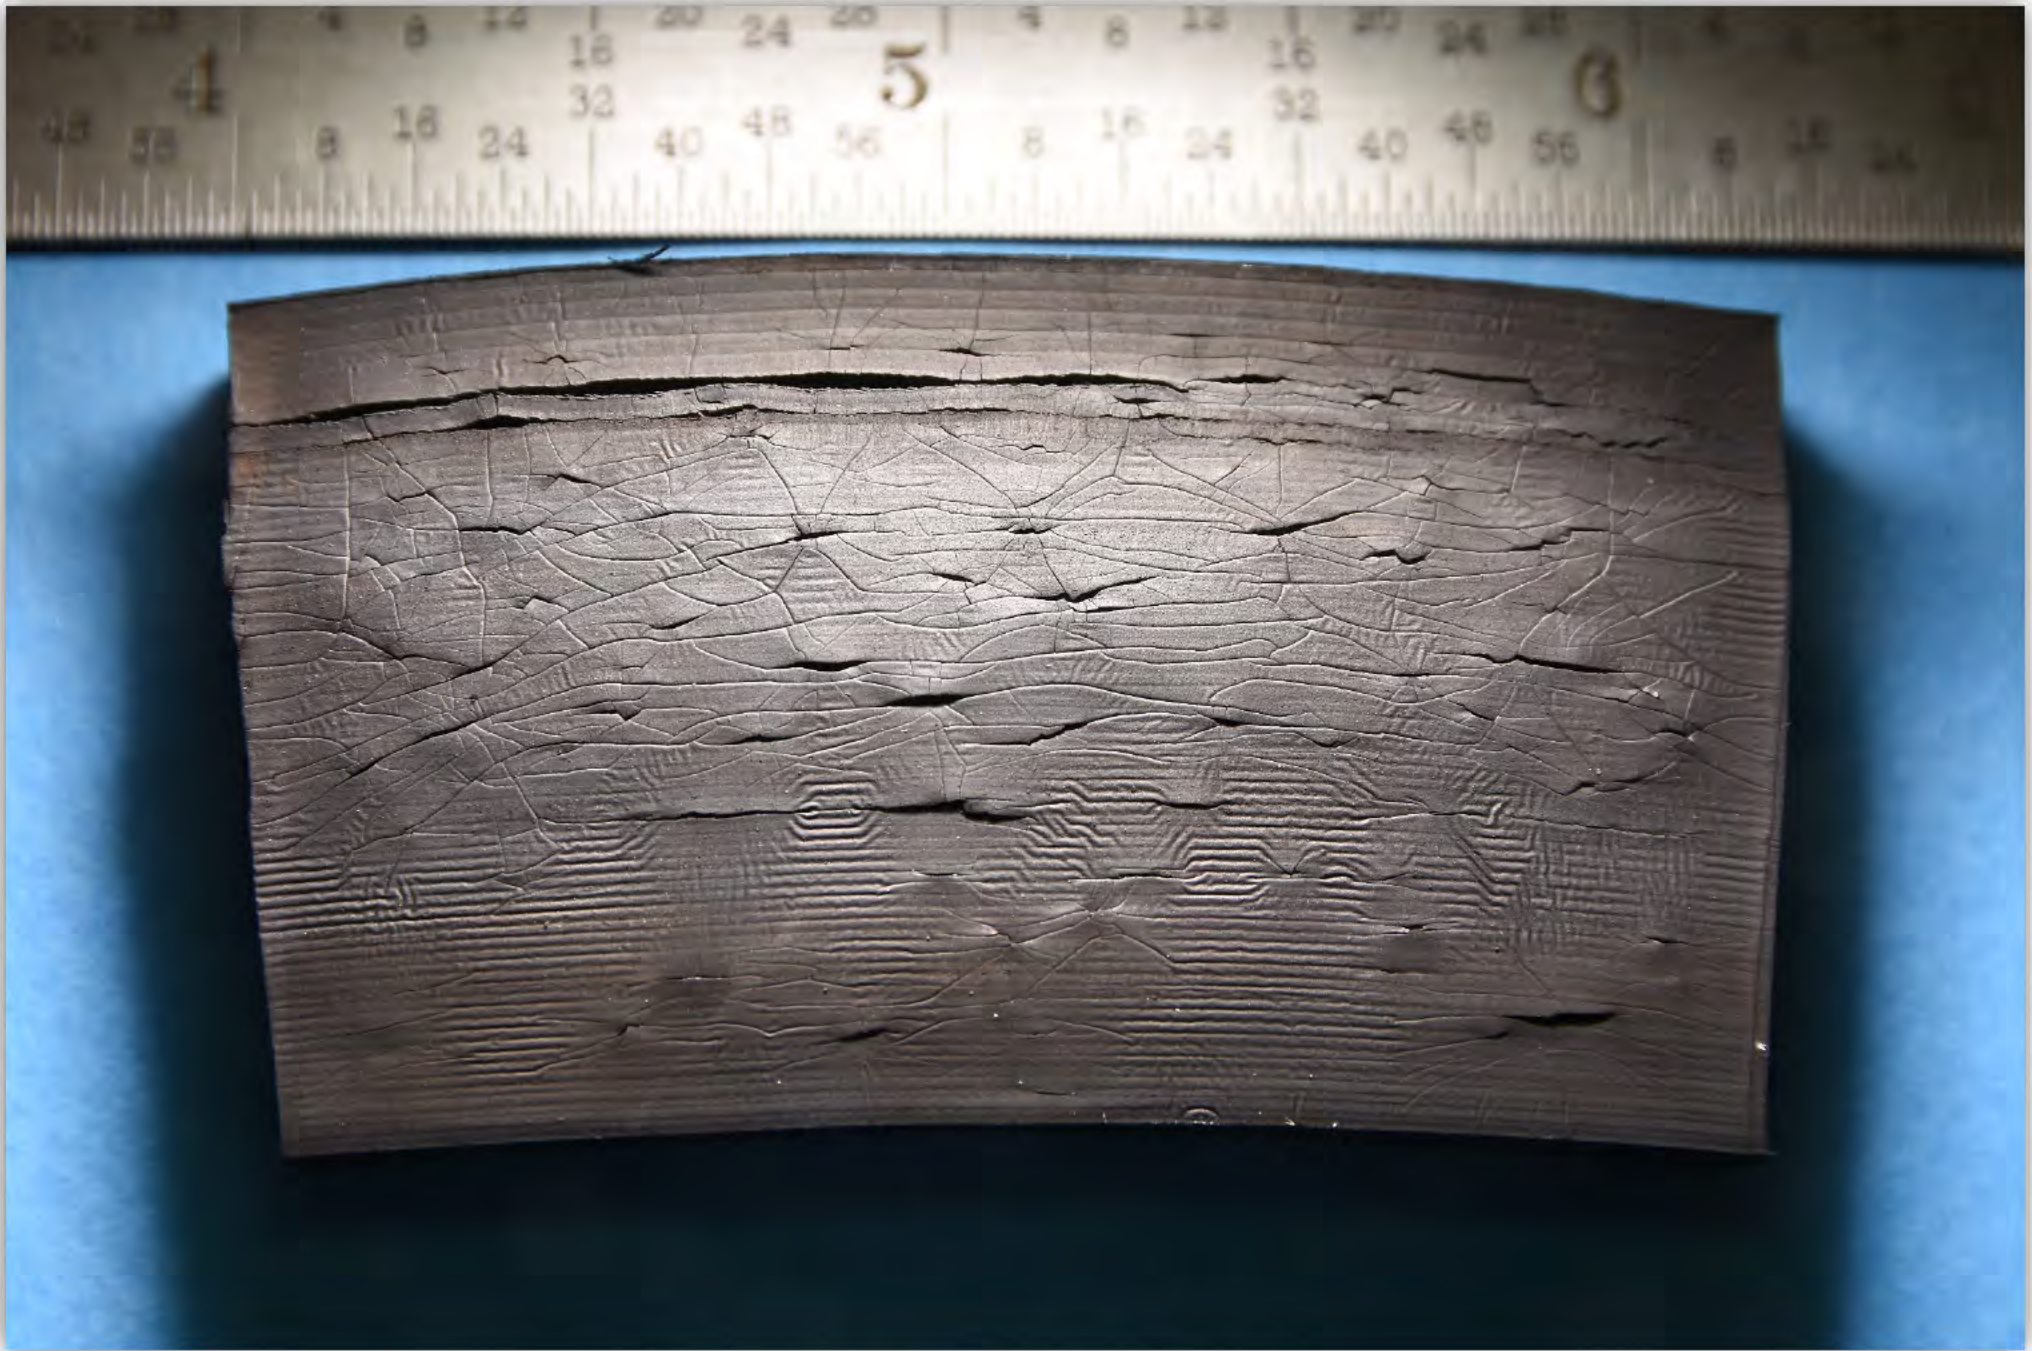
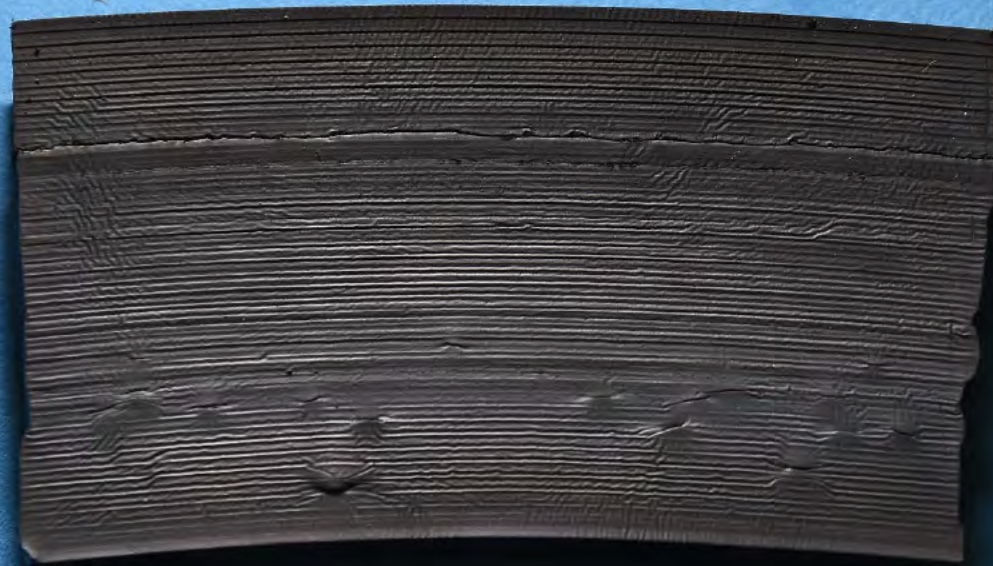
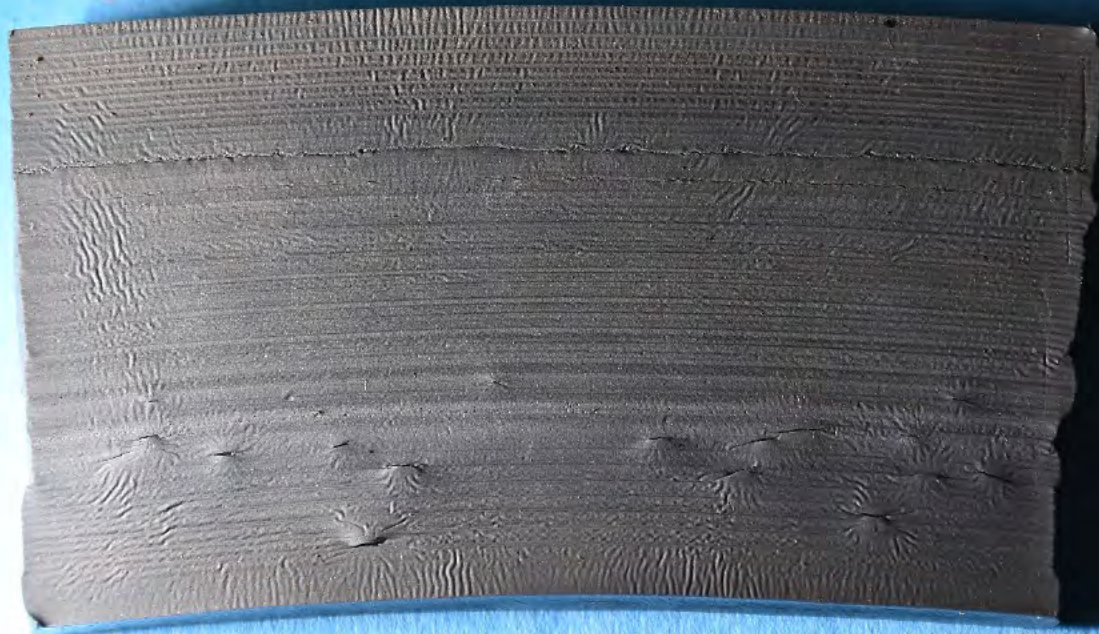
(1) 300 Deg. C.

The photos after the thermal exposure testing showing the surface appearance of the lab samples tested in the range of 250 to 350 degrees Celsius show a surface that is comparatively similar to the different locations of the subject gasket material. The thermal exposure in the range of 250–300-degrees Celsius leads to formation of micro-cracks on the surface, and as temperature increases to 350, there is evidence of tearing, separation of material between the network of cracks, and hardening of the rubber material. Above 350 degrees Celsius, the rubber material ignited and formed very fragile char that broke easily.

300 degrees Celsius front side burn tested

300 degrees Celsius back side burn tested

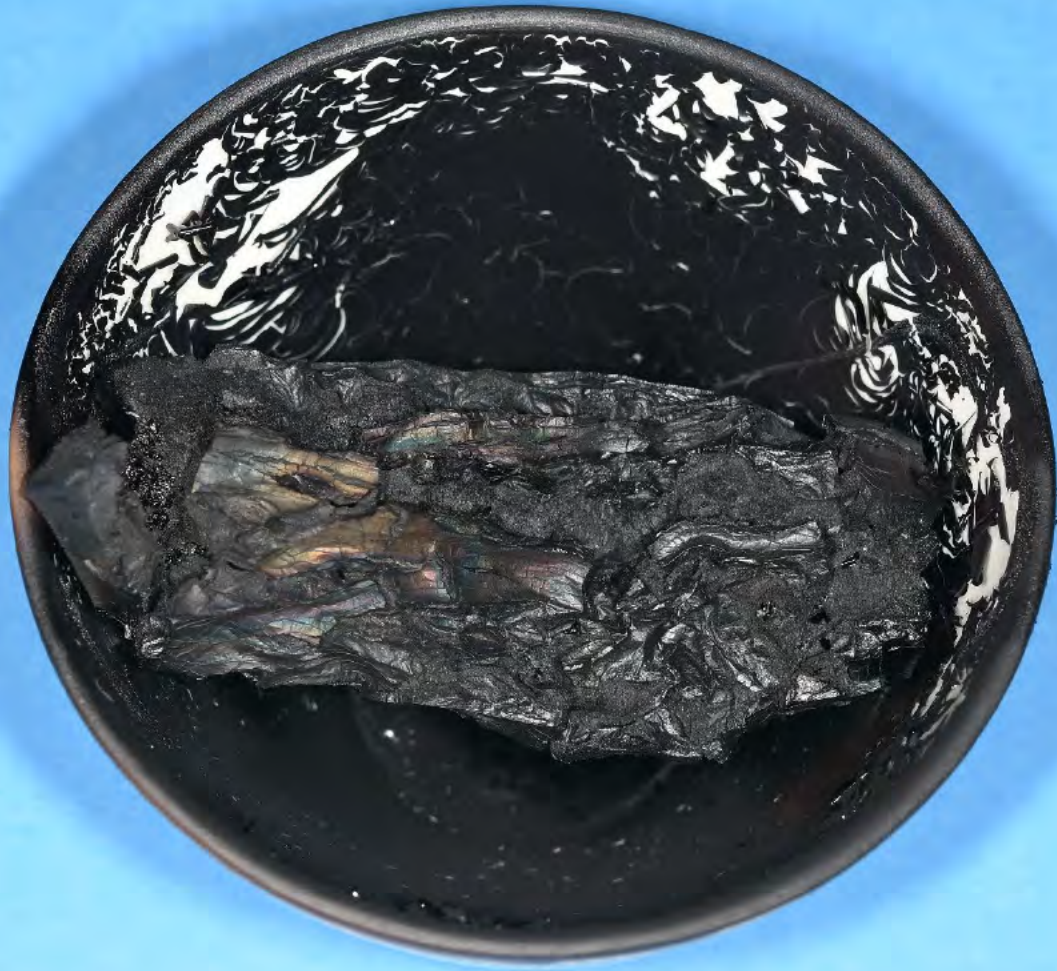
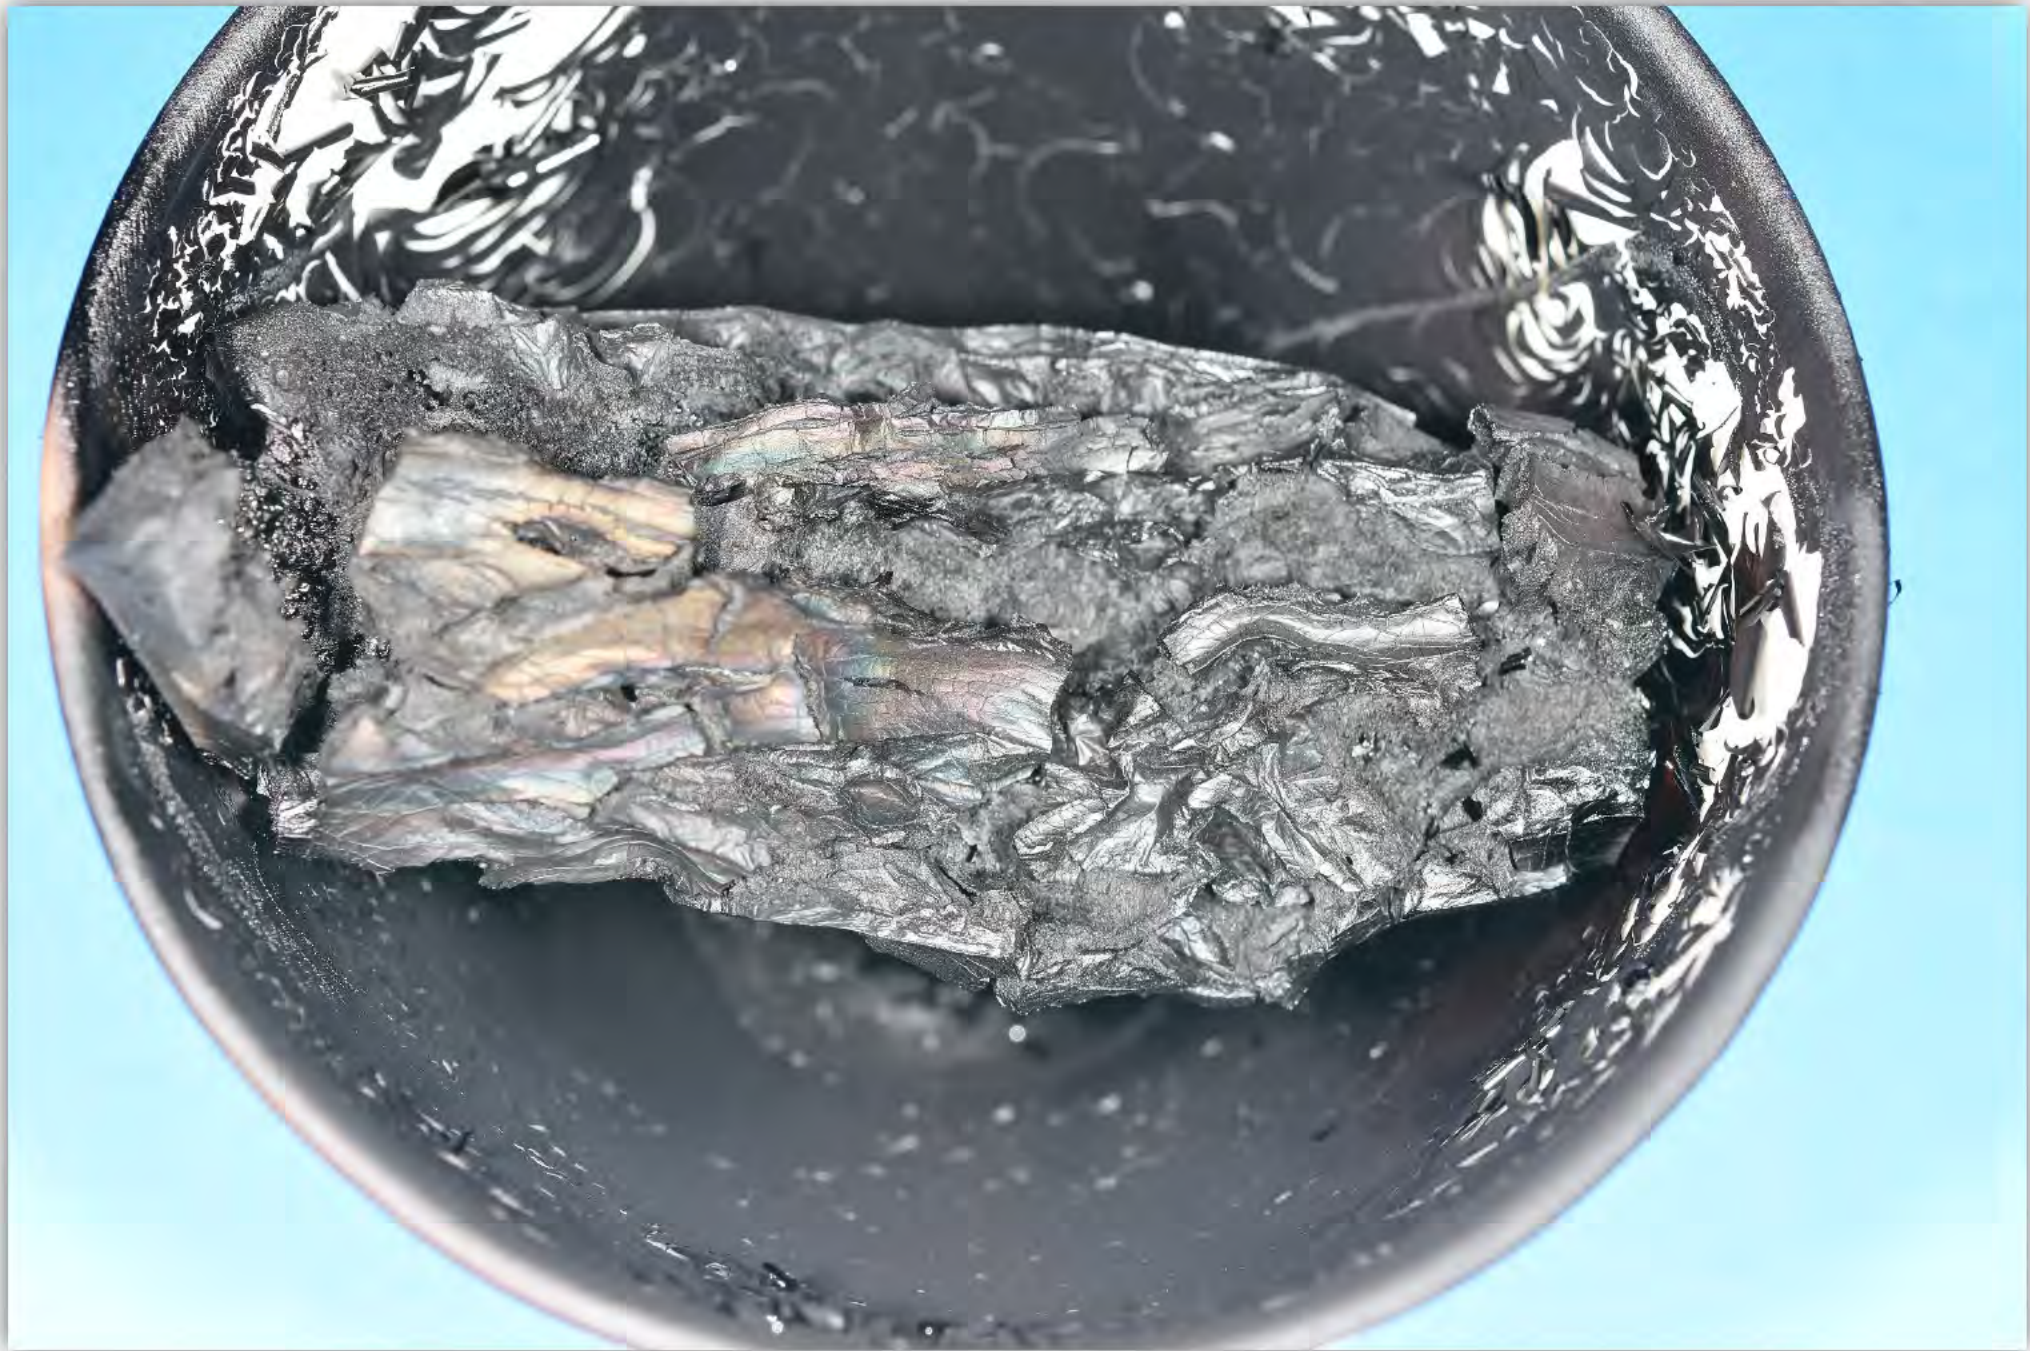
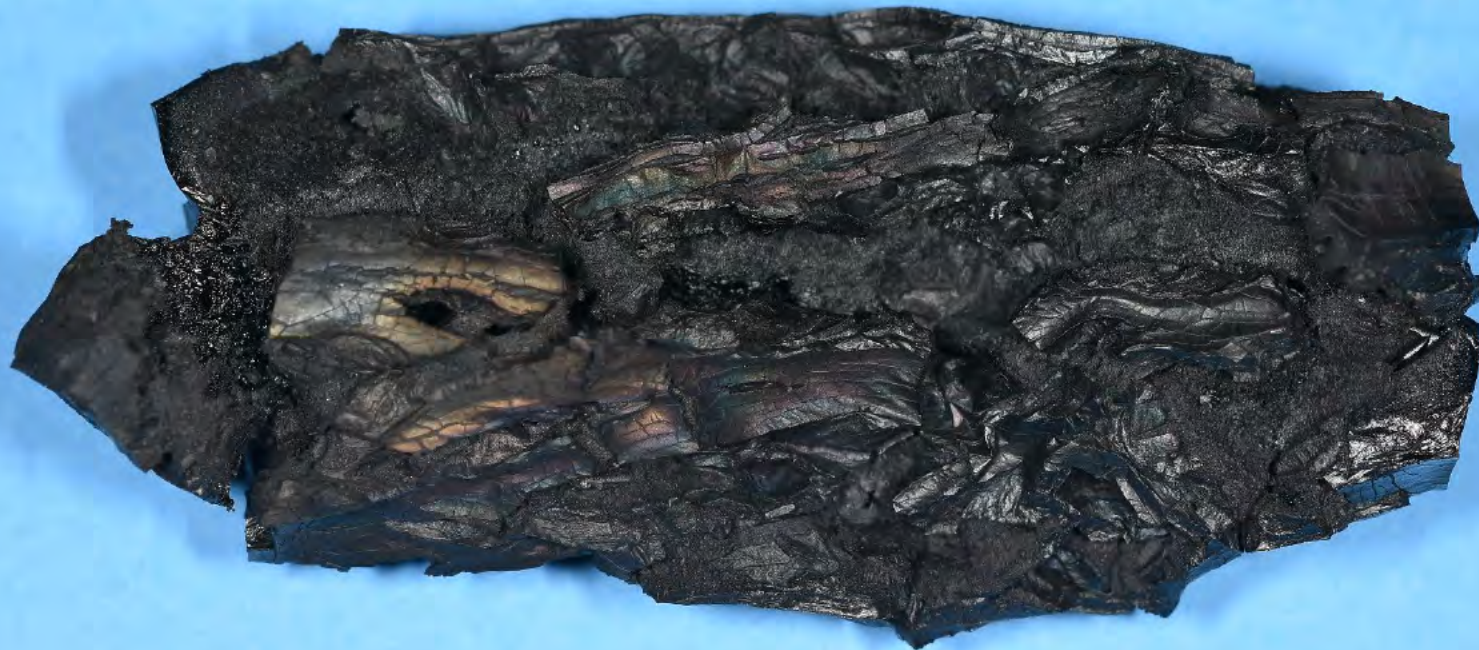
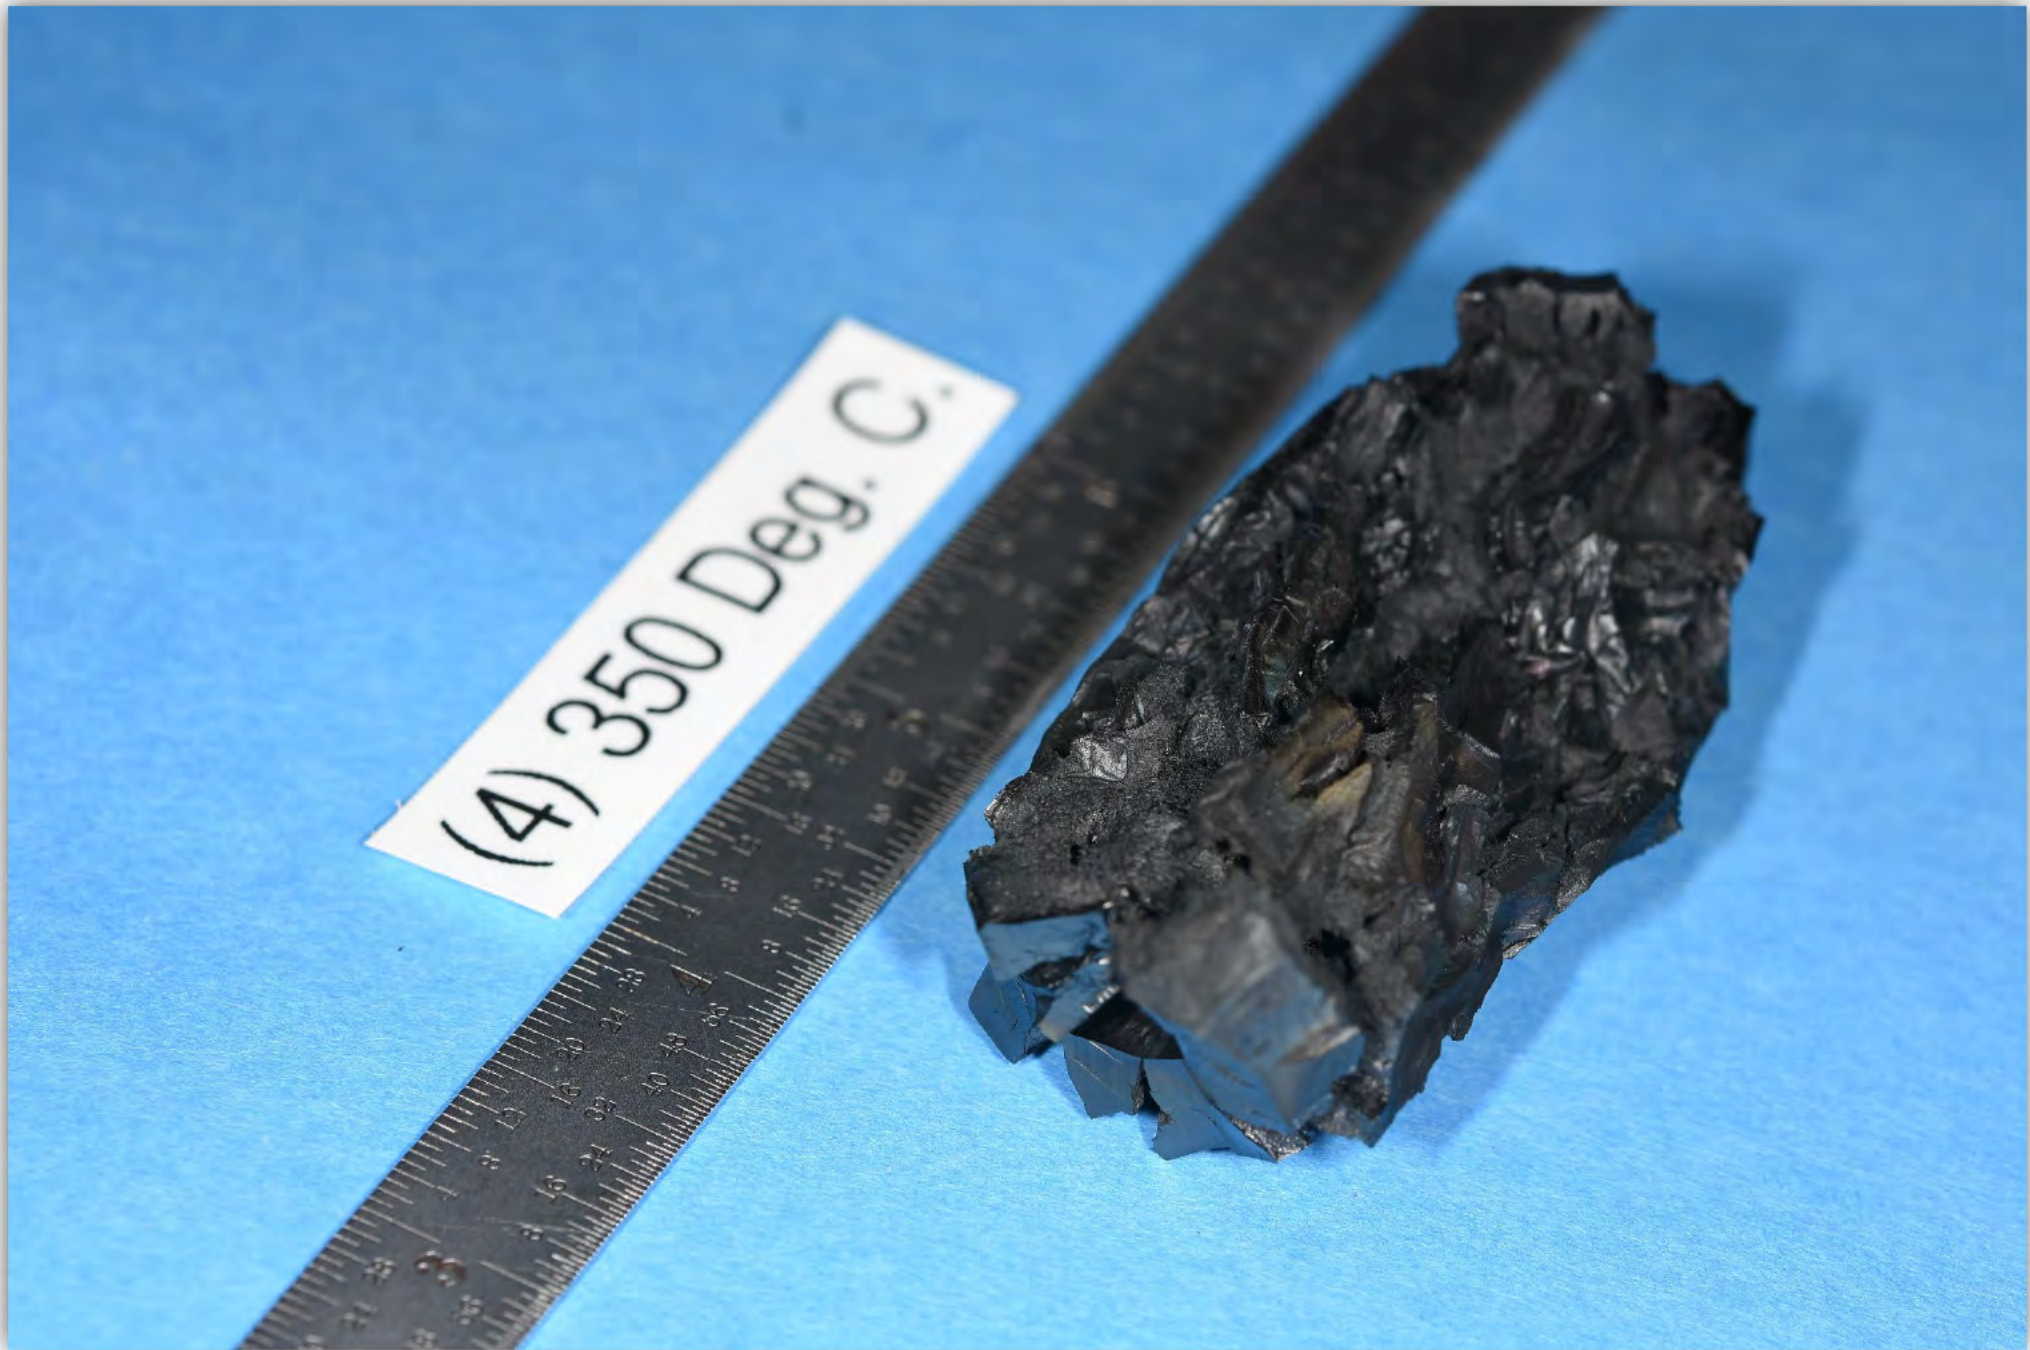
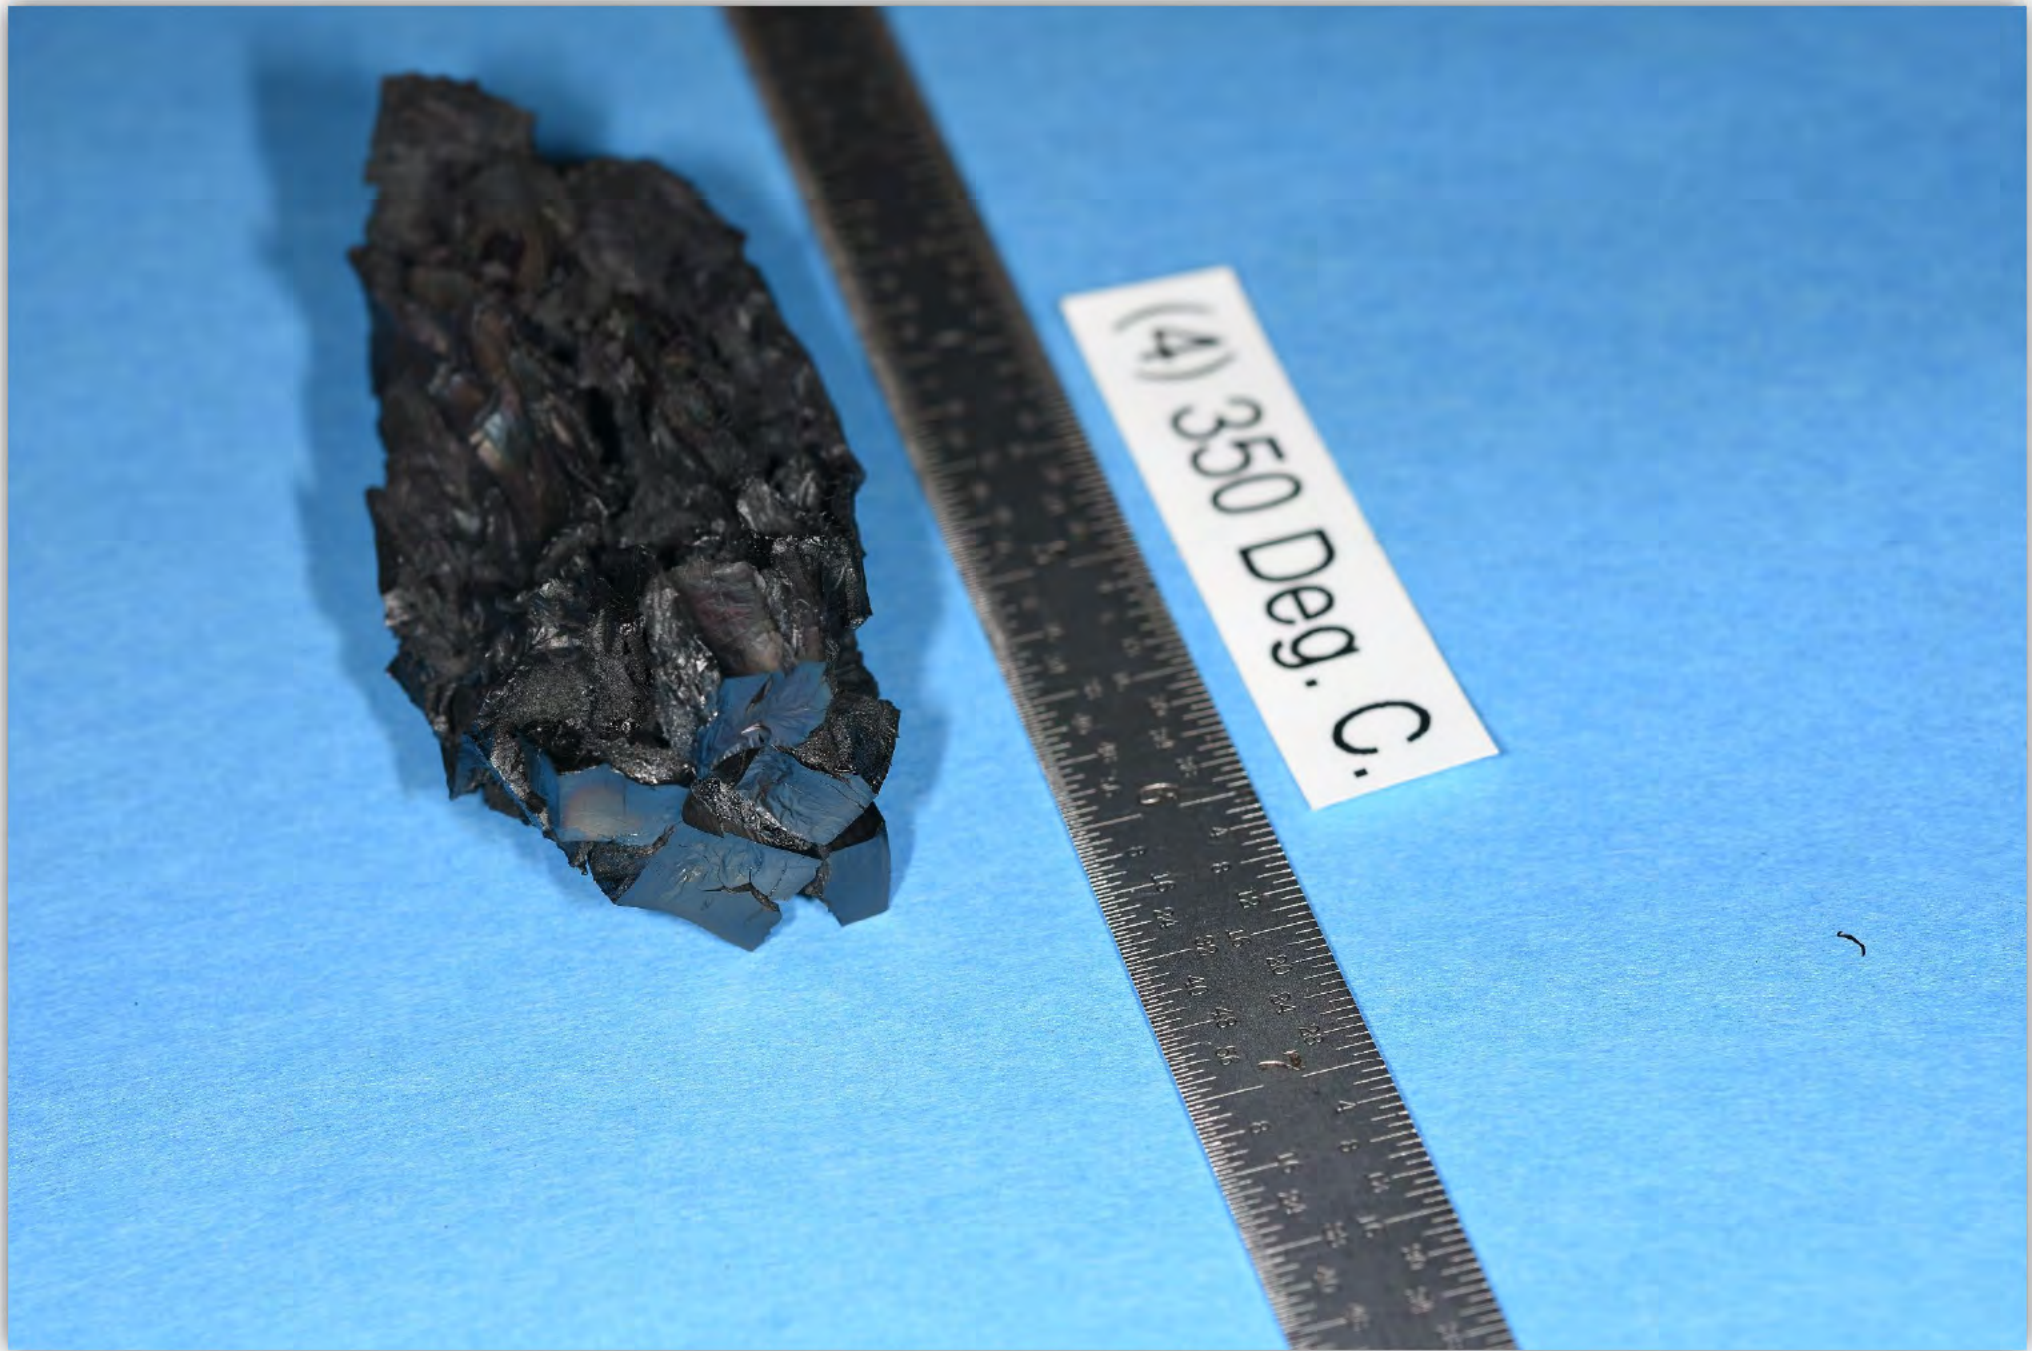
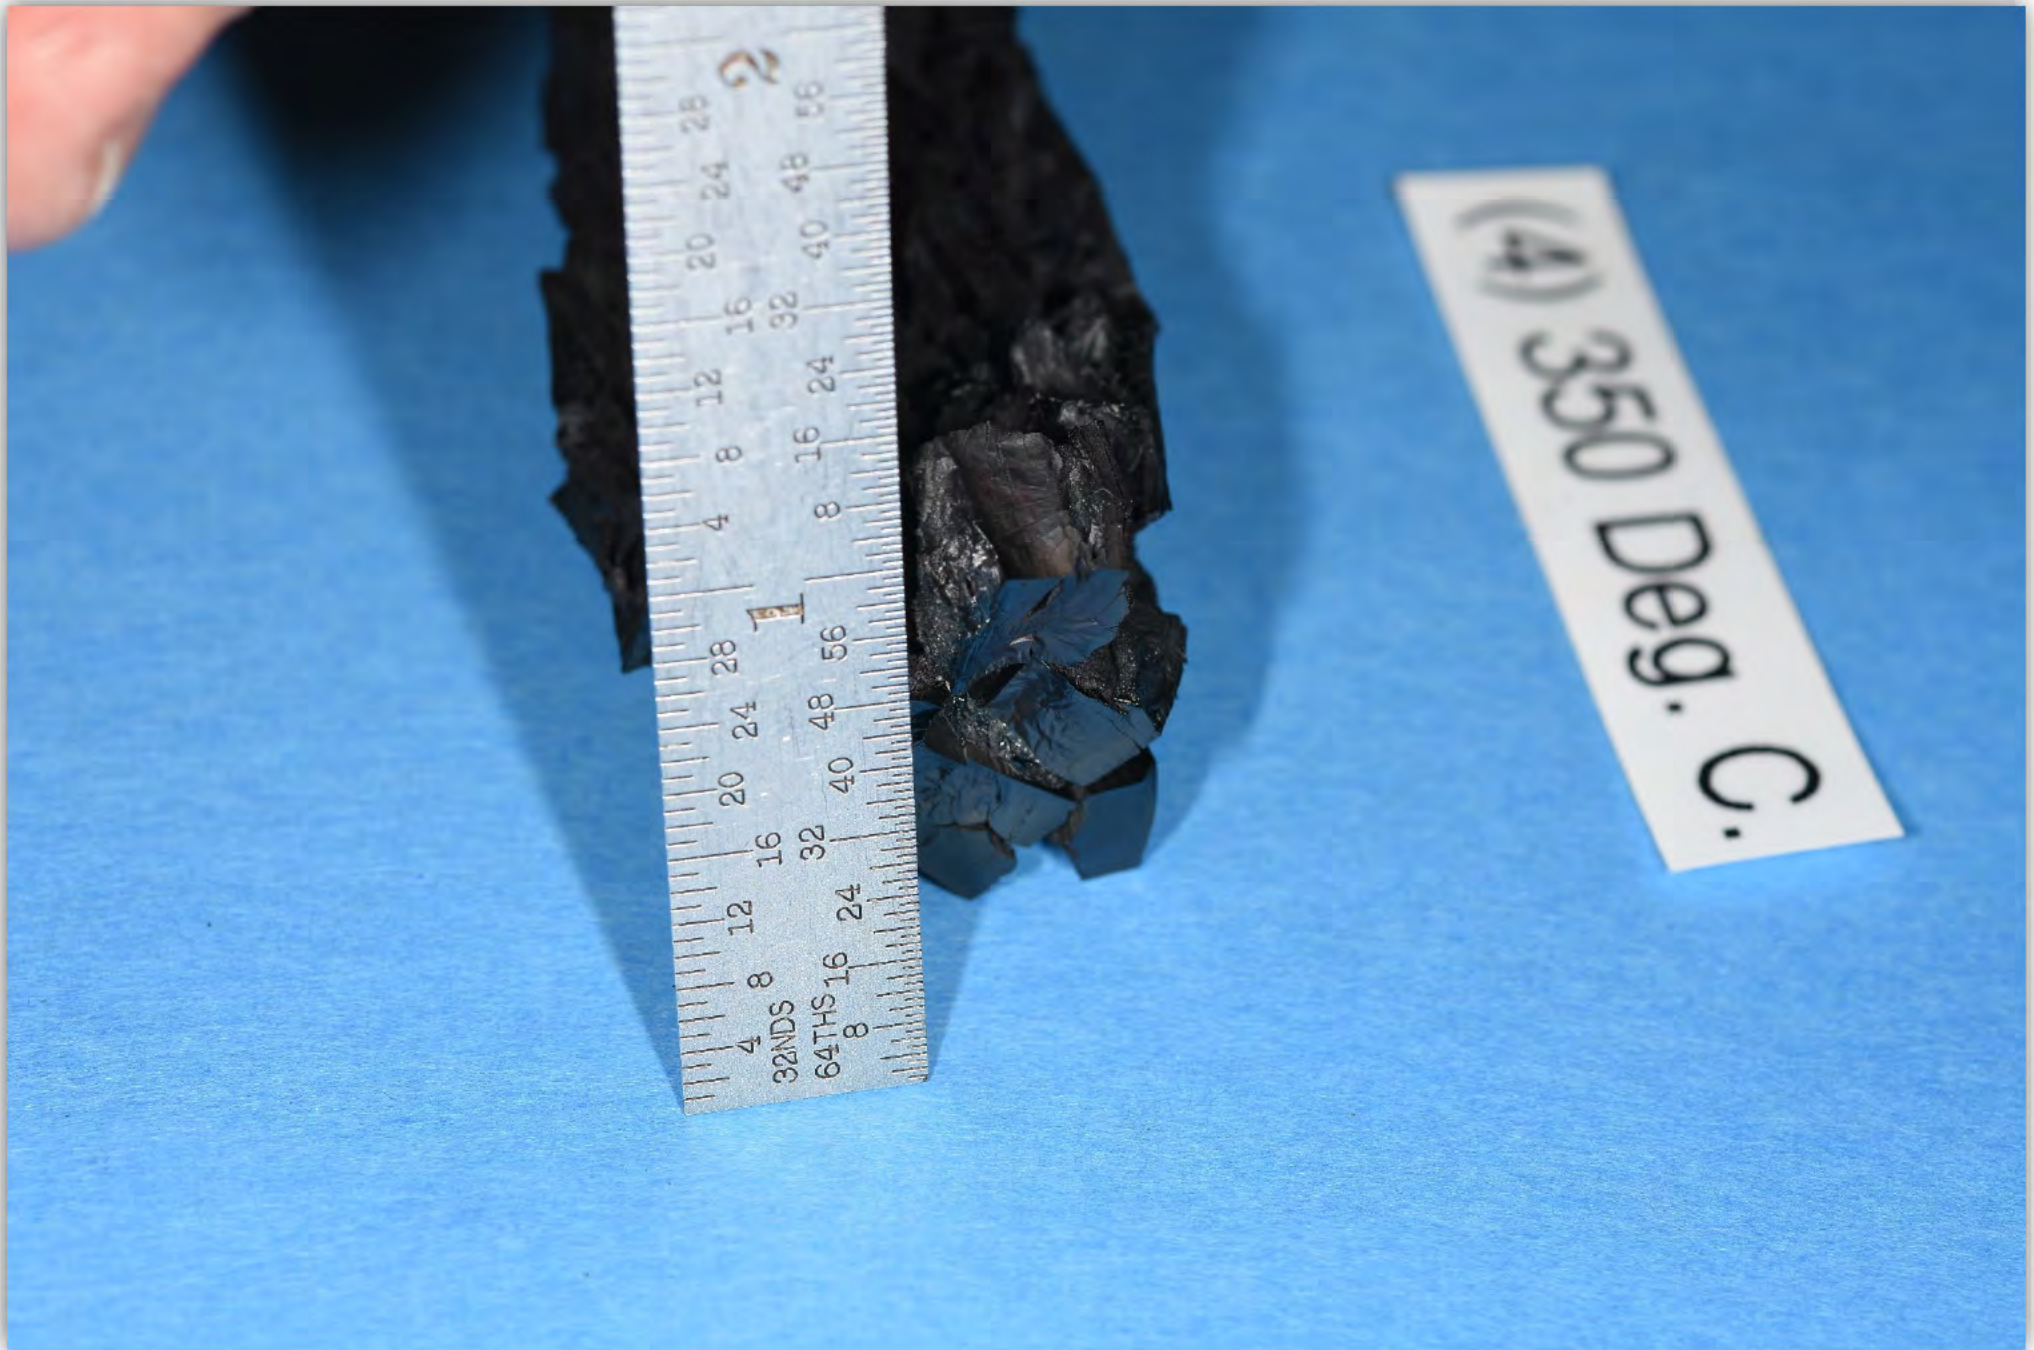
(4) 350 Deg. C.

to 350°C, tearing, separation of material between the network of cracks, and hardening of the rubber material appeared.

350 degrees Celsius burn tested
