# NATIONAL TRANSPORTATION SAFETY BOARD

MATERIALS LABORATORY REVIEW REPORT

Place : Oklaunion, Texas  
Date : January 8, 2022  
Vehicle : BNSF Railway freight train/Ethanol tank car  
NTSB No. : HMD22LR001  
Investigator : Paul Stancil  
RPH-20

# Thermal Testing of Polymeric Railcar Gasket

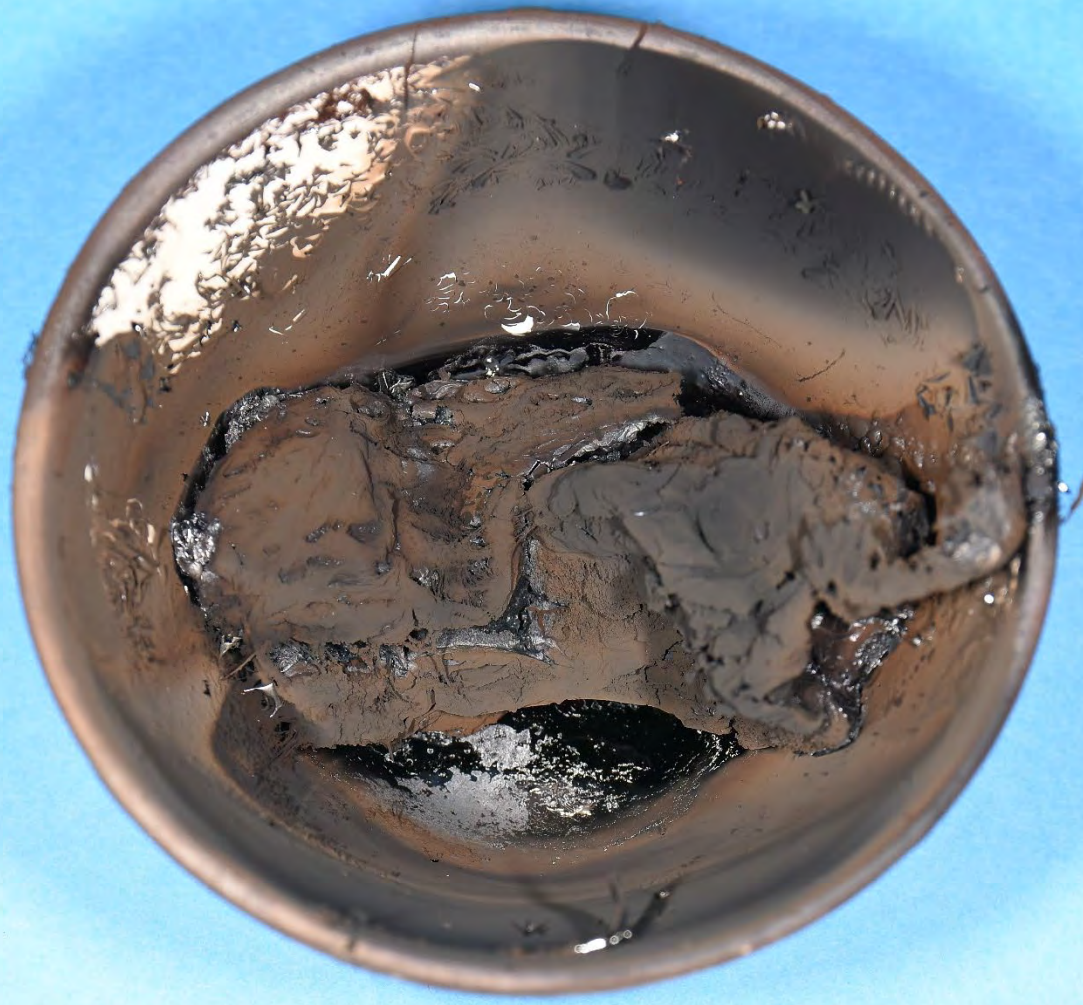
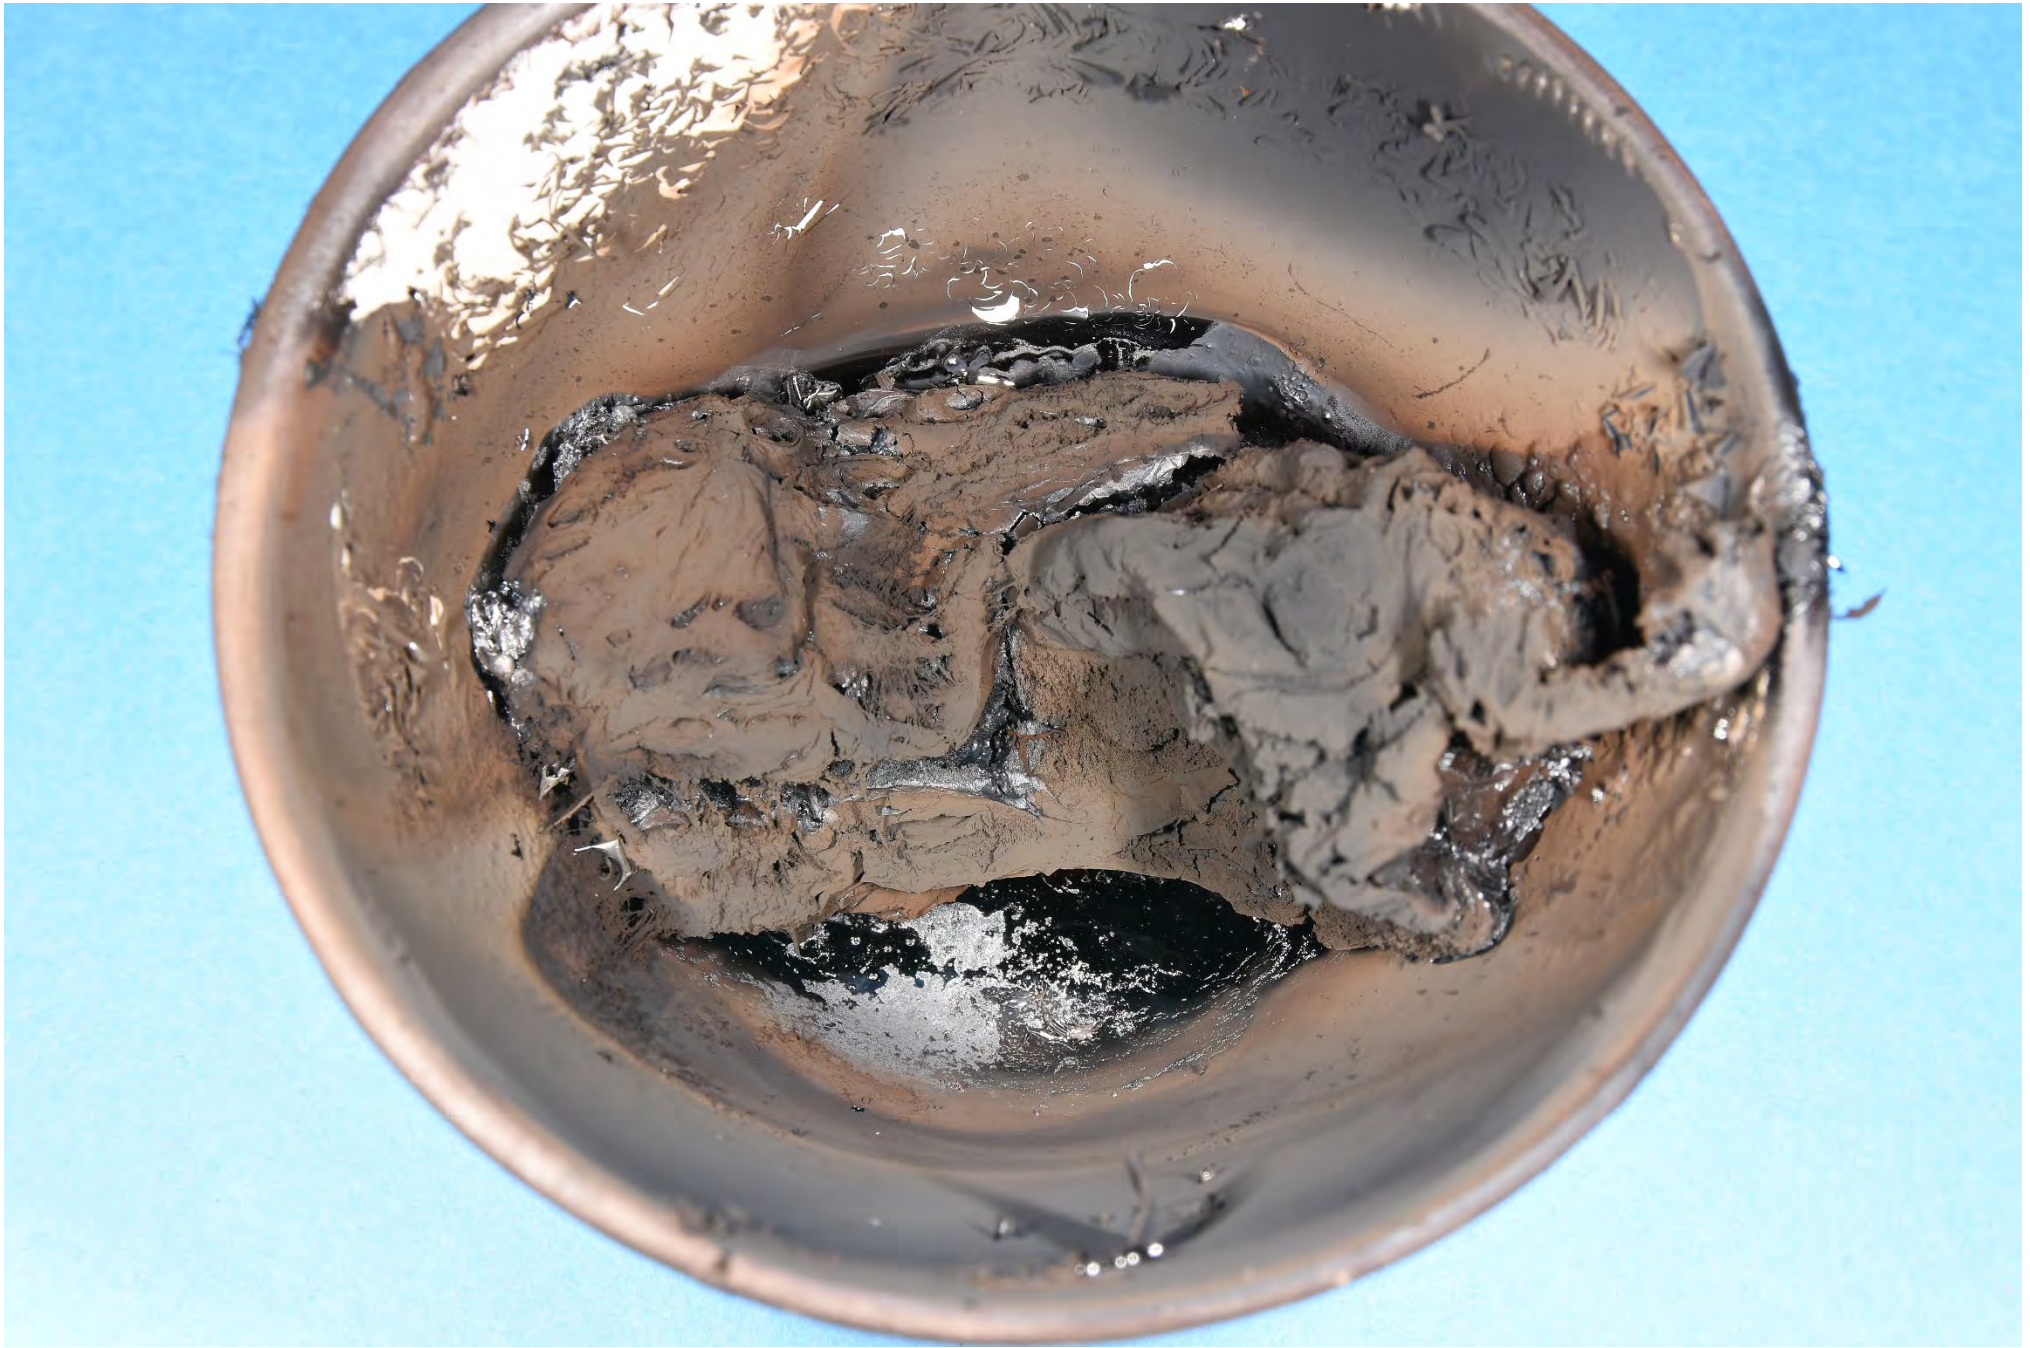
(2) 400 Deg. C.

There was no need to conduct testing beyond 400 degrees Celsius as at this temperature the rubber gasket material was mostly consumed due to igniting in the furnace leaving black soot and char. The measurements of weight loss associated with each of the experiment conducted are reported in Table 1 below.

The photos after the thermal exposure testing showing the surface appearance of the lab samples tested in the range of 250 to 350 degrees Celsius show a surface that is comparatively similar to the different locations of the subject gasket material. The thermal exposure in the range of 250–300-degrees Celsius leads to formation of micro-cracks on the surface, and as temperature increases to 350, there is evidence of tearing, separation of material between the network of cracks, and hardening of the rubber material. Above 350 degrees Celsius, the rubber material ignited and formed very fragile char that broke easily.

400 degrees Celsius burn tested
