# NATIONAL TRANSPORTATION SAFETY BOARD

MATERIALS LABORATORY FACTUAL REPORT

Report No. 22-054

Place : Amherstdale, West Virginia  
Date : June 22, 2022  
Vehicle : Bell UH-1F, N98F  
NTSB No. : ERA22FA279  
Investigator : Lynn Spencer, AS-ERA

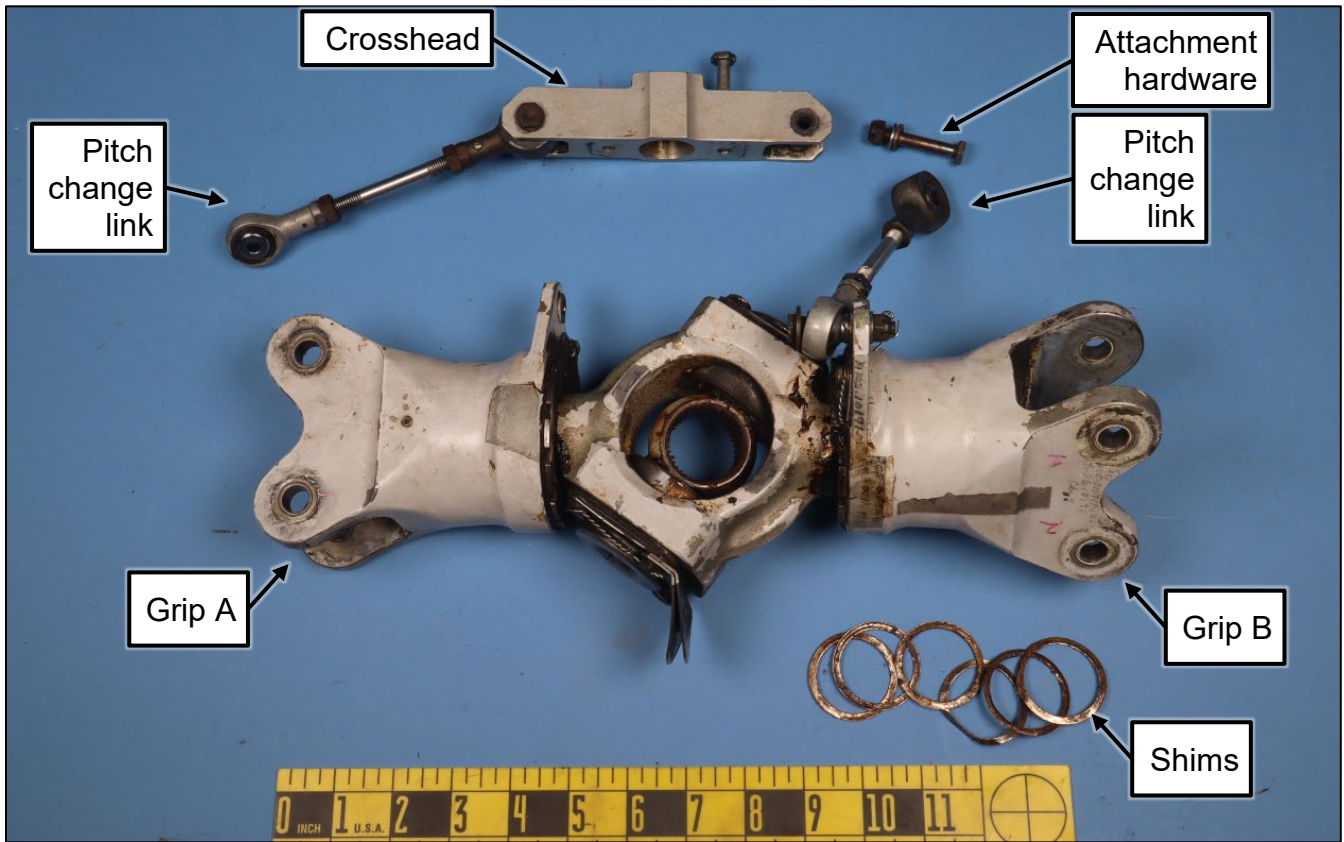
An overall view of the submitted components is shown in figure 1. The blade grips are shown arbitrarily labeled A and B for reference in this report. The pitch change link for grip A was separated at the pitch horn, and the associated attachment hardware was missing. The pitch change link for grip B had been disassembled from the crosshead assembly, and the associated attachment hardware is shown in figure 1. Six shims associated with the hub assembly installation were also included as shown.

Figure 1. Submitted tail rotor hub assembly, pitch change links, and crosshead assembly as received.

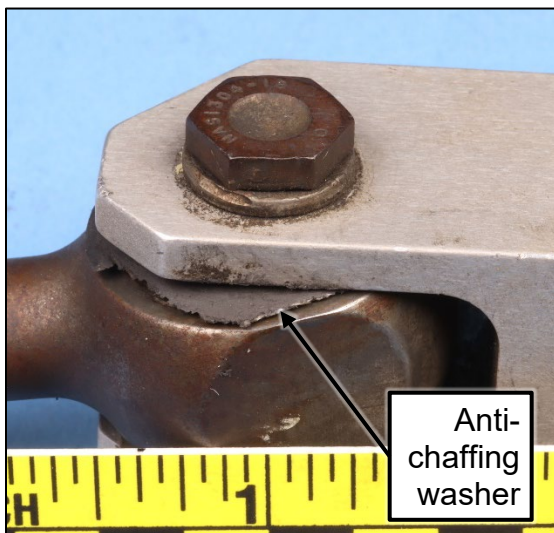
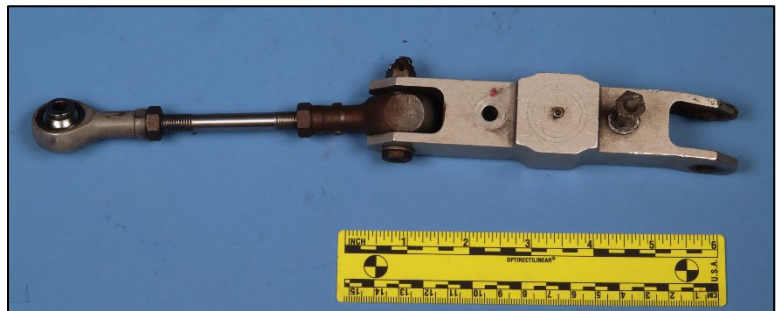
A view of the outboard side of the crosshead assembly is shown in figure 2. The clevis at the grip B end of the crosshead assembly was bent laterally. A closer view of the pitch change link attachment at the grip A end of the crosshead assembly is shown at the left in figure 2. Anti-chafing washers were observed installed on either side of the pitch change link end fitting. The washers appeared worn, and material was missing from the outer diameter of the washers as shown in figure 2. No anti-chafing washers were included with the submitted hardware for the attachment at the B end of the crosshead assembly.

Figure 2. Crosshead assembly with attached grip A pitch change link (above) and closer view of the attached link (left image) showing the installed anti-chaffing washer.

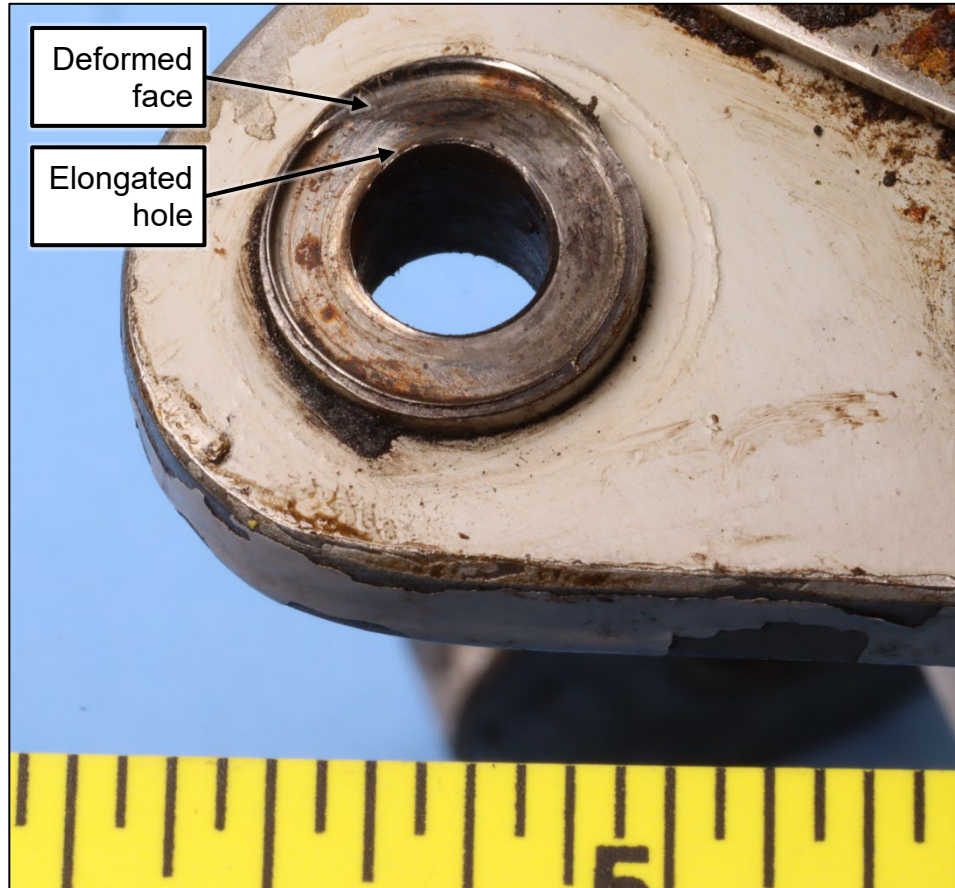
The inboard side of the bushing in the pitch horn on grip A was deformed as shown in figure 3. The inboard face where it had contacted the pitch change link was deformed on one side consistent with heavy contact with the pitch change link bearing inner race. The inner bore of the bushing was also elongated consistent with heavy contact with the shank of the attachment bolt.

Figure 3. Close view of the bushing in the pitch horn on grip A.
