NATIONAL TRANSPORTATION SAFETY BOARD

MATERIALS LABORATORY FACTUAL REPORT

Report No. 22-071

Place : Kalea, Hawaii
Date : June 8, 2022
Vehicle : Bell 407 helicopter, N402SH
NTSB No. : ANC22FA041
Investigator : Aaron Sauer

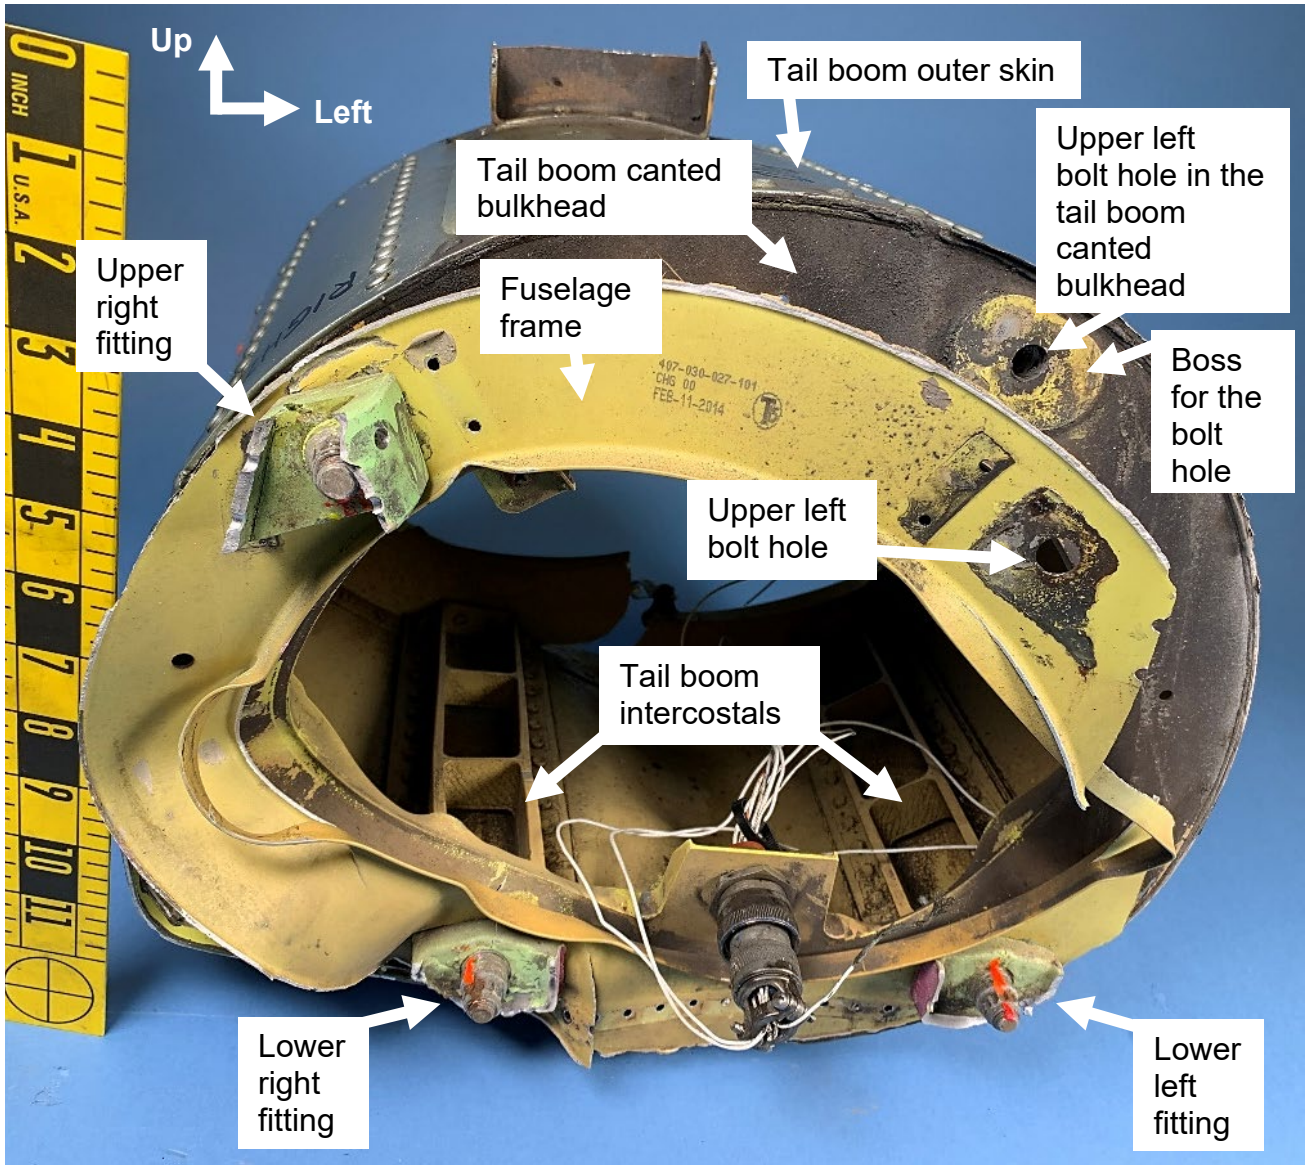
Figure 1. As-received tail boom section that separated at body station (BS) 31.92, looking aft, showing three fractured aft fuselage attachment fittings. The upper left attachment fitting and associated bolt, nut, and washers, separated from the tail boom and is presumed missing (not recovered). The hole for the upper left fitting is exposed. All references to direction are made when looking forward of the helicopter.

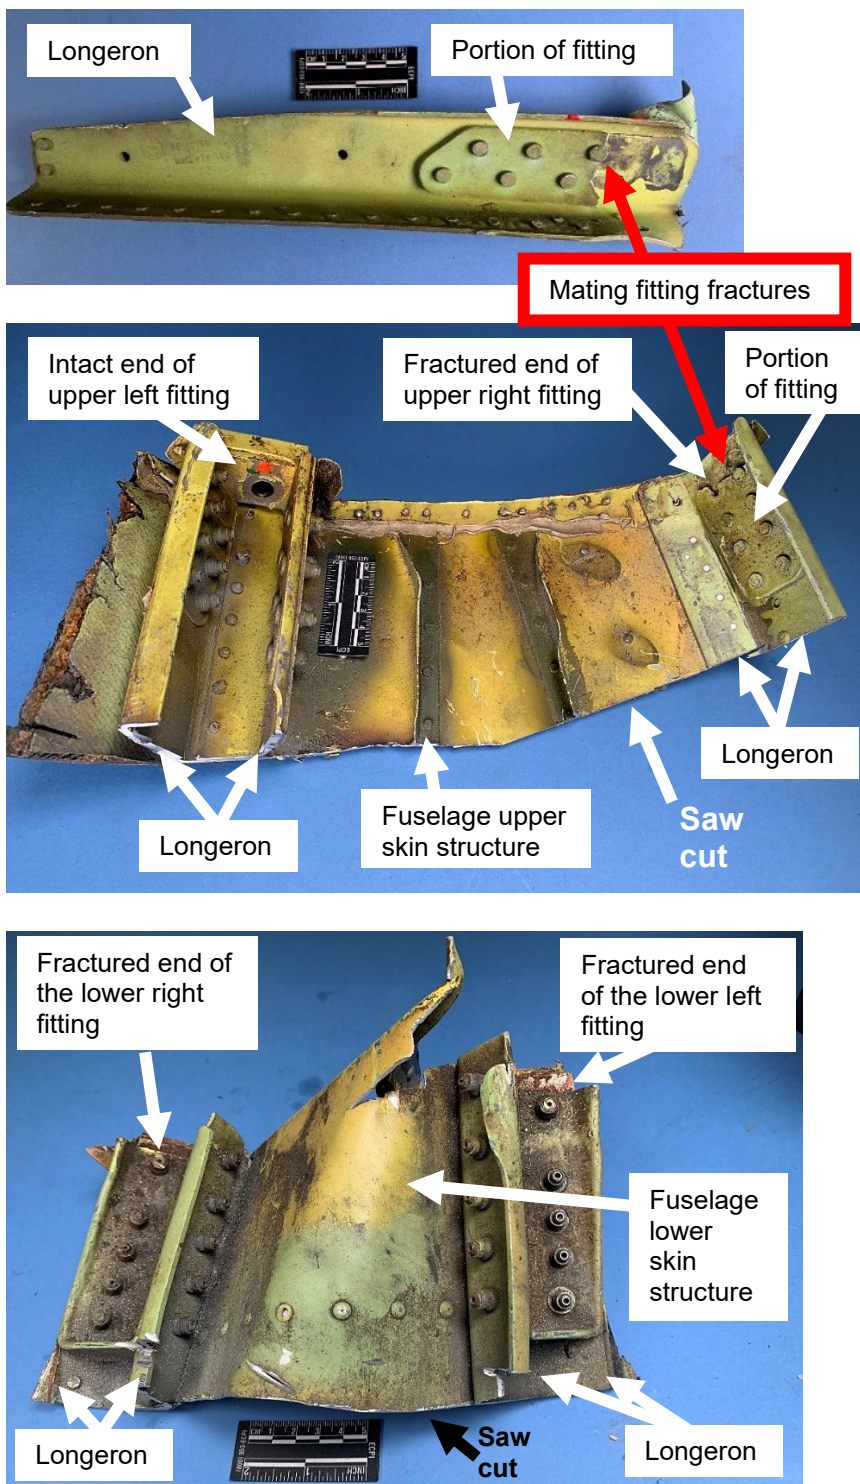
Figure 2. As-received longeron (top of page); fuselage upper skin structure, looking aft at the inner face (middle of page); fuselage lower skin structure showing the inner face (bottom of page). The mating fractures are indicated by a red arrow.

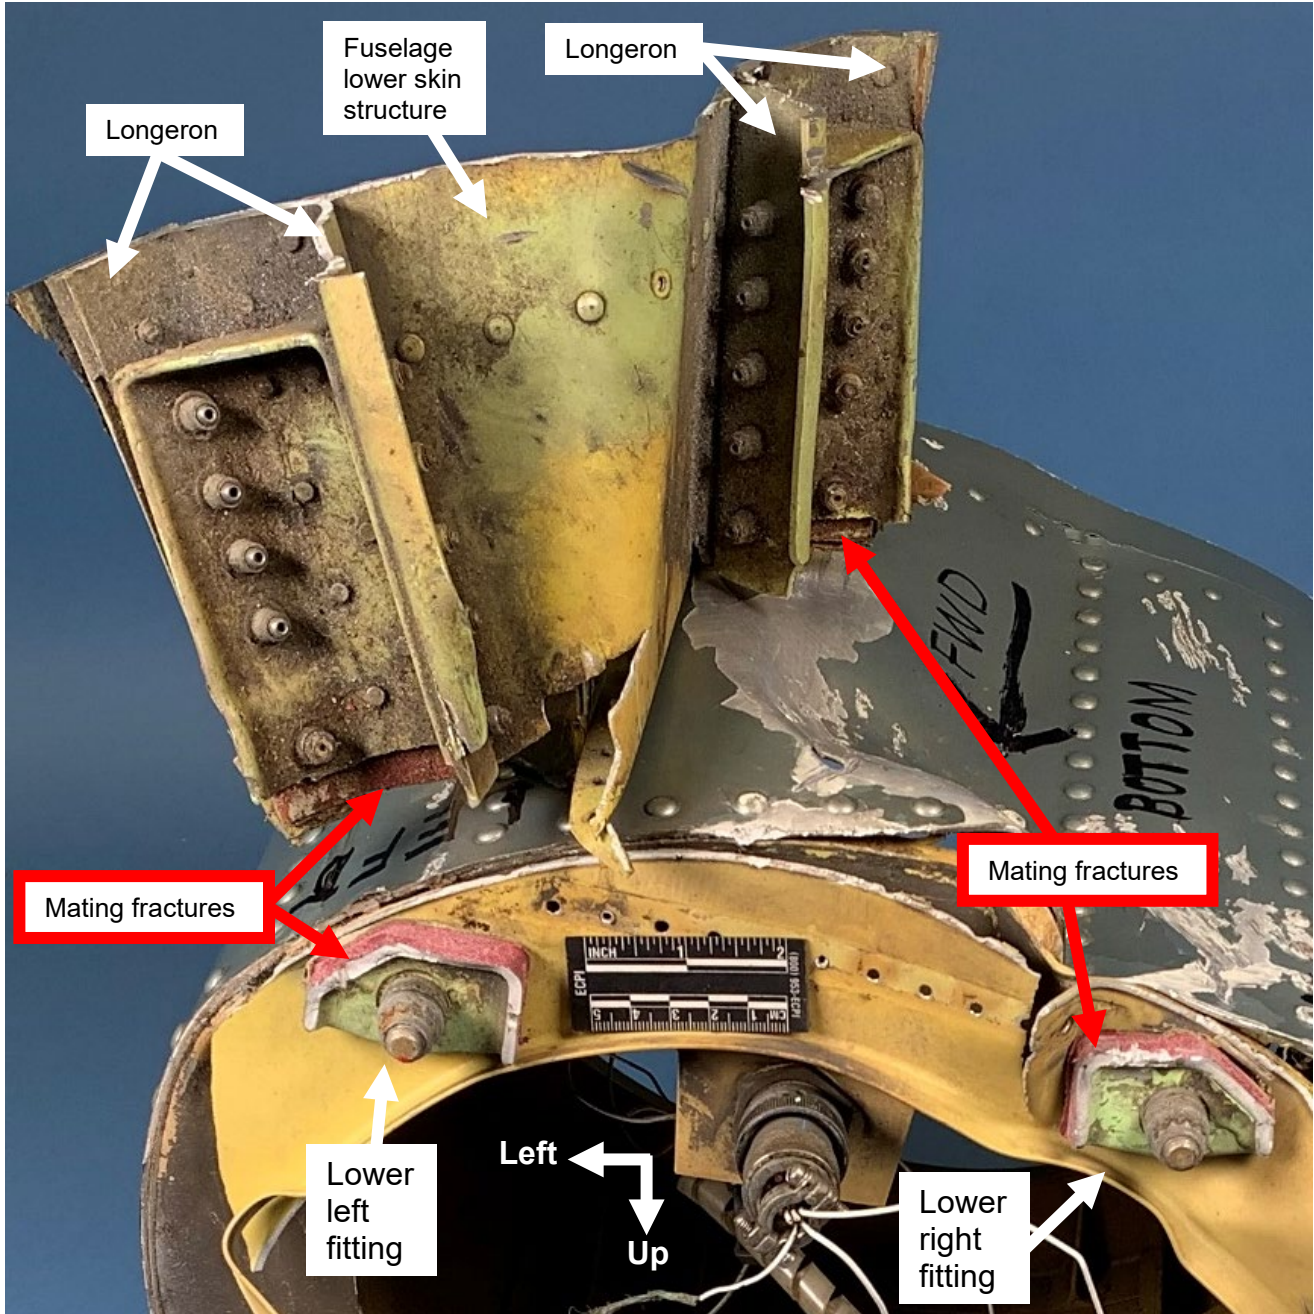
Figure 3. Tail boom looking aft and the lower skin structure showing mating fracture faces for the lower right and left fittings.

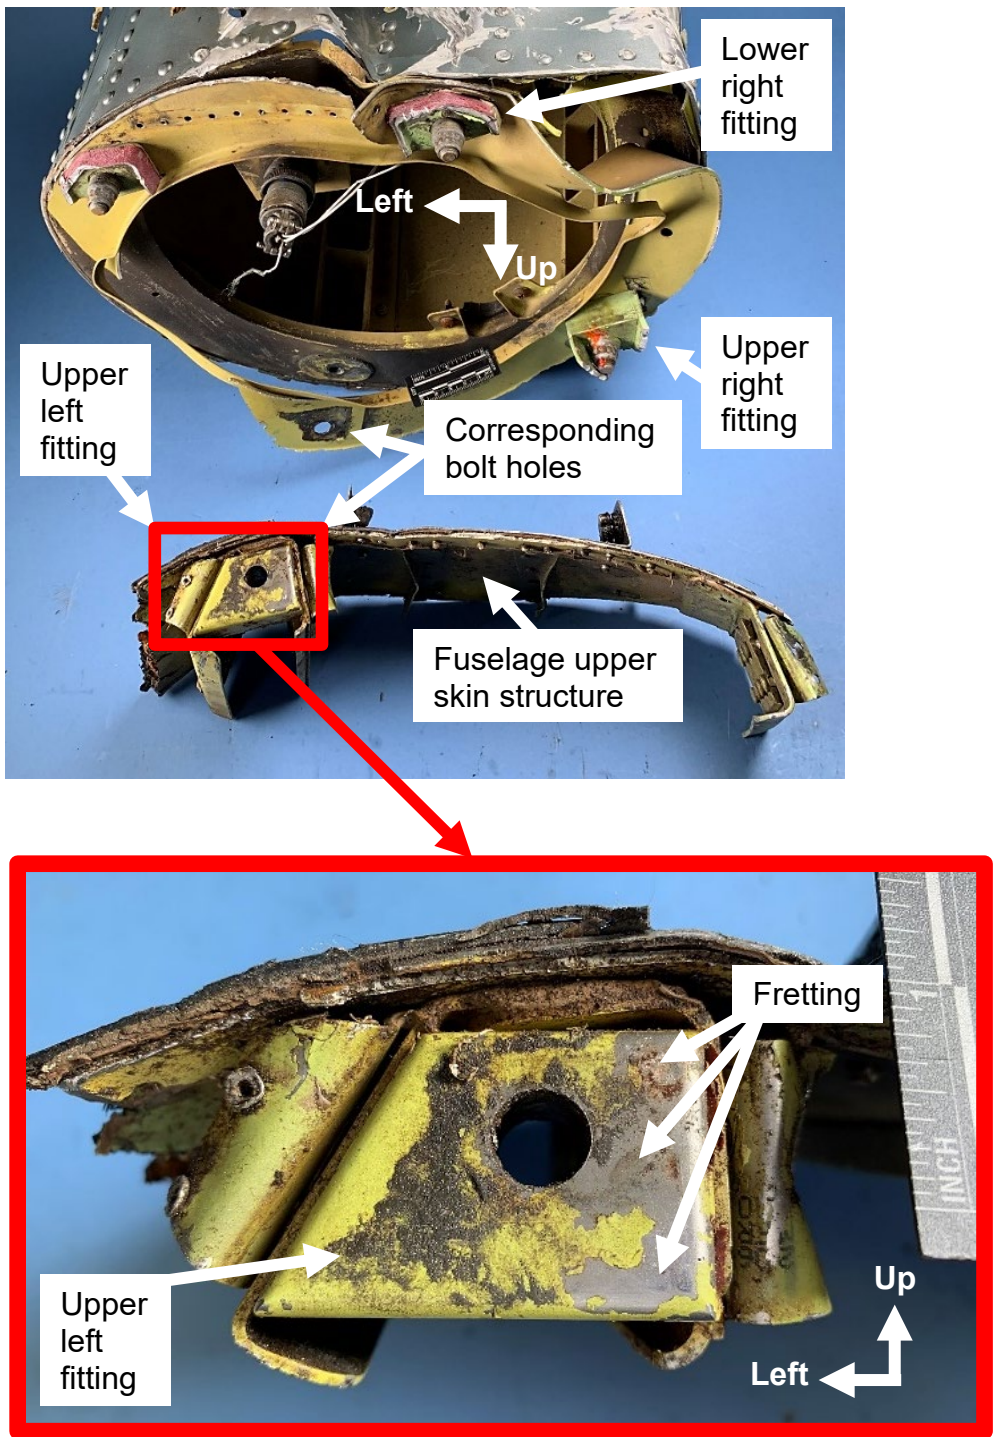
As indicated earlier, upper left fitting remained attached to the longeron member on the upper fuselage structure and showed no evidence of a crack or fracture, see figures 2, 4, 5, and 13. The upper left fitting (see figure 13) was manufactured with a radius block that was bonded to the forward face of the fitting. The bolt hole with a portion of the upper left fitting was saw cut and extracted from the upper skin structure (saw cuts were made along the areas indicated by dashed lines in figure 13). The base material for the fitting was specified as 17-4PH CRES and identified by an alloy analyzer as grade 17-4 PH steel. The radius block was specified as 301 CRES steel and identified by an alloy analyzer as grade 301 stainless steel.

Figure 5. View of the intact upper left fitting showing the aft face (top of page) and close-up photograph of the fretting damage on the aft face of the fitting (bottom of page). Bare metal is exposed in fretting damaged area.

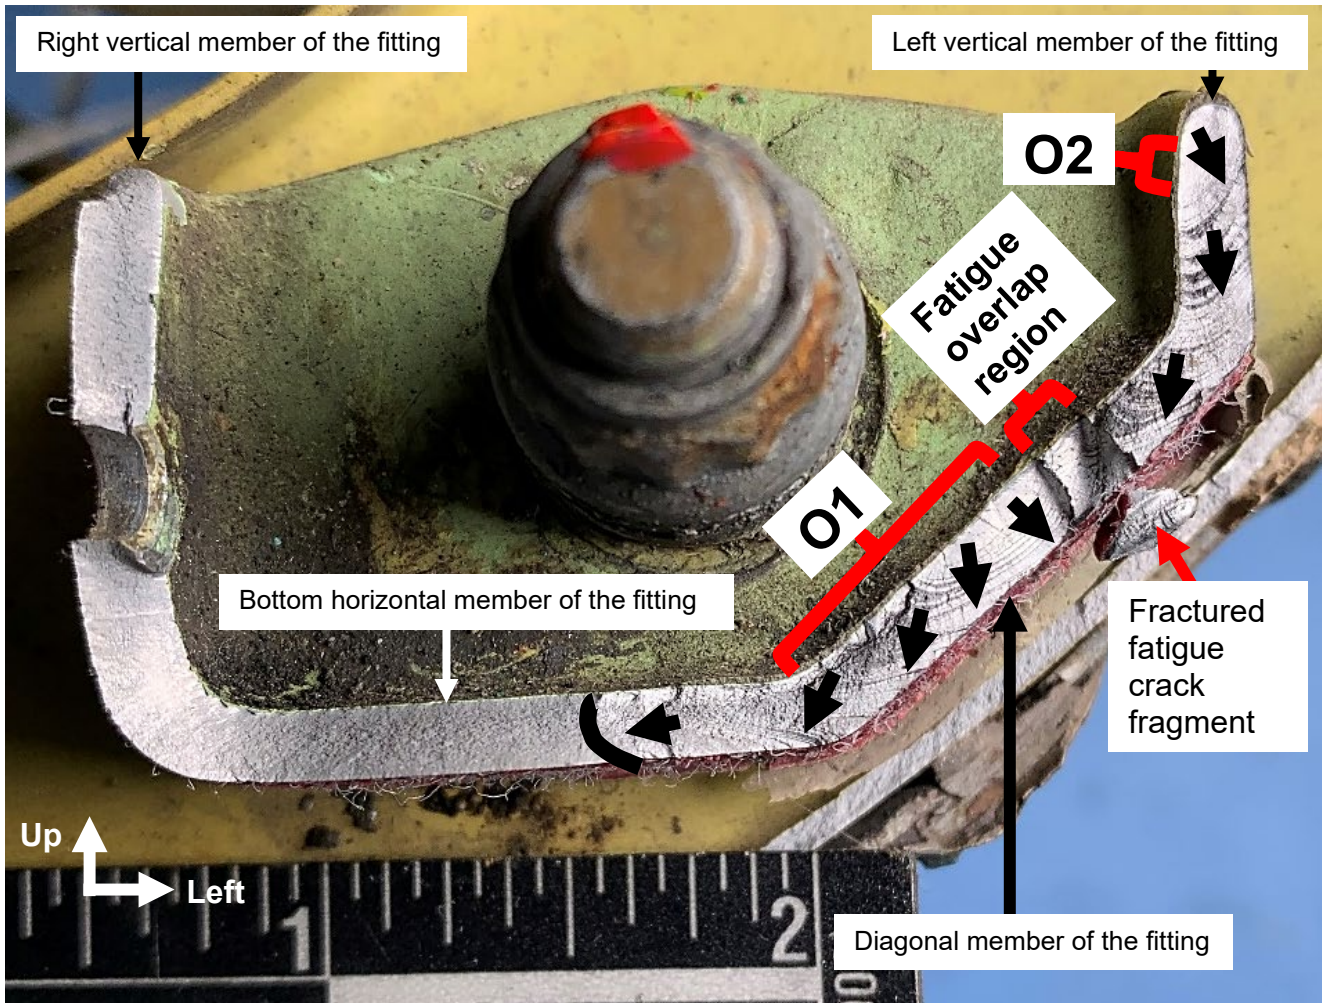
Figures 6 and 7 show photographs of the fractured lower left fitting. Bench binocular microscope examination of the lower left fitting revealed the fracture face contained evidence of crack arrest marks typical of fatigue cracking that emanated from two separate areas, arbitrarily labelled brackets "O1" and "O2" in figures 6 and 7. The fracture face was covered with debris that obscured the fine fatigue crack features. The coating on the fitting was removed with a commercial epoxy paint stripper and this process exposed the bare metal surfaces. The fracture face was cleaned by immersion in a chemical cleaning solution prescribed in American Society for Testing and Standards (ASTM) G1 for cleaning aluminum alloys. The cleaning solution contained chromic acid, phosphoric acid, and water. Scanning electron microscope (SEM) examination of fracture face revealed the ASTM chromic acid-containing cleaning solution exposed the fine fatigue striation features and micro-void coalescence features.

SEM examination of the fracture face revealed fatigue crack "O1" emanated from multiple origins at the outer surface at an area that was located slightly forward of the inner transition radius on the diagonal wall member portion of the fitting. The fatigue origin contained no evidence of pitting corrosion. Figure 8 shows an SEM image of typical fatigue striations that were located near the origin of the fatigue crack. Fatigue propagation was down and through the wall then extended to the right of the fitting. The fatigue crack region contained alternating fatigue crack features and overstress features, see figure 9. The fatigue crack terminated in the area indicated by a solid line in figures 6 and 7. The total length of this fatigue crack measured approximately 1 inch.

Figure 6. Close-up view of the fractured lower left fitting looking aft showing crack arrest features typical of fatigue cracking that emanated from two separate areas indicated by brackets “O1” and “O2”. The number of the fatigue origins were arbitrarily selected.

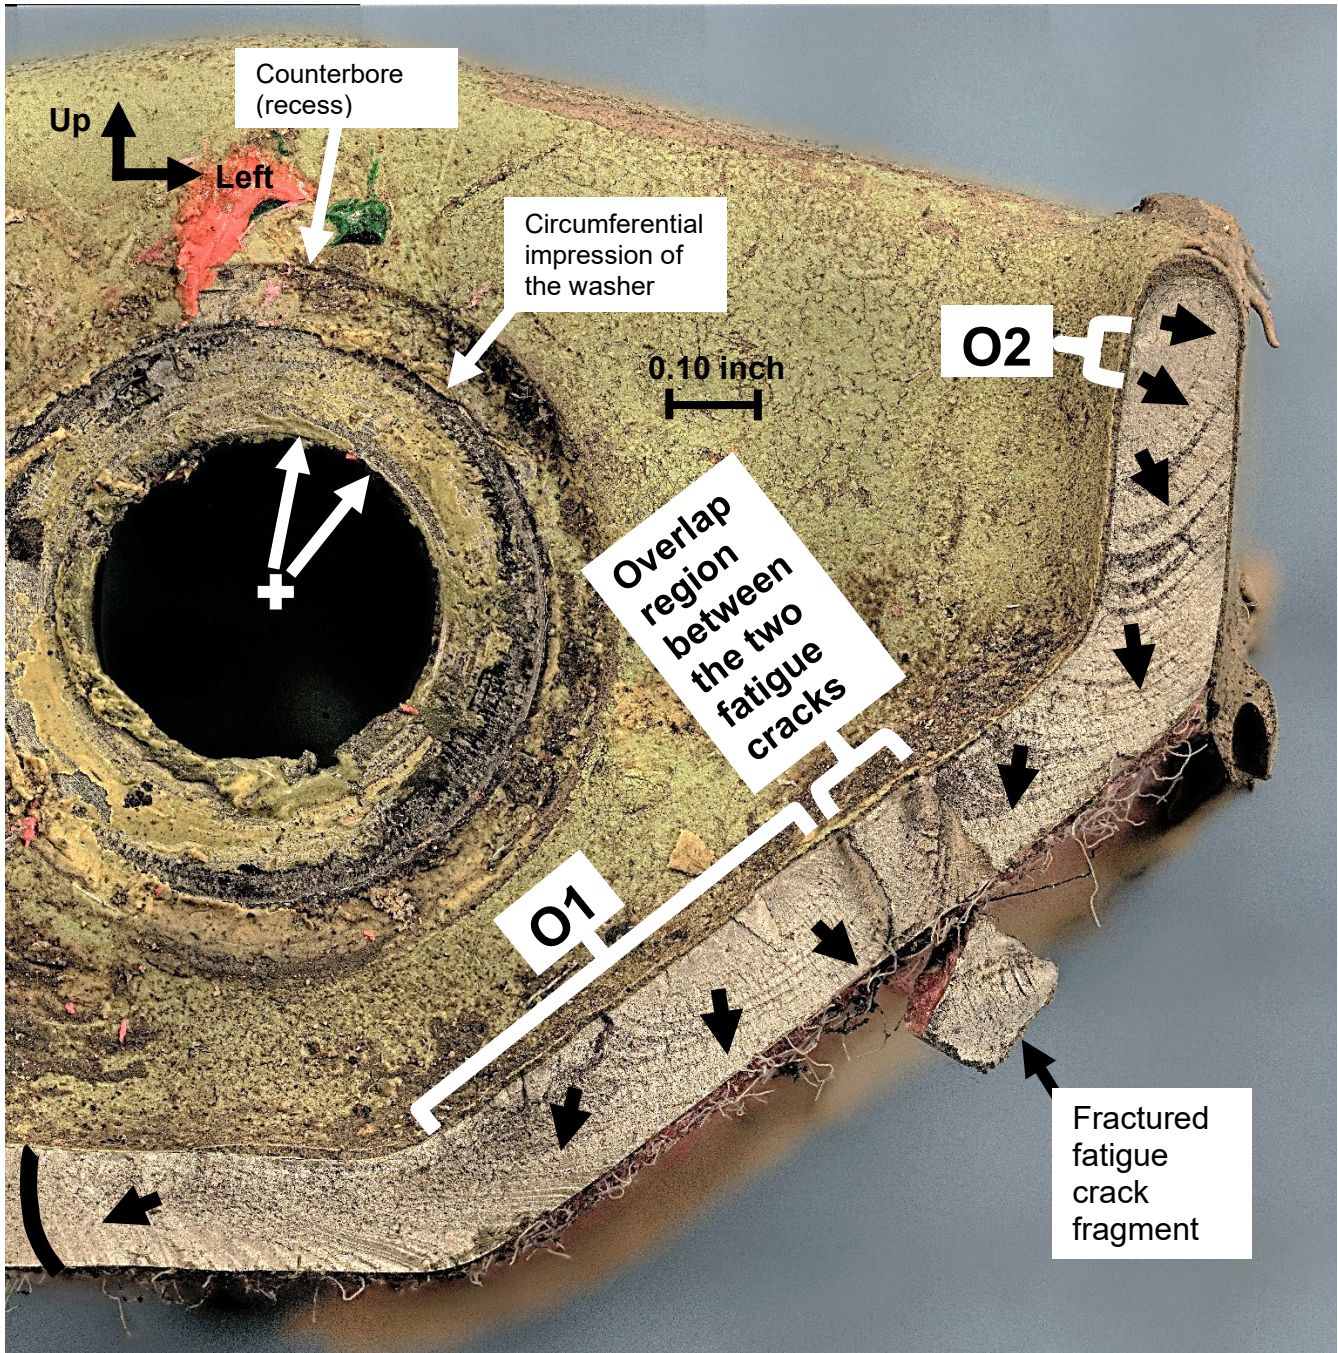
Fatigue crack "O2" emanated from a corrosion pit at the outer surface in an area slightly forward of the inner transition radius near the upper right end of the fitting, see area indicated by bracket "O2" in figures 6 and 7. The length and depth of the corrosion pit measured approximately 0.07 millimeter (mm) and 0.04 mm [0.003 inch and 0.002 inch], respectively. Figure 10 shows an SEM image of the corrosion pit. The fine fatigue crack features at the origin of the fatigue crack were obliterated from relative movement between mating fracture faces. The fatigue crack propagated through the wall and then extended down where it intersected the left edge of fatigue crack "O1". The fatigue crack region contained alternating fatigue crack features and overstress features. The total length of fatigue crack "O2" measured approximately 0.75 inch. The terminus of the fatigue crack "O2" partially overlapped and intersected the origin of fatigue crack "O1", but the terminus of the two fatigue cracks were on different fracture planes. A fragment containing the terminus portion of the two fatigue cracks broke away from the fitting and was held by adhesive fibers in the area near the fitting fracture face, see figures 6 and 7. The remaining portion of the fracture face that was located outside of the fatigue zone exhibited micro-void coalescence features consistent with overstress separation.

Bell Helicopter Alert Service Bulletin (ABS) 407-10-93, dated August 30, 2019, titled "Revision A to Alert Service Bulletin 407-10-93: Tailboom Attachment Hardware, Replacement of.", indicated to select a sufficient number of washers for the opposite end of bolt to obtain a minimum of one to a maximum of three threads showing beyond the nut after proper torque is obtained.³ Examination of all the fittings revealed between one and three threads were exposed beyond the nut as required per the ABS (see table 3); and between two and five washers were installed between the nut and fitting (see table 3). Each bolt contained one washer under the head of the bolt, as require by the ABS. The same ASB indicated that threads are not to be coated with primer or corrosion preventative compound (CPC) prior to installing the nut portions. The exposed threaded portion for each bolt that extended beyond the nut was not covered with CPC. All the fittings contained orange torque paint that extended between the nut and fitting. The fittings contained red torque paint that extended between the exposed threads and nut with the exception of the lower right fitting where a trace of red torque paint was adhering to the nut. The forward face of each fitting in the area adjacent to the washers contained a counterbore (recess), see figure 7. The diameter of the counterbore was slightly larger than the diameter of the washer.

Figure 7. Close-up view of the fractured lower left fitting looking aft and at the two fatigue crack origins indicated by brackets "O1" and "O2".

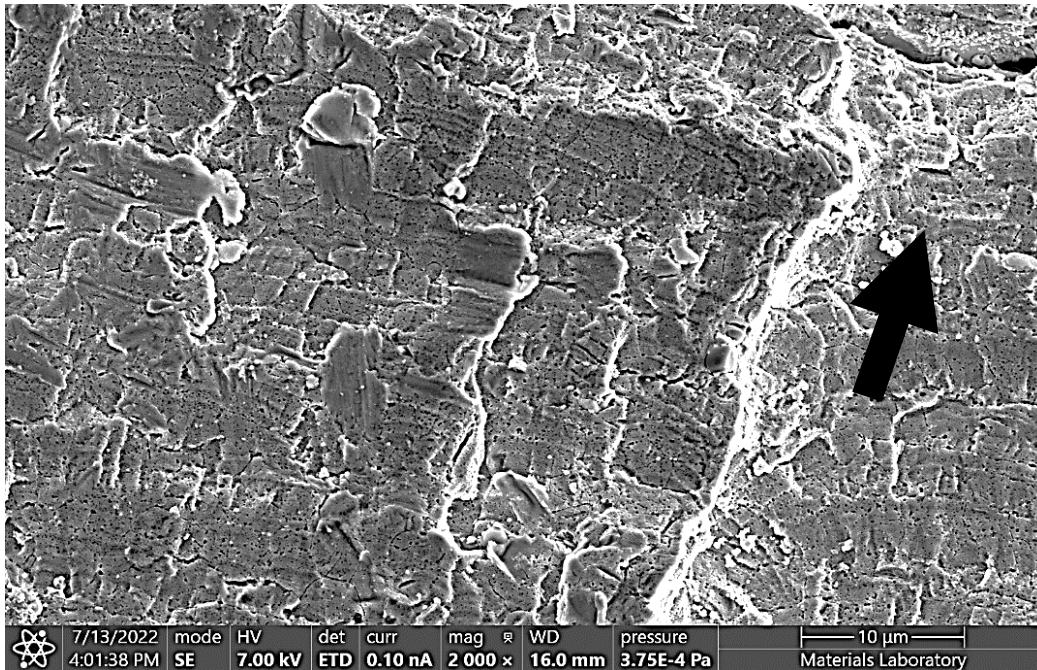
Figure 8 shows an SEM image of typical fatigue striations that were located near the origin of the fatigue crack. Fatigue crack propagation is in the general direction indicated by the arrow.

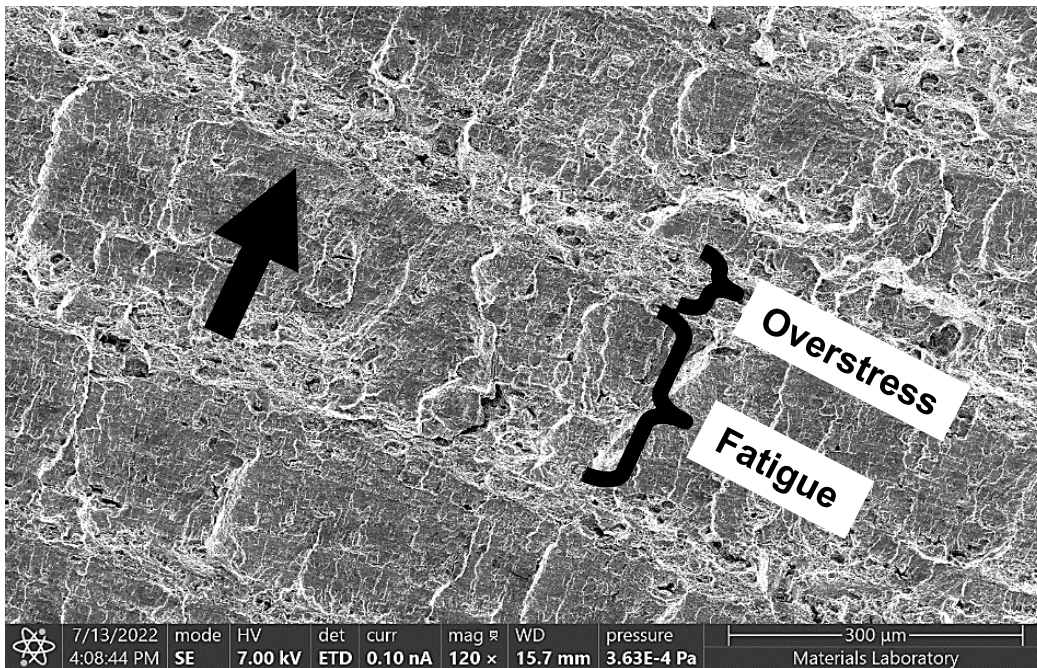
Figure 9 shows an SEM image of alternating fatigue crack features and overstress features. Fatigue crack propagation is in the general direction indicated by the arrow.

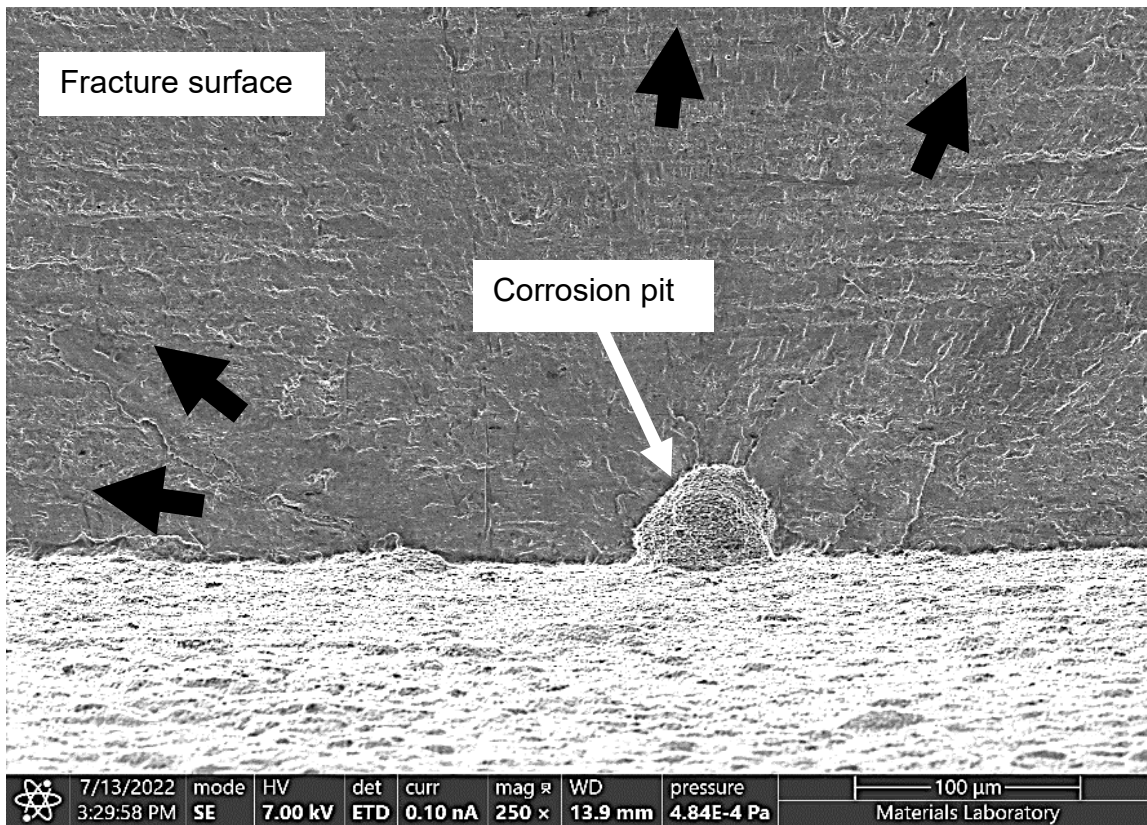
Figure 10. Scanning electron microscope image of fatigue origin “O2” that emanated from a single corrosion pit. Fatigue crack propagation is in the general direction indicated by the arrows.

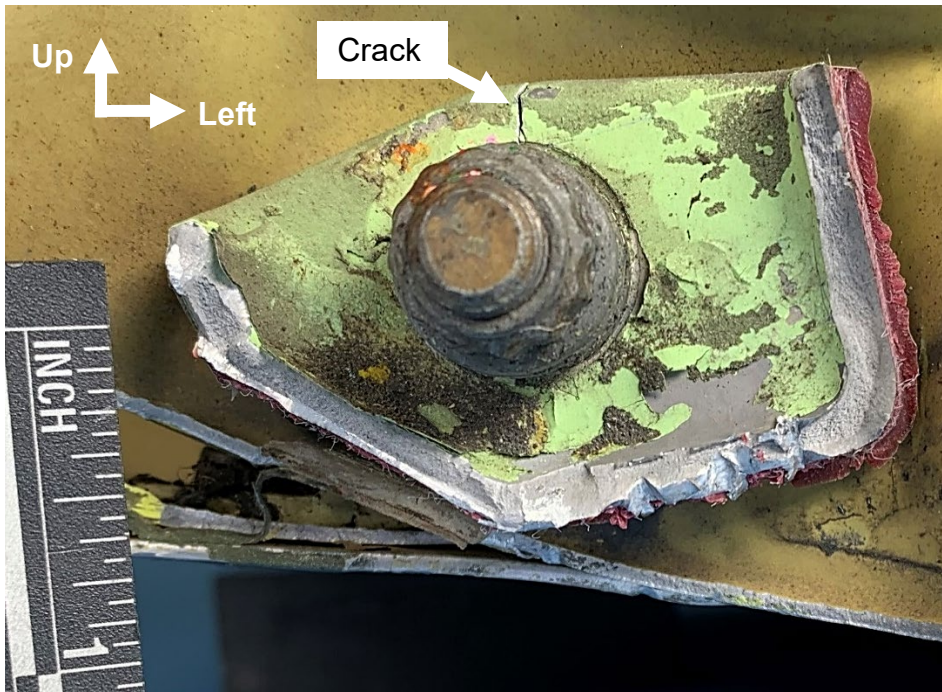
The fracture face of the lower right fitting exhibited a rough texture on slanted planes consistent with overstress separation, see figure 11. The fitting contained a vertical crack that extended between the bolt hole and the top of the fitting. The crack was through the wall. A vertical saw cut was made on the diametrically opposite the bolt hole and this exposed the crack. The exposed fracture face exhibited a coarse texture on a slant plane consistent with overstress separation.

Figure 11. View of the fractured lower right fitting.

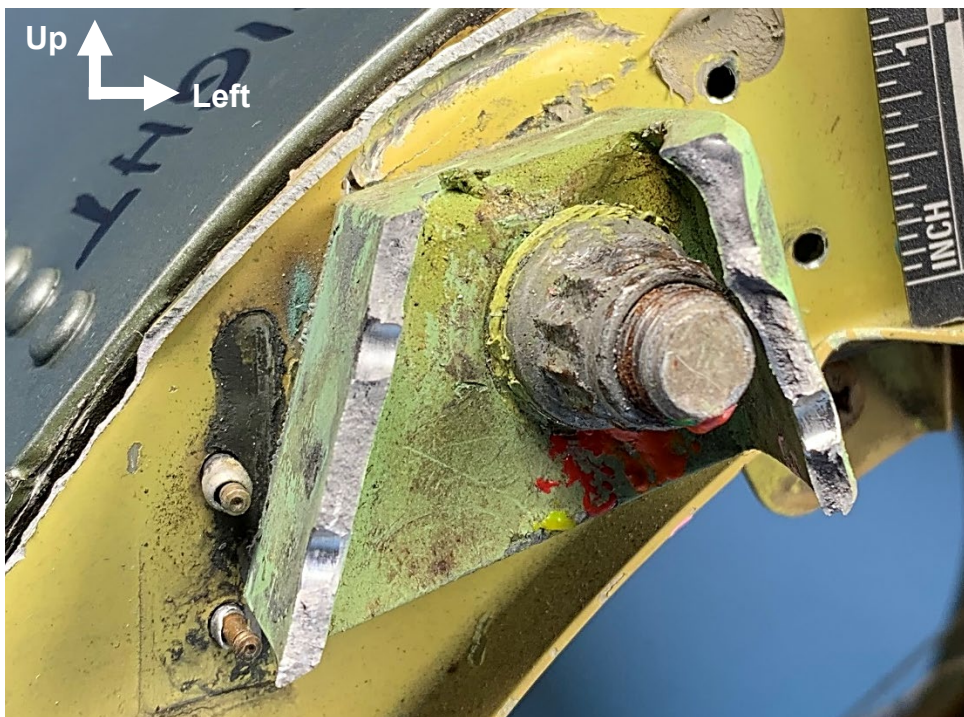
The fracture face of the upper right fitting exhibited a rough texture on slanted planes consistent with overstress separation, see figures 12. The upper right fitting (see figure 18) was specified as having been manufactured from two materials. A reinforcement plate (radius block) is bonded to the forward face of the fitting. The base material for the fitting was specified as 7075-T73 aluminum alloy and a hardness of 78 HRB, minimum. The coating was removed with a commercial epoxy paint stripper. The base material for this fitting was identified by an alloy analyzer as grade 7075 aluminum alloy (see table 1). Rockwell hardness testing of the fitting produced an average hardness value that exceeded the minimum specified hardness values (see table 1). Electrical conductivity measurement was 41.1% IACS (see table 1), which was greater than the specified minimum of 38% IACS per BPS 4453 specification. The radius block was specified as having been made from grade 2024 aluminum alloy (see table 2). The alloy analyzer identified the plate as grade 2024 aluminum alloy (see table 2).

Figure 12. View of the fractured upper right fitting.

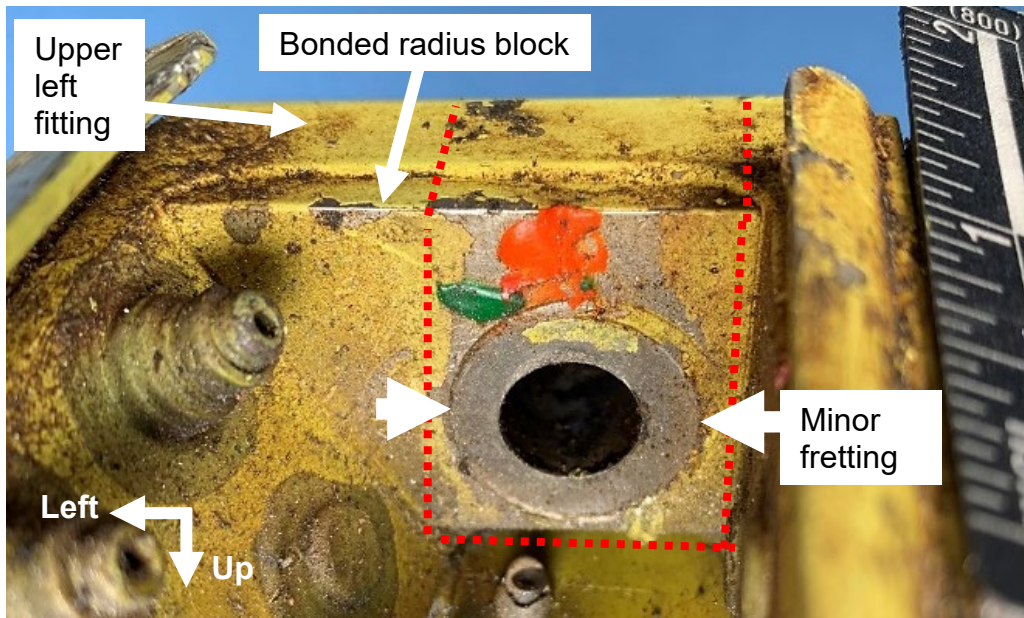
Figure 13. View looking aft at the intact upper left fitting that remained attached to the longeron. Minor fretting was noted between the arrows. Saw cuts were made along the red dashed lines to facilitate examination of the bolt hole. This is a close-up view of the hole shown in figure 4.

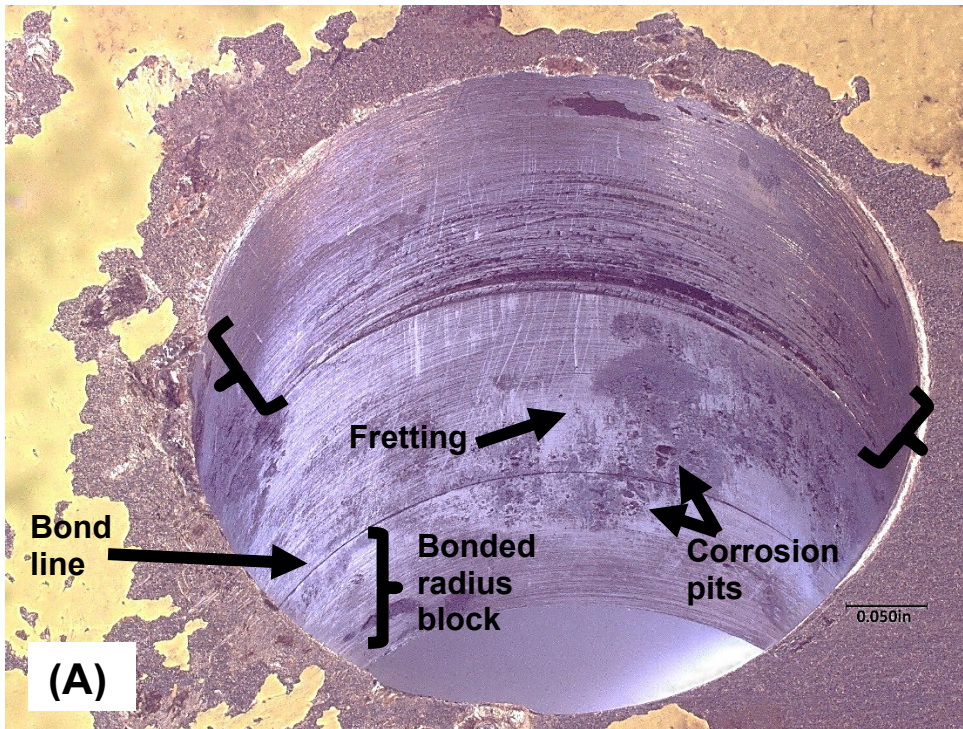
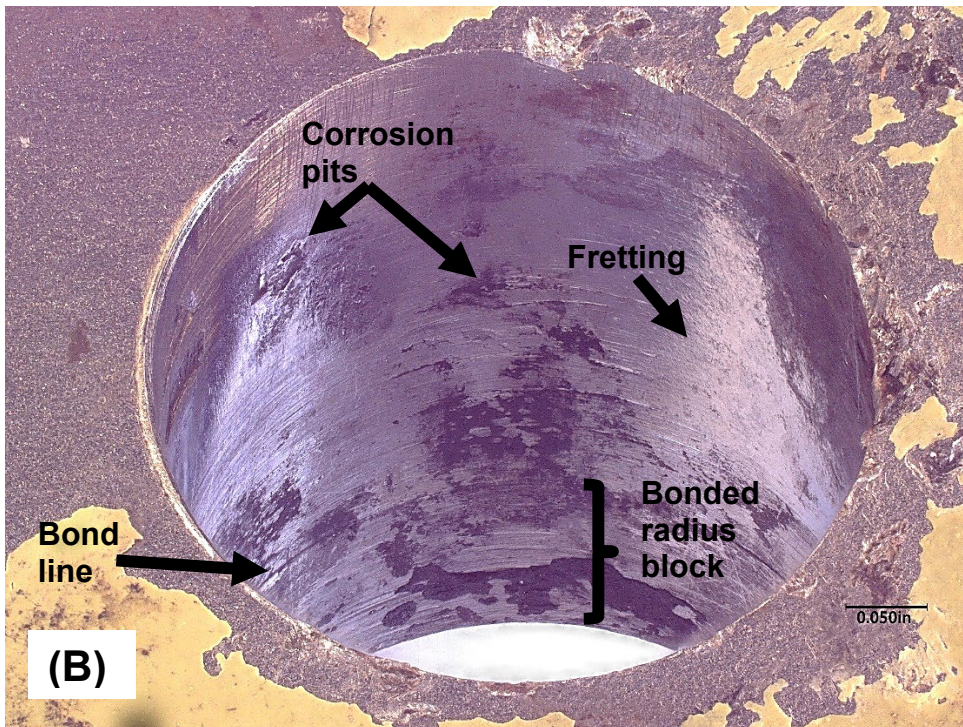
The cut portion with the bolt hole (see cut lines in figure 13) was ultrasonic cleaned with acetone followed by brush cleaning with Alconox. Paint stripper was not applied to this fitting. Figure 14 show photographs of the bolt hole for the upper left fitting after cleaning. Bench binocular microscope examination of the bolt hole revealed evidence of circumferential gouge and impression marks in the area indicated by a bracket; fretting; black and brown deposits consistent with iron oxide; and corrosion pits. The circumferential gouge and impression marks were more severe on one side of the hole. The fretting and pitting corrosion was not uniform around the circumference of the hole.

Figure 14. View "A" is looking forward into the bolt hole for the upper left fitting and view "B" is the diametrically opposite side of the same hole showing circumferential gouge and impression marks in the area between brackets, fretting (surfaces with polished appearance), corrosion deposits (back areas), and corrosion pits (photographs taken after ultrasonic cleaning with acetone followed by brush cleaning with Alconox).

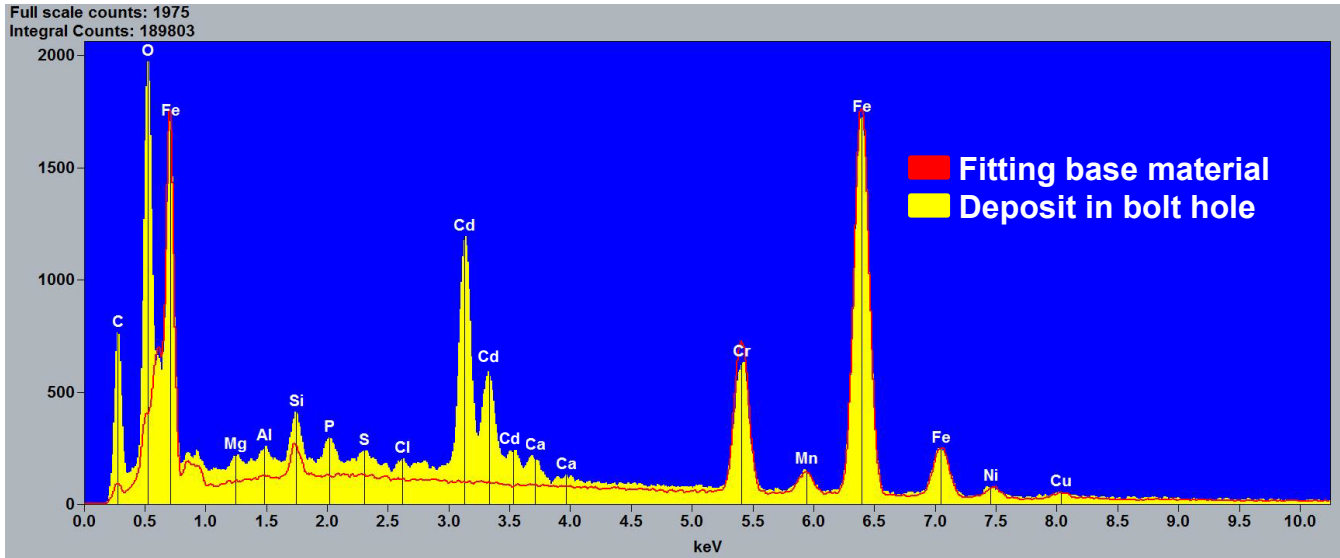
The hole was cut in half to expose the two halves of the hole. EDS analysis of the hole in the areas of fretting produced a spectrum that contained elemental peaks of oxygen (O) in the form of an oxide and cadmium (Cd), among other elements, that were not present in the fitting base metal. Figure 15 shows the EDS spectrum of the base metal for the upper left fitting (red outline) and overlapping EDS spectrum for the fretting areas in the surface of the hole (solid yellow background).

Figure 15. EDS spectrum of the base metal for the upper left fitting (red outline) and overlapping EDS spectrum for the deposits found in the surface of the hole (solid yellow background). The deposits in the bolt hole contained elemental peaks of oxygen (O) in the form of an oxide and cadmium (Cd), among other elements, that were not present in the base metal of the fitting.

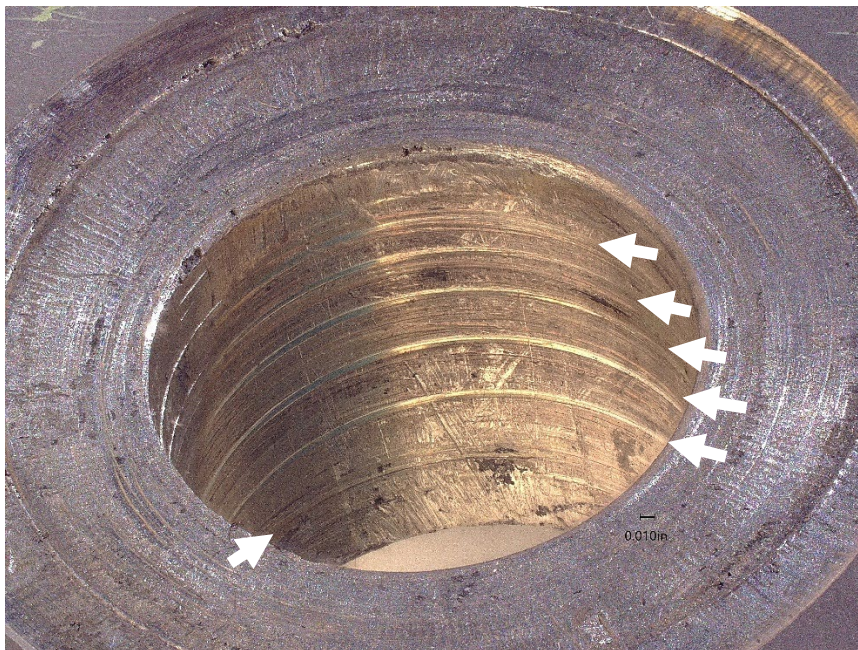
Figures 16 and 17 show photographs of the lower left fitting and upper right fitting, respectively. Both holes showed evidence of severe spiral gouge marks, indicted by arrows, and fine spiral scratches. The spiral gouge marks did not extend all around the bore.

Figure 16. View looking aft into the bolt hole for the lower left fitting showing spiral gouge marks, indicted by arrows, and fine spiral scratches. Shown after removing paint from the fitting with paint stripper.

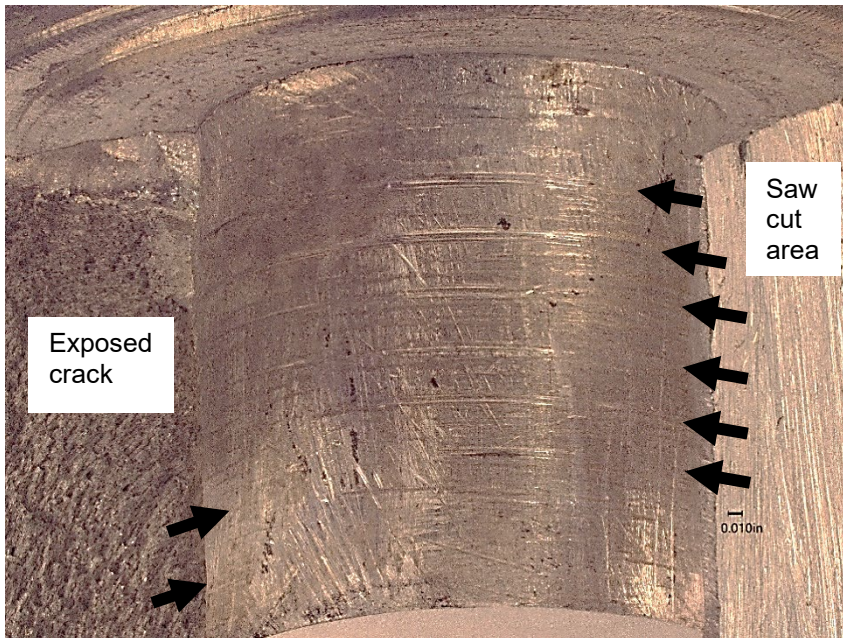
Figure 17. View looking into the bolt hole for the lower right fitting showing spiral gouge marks, indicated by arrows, and fine spiral scratches. Shown after removing paint from the fitting with paint stripper.

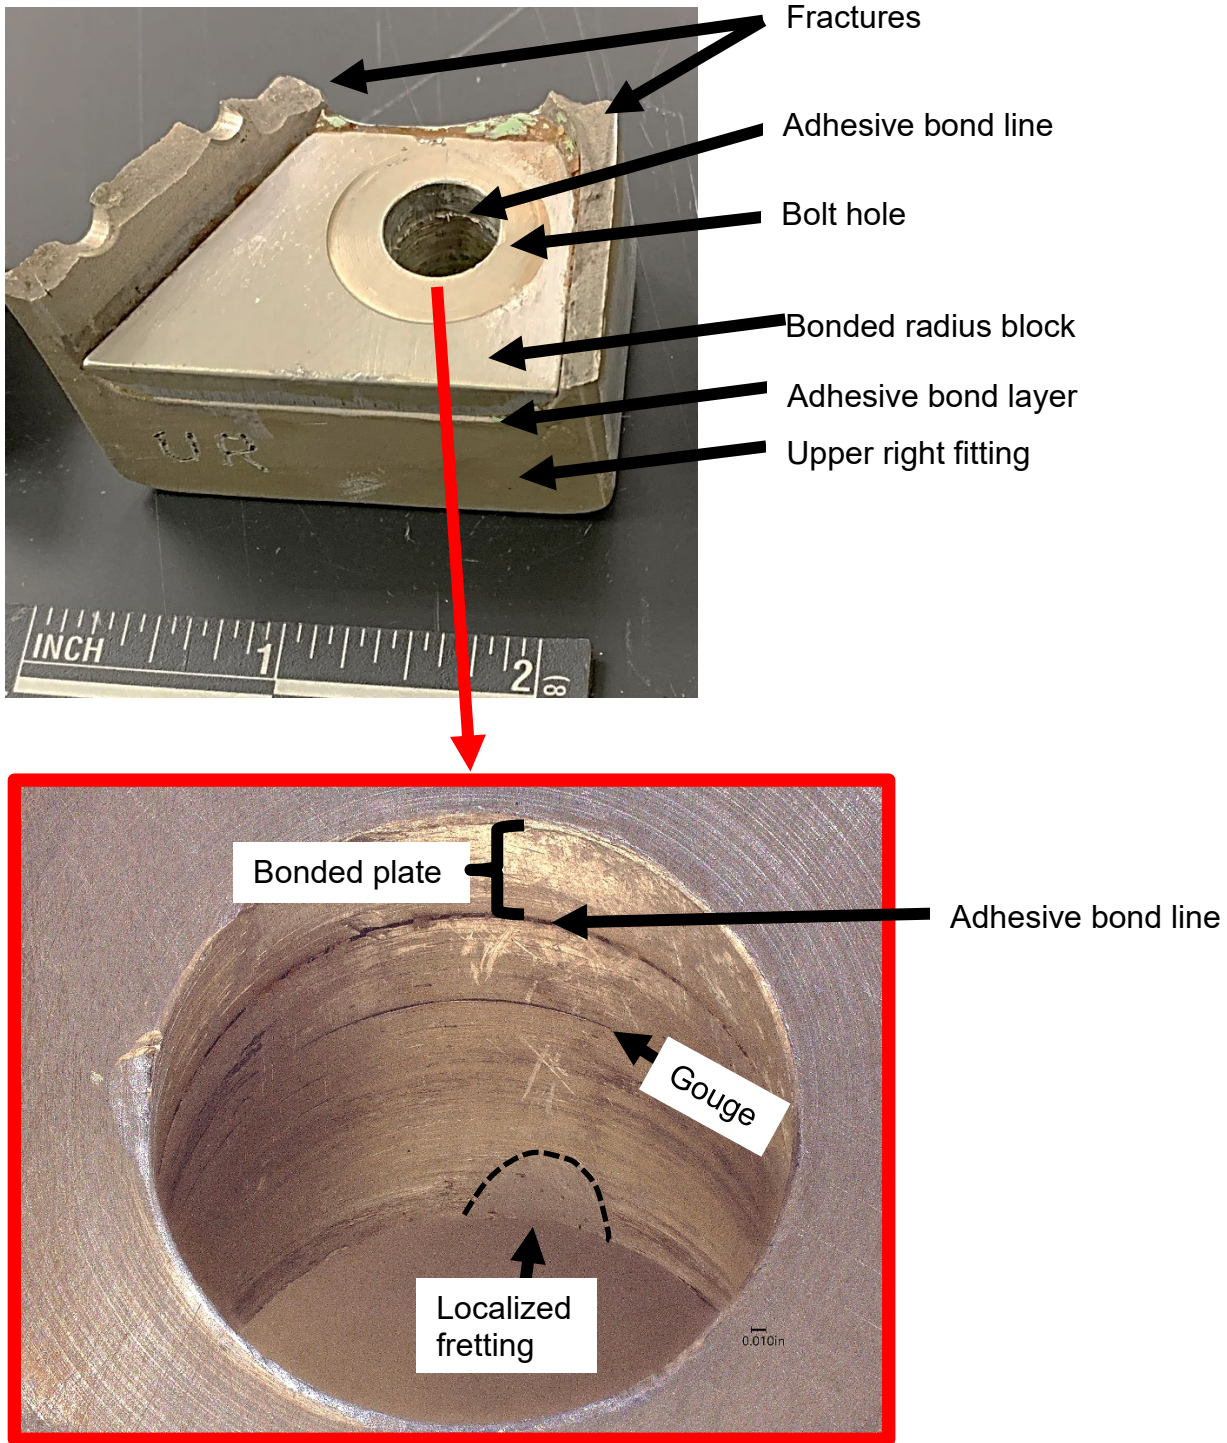
Figure 18 show photographs of the upper right fitting. The hole for this fitting showed evidence of a circumferential gouge mark; fine circumferential scratches; and an isolated area of fretting. The radius block for this fitting showed no evidence of debonding from the fitting.

Figure 18. Overall view of the upper right fitting (top of page) and view looking aft into the bolt hole showing a circumferential gouge mark in the area indicted by an arrow; fine circumferential scratches; and an isolated area of fretting. Photographs are shown after removing paint from the fitting with paint stripper. The upper right and left fittings are manufactured with a radius block that are bonded to the forward face of the fitting. The plate showed no evidence of debonding from the fitting.

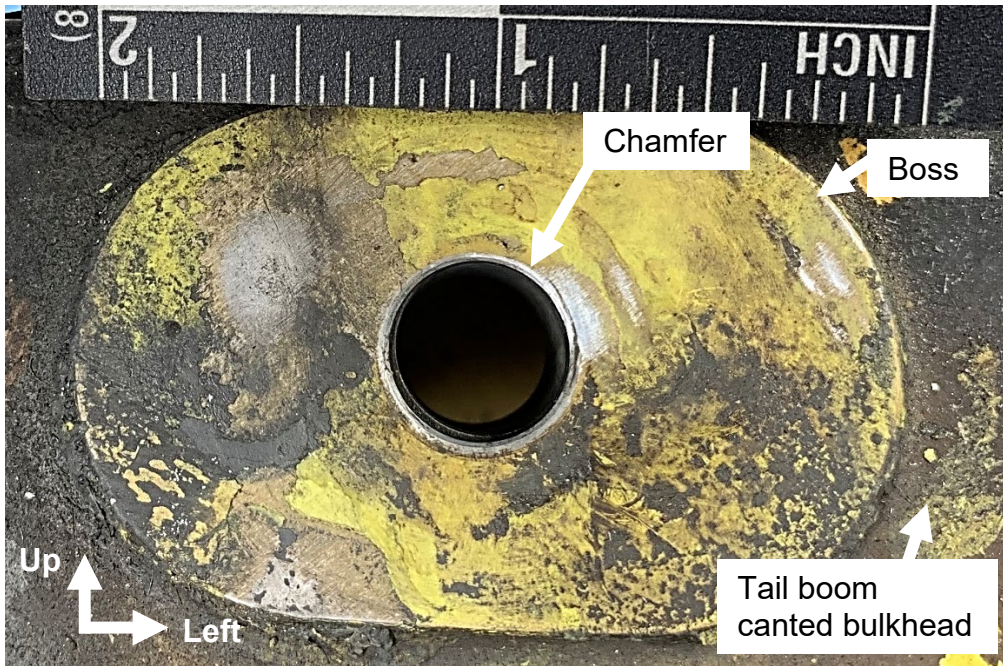
Figure 19. View looking aft into the bolt hole for the upper left fitting, after cleaning the rim portion with a cloth rag. The rim portion of the hole contained a chamfer. The chamfer portion showed no evidence of gouging or metal deformation.
