NATIONAL TRANSPORTATION SAFETY BOARD

MATERIALS LABORATORY FACTUAL REPORT

Report No. 22-071

Place : Kalea, Hawaii
Date : June 8, 2022
Vehicle : Bell 407 helicopter, N402SH
NTSB No. : ANC22FA041
Investigator : Aaron Sauer

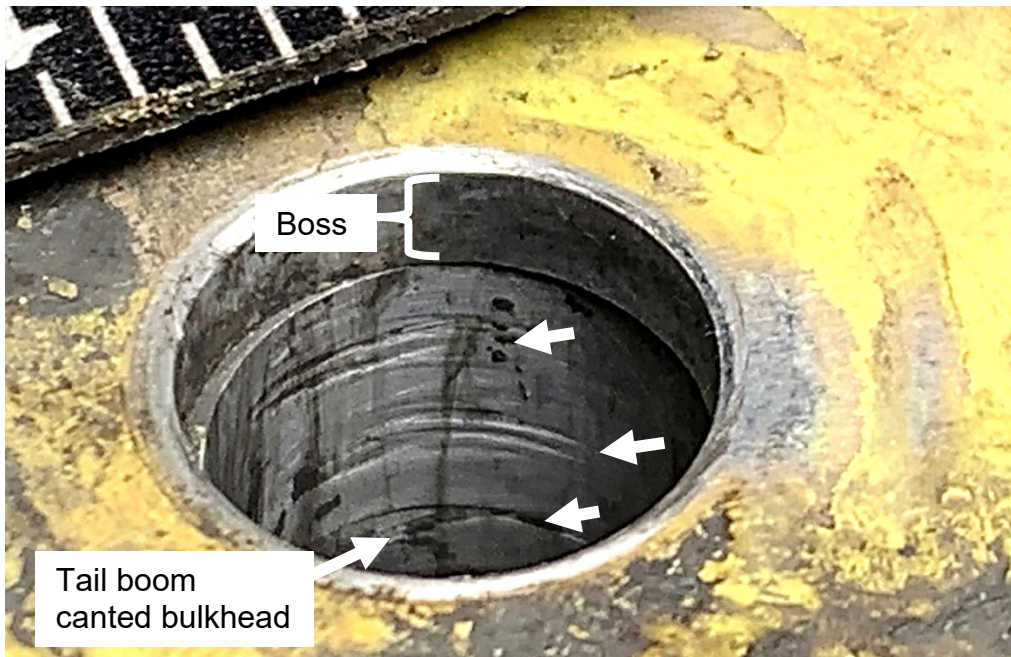
Bench binocular microscope examination of the fuselage frame⁴ revealed that the bolt holes at the forward edge contained a chamfer. The chamfer edge of each hole contained no evidence of gouging or metal deformation (see figure 19). The bolt hole that corresponded to the upper left fitting contained circumferential gouge and impression marks, see figure 20. The circumferential gouge and impression marks were more severe on one side of the hole. The remaining bolt holes in the fuselage frame showed no evidence of circumferential gouge marks or impressions (see figures 21 through 23).

Figure 20. View looking aft into the bolt hole for the upper left fitting showing circumferential gouges, indicated by arrows.

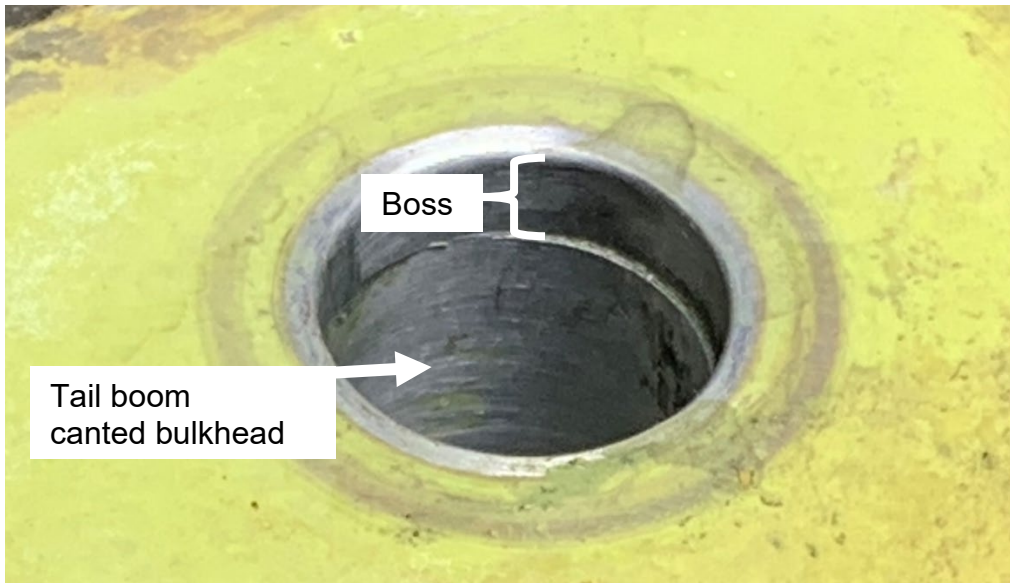
Figure 21. View looking aft into the bolt hole for the upper right fitting showing a smooth finish surface.

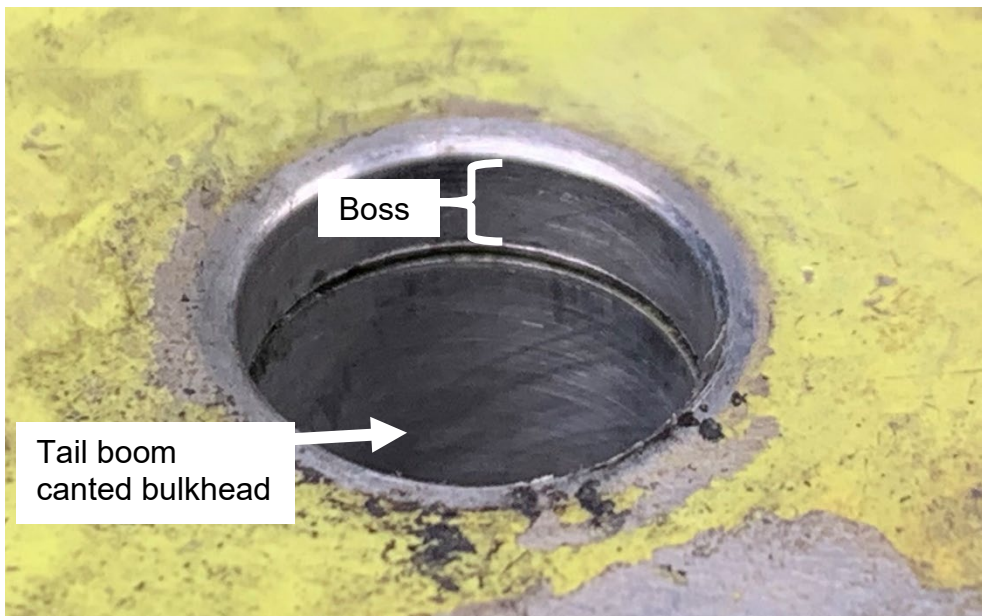
Figure 22. View looking aft into the bolt hole for the lower left fitting showing a smooth finish surface.

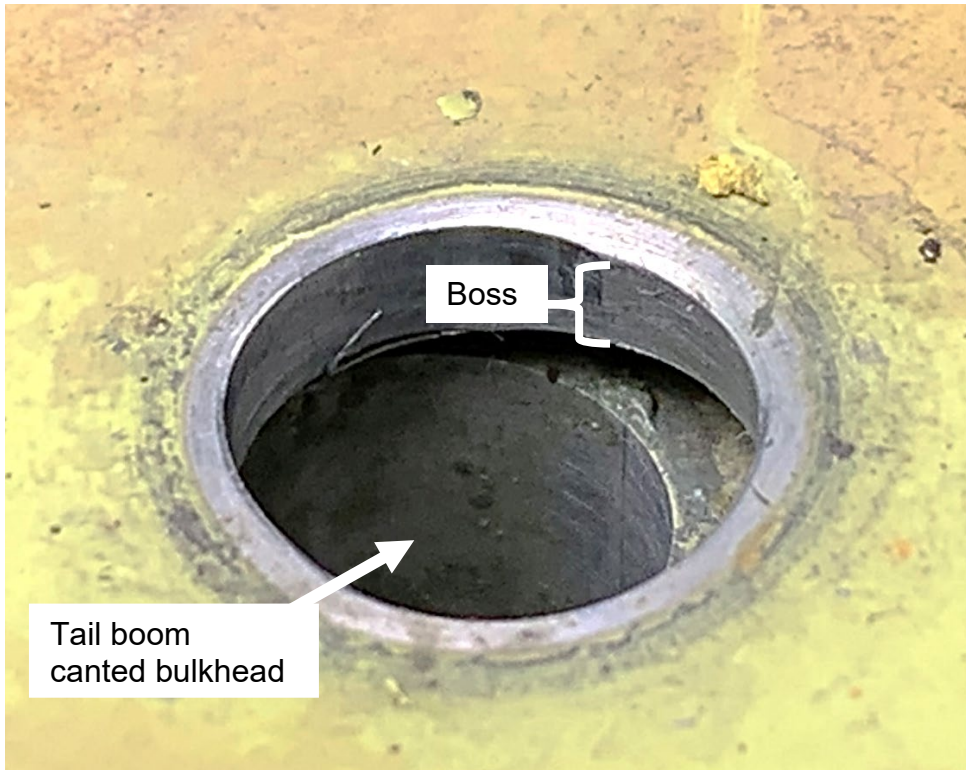
Figure 23. View looking aft into the bolt hole for the lower right fitting showing a smooth finish surface.

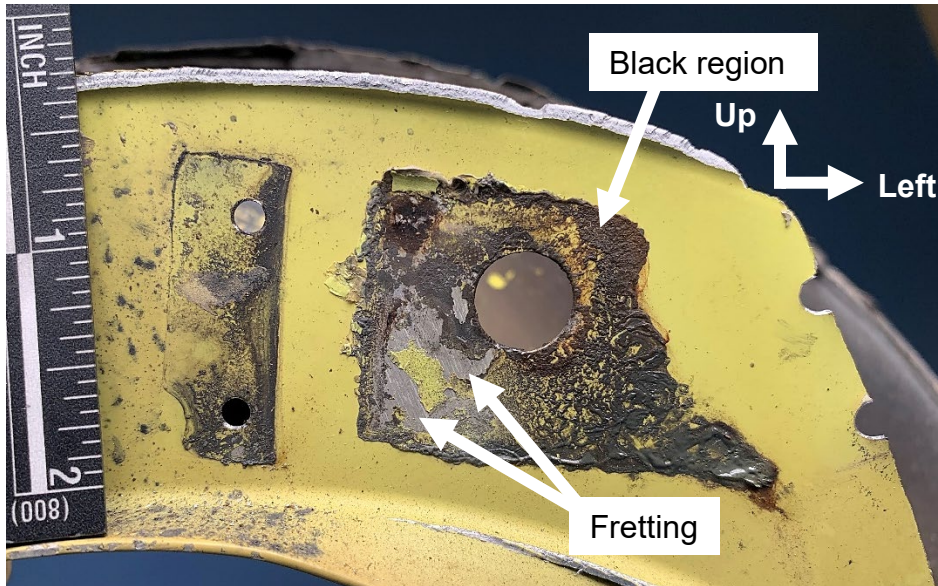
Figure 24. Forward face of the fuselage frame in the area of the bolt hole for the upper left fitting. The forward face in the area that corresponded to the location of the fitting contained a black paste-like deposit, consistent with CPC that was exposed to the environment and exhaust from the engine.

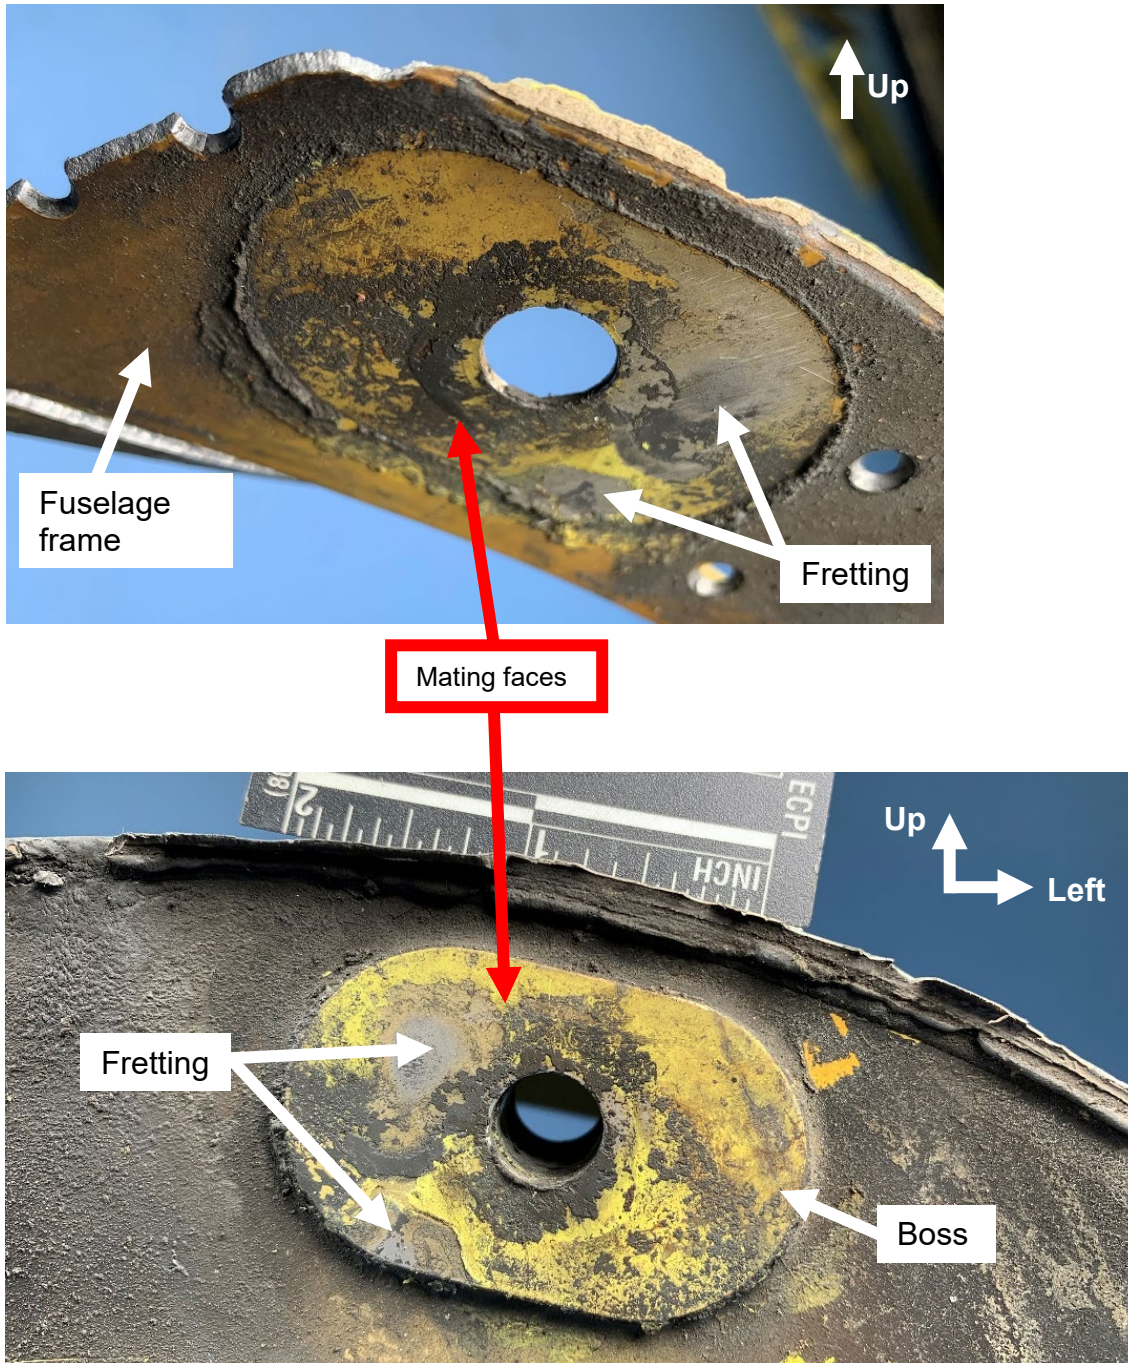
Figure 25. Aft face of the fuselage frame in the area of the bolt hole for the upper left fitting (top of page) and the mating forward face of the tail boom canted bulkhead in the area of the same bolt hole (bottom of page). The mating faces show evidence of fretting.

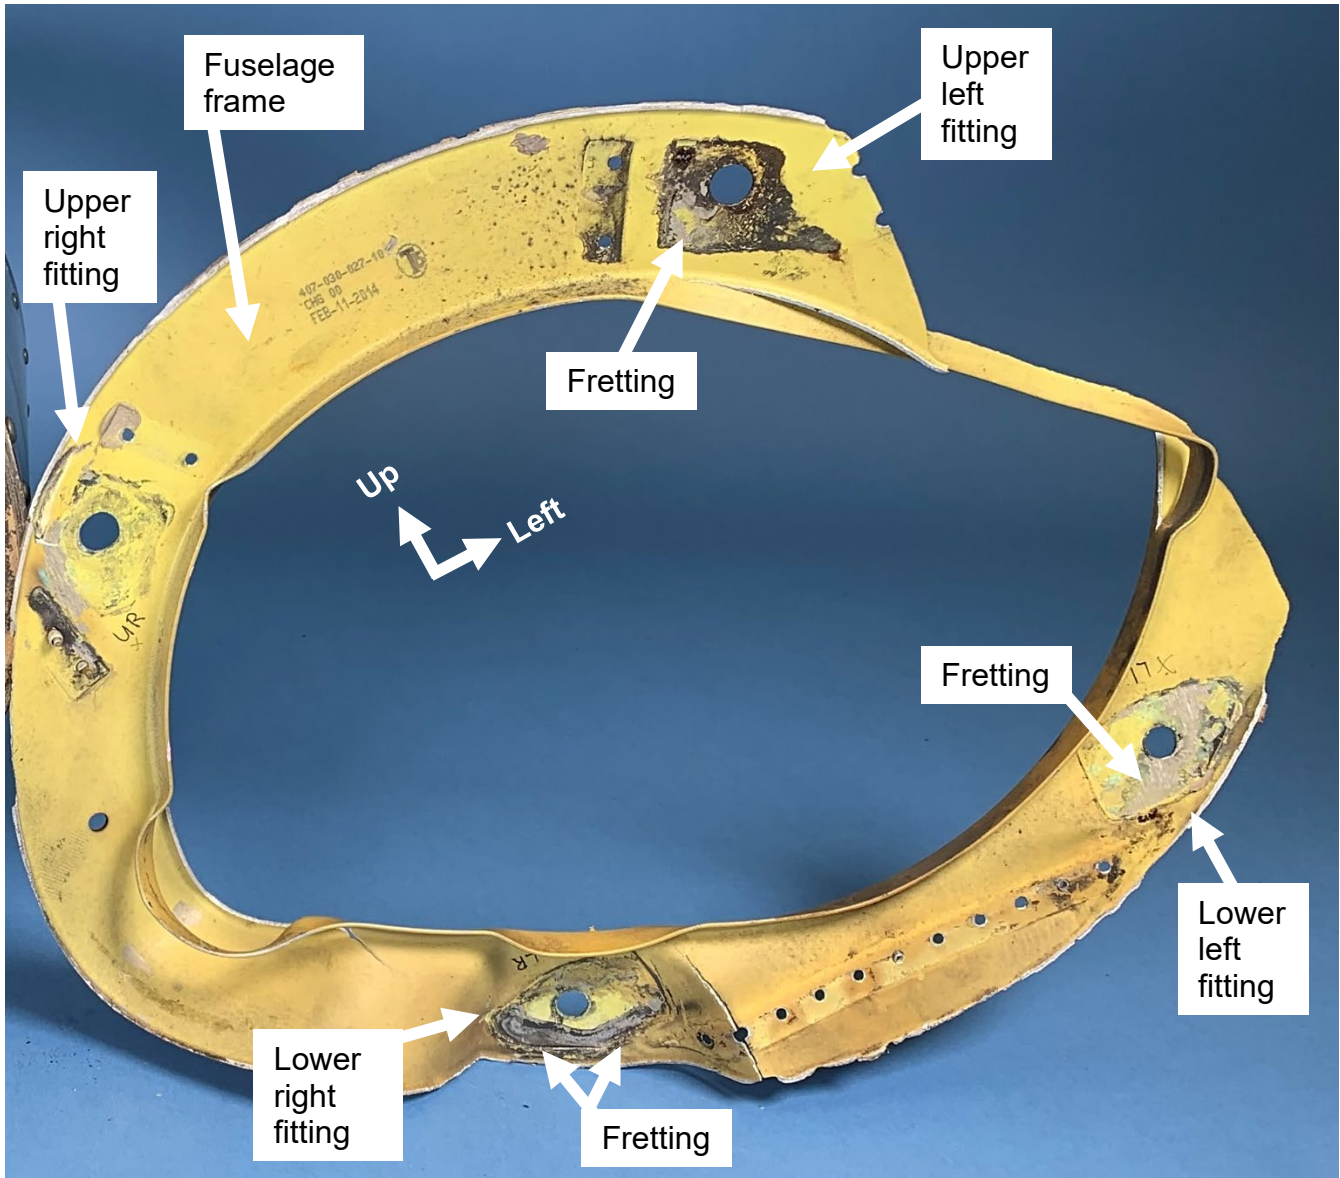
Figure 26. View looking aft at the fuselage frame after the fittings were disassembled. The forward surface of the fuselage frame in the areas that corresponded to upper left fitting exhibited a black deposit of CPC, consistent with exposure of CPC to the environment and exhaust from the engine, whereas the areas that corresponded to the remaining fittings exhibited for the most part clean CPC (yellow-green past-like texture).
