National Transportation Safety Board

DCA22FM022

MATERIALS LABORATORY

Factual Report 22-080

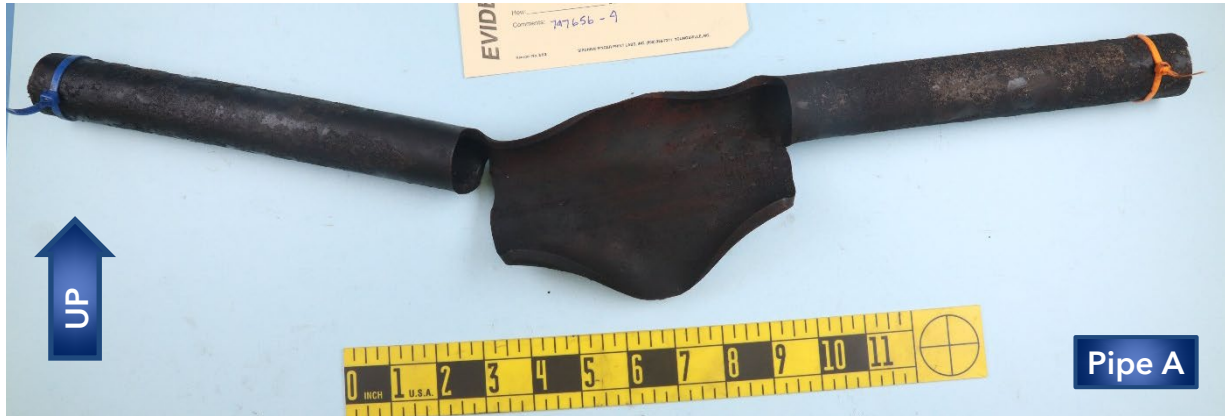
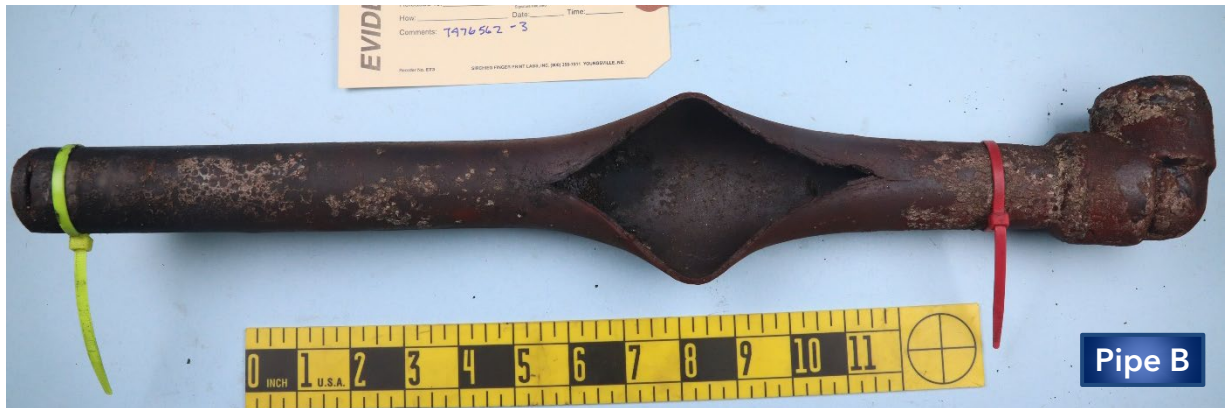
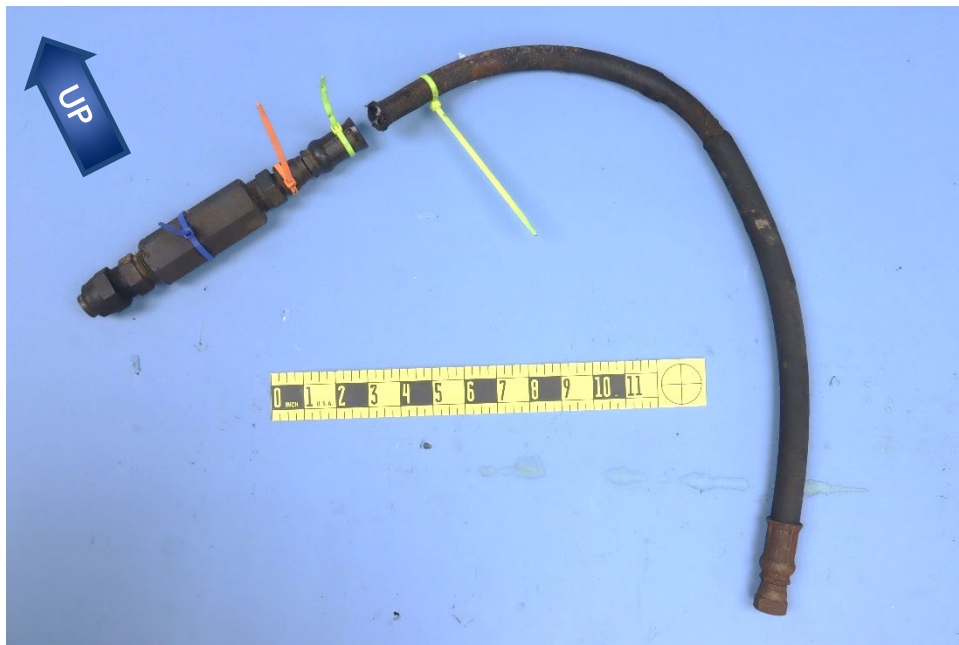
Overall views of the submitted components are shown as received in figure 1. One pipe piece (upper image in figure 1 shown labeled pipe A for this report) was cut from a location at the outboard side of the port engine. The other pipe piece (middle image in figure 1 shown labeled pipe B for this report) was cut from pipe located in the hydraulic pump space. The hydraulic relief valve hose and fittings were also collected from the hydraulic pump space. All components were reportedly associated with the hydraulic steering system. The fittings at the upper end of the hose were disassembled from the steering hydraulic pump reservoir, and the hydraulic hose was disassembled from the relief valve.

All components were tinted dark and were heavily oxidized consistent with exposure to heat and fire. On the hydraulic hose, heat damage was more substantial at the upper end of the hose where the liner and external sheath were both missing, leaving only the braided reinforcement. On the lower half of the hose, the external sheath remained in place. The condition of the internal liner at the lower end of the hose was not determined. The reinforcement braid consisted of two layers of reinforcement, consistent with the system engineering drawing specification.

The two pipes were fractured longitudinally at the upper side of each pipe. On pipe A, the longitudinal fracture transitioned to circumferential fractures that extended around most of the pipe circumference at each end of the longitudinal fracture. The hydraulic hose had separated from the crimped sleeve for the hose end fitting at the upper end of the hose.

Figure 1. Overall views of the hydraulic pipe located at the outboard side of the port engine (upper image), upper side of the hydraulic pipe from the hydraulic pump space (middle image), and hydraulic relief valve hose and fittings (lower image).

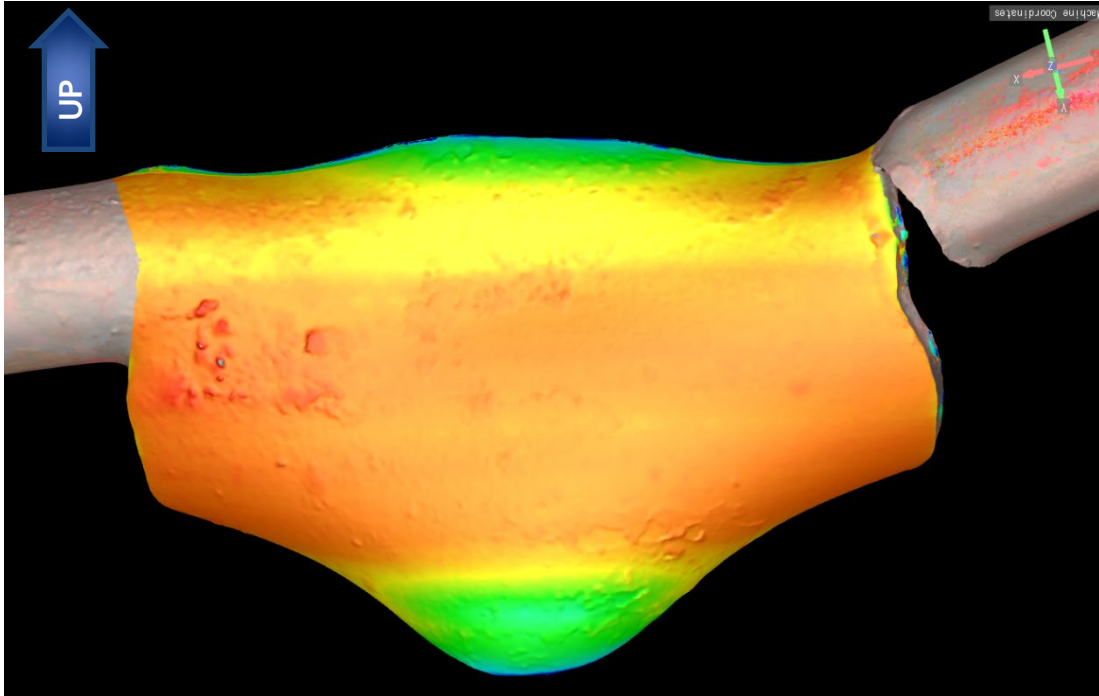
The section of pipe A between the circumferential fractures was deformed from a cylindrical shape to a shape resembling a wavy plate with curled edges. The fractured and deformed section was placed into a Keyence VL 500 series 3D scanner, and a thickness contour map showing thickness variations for the section between the circumferential fractures was produced as shown in figure 2. The thickness contours showed the wall thickness was relatively thinner in a circular area (appearing yellow, green and blue in figure 2) that would have been at the upper side of the pipe before fracture. The thinner area was also associated with an outward bulge in the wall.

Figure 2. Thickness contour map image of pipe A obtained using a Keyence VL 500 series 3D scanner showing the external side of the pipe fracture (opposite view from figure 1). Blue, green, yellow, orange, and red colors indicate thickness variation from thinner to thicker.

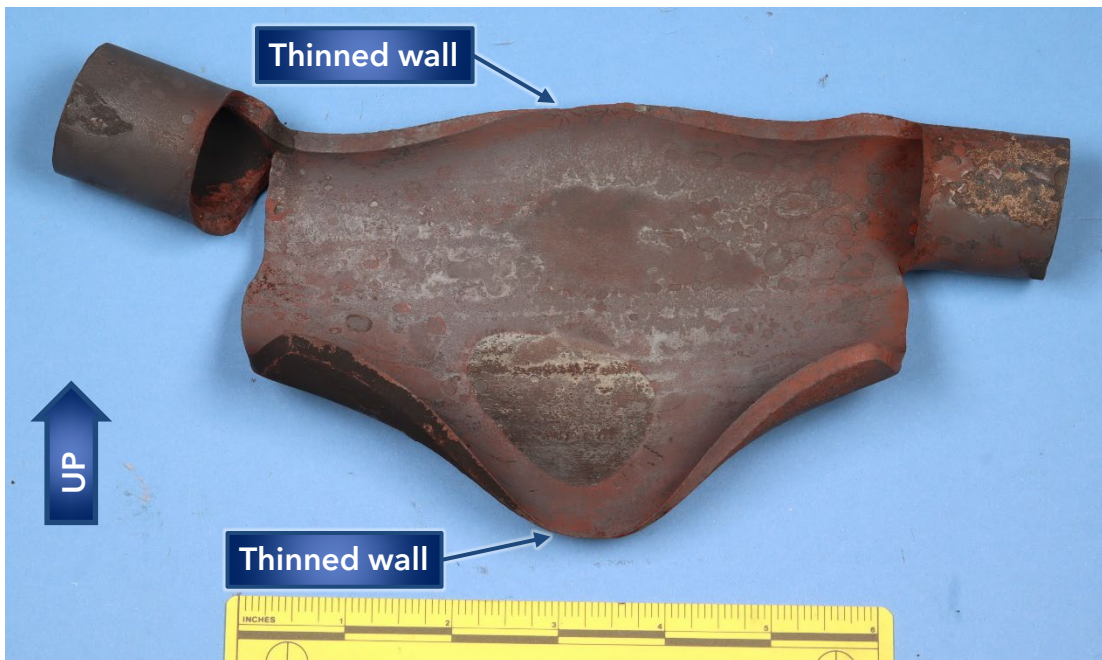
Views of the pipe A fracture after soaking in Evapo-Rust are shown in figures 3 and 4. The longitudinal fracture occurred on a slant plane consistent with ductile overstress fracture. At the middle of the fracture, the wall showed thinning deformation and outward deformation, consistent with substantial local plastic deformation before fracture.

Figure 3. Closer view of the pipe A fracture after sectioning and partial oxide removal. Areas of reduced wall thickness at the fracture location are indicated.

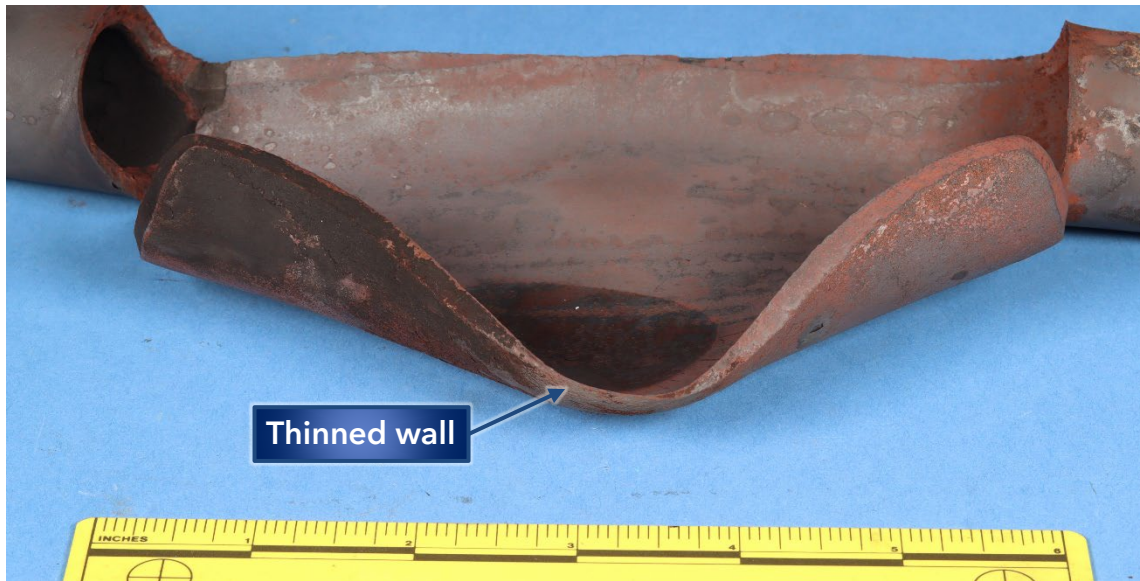
Figure 4. View from the lower side of pipe A showing wall thinning at the center of the bulge in the fracture location.

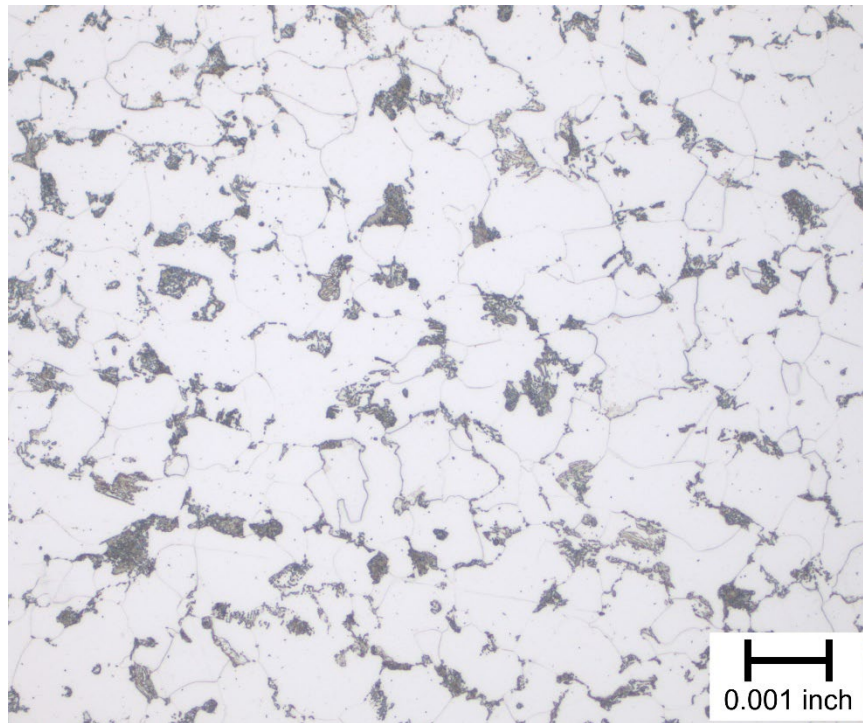
One of the pieces cut from pipe A before starting the oxide removal procedure was further sectioned to prepare a sample for metallographic examination of the transverse cross-section. An approximately ¼-inch ring section from pipe A was submerged in Alconox and warm water and cleaned using an ultrasonic cleaner before mounting in a metallurgical mount using a hot press. The mounted sample was then polished and etched with 2% nital⁴ to reveal the microstructure as shown in figure 5. The microstructure consisted of mostly ferrite with partially spheroidized pearlite, consistent with a low-carbon steel exposed to high heat.

Figure 5. Typical microstructure for pipe A. White areas are ferrite, and darker areas are partially spheroidized pearlite. (Etched with 2% nital.)

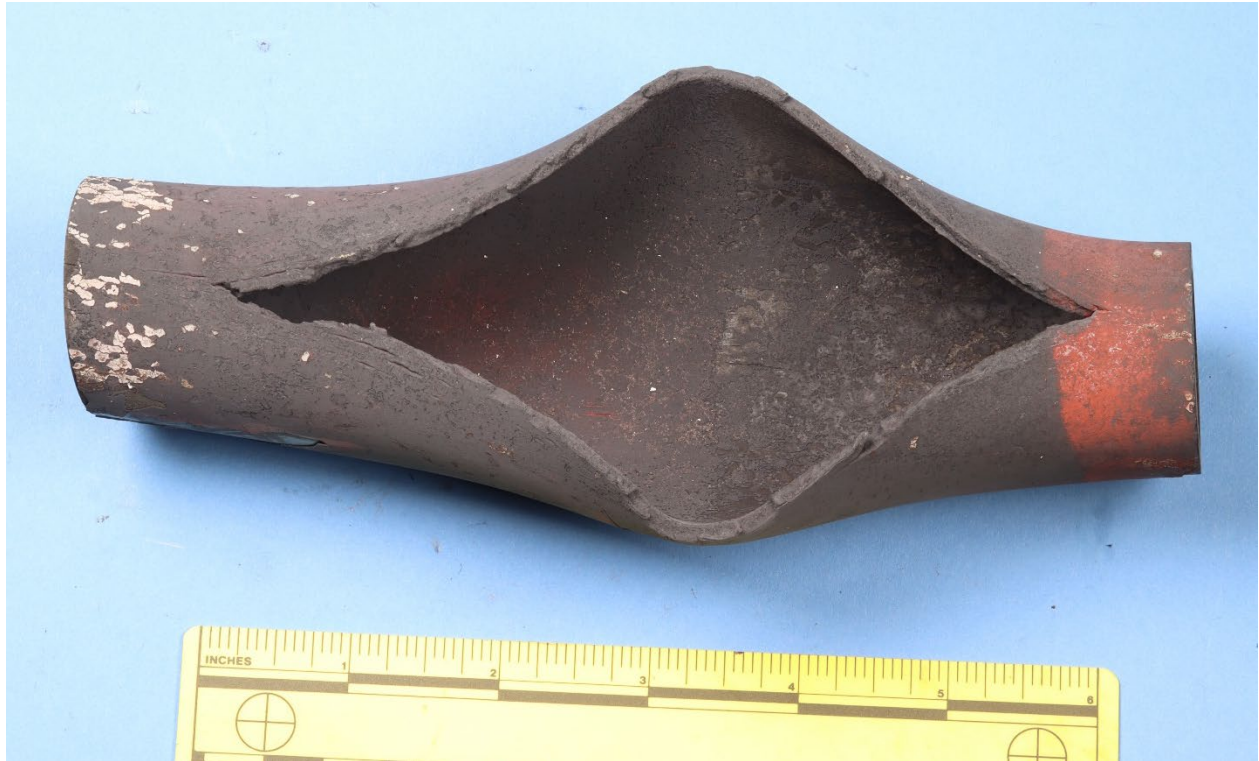
Next, pipe B was examined after the 24-hour soak in Evapo-Rust. The longitudinal fracture occurred mostly in planes perpendicular to the pipe surfaces. Although general macroscopic features were visible, relatively thick oxides remained covering all surfaces including the fracture surfaces. To assist in removing more oxides, pipe piece B submerged in a beaker of Evapo-Rust, and the beaker was placed in an ultrasonic cleaner for 1 hour followed by brushing to remove loose material. Views of the pipe B piece after deoxidation in the ultrasonic cleaner are shown in figures 6 and 7. The middle portion of the fracture occurred on multiple planes in longitudinal segments linked by short circumferential fractures joining the longitudinal segments to form a step-like pattern to the fracture. Many of the step edges were curled inward consistent with the final separation at the step edges as the pipe fracture opened. Multiple longitudinal crack-like pits were also observed adjacent to the fracture surface such as those indicated with unlabeled arrows in figure 7. The longitudinal fracture planes appeared to coincide with the locations of the crack-like pits such as the one shown by the arrow at the right side of the image in figure 7.

Figure 6. Close view of the pipe B fracture after sectioning and partial deoxidation.

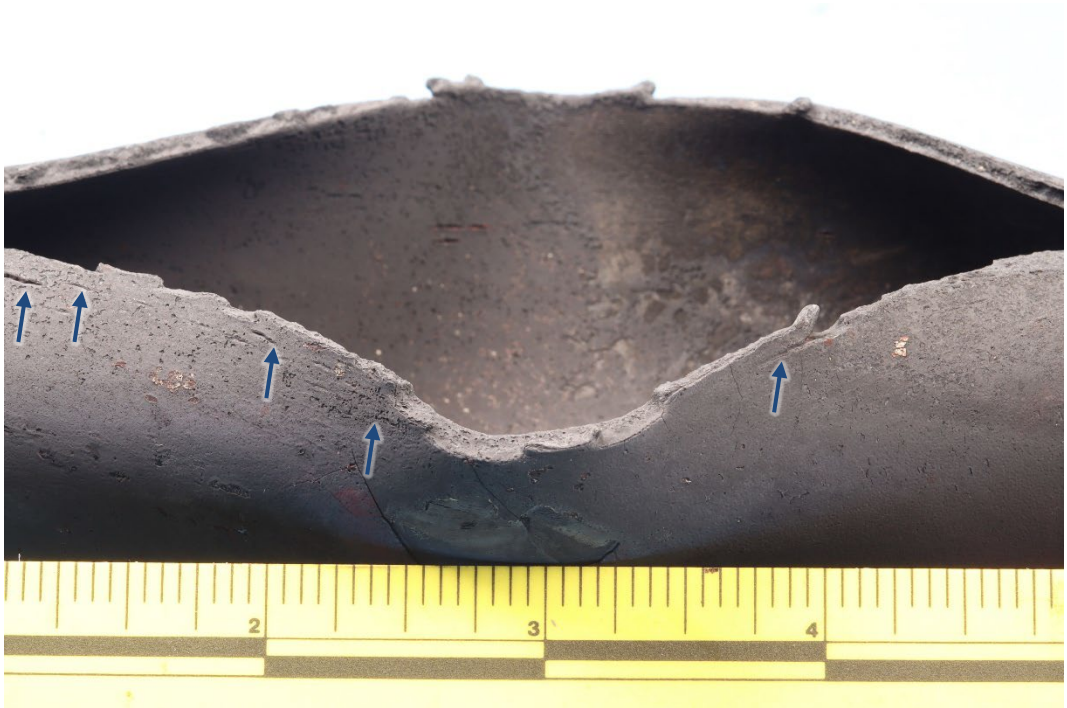
Figure 7. Oblique view of the pipe B fracture showing step features in the fracture plane corresponding to longitudinal crack-like pits (indicated with unlabeled arrows) on the exterior surface.

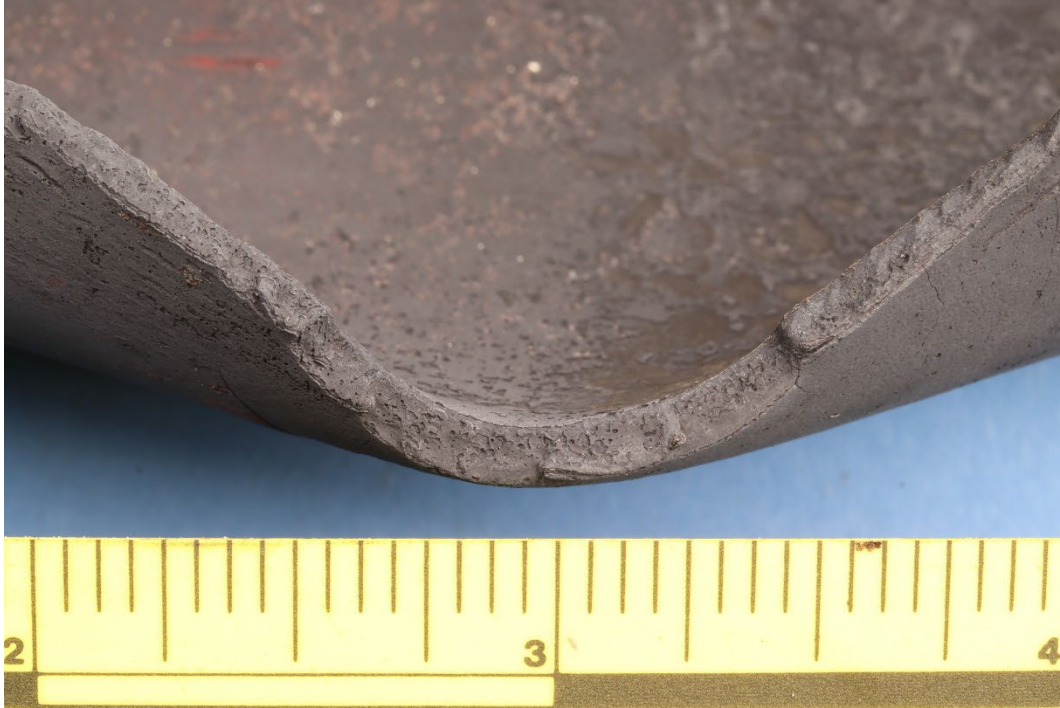
A view of the fracture surface for pipe B at the location of greatest opening displacement is shown in figure 8. The fracture surface had shallow pits in the oxidation layer likely from uneven removal of oxides during the ultrasonic removal stage, and fine fracture features remained obscured and likely obliterated by post-fracture oxidation. However, the overall pattern of fracture showed flat fractures on multiple planes with limited wall thinning associated with the fracture. At the step edges, there was more overlap of adjacent fracture planes at the outer surface, consistent with fracture initiation from the longitudinal crack-like pits on the exterior surface.

Figure 8. Fracture surface at the center of the longitudinal fracture in pipe B.

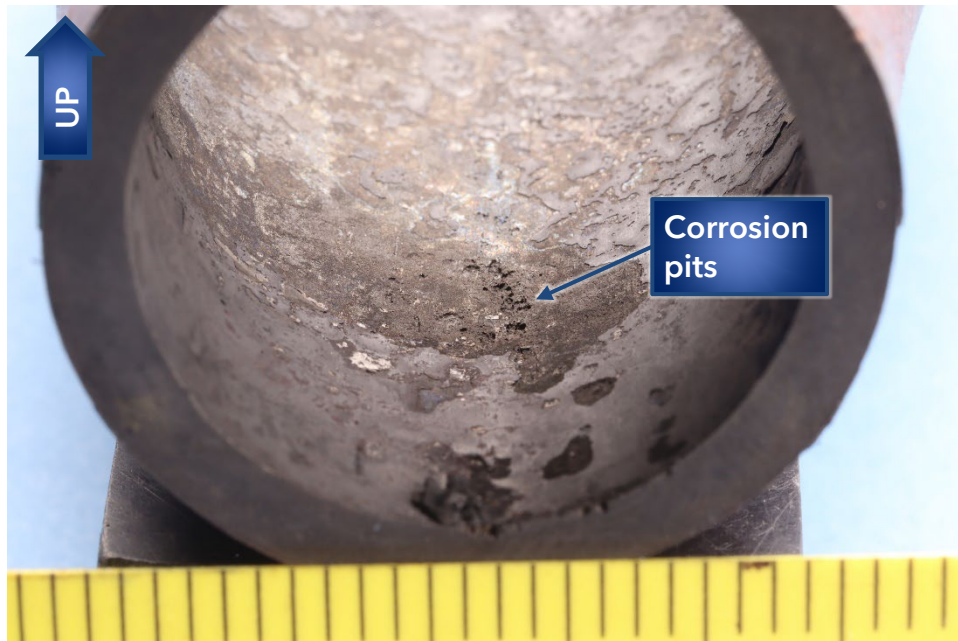
Corrosion pits were also observed on the interior surface on the lower side of the pipe after deoxidation in the ultrasonic cleaner. A view of some of the exposed pits is shown in figure 9. No cracks were observed associated with the pits on the lower side of the pipe.

Figure 9. Corrosion pits on the interior surface on the lower side of pipe B.

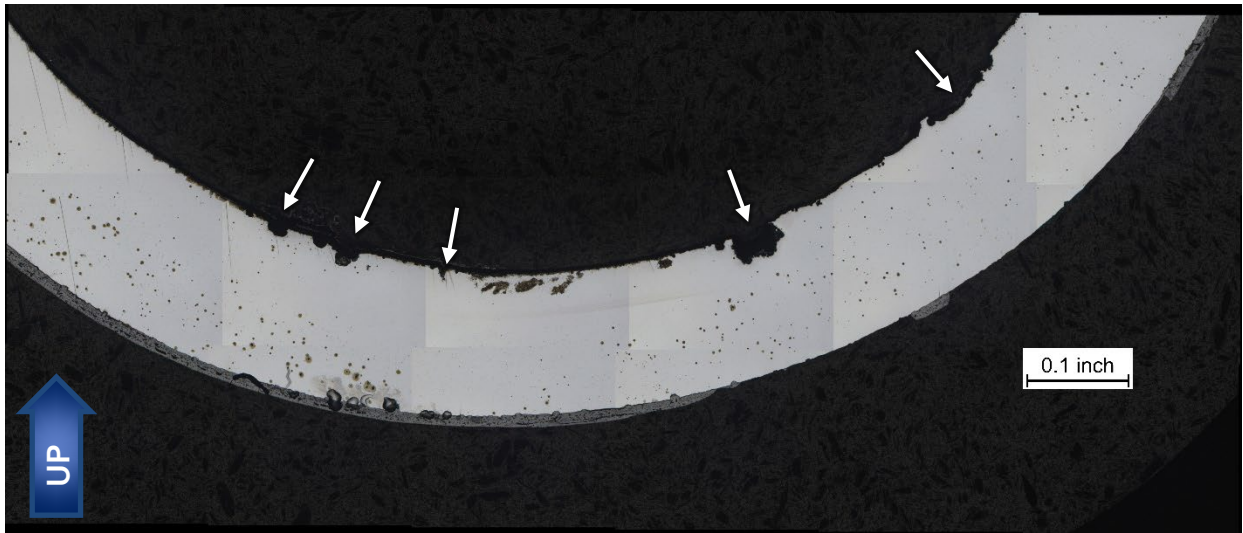
transverse cross-section. An approximately ¼ inch ring section from pipe B was submerged in Alconox and warm water and cleaned using an ultrasonic cleaner before mounting in a metallurgical mount using a hot press. The mounted sample was then polished and examined using a Zeiss AxioObserver inverted metallograph. A stitched montage of micrographs imaging the as-polished lower section of the pipe is shown in figure 10. Arrows point to corrosion pits on the inner surface of the pipe. No cracks were observed emanating from the pits.

Figure 10. Stitched montage of micrographs of the as-polished cross-section through pipe B. Arrows point to corrosion pits on the interior surface at the lower side of the pipe.

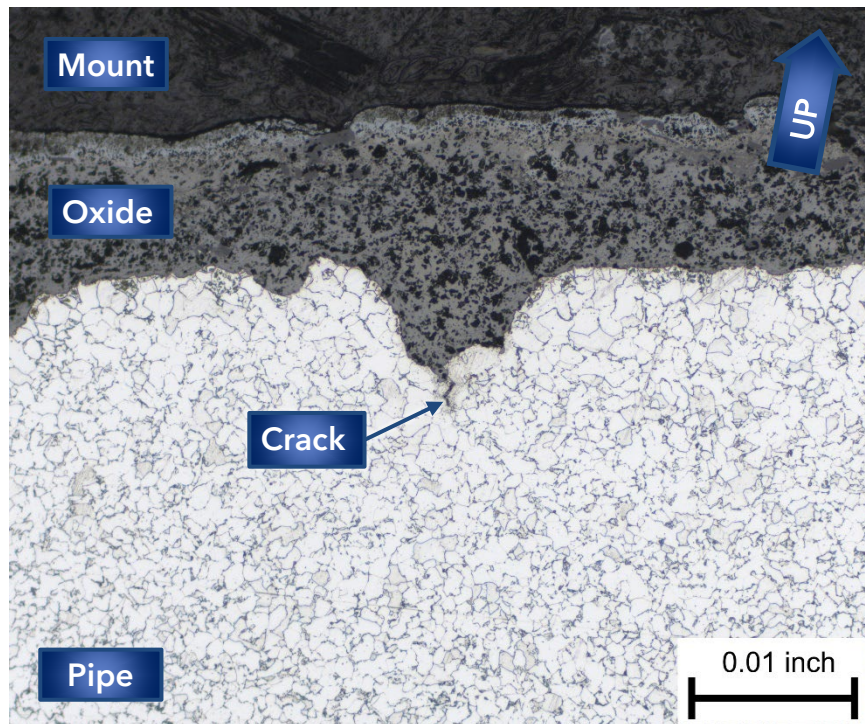
The polished cross-section of pipe B was then etched with 2% nital. The transverse cross-section intersected multiple longitudinal crack-like pits on the exterior surface on the upper side of the pipe. One of the larger of these crack-like pits is shown in figure 11 on the etched cross-section. A thick oxide layer covered the surface as shown, including the crack-like pit. The profile of the crack-like pit had a rounded tip like that of a pit. A crack extended from the lower end of the pit as indicated in figure 11.

Figure 11. Micrograph showing a crack extending from a crack-like pit in the exterior surface on the upper side of pipe B.

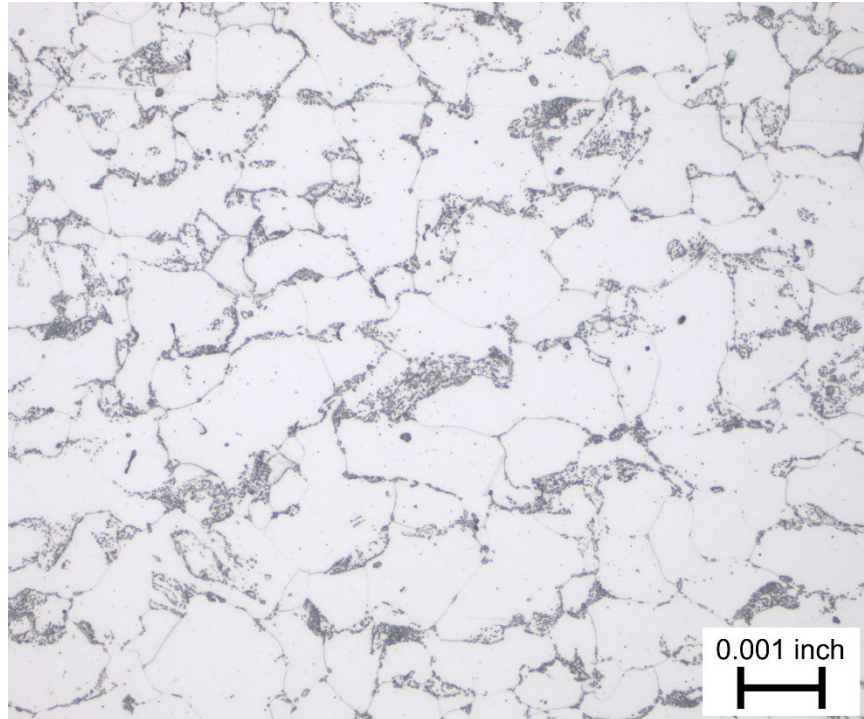
A micrograph of the etched sample showing typical microstructural features for pipe B is shown in figure 12. The microstructure consisted of mostly ferrite with mostly spheroidized pearlite, consistent with a low-carbon steel exposed to high heat.

Figure 12. Typical microstructure for pipe B. White areas are ferrite, and darker areas are pearlite that has been mostly spheroidized. (Etched with 2% nital.)

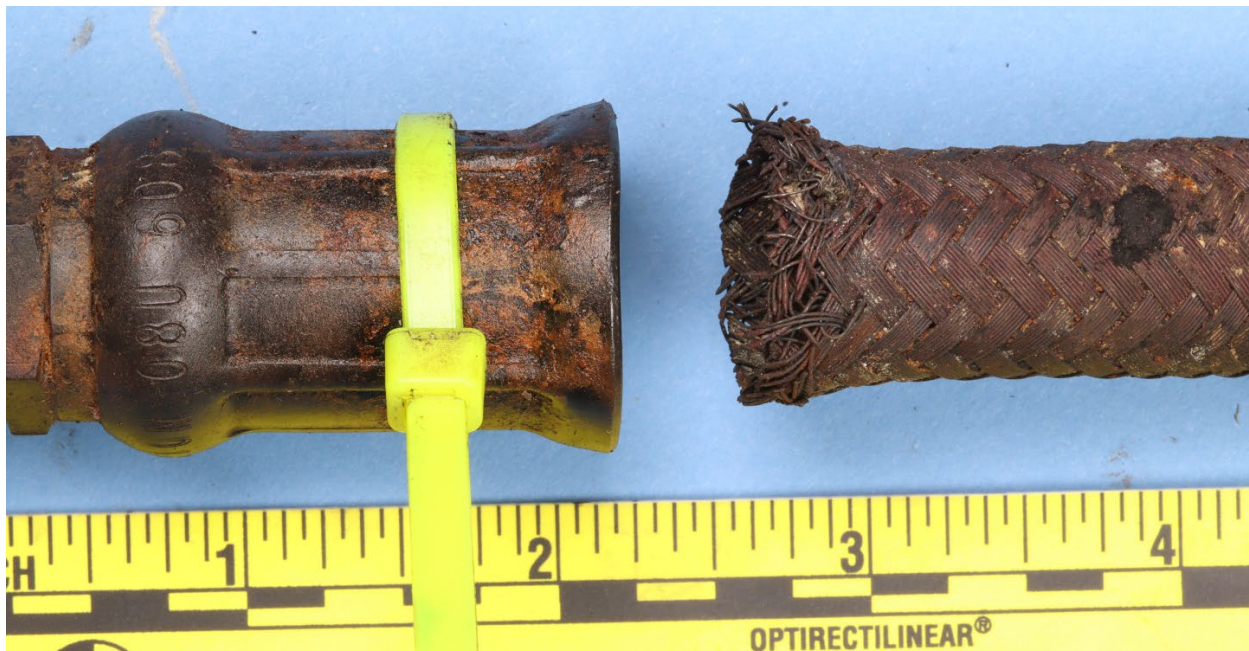
A close view of the separated end of the hydraulic hose and the corresponding crimped sleeve is shown in figure 13. The reinforcement braids on the hose were disturbed and splayed slightly outward within approximately 3/8 inch of the cut end of the hose. The crimped sleeve on each end of the hose was marked "EATON 08U-608". The nuts were marked "-8" on one flat and "EATON" on the opposite flat. No part markings could be detected on the hose. The crimps on each end had similar geometry. The average nominal crimped diameter measured 0.926 inch and 0.922 inch on the separated and intact sleeves, respectively. According to the

Danfoss website, the specified nominal crimp diameter is 0.915 inch for an Eaton U-series fitting connected to a size 08, Weatherhead H425, SAE 100R2AT hose.^{5, 6} According to a representative in product support at Danfoss, the crimp specification has a tolerance of ± 0.005 inch. Crimp specifications for U-series fittings with an Aeroquip SAE 100R2A hose for sale at the time of ship construction in 1992 were not readily available.

Figure 13. Close view of the separated end of the hose and corresponding crimped sleeve. The reinforcement braid adjacent to the cut end was disturbed and splayed slightly outward within 3/8 inch of the end face.

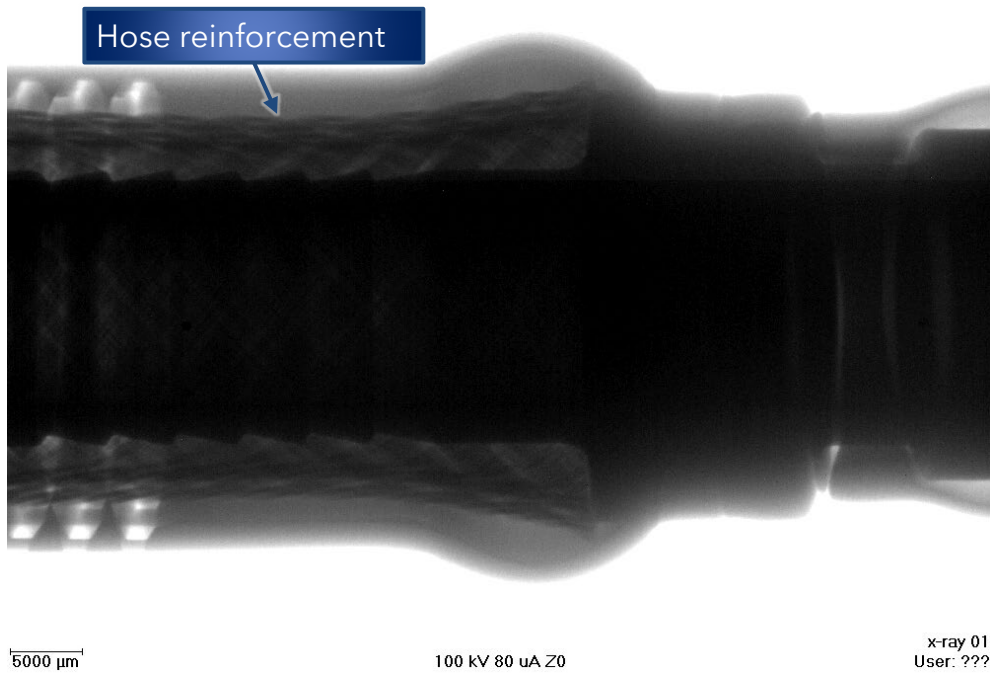
The fitting at the intact end of the hose was examined using radiographic (x-ray) imaging, and the resulting radiograph is shown in figure 14. The overall geometry of the of the braided hose reinforcement within the crimped sleeve had a slight outward flare within the last $\frac{3}{4}$ inch from the tube end with no significant change in the last $\frac{3}{8}$ inch. The fitting at the separated end was also examined using radiographic imaging as shown in figure 15. No braided hose reinforcement remnants were detected within the crimped sleeve.

Figure 14. Radiograph of the intact hose end within the crimped sleeve at the lower end of the hose.

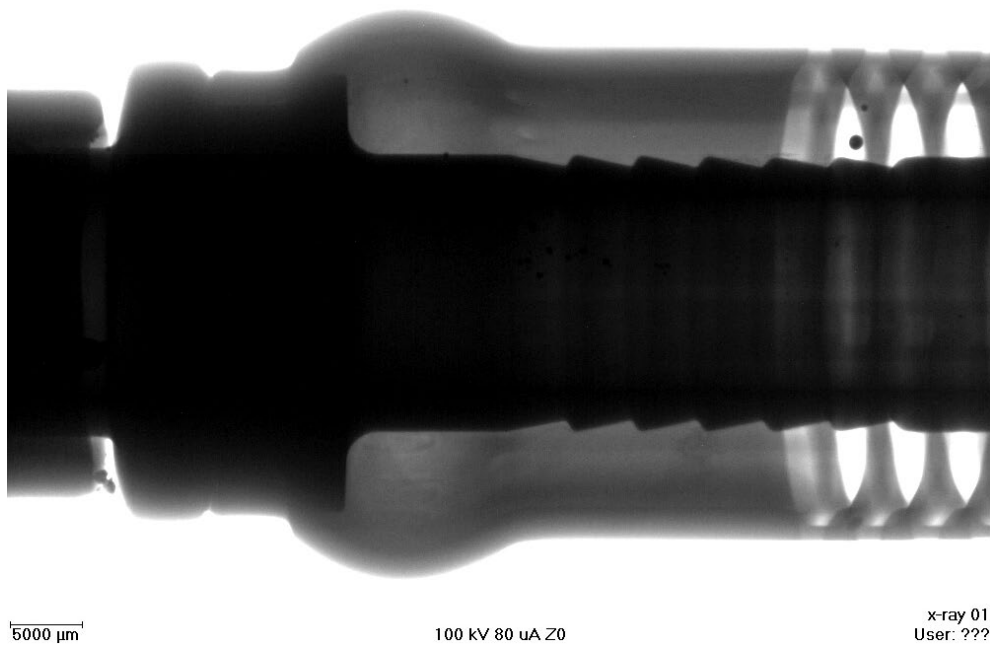
Figure 15. Radiograph of the crimped sleeve at the upper end of the hose.
