# National Transportation Safety Board

Office of Research and Engineering

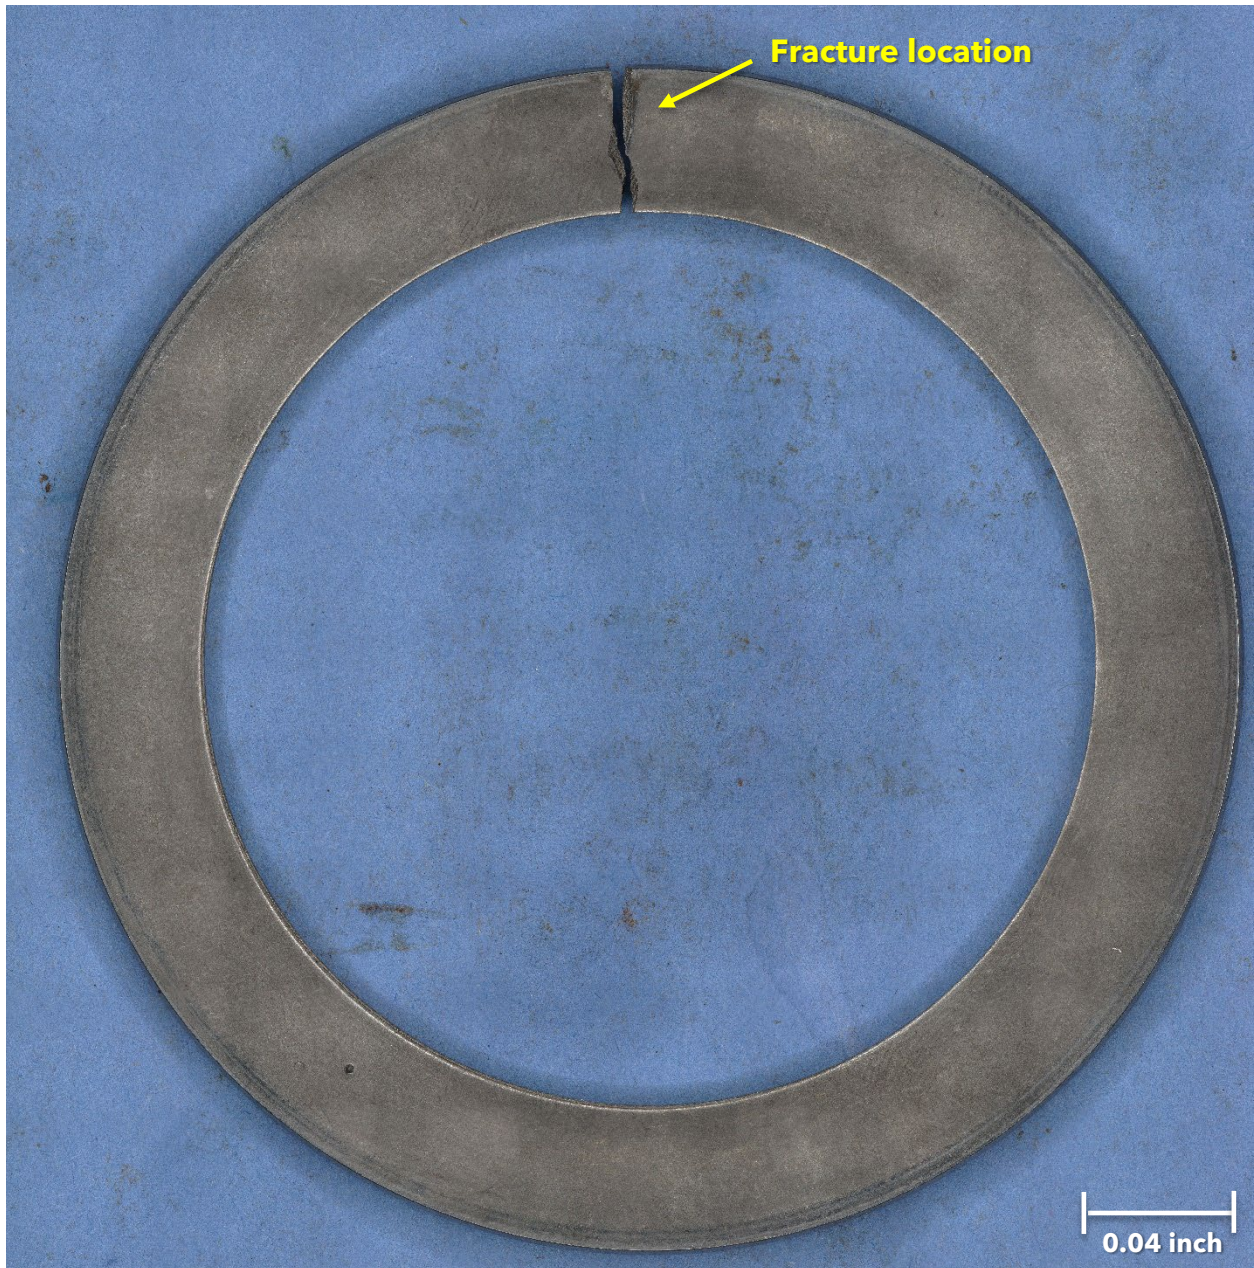
**Figure 1.** View of the washer from the concave side, as received, with the radial fracture shown in the 12 o'clock position.

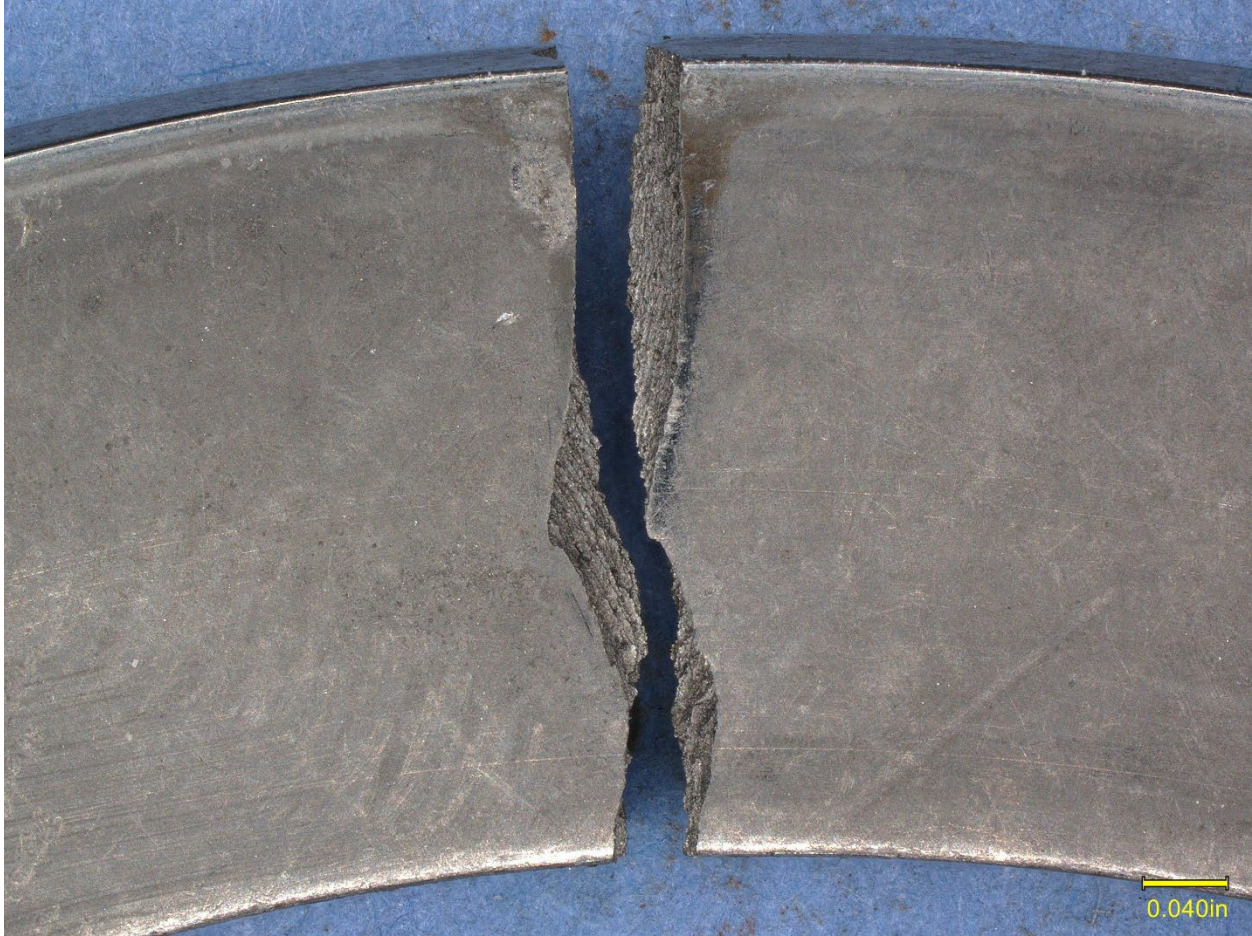
**Figure 2.** Closer view of the fractured area of the washer from Figure 1, as received.

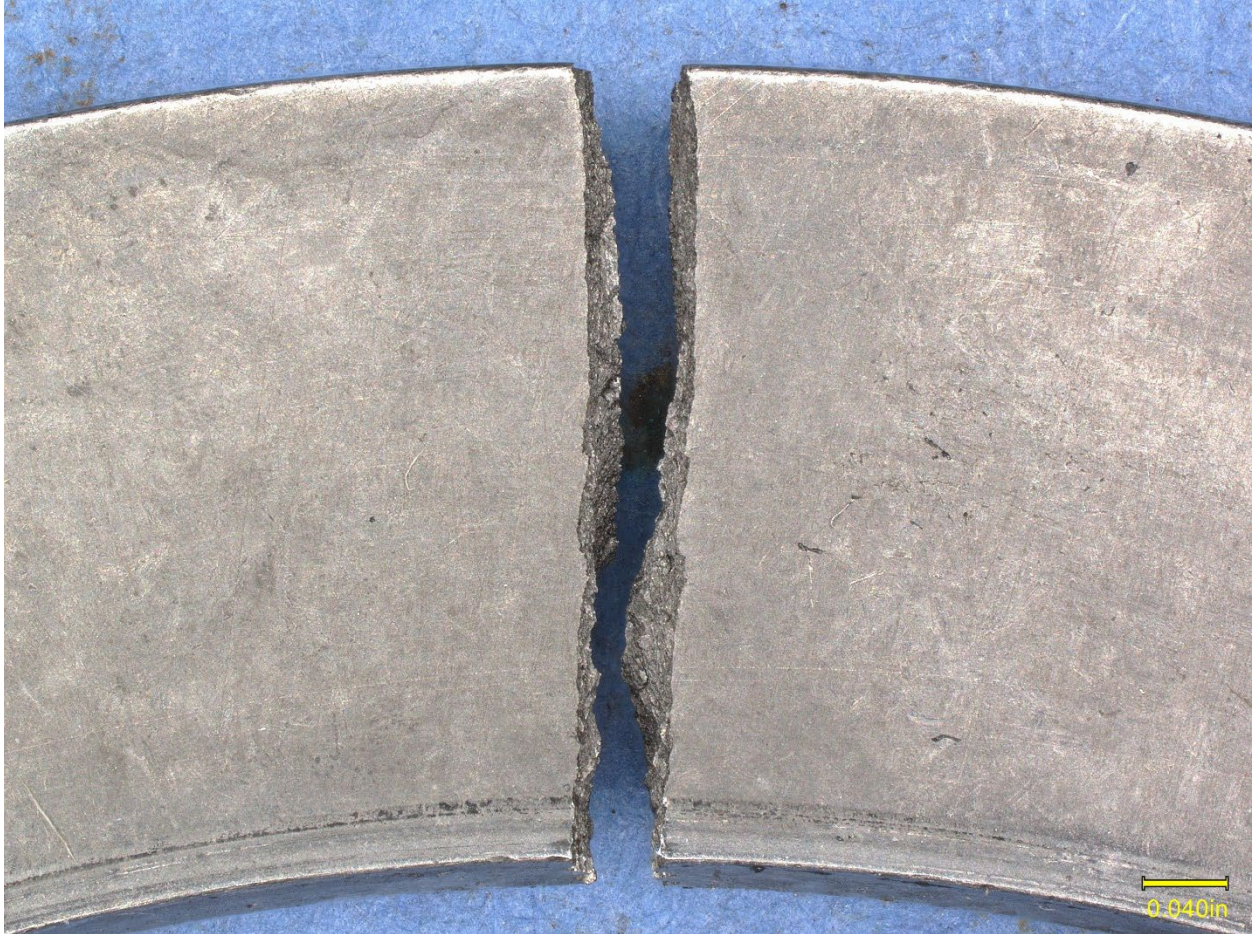
**Figure 3.** View of the fractured washer area from the opposite convex side, as received.

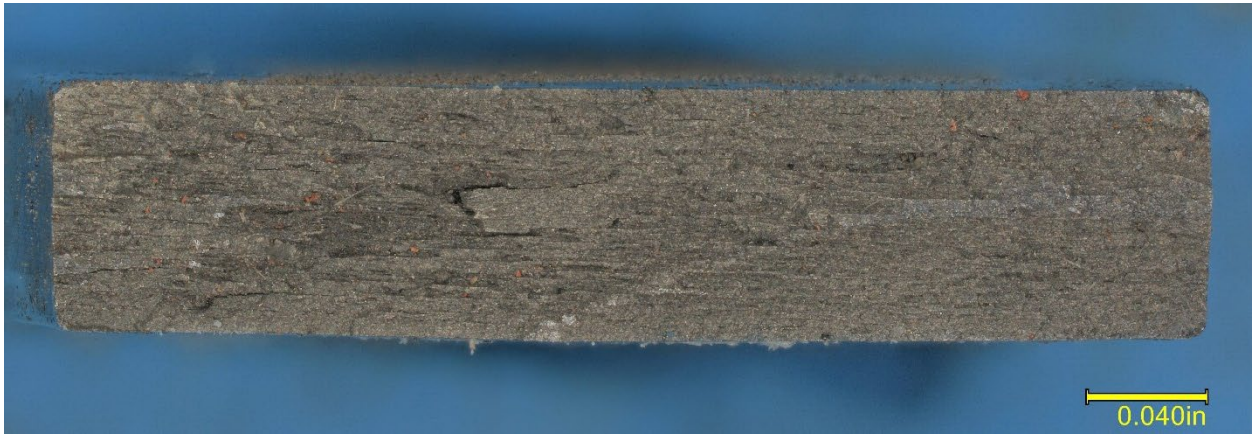
**Figure 4.** Overall view of the washer fracture surface, after sectioning.

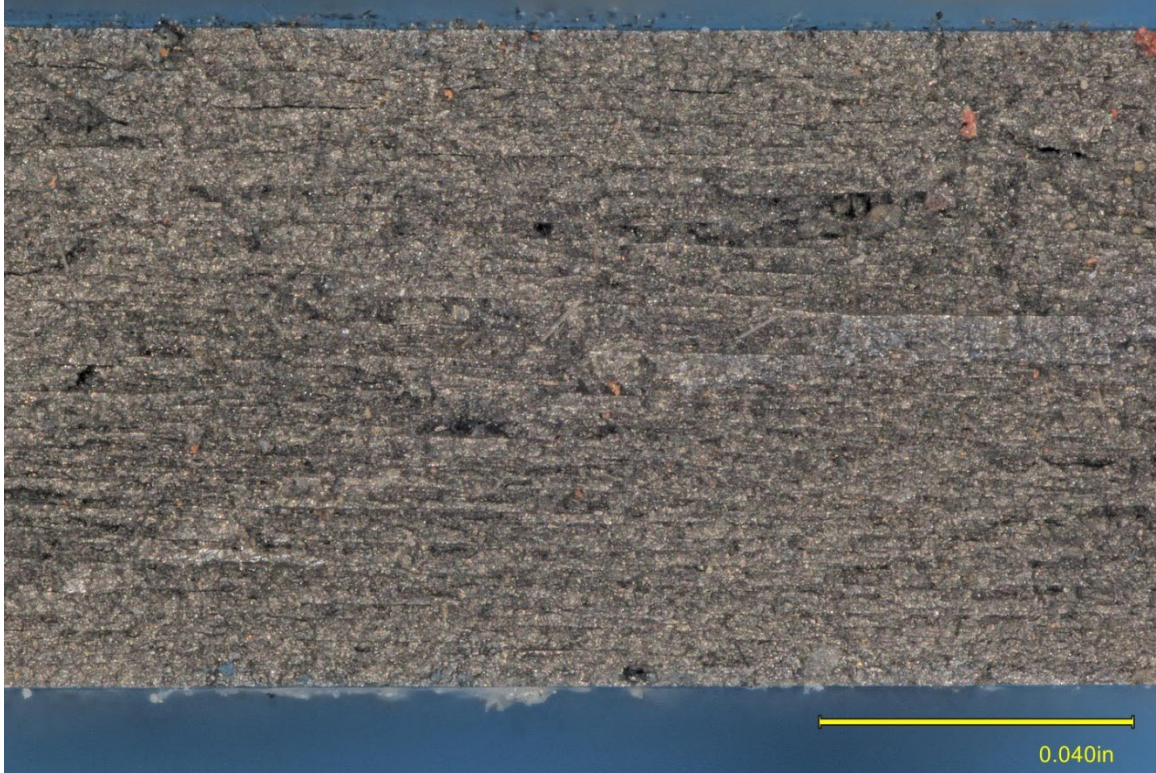
**Figure 5.** Closer view of the washer fracture, showing woody or fibrous fracture features.

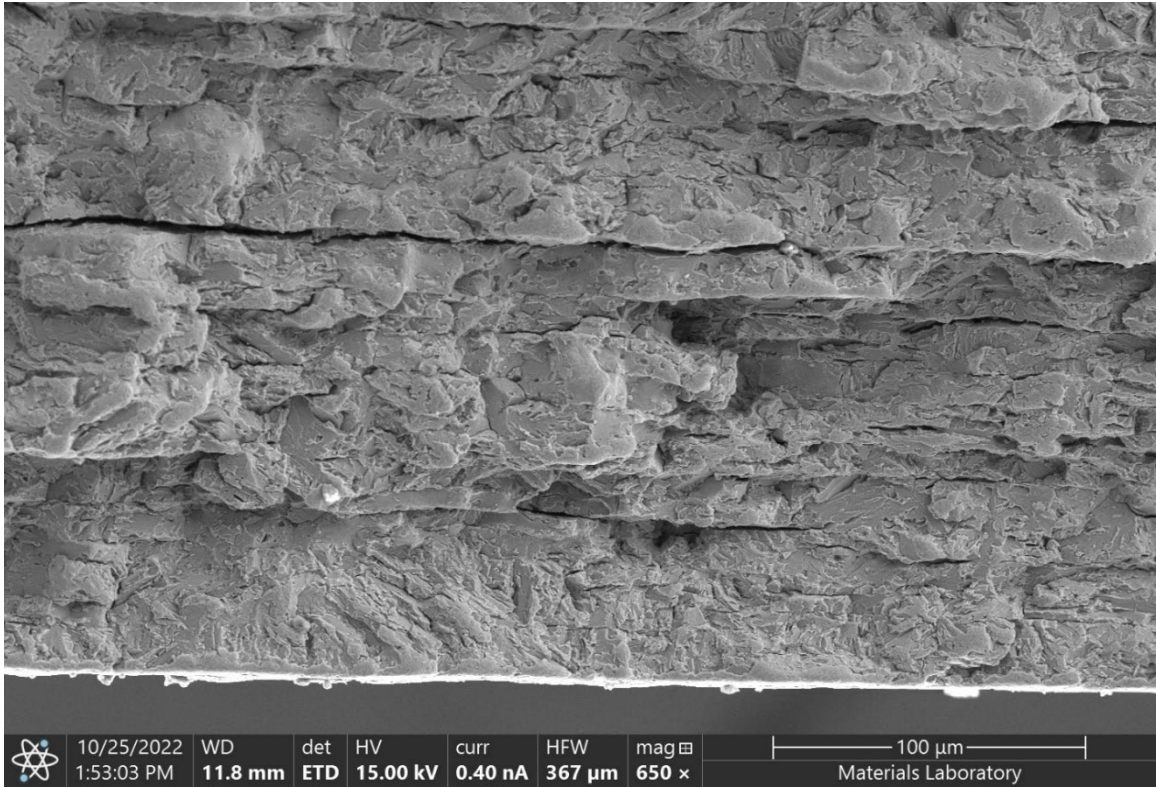
**Figure 6.** Secondary electron (SE) micrograph of the washer fracture surface, showing layered, fibrous features.

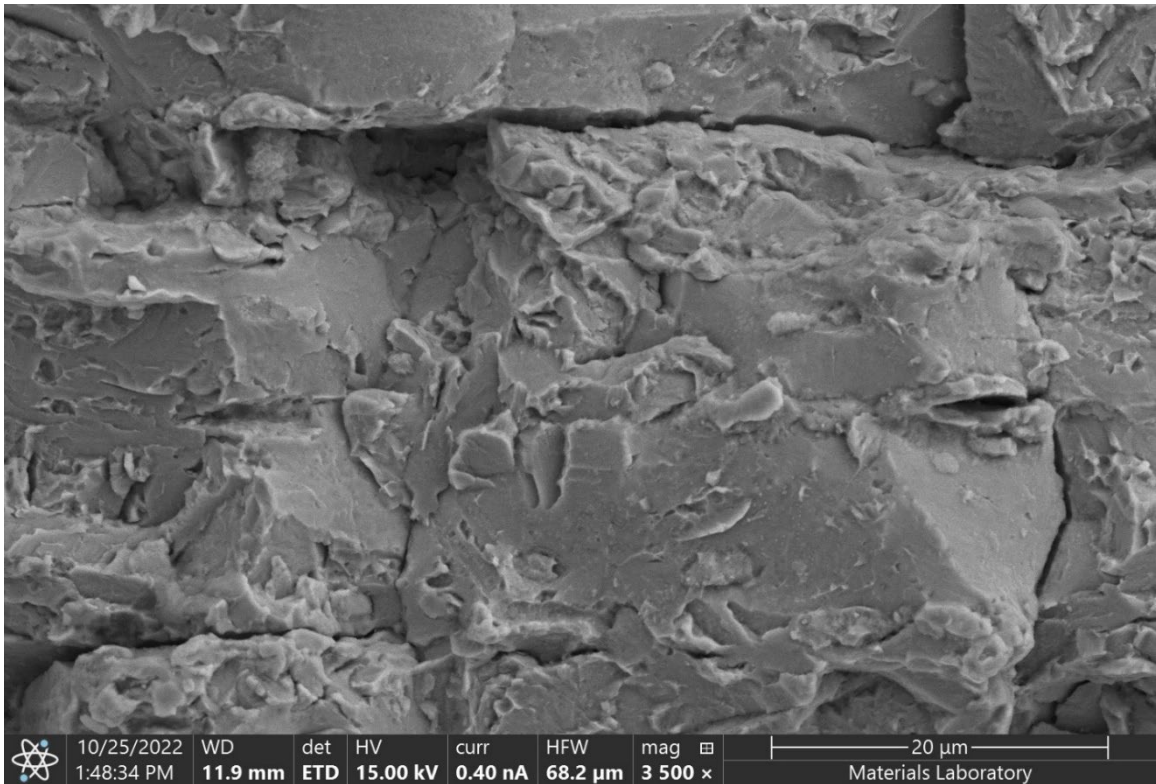
**Figure 7.** SE micrograph of cleavage facets and tear ridges on the washer fracture.

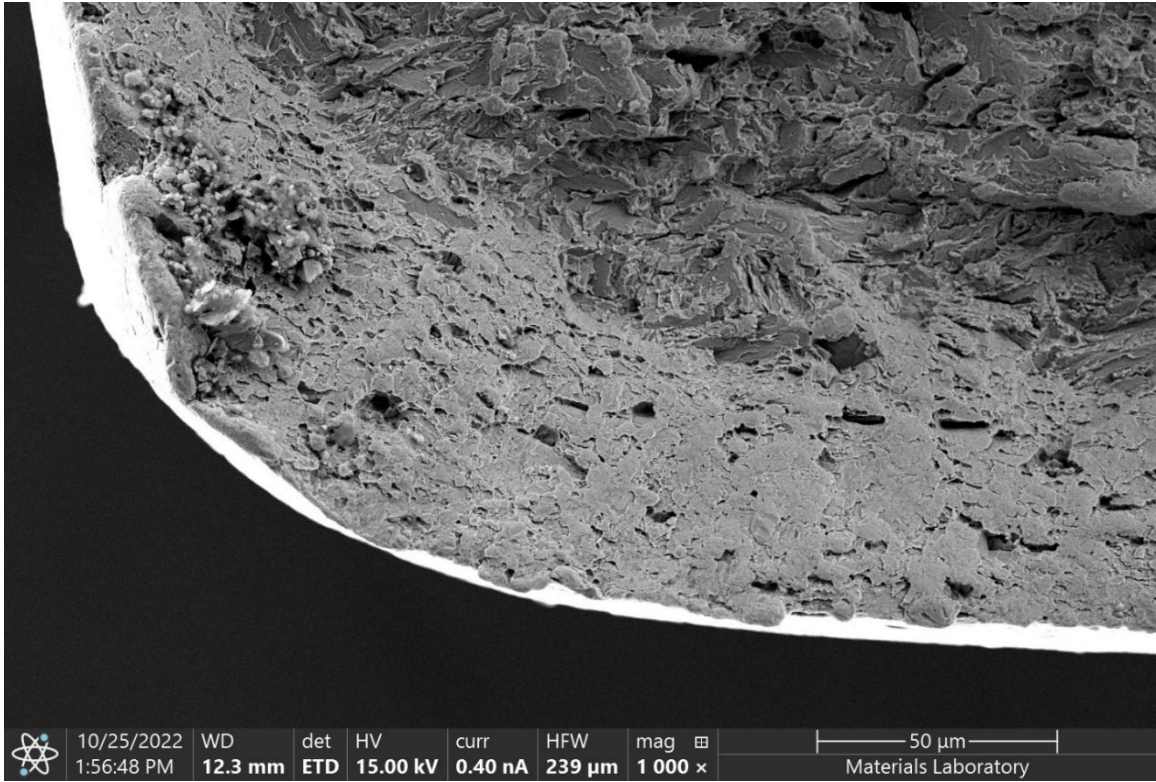
**Figure 8.** SE micrograph of a corner of the fracture surface, exhibiting a shear lip.

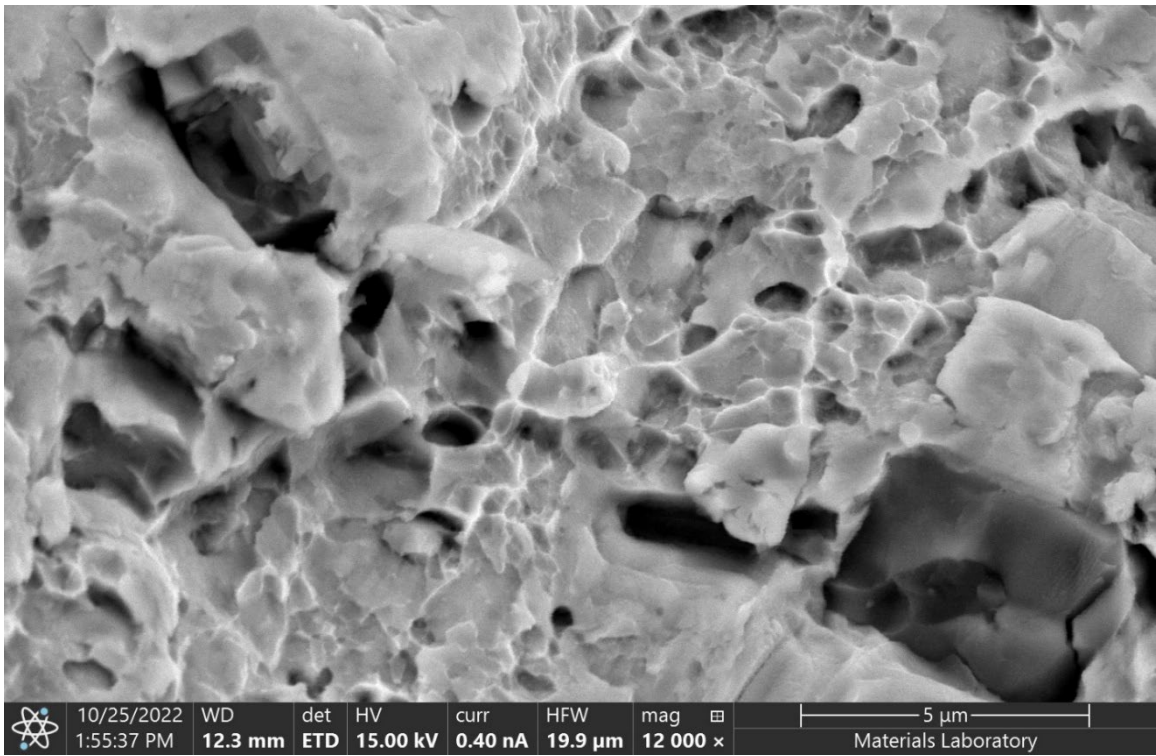
**Figure 9.** SE micrograph of dimpled rupture in the shear lip in **Figure 8**.

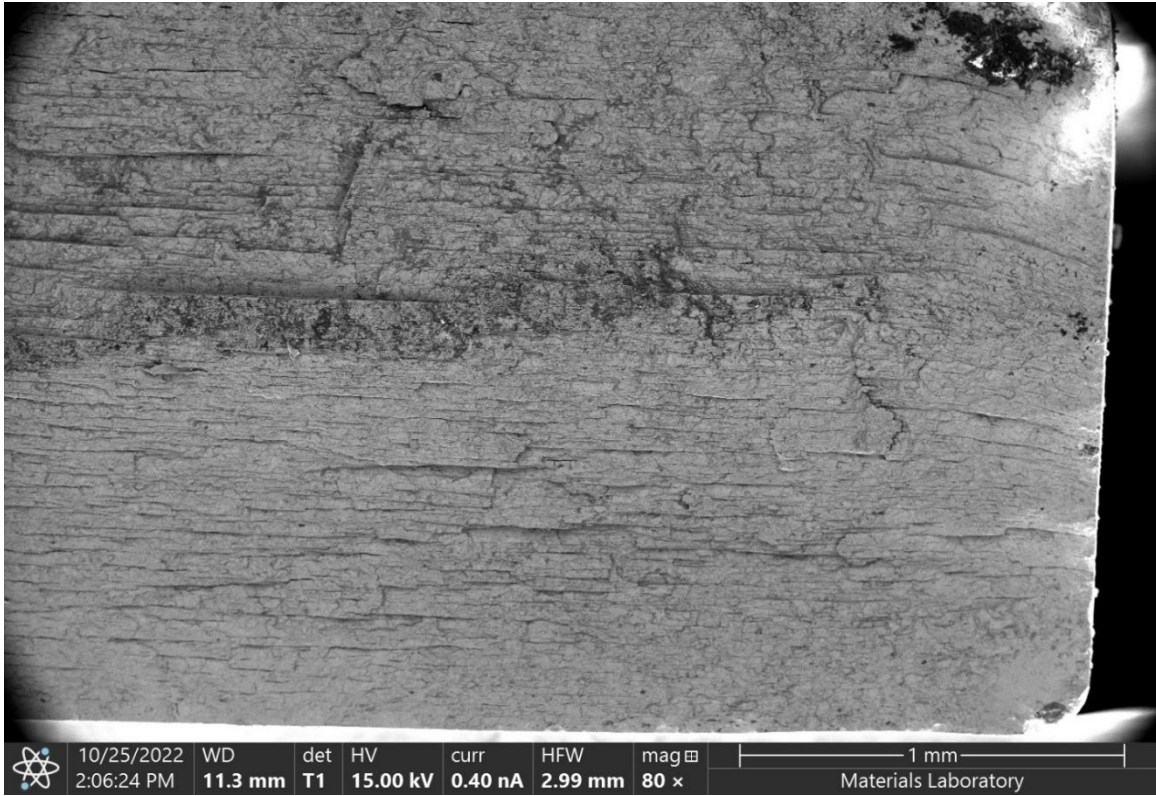
**Figure 10.** SE micrograph of deformation in the fractured grain structure on a side of the fracture surface of the washer.

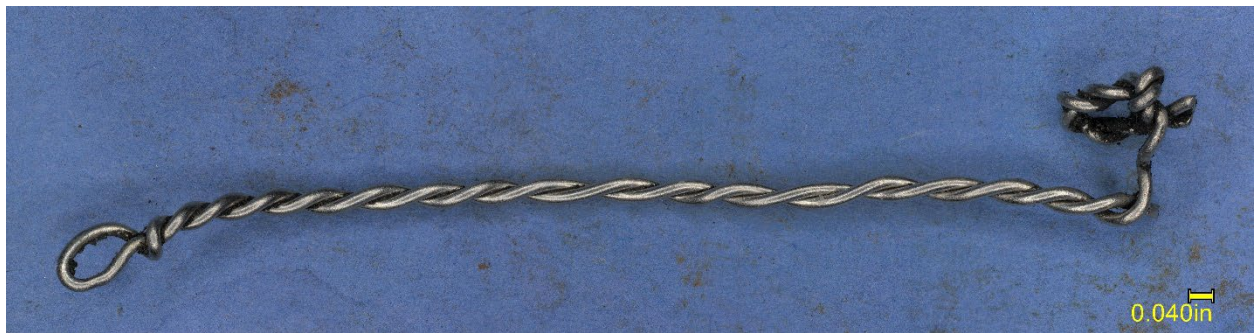
**Figure 11.** Montage image of the lock wire section, as received.

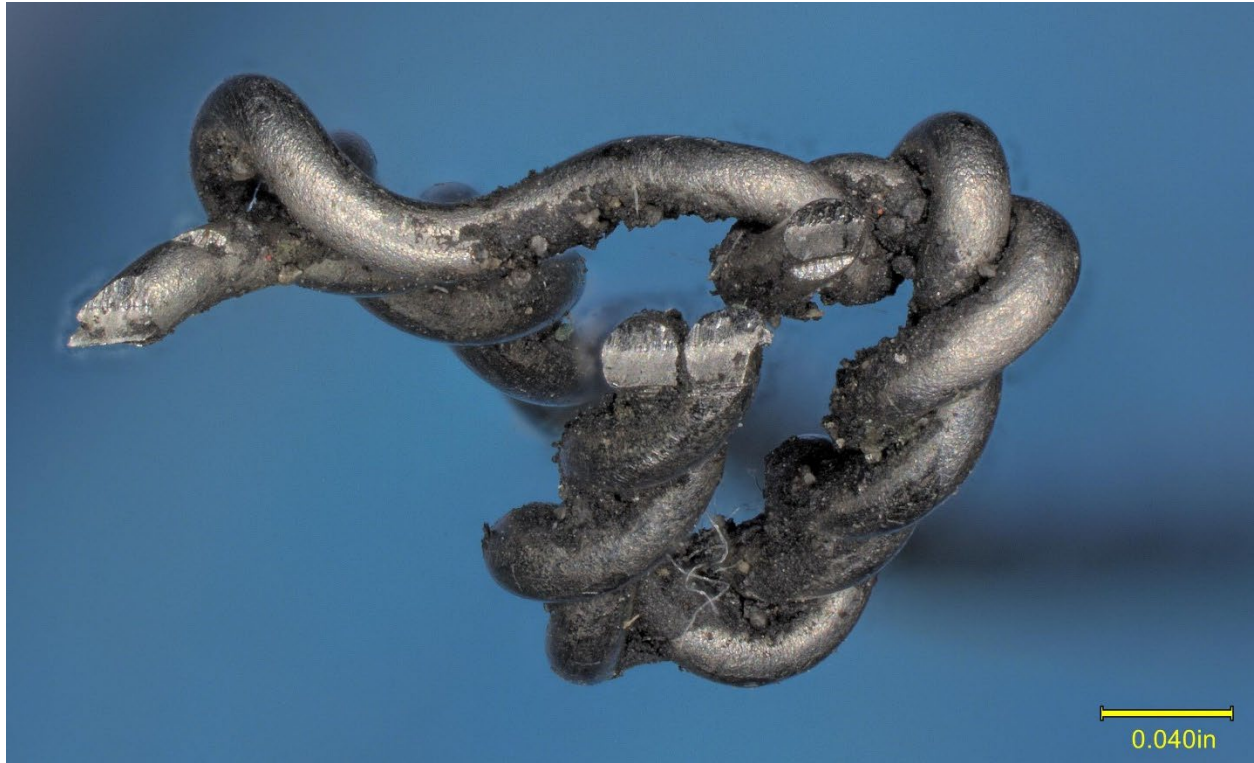
**Figure 12.** View of the fractured wires in the lock wire, as received.

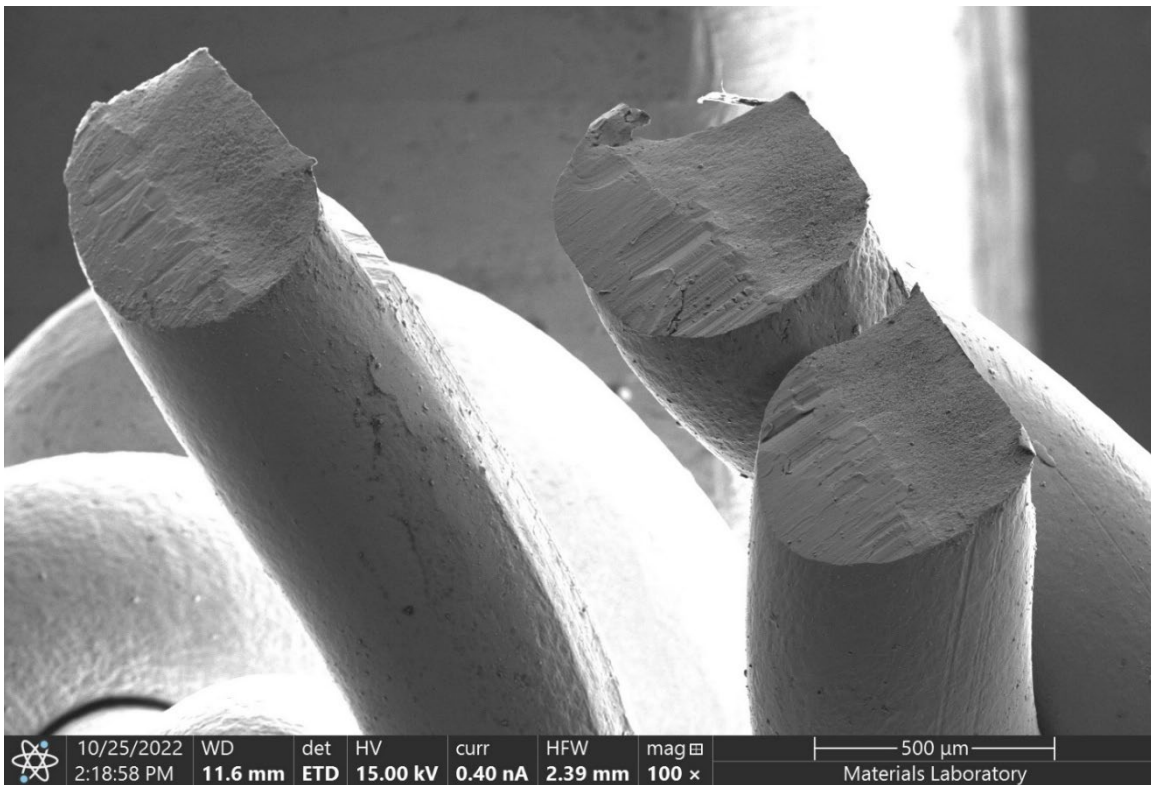
**Figure 13.** SE micrograph of three of the cut wires.

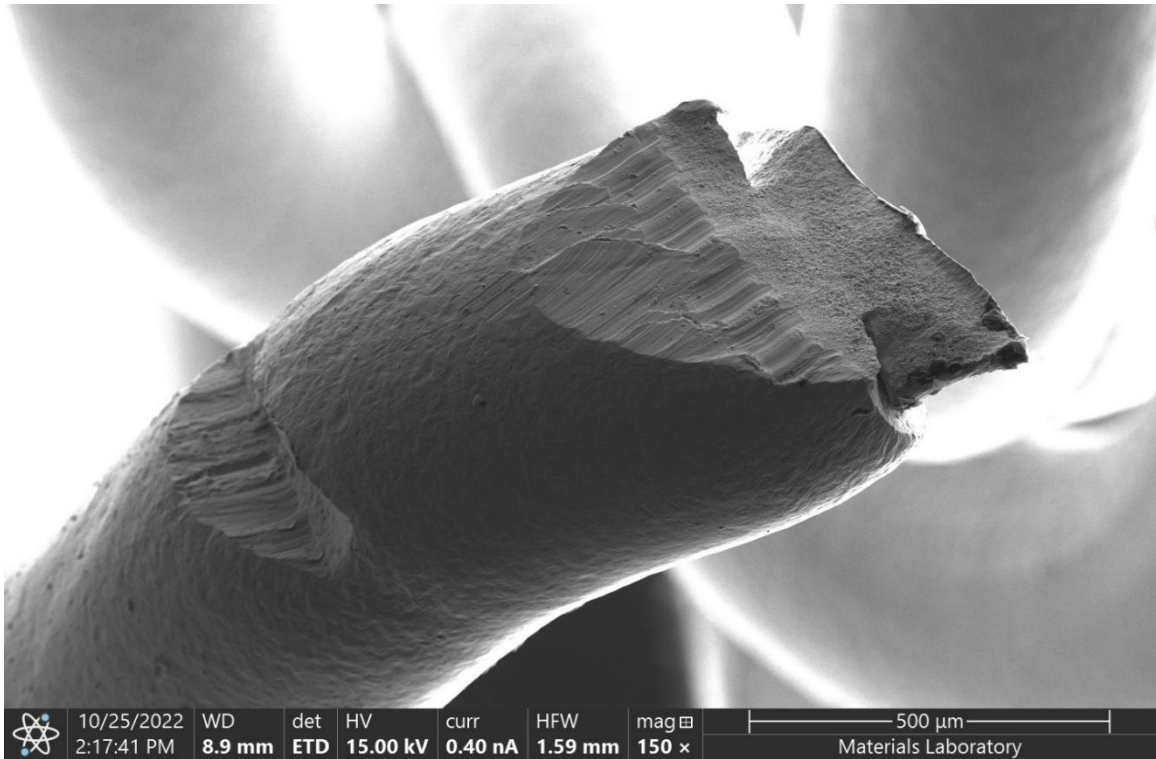
**Figure 14.** The fourth cut wire fracture surface, showing areas of smearing, pinching, and overstress.

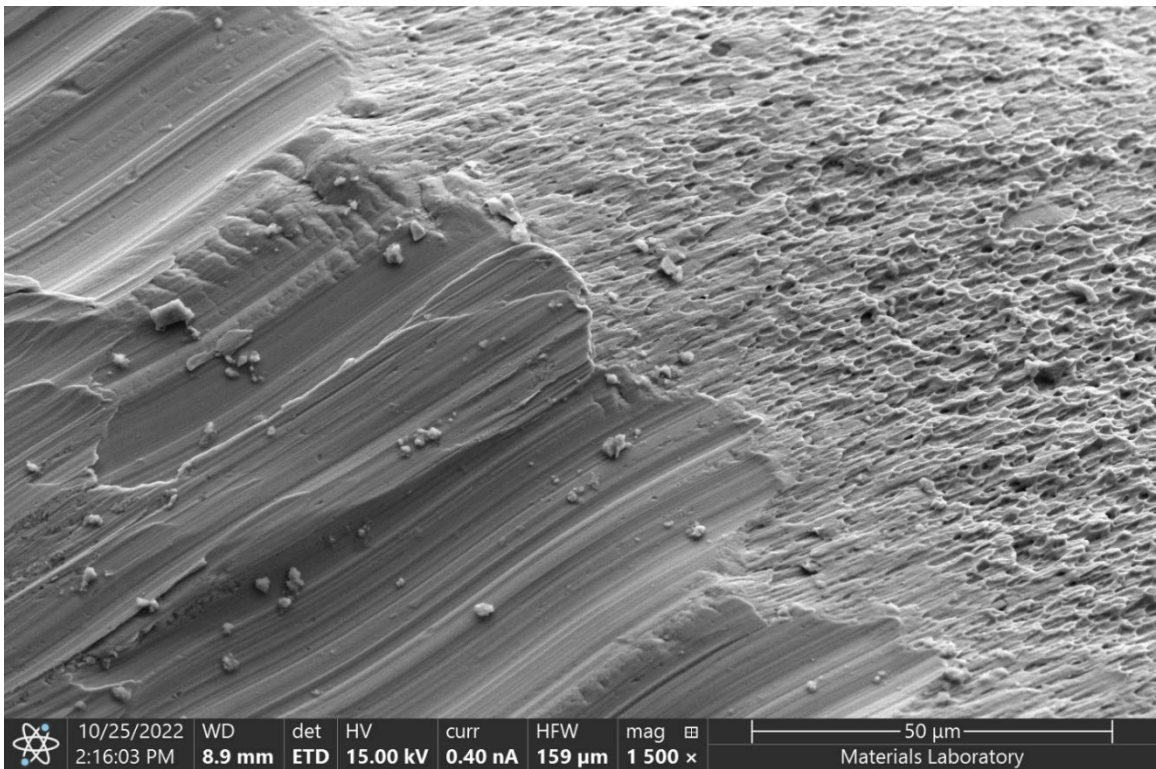
**Figure 15.** SE micrograph of shear dimpled rupture at the edge of the wire cutting.

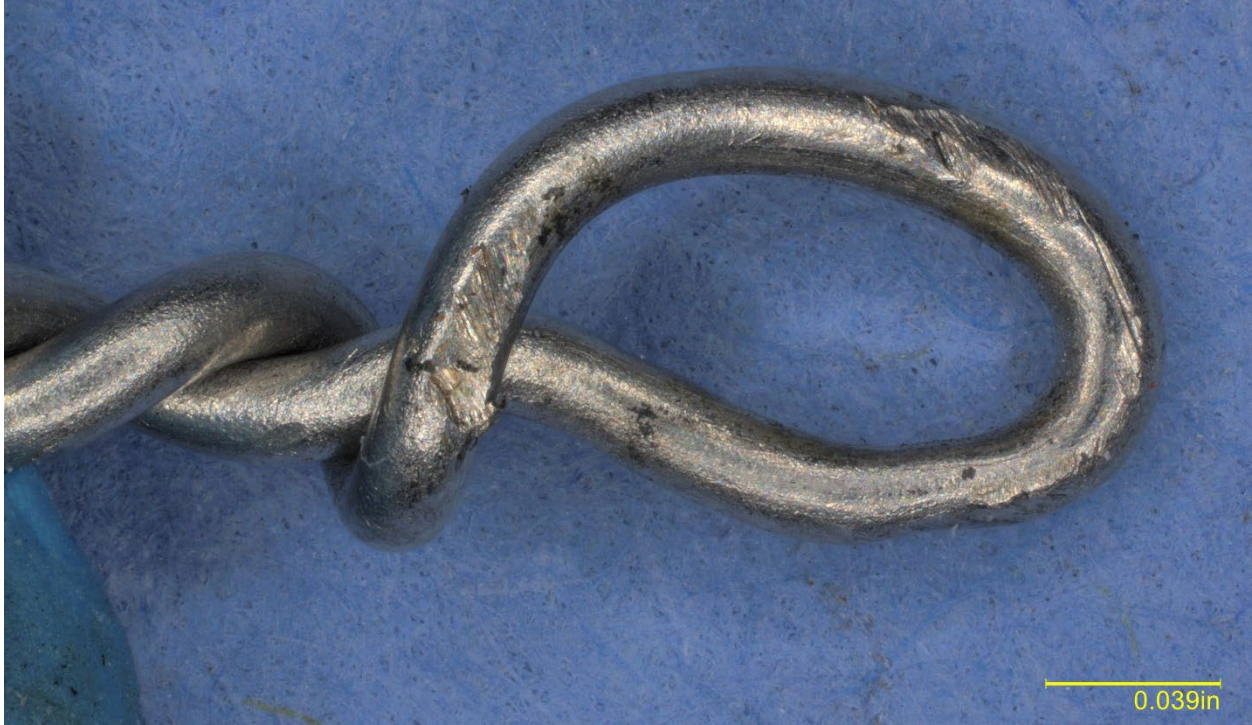
**Figure 16.** Closer view of the loop of the lock wire, showing witness marks (arrows).

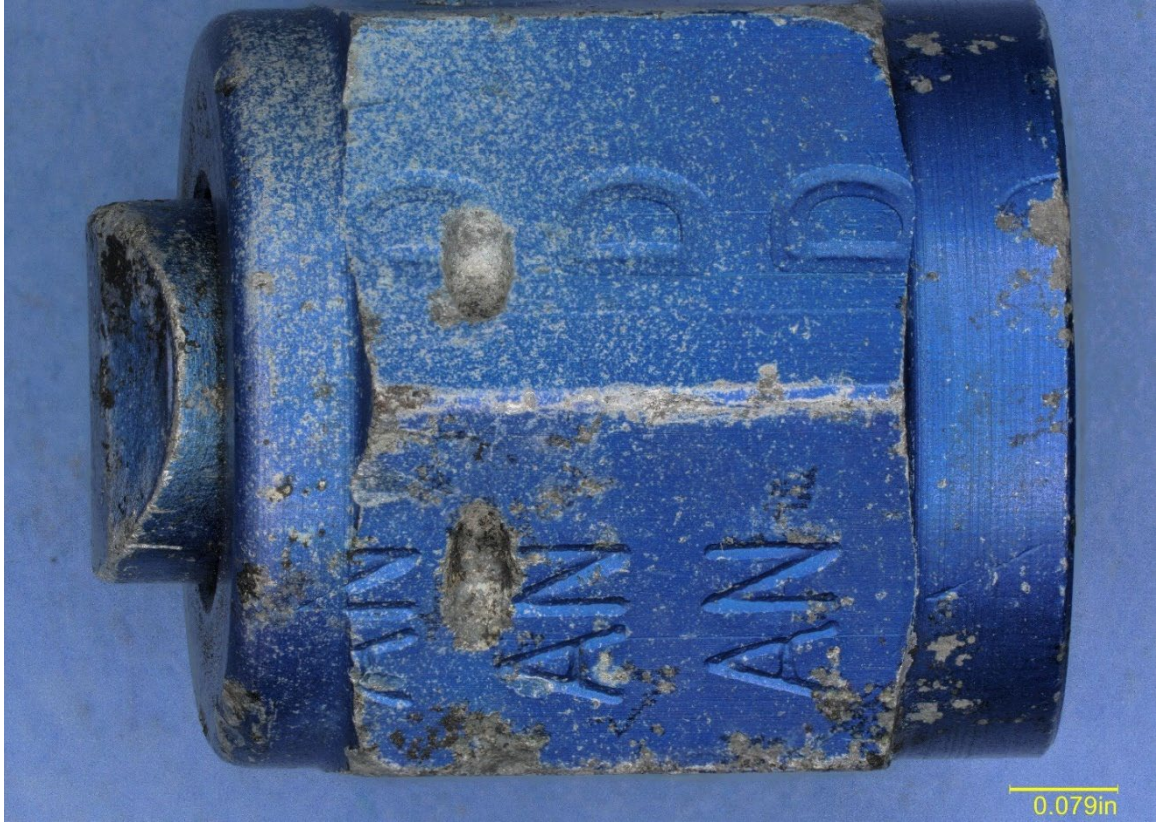
**Figure 18.** Side of the exemplar cap from an area of slight wear in the wire holes.

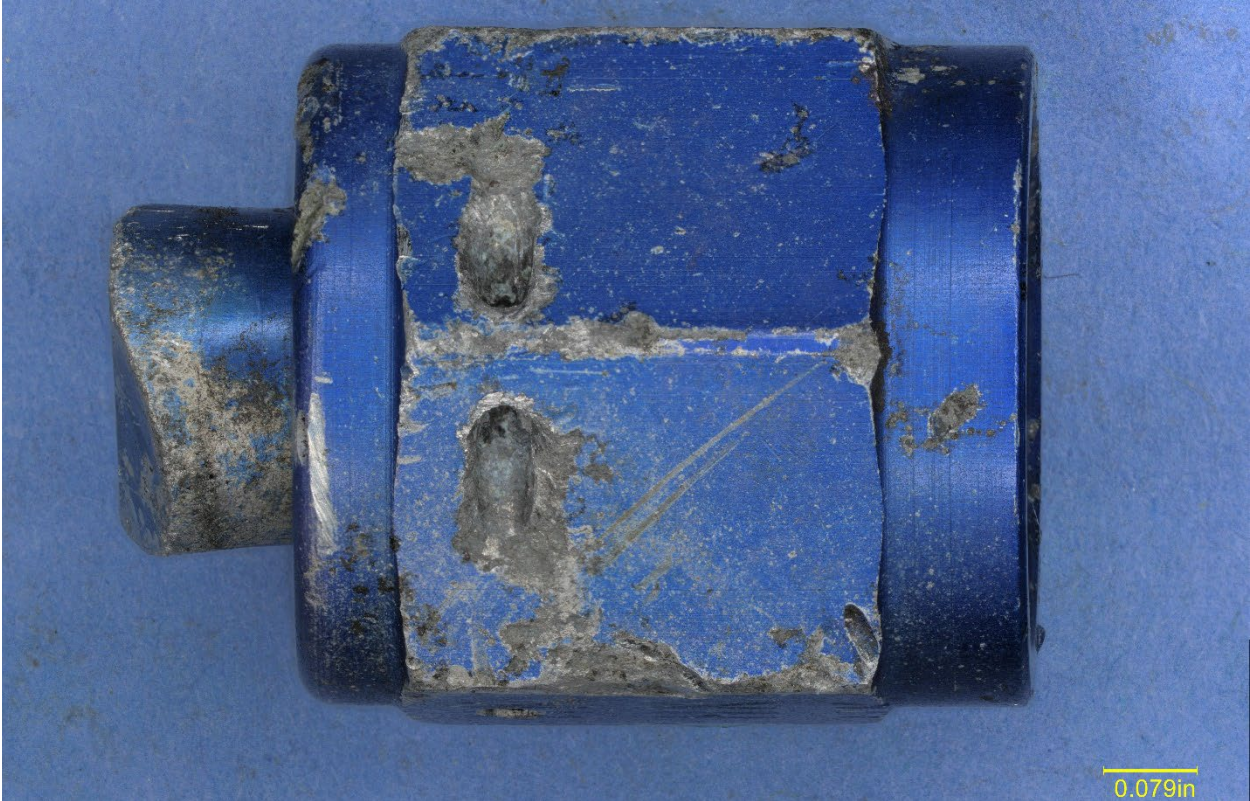
**Figure 19.** View of the worn wire holes of an exemplar cap from the same assembly.

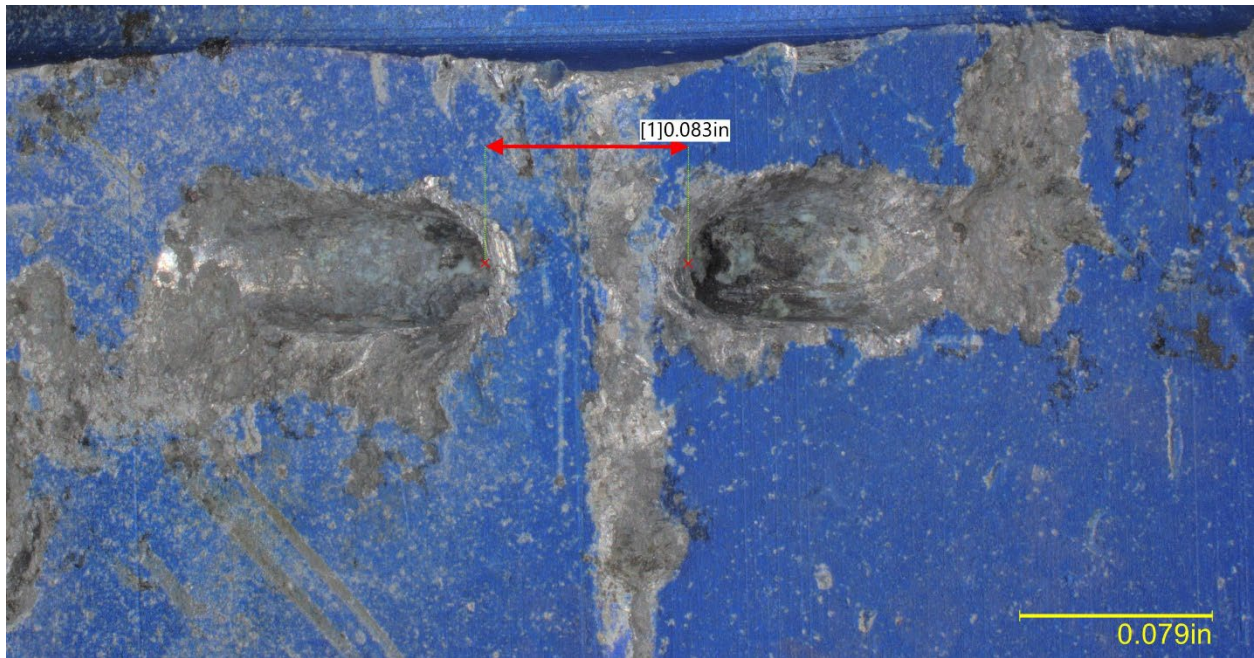
**Figure 20.** Measurement of the minimum distance between the worn wire holes of the cap.

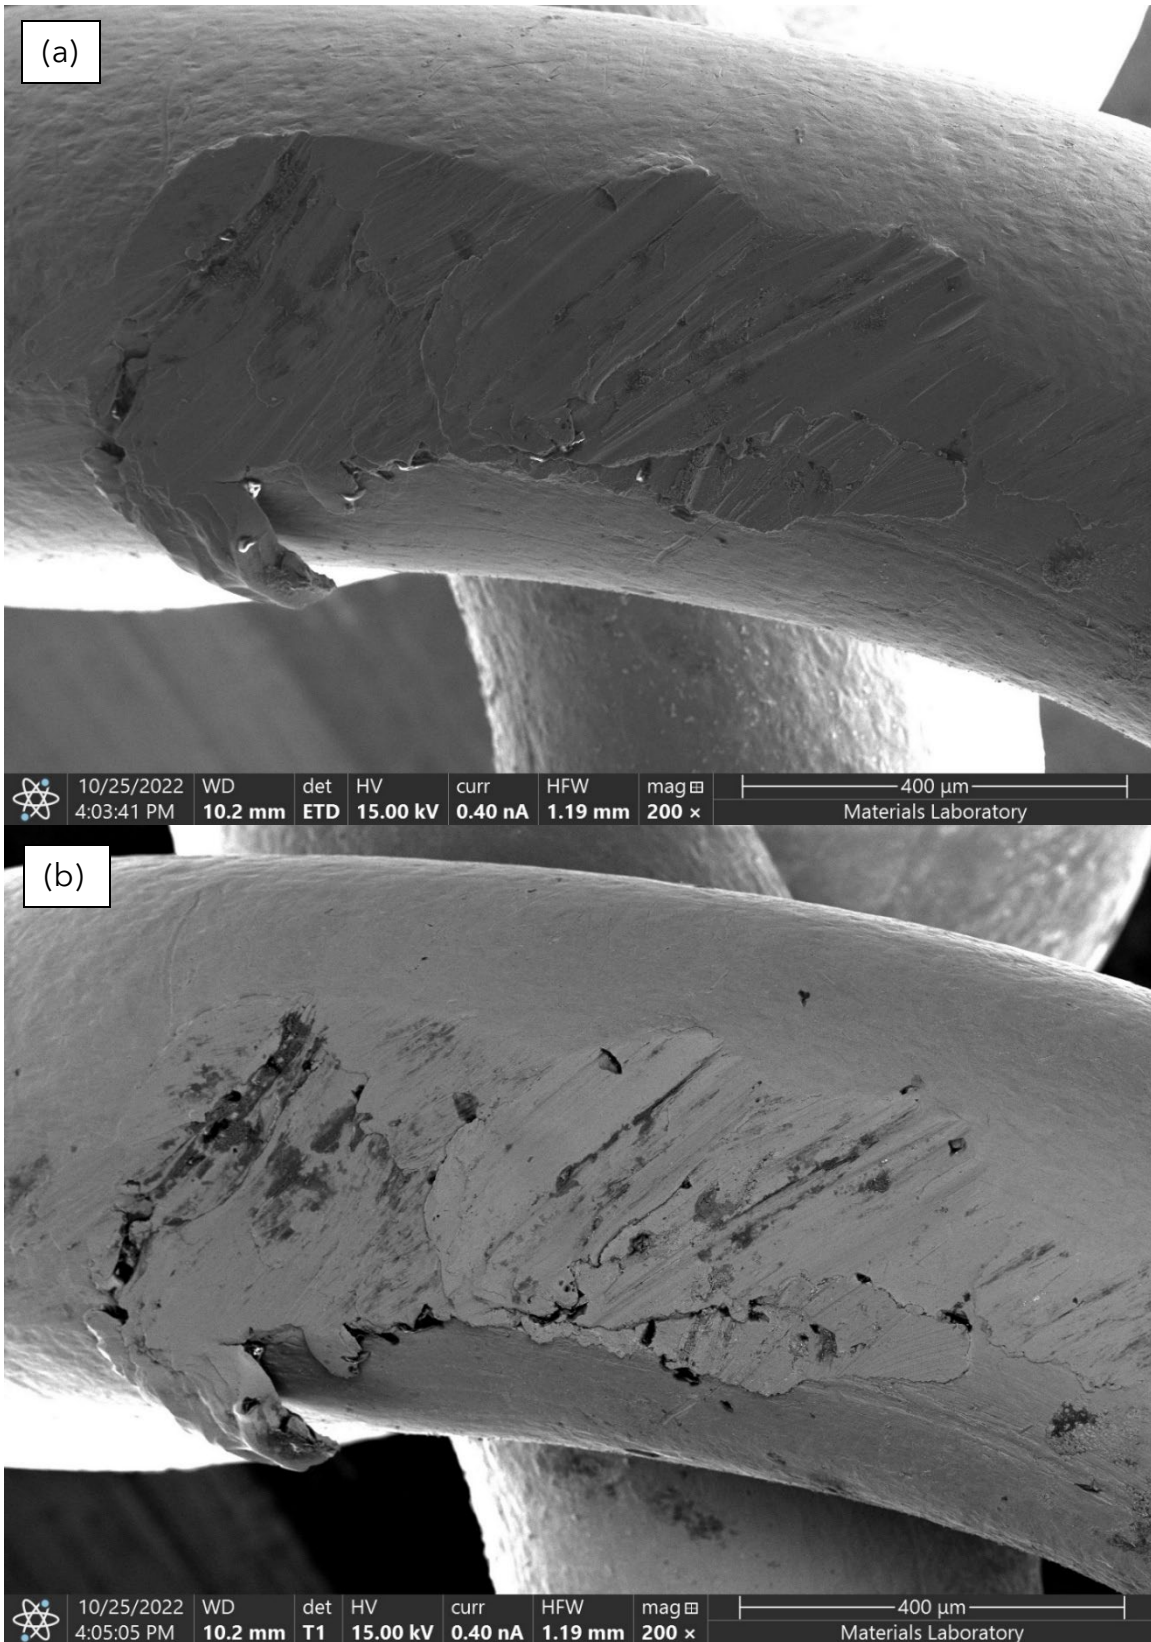
**Figure 21.** SE and backscattered electron (BE) micrographs of one of the witness marks on the loop of the lockwire.
