National Transportation Safety Board

WPR22FA235

MATERIALS LABORATORY

Factual Report 22-098

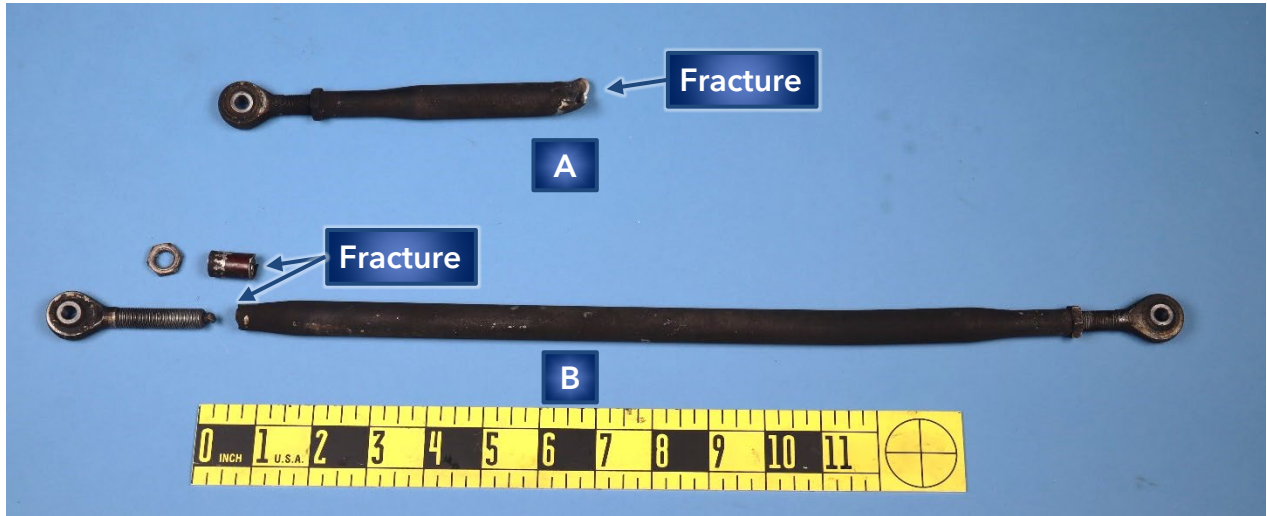
An overall view of the submitted control rod assembly pieces from the ruddervator control system are shown in figure 1. The assemblies in figure 1 are shown arbitrarily labeled A and B for reference in this report. Control rod A was fractured approximately 6 inches from the rod end fitting attachment location, and control rod B fractured at the end fitting attachment location. The clamp nut and smaller piece of the fractured control rod B had been separated from the end fitting on scene before they were sent to the NTSB Materials Laboratory.

The cross section in control rod A was collapsed adjacent to the fracture consistent with a ductile overstress fracture with bending deformation. The fracture surfaces on control rod B were on slant planes, also consistent with ductile overstress fracture. The separated end fitting was bent consistent with a bending overload as shown in figure 2. Threads for the separated end fitting and mating control rod piece were intact.

Figure 1. Overall view of the submitted ruddervator control rod assembly pieces.

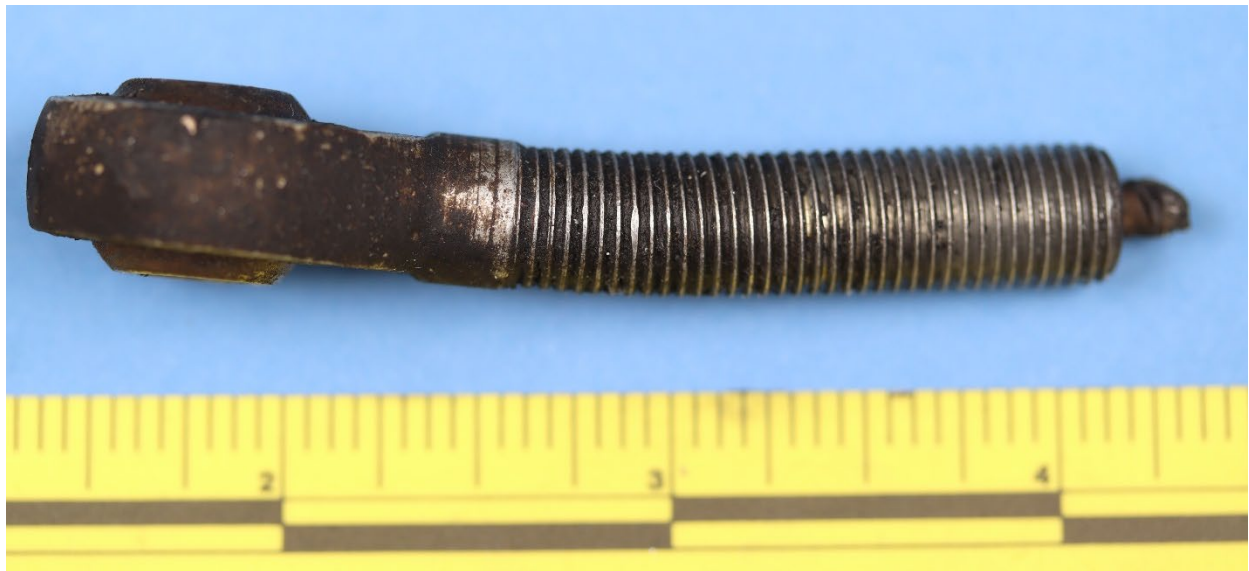
Figure 2. Bent control rod end fitting from the fractured end of the ruddervator control rod assembly B.
