# National Transportation Safety Board

CEN22LA250

## **MATERIALS LABORATORY**

Factual Report 22-102

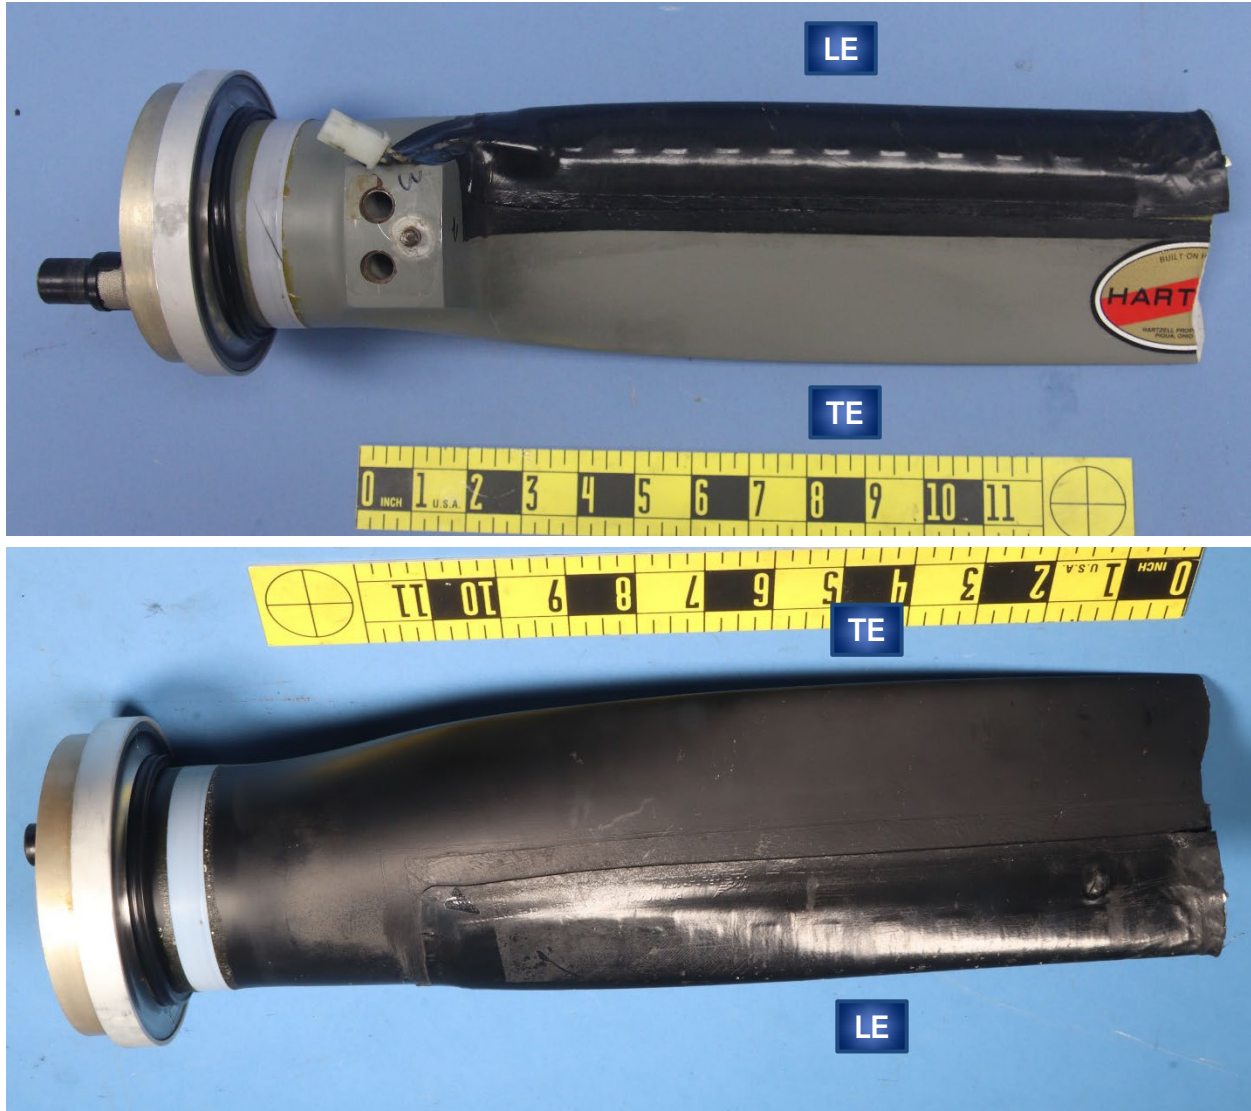
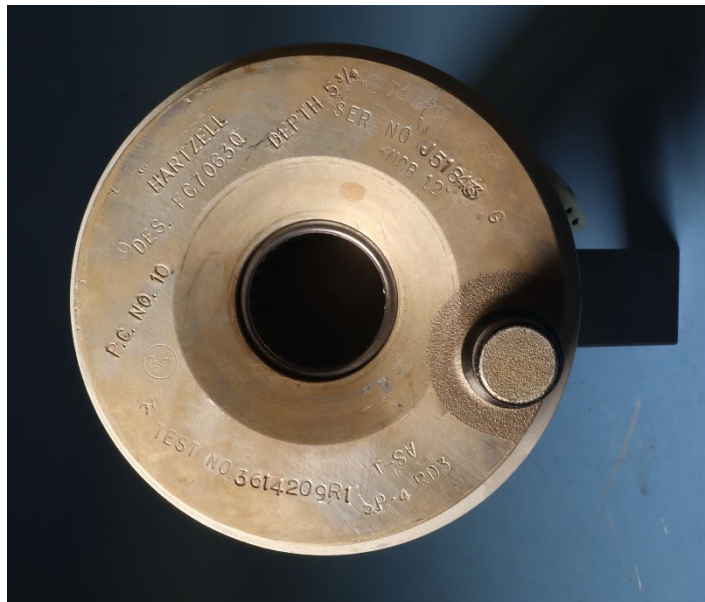
Overall views of the propeller blade piece as received are shown in figure 1. The blade was fractured 16.89 inches from the root end face. Stamped markings on the root end face indicated the propeller blade was a Hartzell part number FC7063Q propeller blade with serial number J51843. According to Hartzell build records, the propeller assembly manufacture date was October 9, 2000.

**Figure 1.** Overall views of the submitted propeller blade piece.

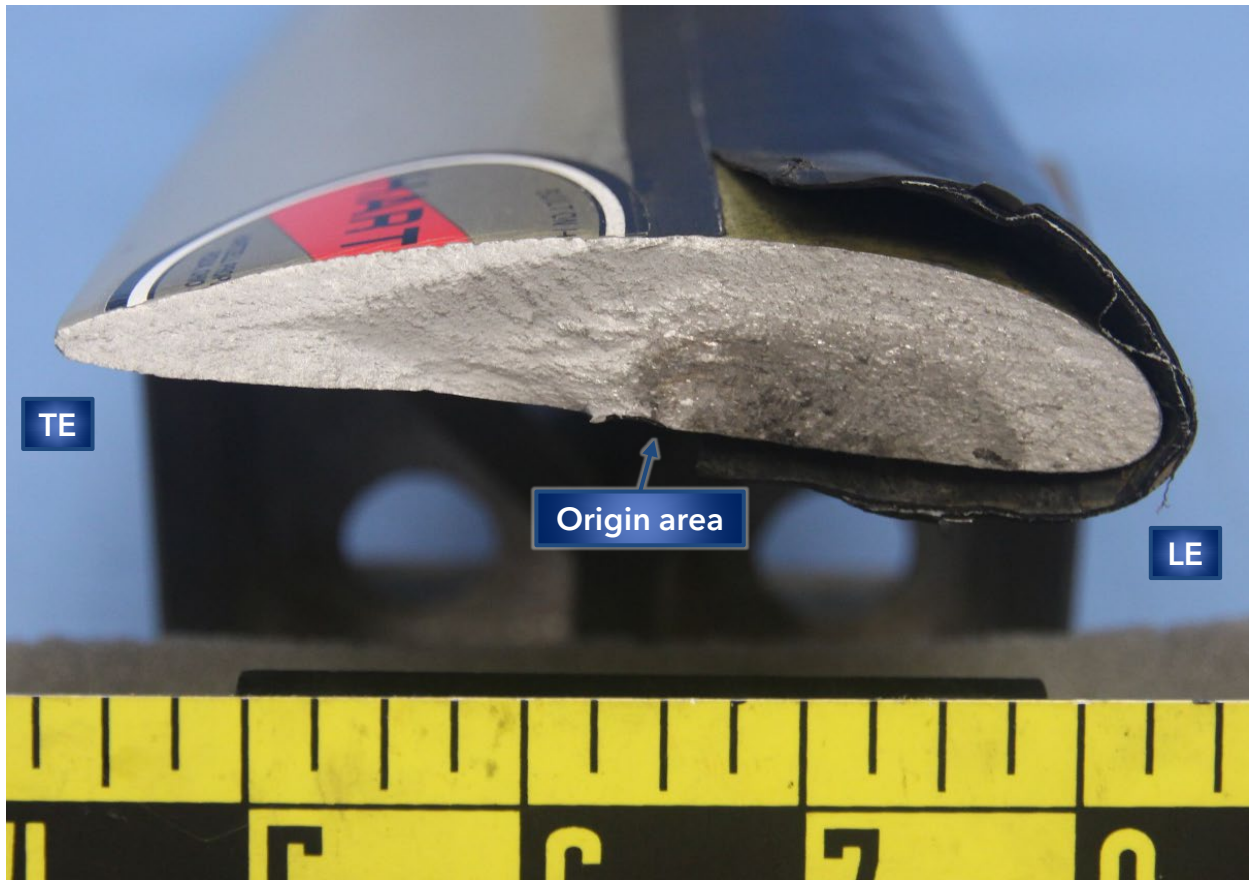
An overall view of the fracture surface is shown in figure 2. A portion of the fracture surface was oriented in a flat, chordwise plane consistent with fatigue. The fatigue region had faceted features with curving crack arrest lines, features consistent with fatigue crack growth. The fatigue features emanated from an origin area on the flat side of the blade near the middle of the chord as indicated in figure 2. The fatigue origin area was associated with a series of grooves in the blade surface adjacent to the trailing edge of the de-icing boot as shown circled in figure 3.

**Figure 2.** Fracture surface of the propeller blade piece as received.

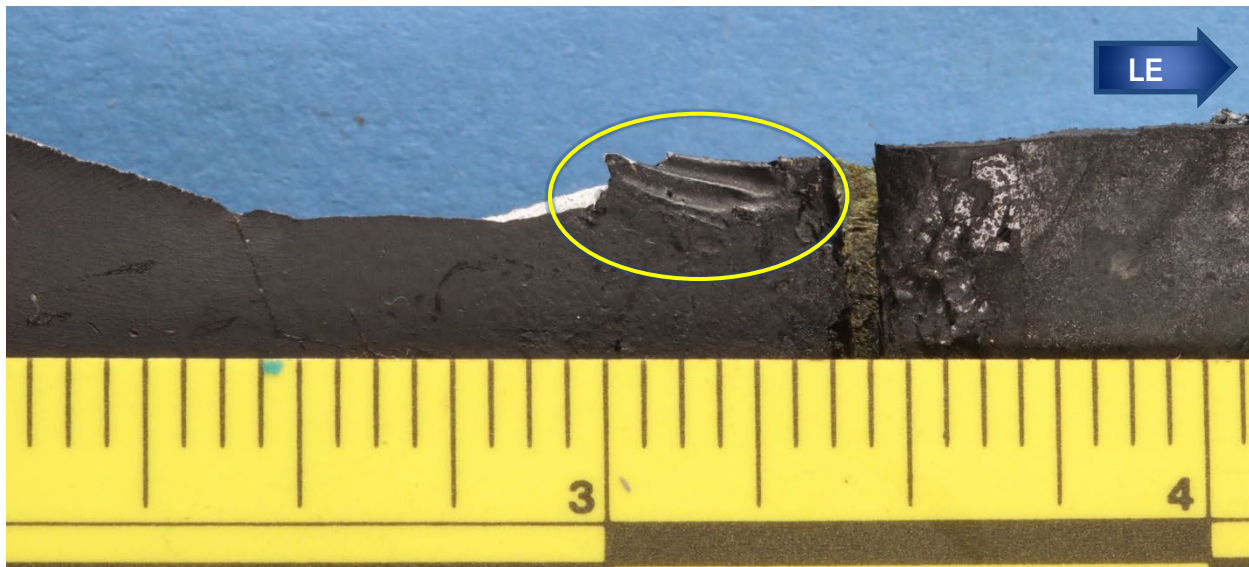
**Figure 3.** Closer view of the anomaly (circled area) on the flat side of the blade.

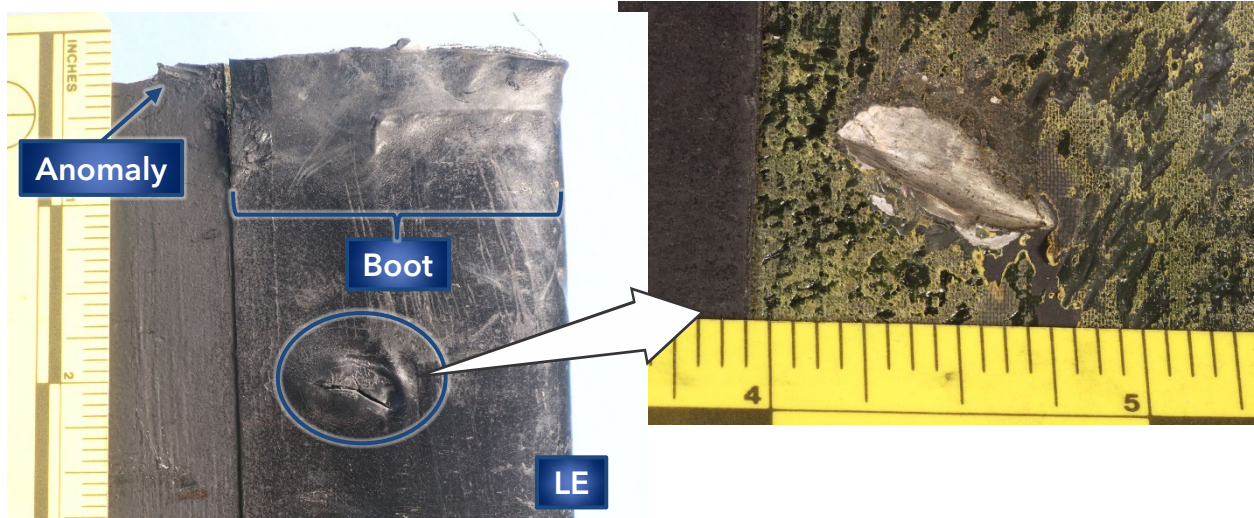
The leading edge of the blade within a couple inches of the fracture surface is shown in figure 4. In that area, the boot appeared fractured and disturbed in the circled area about 1.75 inches from the fracture surface. The boot was pulled away from the surface, revealing an impact mark in the blade as shown in the right image in figure 4. The geometry of the impact mark was different from the series of groove-like features observed with the fatigue origin anomaly shown in figure 3.

**Figure 4.** Flat side of the blade showing an anomaly at the fatigue origin area and a tear in the boot near the fracture surface (left) and a view of the damage where the boot tear was observed after removing the boot (right image).

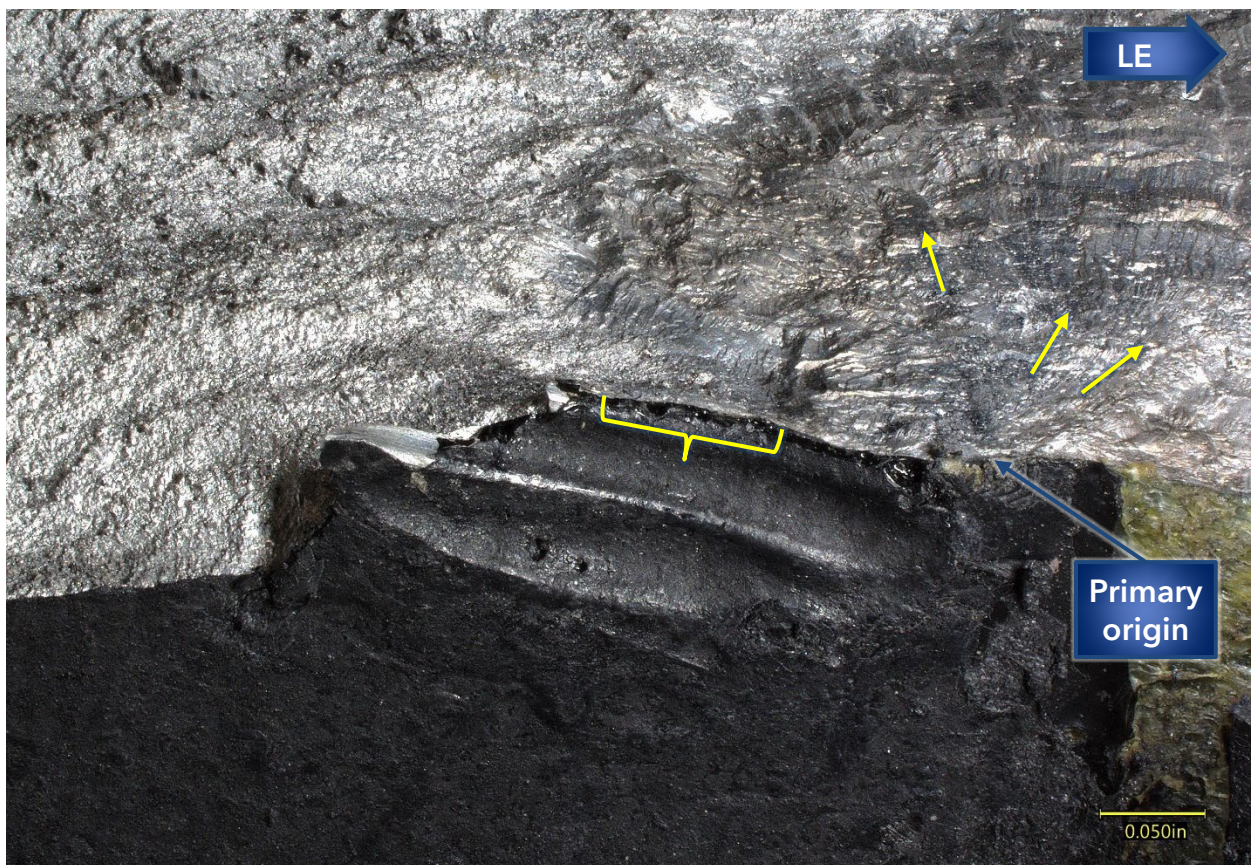
The blade piece was cut chordwise approximately 1 inch from the fracture surface to facilitate further examination of the fracture surface and the anomaly associated with the origin area. An oblique view of the anomaly and the adjacent fracture surface is shown in figure 5. The majority of the fatigue features emanated from an origin area at the leading edge of the anomaly, labeled the primary origin in figure 5. Unlabeled arrows on the fracture surface show local directions of fatigue crack propagation away from the primary origin area. Additional secondary origin areas were noted along the length of the anomaly in the area indicated with an unlabeled bracket in figure 5.

**Figure 5.** Oblique view of the anomaly. Arrows indicate the direction of fatigue features emanating from the primary origin at the leading end of the anomaly. A bracket indicates an area of secondary fatigue origins.

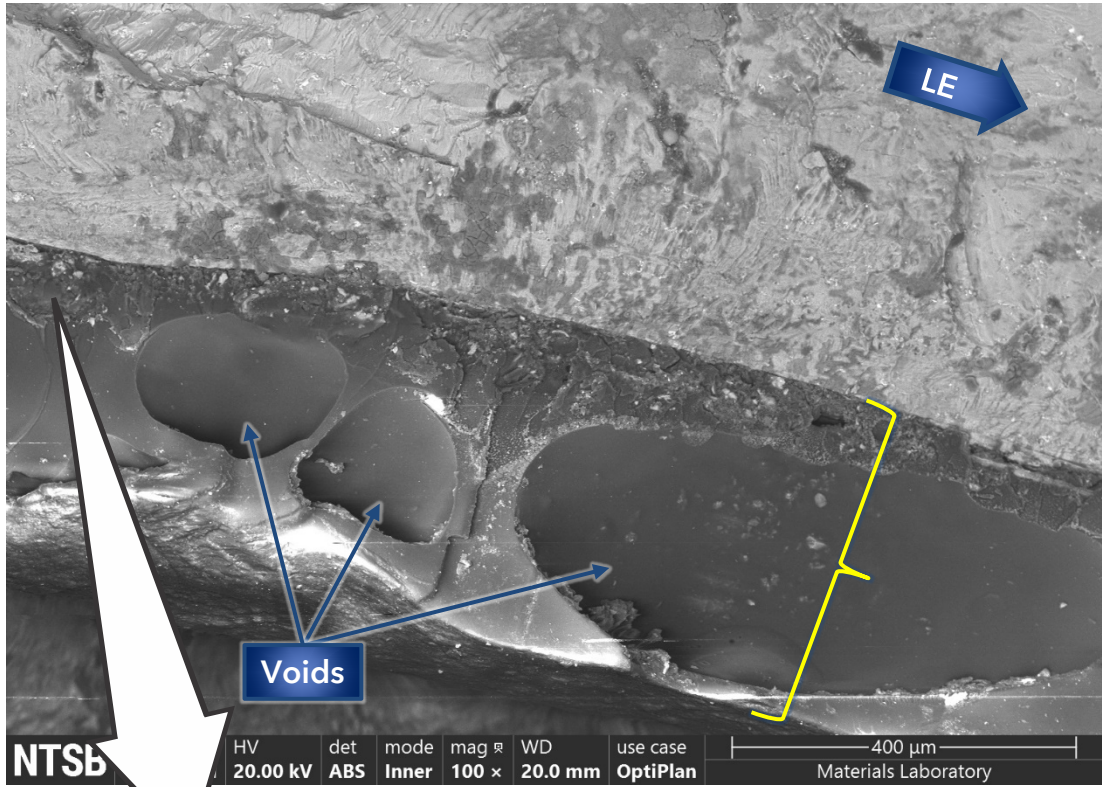
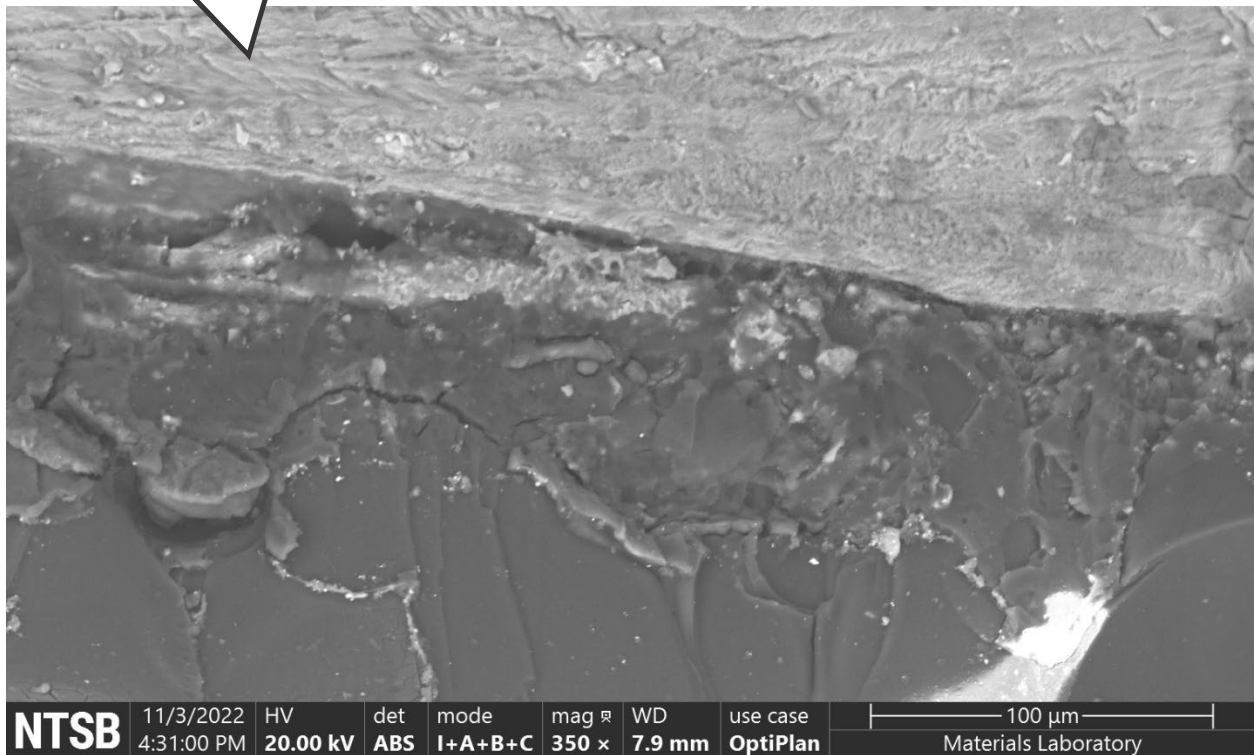
Before cleaning the fracture surface for a more detailed examination of fracture features, an examination of the surface coatings was completed using a scanning electron microscope (SEM). The surface coating at the anomaly was relatively thick and had multiple voids as shown in the upper image in figure 6. The fracture surface of the coating had a flat faceted appearance that appeared relatively uniform in texture across the thickness. In contrast, the coating on the flat side of the blade closer to the trailing edge had a thinner thickness with varying texture through the thickness as shown in figure 7.

**Figure 6.** SEM images of the coating on the anomaly as viewed using a backscatter detector in composition mode. A bracket in the upper image indicates the thickness of the coating, and the arrow emanates from the area shown at higher magnification in the lower image.

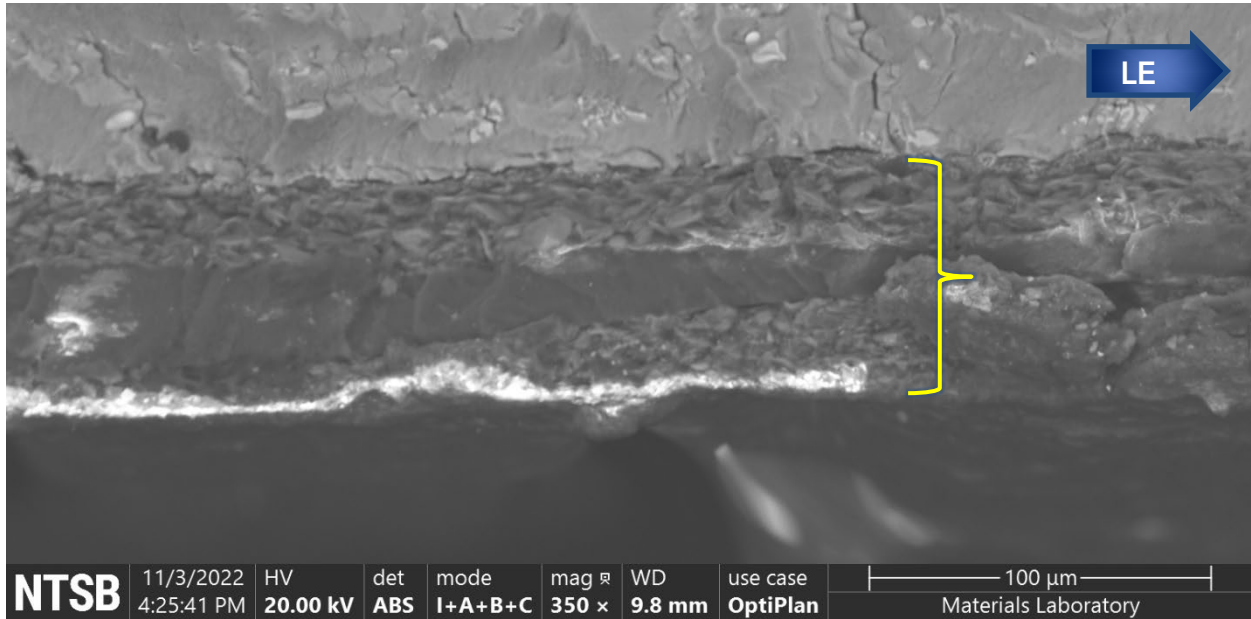
**Figure 7.** SEM image of the coating on the flat side of the blade away from the anomaly as viewed using a backscatter detector in composition mode. A bracket in the upper image indicates the thickness of the coating.

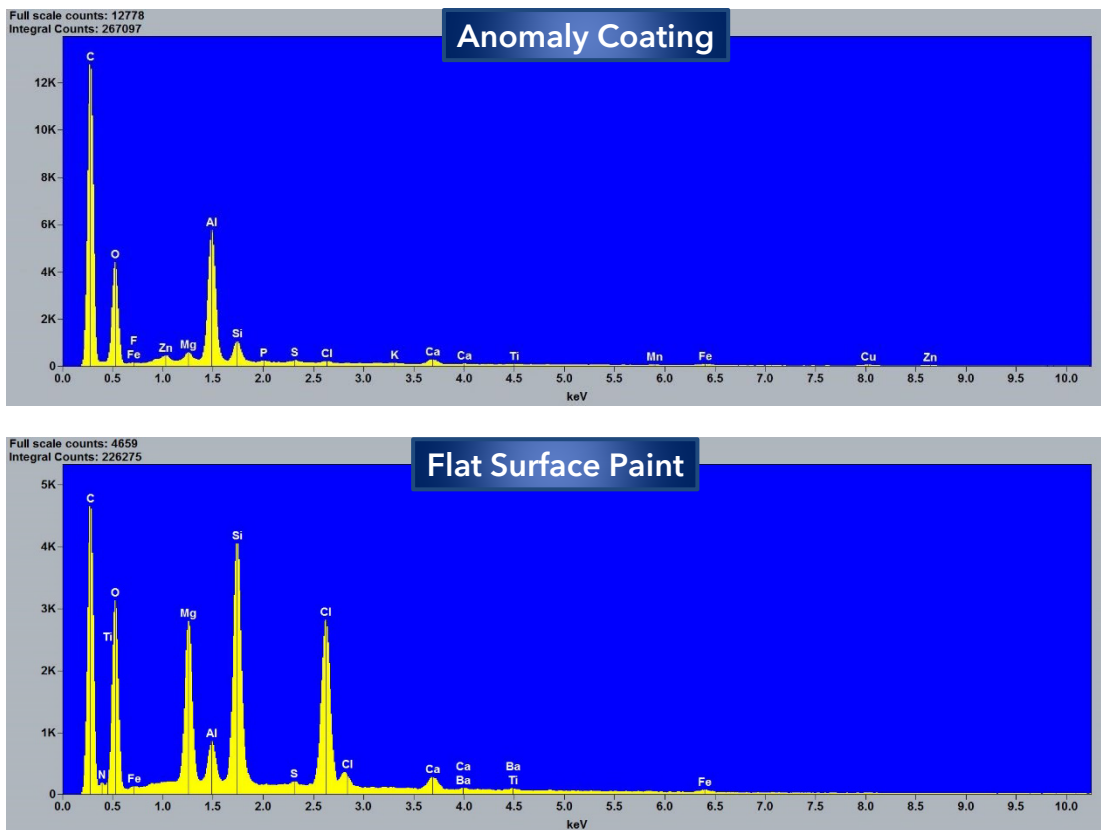
The coating composition in the areas shown in figures 6 and 7 were also analyzed using energy dispersive x-ray spectroscopy (EDS), and the resulting spectra are shown in figure 8. The coating on the anomaly had high peaks of aluminum, oxygen, and carbon as shown in the upper spectrum in figure 8. In contrast, the

coating on the blade flat closer to the trailing edge had high peaks of silicon, magnesium, chlorine, carbon, and oxygen.

**Figure 8.** EDS spectra of the coating on the anomaly shown in figure 6 (upper spectrum) and on the flat side of the blade shown in figure 7 (lower spectrum).

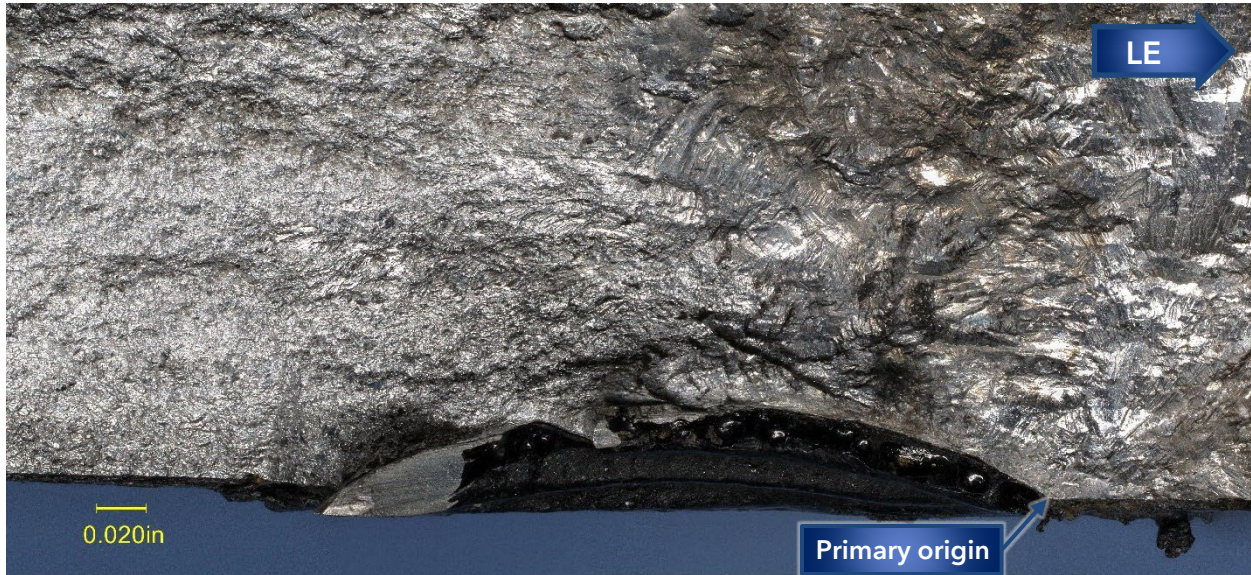
After the initial SEM and EDS examination of the coatings was completed, the fracture surface was rinsed using acetone. The coating on the anomaly appeared to soften with the exposure to acetone, so the surface cleaning process was interrupted to facilitate coating analysis using Fourier-transform infrared spectroscopy (FTIR). The samples were examined using an FTIR spectrometer with a diamond attenuated total reflectance (ATR) accessory in accordance to ASTM E1252-98 (American Society for Testing Materials E1252-98: *Standard Practice for General Techniques for Obtaining Infrared Spectra for Qualitative Analysis and American Society for Testing Materials*). The spectrometer was used to collect and process infrared wavelength absorbance spectra of the unknown material. Three areas on the sectioned piece of the blade were selected for further analysis; Area A (area of painted blade near the trailing edge); Area B (sealant at the trailing edge of de-icing boot) and Area C (an unknown material covering the anomaly). Three swab samples taken from Area C were also analyzed.

**Figure 9.** Stitched optical image of the origin area after an acetone rinse.

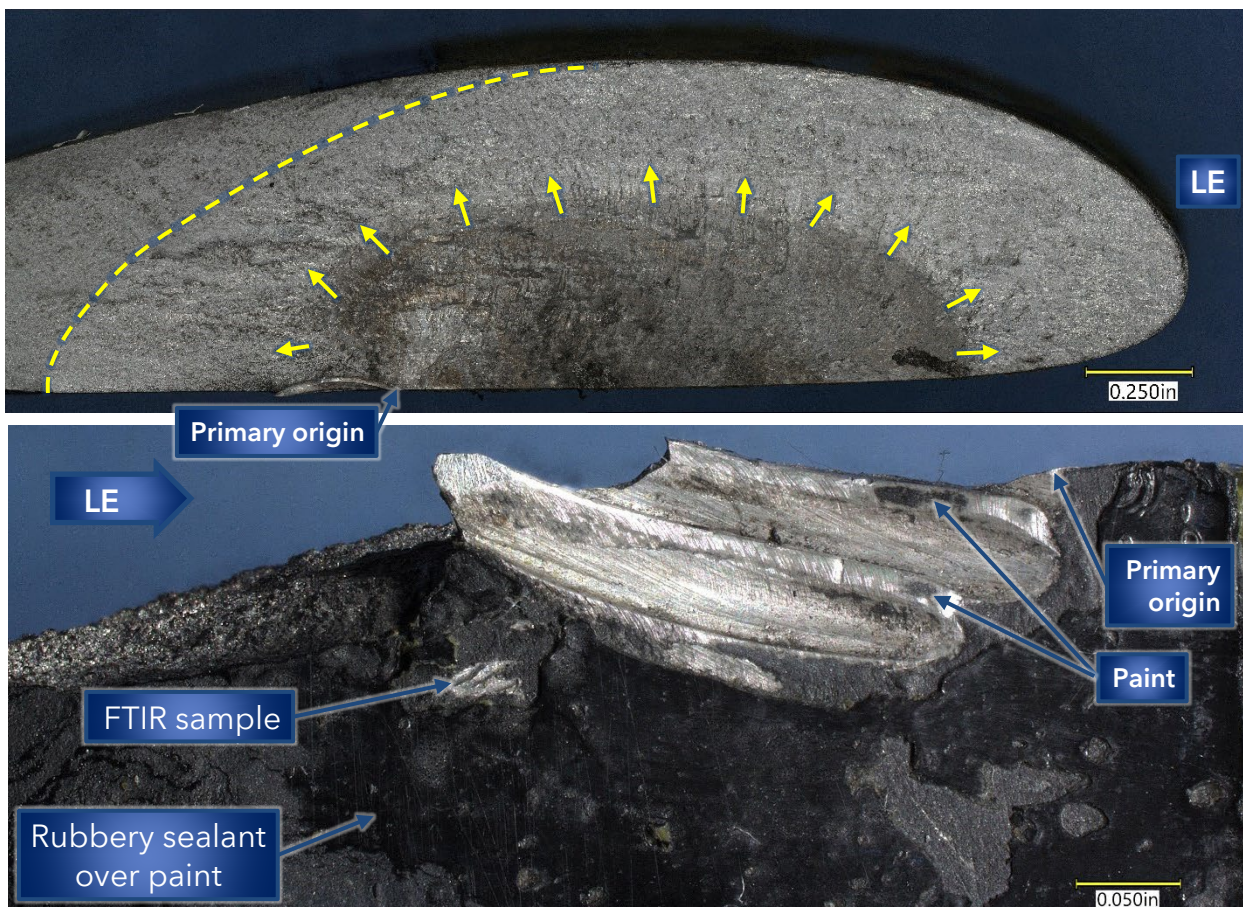
Next, the sectioned piece with the fracture surface was submerged in acetone and cleaned using an ultrasonic cleaner, and a view of the fatigue region on the cleaned fracture surface is shown in figure 10. A portion of the fracture surface had a darker appearance with a smooth curving boundary, consistent with fatigue crack growth. Relatively smoother features consistent with stable crack growth continued

slightly beyond the dark region, and unlabeled arrows indicate the extent of the stable crack growth region. As the crack grew through the thickness, it grew faster toward the leading edge than toward the trailing edge, leaving the origin area skewed closer to the trailing edge of the stable fatigue crack growth region. In the region beyond the arrows, the fracture surface had a rougher texture and duller appearance but remained in a flat plane consistent with a transition to unstable progressive crack growth. The progressive growth extended to the leading edge and to the camber surface, ending at the dashed line in figure 10. The remainder of the fracture showed rough, matte gray features consistent with ductile overstress fracture.

The anomaly at the fatigue origin is shown in the lower image in figure 10 after the coating had been removed with acetone. The anomaly consisted of multiple parallel grooves with rounded bottoms. The original surface coating (paint) was missing from the surfaces of the grooves, but remnant areas of black coating that appeared to be paint was observed on the peaks between the grooves such as the areas indicated in the lower image in figure 10. A black sealant with a rubbery texture was observed over the paint at the trailing edge of the de-icing boot, and both the sealant and the paint appeared to be disturbed from the groove surfaces of the anomaly. Neither the paint nor the rubbery sealant was easily removed with acetone.

**Figure 10.** Fracture surface (upper image) and anomaly (lower image) after swabbing and ultrasonic cleaning with acetone. Arrows in the upper image indicate steady crack growth fracture features, and a dashed line indicates the extent of progressive crack growth.

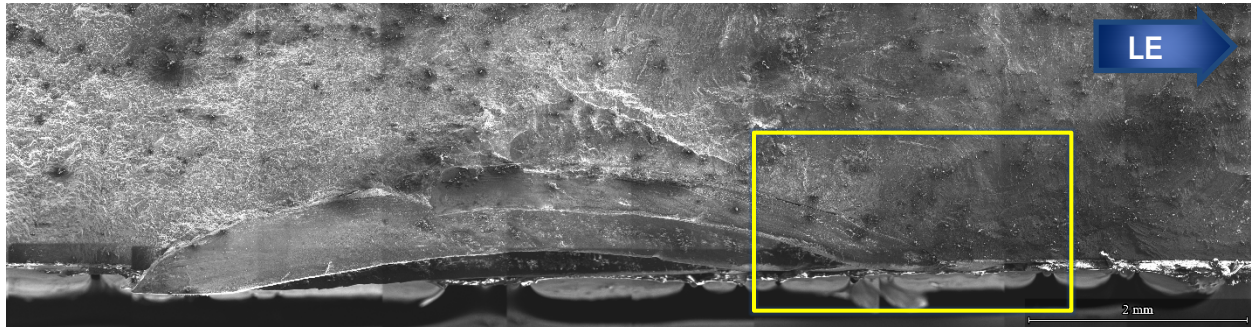
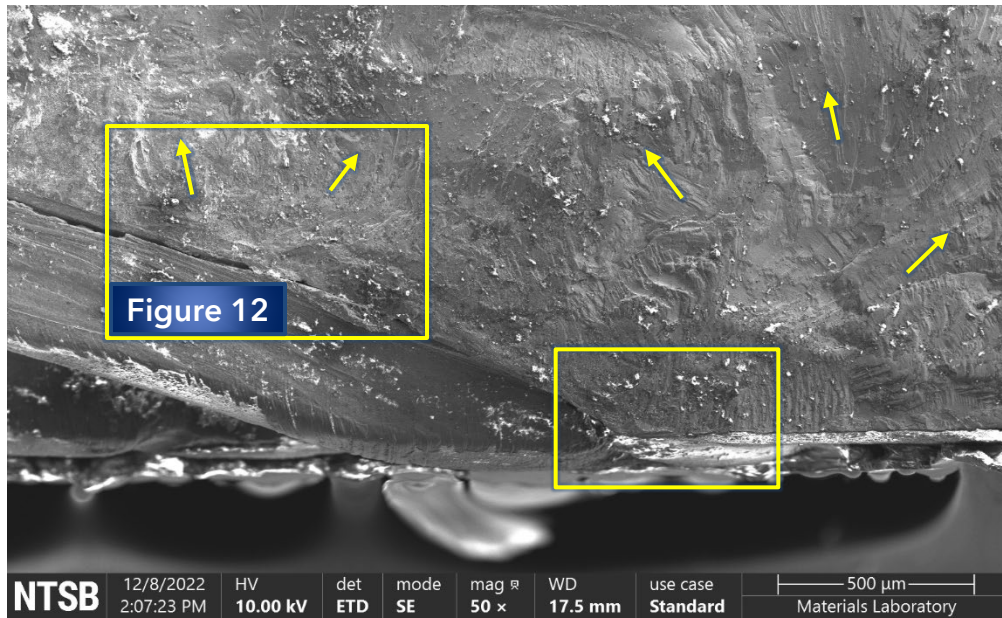
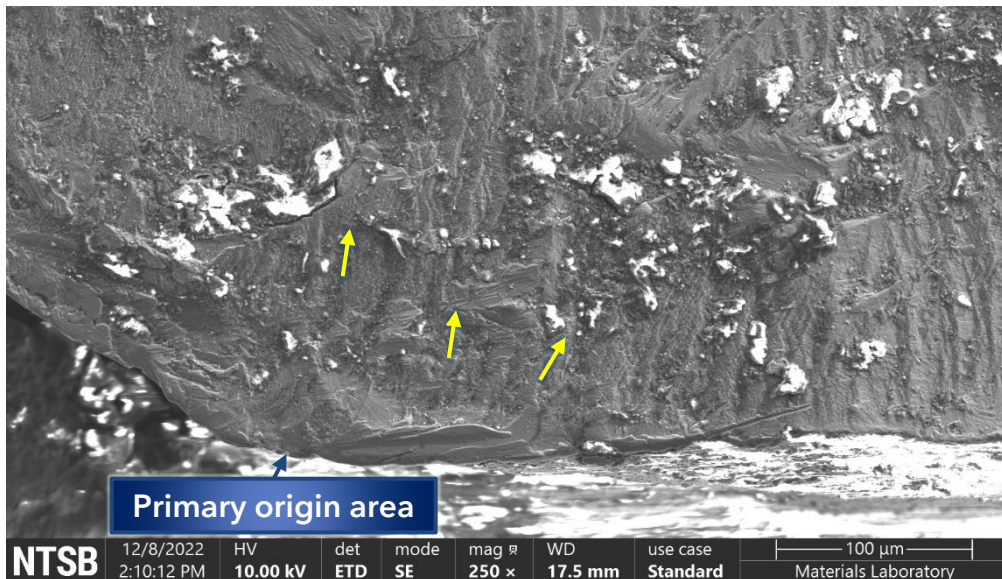
The fracture surface was further examined using the SEM, and resulting images are shown in figures 11 through 15. A montage of images showing an overall view of the origin area and the anomaly is shown in the upper image in figure 11, and closer views of the origin areas are shown in the lower images in figure 11 and in figure 12. The primary origin, shown in the lower image in figure 11, was located at the flat face of the blade near the leading edge of the anomaly. The fracture surface at the origin was damaged adjacent to the flat surface, but unlabeled arrows indicate local propagation directions consistent with the primary fatigue origin at the location indicated. Secondary origin areas were located along the edge of the anomaly closer to the trailing edge in the area shown in figure 12. Unlabeled arrows in figure 12 indicate local crack directions with crack features emanating from the secondary origin area indicated with a bracket. However, these cracks soon merged with the primary crack front. Typical fatigue fracture features consistent with high-cycle fatigue were observed within the stable fatigue region such as the areas shown in figures 13 and 14. Striations such as those shown in figure 15 were observed in the region of unstable progressive growth (between the arrows and camber surface or dashed line shown in figure 11).

**Figure 11.** SEM images of the primary origin area after ultrasonic cleaning with acetone. The upper image is a stitched montage, and rectangles indicate areas shown magnified in subsequent images in this figure and in figure 12. Unlabeled arrows indicate local directions of fatigue crack growth.

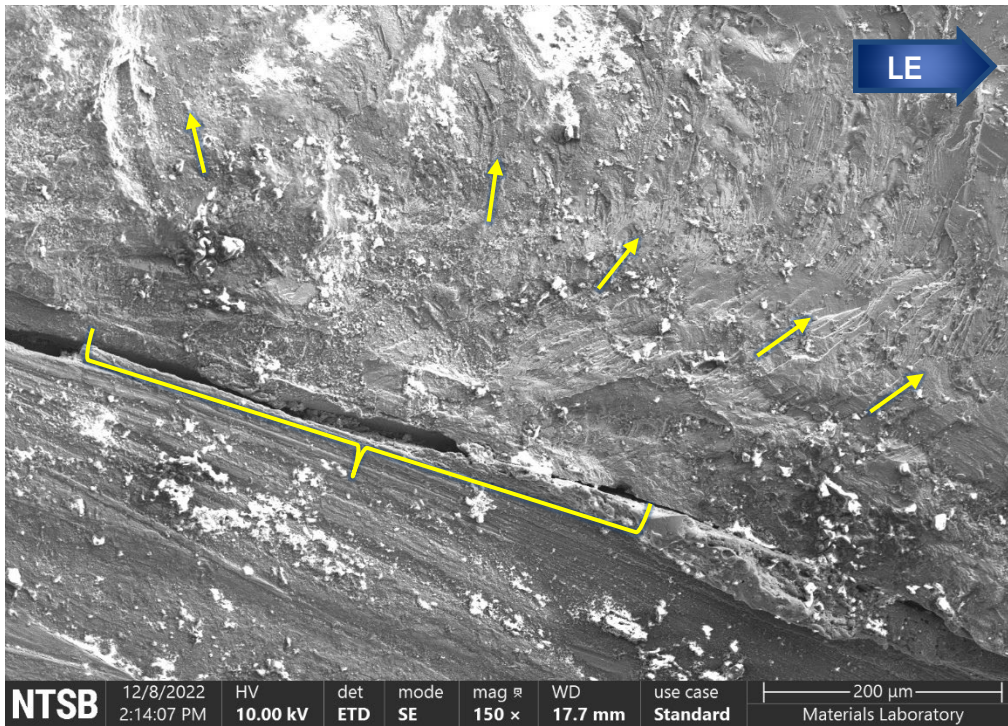
**Figure 12.** Secondary origin area (indicated with a bracket) emanating from the anomaly in an area trailing the primary origin area. Unlabeled arrows indicate the local direction of fatigue crack growth.

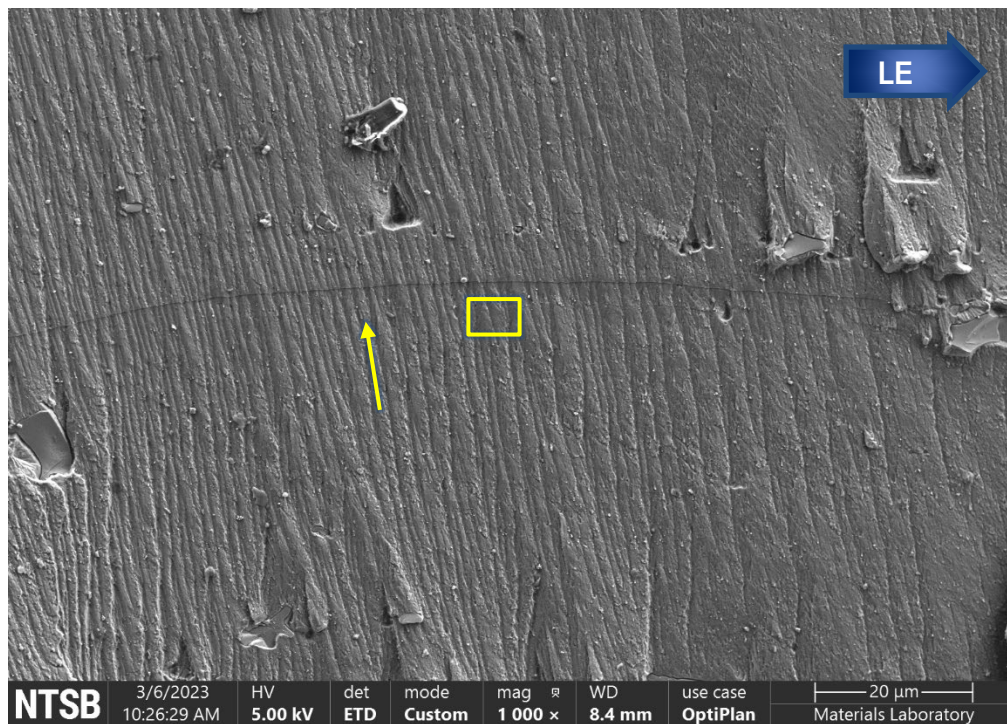
**Figure 13.** Typical fatigue features within the region of stable fatigue crack growth approximately 0.157 inch from the primary origin. An unlabeled arrow indicates the direction of crack growth, and the rectangle indicates the area shown at higher magnification in the next figure.

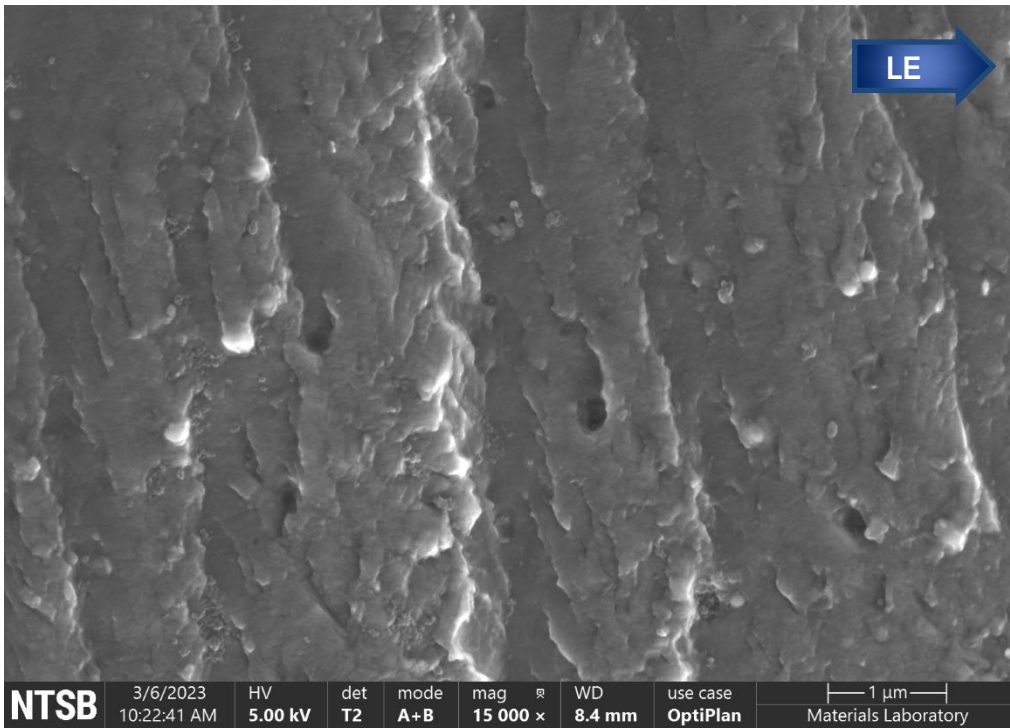
**Figure 14.** Fatigue features within the region of stable fatigue crack growth in the rectangle shown in the previous figure.

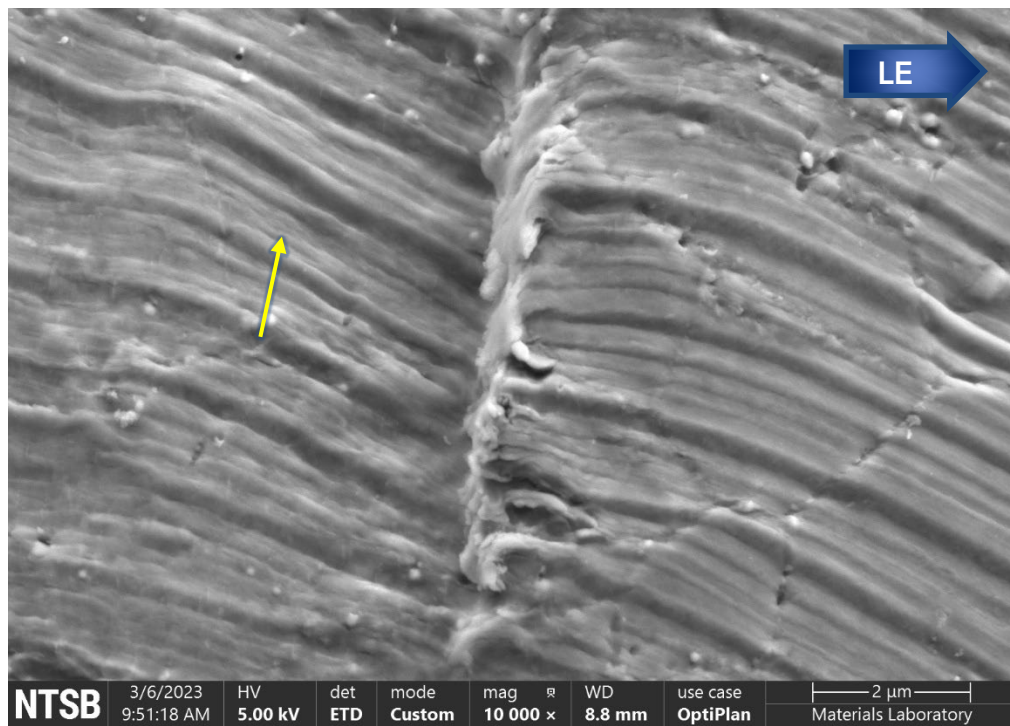
**Figure 15.** Typical fatigue features in the region of unstable fatigue crack growth. An unlabeled arrow indicates the direction of crack growth.

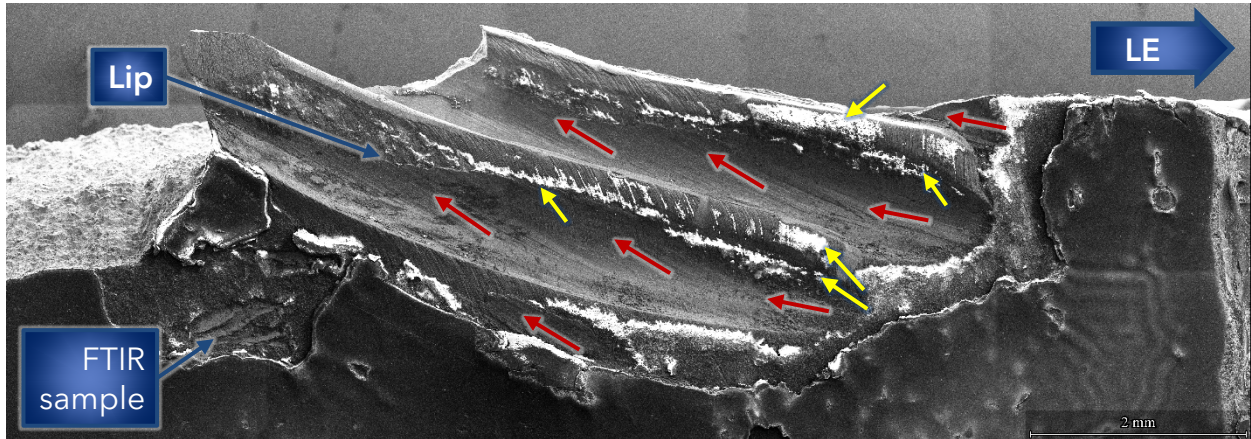
A montage of SEM images of the flat surface adjacent to the fracture surface showing the anomaly at the fatigue origin is shown in figure 16. Portions of the anomaly surface such as those indicated with the yellow arrows appear white in the

image due to charging.<sup>1</sup> The area indicated by the uppermost yellow arrow in figure 16 was analyzed using EDS, and the resulting spectrum is shown in figure 17. The spectrum showed high peaks of silicon, magnesium chlorine, carbon, and oxygen, consistent with paint (see paint spectrum in figure 8). The paint was observed on the peaks between the grooves for the anomaly. In areas with less paint covering the surface, the paint filled spanwise scratches in the surface. During blade manufacture, the surface is sanded spanwise, and similar spanwise scratches were observed in other undisturbed areas of the blade surface.

Sliding contact marks were observed at the bottoms of the grooves, and red arrows in figure 16 indicate the local direction of the sliding contact. A lip of disturbed material was observed at the outboard trailing edge of the marks such as the lip indicated in figure 16. Closer views of features associated with the anomaly are shown in figures 18 and 19. Spanwise scratch marks at the peaks between the grooves continued along the sides of the groove consistent with an impression into the surface, and the surface at the deepest portion of the groove had a smeared surface consistent with sliding contact. The inboard flank of the outboard groove had curved sliding contact marks as shown in figure 18, and spanwise marks on the peaks between the grooves were deformed toward the trailing edge at the outboard edge of the peak consistent with sliding contact along the inboard flank of the groove.

**Figure 16.** Anomaly after ultrasonic cleaning with acetone. Yellow arrows indicate some paint deposits, and red arrows indicate the direction of sliding contact.

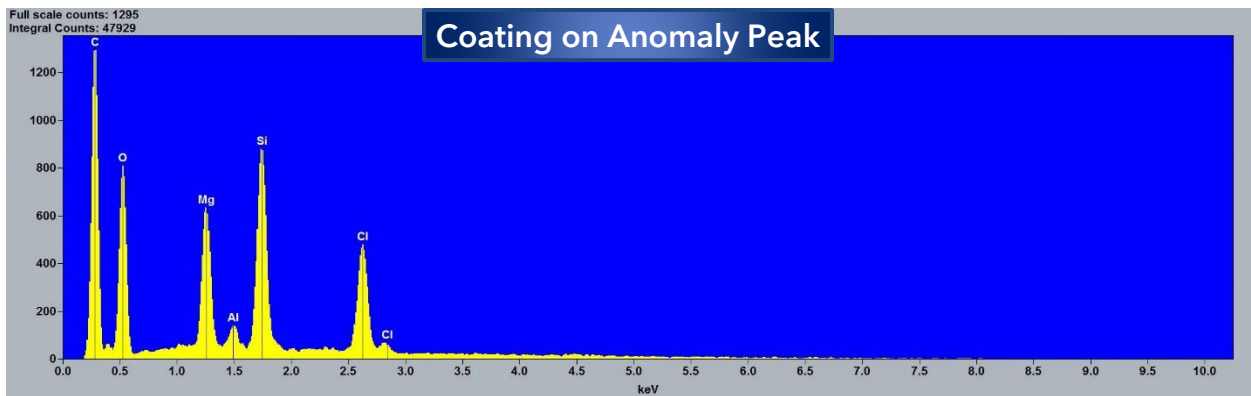
**Figure 17.** EDS spectrum for a coating on the anomaly peak (uppermost yellow arrow in figure 14) after ultrasonic cleaning with acetone.

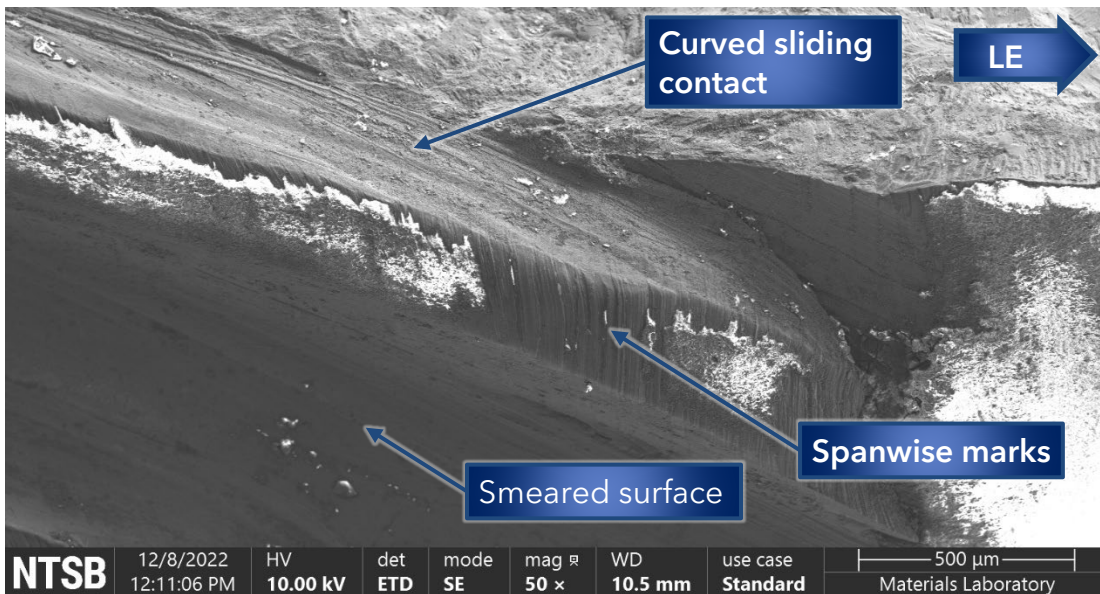
**Figure 18.** SEM image of the leading edge of the anomaly after ultrasonic cleaning with acetone.

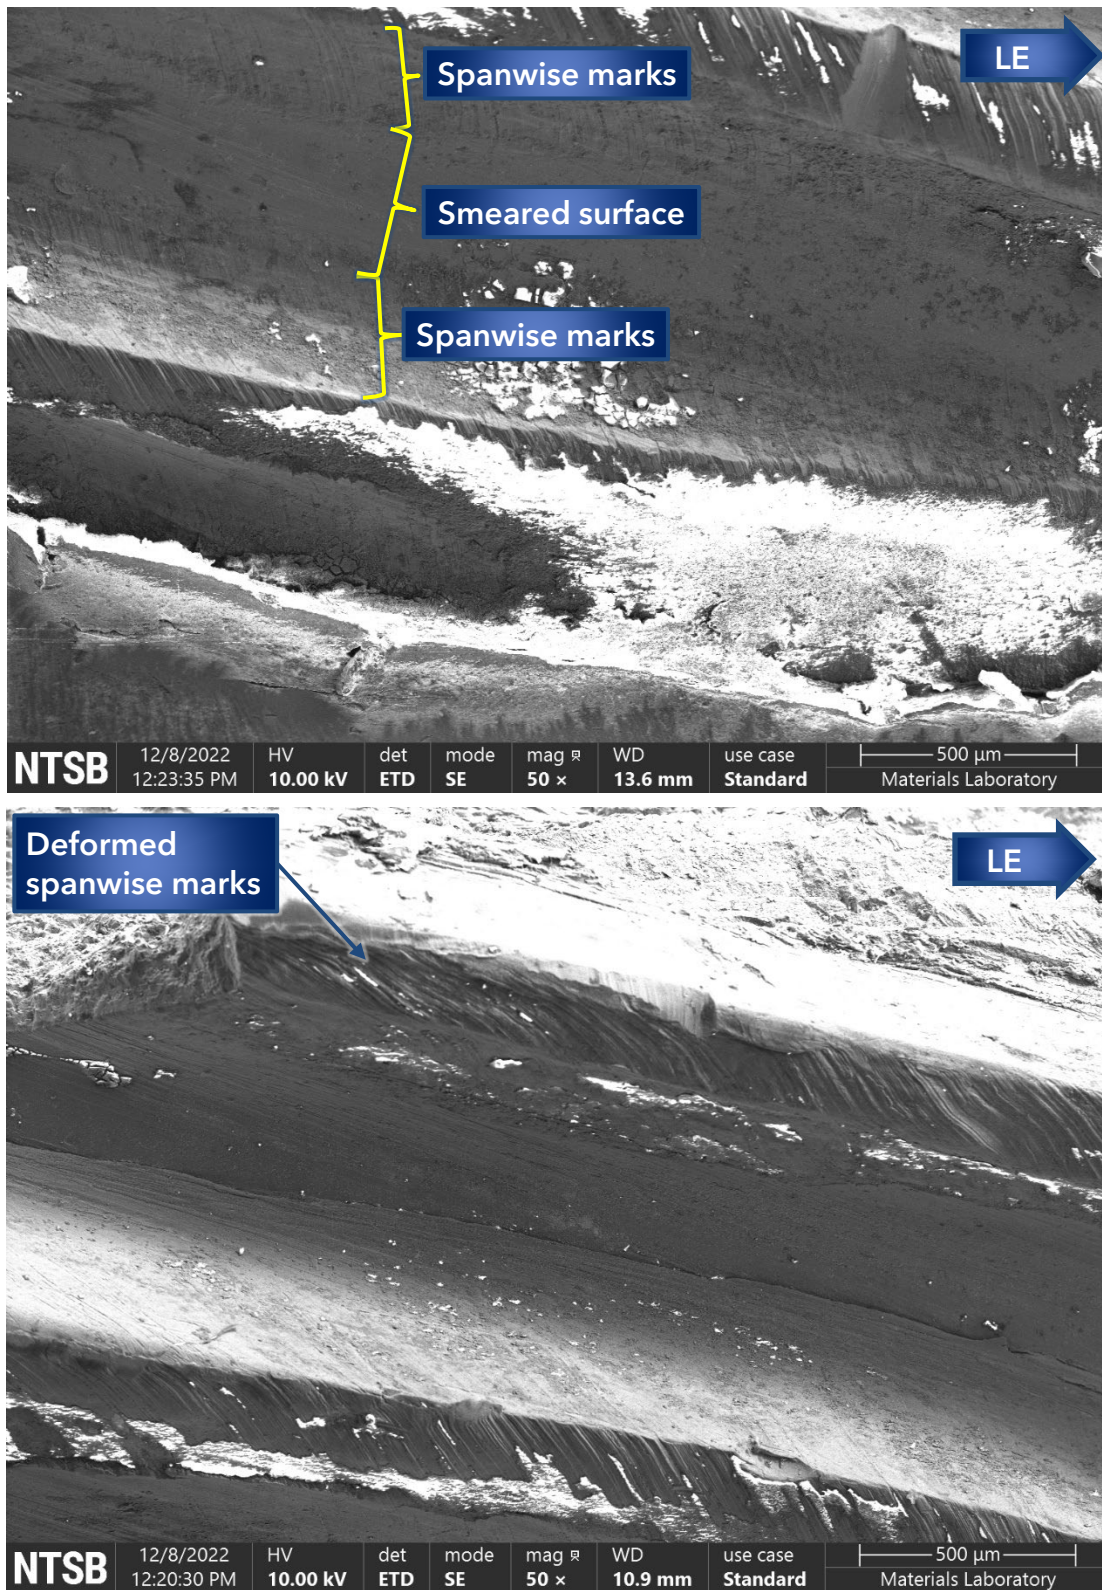
**Figure 19.** SEM images of the anomaly after ultrasonic cleaning with acetone.
