# National Transportation Safety Board

CEN22LA250

## **MATERIALS LABORATORY**

Factual Report 22-102

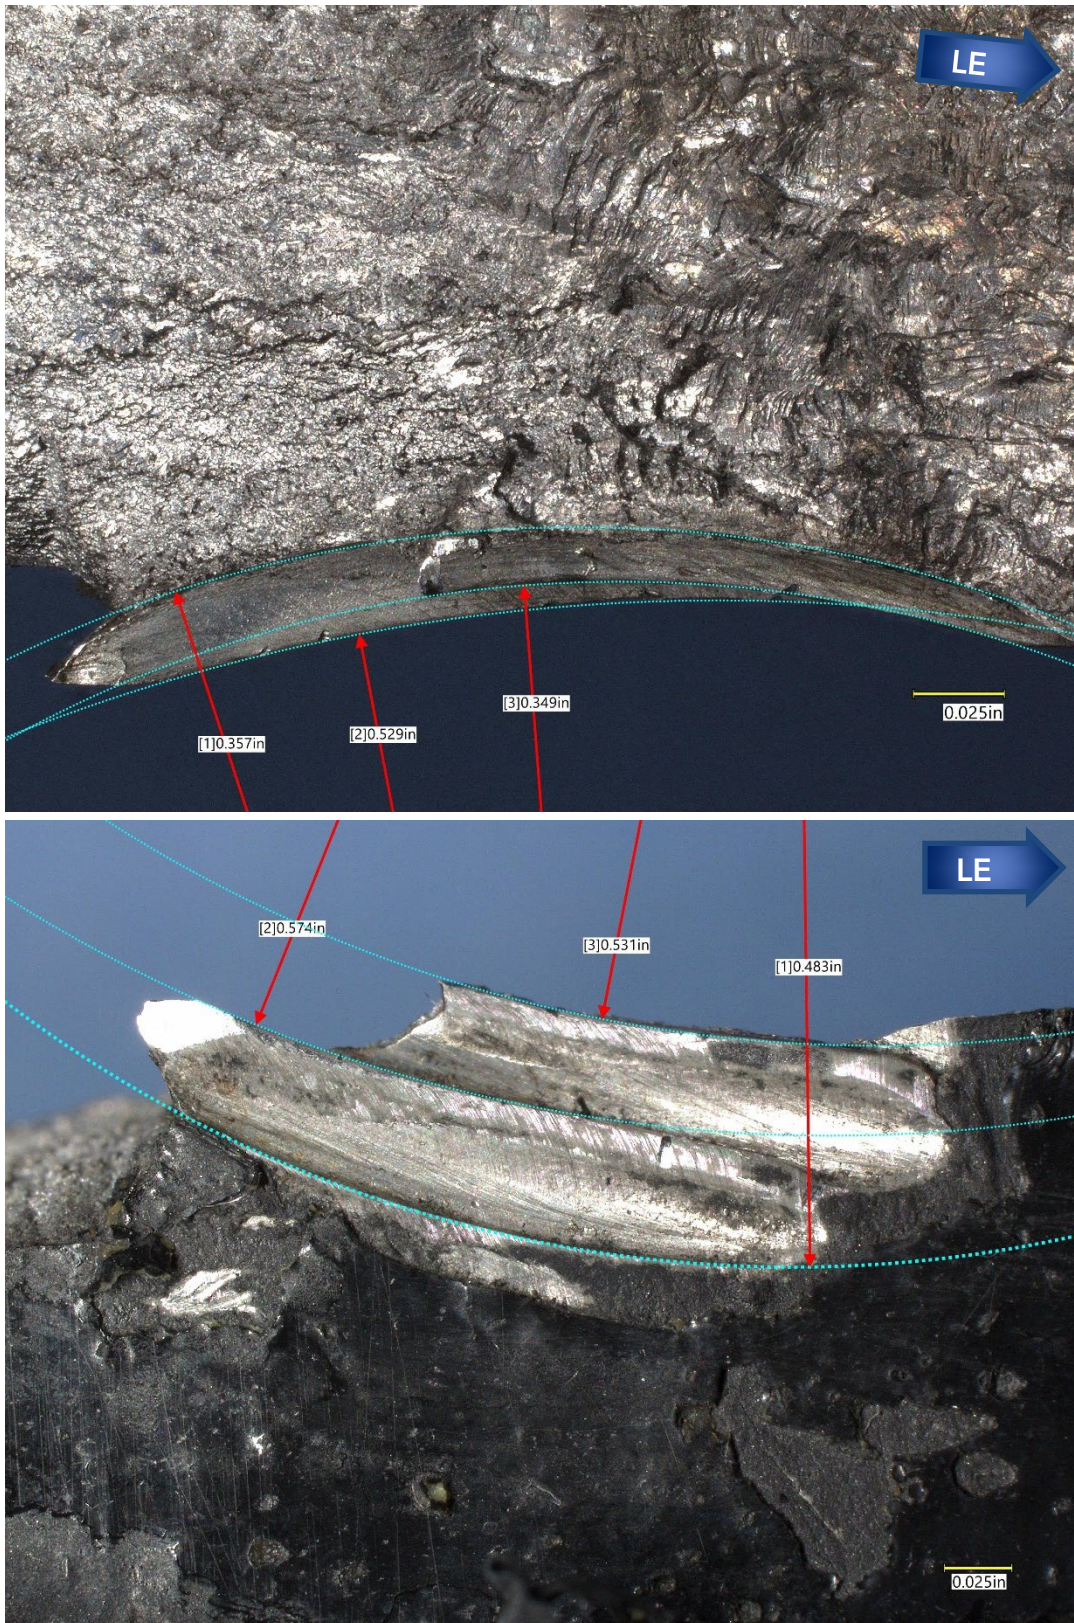
The grooves had a curved profile both in the nearly spanwise direction and facing the flat face. Measurements of the radii of curvature of anomaly features in two orientations are shown in figure 20. In the upper image, the feature was oriented such that the plane of the measured radii was approximately perpendicular to the viewing direction. Radii of the peaks for two of the grooves measured 0.349 inch and 0.529 inch. The deepest part of the groove for the two grooves intersecting the fracture surface intersected the same circle as shown with a radius of 0.357 inch. Curvature of the inboard flank on three of the grooves was measured on the flat face as shown in the lower image in figure 20. The radii measured 0.531 inch, 0.574 inch, and 0.483 inch.

**Figure 20.** Radii of curvature measured on a nearly spanwise plane viewed approximately perpendicular to the anomaly flanks (upper image) and in a plane approximately parallel to the blade flat (lower image).

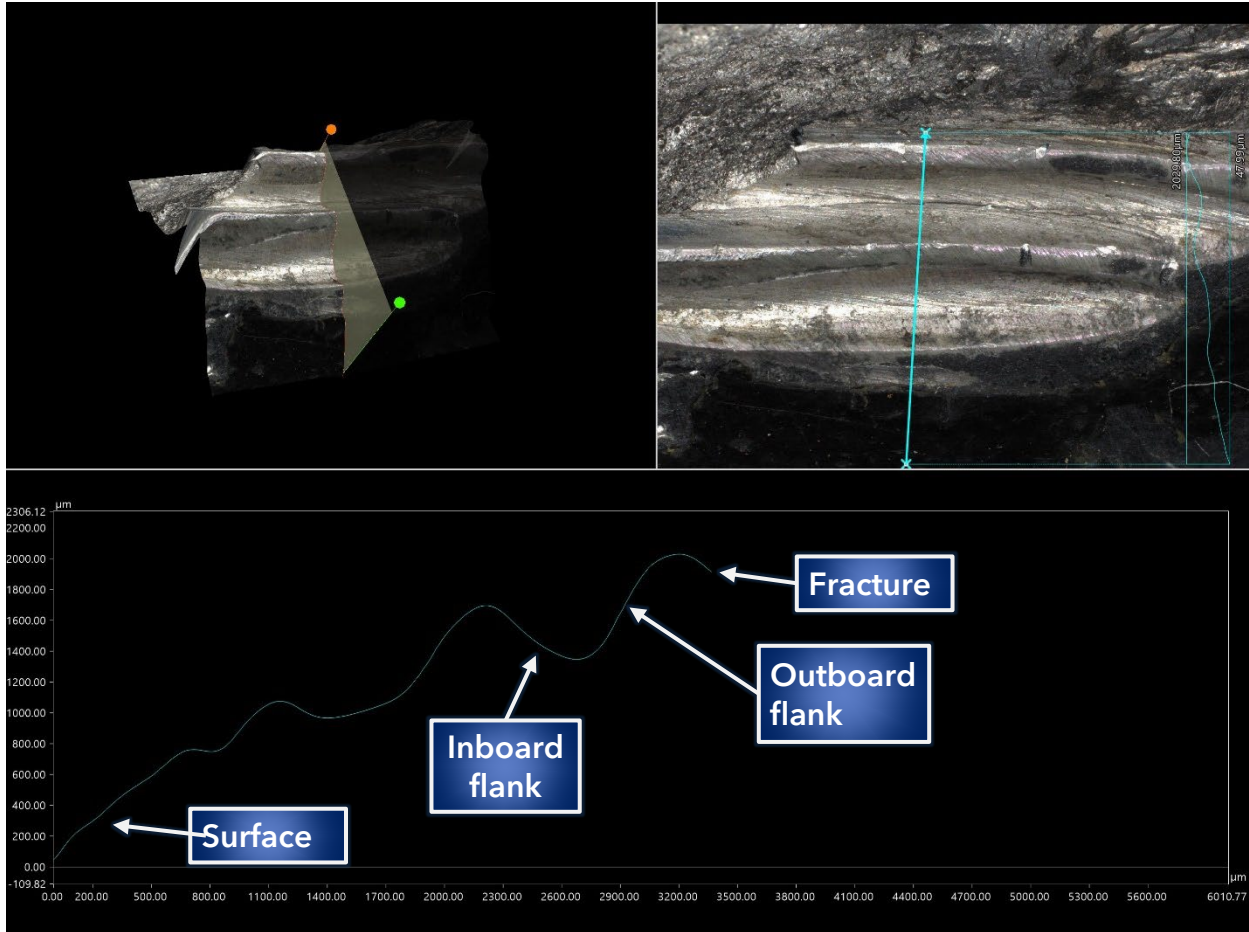
A 3-dimensional image of the anomaly was obtained using a Keyence VHX 7000 in depth mode. The sample was tilted to optimize viewing on the flank surfaces on either side of the grooves. Next, a depth profile along a linear trace through the middle of the anomaly was obtained. Results of the analysis are shown in figure 21. The profile at the lower side of figure 9 shows several grooves with varying depths relative to the outside surface. The overall shape of the grooves where the flanks transitioned to the peak appeared to be more rounded on the outboard flank and had a more abrupt transition on the inboard flank.

**Figure 21.** Three-dimensional profile of the anomaly obtained using a Keyence VHX 7000 in depth mode. In the chart, the vertical axis ranges from 0 to 2306 microns at 200-micron intervals, and the horizontal axis ranges from 0 to 6011 microns starting with a 200-micron interval followed by 300-micron intervals.
