National Transportation Safety Board

CEN22FA317

MATERIALS LABORATORY

Factual Report 23-003

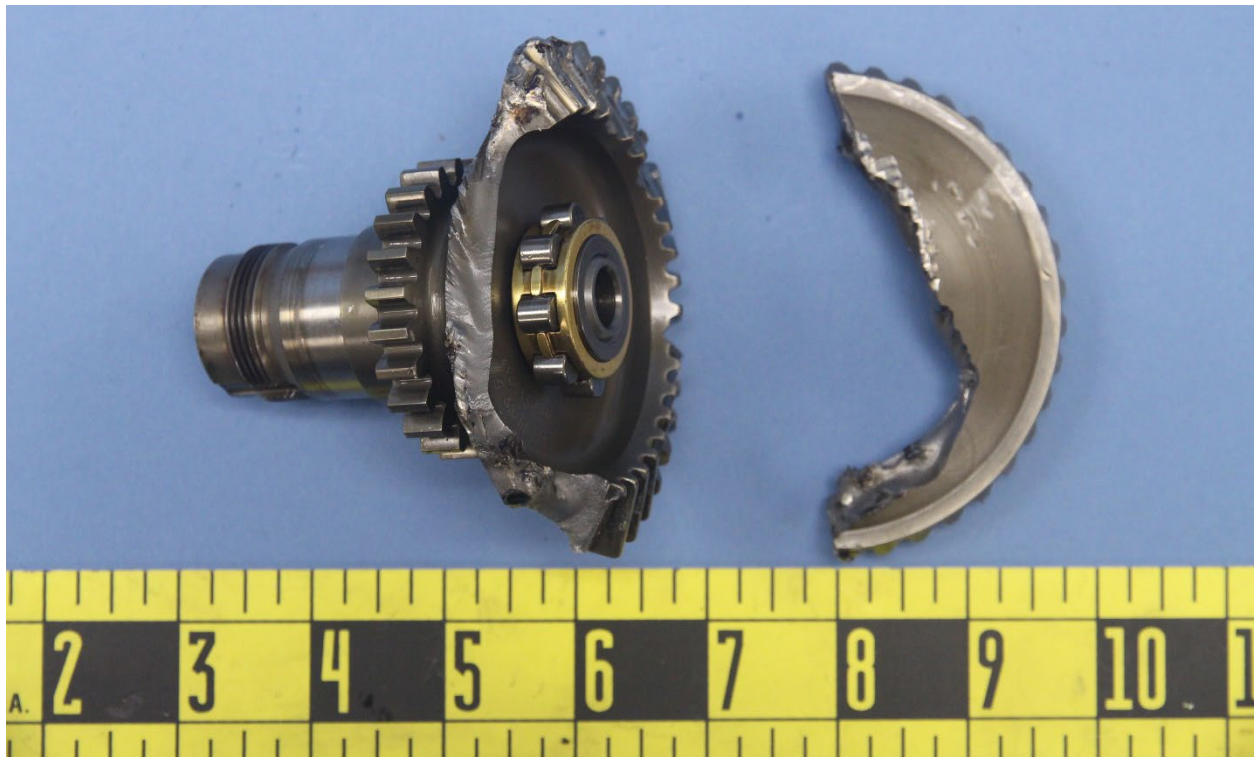
Figures 1 and 2 show the fractured bevel gear as received. The gear exhibited multiple fractured teeth, along with an L-shaped chord-oriented fracture that separated the fractured fragments of the gear. The gear did not exhibit any local deformation adjacent to the fracture surface. The vibroetched markings on the faces of the gear remnants stated the following:

Figure 1. The largest gear fragments, as received.

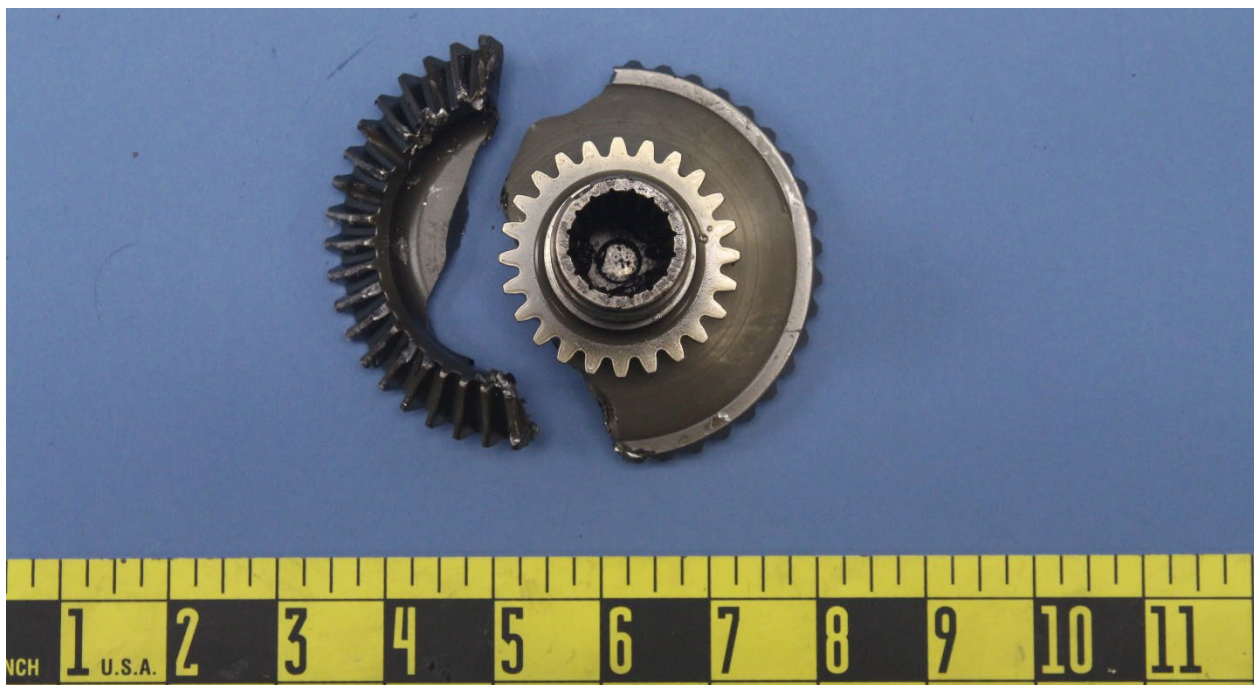
Figure 2. View of the mating fractured pieces, from the shaft side.

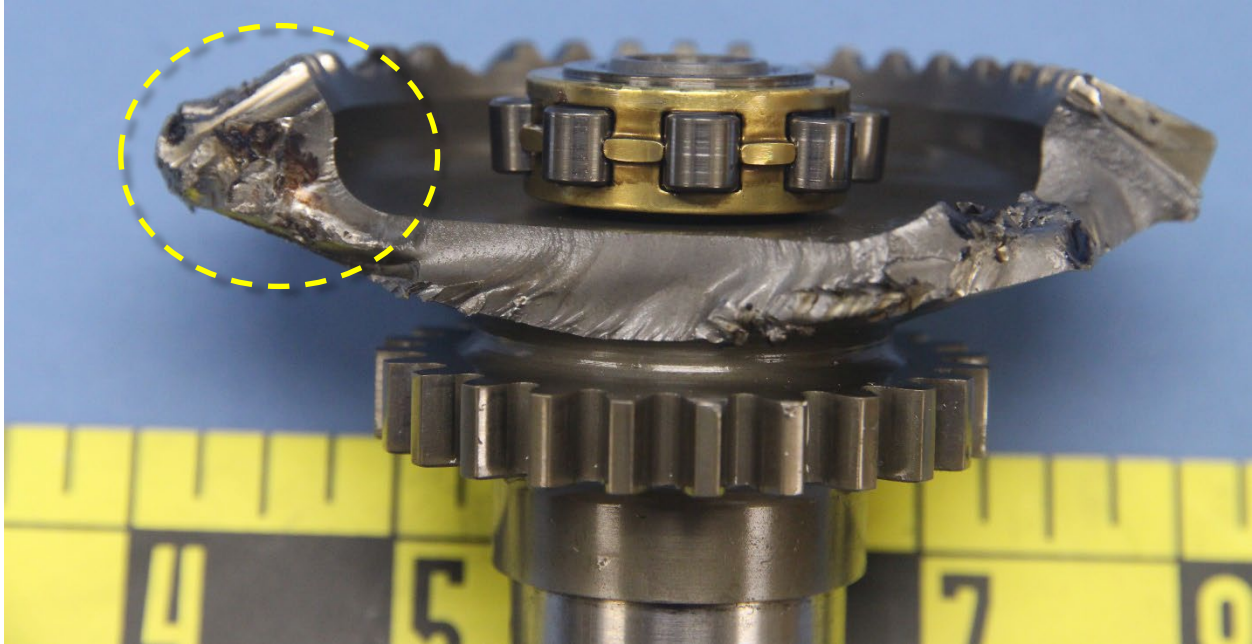
Figure 3 shows a view of the largest fracture surface on the gear. The fracture surface on the gear consisted of several areas with distinct orientations. The initial fracture parallel to the fractured and liberated tooth measured 0.692, with an initiation area for the fracture about 0.327 inches from the outer surface. The larger chord-oriented

fracture portion through the gear measured 1.844 inches long before turning 90°—this section was 1.420 inches long. The remaining 0.668 inches of the fracture exhibited features consistent with ductile overstress fracture. The total length of this fracture surface was 4.62 inches.

Figure 3. Closer view of the inboard mating main fracture surface of the gear. The circled area is highlighted in Figure 4.

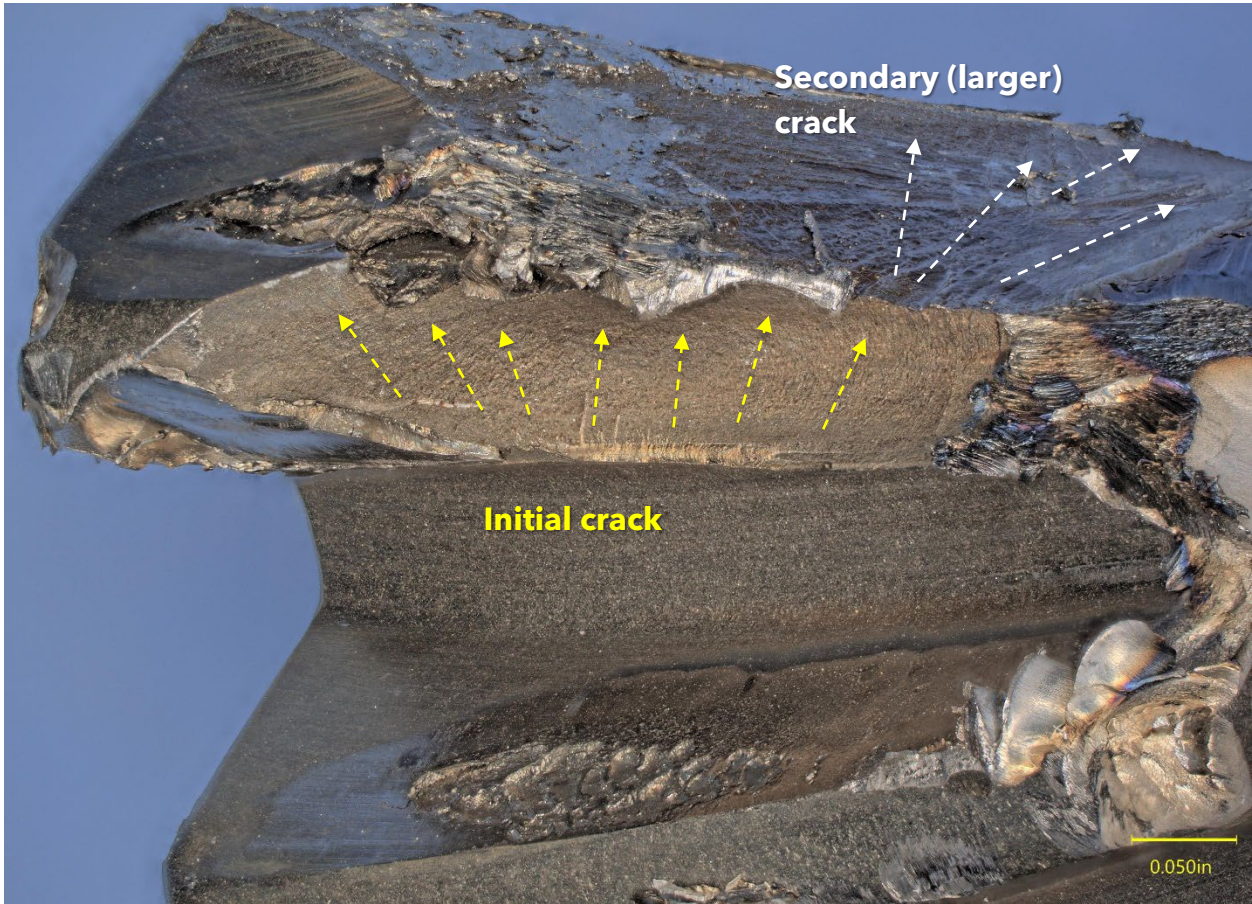
The large crack exhibited crack arrest marks, consistent with crack propagation, later determined to be consistent with fatigue. The large fatigue crack initiated at a smaller fatigue crack, present where a liberated gear tooth remnant had been located. Figure 4 shows the smaller, initial fatigue crack and its initiation region, along with the initiation region of the more prominent secondary fatigue crack.

Figure 4. Rotated view of the area in Figure 3, showing the crack initiation area.

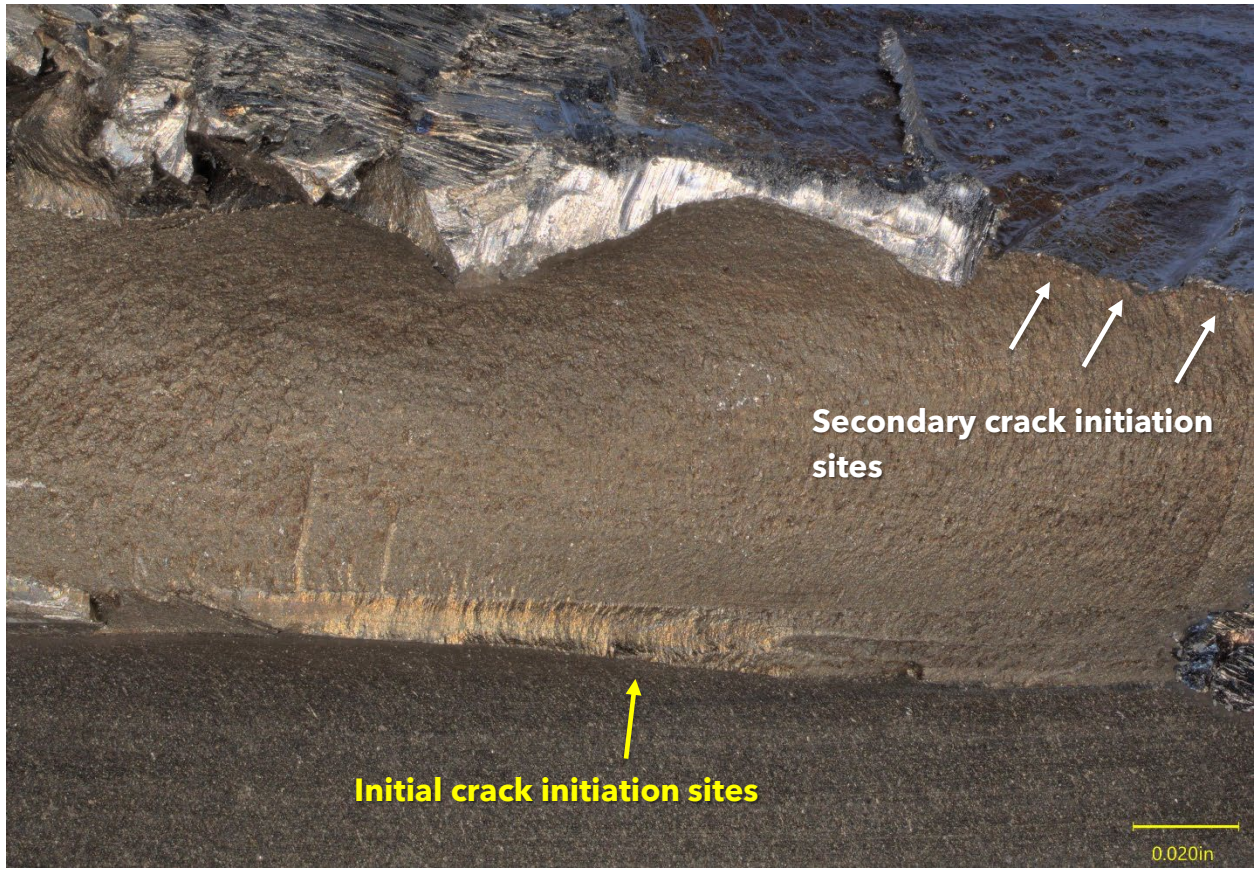
The initiation of the smaller, initial crack was located along the flank of the missing gear tooth, as illustrated in Figure 5. The opposite tooth, which was still part of the gear, exhibited impact, smearing, and wear damage on the face and flank facing the fractured tooth (lower portion of Figure 4). Figure 6 shows that the initial fatigue crack had initiated at multiple sites, present on the edge with the flank.

Figure 5. View of the initiation areas of the initial crack and the secondary crack.

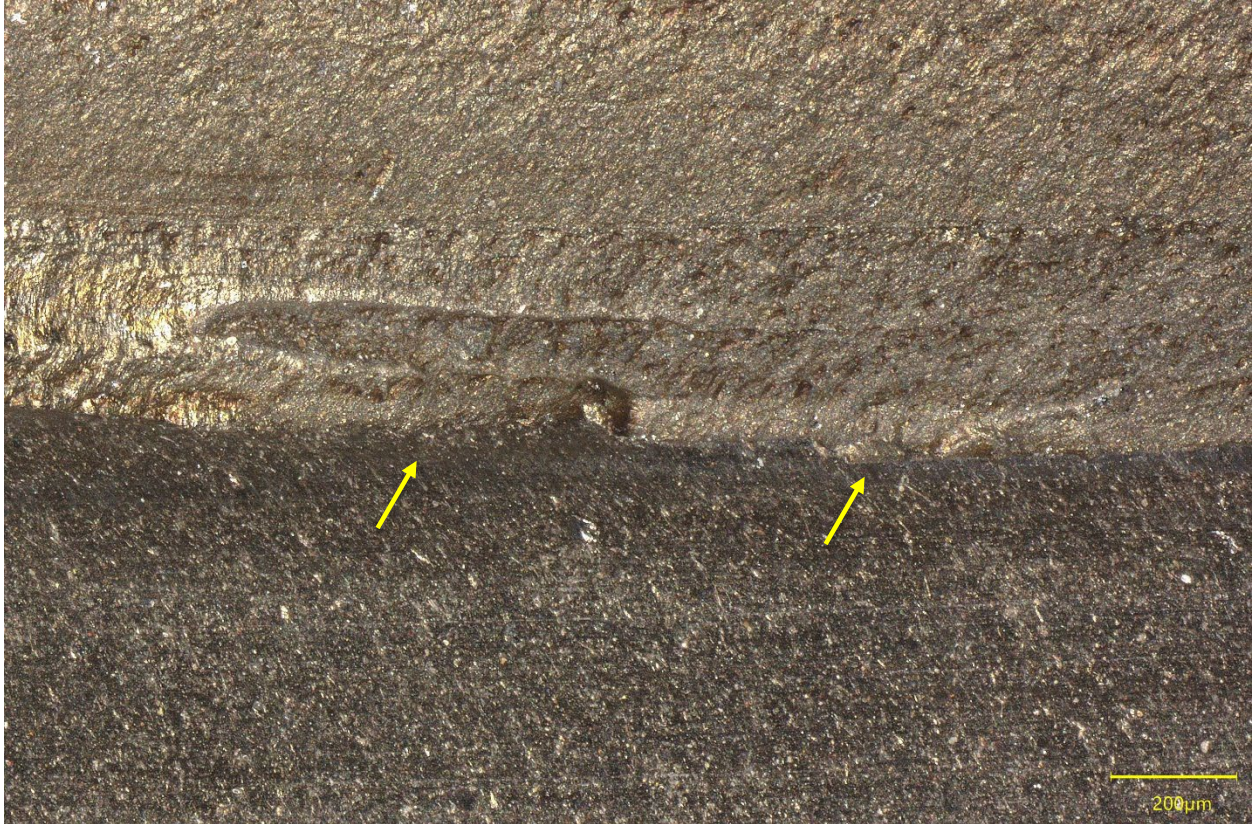
Figure 6. Closer view of the initial crack initiation sites (yellow arrows).

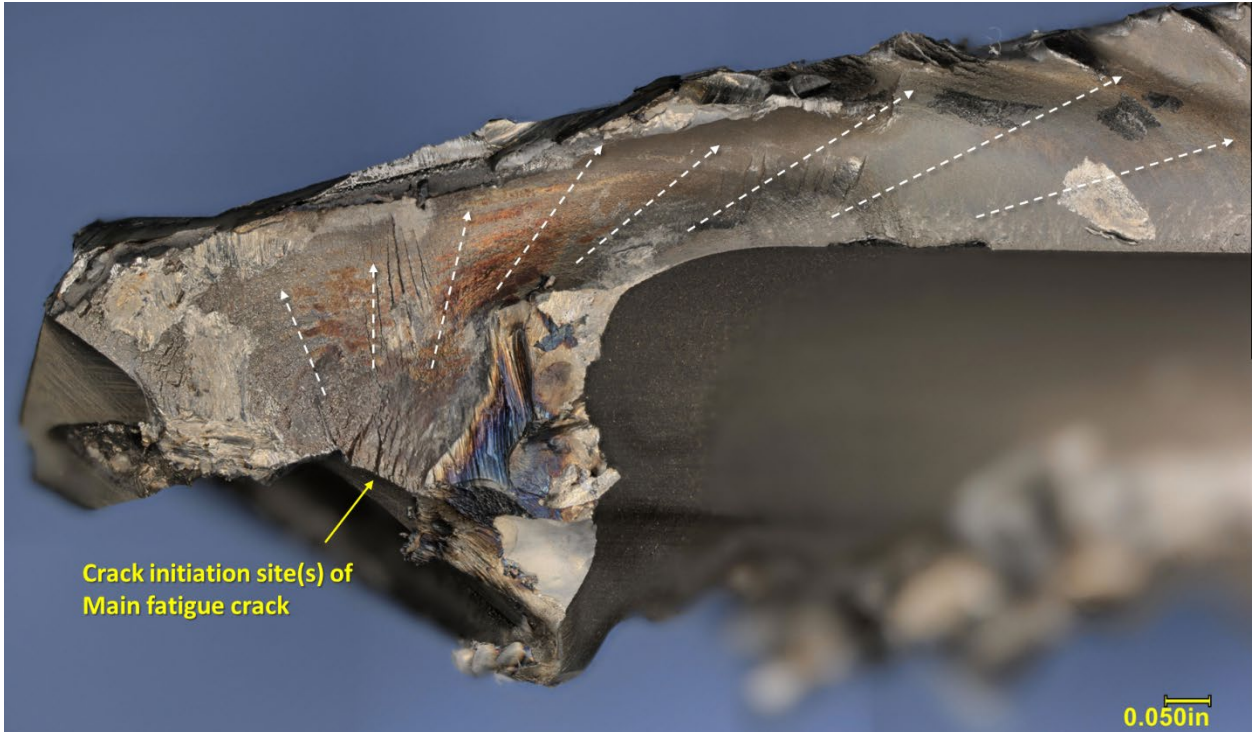
The initial fatigue area of the crack served as an initiation region for the larger fatigue crack. Figure 7 shows this area, annotated to show the crack propagation direction and its multiple initiation sites. Figure 8 shows some of the initiation sites, consistent with the undulating morphology of the initial fatigue crack.

Figure 7. The initiation and initial propagation of the larger secondary crack.

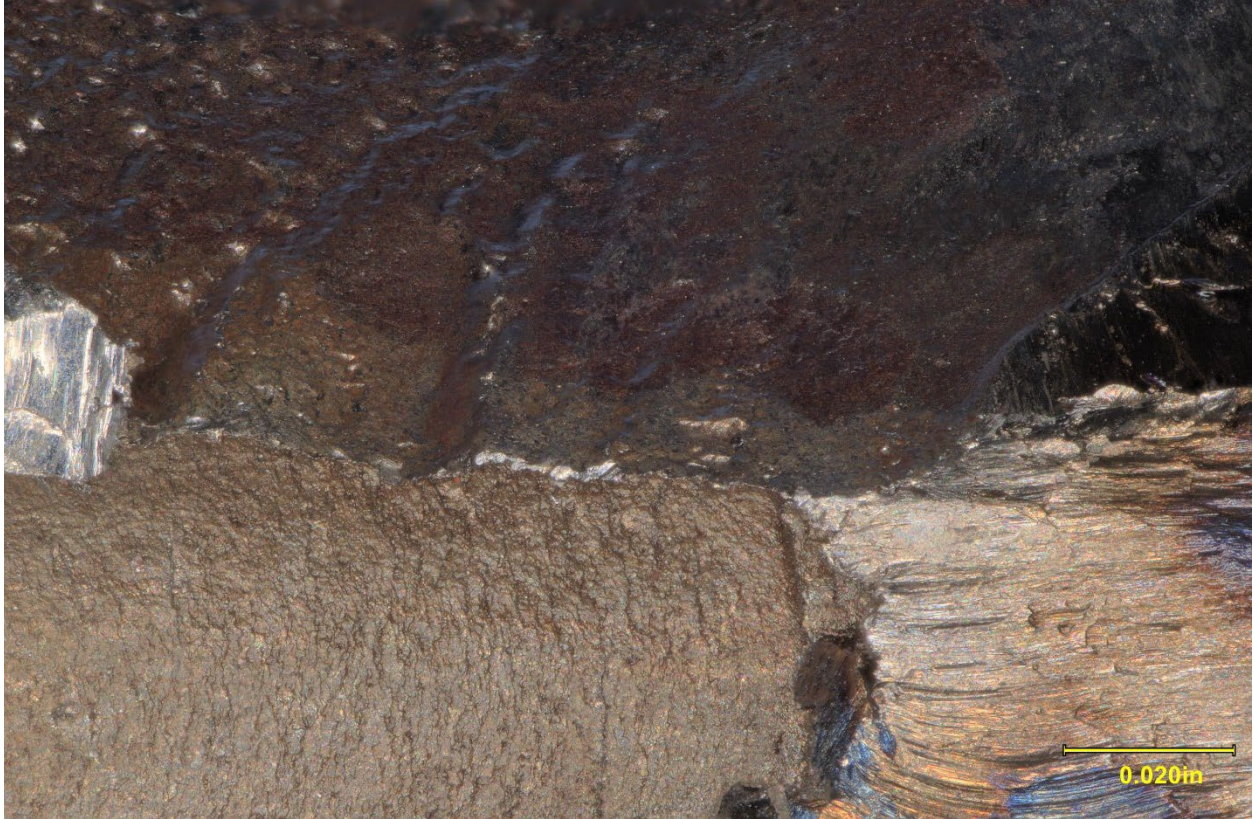
Figure 8. Closer view of the secondary crack initiation sites, originating from the initial fatigue crack.

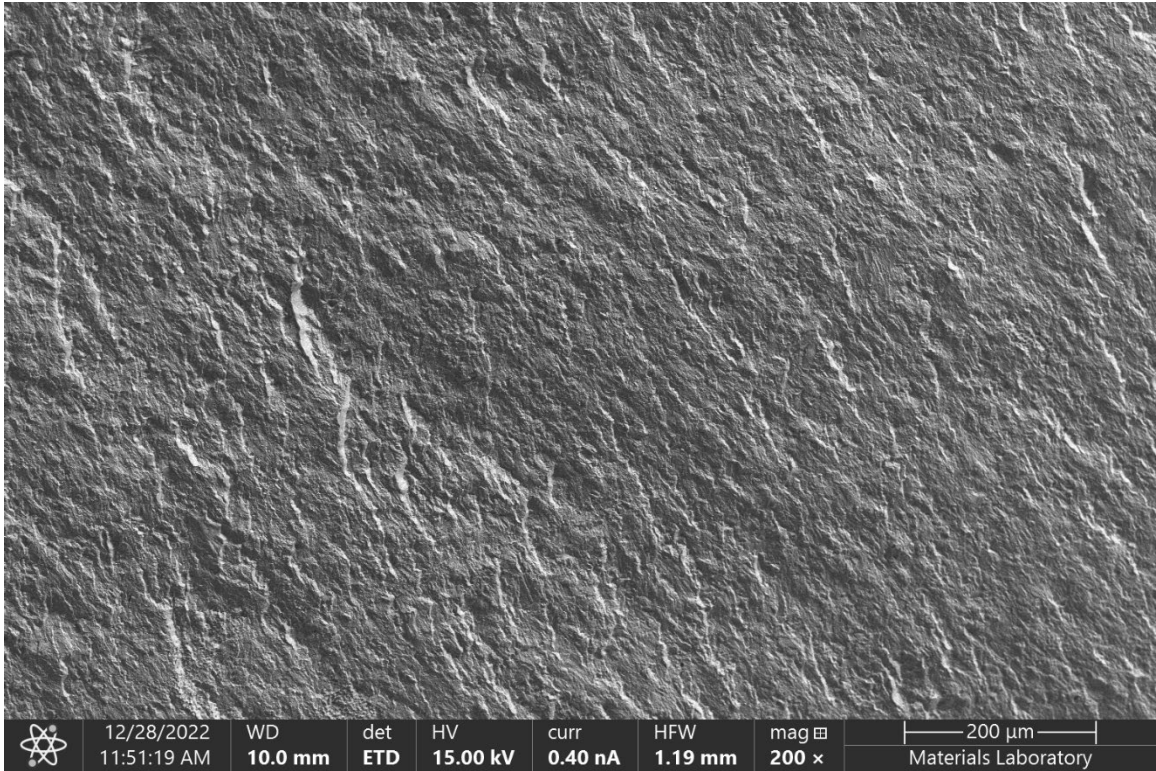
The larger fracture surface from the bevel gear was examined using a field emission scanning electron microscope (SEM). Figure 9 shows a typical area on the larger portion of the fatigue crack. Closer views, illustrated sequentially in Figures 10 and 11, demonstrate the fatigue striations present on the surface. The orientation of the striations was consistent with crack propagation from the fractured tooth inward toward the opposite end of the crack.

Figure 9. Secondary electron (SE) micrograph of a typical area of the larger fatigue crack.

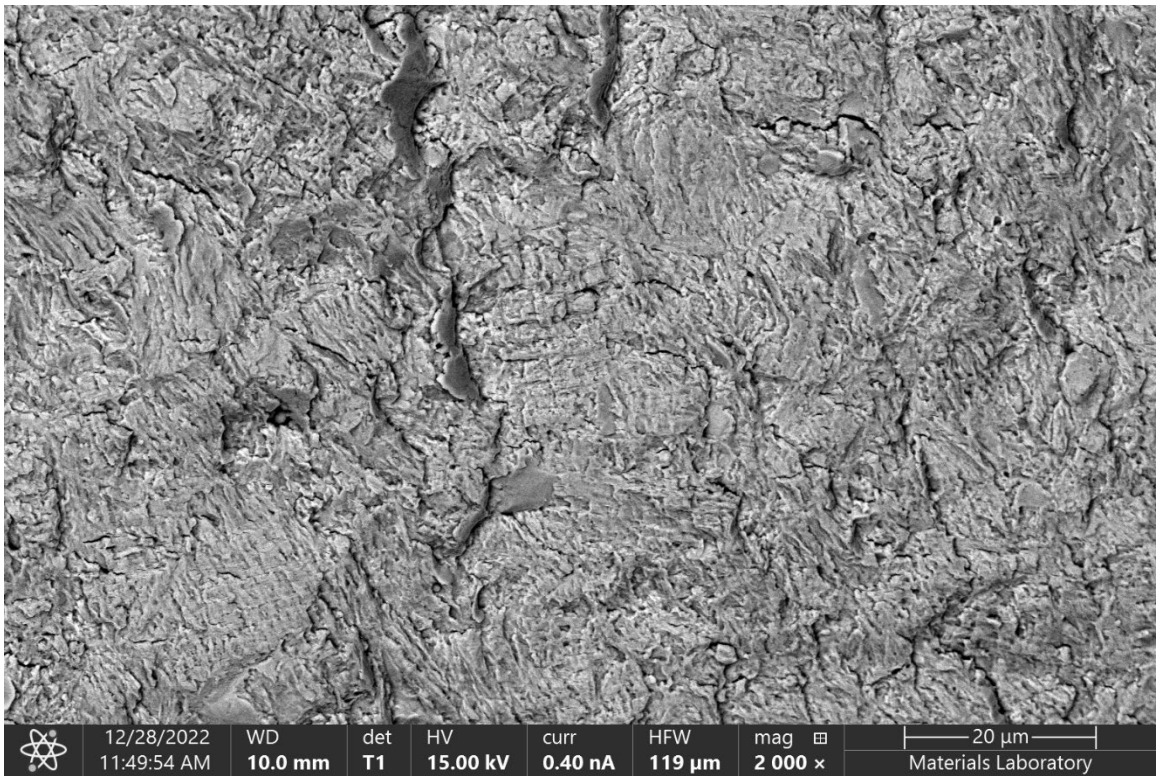
Figure 10. Backscattered electron (BE) micrograph of the center of Figure 9.

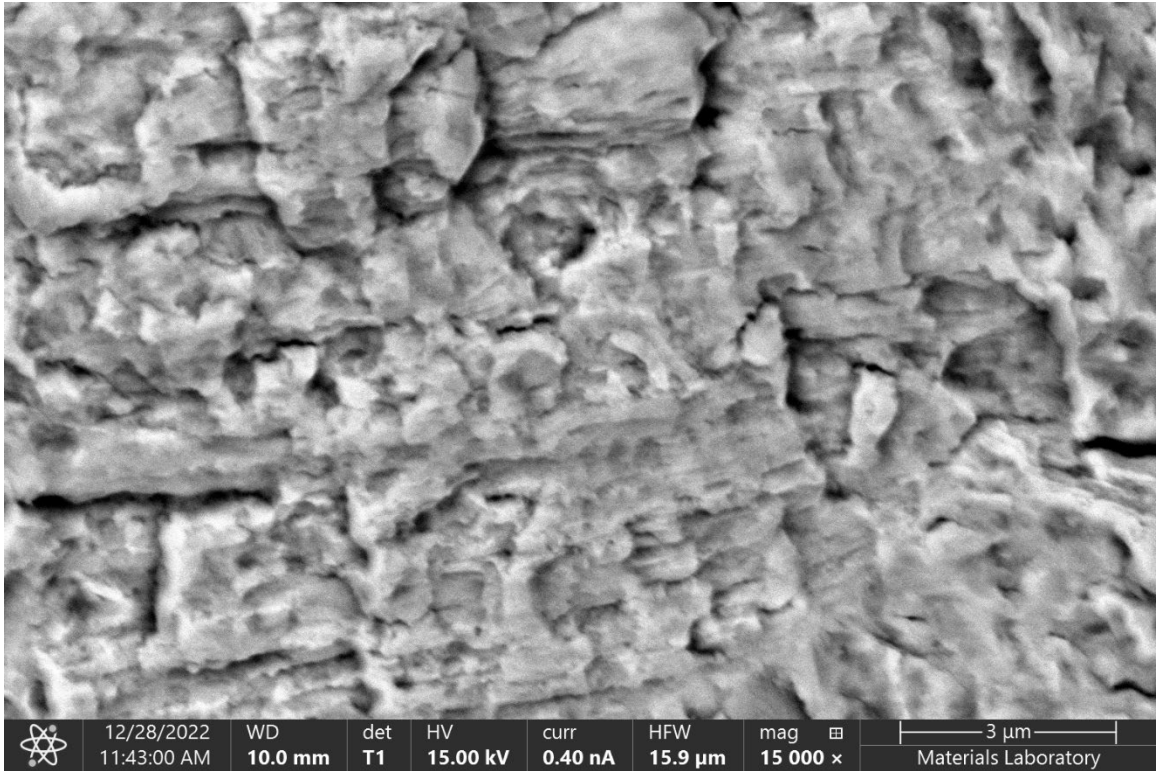
Figure 11. BE micrograph of fatigue striations from Figure 10.

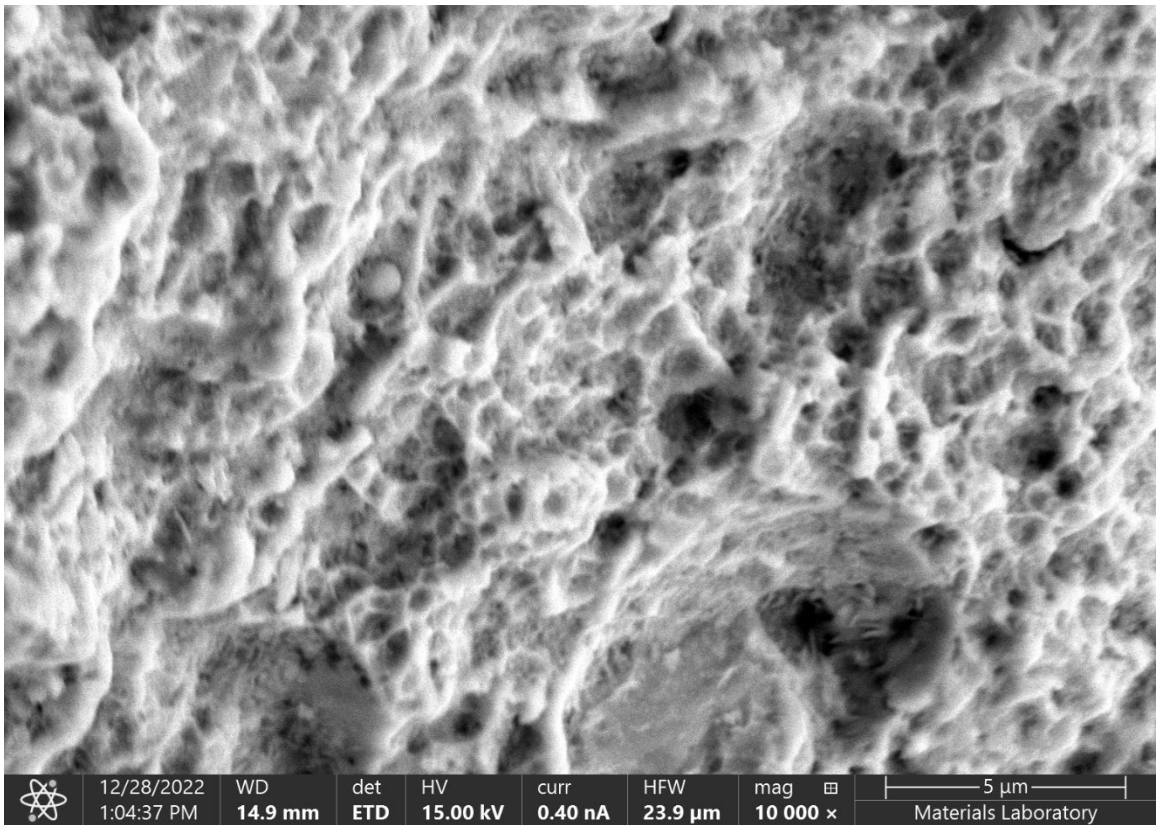
The small area past the fatigue crack (the final 0.067 inches) exhibited dimpled rupture, consistent with subsequent overstress fracture of the remaining gear cross-section. The fatigue crack's length relative to the gear chord cross-section (~86%) was consistent with relatively low stresses on the gear during crack propagation.

Figure 12. SE micrograph of dimpled rupture outside of the large fatigue crack.

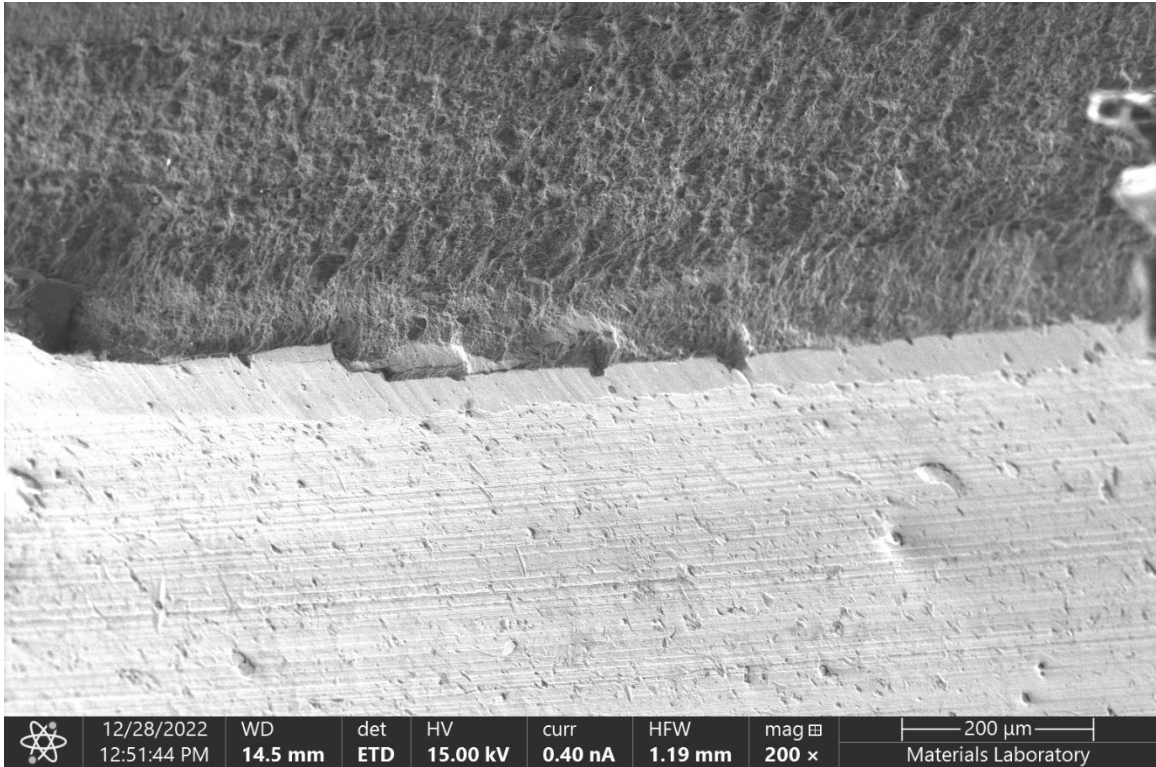
Figure 13 shows a closer view of the initiation sites of the initial crack area at the tooth flank. The edge exhibited smearing damage, indicated by the linear, smooth surface near the edge. There were no indications of corrosion pits or oxide inclusions, but the features present were consistent with wear marks and mechanical damage.

Figure 13. SE micrograph of initiation area of the initial fatigue crack.

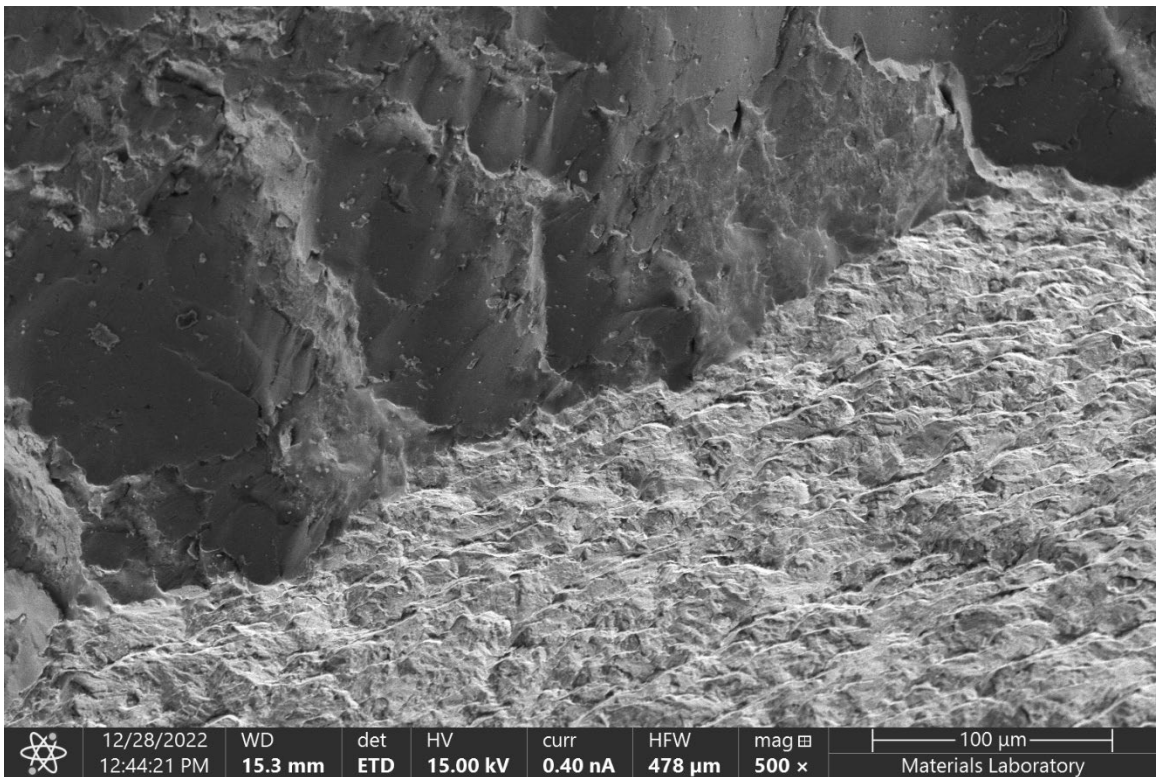
Figure 14 shows the initiation sites of the more prominent secondary fatigue crack. This second set of initiation sites exhibited concentric marks consistent with crack arrest marks oriented inward, consistent with having emanated from the edge (Figure 15). These locations did not reveal material defects such as pits or inclusions. The

features were consistent with geometrical undulations in the lower fatigue crack surface.

Figure 14. SE micrograph of the initiation sites of the secondary fatigue crack from the initial fatigue crack.

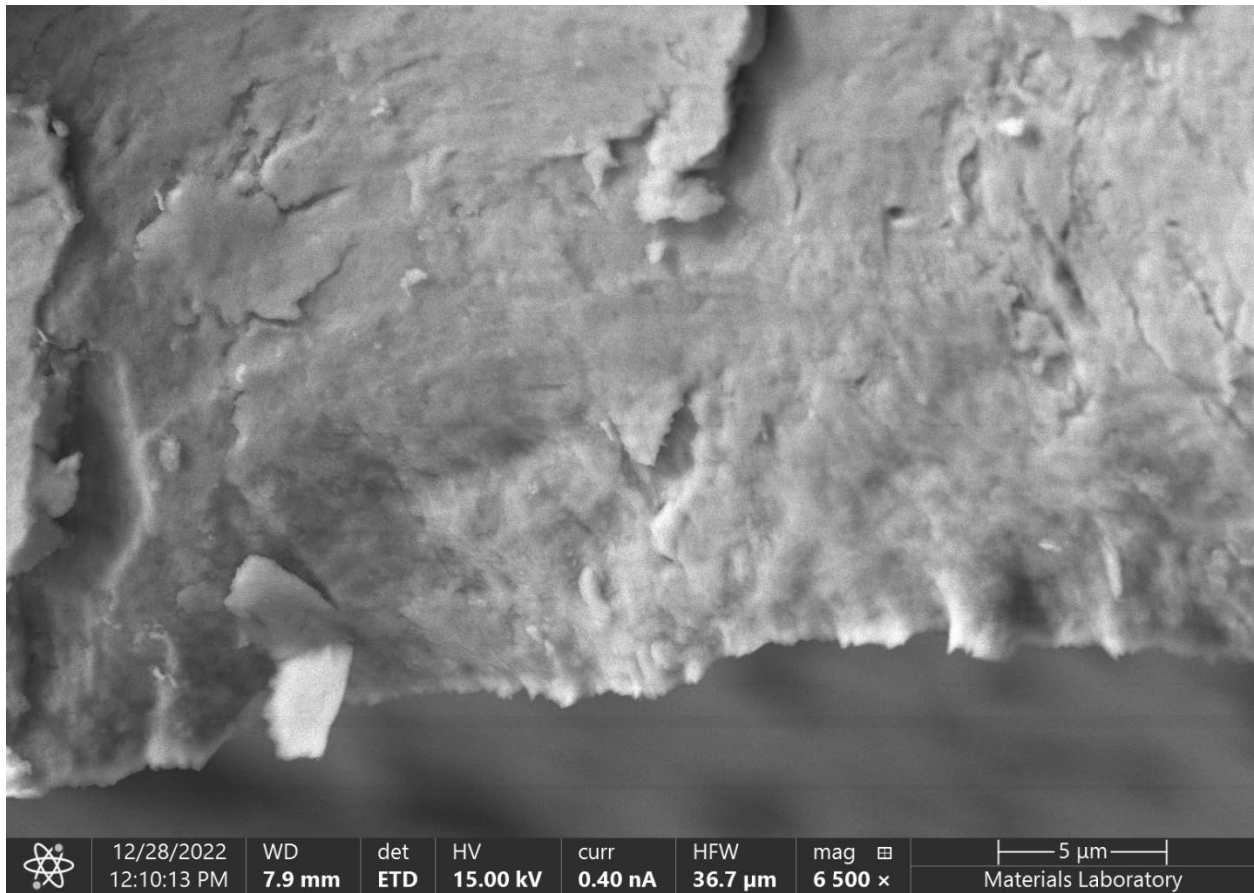
Figure 15. Closer view of the one of the initiation sites in Figure 14, showing striations propagating from the edge.

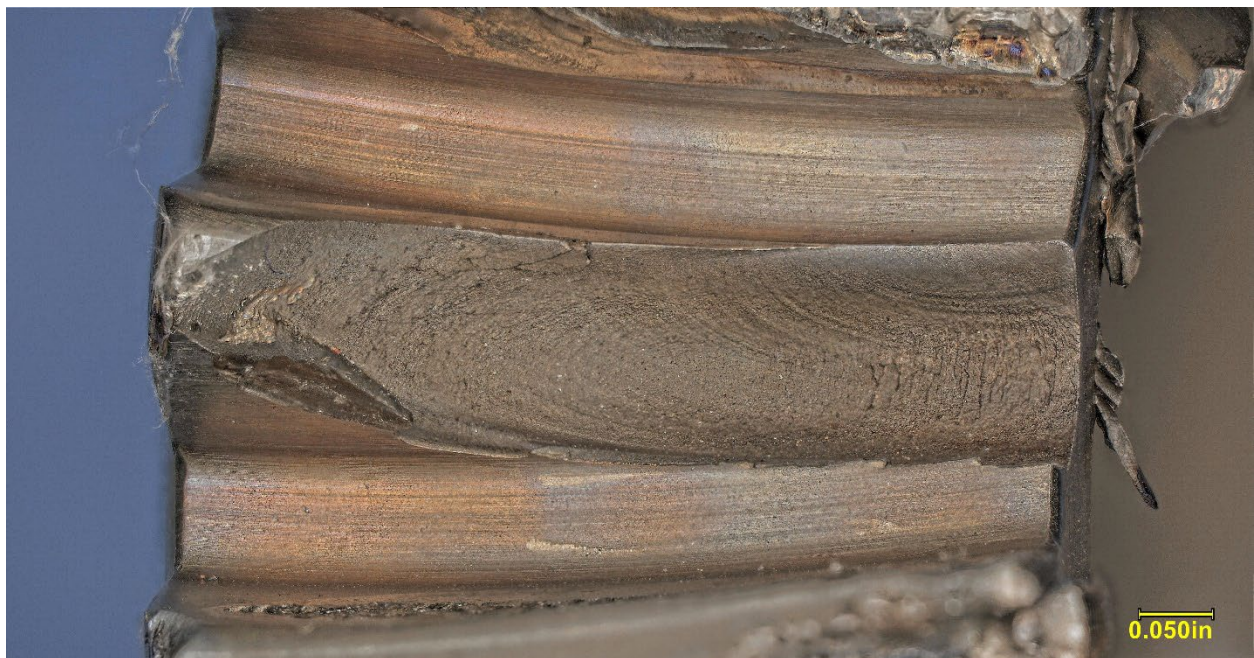
Besides the tooth concurrent with the through fracture of the gear, seven other teeth had liberated from the gear. Figure 16 highlights one of the other fractured teeth, exhibiting crack arrest marks similar to that seen early in the large fracture surface. The crack initiation area is located in the middle right of the figure, along the flank toward the inboard side of the tooth valley. Figure 17 shows a different fractured tooth. This fracture exhibited crack arrest marks like the one in Figure 16, along with a second smaller thumbnail crack. This initiation site was also located on a tooth flank toward the outboard corner of the tooth. This fracture also exhibited a secondary crack parallel to the longitudinal tooth direction and consistent with the orientation of the larger fracture surface fatigue crack.

Figure 16. Another fatigue crack across a missing tooth on the gear.

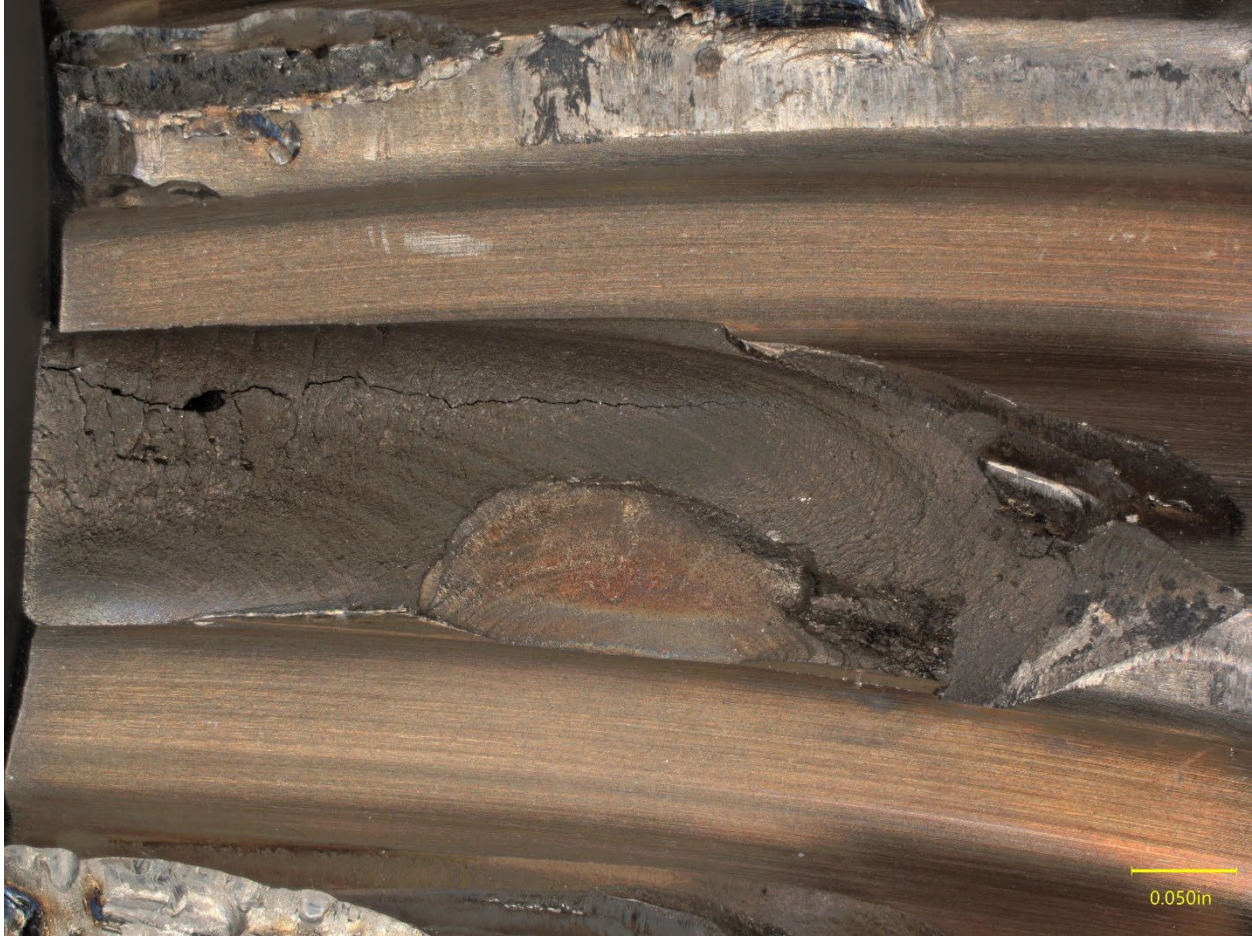
Figure 17. Smaller fatigue cracks across a tooth of the gear, showing secondary cracking normal to the crack facing the reader.

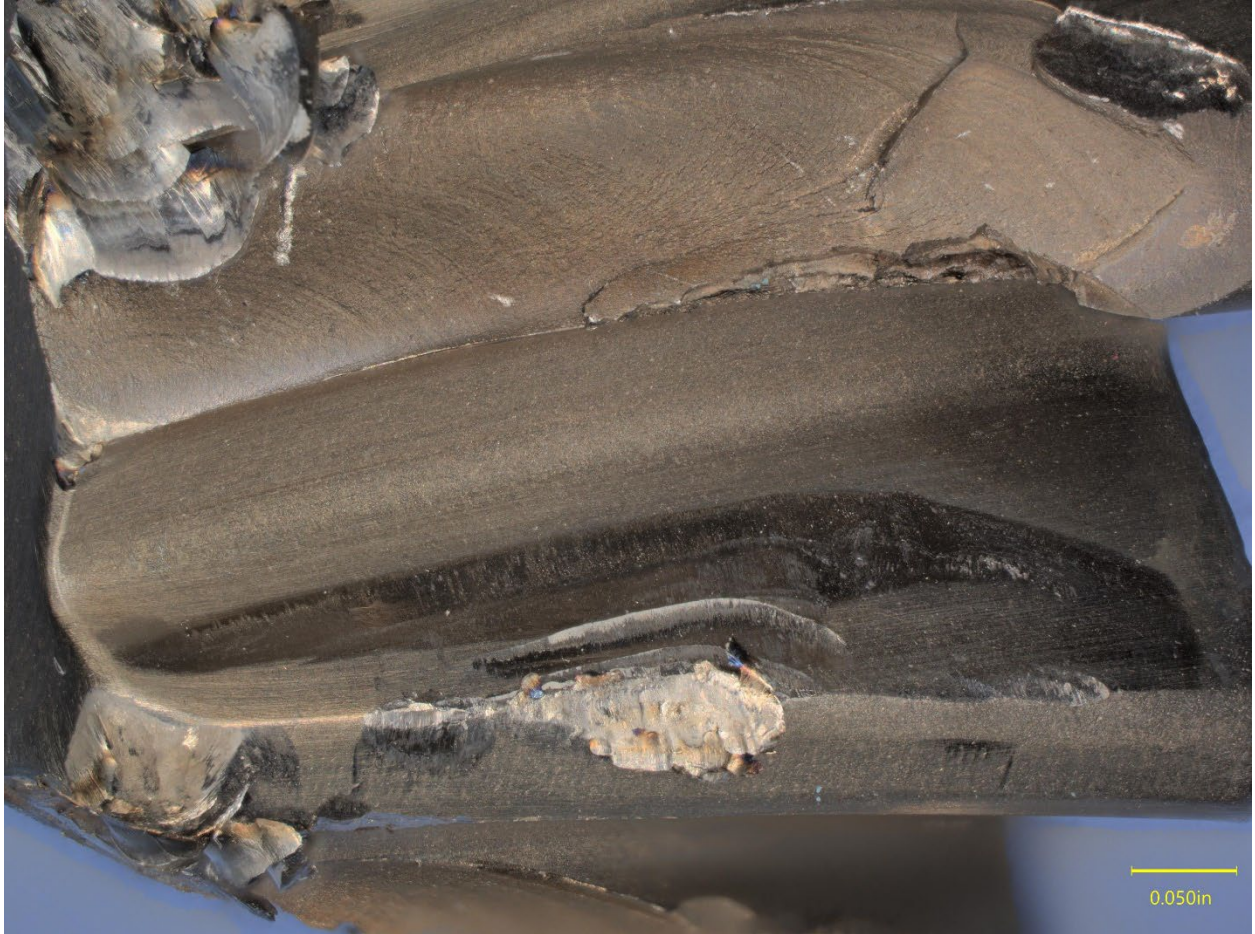
Figure 18 shows the damage to the flank of an adjacent tooth. Oriented longitudinally on the flank, the mark exhibited upward material deformation in the form of smearing. These features were consistent with repeated contact with the mating gear teeth.

Figure 18. View of a fatigue crack at a third missing tooth, showing adjacent damage to a land.

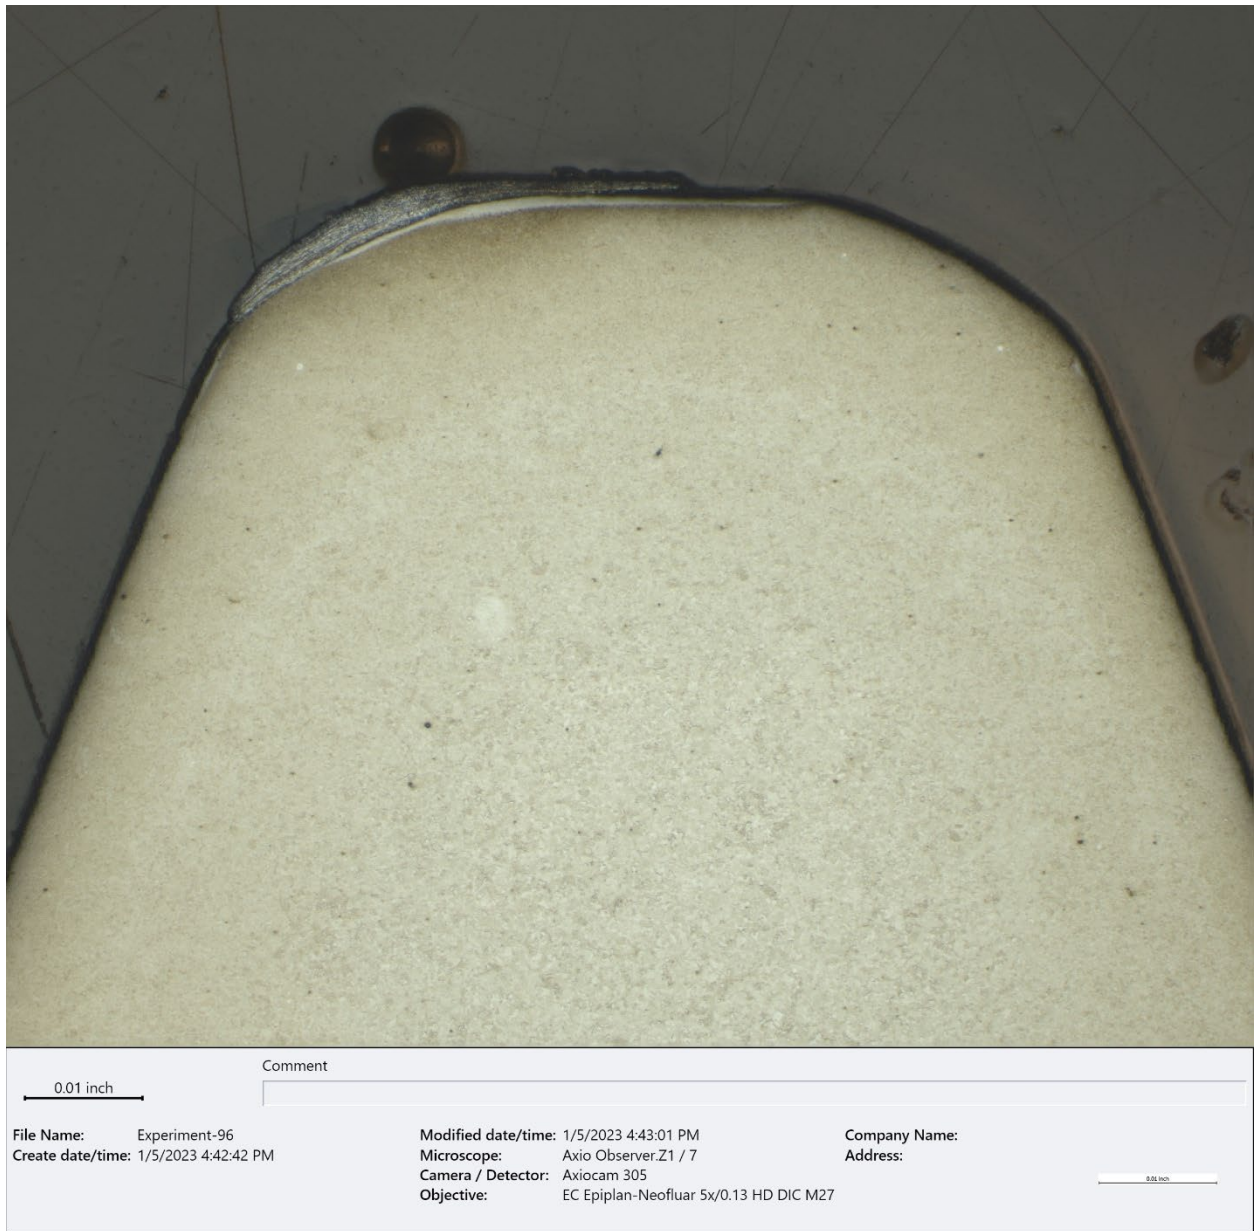
The teeth adjacent to the fracture surface were sectioned, mounted in cold epoxy under vacuum, polished, and etched with a 2% Nital solution. Figure 19 shows a tooth in cross-section, showing a generally uniform microstructure, except for the top land. This region exhibited a white layer, which contrasted with the internal microstructure. The core microstructure of the gear exhibited an acicular morphology consistent with a tempered martensitic structure.

Figure 19. Bright-field (BF) electron micrograph of a cross section of the tooth near the main fatigue fracture (~50X, etched 2% Nital).

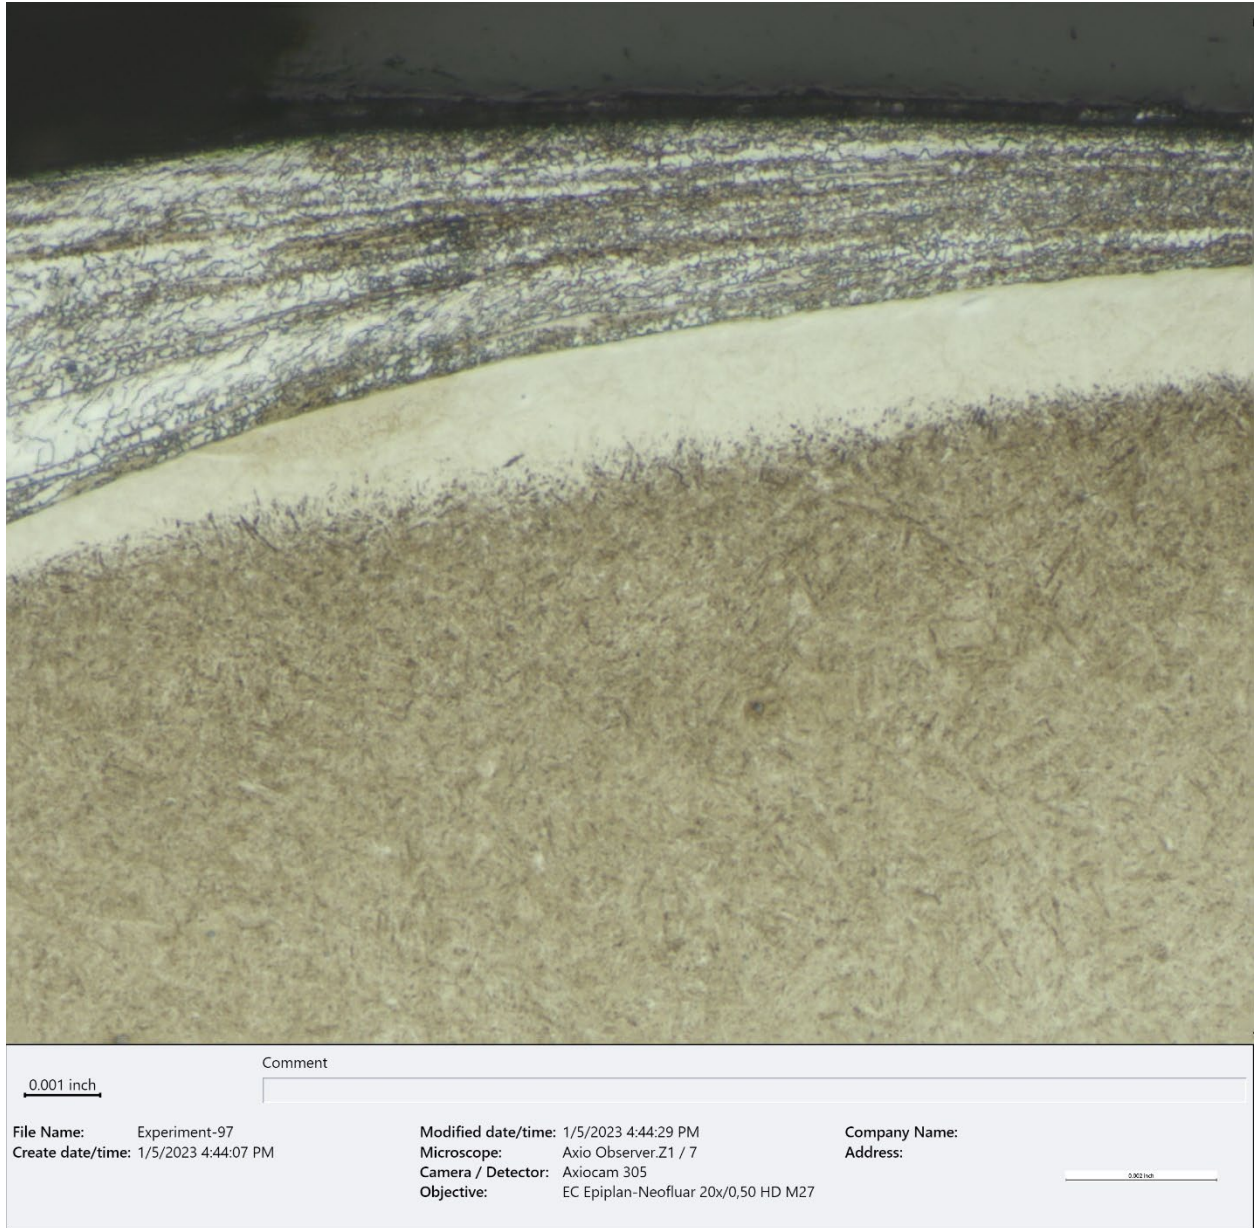
Figure 20 shows a closer view of the top land damage, highlighting material deformation. This area exhibited a white color, indicative of untempered martensite. The top land also displayed material with white contrast and acicular dark features, consistent with untempered plate martensite. These features were typical of material being deposited at elevated temperatures (greater than 1300 °F) and rapidly cooled.

Figure 20. BF micrograph of the damaged top land of the gear thread in Figure 19 (~500X, etched 2% Nital).
