National Transportation Safety Board

CEN22FA317

MATERIALS LABORATORY

Factual Report 23-003

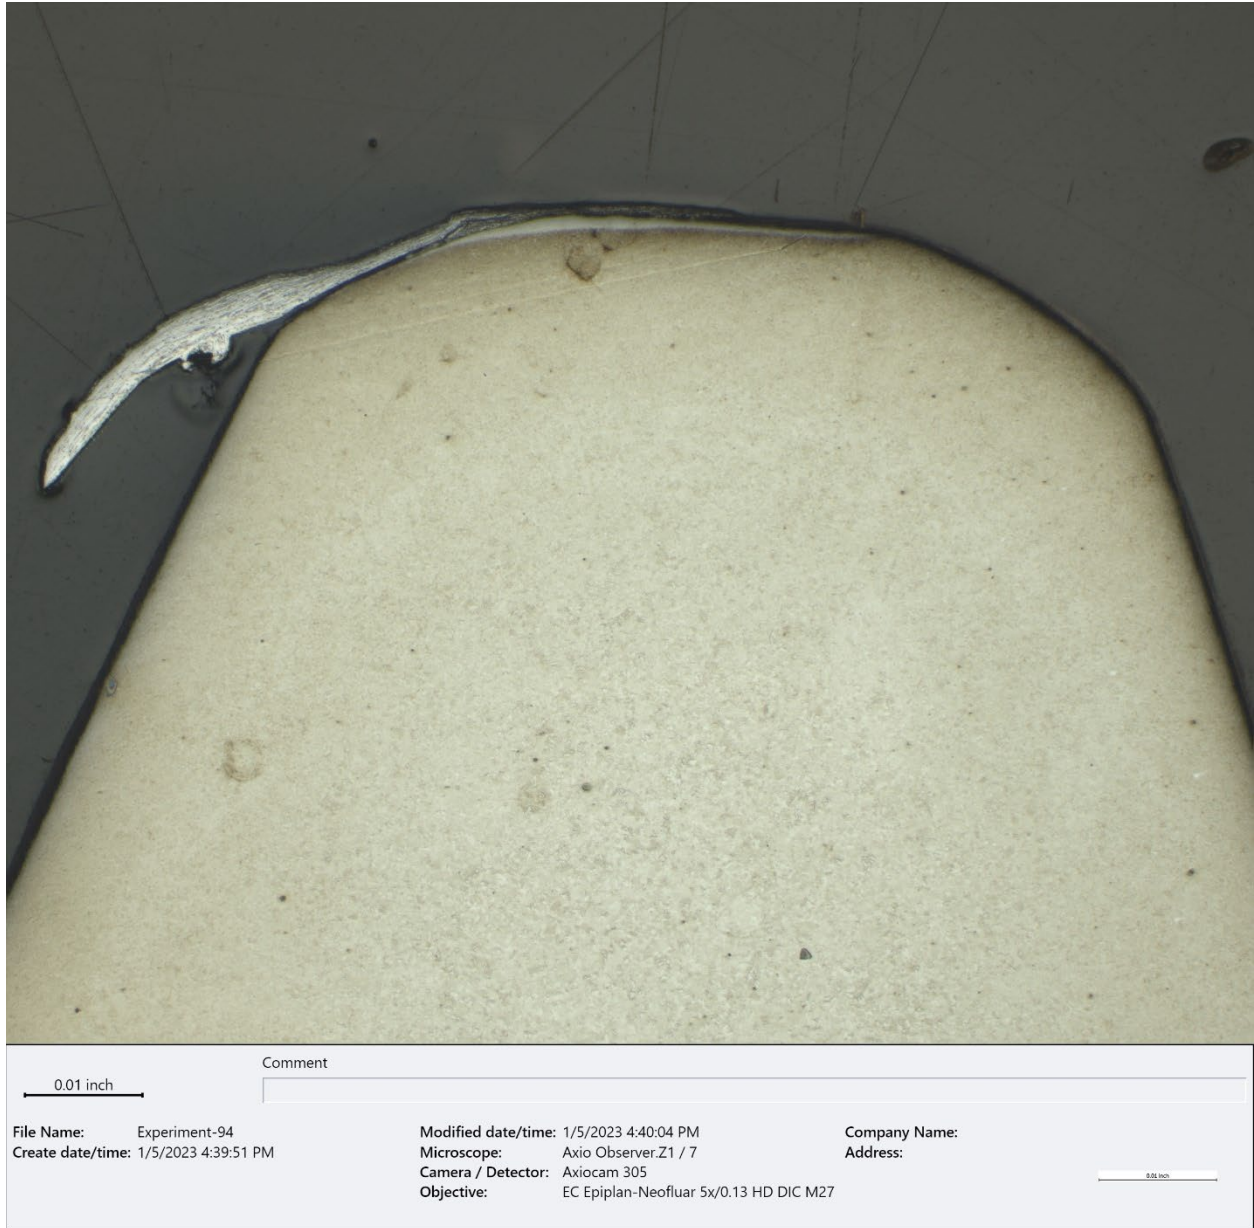
Figure 21 shows an adjacent cross-sectioned tooth, which exhibited similar features but with a more pronounced deformed deposit on the top land. This material had been deformed away from the tooth, consistent with the direction opposite that of rotation. Figure 22 shows a closer view, with the tempered microstructure of the tooth core, a surface layer of white untempered martensite, consistent with elevated temperature exposure and rapid cooling, consistent with localized frictional forces. The deposited surface layer exhibited a microstructure similar to the tooth in Figure 20. However, there was also a longitudinal crack along the length of the deformed deposit.

Figure 21. BF micrograph of a cross section of the tooth next to the one in Figure 19, showing deformed material and damage to the top land (~50X, etched 2% Nital).

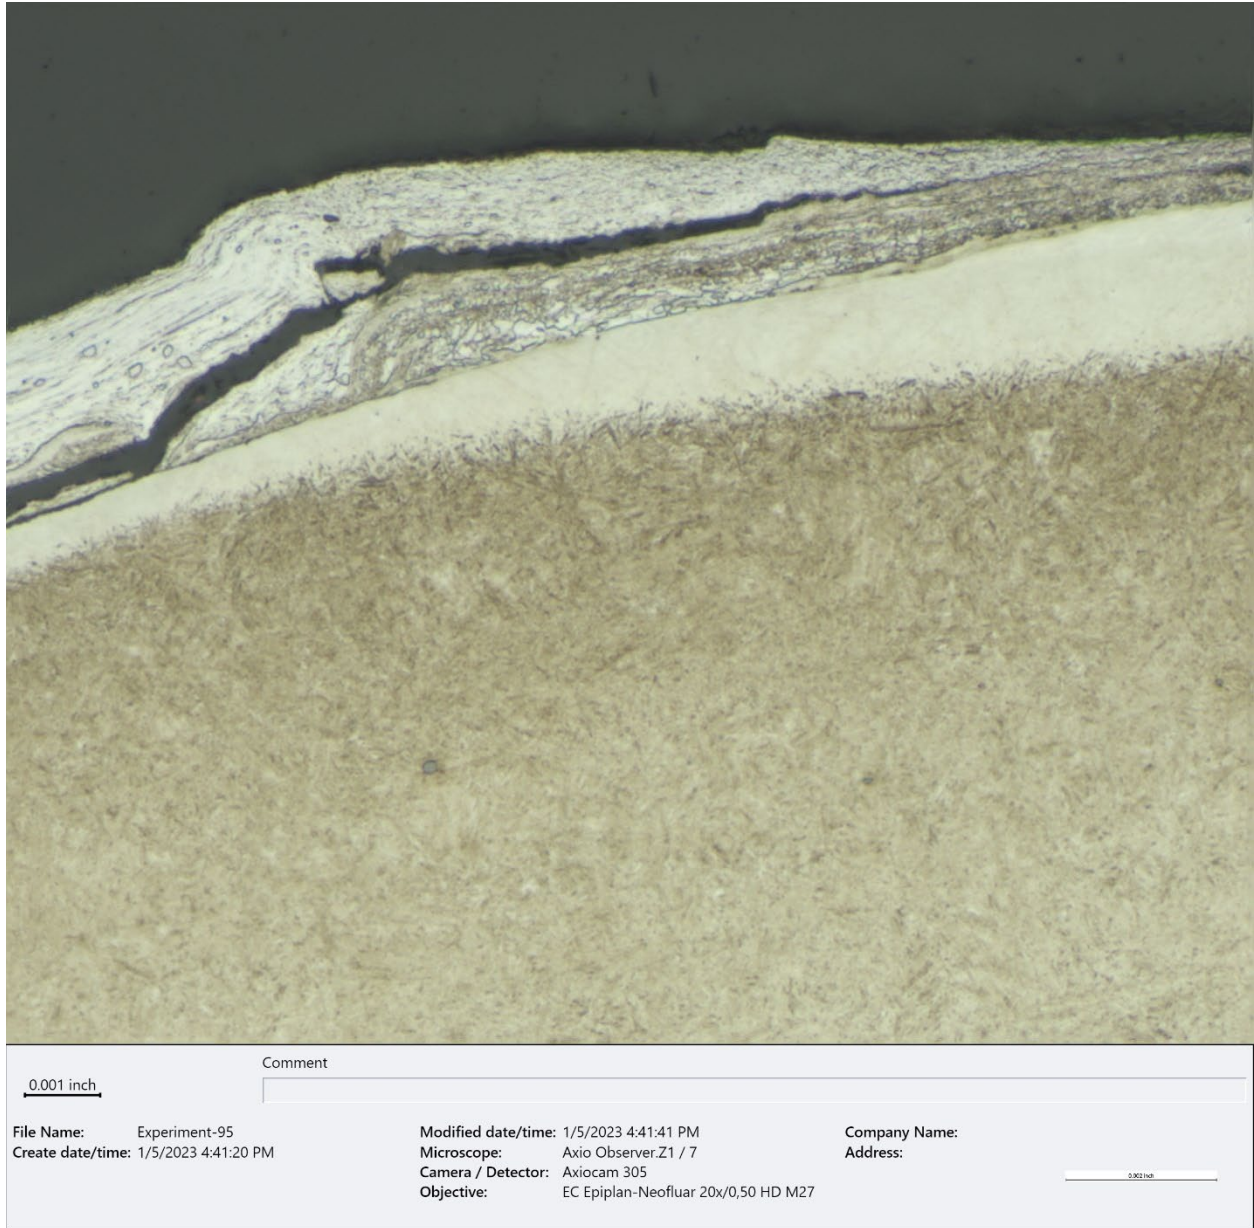
Figure 22. BF micrograph of a closer view of the tip in Figure 21, showing cracking in the deposited material on the top land (~500X, etched 2% Nital).

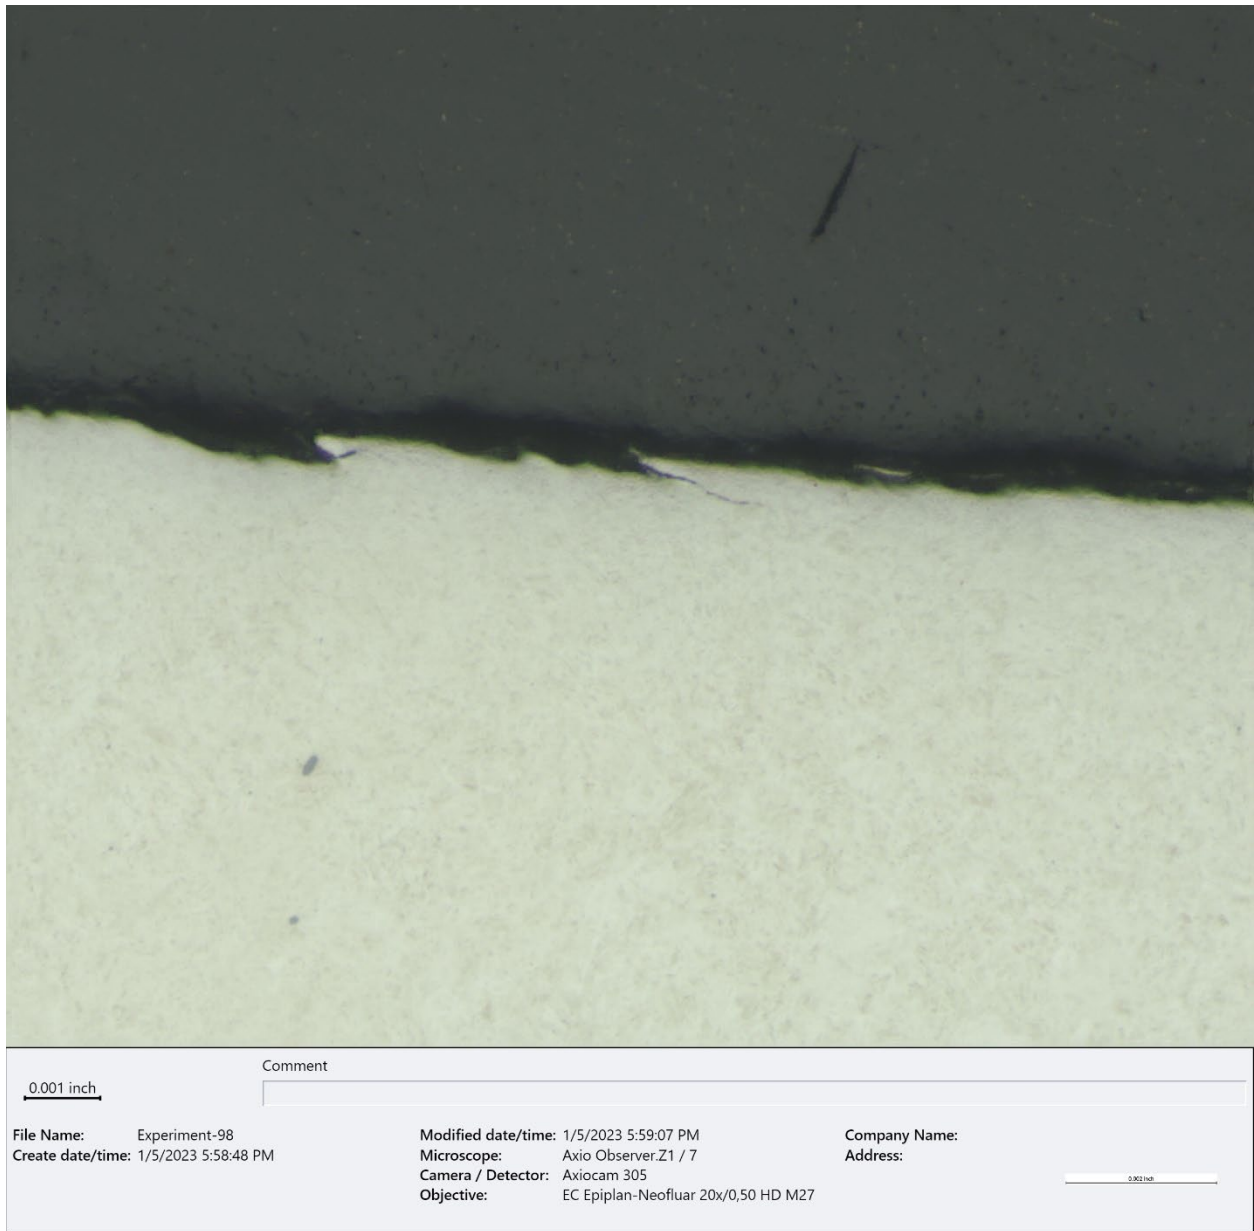
Figure 23 shows a closer view of the flank surface of the tooth cross-section in Figure 19. This flank area did not exhibit any indications of excess high input, showing over

or under-tempering. However, the surface did exhibit minute jagged features, consistent with damage from wearing contact against the faying surfaces of the opposite gear. As shown in the Figure, some of these features had developed into microcracks.

Figure 23. BF micrograph of small cracks from the worn and damaged areas of the flank, shown in Figure 4.

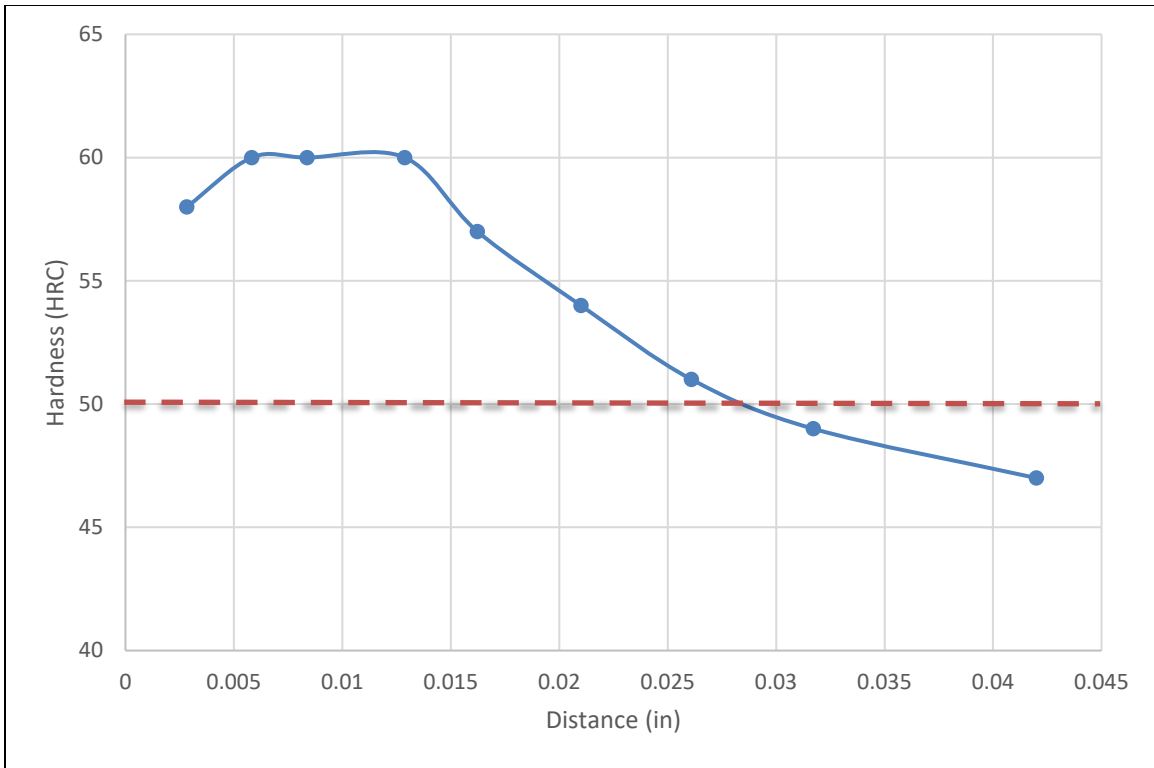
The tooth near the largest fatigue fracture was examined using microindentation hardness per ASTM E384.³ The data were plotted in HRC (converted from HK₅₀₀) versus the depth from the surface, as illustrated in Figure 24.⁴ The amount of data above 50 HRC near the surface was consistent with a case hardening surface treatment. Interpolating the data found the case depth to be consistent with 0.029 inches (0.73 mm) below the surface. This depth was consistent with the drawing requirement to carburizing surfaces to an effective case depth of 0.025 ± 0.005 inches.

Figure 24. Chart plotting microindentation hardness data (in HRC converted from HK_{500}) versus the depth from the tooth surface. The dashed orange line represents 50 HRC, or the typical effective case depth hardness.
