# National Transportation Safety Board

ERA22FA279

## **MATERIALS LABORATORY**

Factual Report 23-005

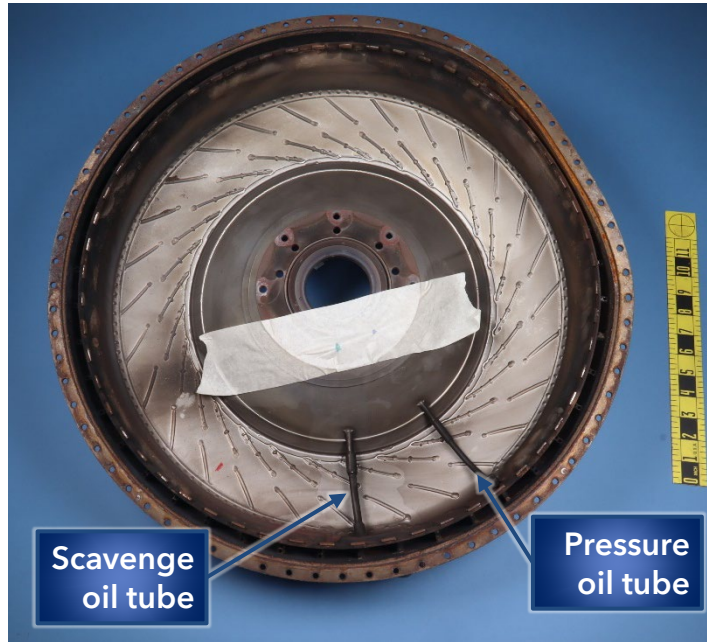
As described in the engine teardown notes, no obstructions were detected in the number 2 bearing oil pressure (supply) tube in the air diffuser housing (see figure 1). However, an obstruction was detected in the oil scavenge tube. Starting at the inlet for the oil scavenge tube, a cannula cleaning brush was inserted approximately 3.1 inches until it met resistance. This location corresponded to a change in tube diameter on the forward side of the air diffuser housing cavity. An abrasive cutting tool was used to cut the tube on inlet side of the diameter change, and the cannula cleaner was inserted at the cut location with no resistance felt for approximately 3.75 inches, a location corresponding to another change in tube diameter. An abrasive cutting tool was used to cut out a section of the scavenge tube on the aft side of the diffuser shown in figure 1, and the tube appeared to be partially obstructed. The cannula cleaning brush was used to push out material in the tube into a sample dish, and the resulting deposit is shown in figure 10. On the outer diameter of the air diffuser housing, an abrasive cutting tool was used to cut an opening near the oil scavenge outlet fitting, and no additional obstructions were observed.

**Figure 1.** Air diffuser housing as received.

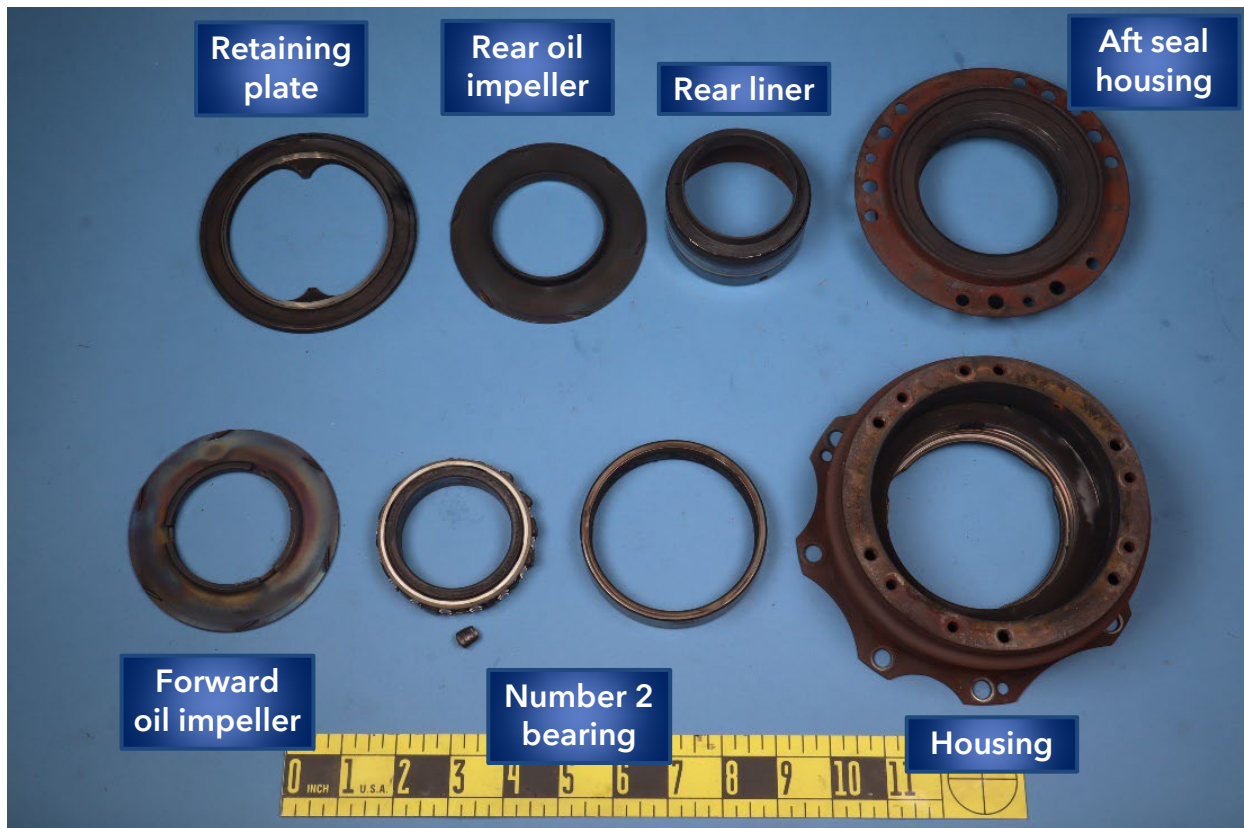
The number 2 bearing was received with the outer race and one of the rolling elements separated from the rest of the bearing as shown in figure 2. A closer view of the rolling elements is shown in figure 8. The bearing cage and inner race were intact, and the inner race was darkened with heat tinting. The rolling elements were also heat damaged and flattened on one side consistent with skidding. The outer race, shown in figure 9, was also intact. The raceway had metal deposits on the surface that protruded from the original surface consistent with metal transfer from

**Figure 2.** Number 2 bearing and associated components as received.

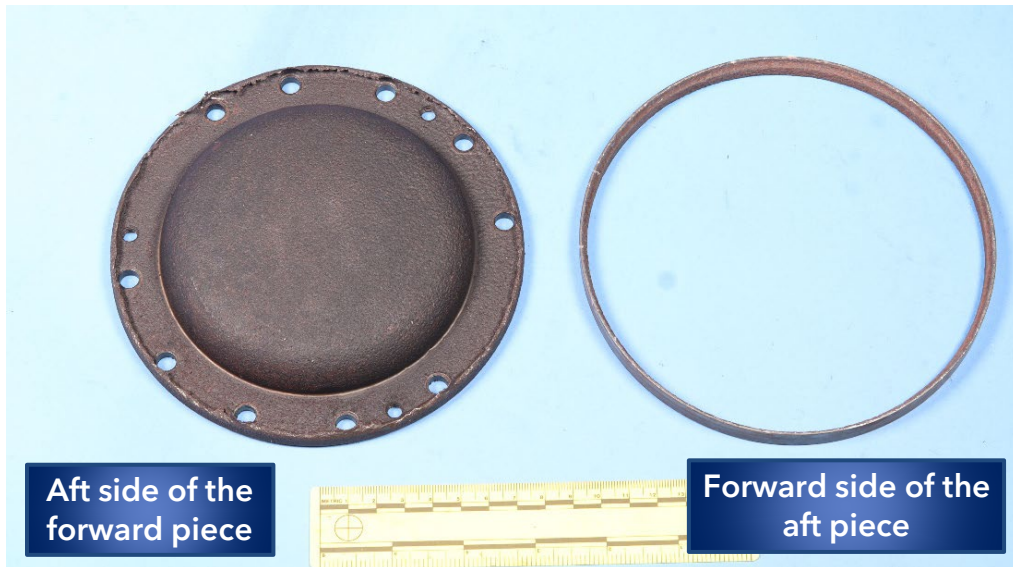
The number 3 and 4 bearing retaining cover was recovered in two pieces as shown in figure 3. During the engine teardown, the forward side of the retaining

cover was found secured to the aft end of the exhaust diffuser, and the aft flange piece of the retaining cover was found loose. When compared to an exemplar bearing retaining cover, approximately ½ inch of the outer diameter flange material was missing between the recovered pieces shown in figure 3.

**Figure 3.** Rear bearing cover as received.

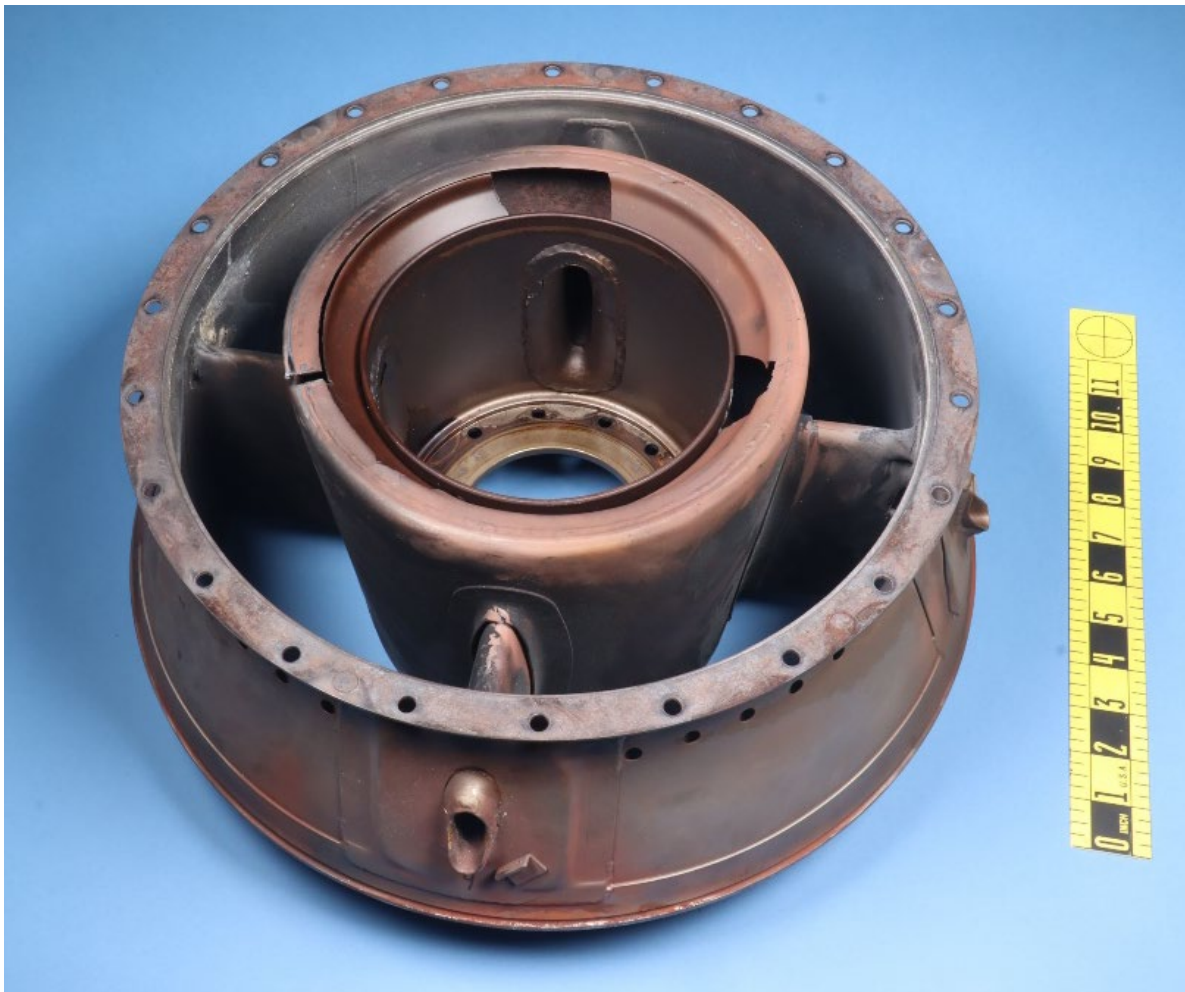
Views of the forward side of the exhaust diffuser are shown in figures 4 and 19, and a cutaway diagram labeling components of the diffuser is shown in figure 20. As shown in the diagram, the exhaust diffuser consisted of an outer cone and a mid cone that were attached at the forward outer flange and an inner cone that was attached to the forward end of the bearing housing support. The outer cone was connected to the bearing housing by four inner struts, and the inner struts were surrounded by an outer strut that was attached to the mid cone and could slide radially within the outer strut fairing on the inner cone.

**Figure 4.** Exhaust diffuser as received.

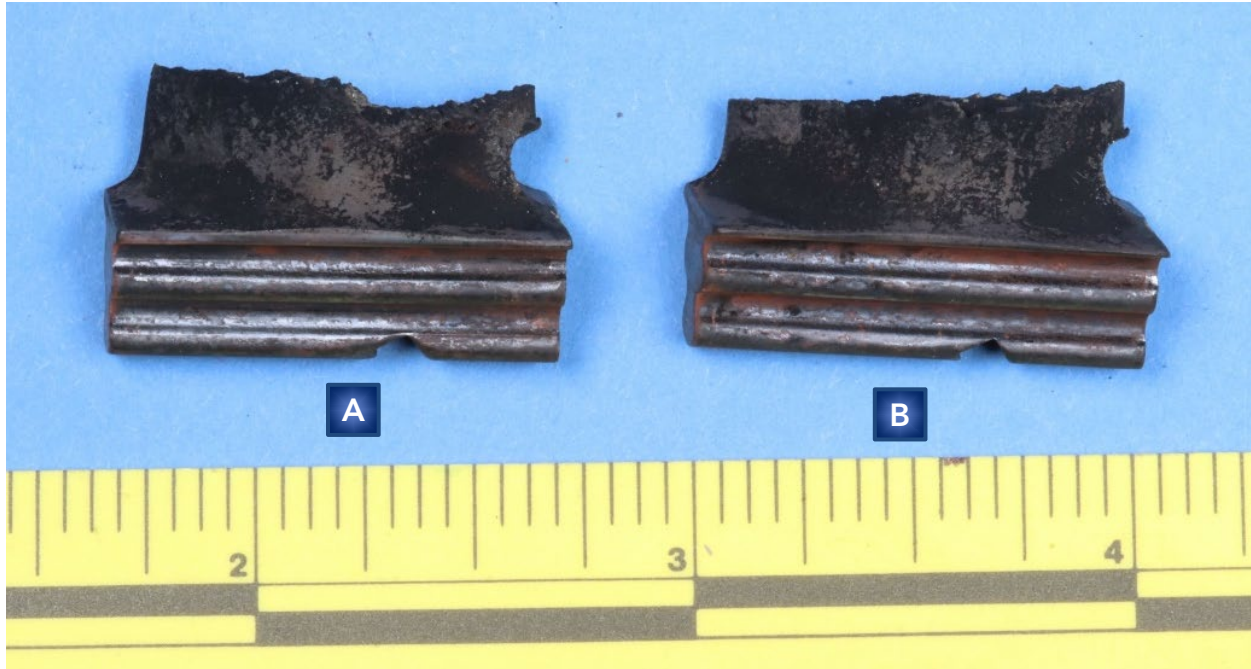
As shown in figure 5, the PT blades were received covered with black sooty deposits. For purposes of this report, the blade fragments were arbitrarily labeled A

and B for reference as shown in figure 5. Blades A and B were fractured approximately 0.24 inch and 0.19 inch from the root platform, respectively, and both blades had a similar groove in the leading edge between the platform and the fracture surface consistent with post-fracture circumferential rub damage.

**Figure 5.** PT blade root fragments as received.

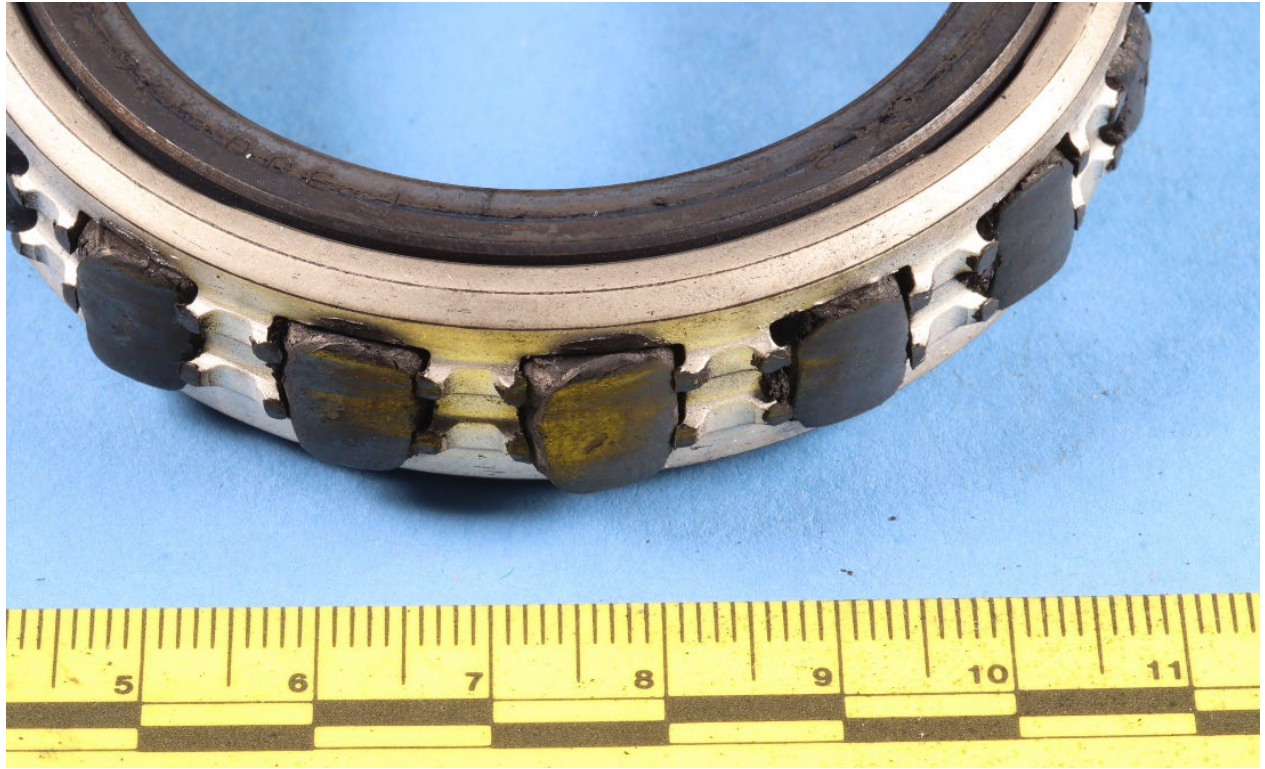
**Figure 8.** Number 2 bearing inner race, cage, and rolling elements (metric side of ruler shown).

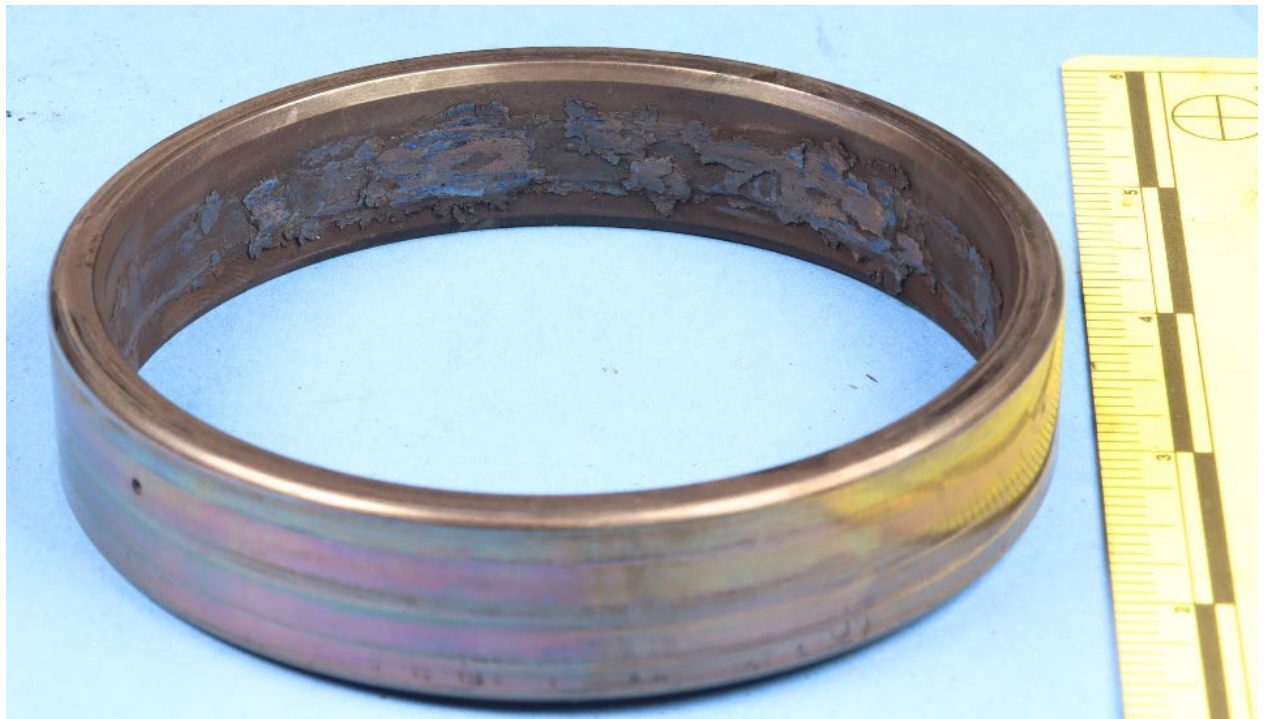
the rolling elements. The outer race was slightly heat tinted, but no evidence of pits or spalling damage was observed.

**Figure 9.** Number 2 bearing outer race.

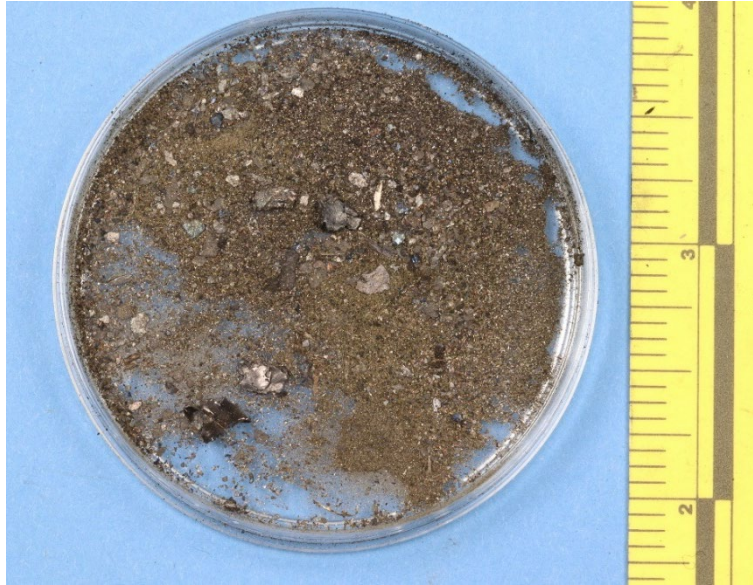
Several of the larger pieces of debris collected from the oil scavenge tube shown in figure 10 were mounted on a stub for analysis using energy dispersive x-ray spectroscopy (EDS). A typical EDS spectrum for the debris is shown in figure 11, where peaks consistent with a low alloy steel were observed. The separated rolling element from the number 2 bearing was also analyzed using EDS, and the resulting spectrum is also shown in figure 11. Both spectra had similar detected elements and relative peak heights.

**Figure 10.** Debris removed from the air diffuser scavenge oil tube after cutting using an abrasive cutting tool.

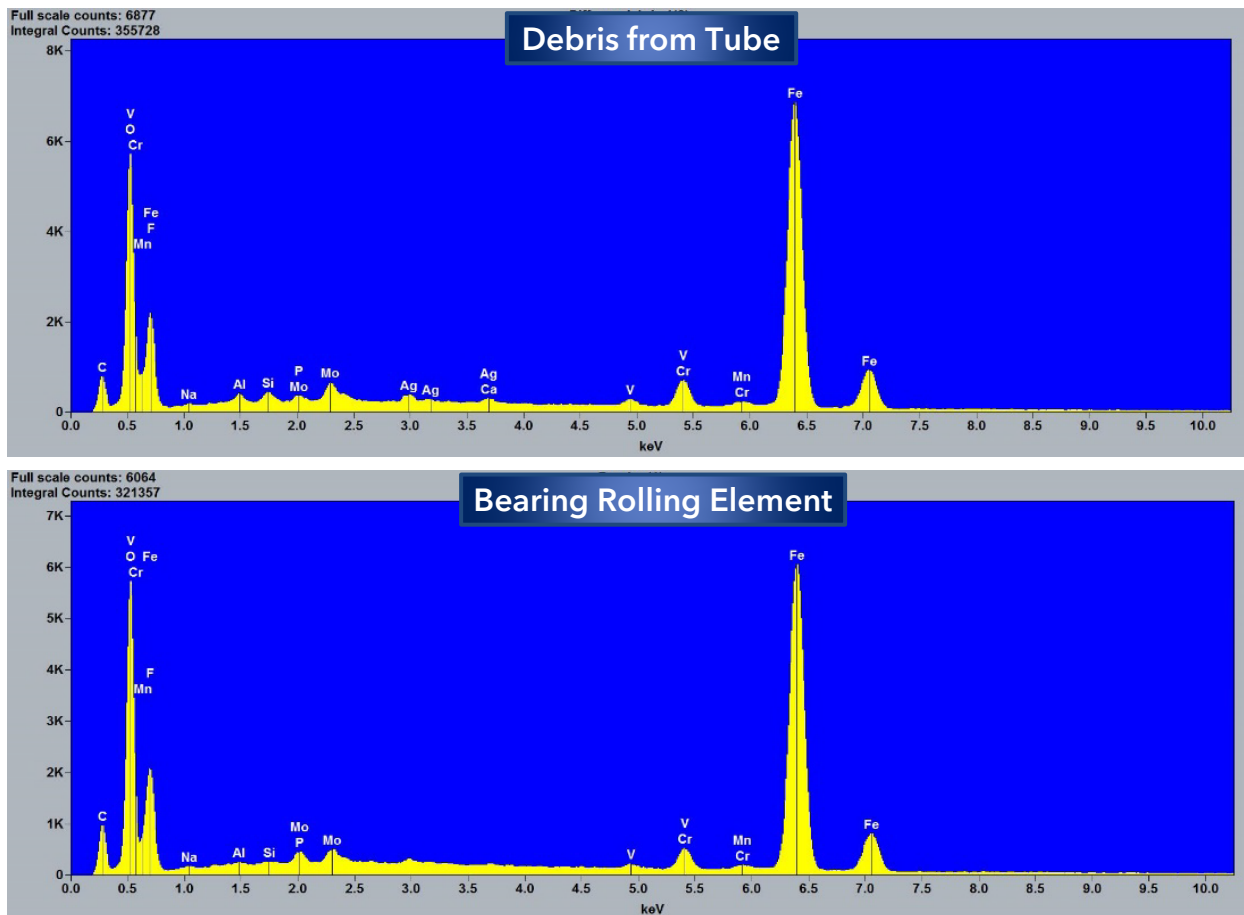
**Figure 11.** EDS spectrum of larger debris pieces from the oil scavenge tube (upper spectrum) and a rolling element from the number 2 bearing (lower spectrum).

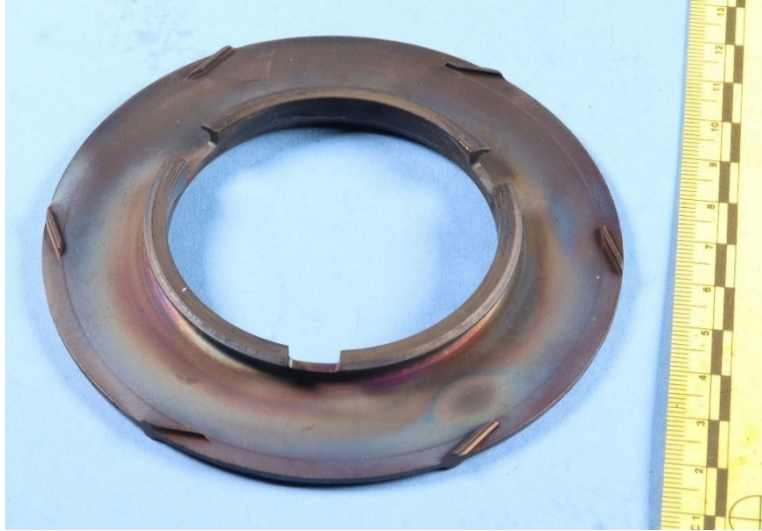
The forward oil impeller is shown in figure 12. The oil impeller showed heat damage that radiated from the inside diameter with more intense discoloration near the inside diameter and less at the outside diameter. The aft oil impeller showed less heat tinting. Rub damage was observed at the inside diameter of the retaining plate as indicated in the upper image in figure 13, and static contact marks corresponding to contact with the retaining plate were observed on the aft oil impeller also shown in figure 13. According to notes from the engine teardown, the oil holes near the rub damage on the retaining plate were found to be unobstructed.

**Figure 12.** Forward oil impeller (metric side of ruler shown).

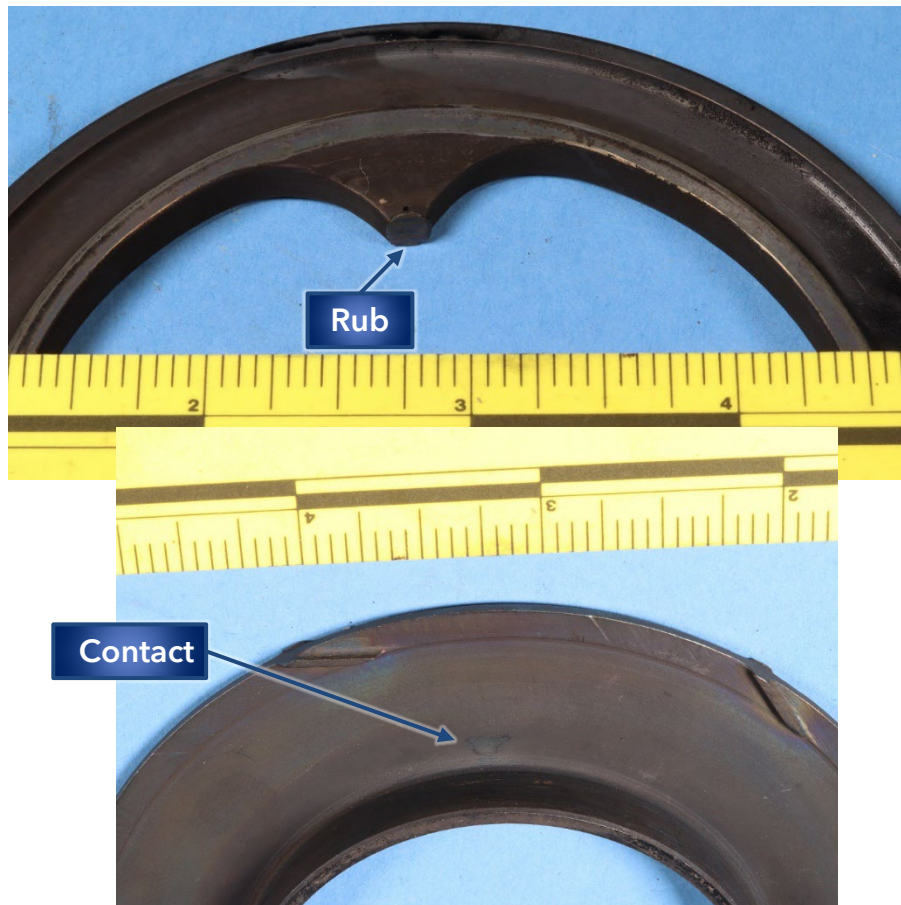
**Figure 13.** Retaining plate (above) and aft oil impeller (below).

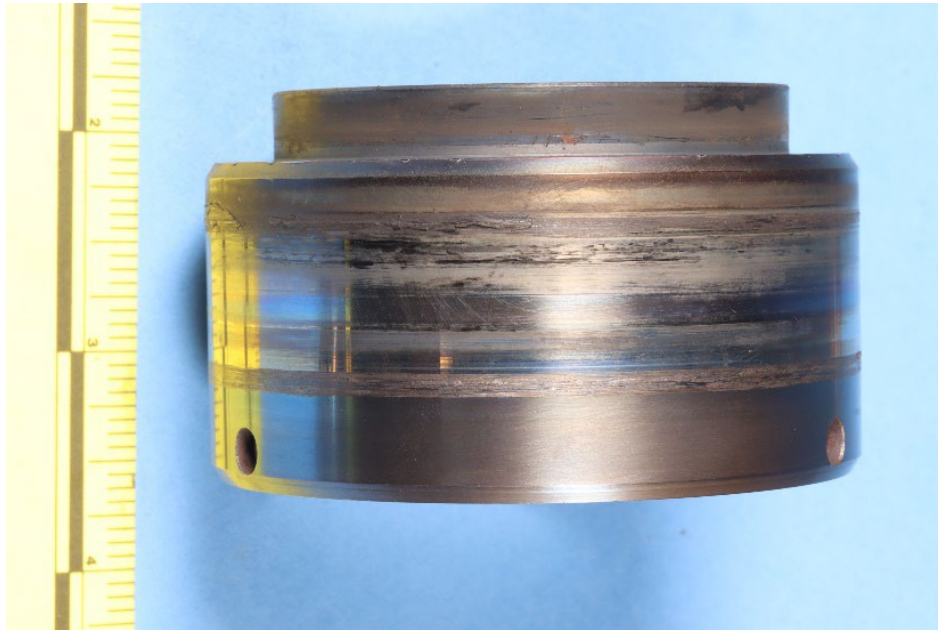
Close views of the rear liner and the aft seal housing are shown in figures 14 and 15. Circumferential rubbing and heat tinting was observed on the rear liner. The aft seal also showed heat tinting, rubbing, and degradation of the seals.

**Figure 14.** Rear liner.

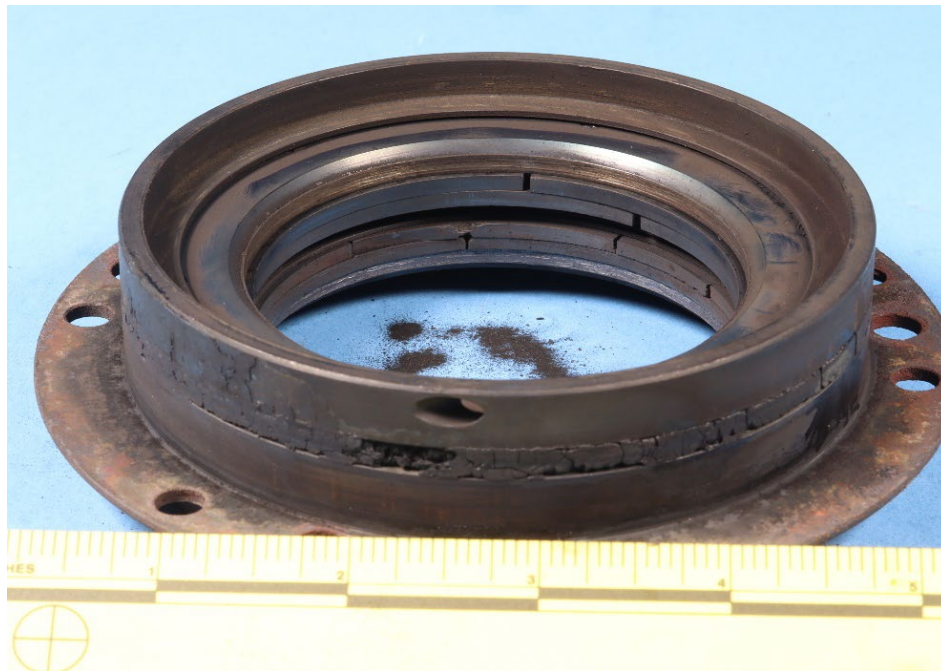
**Figure 15.** Aft seal.

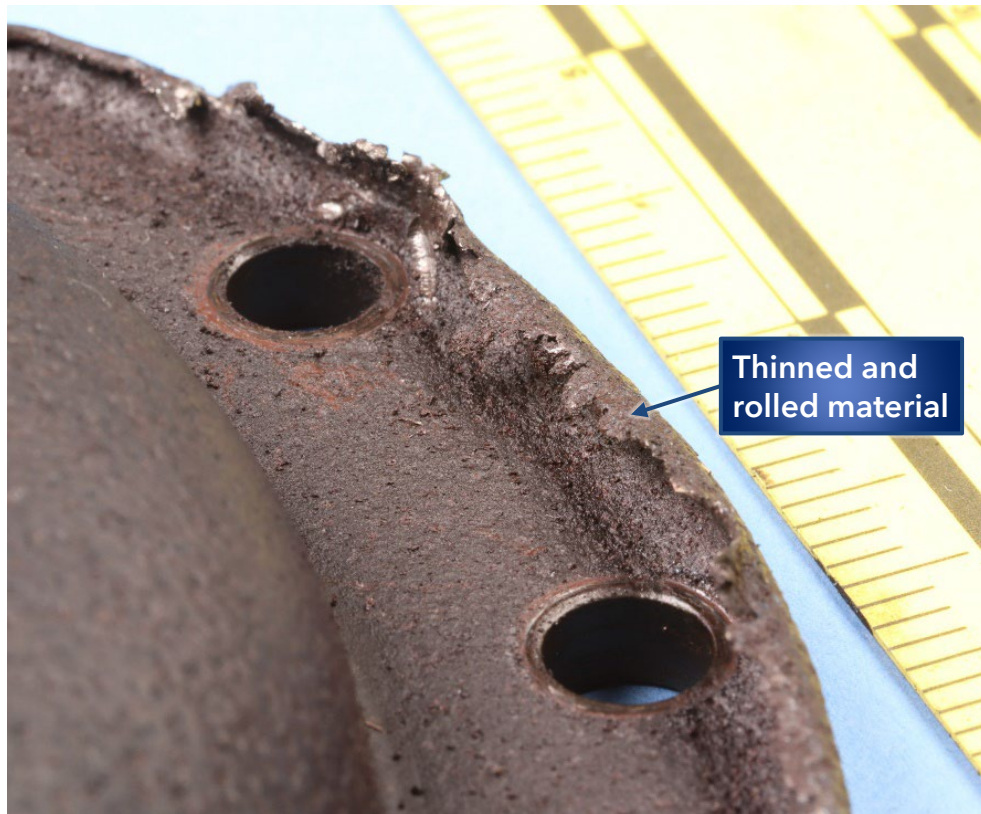
A close view of the flange separation surface at the outside diameter of the forward piece of the number 3 and 4 bearing retaining cover is shown in figure 16. The flange wall thickness was thinned at the separation location, and the thinned edges were rolled inward. The exterior surfaces of the rolled material appeared battered consistent with repeated contact with the separated aft flange piece. The forward end of the aft flange piece also showed thinned material that was rolled inward as shown in figure 17.

**Figure 16.** Aft side of the rear bearing cover showing thinned and rolled material at the flange separation around the outer diameter.

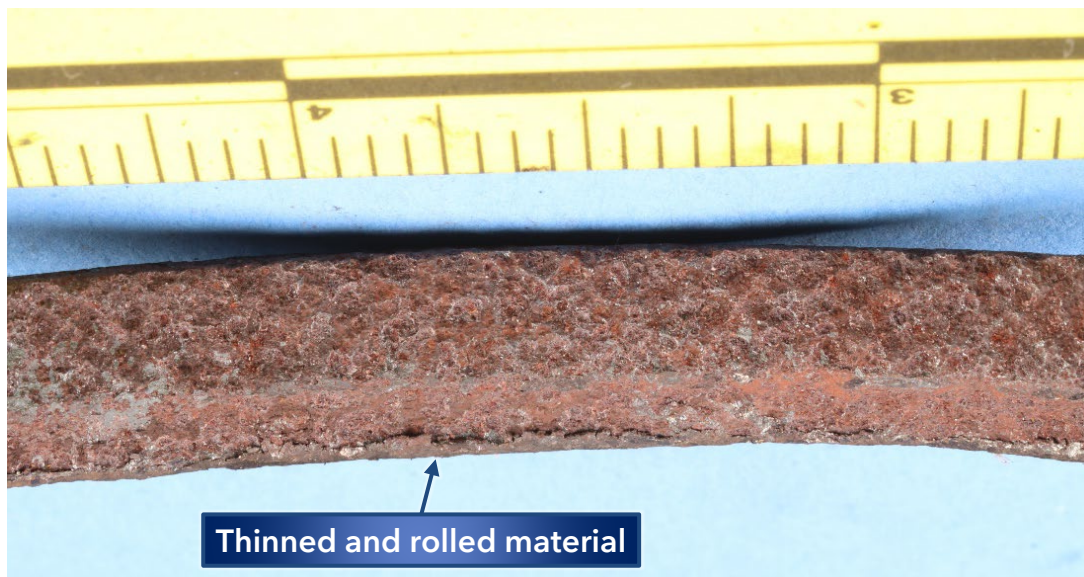
**Figure 17.** Rear bearing cover aft flange inner diameter face showing thinned and rolled material at the forward edge.

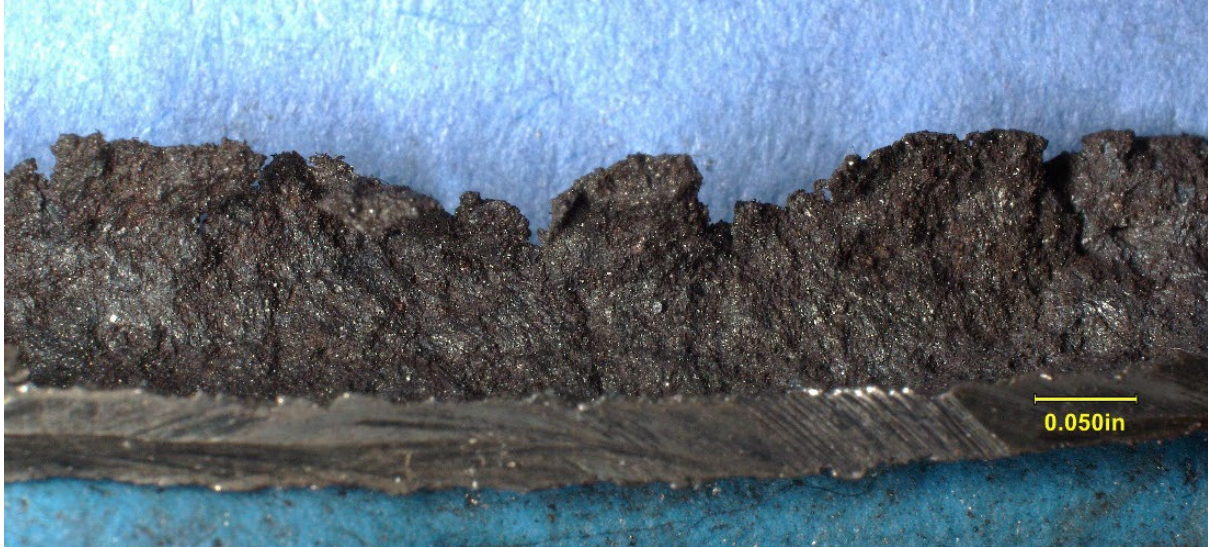
On the forward piece of the number 3 and 4 bearing support cover, a piece of rolled flange material at the outside diameter was cut from the remainder of the piece to view the interior surface adjacent to the separation surface, and a view of the surface is shown in figure 18. The interior surface was rough and oxidized consistent with heavy corrosion.

**Figure 18.** Piece of the rear bearing cover outer diameter flange cut from the forward piece showing the flange remnant surface on the inside of the curl.

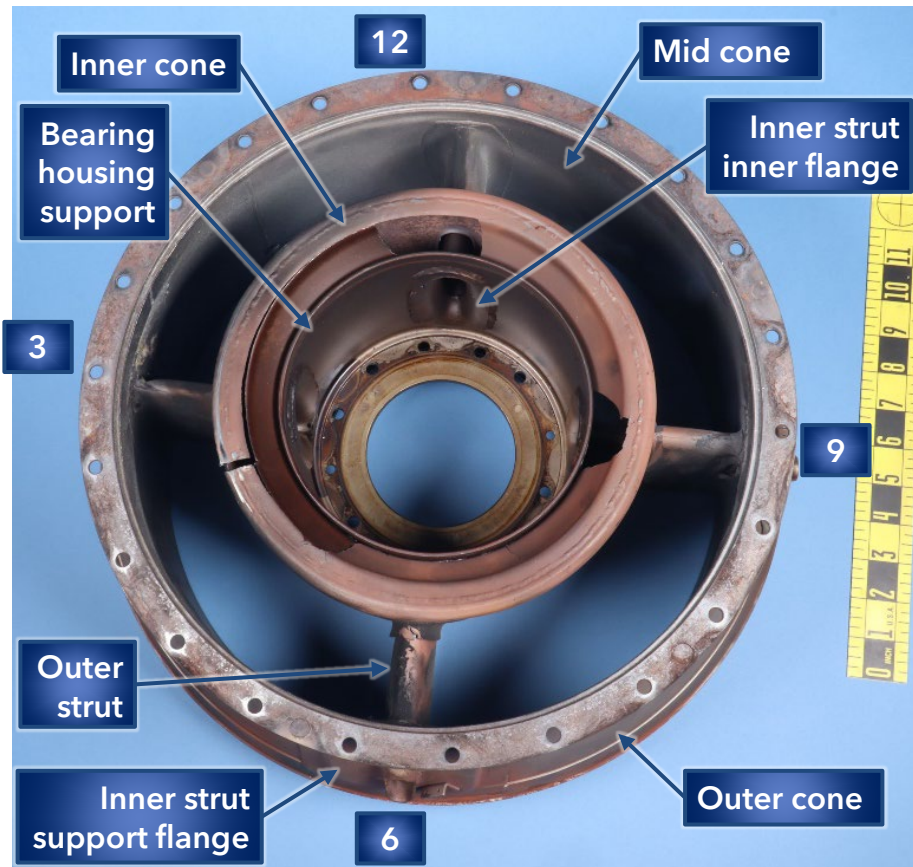
Clock positions as viewed looking forward were marked on the exhaust diffuser as received, and struts were located at the 3, 6, 9, and 12 o'clock positions as indicated in figure 19. Cracks were observed in multiple locations including the outer struts, inner strut support (outer) flanges (outer cone attachments), inner strut inner flanges (bearing housing support attachments), and the forward end of the inner cone as detailed below.

**Figure 19.** Forward side of the aft diffuser housing.

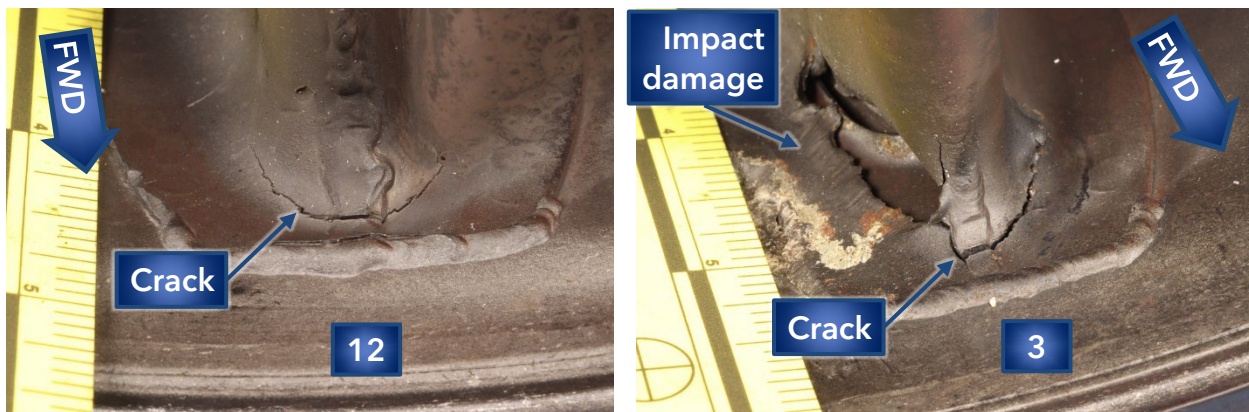
Each of the outer struts were cracked at the leading edge in the radius between the strut and the flange attaching the strut to the mid cone. Views of cracks in two of these struts are shown in figure 21. Outer struts at the 3 o'clock and 9 o'clock positions also showed impact damage on the counter-clockwise side of the strut near the leading edge. Cracks in struts at the 6, 9, and 12 o'clock positions had a relatively smooth curving path such as the crack shown at the left in figure 21, but the crack at the 3 o'clock position had a discontinuity in the crack path on the side with the impact damage as shown at the right in figure 21. The impact damage at the

6 o'clock position was at the edge of the flange attaching the strut to the mid cone and did not appear to affect the crack path.

**Figure 21.** Cracks at the leading edges of two outer struts where they attached to the mid cone at the 12 o'clock and 3 o'clock positions.

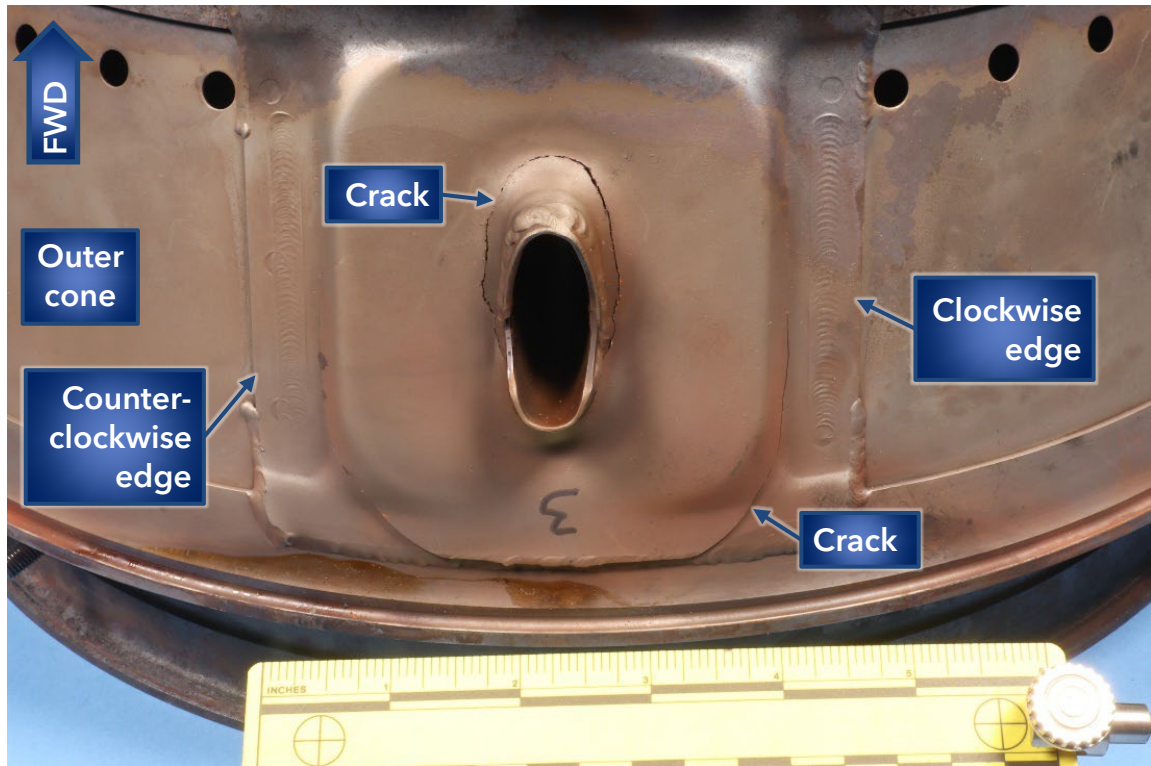
Multiple cracks were observed in each of the inner strut support flanges attached to the outer cone. The support flange at the 3 o'clock position shown in figure 22 shows typical crack locations observed on the support flanges. Each of the flanges was cracked at the aft side of the support flange where it was attached to the outer cone, and cracks turned toward the forward direction near the clockwise and counterclockwise edges of the plate. The cracks at the edges of the plate extended further forward at the 3 o'clock and 9 o'clock positions than at the other two positions.

Cracks in the support flanges were also observed near the middle of the flanges around the inner strut attachment weld (see figure 22). At the 3, 6, and 9 o'clock positions, cracks were generally located at the transition radius between the flange and the strut around the forward side of the strut and transitioned radially outward to the toe of the strut attachment weld at the aft side of the strut. Around the inner strut at the 12 o'clock position, the support flange was only cracked through the weld in the aft clockwise quadrant of the strut attachment. The support flange was cracked around the entire perimeter of the inner strut at the 6 o'clock position. At the 3 o'clock position, the support flange was cracked around  $\frac{3}{4}$  of inner strut perimeter. At the 9 o'clock position, the support flange was cracked around the forward and clockwise sides of the inner strut.

**Figure 22.** Number 3 inner strut support flange on the outer cone showing cracks around the strut attachment and at the aft edge of the flange.

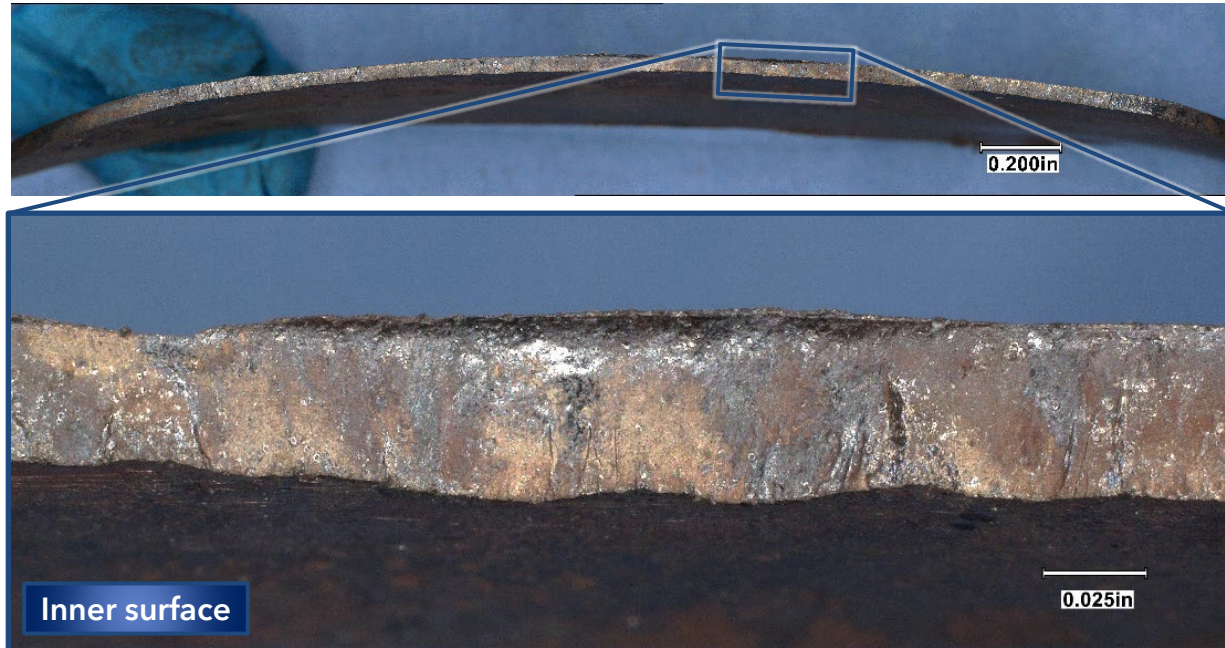
The cracks at the aft edges of the support flanges had relatively smooth features across most of the fractures with multiple ratchet marks radiating from the inner surface of the support flange, features consistent with fatigue cracking from

multiple origins at the inner surface.<sup>1</sup> Typical fracture features at the aft edge of the support flange at the 12 o'clock position are shown in figure 23. The fracture surfaces generally had a relatively uniform straw-colored oxide tint under rubbed black deposits from the origin areas to the forward ends of the cracks at the clockwise and counterclockwise sides of the support flange.

**Figure 23.** Fracture surface for the number 12 inner strut support flange crack at the aft edge of the flange.

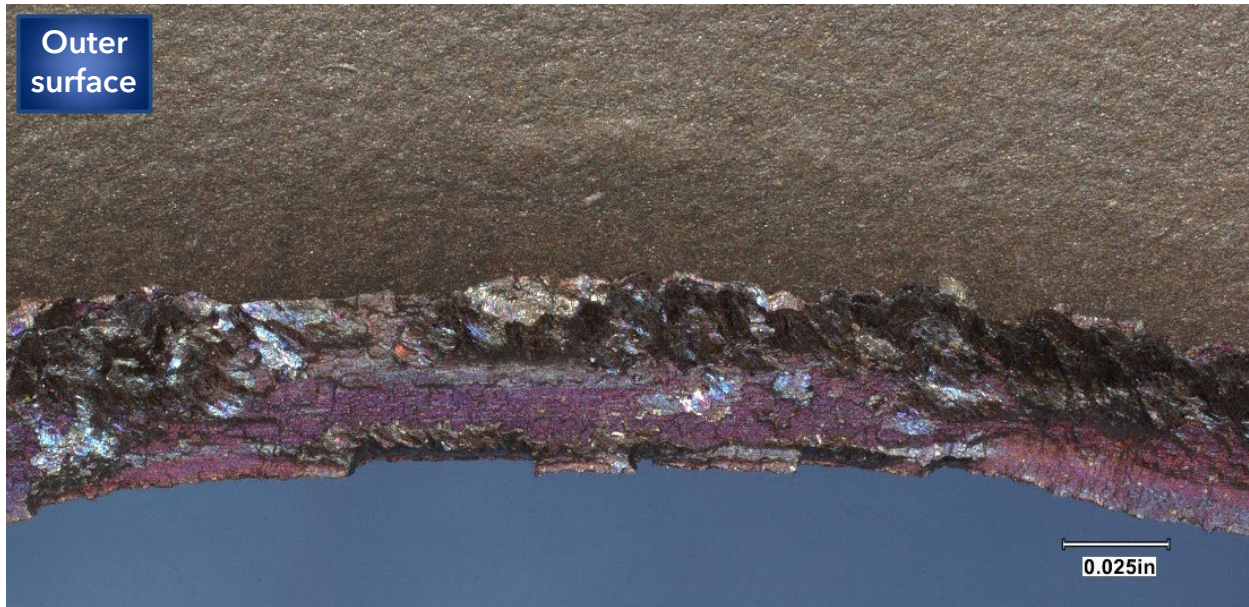
Cracks at the middle of the support flange around the inner support attachment generally had a rougher appearance consistent with higher cyclic stresses and showed more rubbing damage from post-fracture recontact. Fracture surfaces generally had irregular multi-colored tint patterns with orange, red, blue, and purple oxide hues such as the fracture surface at the 9 o'clock inner strut position shown in figure 24.

**Figure 24.** Fracture surface for the inner strut support flange crack at the inner strut attachment location (9 o'clock position).

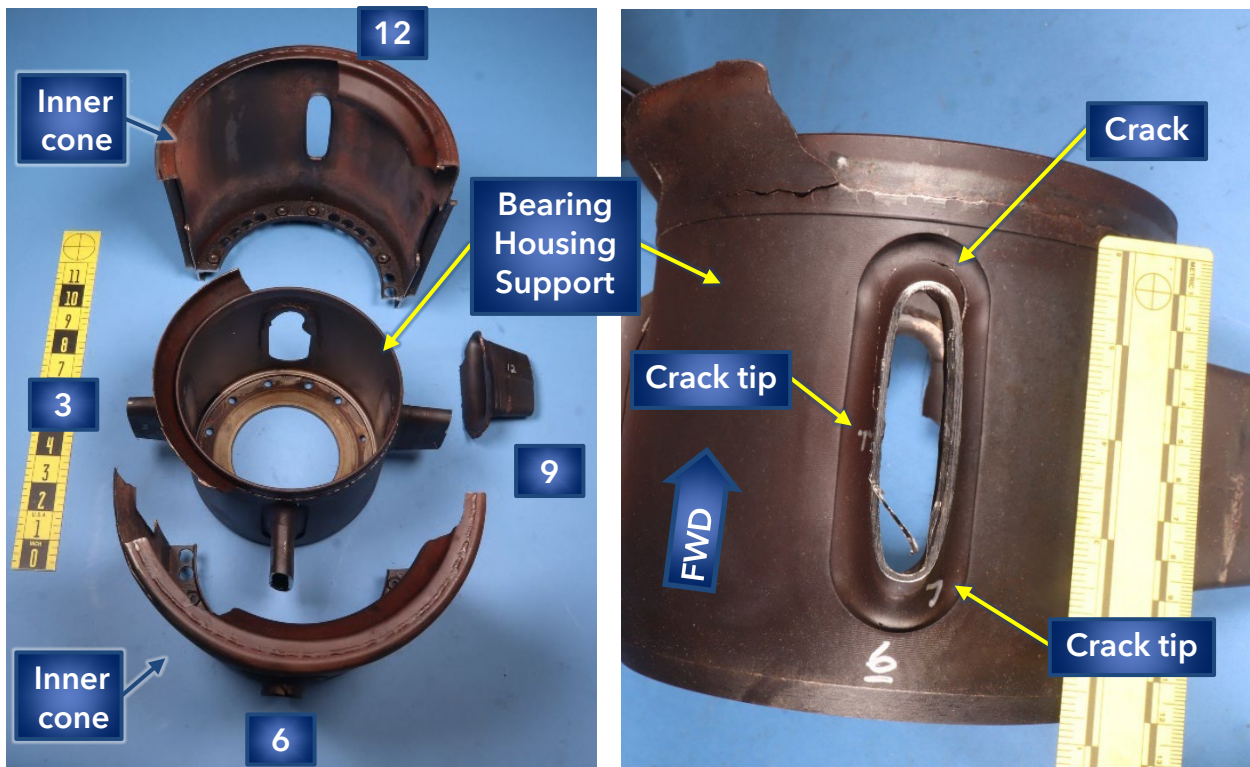
To facilitate further examination of the inner cone and inner strut inner flange fracture surfaces, the inner cone was sectioned longitudinally at the 3 o'clock and 9 o'clock positions using both a handheld bandsaw and an abrasive cutter, and a view of the inner cone and bearing housing support after sectioning is shown in figure 25. The inner strut inner flange at the 12 o'clock position was fractured around the perimeter of the strut, so it is shown separated from the bearing housing support in figure 25.

Each inner strut was fractured or cracked in the radius where the inner flange transitioned to the inner strut such as the crack indicated at the 6 o'clock position in the right image in figure 25. At the 12 o'clock position, the inner flange was fractured through the transition radius around the forward half of the strut. The fracture transitioned outward to the welded edge of the flange at the aft side of the strut, where the weld was fractured in a shear plane nearly parallel to the flange surface. Views of the separated strut at the 12 o'clock position and the weld fracture at the aft side of the strut flange are shown in figure 26. The fracture features at the forward

**Figure 25.** Views of the bearing housing support and inner struts after separating the inner cone from the support.

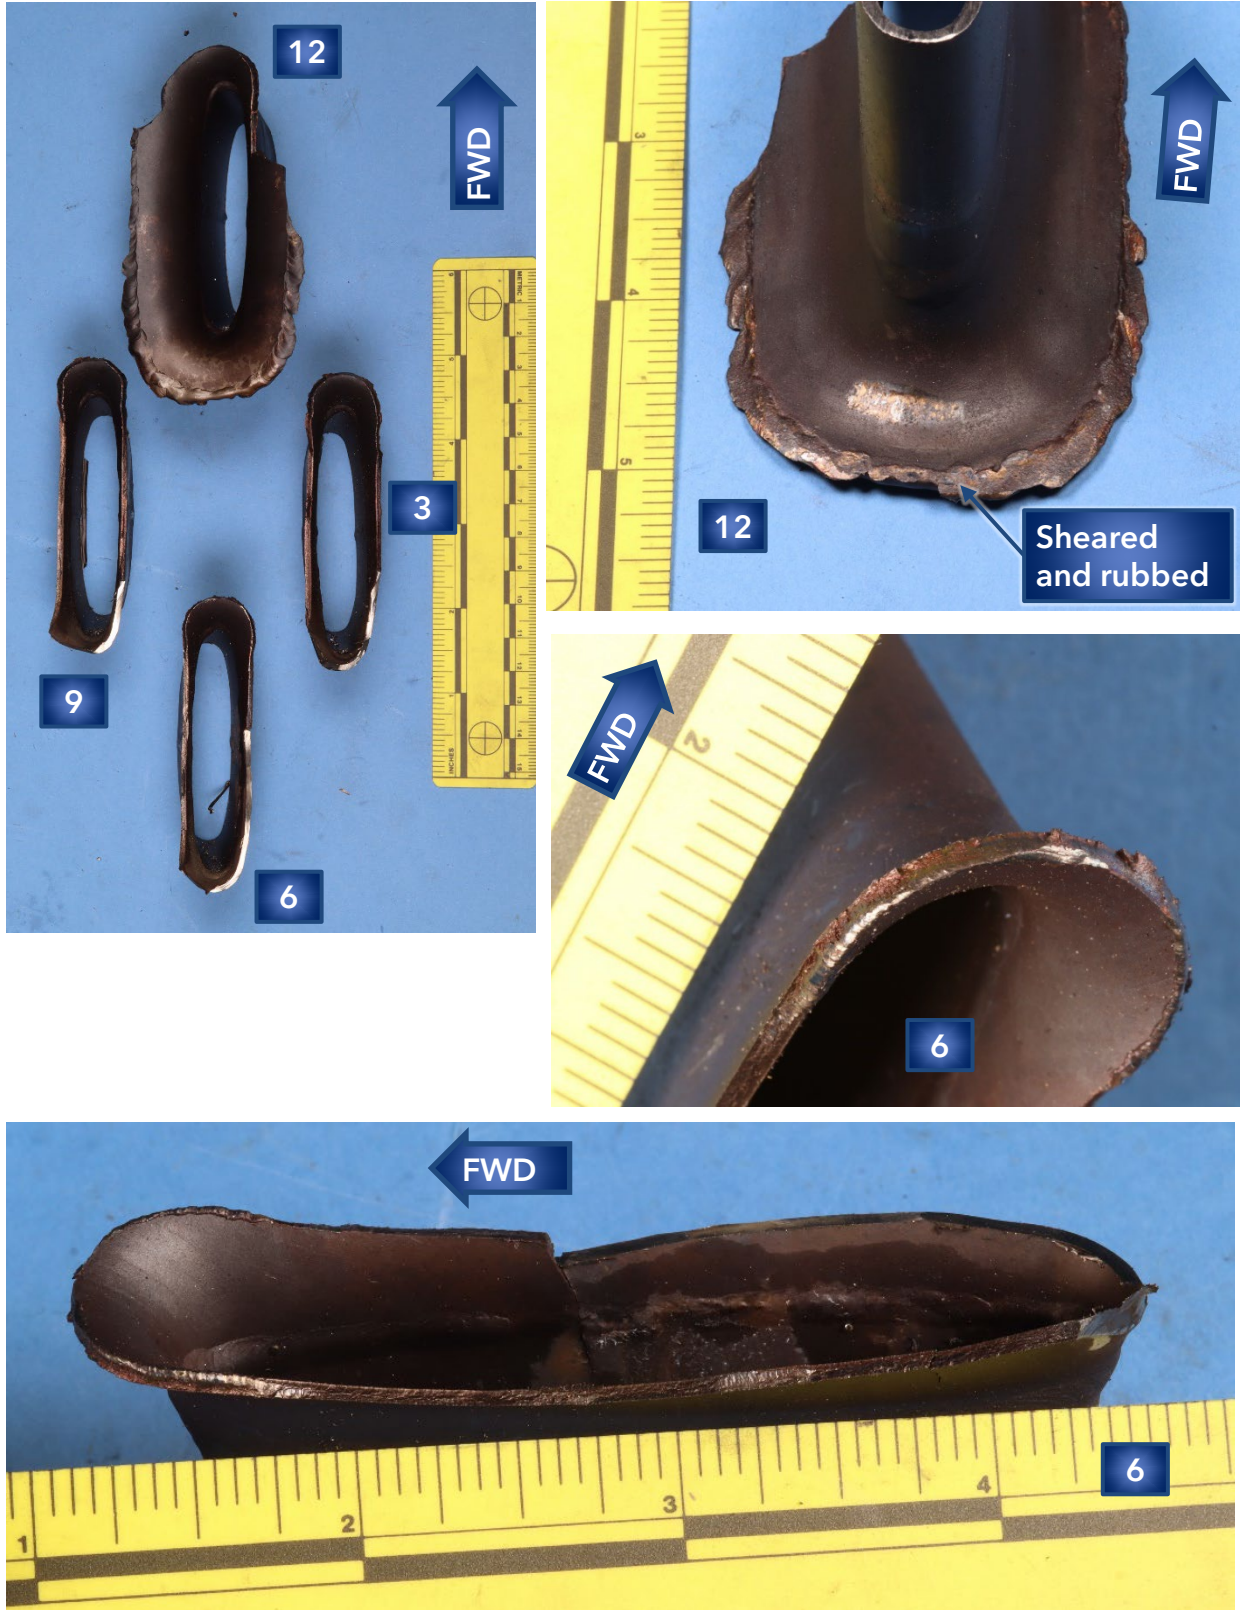
end of the fracture had relatively rough features with rubbing damage. Oxides on the surfaces had straw-colored, orange, and red tints. Fracture features at the aft end of the strut at the 12 o'clock position appeared substantially rubbed.

The inner strut inner flanges for the 3, 6, and 9 o'clock positions were each cracked around approximately  $\frac{3}{4}$  of the inner strut perimeter. The inner flange remained intact at the aft end of the inner strut at the 3 o'clock position, and the aft counterclockwise quadrant of the inner flanges remained intact at the 6 o'clock and 9 o'clock positions. Additionally at the 3 o'clock and 6 o'clock positions, welds attaching the inner strut inner flanges to the bearing housing support were cracked at the forward ends of the flanges.

**Figure 26.** Inner ends of the inner struts after cutting from the bearing housing support (upper left). Closer views of fractures through the inner strut inner flanges at the 12 o'clock (upper right) and 6 o'clock (lower right and lower center) positions.
