# National Transportation Safety Board

ERA22FA279

## **MATERIALS LABORATORY**

Factual Report 23-005

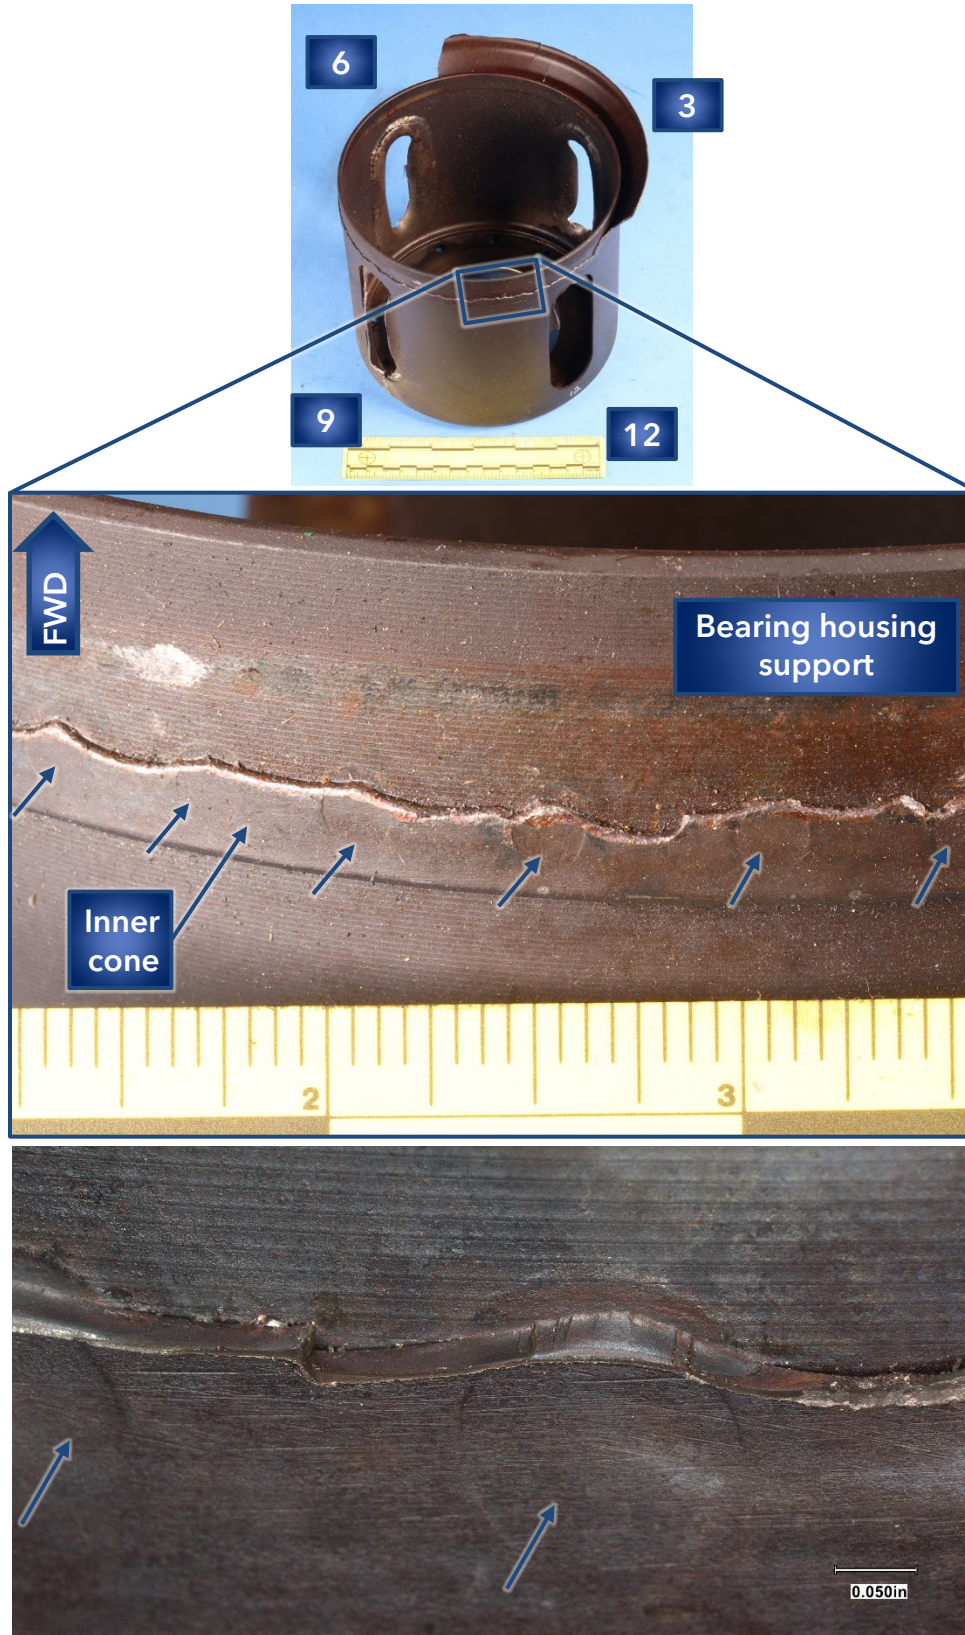
A view of the bearing housing support with attached piece of the inner cone after sectioning is shown in figure 27. The inner diameter of the inner cone was spot welded to the outer diameter of the bearing housing support near the forward end of the support. Unlabeled arrows in figure 27 point to spot welds in the close-up views of the fracture around the perimeter. The circumferential fracture of the inner cone from the 5 o'clock position clockwise to the 1 o'clock position intersected the forward edges of the spot welds. Additionally, a separate circumferential crack intersecting the forward edges of 5 spot welds was observed at the 3 o'clock position.

**Figure 27.** Bearing housing support with attached inner cone piece. Arrows indicate spot welds attaching the inner cone to the outer surface of the support.

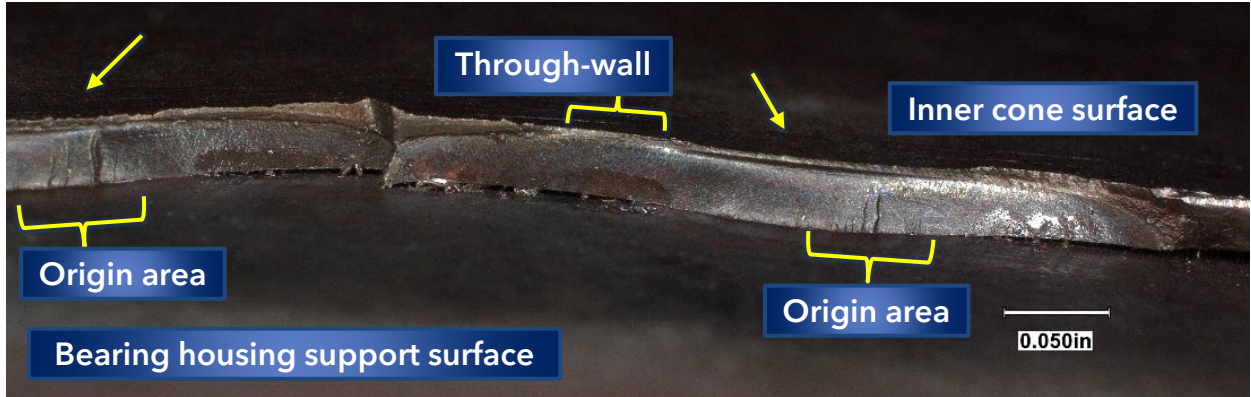
A view of fracture features on the inner cone fracture surface at the forward edge of the spot welds are shown in figure 28. The fracture surface had multiple often-intersecting areas with relatively smooth features with curving boundaries, features consistent with fatigue. The fatigue features emanated from the forward edges of individual spot welds consistent with multiple-site fatigue cracks initiating at the spot welds. The fatigue regions had dark gray to black oxides that extended completely or nearly through the inner cone wall thickness in multiple areas. Ratchet marks were observed at each of the origin areas associated with the spot welds such as the two shown in figure 28. An area where the fatigue region extended completely through the inner cone wall is also indicated in figure 28.

**Figure 28.** Portion of the fracture surface through the inner cone at the spot welds to the bearing housing support (viewed looking aft). Unlabeled arrows point to locations of spot welds on the shadowed inner cone surface.

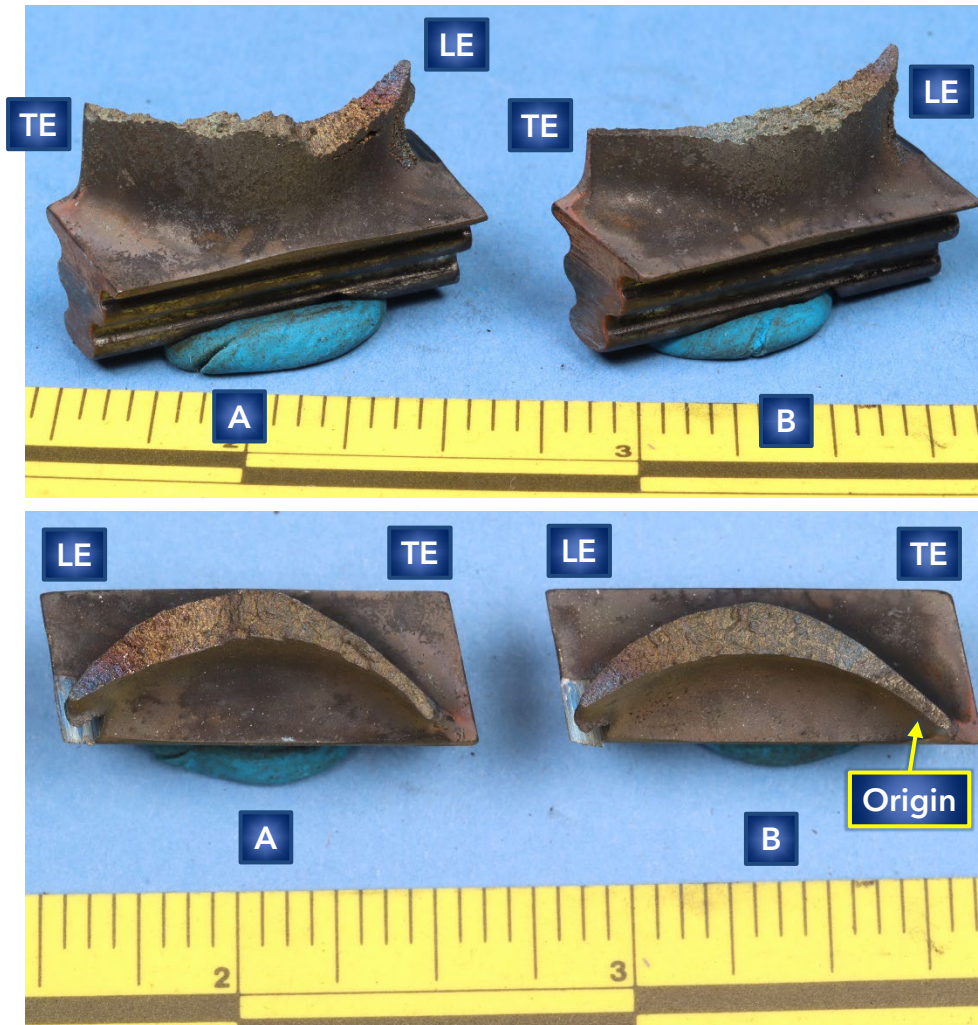
Overall views of the cleaned PT blades are shown in figure 29, and closer views of the fracture surfaces are shown in figure 30. The fracture surface of blade A had relatively rough fracture features consistent with overstress fracture with influence from the cast microstructure. Heat tinting was observed at the leading edge consistent with post-fracture local heating from rubbing contact at the leading edge.

**Figure 29.** PT blades A and B after cleaning in a solution of Alconox and water using an ultrasonic cleaner.

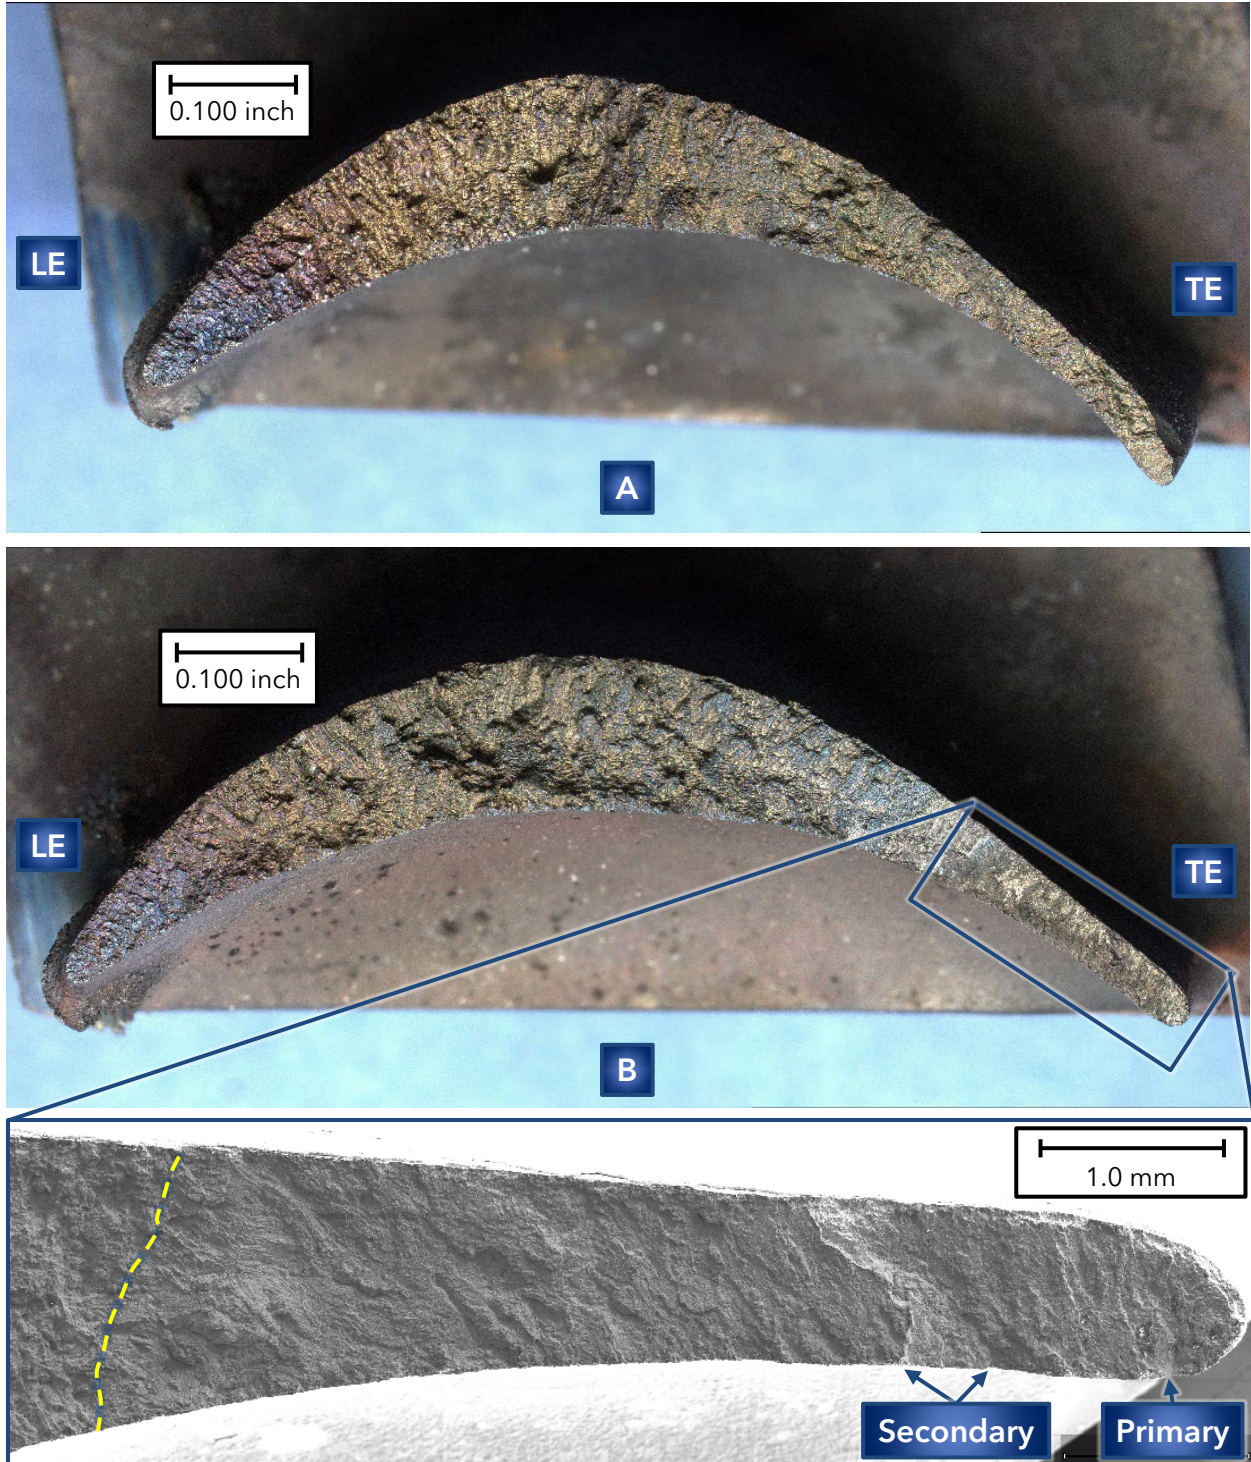
The fracture surface for blade B also had rough fracture features across most of the fracture surface with heat tinting at the leading edge associated with heating from post-fracture rubbing contact. However, an area near the trailing edge had a relatively smoother appearance and had a different tint to the surface oxides. Blade B was further examined using a scanning electron microscope (SEM), and a stitched montage of SEM images of the fracture surface at the trailing edge is shown in the lower image in figure 30. Fatigue striations were observed emanating from a primary origin area located on the convex side of the blade near the trailing edge and from two secondary origin areas on the convex side as shown in the lower image in figure 30. The fatigue region extended to the dashed line boundary shown in figure 30, located approximately 0.243 inch from the blade's trailing edge.

**Figure 30.** Optical images of PT blades A and B fracture surfaces (upper images) and a stitched montage SEM image of the blade B trailing edge showing primary and secondary fatigue origin areas (lower image). A dashed line in the SEM image indicates the fatigue boundary.

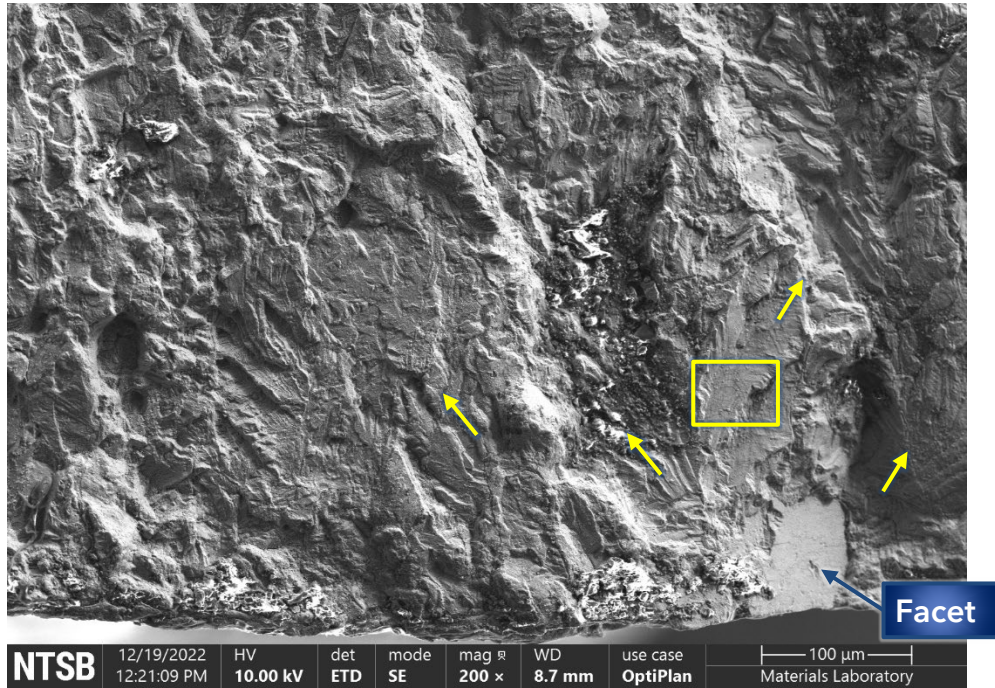
A closer view of the primary origin area is shown in figure 31. Unlabeled arrows indicate local fatigue crack propagation directions emanating from the primary origin that was comprised of a featureless facet at the blade convex surface. No evidence of any anomalies or preexisting damage was observed at the origin area.

**Figure 31.** SEM image of fatigue features at the primary origin area on the PT blade B fracture surface. Arrows indicate fracture propagation directions emanating from smooth facet at the primary origin.

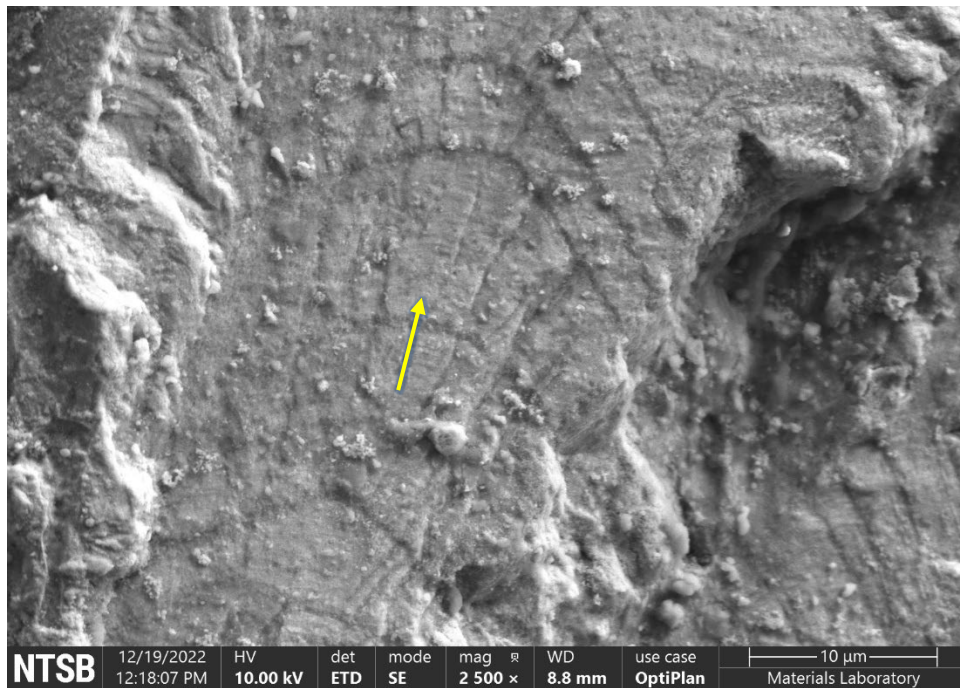
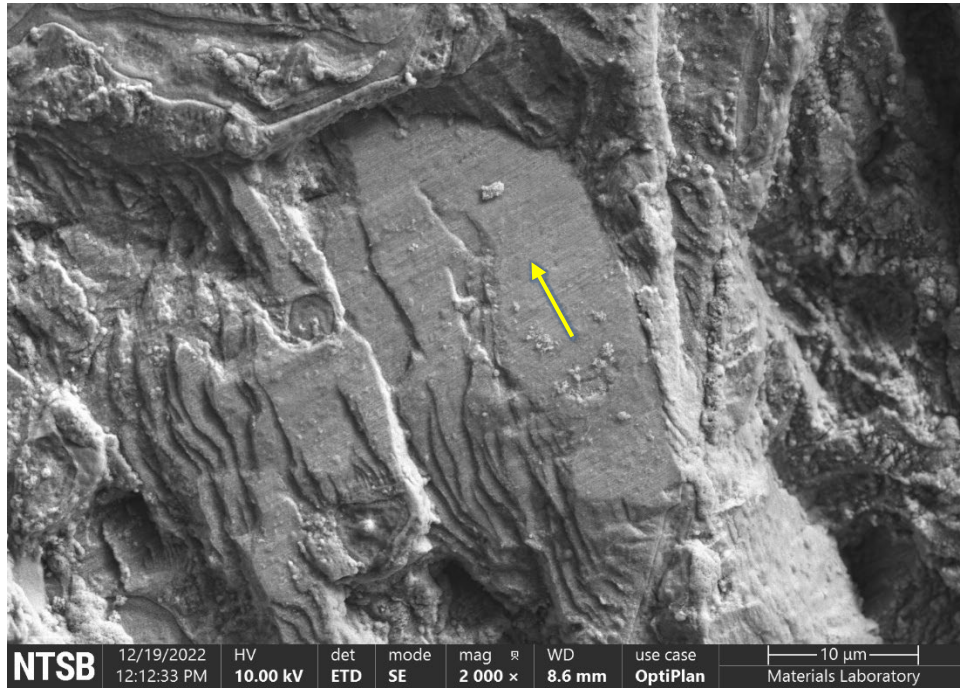
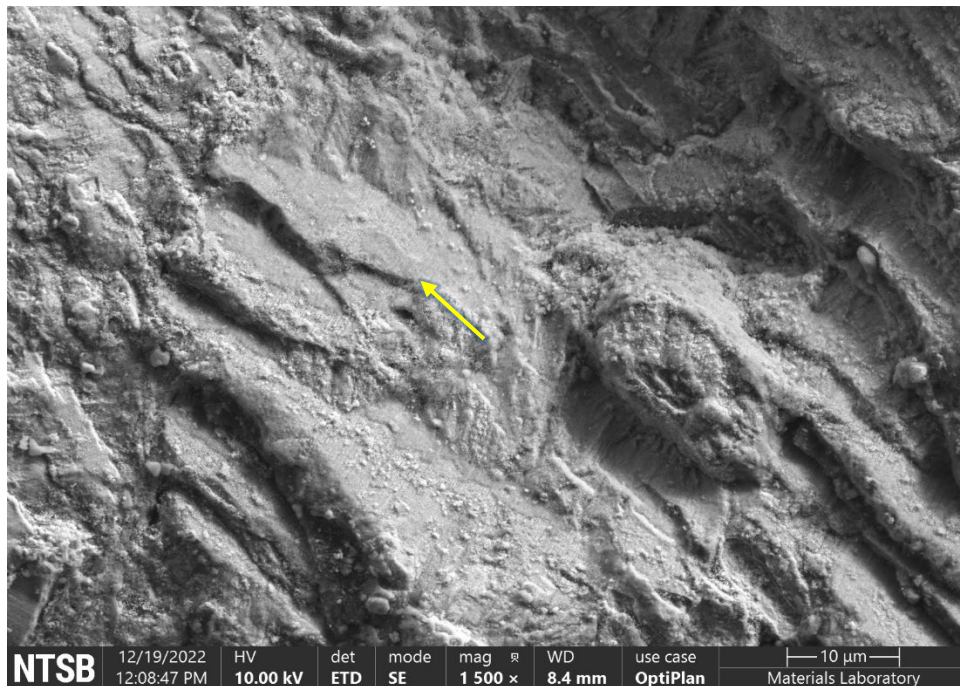
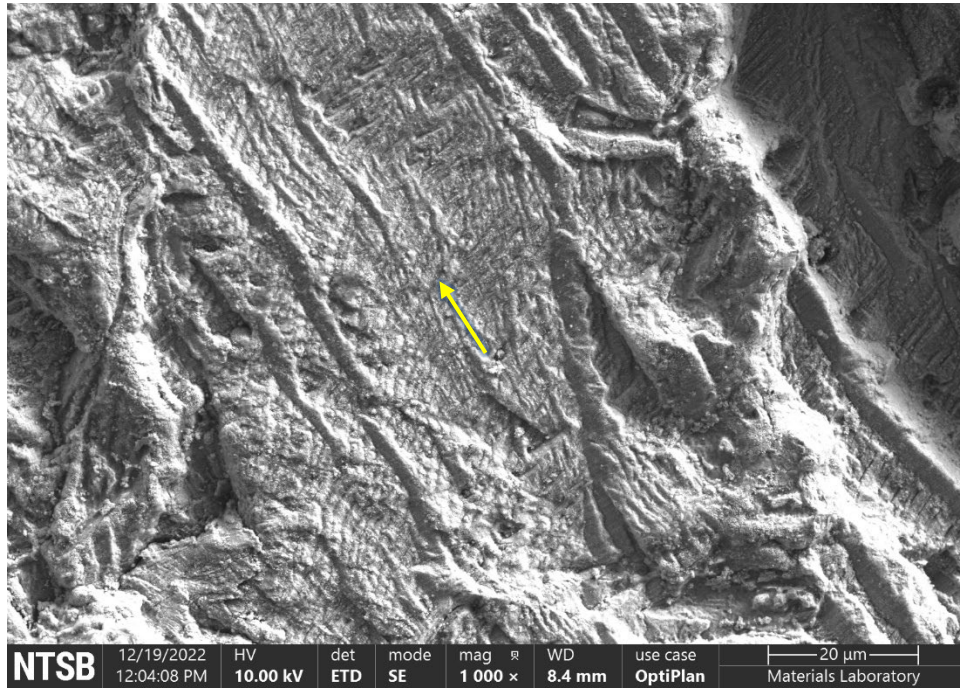
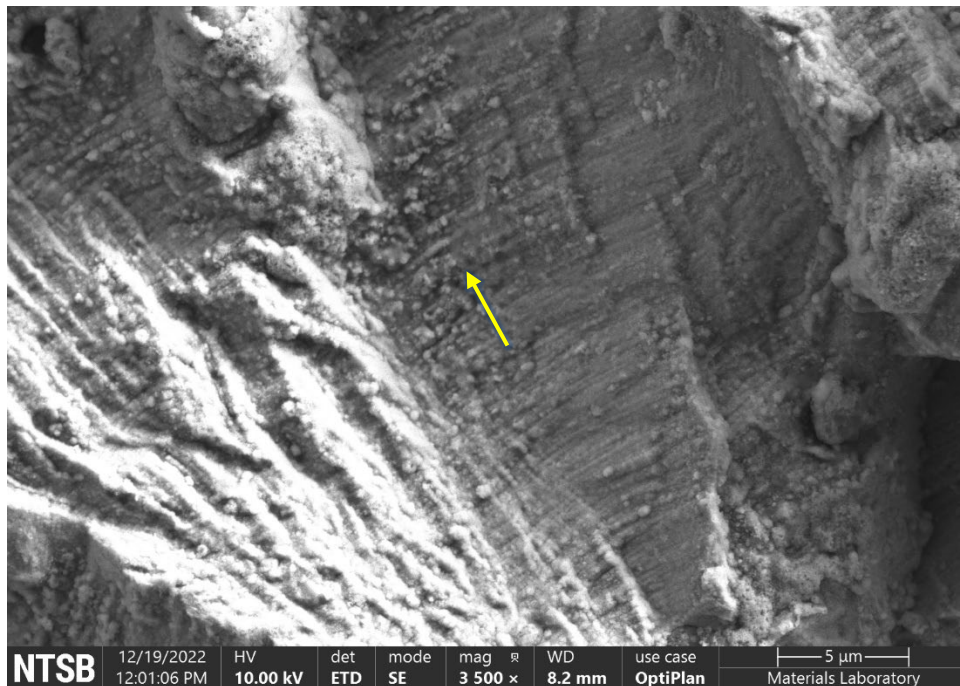
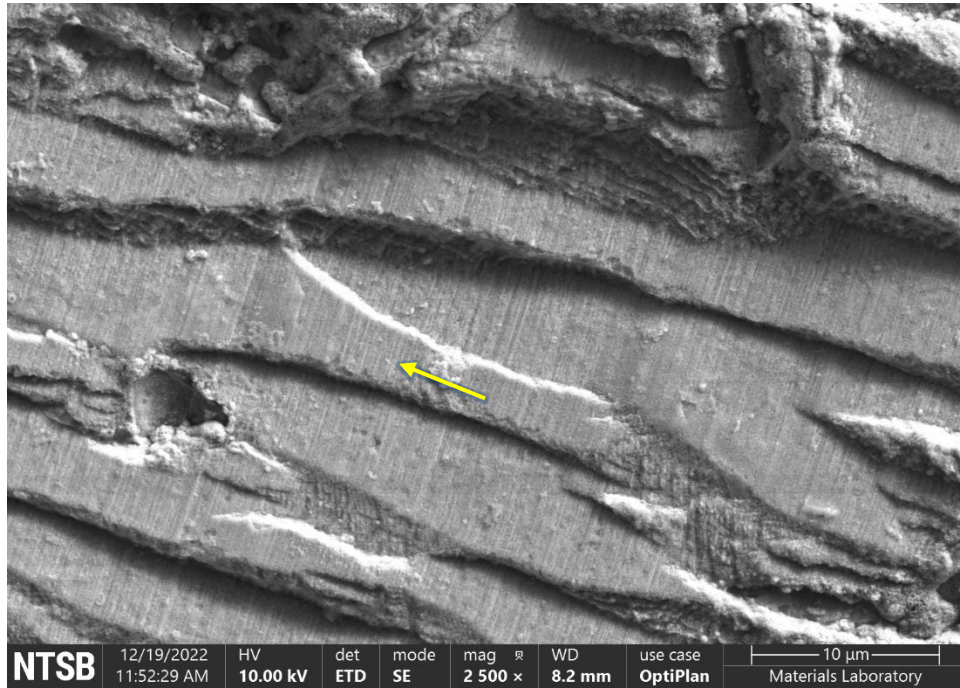
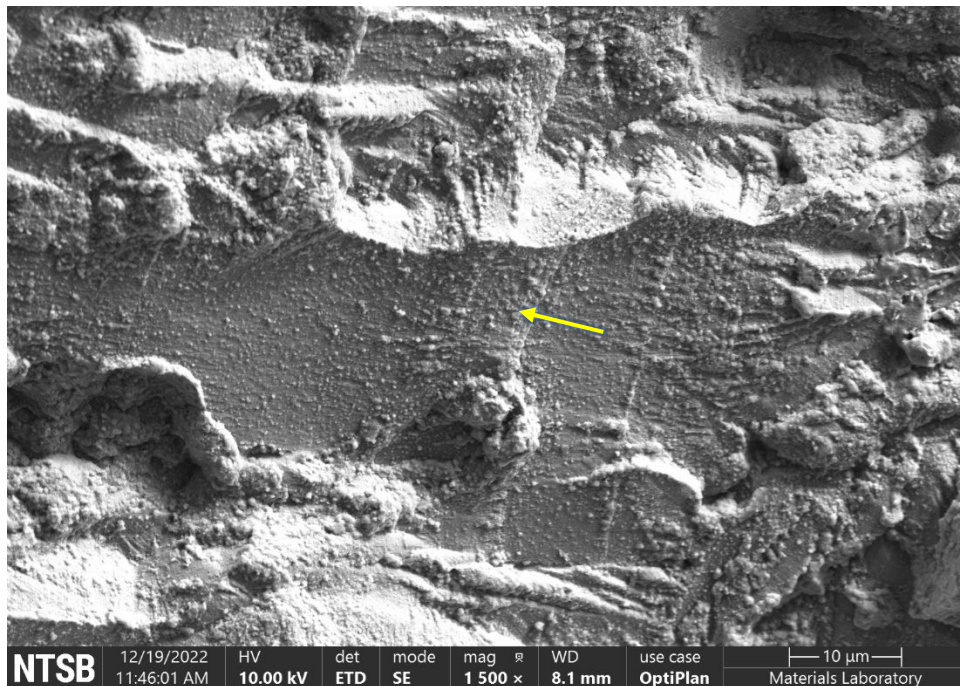
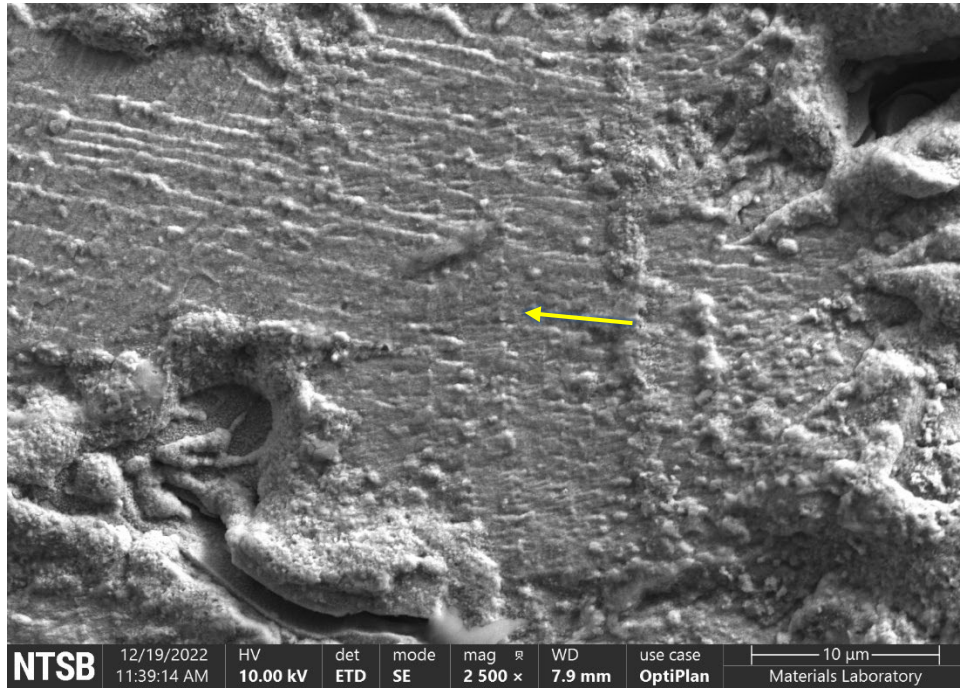
Representative fracture features in the fatigue region at increasing distances from the primary origin area are shown in figures 32 to 39. Finely-spaced striations on faceted planes were observed in many areas, sometimes separated by more distinct arrest marks such as those shown in figure 38. Forward of the fatigue boundary, fracture features consisted of dimpled features and tear ridges roughly following boundaries in the cast microstructure, such as the area shown in figure 40.

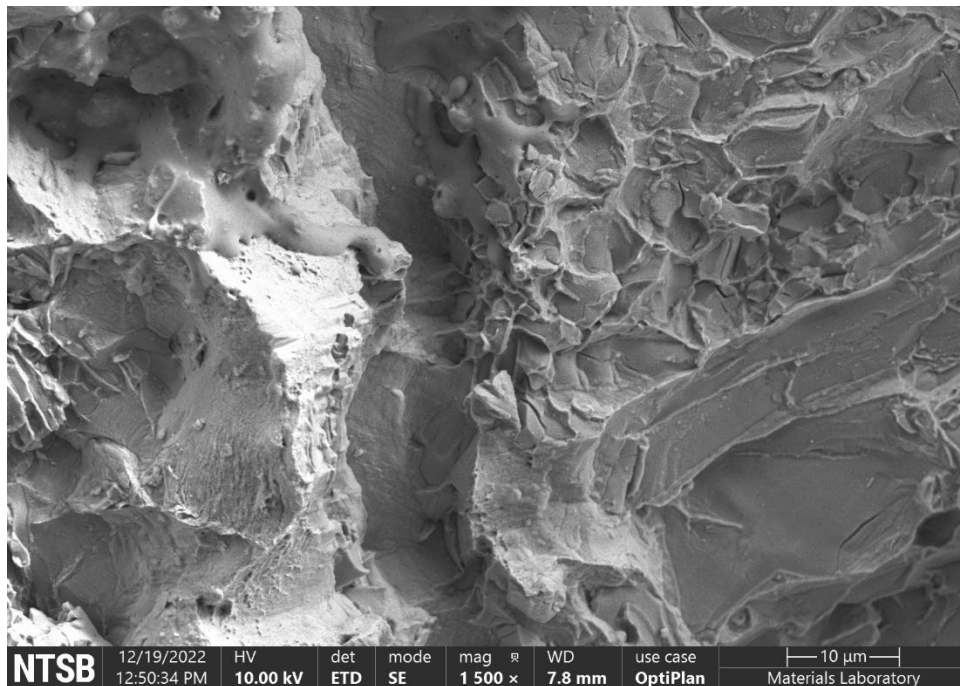
**Figure 40.** SEM image of typical overstress features on the PT blade B fracture surface.
