# National Transportation Safety Board

DCA22MA193

Factual Report 23-019 Actuator - Accident

Location: Freeland, Washington  
Date: September 4, 2022  
Vehicle: de Havilland Aircraft DHC-3 Otter, N725TH  
Investigator: Adam Huray

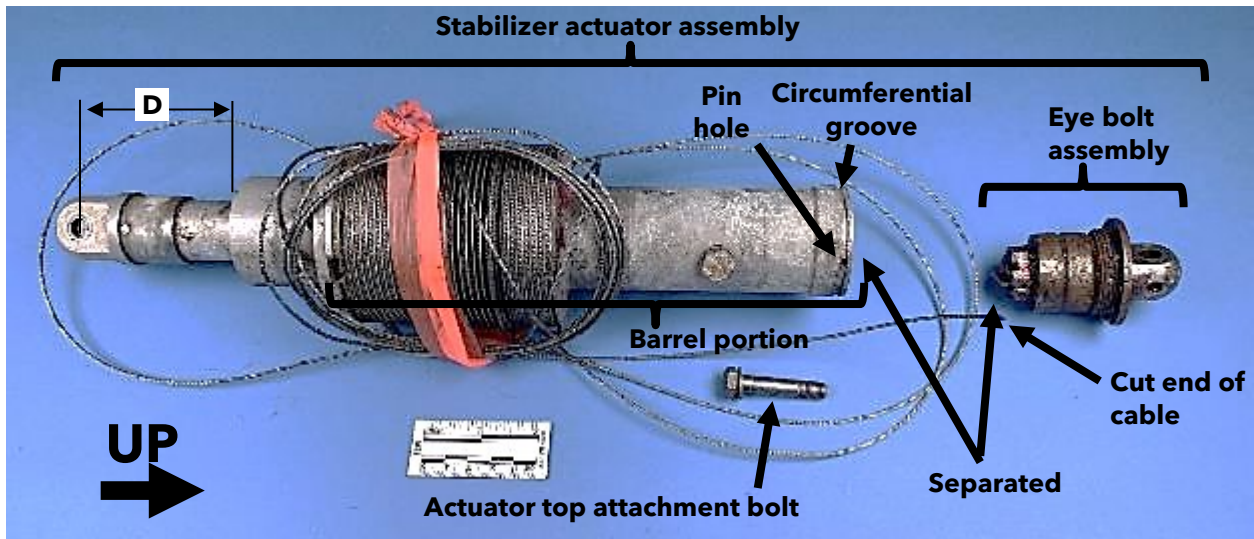
Figure 1 shows a photograph of the as-received horizontal stabilizer trim actuator assembly, P/N C3CF290.<sup>1</sup> A part number was not marked on the submitted part. The top eye bolt assembly was separated from the barrel portion, that is, the actuator was found separated where the clamp nut threads into the barrel section. The top attachment bolt (without attaching hardware) that was used to attach the actuator to the horizontal stabilizer was also submitted and showed no evidence of damage.

**Figure 1.** As-received horizontal stabilizer trim actuator assembly with the separated eye bolt assembly and actuator top attachment bolt. The eye bolt assembly is also referred to in the maintenance manual as the top eye end and bearing assembly.

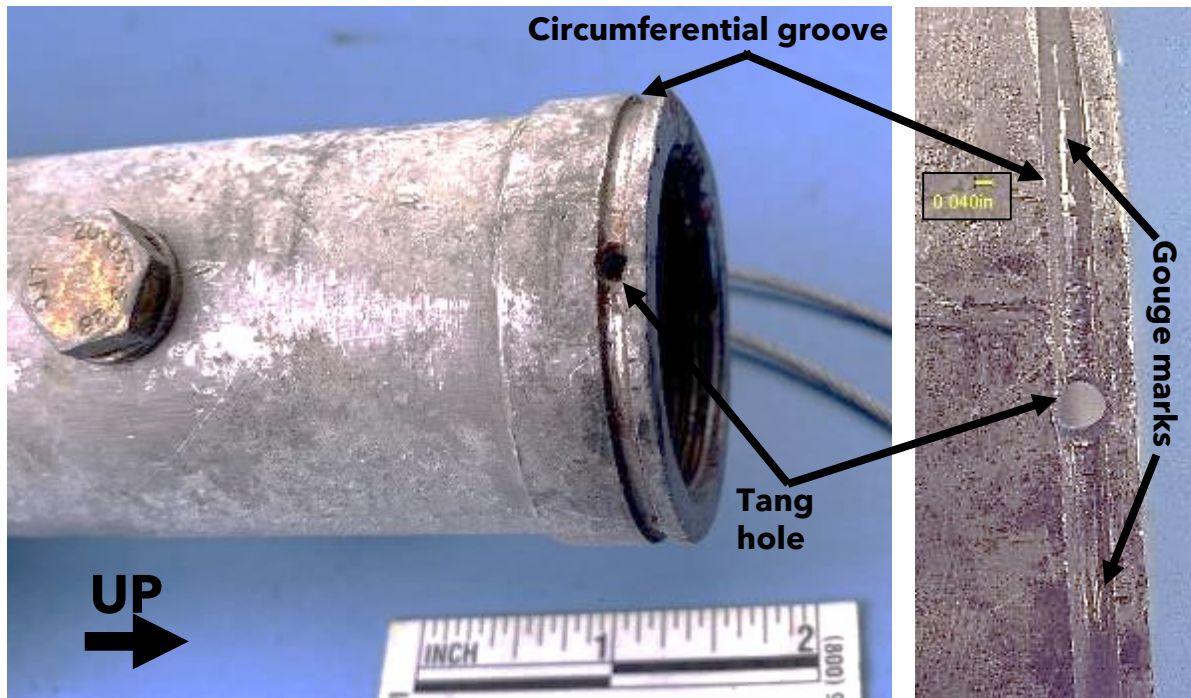
The diameter of the tang hole in the barrel (for the lock ring) was specified as 0.098 inch. The shank portion of a 0.098 inch nominal diameter drill bit was inserted into the tang hole. The drill bit easily fitted into the hole. The tang hole at the outer surface exhibited evidence of elongation deformation on both lateral sides (perpendicular to the length of the barrel). The groove contained circumferential gouge marks that extended as much as approximately 0.9 inches to either side of the tang hole (see figure 3). The groove in areas outside of the gouge marks exhibited light contact (polished) marks consistent with the size of a lock ring. Several longitudinal-like gouge marks were noted in the general area of the tang hole (see figure 4).

**Figure 3.** Oblique view of the top end of the barrel showing the circumferential groove for the lock ring and hole for lock ring (left image); and close-up view of gouge marks in the groove (right image).

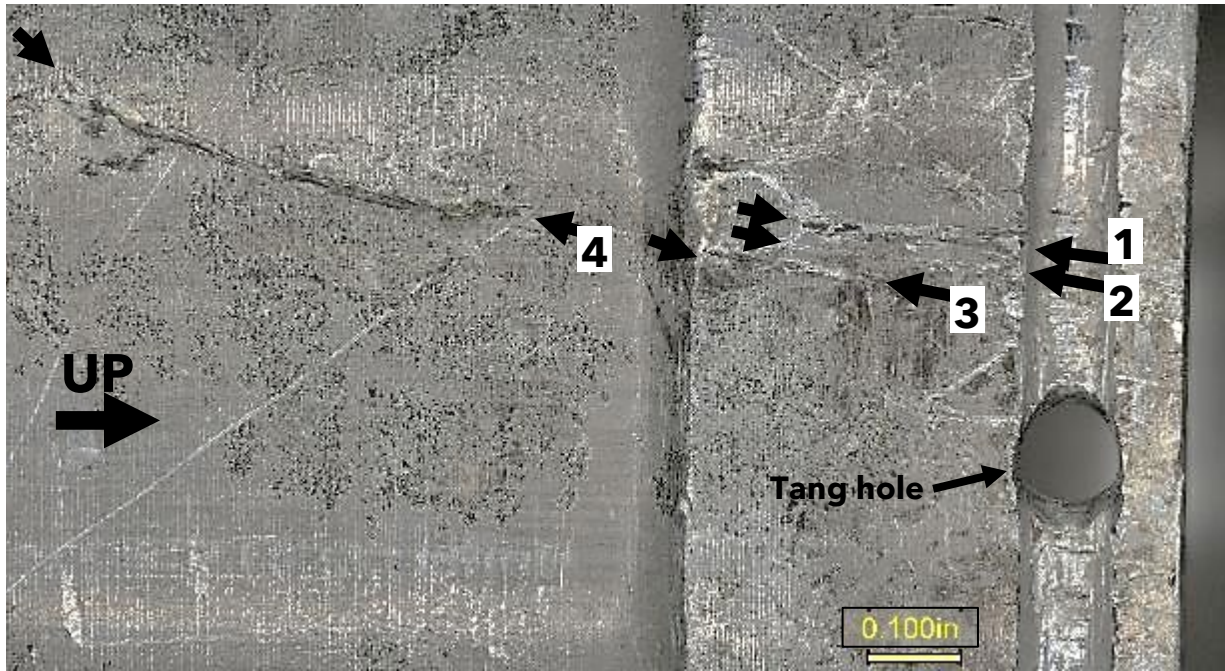
**Figure 4.** Side view of the barrel showing the longitudinal-like gouge marks that extended from the circumferential groove, in the areas between arrows "1" through "4".

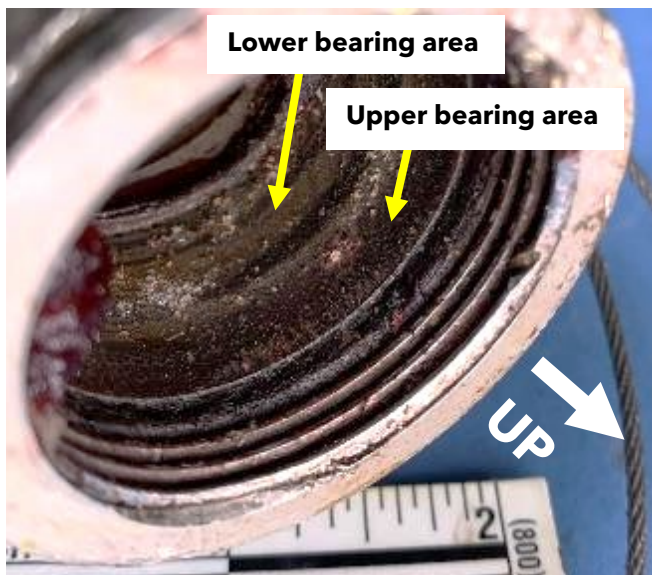
The inner threads at the top end of the barrel at one isolated location was covered with translucent red grease. The inner surface of the barrel in the area below the inner threads contained two bands that corresponded to the position of two ball bearing assemblies (see figure 5). The inner threads and areas corresponding to the location of the two ball bearing assemblies were cleaned with a cotton swab soaked with acetone. Stereo microscope examination of the upper barrel end revealed the

**Figure 5.** Inner threads at the upper end of the barrel portion in the as-received condition. Areas on the inner surface that corresponds to the locations of the two bearing assemblies are indicated in the photograph.

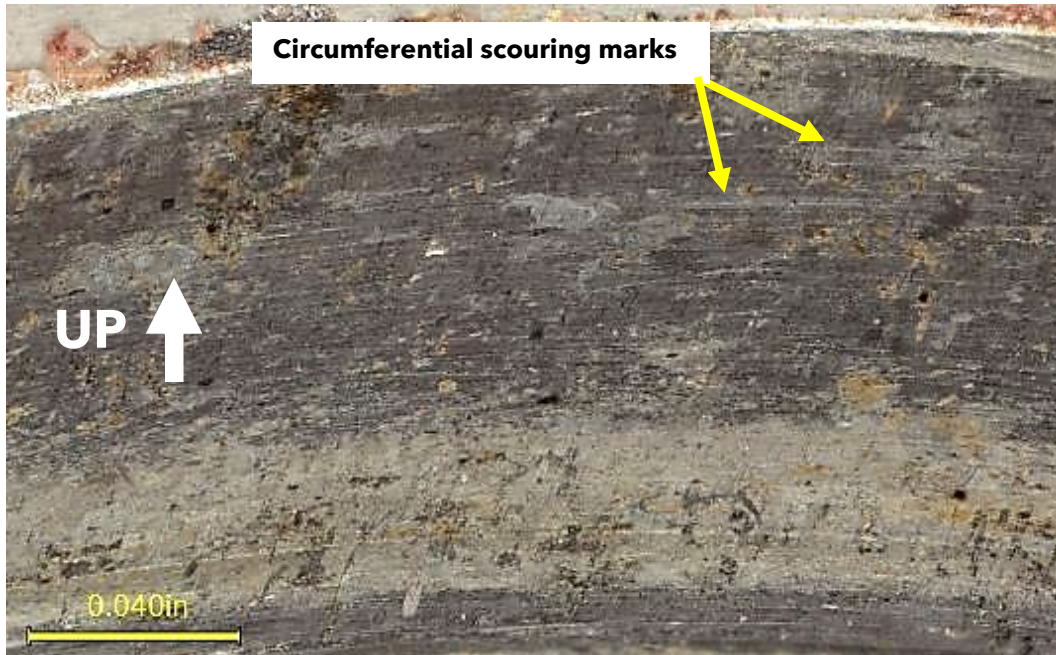
two areas corresponding to the location of the duplex ball bearing assemblies exhibited light scouring marks that were oriented in the circumferential direction (see figure 6). The inner threads were intact and contained no evidence of sheared threads (stripped threads). The crest portions of the threads showed no evidence of the mating clamp nut threads having been pulled straight out of the barrel. The flank portion of the two outermost inner threads (adjacent to the open end of the barrel) in several areas showed evidence of minor galling<sup>3</sup> (see figure 7). The inner threads (root and crown portions) at several locations showed evidence of impact damage, consistent with an external object that entered the bore of the barrel when the clamp nut was not installed. The mating threads (on the clamp nut) could not be screwed (threaded) onto the barrel due to this damage.

**Figure 6.** Inner surface of barrel showing circumferential scouring marks in the area that corresponded to the upper bearing assembly.

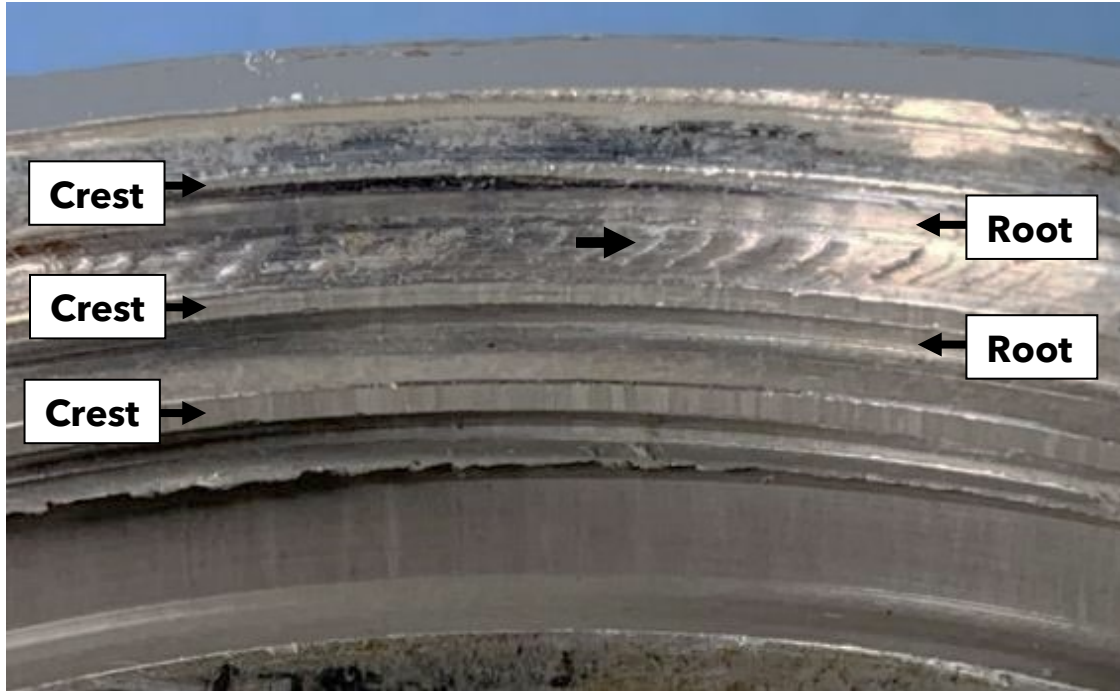
**Figure 7.** Inner threads at the upper end of the barrel portion, after cleaning the threads with a cotton swab soaked with acetone. The thread flank in the general area indicated by an arrow contained evidence of minor galling.

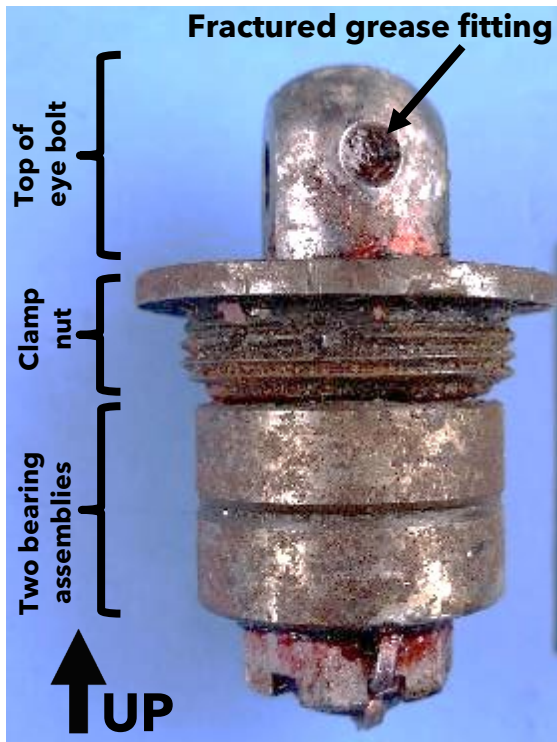
Figures 8 and 9 show photographs of the as-received top eye bolt assembly. The top eye bolt assembly contained an eye bolt portion, clamp nut, moisture seal (not part of the type design), duplex bearing assemblies, castellated nut, washer, and cotter pin. The grease (Zerk) fitting at the top of the eye bolt portion was missing. Duplex bearing assemblies are two matched bearing assemblies that are placed next to each other. In the as-received condition, the outer race of the two bearing assemblies could not be rotated by hand relative to the eye bolt.

The grease fitting fractured from the eye bolt leaving a threaded fragment inside the hole for the grease fitting (see figure 8). The fractured grease fitting portion was not submitted and was not found during the investigation. The hole for the grease fitting and bottom side of the lower bearing were covered with red translucent grease. The outer threads of the clamp nut was covered with grease that appeared opaque and red (with certain portions having a brown appearance). The fracture face of the grease fitting, after cleaning with a cotton swap soaked with acetone, exhibited a rough texture on slant planes consistent with overstress separation.

**Figure 8.** Side view of the as-received eye bolt assembly.

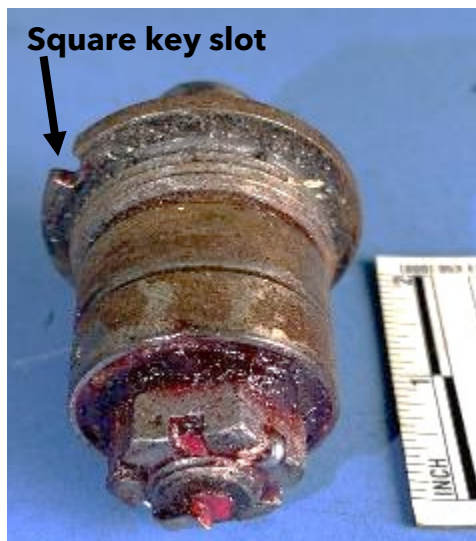
**Figure 9.** As-received eye bolt assembly showing the bottom end of roller bearing assembly that was covered with translucent red grease.

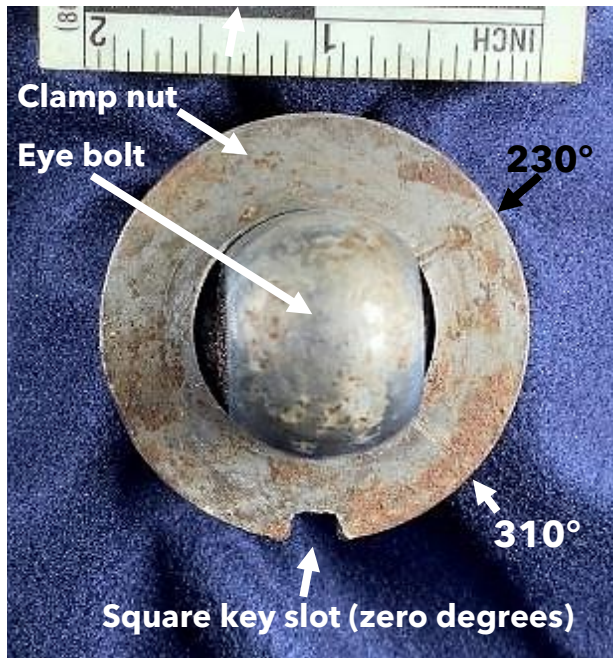
The clamp nut showed no evidence of a part number. The external threads of the clamp nut were cleaned with a cotton swab soaked with acetone. Stereo microscope examination of the clamp nut revealed the external threads were intact and showed no evidence of sheared threads (stripped threads). The clamp nut in the area of the external threads contained a total of five drilled through-holes. For the purpose of this report, the rotational position of the drilled holes were measured when looking down at the center of the eye bolt and rotating clockwise relative to the square key slot (where the slot was arbitrarily assigned the zero degrees position), see figure 10. The drilled holes in the clamp nut were located in the 90, 100, 110, 230, and 310 degrees position relative to the slot (see figure 11). According to a representative from NW Seaplanes, NW Seaplanes did not drill any of the holes in the clamp nut.

**Figure 10.** Top view of the eye bolt and clamp nut. For the purpose of this report, the position of the drilled holes in the clamp nut outer threads were measured when looking down at the center of the eye bolt and when rotating clockwise relative to the square key slot, where the slot is the arbitrary zero position. Radial scribe marks were found at approximately the 230 degrees and 310 degrees position that corresponded to the location of two of the five drilled holes in the nut clamp.

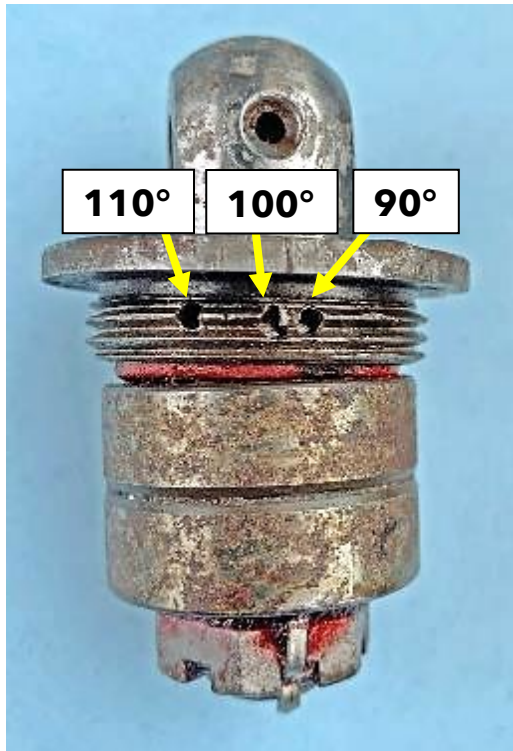
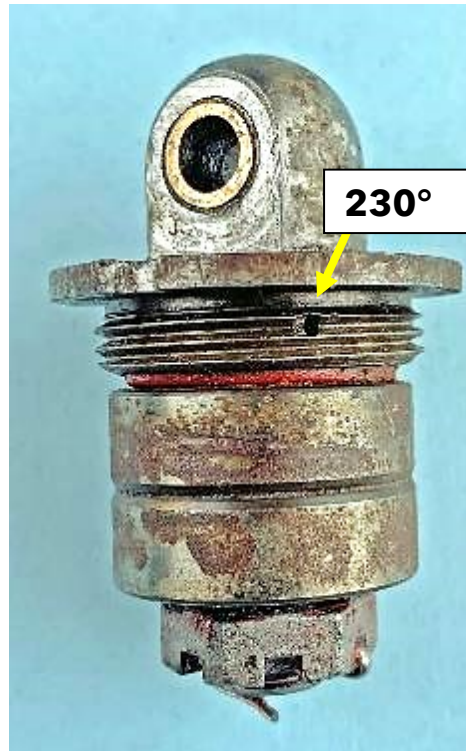
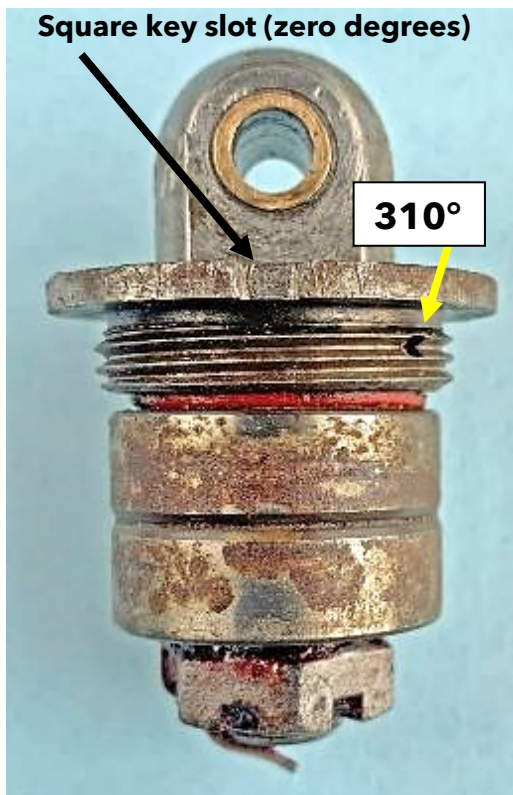
None of the holes contained a fragment of the lock ring or foreign material. Two of the five drilled through-holes (90 and 110 degrees) were unobstructed, and the remaining through-holes (100, 230, and 310 degrees) were obstructed by deformation in the wall that constricted (reduced) the diameter of the hole (see figures 12 through 15). The deformation was in the form of a flat bottom land that extended partially down into the hole and on one side of each respective hole. The flat bottom land at the 100 and 230 degrees position holes extended as deep as the root portion of the threads, whereas the flat bottom land in the hole at the 310 degrees position extended slightly below the root portion of the threads. The contour of the flat land appeared similar to the contour of a metal surface that was struck with a flat bottom tool punch.

The nominal diameter of the circular wire lock ring was specified as 0.08 inch. Per the engineering drawing C3 CF 290 for the assembly of the actuator, a 0.098 inch diameter hole should have been drilled into the clamp nut. The shank end of a 0.0755 inch diameter drill bit was inserted into the drilled holes within the clamp nut to determine whether the drill bit could be fully inserted into each respective hole. The drill bit simulated the diameter of the lock ring. The drill bit penetrated the holes at the 90 and 110 degrees positions. The end of the drill bit partially penetrated the holes at the 100, 230, and 310 degrees position, stopping at the flat bottom land of these respective holes.

**Figure 11.** Side view of the eye bolt assembly, after cleaning the threads and threaded hole for the grease fitting with a cotton swab soaked with acetone, showing drilled through-holes in the outer threads of the clamp nut, at approximately the 90, 100, 110, 230, and 310 degrees position, relative to the square key slot; when looking down at the eye bolt and rotating clockwise. The square key slot is the zero degrees position.

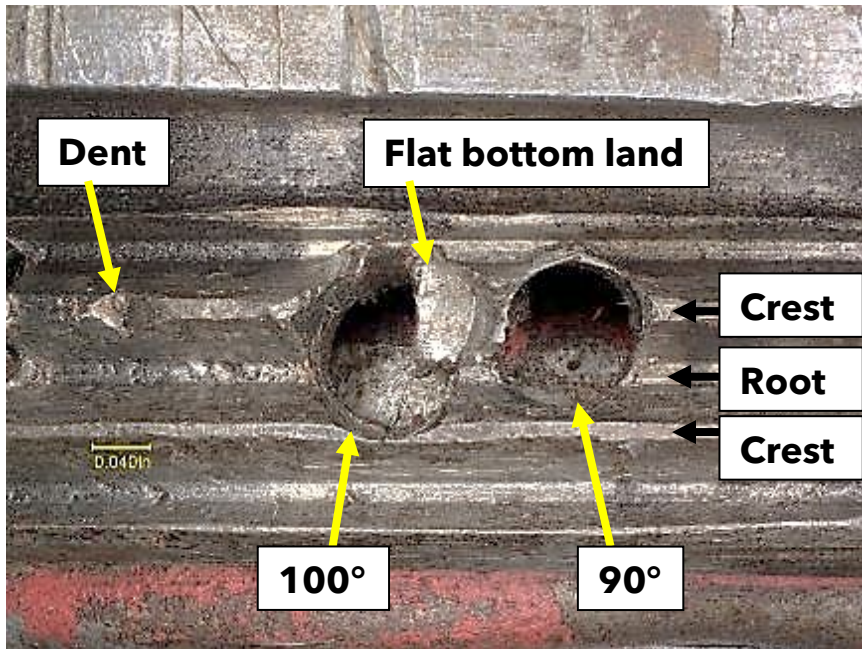
**Figure 12.** Side view of the clamp nut showing radial-oriented drilled through-holes in the outer threads, at approximately 100 and 90 degrees (left to right); after cleaning the threads with a cotton swab soaked with acetone. Metal enclosure for the moisture seal assembly is located under the drilled holes.

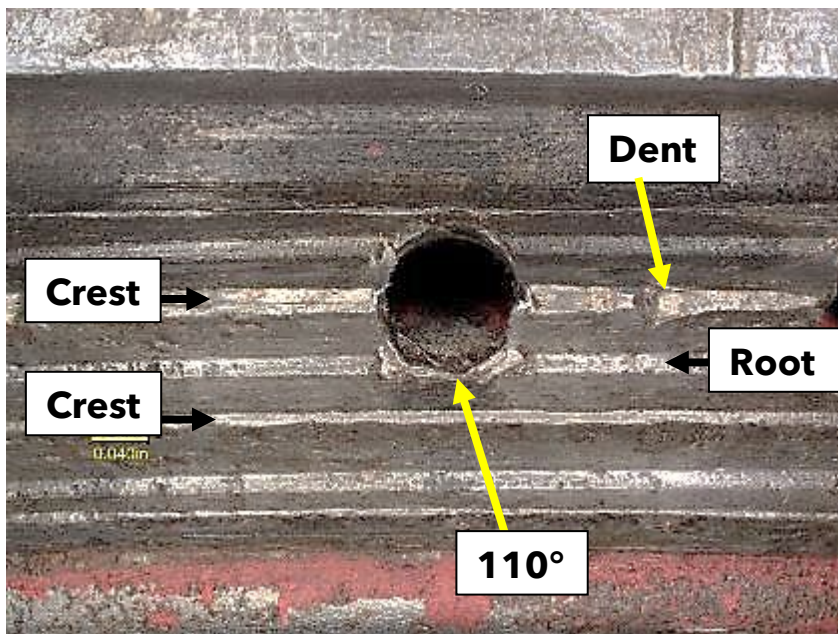
**Figure 13.** Side view of the clamp nut showing a radial-oriented drilled through-hole in the outer threads, at approximately 110 degrees; after cleaning the threads with a cotton swab soaked with acetone. Metal enclosure for the moisture seal assembly is located under the drilled holes.

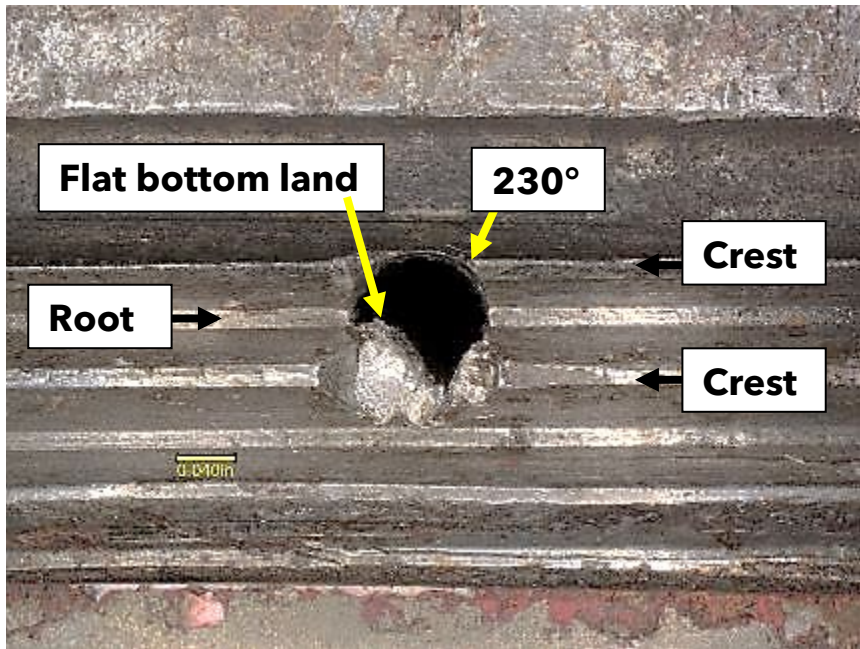
**Figure 14.** Side view of the clamp nut showing a radial-oriented drilled through-hole in the outer threads, at approximately 230 degrees; after cleaning the threads with a cotton swab soaked with acetone.

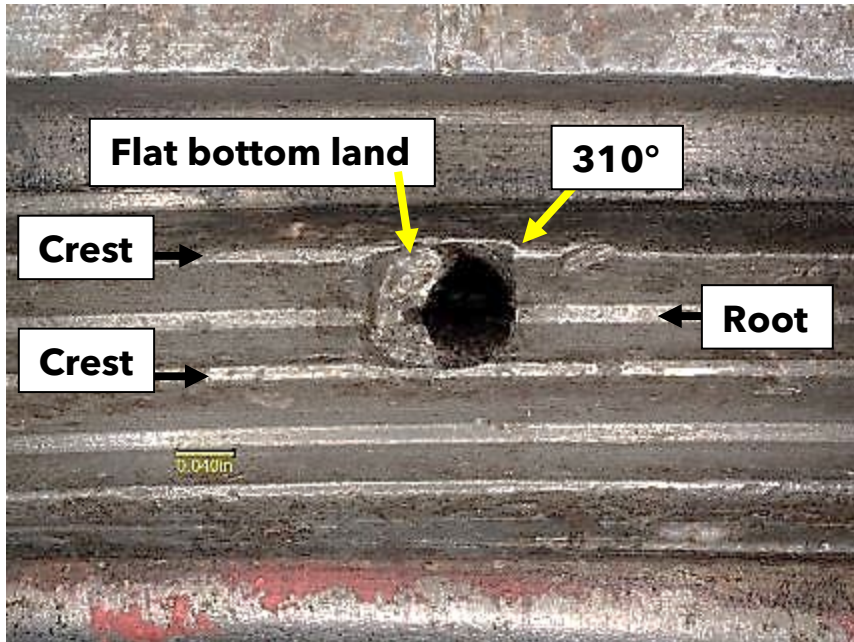
**Figure 15.** Side view of the clamp nut showing a radial-oriented drilled through-hole in the outer threads, at approximately 310 degrees; after cleaning the threads with a cotton swab soaked with acetone.

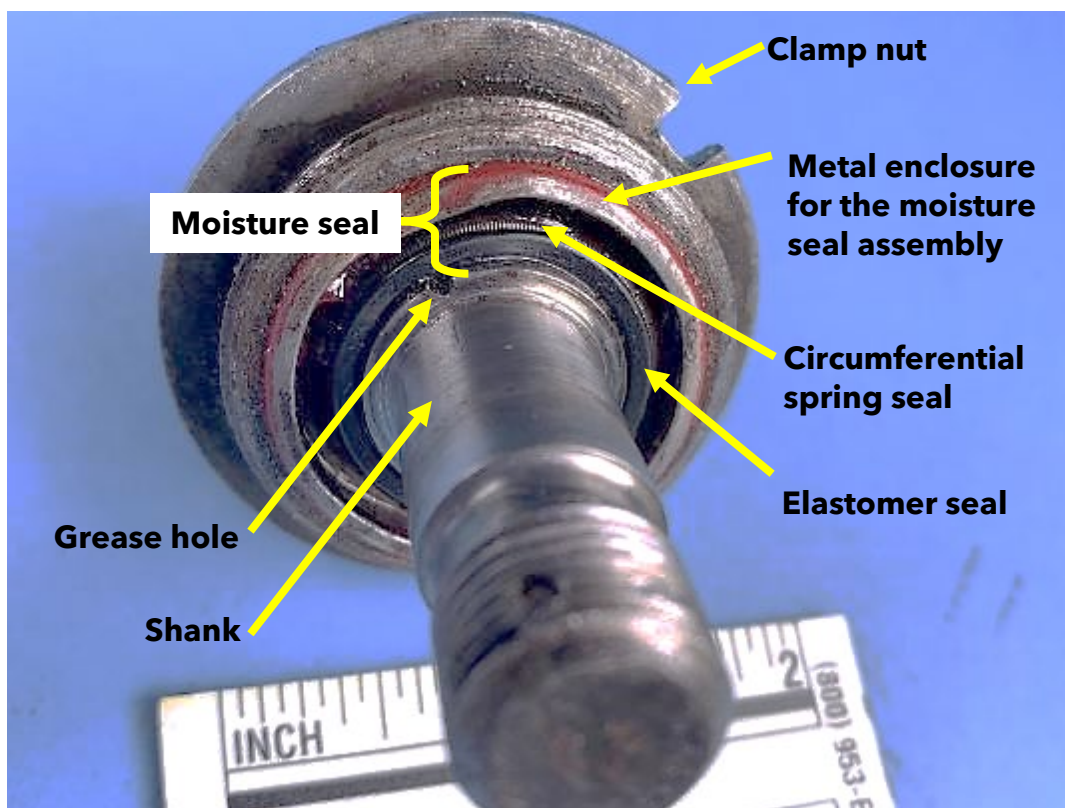
A moisture seal assembly was installed between the inner face of the clamp nut and the larger diameter of the shank portion of the eye bolt. Figures 16 through 19 show the moisture seal in various stages of disassembly. It consisted of a circumferential metal enclosure that was installed against the inner face of the clamp nut. The inner diameter portion of the metal enclosure contained an elastomer seal that extended all around the inner diameter of the metal enclosure. The elastomer seal could not be removed from the metal enclosure and was bonded to the inner diameter portion of the enclosure. A circumferential spring seal made from steel was installed on the outer surface of the elastomer seal. A moisture seal assembly is not shown or listed in the de Havilland aircraft illustrated parts catalog, aircraft maintenance manual, or actuator assembly drawing. The moisture seal was installed after the airplane was delivered from the factory. According to the current operator of the airplane, the purpose of the moisture seal was to prevent environmental elements (moisture, water, dirt) from entering the lubricated portion of the bearings.

**Figure 17.** View looking up at the clamp nut showing the moisture seal assembly. It was installed between the inner diameter of the clamp nut and the larger diameter portion of the shank. It is composed of a circumferential metal enclosure, an elastomer seal and circumferential spring seal.

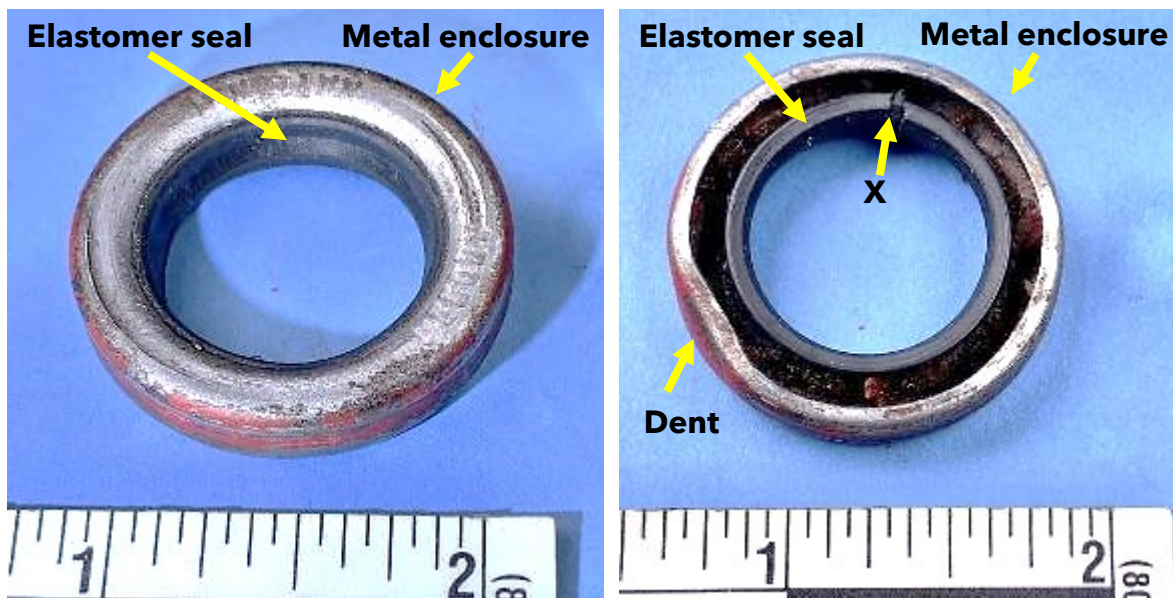
**Figure 19.** View of the disassembled moisture seal assembly. The metal enclosure portion was stamped "NATIONAL" and "180954". The elastomer seal was in the area indicated by arrow "x" and was cut by the NTSB Materials Laboratory to facilitate disassembly. The dent was present in the as-received condition.

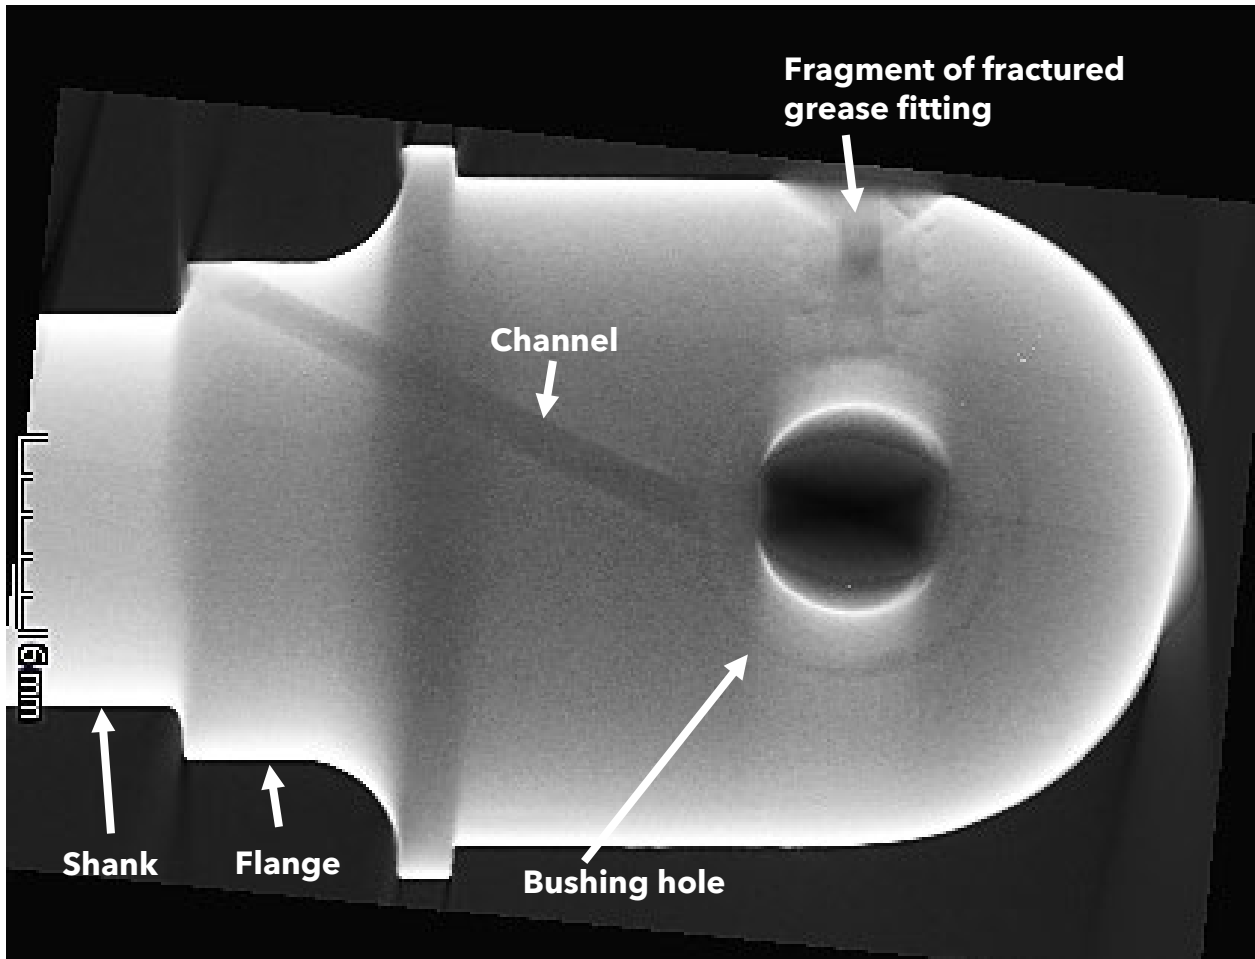
X-ray inspection of the upper eye bolt cross section revealed a channel extended between the flange on the top of the bolt shank and the bushing hole (see figure 20). According to a representative from Viking, a review of the engineering drawings history revealed the eye bolt never contained a channel that extended between the shank flange and bushing hole.

**Figure 20.** X-ray image of the eye bolt cross section showing a channel that extended between the flange on the top of the bolt shank and the bushing hole.
