National Transportation Safety Board

DCA22MA193

Factual Report 23-020 Actuator - Exemplar

Location: Freeland, Washington
Date: September 4, 2022
Vehicle: de Havilland Aircraft DHC-3 Otter, N725TH
Investigator: Adam Huray

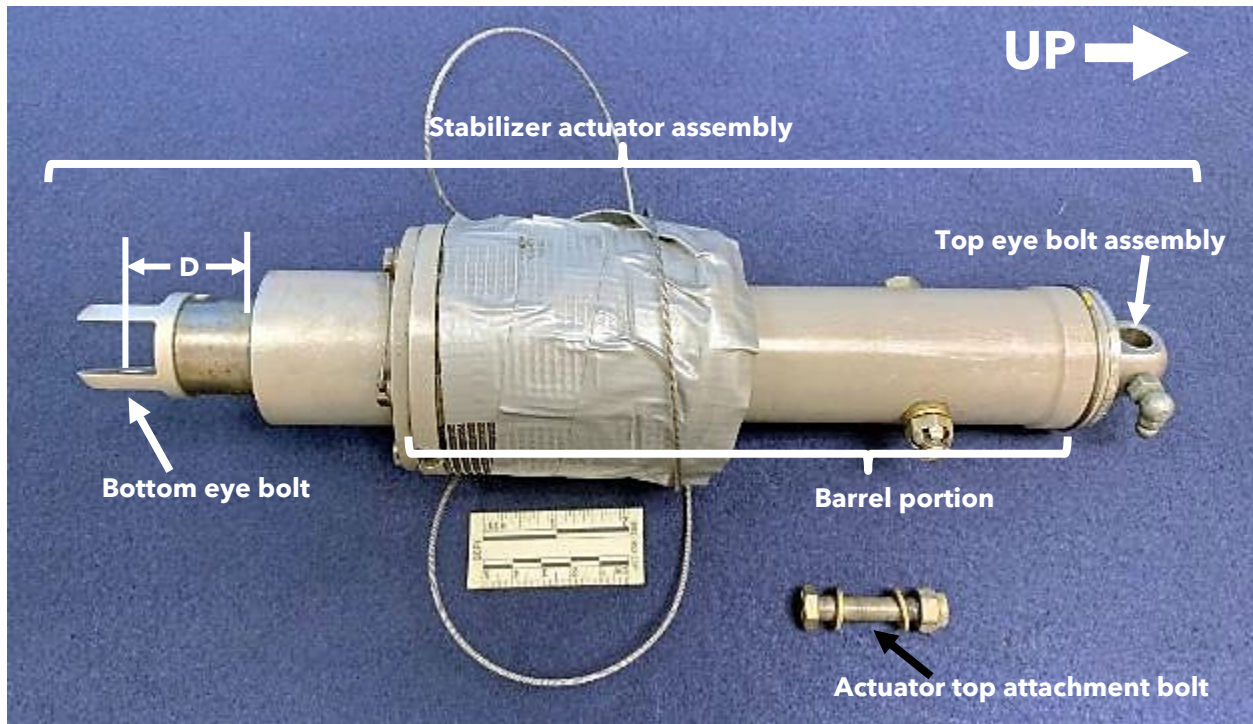
Figure 1 shows a photograph of an exemplar horizontal stabilizer trim actuator assembly, P/N C3CF290, that was removed from an airplane that was not involved in the accident.² The submitted actuator assembly included the top eye bolt assembly and lock ring (see figure 2). The actuator assembly showed no evidence of mechanical damage.

Figure 1. Exemplar horizontal stabilizer trim actuator assembly.

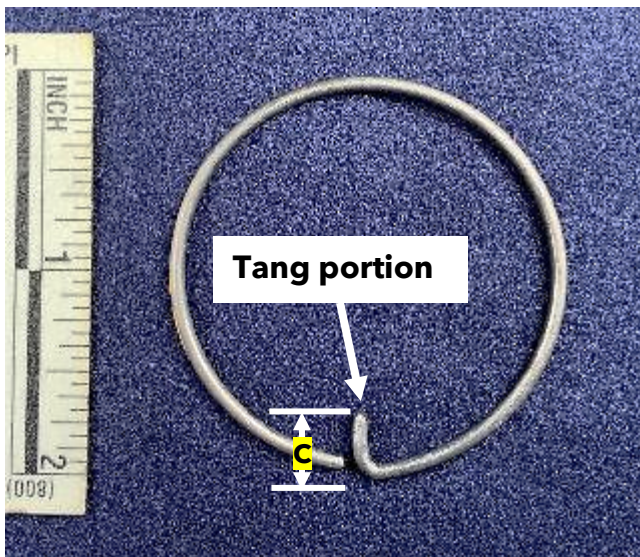
The dimensions of the lock ring mostly were measured with a caliper. The diameter of the lock ring measured approximately 0.08 inch (within the specified range 0.07 inch and 0.09 inch). The length of the tang portion, between arrows "C" in figure 2, measured approximately 0.321 inch (within the specified range of 0.297 inch and 0.328 inch). The inner diameter of the ring, in the general area of the tang, measured approximately 1.79 inch (outside of the specified range 1.73 inches and 1.77 inches), and when rotated 90 degrees rotation away from the tang portion measured approximately 1.77 inches (within the specified range 1.73 inches and 1.77

Figure 2. Lock ring that was disassembled from the exemplar actuator. The portion that is curved radially inward is referred to as the tang portion (between arrows "C").

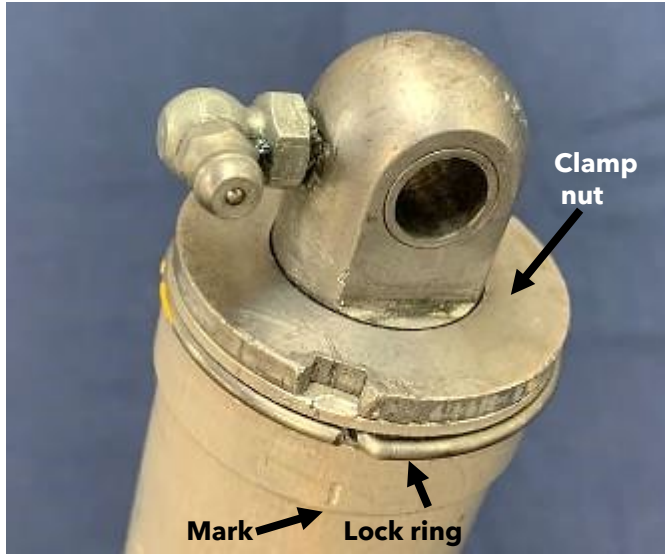
Figure 3. Oblique view of the top eye bolt assembly in the as-received condition showing a lock ring that is in the fully engaged position. Area indicated by "mark" was vibro-peen marked by the NTSB Materials Laboratory to mark the as-received position of the lock ring. Lock ring is bent to the right relative to the tang portion when looking into exterior hole of the barrel.

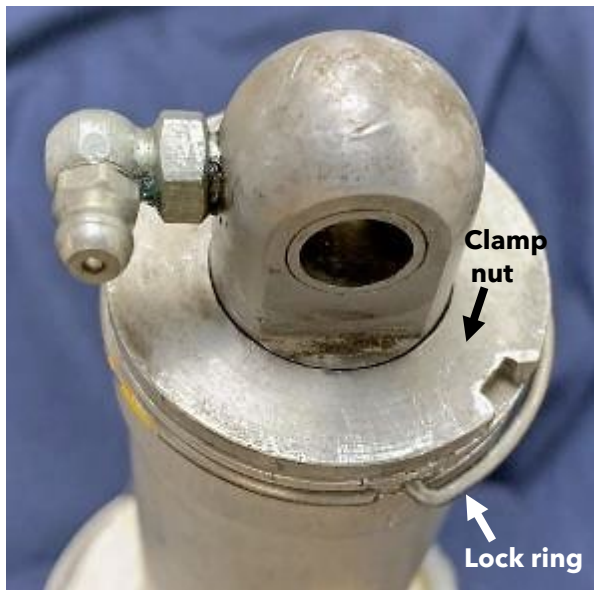
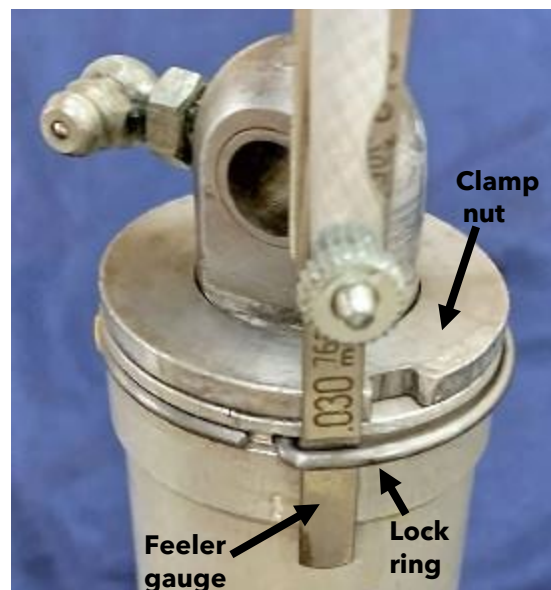
Figure 4. Oblique view of the top eye bolt assembly showing a lock ring that is partially engaged (inserted in the hole of the actuator barrel groove but not inserted in the hole of the clamp nut) [left side of page]; and with a feeler gauge between the lock ring and barrel showing a gap of 0.030 inches (right side of page).

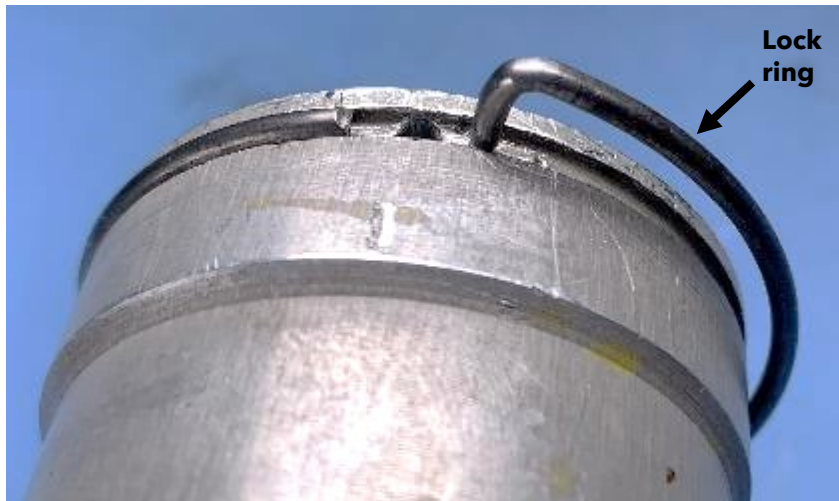
purposes, figure 5 shows an example of a lock ring where the tang portion was resting in the circumferential groove of the barrel.³

Figure 5. Oblique view of the top end of the barrel showing the tang portion of the lock ring intentionally positioned in the groove portion outside of the hole. The purpose of this demonstration was to show the large gap between the lock ring and barrel.

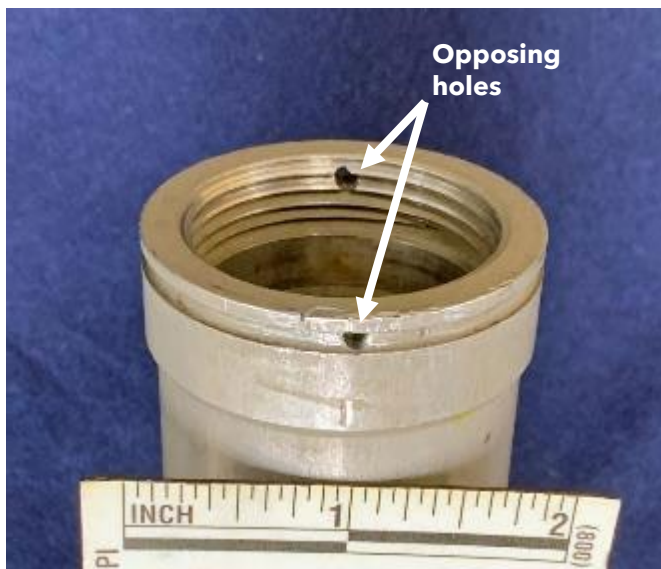
Examination of the barrel after removal of the lock ring revealed the outer groove contained two drilled holes (see figure 6). The drilled holes were located nearly diametrically opposite each other. The diameter of the hole (for the lock ring) was specified as 0.098 inch. The shank portion of the 0.098 inch nominal diameter drill bit was inserted into each hole. The drill bit easily fit into each hole.

Figure 6. Oblique view of the top end of the barrel showing two drilled holes that were located approximately diametrically opposite each other and in the groove.

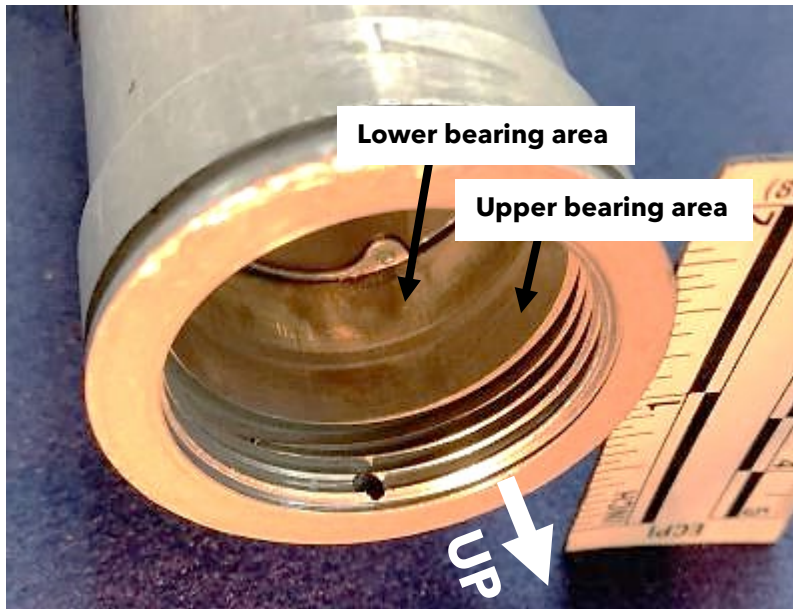
Figure 7. Inner threads at the upper end of the barrel portion, after cleaning.

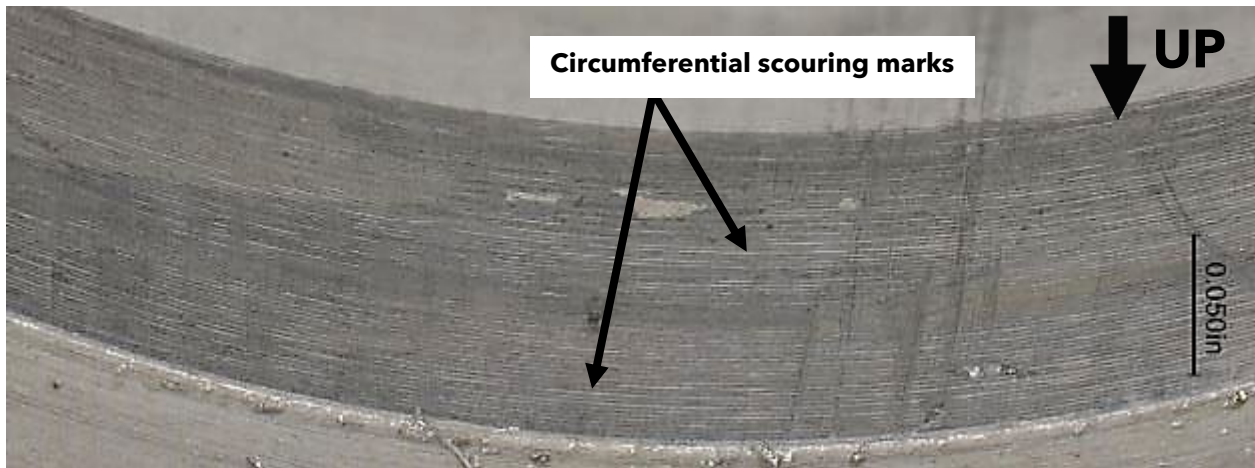
The lock ring was disassembled from the barrel and the top eye bolt assembly was unscrewed from the barrel. The top eye bolt assembly was pulled out of the barrel portion. The exposed bearing assemblies and attachment nut at the bottom of the bearing assembly were covered with a liberal amount of green opaque grease. Figures 6 and 7 show photographs of the barrel after removal of the grease. The inner surface of the barrel in the area below the inner threads contained two bands that corresponded to the position of the two ball bearing assemblies. The inner threads and areas corresponding to the location of the two ball bearing assemblies were cleaned with a cotton rag soaked with acetone. Stereo microscope examination of the upper barrel end revealed the inner threads were intact and contained no evidence of sheared threads (stripped threads). The two areas corresponding to the location of the duplex ball bearing assemblies exhibited light scouring marks that were oriented in the circumferential direction (see figure 8).

Figure 8. Inner surface of barrel showing circumferentially oriented scouring marks in the area that corresponded to the upper bearing assembly (after cleaning).

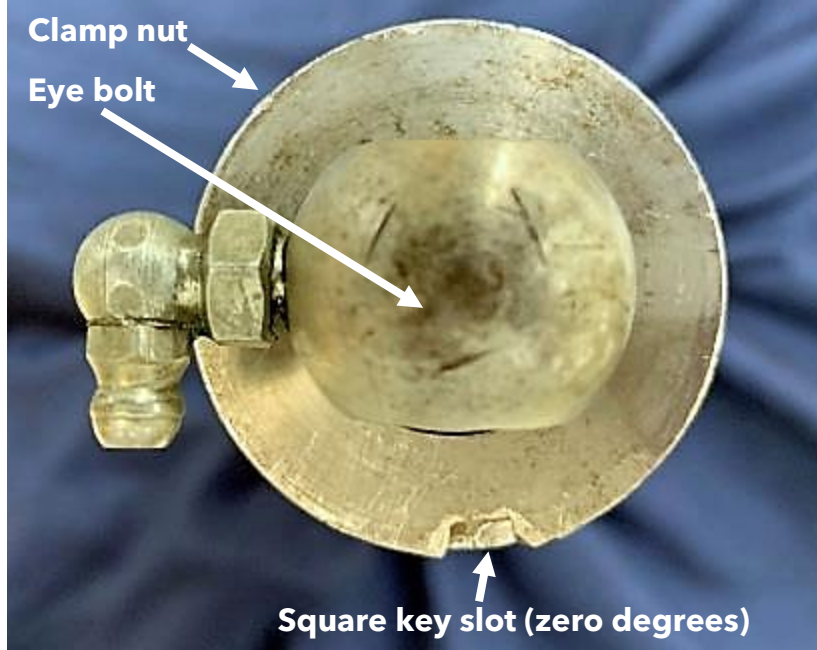
Figures 9 and 10 show photographs of the top eye bolt assembly after removal from the barrel. The top eye bolt assembly contained an eye bolt portion, a grease (Zerk) fitting at the top of the eye bolt portion, clamp nut, moisture seal (not called for in the manual), duplex bearing assemblies, castellated nut, washer, and cotter pin. Duplex bearing assemblies are two matched bearing assemblies that are placed next to each other. The outer race of the two bearing assemblies could be rotated by hand, relative to the eye bolt.

Figure 9. Top view of the eye bolt and clamp nut. For the purpose of this report, the position of the drilled holes in the clamp nut outer threads were measured when looking down at the center of the eye bolt and when rotating clockwise relative to the square key slot, where the slot is the arbitrary zero position.

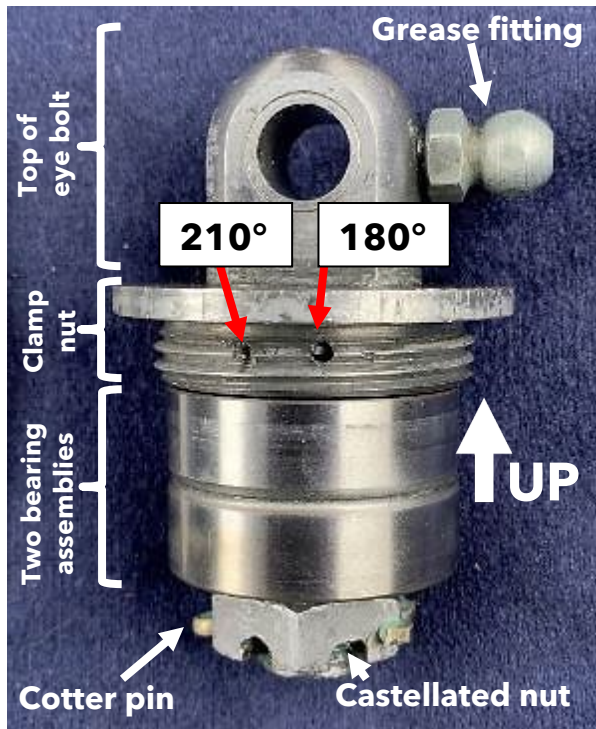
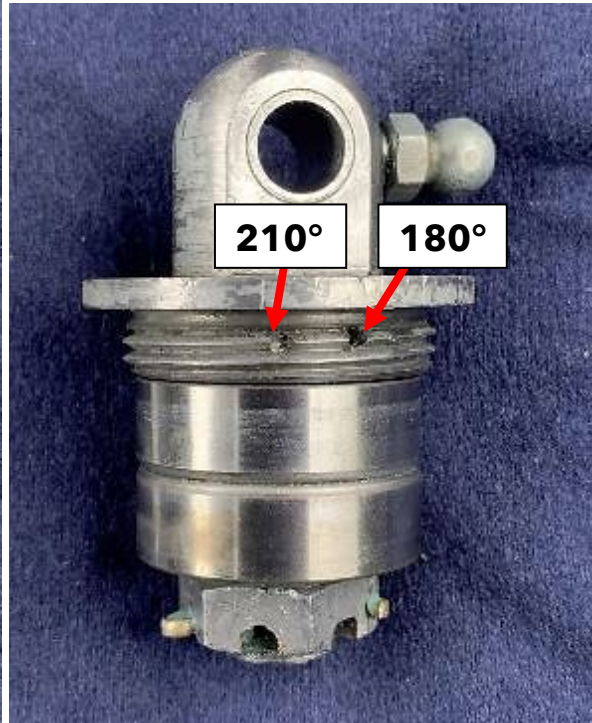
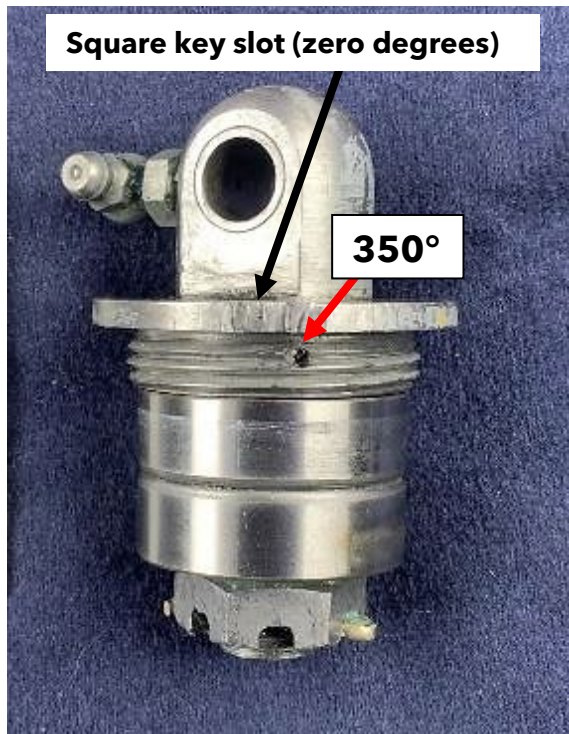
The clamp nut showed no evidence of a part number. The external threads of the clamp nut were cleaned with a rag that was soaked with acetone. Stereo microscope examination of the clamp nut revealed the external threads were intact and showed no evidence of sheared threads (stripped threads). The clamp nut in the area of the external threads contained a total of three drilled holes. For the purpose of this report, the rotational position of the drilled holes were measured when looking down at the center of the eye bolt and rotating clockwise relative to the square key slot (where the slot was arbitrarily assigned the zero degrees position). The drilled holes in the clamp nut were located at approximately the 180, 210, and 350 degrees position relative to the slot (see figure 10).

Figure 10. Side view of the eye bolt, after cleaning, showing drilled holes in the outer threads of the clamp nut, at approximately the 180, 210 and 350 degrees positions, relative to the square key slot; when looking down at the eye bolt and rotating clockwise. The square key slot is the zero degrees position.

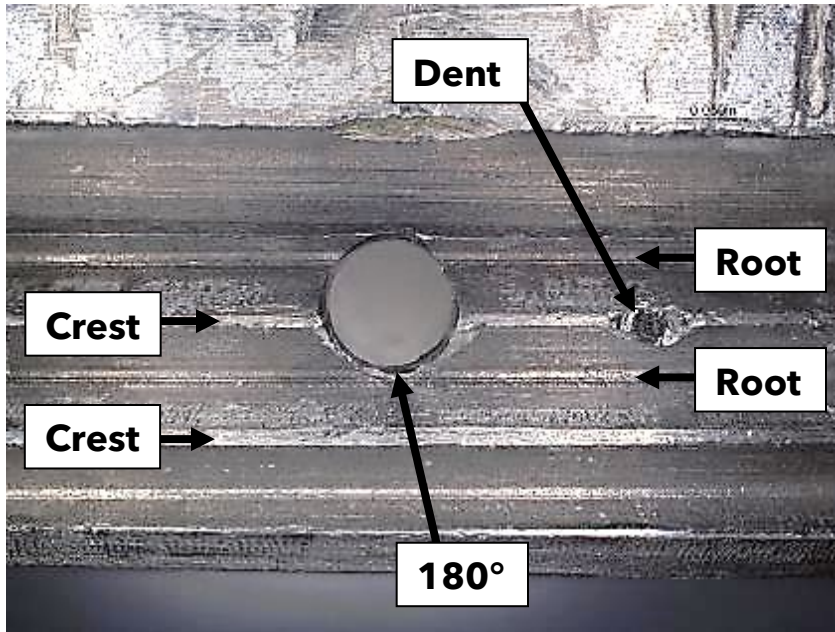
The hole at approximately the 180 degrees position was a through-hole (hole was drilled through the wall of the clamp nut); see figure 11. The drilled hole at approximately the 210 degrees position extended partially into the wall of the clamp nut (see figure 12). It was not a through-hole. The bottom of the hole exhibited a cone contour consistent with the contour at the tip of a drill bit. The bottom of the drilled hole extended slightly below the root portion of the threads. The drilled hole at approximately the 350 degrees position was obstructed by deformation in the wall that constricted (reduced) the diameter of the hole; see figure 13. The deformation was in the form of a round flat bottom land that extended partially down into the hole and on one side of the hole. The center of the round flat bottom land was offset from the center of the hole. The flat bottom land in the hole extended slightly below the root portion of the threads. The contour of the flat land exhibited a round shape that

Figure 11. Outer threads of the clamp nut showing a drilled through-hole at approximately the 180 degrees position; after ultrasonically cleaning the clamp nut with acetone. The clamp nut is in the full disassembled condition (notice that the moisture seal is not behind the hole).

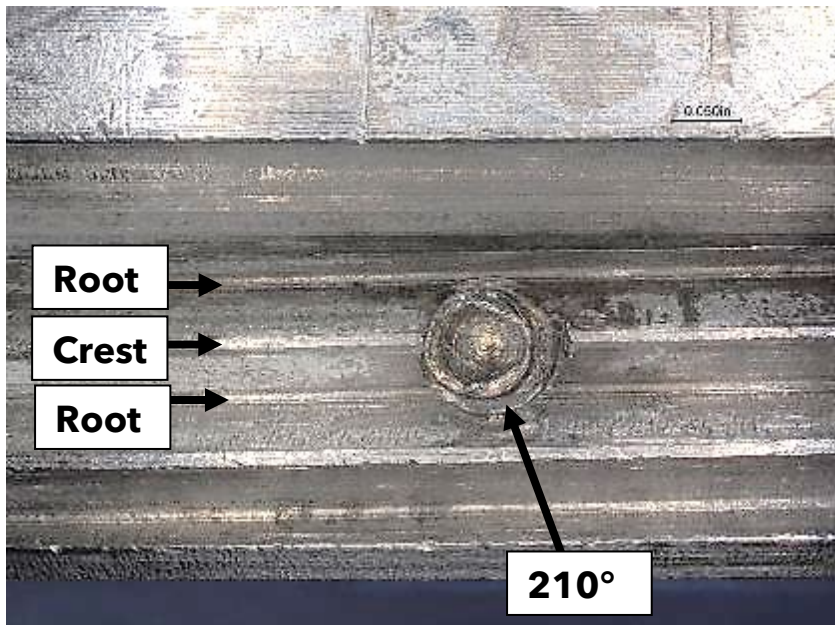
appeared similar to the contour of a metal surface that was struck with a round flat bottom tool punch.

Figure 12. Outer threads of the clamp nut showing a partially drilled hole that did not penetrate the wall of the clamp nut at approximately the 210 degrees position; after ultrasonically cleaning with acetone. This is not a through-hole. The clamp nut is in the full disassembled condition.

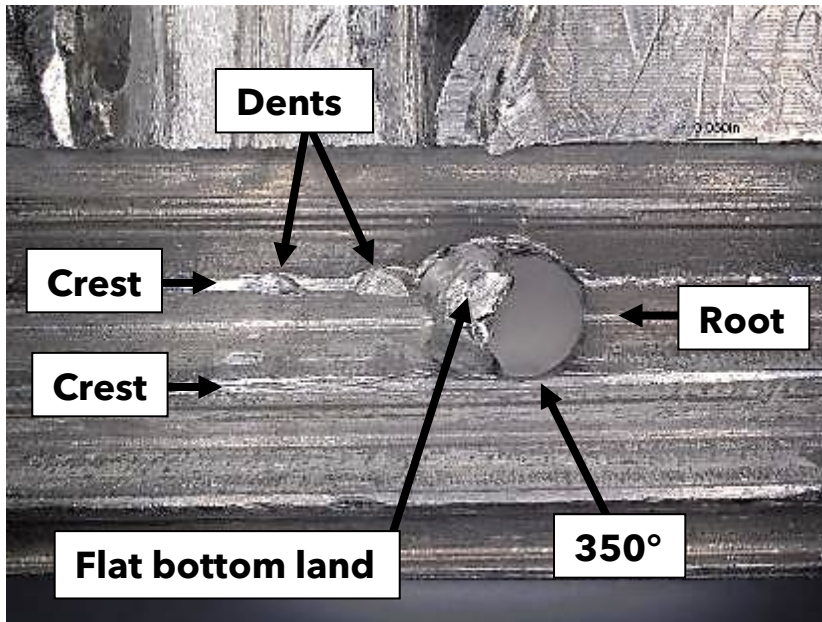
The nominal diameter of the circular wire lock ring is specified as 0.08 inch and the hole in the clamp nut is specified as 0.098 inch nominal diameter. The shank end of a 0.0755 inch diameter drill bit was inserted into the drilled holes within the clamp nut to determine whether the drill bit could be fully inserted into each respective hole. The drill bit simulated the diameter of the lock ring. The drill bit penetrated the hole at approximately the 180 degrees position. The drill bit hit the bottom of the partially drilled hole at approximately the 210 degrees position. The drill bit did not penetrate the hole at approximately the 350 degrees position (struck the flat bottom of the damaged hole).

Figure 13. Outer threads of the clamp nut showing a partially obstructed through-hole at approximately the 350 degrees position; after ultrasonically cleaning the clamp nut with acetone. The clamp nut is in the full disassembled condition.

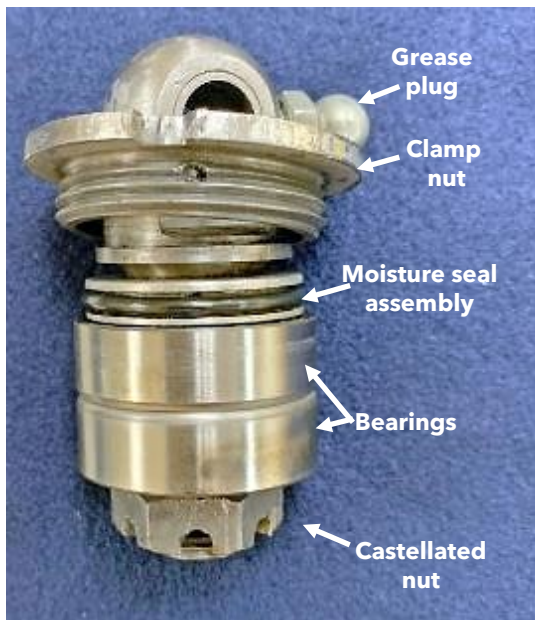
A moisture seal assembly was installed between the inner face of the clamp nut and the larger diameter portion of the eye bolt shank (see figure 14 through 17). The moisture seal assembly was comprised of a metal ring, with a circumferential groove on the inner and outer diameter portion, and elastomer seals that were installed at inner and outer diameter groove portions of the ring. A moisture seal assembly is not

shown or listed on the de Havilland illustrated parts catalog, aircraft maintenance manual, or actuator assembly drawing.

Figure 14. Partially disassembled eye bolt assembly where the clamp nut was pulled up to expose the moisture seal assembly (ring with elastomer seals).

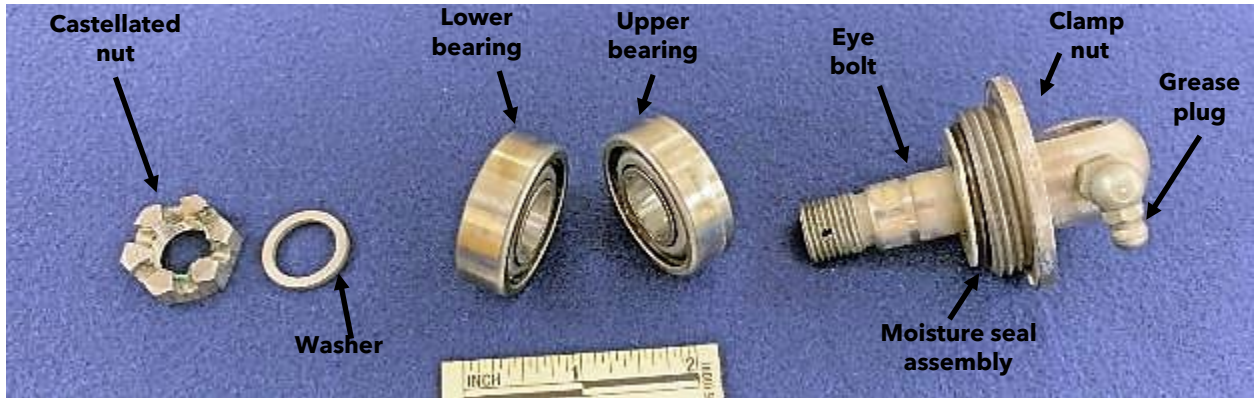
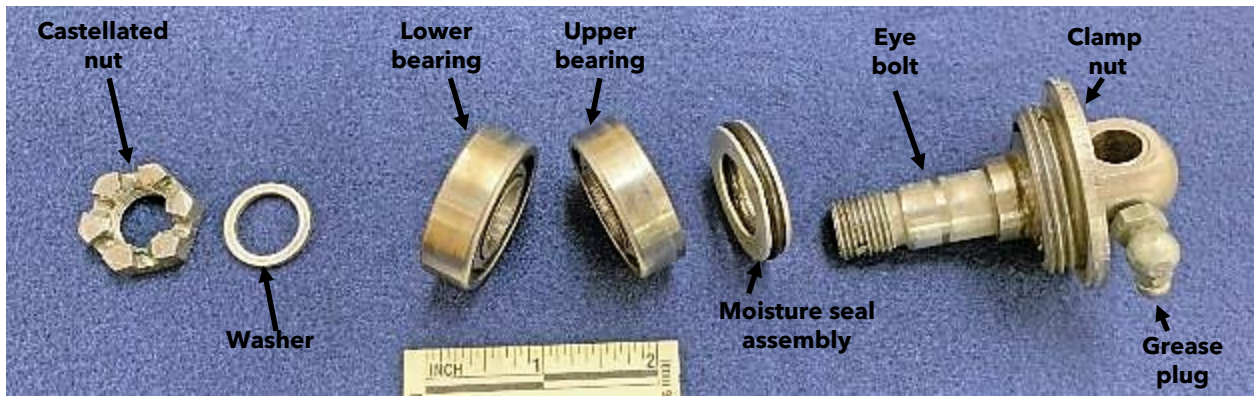
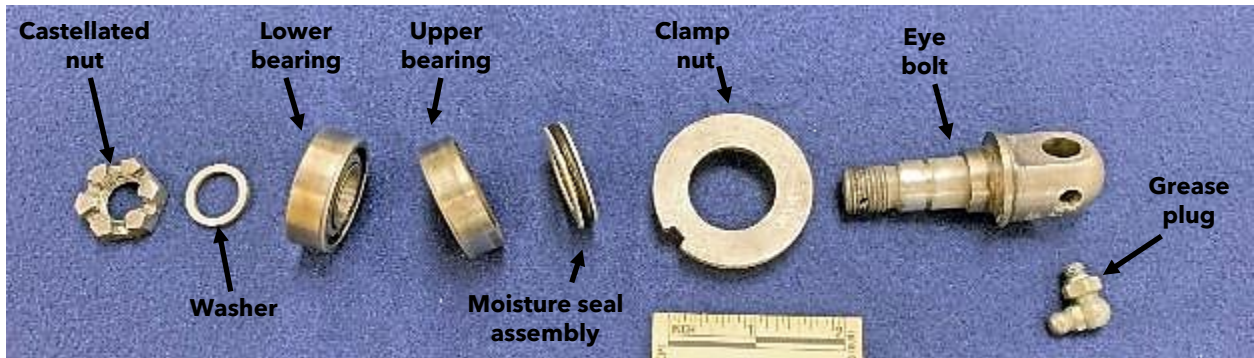
Figure 15. Eye bolt assembly in various stages of disassembly showing the castellated nut; washer; lower and upper bearing assemblies; moisture seal assembly; clamp nut; eye bolt; and grease fitting (left to right).

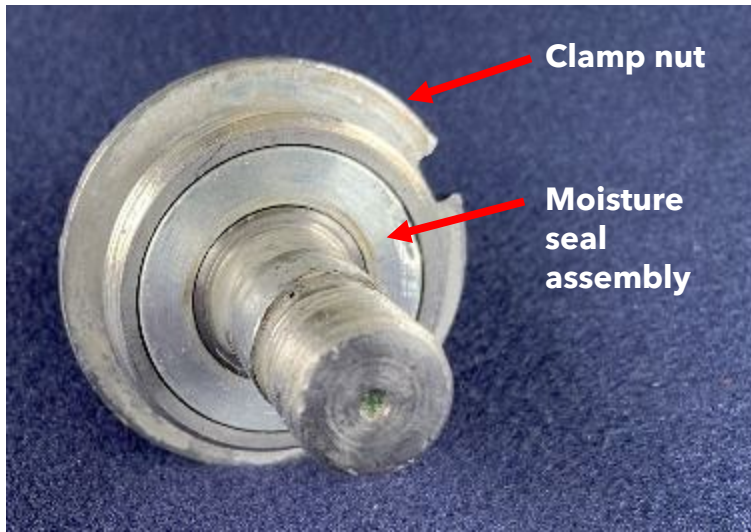
Figure 16. Bottom view of the clamp nut showing the moisture seal in the installed condition.

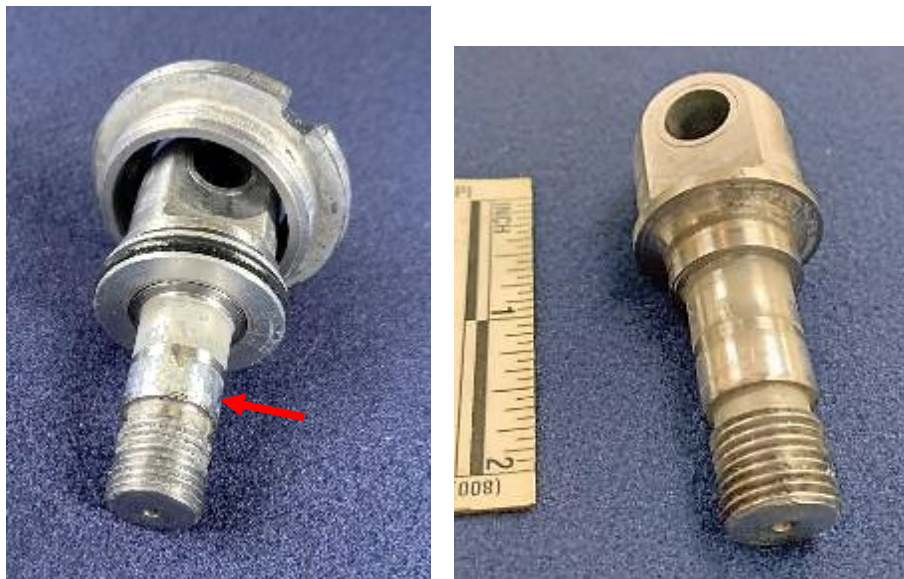
Figure 17. Left photograph shows a partially disassembled eye bolt with moisture seal. Right photograph shows an exposed eye bolt. During reassembly exercises at the NTSB Materials Laboratory, the shank in the area that corresponded to the lower bearing, indicated by an arrow, was ground with a file (to facilitate reassembly).

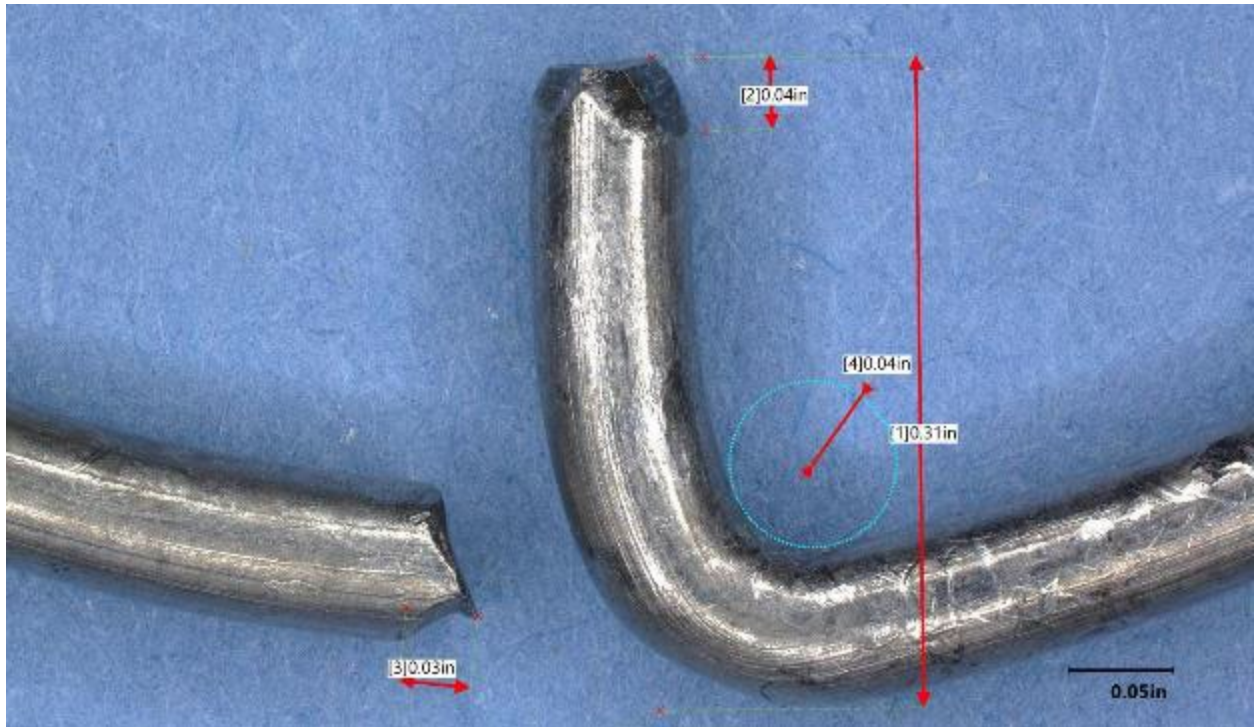
inches). AN996-28 provides a dimension for the inner curvature at the base of the tang (where the tang intersects the overall curvature of the lock ring). This is the specified inner radius dimension. The specified range for the inner radius was between 0.0782 inch and 0.109 inch. The inner radius at the base of the tang measured (with a Keyence VHX digital microscope) approximately 0.04 inches, which was less than the range for the specified inner radius. Bench binocular examination of the lock ring revealed the tang portion contained a beveled end. The AN996-28 specification does not call out a requirement for how to terminate the tang end.

Figure 18. Side view of the lock ring in the area of the tang portion. The inner radius at the base of the tang measured approximately 0.04 inch.

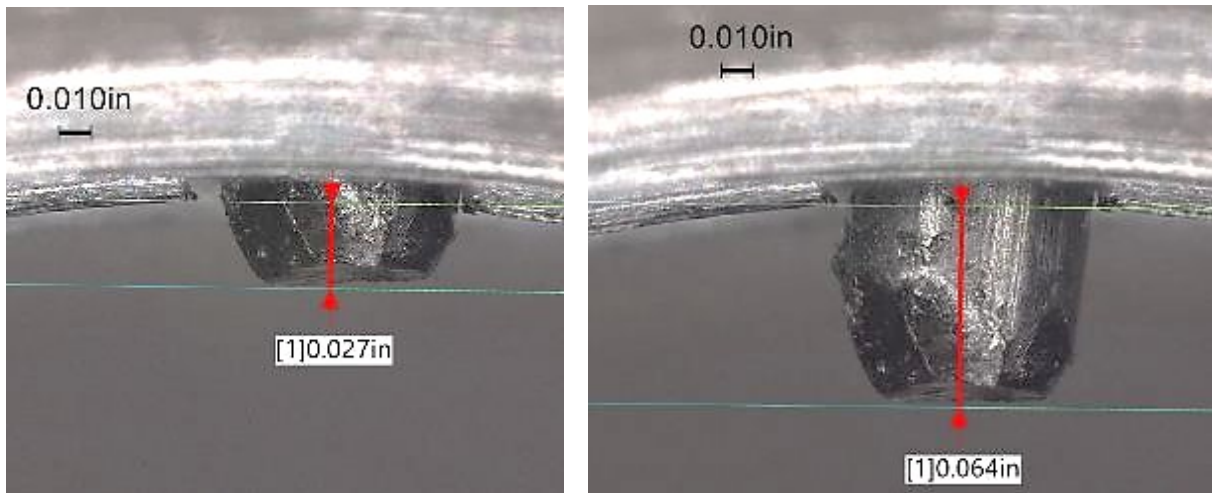
A lock ring was attached to (inserted into) the circumferential outer groove portion of the barrel, and the length of the tang portion that extended (protruded) beyond the inner threads of the barrel was measured with the Keyence VHX digital microscope. The length of the tang portion that extended beyond the crown portion of the inner threads measured approximately 0.027 inch, see figures 18 and 19.

At the base of the tang (where the tang is bent into the circumferential portion of the lock ring), a gap existed between the inner diameter of the lock ring and the outer face of the groove. To close this gap, the diametrically opposite ends of the lock ring, in the area of the tang, was compressed with a c-clamp so that all portions of the lock ring made full contact with the groove portion of the barrel. Having been compressed, the tang portion of the lock ring extended (protruded) further beyond the inner thread of the barrel, compared to when the lock ring was not compressed, see the right image in figure 19. The distance between the crown portion of the barrel inner thread and the tip of the tang portion measured approximately 0.064 inch (slightly more than double the length compared to that of a free sitting non-compressed lock ring).

Figure 19. Side view of the barrel inner thread showing the tip end of the tang portion of a lock ring that extended approximately 0.027 inch out of the hole (left side of page) and when the lock ring was pressed inward into the groove portion of the barrel showing the tip end of the tang portion that extended approximately 0.064 inch out of the hole. Measurements were made between the crest of the inner thread and the tip end of the tang portion of the lock ring.
